Building Inspection Report

Inspection Date: Mon, 16 Feb 2026

Property Address: 131 Greens Rd, Wyndham Vale VIC 3024,
Australia

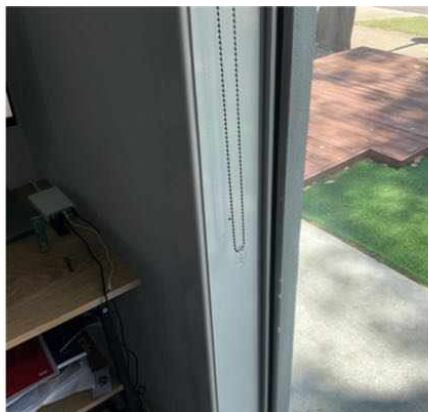
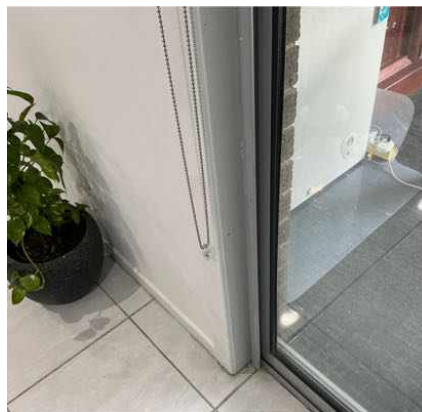
Defects 1.01

| Finding: | Unsecured Blind Cords – Safety Hazard |
| Information: | During the inspection, several window coverings were found to have unsecured blind cords that were not fastened to the window frame or wall. This condition presents a significant safety risk, particularly to young children, as unsecured cords and loops have been linked to strangulation incidents. |

- Increased risk of injury or fatality due to entanglement hazards, particularly in homes with children.
- Non-compliance with the Mandatory Safety Standards for Corded Window Coverings (ACCC) may result in legal penalties.
- Liability risks for landlords or property owners if not rectified, particularly in rental or tenanted properties.

- Secure all blind cords using compliant cleats, cord tensioners, or guides installed at a minimum height of 1600mm from the floor, as per ACCC safety regulations.
- Replace any non-compliant blind mechanisms or convert to cordless alternatives where possible.
- Conduct a full check of all window coverings throughout the property to ensure compliance with applicable safety requirements.
- Property owners and landlords should ensure all corded window furnishings meet the current safety standards prior to occupancy or leasing.

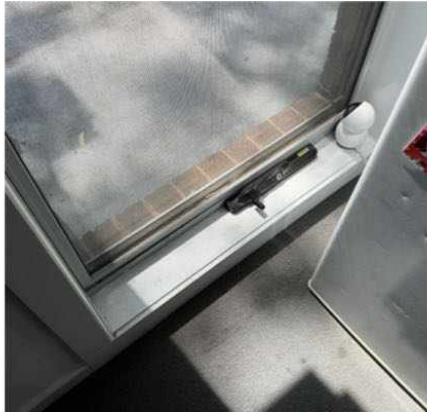
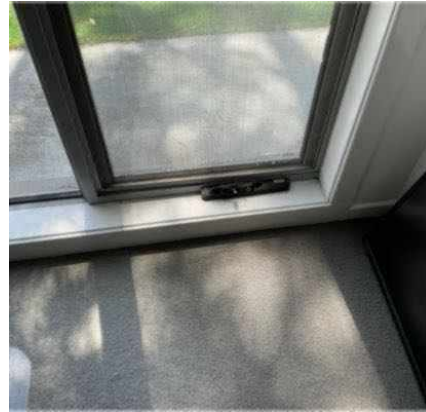
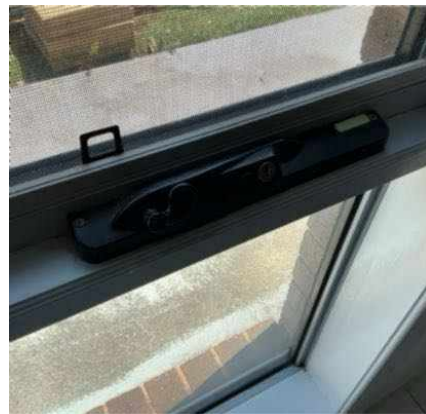
Defects 3.01

| Finding: | Defective and Inconsistent Window Winder Operation |
| Information: | During the inspection, several window winders were observed to be defective or inconsistent in operation. Issues noted include missing plastic operating handles to some winders, difficulty opening or closing certain windows, some winders found to be locked or seized, and others producing grinding noises during operation. These conditions indicate wear, damage, or incorrect adjustment of the window winder mechanisms. |

- Difficult or inoperable window winders can restrict ventilation and normal use of the windows
- Missing handles and grinding noises indicate deterioration or damage that may worsen over time
- Locked or seized winders may prevent windows from being opened in an emergency, posing a potential safety concern
- Continued use of defective winders may lead to complete mechanism failure or damage to window frames

- Missing handles should be replaced, and winders that are difficult to operate, locked, or noisy should be repaired or replaced as required
- Following rectification, all windows should be tested to confirm smooth operation and safe opening and closing

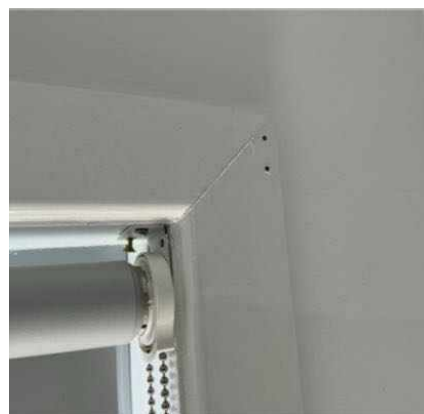
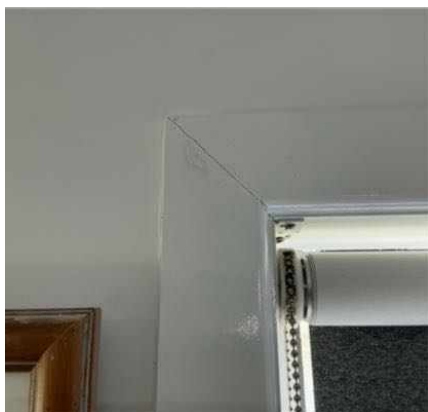
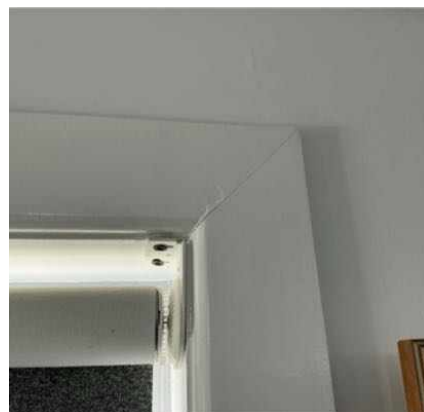
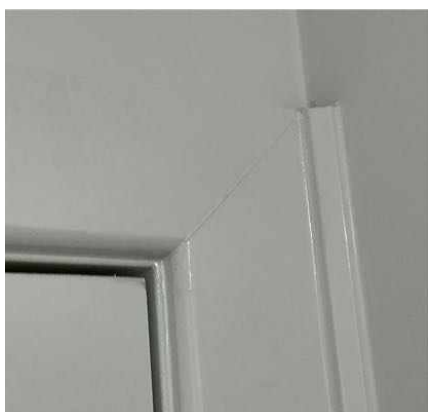
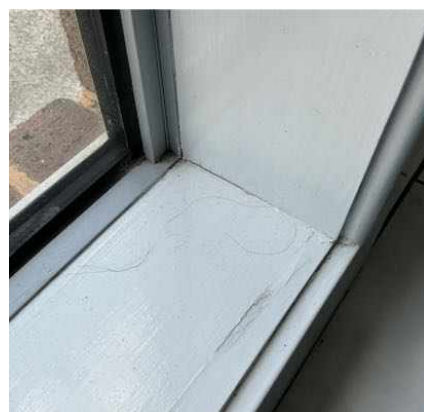
Defects 3.02

| Finding: | Cracking to Painted Architraves and Skirting Boards |
| Information: | Cracks were observed opening up in various sections of the painted architraves and skirting boards. These cracks may be associated with minor building movement, timber shrinkage, or inadequate surface preparation prior to painting. |

- Aesthetic presentation is compromised by visible cracking.
- Potential ongoing movement may lead to further deterioration or require repeated maintenance.
- May indicate underlying workmanship or preparation issues.

- Engage a qualified painter or builder to assess the extent of cracking and undertake necessary repairs, which may include filling, sanding, and repainting affected areas.
- Monitor for any signs of worsening or recurring movement over time.

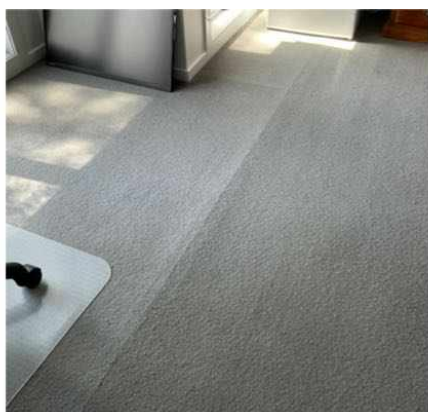
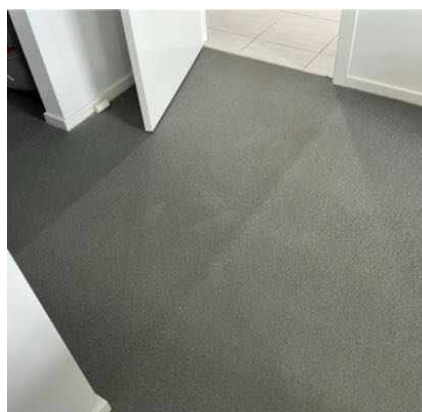
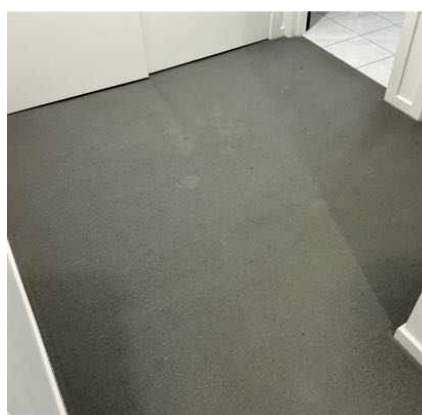
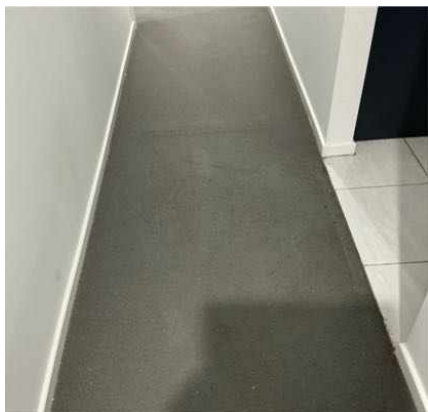
Defects 3.03

| Finding: | Early Wear to Carpeted Flooring |
| Information: | During the inspection, the carpet in areas was observed to be showing early signs of wear. This includes visible flattening of the pile, localised tracking along the main traffic path, and minor surface irregularities. These conditions are commonly associated with regular foot traffic, furniture movement, and general use over time, particularly in high-use circulation areas. |

- Progressive wear may lead to further deterioration of the carpet fibres, reducing overall service life.
- Worn areas can detract from the cosmetic presentation of internal spaces.
- If deterioration continues, localised repairs may become impractical, requiring partial or full replacement.

- Continue routine cleaning and maintenance to slow further wear, including professional carpet cleaning as required.
- Consider the use of runners or protective mats in high-traffic areas to reduce ongoing deterioration.
- If wear becomes more pronounced or unacceptable, seek advice from a flooring specialist regarding repair or replacement options.

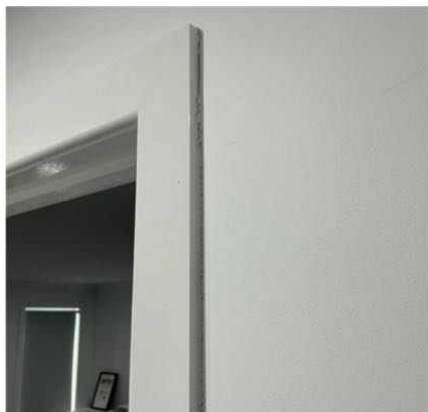
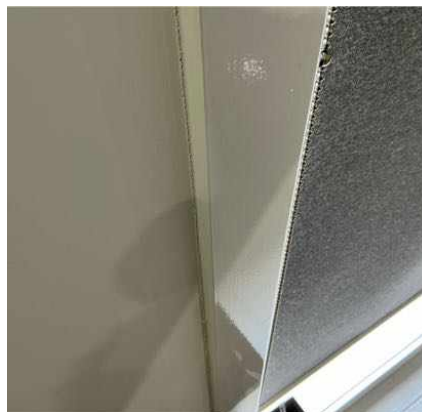
Defects 3.04

| Finding: | Cracking Between Architrave and Wall Junction |
| Information: | During the inspection, cracking and separation were observed between the architrave and the adjoining wall surface. This condition is commonly caused by normal building movement, minor frame shrinkage, or seasonal expansion and contraction of materials. In some cases, movement may also be influenced by additional loads from attached fittings such as blinds or curtain brackets. |

- Cracking detracts from the appearance of internal finishes.
- Minor separation may continue with seasonal changes or building movement.
- Unsealed gaps can collect dust or allow minor moisture staining over time.

- Inspect the affected areas and refix or reinforce the architrave where movement is evident.
- Recaulk or fill the junction using a flexible sealant suitable for painted surfaces, then sand and repaint.
- Ensure that any attached fittings are adequately supported to reduce future stress on trim components.

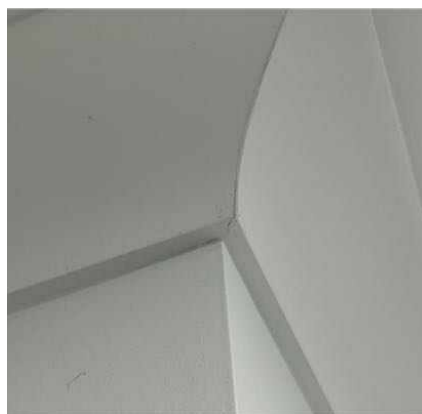
Defects 3.05

| Finding: | Cracking to Internal Wall Linings |
| Information: | Cracking was observed to internal wall linings during the inspection. These types of cracks are generally considered common and are typically the result of natural building movement, age-related wear, thermal expansion and contraction, or minor installation-related issues in plasterboard or supporting framing members. |

- Engage a qualified plasterer to repair cracks and consider installing expansion joints if necessary to accommodate ongoing building movement.
- Arrange for repainting by a qualified painter following any plaster repairs.
- Monitor cracks over time for signs of progression (e.g. widening, lengthening, or new cracks forming).
- If deterioration continues or operational issues with doors/windows arise, seek further assessment from a building inspector or structural engineer.

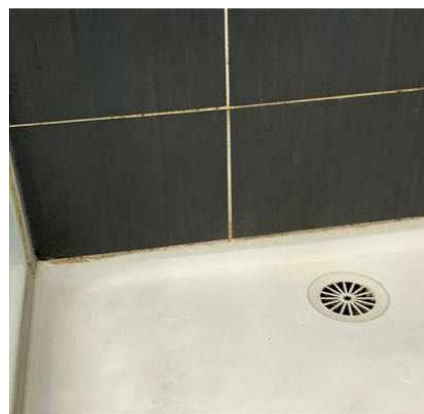
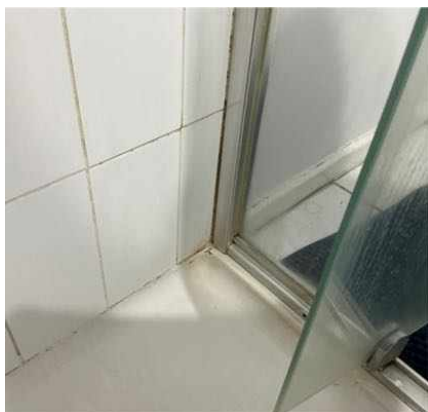
Defects 3.06

| Finding: | Deteriorated Sealant and Caulking – Ensuite, Bathroom, Laundry and Kitchen |
| Information: | During the inspection, the sealant to tiled junctions in the ensuite, bathroom, laundry and kitchen was found to be significantly deteriorated, with visible cracking, separation, and areas of missing caulking. This condition is typically caused by general ageing, exposure to moisture, and differential movement between adjacent surfaces such as wall tiles, vanity units, benchtops, and skirting boards. The failure of these joints compromises the waterproofing integrity of the wet areas. |

- Potential for water ingress into wall cavities, subfloor spaces, and adjacent joinery.
- Moisture-related damage to skirting boards, cabinetry, flooring, and wall linings.
- Increased risk of mould and mildew growth, potentially affecting occupant health.
- Reduced visual appeal and presentation of wet area finishes.

- Engage a qualified trade to remove failed sealant and reapply with mould-resistant, flexible waterproof caulking.
- Inspect adjacent grout lines for similar deterioration and re-grout as required.
- Repair or replace any skirting boards or fixtures already affected by water damage.
- Ensure wet areas are adequately ventilated to prevent premature sealant degradation.

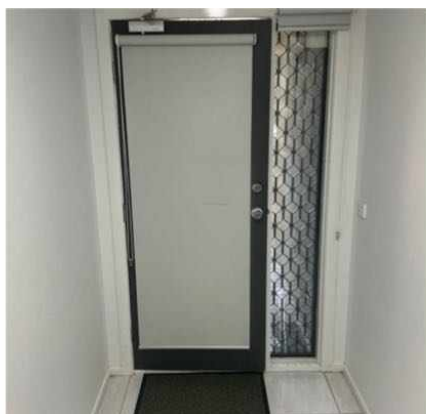
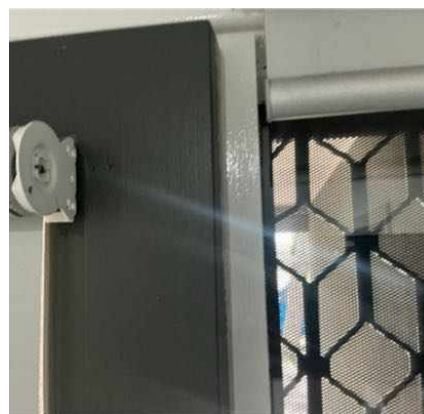
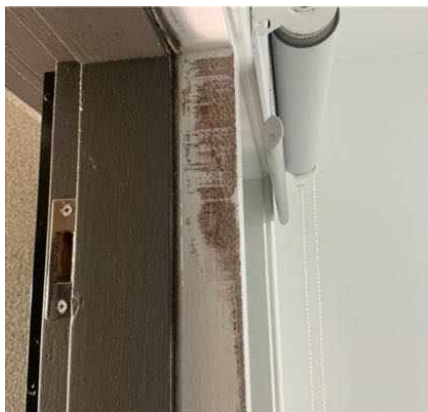
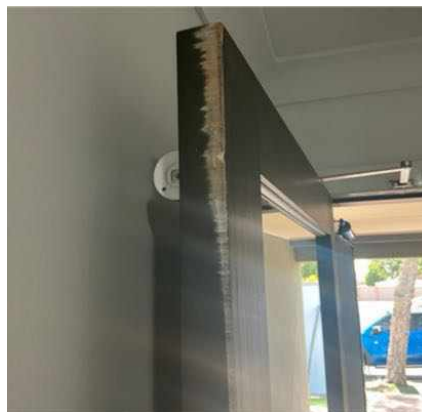
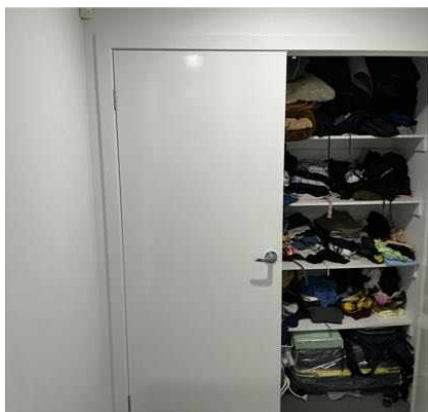
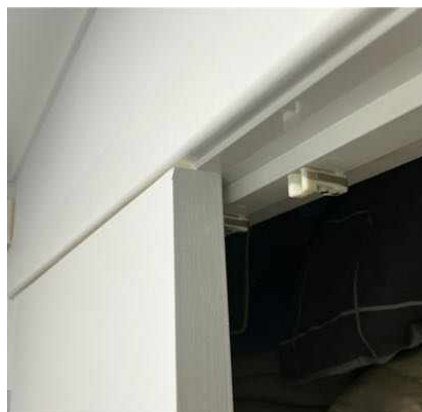
Defects 3.08

While commonly considered a maintenance item, binding doors should be corrected to ensure proper usability and to prevent further deterioration of door components.

- Engage a qualified carpenter or handyman to inspect and adjust the affected doors
- Repair or replace worn or sagging hinges as needed
- Plane or rehang doors to restore correct clearance and function
- Monitor affected areas for signs of structural movement if issues persist or worsen

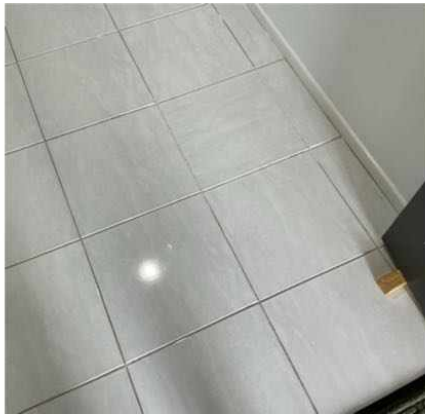
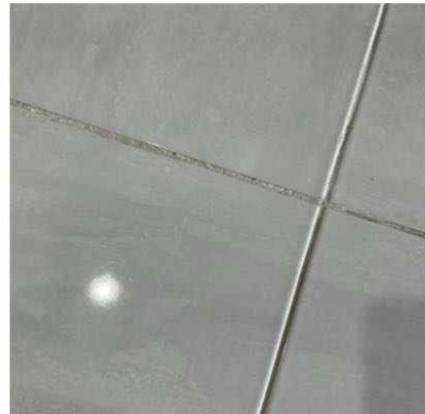
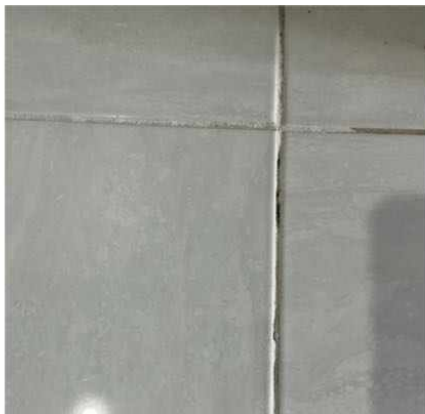
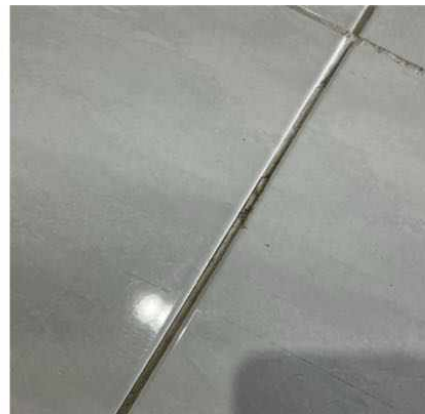
Defects 3.09

In summary, the cracked and previously repaired grout in the entry area indicates unresolved movement or installation-related issues, and remedial works should be undertaken to restore durability and prevent further deterioration.

- Further assessment should be carried out to determine whether the cracking is cosmetic or related to substrate movement
- Affected grout should be removed and reinstalled using an appropriate grout material after confirming the stability of the tiled substrate
- If movement is ongoing, investigation by a suitably qualified contractor is recommended prior to regrouting to reduce the risk of recurrence

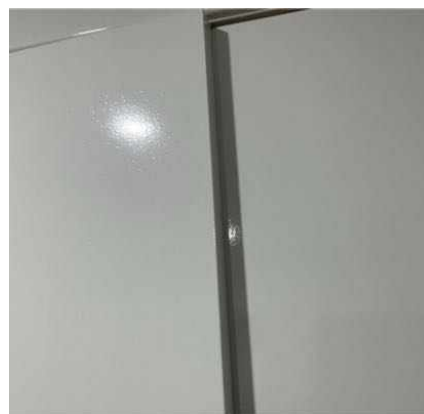
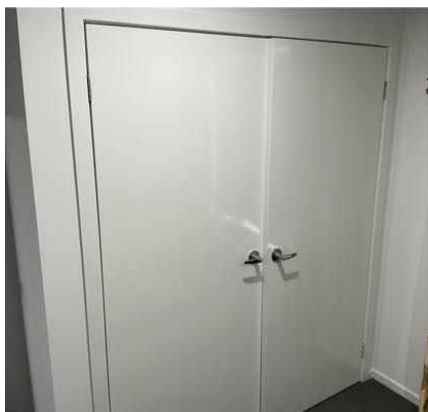
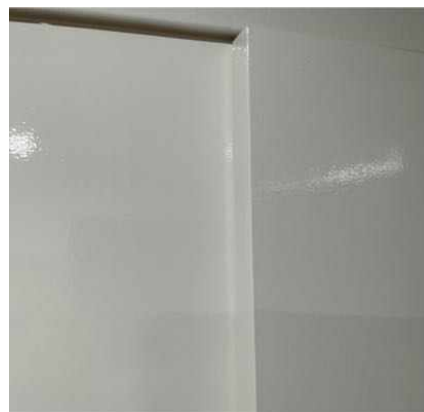
Defects 3.10

Correcting this issue will restore proper functionality and prevent long-term deterioration of cupboard door systems.

- Engage a qualified carpenter or handyman to assess all affected robe doors.
- Adjust hinges, realign doors, or plane down contact points as needed to ensure smooth operation.
- Inspect hardware for wear or looseness and replace if necessary.
- Continue to monitor door performance and perform routine maintenance such as hinge tightening and lubrication.

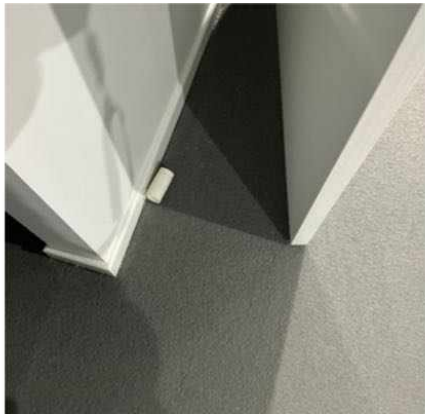
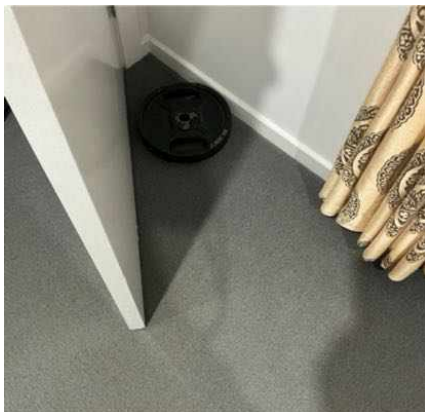
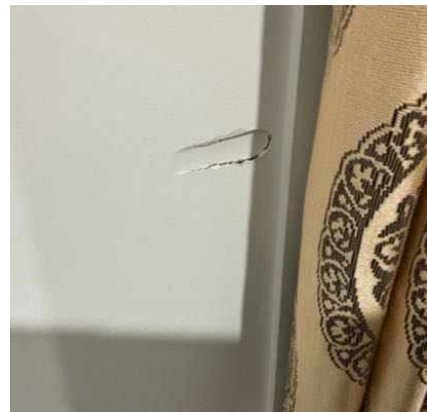
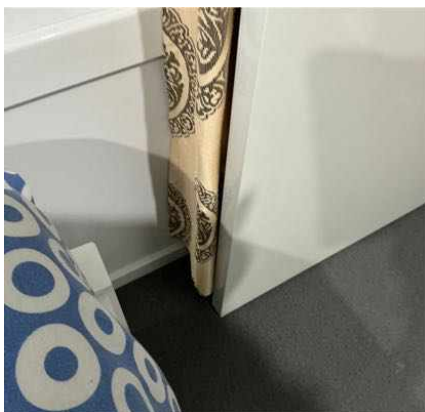
Defects 3.11

Restoring effective door stops is a simple preventative measure that will help protect finishes, improve durability, and maintain the overall condition of the dwelling.

- Ensure door stops are appropriate for the door configuration and swing direction (e.g. floor-mounted, wall-mounted, or hinge-pin types).
- Inspect and repair any associated surface damage caused by previous door impact.

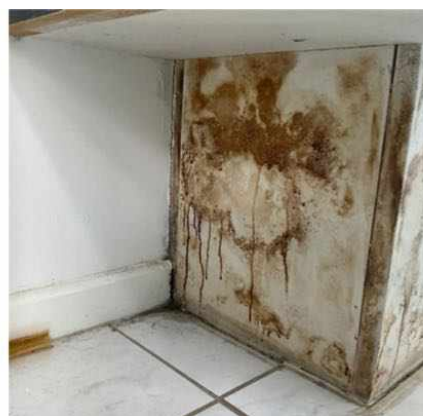
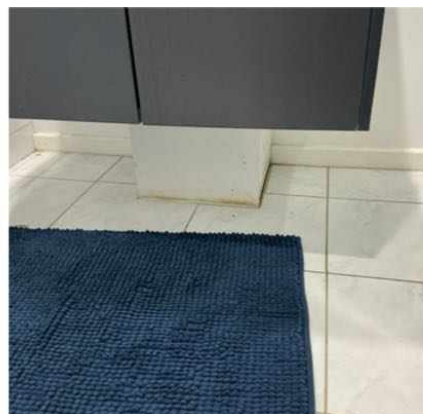
Defects 3.12

In summary, staining to the vanity kick panels in both the bathroom and ensuite is consistent with past moisture exposure. Further investigation and appropriate rectification are recommended to prevent continued deterioration and restore the finish of the cabinetry.

- The vanities and surrounding areas should be checked to confirm there is no active plumbing leak or ongoing moisture source
- If no active moisture source is identified, the staining can be treated as historical and affected kick panels repaired or replaced as required
- Any identified plumbing or moisture-related issues should be rectified prior to undertaking cosmetic repairs

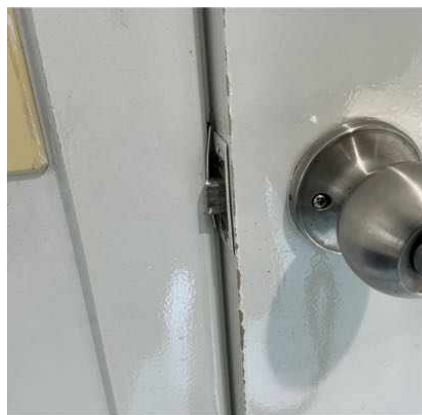
In summary, misaligned striker plates were observed to one or more internal doors. Minor adjustment and maintenance are recommended to restore proper functionality.

- Adjust door hardware and hinges where necessary to ensure smooth and secure operation.
- Monitor for any signs of further frame movement that may cause recurrence.

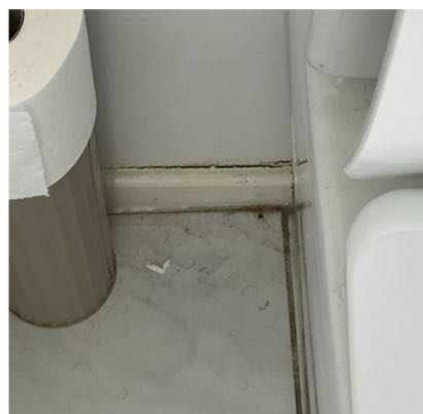
Defects 3.14

| Finding: | Cracking and Deterioration to Skirting Board / Wall Junction Behind Toilet |
| Information: | During the inspection, cracking and separation were observed at the junction between the skirting board and wall behind the toilet. The affected area shows deterioration to the sealant and finish, with visible gaps and minor staining/discolouration consistent with possible past moisture exposure. Thermal imaging of the area was undertaken at the time of inspection and did not indicate elevated moisture levels, suggesting the condition is likely historical rather than active. |

- Cracking and separation at the skirting–wall junction can allow moisture to enter wall and floor junctions if water exposure reoccurs
- While thermal imaging did not identify active moisture at the time of inspection, past water exposure may have affected finishes or concealed materials
- If moisture exposure occurs again, further deterioration to wall linings or skirting materials may result
- The condition detracts from the overall finish and presentation of the bathroom area

In summary, cracking at the skirting and wall junction behind the toilet appears consistent with historical moisture exposure, with no active moisture detected by thermal imaging at the time of inspection; however, repairs and ongoing monitoring are recommended to prevent future issues.

- The area should continue to be monitored for any signs of renewed moisture or

deterioration

- If no ongoing moisture source is identified, affected skirting boards and junctions should be repaired, resealed, and refinished
- If changes are observed in the future, further investigation by a suitably qualified tradesperson is recommended

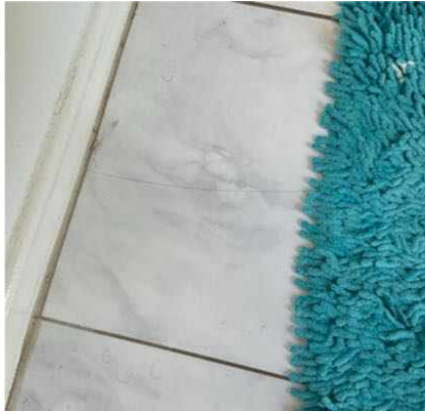
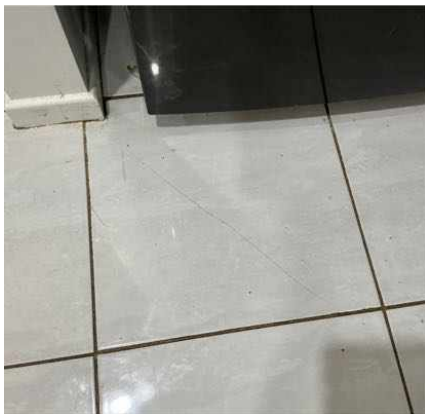
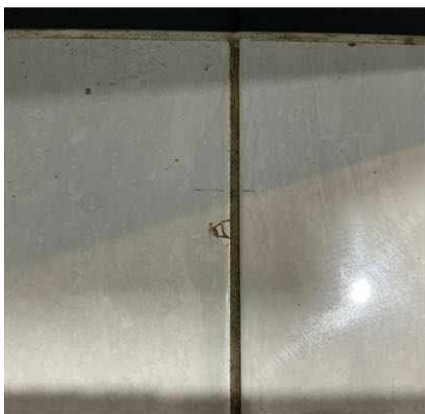
Defects 3.15

| Finding: | Cracked Floor Tiles - Non Structural |
| Information: | Cracks were observed in the floor tiles across multiple areas of the home. These appear to be the result of minor settlement in the floor structure or natural expansion and contraction of materials over time. The cracking is localised and does not appear to indicate any structural concern at this stage. |

- Aesthetic presentation is affected in the areas where tiles have cracked.
- Cracks may harbour dirt or moisture if not addressed.
- Replacement tiles may be difficult to match in colour or pattern depending on availability.

Cracked tiles are a relatively common occurrence and typically considered a maintenance or cosmetic issue unless accompanied by other signs of structural movement.

- Engage a tiling contractor or qualified handyperson to assess and replace affected tiles as required.

- If cracking becomes more extensive, consult a registered builder or building inspector for further evaluation.

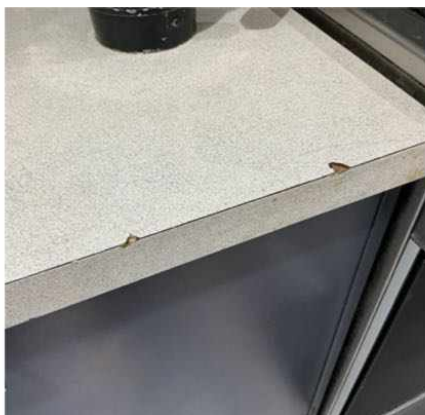
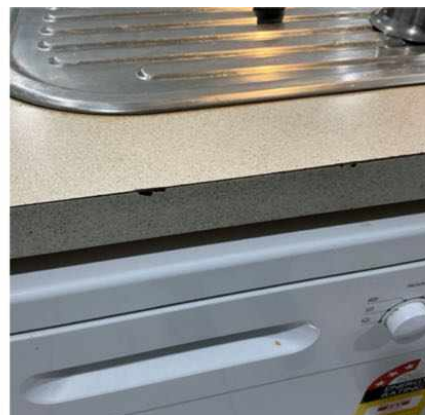
Defects 3.16

Building: Main Building
Location: Kitchen
Finding: Damaged and Chipped Laminate Edging to Kitchen Benchtop

Information: During the inspection, the laminate edging to the kitchen benchtop was observed to be physically damaged and chipped in multiple locations, including corners and along exposed edges. The damage extends beyond minor delamination, with sections of laminate missing and the underlying substrate exposed. This condition is consistent with impact damage and/or prolonged moisture exposure affecting the integrity of the benchtop edge.

- Exposed substrate is vulnerable to moisture ingress, which can lead to swelling and accelerated deterioration of the benchtop
- Once the substrate has been exposed, damage is typically progressive and cannot be reliably reversed
- Chipped and broken laminate edges increase the risk of further damage during normal use and cleaning
- The condition detracts from the overall presentation, durability, and serviceability of the kitchen

In summary, the laminate edging to the kitchen benchtop is damaged beyond minor delamination, with exposed substrate evident. Remedial works or replacement are recommended to prevent further deterioration and restore functionality and appearance.

- Affected benchtop sections should be assessed to determine whether localised edge repair is feasible
- Where the substrate has degraded or swollen, replacement of the benchtop may be required to achieve a durable outcome
- Water exposure to damaged edges should be minimised until rectification works are completed

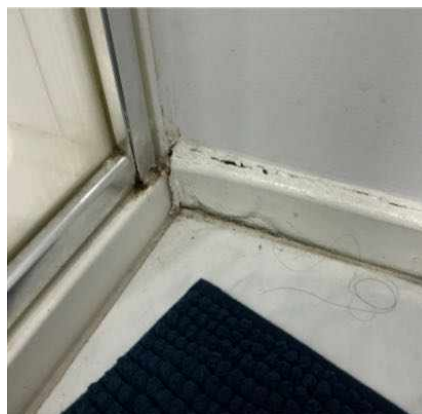
Defects 3.17

| Finding: | Shower water damage - Skirtingboards |
| Information: | Water damage was identified to surrounding building elements located outside of the shower area. The visible damage is consistent with prolonged exposure to moisture and suggests that water from the shower has regularly reached areas beyond the intended wet zone. The staining, swelling, or deterioration of skirtings, architraves, or adjacent wall surfaces indicates that moisture has been penetrating materials not designed to withstand constant water exposure. |

- Ongoing water ingress can result in continued deterioration of timber elements and internal linings
- Prolonged exposure may compromise structural components concealed behind the wall or floor finishes
- Damaged materials can become a source of mould growth, which may pose health risks and increase remediation costs
- If active water ingress is present, it may indicate inadequate waterproofing or sealing around the shower area

The water damage noted adjacent to the shower suggests a failure to adequately contain water within the wet area. Although the visible damage may be manageable with minor repair works, it also raises concerns about possible concealed defects. Further investigation is recommended to ensure the issue is not ongoing and to determine the appropriate scope of rectification.

- Engage a licensed plumber or waterproofing specialist to investigate the cause and determine whether the waterproofing membrane or shower enclosure is failing
- Conduct a moisture meter assessment to determine if the area remains damp or if the damage is historic and no longer active
- If no further moisture ingress is detected, the damaged materials may be repaired or

replaced by a qualified carpenter, painter, or registered builder

- Where active leaks are present, necessary rectification should be prioritised to prevent further internal damage

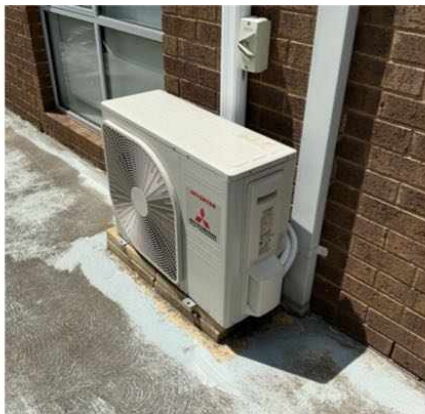
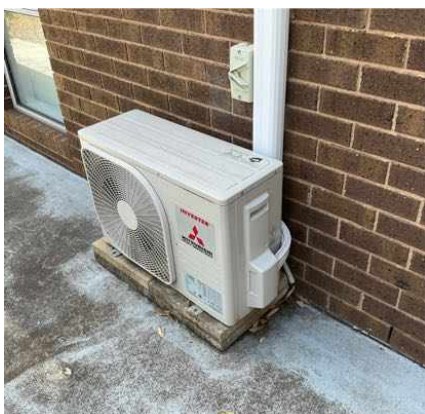
Defects 3.18

| Finding: | Uncontrolled Discharge from Air Conditioner Overflow Pipe |
| Information: | The air conditioning unit's overflow pipe discharges directly onto the adjacent surface, rather than being connected to a compliant stormwater or drainage system. This results in persistent dampness in the immediate area, particularly during extended periods of use. |

- Elevated moisture levels near the structure may promote fungal growth or decay in adjacent materials.
- Prolonged dampness can lead to corrosion of nearby metal components or deterioration of timber framing and finishes.
- Termites are attracted to damp and decaying conditions, increasing the risk of termite ingress and concealed structural damage.
- Pooling water may create slip hazards on nearby paved or hard surfaces.

Although this is a relatively minor plumbing oversight, it presents an ongoing risk to nearby building elements and termite management. Correction is typically straightforward and should be planned as part of post-settlement maintenance to preserve building durability and reduce pest-related risks.

- Engage a licensed plumber to assess and reroute the overflow pipe into a compliant drainage system, ensuring water is directed safely away from the property.
- Monitor adjacent building elements for signs of moisture damage, corrosion, or fungal growth.
- Ensure that landscaping, garden beds, or other features around the area do not trap moisture against the building.
- Incorporate this item into ongoing property maintenance schedules to reduce the risk of long-term damage or pest attraction.

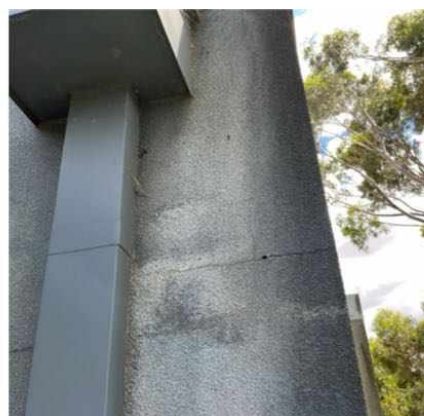
Defects 3.19

| Finding: | Fine Cracking to External Render |
| Information: | During the inspection, fine cracking was observed to the external rendered wall surfaces in multiple locations. The cracking appears generally hairline in nature and |

follows linear patterns consistent with minor movement, shrinkage, or thermal expansion of the rendered finish. No significant displacement or bulging of the wall surfaces was observed at the time of inspection.

- Fine cracking in render can allow moisture to penetrate the rendered coating, particularly during prolonged or wind-driven rain
- Moisture ingress may lead to deterioration of the render system and underlying wall materials over time
- If left unmaintained, minor cracking can widen and become more difficult and costly to repair

In summary, fine cracking to the external render is present and, while currently considered minor, requires maintenance to prevent moisture ingress and ongoing deterioration of the rendered wall system.

- The affected render cracking should be monitored and sealed using an appropriate flexible, paintable exterior sealant
- Following sealing, the areas should be repainted to maintain weather resistance and uniform appearance
- Any increase in cracking width, length, or pattern should be further investigated by a suitably qualified professional

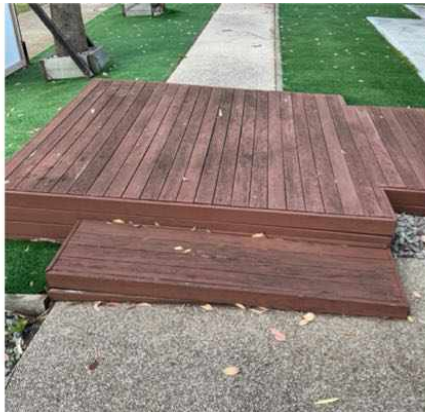
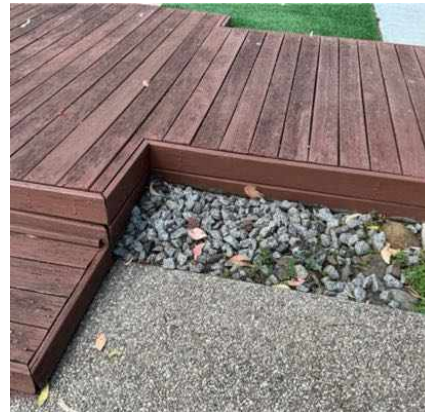
Defects 3.20

| Finding: | Weather-Deteriorated External Decking |
| Information: | At the time of inspection, the external decking areas were observed to be in a weather-deteriorated condition. The decking boards show signs of prolonged exposure to the elements, including surface breakdown, loss of protective coatings, and general material degradation. These conditions indicate that the timber has exceeded routine maintenance levels and is now experiencing reduced durability and serviceability. |

- Reduced structural integrity and load-bearing reliability of decking boards.
- Increased risk of timber decay, moisture ingress, and fungal deterioration.
- Higher likelihood of splintering, surface failure, and trip or injury hazards.
- Shortened remaining service life of the decking structure.

The decking areas are in a weather-deteriorated condition and no longer present as being in sound serviceable order. Remedial works and partial or full replacement should be anticipated to restore safety, durability, and long-term performance.

- Engage a qualified contractor to assess the structural condition of the decking.

- Replace deteriorated decking boards where deterioration is advanced.
- Re-treat or seal any salvageable boards to improve durability.
- Implement a regular maintenance program to reduce further weather-related degradation.

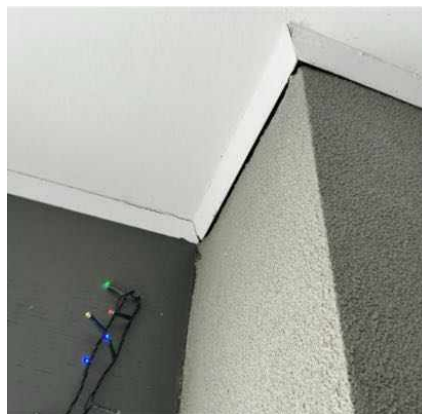
Defects 3.21

| Finding: | Cracking and Separation of Timber Quad Moldings at Eaves |
| Information: | During the inspection, cracking and separation was noted at the mitre joints of timber quad moldings installed around the eaves in multiple locations. This condition is common in aging properties and is typically associated with natural movement and environmental exposure over time. |

- Cosmetic deterioration of external timber finishes.
- Potential for moisture ingress if gaps are left untreated, leading to timber decay.
- May require ongoing monitoring as the building continues to age and move.

The separation observed is consistent with typical age-related wear and environmental exposure, and is considered a maintenance item rather than a structural concern. Prompt attention will help prevent moisture-related deterioration and preserve the external appearance of the property.

- Engage a qualified carpenter or handyman to:
- Reattach and secure any loose quad moldings.
- Fill visible gaps at mitre joints with a flexible, weather-resistant exterior filler.

- Repaint affected areas with a high-quality, weatherproof coating to protect from further weathering.
- Monitor repaired areas as part of routine exterior maintenance, particularly following seasonal changes or heavy rain events.

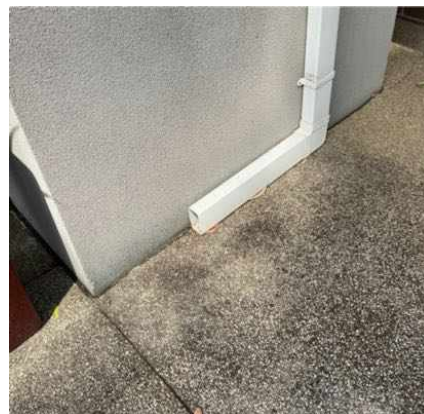
Defects 3.22

| Information: | The stormwater outlet serving the bay window roof projects directly through the gutter and discharges onto the ground surface at the front of the dwelling. No downpipe connection or underground drainage system is provided to convey stormwater away from the structure. This arrangement allows roof water to discharge close to the building's base and foundation area, which is not a compliant or durable method of stormwater disposal. |

- Concentrated roof water discharge can cause localised erosion and softening of soil near footings.
- May contribute to foundation movement or uneven settlement over time.
- Increased risk of water ingress, dampness, and termite attraction in proximity to the structure.
- Non-compliance with accepted stormwater management practices for roof drainage.

In summary, roof water discharge directly to the ground near the building is a non-compliant practice that poses moisture and structural risks. Rectification is required to ensure compliance with standard stormwater drainage provisions and to protect the building's foundation integrity.

- Engage a licensed plumber to connect the gutter outlet to a compliant downpipe and lawful point of discharge.
- Ensure stormwater from all roof catchments is directed into the property's approved stormwater drainage system.
- Verify that surface levels slope away from the dwelling to maintain adequate site drainage.

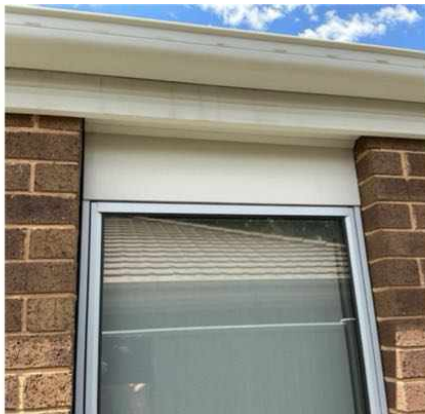
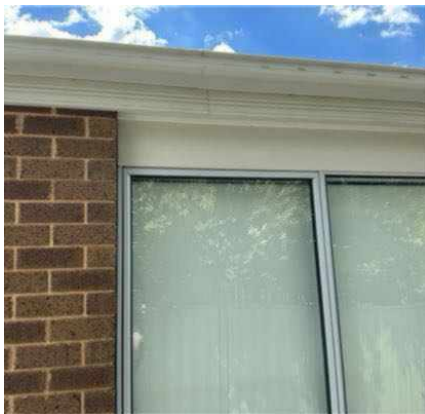
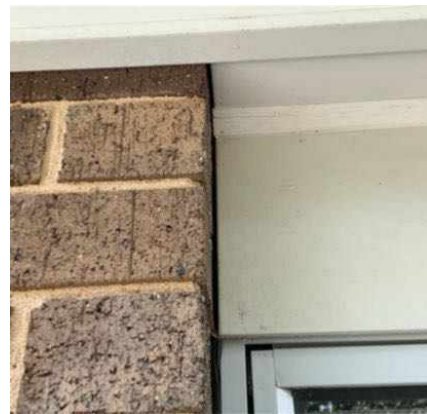
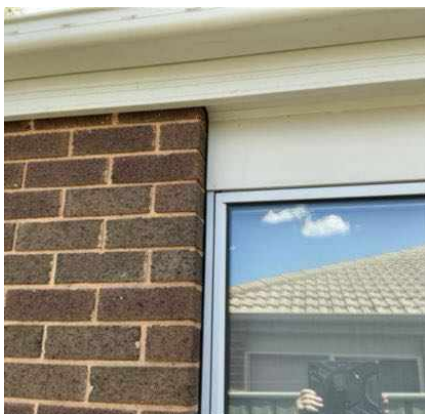
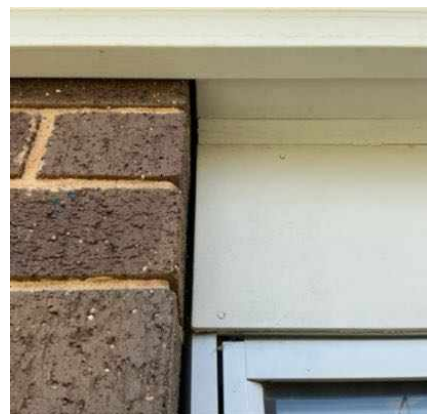
In summary, the gaps observed to multiple infill panels above windows represent a weatherproofing and finish deficiency and should be rectified to improve durability, performance, and protection of the building envelope.

- All gaps between infill panels and adjoining brickwork should be properly sealed using an appropriate external-grade, flexible sealant
- Infill panel installation should be reviewed to ensure correct fit, fixing, and alignment prior to sealing
- Affected areas should be monitored for any signs of moisture ingress or internal damage, particularly following wet weather

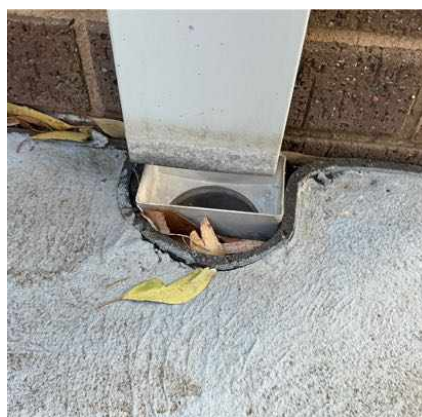
In summary, the downpipe is not correctly connected to the stormwater system and requires rectification to ensure roof water is effectively managed and discharged away from the base of the dwelling.

- The downpipe should be extended and securely connected into the stormwater riser to ensure effective water discharge
- The connection should be checked to confirm it is stable, aligned, and capable of handling roof water flow during heavy rainfall
- Once rectified, the area should be monitored during rain to confirm water is being properly directed away from the dwelling

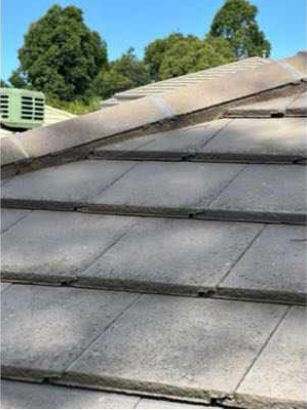
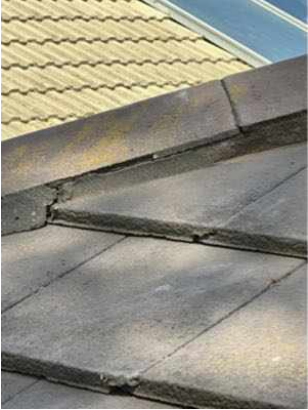
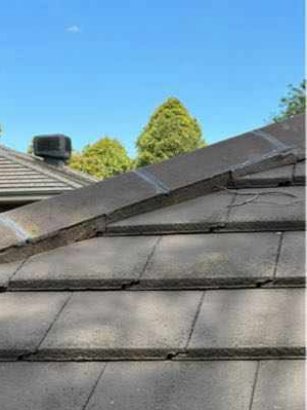
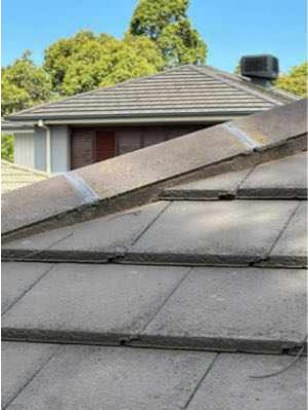
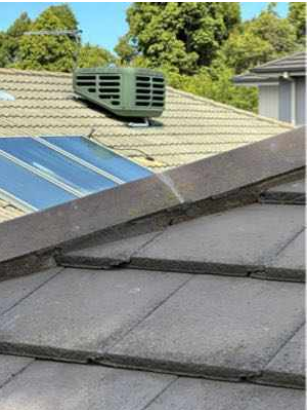
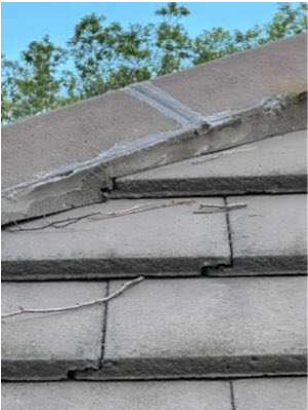
Defects 3.26

In summary, while no active leaks were detected at the time of inspection, the silicone repairs to the hip ridge tiles should be regarded as temporary, and proper rectification is recommended to ensure long-term weatherproofing and roof durability.

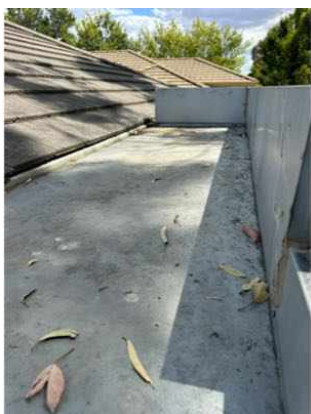
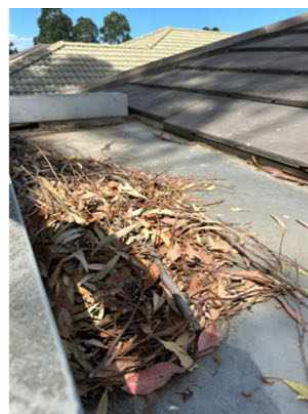
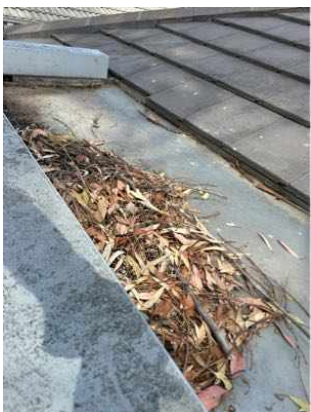
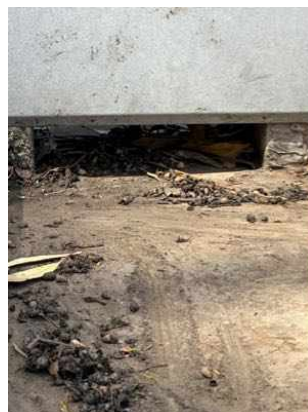
Defects 3.27

Building: Main Building
Location: Roof Exterior
Finding: Shallow Flat Roof Tray Drainage Behind Parapet Walls
Information: During the inspection, it was observed that behind the front parapet walls there is a

While no active leaks were identified at the time of inspection, the existing flat roof tray arrangement presents an elevated risk of water ingress in heavy rainfall conditions and should be addressed to improve long-term reliability and weatherproofing performance.

- Engage a licensed plumber or roofing specialist to assess the flat roof tray design and drainage capacity.
- Consider upgrading the tray depth and/or increasing the size and number of drainage outlets to improve performance.
- Ensure the tray and outlet are regularly cleaned and maintained to minimise blockage from debris.
- Further investigation may be warranted during periods of heavy rainfall to confirm performance under load.

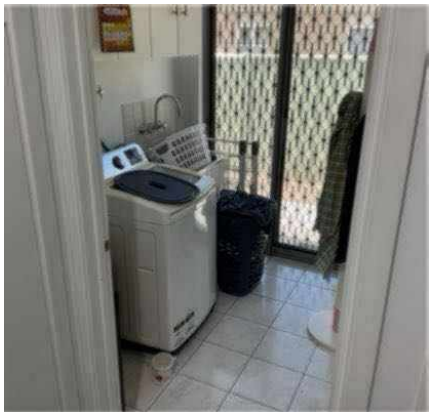
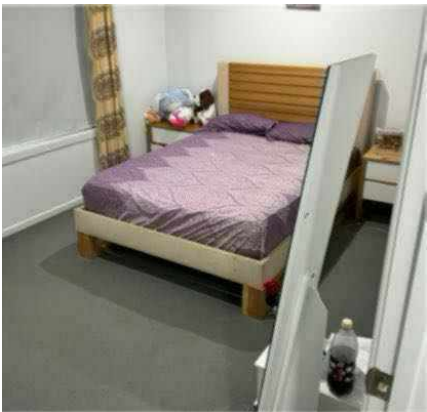
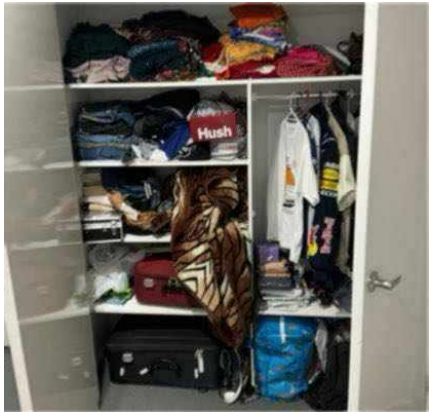
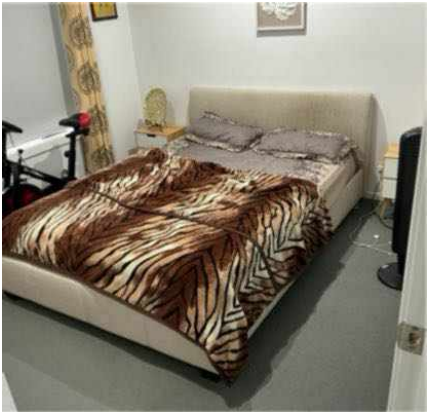
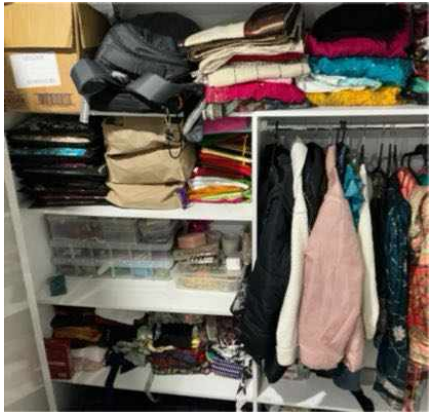
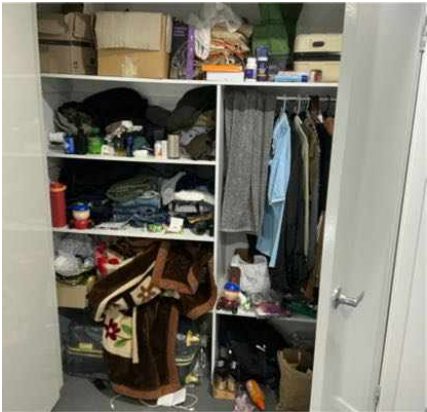
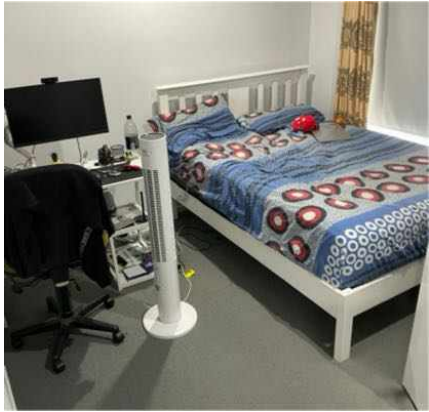
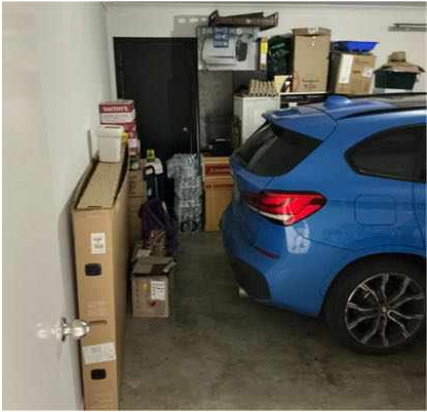
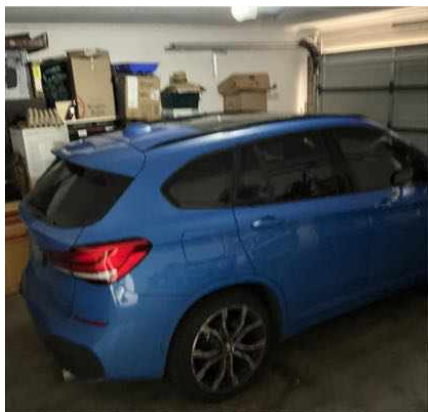
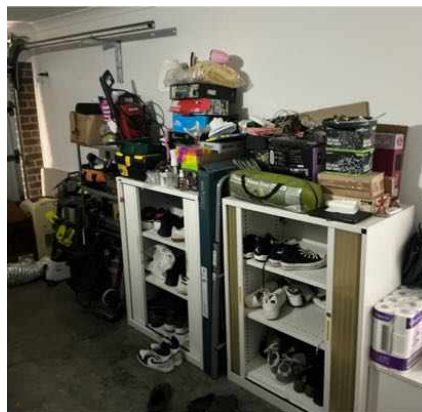
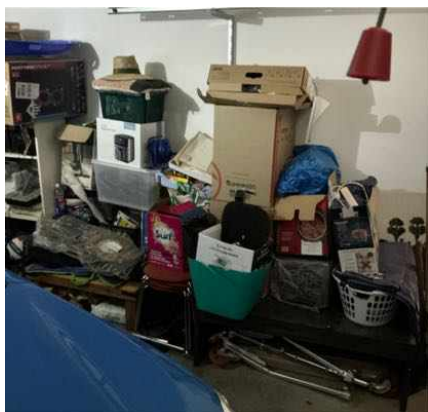
Building: Main Building
Location: All Internal Areas
Finding: Internal Inspection Limitations Due to Obstructions
Information: Multiple internal areas were obstructed at the time of inspection by stored furniture, personal belongings, and other fixed items. These obstructions restricted visibility and access to wall surfaces, floor areas, window reveals, and other internal elements that would ordinarily be inspected. As a result, concealed defects may exist in areas that could not be sighted or reached.

- Obstructions may conceal defects such as cracking, moisture damage, deterioration, or structural movement.
- Restricted access prevents a full assessment of the condition and performance of internal building elements.
- Potential safety hazards, such as electrical or plumbing issues, may remain undetected behind stored items.
- The accuracy and completeness of the inspection are reduced where visibility is impeded.

- Remove or relocate stored items and furniture to allow full visibility and access to all internal areas.
- Arrange a re-inspection once the spaces are cleared so a complete assessment can be performed.
- Monitor any newly exposed areas for signs of moisture, movement, or deterioration once accessible.
- Ensure access points, including doors, cupboards, and walkways, are unobstructed for future inspections.

A re-inspection is recommended once all obstructed areas are made fully accessible, as concealed conditions cannot be assessed until adequate access is provided.
