Building Inspection Report

Inspection Date: Mon, 16 Feb 2026

Property Address: 131 Greens Rd, Wyndham Vale VIC 3024,
Australia

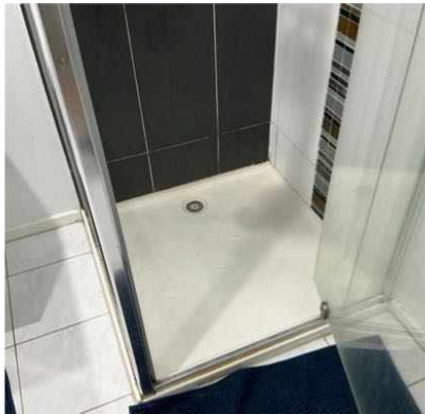
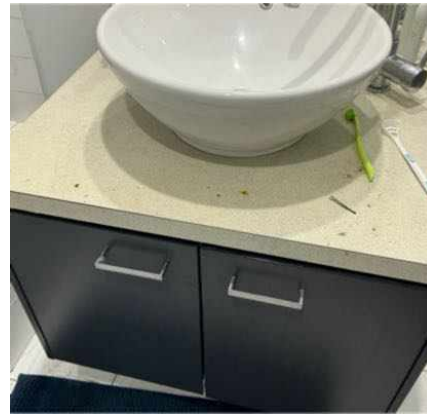
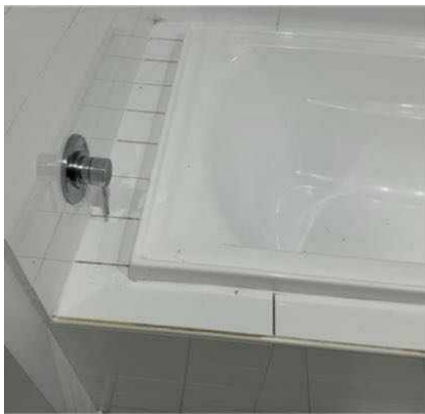
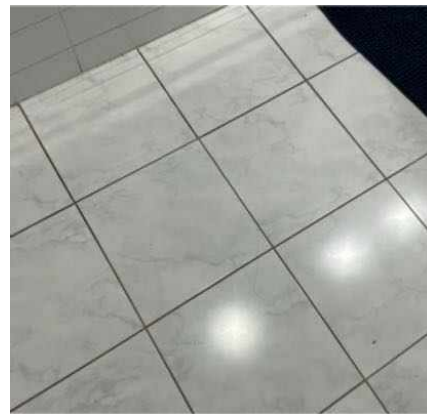
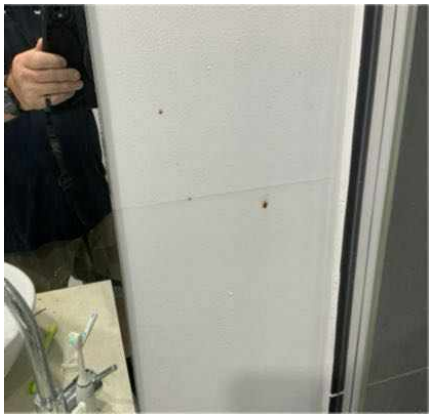
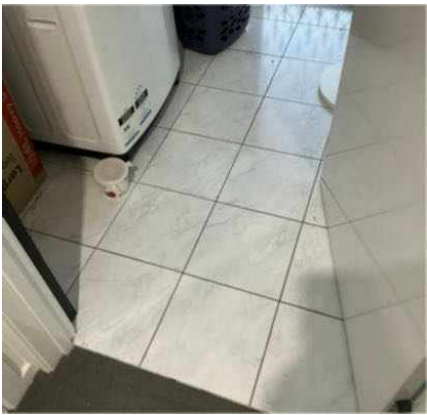
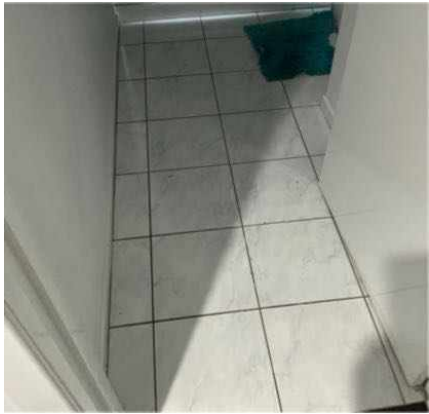
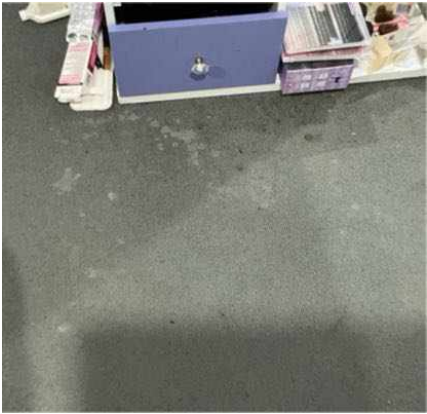
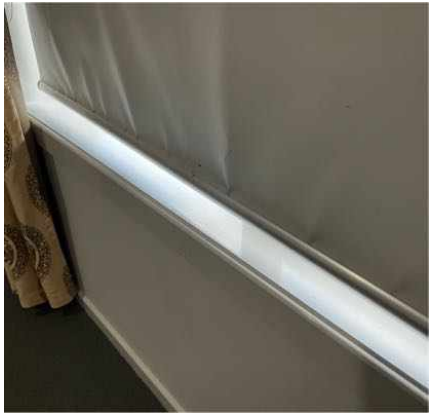
| Finding: | General Condition – Tired Presentation and Localised Cleanliness Issues |
| Information: | At the time of inspection, the dwelling presented as generally tired in appearance, with multiple areas showing signs of wear, ageing, and a lack of routine upkeep. Localised cleanliness issues were noted throughout the house, including accumulated dirt, staining, and marked surfaces, which detract from the overall presentation and indicate that regular maintenance and cleaning have not been consistently maintained. |

- A tired and unclean presentation can obscure defects or early signs of deterioration that may otherwise be more readily identifiable
- Accumulated dirt and staining may contribute to accelerated wear of finishes, fittings, and surfaces
- The condition suggests a likelihood of ongoing maintenance requirements following purchase
- Further issues may become evident once thorough cleaning and general maintenance are undertaken

- A comprehensive clean of the dwelling is recommended to improve presentation and allow clearer assessment of finishes and surfaces
- Allow for ongoing maintenance, repairs, and cosmetic improvements to address wear and ageing throughout the house
- Any areas of concern identified after cleaning should be further assessed and rectified as required

In summary, the house presents as generally tired with localised cleanliness issues evident, and allowance should be made for cleaning, maintenance, and potential remedial works to restore and maintain the overall condition of the dwelling.

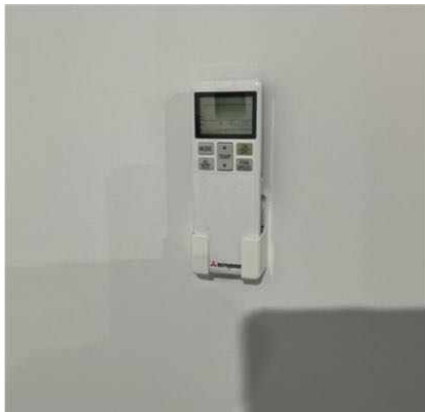
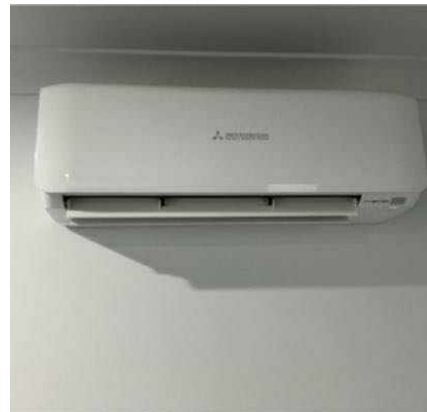
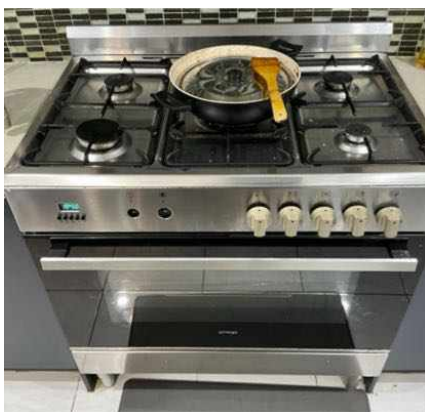
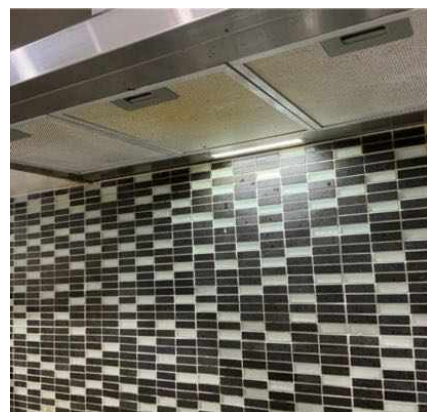
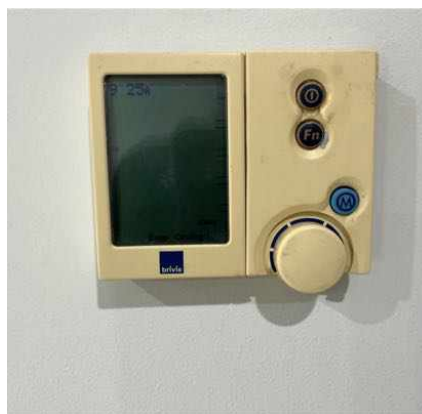
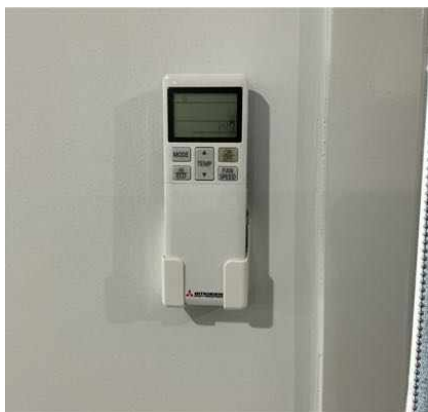
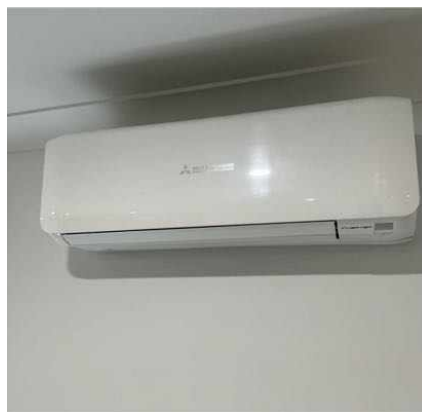
Building: Main Building
Location: All Internal Areas
Finding: Condition of Installed Appliances and Air Conditioner - Operational
Information: the time of inspection, the installed appliances—including the oven, cooktop, rangehood, dishwasher, and reverse cycle air conditioner—were checked for basic operational function. All appliances powered on and responded as expected to standard user inputs, indicating they are in working condition.

- Appliances, including the reverse cycle air conditioner, appear to be functioning as

- No obvious signs of damage, malfunction, or missing components were observed.

- Confirm inclusions with the sales contract to ensure all appliances and the reverse cycle air conditioner are covered.
- Retain user manuals and warranty information where available.
- Re-test all appliances and the air conditioning system upon settlement and prior to first use, as function may vary with time, load, or power supply conditions.
- Engage a licensed electrician or suitably qualified appliance or air conditioning technician to conduct a safety and performance check, particularly if installation dates, service history, or compliance documentation are unknown.

While the appliances and reverse cycle air conditioner were operational during the inspection, it should be noted that a full performance test was not conducted, and future performance or safety compliance cannot be guaranteed.

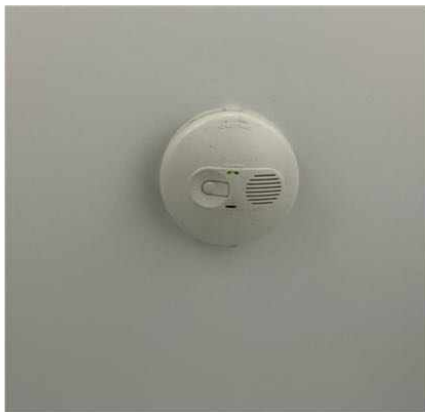
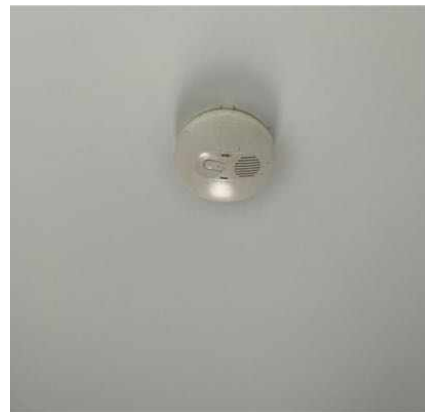
| Information: | The inspection and reporting on the presence, function, and compliance of smoke detectors—whether battery-operated or hard-wired—fall outside the formal scope of this pre-purchase building inspection. However, general observations regarding smoke alarm coverage or deficiencies are noted for the client's awareness. |

- Inspect all existing smoke detectors for compliance, functionality, and correct placement.
- Install new or additional units where necessary, ensuring compliance with AS 3786 and state-based legislation.
- For optimal fire safety, ensure smoke detectors are:
 - Interconnected where required.
 - Positioned in all sleeping areas and paths of travel as per current regulations.
 - Maintained according to manufacturer instructions and replaced every 10 years.
 - Tested monthly, with annual battery replacement where applicable.

This report does not verify the number, condition, location, or legal compliance of smoke detection systems. Clients are strongly advised to confirm fire safety measures prior to occupancy through a specialist inspection.

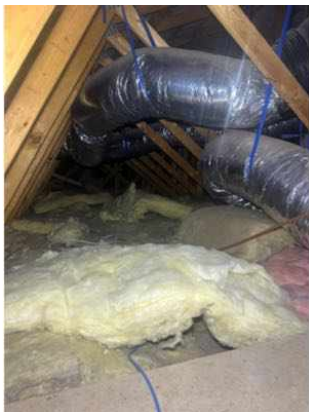
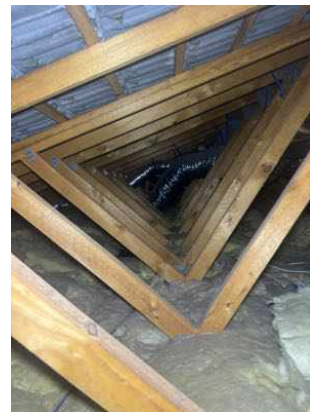
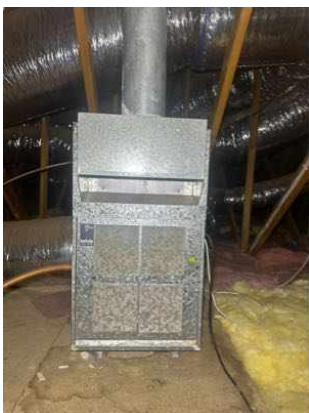
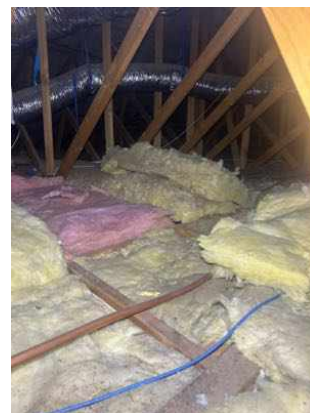
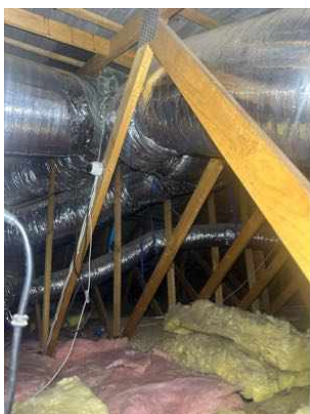
| Information: | Ceiling insulation was observed to be well installed throughout the accessible areas of the roof space. The batts appear evenly distributed, with no significant gaps, compression, or displacement. This level of installation supports good thermal performance and contributes positively to the home's energy efficiency. |

- Conduct periodic checks, especially after trades have accessed the roof space, to ensure insulation remains undisturbed.
- Pay particular attention to areas around lighting, ductwork, and wiring, where gaps are more likely to occur.
- If insulation is ever disturbed or found to be incomplete, engage a qualified insulation installer to reinstate coverage as needed.

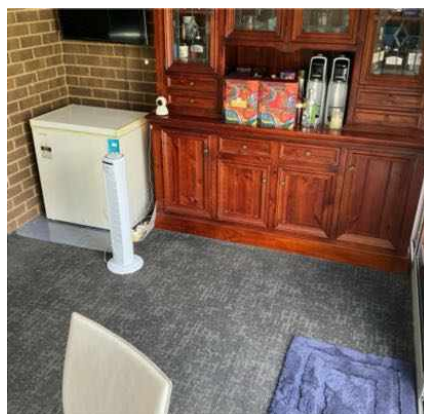
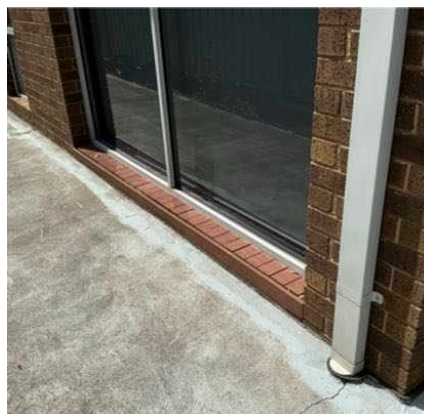
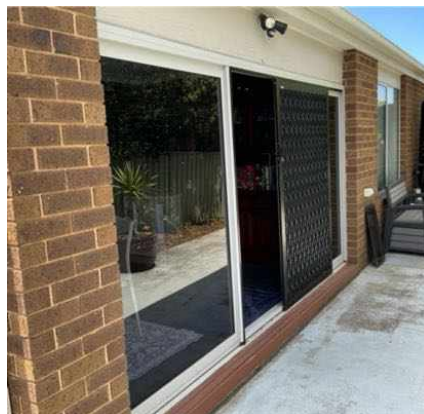
In summary, the enclosure of the decked alfresco area represents a change to the original use of the space, and confirmation of appropriate approvals and compliance should be obtained prior to purchase.

- The vendor should be requested to provide evidence of building permits, approvals, and final inspections relating to the enclosure
- If documentation cannot be provided, further enquiries should be made with the relevant local council or building surveyor
- Independent assessment by a suitably qualified professional may be required to confirm structural adequacy and compliance

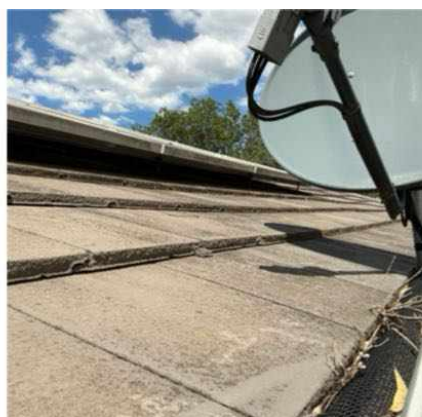
Building: Main Building
 Location: Roof Exterior
 Finding: Aged Roof Covering – General Weathering
 Information: The tiled roof covering was observed to be in fair condition, with signs of general wear and weathering consistent with the age of the property. The roof appears to have performed adequately over time, offering effective protection against the elements.

- Ongoing exposure to weather may gradually degrade roofing materials, increasing the risk of water ingress over time.
- Aged roof coverings are more prone to developing defects such as tile displacement, sealant deterioration, and flashing failure if not periodically maintained.
- Delayed maintenance can result in higher repair costs and potential internal damage from moisture intrusion.

- Engage a licensed roofing contractor to:
- Conduct a comprehensive assessment of the roofing system and identify any areas requiring maintenance or preventative works.
- Carry out minor servicing such as cleaning, resealing flashings, and replacing any worn or deteriorated components.
- Schedule routine roof inspections to monitor condition and ensure timely detection of emerging issues.
- Consider future planning for eventual roof covering renewal as part of a long-term maintenance strategy.

The current condition of the roof suggests it has generally performed well, but proactive upkeep will be required to extend its service life and prevent the development of secondary defects.

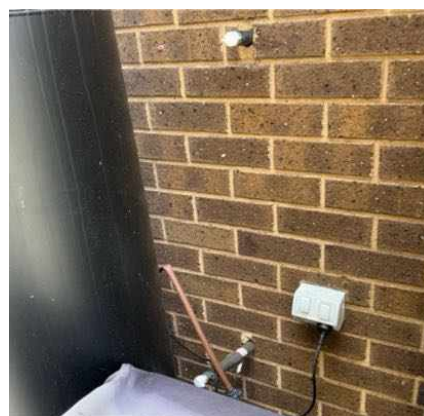
| Information: | During the inspection, redundant solar hot water panels were observed remaining installed on the roof. A reasonably new heat pump hot water system has been installed at ground level and appears to have replaced the original solar hot water system. The solar collectors on the roof are no longer connected or serving an active function. |

- Redundant solar panels add unnecessary weight and fixings to the roof structure without providing any benefit
- Unused roof penetrations, brackets, and flashings associated with the old system may increase the risk of future water ingress if not properly sealed and maintained
- The presence of obsolete equipment may result in additional maintenance obligations and detract from the overall condition and presentation of the roof

- The redundant solar hot water panels should be removed by a suitably qualified contractor
- All associated brackets, pipework, and roof penetrations should be removed and the roof covering professionally made good
- Any disturbed tiles or roof materials should be reinstated to ensure the roof remains weather-tight

In summary, the solar hot water panels are no longer in use following installation of the heat pump system and should be removed, with the roof fully reinstated, to reduce ongoing maintenance risks and potential water ingress issues.
