Building and Timber Pest Inspection Report

Inspection Date: Fri, 27 Mar 2026

Property Address: 109 Coxs Rd, North Ryde NSW 2113,
Australia

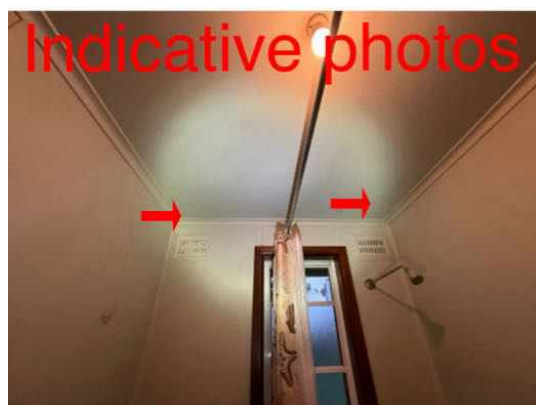
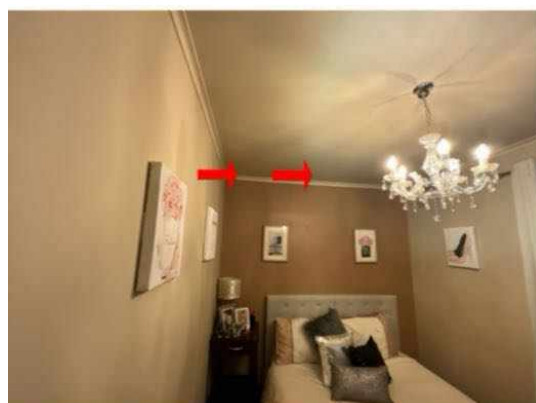
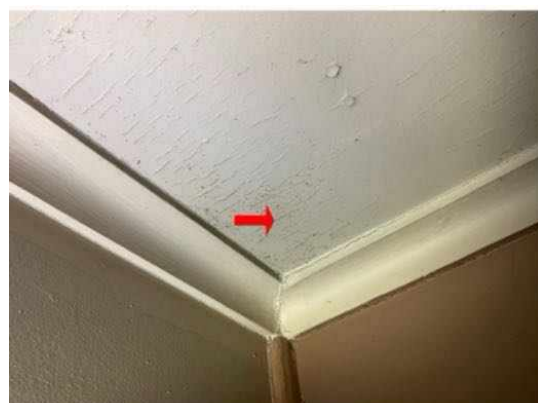
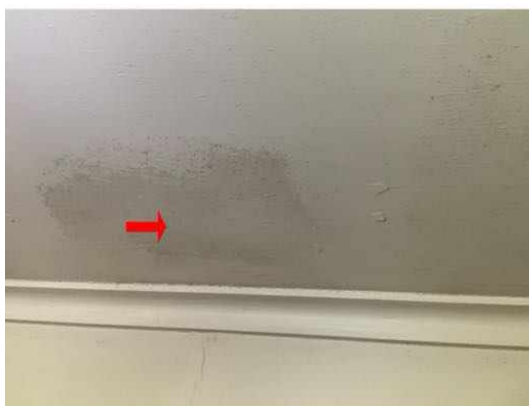
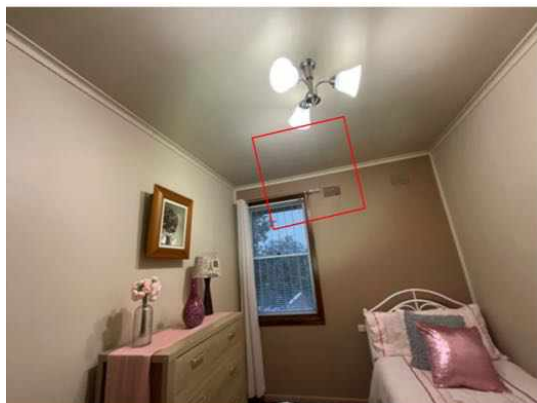
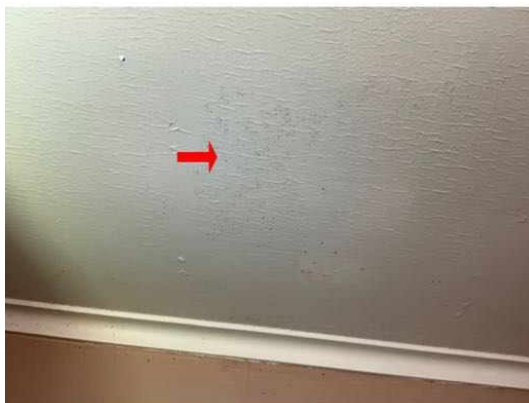
Building:	Main Building
Location:	Multiple areas
Finding:	Mould present - Ventilation
Information:	Evidence of mould growth was noted, which is believed to have grown due to lack of ventilation to the area.

Generally, the client is advised to ensure that the general environment is free of moisture and humidity to aid in the prevention of mould formation and development. Any mould found during the inspection should be cleaned immediately by a cleaning contractor or the homeowner as applicable.

Although the exhaust fan was found to be working at the time of inspection, however a licensed electrician May be appointed to ensure the full exhaust fan operation.

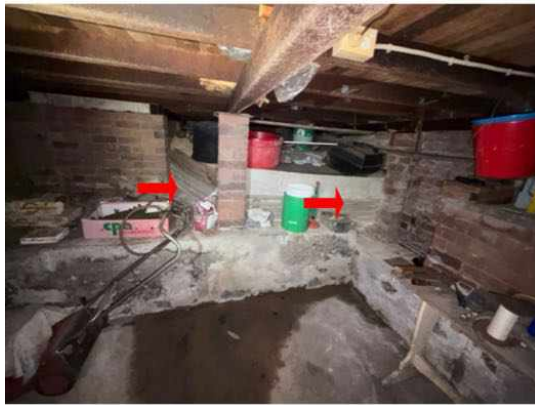
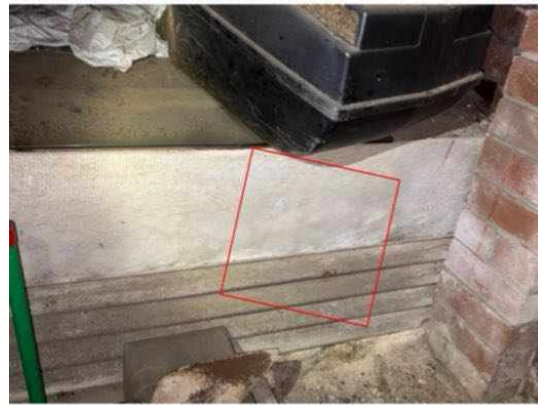
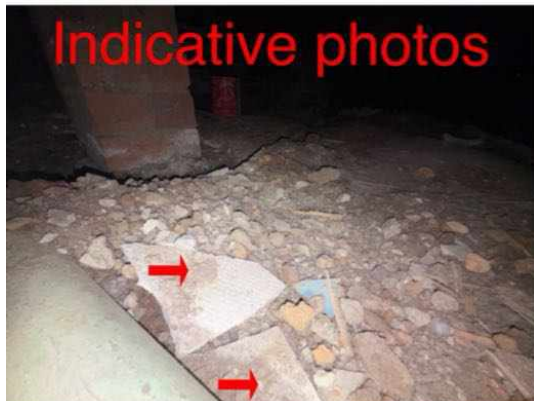
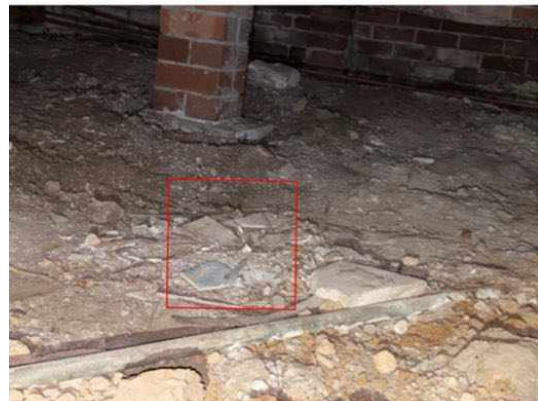
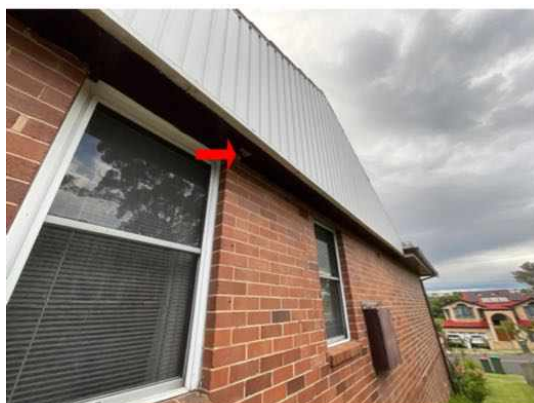
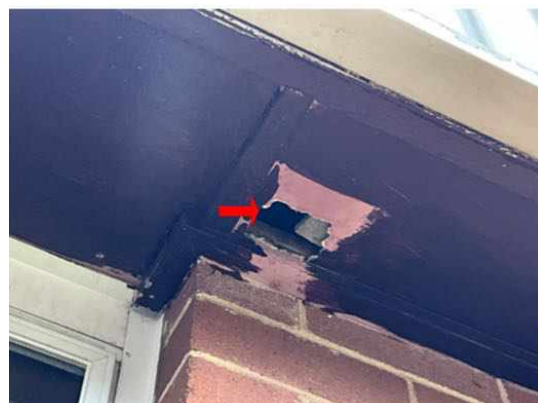
Finding 1.02

Building:	Main Building
Location:	Multiple areas
Finding:	Asbestos - Suspected ACM Identified on Site
Information:	Reporting on Asbestos is outside the Scope of this Report. This suspected defect is highlighted as a caution only. We suspect, based on our experience in the building industry, that there is a higher risk of the identified building element containing asbestos.

As Asbestos Reporting is outside the scope of this report, we advise that you consider a separate Asbestos Inspection and Condition Audit, which can include the taking of samples for definitive confirmation of the presence of Asbestos.

In the interim, the client is advised to act with caution, especially when considering any damage to building materials general wear and tear renovations extensions demolition and general maintenance activities due to the suspected presence of Asbestos.

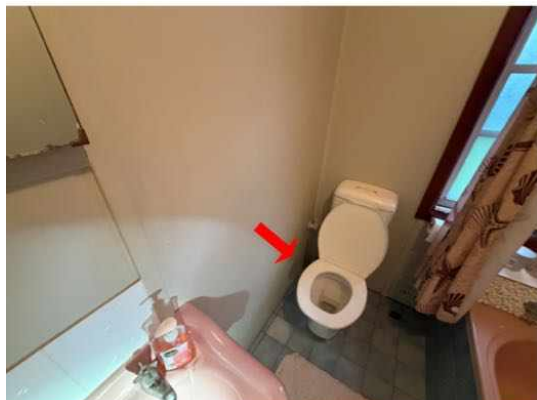
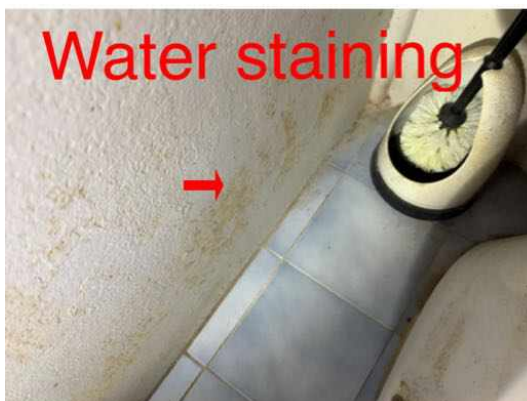
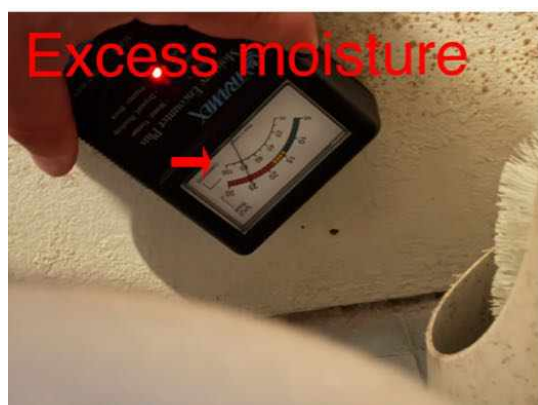
Finding 2.01

Building:	Main Building
Location:	Bathroom
Finding:	Evidence of excessive moisture was present at the time of inspection
Information:	Excessive moisture can attract termites and produce conditions that promote termite attack, fungal growth and wood decay. Excessive moisture is generally caused by deteriorated, inadequate or missing roof drainage, leaking plumbing pipes or fixtures, poorly plumbed HWS overflows or condenser units and poor site drainage. It is highly

recommended that all plumbing and drainage fixtures and fittings be maintained regularly in order to prevent excessive moisture being present in the external / internal property.

A licensed plumber must be appointed urgently for further assessment.

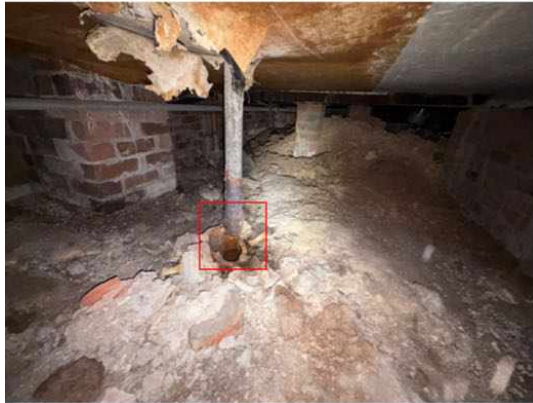
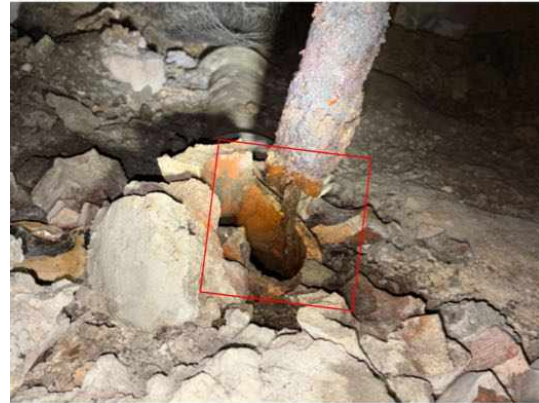
Finding 3.01

Building:	Main Building
Location:	Bathroom
Finding:	Plumbing - Point of connection non-compliant
Information:	At the time of inspection it was noted that connections between above ground pipe work and below ground sewer/storm water systems were incomplete.

Additionally, where sewer pipes are concerned, gases can escape from unsealed connections which can pose a serious health risk.

Engagement of a certified plumber is strongly recommended to ensure all connection points are sealed in accordance with the plumbing construction guidelines.

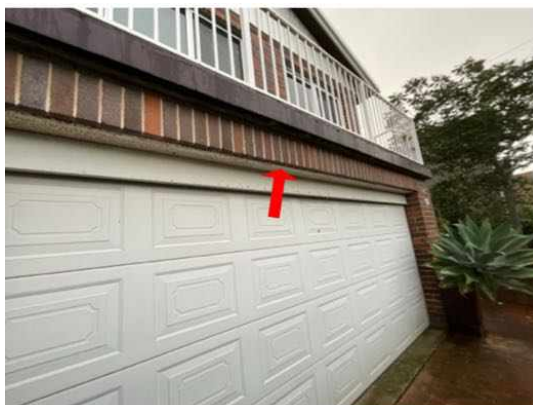
Finding 3.02

Building:	Main Building
Location:	Garage
Finding:	Building element - Rusted or corroded
Information:	This building element shows evidence of rusting and corrosion, which is likely to have developed as a result of excessive exposure to moisture and or inadequate coatings.

As surface rust provides no protection to the underlying iron, the deteriorating condition is likely to worsen if not addressed in the short-term future.

Rusting and corrosion should be managed by ideally removing or limiting the affected surface from exposure to moisture. A licensed painter must be appointed for an adequate paint coating system. A licensed builder may be appointed to replace any building elements that have been severely affected by rust or water damage.

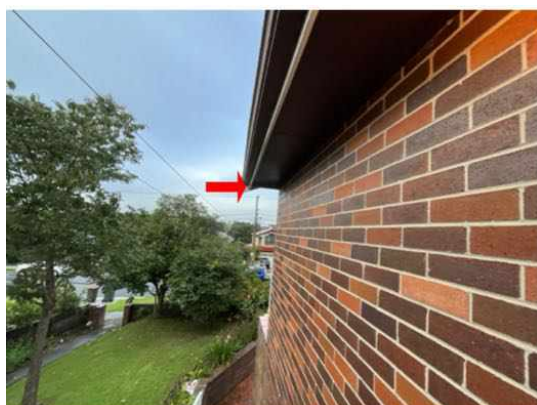
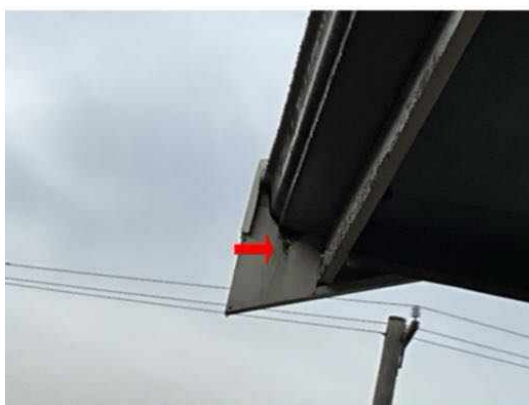
Finding 3.03

Building:	Main Building
Location:	Front left
Finding:	Water leak - External
Information:	Water leaks were found to be present to exterior plumbing work. Leaks are generally caused by deterioration of the plumbing elements over time, due to exposure to weather conditions, but may have also been caused by minor impact damage.

Such leaking creates damp conditions in the affected area, causing potential for water pooling and subsequent water damage if left unattended. These conditions may also attract termite attack, particularly if the area is subject to minimal levels of sun throughout daylight hours.

It is highly advised that a licensed plumber be appointed to rectify any water leaks that may be present. Areas of repair and replacement of plumbing fittings and fixtures may be required and, as such, a quotation should be sought.

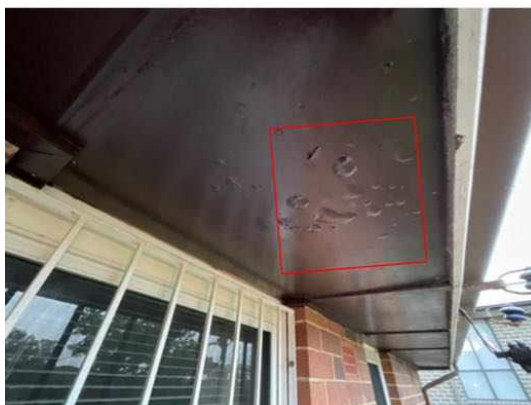
Finding 3.04

Building:	Main Building
Location:	Porch
Finding:	Painted surface - Bubbling
Information:	Sections of paint in this area was found to have bubbled and deteriorated. Paint bubbling is generally an indication of excessive moisture in the area, that is currently hidden by the painted surface.

The presence of excessive moisture can have major implications on associated building elements if left unattended. While only seemingly minor at this stage, the damage cannot be determined due to the paint obstructing any further inspection of the damage.

It is highly advised that the affected paint be cleaned to allow a further, more invasive inspection by a licensed roof plumber. Failure to act on this defect may necessitate

major works in the future.

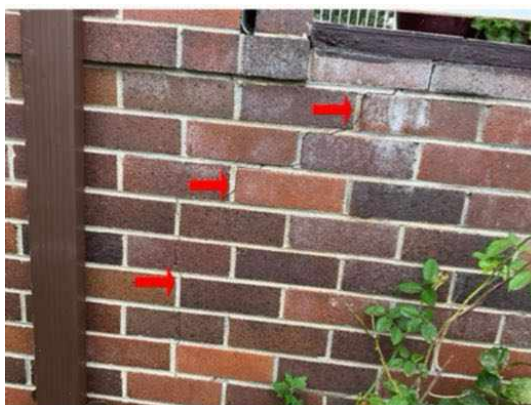
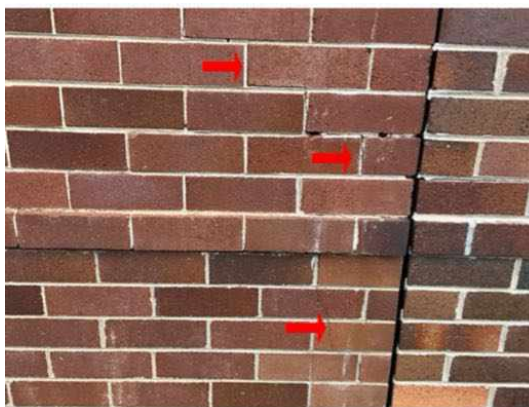
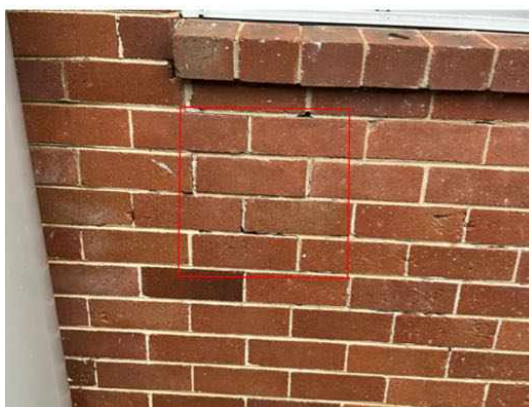
Finding 3.05

Building:	Main Building
Location:	Multiple areas
Finding:	Brickwork - Step cracking
Information:	Step cracking was identified to the brickwork in this area at the time of inspection. Step cracking, which is similar to other forms of cracking, has a variety of possible causes. However, the most common is the subsidence of adjacent footings.

Minor step cracking can be used as a warning sign to address factors causing stress to the wall, which can include the effect of surrounding trees, water leaks, soil erosion, or even the presence of reactive soils in the surrounding area. The degree of damage falls within Category 1, described as fine cracks, which are less than 1.0mm in width limit, and that do not need repair.

Damage of this category is not considered a defect for rectification. Always contact your building inspector should cracks widen, lengthen, or become more numerous.

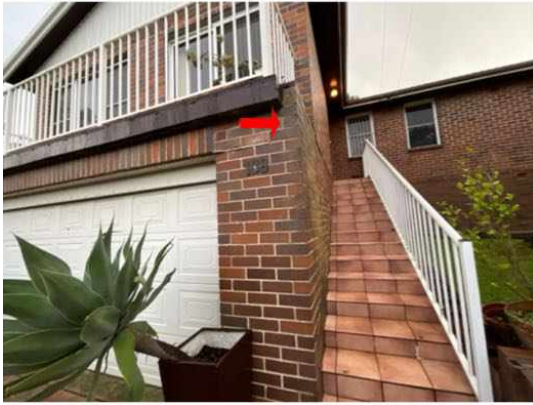
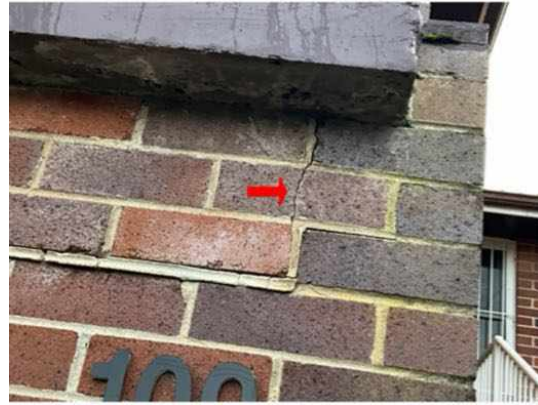
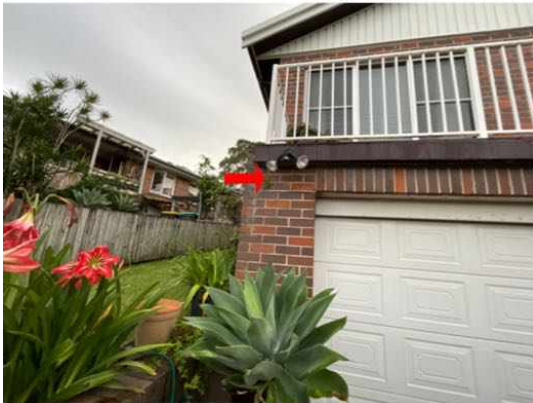
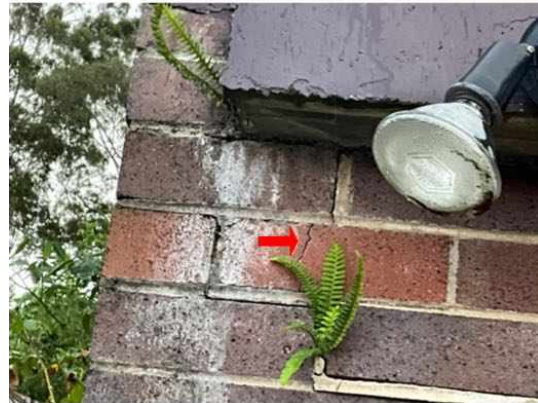
Finding 3.06

Building:	Main Building
Location:	Garage
Finding:	Brickwork - Cracking [Fine]
Information:	Although fine cracks are quite noticeable, they are often only considered to be an appearance defect and usually do not indicate any structural damage. Generally, the cause of a fine crack is indicative of a separation between brickwork and mortar throughout the structure, but single bricks may also show cracks of this nature.

Cracking of this nature can generally be repaired with minor filling and should be conducted by a qualified bricklayer.

Always contact a building inspector should cracks widen lengthen or become more numerous.

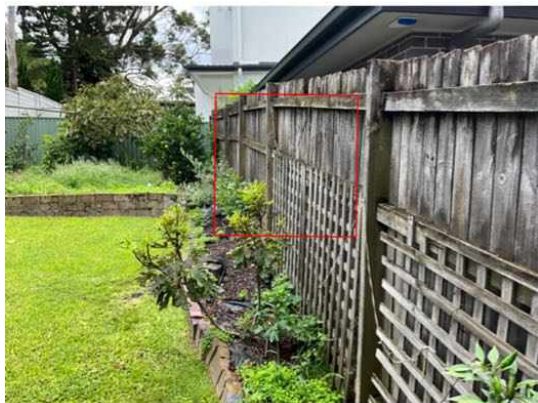
Finding 3.07

Finding: Fencing - Deteriorated

Information: It was noted at the time of inspection that sections of the fencing in this area has deteriorated. Typically fencing deteriorates due to age and or wear, rot and or rust which is generally expected for a structure of this age, due to prolonged exposure to weather conditions. Sometimes inadequate installation or maintenance can be to blame.

If left unattended, it is likely that further damage will occur. It is suspected that repair of several elements of the fencing may be required however replacement may be a consideration of the client also.

A licensed fencing contractor should be appointed to provide further advice and perform rectification works as necessary.

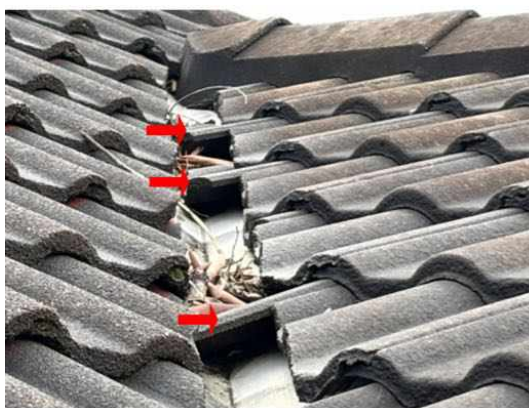
Finding 3.08

Building:	Main Building
Location:	Roof Exterior
Finding:	Roof tiles - Slippage
Information:	Upon inspection of the exterior roof covering, it was noted that numerous tiles have slipped from their original fixing. Tiles may slip over time due to a number of minor causes, including breakage of tiles, failings in the adjoining battens, or fixings that may have failed.

Roof tiles that have moved from their original position are very likely to allow water penetration into the roof void, exposing roofing structures to excessive moisture. This creates an environment that is conducive to water damage and accelerated deterioration of all associated building elements.

Replacement of loose or missing roofing tiles is recommended immediately to prevent the development of any secondary defects. A roofing restoration specialist should be appointed to complete such works as necessary.

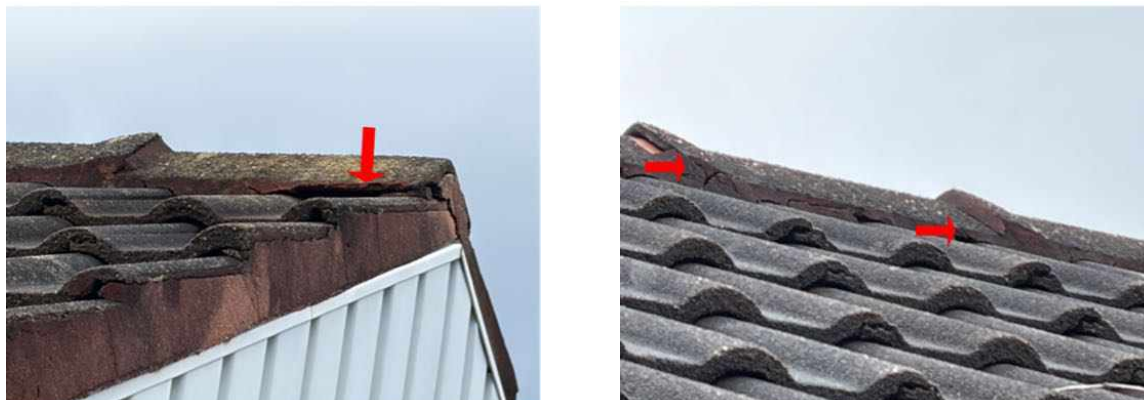
Upon inspection of the exterior roofing, the majority of roof tiles were considered to be in a fair condition. While weathering of the tiles is consistent with the age of the property, maintenance works are required.

Isolated areas of mortar have come loose and minor cracking is also present. Re-pointing and re-sealing the may be considered as an interim solution by the client to help preserve and extend the life span of the tiles.

Where left unmanaged, deteriorating roof tiles are likely to lead to a number of secondary defects, including minor water leaks and weather exposure to internal

roofing structures.

Consultation with a licensed roofing contractor is highly advised to gain advice on cost of remedial works that may be required in the short to medium term. Remedial works are likely to increase the longevity of the exterior roofing structure.

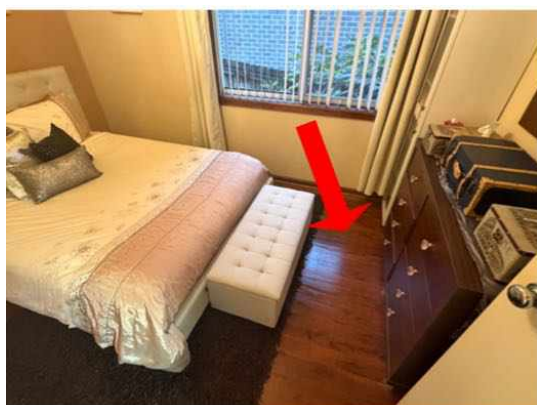
Bouncy floors generally indicate that the floorboards or the subfloor structures are coming loose from the joists that they are installed on. Bouncy flooring may also be the result of gaps between flooring and joist structures, which require packing.

Although not a matter of urgency, the client is advised to seek quotations for required repairs from a licensed Builder.

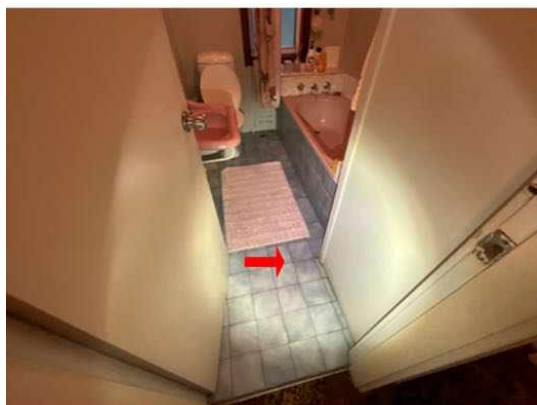
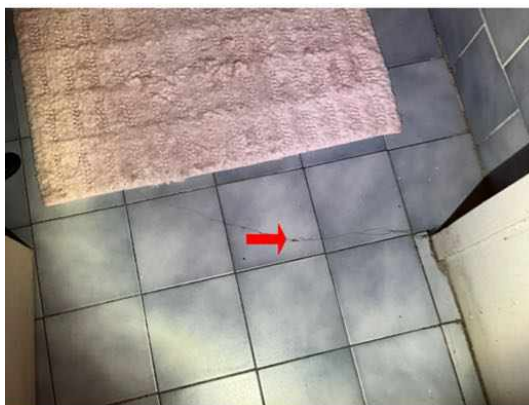
Finding 3.13

Finding: Wet area tiles - Cracked or damaged

Information: Cracking was evident to the tiling in this area at the time of inspection. While the

cracking appears to be minor, this area is frequently exposed to water, allowing potential for water penetration into adjoining sections of walls or flooring.

If left unmanaged, water penetration to these areas may lead to subsequent water damage, which is likely necessitate repair work to affected building elements.

A bathroom specialist should be appointed to determine the integrity of the bathroom waterproofing membrane. If the membrane was found to be intact then relatively minor works to replace the cracked tiles should be carried out to ensure no further damage occurs. The re-application of silicone and grouting throughout remaining tile work is also advised, to further protect the area against water penetration.

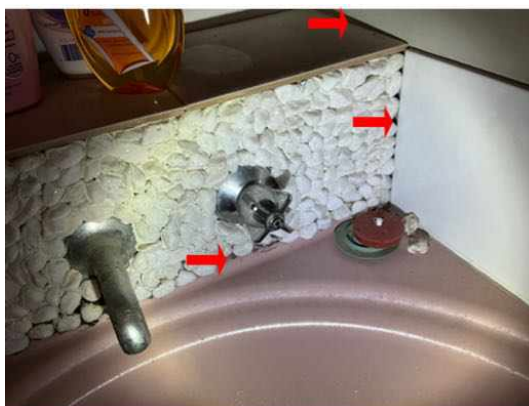
Finding 3.14

Building: Main Building
 Location: All Wet Areas
 Finding: Sealant and grouting - Missing or damaged
 Information:

It was noted on inspection that sealant or grout is degraded to this area.

Different materials and floor areas move at different rates, generally causing cracking to grout or sealant at this point. A flexible sealant is required to allow for expected expansion and contraction, while keeping the joint water tight and protective of all associated building materials.

Flexible and mould resistant materials should be applied to affected areas to prevent any subsequent water damage that is likely to occur. Regular maintenance and replacement of damage or missing or damaged sealant and grout is highly recommended to the wet areas, as this is a regular wear and tear defect. Sealant and grouting in areas that come into regular contact with water should be maintained for the long term care of your property.

A sealant specialist should be appointed to complete these works as soon as possible.

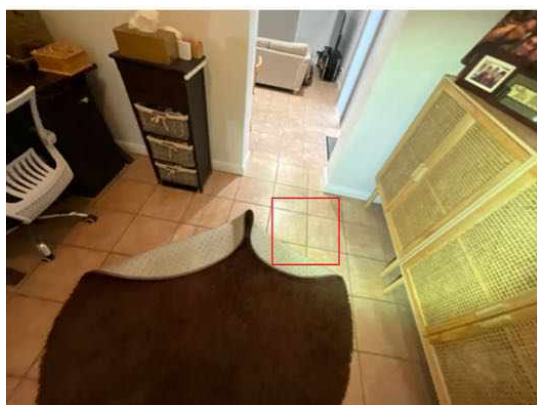
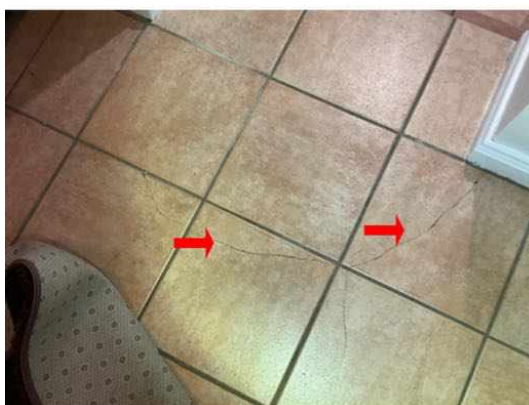
Finding 3.15

Building: Main Building
 Location: Office
 Finding: Cracked floor tiles
 Information:

Cracking in the floor tiles was evident in this area at the time of inspection. It is suspected that this cracking has occurred as a result of minor settlement or shrinkage.

Cracked tiles throughout the household detract from the overall appearance of the affected areas however it is unlikely to create or lead to any secondary defects.

While not considered a matter of urgency, replacement of cracked floor tiles is recommended at the clients discretion. A licensed tiling contractor may be appointed to perform these works. Where cracks become more numerous, contact a licensed building inspector for further investigation.

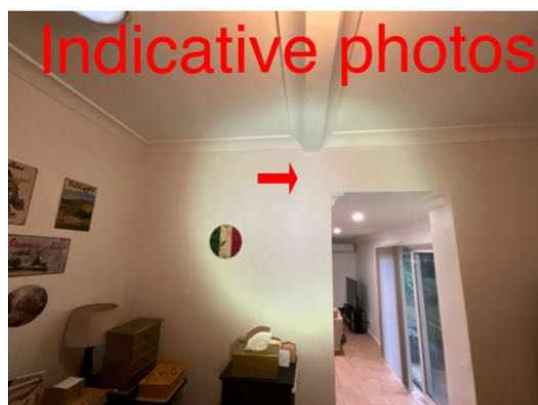
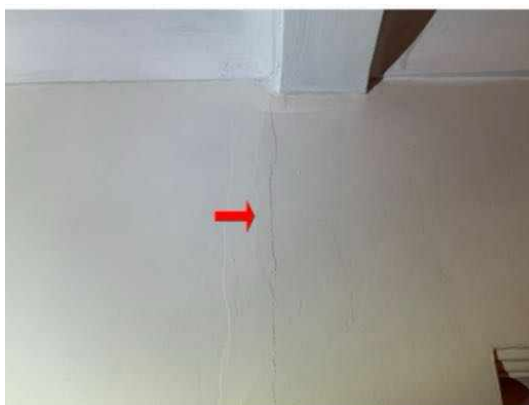
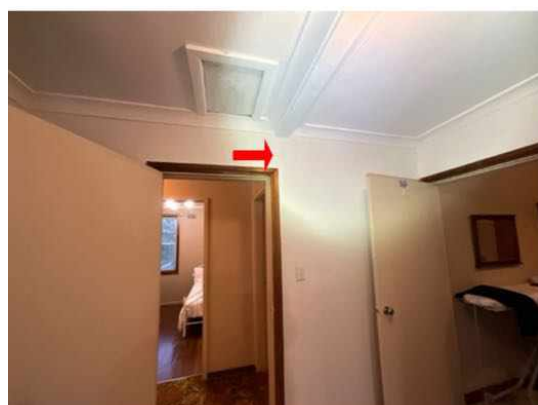
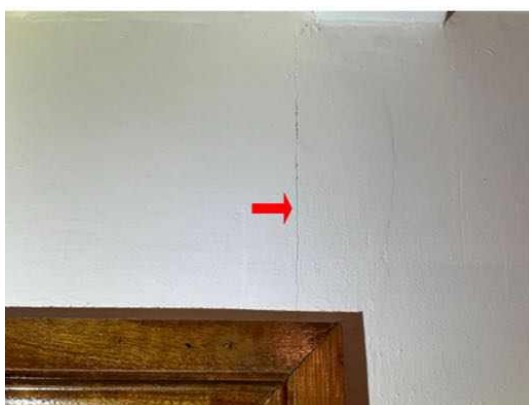
Building: Main Building
 Location: Multiple areas
 Finding: Cracking - Damage Category 1 - Fine (up to 1mm)
 Information: Although fine cracks are quite noticeable, they are often only considered to be an

appearance defect, and usually do not indicate any structural damage. Generally, the cause of a fine crack is indicative of a separation between building materials and finishes (e.g. paint, plaster, etc.) along joins.

Cracking of this nature can generally be repaired with minor sanding, filling and/or repainting. Such works should be performed by a qualified painter or a general handyman.

Monitoring of all cracking should be conducted frequently. Always contact a building inspector should cracks widen, lengthen, or become more numerous.

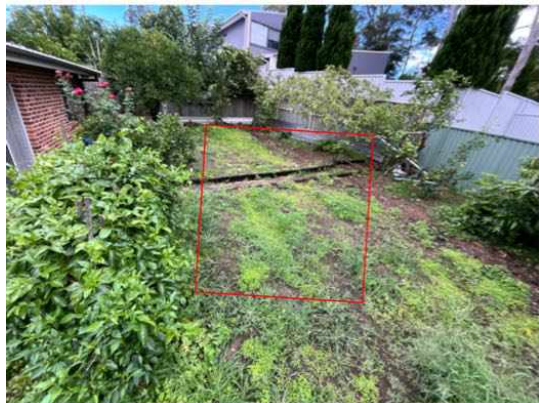
Finding 3.17

Building:	Main Building
Location:	Backyard
Finding:	Site drainage— Inadequate
Information:	The site drainage in this area was found to be inadequate at the time of inspection, creating potential for subsequent water damage to associated building elements. This is additionally conducive to termite activity.

Where site drainage is inadequate, installation of an Agricultural (Aggie) Drain may be required. A licensed plumber should be appointed to further inspect the property and perform any remedial works as necessary. Water damage and secondary defects are likely to occur if left unmanaged.

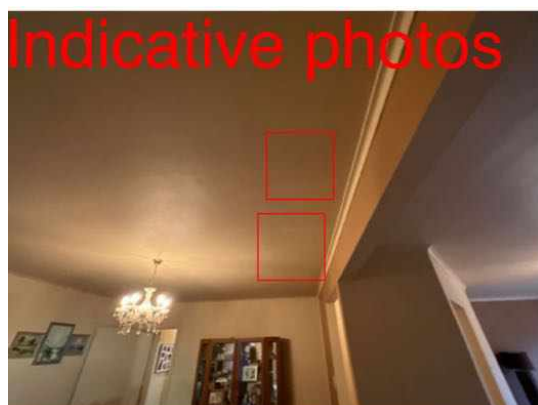
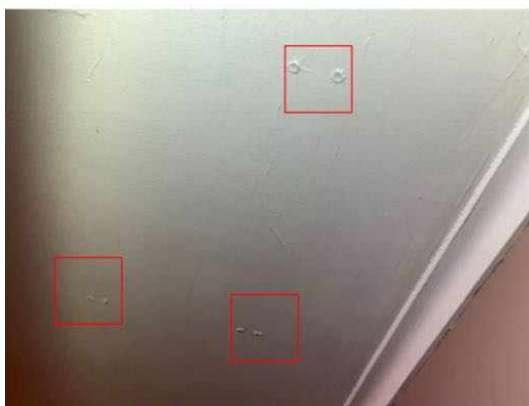
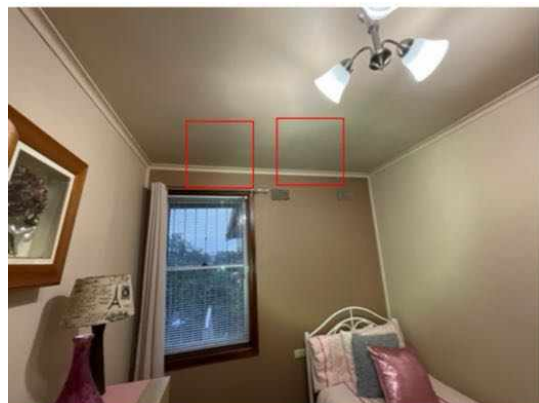
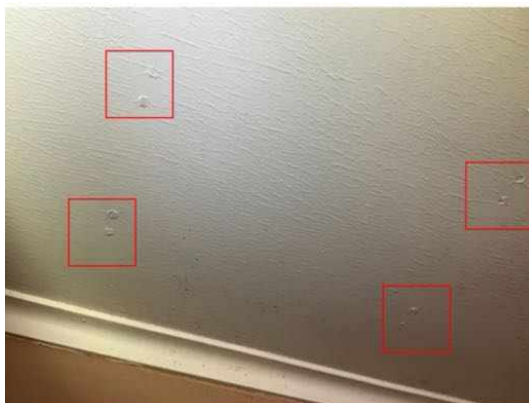
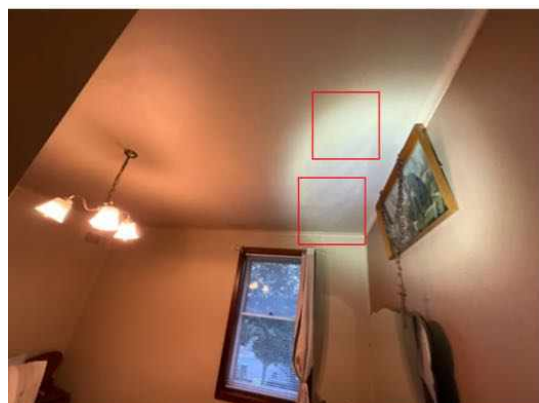
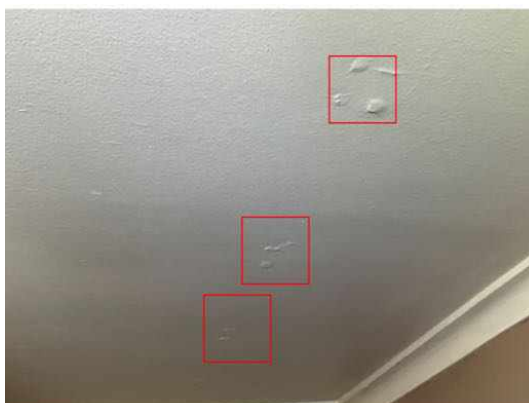
Finding 3.18

Building:	Main Building
Location:	Multiple areas
Finding:	Ceiling nails - Popping
Information:	Numerous popped nails were identified in the internal ceiling at the time of inspection. Nails and screws hold simply by the friction between them and the surface they are applied to. Over time, the nails and screws can back out, which is often a result of general ageing and deterioration of the building structure.

If left unmanaged, the ceiling sheets may become loose and unstable, increasing the rate of deterioration of the internal ceiling and creating potential for the development of secondary defects.

Re-fastening of popped nails will help to maintain the stability of the internal ceiling and associated building elements. Such minor works will also help to improve the appearance of the affected area and secure the ceiling sheets, so as to prevent the onset of ceiling sagging. These works should be performed by a qualified carpenter or plasterer at client discretion.

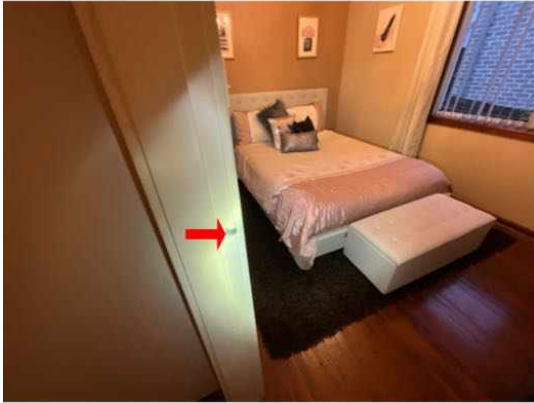
Finding 3.19

Building: Main Building
 Location: Master
 Finding: Door - Striker plate misaligned
 Information: The striker plate to this door appears to have become misaligned and has consequently resulted in the door's operation being compromised.

This is a common defect and is expected in a property of this age, whether being due to substandard installation or general deterioration of the door hardware.

Readjustment of the striker plate is recommended at client discretion. Works such as these can be completed by a general handyman or qualified carpenter.

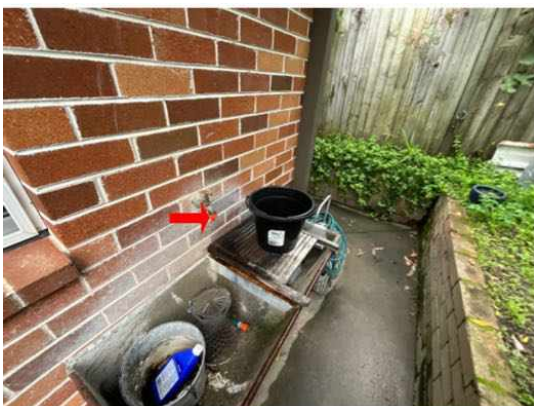
Finding 3.20

Building:	Main Building
Location:	External tap
Finding:	Washers - Degraded
Information:	The washers on the taps in this area appear to have degraded as a result of general ageing. Degraded washers generally result in slow, persistent leakage from taps and plumbing hardware.

Replacement of washers will ensure that water wastage does not occur and that the persistent water leak does not result in secondary damage to surrounding structures. Such damage may range from rust and corrosion to damage of surfaces, e.g. bench tops, etc.

A qualified plumber should be appointed to replace degraded washers and to further inspect associated plumbing fixtures and fittings. Where water damage has occurred, a carpenter or cabinet maker may be appointed to replace affected building elements.

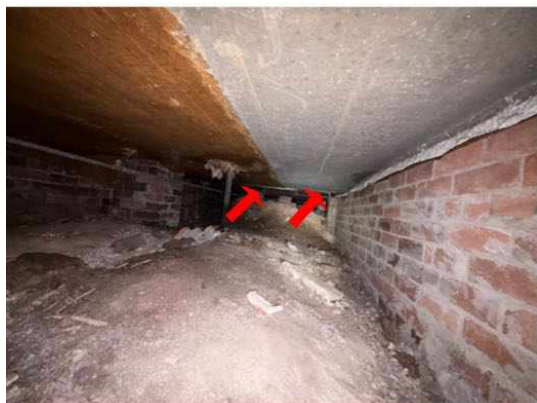
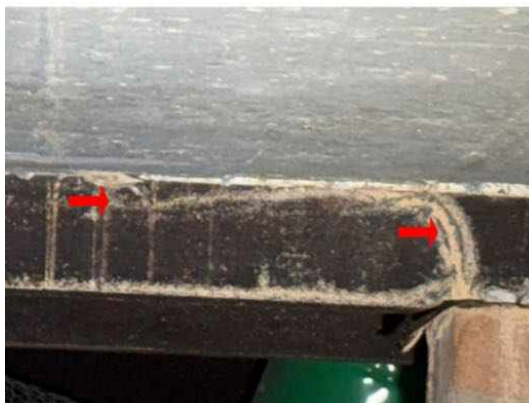
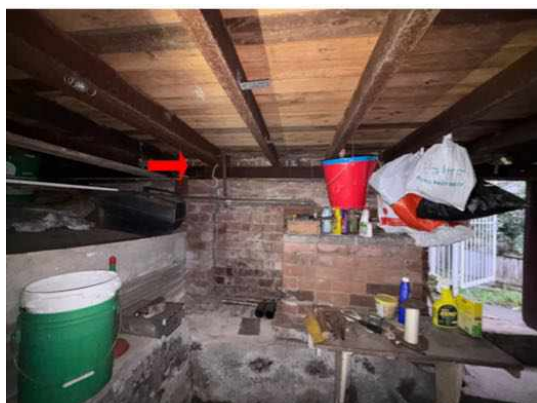
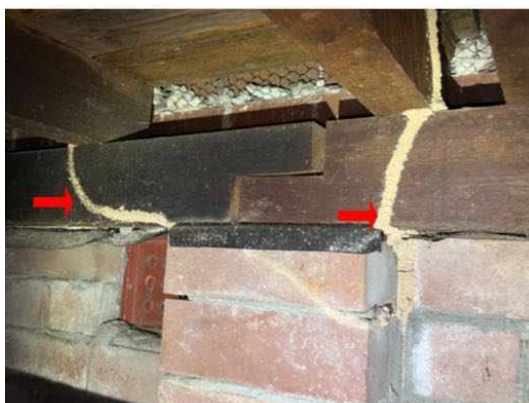
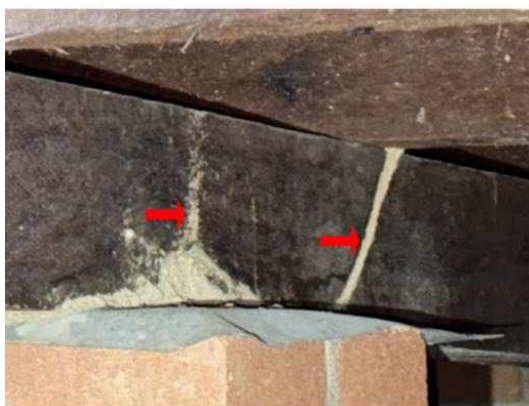
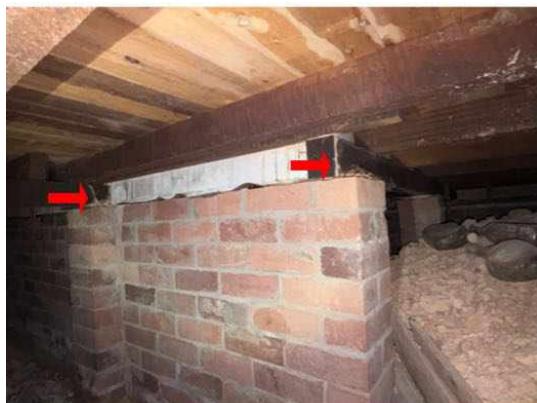
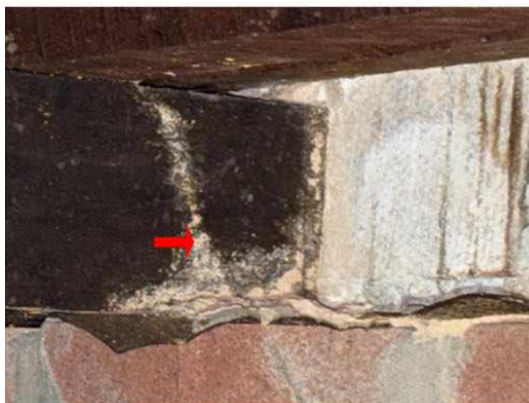
Building:	Main Building
Location:	Subfloor
Finding:	Evidence of termite damage
Information:	Despite no live termite or timber pest activity being indicated, previous termite damage was found to have affected this area or otherwise termite workings were identified at the time of inspection. This damage is considered to be inactive.

It is advised that the area be visually inspected frequently to ensure that the condition of affected building materials does not worsen. At the time of inspection, damage is not structural.

A licensed termite specialist should be appointed urgently for an invasive inspection to determine the extent of damages and also to install a chemical barrier.

A licensed builder should then be appointed to replace any damaged timber elements.

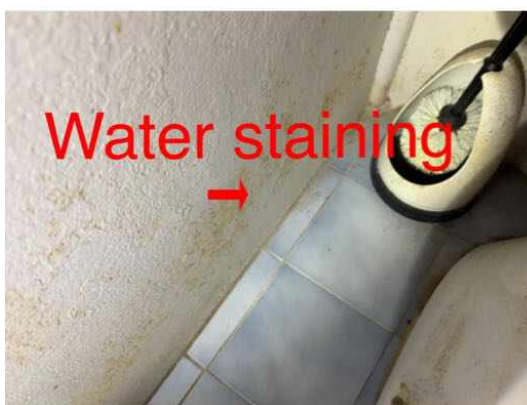
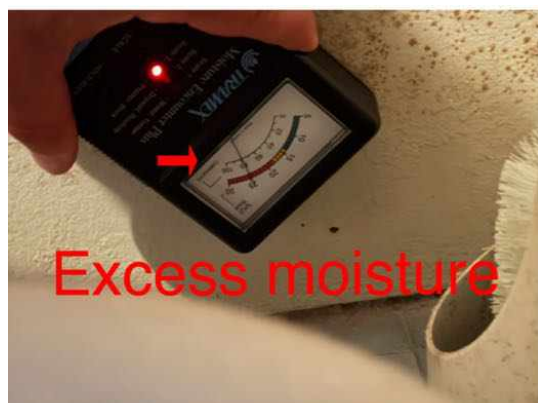
Finding 6.01

Building:	Main Building
Location:	Bathroom
Finding:	Evidence of excessive moisture was present at the time of inspection
Information:	Excessive moisture can attract termites and produce conditions that promote termite attack, fungal growth and wood decay. Excessive moisture is generally caused by deteriorated, inadequate or missing roof drainage, leaking plumbing pipes or fixtures, poorly plumbed HWS overflows or condenser units and poor site drainage. It is highly recommended that all plumbing and drainage fixtures and fittings be maintained regularly in order to prevent excessive moisture being present in the external / internal property.

Excess moisture was identified next to the toilet tap in the bathroom. Furthermore water staining was noticeable at the time of inspection. A licensed plumber must be appointed urgently for further assessment and repairs.

A licensed plumber must be appointed urgently for further assessment.

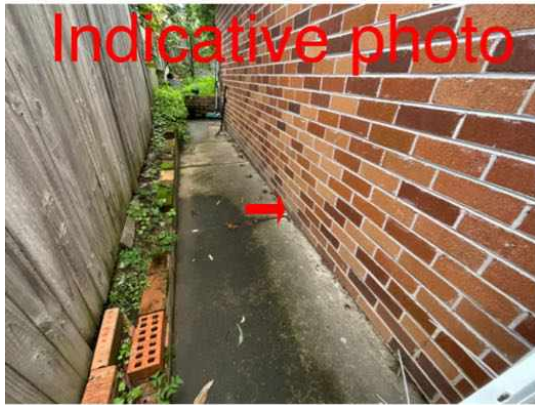
Building:	Main Building
Location:	Rear Extension
Finding:	Slab Edge - Exposure
Information:	Slab Edge Exposure: Where external concrete slab edges are not exposed there is a high risk of concealed termite entry. In some buildings built since July 1995 the edge of the slab forms part of the termite shield system. In these buildings an inspection zone of at least 75mm should be maintained to permit detection of termite entry. The concrete edge should not be concealed by render, tiles, cladding, flashings, adjoining structures, paving, soil, turf or landscaping etc. Where this is the case you should arrange to have the slab edge exposed for inspection. Concealed termite entry may already be taking place but could not be detected at the time of the inspection. This may have resulted in concealed timber damage. Does the slab edge inspection zone fully comply?

Not able to comment. A very high proportion of termite attacks are over the edge of both Infill and other concrete slabs types. Covering the edge of a concrete slab makes concealed termite entry easy. Infill slab type construction has an even higher risk of concealed termite ingress as the slab edge is concealed due to the construction design and cannot be exposed. The type of slab may only be determined by assessment of the construction plans by a qualified person e.g. Builder, Architect. Construction Plans may be obtainable by your local Council or Builder. Termite activity and or damage may be present in concealed timbers of the building. We strongly recommend frequent regular inspections in accordance with AS 3660.2. Where the slab edge is not fully exposed or the slab is an infill slab or the slab type cannot be determined then we strongly recommend inspections every 3 to 6 months in accordance with AS 3660.2 or AS 4349.3.

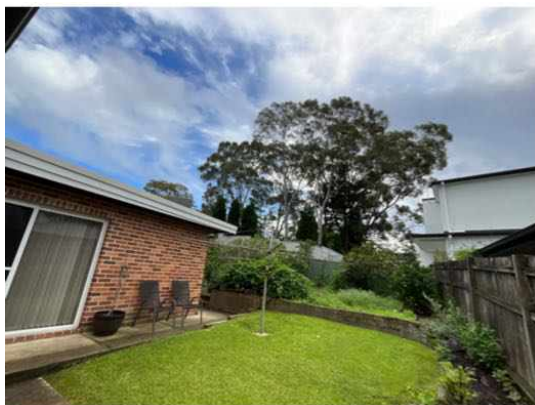
Finding 6.05

Building:	Main Building
Location:	
Finding:	Surrounding bushland - Conductive
Information:	Home and or building is situated in a high risk area for termite activity, due to close proximity to surrounding bushland.

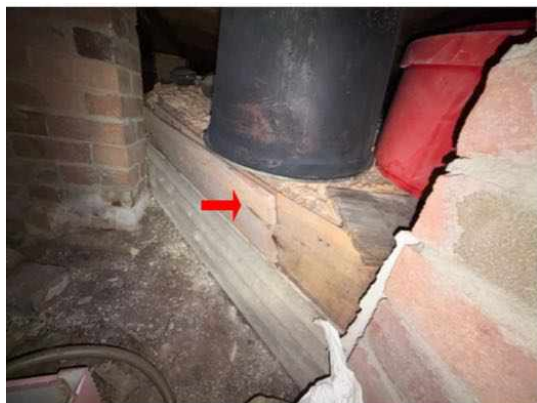
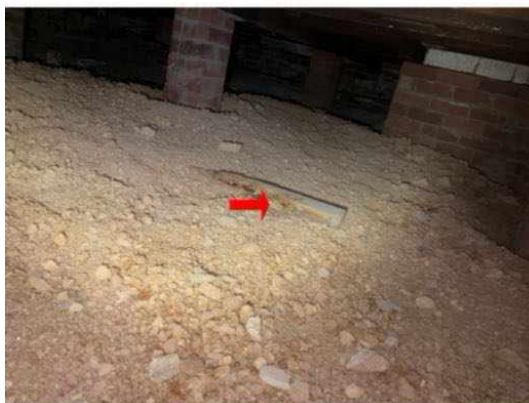
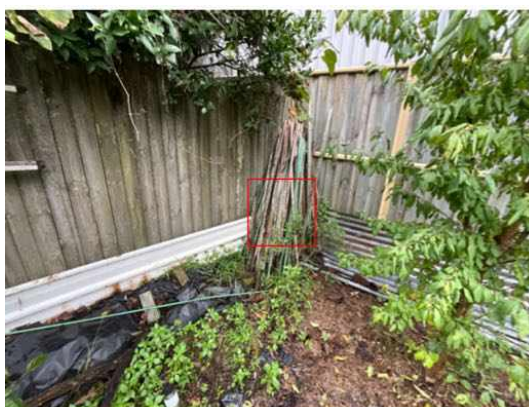
Finding 6.06

Building:	Main Building
Location:	Subfloor, yard
Finding:	Stored timbers - subfloor space or external area
Information:	The storing of timbers in the subfloor space or around the external property increases the risk of termite activity being present. As they are likely to come into contact with

weather conditions or excessive moisture wood rot is likely to develop on timbers that are not treated.

It is highly recommended that any stored timbers be immediately removed from areas in which they may attract any termite / timber pest attack. Minimisation of risk / prevention of termite attack is far more adequate than dealing with the presence of termite activity.

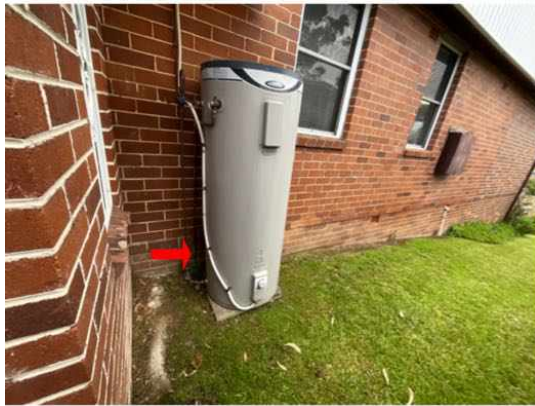
Finding 6.07

Building:	Main Building
Location:	Yard - Side
Finding:	Overflow - Not plumbed for drainage
Information:	The overflow is not plumbed or connected to suitable drainage, which can result in the surrounding area becoming excessively damp.

These damp conditions can lead to secondary defects such as rot, rust or corrosion of associated building elements, the formation of fungal decay, or even the creation of potential slip hazards. When coupled with poor site drainage, pooling of water may also attract termite activity to this area.

It is highly recommended that a licensed plumber be appointed to install adequate drainage to the overflow. These works will ensure that the area remains dry and free of

any secondary defects.

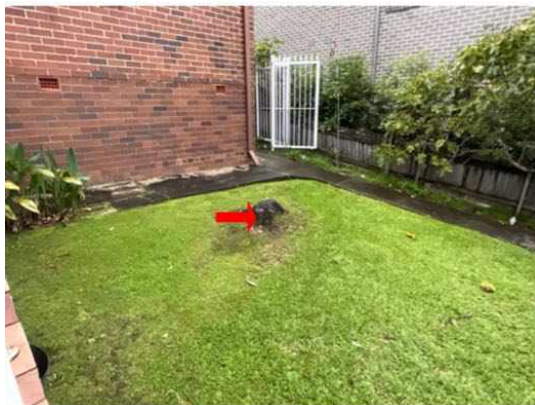
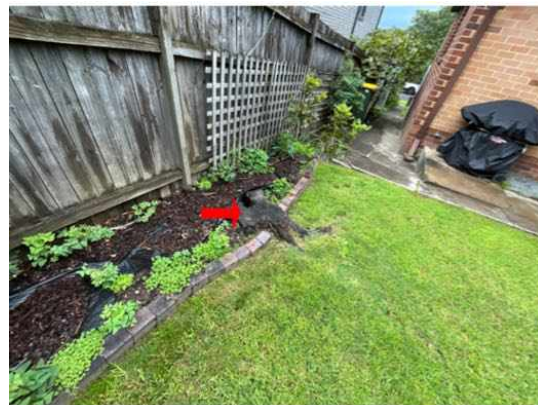
Finding 6.08

Building: Main Building
 Location: Yard
 Finding: Tree stump - Remove
 Information: Old tree stumps were found around the property. Attached photos are examples of these.

Any tree stumps in ground contact provide opportunity for concealed termite infestation and are likely to be subject to decay as the soil retains moisture or damp conditions against the tree stump.

All tree stumps should be removed where possible. Frequent pest inspections are advised to readily identify any termite activity in these areas.

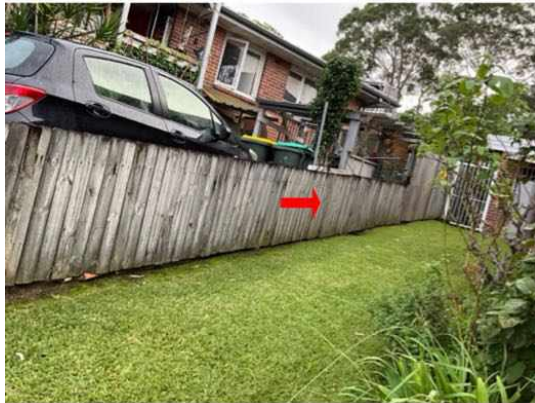
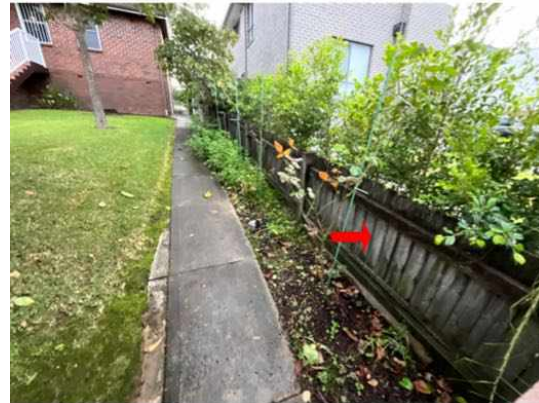
Finding 6.09

Building: Main Building
 Location: Fencing & Landscaping
 Finding: Building materials in direct ground contact - conducive to termites
 Information: Where timber elements are in direct contact with the ground and consequently

moisture or dampness they become conducive to termite activity. Whether timber is used as a building element part of a fencing structure or stored as an unused item they can provide an environment that is attractive to termite infestation.

When met with excessive moisture timber begins to decay and develop wood rot. Any timbers that are in direct contact with external grounds especially if left untreated or non-durable also provide ingress for subterranean termites into that particular element.

The removal of any such materials that may be conducive to termite activity should be removed as soon as possible to minimise the risk of termite attack.

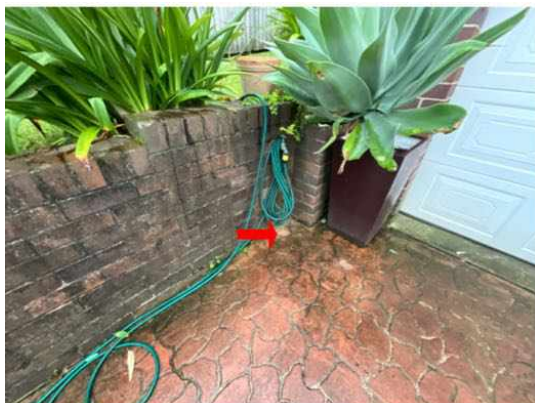
Finding 6.10

Building:	Main Building
Location:	External tap
Finding:	Tap - No drain
Information:	The external tap in this area was noted to have no drain at the time of inspection.

This keeps the surrounding surfaces damp while using the tap, which becomes conducive to termite activity.

A licensed plumber must be appointed to ensure an appropriate drain is installed.

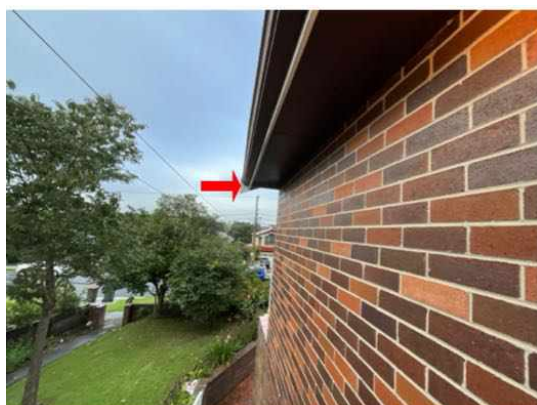
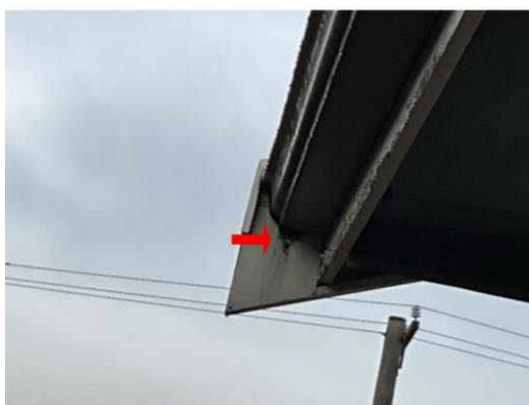
Finding 6.11

Building:	Main Building
Location:	Front left
Finding:	Water leak - External
Information:	Water leaks were found to be present to exterior plumbing work. Leaks are generally caused by deterioration of the plumbing elements over time, due to exposure to weather conditions, but may have also been caused by minor impact damage.

Such leaking creates damp conditions in the affected area, causing potential for water pooling and subsequent water damage if left unattended. These conditions may also attract termite attack, particularly if the area is subject to minimal levels of sun throughout daylight hours.

It is highly advised that a licensed plumber be appointed to rectify any water leaks that may be present. Areas of repair and replacement of plumbing fittings and fixtures may be required and, as such, a quotation should be sought.
