Building and Timber Pest Inspection Report

Inspection Date: Fri, 27 Mar 2026

Property Address: 109 Coxs Rd, North Ryde NSW 2113,
Australia

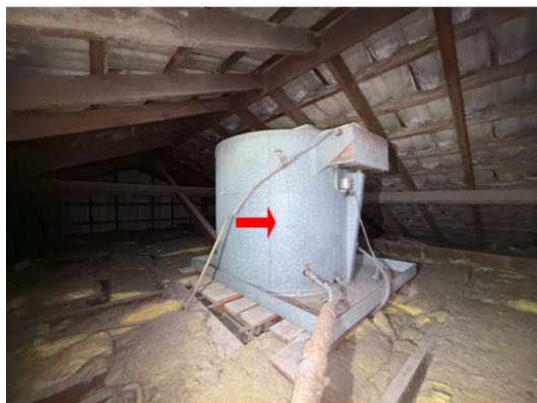
Finding 6.12

Building:	Main Building
Location:	Roof Void
Finding:	Gravity-Fed HWS - Disconnected
Information:	It was noted at the time of inspection that a disconnected gravity-fed hot water system (HWS) remains in this area.

Despite this plumbing structure being unused, it is likely to be storing residual water, and is therefore susceptible to rust and corrosion. If allowed to continue, rust and corrosion is likely to lead to damage to adjoining building elements, and may also make the area susceptible to termite or timber pest activity.

While it is a costly exercise to remove the disused gravity-fed HWS, it is advisable in the short-term future to prevent any further damage to the area. Further consultation with a licensed plumber is required to gain further advice on removal of the structure.

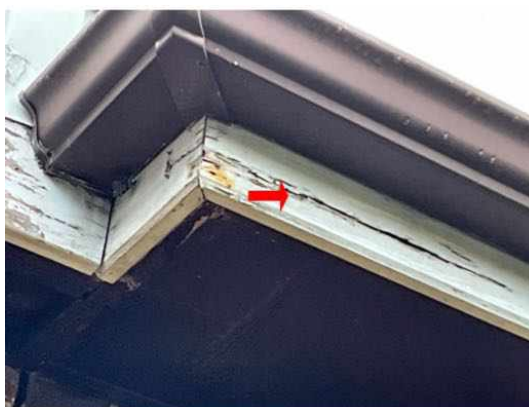
Building:	Main Building
Location:	Fascias
Finding:	Fascias - Wood rot/decay
Information:	Wood rot was found to be affecting fascias and barges in this area, evidenced by the presence of mould on the surface in some areas. Wood rot, also known as Fungal Decay, occurs when timbers and other cellulose building materials are exposed to damp conditions on an ongoing basis.

It is likely that this wood rot has developed as a result of faults in the roof plumbing, creating excessive moisture in this areas. Otherwise frequent exposure to rain and other weather conditions also make fascias and barges susceptible to accelerated deterioration.

Early intervention and regular maintenance will prolong the useful life of these building elements. Prior to any works being performed, the cause of the moisture that has created the visible wood rot should be identified and addressed in a suitable manner.

It is advised that a roof plumber be appointed to inspect all roof plumbing and subsequently identify the cause of the wood rot. Replacement of affected fascias and barges may then be a necessary step in protecting surrounding building elements from such deterioration.

A licensed plumber may be appointed to assess the cause of excessive moisture and to provide advice on any remedial works as required. A licensed carpenter may also be required to replace affected building materials.

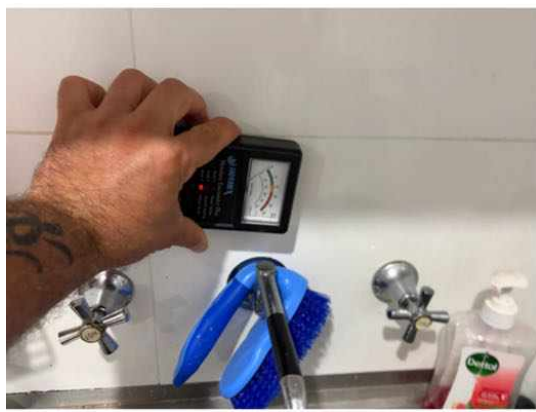
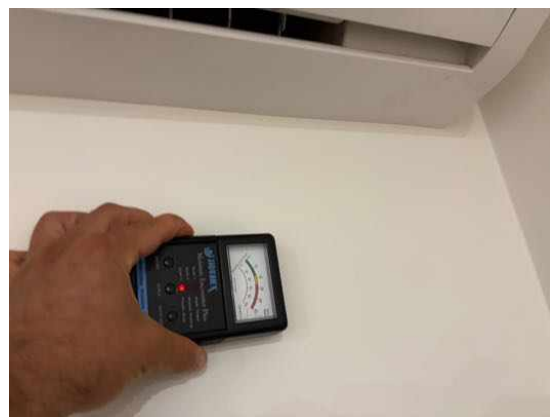
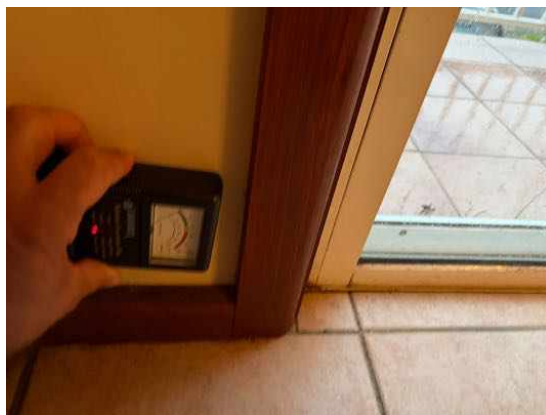
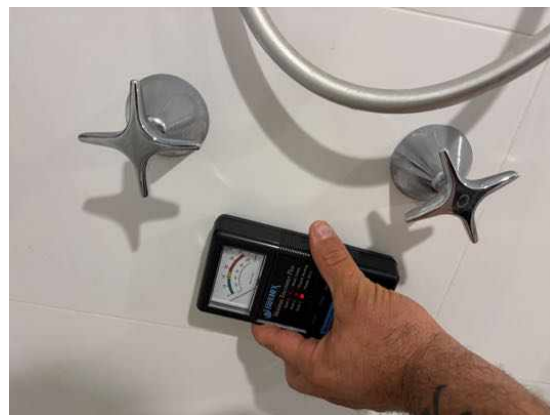
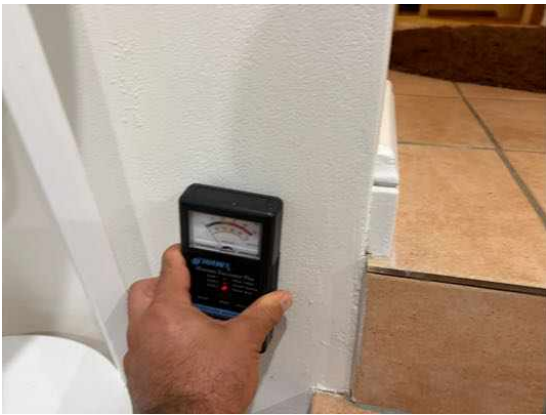
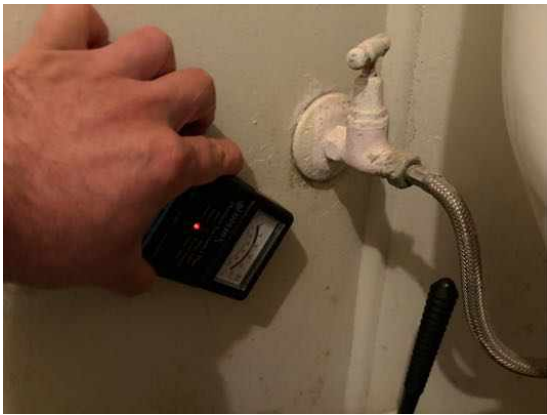
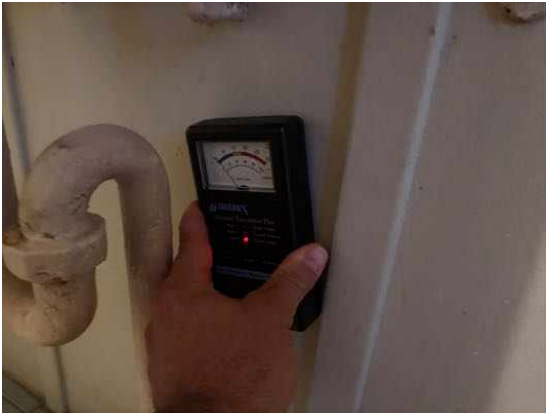
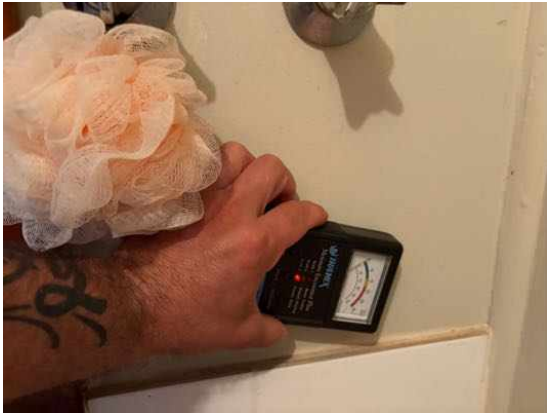
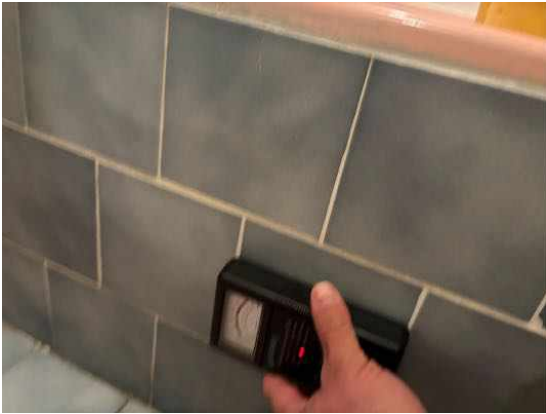
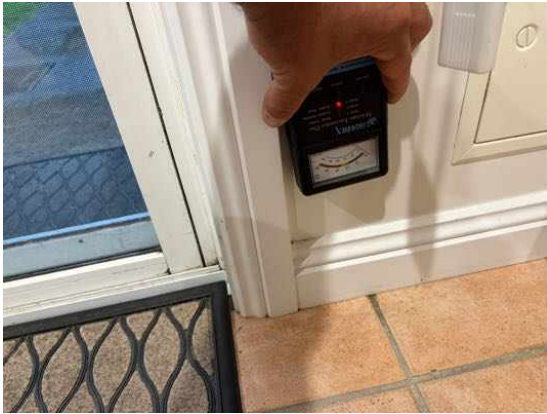
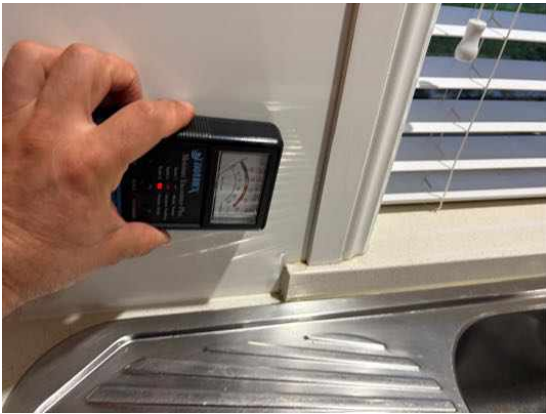
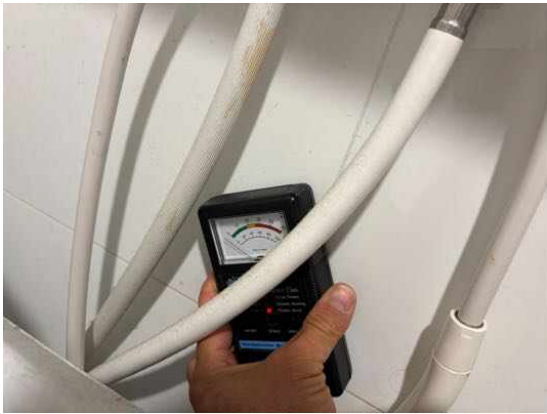
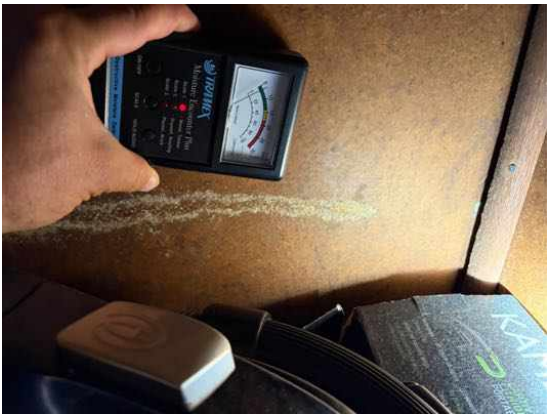
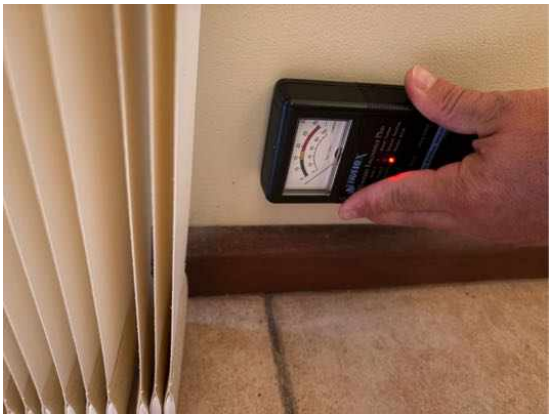
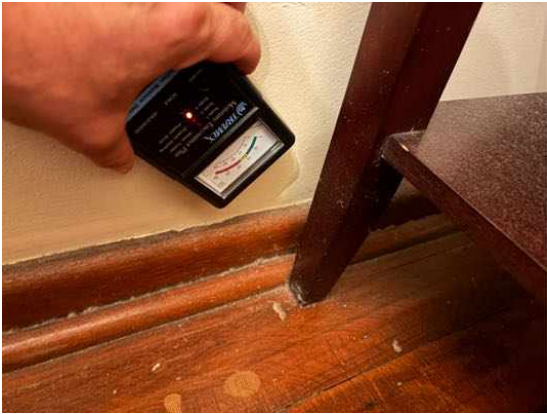
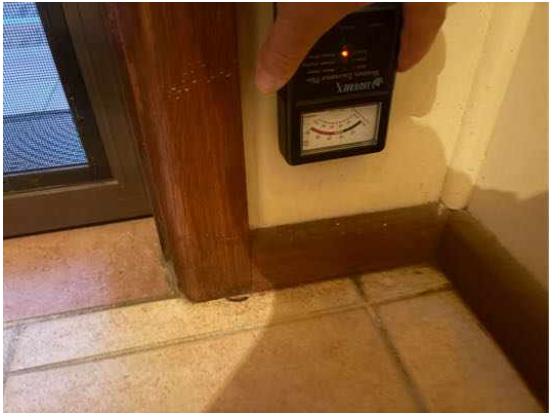
Building: Main Building
Location: All Areas
Finding: Moisture metre
Information: During the inspection the property was checked for moisture using a moisture metre.

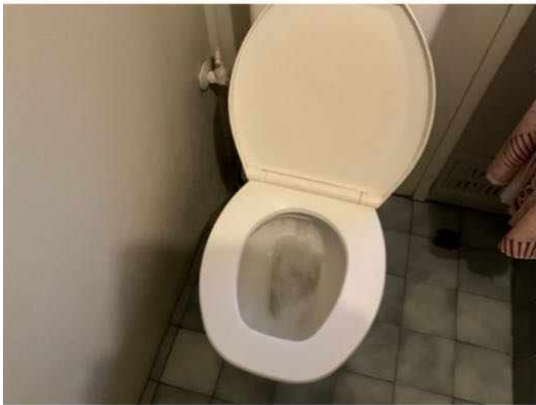
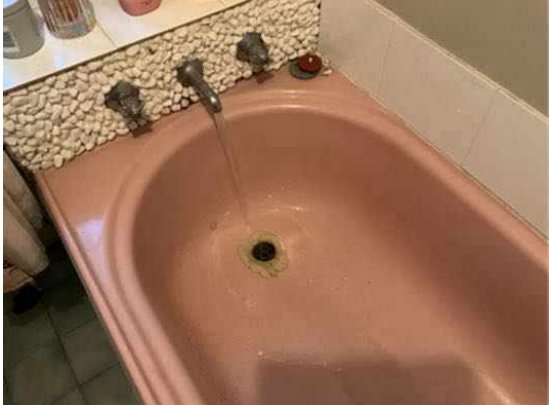
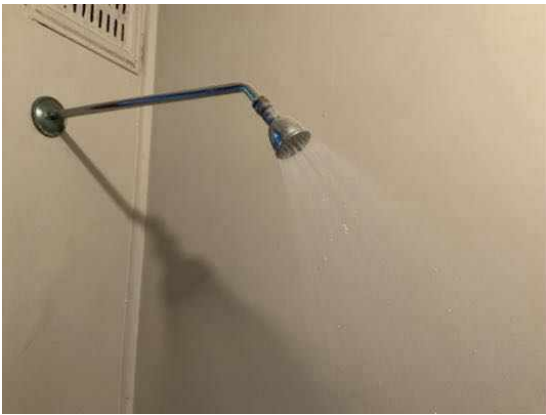
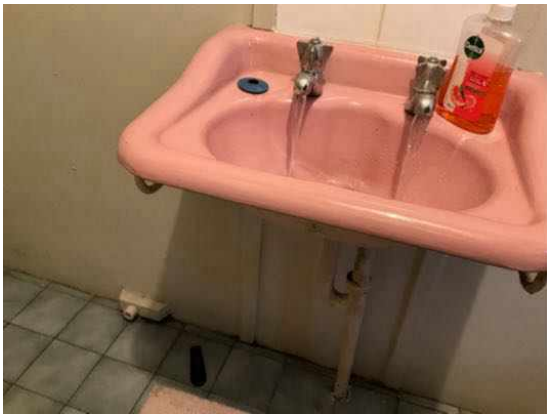
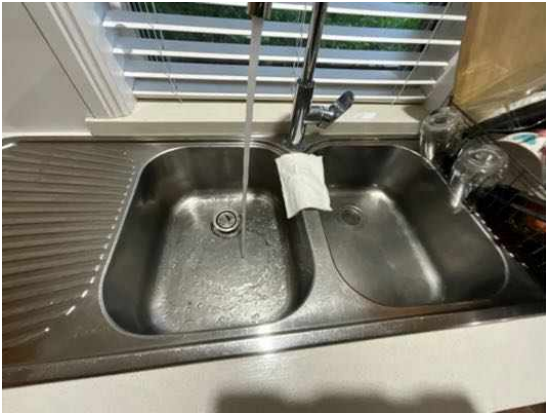
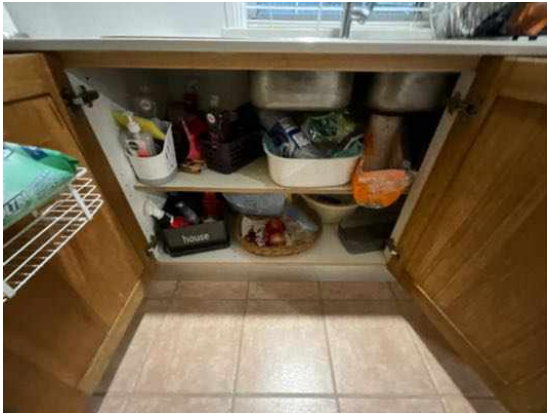
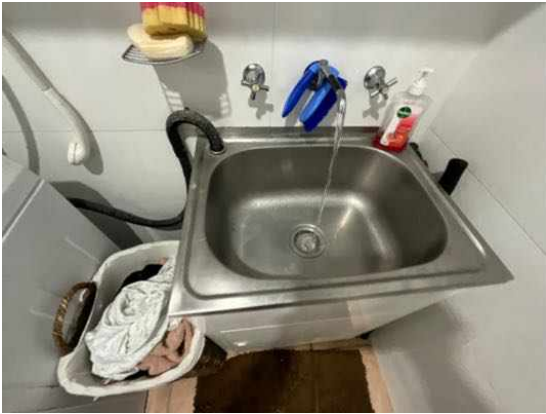
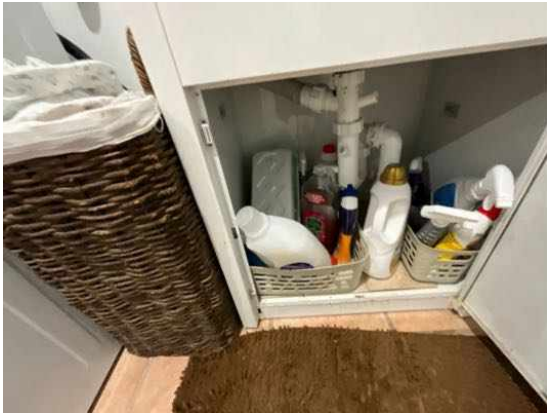
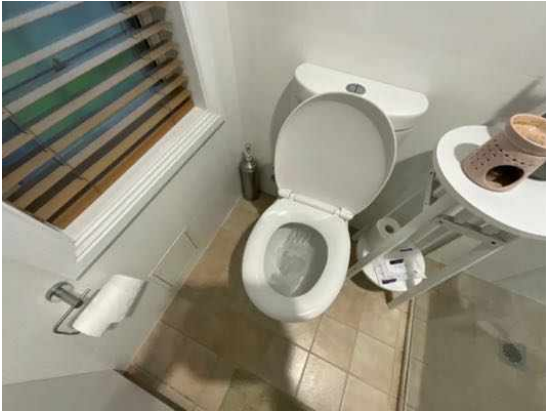
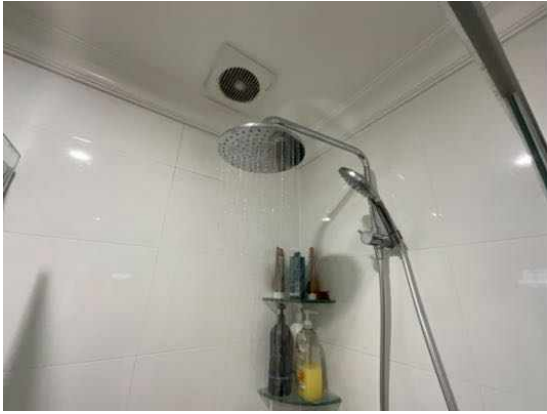
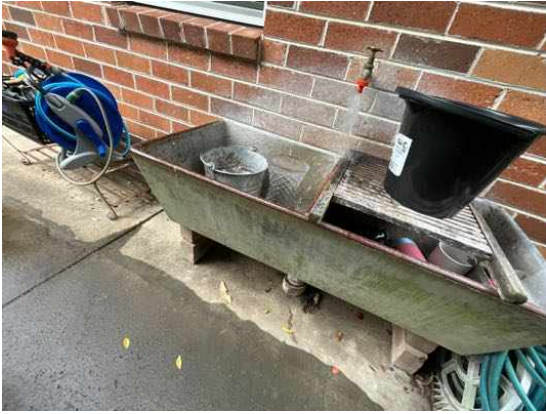
Building: Main Building
Location: All Wet Areas
Finding: Additional Photos
Information:

Additional photos are provided for your general reference.

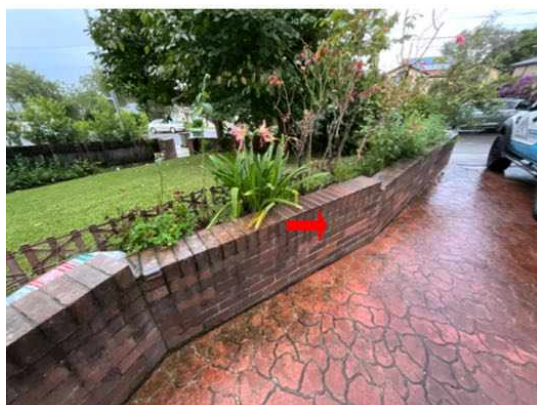
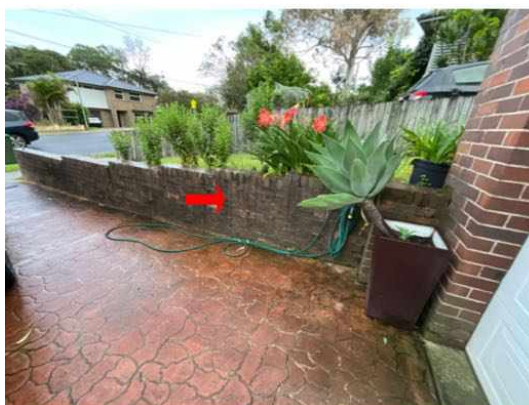
Building: Main Building
 Location: Retaining walls
 Finding: Retaining walls
 Information: At the time of inspection the retaining walls were checked and no defects were observed other than those which May have been mentioned earlier in this report.

AS4349.1-2007 requires all retaining walls in excess of 700mm to be inspected by a licensed and practicing structural engineer.

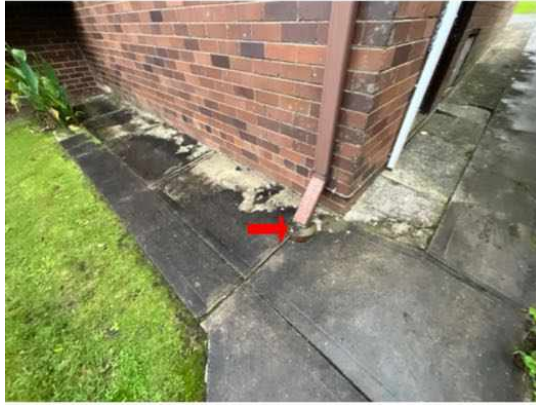
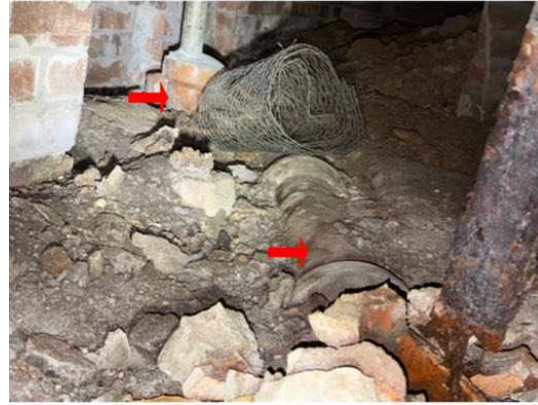
Finding: Pipework - Old urban wear pipes

Information: Old urban wear pipes were identified at the time of inspection.

Consultation with a licensed plumber is advised. CCTV inspection on pipes may be required.

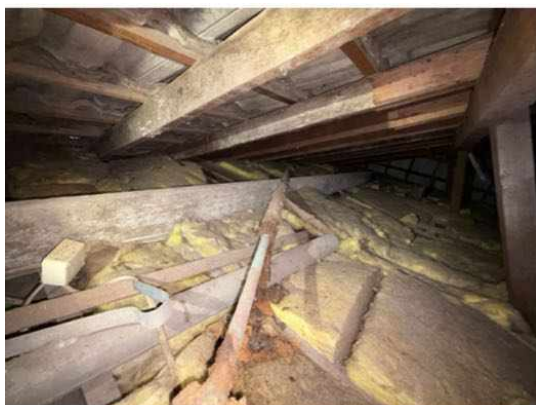
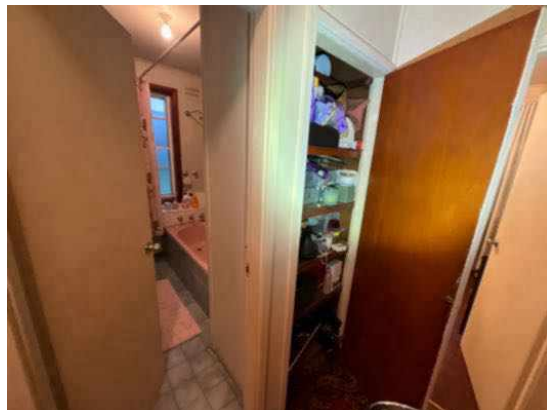
These photographs are an indication of the obstructions and limitations which impeded full inspection of the property at the time of inspection. These obstructions can hide an array of defects and should be removed to allow full inspection to be carried out. A re-inspection is recommended once the areas are made accessible.

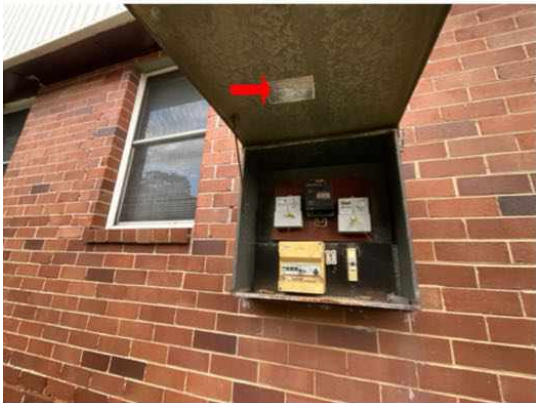
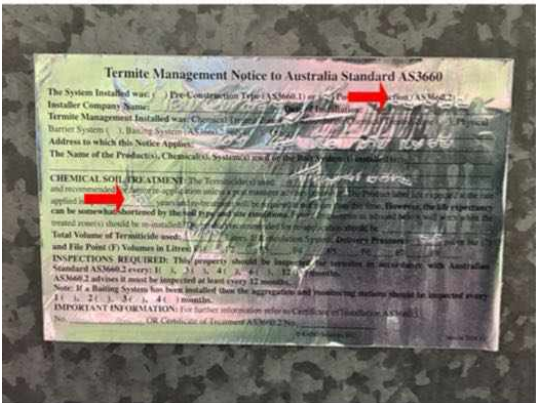
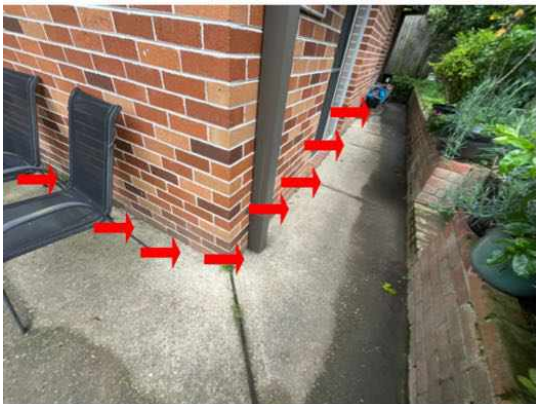
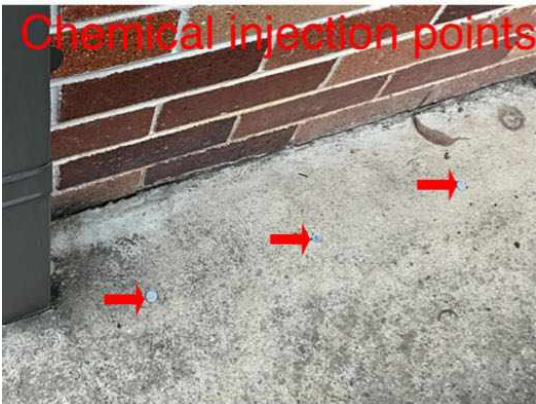
The following items were noted as - Evidence of a previous termite management program

Where a Termite Management System has been identified you should refer to the type of barrier date of installation warranty conditions and any documentation provided by a builder or past owner. Consult the company who installed the barrier to confirm whether the system is still under warranty.

Most chemical termite management systems expire and require replenishment and all physical systems are primarily designed to prevent concealed entry.
