# Building and Timber Pest Inspection Report

Inspection Date: Thu, 19 Mar 2026

Property Address: 6 Union St, Williamstown VIC 3016,  
Australia

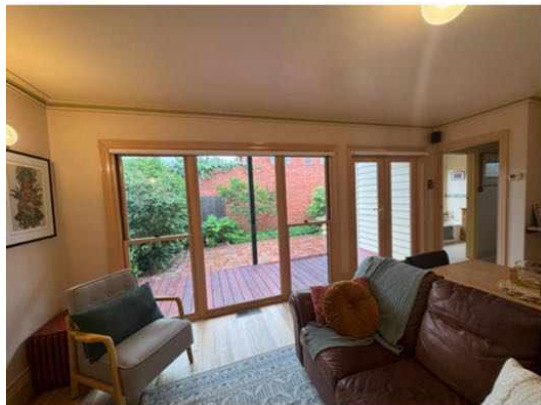
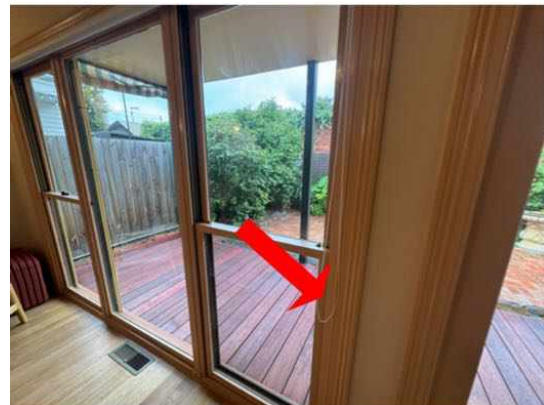
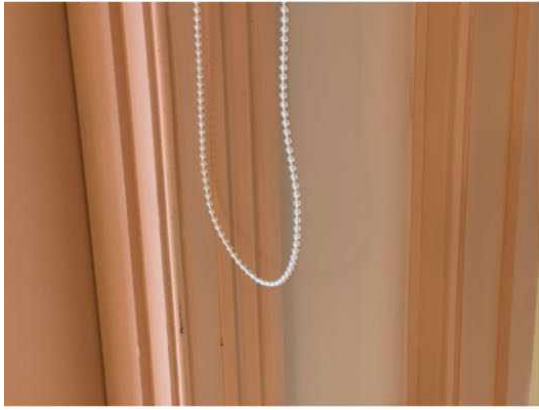
Building: Main Building  
 Location: Lounge Room  
 Finding: Curtain & Blind - Safety Cord  
 Information: Looped curtains and blind cords pose a significant strangulation hazard for children as they can place the loop over their heads and/or get tangled in the loose cords. The mandatory standard for blinds, curtains and window fittings (in place from 30th

December 2010) requires all new window furnishings to come with warning labels and to be installed with tensioning devices. However, as this standard is not retrospective, curtains and blinds installed before 2010 still need to be made safe. Check all the rooms in your house for any blinds or curtains with long, loose or looped cords. This includes any cords within children's reach at floor level or near furniture they can climb on. Secure any loose or looped cords with cleats or tension devices - these can be purchased from your local curtain and blind retailer or hardware store.

When installing new blinds and curtains, ensure you or the installer secures loose or looped cords immediately.

Depending on the types of curtains/blinds in your home, various kits and devices can help you make them safe. These can be purchased from your local hardware store, curtain, or blind retailer.

It is recommended that this defect be resolved immediately to avoid harm to occupants.

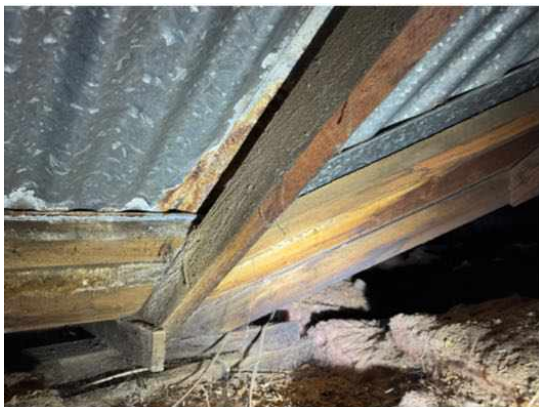
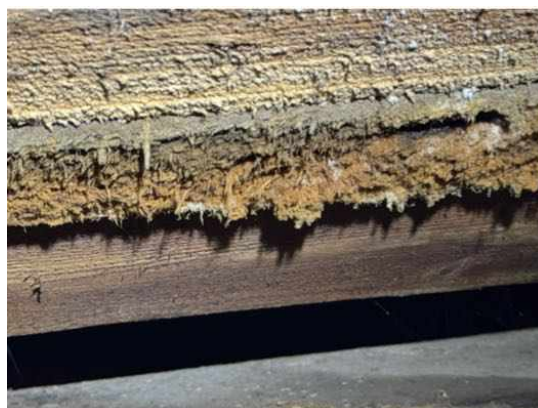
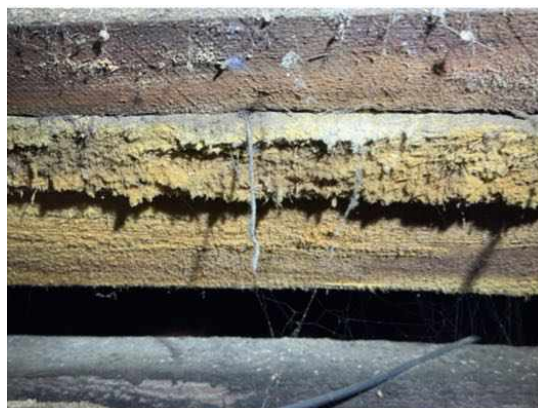
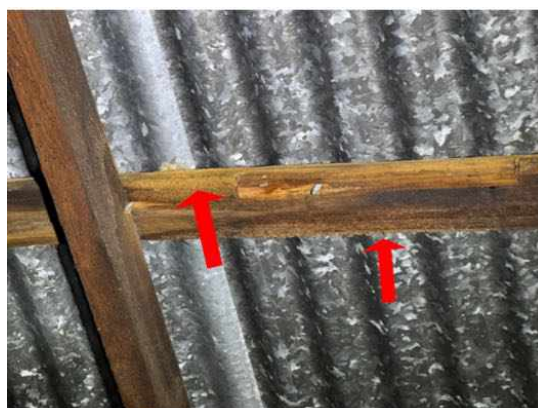
### Finding 2.01

Building:	Main Building
Location:	Roof Void
Finding:	Chemical delignification identified
Information:	Chemical delignification also known as wood defibration refers to the chemical breakdown of timber building elements. This breakdown of the Lignin deteriorates the wood impacting on the structural integrity and tensile strength of the affected building element.

Chemical delignification is most common near marine environments due to the high levels of salt in the air however this deterioration may also occur in other areas where timber elements are frequently exposed to damaging gases chemicals etc.

Where timber building elements have deteriorated repair and / or replacement is required immediately to ensure the safety of the associated structures. The likely cause of the defibration should also be investigated and dealt with accordingly.

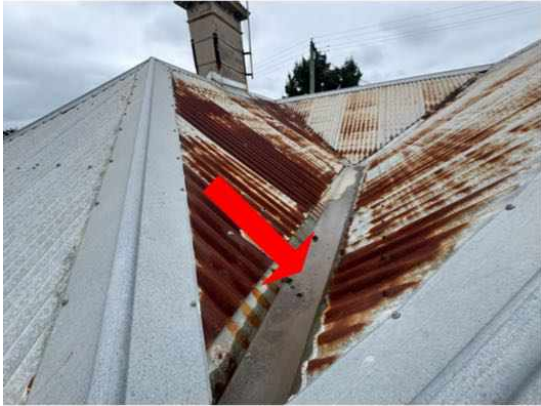
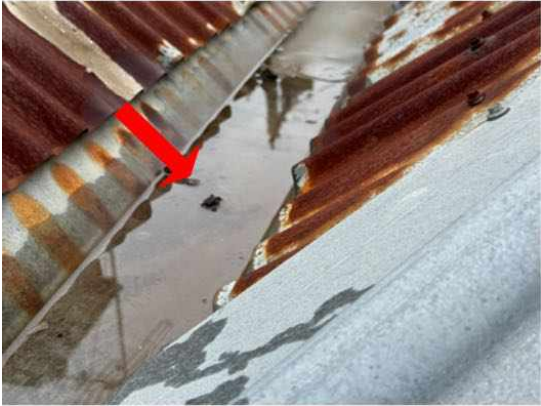
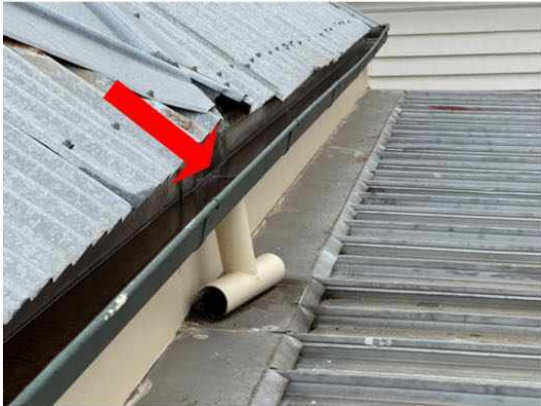
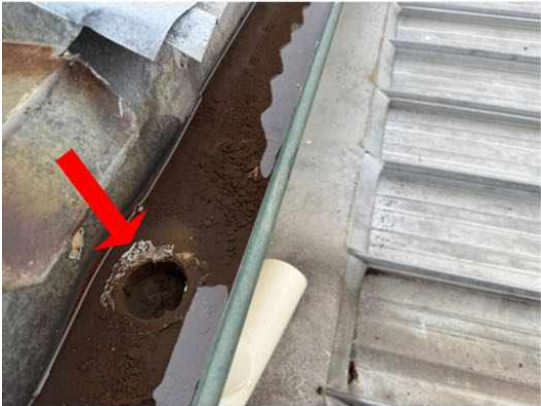
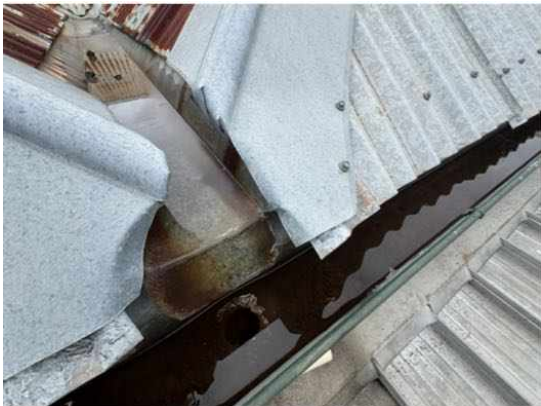
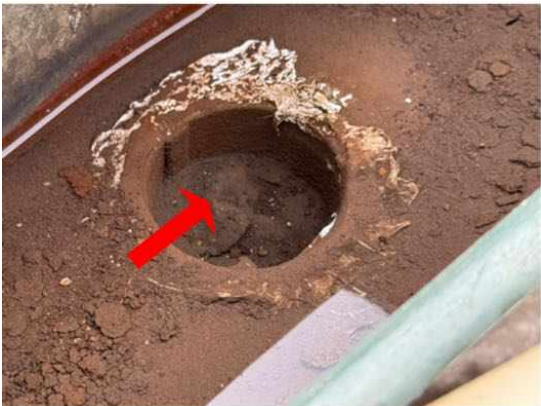
Building:	Main Building
Location:	Roof Exterior
Finding:	Gutters - Water pooling
Information:	Water was found to be pooling in sections of the roof guttering. This is generally a secondary defect caused by blocked or partially blocked gutters. Such blockages and subsequent water pooling are likely to lead to rust and water damage to associated structures if left unattended.

Any areas of guttering that shows evidence of water pooling should be checked for partial or full blockages and any secondary damage that may have occurred as a result. Depending on the extent of the damage, building elements may require repair and/or replacement to ensure adequate roof drainage and function of exterior plumbing system.

A roofing plumber should be appointed as soon as possible to rectify this issue. It is highly advised that all gutters be maintained on a frequent basis to ensure the condition of roof plumbing.

It is also recommended that a CCTV inspection of the stormwater drainage system be carried out to identify any blockages, damage, or defects that may be contributing to poor site drainage.

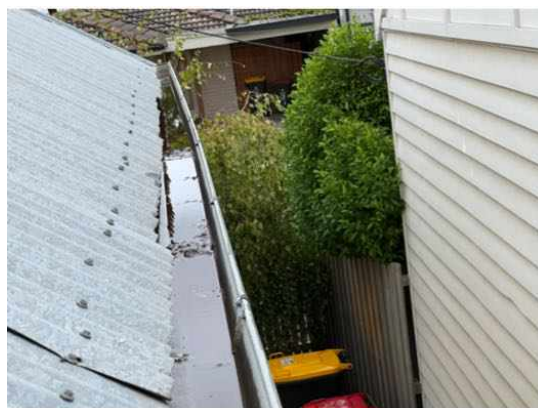
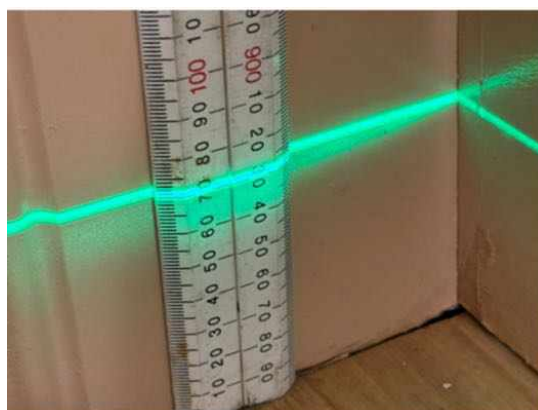
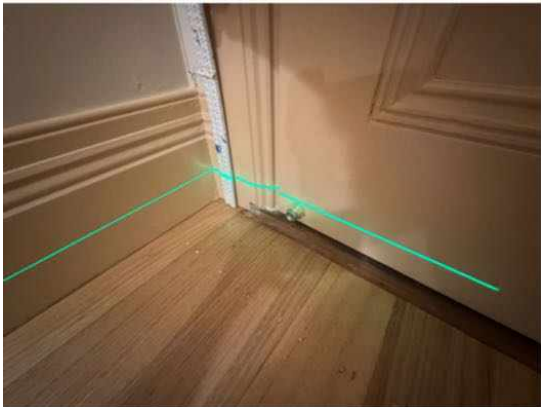
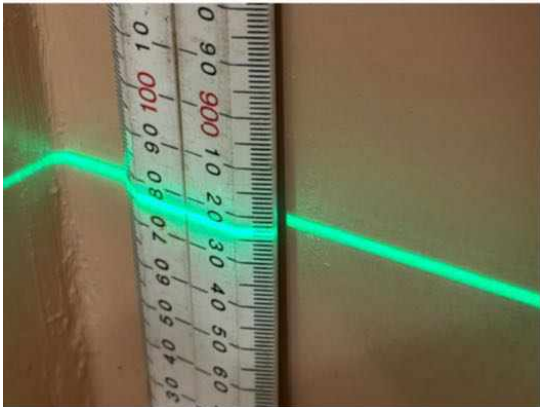
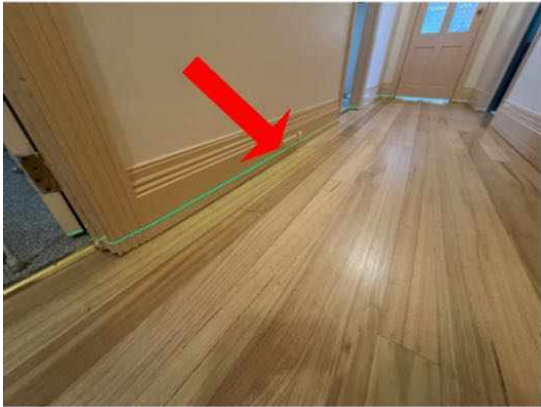
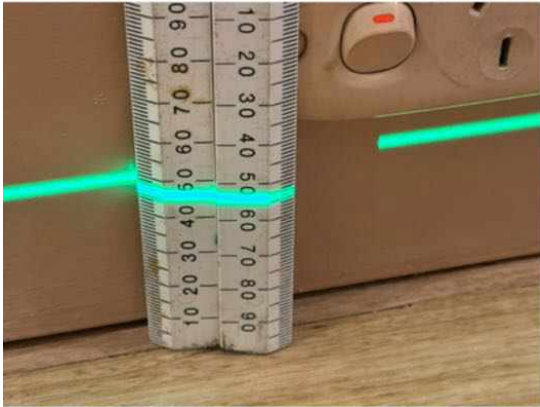
### Finding 2.04

Building: Main Building  
Location: All Internal Areas >  
Finding: Subsidence  
Information:

It appears that the subfloor structure has been affected by movement of the foundations, often referred to as sinking or subsidence. Whilst a degree of movement is expected in subfloors over time, especially as environmental conditions change and buildings 'settle' after construction, this degree of subfloor movement requires attention.

General subsidence is usually initiated by changes in soil moisture content. The most critical factor is identifying the specific causes, and identifying if this is a recurring or ongoing problem, or one that has been resolved by previous works in the past.

Subsidence can have complex and varying causes, which will influence the required remedial works. It is advised to begin by consulting a structural engineer to determine the required scope of works. This generally includes some form of underpinning, as well as addressing the underlying cause. Consultation with a geotechnical engineer may also be necessary where changes to soil moisture content is apparent.

A Registered Builder specialising in re-stumping would then generally carry out works as advised by an Engineer.

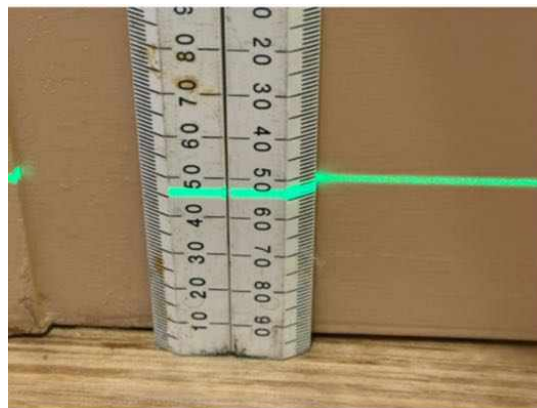
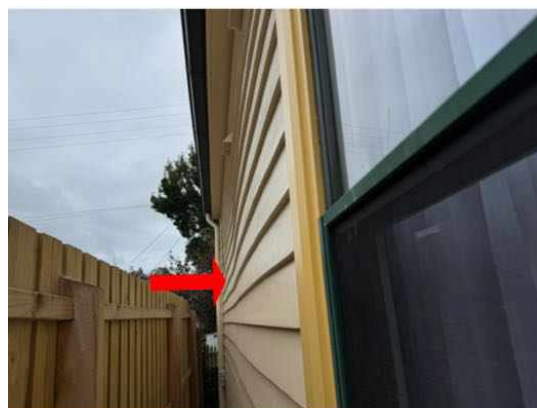
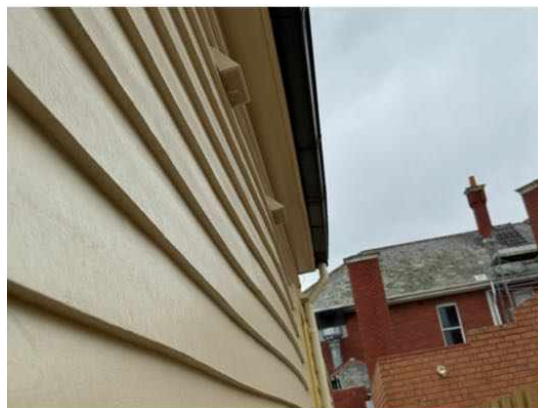
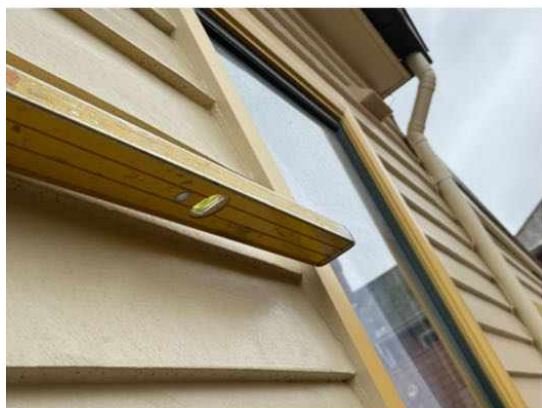
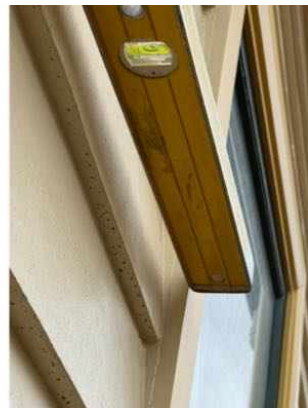
### Finding 2.05

Building:	Main Building
Location:	Exterior walls - right side
Finding:	Walls - Bowed
Information:	Vertical bowing and horizontal bending is caused by lack of resistance to vertical pressures from foundations, upper floors or roofs, or horizontal pressures from a range of causes e.g. environmental conditions.

Quotations for building works required to fix bowing building elements should be sought prior to purchase. It is suspected that extensive works, including works to walls and associated finishes, is likely to be required.

A structural engineer may provide advice prior to seeking quotations on the required scope of works to prevent structural failure. Where bowing is less severe, a registered builder, in association with qualified trades, should be appointed to perform remedial works.

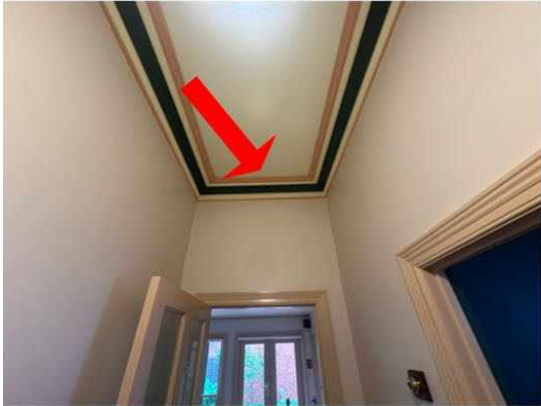
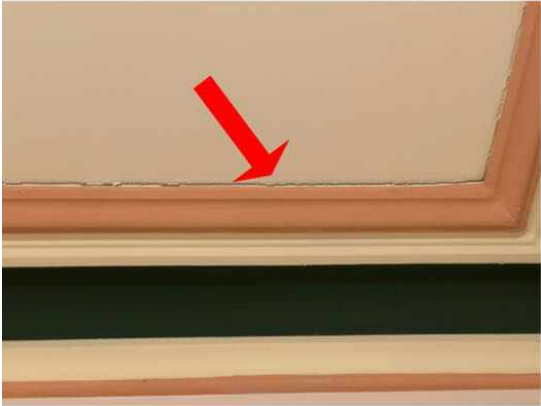
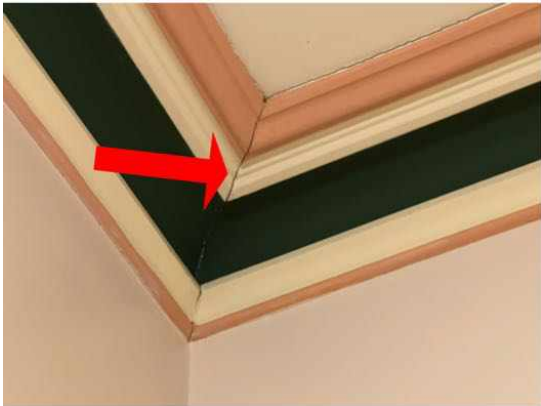
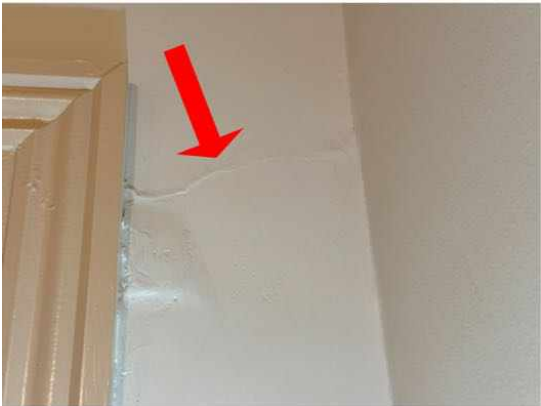
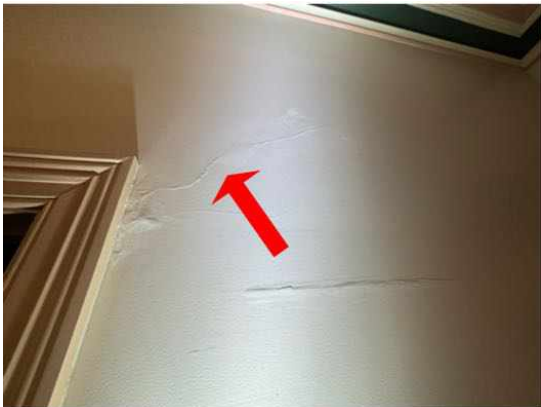
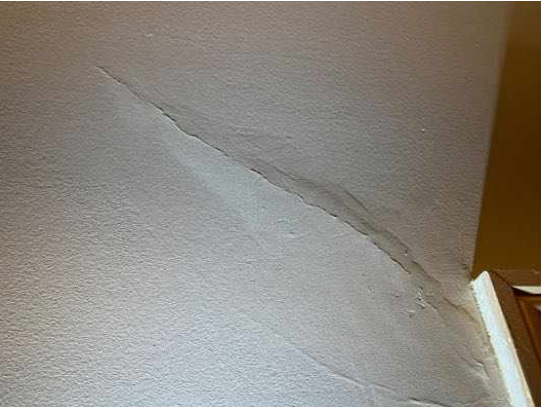
### Finding 3.01

Building:	Main Building
Location:	All Internal Areas
Finding:	Cracking - Damage Category 2 - Noticeable (up to 5mm)
Information:	Noticeable cracks are a common occurrence as a result of many primary defects. Such causes may include age, general wear and tear, expected building movement, general expansion/contraction of building materials in different weather conditions, and/or minor failings in the installation or application of building materials.

Noticeable cracks may result in minor sticking or jamming of associated doors and windows, which require easement. However, noticeable cracks are easily filled and repaired.

Monitoring of all cracking should be conducted frequently. Always contact a building inspector should cracks widen, lengthen, or become more numerous. Additionally, your building inspector should also be contacted if associated building elements such as doors and windows become more difficult to operate over time.

Relevant tradespeople, such as carpenters, painters and plasterers, should be appointed to perform remedial works, as deemed necessary.

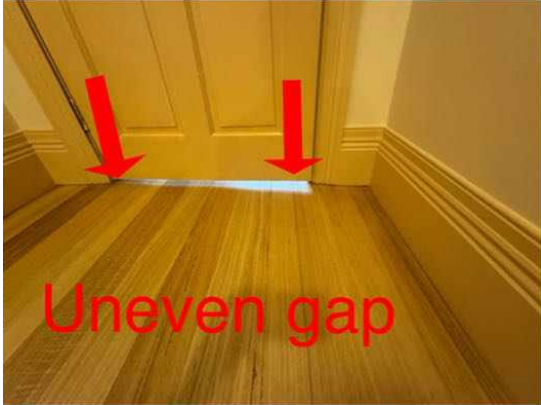
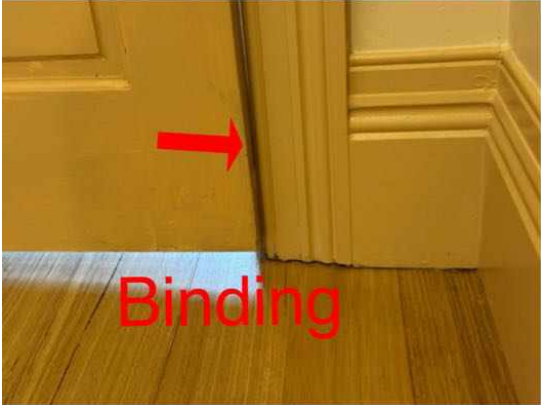
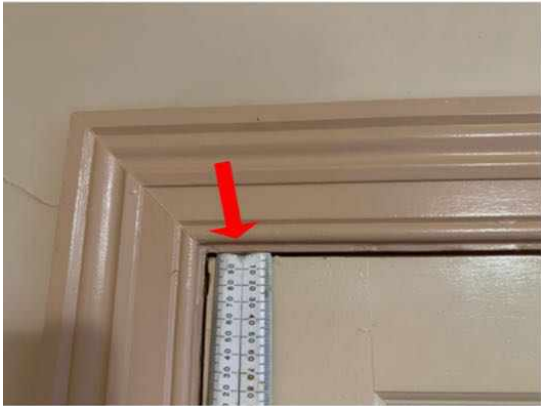
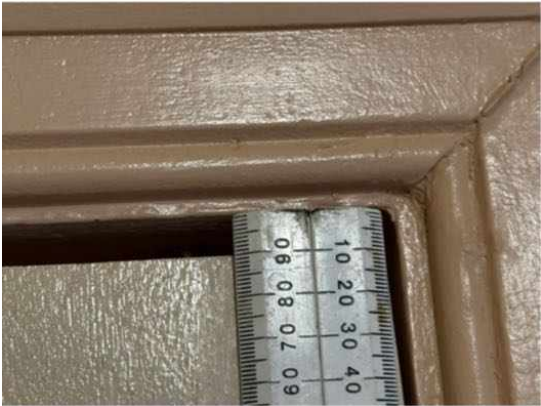
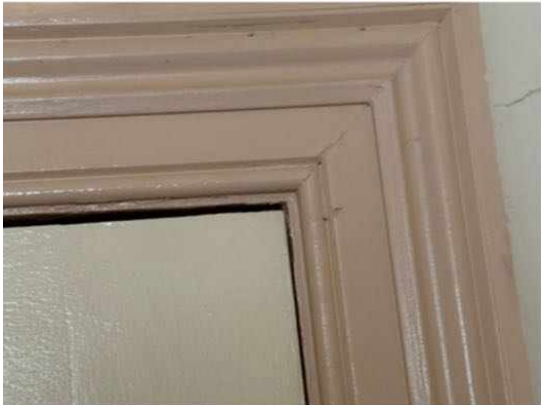
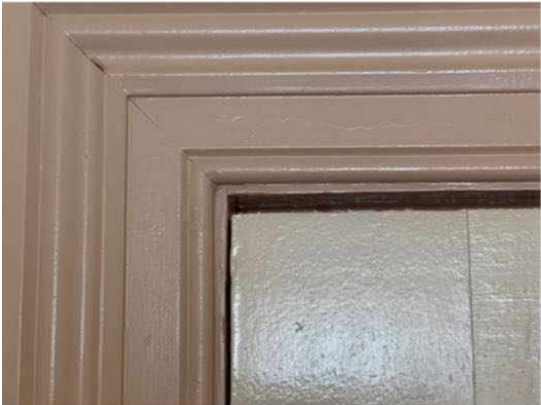
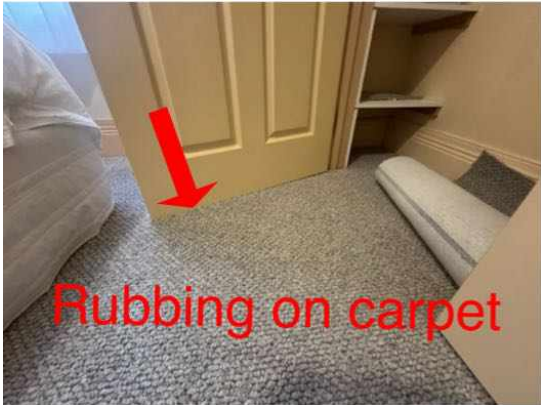
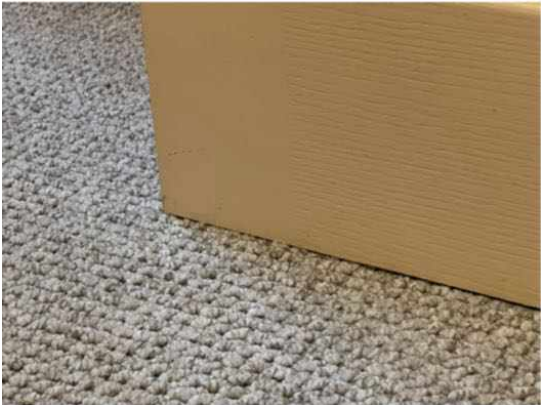
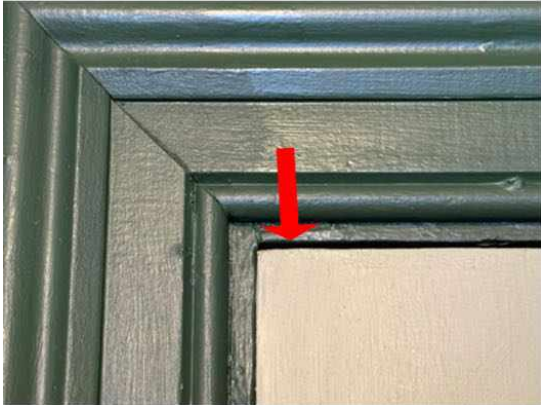
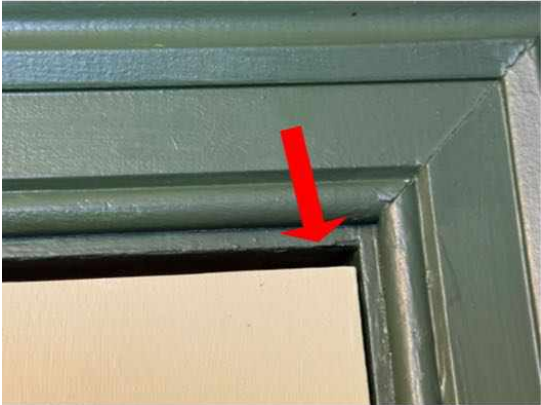
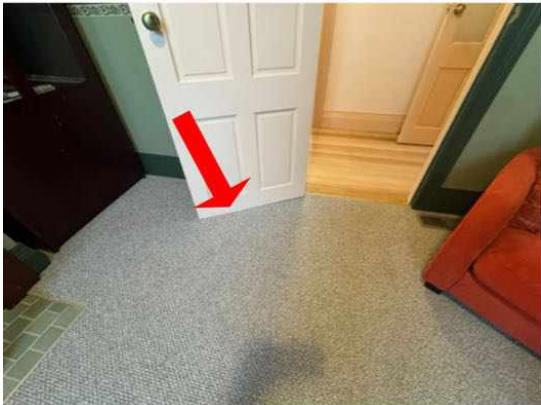
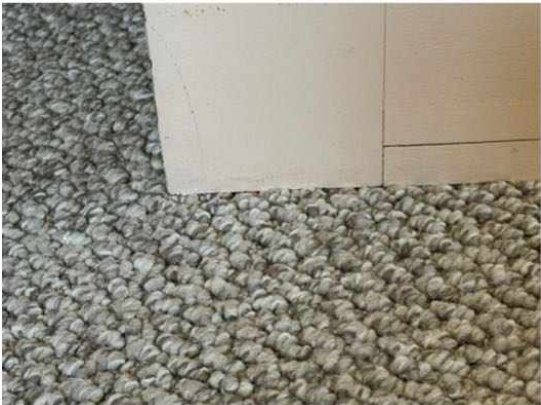
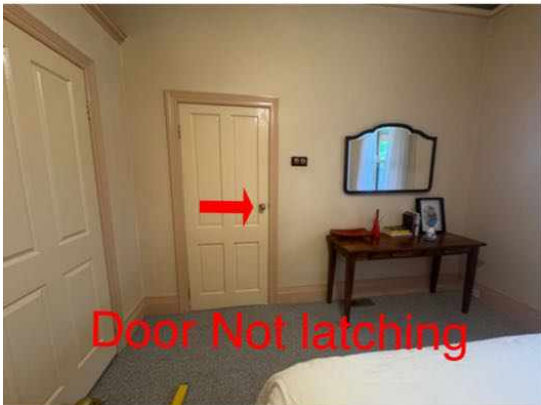
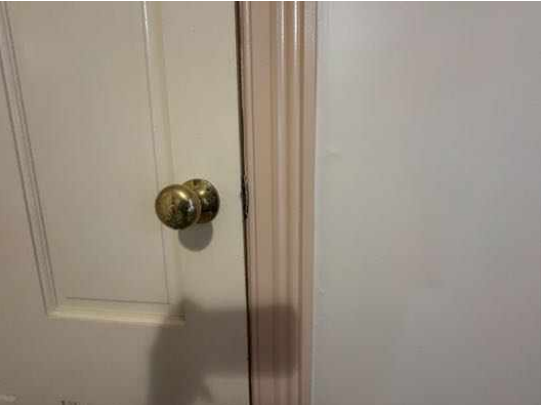
### Finding 3.02

Building:	Main Building
Location:	All Internal Areas
Finding:	Doors - uneven gaps/ rubbing on carpet/ not latching
Information:	Uneven gaps between several doors and door frames and doors rubbing on the carpet, not latching or binding were identified in several areas. Where large gaps to the head or foot of door frames appear, it may indicative of a variety of defects, ranging from uneven framework, sagging hinges or uneven flooring.

A gap to the head of the door may also indicate movement of the foundation of the property, which is a common occurrence and does not indicate structural damage.

A qualified carpenter should be appointed to perform remedial works to restore the doors to a fully operational level.

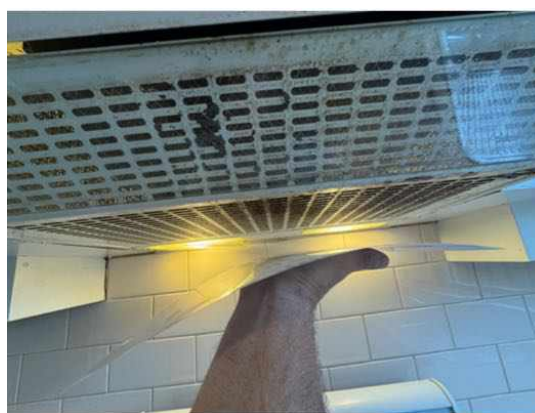
Finding 3.03

Building:	Main Building
Location:	Kitchen
Finding:	Range hood - Not operating
Information:	The range hood appears to be damaged or blocked and is not operating as intended.

Non-operational items should be addressed to ensure that the full function of the building structure is available. Where some building elements are not operating as intended, it is possible that secondary building defects could arise due to their non-operation.

Repair and/or replacement of the faulty building element is recommended. It is highly recommended that the relevant tradesperson be engaged to perform any necessary works.

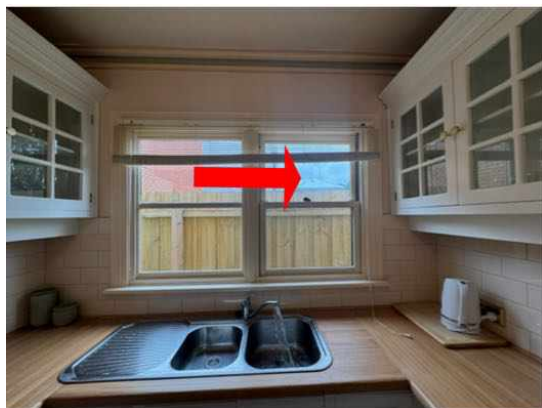
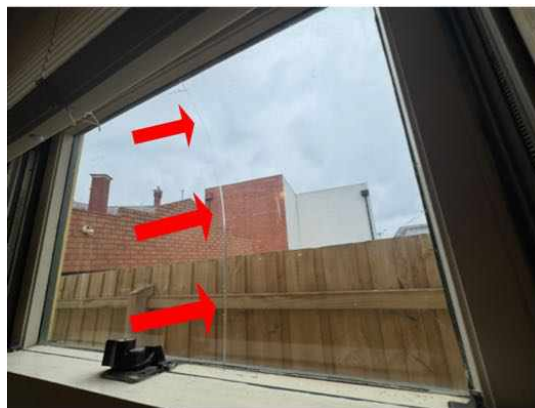
### Finding 3.04

Building:	Main Building
Location:	Kitchen
Finding:	Glass - Cracked
Information:	Cracks were identified to the glass in this area. Cracking in glass is generally the result of impact damage, and is likely to develop further when left unmanaged.

A qualified glazier is required to repair the glass as soon as possible. Please be advised that any persons coming into contact with the cracked window should do so with due caution to avoid any personal injury that may ensue.

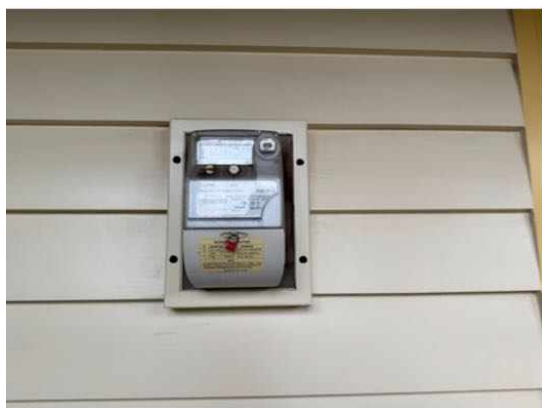
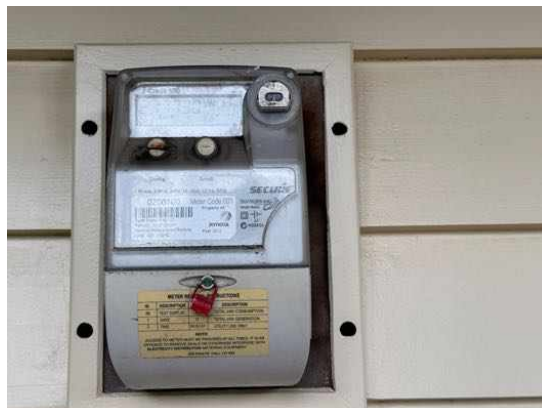
Building:	Main Building
Location:	Meter Box
Finding:	Termite Management System - no evidence of a chemical installation
Information:	The application of a post-construction chemical termite barrier is highly recommended for all properties, particularly if live termite activity has been found on the site previously. Such barriers are highly effective in preventing termite attack on any timber building elements throughout the property.

A durable notice should be placed in the switchboard unit to indicate current termite barriers. At the time of inspection, it appeared as though no termite management system has been installed, with no evidence to suggest preventative works taking place.

The client may consider gaining further advice from a pest controller as to the costs and procedures involved with this application. It is recommended that obtaining such advice be a short-term priority.

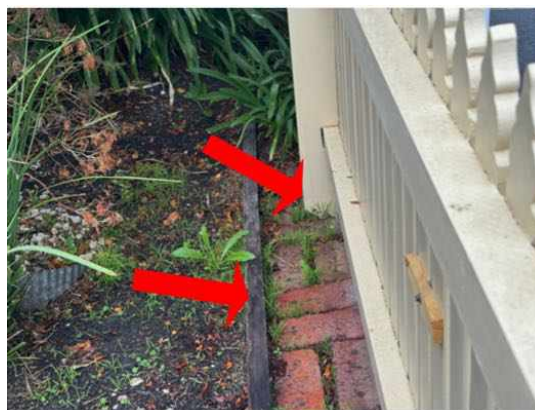
**Finding 6.02**

Building: Main Building  
 Location: Yard - Front  
 Finding: Building materials in direct ground contact - conducive to termites  
 Information: Where timber elements are in direct contact with the ground and consequently moisture or dampness they become conducive to termite activity. Whether timber is used as a building element part of a fencing structure or stored as an unused item they can provide an environment that is attractive to termite infestation.

When met with excessive moisture timber begins to decay and develop wood rot. Any timbers that are in direct contact with external grounds especially if left untreated or non-durable also provide ingress for subterranean termites into that particular element. Consider replacement with more durable materials i.e. treated timber or non timber elements.

It is highly recommended that termite or timber pest inspections be carried out every 6-12 months to aid protection of the property against infestation.

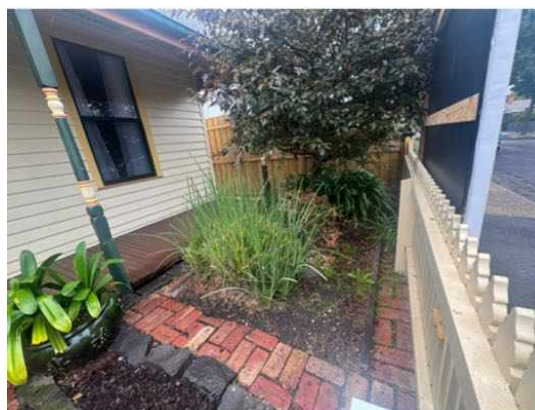
### Finding 6.03

Building:	Main Building
Location:	Yard - Front
Finding:	Garden Beds - Conditions Conducive to Termites
Information:	Garden beds were found at the time of inspection. These garden beds can include untreated timber, and with a combination of moisture from watering hosing can make conditions conducive to termite activity and termite ingress.

The building of gardens or planting of shrubs close to the perimeter of the building may promote termite activity. It is highly recommended that termite or timber pest inspections be carried out every 6-12 months to aid protection of the property against infestation.

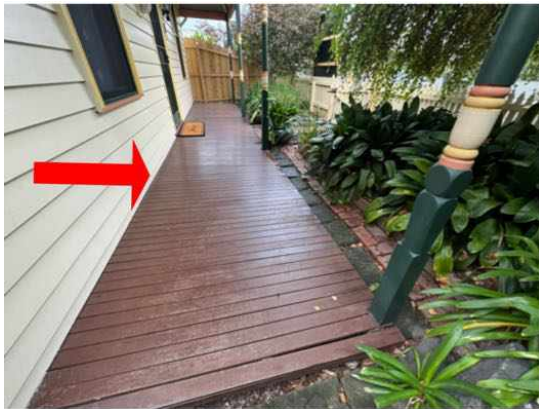
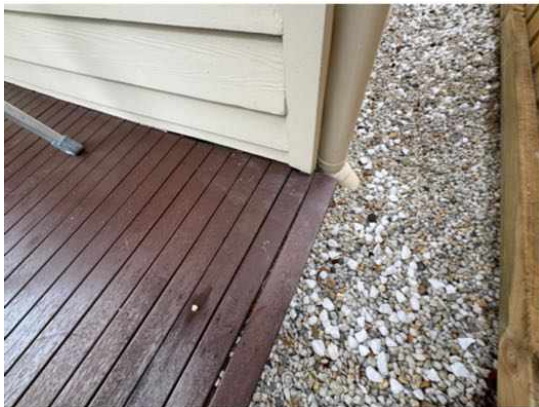
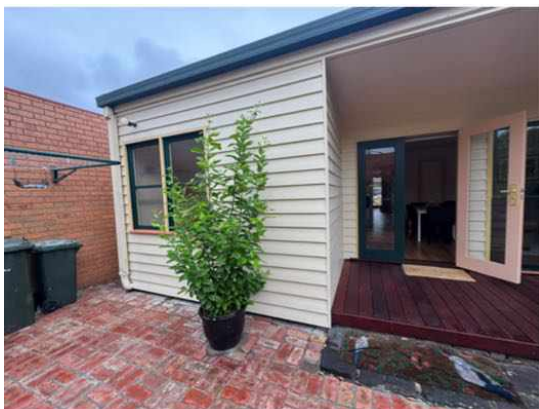
### Finding 6.04

Building:	Main Building
Location:	All External Areas
Finding:	Attachments and items adjacent to buildings
Information:	Attachments to buildings shall have a nominal gap to allow clear and uninterrupted visual inspection across the inspection zone.

porches, access ramps, carports, trellises, decks, hot-water systems, air conditioners, downpipes, service pipes, or similar attachments, shall be separated from the building by a gap of at least 25 mm, to allow clear and uninterrupted visual inspection. Where it is not possible to separate existing attachments from the building, frequent inspections of these areas shall be undertaken to provide early detection of infestation.

When bridging has occurred, full inspection is prevented, and termites may enter a property in a concealed or undetectable manner. It is highly recommended that termite or timber pest inspections be carried out every 6-12 months to aid protection of the property against infestation.

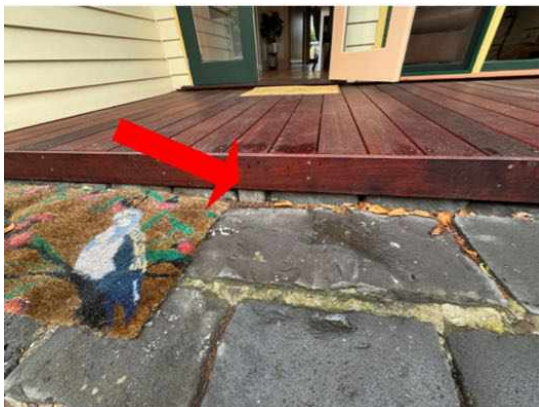
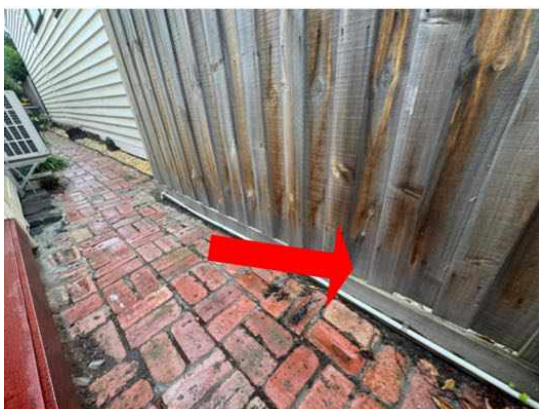
### Finding 6.05

Building:	Main Building
Location:	Yard - Back
Finding:	Building materials in direct ground contact - conducive to termites
Information:	Where timber elements are in direct contact with the ground and consequently moisture or dampness they become conducive to termite activity. Whether timber is used as a building element part of a fencing structure or stored as an unused item they can provide an environment that is attractive to termite infestation.

When met with excessive moisture timber begins to decay and develop wood rot. Any timbers that are in direct contact with external grounds especially if left untreated or non-durable also provide ingress for subterranean termites into that particular element. Consider replacement with more durable materials i.e. treated timber or non timber elements.

The removal of any such materials that may be conducive to termite activity should be removed as soon as possible to minimise the risk of termite attack. Where it is not possible frequent inspections of these areas shall be undertaken to provide early detection of infestation

It is highly recommended that termite or timber pest inspections be carried out every 6-12 months to aid protection of the property against infestation.

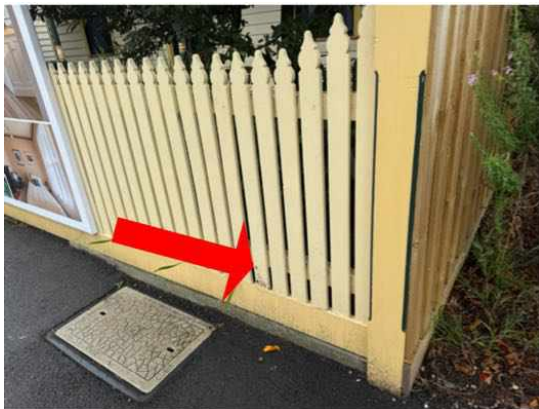
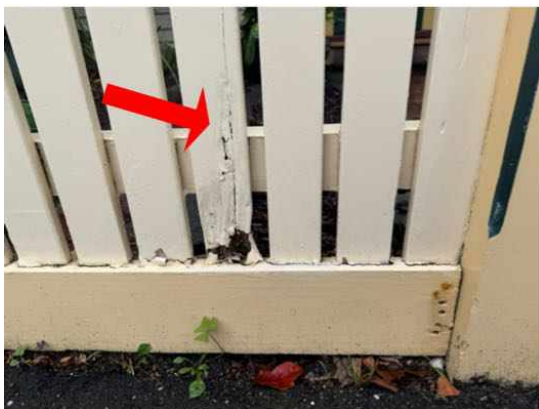
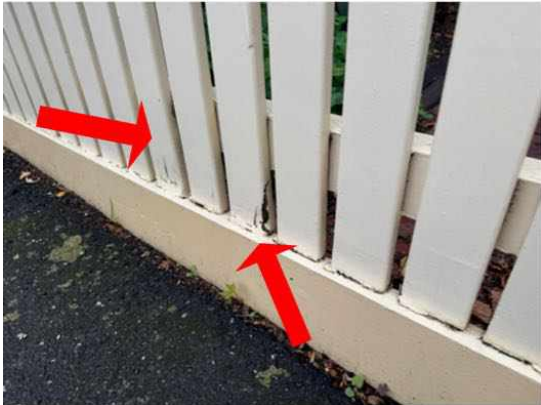
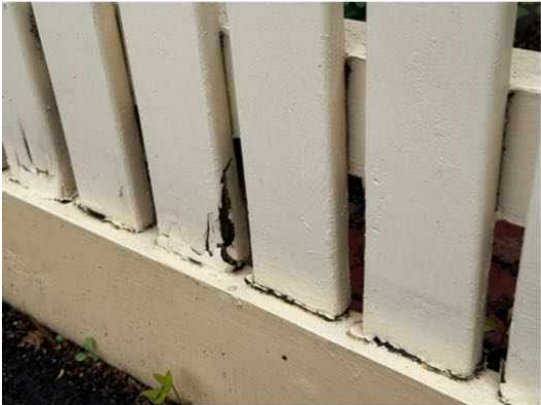
## Evidence of fungal decay activity and/or damage

If left unattended, it is likely that further damage will occur. It is suspected that repair of several elements of the fencing may be required.

A fencing contractor should be appointed to provide further advice and perform rectification works as necessary.

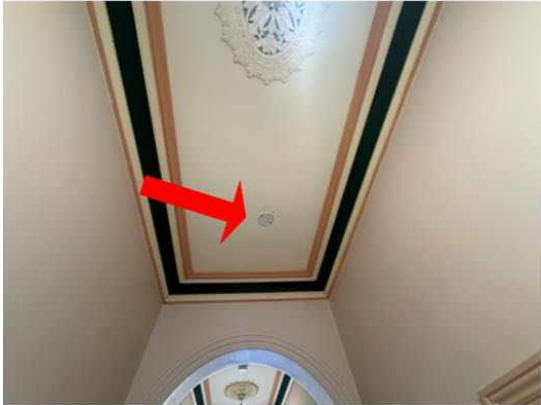
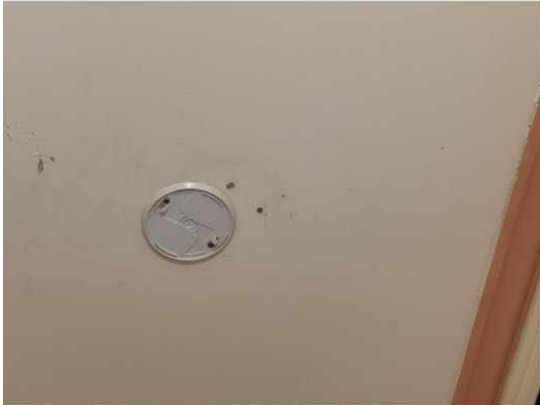
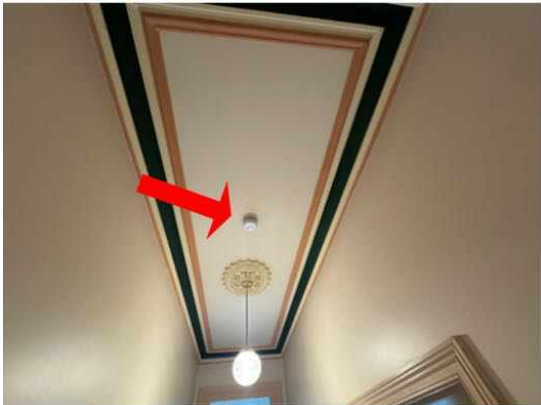
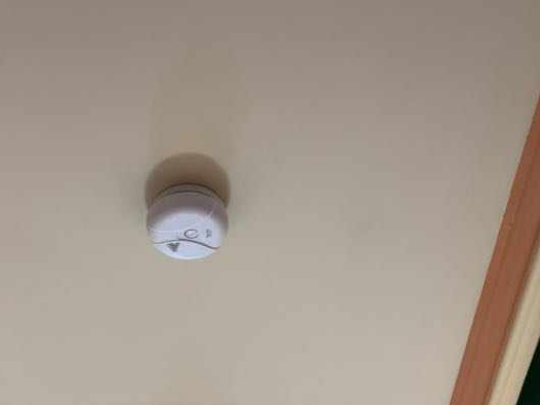
Building: Main Building  
 Location: All Areas  
 Finding: Smoke Detectors and Alarms  
 Information: Reporting on Smoke Detectors or Alarms, including hard wired smoke detection systems and their legislative requirements, is outside the Scope of this Report.

Always ensure sufficient working and suitable smoke detectors are installed prior to occupying any building. Additionally, it is advised that all smoke detectors be tested by the homeowner on a monthly basis.

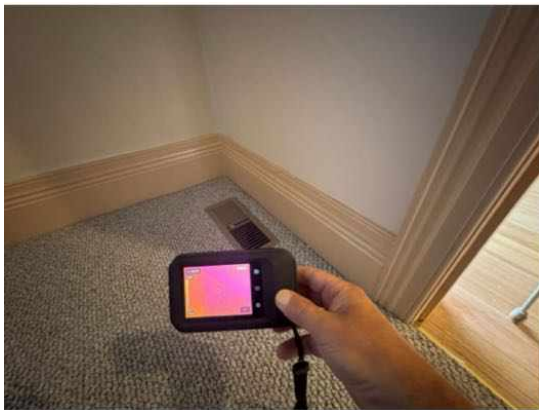
Building: Main Building  
 Location: All Areas  
 Finding: Ducted heating and cooling - Not operating (suspected)  
 Information: At the time of inspection, it was suspected that the ducted heating and cooling system may not be operating. The operational status could not be confirmed.

Non-operational items should be addressed to ensure that the full function of the building structure is available. Where some building elements are not operating as intended, it is possible that secondary building defects could arise.

It is highly recommended that a licenced HVAC contractor be engaged to perform any necessary works to ensure the ducted heating and cooling system is working safely and efficiently.

Further clarification and confirmation of the operational status of the ducted heating and cooling system should be obtained from the vendor.

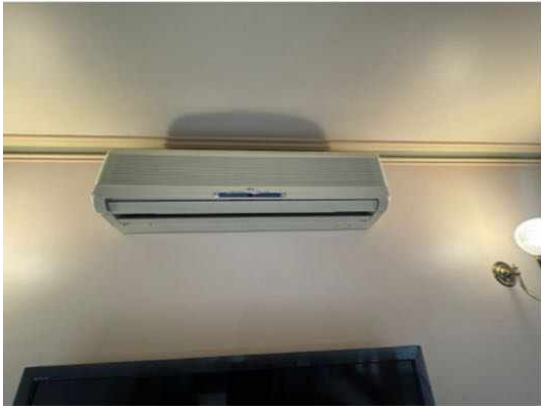
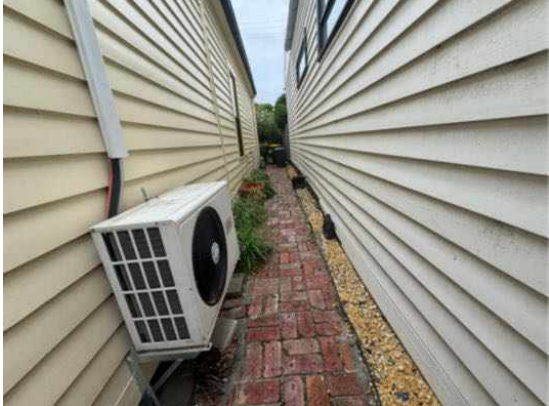
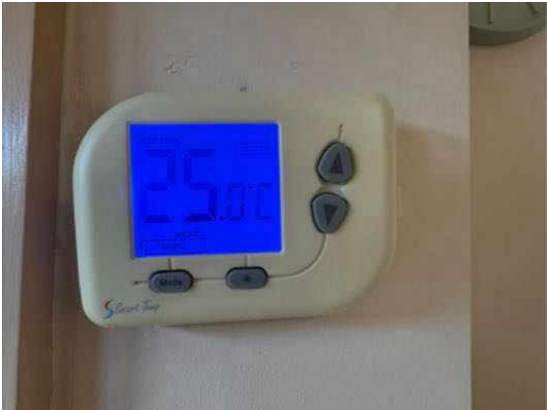
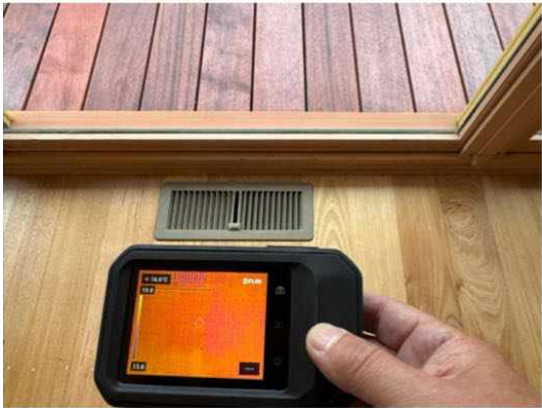
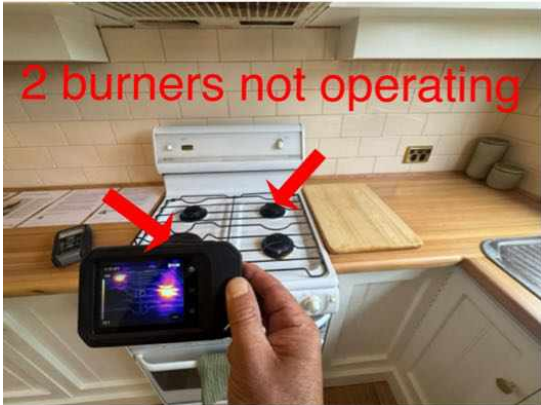
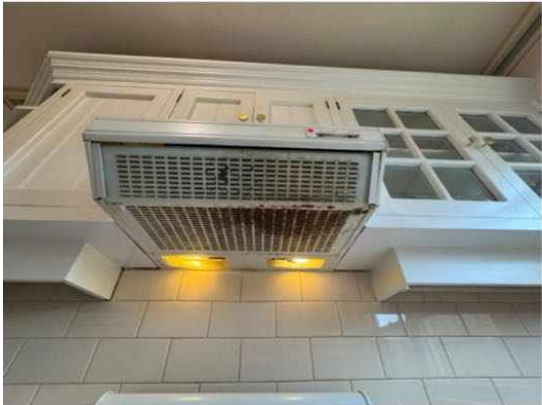
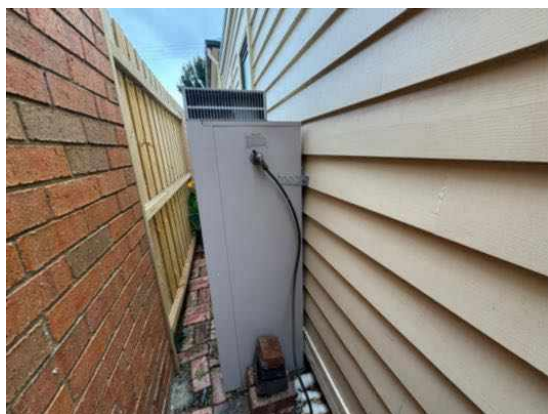
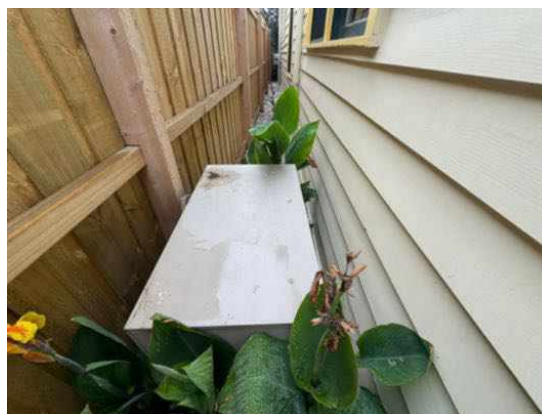
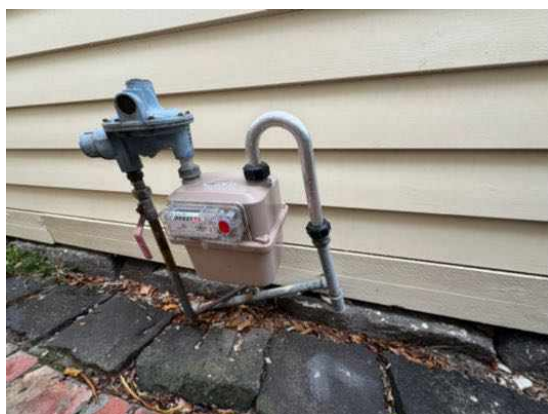
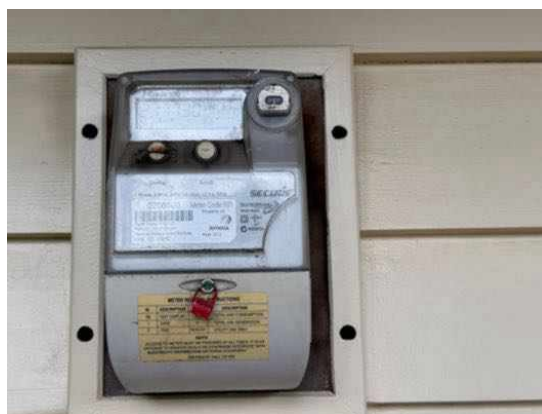
Building: Main Building  
 Location: All Areas >  
 Finding: Plumbing and Electrical  
 Information: All gas and electrical appliances need to be serviced and maintained in good order. I can not guarantee that all appliances are working to full capacity and always recommend that heating/cooling equipment be serviced regularly.

Plumbing and electrical inspections are outside the scope of the building inspection and must be conducted by Licensed and registered tradespersons. It is recommended that the client arrange to have the gas and electrical appliances

checked by licensed and registered tradespersons to ensure they work safely and efficiently.
