# Building and Timber Pest Inspection Report

Inspection Date: Thu, 19 Mar 2026

Property Address: 6 Union St, Williamstown VIC 3016,  
Australia

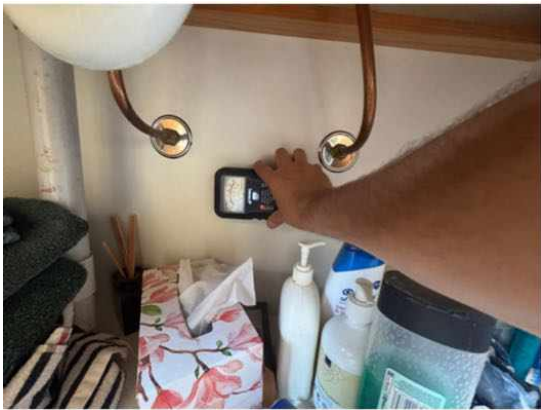
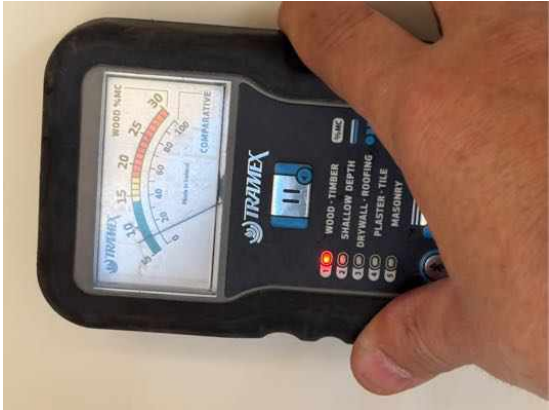
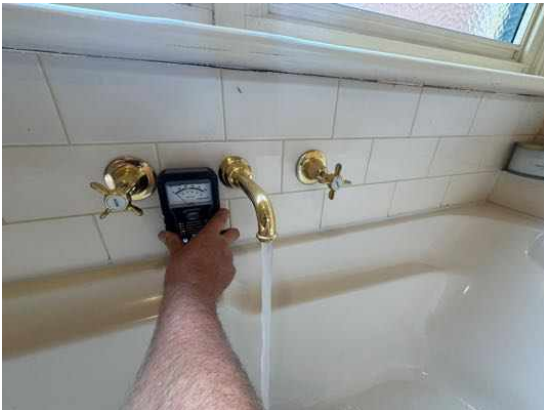
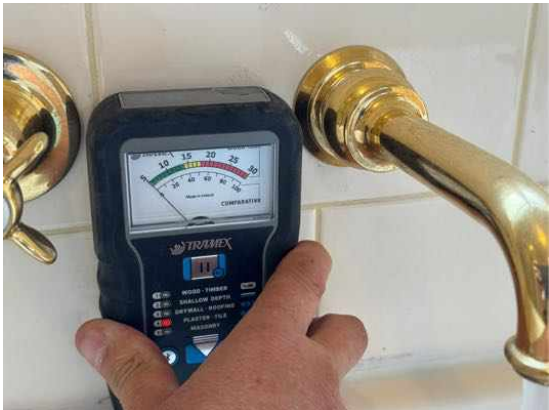
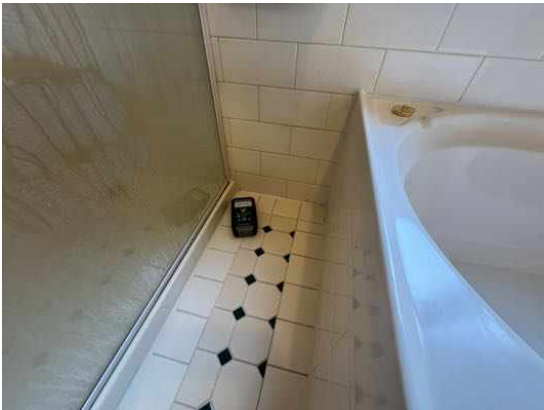
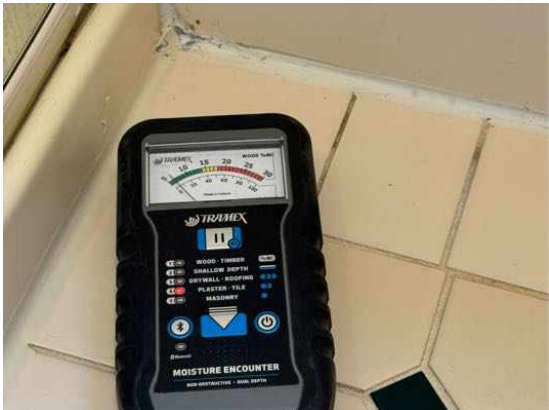
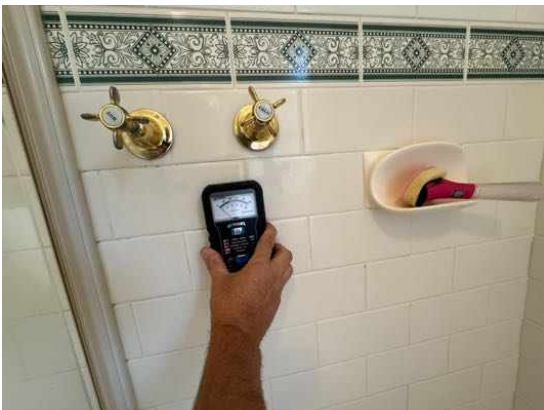
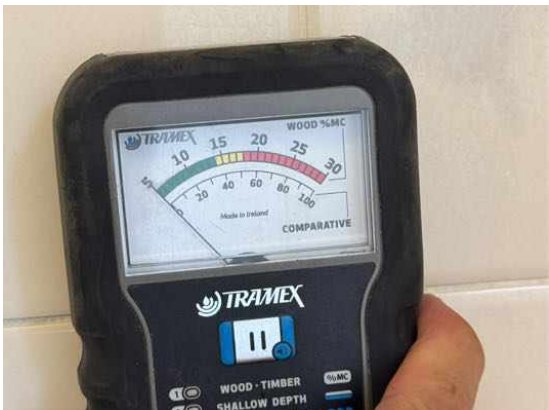
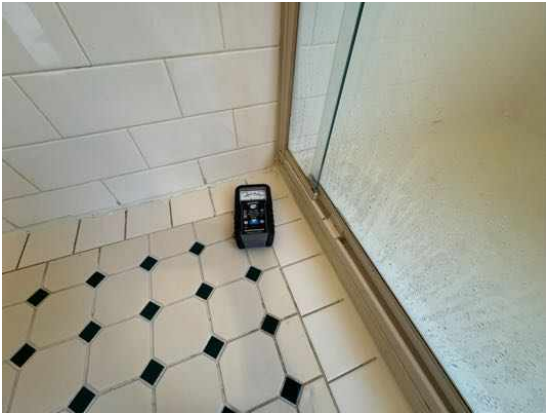
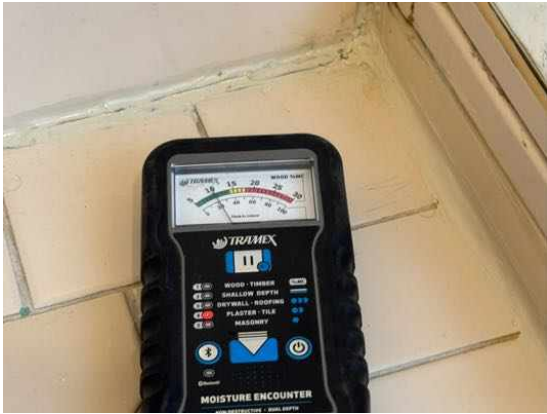
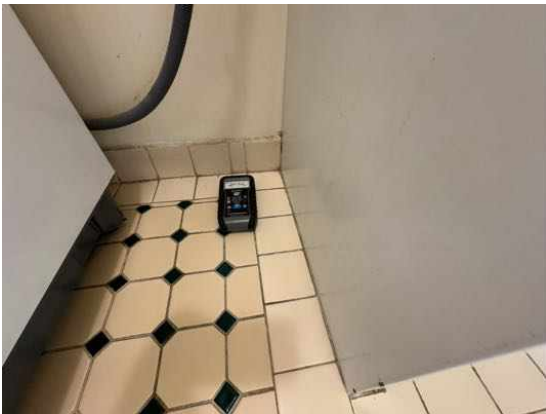
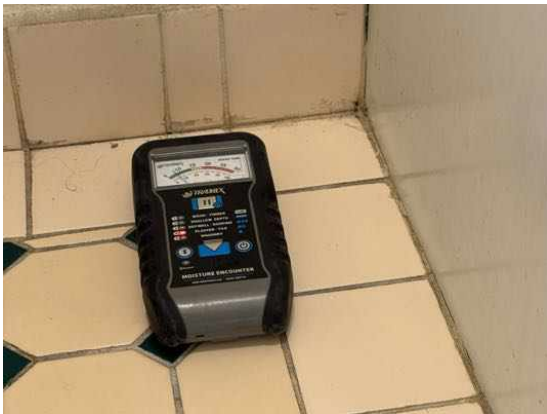
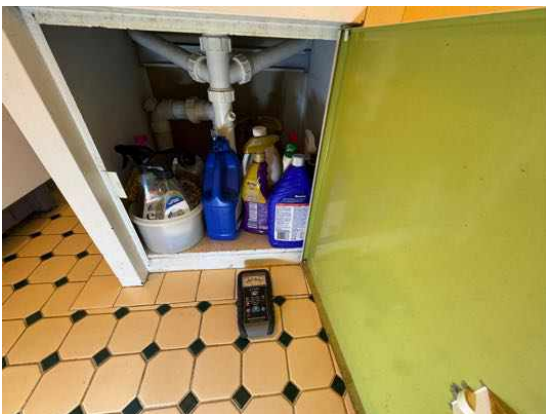
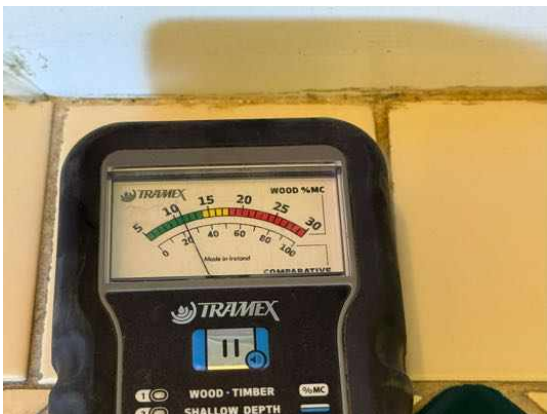
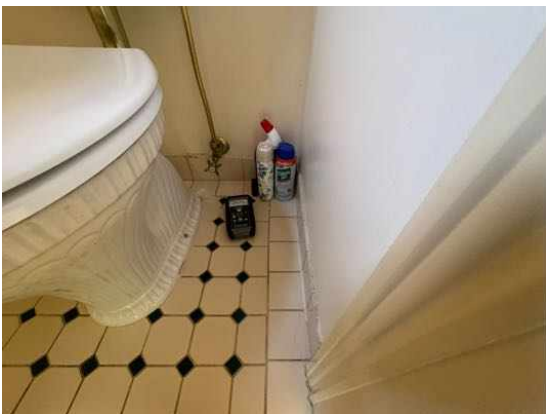
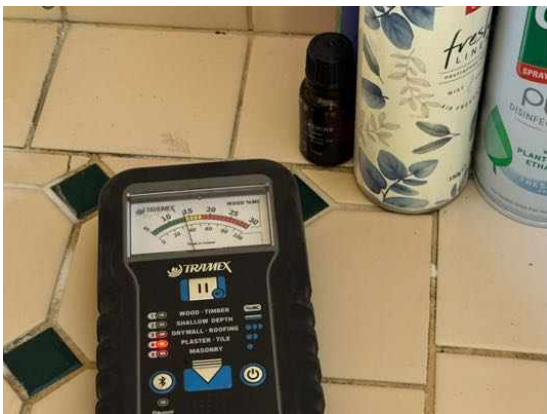
Building: Main Building  
 Location: All Internal Areas  
 Finding: Wet area - Inspection  
 Information: There was no visible evidence of water escape from the accessible areas around the wet areas of the property at the time of inspection.

Plasterboard walls, ceilings, carpet, cabinetry or timber skirting adjoining the wet areas showed no evidence of water staining or damage.

Moisture readings taken did not indicate any areas of elevated dampness to the external areas and to the opposing walls. If the property has been vacant for some time, moisture levels or leaks may not be detectable during the inspection because often only frequent use of water pipes (showers, taps, etc) results in a leak being identifiable.

The client should be aware that all wet areas should be inspected regularly. Deteriorated grout and sealants should be immediately addressed to prevent water from escaping. Even the smallest break in sealants or grout will allow water to escape into the adjoining structures.

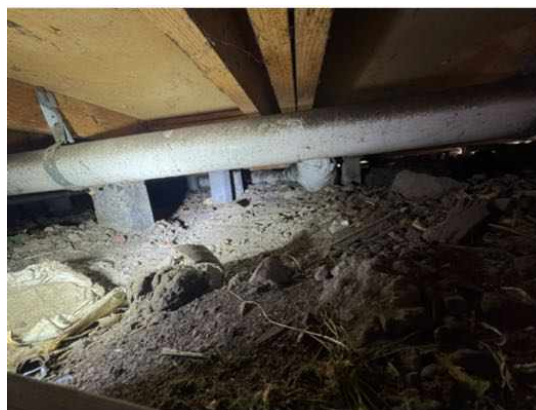
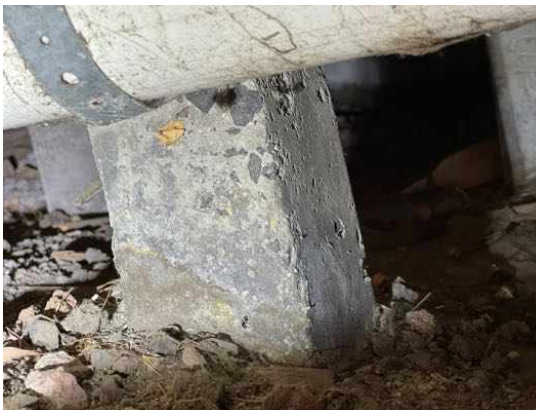
Building: Main Building  
Location: Subfloor  
Finding: Access restricted - subfloor  
Information: There was a problem with gaining access to the sub floor to conduct an inspection of this area at the time of the inspection. Being unable to gain access to a large area of the building increases the risk of undetected termite timber pest activity.

We recommend a reinspection once access can be provided and where possible, any physical barrier should be removed and a manhole installed to allow a full inspection to be carried out.

A re-inspection should be arranged once the areas are made accessible.
