## Building Inspection Report

Inspection Date: Tue, 24 Feb 2026

Property Address: 57 Villa Doria Dr, Clyde North VIC 3978,  
Australia

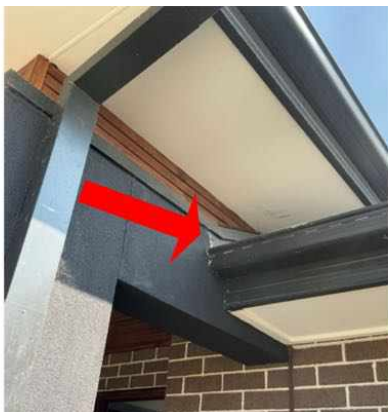
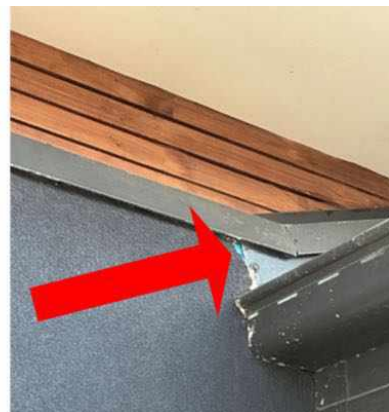
### Defects 3.02

A visible gap was observed at the junction between the metal capping flashing and the rendered wall at the front elevation. The flashing termination does not sit tightly against the wall surface, and sealant application appears incomplete, leaving an open section at the corner junction. The flashing edge and fixing are partially exposed.

Open gaps at capping flashing locations compromise the weatherproof integrity of the wall system. This area is a primary water-shedding point, and any separation can allow rainwater to enter behind the render and into the wall cavity. Over time, this may result in moisture ingress, deterioration of the render substrate, corrosion of metal components, and potential internal damp-related issues.

It is recommended that a qualified roof plumber remove and reinstate the affected flashing section to ensure it is properly dressed, mechanically secured, and sealed. All junctions should be sealed with a suitable external-grade flexible sealant, and the flashing should be finished to provide a continuous, watertight barrier in accordance with NCC requirements and good building practice.

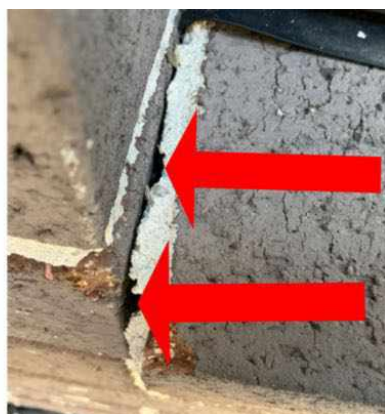
### Defects 3.03

| Finding: | Brickwork - Deteriorated mortar |
| Information: | Mortar, or 'bedding', is the material which fills joints and intersections between bricks in masonry walls and structures. Sections of mortar in this brickwork were identified as having deteriorated, which is generally expected for a property of this age and condition. |

Mortar may deteriorate as a result of age of building materials, minor movement of bricks, or frequent exposure to weathering. Mortar should be replaced to ensure that bricks remain in their intended location and to prevent gaps, which would allow water or moisture ingress and secondary damage as a result.

Mortar deterioration can be addressed by a bricklayer where areas of deterioration are localised and easily accessible. Alternatively, appointment of a registered builder is advised, to repoint large areas of decaying mortar. Where secondary structural defects have become evident, consultation with a structural engineer may be required.

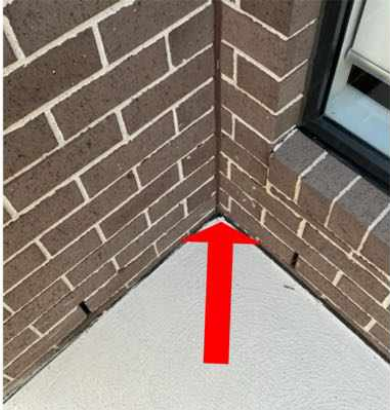
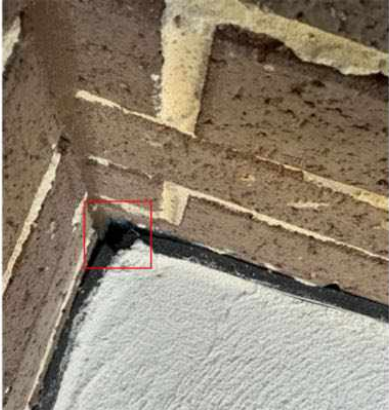
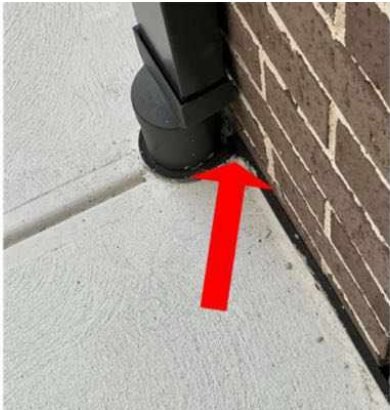
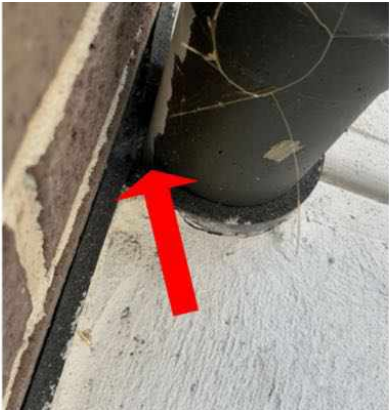
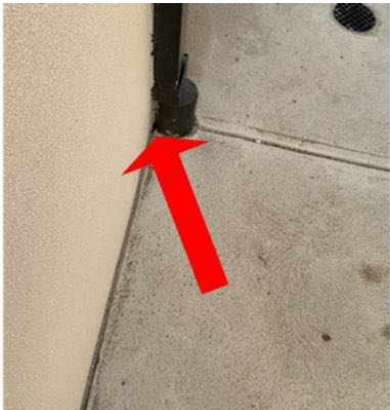
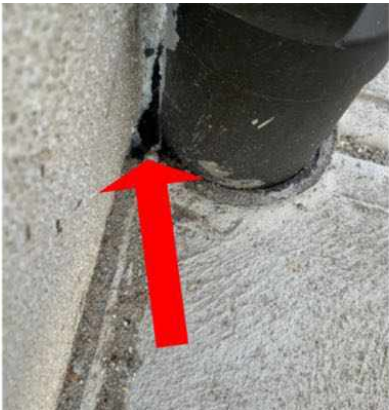
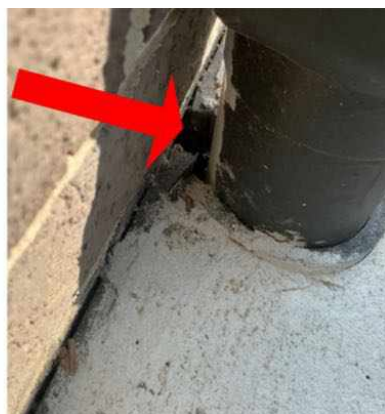
### Defects 3.04

Gaps were observed between the external concrete paving and the adjacent brick veneer wall, as well as voids behind downpipes where they are fixed against the external wall surface. The separations appear unsealed and provide open pathways at the wall-to-ground and wall-to-downpipe junctions.

Open gaps at these locations can allow surface water to track toward and potentially into the wall cavity, particularly during heavy rainfall. Prolonged moisture exposure at the base of external walls may contribute to dampness issues, deterioration of mortar joints, and increased risk of concealed moisture-related defects. Gaps behind downpipes may also allow water splash-back or leakage to enter the wall interface.

It is recommended that a qualified tradesperson seal the affected junctions using an appropriate exterior-grade flexible sealant. The interface between paving and brickwork should be properly sealed while maintaining adequate drainage fall away from the structure, and all gaps behind downpipes should be closed to minimise the risk of water ingress in accordance with good building practice.

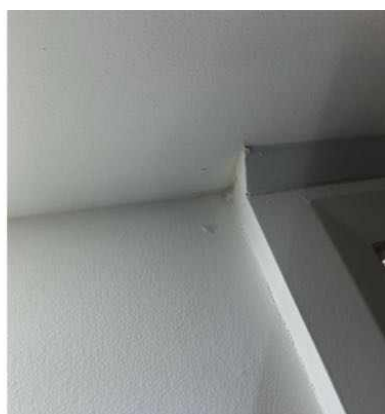
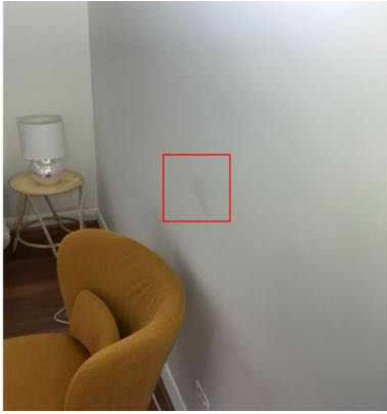
### Defects 3.05

Building: Main Building  
 Location: Lounge  
 Finding: Minor Workmanship Defects to Door Frame Finishes in Lounge Room  
 Information:

Minor workmanship issues were observed in the lounge room, primarily around the door frame finishes. Localised areas exhibit rough finishing and incomplete preparation, with visible surface irregularities that require sanding. In addition, an isolated section of paint inconsistency was noted where the colour and finish do not match the surrounding surfaces.

Although cosmetic in nature, unfinished or poorly prepared surfaces detract from the overall quality of workmanship and presentation. Inconsistent paint application may lead to premature peeling or uneven wear over time if not properly rectified.

It is recommended that a qualified painter sand and prepare the affected door frame areas, apply appropriate undercoat where required, and repaint to achieve a consistent finish that matches the adjoining surfaces in accordance with acceptable trade standards.

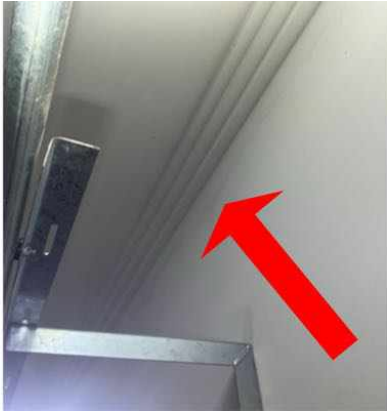
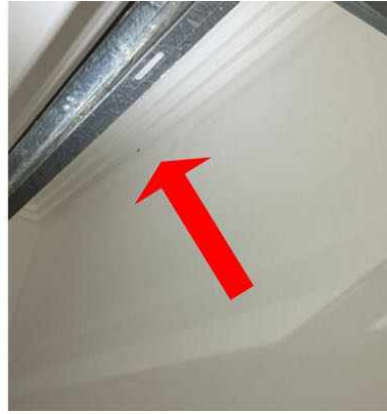
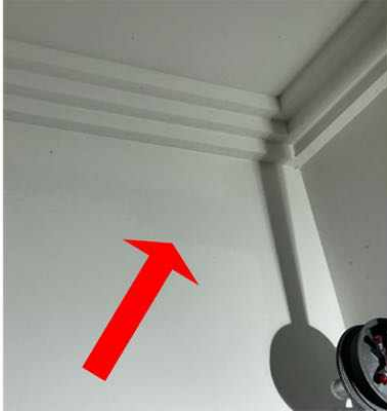
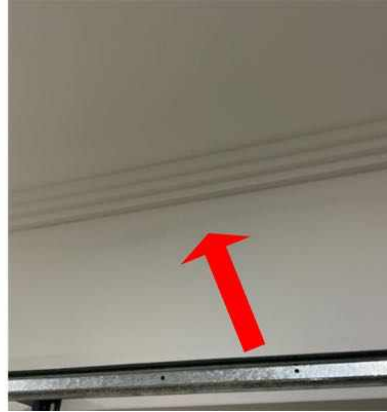
### Defects 3.06

Building: Main Building  
 Location: Garage  
 Finding: Inadequate Paint Finish to Garage Walls  
 Information:

The paint finish within the garage was observed to be of poor workmanship, particularly at the upper sections of the walls and around the garage perimeter. The finish presents as inconsistent, with uneven coverage, visible lap marks and areas lacking uniform appearance. The overall presentation does not reflect an acceptable trade standard.

An inconsistent or poorly applied paint finish detracts from the quality of the build and may result in premature deterioration, patchiness or ongoing aesthetic concerns. While primarily cosmetic, such workmanship issues fall below reasonable expectations for a completed residential project.

It is recommended that a qualified painter return to site to properly prepare the affected surfaces, including sanding and spot priming where required, and reapply paint to achieve an even, consistent and uniform finish throughout the garage in accordance with acceptable painting standards.

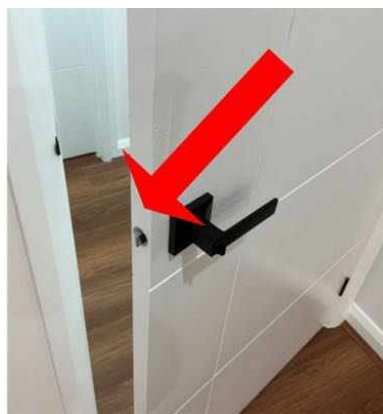
### Defects 3.07

| Information: | It was noted that the door in the master bedroom 1 was not latching during operation at the time of inspection. Whilst detracting from the functionality of this building element, this minor defect may also be a security risk, and may therefore have serious implications if left unattended. |

It is suspected that this defect has occurred due to minor issues with the associated hinges. Such damage is identified as general wear and tear, which is expected for building elements of this age.

A qualified carpenter or general handyperson may be appointed to perform rectification works as necessary, at client discretion. If left unattended, further functional impairment is likely to occur.

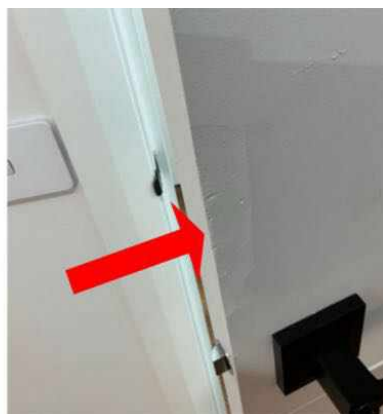
### Defects 3.08

Building: Main Building  
 Location: Bedroom - Master 1  
 Finding: Poor Paint Finish to Master Bedroom 1 Door  
 Information:

The paint finish to the door of Master Bedroom 1 was observed to be of poor workmanship. A localised area has been patched and repainted; however, the finish is inconsistent with the remainder of the door surface. The colour tone and sheen do not match uniformly, and the patched section remains visibly distinguishable.

Inconsistent paint application and colour variation detract from the overall presentation and indicate inadequate surface preparation and finishing. While cosmetic in nature, such defects fall below acceptable trade standards for a completed residential dwelling.

It is recommended that a qualified painter return to properly prepare the affected door surface, including sanding and priming as required, and repaint the entire door (not just the patched section) to ensure a uniform colour, sheen, and consistent finish throughout.

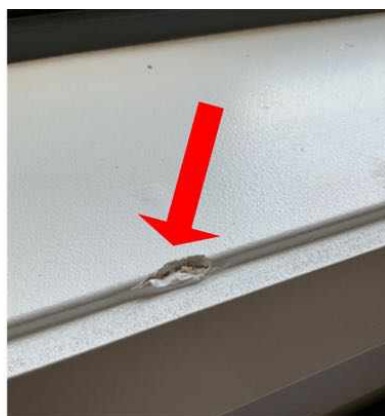
### Defects 3.09

A dented section was identified to the window sill in Master Bedroom 1. The affected area presents as surface damage to the finished element, which is inconsistent with the expected condition of a newly constructed dwelling.

Surface dents and imperfections detract from the overall quality and presentation of the property and indicate incomplete finishing works. In a brand new home, internal elements such as window sills are expected to be delivered free from visible damage and finished to an acceptable trade standard.

It is recommended that a qualified plasterer or painter return to site to properly fill the damaged section, sand the surface smooth, and repaint the entire affected area as required to achieve a consistent and uniform finish in line with new-build expectations.

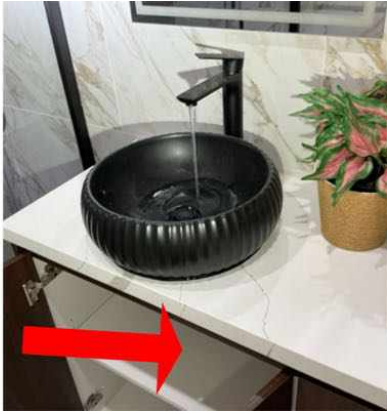
### Defects 3.10

Building: Main Building  
 Location: Ensuite - Master 1  
 Finding: Leaking Plumbing to Sink Tap in Master Ensuite 1  
 Information: Upon visual inspection, it was observed that the plumbing connected to the sink tap in master ensuite 1 is leaking. When the tap was tested, it was evident that the plumbing pipes beneath the sink are leaking into the vanity unit, affecting the cupboards and shelves underneath.

It is strongly recommended that a licensed plumber be engaged immediately to investigate the source of the leak and carry out the necessary repairs. Prompt action is required to prevent further water damage to the vanity and surrounding areas.

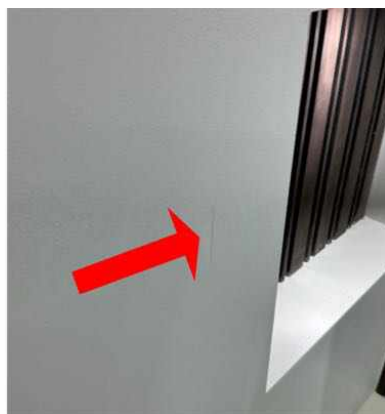
### Defects 3.11

Building: Main Building  
 Location: Nook  
 Finding: Poor Paint and Surface Finish to Nook Area Walls  
 Information:

The paint and surface finish to the nook area walls were observed to be of poor workmanship. Multiple dents and minor surface damages were identified, along with inconsistent paint application and uneven finish across various sections of the wall. The overall presentation does not meet acceptable trade standards for a newly constructed property.

Surface imperfections and inconsistent finishing detract from the quality of the build and indicate inadequate preparation prior to painting. In a new dwelling, internal wall surfaces are expected to be free from visible dents, patch marks, and uneven coating, with a uniform and consistent finish throughout.

It is recommended that a qualified painter properly prepare the affected areas by filling all dents and damaged sections, sanding the surfaces smooth, applying primer where required, and repainting to achieve a uniform, consistent, and professional finish in accordance with acceptable industry standards.

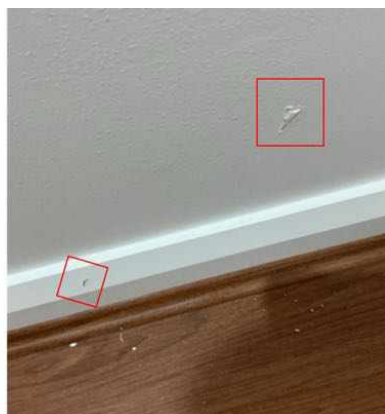
### Defects 3.12

Building: Main Building  
 Location: Walk-In Robe - Master 1  
 Finding: Dented Plaster and Skirting Finishes to Walk-In Robe (Master Bedroom 1)  
 Information:

Dents and minor surface damage were observed to the plasterboard wall linings and skirting boards within the walk-in robe of Master Bedroom 1. The affected areas present as localised indentations and inconsistent surface finishes, which are not consistent with the expected standard of a newly completed dwelling.

Such surface defects detract from the overall presentation and indicate inadequate care during installation or finishing works. In a new property, plaster surfaces and skirting boards are expected to be delivered free from visible dents and damage, with a smooth and uniform finish.

It is recommended that a qualified painter or plasterer return to site to fill all dents and damaged sections, sand the surfaces smooth, prepare the skirting boards appropriately, and repaint to achieve a consistent and professional finish in accordance with acceptable trade standards.

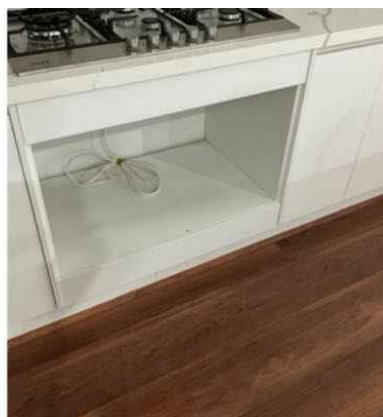
### Defects 3.13

The absence of the oven prevents verification of installation compliance, operational performance, and safe connection to electrical supply in accordance with NCC requirements. In a newly constructed dwelling, all specified fixtures and fittings are expected to be installed and operational prior to handover.

It is recommended that the builder arrange for the oven to be supplied, installed, and fully commissioned by a licensed electrician prior to practical completion and handover. Confirmation of compliance and safe operation should be provided upon installation.

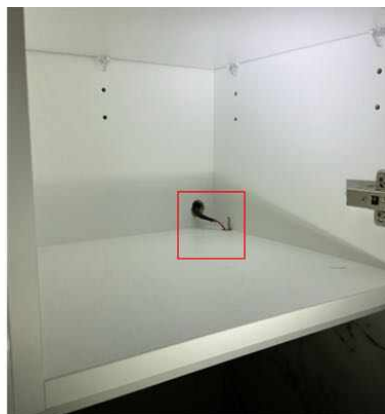
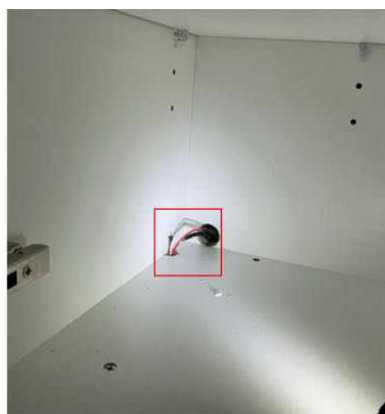
### Defects 3.14

Building: Main Building  
 Location: Kitchen  
 Finding: Poor Workmanship to Kitchen Cabinetry and Joinery  
 Information:

Poor workmanship was observed to the kitchen cabinetry and joinery finishes throughout. Untidy and inconsistent gaps were noted between panels and at junctions, with sections appearing unfinished. Debris and construction residue were present inside multiple cupboards. Exposed electrical wiring was observed within cabinetry cavities, not properly secured or concealed. In addition, several cupboard doors were misaligned and did not open and close smoothly.

Deficient joinery workmanship and incomplete finishing detract from the overall quality of the installation and fall below acceptable trade standards for a newly constructed dwelling. Exposed or unsecured electrical wiring within cupboards presents a potential safety risk and does not reflect compliant installation practice. Misaligned doors and poor clearances may lead to premature wear of hinges and hardware.

It is recommended that the cabinet maker return to site to rectify all identified issues. This should include realignment and adjustment of all cupboard doors and hardware, correction of uneven gaps, proper finishing of all joinery interfaces, removal of debris, and ensuring all electrical wiring within cabinetry is properly secured and safely concealed by a licensed electrician where required. All works should be completed to an acceptable professional standard prior to handover.

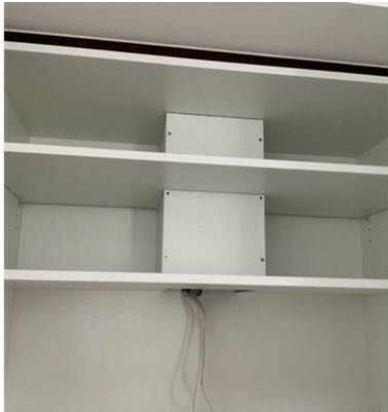
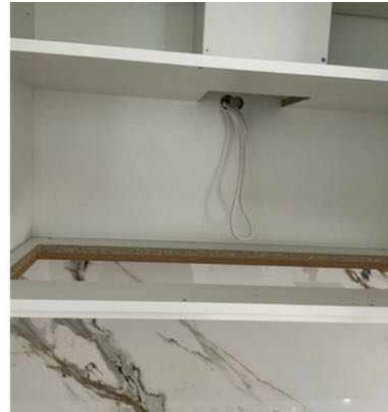
### Defects 3.15

Building: Main Building  
 Location: Kitchen  
 Finding: Rangehood Not Installed  
 Information:

The absence of a rangehood prevents adequate mechanical ventilation of cooking fumes, moisture and grease-laden air. In a newly constructed dwelling, the rangehood forms part of the required kitchen fixtures and contributes to ventilation performance in accordance with NCC requirements.

It is recommended that the builder arrange for the rangehood to be supplied, installed,

and commissioned prior to practical completion and handover. Installation should be carried out in accordance with manufacturer specifications and relevant electrical requirements by a licensed electrician.

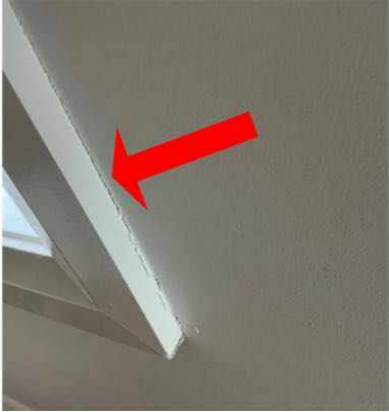
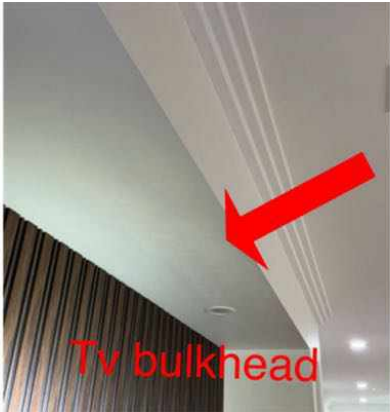
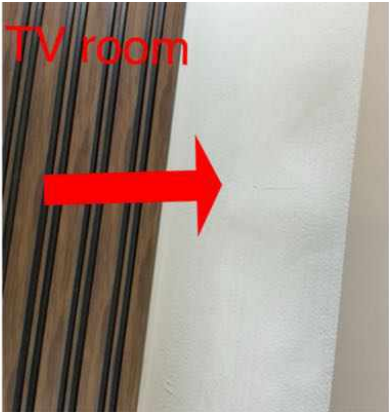
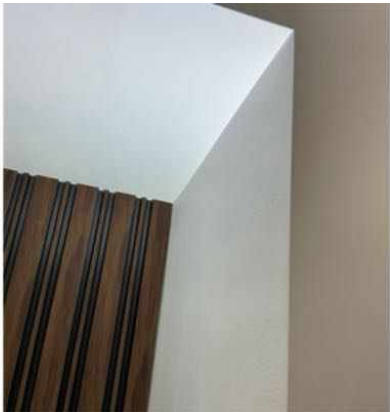
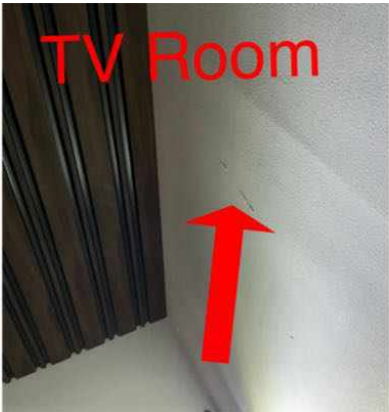
### Defects 3.16

| Finding: | Multiple Workmanship and Finishing Defects Throughout Dwelling |

The photographs below indicate multiple workmanship and finishing defects throughout the dwelling. These include exposed and poorly routed wiring within kitchen cabinetry that has not been properly concealed, untidy and inconsistent finishes to skirting boards, and widespread painting and surface finishing defects across various areas of the home. Several locations exhibit poor plaster finishing, uneven surfaces, and substandard paint application.

The overall standard of finishing observed falls below the reasonable expectations for a newly constructed dwelling at handover stage. Exposed wiring should be properly concealed and secured, and internal finishes including painting, plastering, and trim works are expected to be completed to an acceptable professional standard. Incomplete or poorly executed finishes detract from the presentation and quality of the build.

It is recommended that the builder undertake a comprehensive review of all identified locations prior to handover and arrange for rectification by the relevant qualified trades. This should include proper concealment of wiring by a licensed electrician where required, rectification of plaster defects, correction of skirting finishes, and repainting to achieve a consistent and professional finish throughout the property before practical completion.

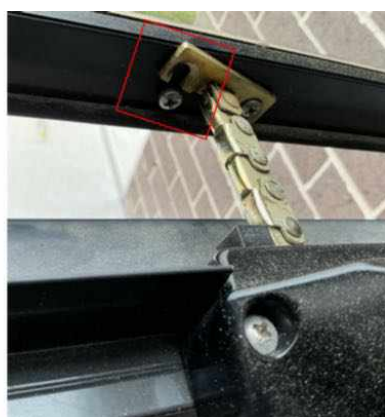
**Defects 3.18**

The window restrictor arm to the aluminium window has not been installed properly. The mechanism appears loosely fitted and not securely fixed to the frame, with poor alignment at the bracket connection.

Improper installation of the restrictor may affect its ability to function correctly as a safety device and may compromise compliance with fall prevention requirements.

It is recommended that the builder arrange for the window restrictor to be properly refixed and installed in accordance with manufacturer specifications to ensure secure and correct operation.

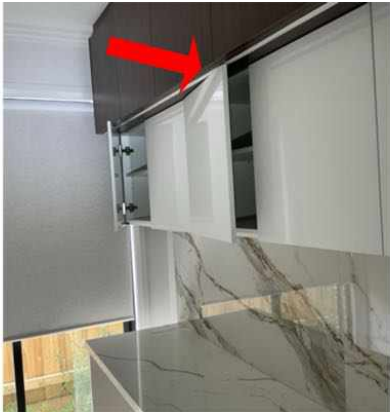
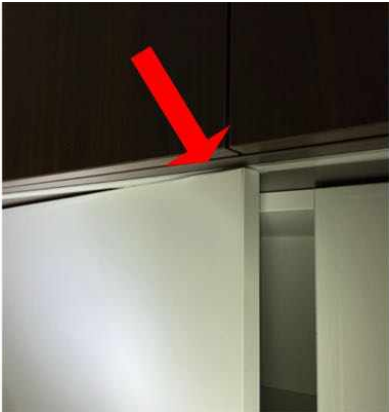
### Defects 3.19

The laundry overhead cupboard doors were observed to be misaligned and not operating correctly. The doors do not open and close smoothly, with visible uneven gaps between panels. The underside strip (appears to be a light strip or trim) is interfering with the door movement, causing friction and restricting proper operation.

Cabinetry doors that rub, bind, or display inconsistent alignment indicate poor installation and hinge adjustment. Continued friction may result in premature wear to hinges, damage to door edges, and deterioration of the finish. In a newly constructed dwelling, cabinetry is expected to be properly aligned and operate freely without obstruction.

It is recommended that the cabinet maker return to site to realign and adjust all affected cupboard doors, recalibrate hinges, and reposition or properly secure the underside strip/light fitting to eliminate obstruction. All cabinetry should operate smoothly and present with consistent gaps in accordance with acceptable trade standards prior to handover.

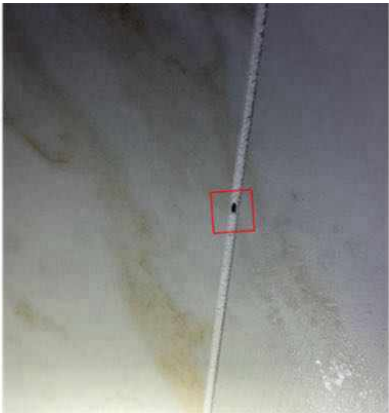
**Defects 3.20**

Building: Main Building  
Location: Powder Room  
Finding: Poor Tiling and Grouting Finish to Powder Room  
Information:

Poor workmanship was observed to the wall tiling within the powder room. A section of grout was noted to be missing between tiles, and additional grout residue has been left on the tile surfaces. The finish appears incomplete and has not been properly cleaned following installation.

Missing grout can allow moisture penetration behind tiles, while excess grout residue affects the overall presentation and indicates inadequate finishing. In a newly constructed dwelling, tiling works are expected to be neatly finished, fully grouted, and free from visible residue.

It is recommended that a qualified tiler return to site to properly re-grout the affected joints, remove all excess grout residue from tile surfaces, and ensure the finish is completed to an acceptable professional standard.

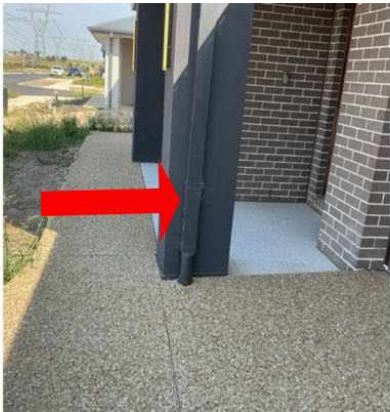
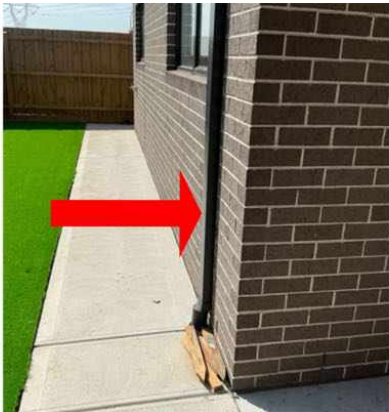
**Defects 3.24**

Where attachments are not isolated and do not maintain a clear inspection gap of at least 25mm from the building, they create a potential risk of concealed termite entry. Such concealed pathways compromise the effectiveness of any termite management system in place.

It is recommended that these areas be regularly inspected by a licensed and qualified pest inspector. Where bridging is identified, modifications should be made to restore adequate clearance or install appropriate barriers to mitigate the risk of concealed termite ingress.

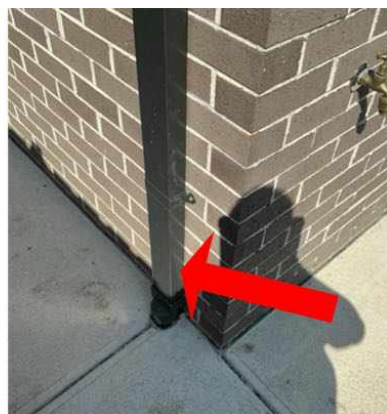
### Defects 3.25

Building: Main Building  
 Location: All external areas  
 Finding: Termite Management System - no evidence of a chemical installation  
 Information: At the time of inspection, there was no evidence to indicate that a previous or current termite management system has been installed at the property. No durable notice was observed within the electrical switchboard or elsewhere on site to confirm the presence of any chemical or physical termite protection measures. Additionally, there were no visible indicators to suggest that preventative termite treatments or barriers have been applied in the past.

The absence of a termite management system leaves the property vulnerable to potential termite attack, which could lead to significant damage to timber building elements if left unaddressed.

It is highly recommended that the client consult with a licensed pest controller regarding the installation of a post-construction chemical termite barrier. Such systems are proven to be effective in preventing termite ingress and should be considered a priority, particularly where no existing protection is in place. A durable notice confirming the installation of any future system should be affixed within the switchboard in accordance with AS 3660.
