Building and Timber Pest Inspection Report

Inspection Date: Wed, 11 Feb 2026

Property Address: unit 51/2 Crewe Pl, Rosebery NSW 2018,
Australia

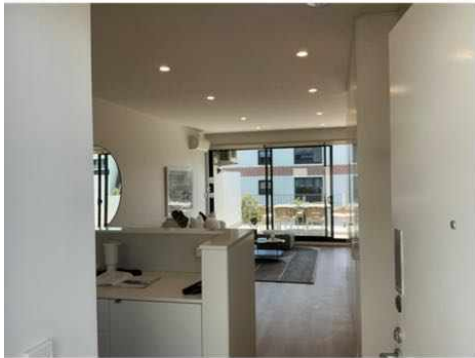
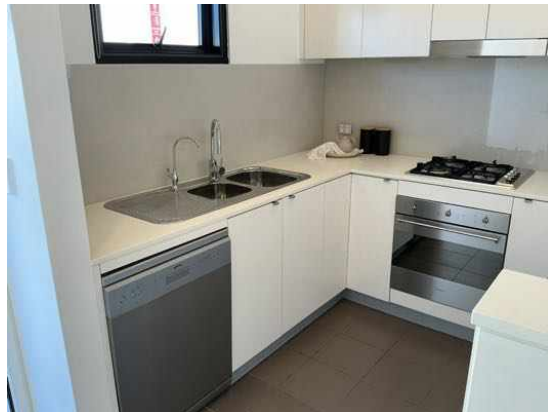
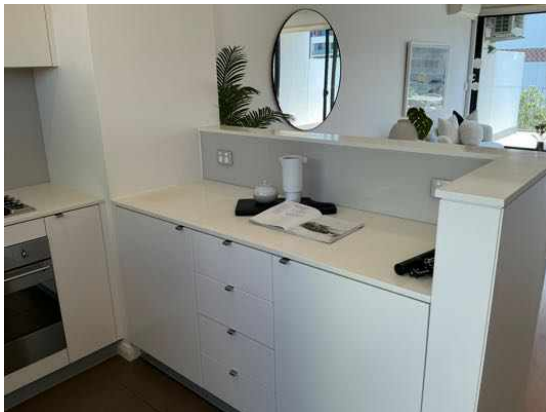
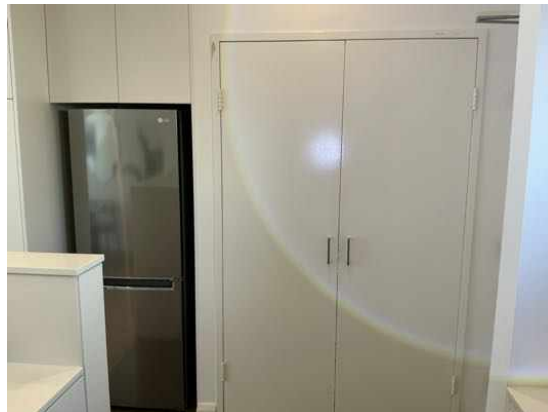
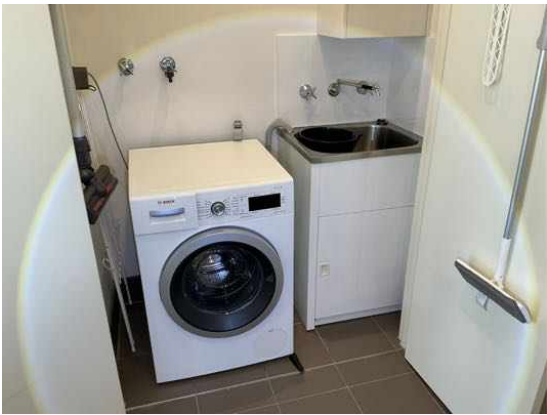
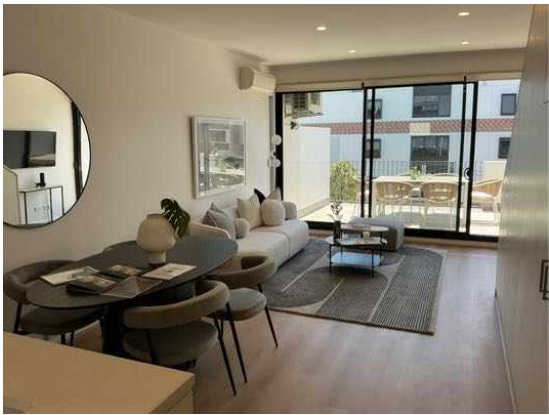
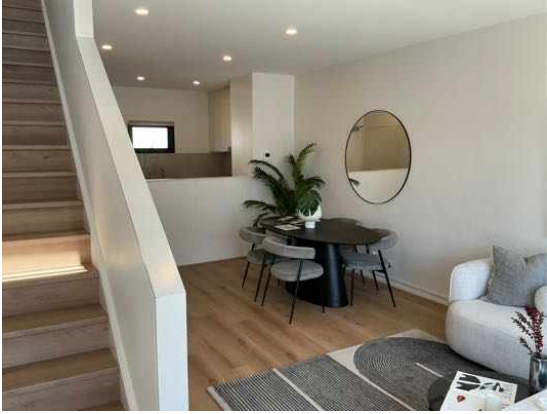
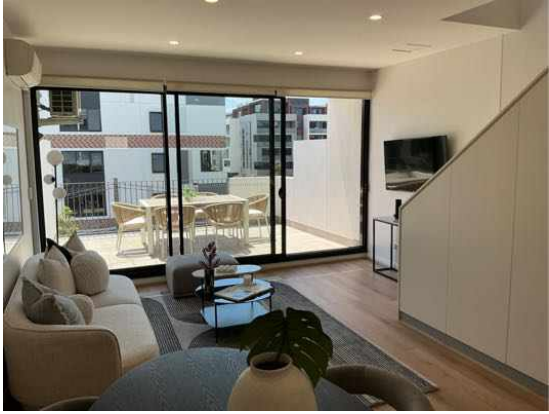
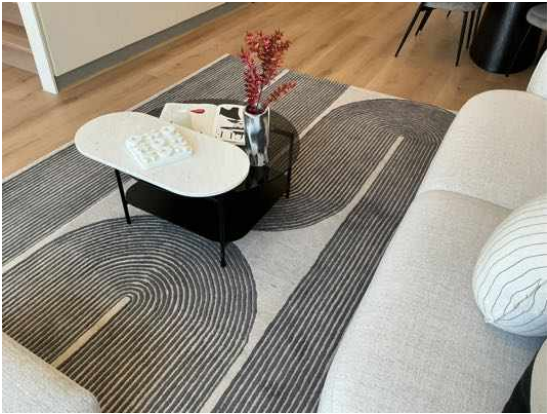
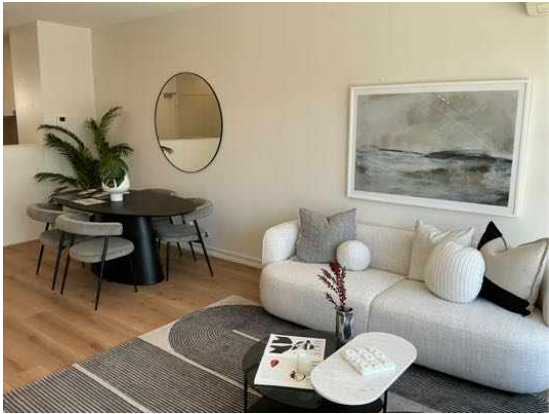
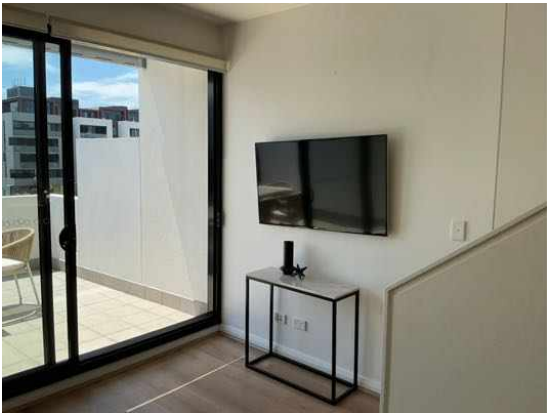
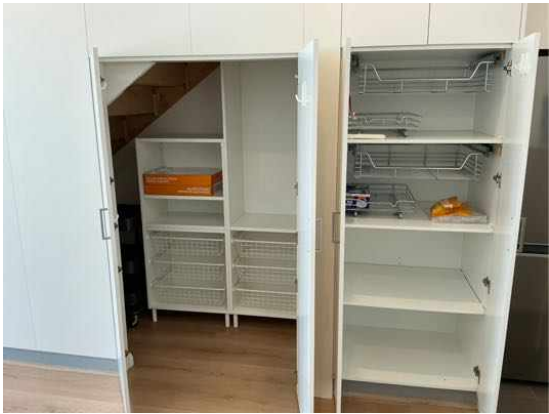
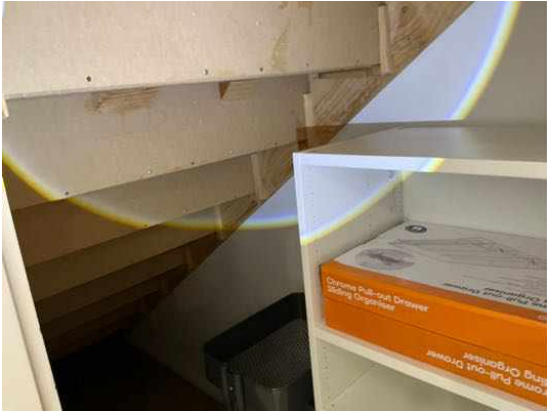
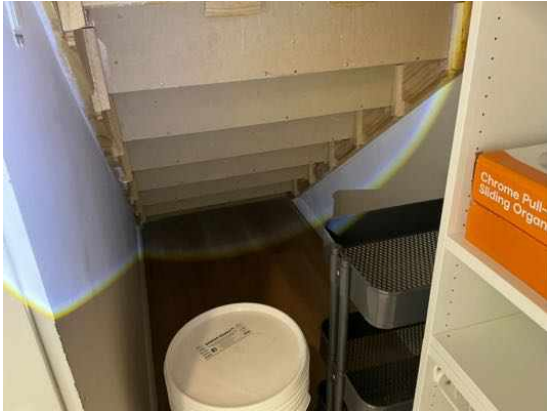
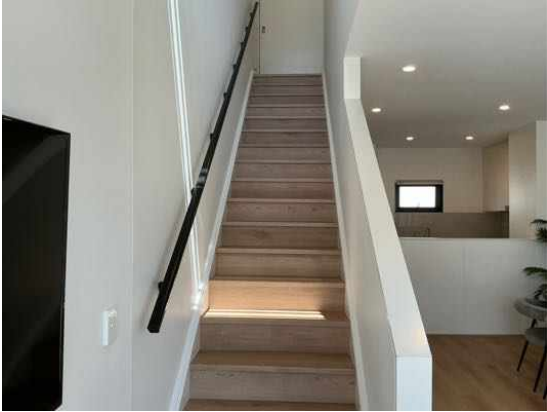
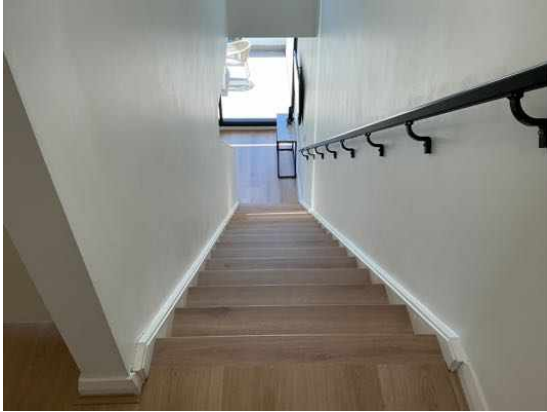
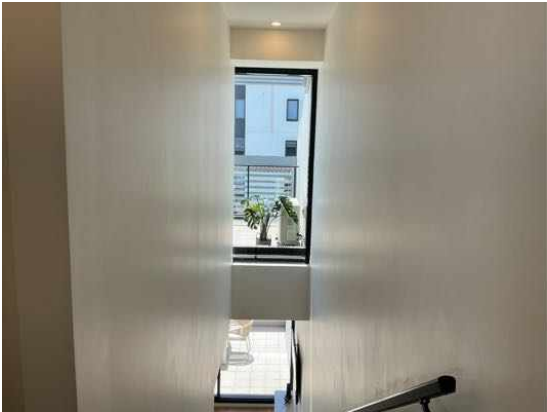
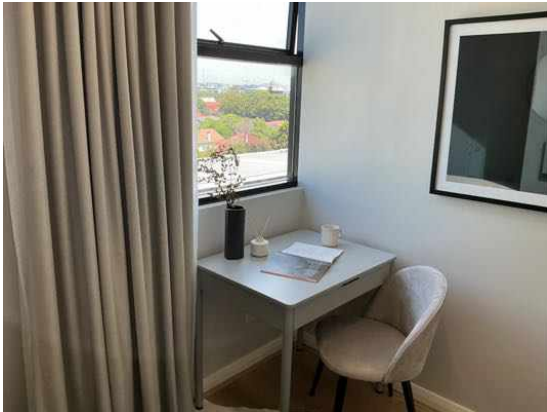
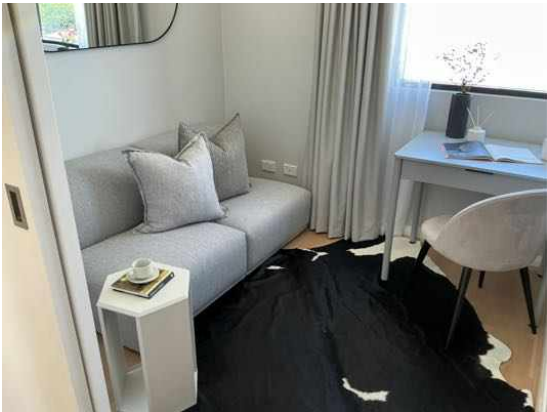
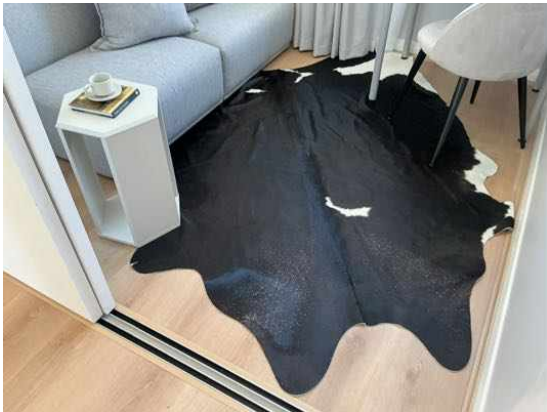
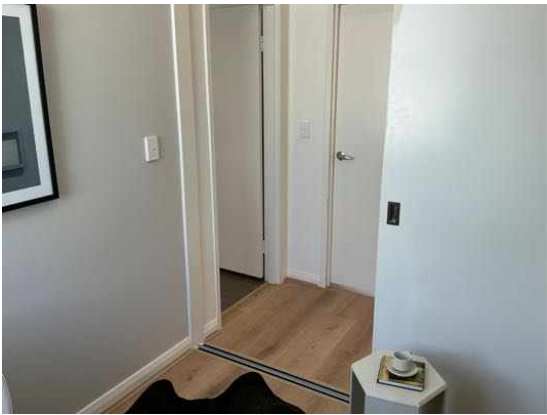
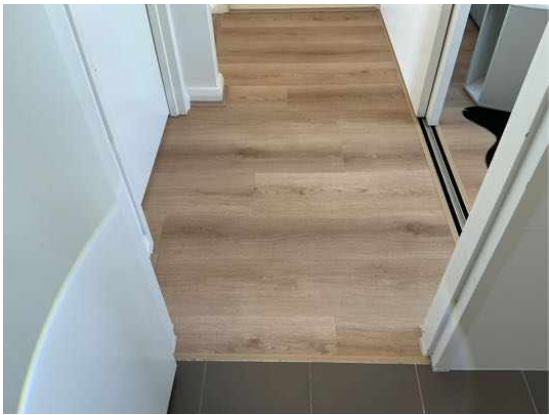
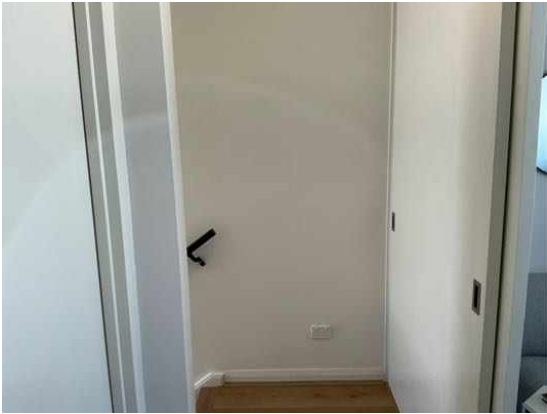
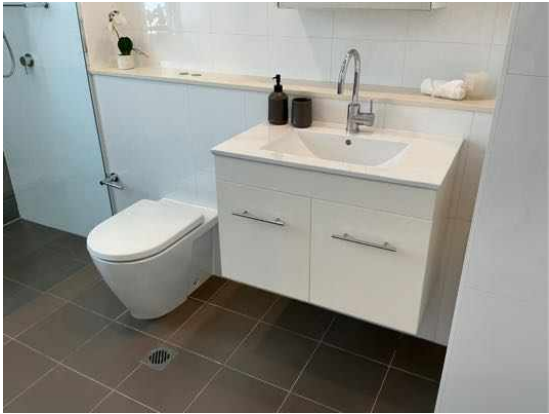
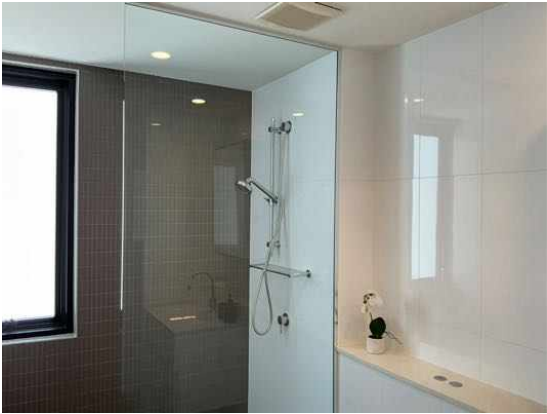
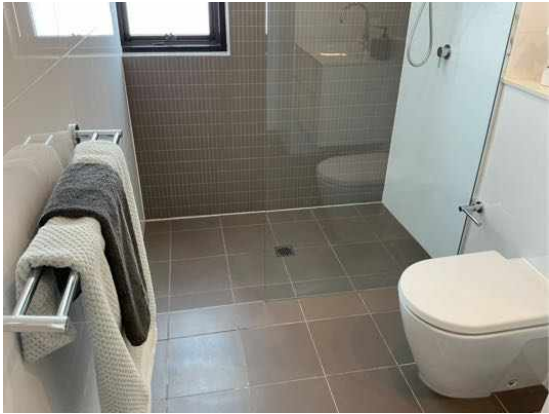
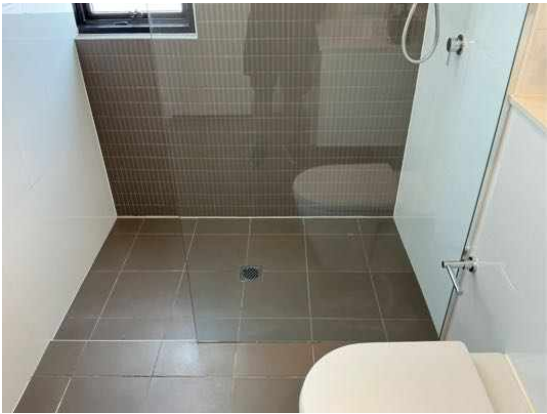
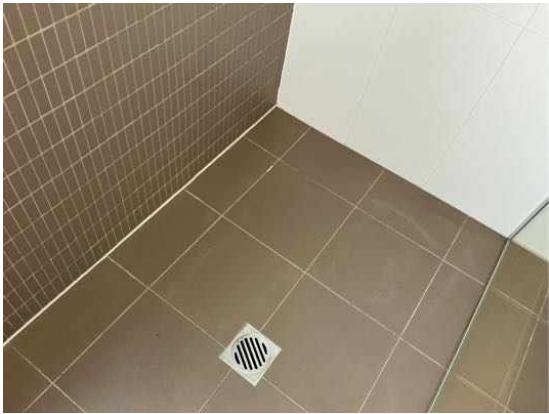
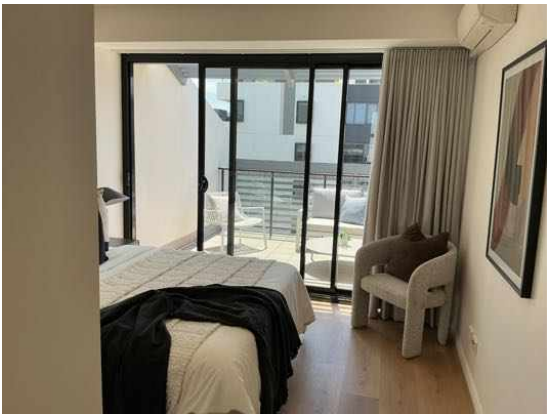
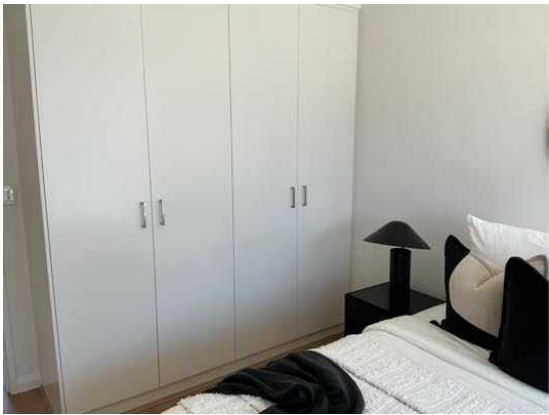
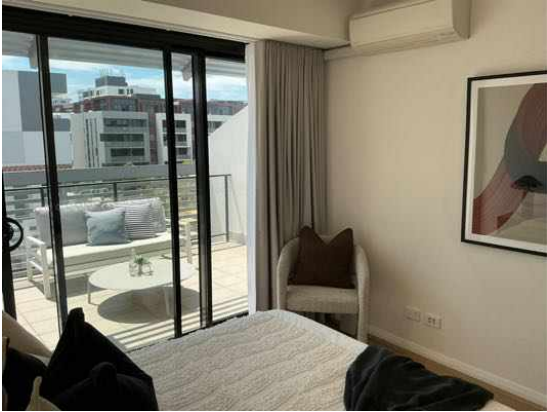
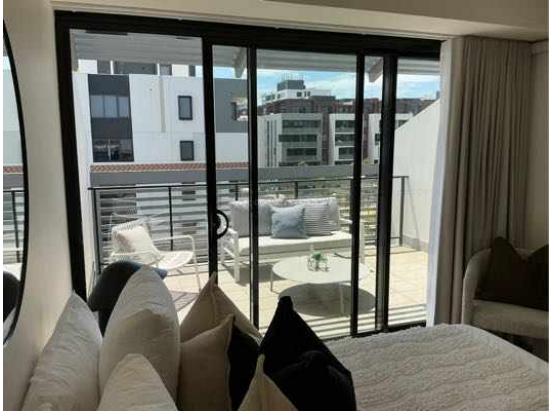
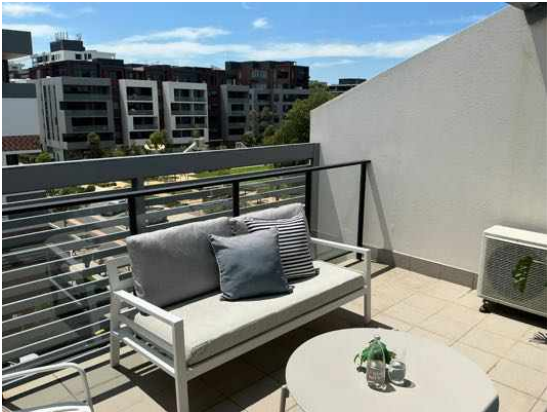
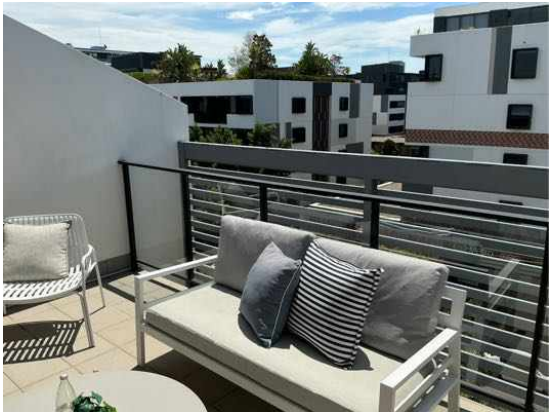
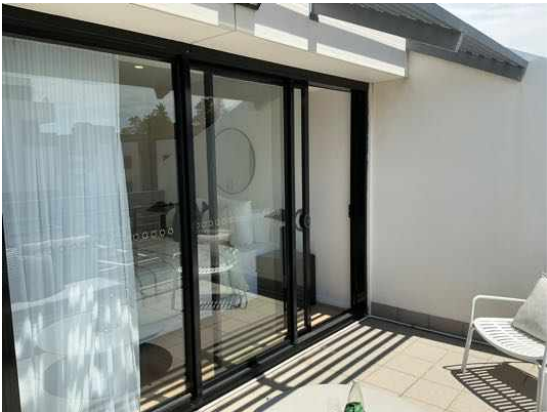
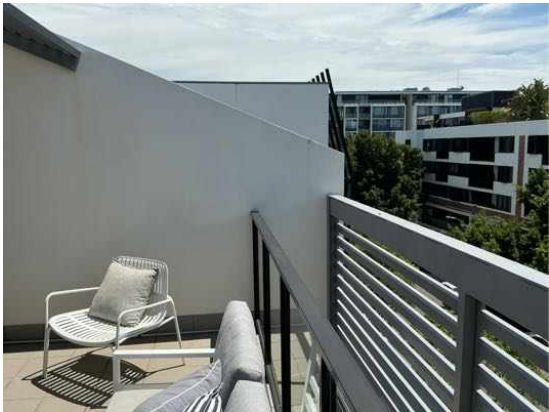
Noted Item

Building: Main Building
Location: All Areas- internal
Finding: Additional Photos - Obstructions and Limitations
Information: These photographs are an indication of the obstructions and limitations which impeded full inspection of the property at the time of inspection. These obstructions can hide an array of defects and should be removed to allow full inspection to be carried out. A re-inspection is recommended once the areas are made accessible.

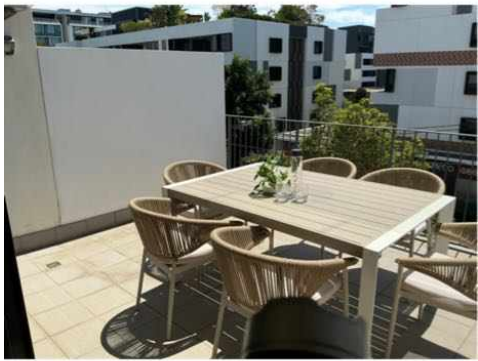
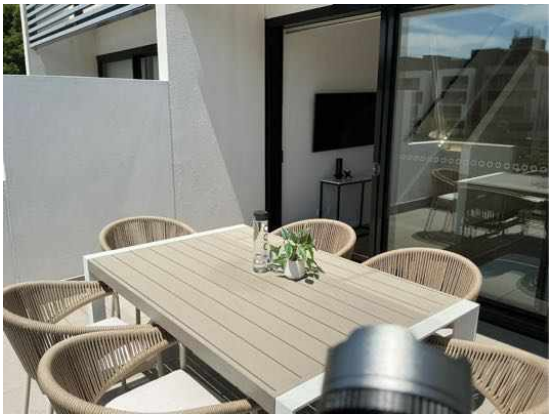
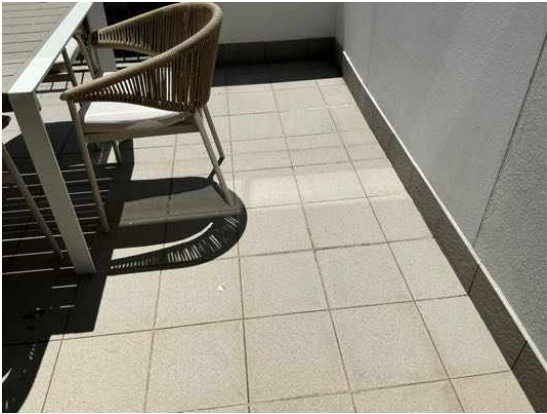
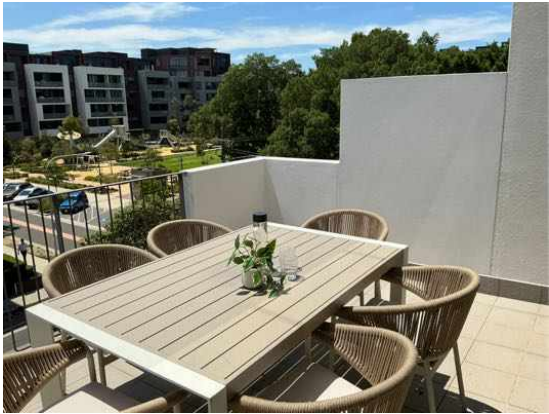
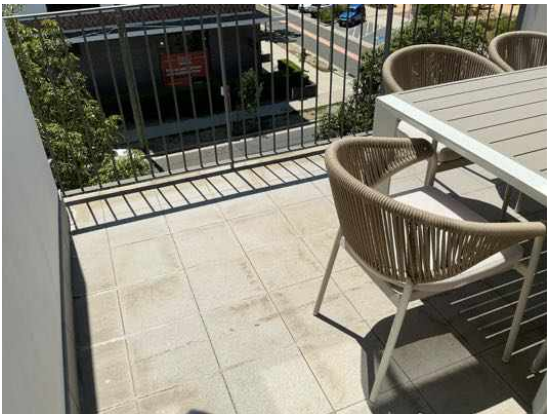
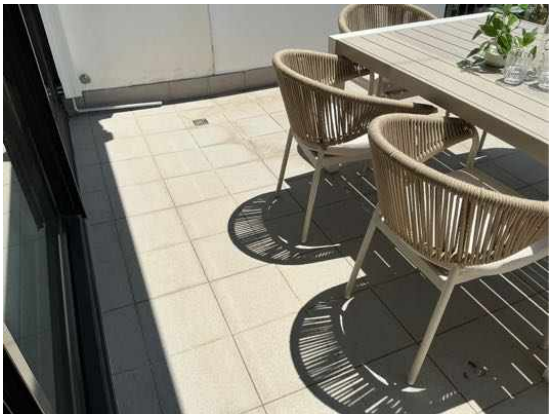
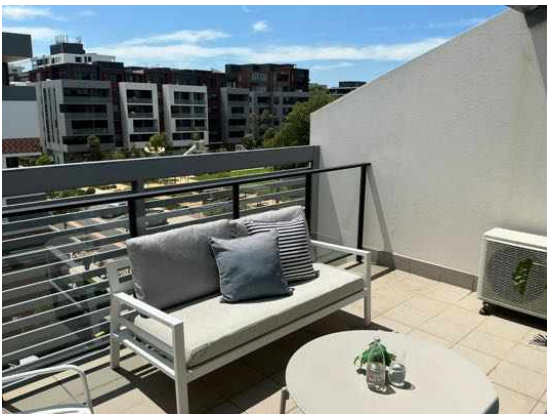
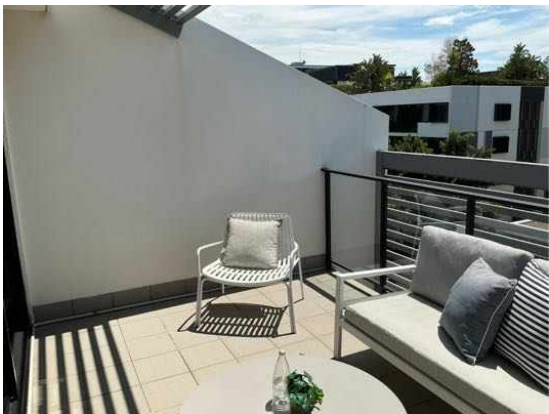
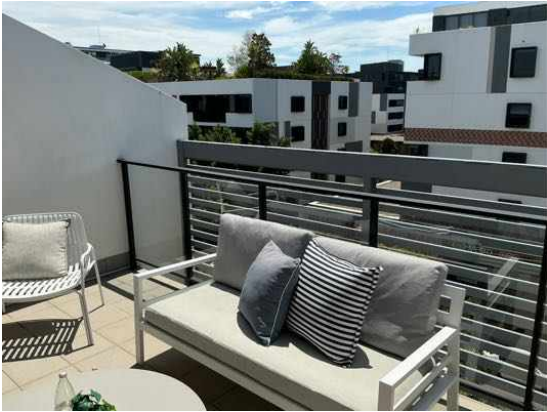
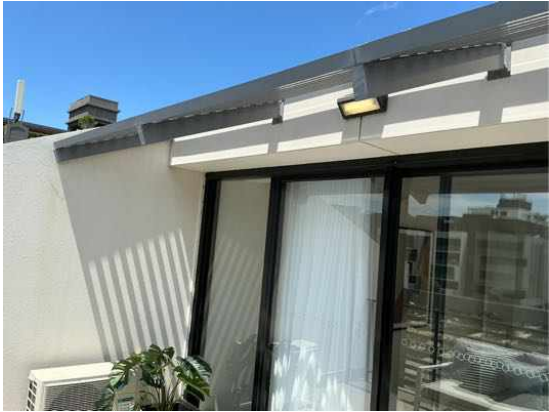
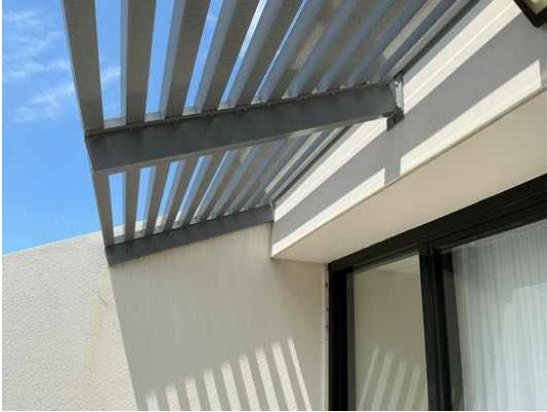
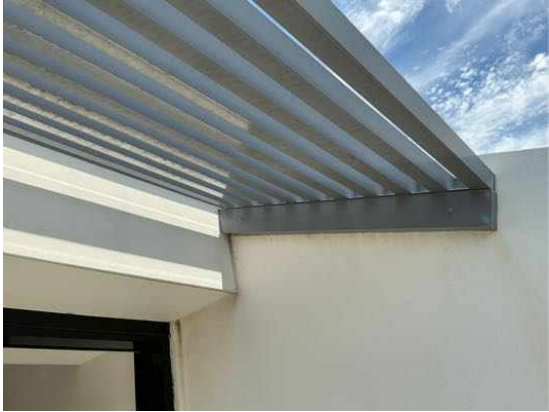
Building:	Main Building
Location:	All Areas- external
Finding:	Additional Photos - Obstructions and Limitations
Information:	These photographs are an indication of the obstructions and limitations which impeded full inspection of the property at the time of inspection. These obstructions can hide an array of defects and should be removed to allow full inspection to be carried out. A re-inspection is recommended once the areas are made accessible.
