Building Inspection Report

Inspection Date: Wed, 21 Jan 2026

Property Address: 13/19 Drusilla Glade, Riverstone NSW 2765,
Australia

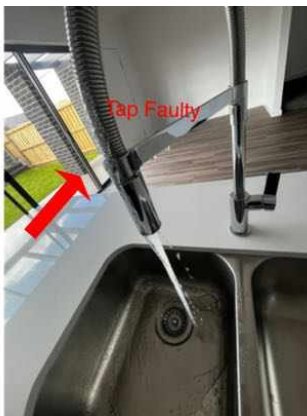
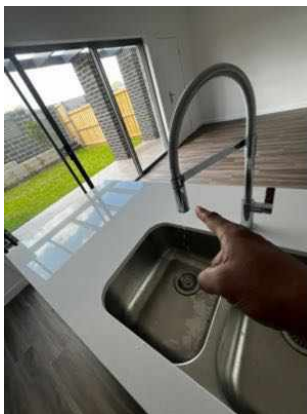
Defects 3.02

Building: Main Building
Location: Kitchen/ Pantry

Finding: Cabinetry Plumbing - Kitchen- Pantry
 Information: Upon Inspection of the Kitchen and the Pantry all cupboards where sinks and basins with drainage plumbing were inspected and no evidence of leaks were present at the time of inspection.

For your information only no remedial works are required at the time of inspection.

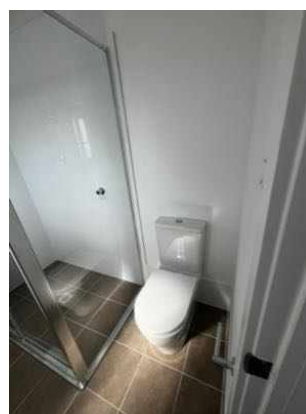
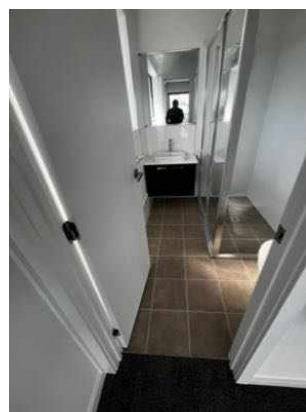
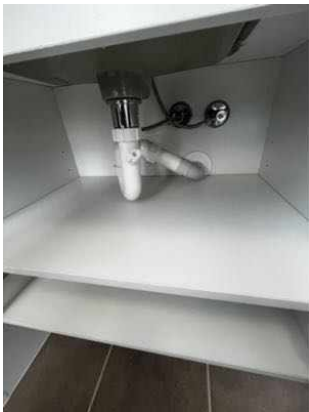
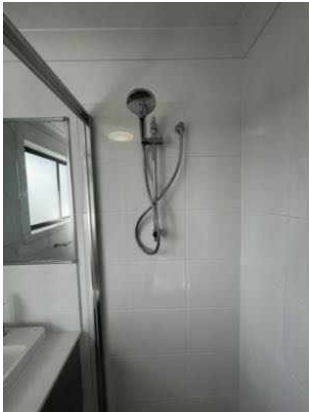
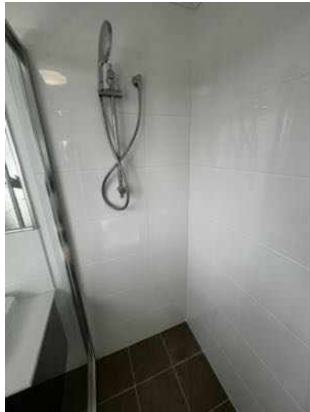
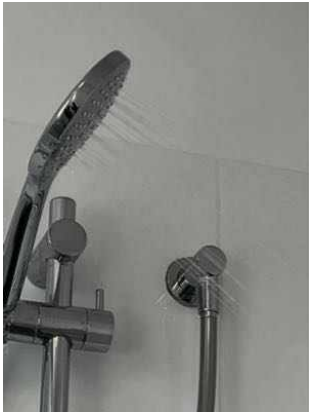
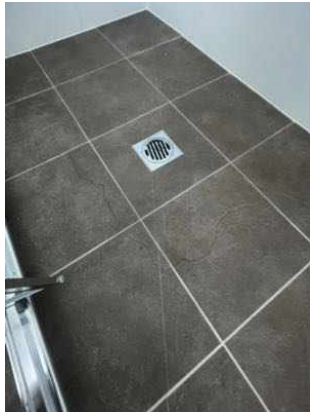
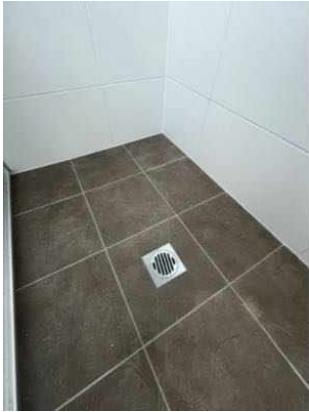
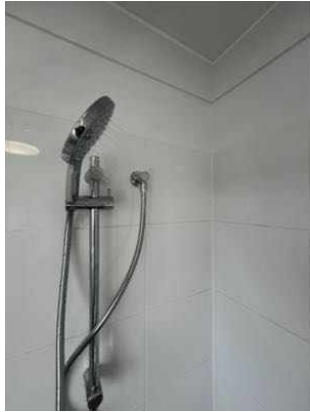
Defects 3.03

Building: Main Building
 Location: Master Ensuite
 Finding: Cabinetry Plumbing / Master Ensuite Inspection/ Moisture Checked
 Information: All cupboards where sinks and basins with drainage plumbing were inspected no evidence of leaks were present at the time of inspection.

Upon Inspection of the area there was no excess moisture reading was found during inspection.

It is highly recommended that all plumbing and drainage fixtures and fittings be maintained regularly in order to prevent excessive moisture being present in the external / internal property.

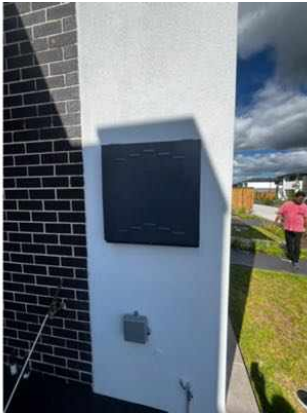
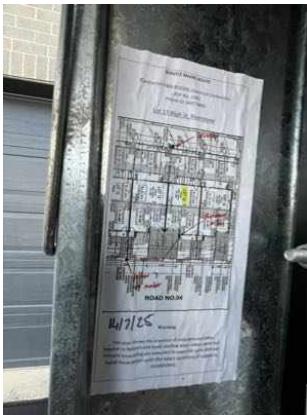
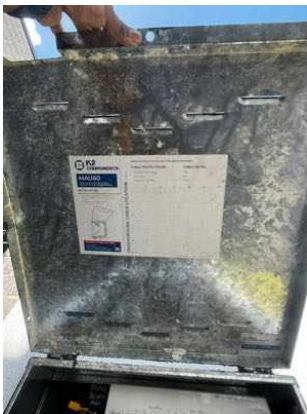
Building: Main Building
 Location: Driveway
 Finding: For information only
 Information: No remedial works are required at the current time.

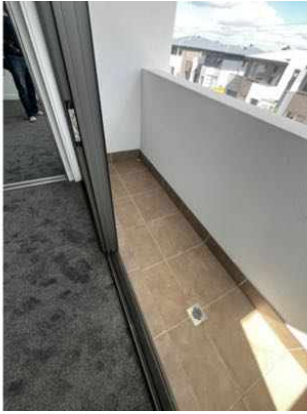
Building: Main Building
Location: Balcony
Finding: Balcony -
Information: The balcony in this area has been inspected .

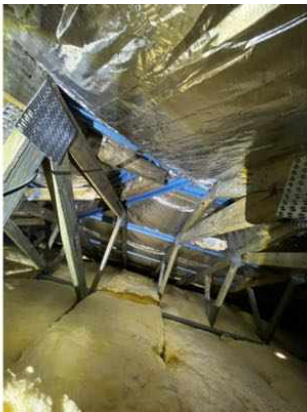
Building: Main Building
 Location: Hallway - Upstairs
 Finding: Obstructions and Limitations - Roof space
 Information: The roof void was inspected up to a safe accessible reachable point inside.

These obstructions can hide an array of defects and should be removed to allow full inspection to be carried out.

A re-inspection is recommended once the areas are made accessible.

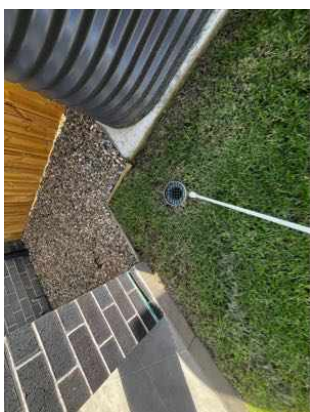
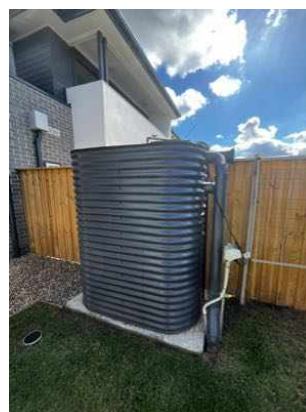
Building:	Main Building
Location:	All External Areas
Finding:	Slab Edge - Exposure
Information:	An inspection zone of at least 75mm in relation to the exposed slab edge, between the bottom brick and the perimeter pavement, is required. This inspection zone should be maintained in order to force termites into the open where they can be detected more readily during regular inspections. The slab edge should not be concealed by anything that may prevent inspection of the area, including render, landscaping, soil, turf, paving, concrete cladding or other structures.

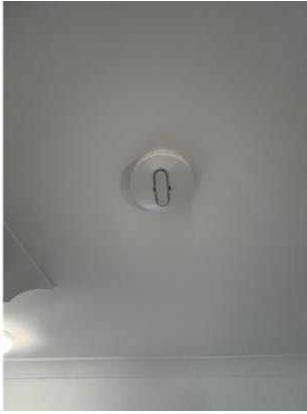
Please note that this defect is highlighted as a caution only. We suspect, based on our experience in the building industry, that the absence of smoke detectors, or their poor condition, should be addressed as a matter of urgency to improve occupant safety.

Always ensure sufficient working and suitable smoke detectors are installed prior to occupying any building. Additionally, it is advised that all smoke detectors be tested by the homeowner on a monthly basis.

Please refer to AS3786 and state based legislation, which may also apply.

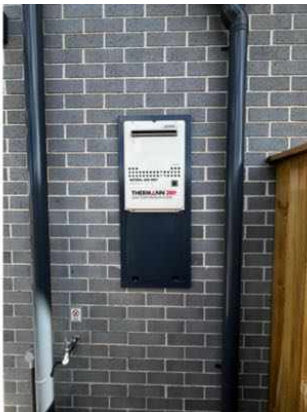
Building: Main Building
 Location: Yard
 Finding: Hot Water Unit
 Information: The HWS appeared to be in good condition at the time of inspection. All Taps where Hot water plumbing existing has been checked for hot water flow.

Water pressure appears to be normal, however, this is not an opinion of a licensed plumber. No water hammer was noted when taps are turned off fast.

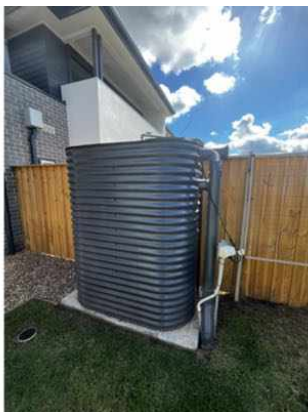
Building: Main Building
 Location: Yard
 Finding: Storm Water Tank
 Information: Storm Water Tank photos taken at the time of inspection.

Please consult a licensed Plumber to check the Connections/ pressure/ pumps/ flow of water and functionality.

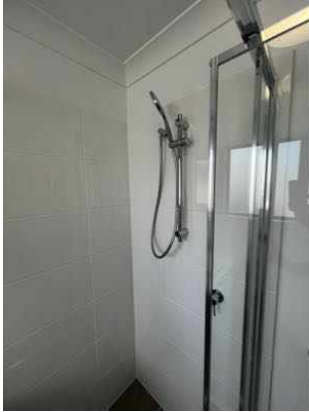
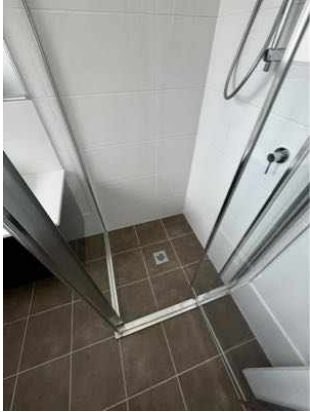
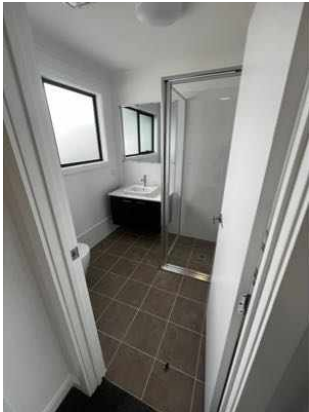
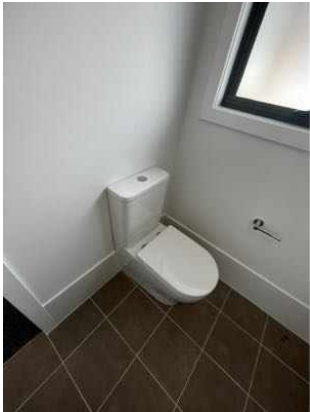
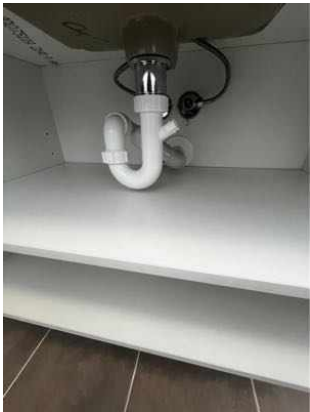
Building: Main Building
 Location: Main Bathroom
 Finding: Cabinetry Plumbing / Main Bathroom Inspection/ Moisture Checked
 Information: All cupboards where sinks and basins with drainage plumbing were inspected no evidence of leaks were present at the time of inspection.

Upon Inspection of the area there was no excess moisture reading was found during inspection.

It is highly recommended that all plumbing and drainage fixtures and fittings be maintained regularly in order to prevent excessive moisture being present in the external / internal property.
