Building and Timber Pest Inspection Report

Inspection Date: Tue, 27 Jan 2026

Property Address: U3/4 James Ln, Kiama NSW 2533, Australia

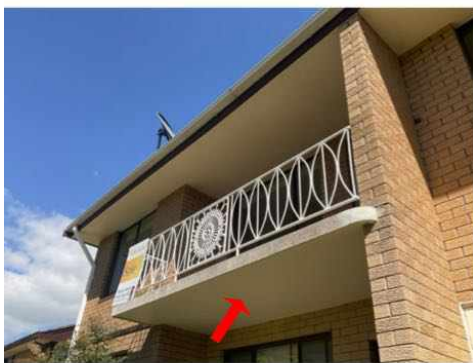
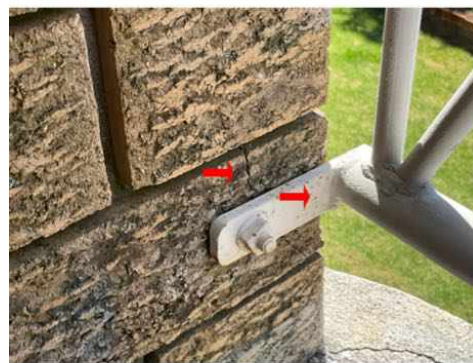
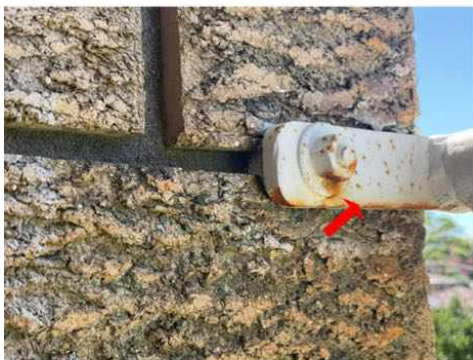
Nothing contained in this report should be taken as an indicator that an assessment has been made, on any elevated structure, as suitable for any specific number of people or purpose. This can only be done by a qualified engineer. For the purpose of this report, the Structure includes the elevated front verandah which shows very minor rust to some brackets cracking to one brick and the corner concrete (2mm) in the easy corner.

You should also arrange annual inspections of the structure by an engineer or other suitably qualified person to ensure any maintenance, that may become necessary, is identified. Care must be taken not to overload the structure.
