Building and Timber Pest Inspection Report

Inspection Date: Mon, 2 Mar 2026

Property Address: 8 Cope St, Airport West VIC 3042, Australia

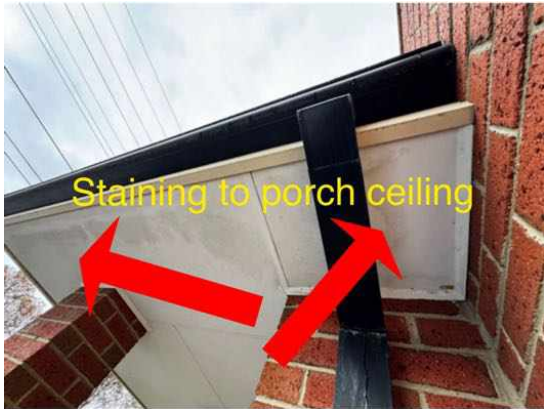
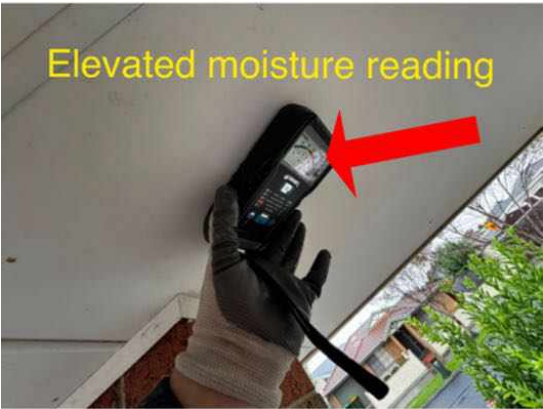
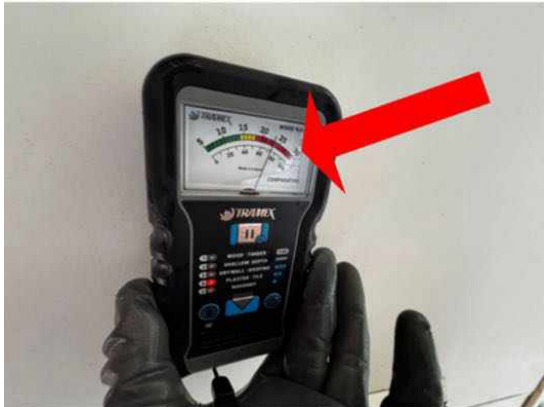
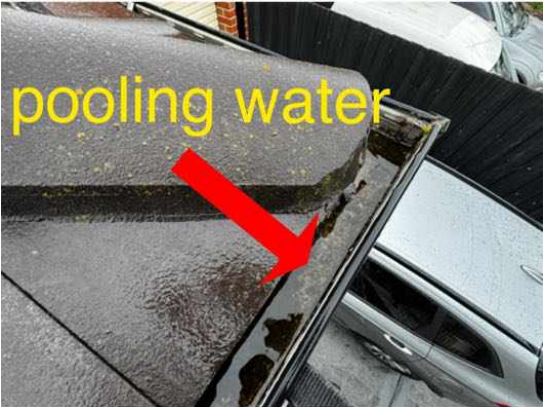
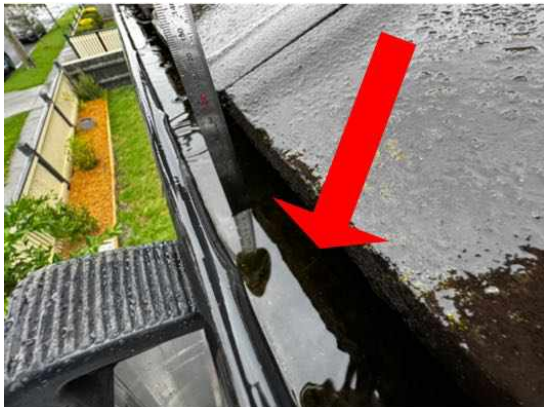
Building: Main Building
Location: Porch > Front
Finding: Porch Ceiling Moisture Ingress – Localised Active Moisture Detected (Major Defect)
Information: Staining was observed to the porch ceiling lining. Moisture testing was conducted to several sections of the front porch ceiling. Elevated moisture readings were detected in some areas, while other sections returned normal readings. This indicates that the moisture ingress appears to be localised rather than widespread.

Inspection of the roof covering above did not reveal any obvious cracked or displaced roof tiles. However, sections of the gutters were observed to be holding pooled water, indicating insufficient fall toward drainage outlets. During heavy rainfall events, ponding gutters may overflow and allow water to backflow toward the porch lining, potentially causing intermittent moisture ingress.

In accordance with AS 4349.1–2007, the presence of confirmed elevated moisture readings affecting building elements and having the potential to cause deterioration of ceiling linings and supporting framing is considered a Major Defect, as it may lead to timber decay, mould development and concealed damage if not rectified.

It is recommended that a licensed roofing plumber assess the front porch gutter system to correct inadequate fall and ensure compliant drainage. Gutters should be adjusted or regraded as required to prevent ponding and overflow. Following rectification, the affected ceiling lining should be reassessed to determine the extent of damage and repaired or replaced as necessary. Monitoring during rainfall events is recommended to confirm resolution.

Rectification recommended in the short term to prevent further moisture-related deterioration.

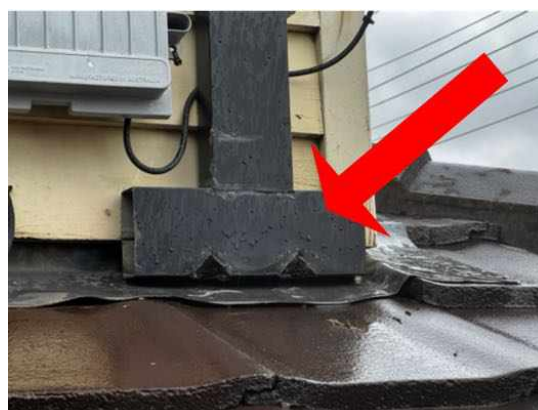
Finding 2.02

Building: Main Building
 Location: Roof Exterior > Front Left
 Finding: Roof Plumbing – Downpipe Discharging onto Roof Flashing
 Information: A downpipe and spreader located above the living area was observed to be discharging stormwater directly onto a lower roof flashing. Discharging concentrated water flow onto flashing details is considered poor roof plumbing practice and increases the likelihood of water tracking beneath roof coverings.

Rectification recommended in the short term to reduce risk of moisture ingress and associated deterioration.

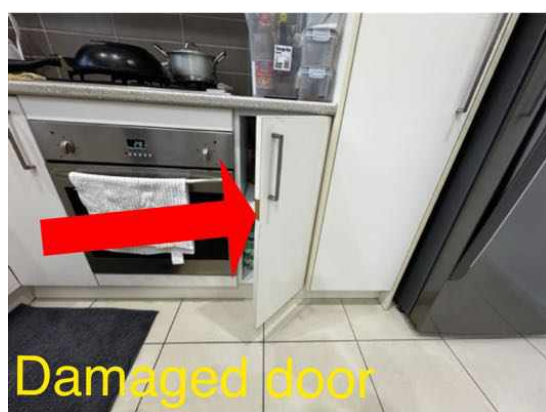
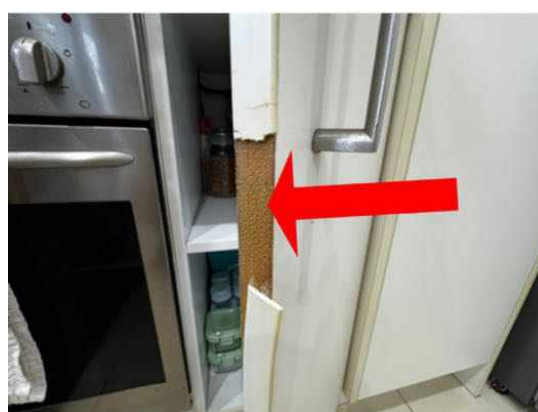
Finding 3.02

Building: Main Building
 Location: All Areas > All Areas
 Finding: Minor Internal Defects – Joinery, Plaster, Ceilings and Flooring
 Information: The following internal defects were observed during the inspection:

Maintenance recommended in the short to medium term.

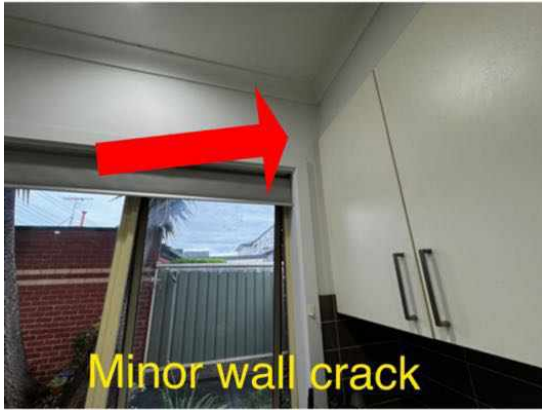
Minor wall crack

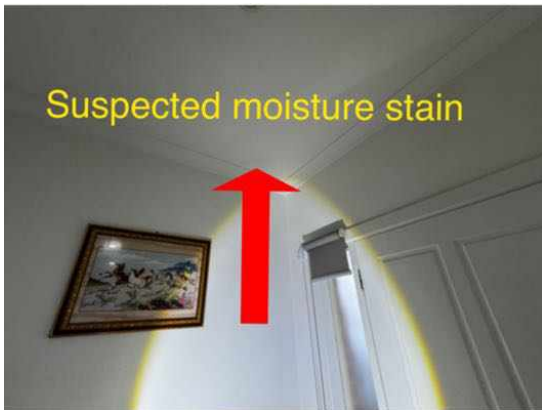
Suspected moisture stain

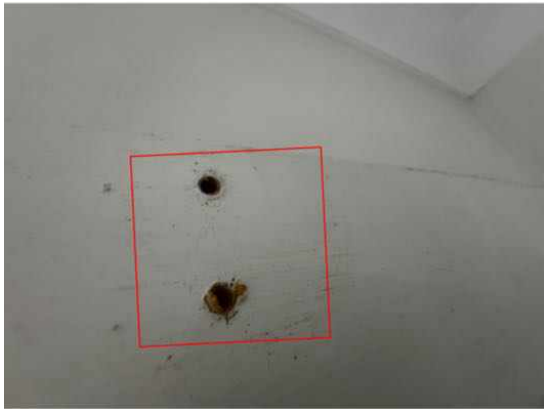
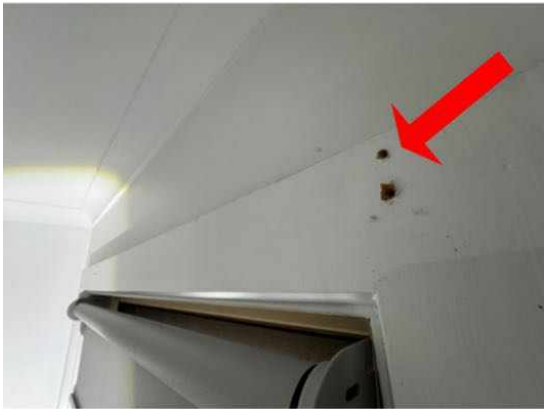
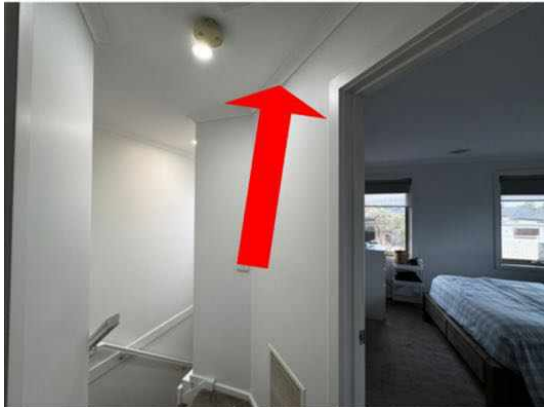
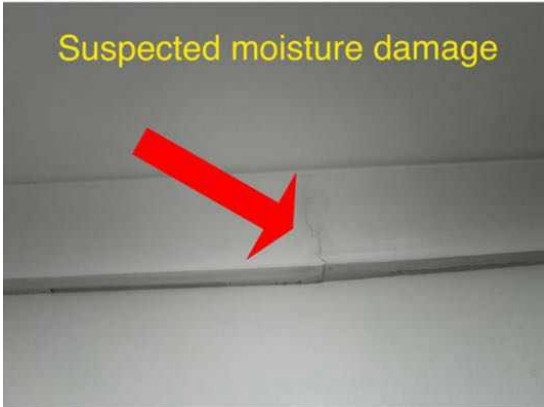
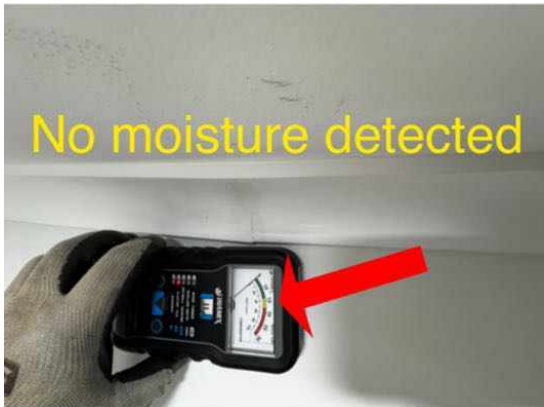
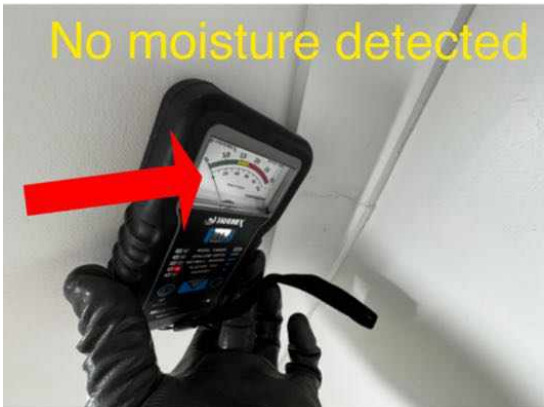
A damaged kitchen cabinet door was noted adjacent to the oven. The dishwasher door handle was broken and was difficult to operate. Minor cracking was observed to wall plaster in the kitchen area.

Suspected moisture staining was observed to the entry and first-floor hallway ceiling and cornice. Moisture testing was undertaken using a moisture meter; however, no

elevated moisture readings were detected at the time of inspection, suggesting the staining is likely historical in nature.

Minor cracking was observed to the garage concrete floor, measuring less than 5mm in width and consistent with normal shrinkage or settlement cracking.

Creaking floors were noted to the upper level, including the staircase and bedroom areas. This is commonly associated with minor movement in timber floor components or fixings.

Damage was observed to the window architraves in the front bedroom, likely associated with a previously removed curtain fixture, leaving small holes and cosmetic damage.

Overall, the defects listed above are considered minor maintenance and cosmetic items consistent with a dwelling of approximately 15 years of age.

Recommendation:

It is recommended that damaged joinery and fixtures be repaired or replaced as required. Plaster cracking and architrave damage should be patched and repainted. Ceiling stains should be monitored, particularly during rainfall events. Cracked concrete and creaking floors should be monitored and addressed if movement or deterioration increases.

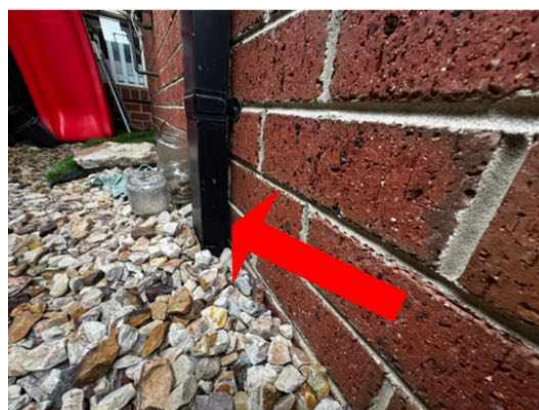
Building:	Main Building
Location:	Walls > All Areas
Finding:	Downpipes hard against brickwork concealing inspection zones (TP)
Information:	At the time of inspection, several downpipes were observed to be installed hard against the external brick walls. This configuration restricts visual access to the wall surface and slab edge behind the downpipes, making it difficult to identify early signs of termite activity.

Effective termite risk management relies on maintaining clear and accessible inspection zones to allow early detection of termite activity. Where services such as downpipes are installed directly against masonry walls, concealed termite entry paths may develop behind these elements without being readily visible, increasing the likelihood of undetected termite ingress.

As a result, the positioning of downpipes hard against the brickwork is considered to increase the risk of concealed termite entry. It is recommended that a licensed termite management or pest control contractor be engaged to assess these locations and provide advice on improving inspection access or implementing supplementary termite management measures to address the increased risk.

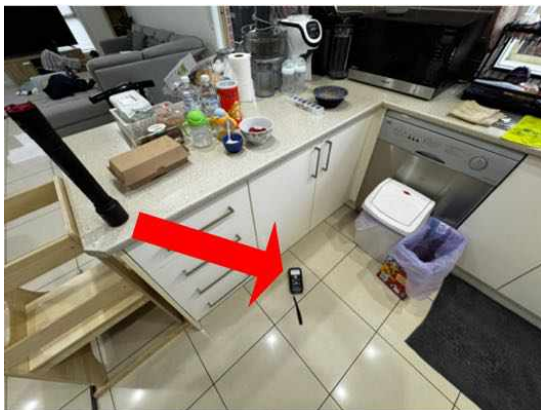
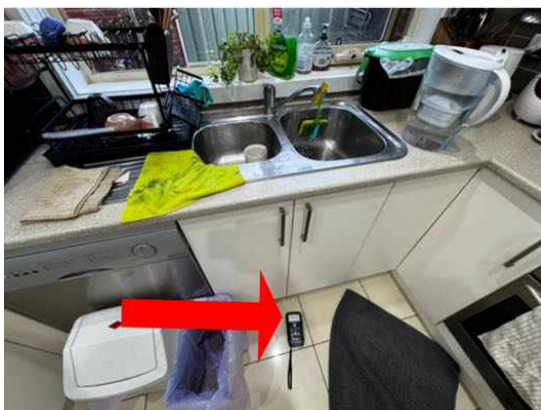
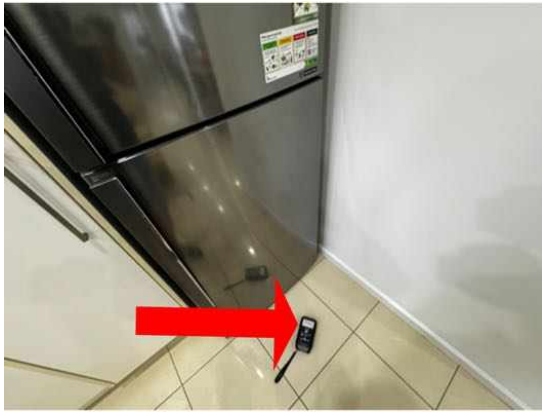
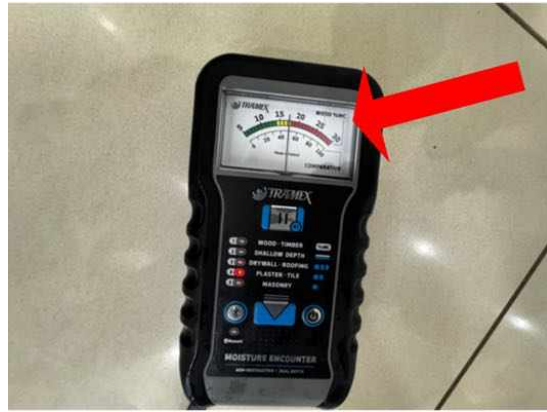
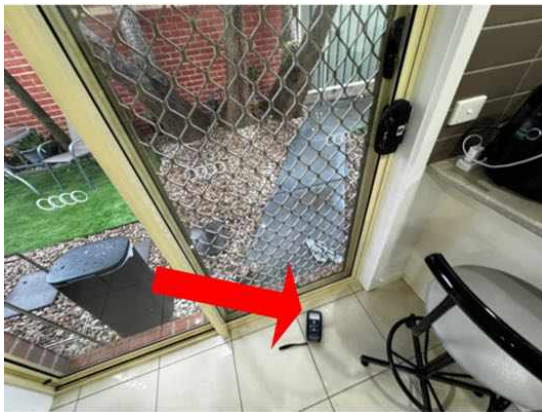
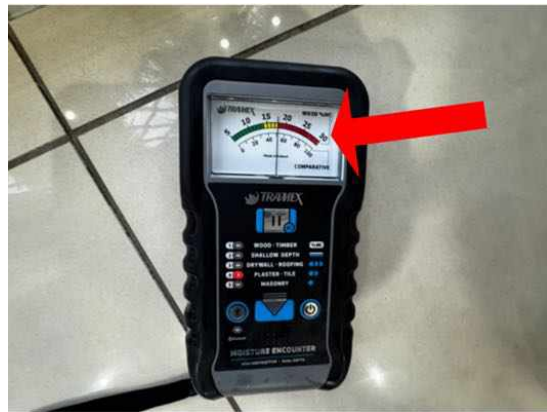
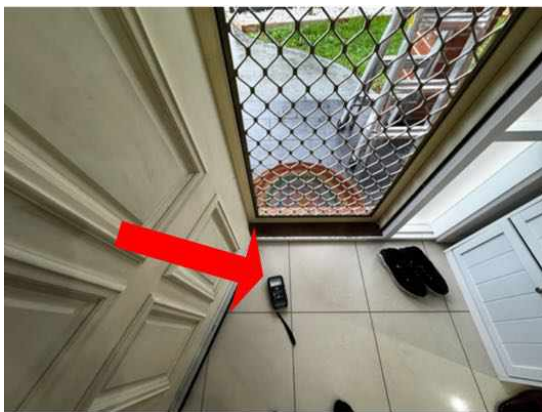
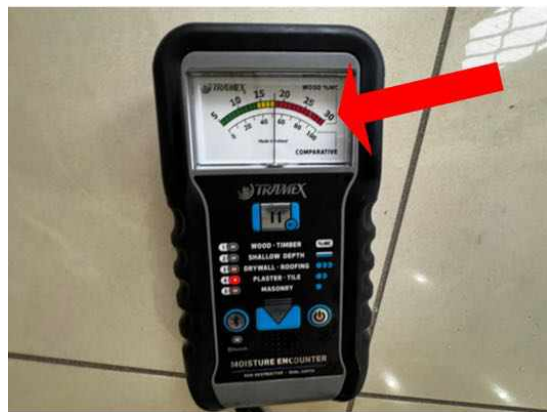
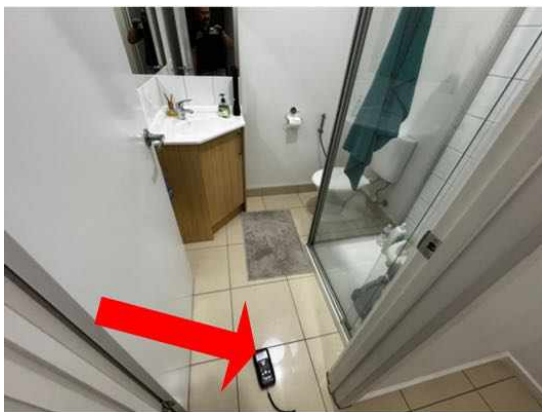
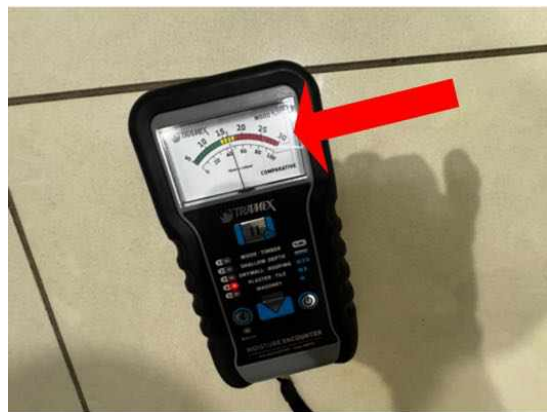
Finding 6.02

Finding: Moderate moisture levels to ground level floor tiles (TP)

Information: At the time of inspection, moderate moisture readings ranging between 40% and 50% were detected using a moisture meter in the kitchen, dining, entry, laundry and the toilet floor tiles on the ground floor. No active water leaks were observed during the inspection. Moisture readings in adjoining rooms were normal. It appears that the moisture is contained to these tiled areas only. No moisture damage was found to any of the skirting boards, door jambs, architraves or joinery suggesting that the moisture levels are stable and not spreading. It is suspected that the moisture may be from conditions such as excessive wet mopping, spills, or historic overflows or leakages from appliances or plumbing fixtures.

In accordance with AS 3660.2, wet areas and plumbing-related moisture issues are recognised as increasing termite risk, as persistent dampness within building elements can create conditions conducive to termite activity and concealed access. Ongoing moisture exposure may also lead to deterioration of surrounding materials, further elevating termite susceptibility.

As a result, the moisture issues identified within these areas are considered to increase the risk of termite activity and material deterioration. It is recommended that these areas are periodically monitored for ongoing moisture issues. Assessment is recommended by a licensed termite management or pest control contractor where elevated termite risk is identified.

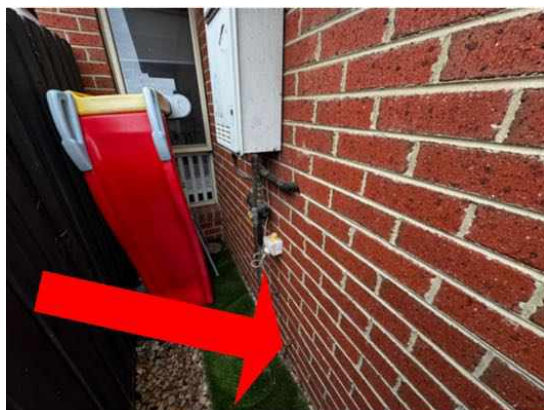
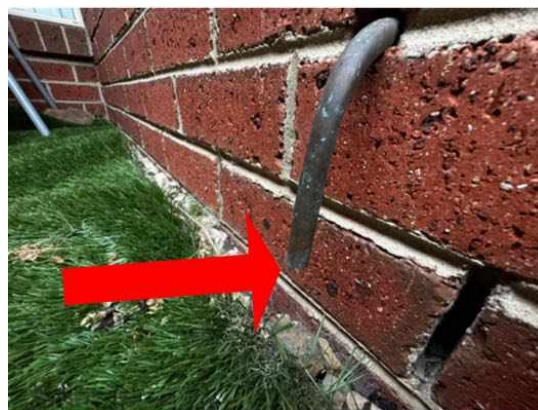
Finding 6.07

Building:	Main Building
Location:	Meter Box > Front Left
Finding:	Termite management system - no evidence of chemical installation (TP)
Information:	At the time of inspection, there was no visible evidence to suggest that a chemical termite management system has been installed or remains effective. In addition, no durable notice was observed within the electrical switchboard to identify the presence, type, or date of any termite protection measures.

For this reason, the installation of a post-construction chemical termite management system is highly recommended to reduce the risk of termite activity. A durable notice should also be installed within the electrical switchboard to clearly identify the treatment provided and support ongoing inspection and maintenance.

Engagement of a licensed termite management or pest control contractor is recommended as a matter of priority to assess the site conditions, consider local termite risk, and determine the most appropriate treatment method and procedures for this property.

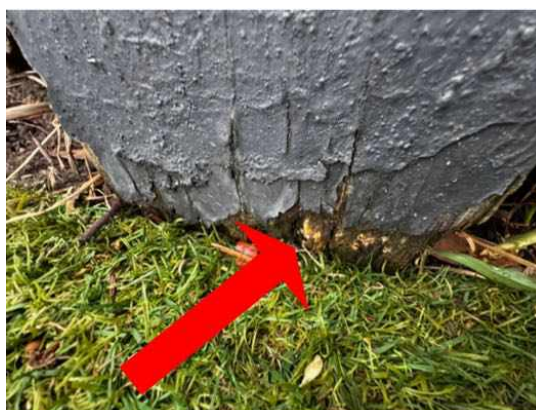
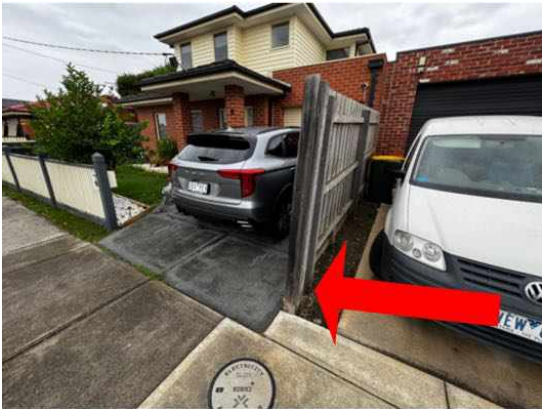
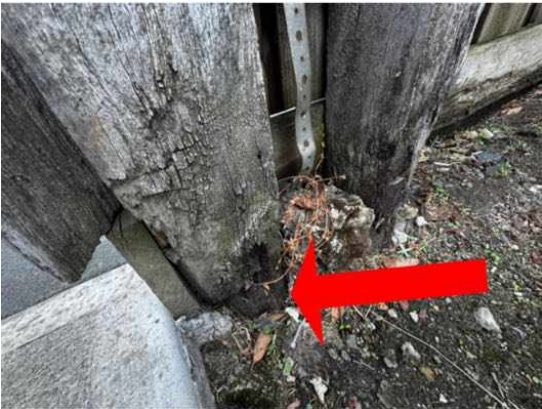
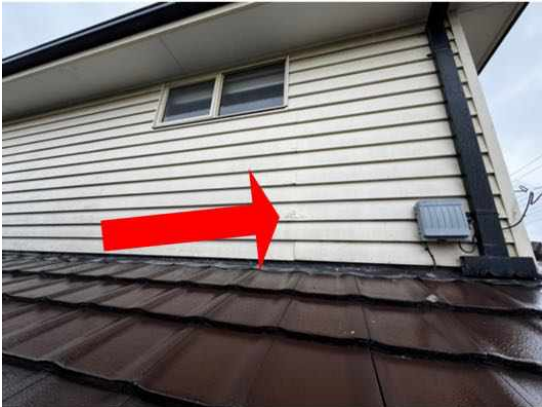
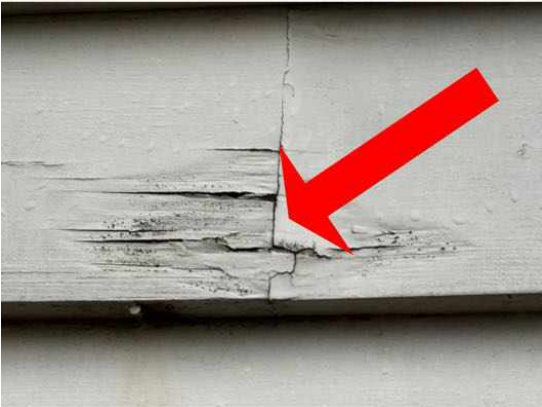
Building: Main Building
 Location: Fence and weatherboard > Front Left, Front Right
 Finding: Timber decay & rot - Conducive conditions (TP)
 Information: At the time of inspection, timber decay was observed to the front and boundary fence posts. The affected area was located to the bottom of the posts with the remaining sections relatively intact. The right hand side boundary fence was heavily decayed and the structure of the fence was in poor condition. Timber decay was also observed to a small section of weatherboard cladding above the living area.

These conditions are suspected to have developed over time due to prolonged moisture exposure and a lack of appropriate timber maintenance, allowing moisture ingress and decay to progress within the timber elements. In accordance with AS 3660.2, deteriorated and moisture-affected timber is recognised as increasing the risk of termite activity, as decayed timber can attract termites and may provide concealed access or harbourage, particularly where defects are obscured by finishes such as paint.

As a result, these condition are considered to present an elevated risk of ongoing deterioration and potential termite susceptibility. It is recommended that an appropriately qualified builder or carpenter be engaged to further assess the extent of timber decay, remove any concealed deteriorated material, and undertake suitable repairs or replacement, with consideration also given to advice from a licensed termite management or pest control contractor where termite risk is identified.

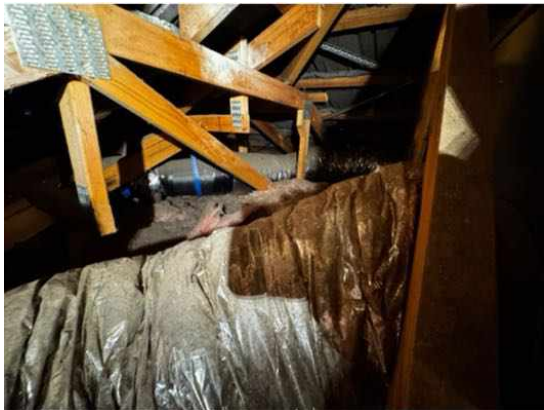
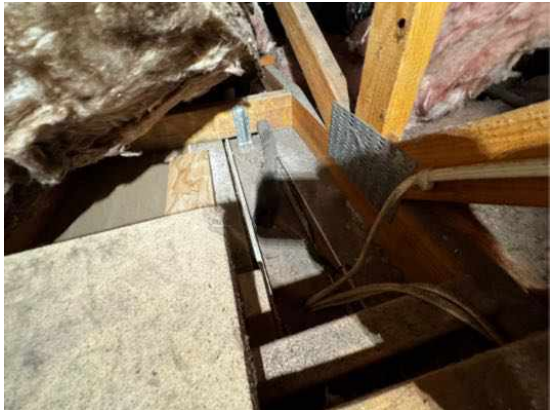
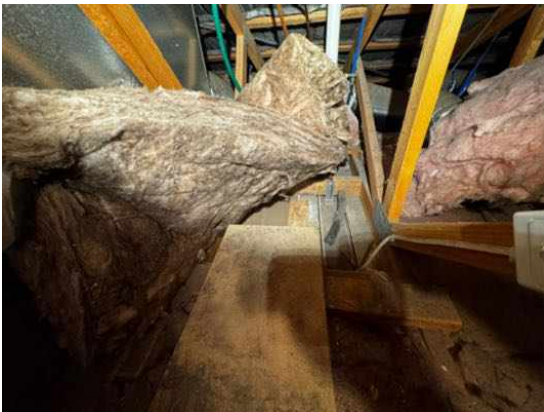
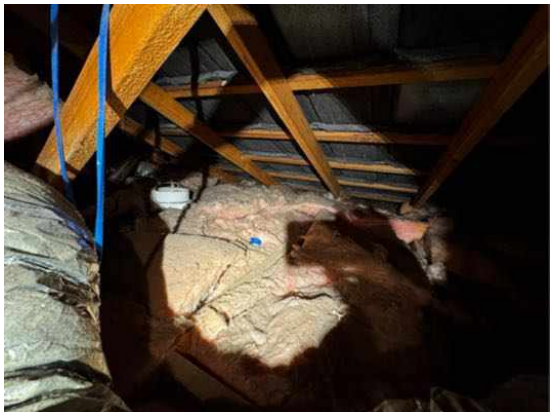
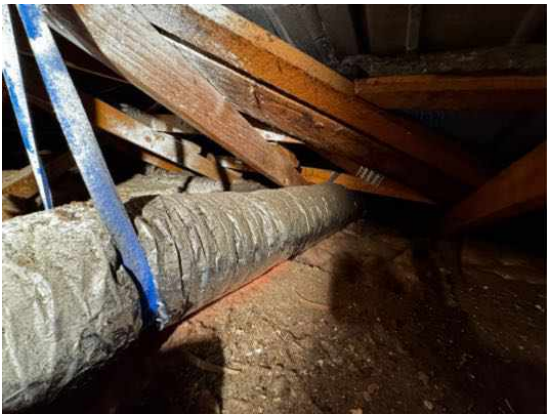
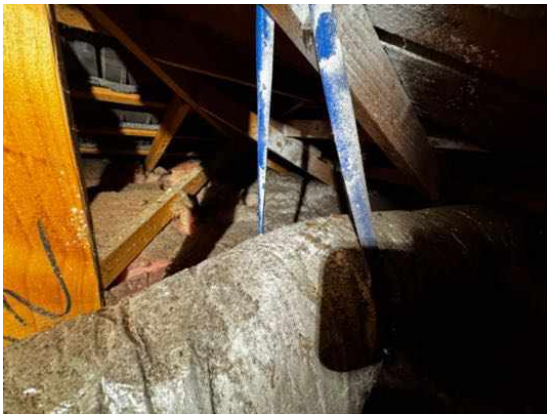
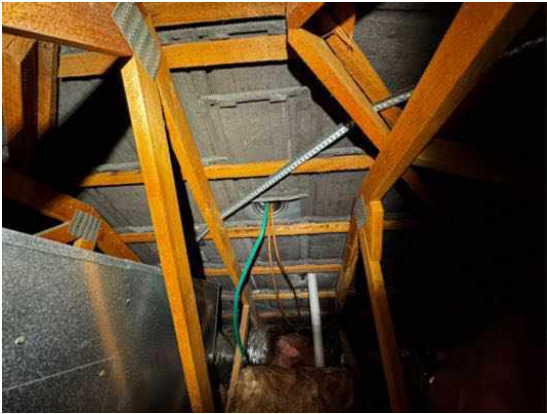
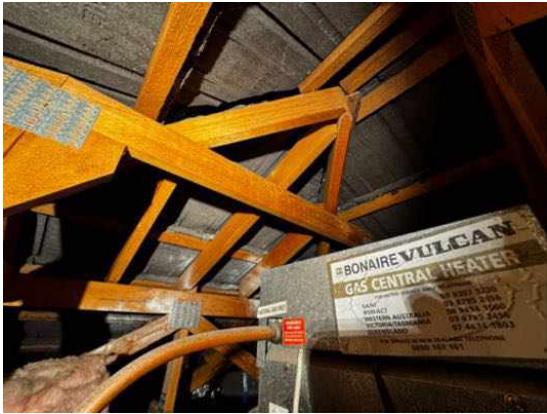
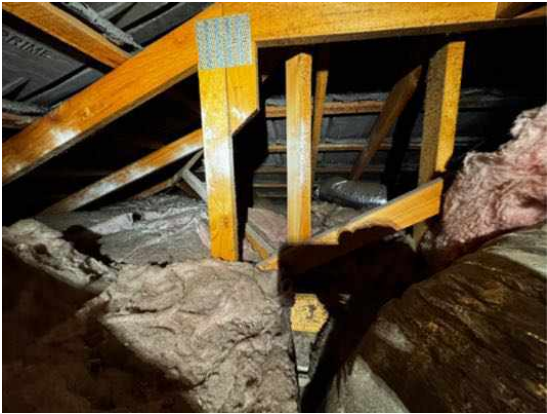
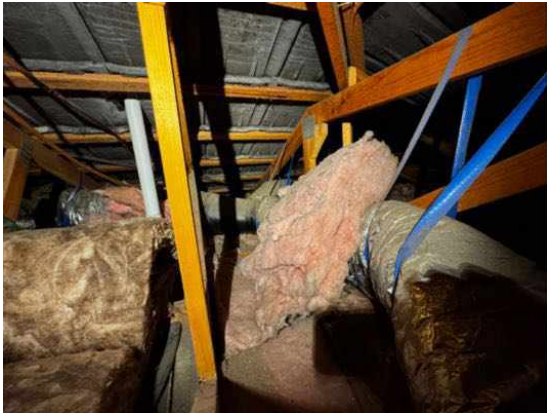
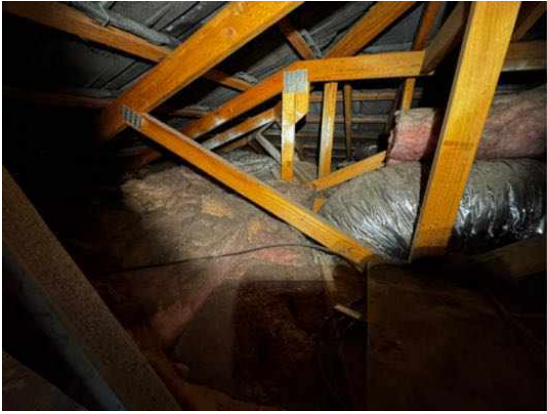
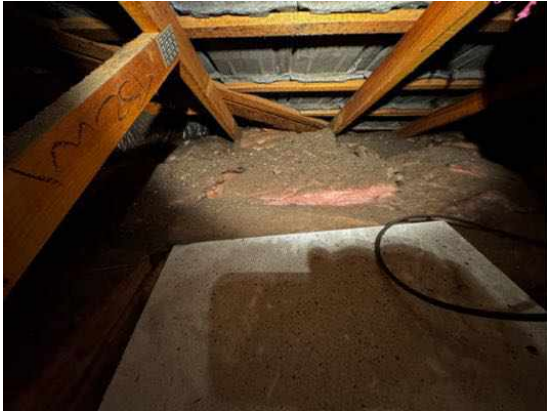
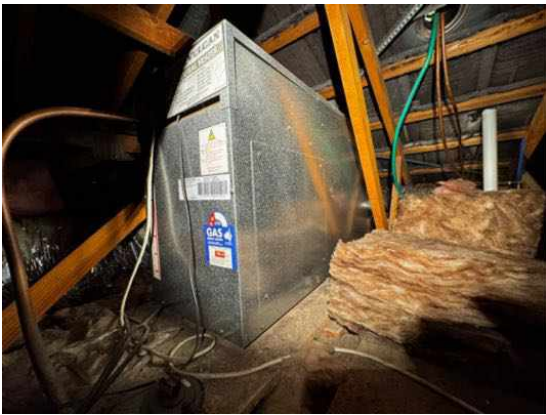
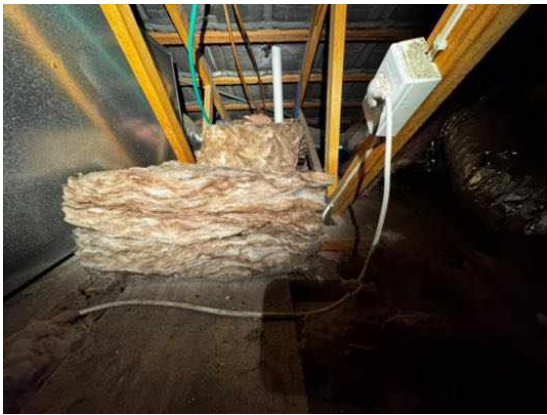
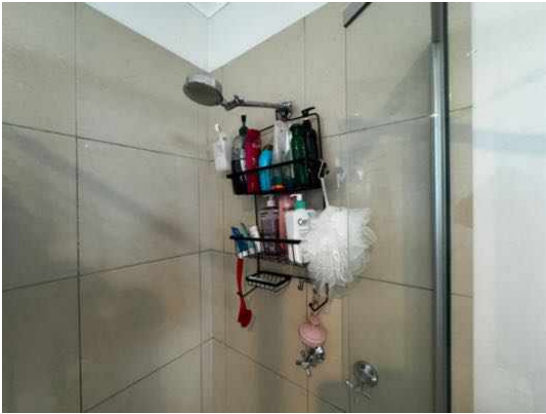
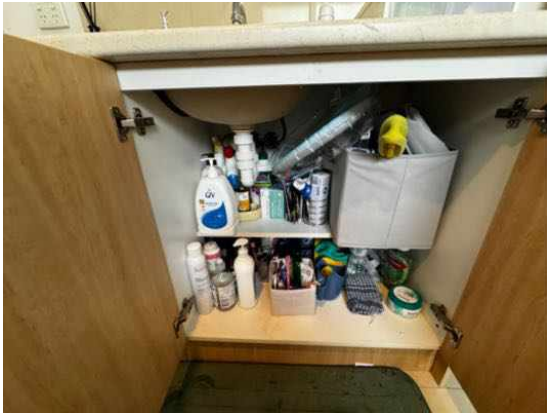
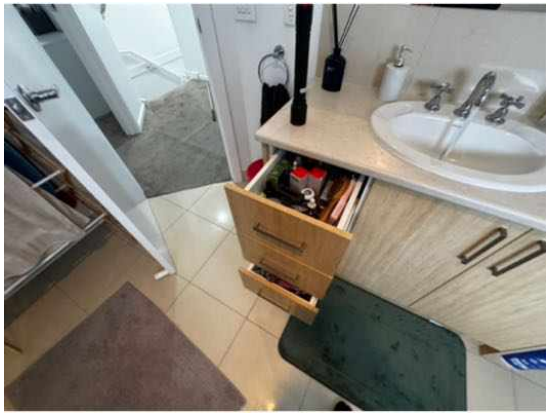
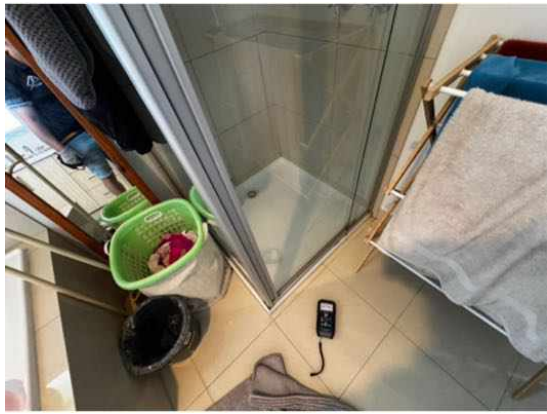
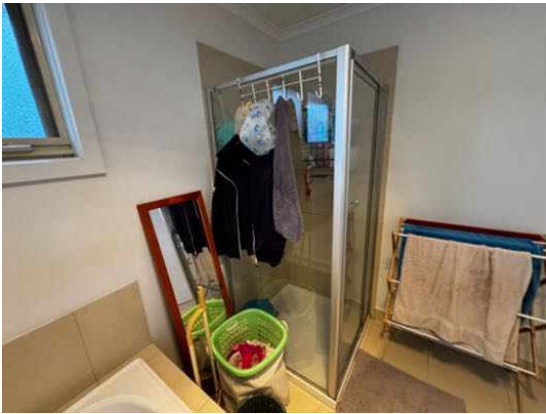
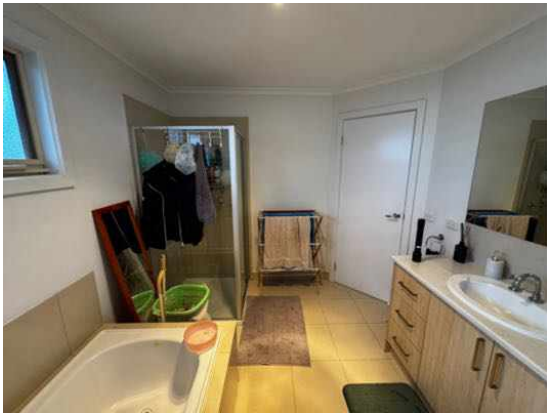
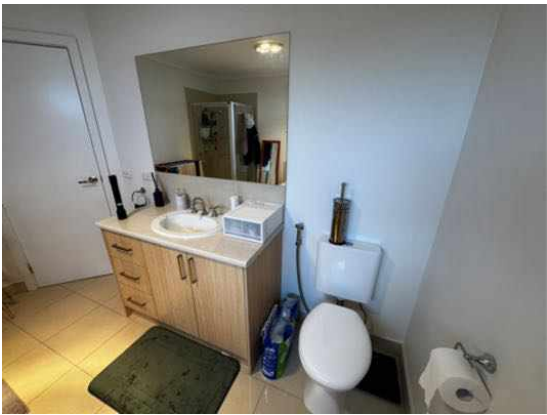
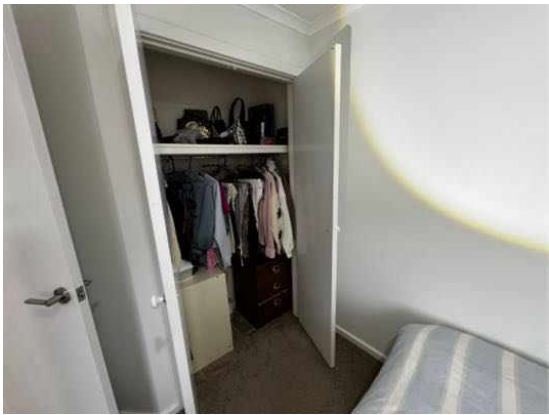
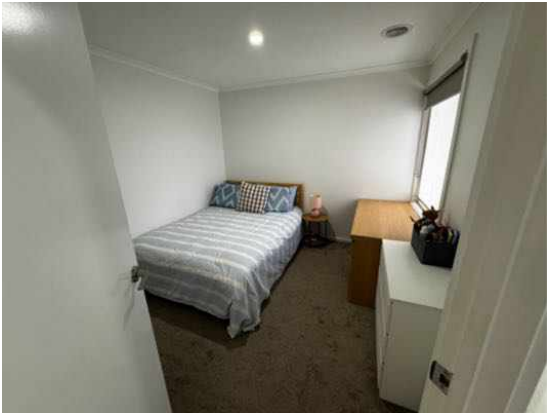
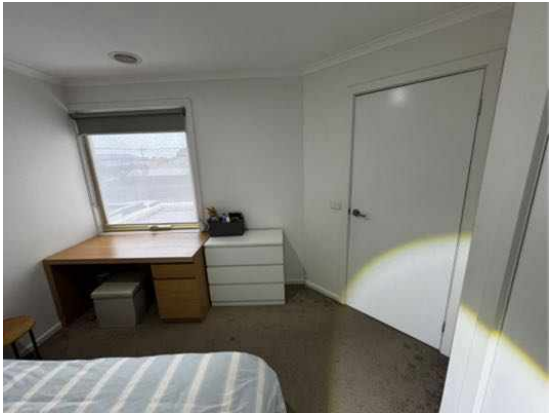
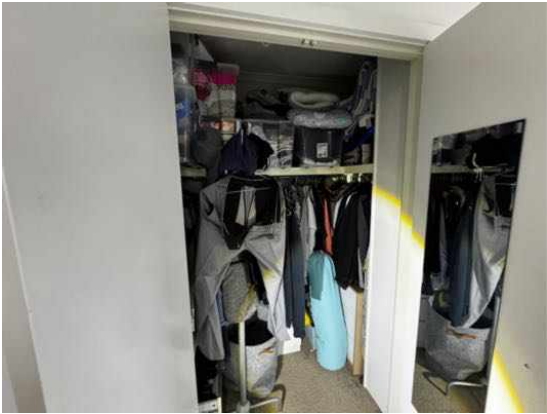
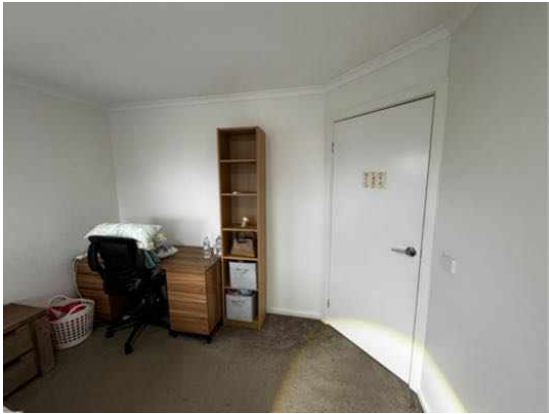
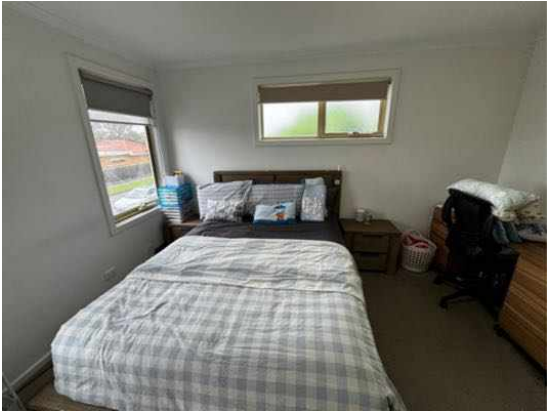
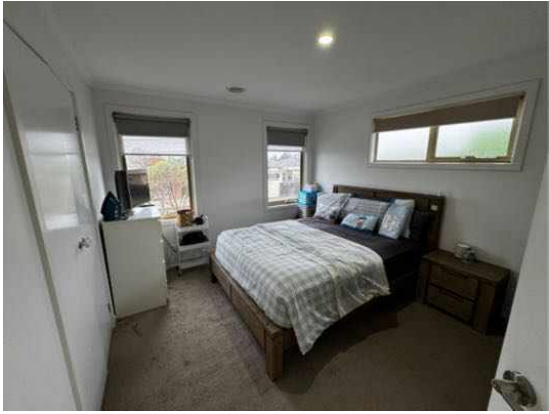
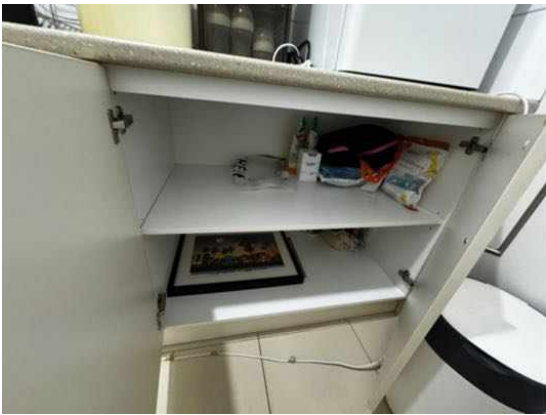
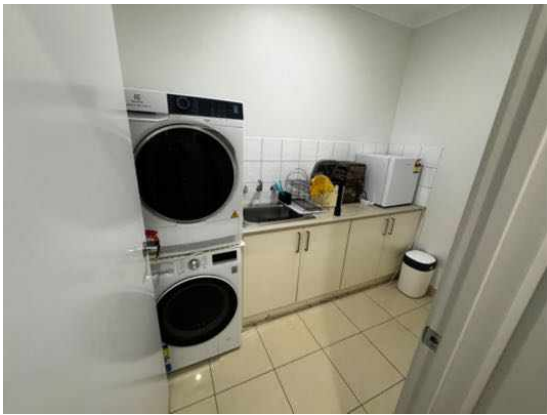
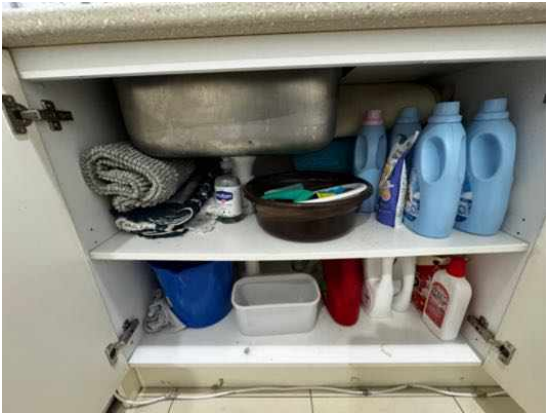
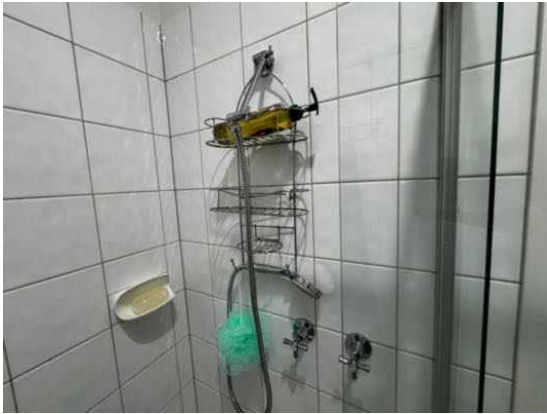
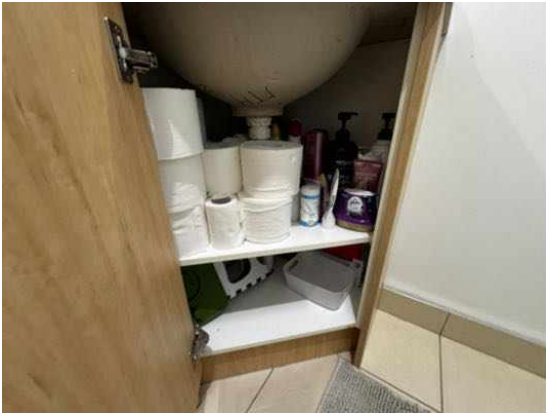
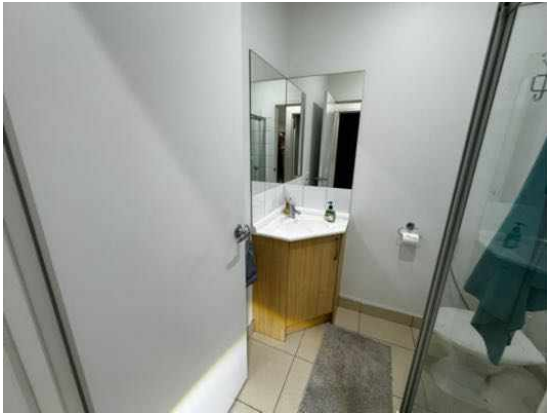
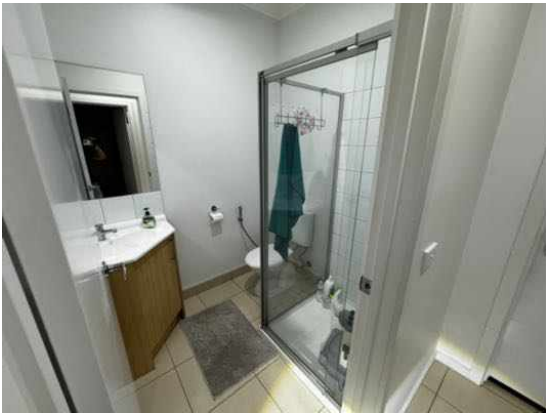
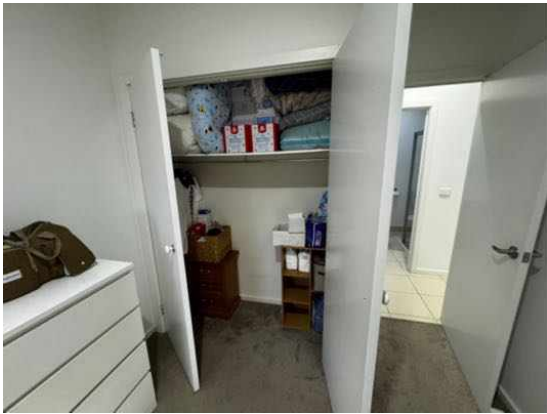
Building: Main Building
Location: All Areas > All Areas
Finding: Additional Photos - Obstructions and Limitations
Information: These photographs are an indication of the obstructions and limitations which impeded full inspection of the property at the time of inspection. These obstructions can hide an array of defects and should be removed to allow full inspection to be carried out. A re-inspection is recommended once the areas are made accessible.

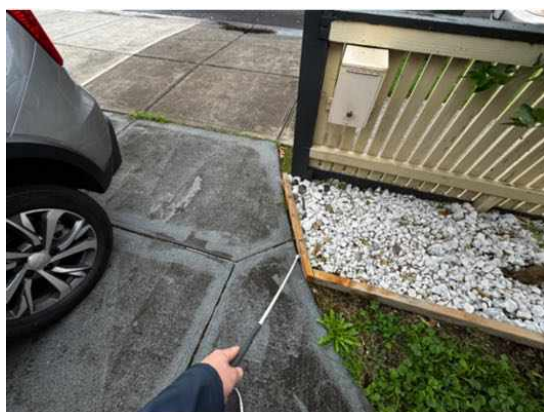
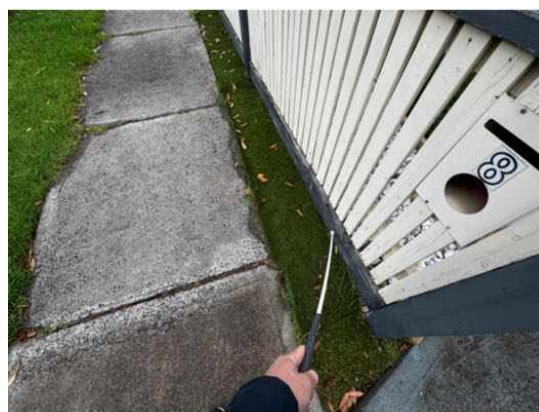
Building: Main Building
Location: All Areas > All Areas
Finding: Termite investigation techniques (TP)
Information: All accessible areas of the dwelling were inspected, with particular attention paid to wet areas, which were closely assessed for elevated moisture levels and temperature anomalies that may indicate conditions conducive to termite activity. No evidence of termite activity was identified within the interior of the dwelling at the time of inspection.

In an attempt to identify concealed or hidden timber pest activity, a range of inspection techniques were adopted. These included the use of a moisture meter to assess susceptible areas, sounding of timber elements using a handheld probing device, and visual assessment of materials for signs commonly associated with termite activity. These signs include moisture-related deterioration, deformation of timber, termite mud leads or bridging, and irregular or regular shaped holes within timber elements that may indicate pest-related damage.

It is noted that termite activity can generate increased moisture and localized temperature variations, and where such irregularities are detected, further investigation may be warranted. However, it is also acknowledged that certain obstructions, including floor coverings, wall linings, wall tiles, and fixed cabinetry such as bathroom fit-offs, can conceal termite activity and limit the effectiveness of visual inspection. As a result, the absence of visible evidence at the time of inspection does not eliminate the possibility of concealed termite activity within inaccessible or obstructed areas of the building.
