Building and Timber Pest Inspection Report

Inspection Date: Thu, 5 Mar 2026

Property Address: 53 Newington Blvd, Newington NSW 2127,
Australia

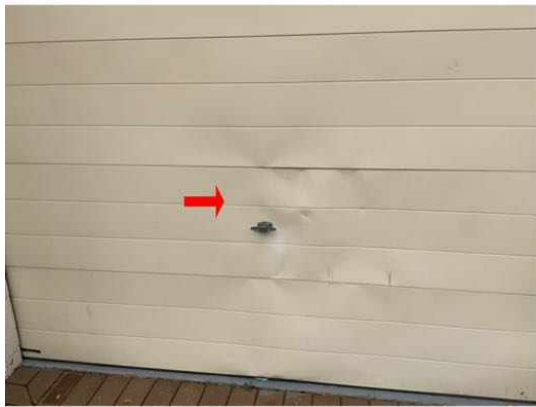
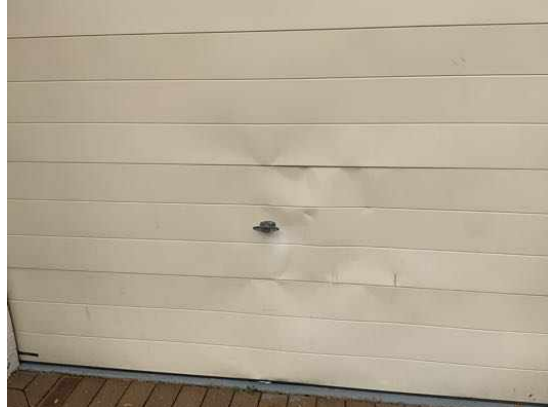
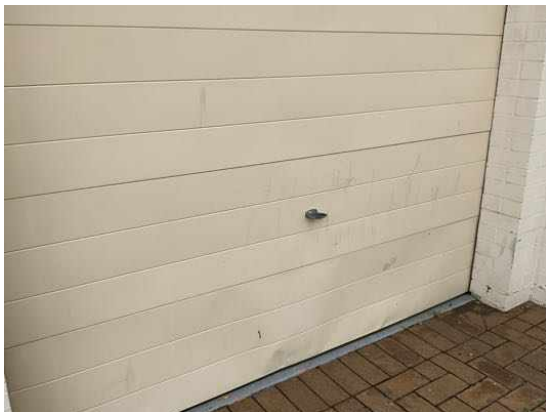
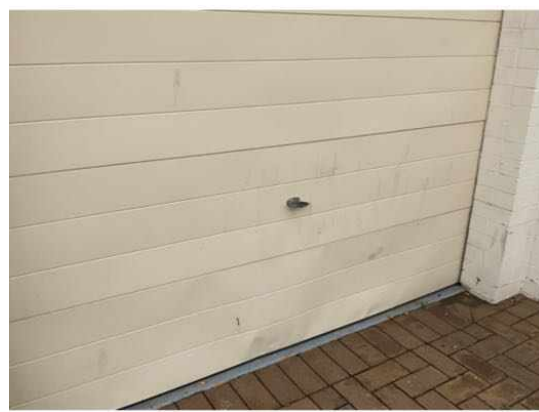
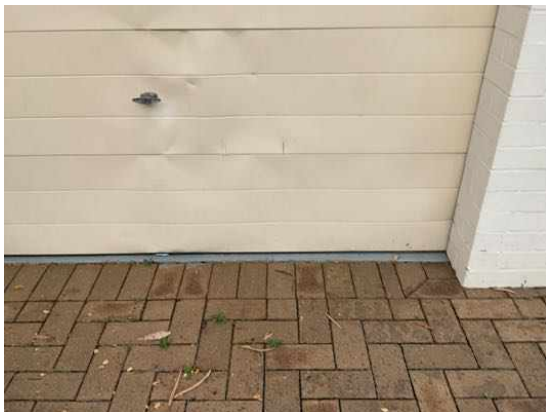
Finding 3.02

Building: Main Building
Location: Garage
Finding: Minor Dent on Garage Door
Information: A minor dent is visible on the lower section of the garage door. It does not affect how the door works but does impact its appearance.
Risk:
Low. Mainly cosmetic. Could worsen over time if hit again.
Who Can Fix It:

A garage door technician or handyman can repair or replace the panel if needed.

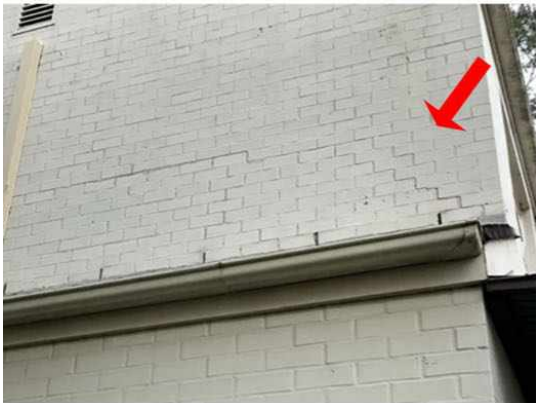
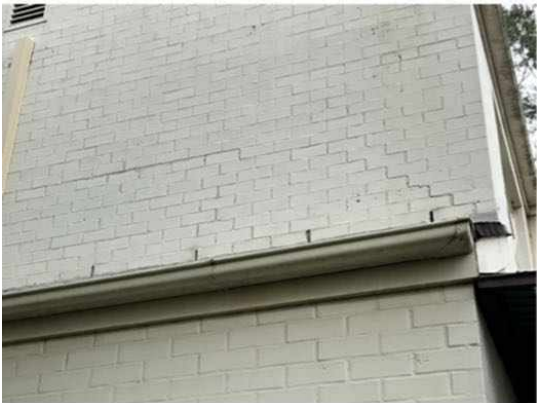
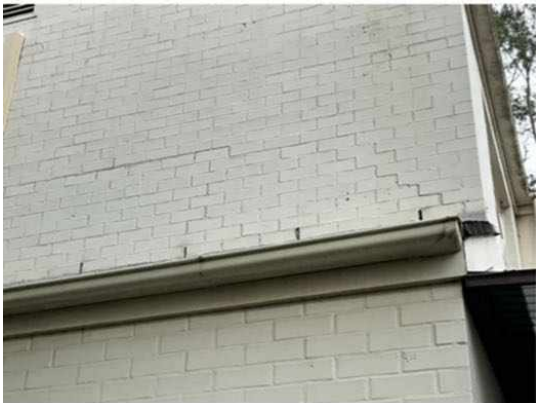
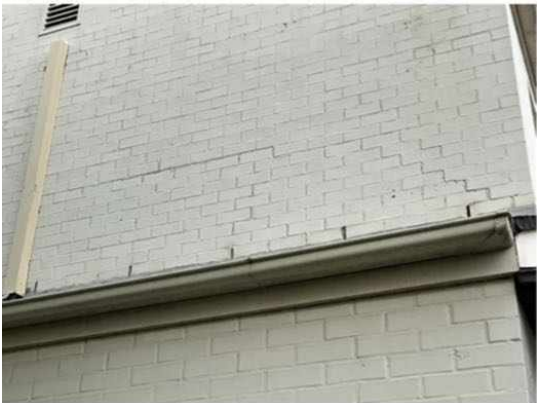
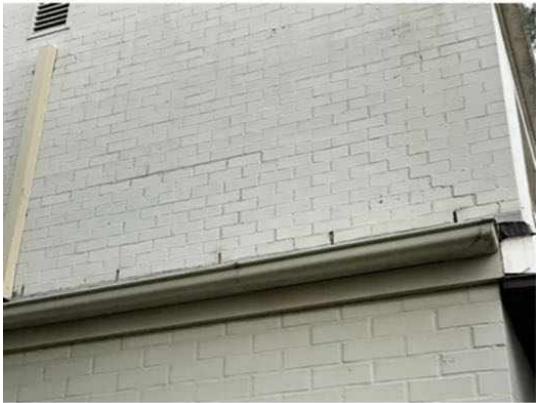
Finding 3.03

Building: Main Building
 Location: Exterior walls - rear
 Finding: Brickwork - Cracking [Repair required]
 Information: cracking was identified to the brickwork in this area. Cracks of this type are likely to have been caused by expected movement of building elements, but may also have a structural cause that is more significant.

A crack of this size may be repaired by extensive filling. Additionally, further remedial

A qualified bricklayer should be contacted immediately to estimate and perform repair and restoration works. Consultation with a structural engineer may be required where structural instability is found to be the underlying cause of the cracking.

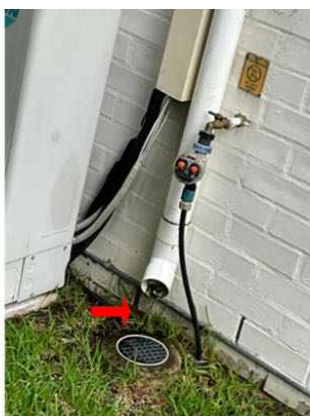
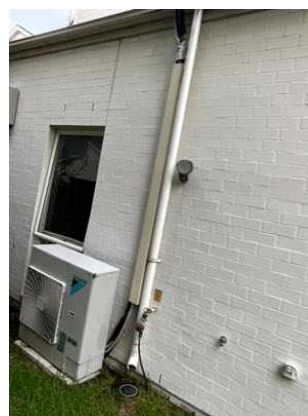
Finding 3.04

Building: Main Building
Location: Exterior walls - rear

Finding: Disconnected downpipe
 Information: A notable defect with a disconnected downpipe, compromising the efficient drainage of rainwater from the roof. This disconnectivity poses an increased risk of water accumulation, potentially leading to foundation erosion, water damage to the property, and a conducive environment for mold growth.”

1. Foundation Erosion: Accumulated water around the foundation due to the disconnected downpipe can lead to soil erosion, jeopardizing the stability of the property's foundation.
2. Water Damage: Uncontrolled water runoff can result in water penetrating the building envelope, causing interior water damage to walls, ceilings, and other structural components.
3. Mold Growth: The presence of excess moisture provides an ideal environment for mold growth, posing health risks and necessitating costly remediation.

Engage a qualified and licensed roofing or gutter specialist to address the disconnected downpipe. This professional will reconnect the downpipe to ensure proper water drainage, mitigating the associated risks and preserving the integrity of the property.

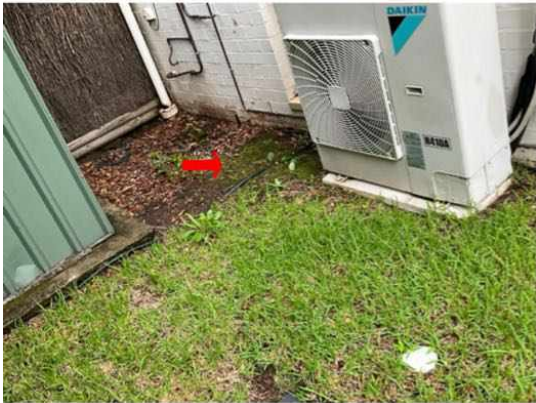
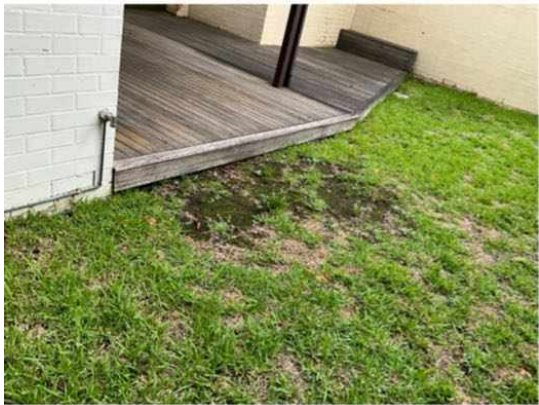
Finding 3.05

Building: Main Building
 Location: All Areas
 Finding: Perimeter - Insufficient Fall
 Information: The perimeter ground levels were found to have an inadequate slope away from the adjoining building structure, creating potential for water pooling in this area.

and bare ground should fall away from the house by 50mm in the first meter. This standard ensures that excessive moisture does not pool around the base of building structures, which creates potential for water and structural damage, as well as making the area susceptible to termite and timber pest activity.

Where ground levels do not have adequate fall, a licensed paving contractor should be appointed to install or remove and re-level pavement.

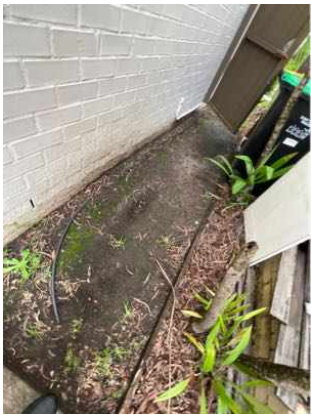
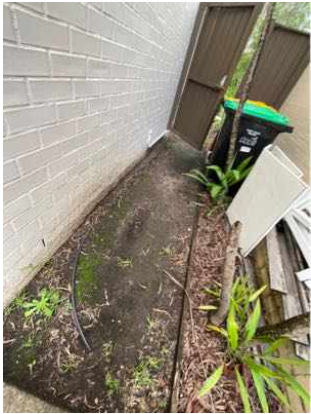
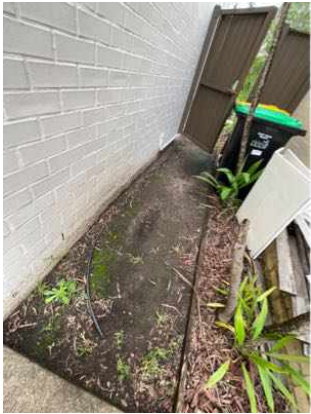
Finding 3.06

Building: Main Building
Location: All Areas
Finding: Flaky Paint
Information: Sections of the paint in this area was found to have deteriorated. Paint deteriorating is generally an indication of excessive moisture in the area that is currently hidden by the painted surface.

The presence of excessive moisture can have major implications on associated building elements if left unattended. While only seemingly minor at this stage, the damage cannot be determined due to the paint, obstructing any further inspection of the damage.

It is highly advised that the affected paint to be cleaned to allow a further, more invasive inspection by a licensed builder/painter. Failure to act on this defect may necessitate major works in the future.

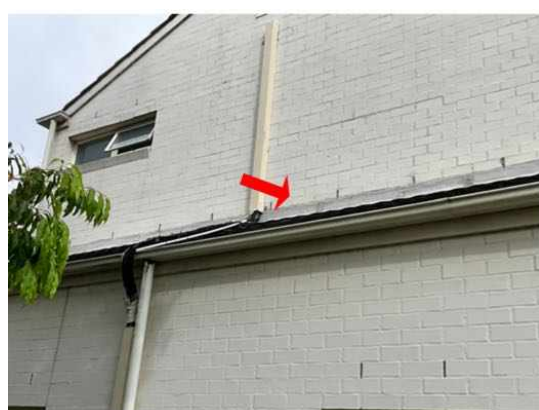
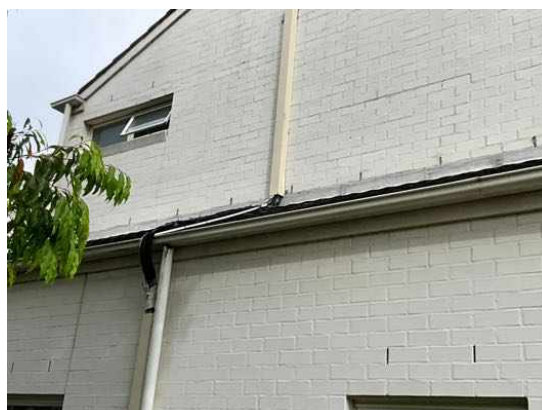
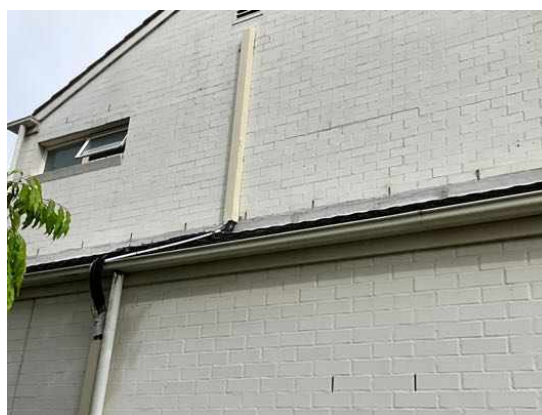
Finding 3.08

Building: Main Building
 Location: Roof Exterior
 Finding: Blocked gutters - organic debris
 Information: The roof gutter system was observed to be blocked with organic debris and moss growth, as evident in the provided images.
 Risk:

- Water ingress into the eaves or walls,
- Timber rot or deterioration of fascia and soffits,
- Accelerated moss and algae growth, promoting further blockages,
- Potential foundation issues if water pools near the base of the structure.

A licensed roofing contractor or qualified gutter cleaning service should be engaged to remove the debris and inspect the system for any further issues.

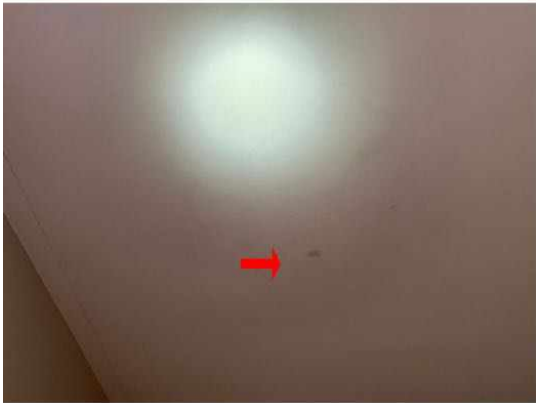
Finding 3.10

Finding: Water staining

Information: Water staining was evident in this area at the time of inspection. Water staining indicates that surfaces have been exposed to excessive moisture over time. The minerals and other elements in the water lead to staining, which may graduate to corrosion and deterioration if left unmanaged.

water staining can be indicative of more serious defects, which may be currently concealed by other building elements.

Where water staining is active, a licensed plumber must be consulted to identify the cause of the staining and to provide advice on any reparation works that may be required. Replacement of any broken or damaged structures is advised.

Conversely, where water staining is old and inactive, affected building materials may be repaired or replaced at client discretion. A qualified carpenter or registered builder may be appointed to perform these works.

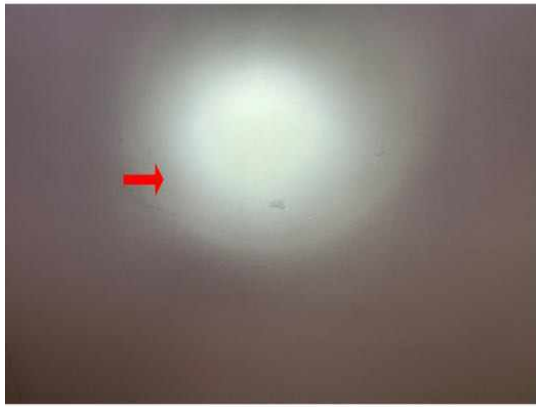
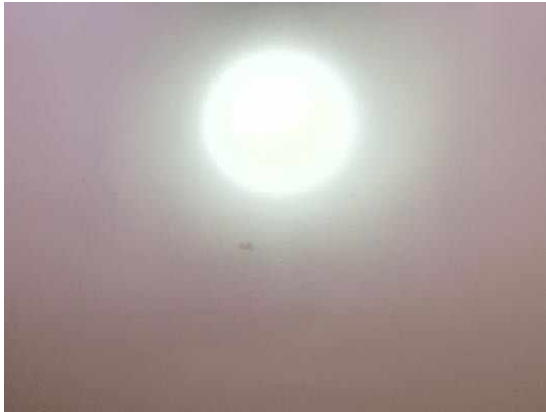
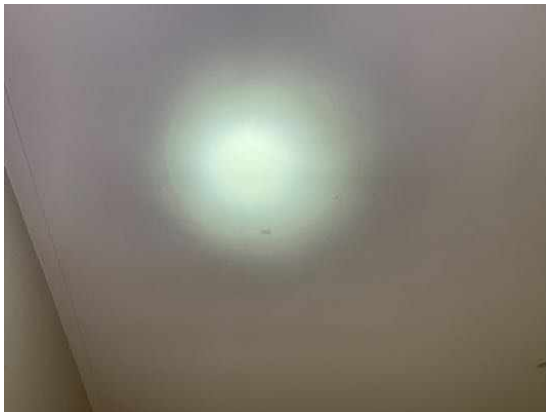
Finding 3.11

Building:	Main Building
Location:	Toilet (WC)
Finding:	Evidence of excessive moisture - Drywall
Information:	Excessive moisture is present at the time of , indicating a potential water leakage issue within the wall.

The prolonged presence of moisture can lead to mold growth, deteriorate the structure, and create an environment conducive to health hazards. Additionally, it may compromise the adhesive holding the tiles, leading to their detachment.

A licensed plumber or a qualified contractor specializing in water damage remediation

should investigate the source of the moisture, fix any leaks, and address the damage. Additionally, replacing affected tiles and ensuring proper waterproofing are crucial to preventing future issues.

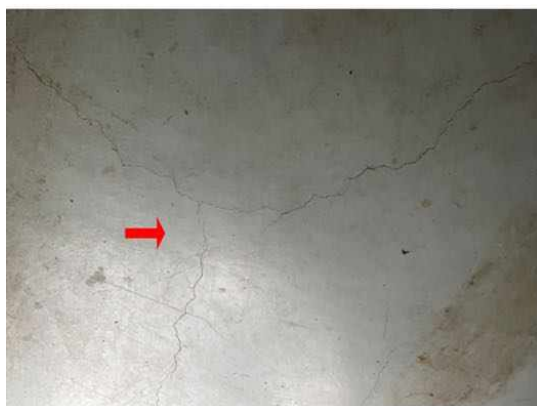
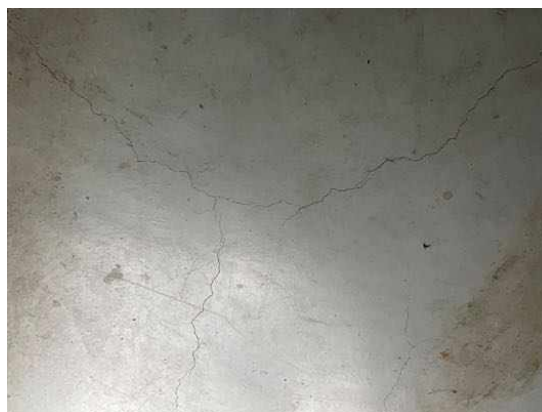
Building: Main Building
 Location: Garage
 Finding: Crack in concrete slab - Category 0
 Information: A crack coded as Category 0 was identified in the slab. A Category 0 crack is described as a hairline crack, representing insignificant movement of slab from level.

The approximate width of the crack to be considered Category 0 is 0.3mm, or change in offset of less than 8mm when a 3m straight edge is placed over the defect.

No rectification is required at this time. However, all cracking should be monitored over a 12 month period to identify any further damage in the area.

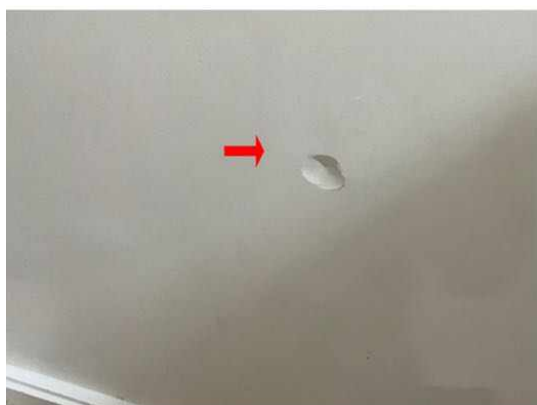
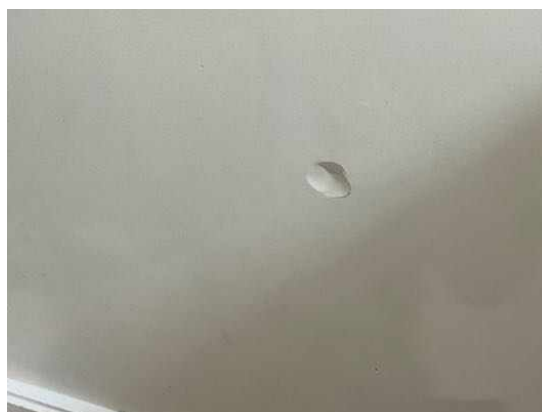
Finding 3.13

Building:	Main Building
Location:	Stairs - Internal
Finding:	Wall Gyprock damaged
Information:	Sections of plaster sheeting in this area appear to be damaged .

The most common causes of plaster failure are physical damage and moisture damage. Moisture causes plaster to swell and shrink as the humidity of the air changes, or as a consequence of leaks.

Plaster generally needs chemical re-adhesion or to be screwed back to the substrate, with minor consequent patching and painting required.

Ensure that the general environment is free from physical damage such as door handles in this instance . Appointment of a qualified plasterer is advised in order to complete remedial works as necessary.

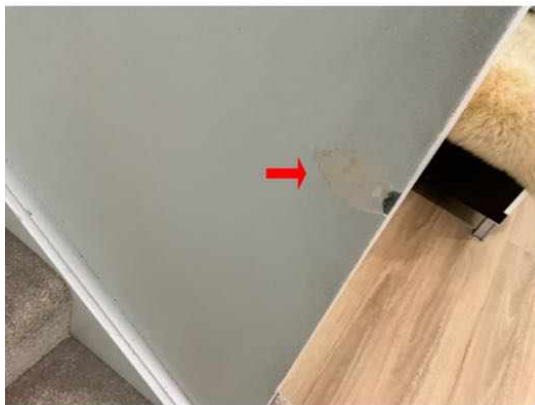
Finding 3.14

Building:	Main Building
Location:	Stairs - Internal
Finding:	Paint surface - Scratches
Information:	Scratches have been identified on the paint surface, detracting from the overall

1. Aesthetic Degradation: Scratches mar the appearance of the painted surface, diminishing its visual appeal and potentially lowering property value.
2. Corrosion Vulnerability: Exposed areas of bare metal due to scratched paint are susceptible to corrosion, leading to structural damage and compromised durability.
3. Environmental Hazards: Scratched paint can release hazardous chemicals into the environment, posing risks to both human health and the ecosystem.

A qualified painter should address the issue promptly to repair the scratched paint. Depending on the severity of the scratches, repair options may include sanding, priming, and repainting the affected area to restore the integrity and appearance of the paint surface.

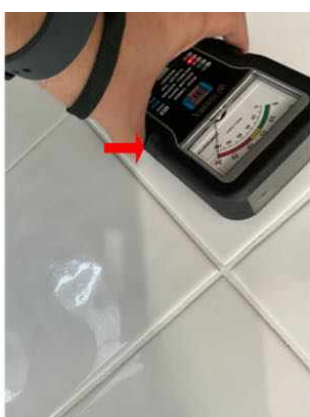
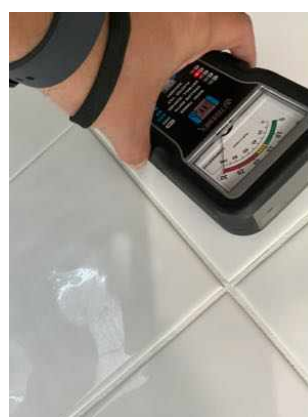
Finding 3.15

Building:	Main Building
Location:	Ensuite
Finding:	Shower - Damp
Information:	Damp is evident to the lower 300mm of wall to the shower alcove. This defect is quite common, and is suspected to have been caused by moisture permeating through the grouting in this area, which shows evidence of deterioration. Leaking pipes within the adjoining wall is also a possible cause.

Damp (or structural damp) refers to the presence of unwanted moisture in the structure of a building, either as the result of intrusion from outside, or condensation from within the structure. In the shower area, internal water leaks or other sources of excessive moisture are generally the cause of damp.

Unmanaged damp in the shower recess is likely to facilitate the formation and development of mould and fungi growth, decaying associated building materials and compromising their structural integrity. It is important to address damp conditions, as the World Health Organisation notes that excess moisture leads - on almost all indoor materials - to growth of microbes such as moulds, fungi and bacteria, which subsequently emit spores and other matter into the indoor air. Exposure to these contaminants is associated with a wide range of respiratory and other health-related problems.

Consultation with a qualified plumber or bathroom specialist is advised immediately to identify the cause of damp and to perform remedial works as required. Where excessive mould growth is present, further inspection by a specialist environmental health inspector should also be considered.

Always ensure that sealant and grout is in good condition to prevent any moisture issues occurring in the future.

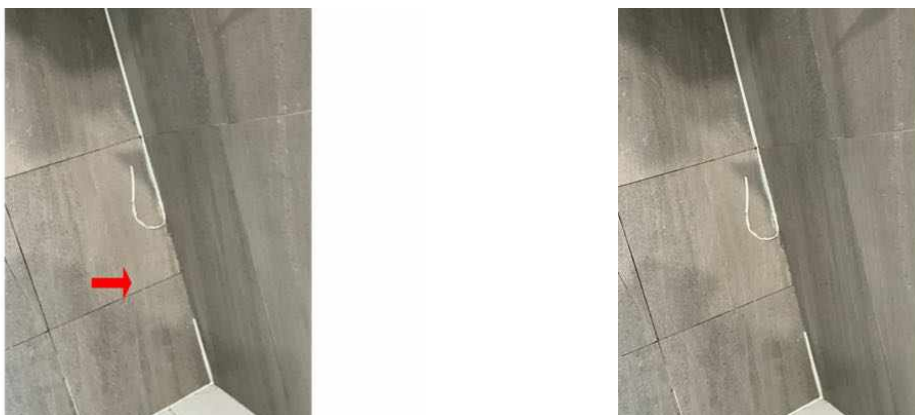
Finding 3.16

Building:	Main Building
Location:	Bathroom
Finding:	Sealant and grouting - Missing or damaged
Information:	It was noted on inspection that sealant or grout is degraded to the tiled shower alcove and or other areas of the bathroom.

Different materials and floor areas move at different rates, generally causing cracking to grout or sealant at this point. A flexible sealant is required to allow for expected expansion and contraction, while keeping the joint water tight and protective of all associated building materials.

There appears to be excessive mould to the sealant and grout which will likely require scraping out and replacement.

Flexible and mould resistant materials should be applied to affected areas to prevent any subsequent water damage that is likely to occur. Regular maintenance and replacement of damage or missing or damaged sealant and grout is highly recommended to the wet areas, as this is a regular wear and tear defect. Sealant and grouting in areas that come into regular contact with water should be maintained for the long term care of your property.

A sealant specialist or tiling contractor should be appointed to complete these works

as soon as possible

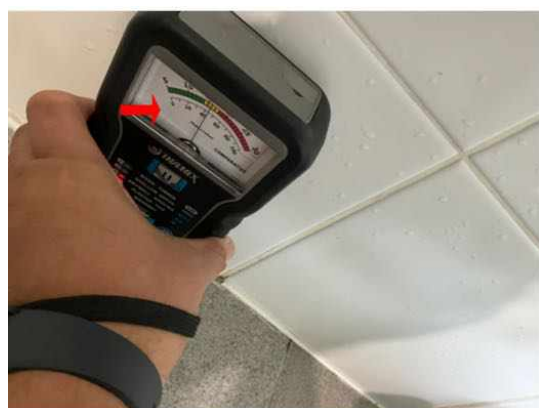
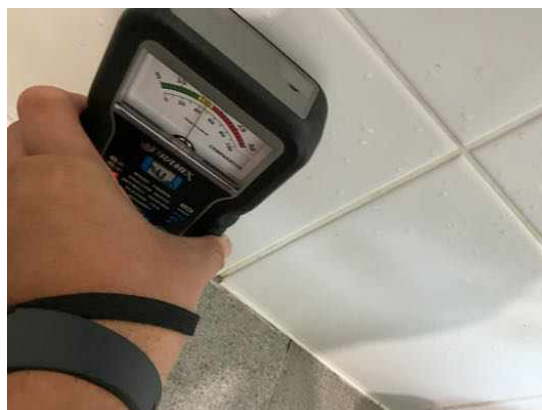
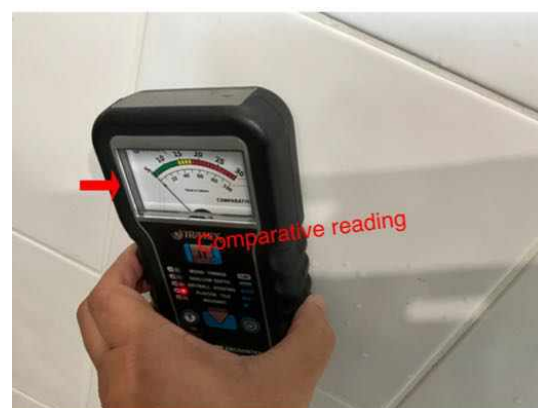
Finding 3.17

Information: Damp is evident to the lower 300mm of wall to the shower alcove. This defect is quite common, and is suspected to have been caused by moisture permeating through the grouting in this area, which shows evidence of deterioration. Leaking pipes within the adjoining wall is also a possible cause.

Damp (or structural damp) refers to the presence of unwanted moisture in the structure of a building, either as the result of intrusion from outside, or condensation from within the structure. In the shower area, internal water leaks or other sources of excessive moisture are generally the cause of damp.

Unmanaged damp in the shower recess is likely to facilitate the formation and development of mould and fungi growth, decaying associated building materials and compromising their structural integrity. It is important to address damp conditions, as the World Health Organisation notes that excess moisture leads - on almost all indoor materials - to growth of microbes such as moulds, fungi and bacteria, which subsequently emit spores and other matter into the indoor air. Exposure to these contaminants is associated with a wide range of respiratory and other health-related problems.

Consultation with a qualified plumber or bathroom specialist is advised immediately to identify the cause of damp and to perform remedial works as required. Where excessive mould growth is present, further inspection by a specialist environmental health inspector should also be considered.

Always ensure that sealant and grout is in good condition to prevent any moisture issues occurring in the future.

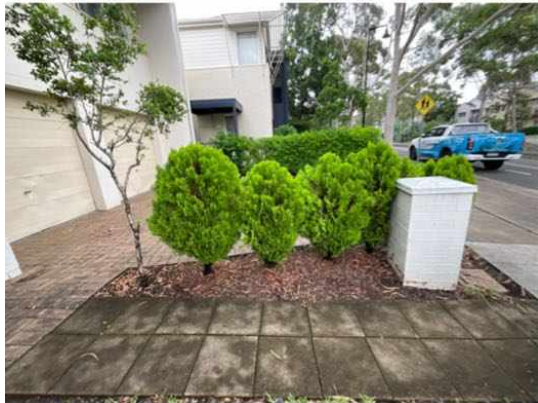
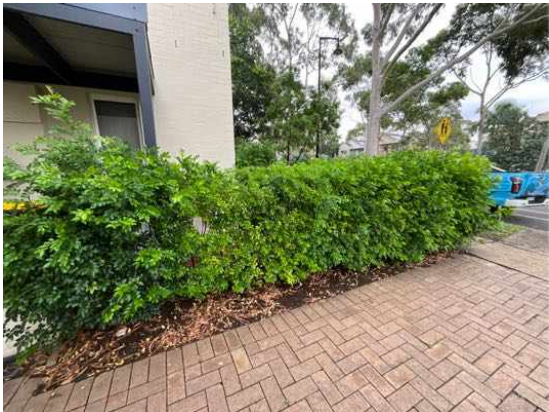
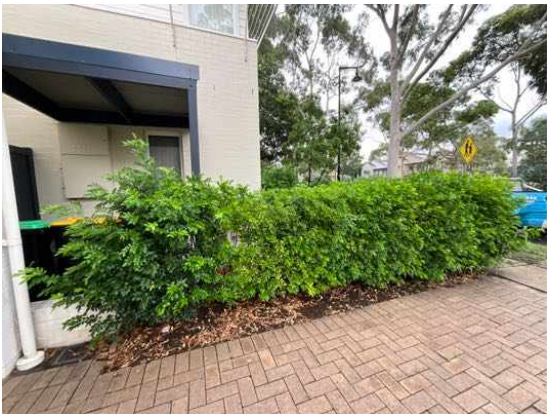
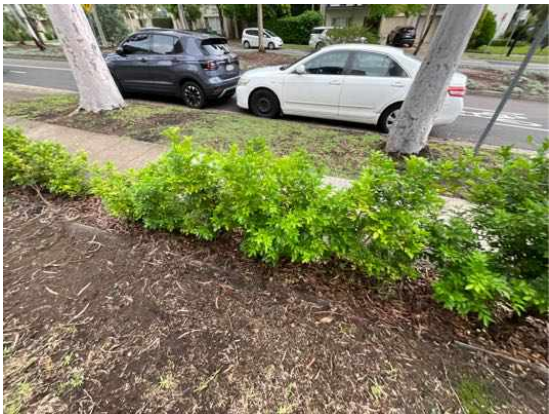
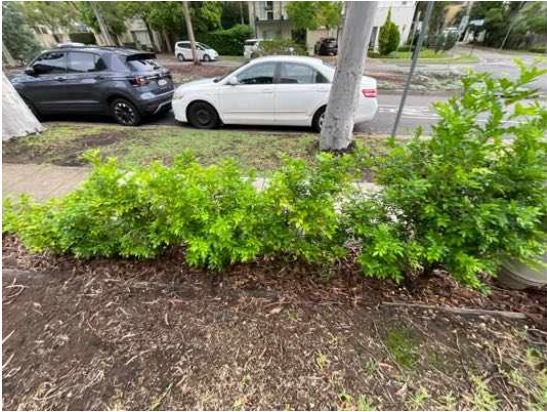
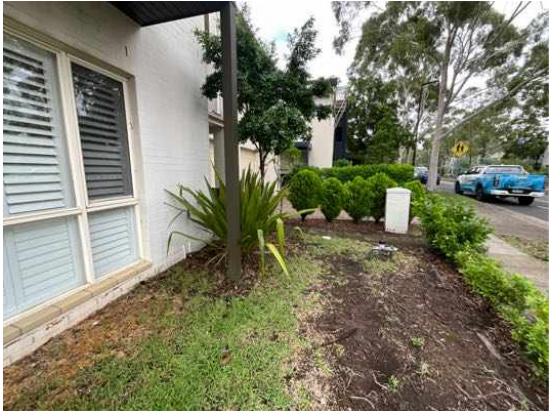
Finding 6.02

Building: Main Building
Location: All Areas
Finding: vegetation around a property can increase the risk of termite infestation
Information: The presence of vegetation around a property can increase the risk of termite infestation, as it provides a conducive environment for them. To address this, consider maintaining a clear space between the vegetation and your home. If you suspect a termite issue, it's advisable to consult with a licensed pest control professional for inspection and treatment.

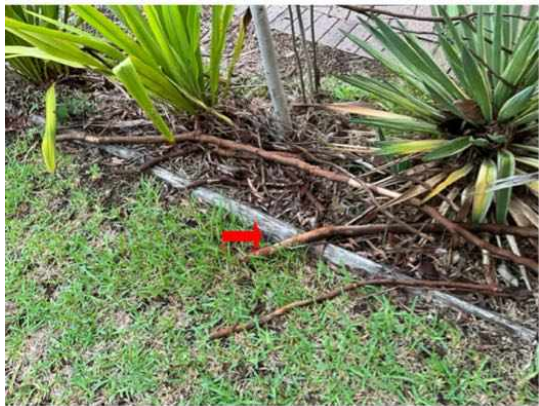
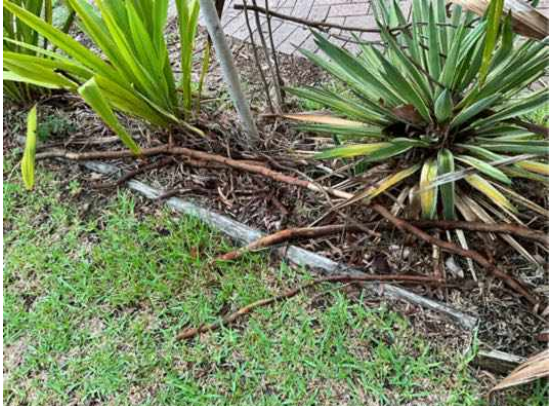
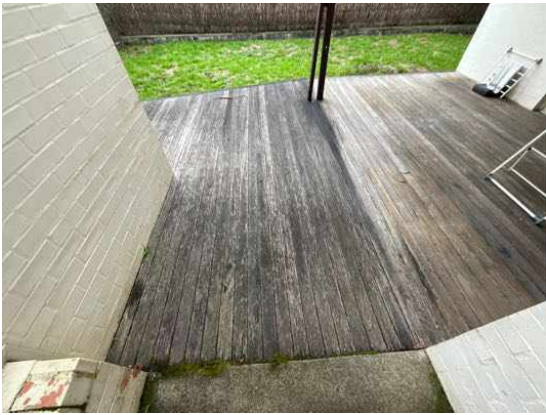
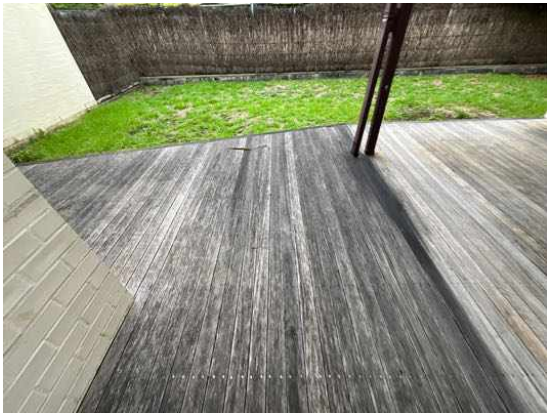
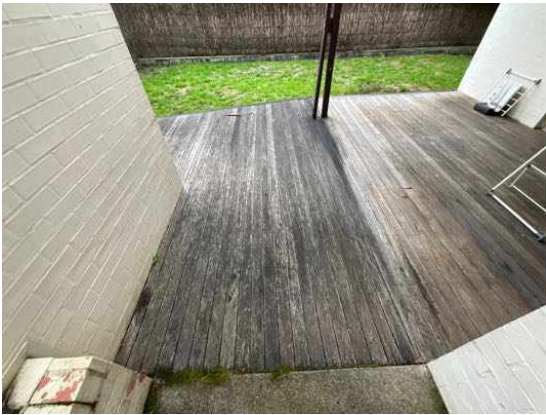
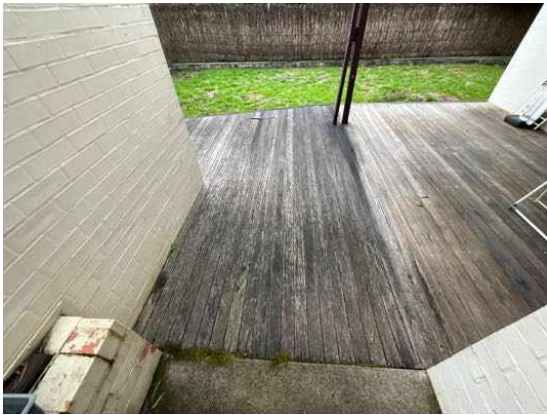
Finding 6.03

Building: Main Building
 Location: All Areas
 Finding: Timber on ground / conducive conditions to termite damage
 Information: Timber on the ground is indeed conducive to termite damage. Termites are known to thrive in moist environments, and wood in contact with soil or moisture is more susceptible to infestation.

To prevent this, it's important to keep timber elevated and away from direct ground contact. Regular inspections and proper termite control measures are also essential to protect your wooden structures from termite damage.

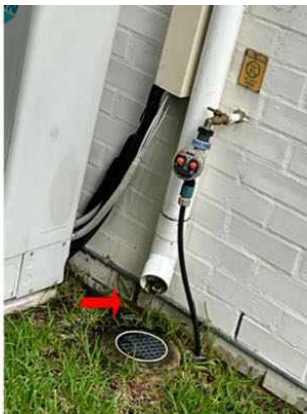
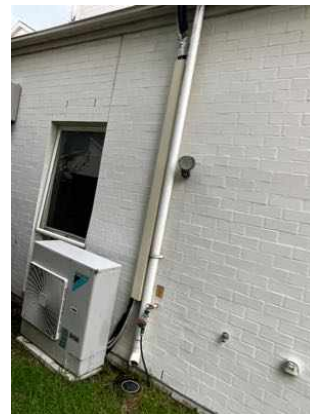
Finding 6.04

Building:	Main Building
Location:	Exterior walls - rear
Finding:	Downpipes not connected- Conducive conditions for timber pest
Information:	Unconnected downpipes can indeed pose a risk for attracting termites, as they provide a source of moisture near a building's foundation. Termites are attracted to moisture and wood, so it's important to address this issue to prevent potential infestations. Connecting downpipes to the stormwater system or ensuring proper drainage away from the building can help mitigate this a licensed plumber is the most qualified professional to handle plumbing-related tasks, including connecting downpipes to the stormwater system. They have the necessary expertise and tools to ensure proper installation.

Please remember that proper installation is essential to ensure effective drainage and prevent future issues, so it's often best to hire a qualified professional, especially for complex or extensive downpipe installations.

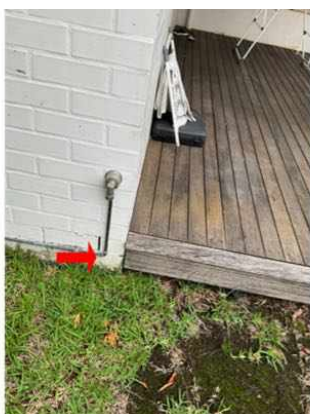
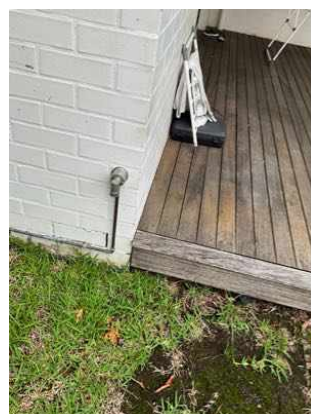
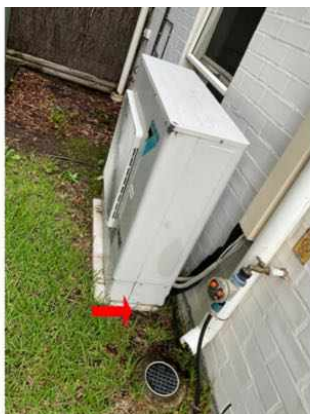
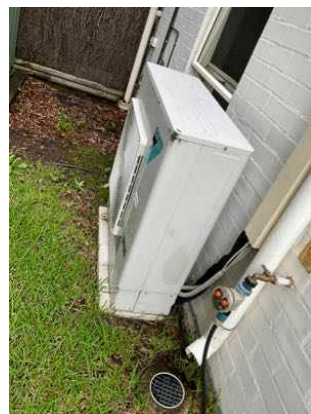
Where bridging has occurred full inspection is prevented and termites may enter a property in a concealed or undetected manner.

Recommended moving obstructions away from the external walls for further and future inspections.

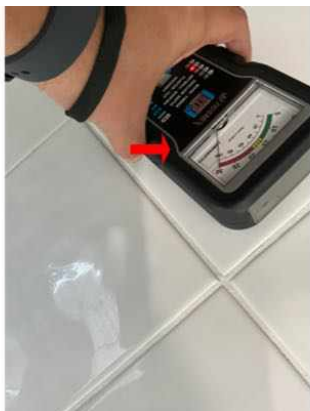
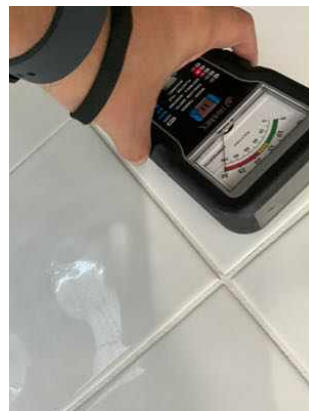
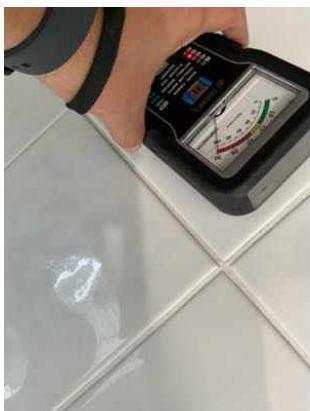
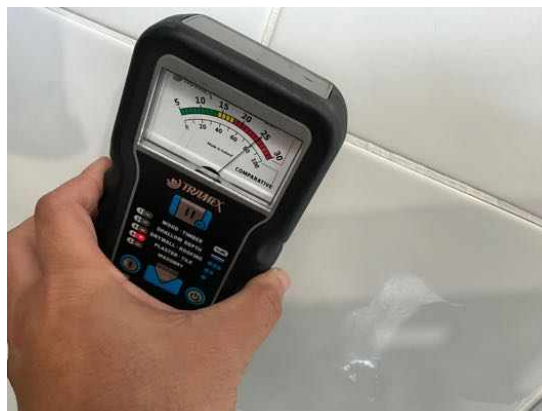
Building:	Main Building
Location:	Ensuite
Finding:	Excessive moisture - Conducive to Timber pest
Information:	Excessive moisture can attract termites and produce conditions that promote fungal growth and wood decay.

Excessive moisture is generally caused by deteriorated inadequate or missing roof drainage leaking plumbing pipes or fixtures poorly plumbed HWS overflows or condenser units and poor site drainage.

Prior to any remedial works being performed a qualified plumber should be appointed to further inspect the property and to identify the cause of the excessive moisture. Works to remove affected building elements may then be necessary and should be performed by an appropriate tradesperson.

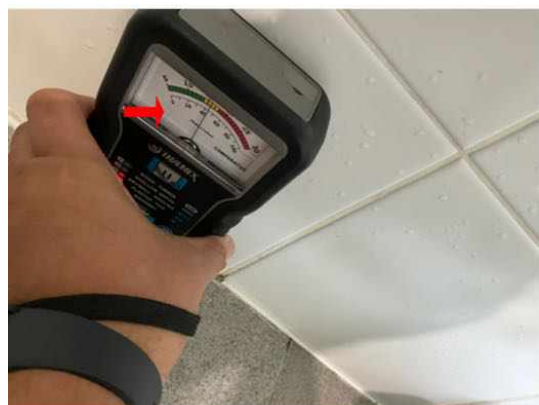
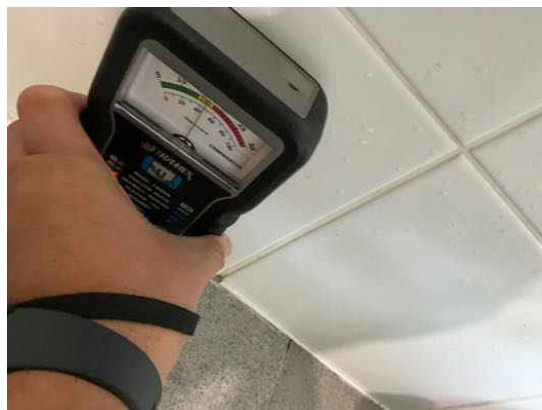
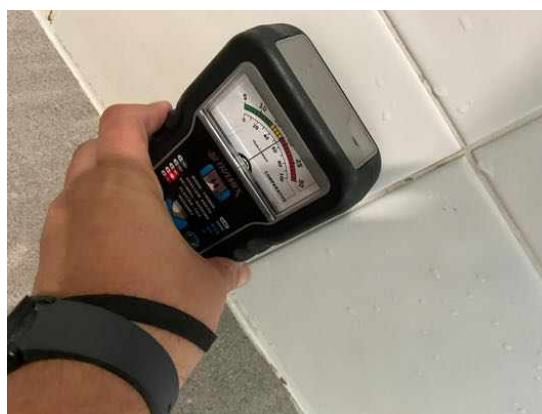
Finding 6.08

Building:	Main Building
Location:	Bathroom
Finding:	Excessive moisture - Conducive to Timber pest
Information:	Excessive moisture can attract termites and produce conditions that promote fungal growth and wood decay.

Excessive moisture is generally caused by deteriorated inadequate or missing roof drainage leaking plumbing pipes or fixtures poorly plumbed HWS overflows or condenser units and poor site drainage.

Prior to any remedial works being performed a qualified plumber should be appointed

to further inspect the property and to identify the cause of the excessive moisture. Works to remove affected building elements may then be necessary and should be performed by an appropriate tradesperson.

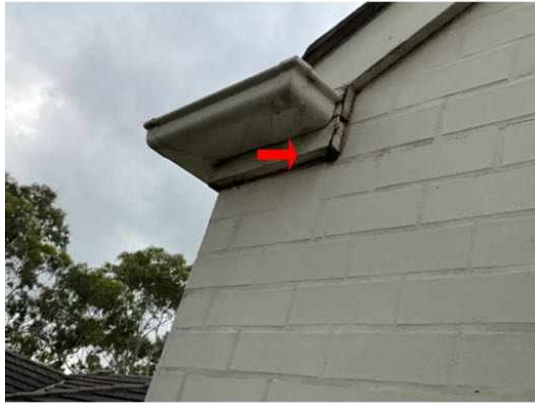
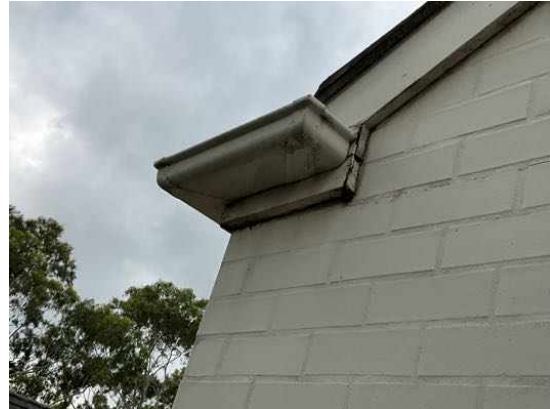
Finding 7.01

Building:	Main Building
Location:	All Areas
Finding:	Wood rot
Information:	This building element shows evidence of wood rot. Wood rot, also known as Fungal Decay, occurs when timbers and other cellulose building materials are exposed to damp conditions on an ongoing basis. This could be the result of exposure to weathering over a prolonged period of time, or the attraction of excessive moisture from other abutting building materials. Contributing factors also include poor air ventilation in the area.

Wood rot is often associated with general damp problems and is evidenced by a 'musty' smell or mould and mildew occurring on surfaces. If left unmanaged, damp conditions can lead to further health problems and the decay of timbers will continue.

Early intervention and regular maintenance, particularly of exterior timbers, will prolong the useful life of these building elements. Prior to any works being performed, the cause of the moisture that has created the visible wood rot should be identified and addressed in a suitable manner. Replacement of affected timbers may then be a necessary step in protecting surrounding building elements from such deterioration.

A qualified plumber may be appointed to assess the cause of excessive moisture and to provide advice on any remedial works as required. A qualified carpenter or registered builder may also be required to replace affected building materials.

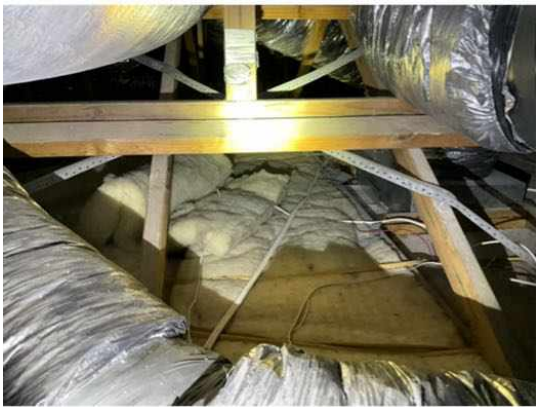
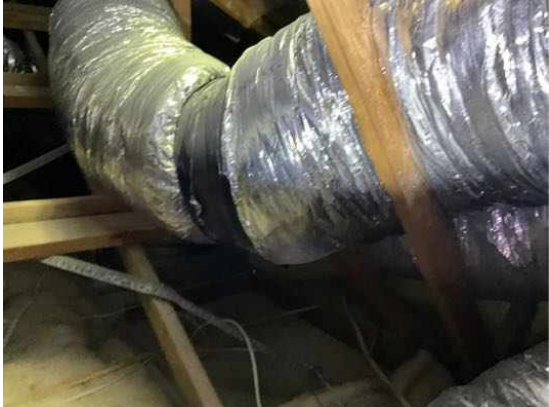
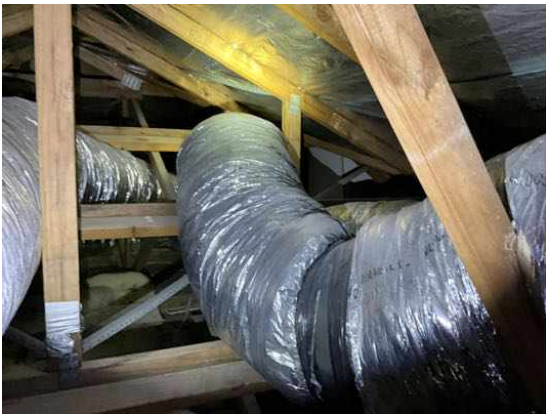
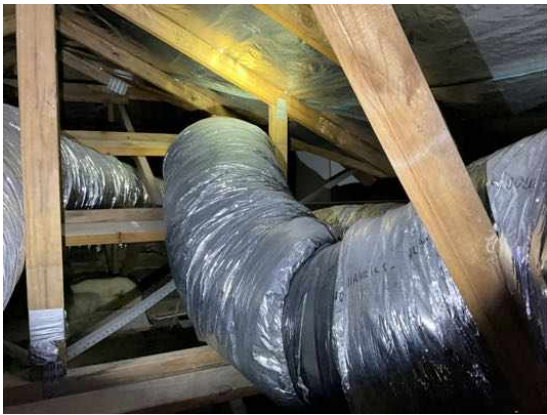
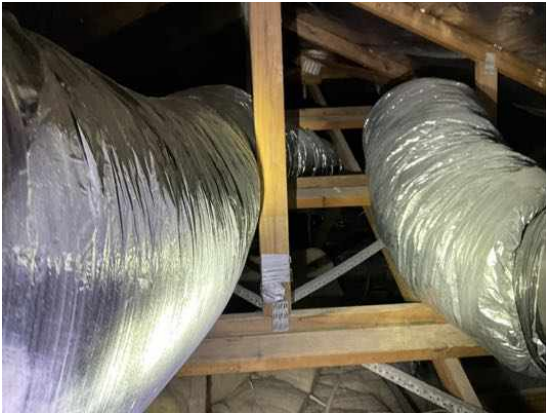
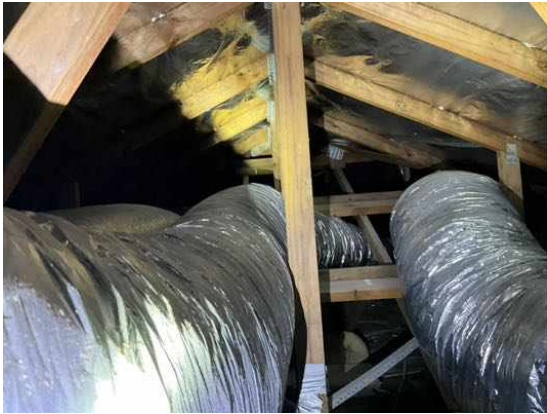
Building: Main Building
Location: All Areas
Finding: Additional Photos - Obstructions and Limitations
Information: These photographs are an indication of the obstructions and limitations which impeded full inspection of the property at the time of inspection. These obstructions can hide an array of defects and should be removed to allow full inspection to be carried out. A re-inspection is recommended once the areas are made accessible.
