Building and Timber Pest Inspection Report

Inspection Date: Thu, 5 Mar 2026

Property Address: 53 Newington Blvd, Newington NSW 2127,
Australia

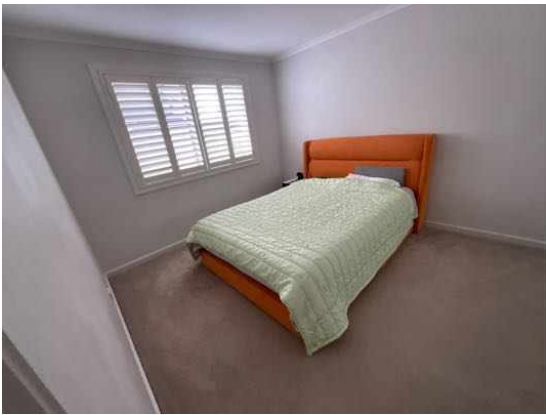
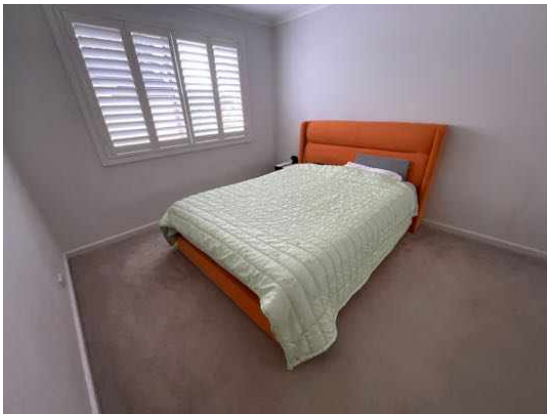
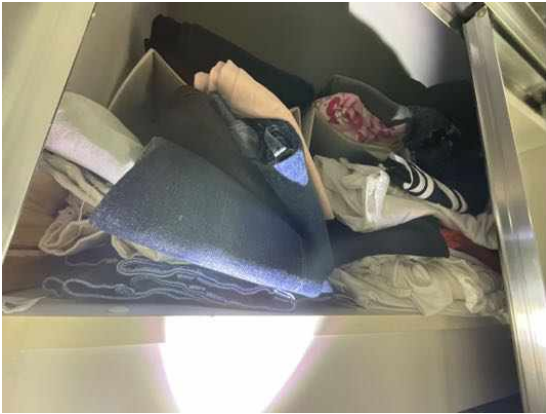
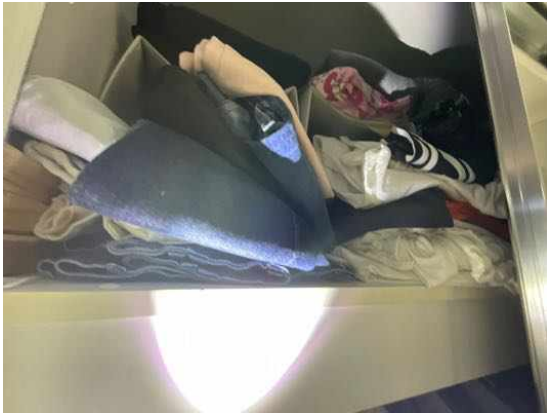
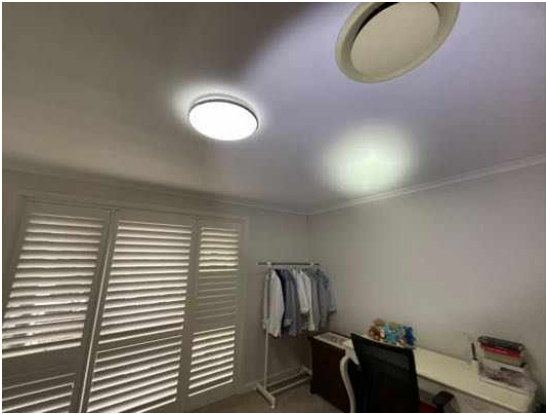
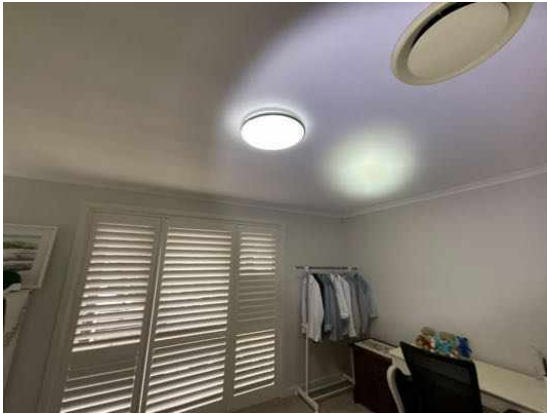
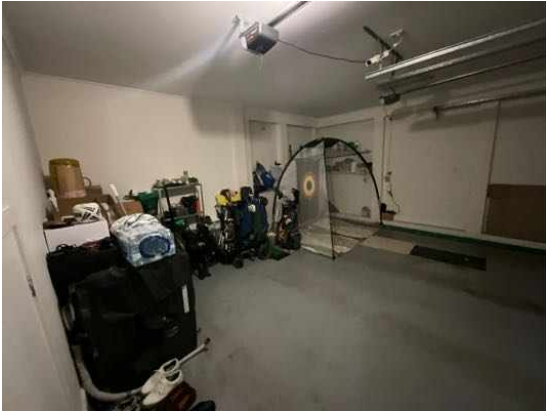
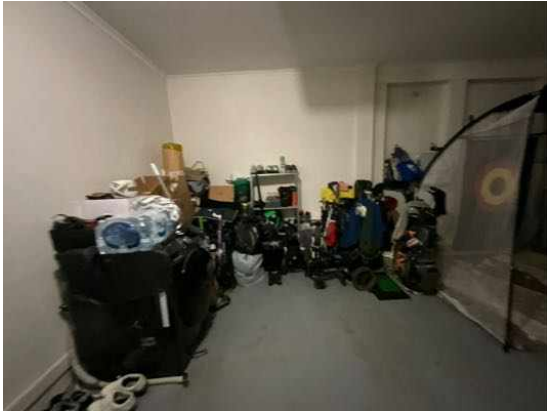
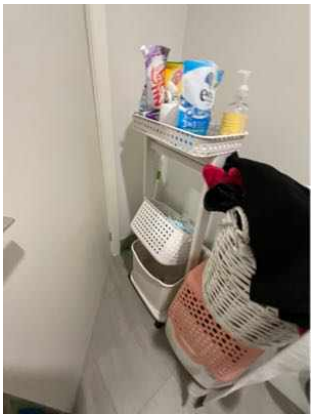
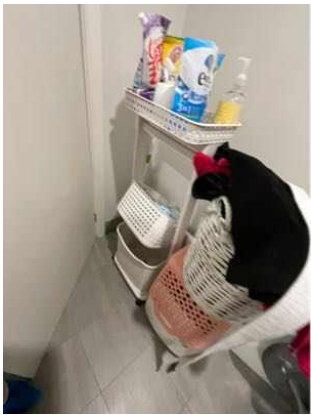
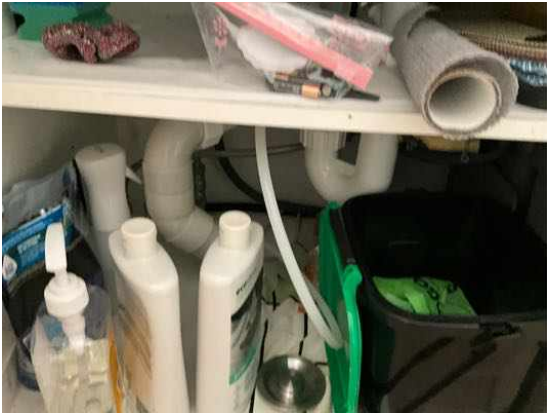
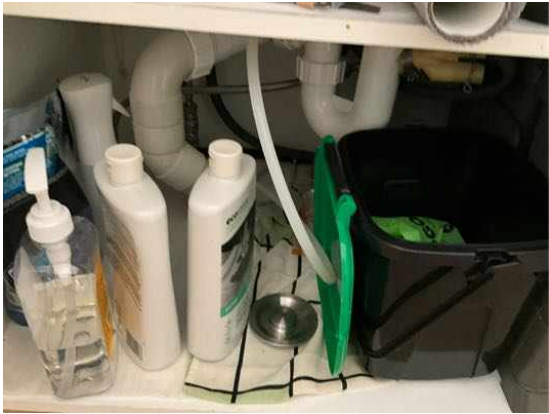
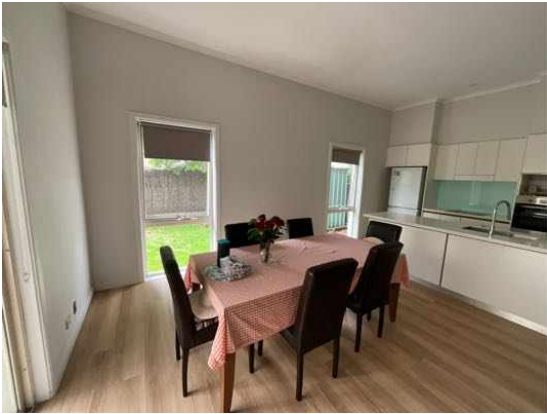
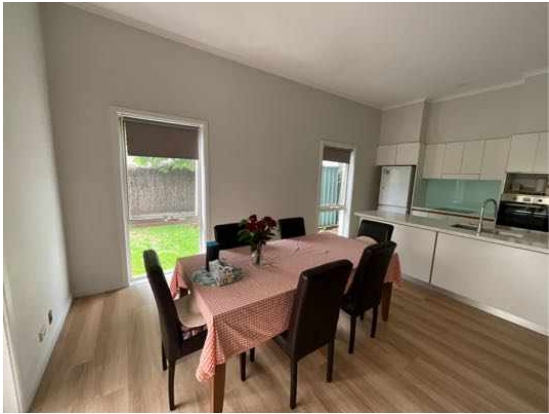
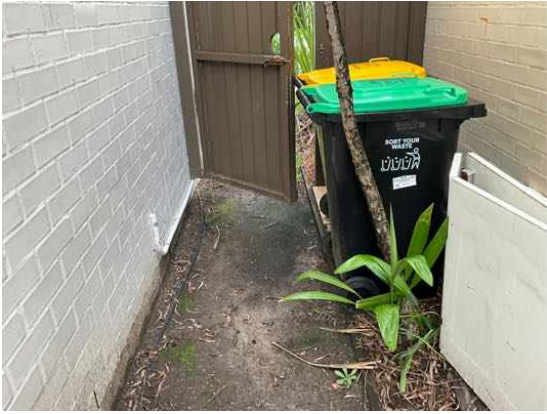
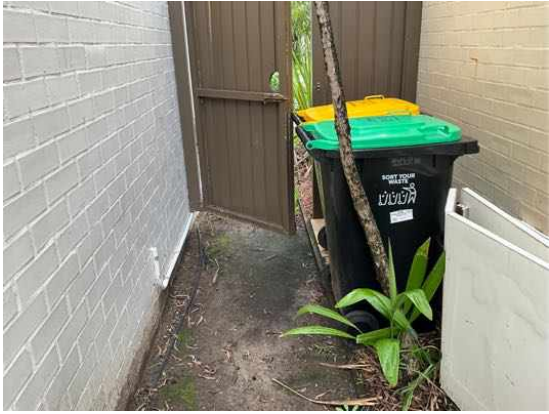
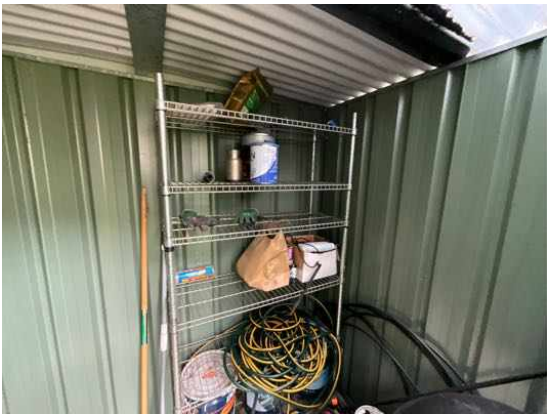
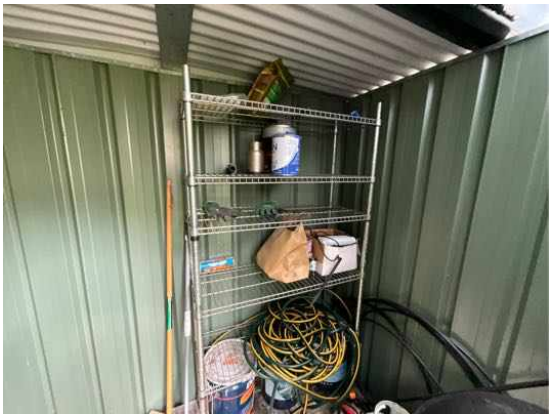
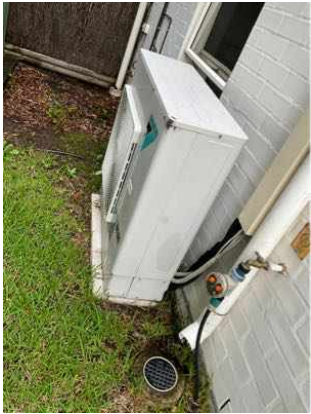
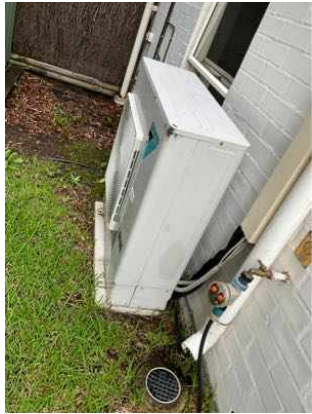
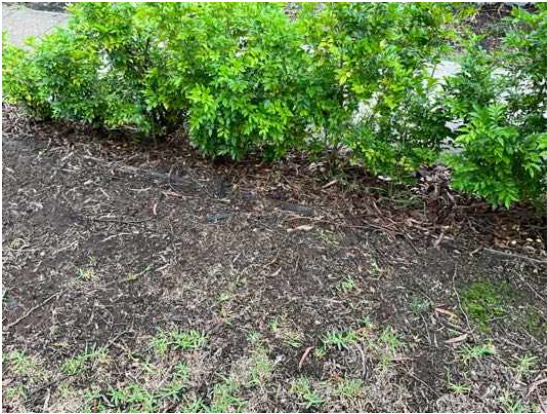
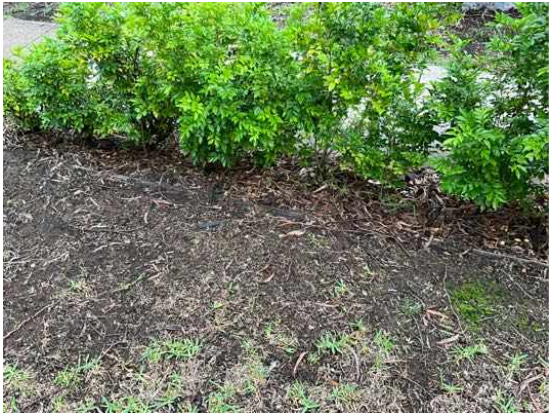
Building: Main Building
Location: All Areas
Finding: Additional Photos - Obstructions and Limitations
Information: These photographs are an indication of the obstructions and limitations which impeded full inspection of the property at the time of inspection. These obstructions can hide an array of defects and should be removed to allow full inspection to be carried out. A re-inspection is recommended once the areas are made accessible.

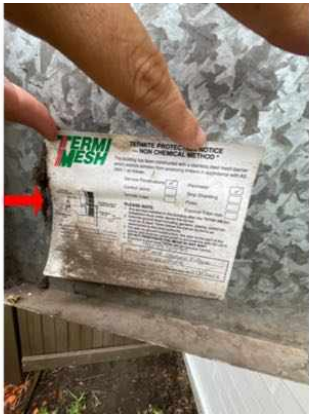
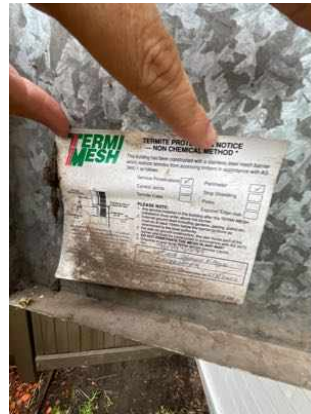
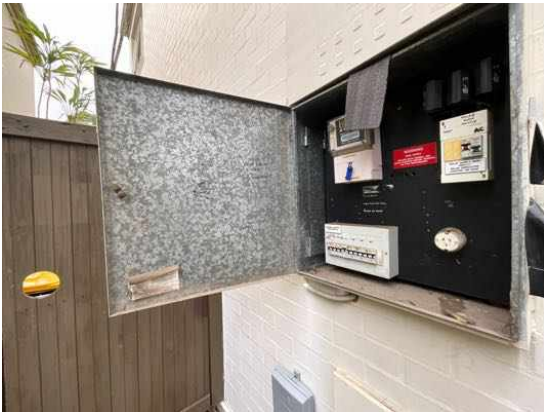
- Building: Main Building
- Location: Exterior walls - left side
- Finding: Evidence of Termite Management System - Durable notice / Legible Sticker - seek further information
- Information: The application of a pre & post-construction chemical termite barrier is highly recommended for all properties. Such barriers are highly effective in preventing termite

A durable notice placed in the switchboard unit to indicate termite barriers at the time of inspection.

Client must seek further information from the vendor or real estate agent if the conditions of termite management systems were maintained as per the label or seek advise from licensed pest controller.
