# Building and Timber Pest Inspection Report

Inspection Date: Fri, 6 Mar 2026

Property Address: 703/16-20 Smallwood Ave, Homebush NSW  
2140, Australia

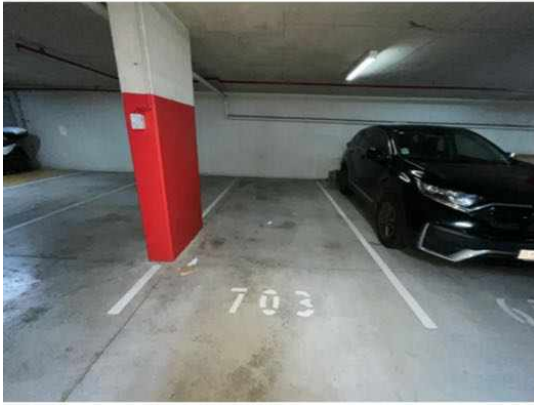
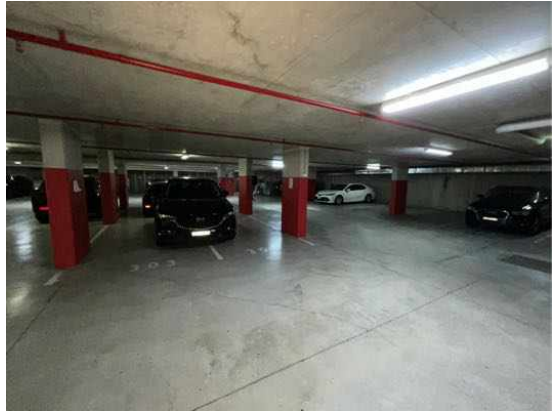
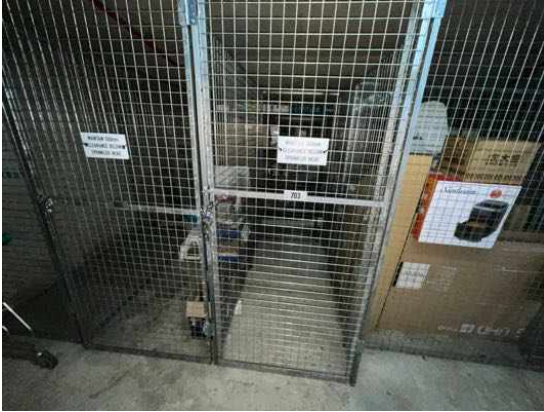
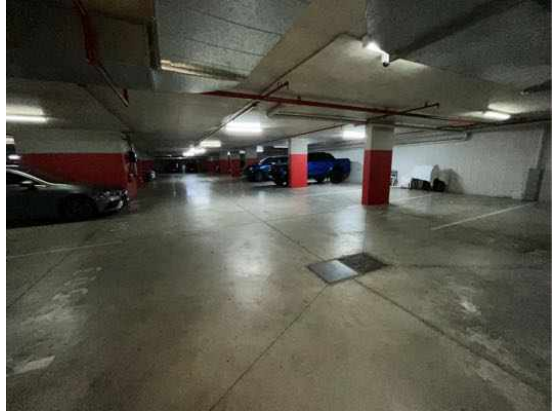
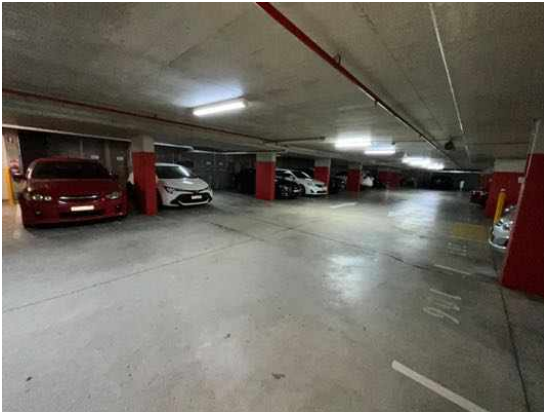
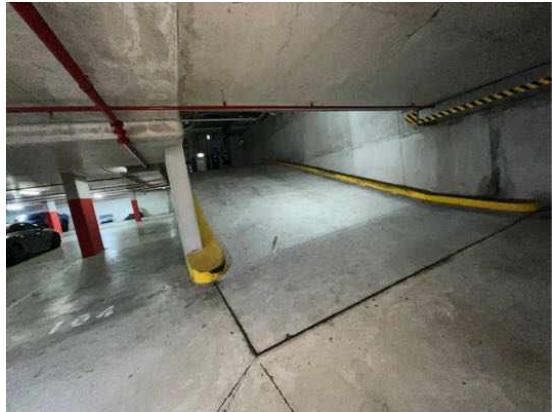
Building:	Main Building
Location:	Garage
Finding:	Additional Photos- Garage
Information:	Additional photos are provided for your general reference. Arrows may have been included to highlight areas of importance. Please discuss these photos with your building consultant for clarification.

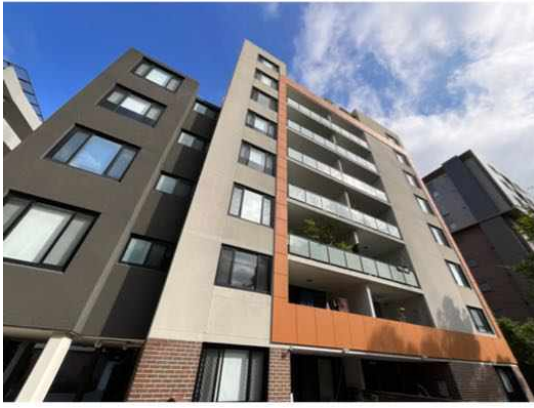
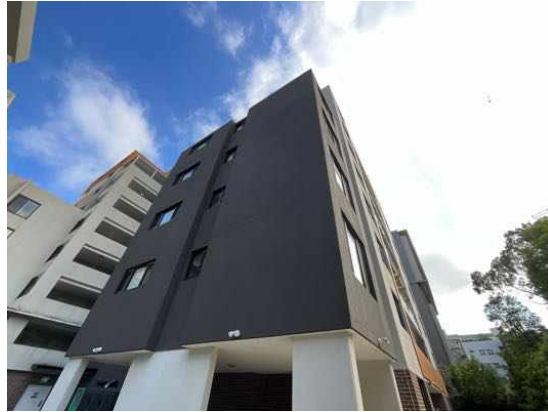
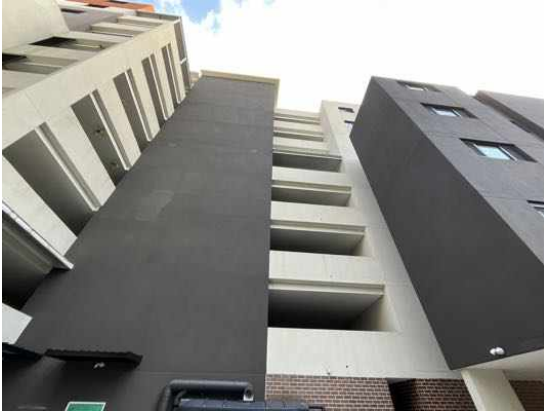
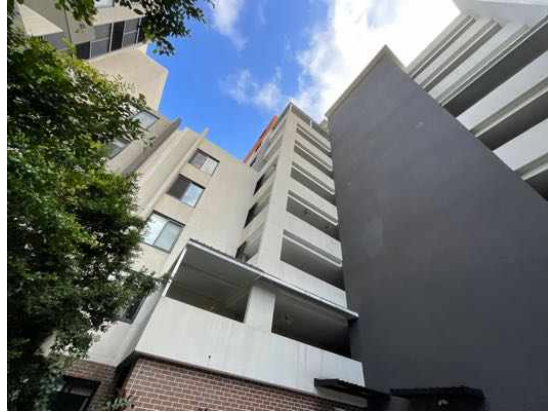
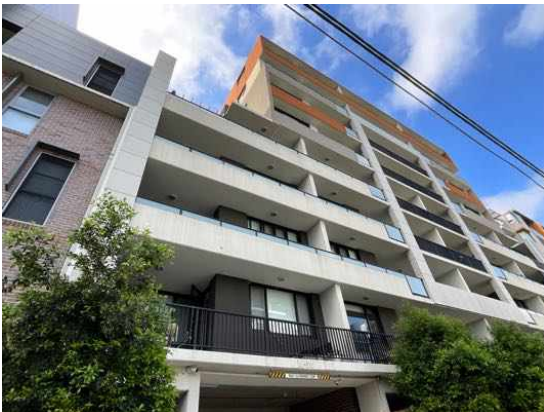
Building: Main Building  
Location: Exterior  
Finding: Additional Photos  
Information:

Additional photos are provided for your general reference.
