Building and Timber Pest Inspection Report

Inspection Date: Fri, 6 Mar 2026

Property Address: 12 Riverwood Dr, Botanic Ridge VIC 3977,
Australia

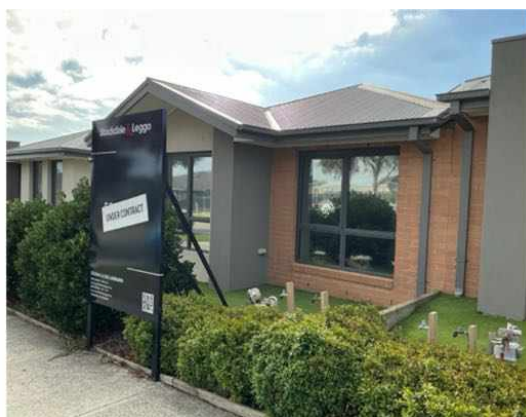
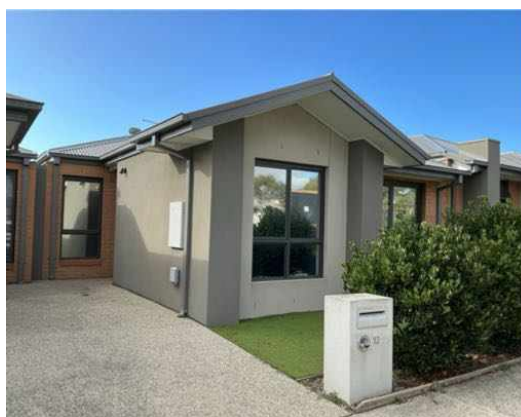
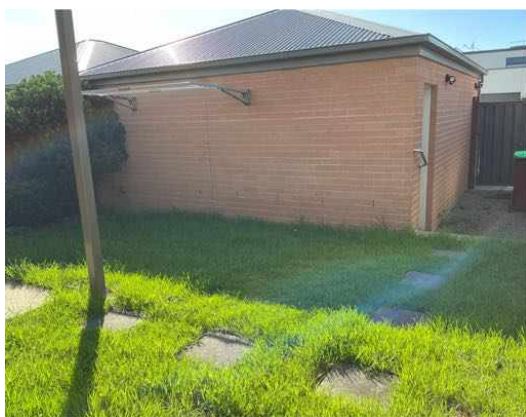
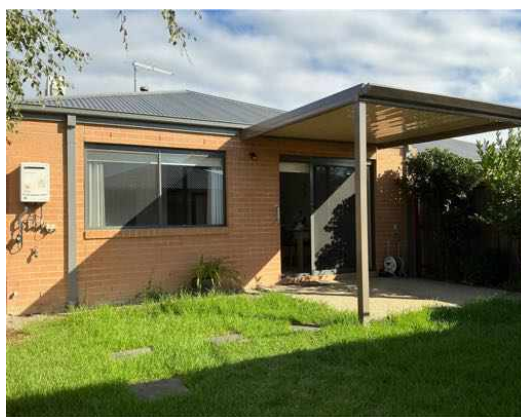
Building:	Main Building
Location:	All External Areas
Finding:	Additional Photos - Obstructions and Limitations
Information:	These photographs are an indication of the obstructions and limitations which impeded full inspection of the property at the time of inspection. These obstructions can hide an array of defects and should be removed to allow full inspection to be carried out. A re-inspection is recommended once the areas are made accessible.

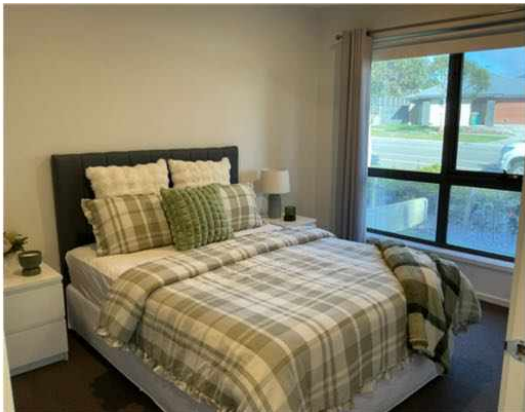
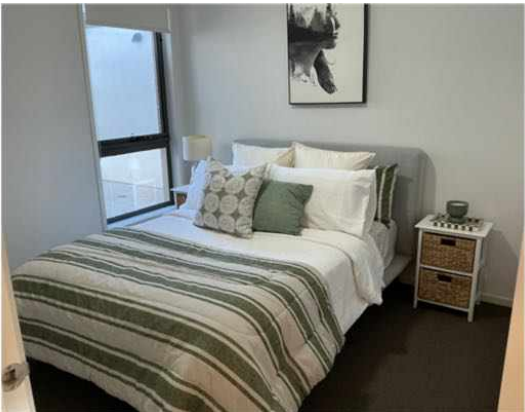
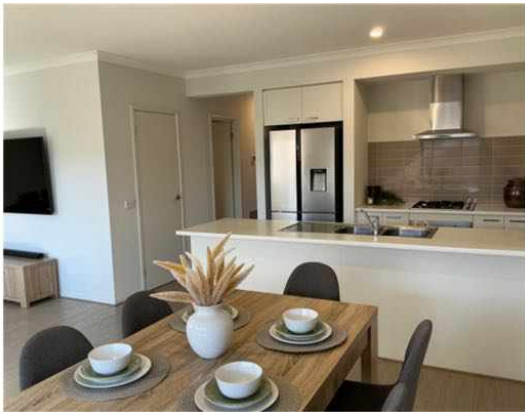
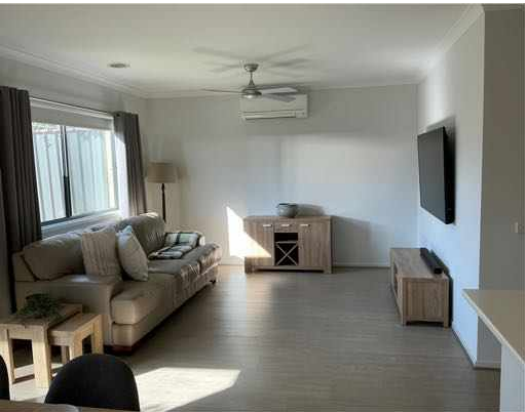
Building:	Main Building
Location:	All Internal Areas
Finding:	Additional Photos - Obstructions and Limitations
Information:	These photographs are an indication of the obstructions and limitations which impeded full inspection of the property at the time of inspection. These obstructions can hide an array of defects and should be removed to allow full inspection to be

carried out. A re-inspection is recommended once the areas are made accessible.

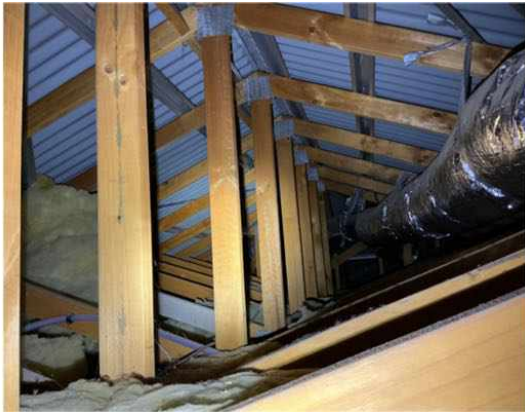
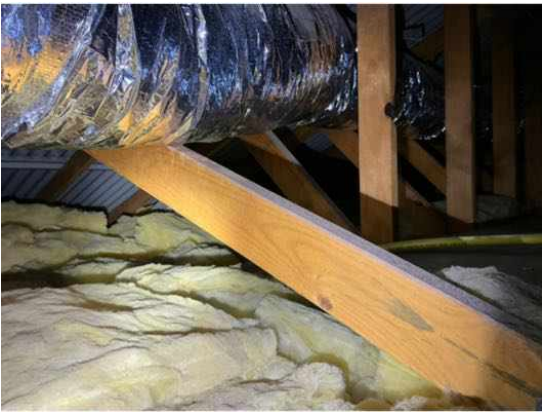
Building: Main Building
Location: Roof Void
Finding: Obstructions and Limitations -roof cavity
Information: These photographs are an indication of the obstructions and limitations which impeded full inspection of the roof cavity at the time of inspection. These obstructions can hide an array of defects and should be removed to allow full inspection to be carried out. A re-inspection is recommended once the areas are made accessible.
