Building and Timber Pest Inspection Report

Inspection Date: Mon, 2 Mar 2026

Property Address: 24 Carroll St, North Melbourne VIC 3051,
Australia

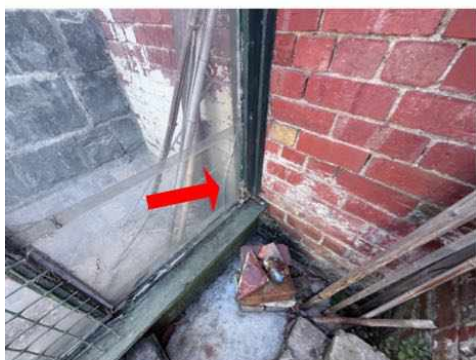
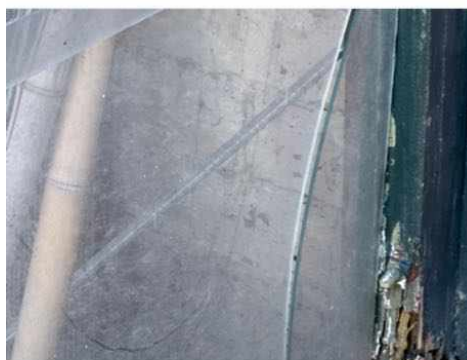
Building:	Main Building
Location:	Yard - Back
Finding:	Cracked Glass
Information:	There appears to be a window which is cracked or was accidentally damaged.

Broken glass creates a potential safety hazard in the area. Care must be taken by anyone working site or using the space in its vicinity until its replaced by a glazier or a building maintenance provider.

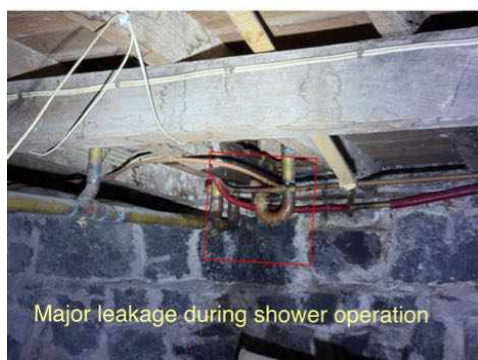
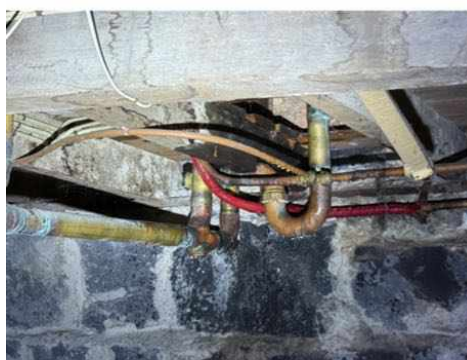
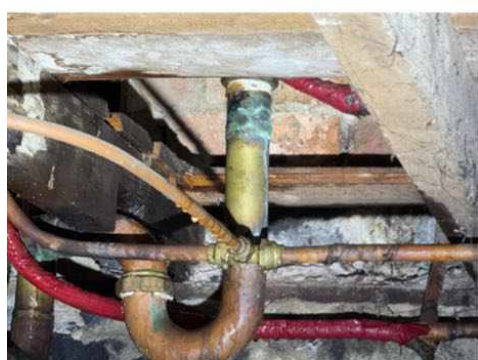
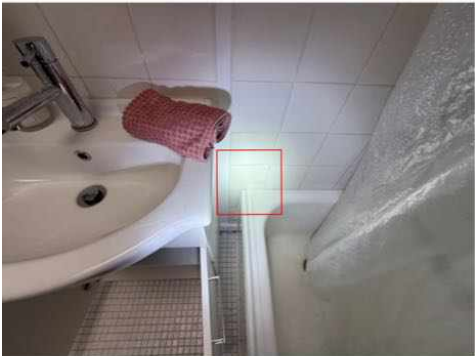
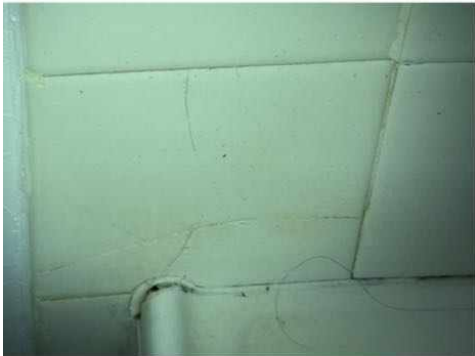
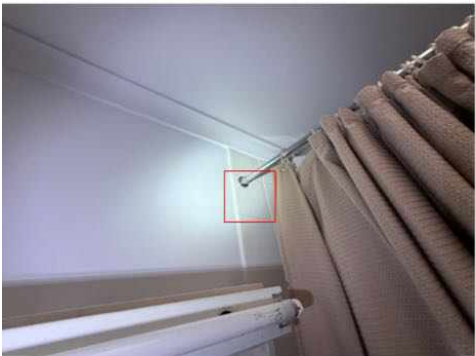
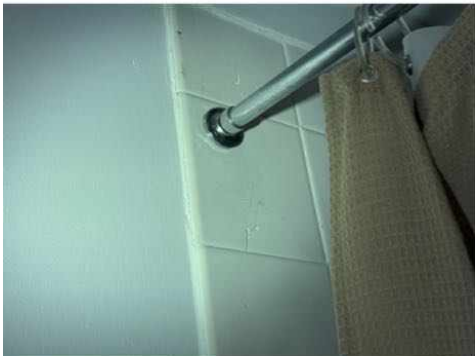
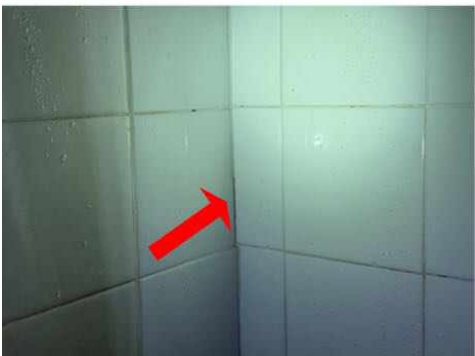
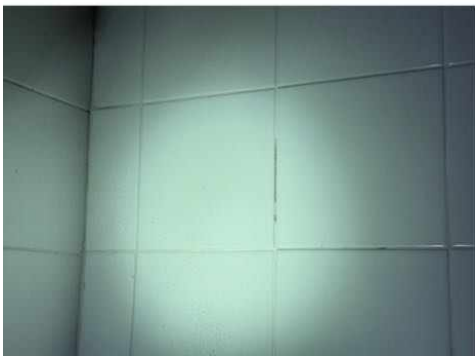
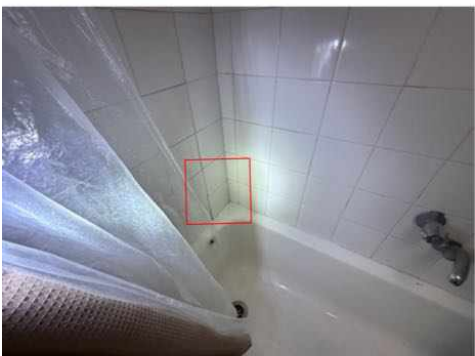
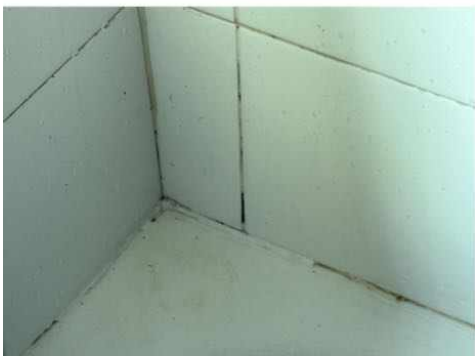
Finding 2.01

Building:	Main Building
Location:	Bathroom/ subfloor
Finding:	Bathroom Waterproofing Failure & Active Subfloor Leakage
Information:	Significant defects were observed within the bathroom shower enclosure and the associated subfloor area. Internally, visible cracking to multiple shower wall tiles and junctions was noted, along with deteriorated and missing grout to vertical and horizontal joints. These defects compromise the integrity of the tiled surface and allow water ingress behind the wall lining. Gaps at wall junctions and failed sealant indicate the waterproofing system is likely breached.

Subfloor inspection revealed extensive and active moisture ingress beneath the bathroom. Water staining, damp masonry, and wet timbers were observed directly below the shower area. Importantly, moisture was not limited to the waste/drain location; active dripping and dampness appear to be tracking from wall areas, raising

concerns of a leaking supply line and/or concealed plumbing within the wall cavity. Pipework showed signs of prolonged moisture exposure, and surrounding structural timbers are at risk of ongoing saturation.

The extent of moisture present indicates a long-standing leak rather than minor seepage. Continued exposure of subfloor framing to elevated moisture levels may result in timber decay, reduced structural capacity, fungal growth, and increased risk of termite activity due to persistently damp conditions.

Urgent rectification is recommended. A licensed plumber should be engaged immediately to pressure test supply lines, inspect concealed pipework, and identify all active leak sources. Following plumbing repairs, a full bathroom strip-out and replacement of the waterproofing membrane system in accordance with current standards is likely required. Affected subfloor timbers should be assessed for structural integrity and replaced where deterioration is identified. Prompt action is necessary to prevent further structural damage.

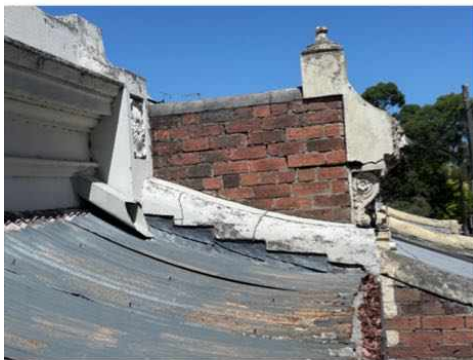
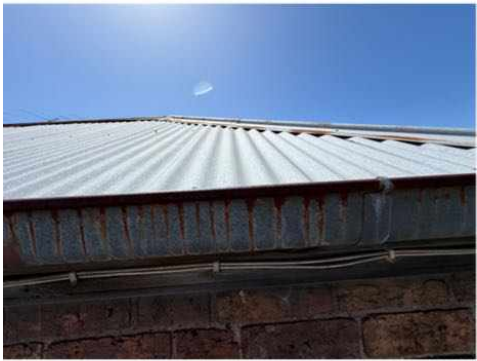
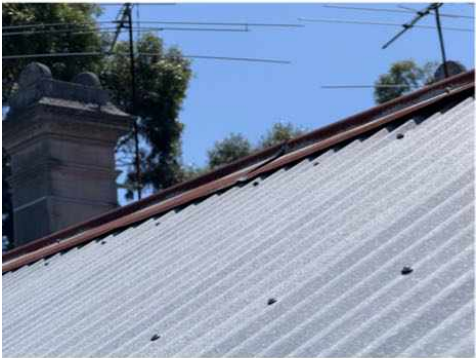
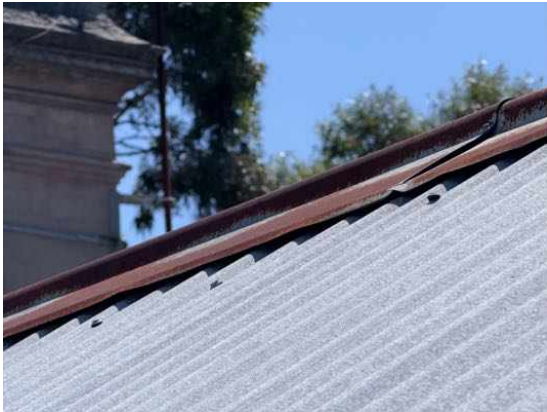
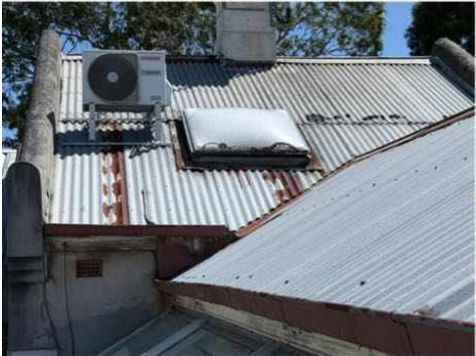
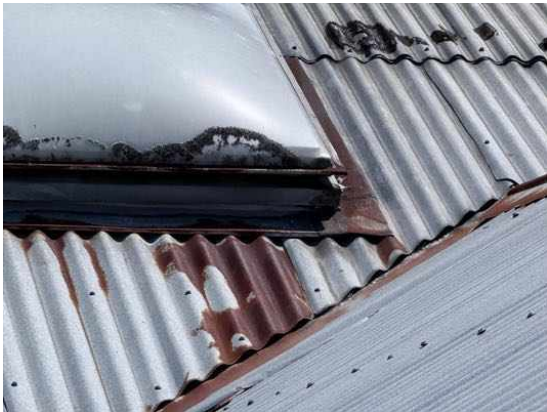
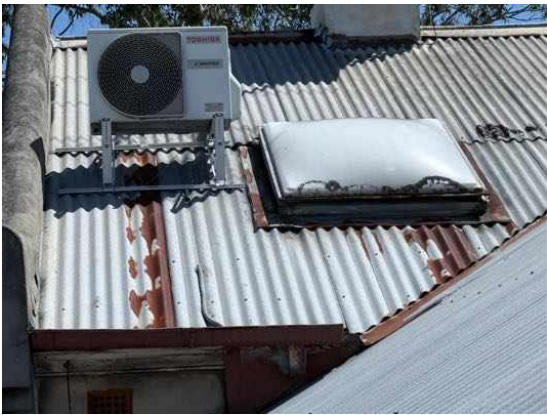
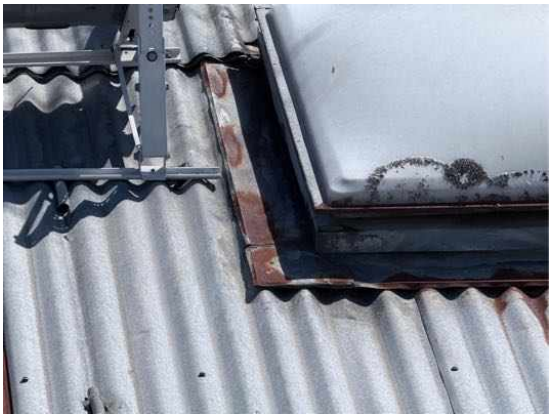
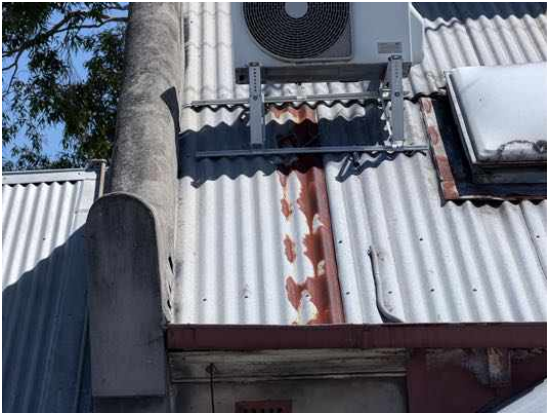
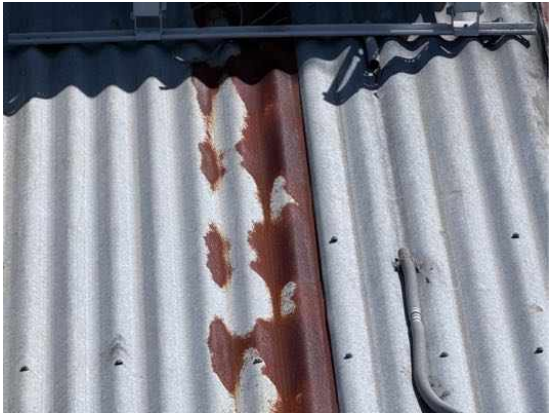
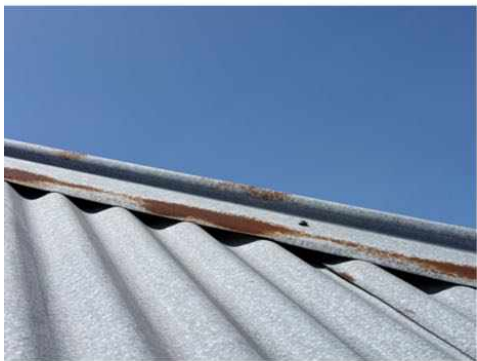
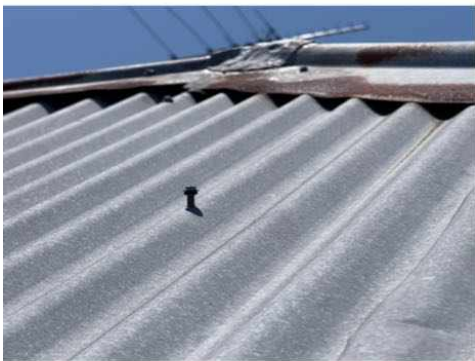
Finding 2.02

Building:	Main Building
Location:	Roof Exterior
Finding:	Roofing, Flashings & Gutters (Advanced Corrosion- moderate to major)
Information:	The metal roof sheeting, associated flashings, ridge/valley cappings and perimeter gutters exhibit widespread surface corrosion and localised advanced rusting at multiple locations. In several areas, protective coatings have deteriorated, with visible oxidation and rust tracking evident along laps, fixings and sheet junctions. The corrosion appears progressive in nature and, if left unaddressed, may result in sections becoming wafer-thin, particularly to flashings and guttering components which are more susceptible to water retention and accelerated decay.

Although no active internal leakage was detected at the time of inspection, the current condition presents an elevated risk of future water ingress. It is also noted that ceilings have been recently painted, which may temporarily obscure historical staining or minor seepage. Given the age and visible deterioration of the metal elements, performance reliability cannot be assured.

Rectification is recommended in the short to medium term. A licensed roofing contractor should undertake a comprehensive assessment to determine the extent of metal thinning, treat or replace affected sections (including flashings and gutters), and ensure all junctions and penetrations are adequately sealed to mitigate the risk of water ingress and consequential internal damage.

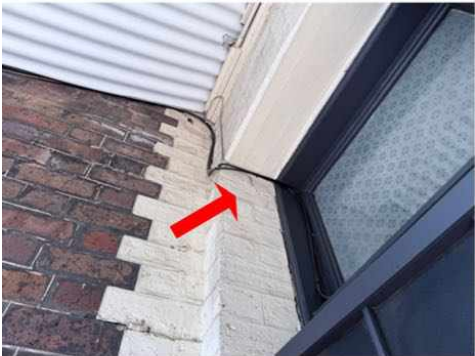
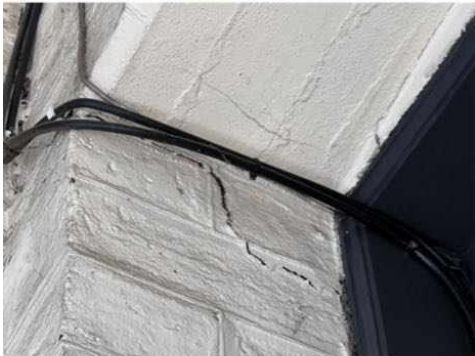
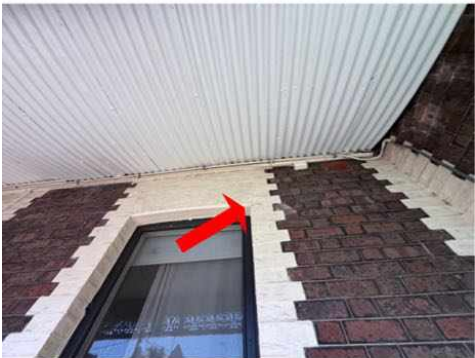
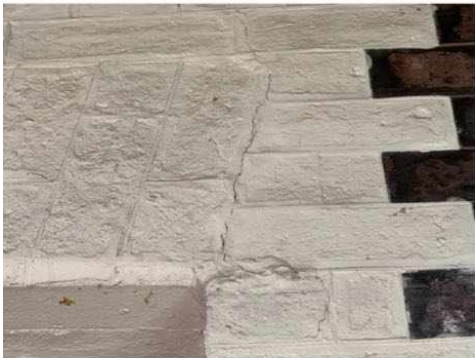
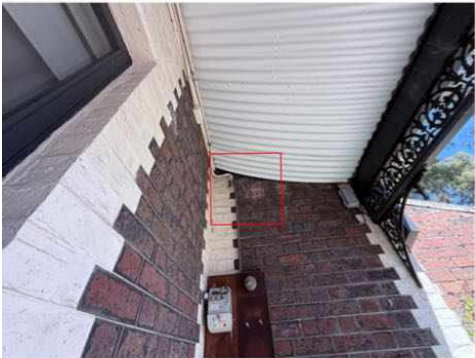
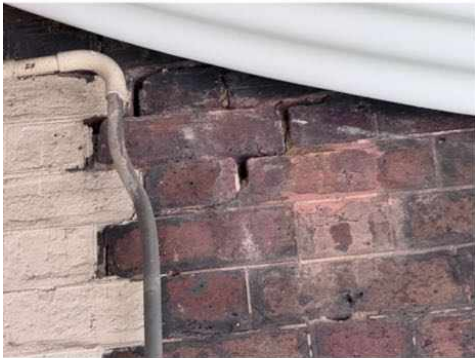
Finding 3.01

Building: Main Building
Location: All External Areas
Finding: Brickwork - Step cracking (moderate to major)
Information: Step cracking was identified to the brickwork in this area at the time of inspection. Step cracking, which is similar to other forms of cracking, has a variety of possible causes. However, the most common is the subsidence of adjacent footings.

Step cracking is a relatively common defect, and is most likely to occur adjacent to windows, doors and other openings. Mortar failure in the gaps between affected bricks indicates the stresses and tensions affecting the wall. While most of the cracks were found to be minor to moderate. A couple of the cracks were found to be significant/major.

Where step cracking is extensive or severe, the client is advised to consult a structural engineer. Minor step cracking can be used as a warning sign to address factors causing stress to the wall, which can include the effect of surrounding trees, water leaks, soil erosion, or even the presence of reactive soils in the surrounding area.

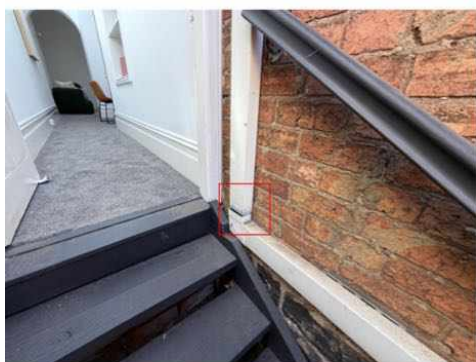
Finding 3.02

Building:	Main Building
Location:	Exterior walls - rear
Finding:	Overflow - Not plumbed for drainage adequately
Information:	The overflow is not plumbed or connected to suitable drainage, which has resulted in the surrounding area becoming excessively damp. These damp conditions can lead to secondary defects such as rot, rust or corrosion of associated building elements, the formation of fungal decay, or even the creation of potential slip hazards. When coupled with poor site drainage, pooling of water may also attract termite activity to this area. It is highly recommended that a qualified plumber be appointed to install adequate drainage to the overflow. These works will ensure that the area remains dry and free of any secondary defects.

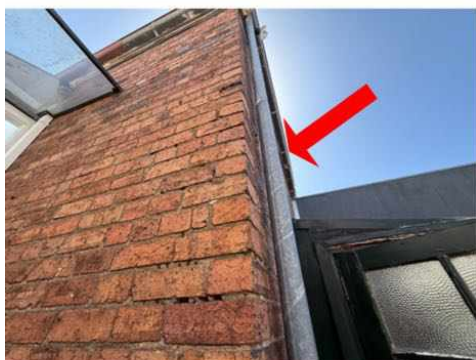
Finding 3.03

Building:	Main Building
Location:	Exterior walls - rear
Finding:	Pipework - Not clipped off
Information:	Plumbing pipes in this area have not been correctly clipped off (secured) to the adjoining structure. Where pipes have not been clipped off, they are more susceptible to impact damage and moisture damage, particularly if they are in direct contact with the ground.

A qualified plumber should be appointed immediately to provide adequate clipping for the plumbing pipes. Failure to do so may necessitate repair works to affected plumbing pipes, which may be a costly exercise.

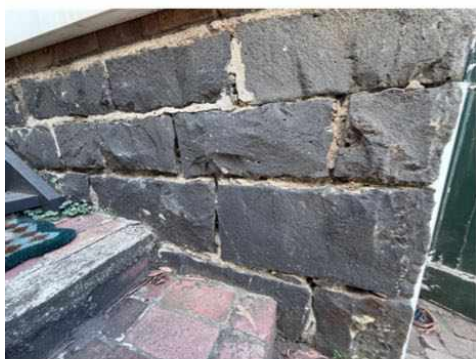
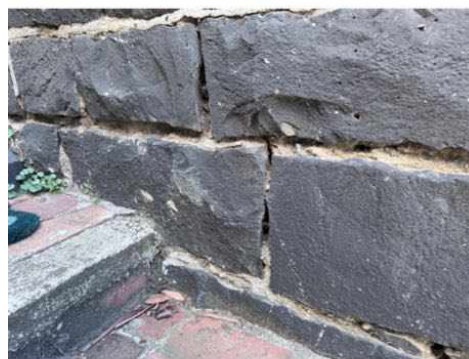
Finding 3.04

Building:	Main Building
Location:	Some External Areas
Finding:	Deteriorated mortar
Information:	Mortar, or 'bedding', is the material which fills joints and intersections between bricks in masonry walls and structures. Sections of mortar in this brickwork were identified as having deteriorated, which is generally expected for a property of this age and condition.

Mortar may deteriorate as a result of age of building materials, minor movement of bricks, or frequent exposure to weathering. Mortar should be replaced to ensure that bricks remain in their intended location and to prevent gaps, which would allow water or moisture ingress and secondary damage as a result.

Mortar deterioration can be addressed by a bricklayer where areas of deterioration are localised and easily accessible. Alternatively, appointment of a registered builder is advised, to repoint large areas of decaying mortar. Where secondary structural defects have become evident, consultation with a structural engineer may be required.

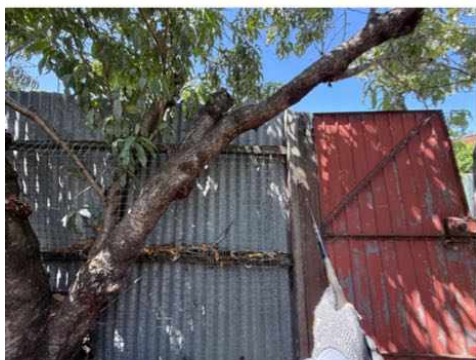
Finding 3.05

Building:	Main Building
Location:	Yard - Back

Finding: Fence-Bowed
 Information: Vertical bowing and horizontal bending is caused by lack of resistance to vertical pressures from foundations or horizontal pressures from a range of causes e.g. environmental conditions. If left unmanaged, bowing and bending may eventually lead to fence collapsing. As such, any bowing or bending of fence should be rectified as soon as possible.

Where bowing is less severe, a registered builder, in association with qualified trades, should be appointed to perform remedial works.

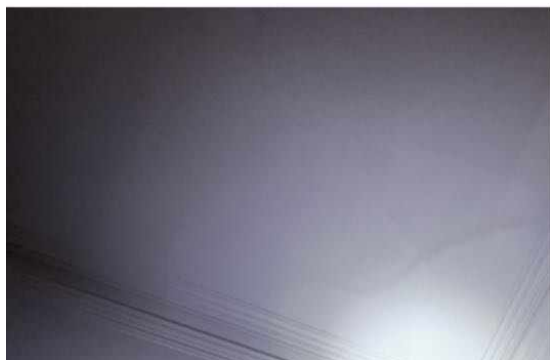
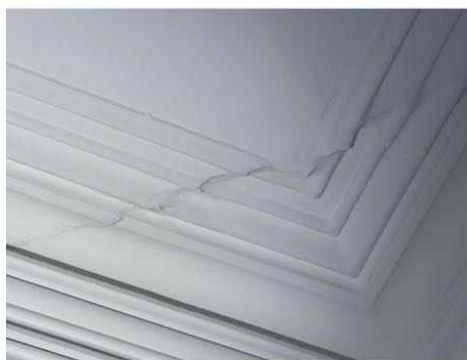
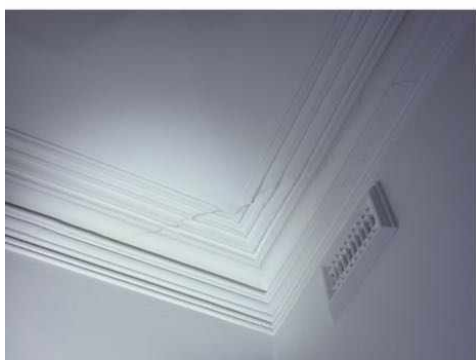
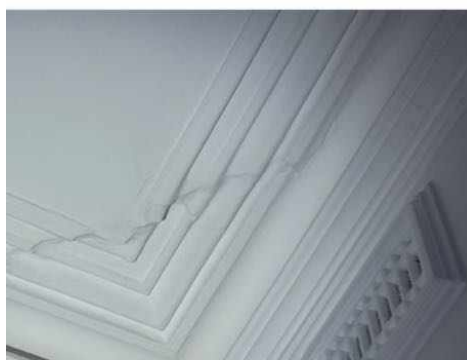
Finding 3.06

Building: Main Building
 Location: Bedroom 1
 Finding: Patched Cornice/Ceiling Junction
 Information: A section of the cornice and adjacent ceiling area shows evidence of previous patching and plaster repair. Hairline cracking is visible along the repaired junction, indicating past movement or joint separation. While the area appears currently stable and cosmetic in nature, patched plaster joints are prone to re-cracking over time due to minor structural movement, thermal expansion/contraction, or differential movement between ceiling sheets and cornice.

Monitoring is recommended, and if cracking reoccurs, further preparation and flexible joint treatment may be required prior to repainting.

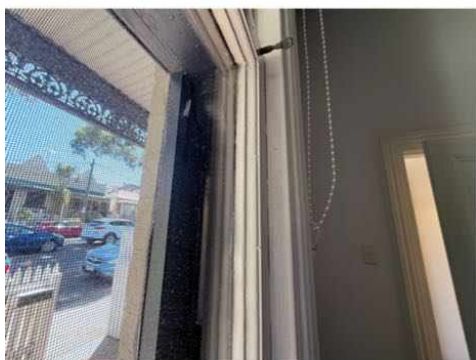
Finding 3.07

Windows provide ventilation to the adjoining area and should be at a fully operational level to ensure user comfort. Restricted function of the window may also pose as a potential safety hazard if required for emergency egress from the building.

Where windows have been painted shut the seal of the paint needs to be broken. This is generally done by breaking the seal of the paint and then maintaining the sash tracks clearing and lubricating them with silicone. Remedial paint work will likely be required and can be completed along with the rest of the remedial works necessary by a general handyman.

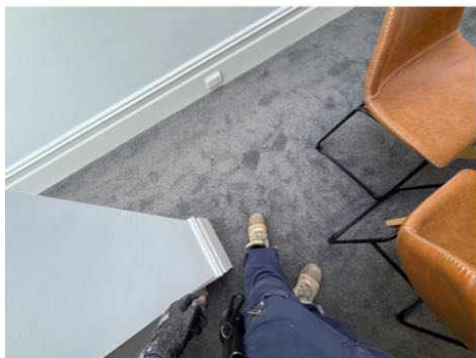
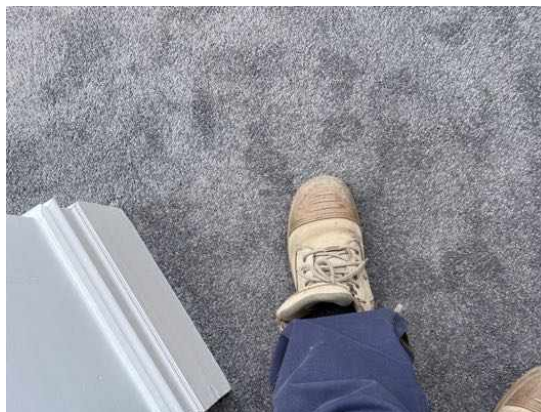
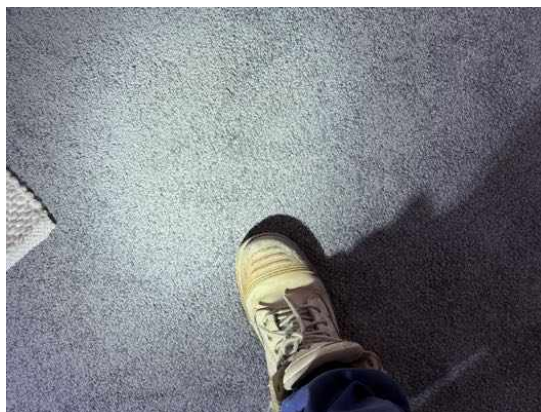
Finding 3.08

Building:	Main Building
Location:	Some Internal Areas
Finding:	Squeaking floors
Information:	The noise that you hear when you step on a floorboard (or floorboards) is usually a result of loose boards. The bounciness and movement in these loose boards causes them to rub together or onto a fixing nail or floor joist which, in turn, creates an unpleasant and annoying noise referred to as creaking or squeaking.

Dependent on the following possible causes, rectification method might vary.

1. Incorrect nails being used to secure the floor to the joist.
2. Nails being fitted inadequately
3. A gap between the top of the floor joist and the underside of the subfloor.
4. An issue with the supporting joists underneath the boards

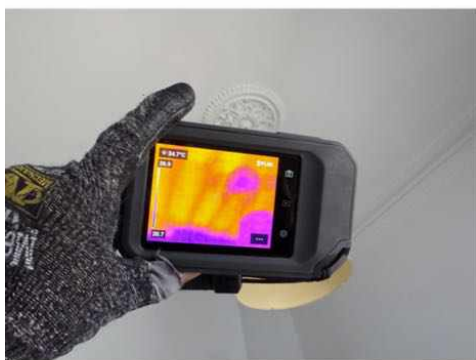
Finding 3.09

Building:	Main Building
Location:	Roof Void
Finding:	Insulation - Missing
Information:	Upon inspection of the roof void it was noted that insulation is not present.

Insufficient insulation will result in a comparatively higher cost to heat and cool a property as there is a lack of Insulation (or uneven coverage of insulation) which works as a barrier to heat transfer. This helps to keep out unwanted heat in summer and preserves warmth inside your home in winter. It can also help soundproof your home from unwanted airborne noise transfer.

Where insulation is absent, the area does not meet current Australian Standards. Installation of adequate insulation is required and should be conducted as soon as possible.

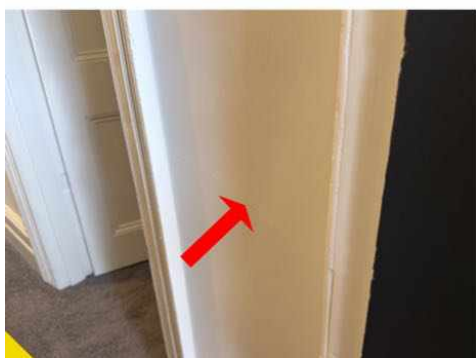
Finding 3.10

Building:	Main Building
Location:	Some Internal Areas
Finding:	Cracking - Damage Category 1 - Fine (up to 1mm)
Information:	Although fine cracks are quite noticeable, they are often only considered to be an appearance defect, and usually do not indicate any structural damage. Generally, the cause of a fine crack is indicative of a separation between building materials and finishes (e.g. paint, plaster, etc.) along joints.

Cracking of this nature can generally be repaired with minor sanding, filling and/or repainting. Such works should be performed by a qualified painter or a general handyman.

Monitoring of all cracking should be conducted frequently. Always contact a building inspector should cracks widen, lengthen, or become more numerous.

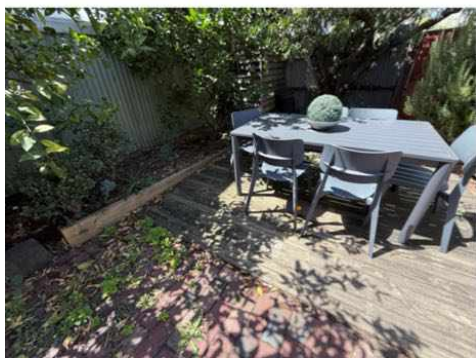
Finding 6.02

Building:	Main Building
Location:	All External Areas
Finding:	Garden Bed/ Mulch - Conditions Conducive to Termites
Information:	Mulch were found around the property. These areas can include untreated timber, and with a combination of moisture from watering hosing can make conditions conducive to termite activity and termite ingress.

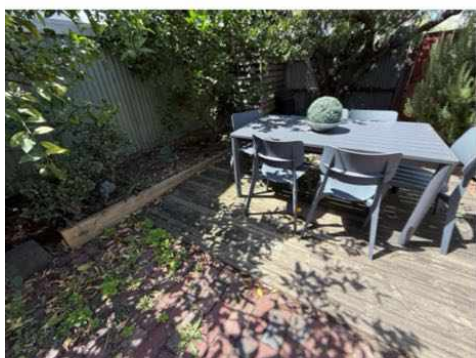
Finding 6.03

Building:	Main Building
Location:	All External Areas
Finding:	In ground contact
Information:	Any timbers in direct ground contact provide opportunity for concealed termite entry and are likely to be subject to premature rot and decay as the soil retains moisture or damp conditions against the timbers.

Remove untreated timber that is in direct contact with external grounds. Consider replacement with more durable materials i.e. treated timber or non timber elements. Frequent pest inspections are advised to readily identify any termite activity in these areas.

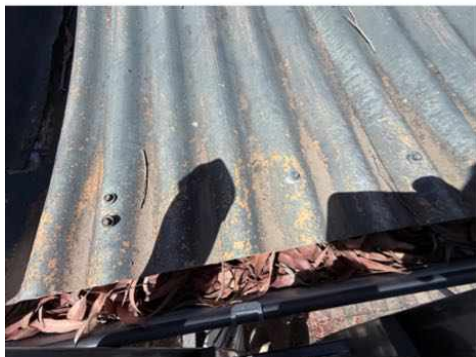
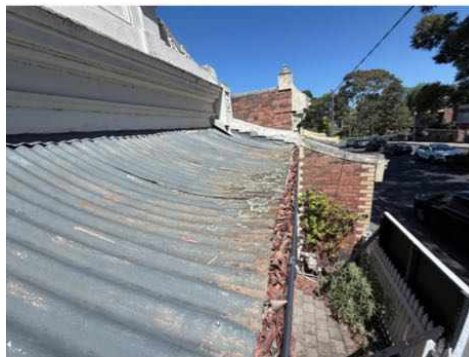
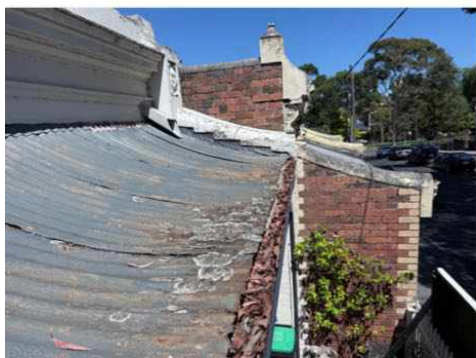
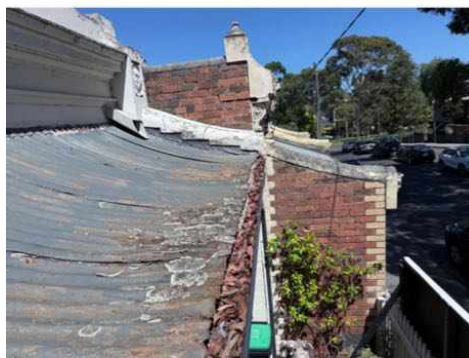
Finding 6.04

Building:	Main Building
Location:	Roof Exterior
Finding:	Gutters - Blocked
Information:	Roof plumbing structures, such as guttering and downpipes, should be free of all debris to prevent blockages. Blockages of the guttering and downpipes will lead to pooling and accumulated water overflows, which is likely to subsequently flood eaves and exterior walls.

Blocked gutters are likely to lead to high levels of moisture in the affected areas. Such moisture will not only cause rust and decay of the associated building materials, but can also provide conditions that are conducive to termite and timber pest activity. Blockages in gutters should therefore be removed immediately to ensure dry conditions are maintained.

Consult a Licensed Plumber for further specific advice on remedial works that may be required. In the interim, it is highly advised that blocked gutters be removed by the homeowner or a general handyperson as a matter of urgency.

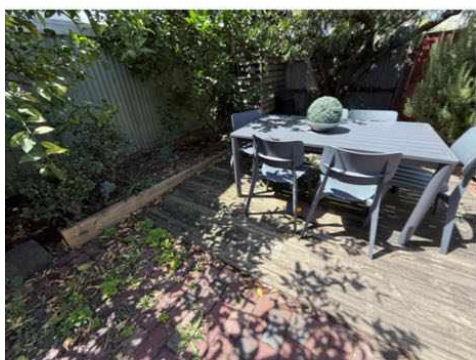
Finding 6.05

Building:	Main Building
Location:	Yard - Back
Finding:	Timber deck- High conducive condition.
Information:	We are unable to inspect under the timber deck if its in close proximity to the ground.

Where we are unable to inspect timber structures, decks and subfloor areas the risk of undetected termite activity is rated as extremely High.

We strongly recommend the purchaser prioritise a termite treatment by a Licensed Pest Controller to protect and maintain the asset as it is a timber structure.

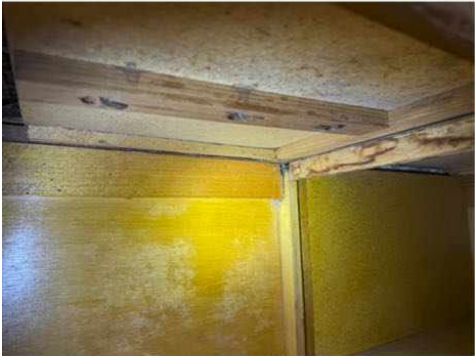
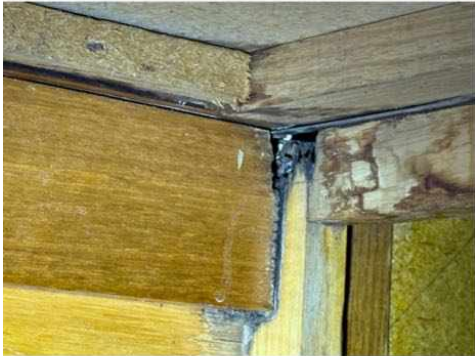
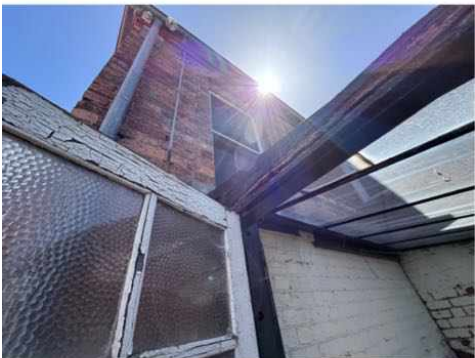
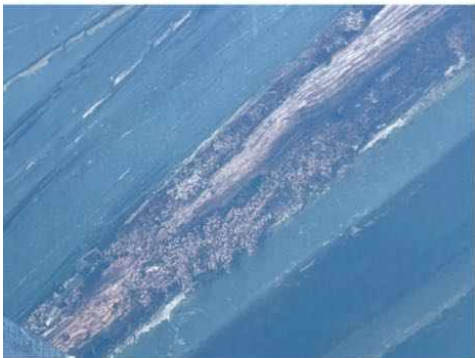
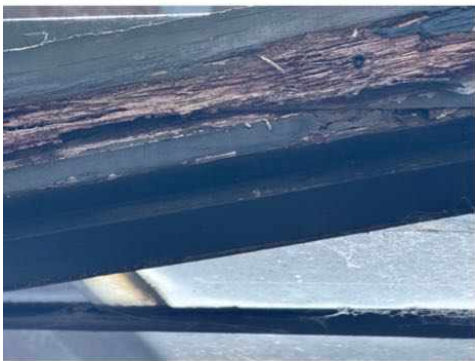
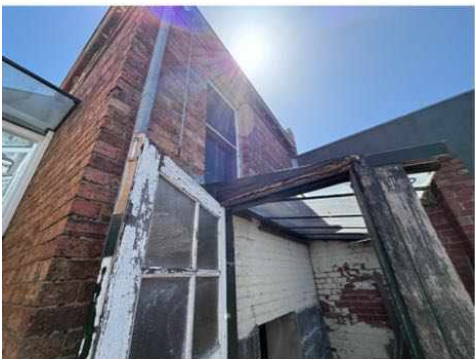
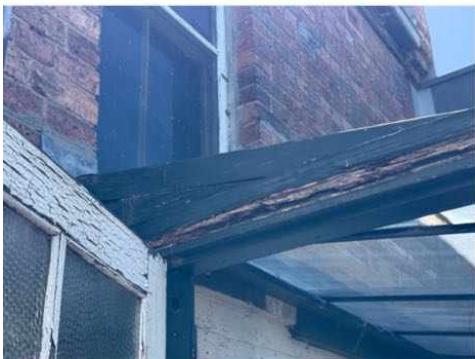
Finding 7.01

Building:	Main Building
Location:	All External Areas
Finding:	Wood rot
Information:	These building elements shows evidence of wood rot. Wood rot, also known as Fungal Decay, occurs when timbers and other cellulose building materials are exposed to damp conditions on an ongoing basis. This could be the result of exposure to weathering over a prolonged period of time, or the attraction of excessive moisture from other abutting building materials. Contributing factors also include poor air ventilation in the area.

Wood rot is often associated with general damp problems and is evidenced by a 'musty' smell or mould and mildew occurring on surfaces. If left unmanaged, damp conditions can lead to further health problems and the decay of timbers will continue. Can also boost termite activity.

the useful life of these building elements. Prior to any works being performed, the cause of the moisture that has created the visible wood rot should be identified and addressed in a suitable manner. Replacement of affected timbers may then be a necessary step in protecting surrounding building elements from such deterioration.

A qualified plumber may be appointed to assess the cause of excessive moisture and to provide advice on any remedial works as required. A qualified carpenter or registered builder may also be required to replace affected building materials.

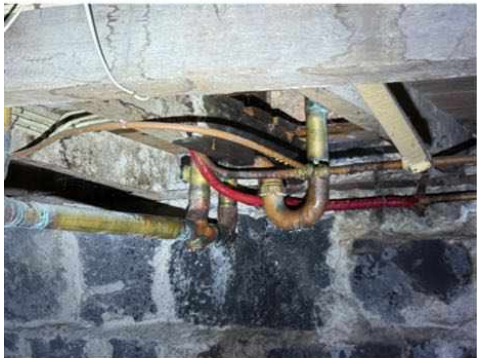
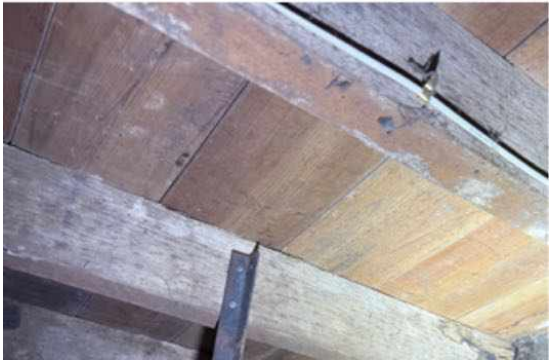
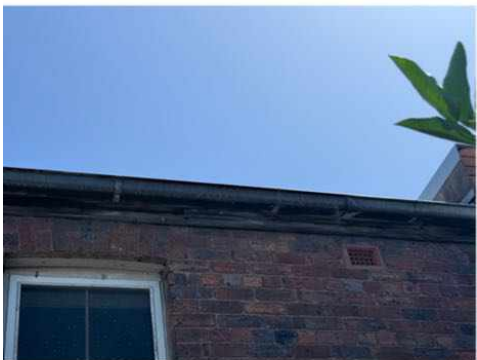
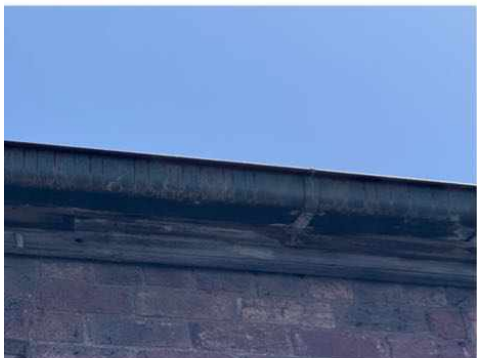
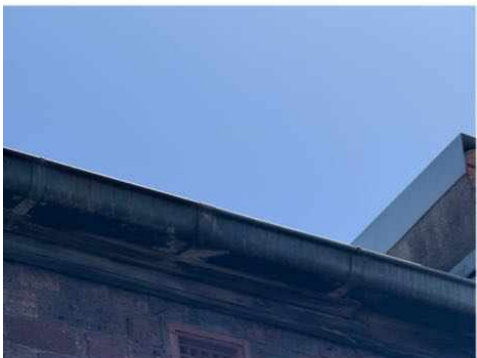
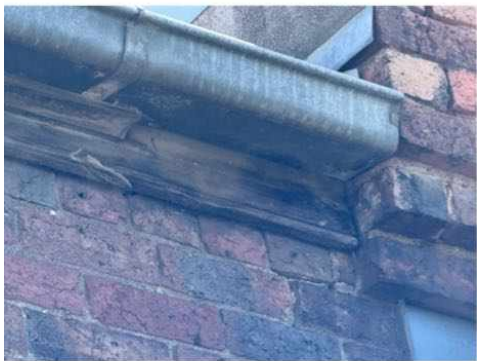
Building: Main Building
Location: All Areas
Finding: Timber- early stages of wood rot.
Information: Timbers that are frequently exposed to moisture require adequate protection in order to maintain their condition. Where leaks are not fixed or timbers have not been painted or treated adequately, general deterioration is likely to occur at an accelerated rate.

If left unattended, replacement of these timbers is likely to be necessary in the short-term future. Adequate treatment of these timbers is required as soon as possible by a painting contractor or general handyman.

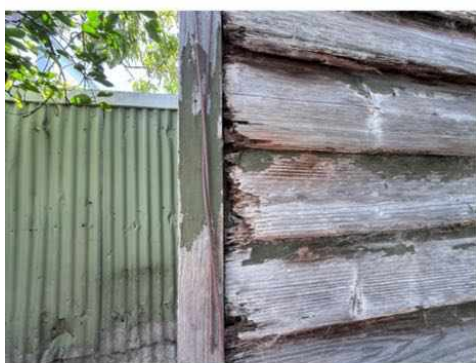
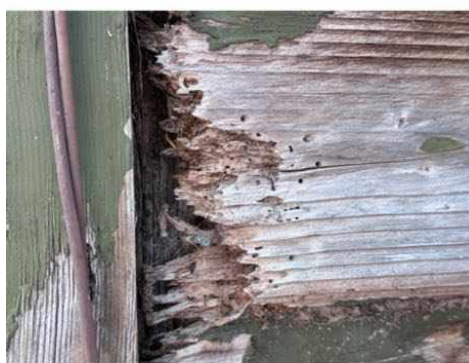
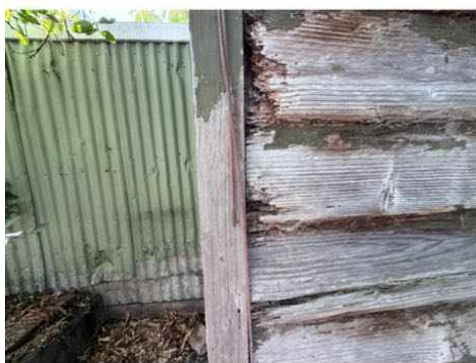
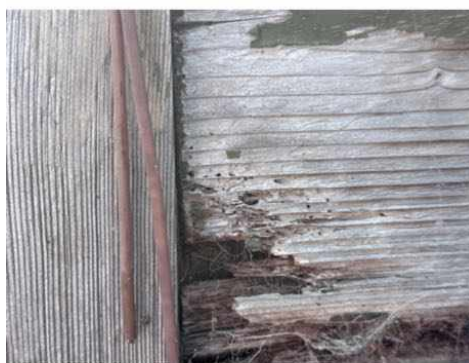
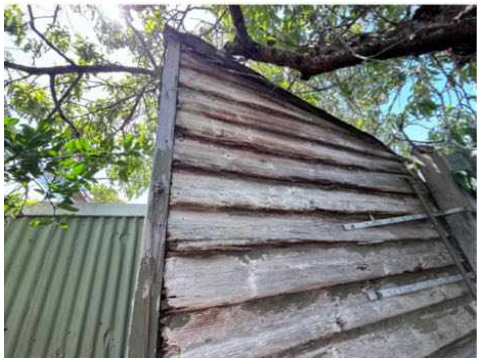
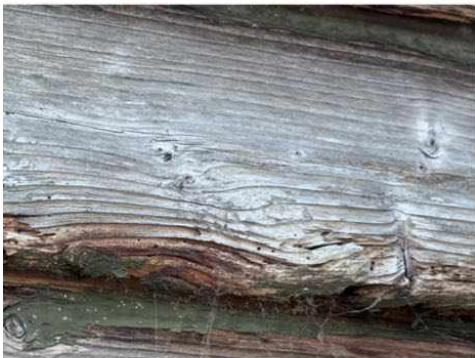
Finding 8.01

Building: Main Building
Location: Yard - shed
Finding: Evidence of wood borer activity identified
Information: Wood borers small beetles that colonise in exposed timber elements are a common timber pest that are regularly mistaken for termites. Although wood borer activity is generally not detrimental to the affected timber they may lead to serious damage and necessitate replacement of certain building elements if left unattended.

As no live wood borer activity was identified treatment is not required at this time. Replacement of affected timbers may be considered by the client for superficial reasons.

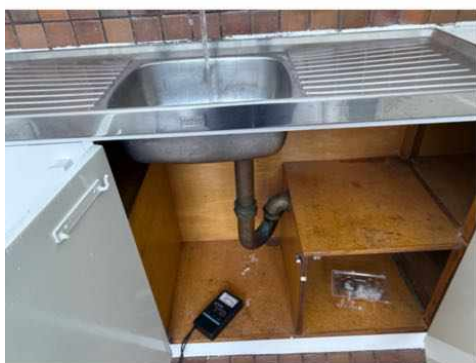
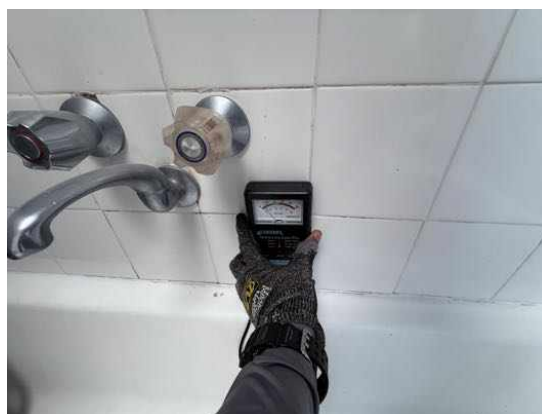
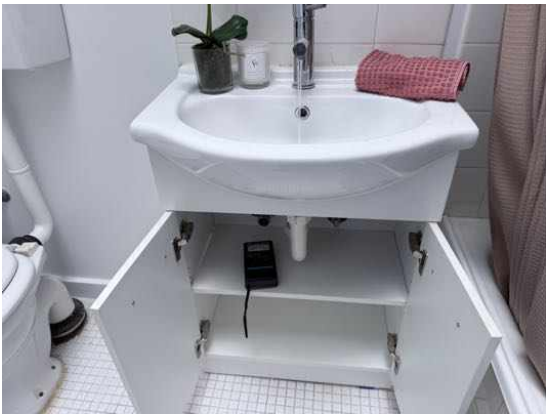
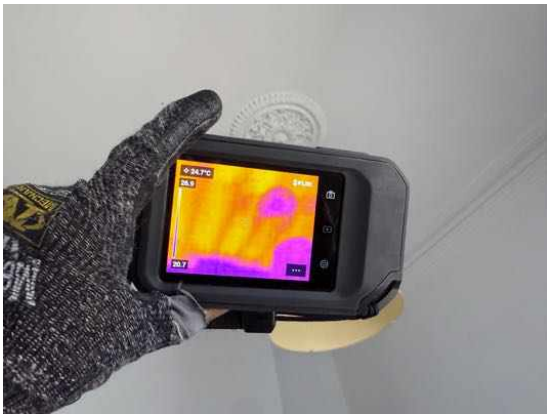
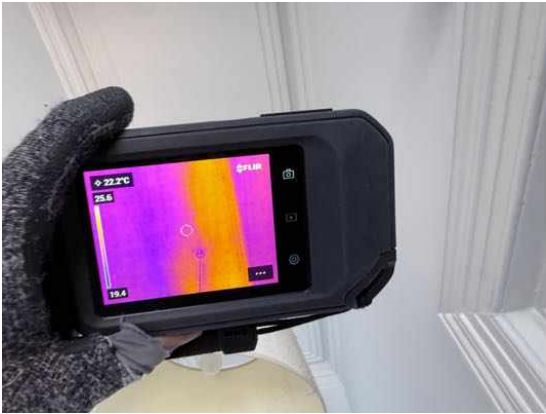
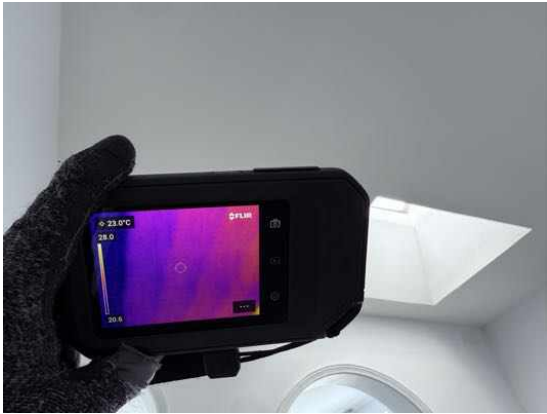
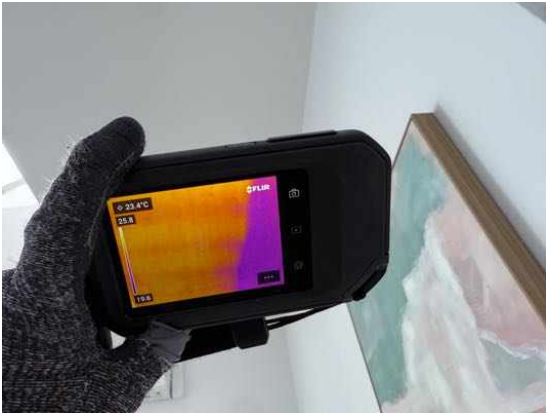
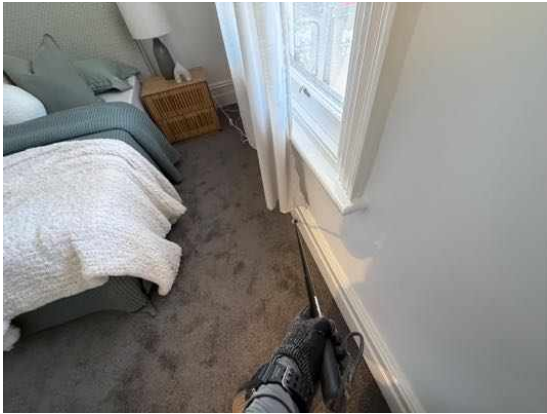
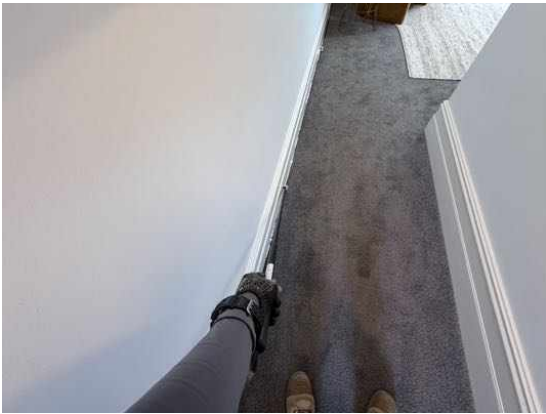
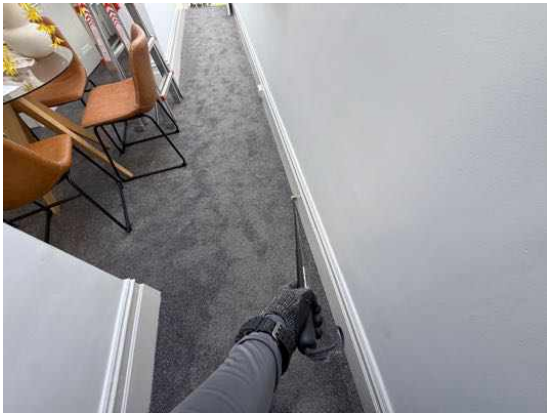
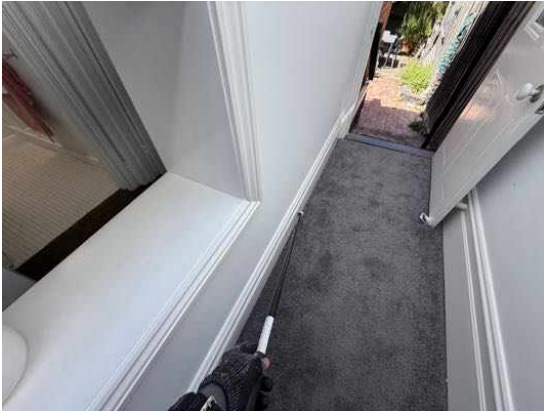
Building: Main Building
Location: All Areas
Finding: Termite Techniques
Information: All areas of the dwelling are checked with particular attention paid to wet areas which were closely assessed to check for excessive levels of moisture and temperature anomalies.

No evidence of termite activity was found inside the house at the time of the inspection.

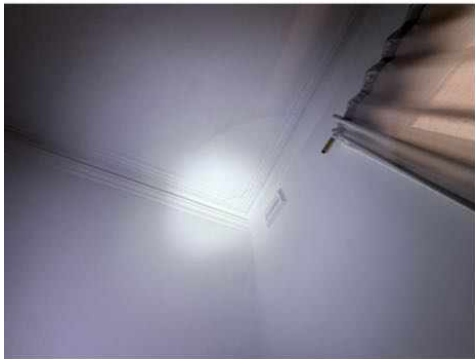
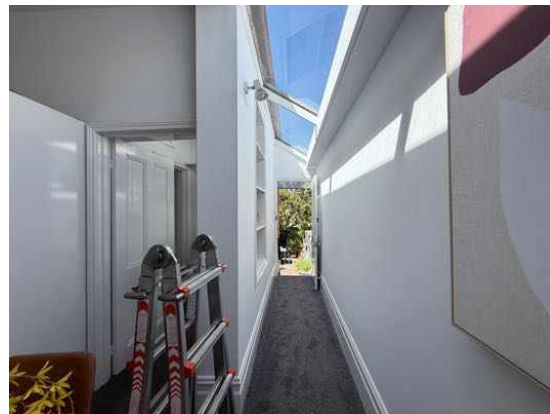
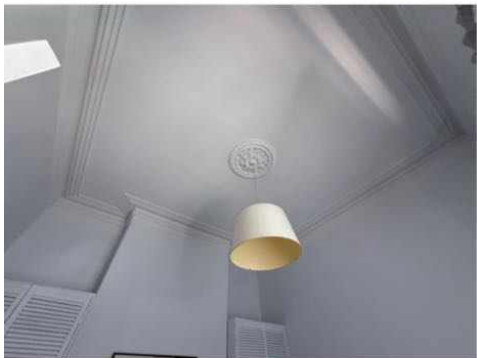
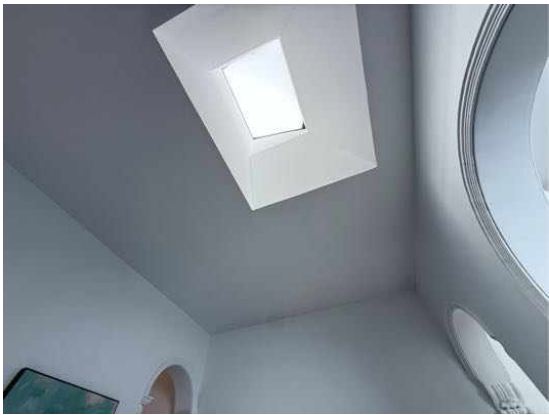
Information: Whenever a property is refurbished, majority of the defects if present could get obscured beneath the revamped work. The same can be said for this property as well. Some fine cracks are filled over, walls have been painted etc. It is difficult to pinpoint on any particular defects present below such layers.

Once the property is occupied, all areas should be monitored for a period of 12-24 months to lookout for any arising defects. If staining or cracking is noticed extensively in that period, always consult your building inspector.

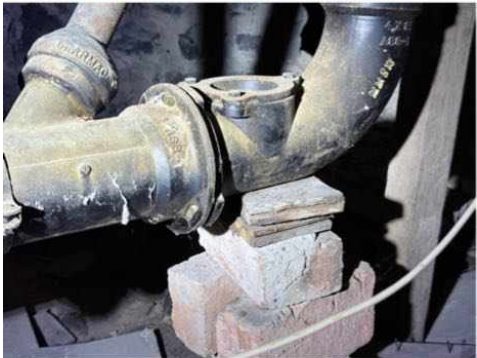
Building: Main Building
Location: All Areas
Finding: Aged Plumbing Infrastructure
Information: The subfloor plumbing observed comprises older cast iron sanitary drainage and copper water supply lines, which appear significantly aged and likely original to the dwelling. Plumbing materials of this age are generally considered to be at or beyond their typical service life expectancy and may be susceptible to internal corrosion, joint deterioration and future failure.

It is recommended that a licensed plumber be engaged to carry out a detailed assessment of the system and provide advice regarding its current condition and whether partial or full replacement should be considered in the medium-term future as part of planned maintenance.
