Building and Timber Pest Inspection Report

Inspection Date: Mon, 2 Mar 2026

Property Address: 24 Carroll St, North Melbourne VIC 3051,
Australia

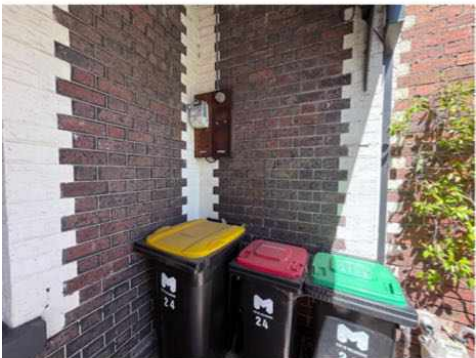
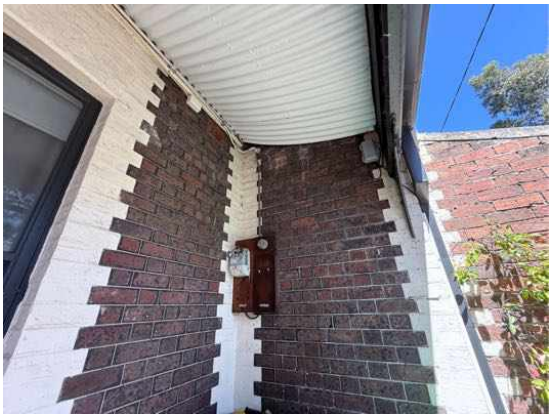
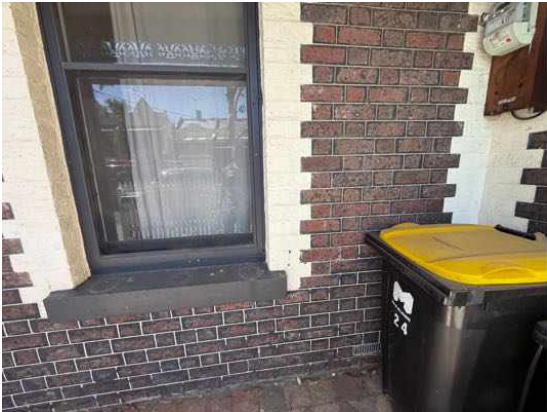
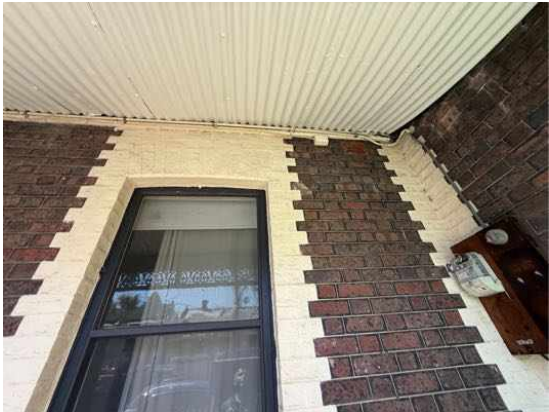
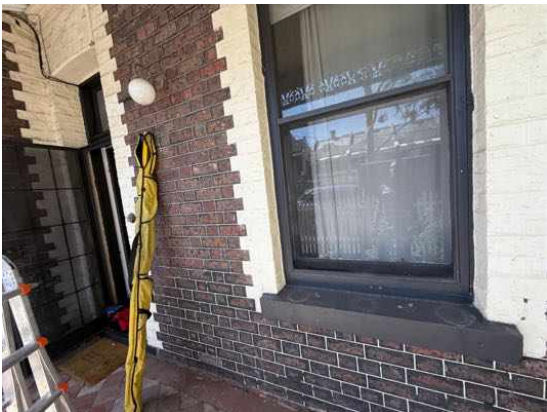
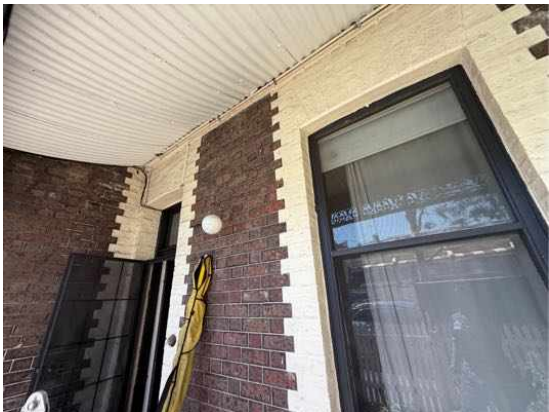
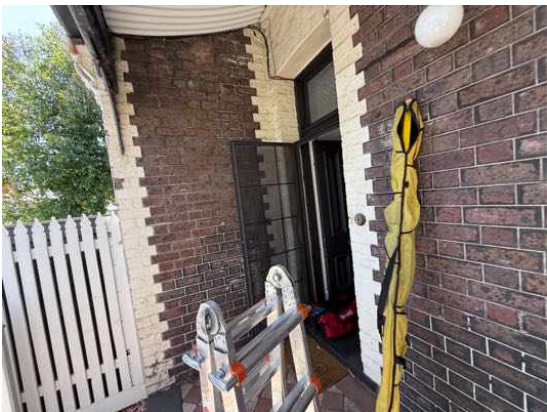
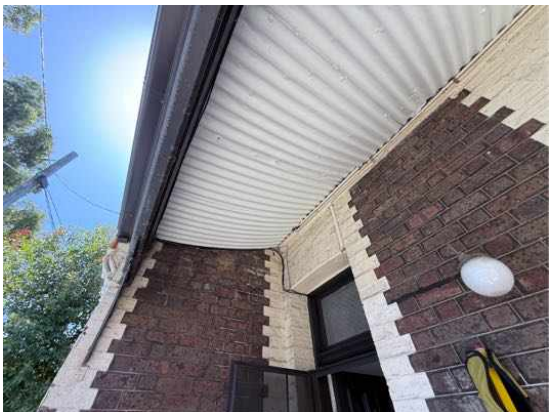
Building:	Main Building
Location:	All Areas
Finding:	Additional photos & Obstruction/Limitations.
Information:	Additional photos for general documentation. May have some minor maintenance items not listed in the defects section.

Furthermore, some photographs are an indication of the obstructions and limitations which impeded full inspection of the property at the time of inspection. These obstructions can hide an array of defects and should be removed to allow full inspection to be carried out. A re-inspection is recommended once the areas are made accessible.
