Building and Timber Pest Inspection Report

Inspection Date: Thu, 12 Mar 2026

Property Address: 159 Nicholson St, Goulburn NSW 2580,
Australia

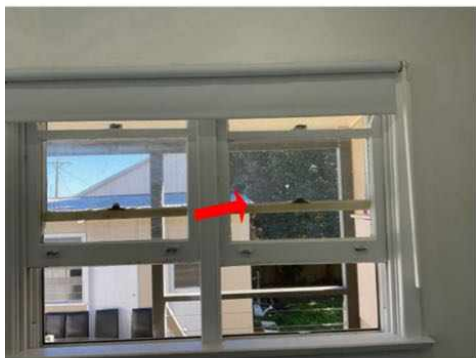
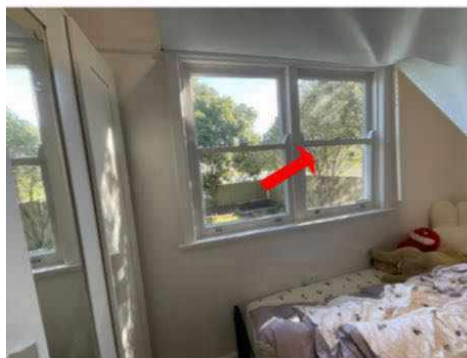
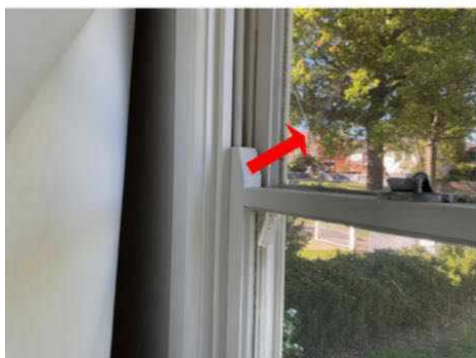
Building:	Building 1
Location:	Kitchen and bedrooms
Finding:	Windows - Cracked
Information:	Cracks were identified to 3 windows in these area. Cracking in windows is generally the result of impact damage, and is likely to develop further when left unmanaged.

The likelihood of this windowpane further cracking and shattering is increased exponentially, providing a safety hazard in the area. The cracked window also impairs the weather tightness of the building, creating potential for minor water leaks.

A qualified glazier is required to repair the window as soon as possible. Depending on the extent of the cracking, replacement of the window may be required. Please be advised that any persons coming into contact with the cracked window should do so with due caution to avoid any personal injury that may ensue.

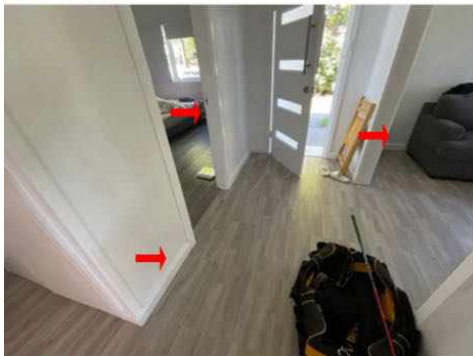
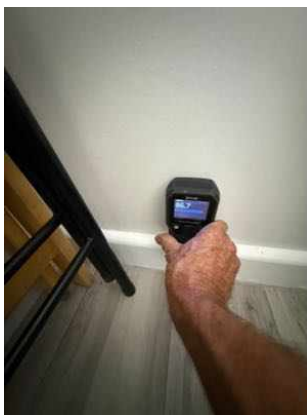
Building: Building 1
 Location: Subfloor, front and right lower wall areas
 Finding: Damp - Rising
 Information: Rising damp was found in the subfloor. It is suspected the very moist subfloor areas has lead to moisture found in the front and right side lower internal house walls.

All moisture was near the skirting with moisture readings of 26.1 to 86.7 recorded. No moisture was found in the mid or upper house walls.

Left unmanaged, rising damp can lead to health problems resulting from mould growth and can have major implications on affected building elements, including wall finishes like paint and plasterwork. Minor mould was found in the front bedroom skirting.

The first step in addressing rising damp is to diagnose the cause. The identified cause should be addressed first before addressing the appearance and other defects which have resulted from the rising damp. If the original cause is not resolved, further cases of damp are likely to ensue, resulting in secondary defects.

Consultation with a qualified plumber is advised immediately to identify the cause of the damp and perform remedial works as required.

Addition brick vents, mechanical ventilation and external drainage will likely be required to reduce this damp.

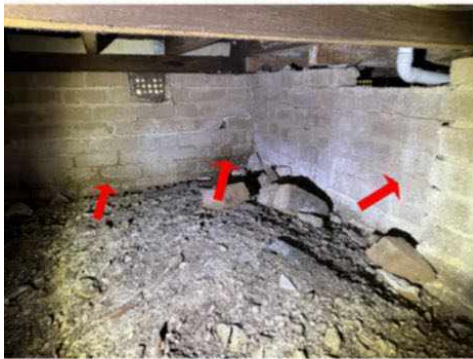
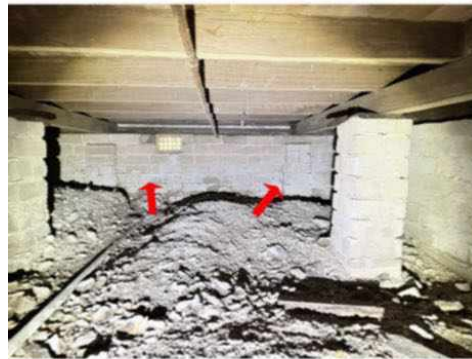
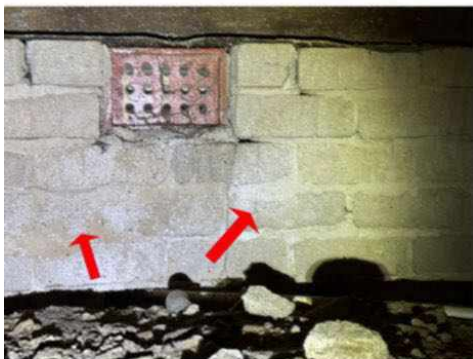
Finding 3.02

Building:	Building 1
Location:	Subfloor
Finding:	Subfloor ventilation - Inadequate
Information:	The subfloor had poor ventilation, with debris blocked many areas and insufficient brick vents. A few external vents were blocked by an air conditioner, tree etc.

Adequate subfloor ventilation aids in preventing excessive moisture, mould, wood rot and termite activity by ensuring a dry subfloor environment.

Subfloor ventilation can be improved in most cases by addressing the causes such as exposing subfloor vents, installing additional vents, installing mechanical ventilation and removing debris from the subfloor.

A registered builder should be appointed as soon as possible to add more vents to the subfloor walls. Mechanical ventilation would also assist the house to increase ventilation and decrease rising damp and mould.

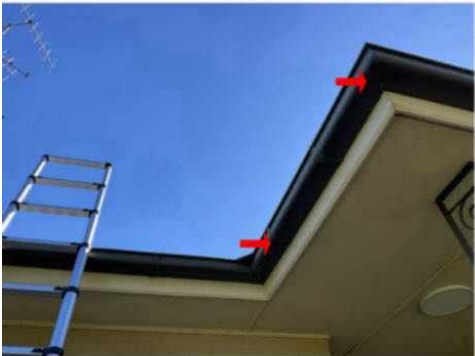
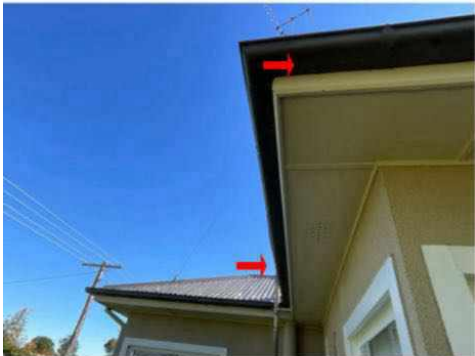
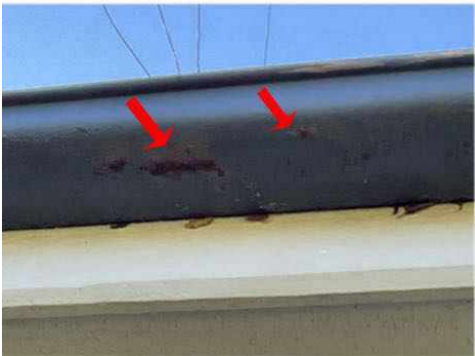
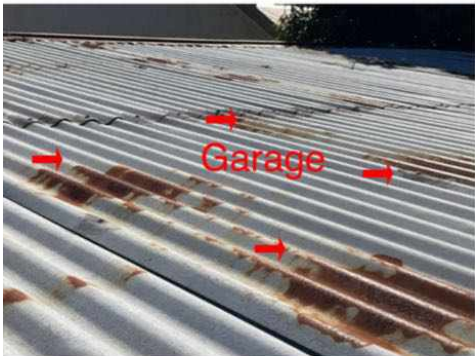
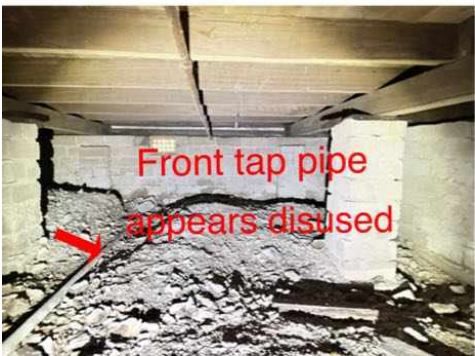
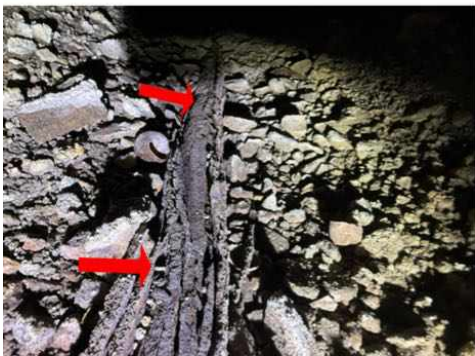
Building:	Building 1
Location:	Pictured external areas
Finding:	Building element - Rusted or corroded
Information:	These building elements including gutters, verandah railing, garage roof, front tap pipe etc shows evidence of rusting and corrosion, which is likely to have developed as a result of excessive exposure to moisture and or inadequate coatings. The pipe to the front tap is severely rusted in the front right subfloor.

As surface rust provides no protection to the underlying iron, the deteriorating condition is likely to worsen if not addressed in the short-term future.

Rusting and corrosion should be managed by ideally removing or limiting the affected surface from exposure to moisture. A registered builder and plumber may be appointed to replace any building elements that have been severely affected by rust or water damage in the next 2 years.

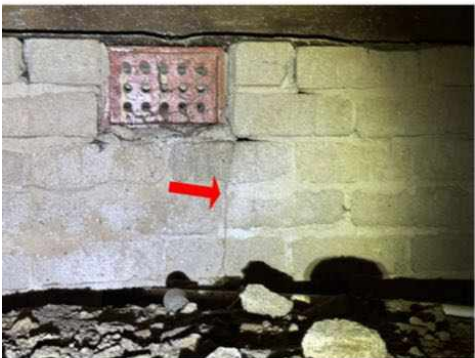
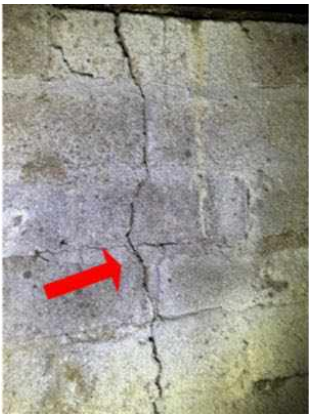
Finding 3.07

Building: Building 1
 Location: Pictured external areas
 Finding: Render (external) cracking.
 Information: It has been observed that cracking to some external rendered surfaces. The degree of damage is described as noticeable cracks which are repairable. Cracking of this size are generally less than 5mm in width.

Always contact your building inspector should cracks widen, lengthen, or become more numerous.

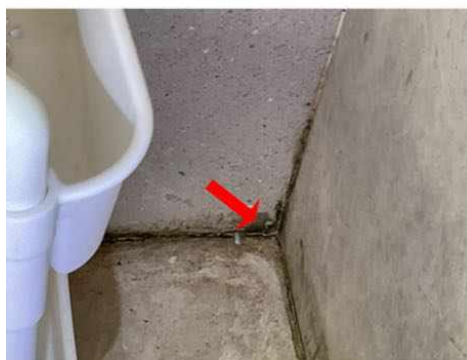
Finding 3.12

Building:	Building 1
Location:	Walls
Finding:	Site drainage - Inadequate
Information:	The site drainage in this area was found to be inadequate at the time of inspection, creating potential for subsequent water damage to associated building elements.

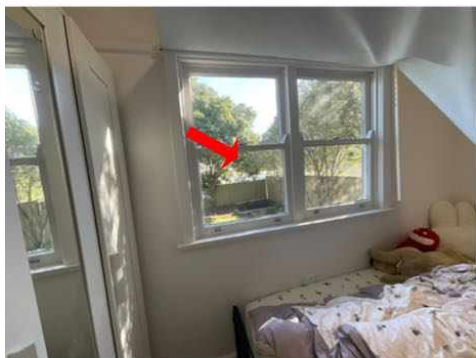
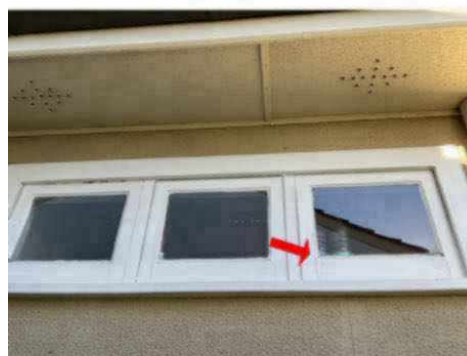
Finding 3.16

Building:	Building 1
Location:	Pictured areas if both buildings
Finding:	Wood rot
Information:	The building shows evidence of wood rot. Wood rot, also known as Fungal Decay, occurs when timbers and other cellulose building materials are exposed to damp conditions on an ongoing basis. This could be the result of exposure to weathering over a prolonged period of time, or the attraction of excessive moisture from other abutting building materials.

Early intervention and regular maintenance, particularly of exterior timbers, will prolong the useful life of these building elements. Prior to any works being performed, the cause of the moisture that has created the visible wood rot should be identified and addressed in a suitable manner. Replacement of affected timbers may then be a necessary step in protecting surrounding building elements from such deterioration.

A qualified carpenter or registered builder may also be required to replace affected building materials.

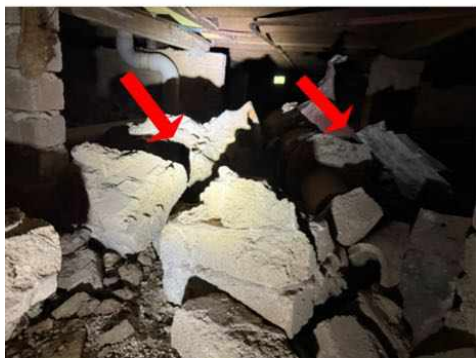
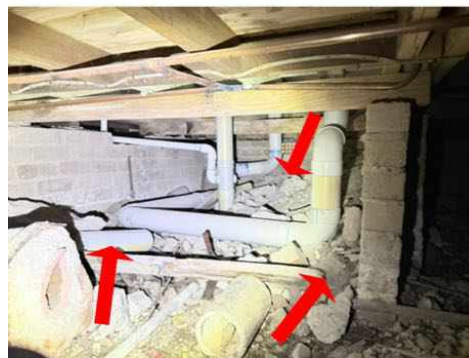
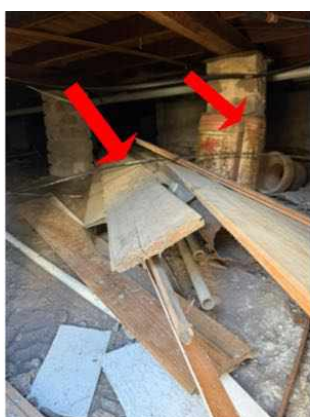
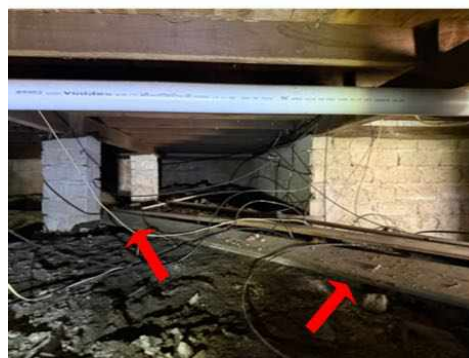
An array of debris was found in the subfloor area at the time of inspection. Debris in this area restricts subfloor ventilation and creates potential for concealed pest entry. Stored timbers and other materials may also make the area susceptible to termite activity and wood rot.

A clear and empty subfloor will be better ventilated and easier to maintain in a dry condition. The removal of any timber debris is vital in minimising the risk of termite or wood borer activity.

Debris in the subfloor should be removed as soon as possible. Depending on the location and amount of debris and stored items, the homeowner may elect to undertake this task. Alternatively there are a large number of rubbish removal subcontractors that could undertake these works.

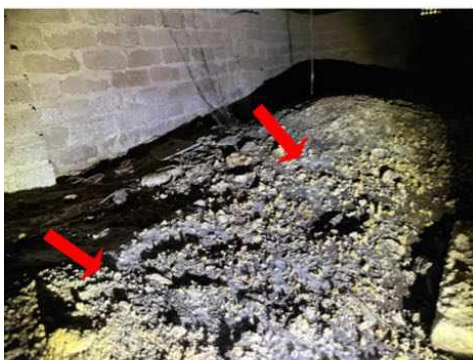
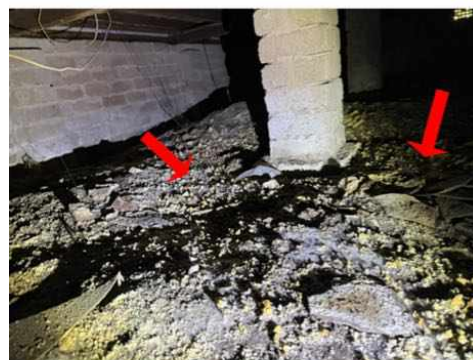
Information: Where evidence of mould growth was noted, there may be environmental, biological or health issues associated with the report. A specialist inspection by a suitably qualified environmental health inspector is warranted, where mould is extensive or where any queries regarding air quality spores or other related issues apply.

Subfloor mould is generally caused by moisture ingress, lack of external drainage, lack of adequate ventilation and subfloor debris present. These issues need rectification

Generally, the client is advised to ensure that the general environment is free of moisture and humidity to aid in the prevention of mould formation and development.

to stop mould development. Any mould found during the inspection should be cleaned immediately by a cleaning contractor or the homeowner as applicable.

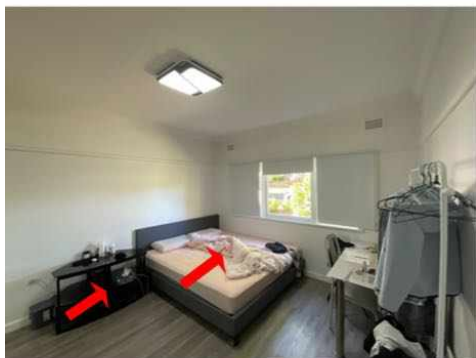
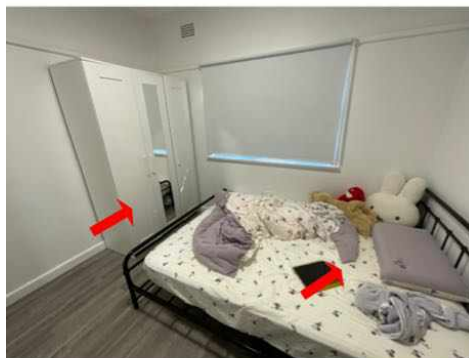
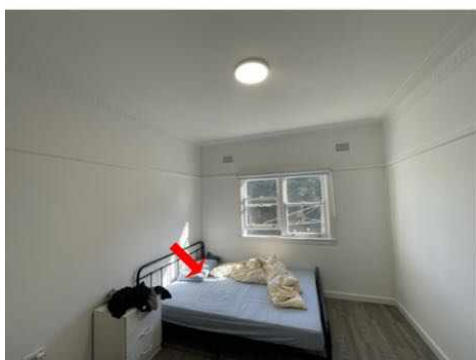
Building: Building 1
 Location: All Internal Areas
 Finding: Additional Photos - Obstructions and Limitations of INTERNAL AREAS
 Information: These photographs are an indication of the obstructions and limitations which impeded full inspection of Internal areas at the time of inspection. These obstructions can hide an array of defects and should be removed to allow full inspection to be carried out. A re-inspection is recommended once the areas are made accessible.

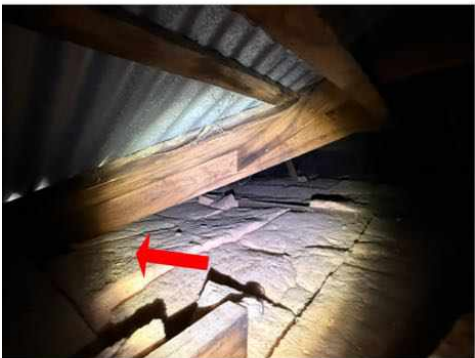
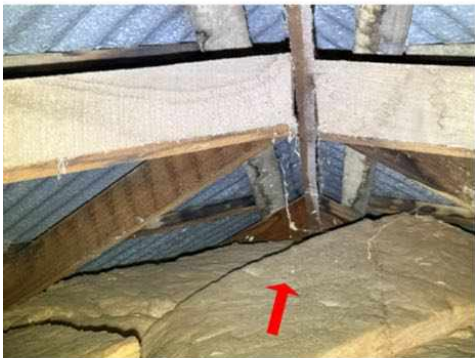
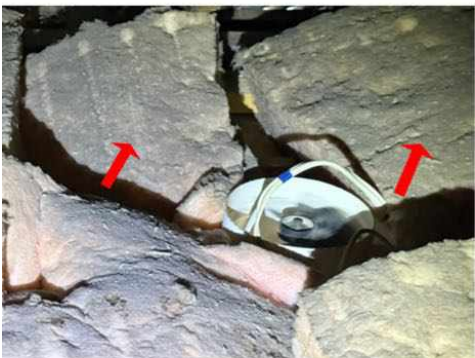
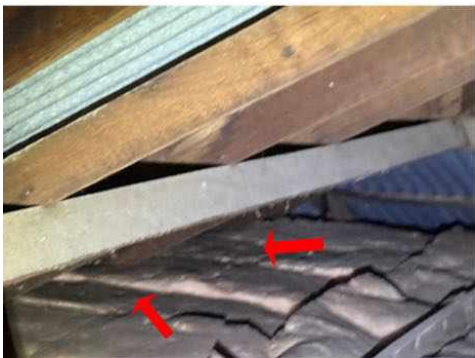
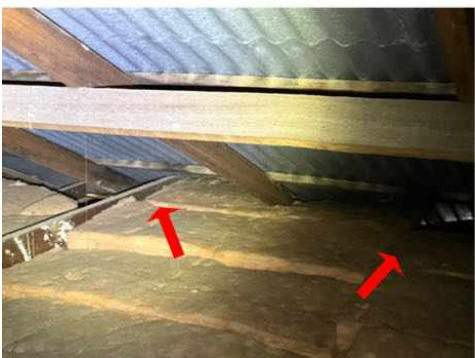
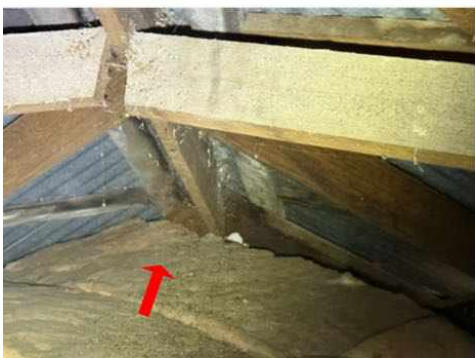
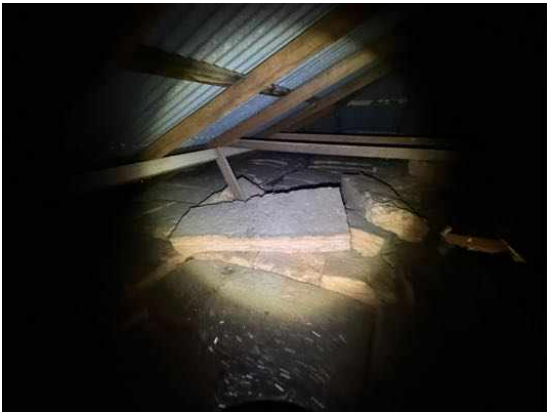
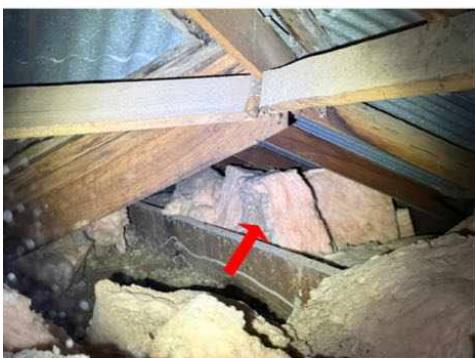
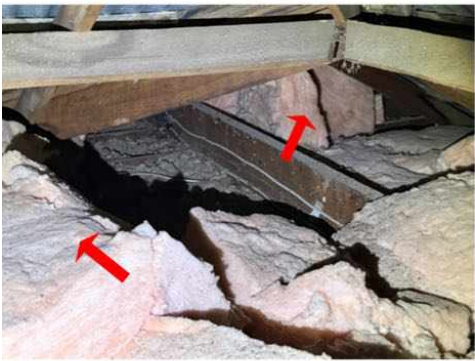
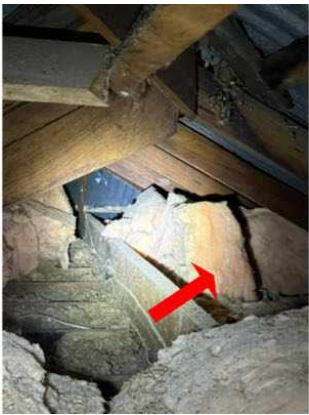
Building:	Building 1
Location:	All Roof cavity areas
Finding:	Additional Photos - Obstructions and Limitations of the ROOF CAVITY
Information:	<p>These photographs are an indication of the obstructions and limitations which impeded full inspection of roof cavity areas at the time of inspection. These obstructions can hide an array of defects and should be removed to allow full inspection to be carried out if applicable. A re-inspection is recommended once the areas are made accessible.</p> <p>The inspection was also limited to areas with an allowable crawl space of 600mm x 600mm, in particular towards the external walls where the roof line diminishes, these areas were not accessible.</p>

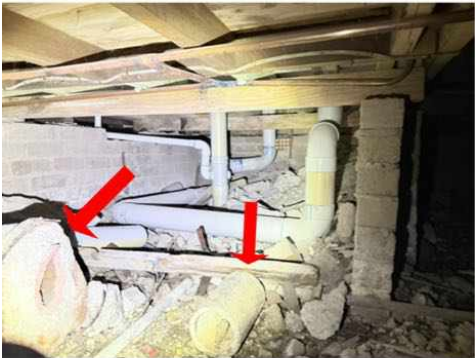
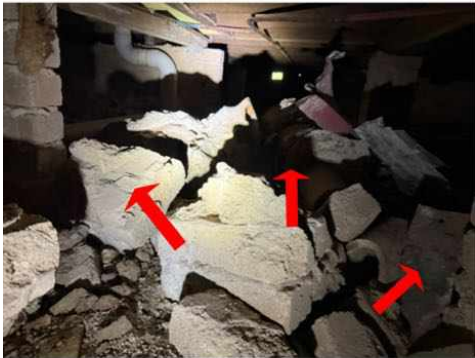
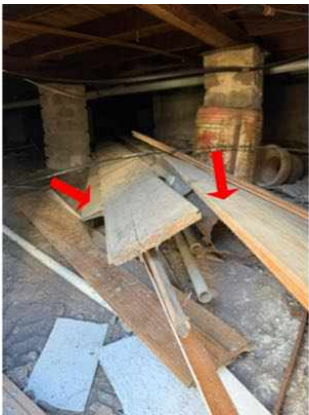
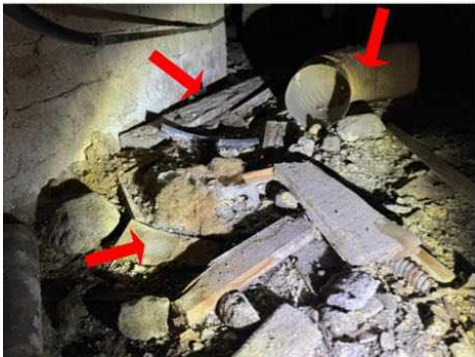
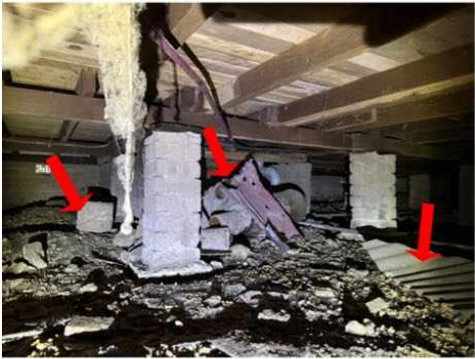
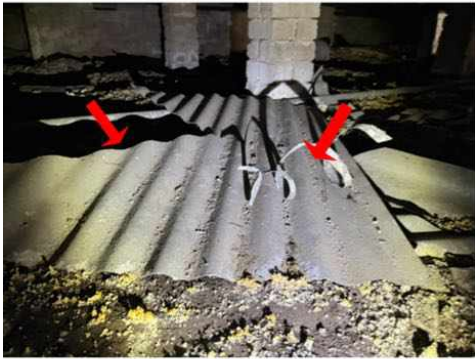
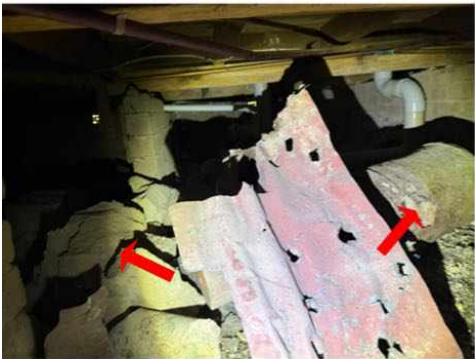
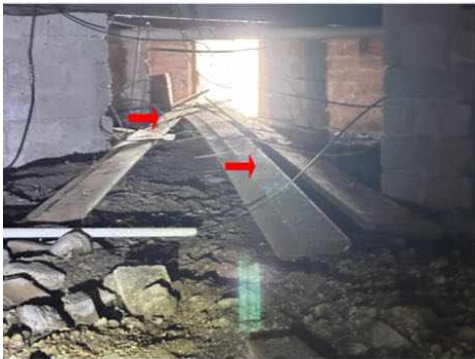
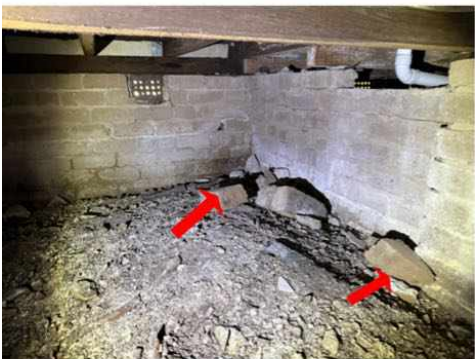
Building: Building 1
Location: All Subfloor Areas
Finding: Additional Photos - Obstructions and Limitations of SUBFLOOR AREAS
Information: These photographs are an indication of the obstructions and limitations which impeded full inspection of subfloor areas at the time of inspection. These obstructions can hide an array of defects and should be removed to allow full inspection to be carried out. A re-inspection is recommended once the areas are made accessible.

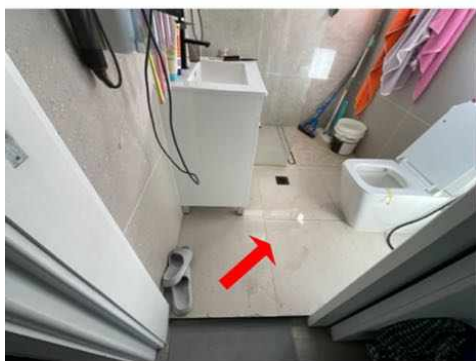
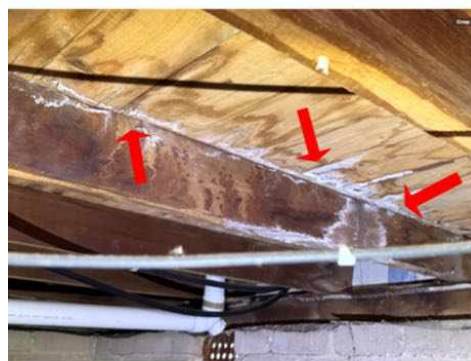
Building: Building 1
 Location: Bathroom
 Finding: Waterproofing membrane
 Information: Internal Water Proofing Membranes, are crucial in preventing water ingress into the property. With older properties, all wet areas should be monitored. If any leaks, water staining, peeling or bubbling of the paint become evident to any adjacent walls or ceilings below a licensed builder or waterproofing specialist is recommended to investigate further. Some staining was found in the subfloor. It is unclear if this is from the currently renovated bathroom or the previous bathroom, no water leaks were visible after running the bathroom / shower taps for 5 minutes.

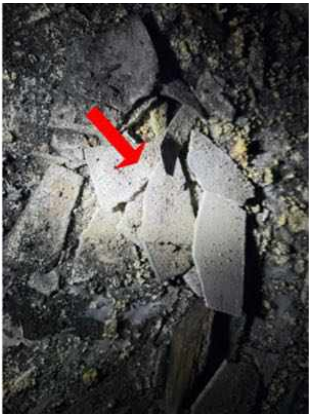
Building: Building 1
 Location: Shed, subfloor, eaves
 Finding: Asbestos - Suspected ACM Identified on Site
 Information: Reporting on Asbestos is outside the Scope of this Report. This suspected defect is highlighted as a caution only. We suspect, based on our experience in the building industry, that there is a higher risk of the identified building element containing asbestos.

As Asbestos Reporting is outside the scope of this report, we advise that you consider a separate Asbestos Inspection and Condition Audit, which can include the taking of samples for definitive confirmation of the presence of Asbestos.

In the interim, the client is advised to act with caution, especially when considering any damage to building materials general wear and tear renovations extensions demolition and general maintenance activities due to the suspected presence of Asbestos.
