Building and Timber Pest Inspection Report

Inspection Date: Fri, 6 Mar 2026

Property Address: 7 Kimberley Ave, Narara NSW 2250,
Australia

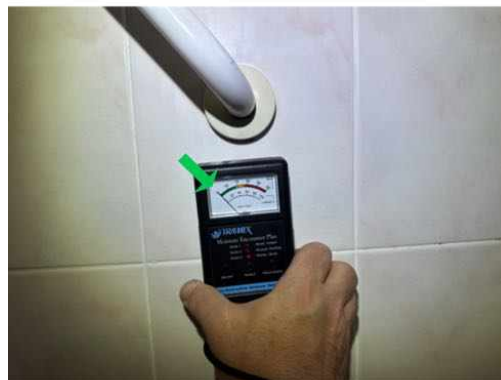
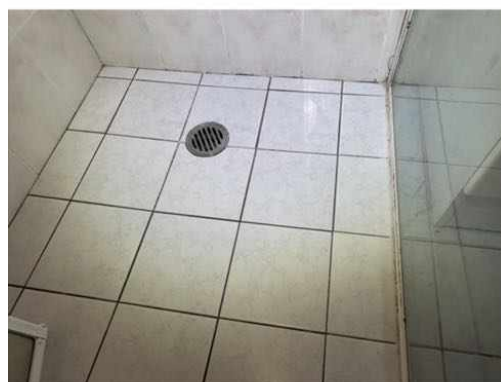
Building: Main Building
Location: Bathroom > Centre Left
Finding: Moisture meter: used in Shower area.
Information: A moisture meter was used during the inspection and isolated spots of excessive moisture was detected to accessible walls inside the property at the time of inspection.

It was noted on inspection that sealant or grout is in fair condition to most of the tiled shower alcove, with some areas requiring maintenance.

Different materials and floor areas move at different rates, generally causing cracking to grout or sealant at this point. A flexible sealant is required to allow for expected expansion and contraction, while keeping the joint water tight and protective of all associated building materials.

A moisture meter was used on all accessible walls during the inspection and excessive moisture was detected to bathroom shower walls on the lower tiled areas. All areas with high moisture should be investigated by way of an invasive inspection by either a plumber and/or pest controller. High moisture levels also increase the likelihood of termite attack and may also be conducive to borer activity, wood decay, mould and deterioration of the building elements.

Flexible and mould resistant materials should be applied to affected areas to prevent any subsequent water damage that is likely to occur. Regular maintenance and replacement of damage or missing or damaged sealant and grout is highly recommended to the wet areas, as this is a regular wear and tear defect. Sealant and grouting in areas that come into regular contact with water should be maintained for the long term care of your property.

Monitoring the area is advised and if any visual signs of excessive moisture appear (peeling paint, mould) then consultation with a qualified plumber or bathroom specialist would be advised to identify the cause of damp and to perform remedial works as required.

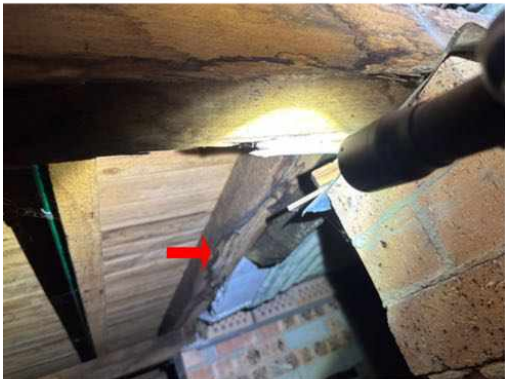
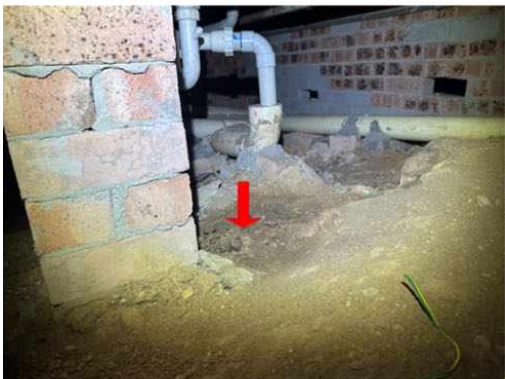
Finding 2.02

Building:	Main Building
Location:	Subfloor-Bathroom > Centre Left
Finding:	Water staining
Information:	Water staining was evident in this area at the time of inspection. Water staining indicates that surfaces have been exposed to excessive moisture over time. The minerals and other elements in the water lead to staining, which may graduate to corrosion and deterioration if left unmanaged.

While mostly an appearance defect, water staining can be indicative of more serious defects, which may be currently concealed by other building elements.

Where water staining is active, a licensed plumber or waterproofing contractor must be consulted to identify the cause of the staining and to provide advice on any reparation works that may be required. Replacement of any broken or damaged structures is advised.

Conversely, where water staining is old and inactive, affected building materials may be repaired or replaced at client discretion. A qualified carpenter or registered builder may be appointed to perform these works.

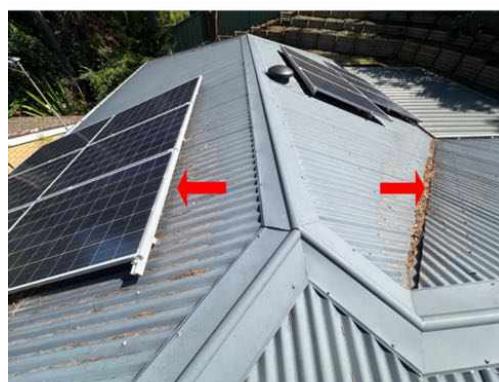
Finding 3.01

Blocked gutters are likely to lead to high levels of moisture in the affected areas. Such moisture will not only cause rust and decay of the associated building materials, but can also provide conditions that are conducive to termite and timber pest activity. Blockages in gutters should therefore be removed immediately to ensure dry conditions are maintained.

Consult a Licensed Plumber for further specific advice on remedial works that may be required. In the interim, it is highly advised that blocked gutters be removed by the homeowner or a general handyperson as a matter of urgency.

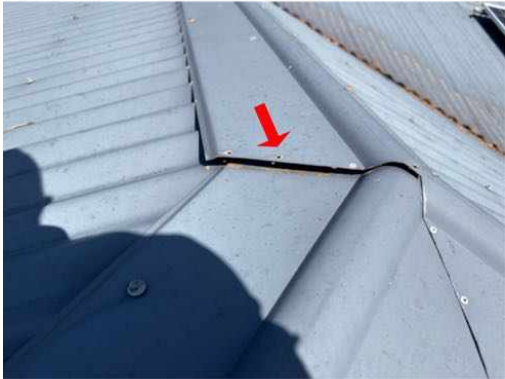
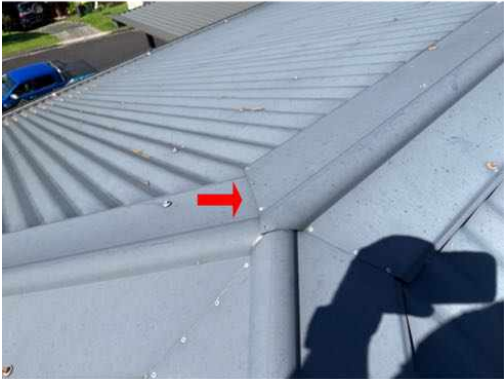
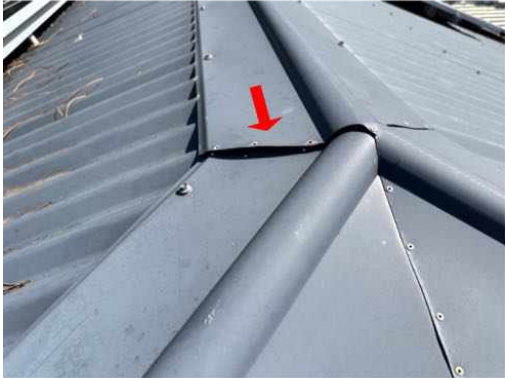
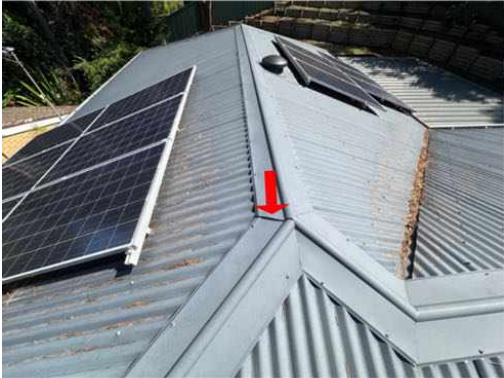
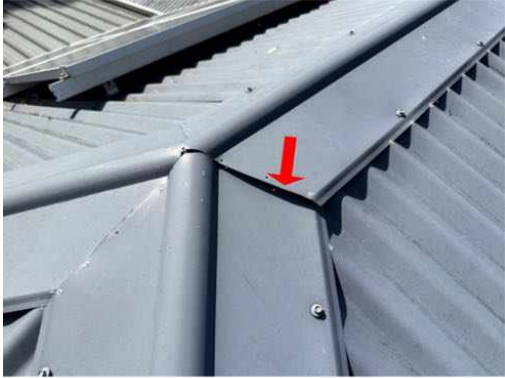
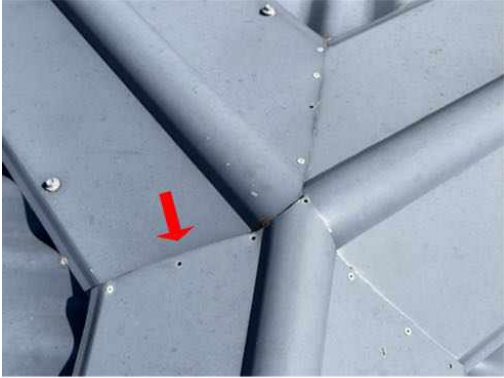
Finding 3.02

Building:	Main Building
Location:	All Areas > All Areas
Finding:	Roof plumbing - Loose flashing
Information:	Metal and other material flashings are applied to seals and intersections between roof coverings and building elements. They are designed to aid in weatherproofing of roof joins, and require regular inspection and maintenance as they are more subject to rust-related deterioration.

The flashing in this section of the exterior roofing appears to have come loose from its original fixing. It is suspected that this minor defect has occurred as a result of general deterioration over time.

Re-fixing and potential replacement of certain areas of flashing is advised to promote adequate roof drainage and protection from water penetration. Failure to perform these works may result in water damage and accelerated deterioration of associated building elements.

A roofing contractor or roofing plumber should be appointed as soon as possible to restore the flashing to a fully operational state.

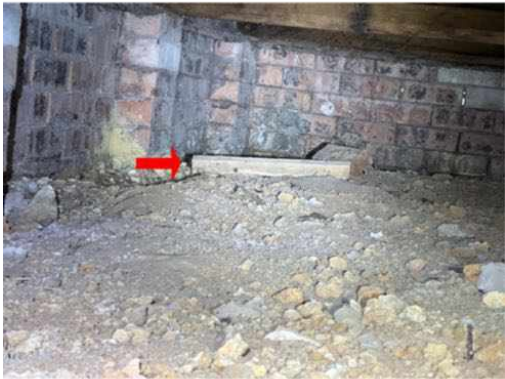
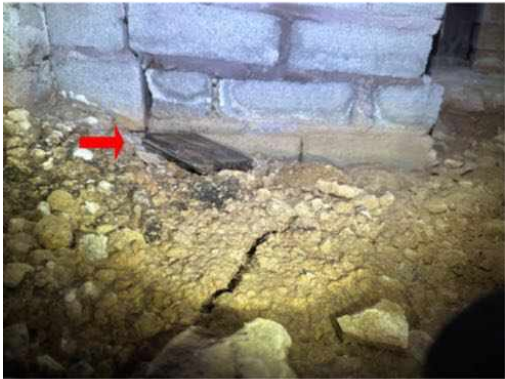
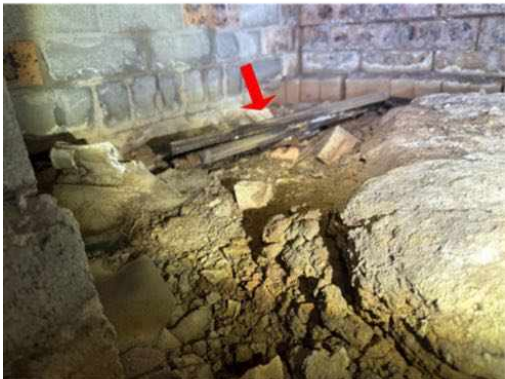
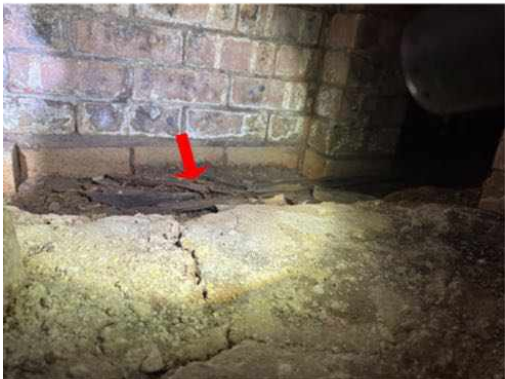
Finding 3.03

Building:	Main Building
Location:	Subfloor > All Areas
Finding:	Subfloor - Debris
Information:	An array of debris was found in the subfloor area at the time of inspection. Debris in this area restricts subfloor ventilation and creates potential for concealed pest entry. Stored timbers and other materials may also make the area susceptible to termite activity and wood rot.

A clear and empty subfloor will be better ventilated and easier to maintain in a dry condition. The removal of any timber debris is vital in minimising the risk of termite or wood borer activity.

Debris in the subfloor should be removed as soon as possible. Depending on the location and amount of debris and stored items, the homeowner may elect to undertake this task. Alternatively there are a large number of rubbish removal subcontractors that could undertake these works.

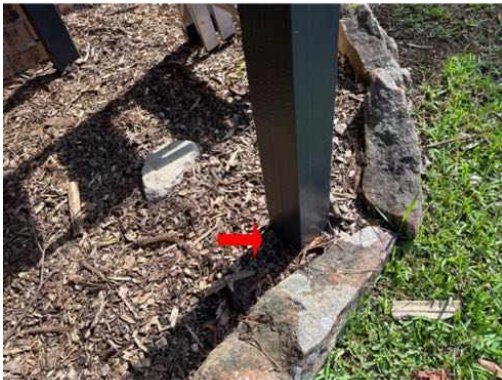
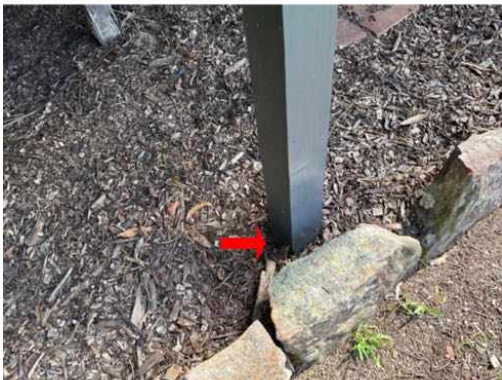
Building: Main Building
Location: All Areas > All Areas
Finding: Building materials in direct ground contact - conducive to termites
Information: Where timber elements are in direct contact with the ground and consequently moisture or dampness they become conducive to termite activity. Whether timber is used as a building element part of a fencing structure or stored as an unused item they can provide an environment that is attractive to termite infestation.

When met with excessive moisture timber begins to decay and develop wood rot. Any timbers that are in direct contact with external grounds especially if left untreated or non-durable also provide ingress for subterranean termites into that particular element.

The removal of any such materials that may be conducive to termite activity should be removed as soon as possible to minimise the risk of termite attack.

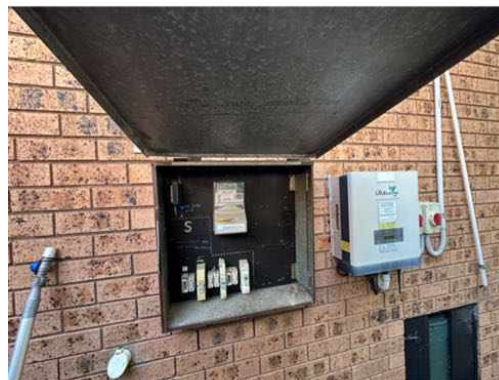
Finding 6.02

Building:	Main Building
Location:	Electrical circuit box > Front Left
Finding:	Termite Management System - no evidence of a chemical installation
Information:	The application of a post-construction chemical termite barrier is highly recommended for all properties, particularly if live termite activity has been found on the site previously. Such barriers are highly effective in preventing termite attack on any timber building elements throughout the property.

A durable notice should be placed in the switchboard unit to indicate current termite barriers. At the time of inspection, it appeared as though no termite management system has been installed, with no evidence to suggest preventative works taking place.

The client may consider gaining further advice from a pest controller as to the costs and procedures involved with this application. It is recommended that obtaining such advice be a short-term priority.

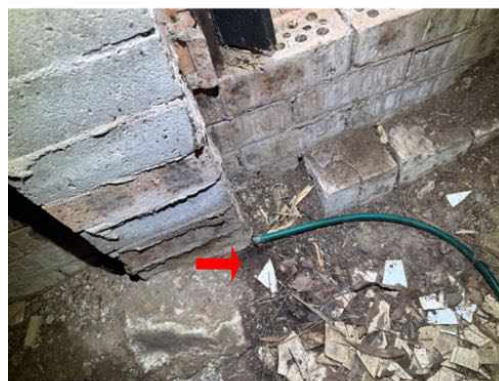
Finding 6.03

Building:	Main Building
Location:	Subfloor > Front Left
Finding:	HWS Overflow - Not Connected
Information:	The Hot Water System (HWS) overflow was found to be disconnected from storm water drainage and is creating excessive moisture in the surrounding area.

These damp conditions can lead to secondary defects such as rot, rust or corrosion of associated building elements, the formation of fungal decay, or even the creation of potential slip hazards. When coupled with poor site drainage, pooling of water may also attract termite activity to this area.

It is highly recommended that a licensed plumber be appointed to connect the HWS overflow in order to prevent such an environment from being created. These minor works should be carried out as soon as possible.

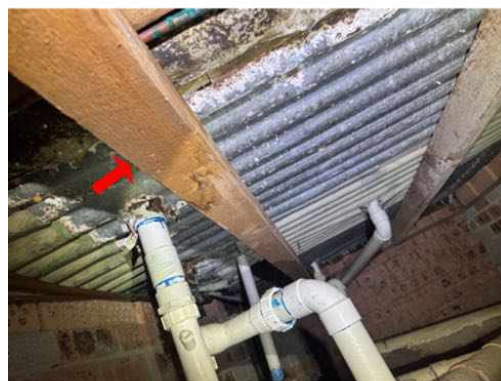
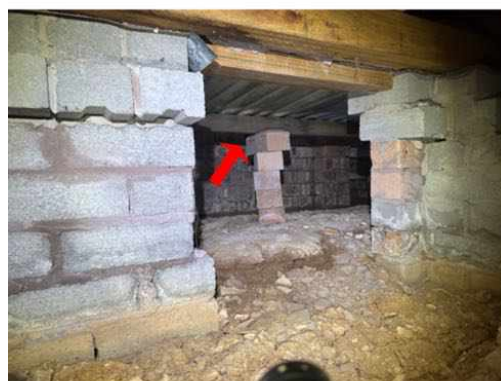
Finding 6.04

Building:	Main Building
Location:	Subfloor-Balcony/Bathroom > Centre Left
Finding:	Formwork timber: Left in situ
Information:	Formwork timber appears to have been left on site and in situ after concrete

construction. Formwork timber is used to support and shape the concrete while pouring during the construction process. Leaving formwork timbers in the subfloor space or around the exterior of the property increases the risk of termite activity being present. As they are likely to come into contact with weather conditions or excessive moisture wood rot is likely to develop on timbers that are not treated. It is highly recommended that any formwork timbers be immediately removed from areas in which they may attract any termite/timber pest attack. Minimisation of risk/prevention of termite attack is far more adequate than dealing with the presence of termite activity.

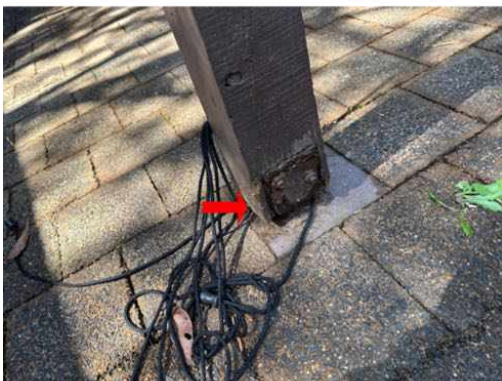
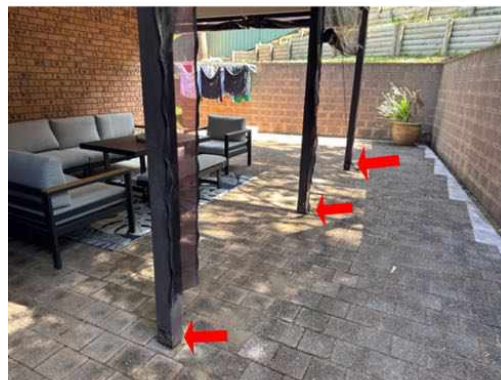
Finding 7.01

Building:	Main Building
Location:	Carport > Centre Right
Finding:	Wood rot
Information:	This building element shows evidence of wood rot. Wood rot, also known as Fungal Decay, occurs when timbers and other cellulose building materials are exposed to damp conditions on an ongoing basis. This could be the result of exposure to weathering over a prolonged period of time, or the attraction of excessive moisture from other abutting building materials. Contributing factors also include poor air

Wood rot is often associated with general damp problems and is evidenced by a 'musty' smell or mould and mildew occurring on surfaces. If left unmanaged, damp conditions can lead to further health problems and the decay of timbers will continue.

Early intervention and regular maintenance, particularly of exterior timbers, will prolong the useful life of these building elements. Prior to any works being performed, the cause of the moisture that has created the visible wood rot should be identified and addressed in a suitable manner. Replacement of affected timbers may then be a necessary step in protecting surrounding building elements from such deterioration.

A qualified plumber may be appointed to assess the cause of excessive moisture and to provide advice on any remedial works as required. A qualified carpenter or registered builder may also be required to replace affected building materials.

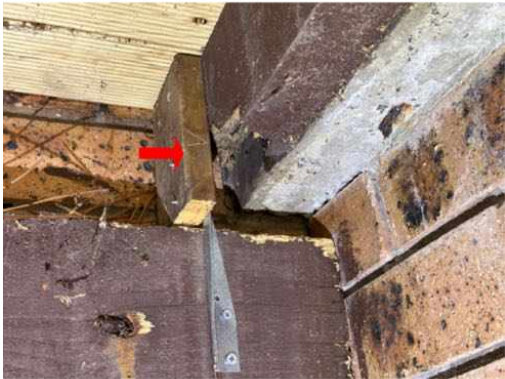
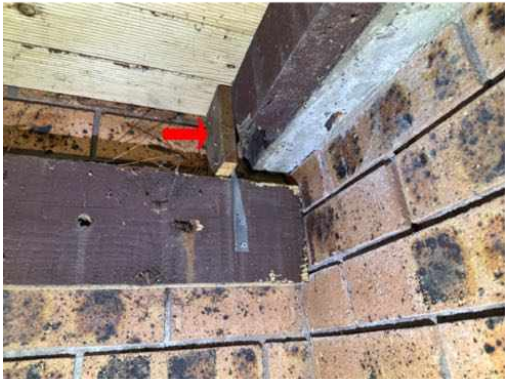
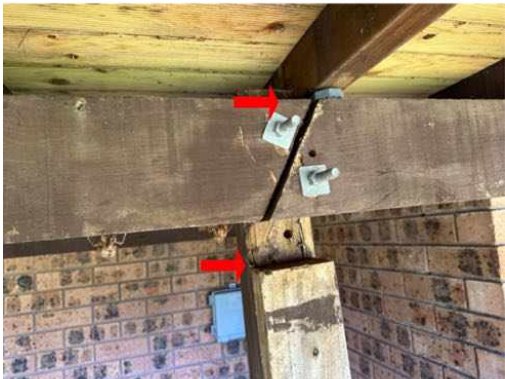
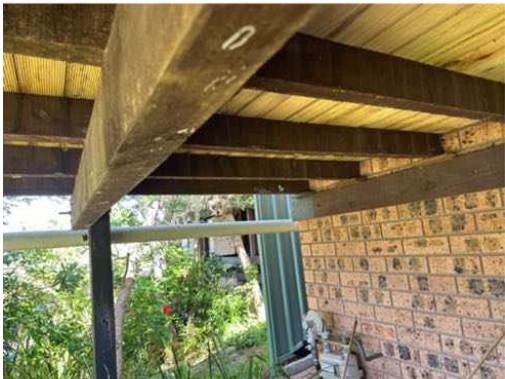
Finding 7.02

Building:	Main Building
Location:	Verandah > Front Left
Finding:	External Timber Balcony or Deck - Structural Stability
Information:	The load capacity of the external balcony or deck could not be verified during the inspection.

External timber structures are also constantly exposed to weather elements and can deteriorate in an accelerated manner, ongoing assessments are required.

This building element shows evidence of wood rot. Wood rot, also known as Fungal Decay, occurs when timbers and other cellulose building materials are exposed to damp conditions on an ongoing basis. This could be the result of exposure to weathering over a prolonged period of time, or the attraction of excessive moisture from other abutting building materials. Contributing factors also include poor air ventilation in the area.

Wood rot is often associated with general damp problems and is evidenced by a 'musty' smell or mould and mildew occurring on surfaces. If left unmanaged, damp conditions can lead to further health problems and the decay of timbers will continue.

Early intervention and regular maintenance, particularly of exterior timbers, will prolong the useful life of these building elements. Prior to any works being performed, the cause of the moisture that has created the visible wood rot should be identified and addressed in a suitable manner. Replacement of affected timbers may then be a necessary step in protecting surrounding building elements from such deterioration.

It is highly recommended that a Structural Engineer further assess the external timber balcony or deck to inform the client of its load capacity. Regular maintenance inspections by competent practitioners is needed.

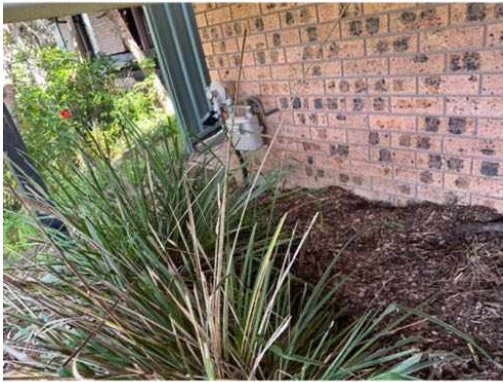
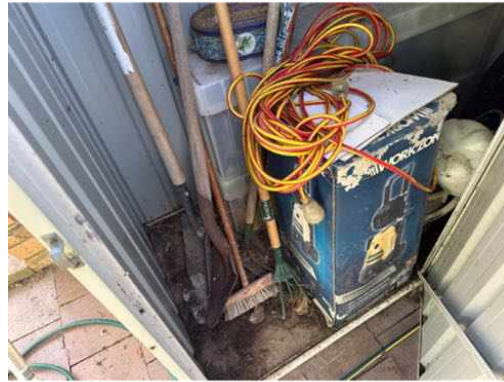
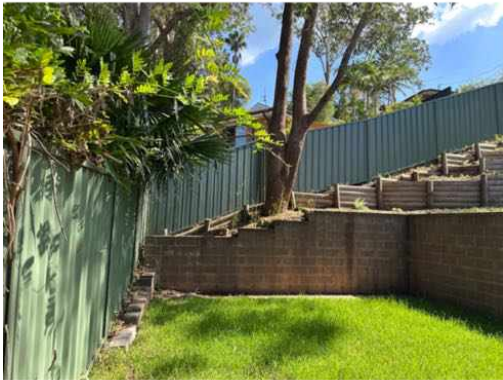
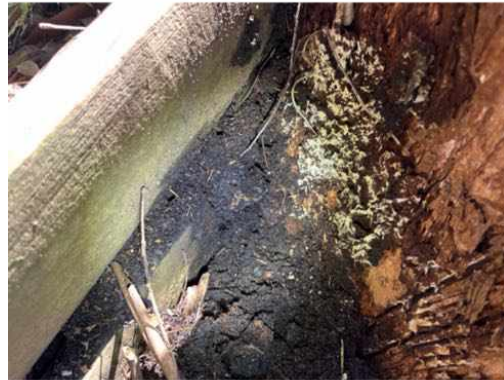
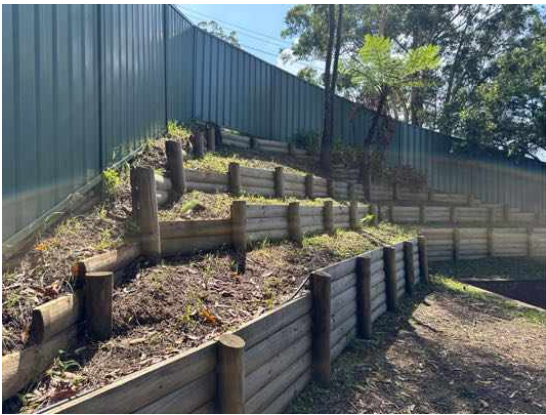
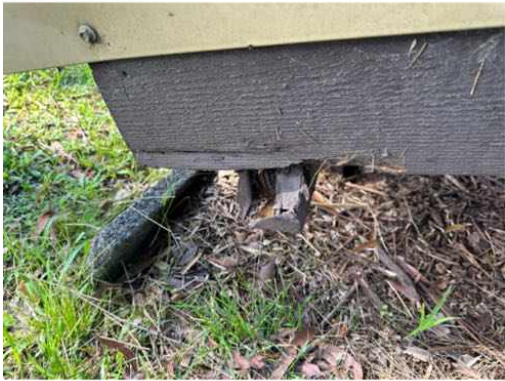
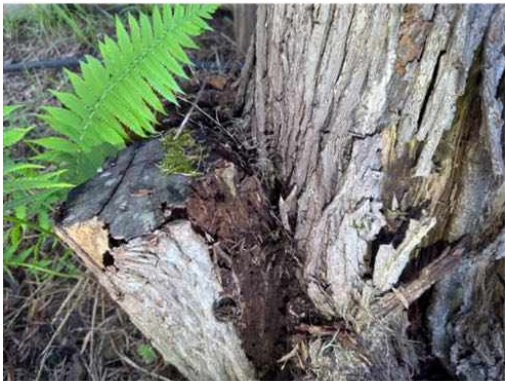
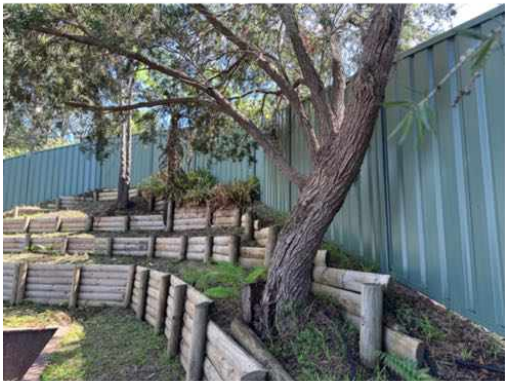
Noted Item

Building: Main Building
Location: All Areas > All Areas
Finding: Additional Photos - Obstructions and Limitations
Information: These photographs are an indication of the obstructions and limitations which impeded full inspection of the property at the time of inspection. These obstructions can hide an array of defects and should be removed to allow full inspection to be carried out. A re-inspection is recommended once the areas are made accessible.

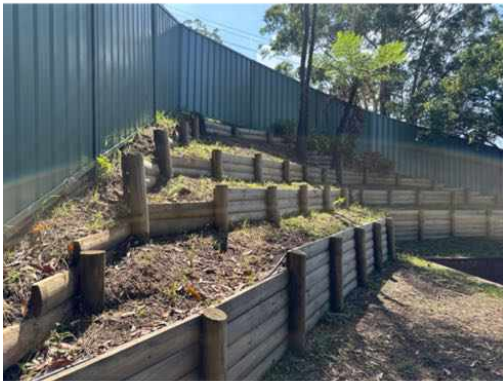
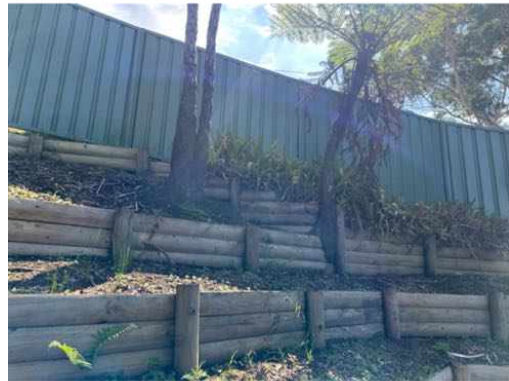
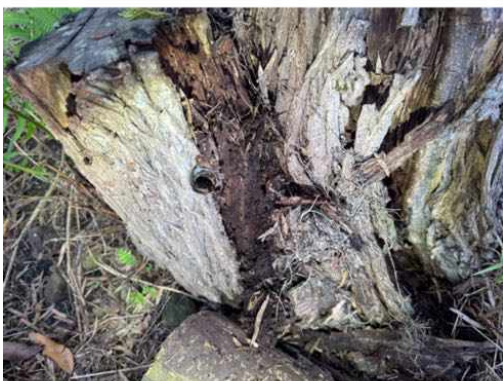
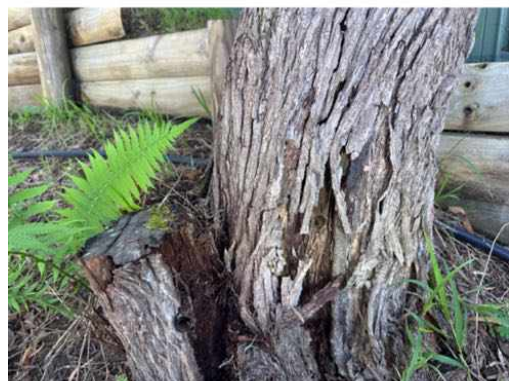
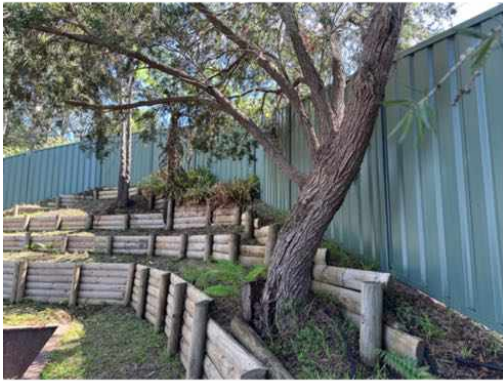
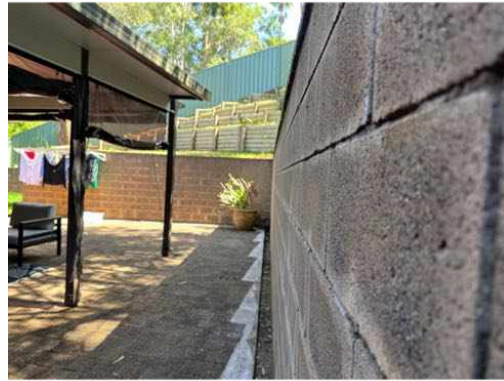
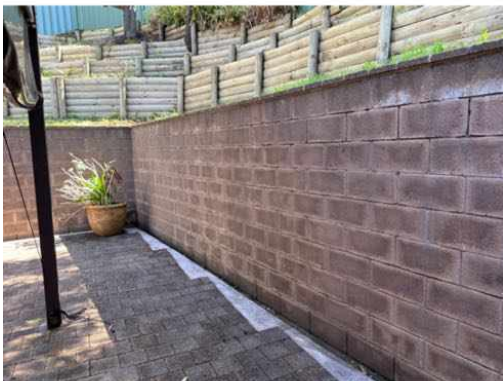
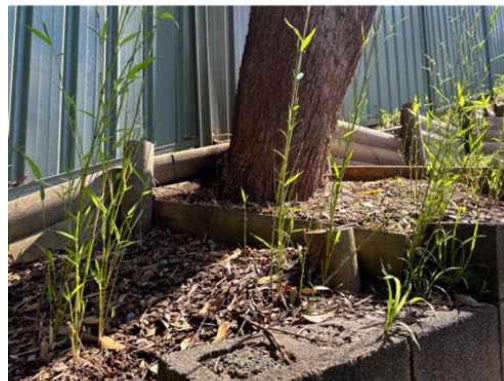
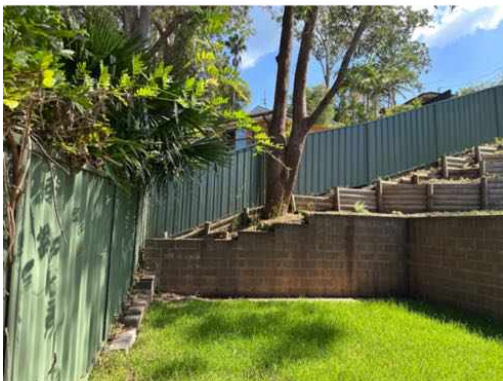
Building: Main Building
Location: Yard - Back > All Areas
Finding: Additional Photos
Information: Additional photos are provided for your general reference

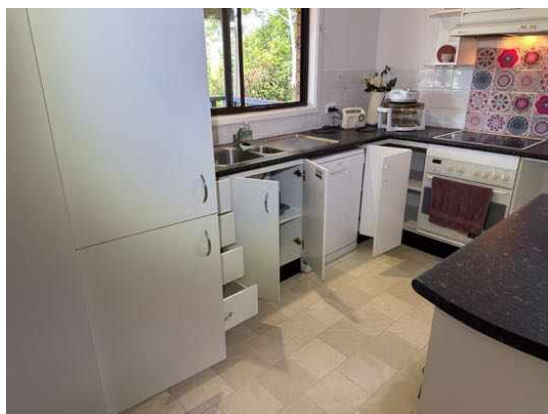
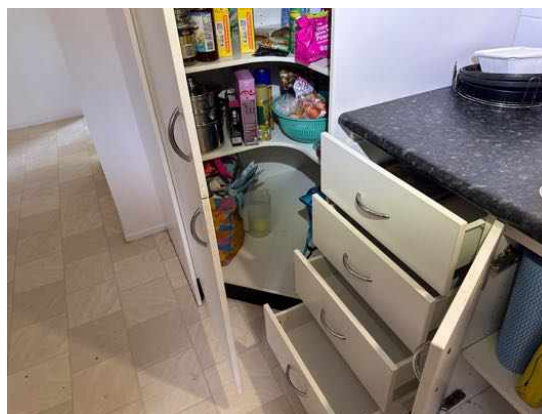
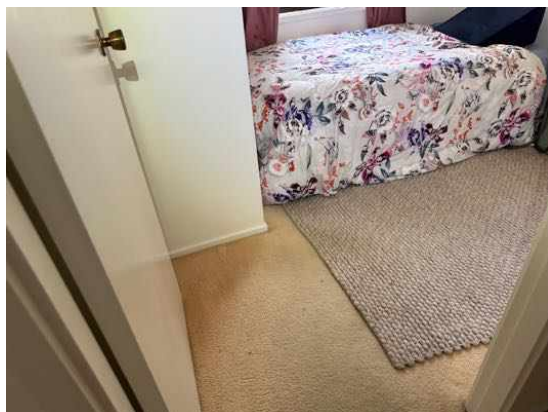
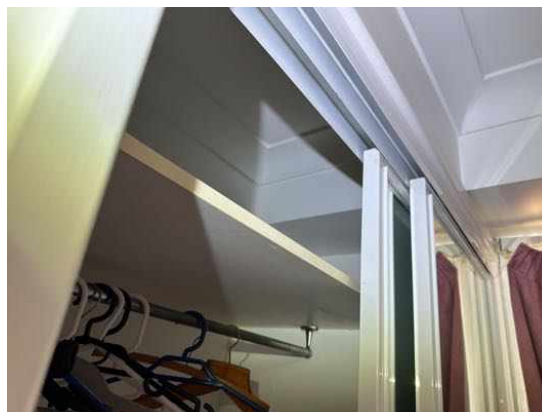
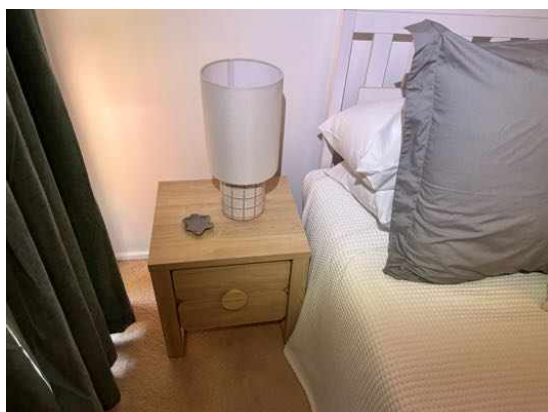
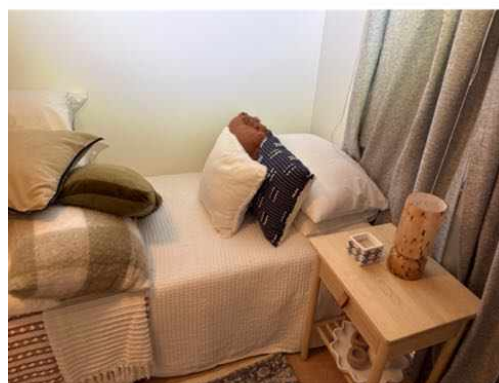
Building:	Main Building
Location:	All Areas > All Areas
Finding:	Additional Photos - Obstructions and Limitations
Information:	These photographs are an indication of the obstructions and limitations which impeded full inspection of the property at the time of inspection. These obstructions can hide an array of defects and should be removed to allow full inspection to be carried out. A re-inspection is recommended once the areas are made accessible.

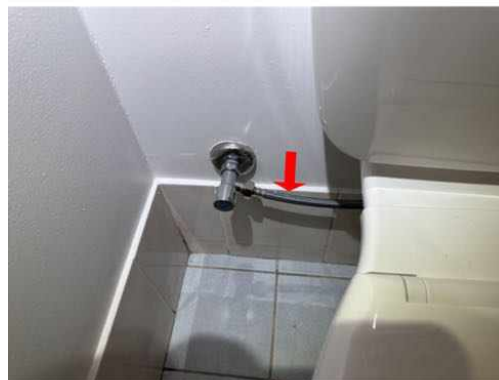
Building: Main Building
 Location: All Areas > All Areas
 Finding: Pipe: Flexible Braided pipes.
 Information: Braided Stainless Steel Flexi connector hose are popular in modern home fit outs because they can be bent into shape. They started to be installed in the early two thousands and their use is now extremely widespread in contemporary construction and renovations.

Flexible braided hoses accounted for more than one in five water damage claims lodged by Australian households according to research released by general insurer IAG.

It is recommended that the Flexi pipes to be replaced at the owners discretion to avoid an “escape water incident” which may lead to water damage to other building elements in the home.

This work can be undertaken by a licensed plumber, general handy person at the owners discretion.

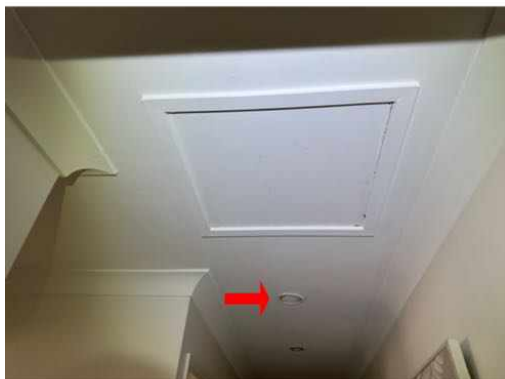
Building:	Main Building
Location:	Hallway > Centre
Finding:	Smoke Detectors and Alarms
Information:	Reporting on Smoke Detectors or Alarms, including hard wired smoke detection systems and their legislative requirements, is outside the Scope of this Report.

Please note that this defect is highlighted as a caution only. We suspect, based on our experience in the building industry, that the absence of smoke detectors, or their poor condition, should be addressed as a matter of urgency to improve occupant safety.

Always ensure sufficient working and suitable smoke detectors are installed prior to occupying any building. Additionally, it is advised that all smoke detectors be tested by the homeowner on a monthly basis.

Please refer to AS3786 and state based legislation, which may also apply.

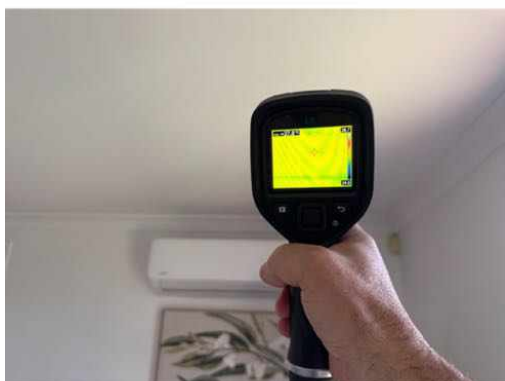
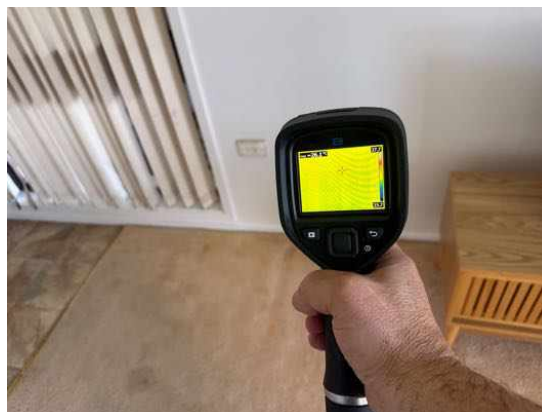
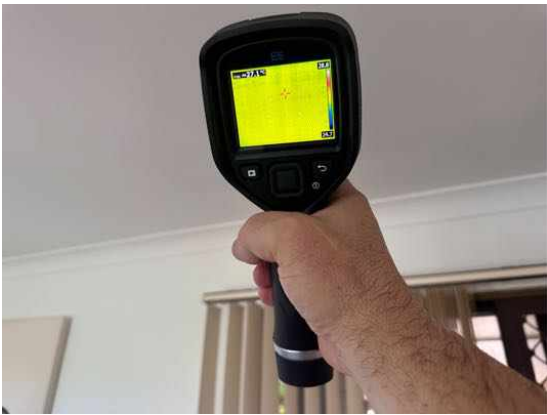
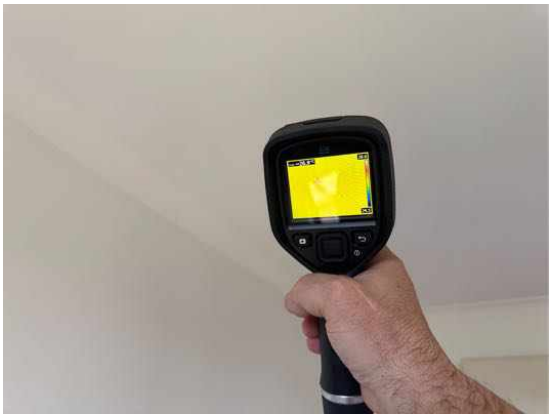
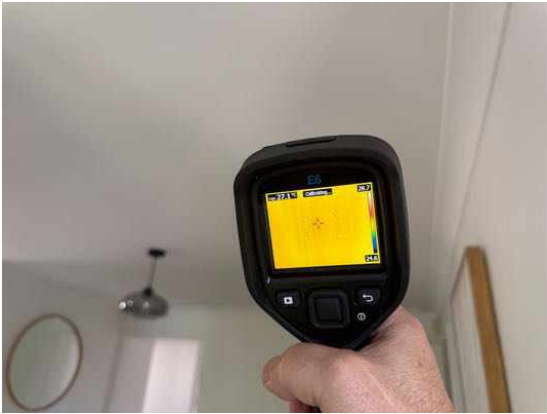
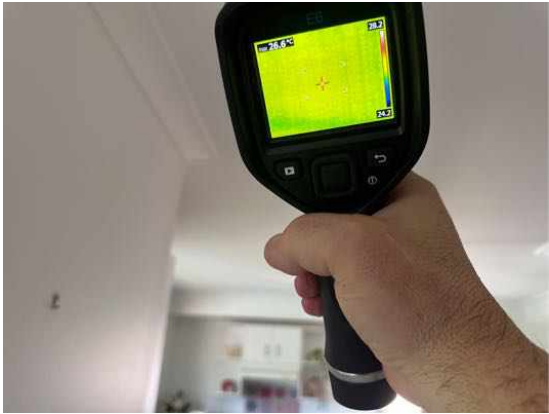
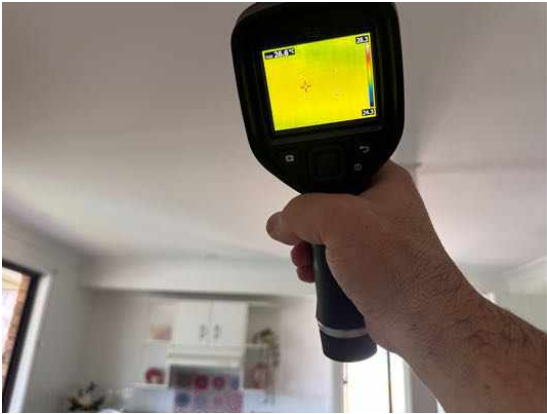
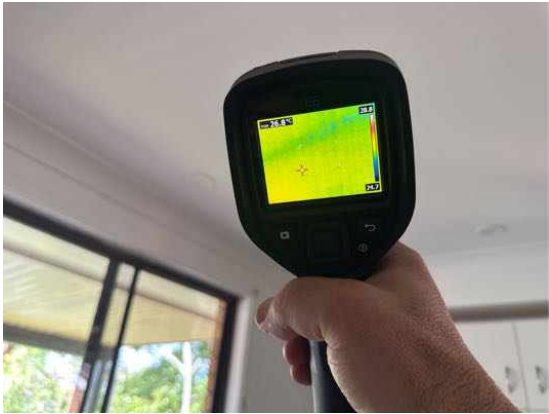
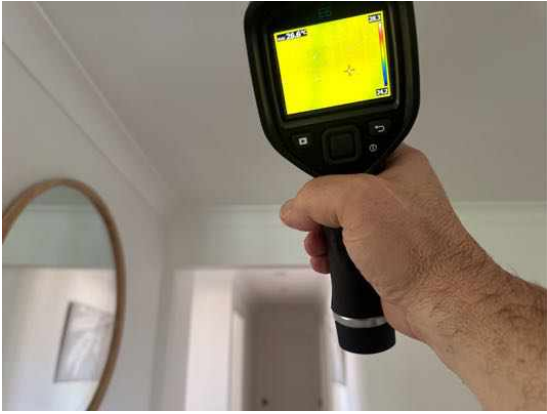
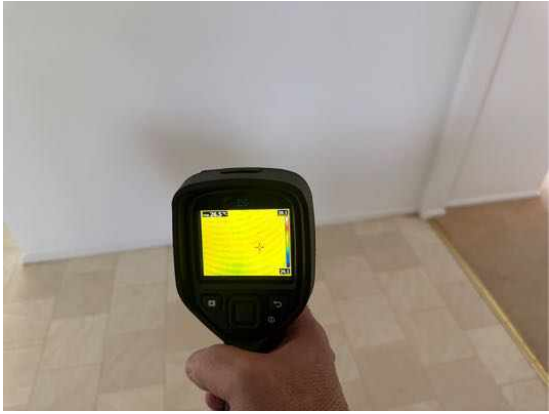
Building: Main Building
 Location: All Areas > All Areas
 Finding: Thermal imaging: No excessive moisture presentation.
 Information: At the time of inspection there appeared to be no excessive moisture presentation in this area.

NOTE: If the Property has been vacant for a period of time or wet areas not used, moisture levels or leaks may not be detectable at the time of the inspection because often only frequent use of water pipes (showers, taps etc) result in a leak being identifiable. We advise further testing on pipes and water susceptible areas (such as the bathroom and laundry) after more frequent use has occurred.

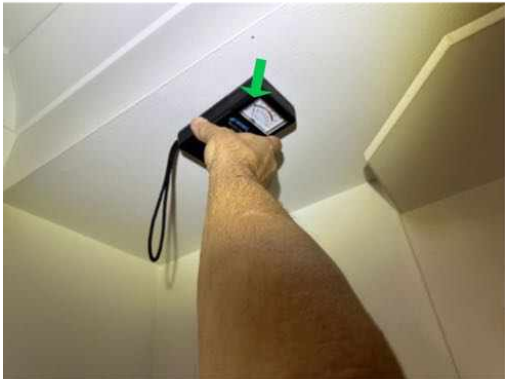
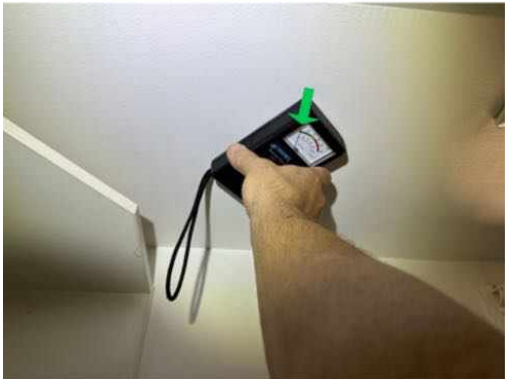
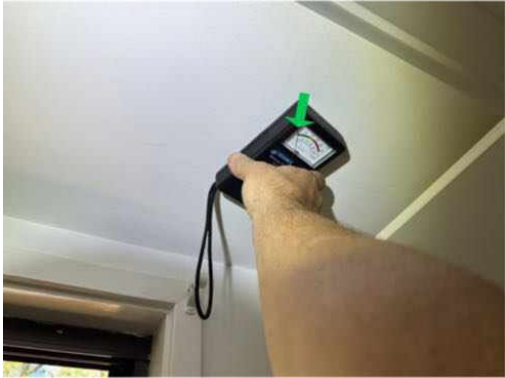
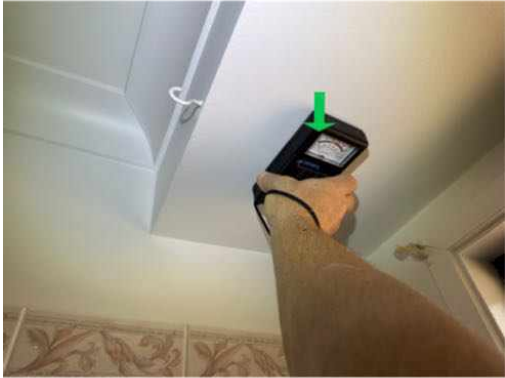
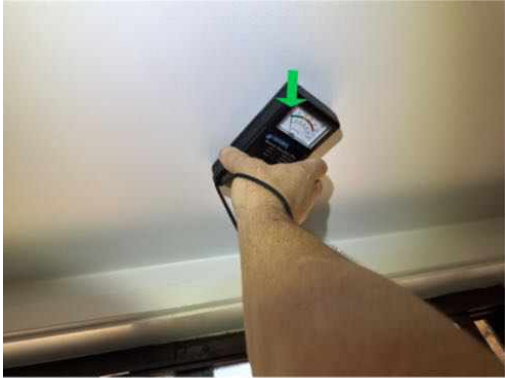
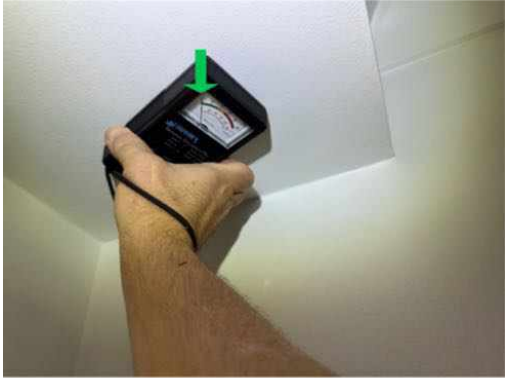
Building: Main Building
Location: All Areas > All Areas
Finding: Moisture Meter used: No Moisture Detected.
Information: Moisture meter was used during the inspection and no excessive moisture was detected to accessible walls inside the property at the time of inspection.

NOTE: If the Property has been vacant or water not used for a period of time, moisture levels or leaks may not be detectable at the time of the inspection because often only frequent use of water pipes (showers, taps etc) result in a leak being identifiable. We advise further testing on pipes and water susceptible areas (such as the bathroom and laundry) after more frequent use has occurred.

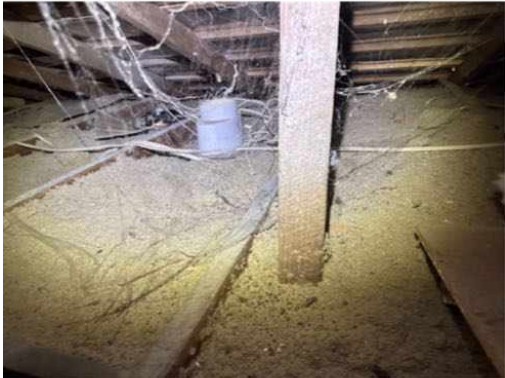
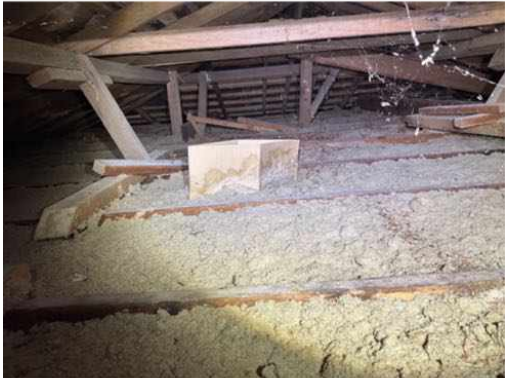
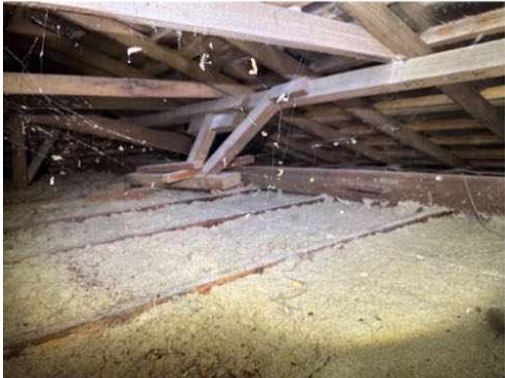
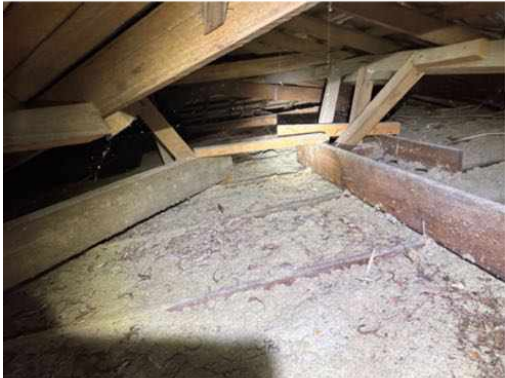
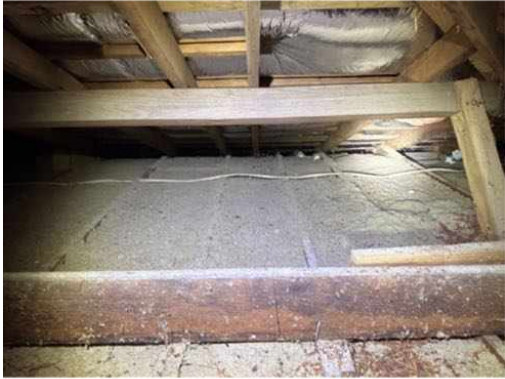
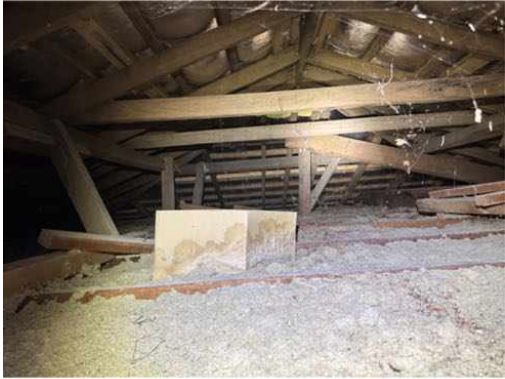
Building: Main Building
Location: All Areas > All Areas
Finding: Roof void: limited access.
Information: Limited access to the roof void was present due to facts including but not limited to access hatch size or placement, insulation, low pitched roof area, for this reason inspection to the roof void was minimal and a range of defect's from minor to major may not be visible at the time of inspection.

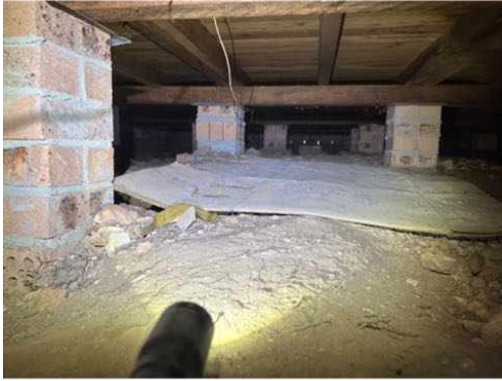
Building: Main Building
Location: Subfloor > Rear
Finding: Sub Floor restricted Access.
Information: At the time of inspection the sub floor area had restricted access due to minimal crawl space between floor and ground levels, and a continuous footing wall with impassable breaks at intervals.
