# Building and Timber Pest Inspection Report

Inspection Date: Wed, 8 Apr 2026

Property Address: 12 Frederick St, Vincentia NSW 2540,  
Australia

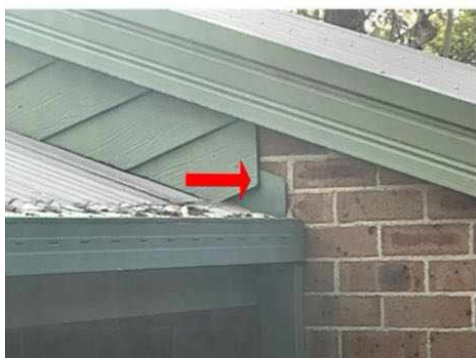
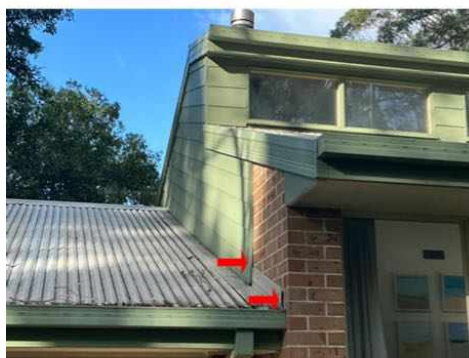
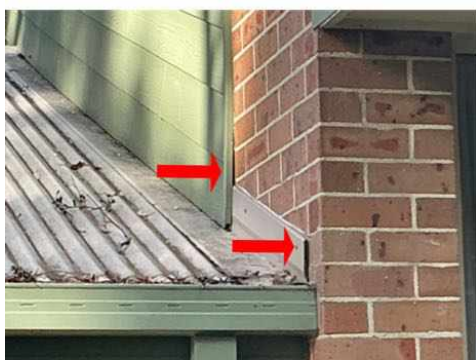
| Finding: | Flashing Inadequate |
| Information: | At the time of inspection the flashing in this area appeared to be inadequate. |

Flashings are an integral element of the building's external waterproofing systems. Flashings divert water away from the structures' openings to prevent any water ingress. If these flashings are inadequate or compromised in any way it will allow water penetration through the exterior cladding skin.

Water ingress will lead to secondary defects such as water staining and internal damage progressing to structural damage if left unmanaged. Damp environments are also conditions suitable for termite activity. It is advisable to get this defect rectified as soon as possible.

Consult a licensed Builder for further instructions.

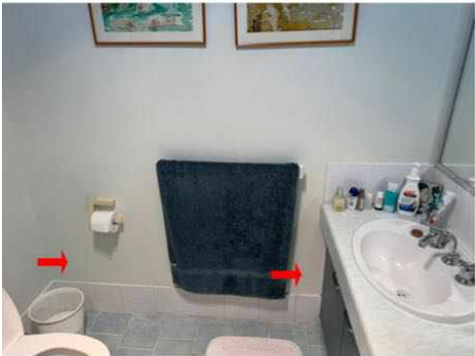
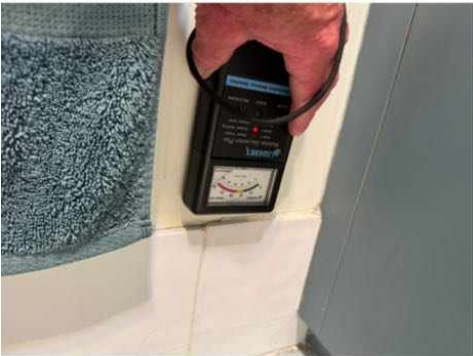
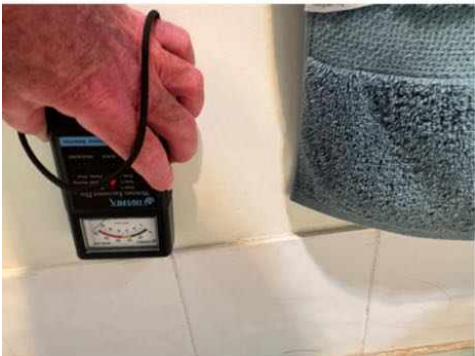
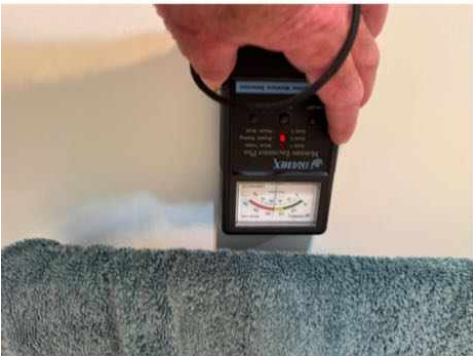
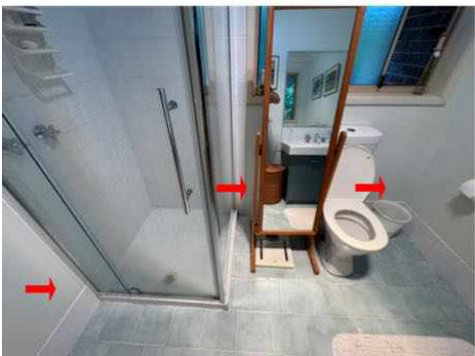
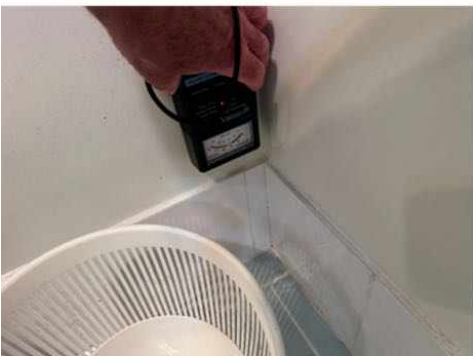
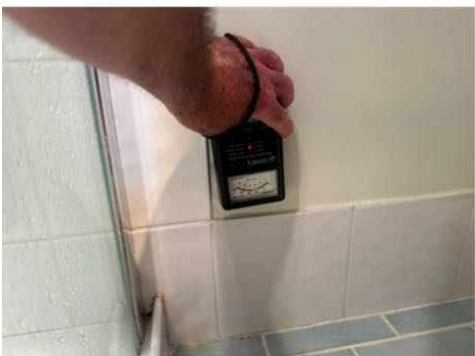
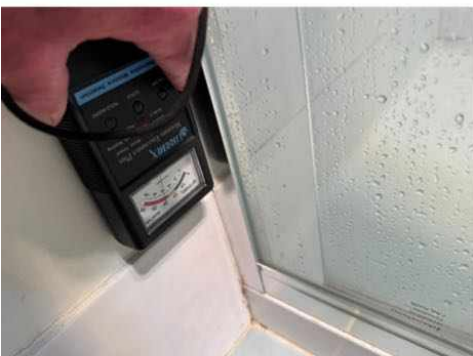
## Finding 2.02

| Finding: | Areas of High Moisture Meter Readings |
| Information: | At the time of inspections this area showed high moisture meter readings. Please note that the moisture meter readings above the towel and outside these walls were normal. |

High moisture meter readings can be the result of recent cleaning, high humidity, poor ventilation, water ingress, rising damp, water pooling against the property and even termite ingress.

High moisture levels can have damaging effects on surrounding building materials, possibly creating moulds which can have health issues in living areas. It is highly advised that the cause of these high moisture meter readings is identified and rectified as soon as possible to ensure a healthier environment for the areas concerned.

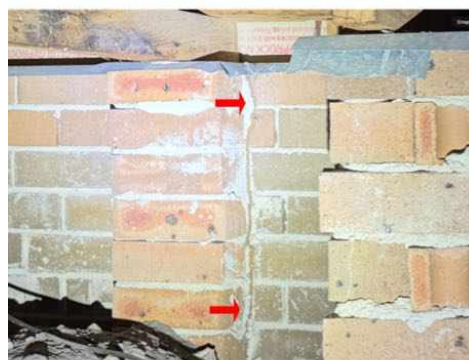
Finding 2.03

| Information: | Termite activity was found to have affected this area of the subfloor. It is advised that the area be visually inspected frequently to ensure that the condition of affected building materials does not reoccur. |

Please note that although no evidence of live termite activity was found in the roof void or subfloor, because of obstructions and access restrictions the extent of any activity, in the wall cavity and roof space areas is unknown.

It is strongly recommended that the licensed Timber Pest Controller who conducted the last treatment is consulted for further information regarding a termite management system. DNA Pest Control (02) 4421 2009 installed their product on 15/5/21, however it is unknown if this treatment is still active.

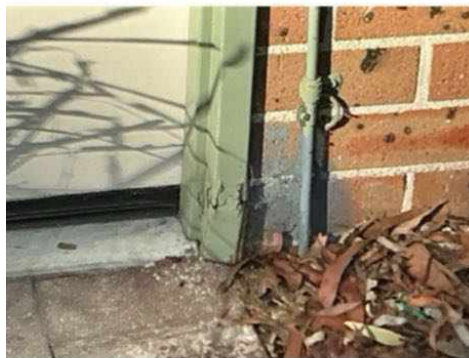
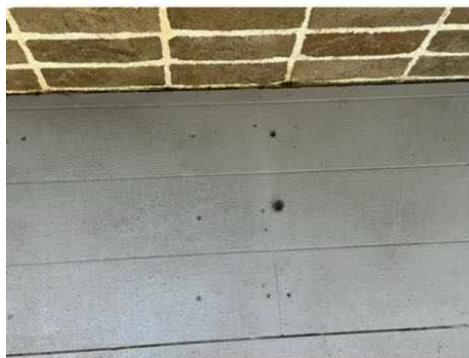
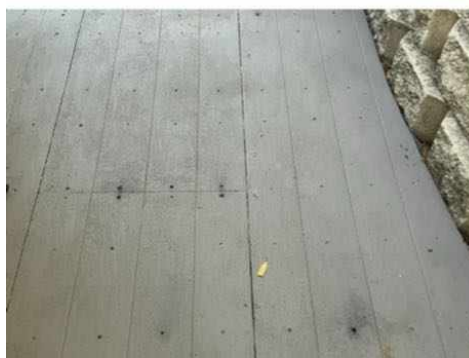
### Finding 3.01

| Finding: | Building element - Rusted or corroded |
| Information: | This building element shows evidence of rusting and corrosion, which is likely to have developed as a result of excessive exposure to moisture and or inadequate coatings. Rusted items include; |

- the garage door jam requires repairs.
- some exterior screws require replacement.

As surface rust provides no protection to the underlying iron, the deteriorating condition is likely to worsen if not addressed in the short-term future. Where possible,

the use of galvanized (treated) metals or aluminium coated metals aid in rust prevention, as does regular general maintenance. Rust formation can be controlled with coatings, such as paint, that isolate the iron from the environment.

Rusting and corrosion should be managed by ideally removing or limiting the affected surface from exposure to moisture. A registered builder may be appointed to replace any building elements that have been severely affected by rust or water damage.

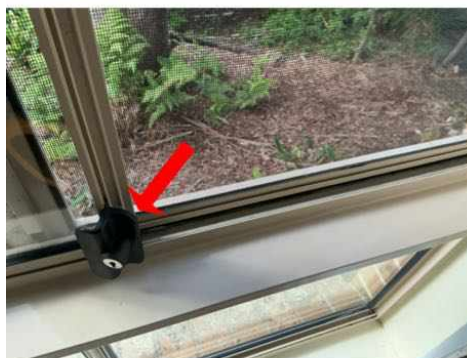
| Finding: | Building element - Damaged |

Repair and/or replacement of broken elements is advised to ensure that additional secondary defects do not arise as a consequence. Such works are necessary, as all building elements play a key role in the operation and function of the overall structure and its performance.

A relevant tradesperson should be appointed to provide a quote to repair or replace the affected building element prior to purchase.

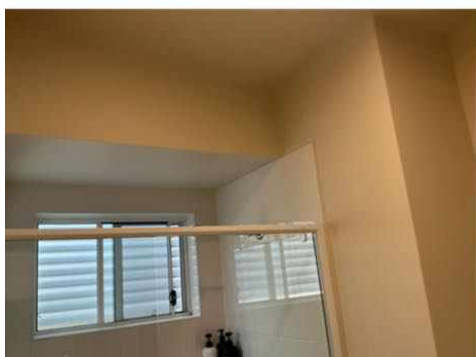
### Finding 3.05

| Finding: | Exhaust fan - Missing |
| Information: | An exhaust fan has not been installed in this area. Missing exhaust fans may lead to the development of more significant defects such as moisture damage to surrounding building materials from inadequate ventilation. Inadequate ventilation in internal areas creates an environment that is conducive to the formation and development of mould and other respiratory hazards. It is highly advised that a licensed electrician be appointed to retrospectively install an exhaust fan. Failure to perform works to aid the ventilation of the area may lead to the development of these secondary defects. |

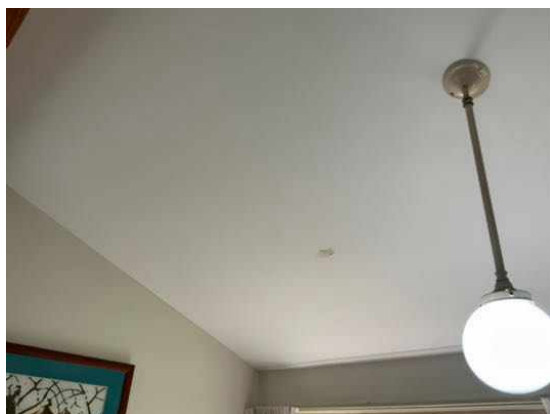
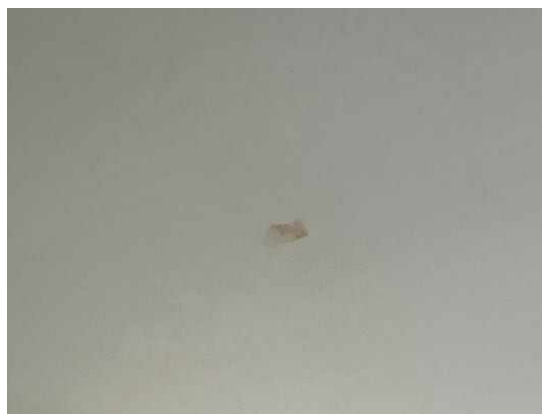
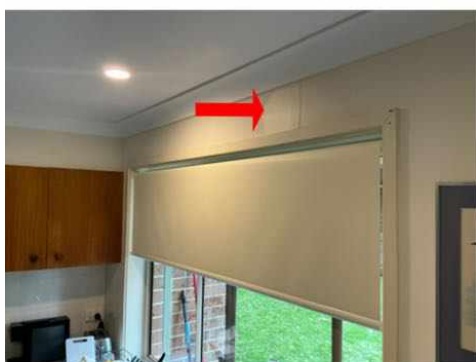
### Finding 3.06

| Information: | Superficial scuff marks were noted to the internal surfaces in this area at the time of inspection. |

A general handyman or cleaning contractor may be appointed to rectify marked or scuffed surfaces at the client's discretion.

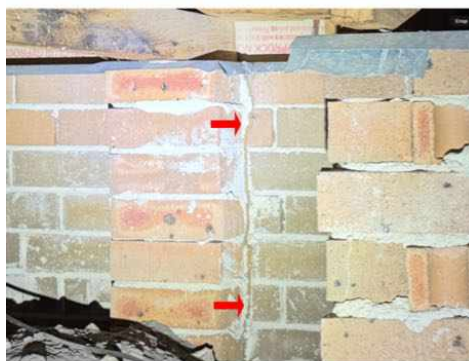
Please note that although no evidence of live termite activity was found in the roof void or subfloor, because of obstructions and access restrictions the extent of any activity, in the wall cavity and roof space areas is unknown.

It is strongly recommended that the licensed Timber Pest Controller who conducted the last treatment is consulted for further information regarding a termite management system. DNA Pest Control (02) 4421 2009 installed their product on 15/5/21, however it is unknown if this treatment is still active.

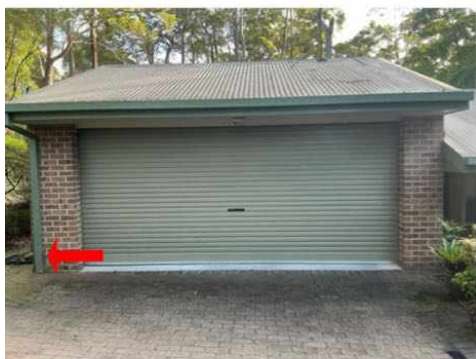
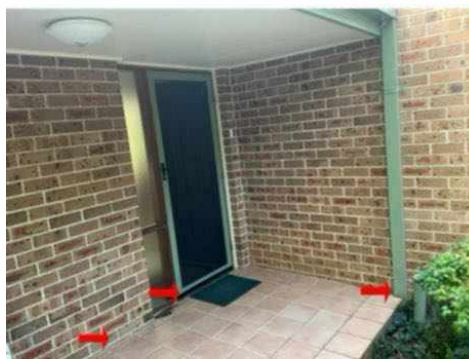
### Finding 6.01

Generally this takes the form of finished ground levels external paving, concrete, fencing posts, gardens, vegetation, plumbing, stored items etc being retrospectively installed above the ant cap level or weep and ventilation holes.

Where bridging of the termite management system has occurred full inspection is prevented and termites may enter a property in a concealed or undetectable manner.

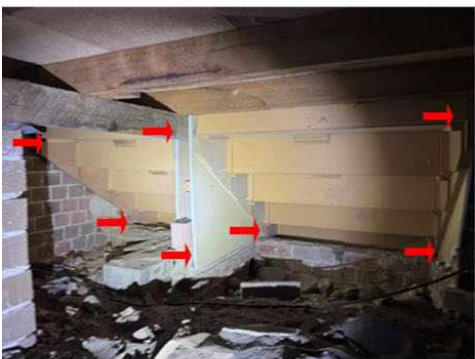
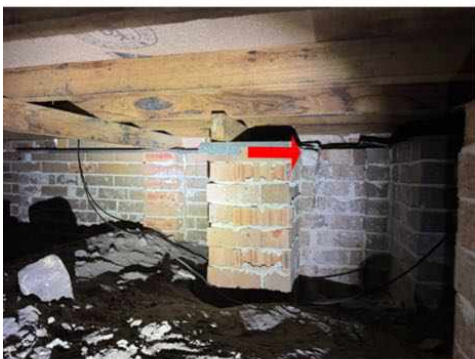
Finding 6.02

Building: Main Building  
Location: All Areas  
Finding: In ground contact  
Information: Any timbers in direct ground contact provide opportunity for concealed termite entry and are likely to be subject to premature rot and decay as the soil retains moisture or damp conditions against the timbers.

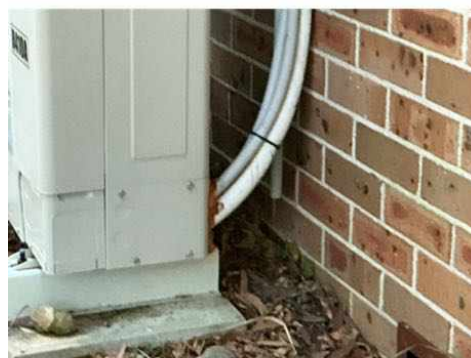
Heavy leaking from the air-conditioning unit is likely to produce damp conditions in the surrounding area conditions which are conducive to termite attack. If left unattended, such leaking can develop into water pooling below the unit, creating potential for subsequent water damage to associated building elements.

A refrigeration mechanic or licensed plumber should be appointed to assess the condition of the unit and to perform any remedial works as necessary. While discharge from an air-conditioning unit can generally be managed through basic plumbing work, such appointments are deemed necessary to identify any major issues.

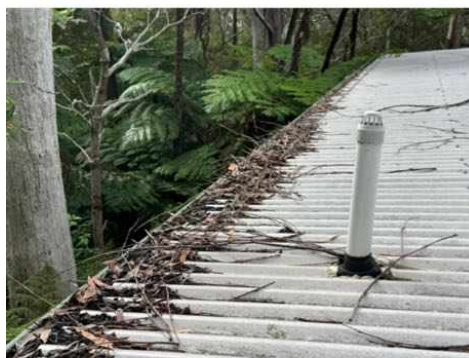
### Finding 6.04

Blocked gutters are likely to lead to high levels of moisture in the affected areas. Such moisture will not only cause rust and decay of the associated building materials, but can also provide conditions that are conducive to termite and timber pest activity. Blockages in gutters should therefore be removed immediately to ensure dry conditions are maintained.

Consult a Licensed Plumber for further specific advice on remedial works that may be required. In the interim, it is highly advised that blocked gutters be removed by the homeowner or a general handyperson as a matter of urgency.

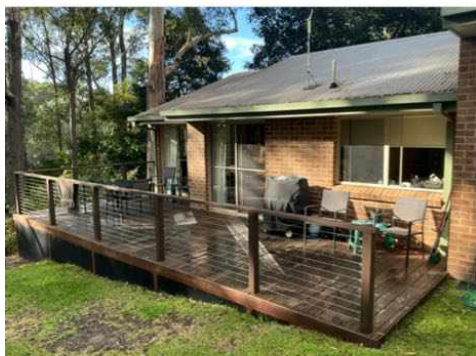
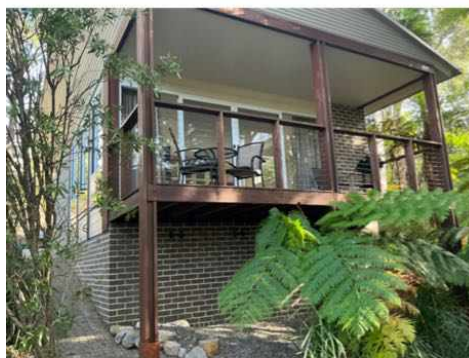
External timber structures and fixings are also constantly exposed to weather elements and can deteriorate in an accelerated manner, ongoing assessments are required.

It is highly recommended that a Structural Engineer further assess the external timber balcony or deck to inform the client of its load capacity. Regular maintenance inspections by competent practitioners is needed.

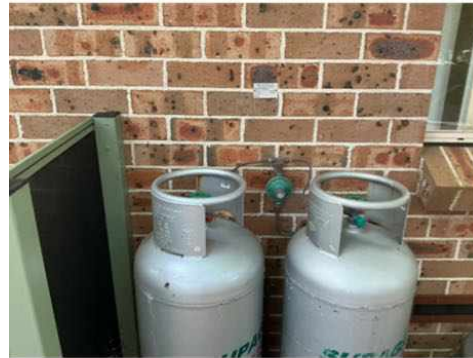
The studio gas bottle compliance plate reads 19 -5-14.

Where installation is out dated, the client should contact the responsible trade (gas plumber) to undertake further inspections.

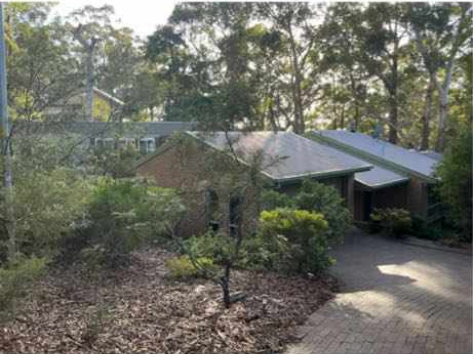
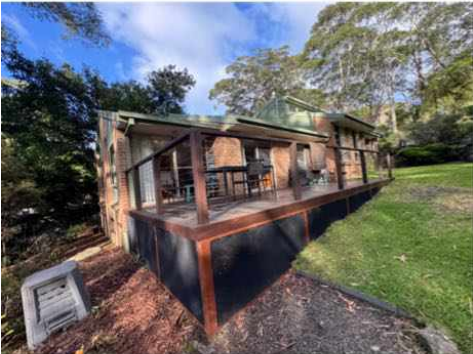
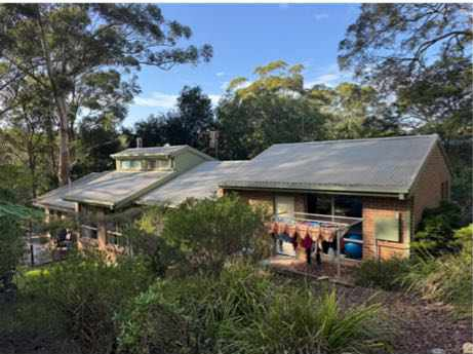
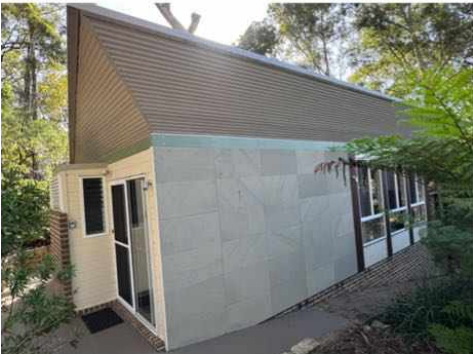
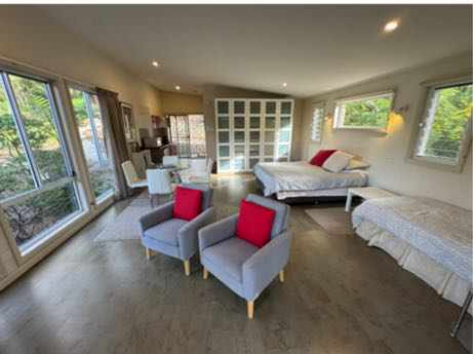
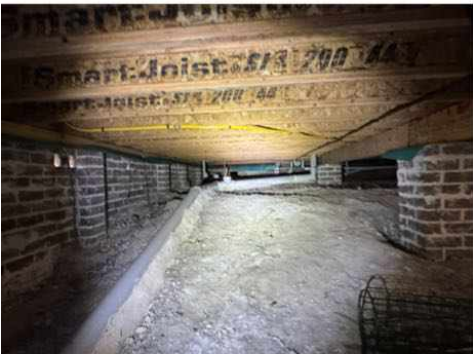
- obstructions from other building materials.
- finished concrete and paving levels.
- finished ground levels.
- vegetation.
- vehicles.

A further invasive inspection is recommended to these areas immediately.
