# Building and Timber Pest Inspection Report

Inspection Date: Thu, 12 Feb 2026

Property Address: 11 Fleet Avenue, Jordan Springs NSW 2747

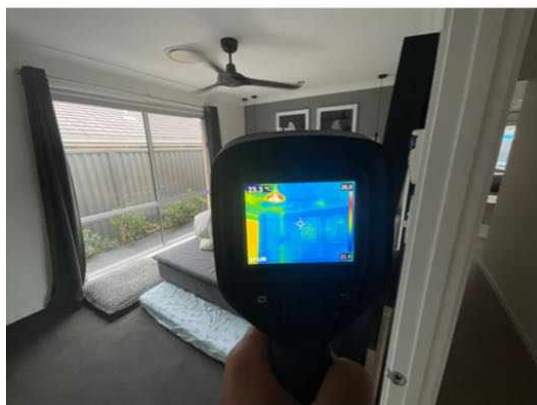
At the time of the inspection, no abnormalities indicating live termite activity were observed. However, it's important to note that various factors—such as obstructions, ambient temperature, and wall material/thickness—can impact the accuracy of thermal readings. In cases where surfaces are visually restricted or obstructed, a

comprehensive thermal scan may not always be feasible.

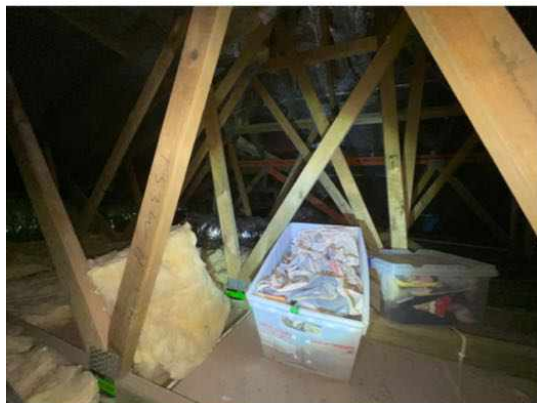
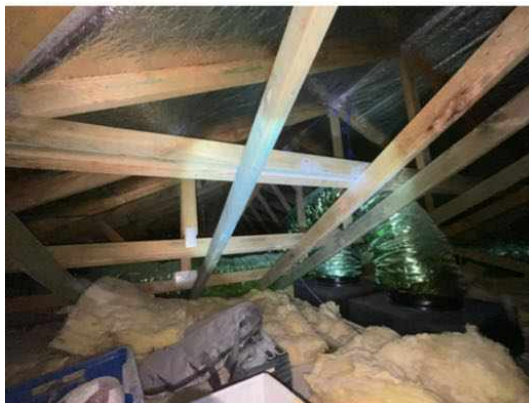
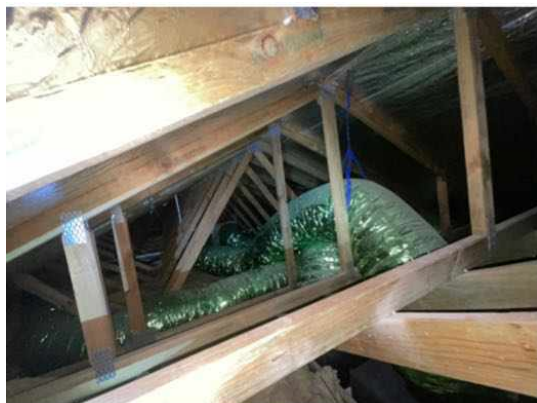
Installation of an additional manhole is recommended to facilitate a re-inspection and enable a more thorough assessment of the roof void in the future. This will help ensure that all structural elements and concealed areas are properly evaluated.

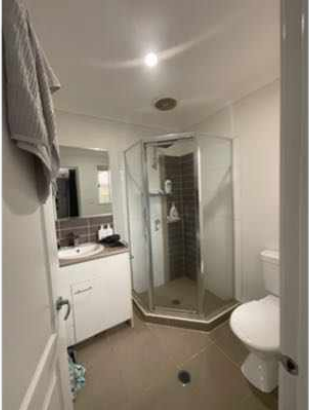
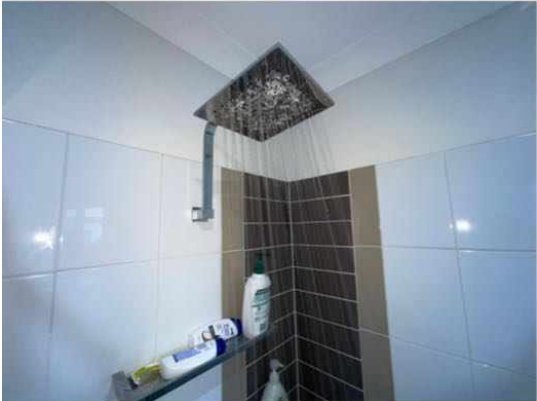
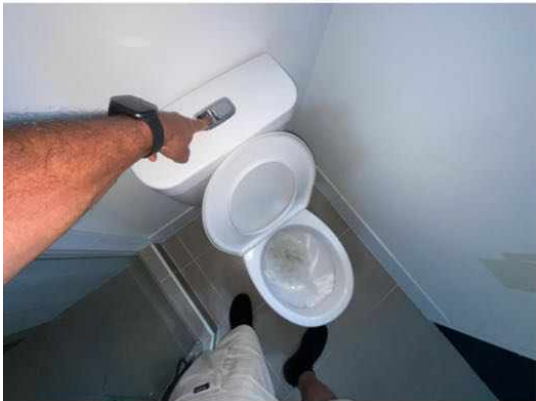
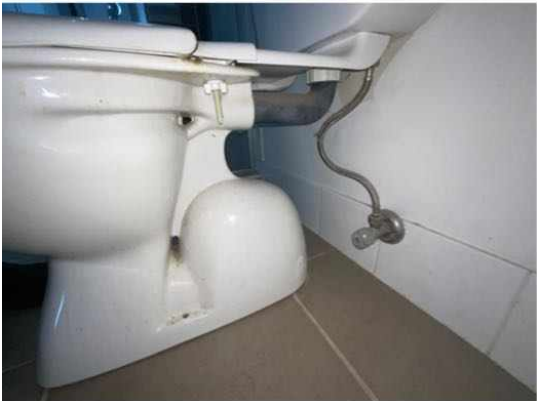
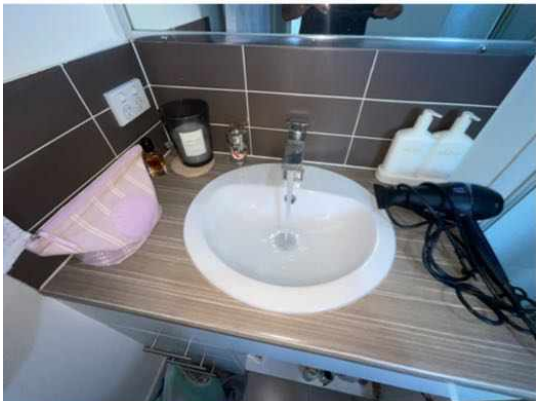
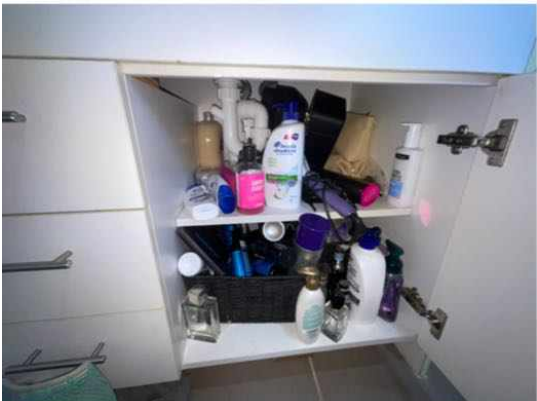
Building: Main Building  
 Location: Ensuite  
 Finding: Wet Areas - Bathroom(s) - Overall Condition & Recommendations.  
 Information: Overall Condition & Recommendations

It is not possible under the visual inspection criteria of a standard pre-purchase report to categorically determine if leaks are present. If a more detailed or accurate assessment is required, a special-purpose inspection should be undertaken.

Alternatively, the assumption should be made that leakage may occur, particularly where historical or environmental conditions are conducive. The visual nature of this inspection cannot detect issues concealed behind wall/floor linings or cabinetry, and invasive investigation may be necessary to confirm the true condition of adjacent or hidden structures.

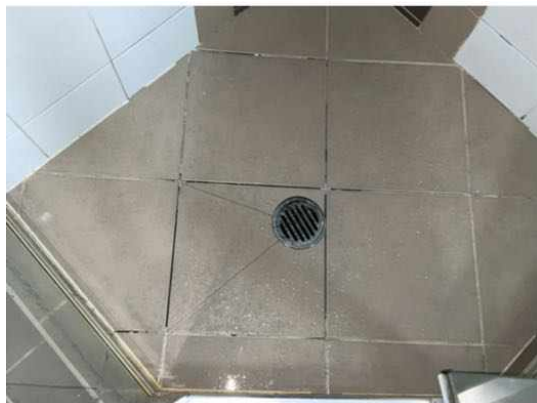
Building: Main Building  
 Location: All Areas  
 Finding: Water Pressure – Observation Only.  
 Information: During the inspection, water pressure appeared to be within a normal operating range based on a basic functional check. However, this observation was made without the use of pressure testing equipment and does not constitute an assessment by a licensed plumber.
