Building and Timber Pest Inspection Report

Inspection Date: Tue, 10 Mar 2026

Property Address: 3 Ash St, Golden Square VIC 3555,
Australia

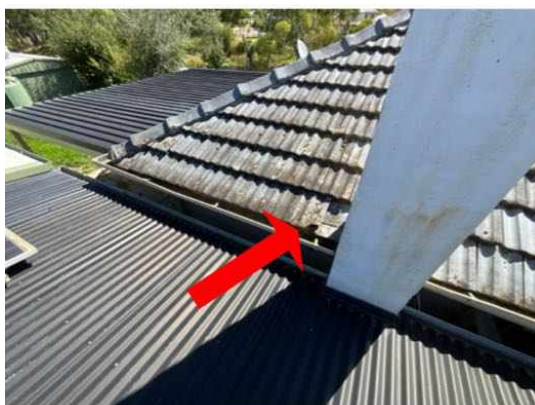
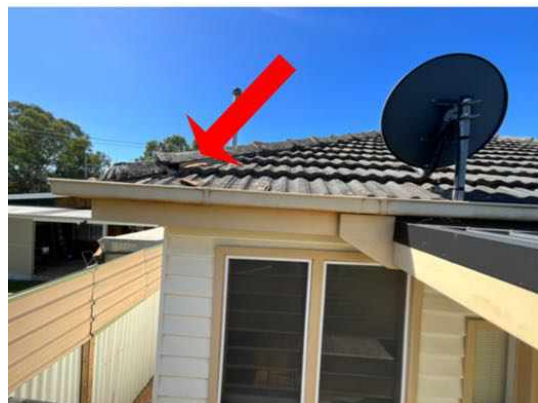
Building: Building 1
Location: Roof Exterior
Finding: Roof tiles - Broken
Information: Upon inspection of the exterior roof covering, broken roofing tiles were identified. Broken and friable roof tiles are generally the result of ageing and weathering of what is essentially a porous material.

If left to further deteriorate, broken and brittle roof tiles are likely to lead to water penetration via the roof into the ceiling space, causing secondary damage to ceiling linings, insulation and roof structures. Broken roof tiles are also likely to detract from the effectiveness of the roof drainage system, creating potential for secondary damage to the exterior roof covering and roof plumbing.

Replacement of broken tiles is required and should be performed by a roofing contractor as soon as possible.

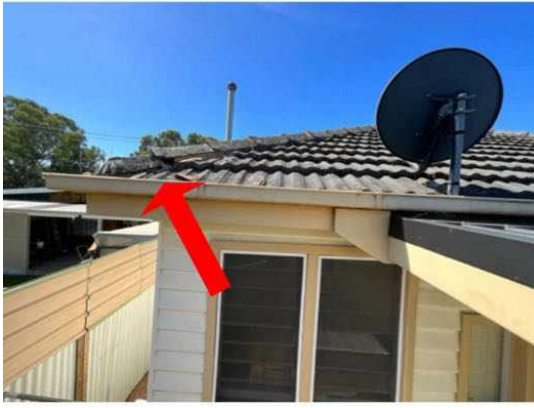
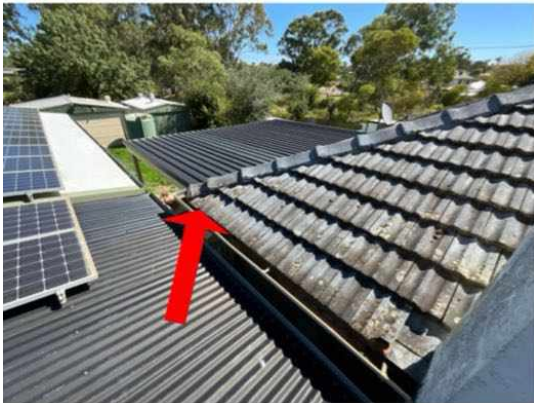
Finding 3.02

Building:	Building 1
Location:	Roof Exterior
Finding:	Mortar - Deterioration
Information:	Mortar, or 'bedding', is the material which fills joints and intersections between tiles and other building elements on the exterior roof covering, such as gable ends, hip capping and valleys. Upon inspection of the exterior roof, it was noted that sections of the mortar show varying levels of deterioration.

Mortar generally deteriorates as a result of frequent exposure to weather conditions over a prolonged period of time. Mortar that is deteriorating may allow water ingress into the roof void, putting associated building elements and roofing structures at risk of water damage. Deteriorated mortar also detracts from the functionality of roof tiles and other roofing elements, potentially decreasing weather tightness and roof drainage.

Mortar deterioration can be attended to by a handyperson where areas of deterioration are localised and easily accessible. Otherwise, consultation with a roofing contractor is advised where greater works are required.

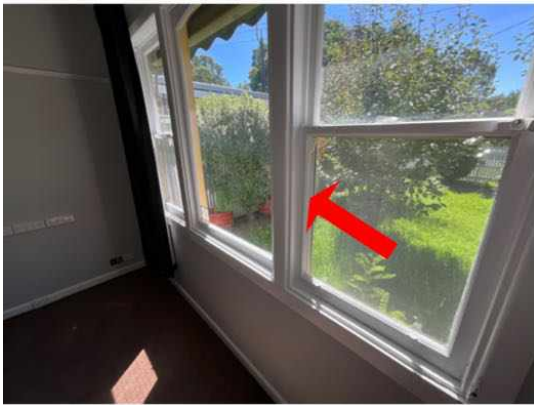
Windows provide ventilation to the adjoining area and should be at a fully operational level to ensure user comfort. Restricted function of the window may also pose as a potential safety hazard if required for emergency egress from the building.

Where windows have been painted shut the seal of the paint needs to be broken. This is generally done by breaking the seal of the paint and then maintaining the sash tracks clearing and lubricating them with silicone. Remedial paint work will likely be required and can be completed along with the rest of the remedial works necessary by a general handyman.

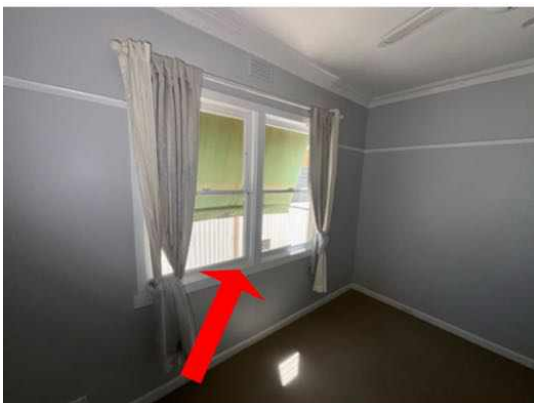
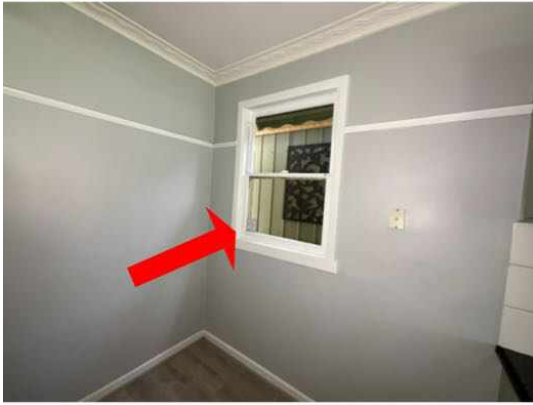
Finding 3.06

Information: Several windows throughout the property were jammed and difficult to operate at the time of the inspection. Windows provide ventilation to the adjoining area and should be at a fully operational level to ensure user comfort. Restricted function of the window may also pose as a potential safety hazard if required for emergency egress from the building.

Generally, factors such as general age of the building element and a lack of maintenance are the usual causes for this type of defect.

Replacement of window hardware or frame may be required, as well as minor repairs and cleaning. A registered builder or general handy person will be required to repair the affected windows.

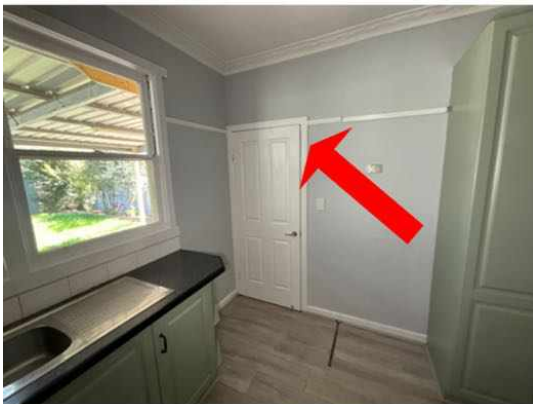
Finding 3.07

Building: Building 1
 Location: Kitchen
 Finding: Door- Binding/jamming
 Information: Binding and/or jamming of this door is evident during standard operation. This defect inhibits the functionality of the affected door as well as creating potential for secondary defects to associated building elements, such as damage to the floor covering.

A qualified carpenter or general handyperson should be appointed to perform minor rectification works at client discretion.

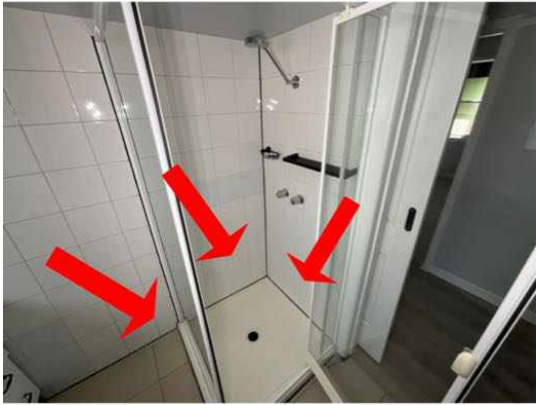
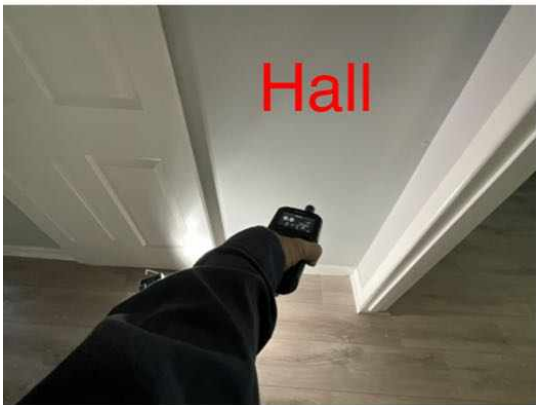
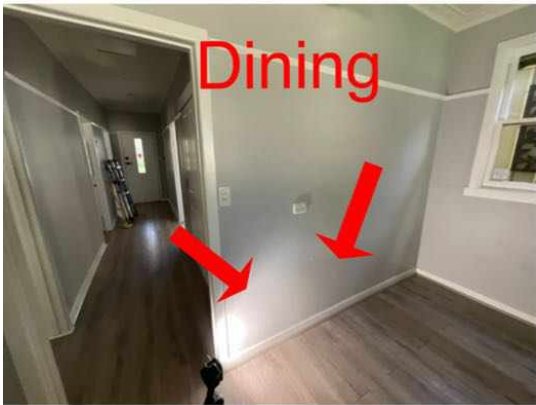
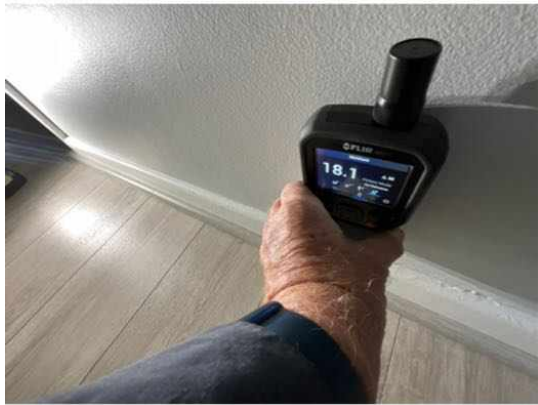
Building:	Building 1
Location:	Bathroom
Finding:	Shower Damp- Significant
Information:	Damp is evident to the lower wall to the Shower Alcove. This is suspected to have been caused by moisture permeating through the grouting in this area.

Relatively High levels of moisture were observed on the outside of the shower walls in the opposite wall.

Damp (or structural damp) refers to the presence of unwanted moisture in the structure of the building, either as a result of intrusion from outside, or condensation from within the structure. In the Shower area, internal water leaks or other sources of excessive moisture are generally the cause of damp.

Consultation with a qualified Plumber or Bathroom Specialist is advised immediately to identify the cause of damp and to perform remedial works as required.

Always ensure that sealant and grout is in good condition to prevent any moisture issues occurring in the future.

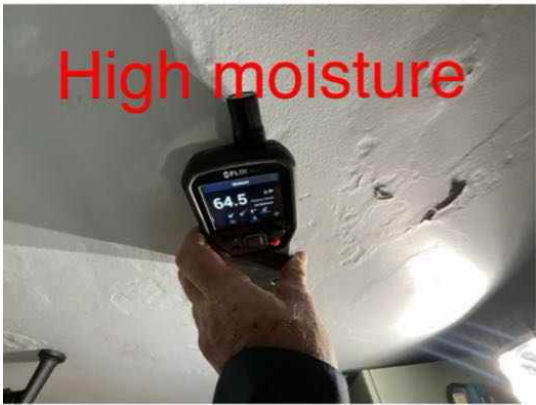
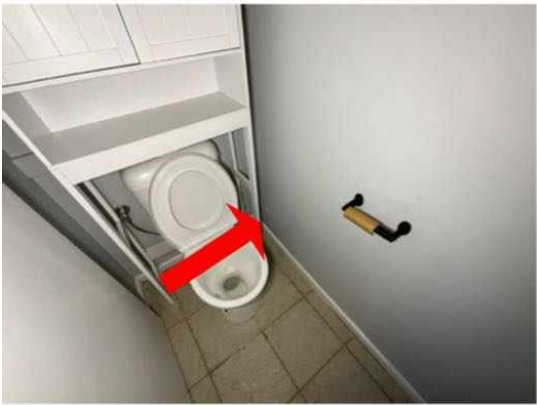
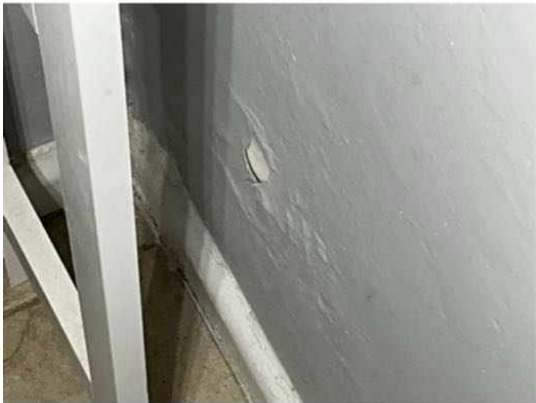
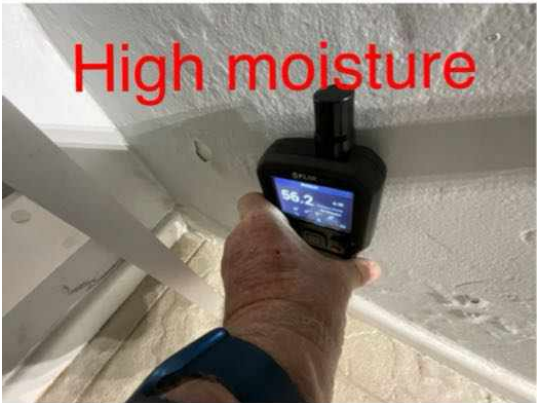
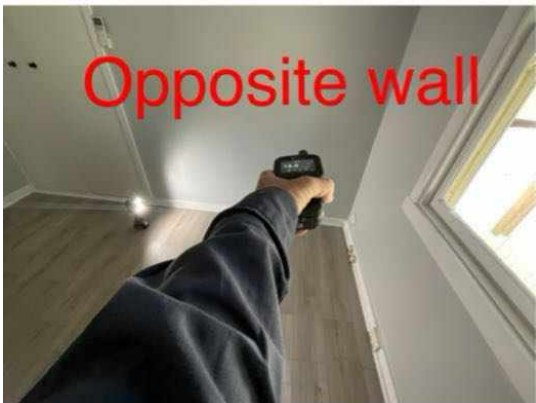
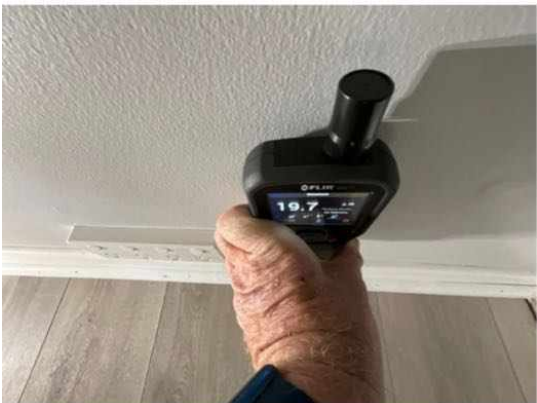
Finding 6.02

Building: Building 1
 Location: Toilet (WC)
 Finding: Evidence of excessive moisture- present at the time of inspection.
 Information: Excessive moisture can attract termites and produce conditions that promote termite attack fungal growth and wood decay. Excess damp in this area may create further deterioration.

Appropriate trades should be contacted soon to restore the area and prevent further deterioration.

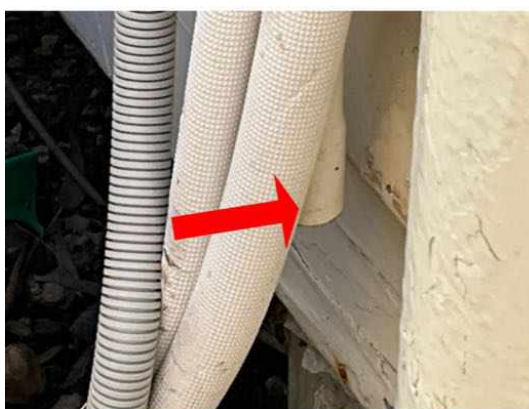
Finding 6.03

Building:	Building 1
Location:	Yard - Side
Finding:	Air conditioner - Disconnected overflow
Information:	The Air Conditioner (A/C) overflow was found to be disconnected from storm water drainage and is creating excessive moisture in the surrounding area.

Such leaking creates an environment which is conducive to an array of defects, including water damage to associated building elements and the attraction of termite or timber pest infestation.

It is highly recommended that a licensed plumber be appointed to connect the A/C overflow in order to prevent such an environment from being created. These minor works should be carried out as soon as possible.

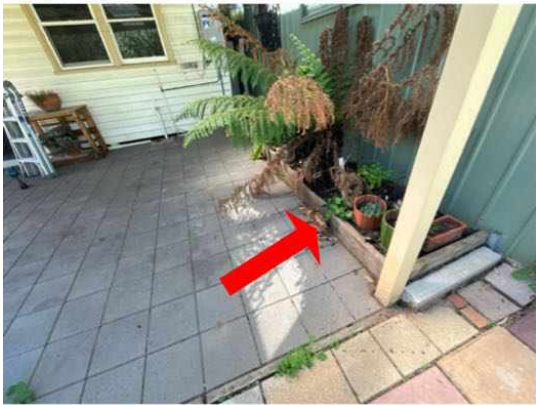
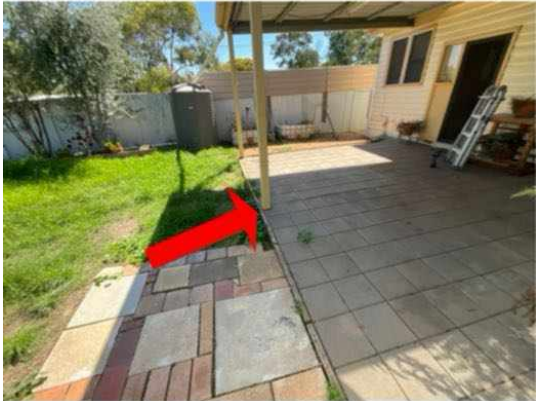
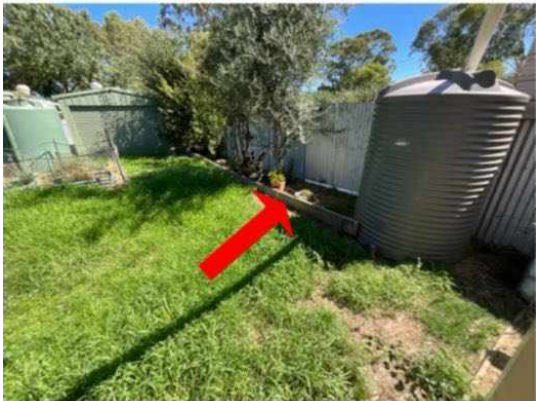
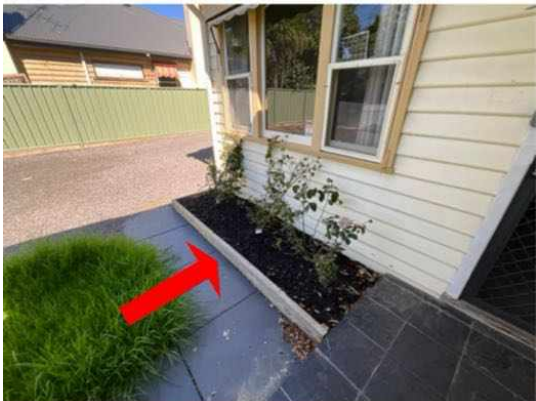
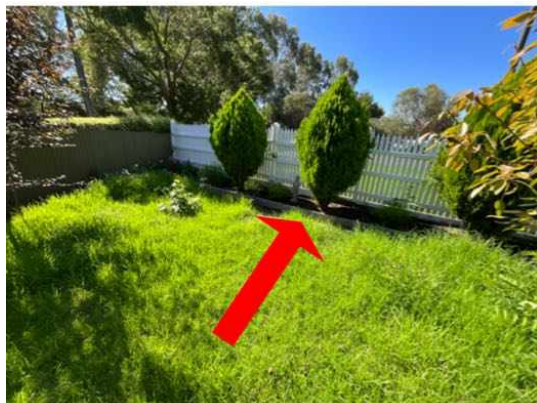
Finding 6.04

Building:	Building 1
Location:	Yard - Back, front
Finding:	Untreated or non-durable timbers in a hazardous environment
Information:	To reduce the risk of timber pest attack it is essential that timber used in a hazardous environment (e.g. in direct contact with the ground or frequently exposed to damp conditions) is of sufficient durability and/or is adequately preservative treated.

Untreated timbers in direct contact with the ground are likely to develop severe wood rot and/or fungal decay if left unattended creating attraction for subterranean termites to infest the timbers from surrounding areas.

If untreated or non-durable timbers are found to be in a hazardous environment it is highly advised that replacement of these building elements be performed as soon as possible to aid the protection of the property against termite / timber pest attack.

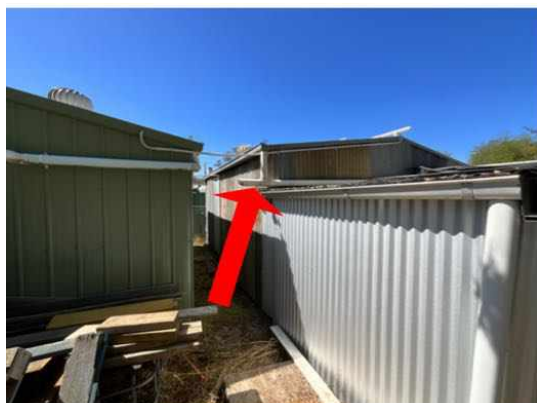
Finding 6.05

Building:	Building 1
Location:	Shed
Finding:	Stormwater drain - Not connected
Information:	The roof plumbing is not adequately connected to stormwater drainage on the site. This disconnection negatively impacts the functional capacity of the roof plumbing.

Where roof plumbing doesn't drain adequately, the area at the base perimeter can become excessively damp, potentially creating an environment that is susceptible to rust and corrosion of surrounding building elements, as well as attracting termites and other pests.

It is highly recommended that a plumber be appointed to further inspect the area and to install adequate drainage equipment where necessary.

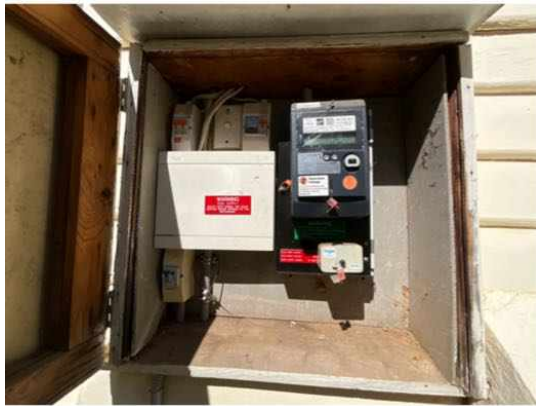
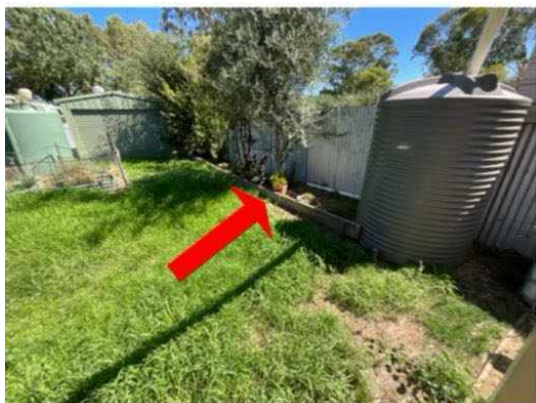
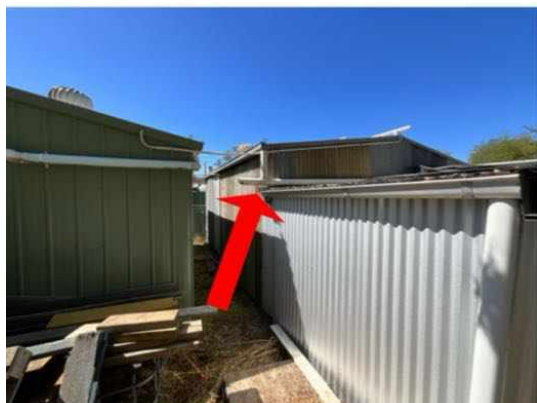
Finding 6.06

Building:	Building 1
Location:	All External Areas
Finding:	Termite Management System - no evidence of a chemical installation
Information:	The application of a post-construction chemical termite barrier is highly recommended for all properties, particularly if live termite activity has been found on the site

A durable notice should be placed in the switchboard unit to indicate current termite barriers. At the time of inspection, it appeared as though no termite management system has been installed, with no evidence to suggest preventative works taking place.

The client may consider gaining further advice from a pest controller as to the costs and procedures involved with this application. It is recommended that obtaining such advice be a short-term priority.

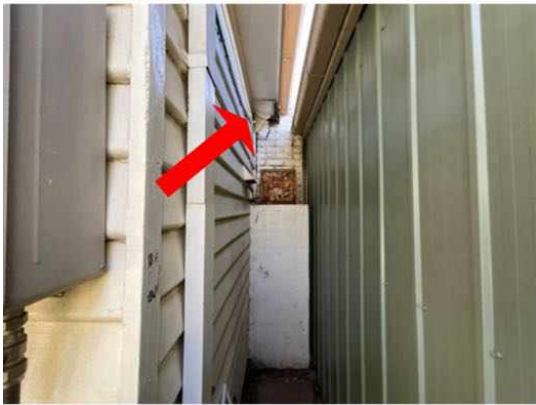
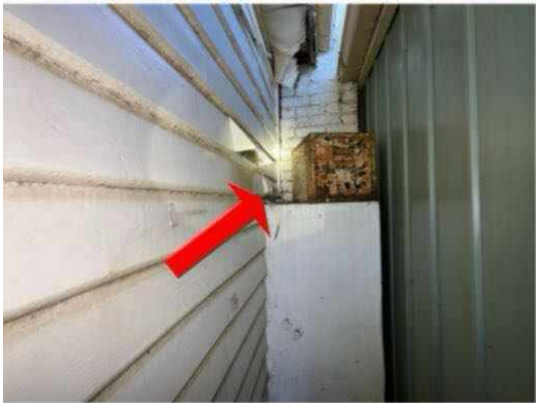
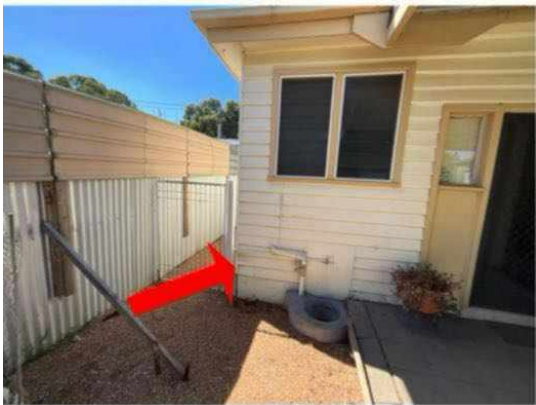
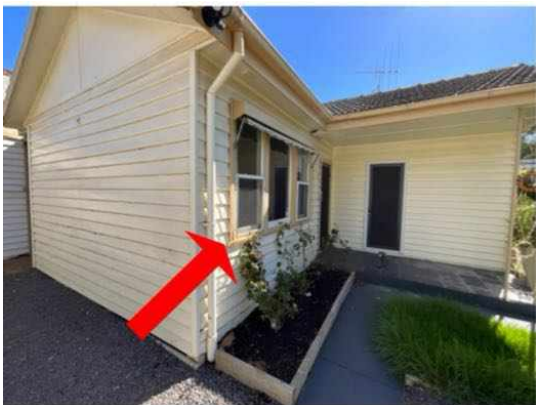
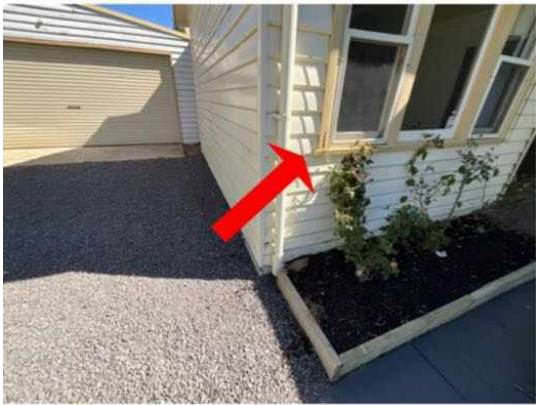
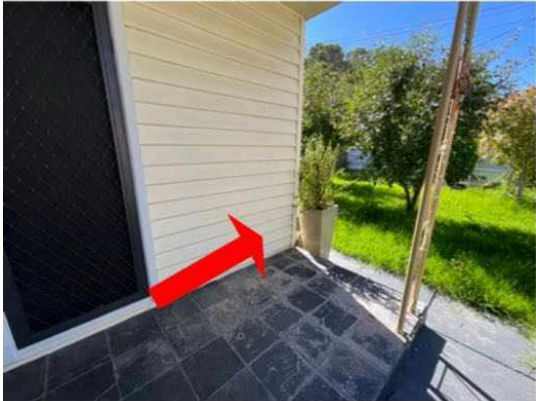
Finding 7.01

Building:	Building 1
Location:	Eaves, back and front walls
Finding:	Fungal decay - present (localised)
Information:	Fungal decay also known as wood decay or wood rot generally refers to the deterioration of timber elements when in contact with excessive levels of moisture for a prolonged period of time.

The development of fungal decay is accelerated by temperatures in the range of 5degreeC to 40degreeC as well as the presence of oxygen. Generally fungal decay develops on timber elements that are in use in an external environment which are exposed to rain penetration.

In this case although the affected timber element is in a decaying state the extent of any visible damage appears to be localised to a specific area and is yet to spread to other parts of the building element or affect adjoining structures. The fungal decay is therefore likely to be of a relatively superficial nature with minimal impact on the structural integrity or tensile strength of the timber element.

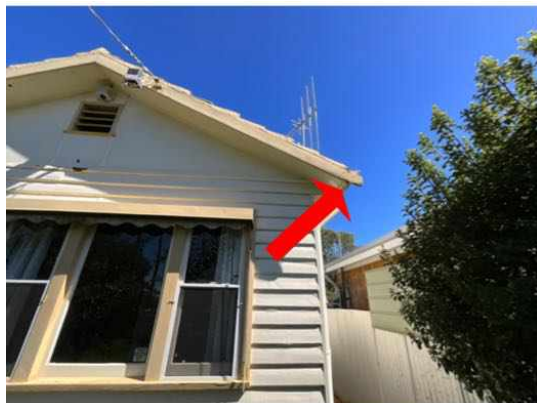
Finding 7.02

Building:	Building 1
Location:	Bedroom 1
Finding:	Fungal decay - present (localised)
Information:	Fungal decay also known as wood decay or wood rot generally refers to the deterioration of timber elements when in contact with excessive levels of moisture for a prolonged period of time.

The development of fungal decay is accelerated by temperatures in the range of 5degreeC to 40degreeC as well as the presence of oxygen. Generally fungal decay develops on timber elements that are in use in an external environment which are exposed to rain penetration.

In this case although the affected timber element is in a decaying state the extent of any visible damage appears to be localised to a specific area and is yet to spread to other parts of the building element or affect adjoining structures. The fungal decay is therefore likely to be of a relatively superficial nature with minimal impact on the structural integrity or tensile strength of the timber element.

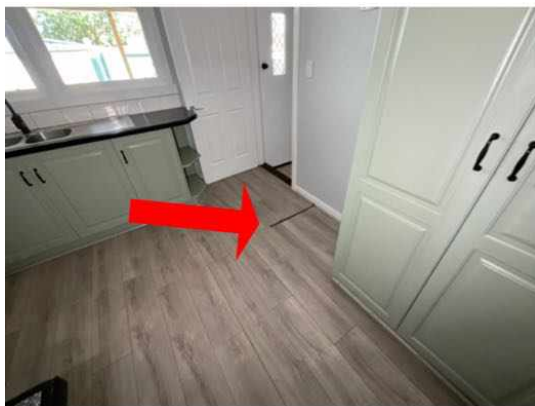
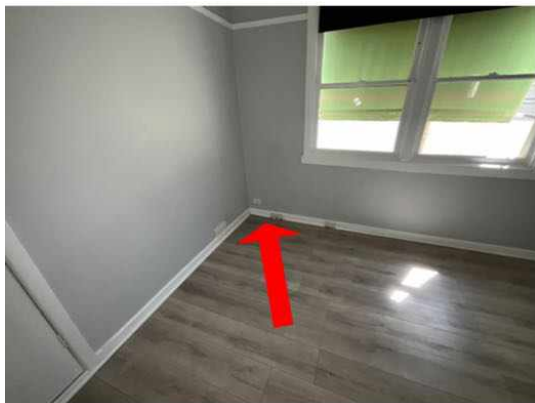
Building: Building 1
 Location: Floating floor
 Finding: Timber flooring- deterioration
 Information: The flooring in this area shows signs of deterioration. Some slight movement and separation of the Boards is evident.

A Flooring specialist should be contacted soon to restore the area and prevent further deterioration.

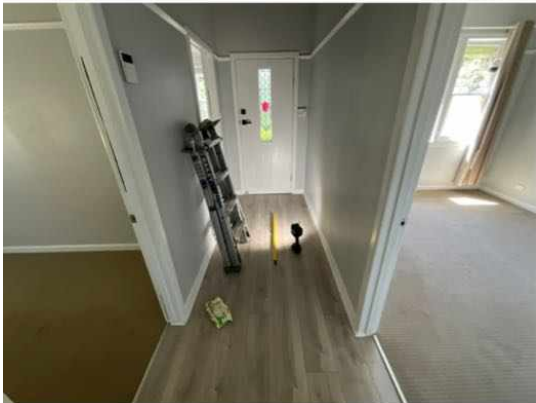
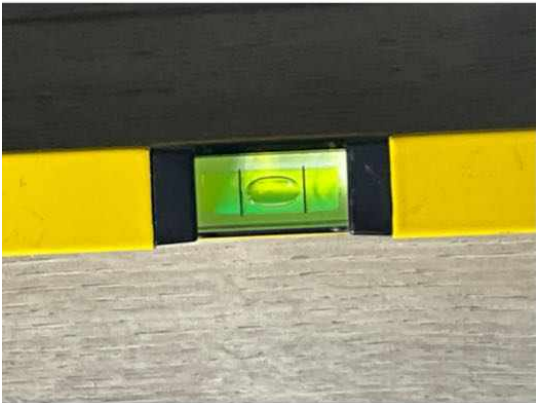
Building: Building 1
 Location: All Internal Areas
 Finding: Flooring- generally level
 Information: The internal flooring in this area is generally level and even. Where slightly uneven flooring is present it is likely to indicate minor defects such as expected movement of the foundations of the property.

No immediate action is needed.

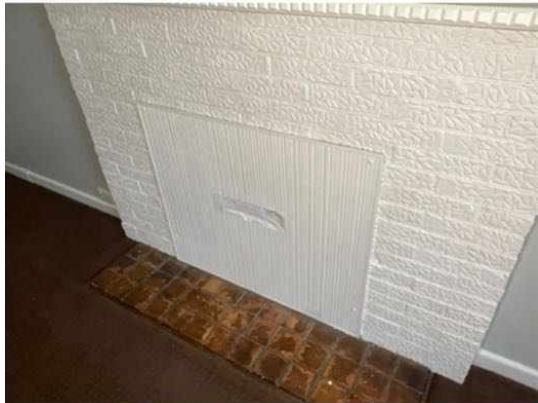
Building: Building 1
Location: All Areas
Finding: Additional Photos - Obstructions and Limitations
Information: These photographs are an indication of the obstructions and limitations which impeded full inspection of the property at the time of inspection. These obstructions can hide an array of defects and should be removed to allow full inspection to be carried out. A re-inspection is recommended once the areas are made accessible.
