Building Inspection Report

Inspection Date: Thu, 12 Mar 2026

Property Address: 16 Crawford Grove, Andrews Farm SA
5114, Australia

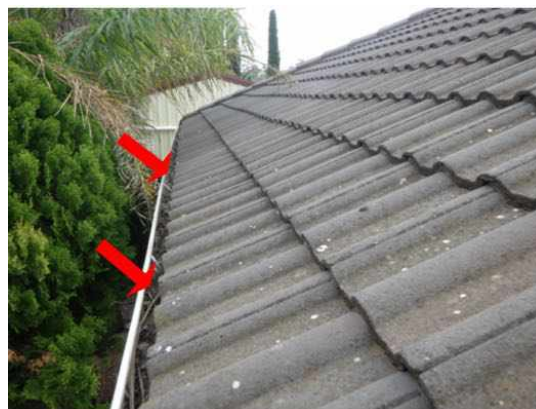
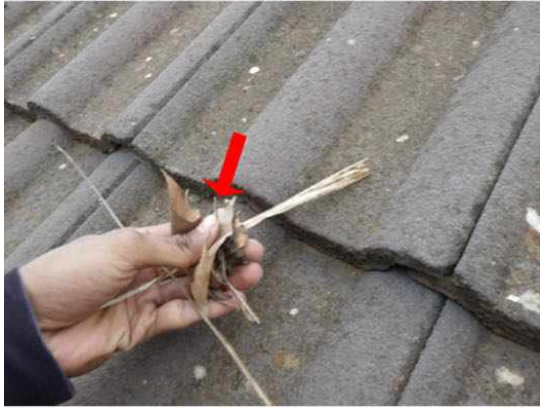
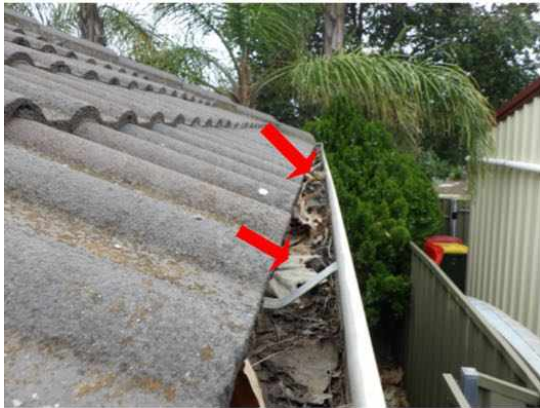
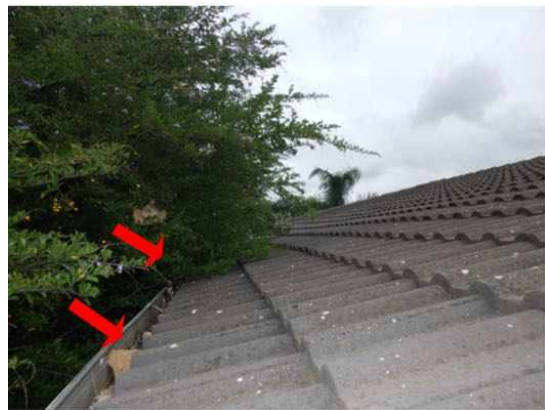
Defects 2.01

Blocked gutters are likely to lead to high levels of moisture in the affected areas. Such moisture will not only cause rust and decay of the associated building materials, but can also provide conditions that are conducive to termite and timber pest activity. Blockages in gutters should therefore be removed immediately to ensure dry conditions are maintained.

Consult a Licensed Plumber for further specific advice on remedial works that may be required. In the interim, it is highly advised that blocked gutters be removed by the homeowner or a general handyperson as a matter of urgency.

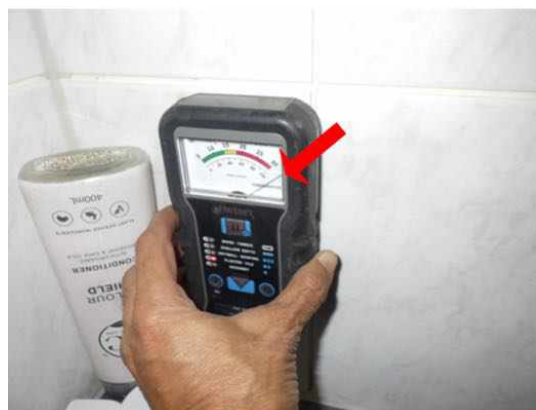
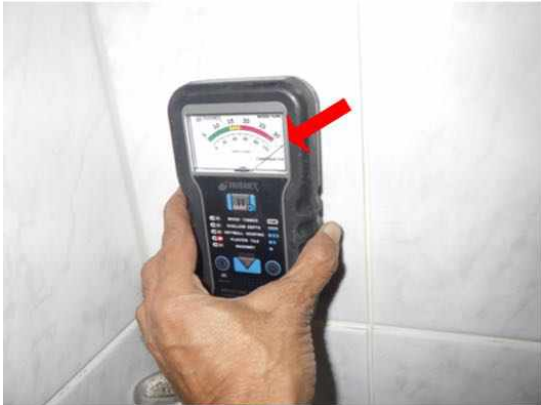
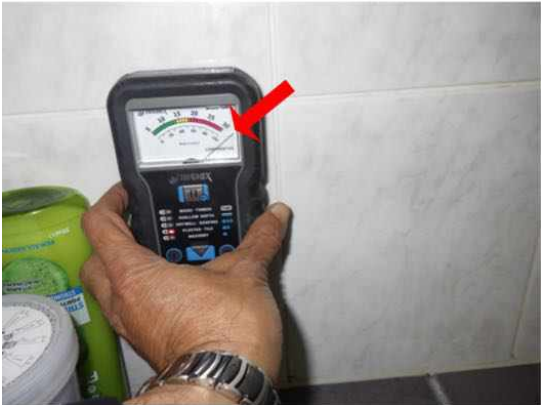
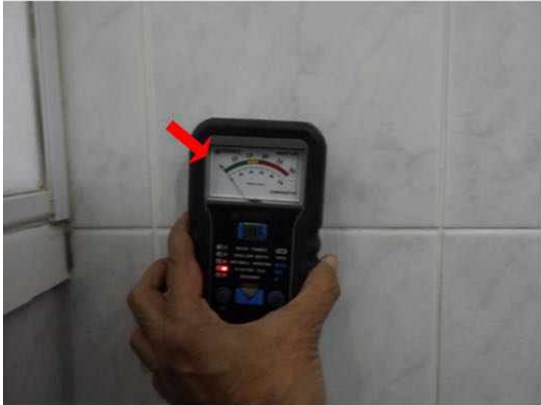
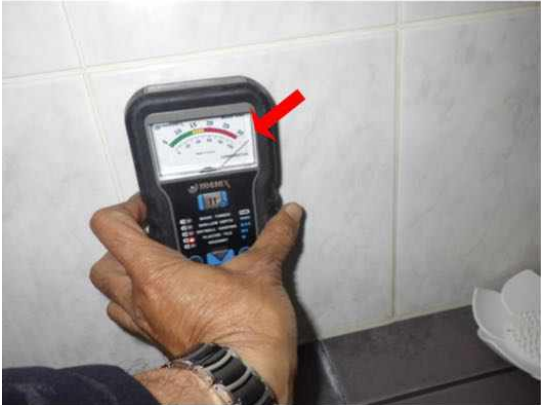
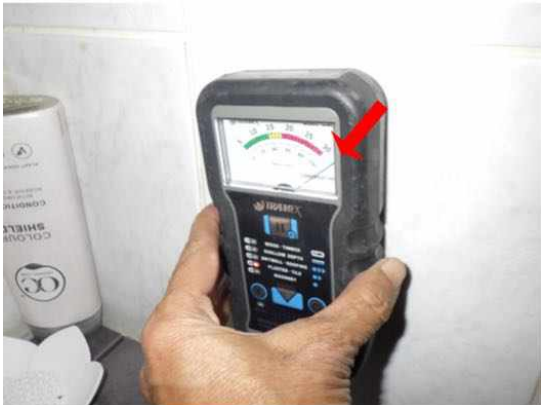
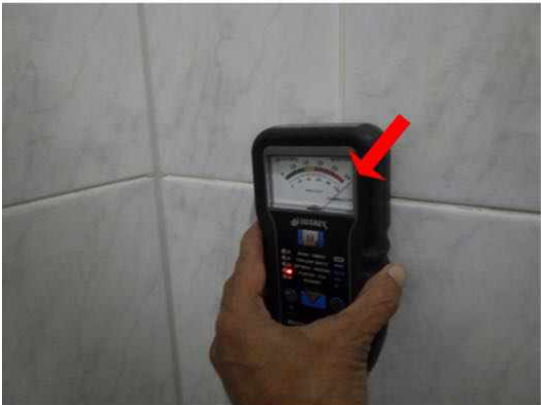
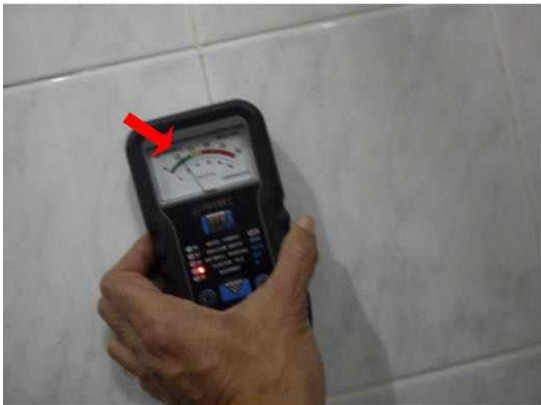
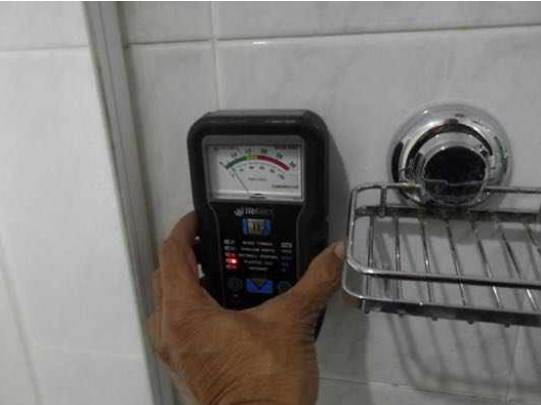
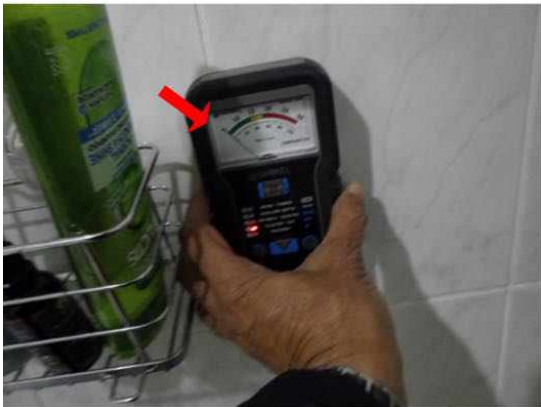
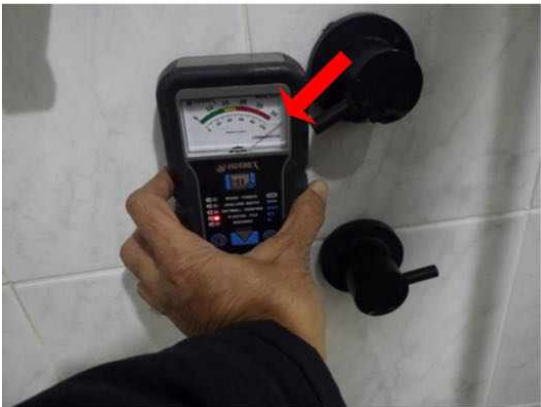
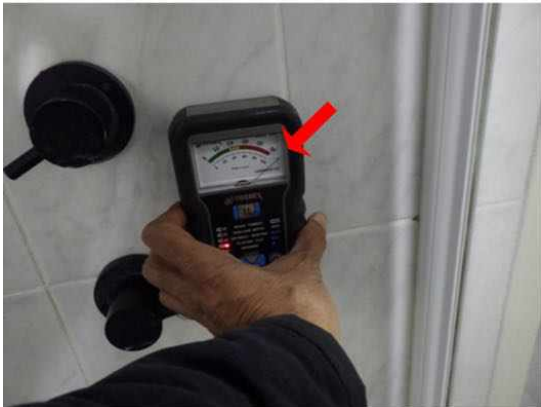
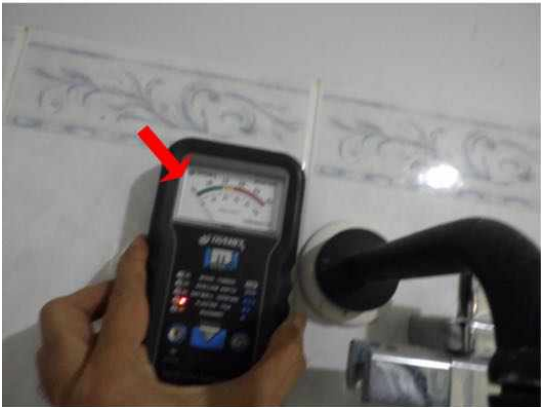
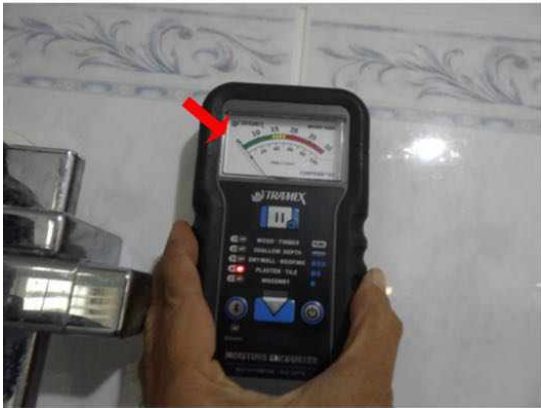
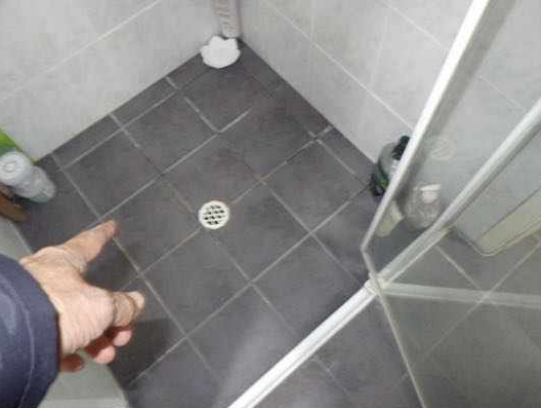
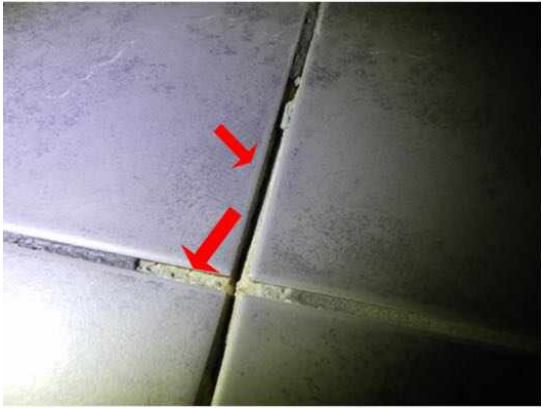
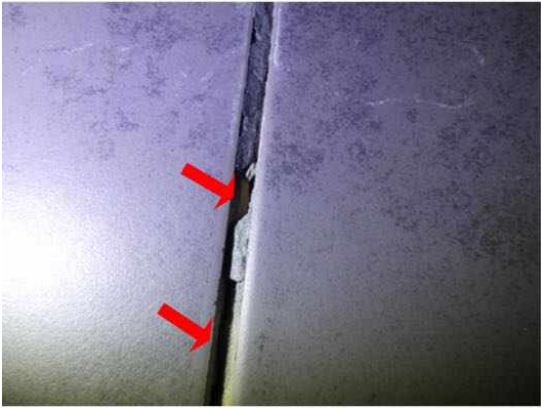
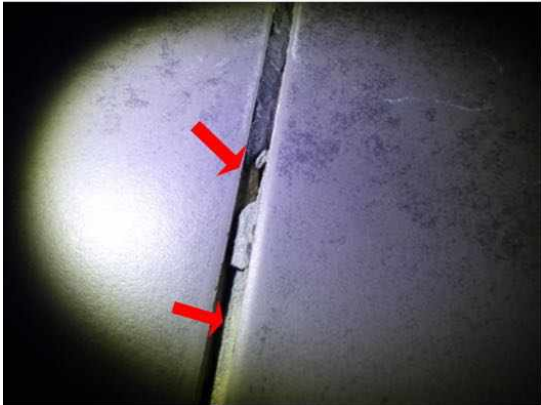
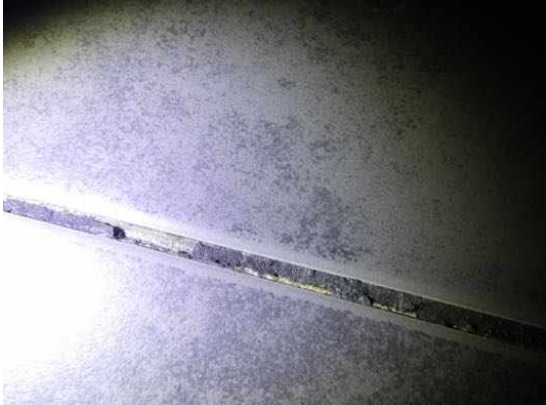
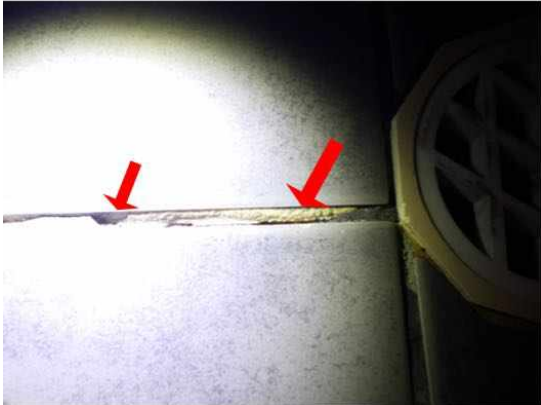
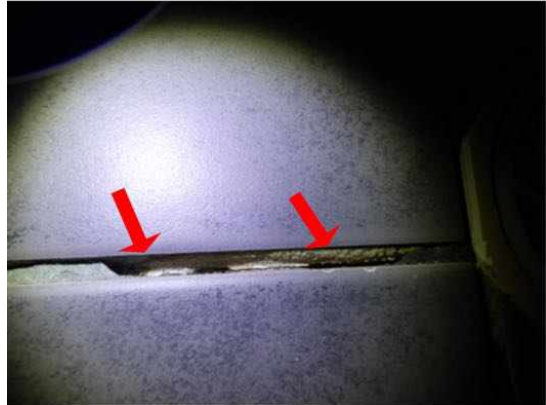
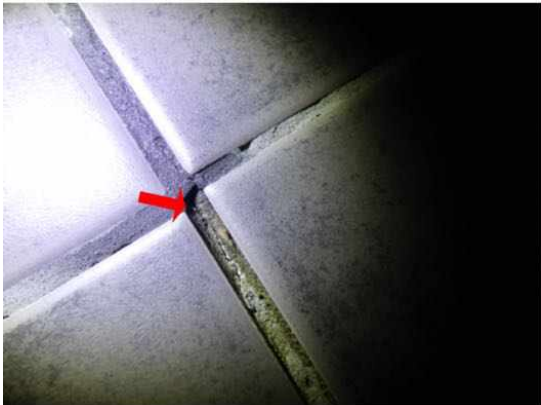
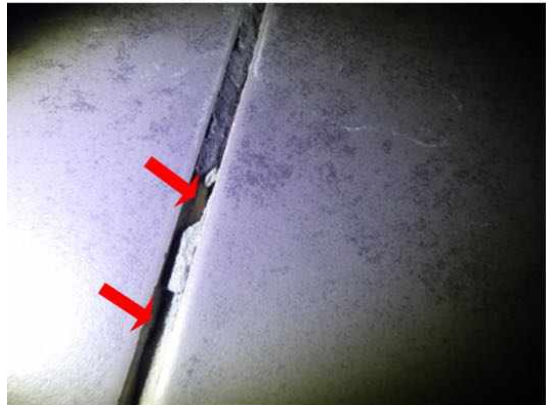
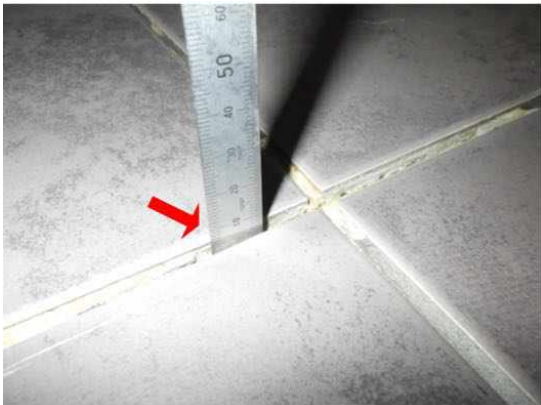
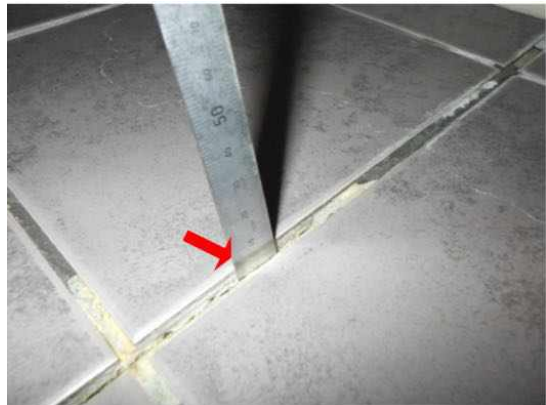
Defects 2.02

Building: Building 1
Location: Bathroom
Finding: Shower Alcove - Damp & Grout Deteriorated
Information: Damp is evident to the lower 400mm approximately of wall to the shower alcove. This defect is quite common, and is suspected to have been caused by moisture permeating through the grouting in this area, which shows evidence of deterioration. Leaking pipes within the adjoining wall is also a possible cause.

Damp (or structural damp) refers to the presence of unwanted moisture in the structure of a building, either as the result of intrusion from outside, or condensation from within the structure. In the shower area, internal water leaks or other sources of excessive moisture are generally the cause of damp.

Unmanaged damp in the shower recess is likely to facilitate the formation and development of mould and fungi growth, decaying associated building materials and compromising their structural integrity. Exposure to these contaminants is associated with a wide range of respiratory and other health-related problems.

Consultation with a qualified plumber or bathroom specialist is advised immediately to identify the cause of damp and to perform remedial works as required. Where excessive mould growth is present, further inspection by a specialist environmental health inspector should also be considered.

Always ensure that sealant and grout is in good condition to prevent any moisture issues occurring in the future.

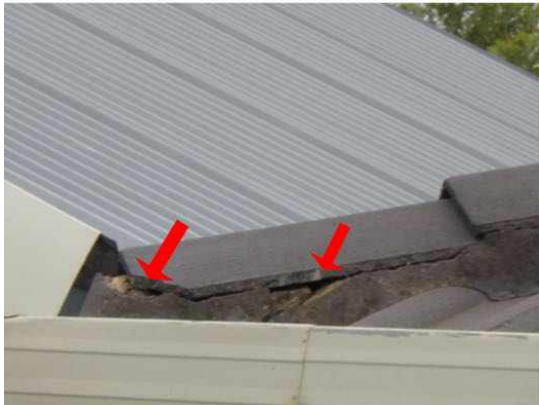
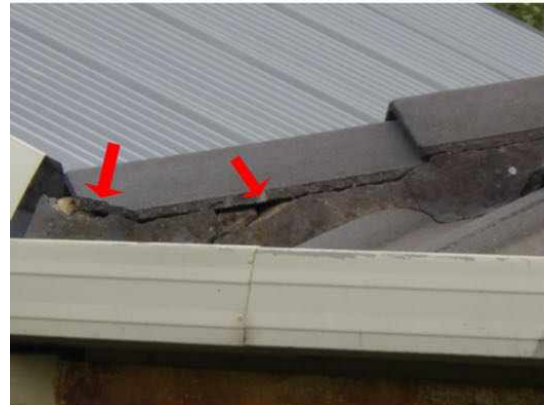
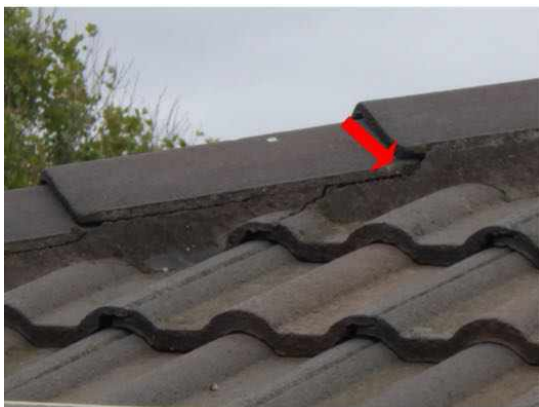
Defects 3.01

Building:	Building 1
Location:	All External Areas
Finding:	Mortar - Deterioration
Information:	At the time of inspection it was noticed evidence of mortar deterioration to few roof tiles around the property.

Mortar, or 'bedding', is the material which fills joins and intersections between tiles and other building elements on the exterior roof covering, such as gable ends, hip capping and valleys. Upon inspection of the exterior roof, it was noted that sections of the mortar show varying levels of deterioration.

Mortar generally deteriorates as a result of frequent exposure to weather conditions over a prolonged period of time. Mortar that is deteriorating may allow water ingress into the roof void, putting associated building elements and roofing structures at risk of water damage. Deteriorated mortar also detracts from the functionality of roof tiles and other roofing elements, potentially decreasing weather tightness and roof drainage.

Mortar deterioration can be attended to by a handyperson where areas of deterioration are localised and easily accessible. Otherwise, consultation with a roofing contractor is advised where greater works are required.

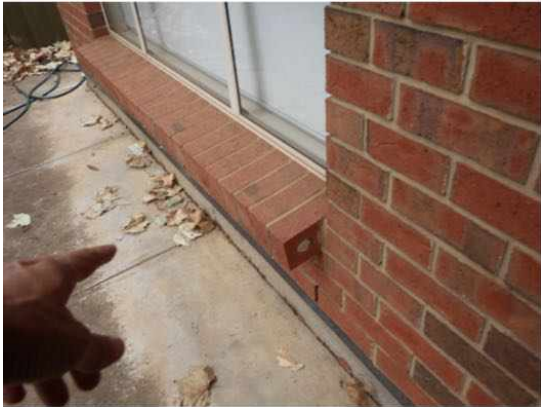
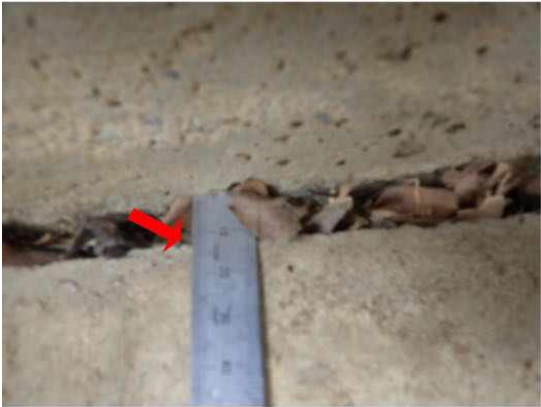
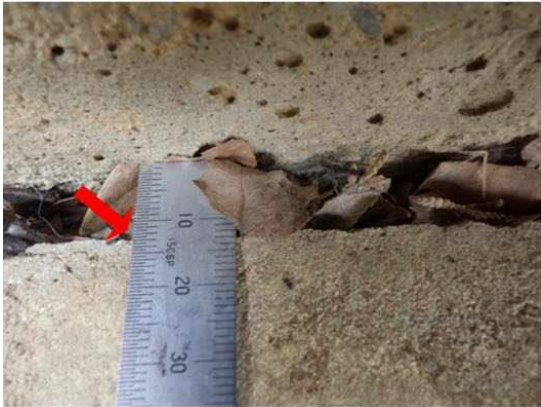
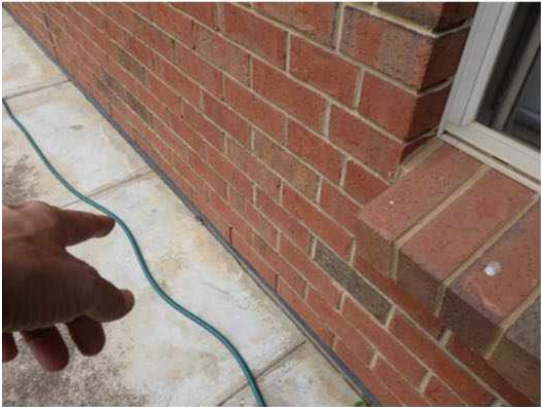
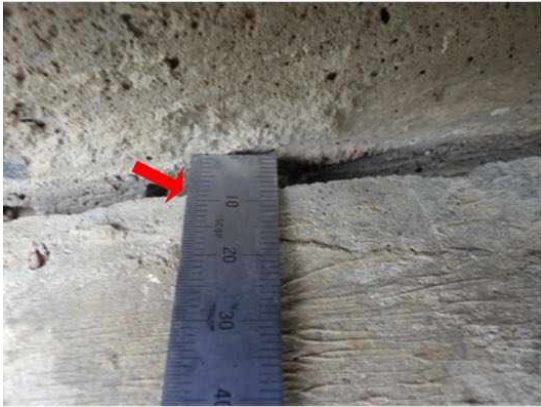
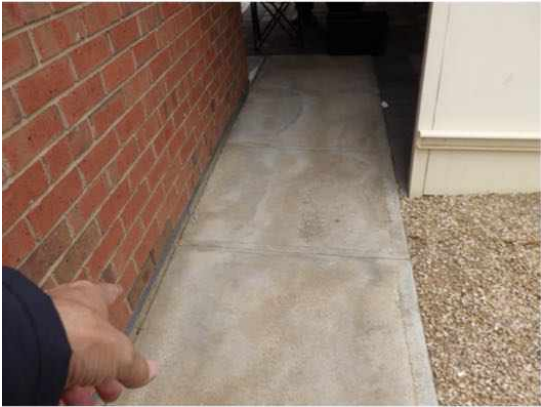
Defects 3.02

Building:	Building 1
Location:	All External Areas
Finding:	Gaps in perimeter pavement
Information:	Gaps in the external concrete paving were identified at the time of inspection. Gaps in the slab are significant and are likely to lead to the development of secondary defects if left unmanaged, such as the creation of a trip hazard and water entry points.

including roof and ground flows, contained and continually maintained. High moisture also creates an environment that is conducive to termite attack.

A licensed Plumber should be appointed immediately to ensure that the stormwater pipework is intact and adequate, and all gaps to concrete, driveways and paths should be sealed by a licensed builder or a general handy person to keep moisture from entering.

A licensed concretor may be required to replace pavements that are beyond repair.

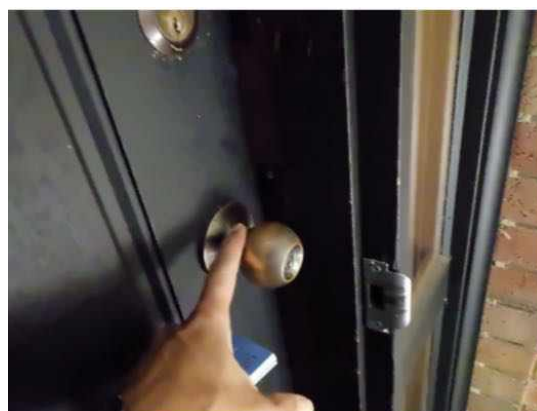
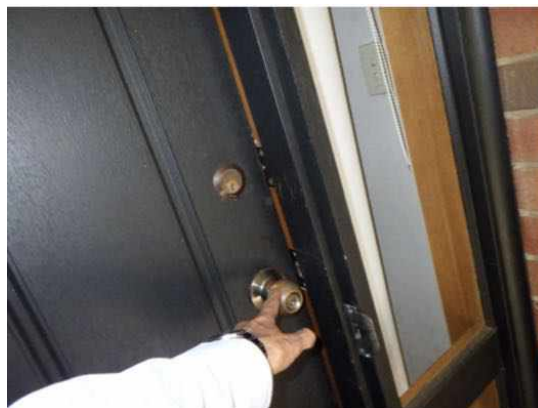
Defects 3.03

Building:	Building 1
Location:	All External Areas
Finding:	Entry Door - Binding/jamming
Information:	Binding and/or jamming of this entry door is evident during standard operation. This defect inhibits the functionality of the affected door as well as creating potential for secondary defects to associated building elements, such as damage to the floor covering.

A door that binds to flooring or to the associated door frame may have several causes, ranging from minor defects, such as poor installation of the door or deteriorated hinges, through to major structural issues, such as damage to subfloor structures.

Where door binding/jamming appears to indicate major structural issues, a registered builder specialising in re-stumping should be appointed to provide an estimate on the cost of rectification.

For minor causes, a qualified carpenter or general handyperson should be appointed to perform minor rectification works at client discretion.

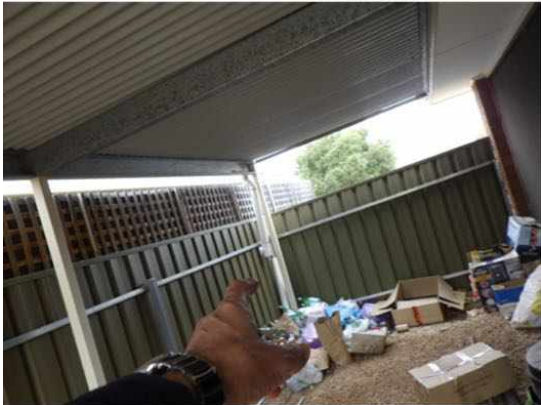
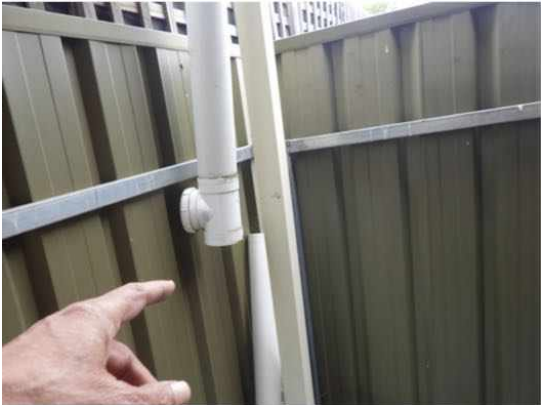
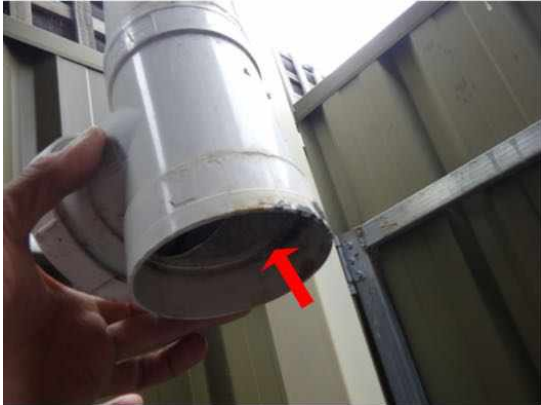
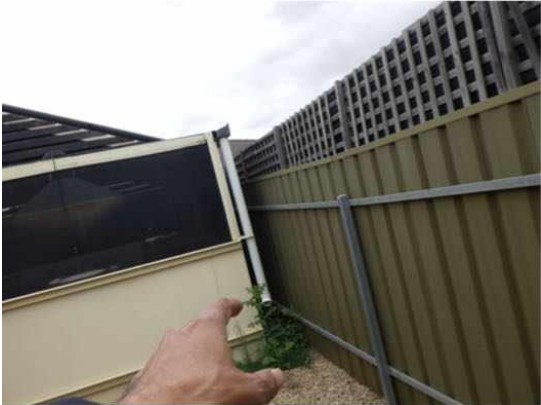
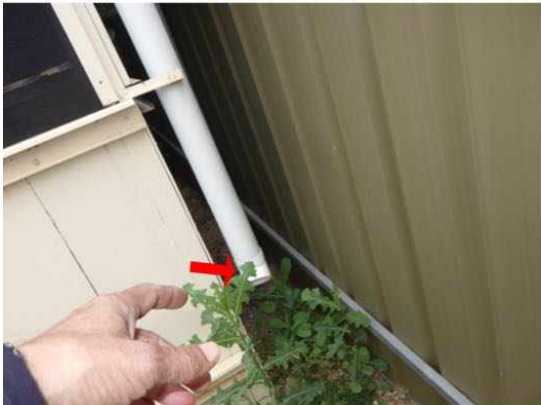
Defects 3.04

Building:	Building 1
Location:	All External Areas
Finding:	Site drainage - Inadequate
Information:	The site drainage in this area was found to be inadequate at the time of inspection, creating potential for subsequent water damage to associated building elements.

It is important that water does not lie against the base of walls; surrounding paths and ground levels should be sloped to drain water away from walls. Downpipes should not discharge stormwater onto lower walls or plinths. Stormwater should be carried away by large, regularly cleaned drains. Ground levels may need to be lowered to expose a buried DPC.

Where site drainage is inadequate, installation of an Agricultural (Aggie) Drain may be required. A qualified plumber should be appointed to further inspect the property and perform any remedial works as necessary. Water damage and secondary defects are likely to occur if left unmanaged.

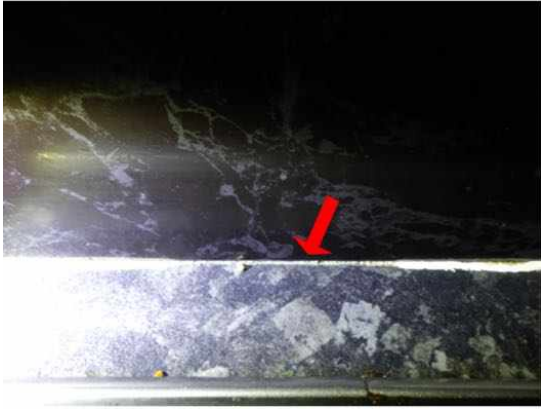
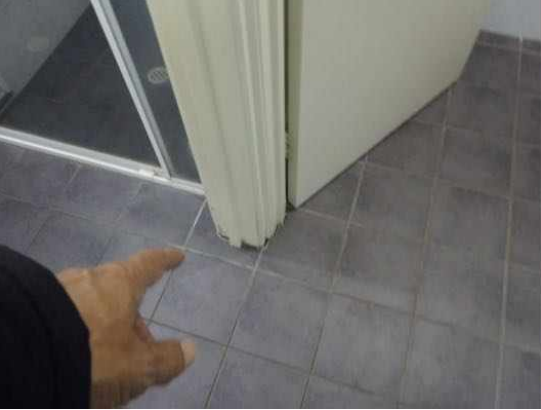
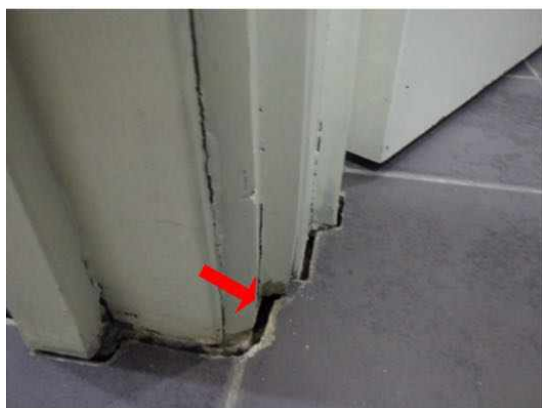
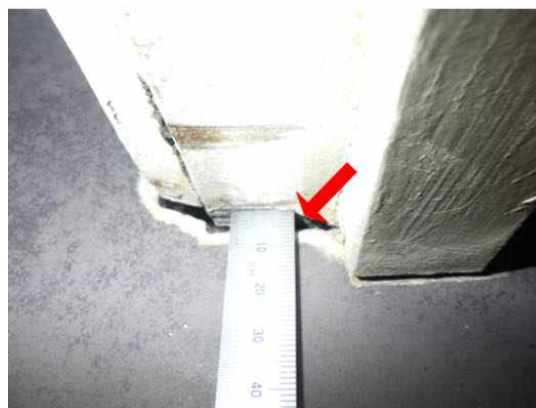
Defects 3.05

Building: Building 1
Location: All Internal Areas
Finding: Grout - Missing/ Deteriorated
Information: Grout is missing / deteriorated in this bathroom , toilet & kitchen area. Grout is used to protect gaps and crevices in building materials to ensure that they are water-tight and prevent water penetration to the associated structures.

Where grout is missing, a tiling contractor should be appointed immediately to apply grout and re-apply any silicone where necessary. Failure to do so is likely to lead to water damage to the surrounding area.

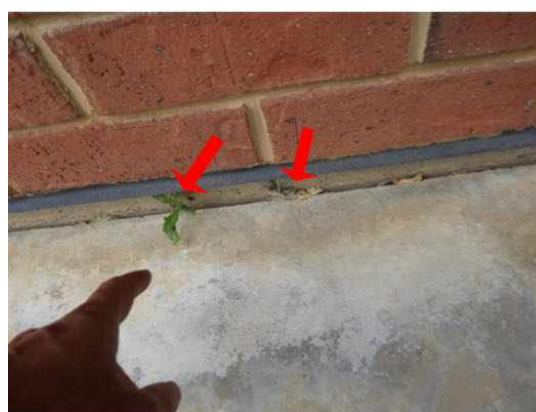
Defects 3.06

Building:	Building 1
Location:	All External Areas
Finding:	Bridging - Vegetation
Information:	Where vegetation obstructs inspection of building elements, also known as bridging as it provides a bridging point for the access of termites, full inspection can not be achieved. Consequently moisture or dampness may be present and the areas becomes conducive to termite activity. Plants against or very close to buildings provide cover, shade and can provide an environment that is attractive to termite infestation.

The removal and replanting of species that do not provide "cover" or cutting back of existing vegetation will assist greatly in preventing Bridging from occurring.

The removal of any such materials that may be conducive to termite activity should be carried out as soon as possible and arrange re inspection to minimize the risk of termite attack.

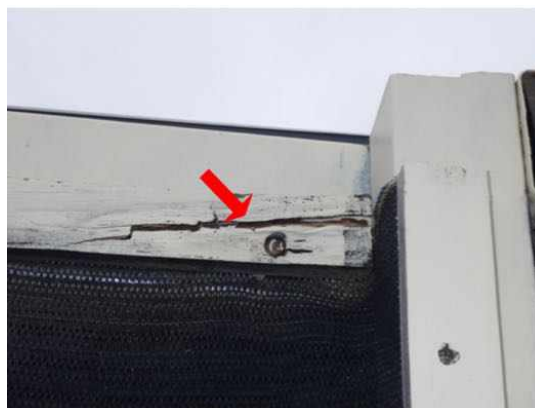
Defects 3.07

Building:	Building 1
Location:	All External Areas

Finding: Wood rot
Information: This building element shows evidence of wood rot. Wood rot, also known as Fungal Decay, occurs when timbers and other cellulose building materials are exposed to damp conditions on an ongoing basis. This could be the result of exposure to weathering over a prolonged period of time, or the attraction of excessive moisture from other abutting building materials. Contributing factors also include poor air ventilation in the area.

Wood rot is often associated with general damp problems and is evidenced by a 'musty' smell or mould and mildew occurring on surfaces. If left unmanaged, damp conditions can lead to further health problems and the decay of timbers will continue.

Early intervention and regular maintenance, particularly of exterior timbers, will prolong the useful life of these building elements. Prior to any works being performed, the cause of the moisture that has created the visible wood rot should be identified and addressed in a suitable manner. Replacement of affected timbers may then be a necessary step in protecting surrounding building elements from such deterioration.

A qualified plumber may be appointed to assess the cause of excessive moisture and to provide advice on any remedial works as required. A qualified carpenter or registered builder may also be required to replace affected building materials.

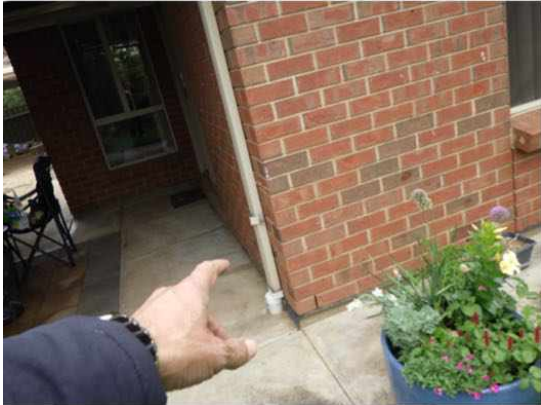
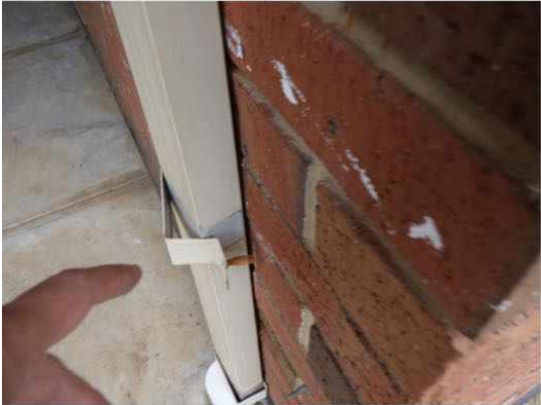
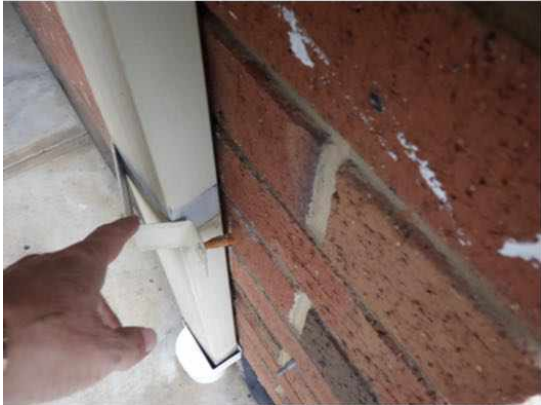
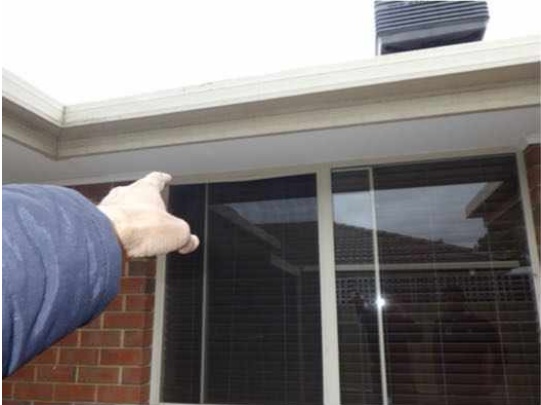
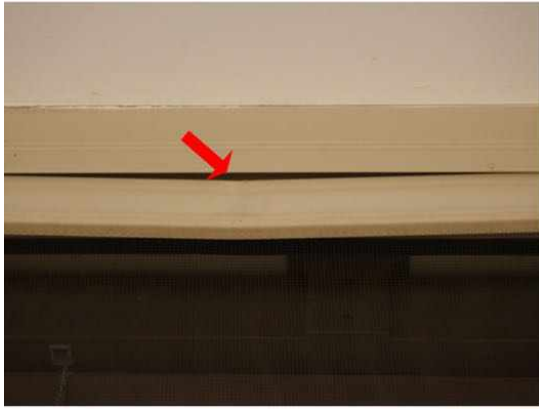
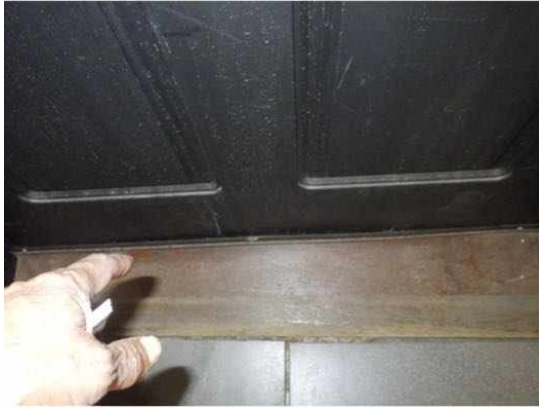
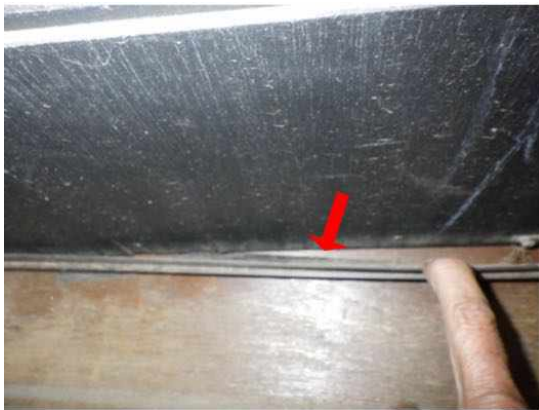
Defects 3.08

Building: Building 1
Location: All External Areas
Finding: Building element - Damaged/ Loose from its original fixing
Information: At the time of inspection it was noticed that few building elements were damaged / loose from its original fixing around the property .

Breakage occurs generally when the building materials have either aged and decayed, or as a result of damage (accidental or deliberate).

Repair and/or replacement of broken elements is advised to ensure that additional secondary defects do not arise as a consequence. Such works are necessary, as all building elements play a key role in the operation and function of the overall structure and its performance.

A relevant tradesperson should be appointed to repair or replace the affected building element prior to any subsequent damage being caused.

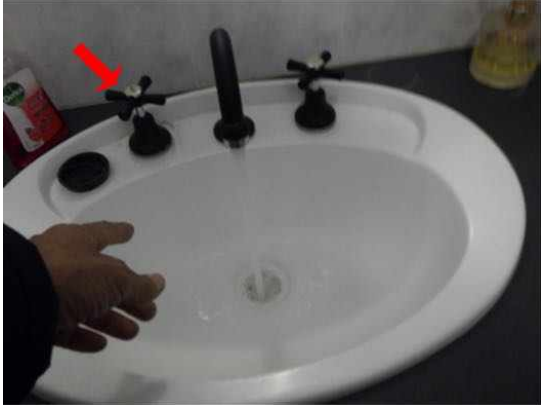
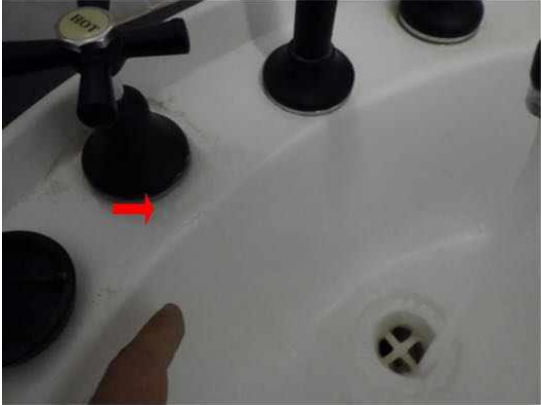
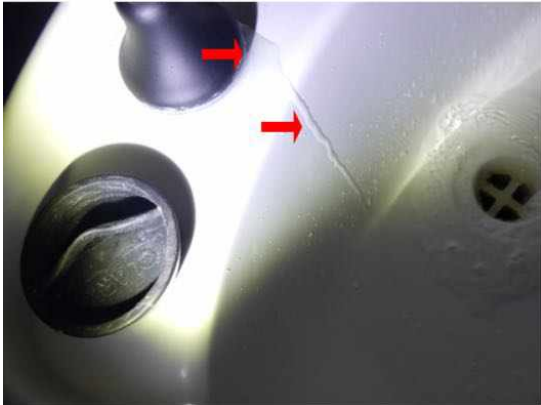
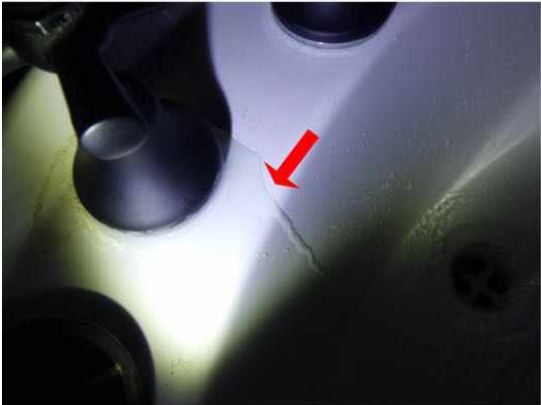
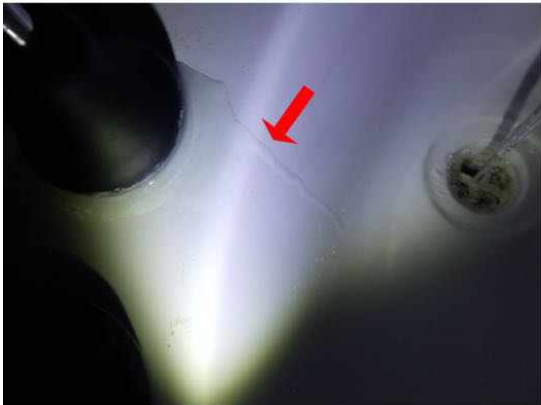
Defects 3.09

Building:	Building 1
Location:	All Internal Areas
Finding:	Toilet Washbasin - Hot water Tap - Leaking
Information:	The hot water tap in this toilet washbasin area was found to be leaking at the time of inspection. This is a common defect that is consistent with general ageing of the building element. However, it may be indicative of substandard plumbing workmanship if the tap is relatively new.

While this defect only seems minor, if left unmanaged, it is likely to result in the development of rust, water damage and/or extensive water usage.

It is advised that a handyman or licensed plumber be appointed to perform remedial works on the affected tap. Such works should be performed prior to the development of secondary defects to ensure adequate functionality of all associated building elements.

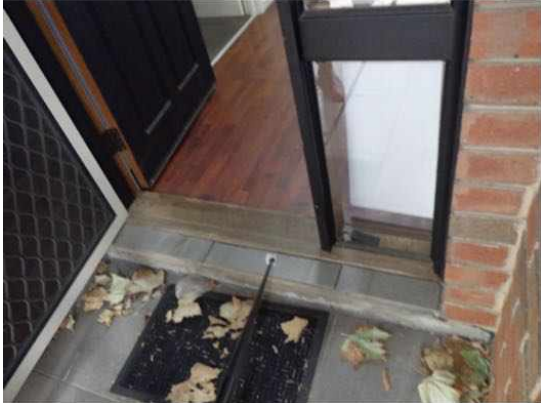
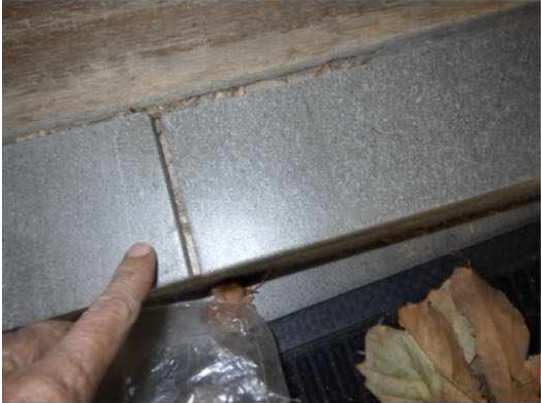
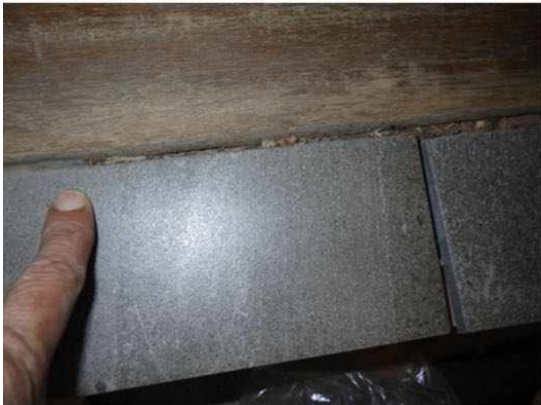
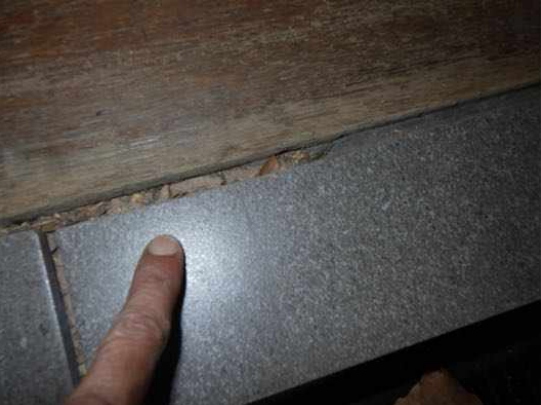
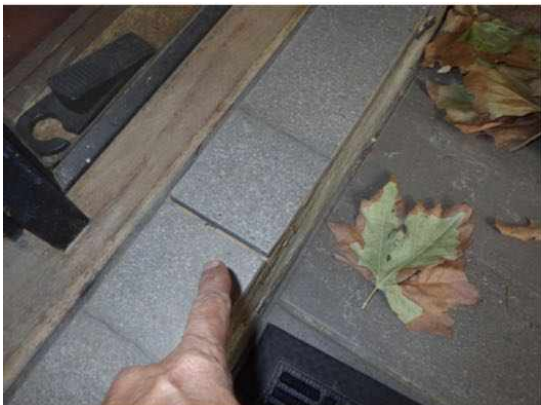
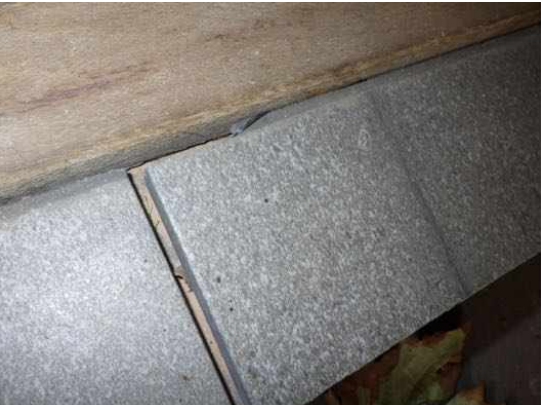
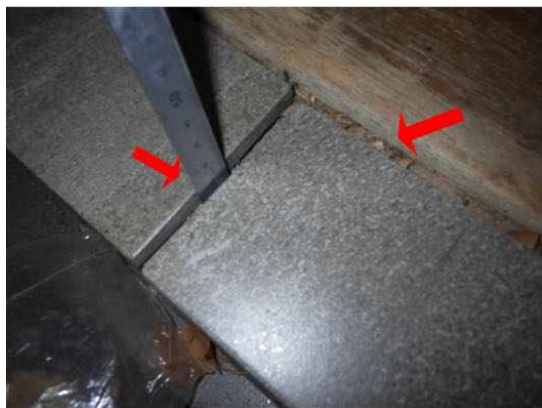
Defects 3.10

Building:	Building 1
Location:	All External Areas
Finding:	Entry Area Grout - Missing/ Deteriorated
Information:	Grout is missing/ deteriorated in this entry area. Grout is used to protect gaps and crevices in building materials to ensure that they are water-tight and prevent water

penetration to the associated structures.

Where grout is missing, a tiling contractor should be appointed immediately to apply grout and re-apply any silicone where necessary. Failure to do so is likely to lead to water damage to the surrounding area.

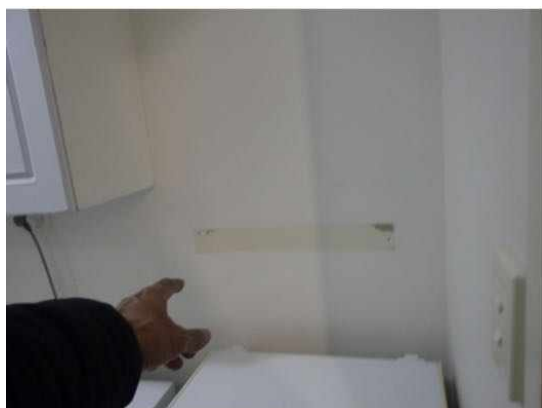
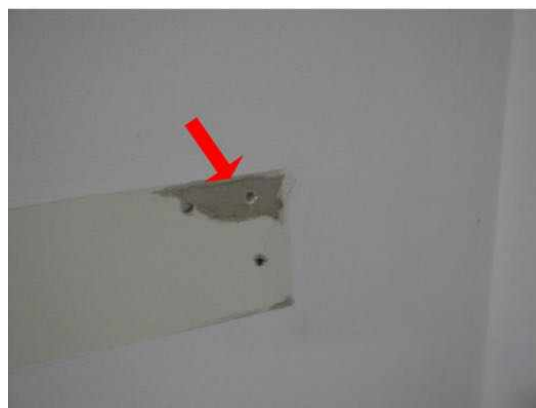
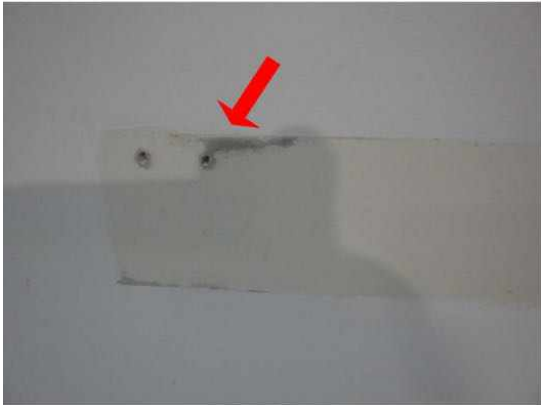
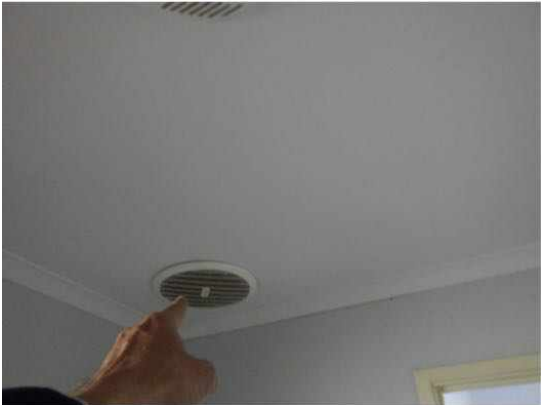
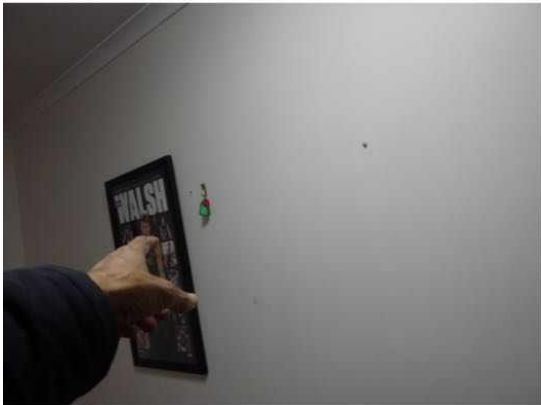
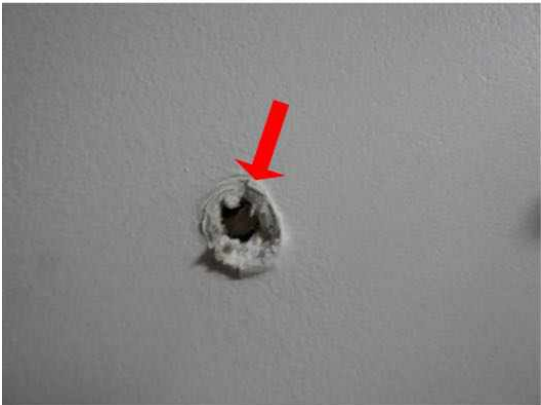
Defects 3.11

Building:	Building 1
Location:	All Internal Areas
Finding:	Internal walls & Ceilings - Scuffed
Information:	At the time of inspection it was noticed that few sections of internal walls and ceiling were scuffed.

Scuffed surfaces, while detracting from the overall appearance of the affected building element, do not indicate any operational or structural damage. This degree of surface damage is consistent with general wear and tear and minor impact damage, normally accumulated over a number of years.

Marked surfaces may be left as is at the discretion of the client; no repairs or replacement are necessarily required, as this is an appearance defect. However, the client may wish to seek quotations for the cost to refurbish or replace the identified building element.

A general handyman or plasterer may be appointed to rectify marked surfaces if considered necessary by the client.

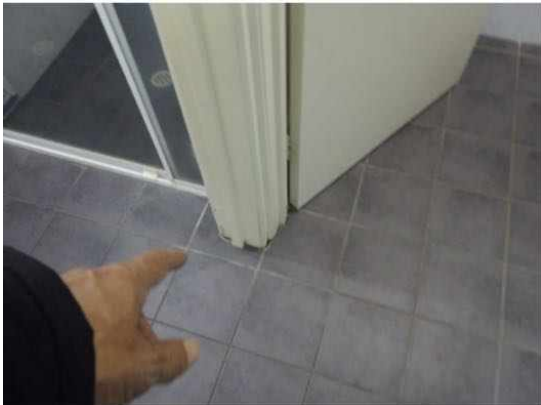
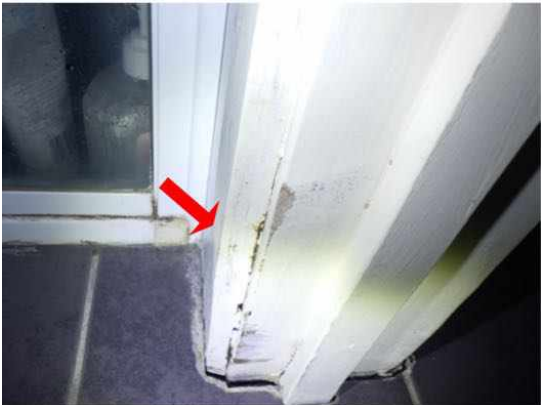
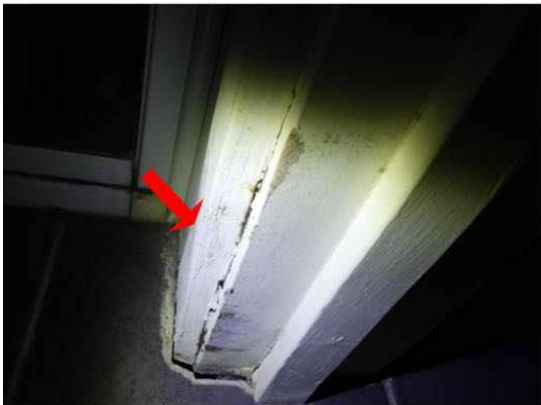
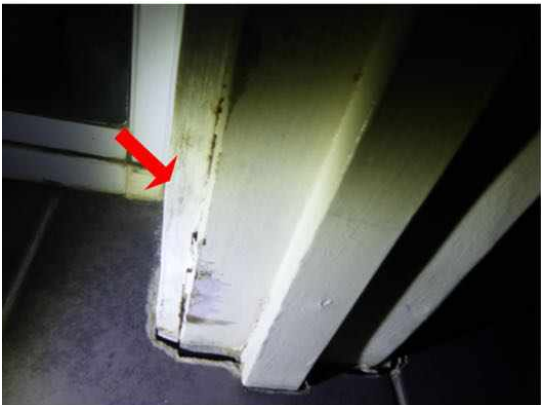
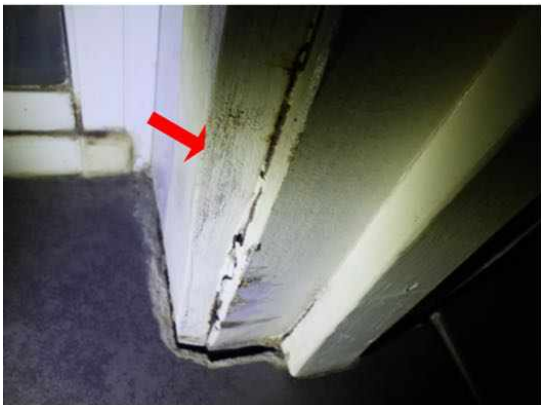
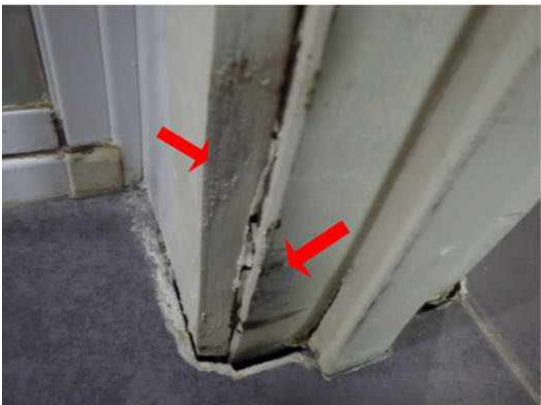
Defects 3.12

Building: Building 1
 Location: All Internal Areas
 Finding: Building element - Swollen
 Information: Swollen building elements generally indicate that the building materials have been affected by excessive moisture over a prolonged period of time, and have swollen as a result. The formation and development of mould/fungi or mildew is also a likely consequence of excessive moisture, which may pose major respiratory issues for occupants, particularly the elderly, the very young and those with existing illnesses and could be potential health safety hazards. In these cases an appropriately qualified inspector/tester should also be contacted for advice and/or technical assistance.

The structural integrity of swollen building elements can not be guaranteed, and further damage is likely to develop if left unmanaged. Excessive moisture is likely to lead to the development of secondary damage to any associated building elements, which may necessitate major reparation works if prolonged.

Rectification of the cause of the water leak should be addressed prior to any remedial works to the swollen building elements. A licensed plumber should be appointed immediately to identify the cause of the leak and provide advice on remedial works as necessary, Repair and/or replacement of swollen building elements should be conducted as a matter of urgency by a registered builder or qualified carpenter.

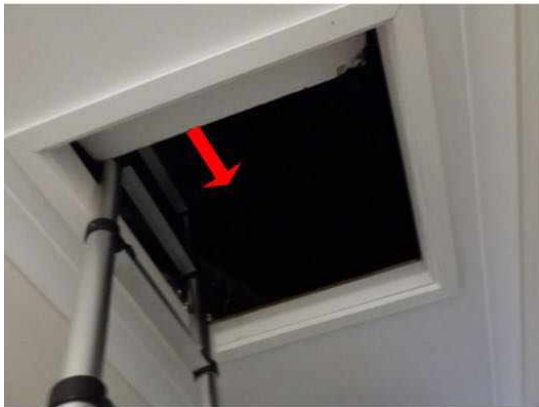
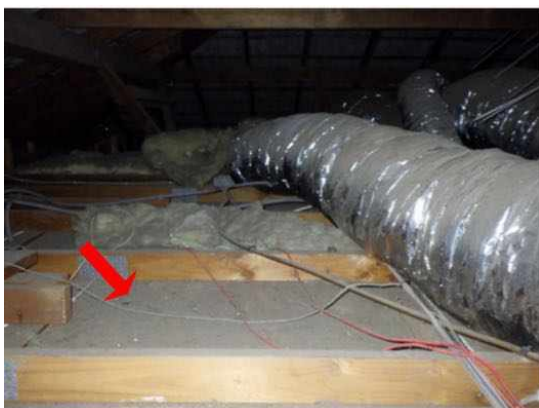
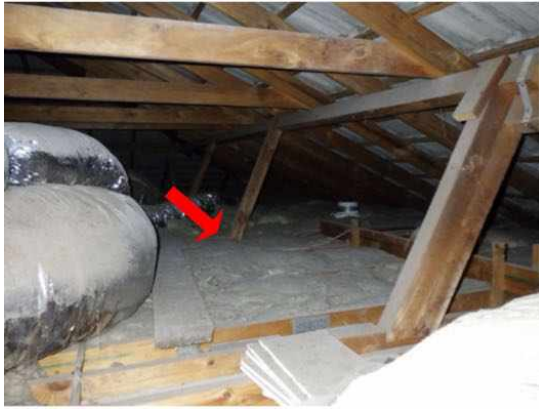
Defects 3.13

Building: Building 1
Location: All Internal Areas
Finding: Insulation - Missing
Information: Upon inspection of the roof void it was noted that insulation is not present in few sections in this roof space area.

Insufficient insulation will result in a comparatively higher cost to heat and cool a property as there is a lack of Insulation (or uneven coverage of insulation) which works as a barrier to heat transfer. This helps to keep out unwanted heat in summer and preserves warmth inside your home in winter. It can also help soundproof your home from unwanted airborne noise transfer.

Where insulation is absent, the area does not meet current Australian Standards. Installation of adequate insulation is required and should be conducted as soon as possible.
