Building Inspection Report

Inspection Date: Thu, 12 Mar 2026

Property Address: 16 Crawford Grove, Andrews Farm SA
5114, Australia

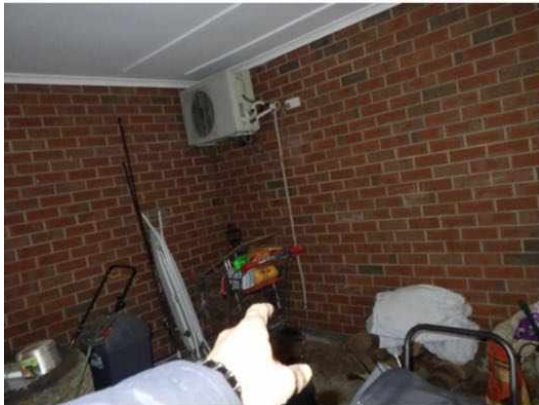
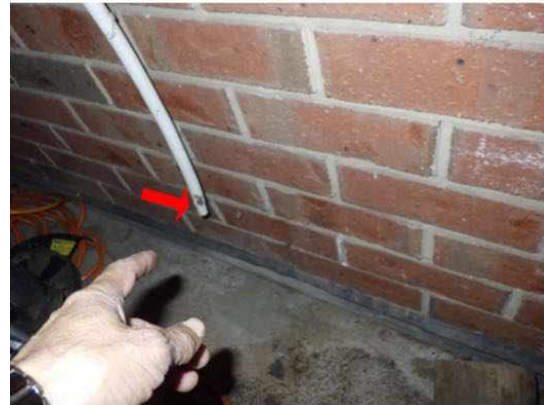
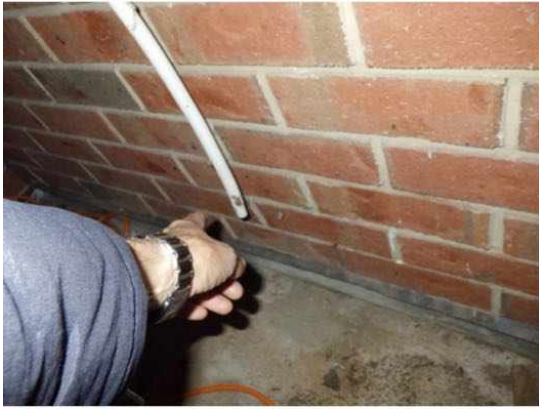
Defects 3.14

Building:	Building 1
Location:	All External Areas
Finding:	Air conditioner - Disconnected overflow
Information:	The Air Conditioner (A/C) overflow was found to be disconnected from storm water drainage and is creating excessive moisture in the surrounding area.

Such leaking creates an environment which is conducive to an array of defects, including water damage to associated building elements and the attraction of termite or timber pest infestation.

It is highly recommended that a licensed plumber be appointed to connect the A/C overflow in order to prevent such an environment from being created. These minor works should be carried out as soon as possible.

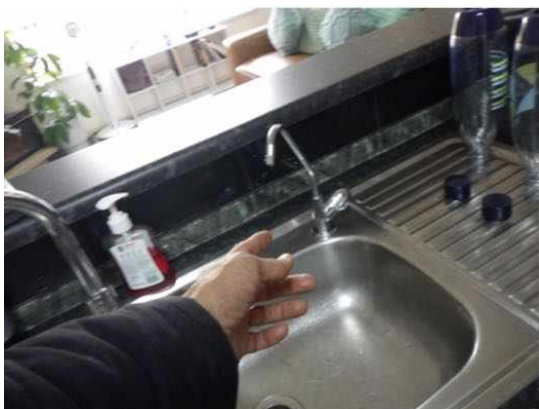
Defects 3.15

Building:	Building 1
Location:	Kitchen
Finding:	Kitchen Area - Pura Tap - Not operating
Information:	At the time of inspection it was noticed that pura tap in this kitchen area is not operational.

Non-operational items should be addressed to ensure that the full function of the building structure is available. Where some building elements are not operating as intended, it is possible that secondary building defects could arise due to their non-operation.

Repair and/or replacement of the faulty building element is recommended. It is highly recommended that the relevant tradesperson be engaged to perform any necessary works.

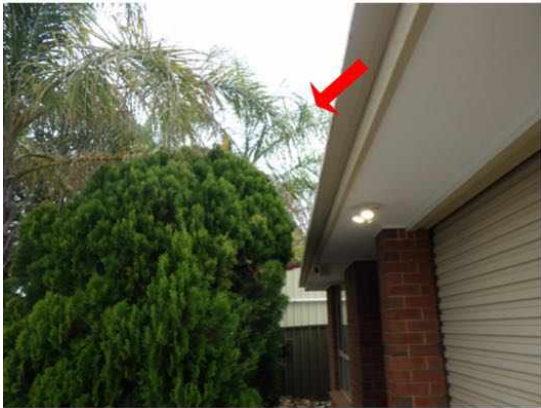
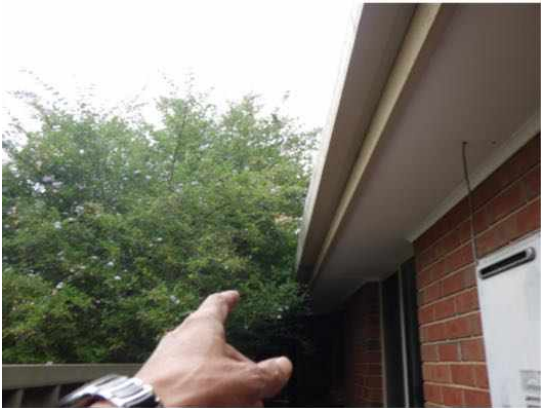
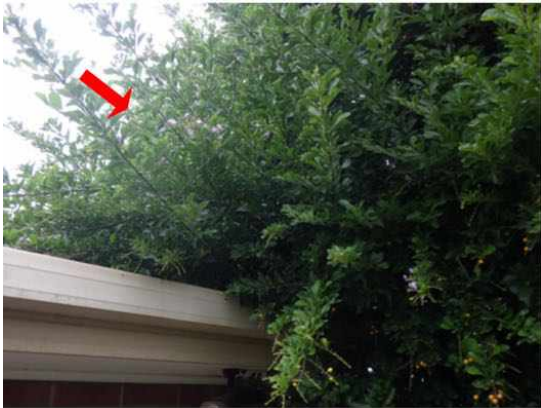
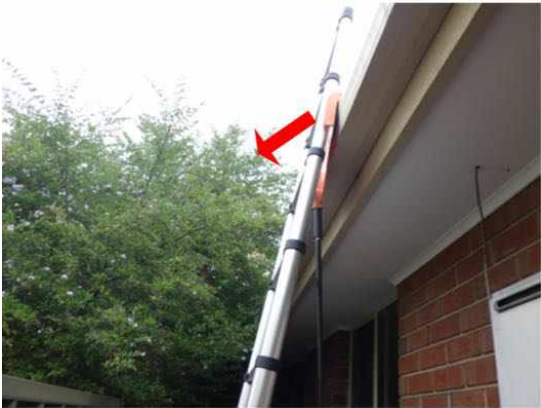
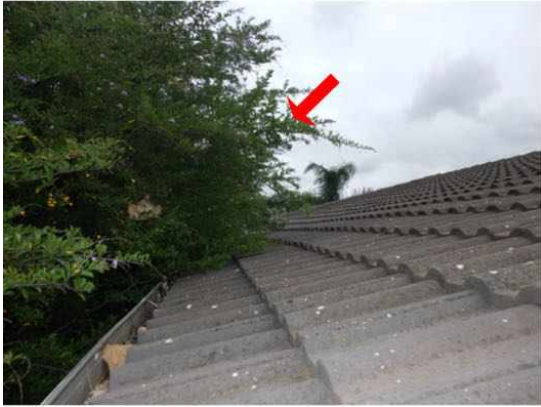
Noted Item

Gutters are a critical part of the building's management of storm water and rain. It is therefore important that they be kept clear to prevent secondary damage to associated building elements, including exterior and interior walls, ceiling linings and

any adjoining building elements. Where gutters are blocked, pooling of rainwater is likely to occur, fast-tracking rust and corrosion of the roof plumbing elements.

It is highly advised that all overhanging tree branches be removed as soon as possible to prevent any further damage. Repair and/or replacement of sections of damaged guttering may also be required where the extent of the damage necessitates.

Such works should be performed by the homeowner; however, appointment of a landscape contractor or an arborist may be required. Consultation with a licensed roof plumber is required where guttering has been damaged.

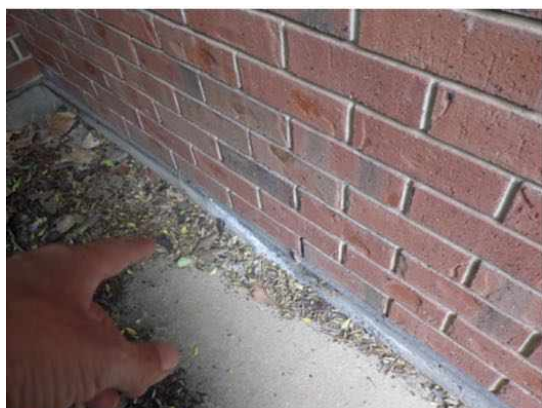
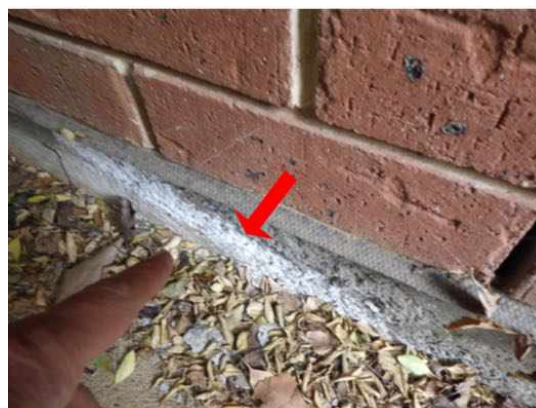
Noted Item

Building: Building 1
 Location: All Areas
 Finding: Slab edge concrete - Efflorescence
 Information: At the time of inspection it was noticed that efflorescence appears to be effecting the slab edge concrete in few sections around the property.

It is typically seen as white salt deposits on the surfaces of concrete pavement or mortar between bricks or tiles. While detracting from the overall appearance of the affected area, efflorescence is not likely to develop into secondary damage if left unmanaged.

Generally, soluble salt deposits can be removed by dry brushing with a stiff-bristled brush. Repeated dry brushing is an ideal treatment for eliminating this forming of efflorescence. A cleaning contractor or general handyperson may be appointed to perform these works at the discretion of the client.

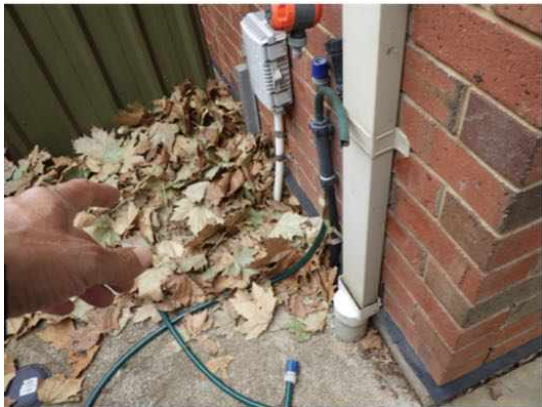
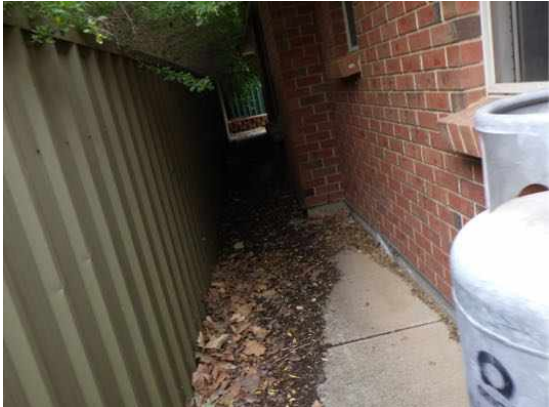
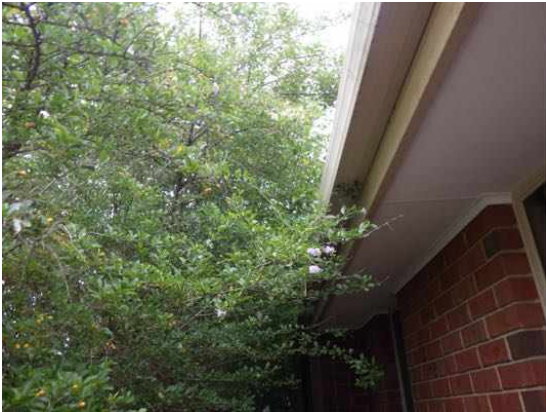
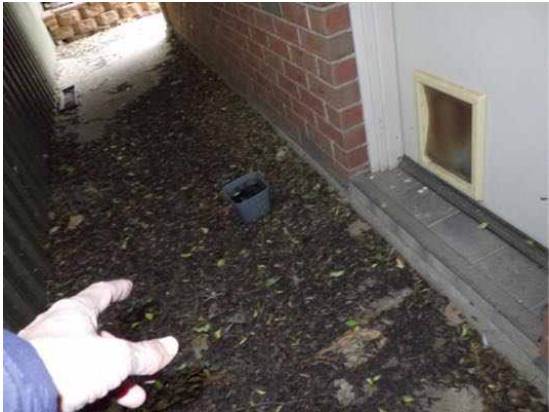
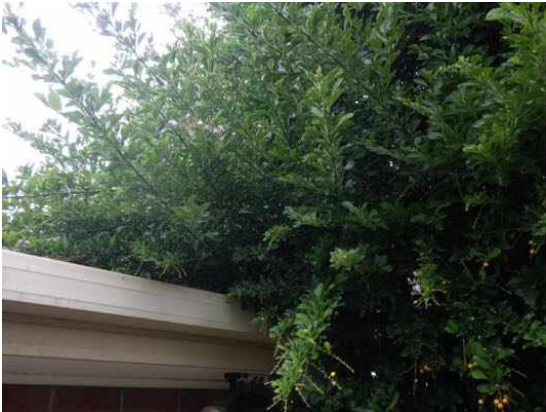
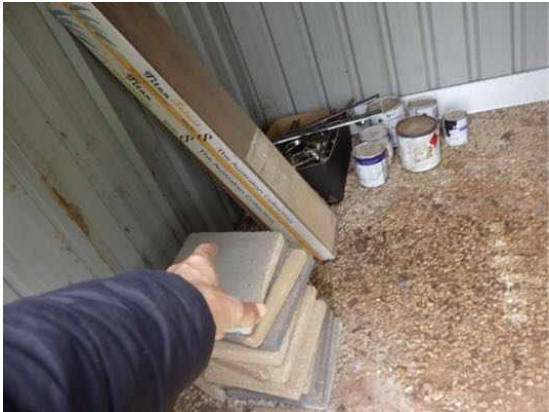
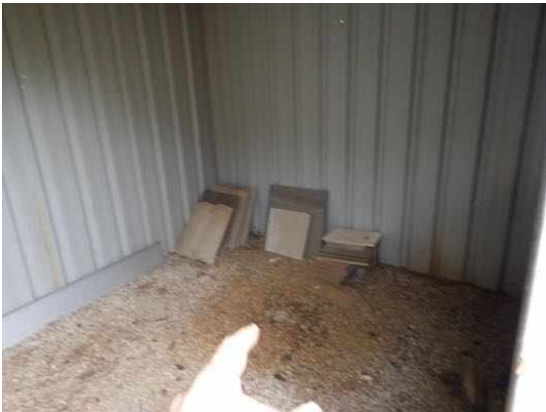
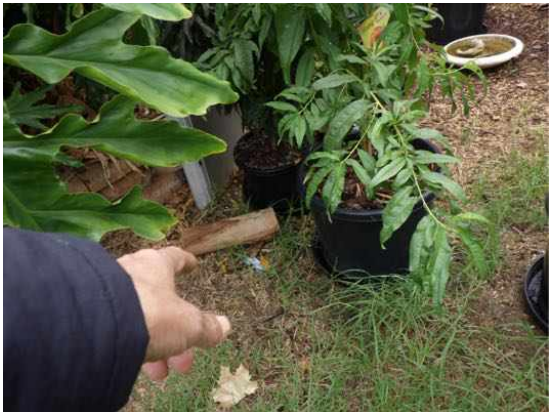
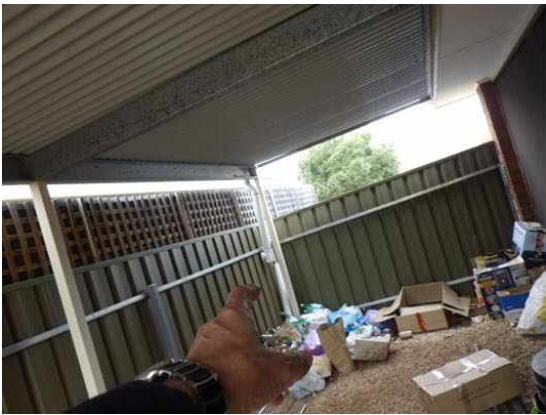
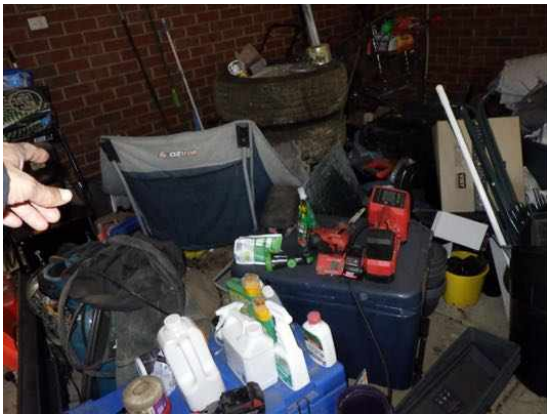
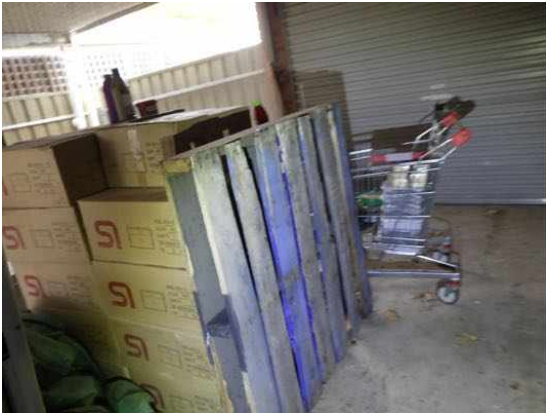
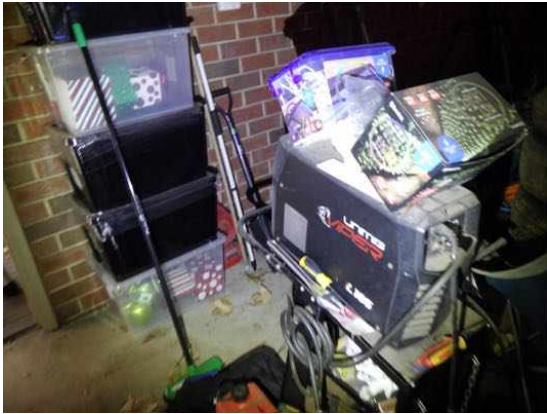
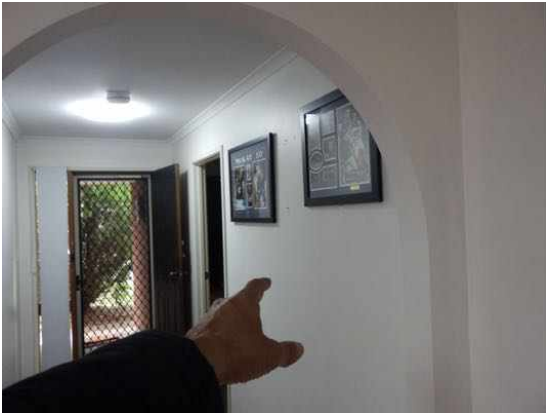
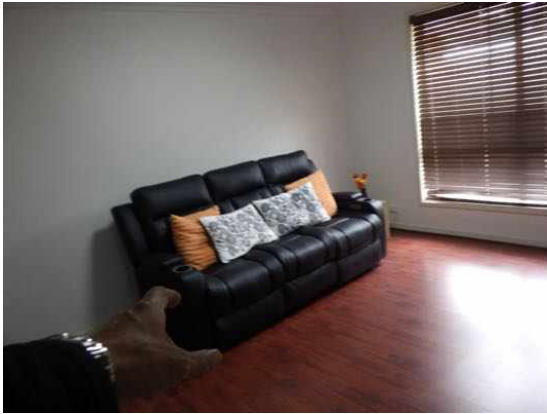
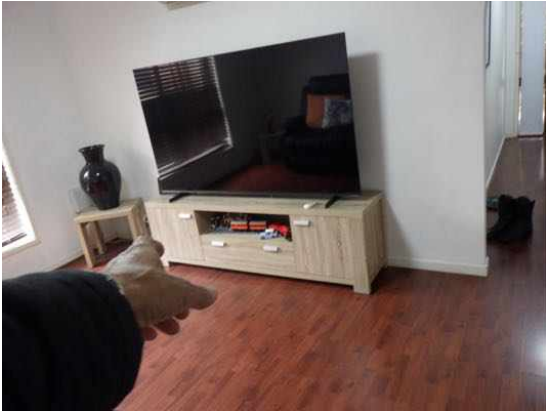
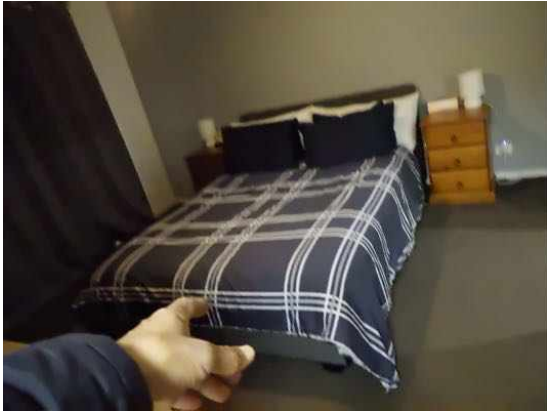
Noted Item

Building: Building 1
 Location: All Areas
 Finding: Additional Photos - Obstructions and Limitations
 Information: These photographs are an indication of the obstructions and limitations which impeded full inspection of the property at the time of inspection. These obstructions can hide an array of defects and should be removed to allow full inspection to be carried out. A re-inspection is recommended once the areas are made accessible.
