Building and Timber Pest Inspection Report

Inspection Date: Wed, 14 Jan 2026

Property Address: 11 Eyre Pl, Caloundra West QLD 4551,
Australia

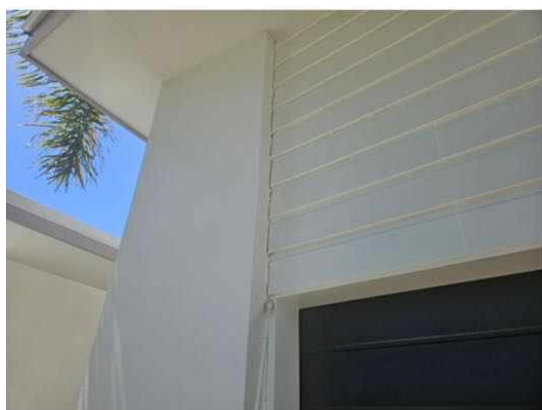
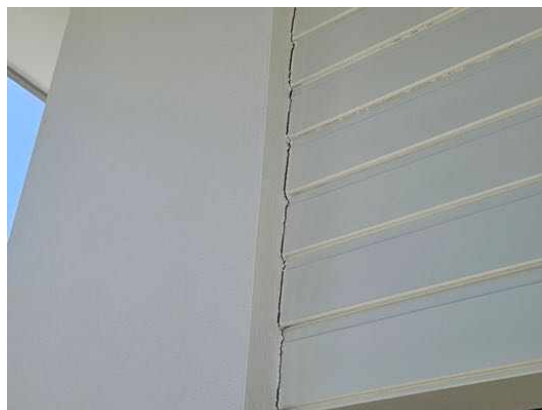
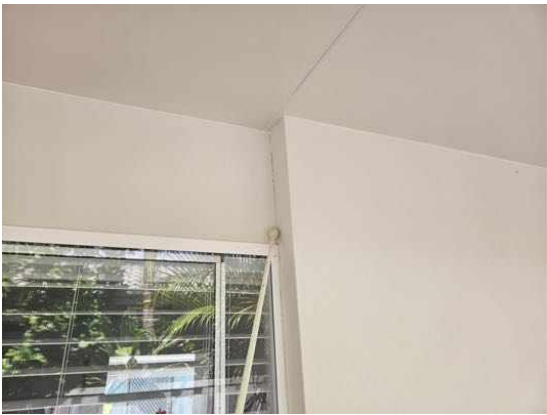
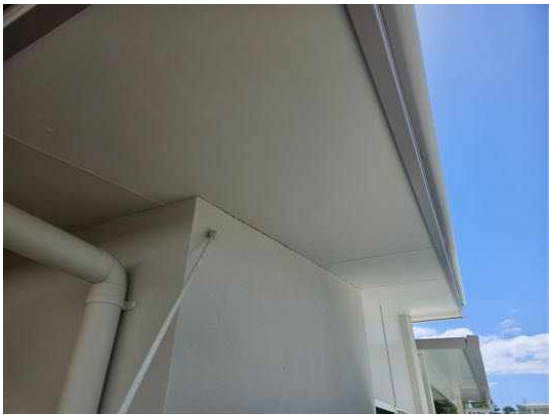
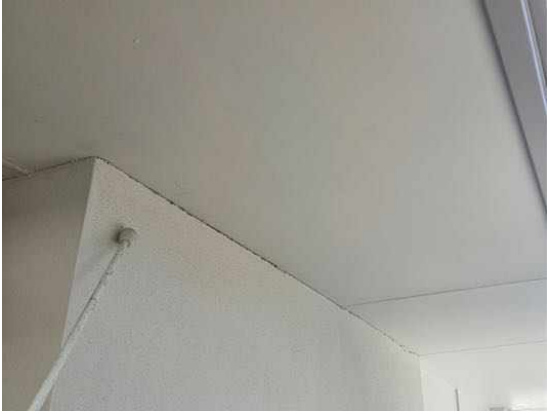
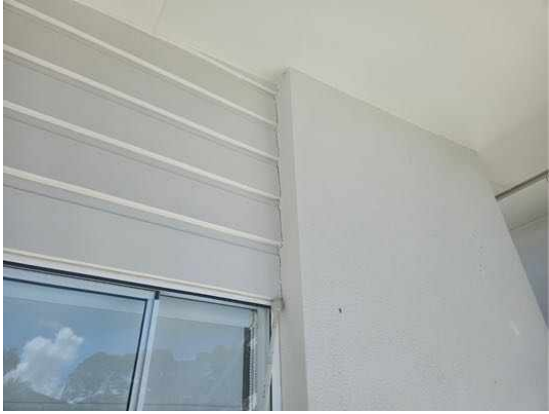
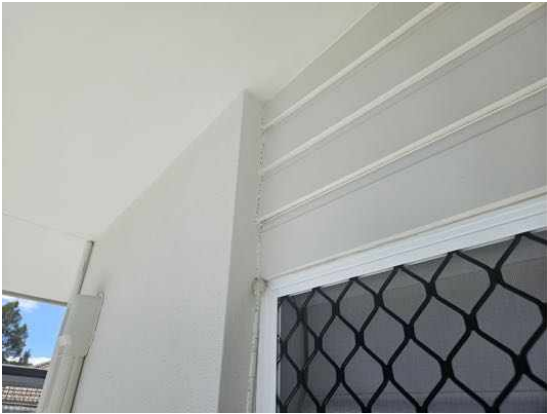
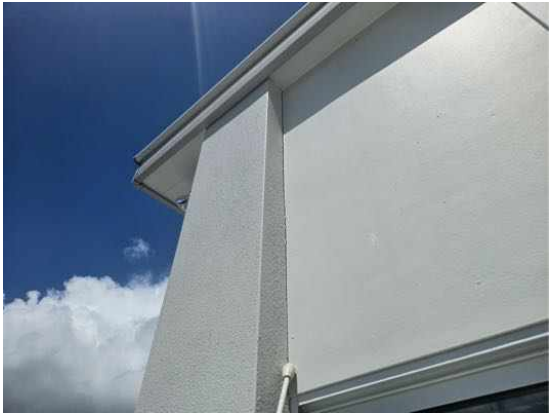
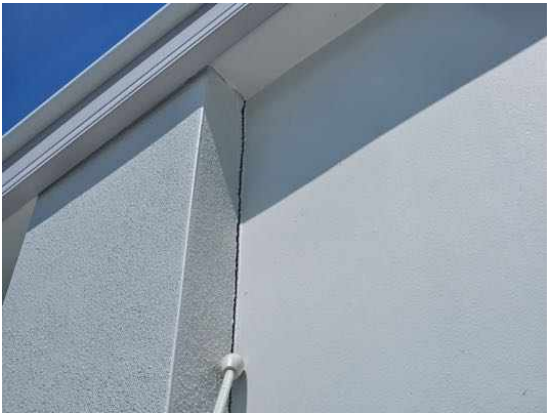
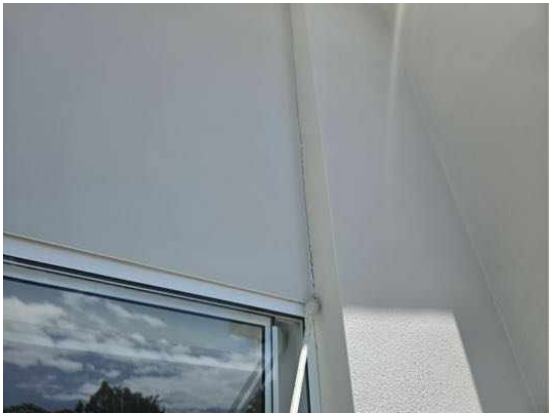
Building:	Main Building
Location:	All External Areas
Finding:	Minor movement cracking - external
Information:	Multiple areas of minor to moderate movement cracking to external wall cladding and ceiling linings in the areas shown in the photos, was observed at the time of the inspection. Internal cracking was not able to be assessed due to recent painting work completed throughout the inside of the home.

Cracking of this nature is expected in this type of building and it appears to be associated with movement of building elements of different types at the positions where they join; however, some locations appear to be somewhat larger and these should be monitored for a period of time. Should there be further greater movement, always contact a structural engineer or a licensed builder.

The fine but visible cracks can be patched and painted over by an experienced painter or handyman at the clients discretion.

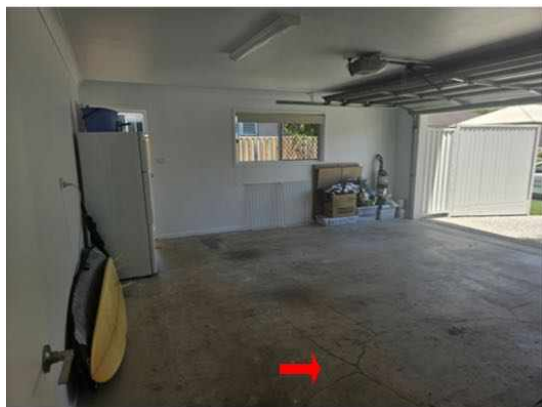
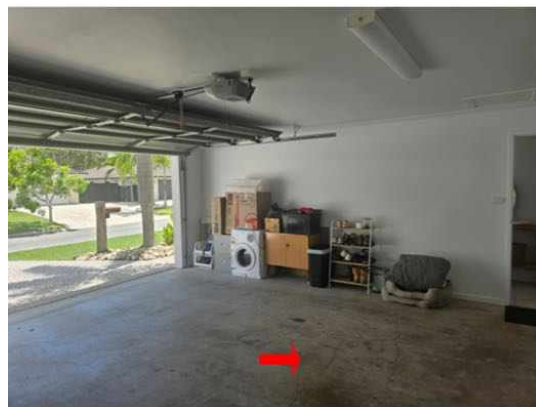
Finding 3.02

Building: Main Building
 Location: Garage
 Finding: Crack in concrete slab - Category 2
 Information: A crack coded as Category 2 was identified in the garage floor slab. A Category 2 crack is described as a distinct crack, with the slab being noticeably curved or changed in level.

To be considered Category 2, the approximate width of the crack is less than 2.0mm, or a change in offset of less than 15mm when a 3m straight edge is placed over the defect.

Category 2 cracks to slabs should be monitored for a period of 12 months. At the end of the monitoring period, cracks rated greater than Category 2 are considered defects that require rectification.

Should any changes be noted in the size, surface level or if concrete is seen to breakdown, consult with a RPEQ structural engineer.

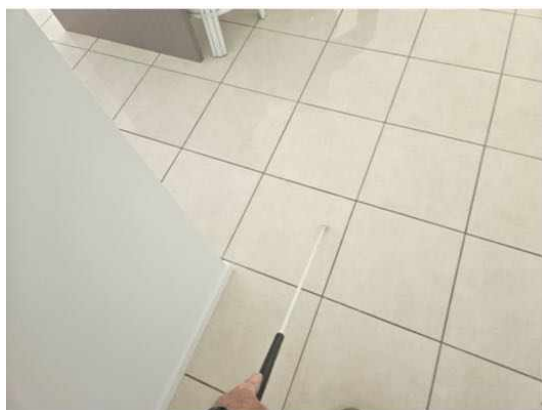
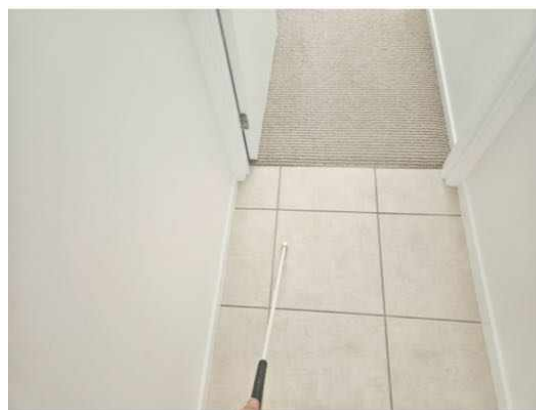
Finding 3.03

Building:	Main Building
Location:	As shown
Finding:	Tiles - Drummy
Information:	Drummy tiled areas were identified at the time of inspection. Please see the attached photos for locations.

The term 'drummy' refers to tiles that have become detached from their fixing, despite otherwise being in relatively good condition. Such defects are generally caused by physical or moisture damage to the area. Drummy tiled areas may also be a direct result of poor workmanship during the construction process.

Tiled areas may swell and shrink with changes in air humidity if the area has sustained moisture damage. Any exposure to moisture is capable of causing tiled areas to become drummy and/or cracked over a prolonged period of time. Drummy tiled areas generally require removal and replacement of affected tiles.

Specialist trades are available for these types of services. A licensed builder may be required to undertake works if damage is extensive or if secondary building defects have resulted. Otherwise, it is advised that a tiling contractor or a tile adhesive injection service may be appointed to perform works as necessary.

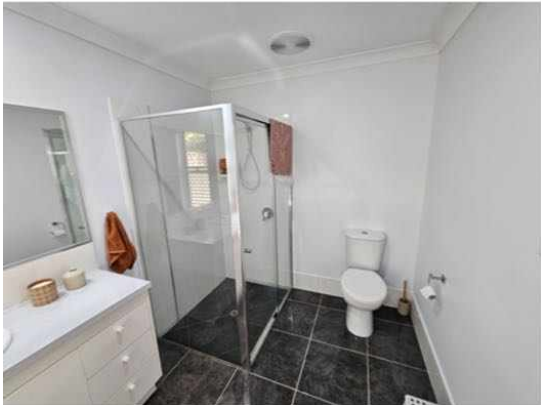
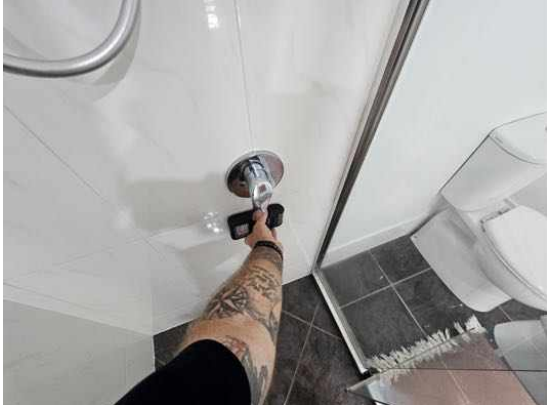
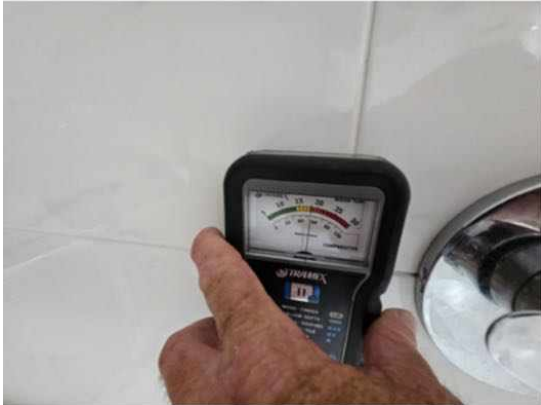
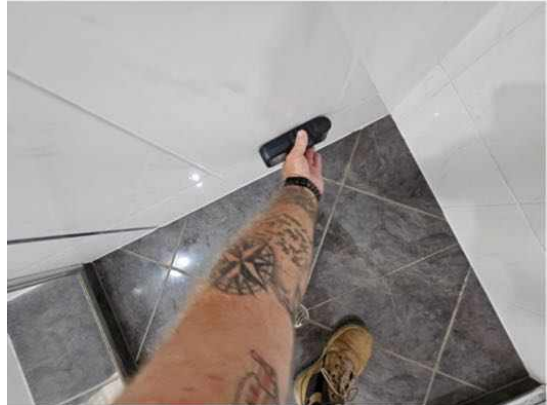
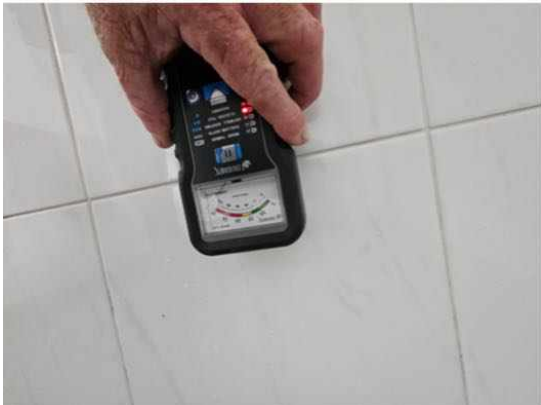
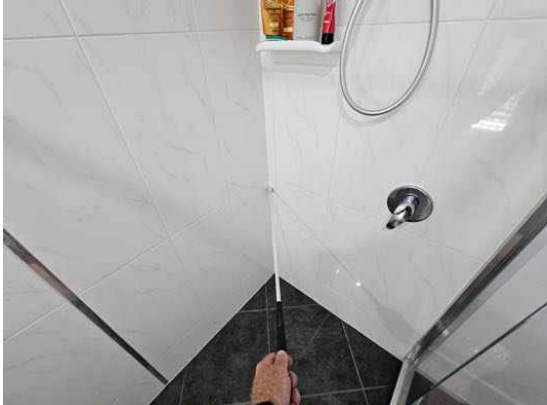
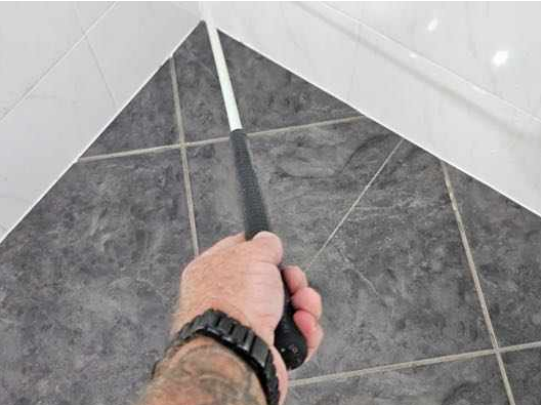
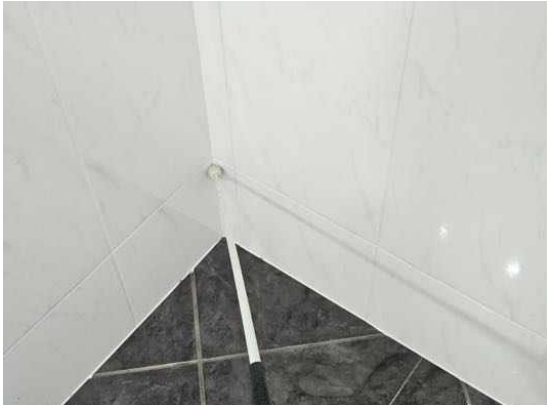
Finding 3.04

Building:	Main Building
Location:	Ensuite - Master
Finding:	Elevated moisture present - ensuite shower
Information:	Elevated moisture was noted in the lower tiled wall surfaces of the ensuite shower.

The levels varied at differing points throughout the recess. This could possibly be due to deteriorated grout and silicone sealants and / or plumbing fittings and fixtures. The grouts and sealants can break down over time and become porous, allowing moisture to enter the wall sheet surface behind the tiles. Some scouring of the grout and deteriorated silicone sealant at the base were noted.

Moisture was not detected the in the walls on the reverse side of the shower.

Elevated moisture can attract timber pests and vermin, and produce conditions that promote timber pest attack, fungal growth and wood decay.

It is recommended that the moisture levels in these areas be monitored over time and the grout and silicone could be renewed to possibly eliminate any further moisture penetration.

A licensed tiler and / or sealant specialist could be engaged to renew these elements.

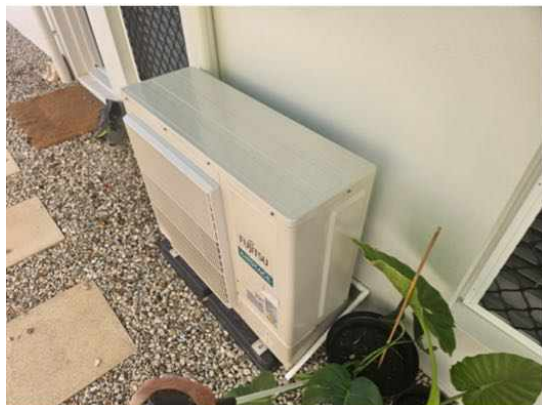
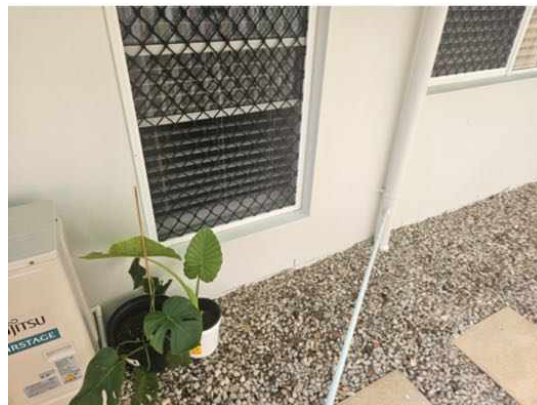
Building: Main Building
 Location: Right side
 Finding: Air conditioner - Disconnected drain
 Information: The Air Conditioner (A/C) overflow was found to be disconnected from storm water drainage and could create excessive moisture in the surrounding area.

Such leaking creates an environment which is conducive to an array of defects, including water damage to associated building elements and the attraction of termite or timber pest infestation.

It is recommended that a licensed plumber be appointed to connect the A/C overflow

to a drainage source in order to prevent such an environment from being created. An alternative is to extend the overflow further into the garden away from the building perimeter.

These minor works should be carried out in the short term.

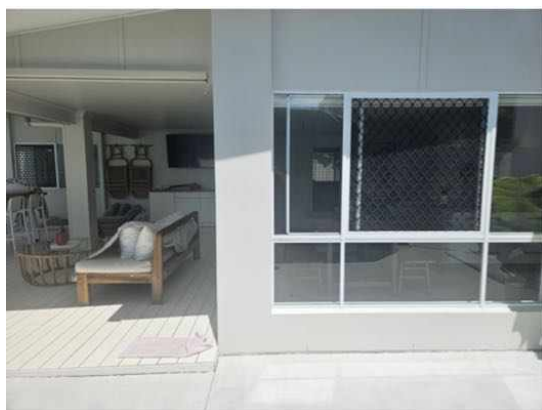
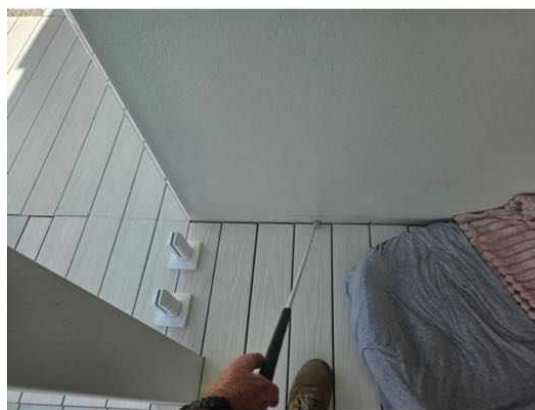
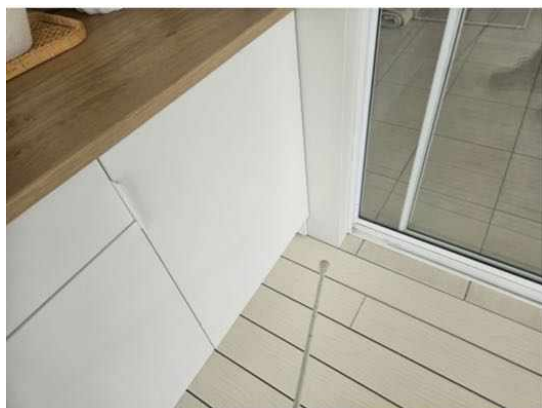
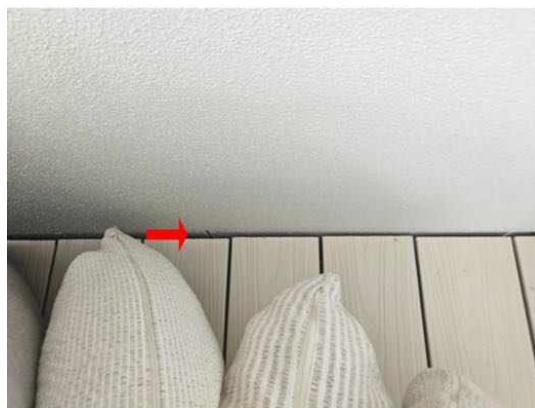
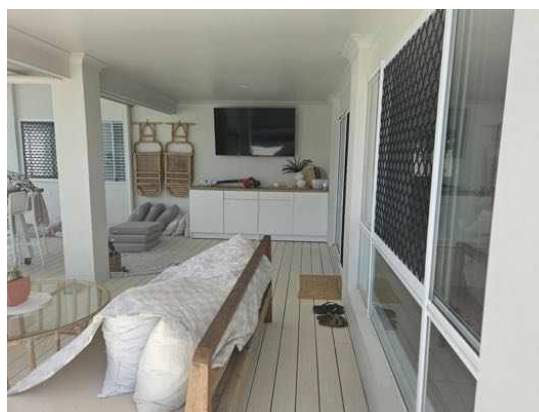
Finding 6.02

Building:	Main Building
Location:	Rear patio
Finding:	Bridging of timber pest barrier - suspected
Information:	Bridging of timber pest barriers occurs when timber pests bridge (usually by building a mud tunnel) a termite barrier or inspection zone or where termites have a passage allowing them to bridge the barrier. Generally this takes the form of finished ground levels external paving or concrete being retrospectively installed above the damp course level the adjacent internal floor level or weep and ventilation holes.

Where bridging has occurred full inspection is prevented and termites may enter a property in a concealed or undetectable manner.

It is recommend that the client consult with a licensed timber pest controller to ascertain the type and installation of the system to ensure coverage.

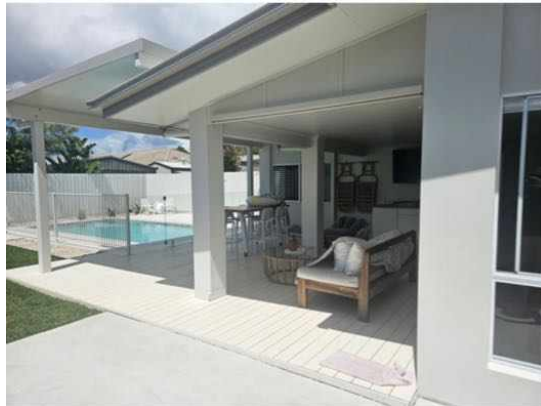
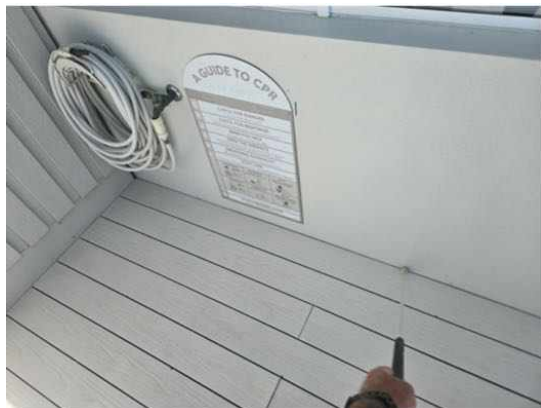
Finding 6.03

Building:	Main Building
Location:	Rear patio
Finding:	Deck against house - inspection zone
Information:	The deck as inspected on the day, is built against the house perimeter and above the weep holes. An inspection zone between decking and the house exterior is required to maintain visual inspection area, gap of greater than 25mm between structures and the slab edge of the home is required.

Where the slab edge cannot be properly inspected, there is a high risk of termite attack. It is usually recommended that termite or timber pest inspections be carried out every 6-12 months to aid protection of the property against infestation.

If the deck or structure is close to the ground and cannot be inspected visually from under the structure, a barrier system may be required to mitigate any risk created by the reduction of inspection ability.

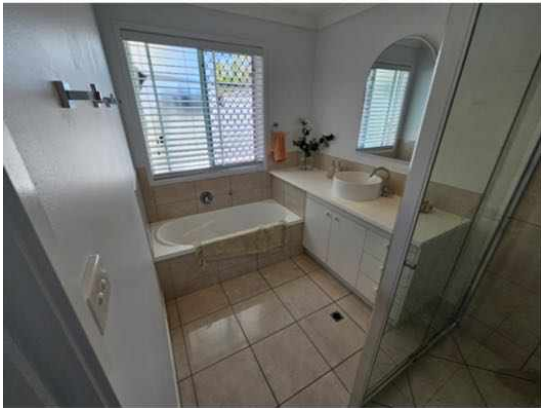
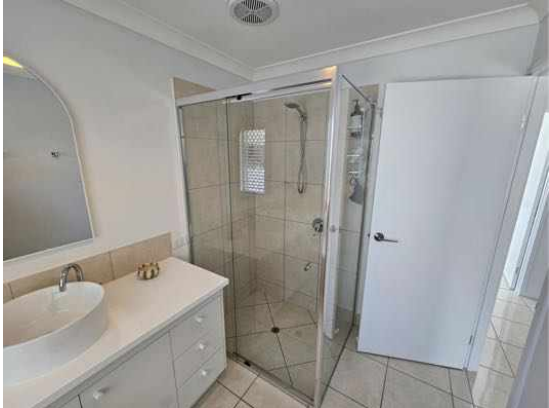
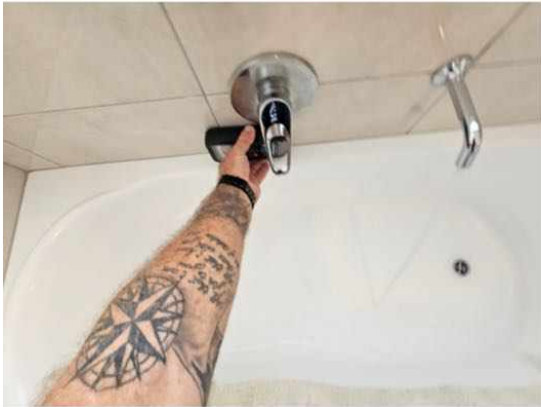
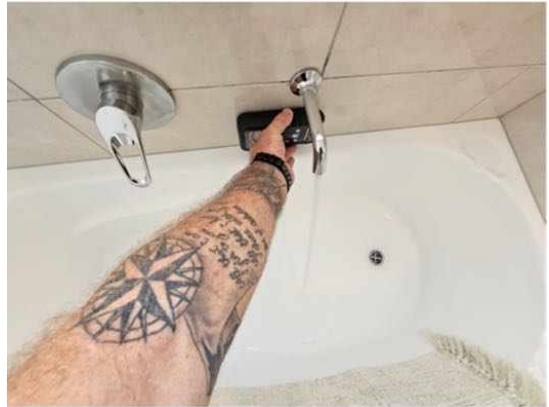
Noted Item

Building: Main Building
Location: Bathroom
Finding: No moisture detected in bathroom
Information: On the day of inspection the shower in the bathroom was measured for moisture using a "Tramex" moisture meter. During this inspection no moisture was detected in these areas and the tiled / sheeted surfaces appear to be in good order.

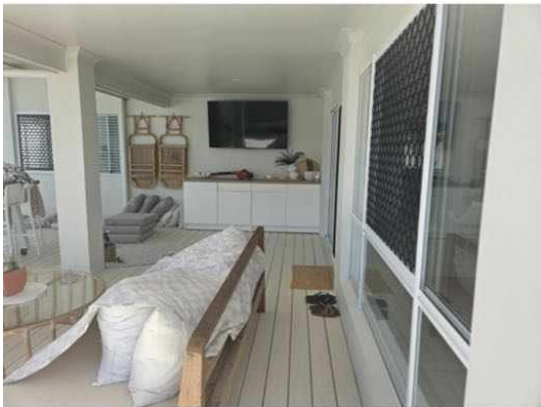
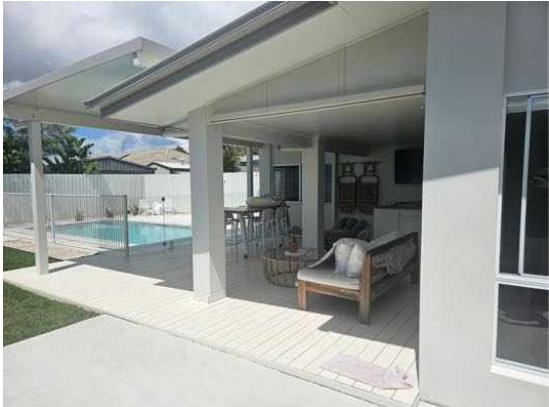
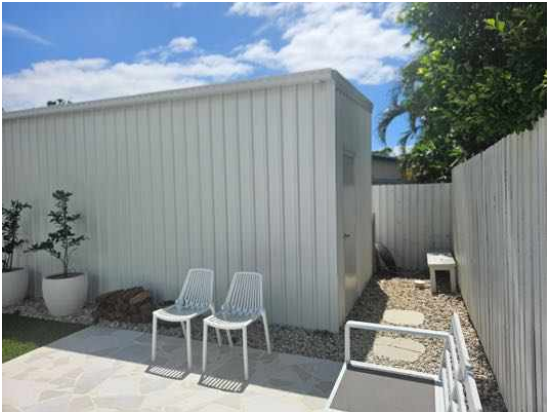
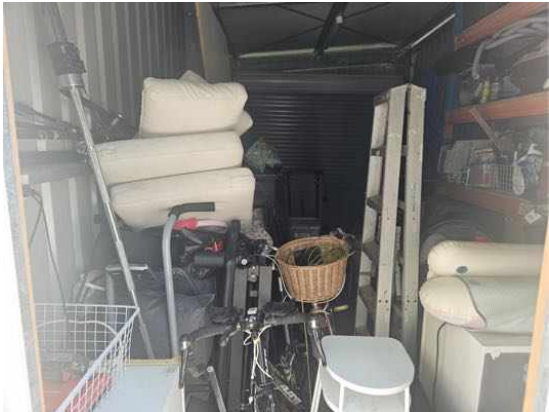
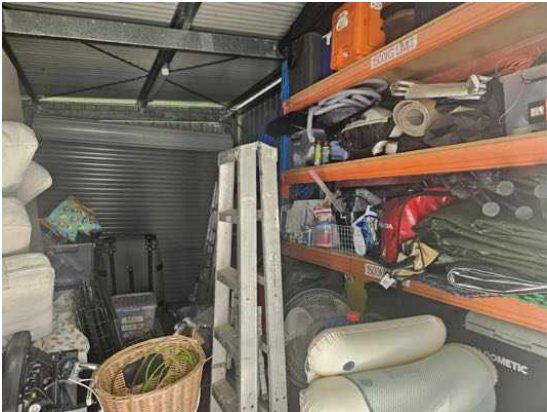
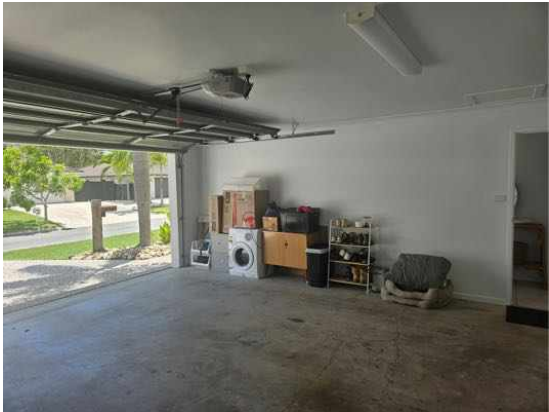
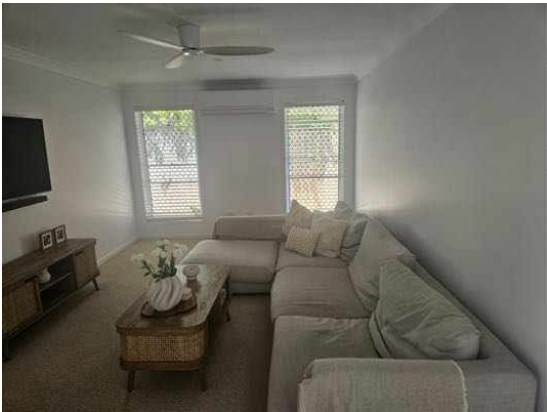
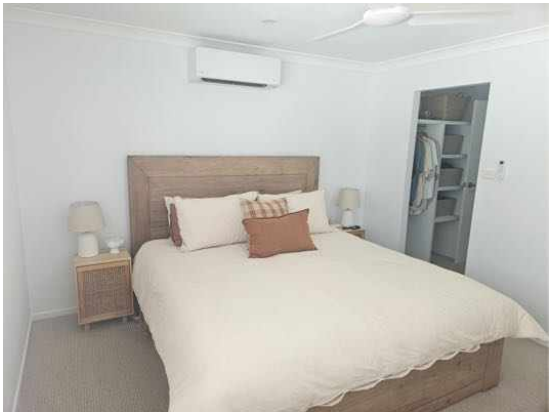
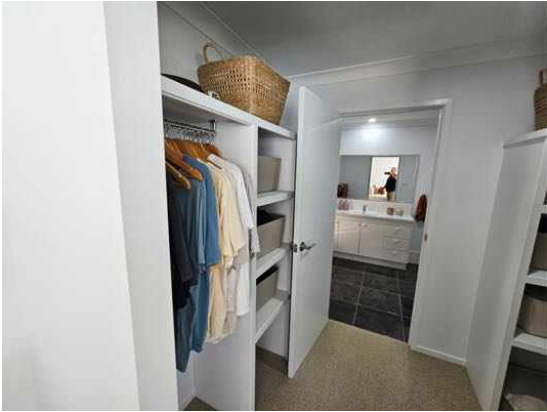
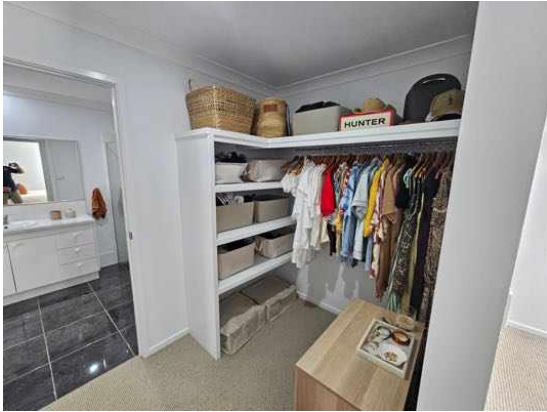
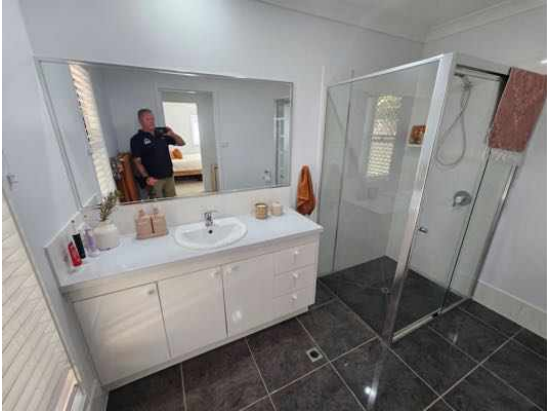
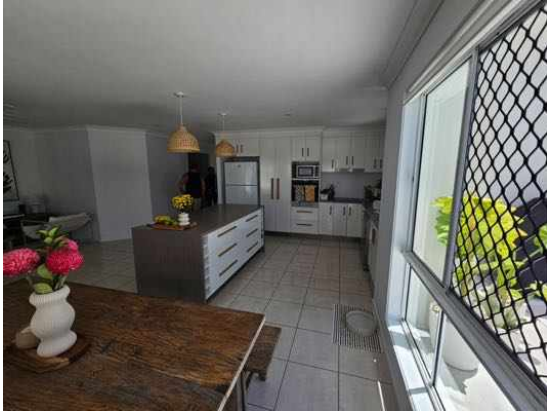
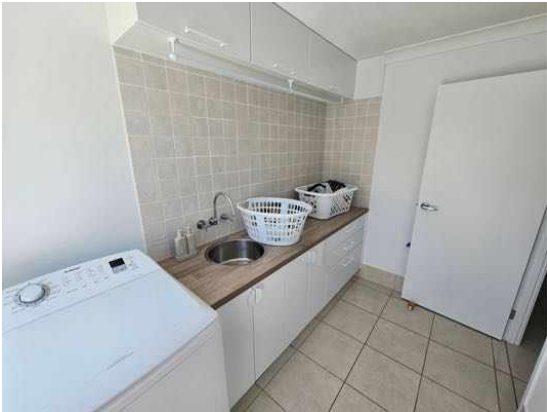
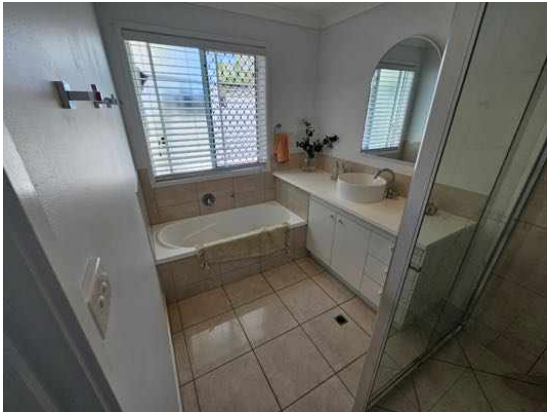
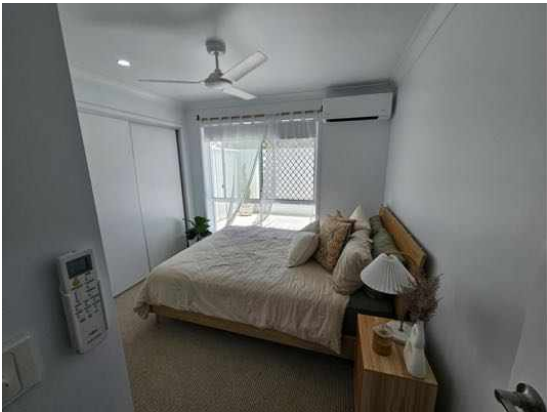
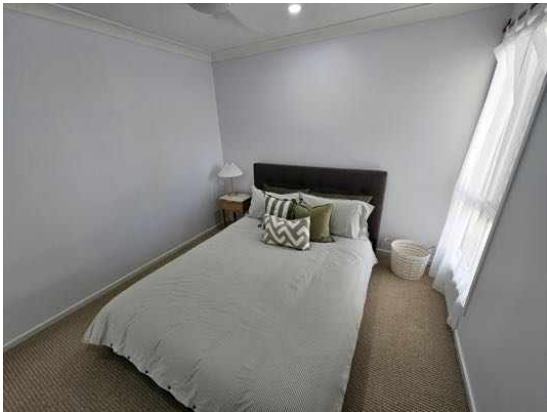
Finding: Additional Photos - Obstructions and Limitations

Information: These photographs are an indication of the obstructions and limitations which impeded full inspection of the property at the time of inspection. These obstructions can prevent full inspections of the areas shown.

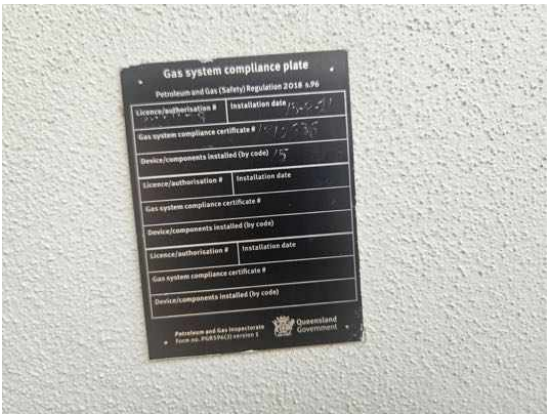
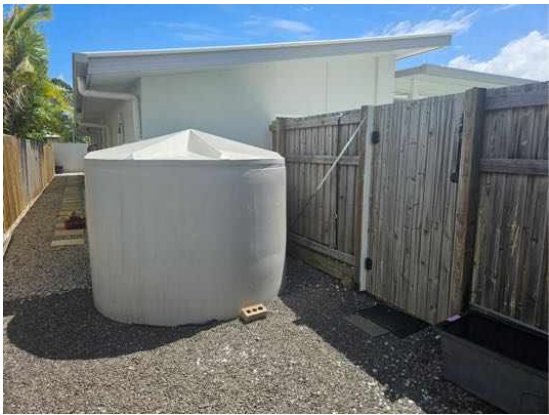
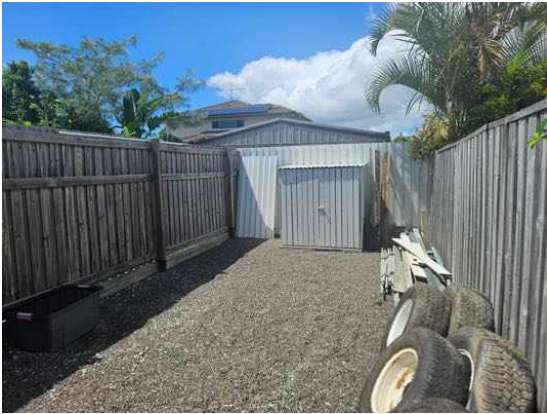
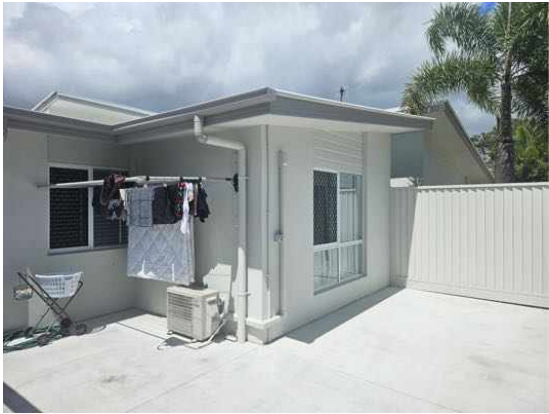
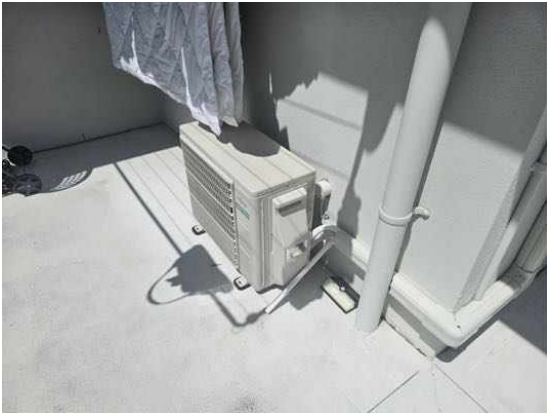
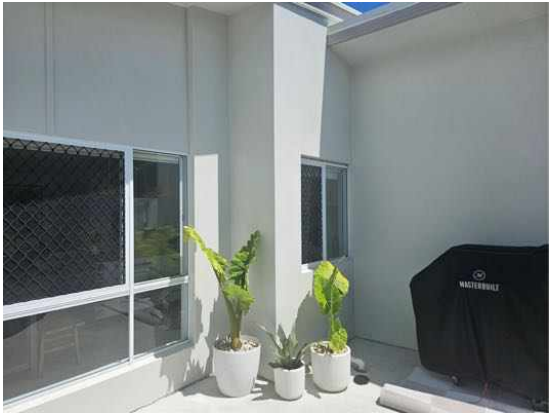
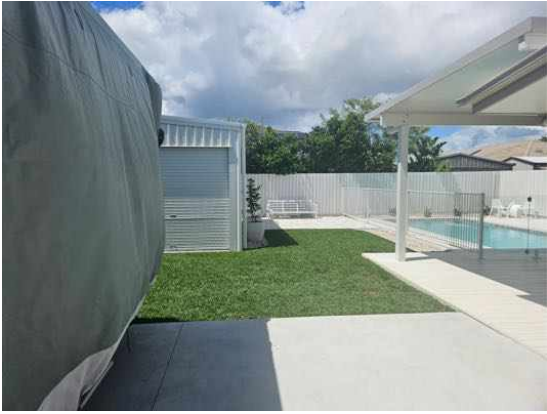
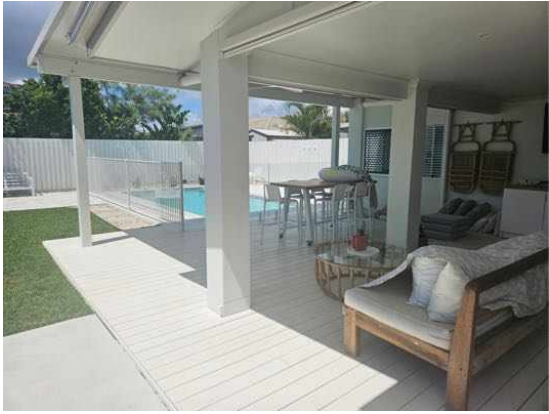
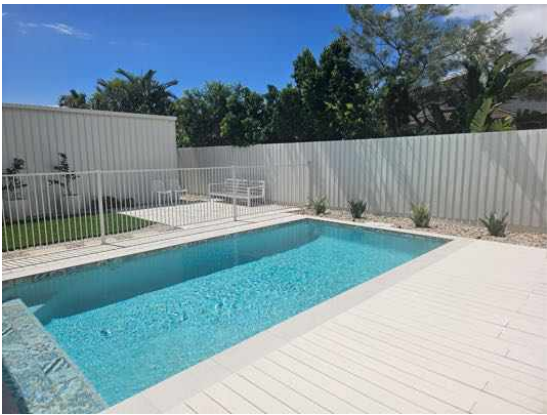
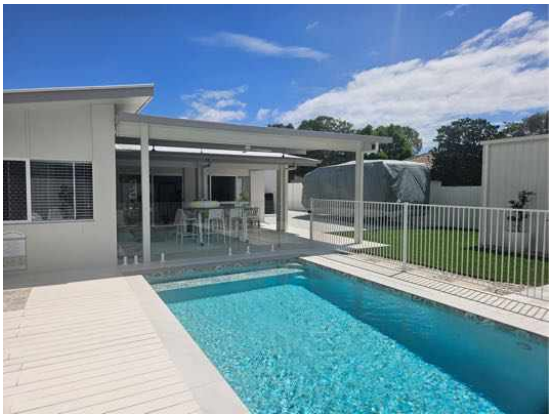
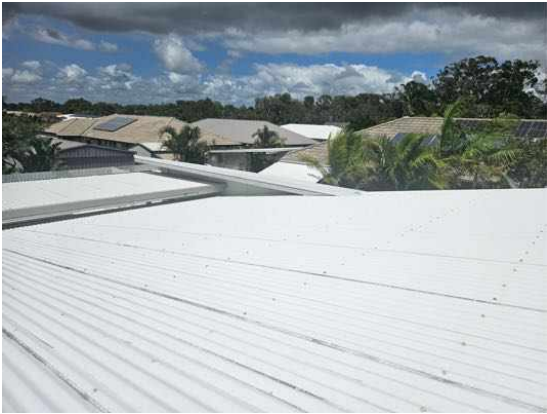
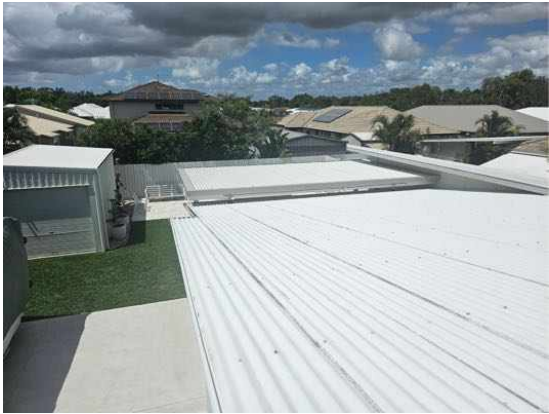
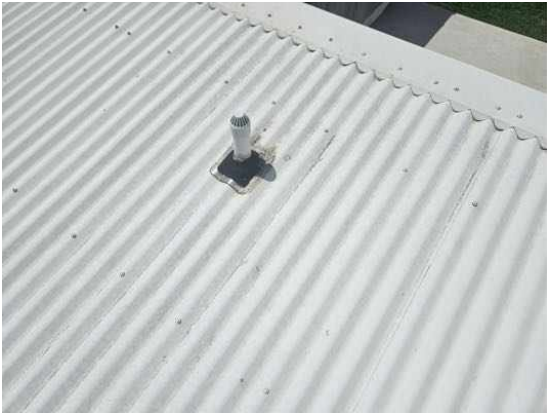
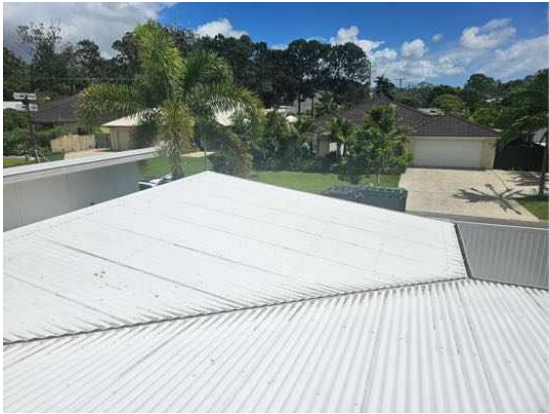
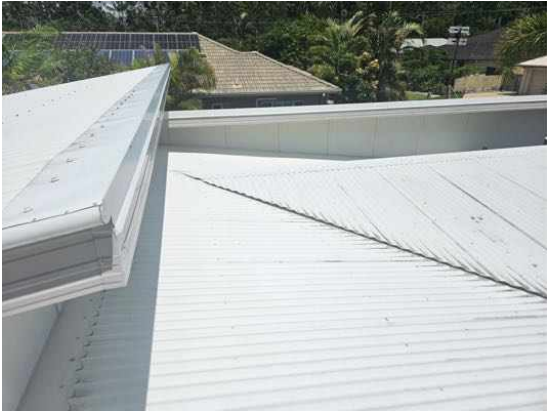
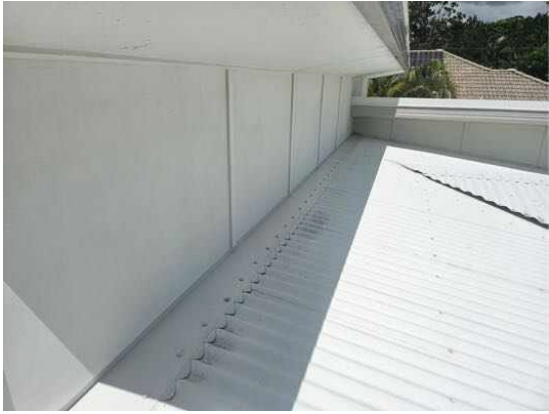
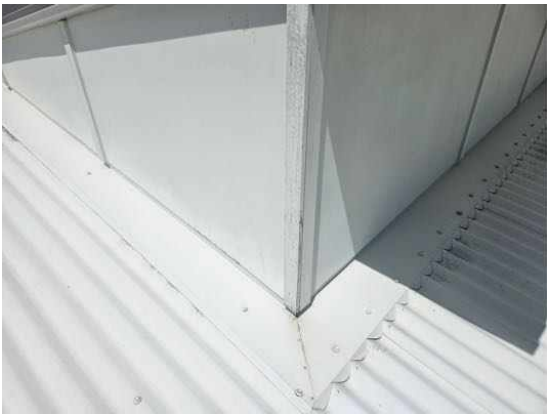
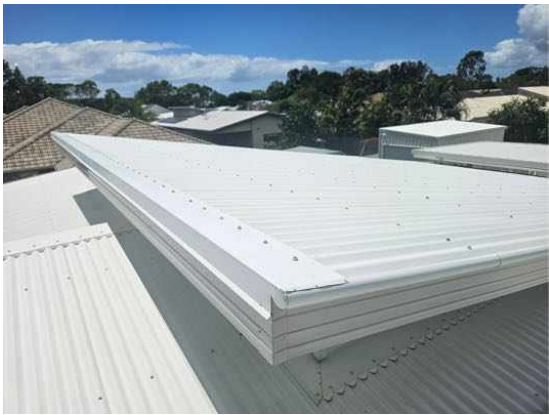
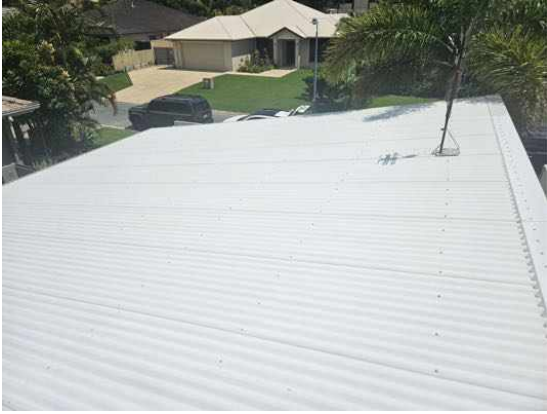
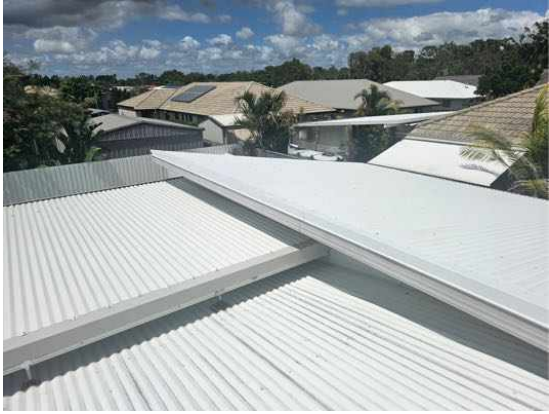
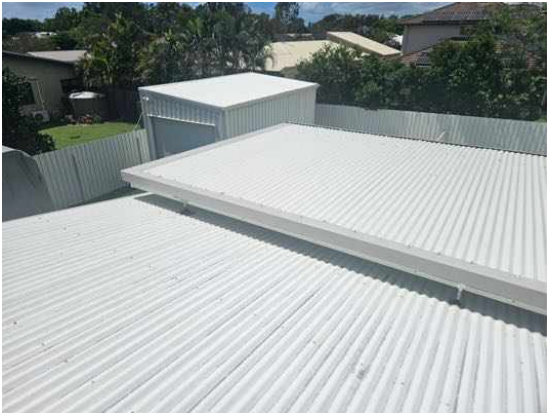
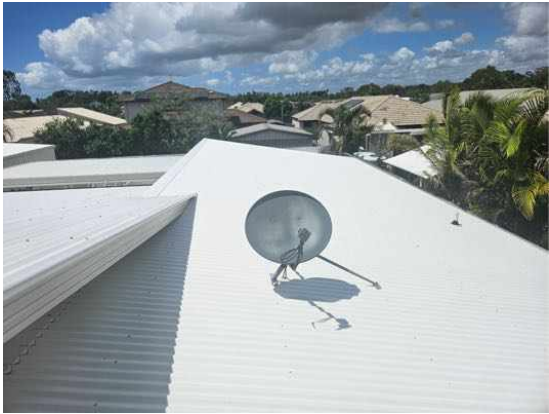
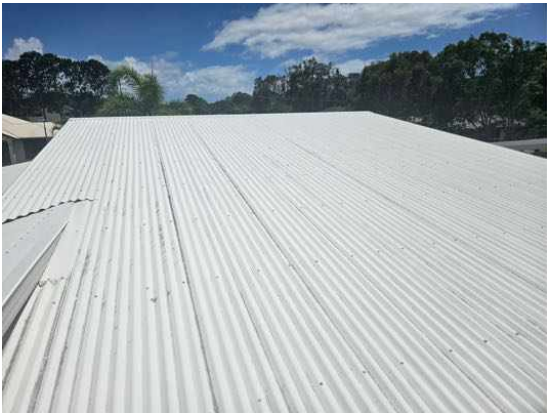
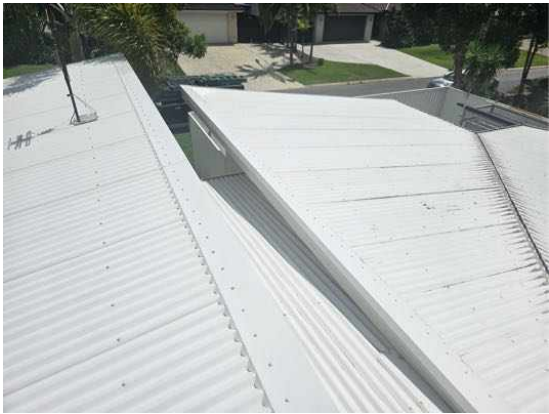
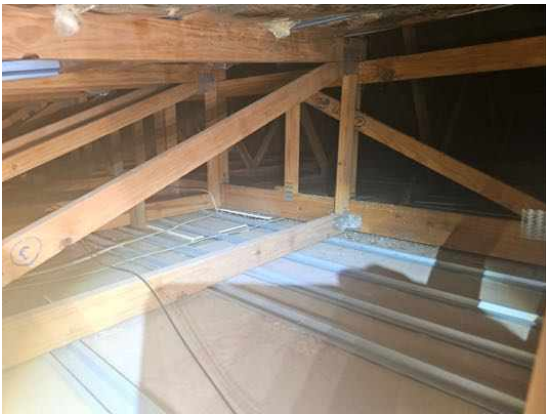
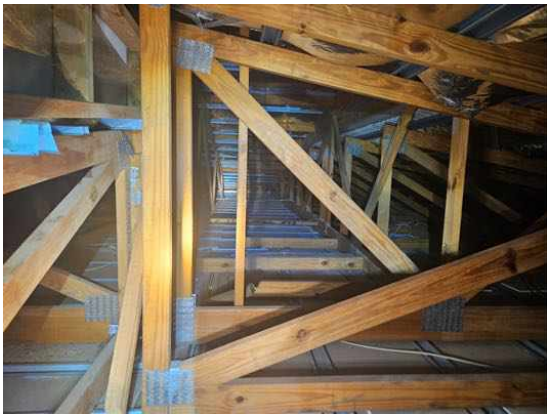
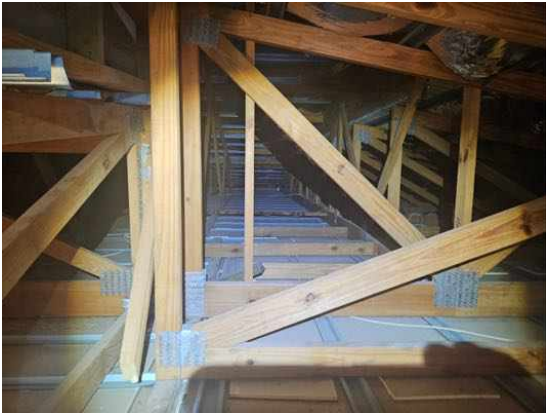
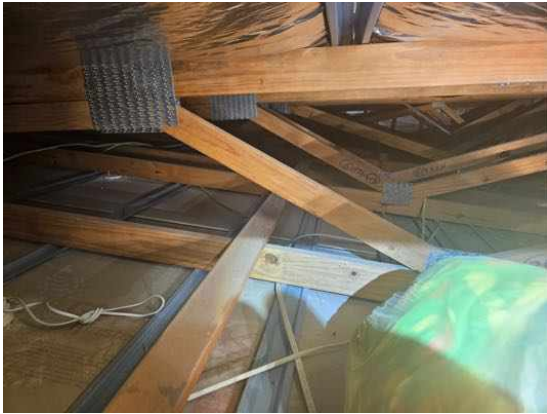
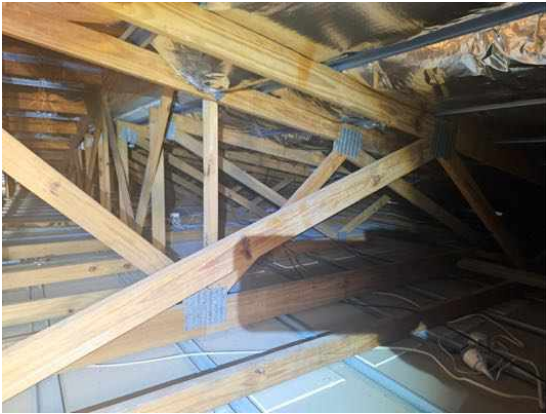
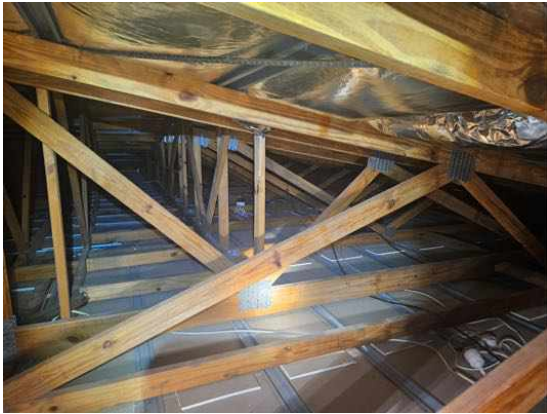
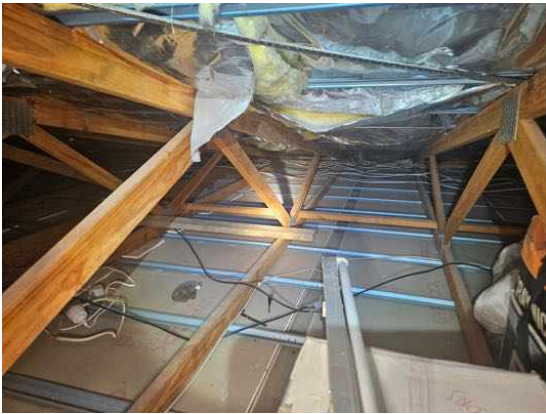
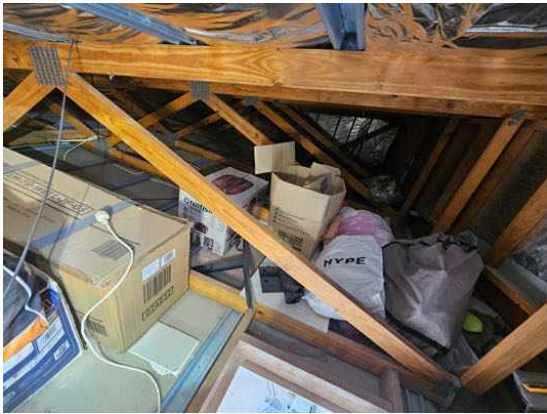
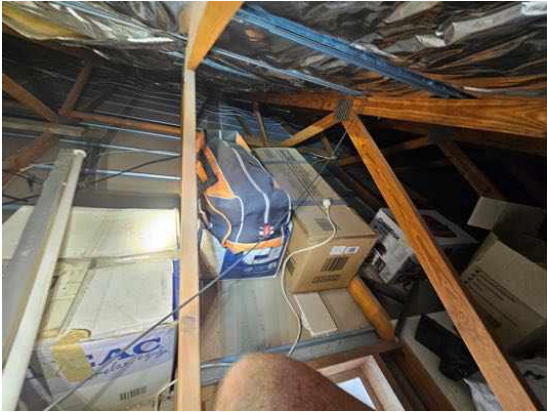
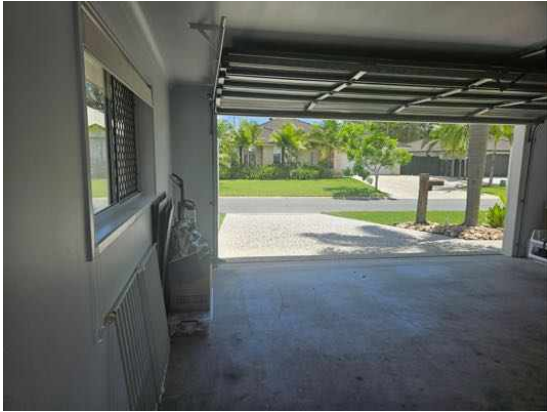
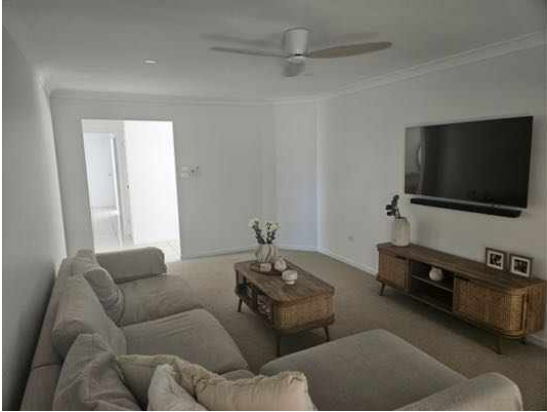
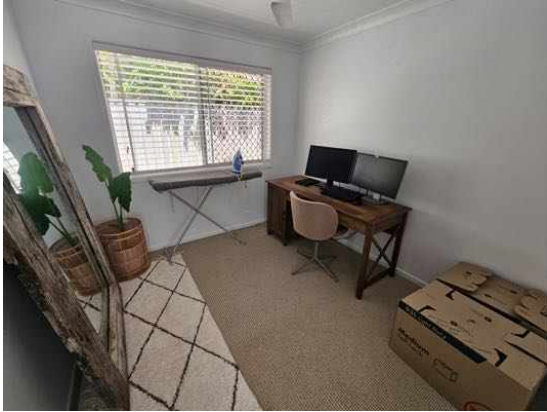
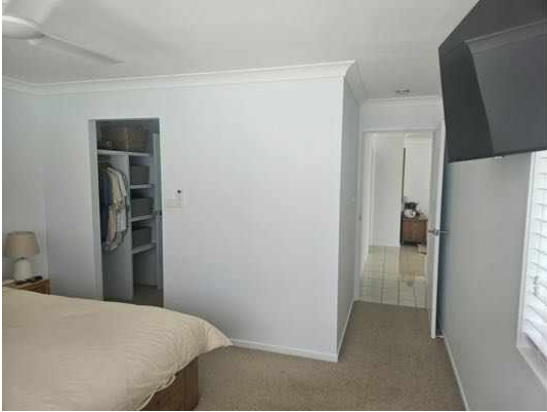
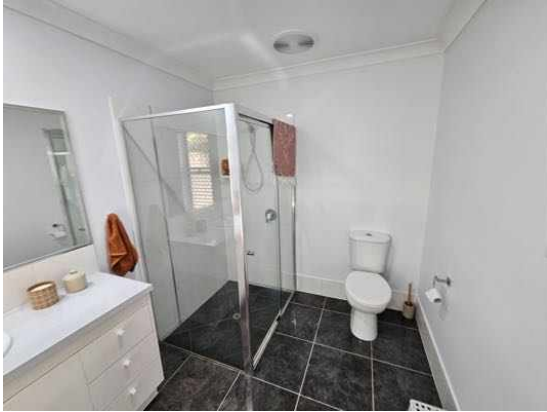
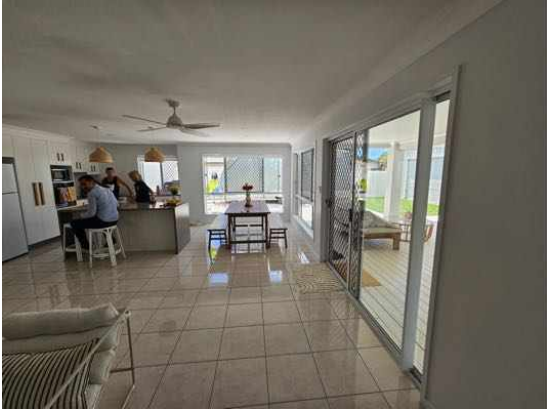
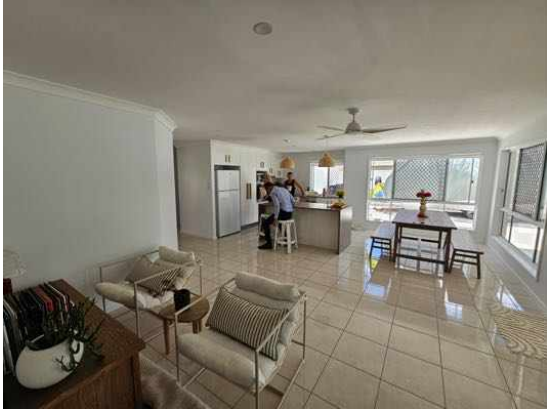
Building: Main Building
Location: All Areas
Finding: Additional Photos for client reference
Information: Additional photos are provided for your general reference.
