Building and Timber Pest Inspection Report

Inspection Date: Wed, 14 Jan 2026

Property Address: 11 Eyre Pl, Caloundra West QLD 4551,
Australia

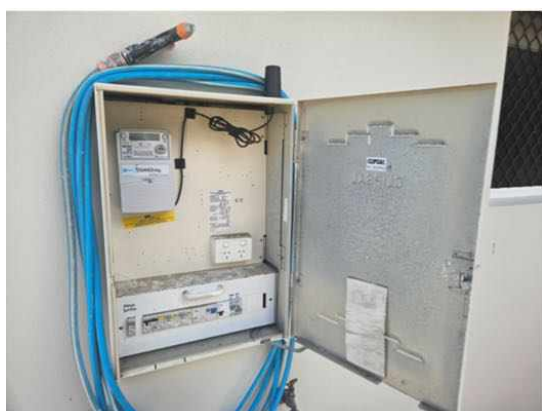
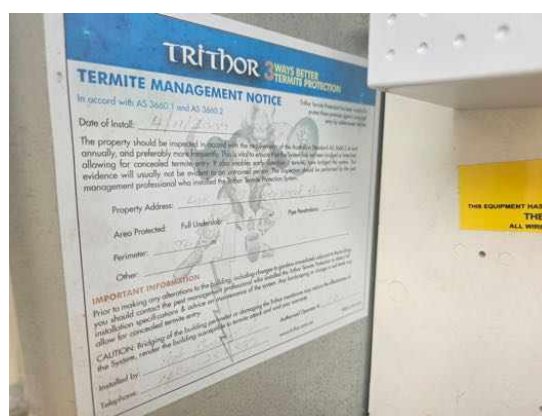
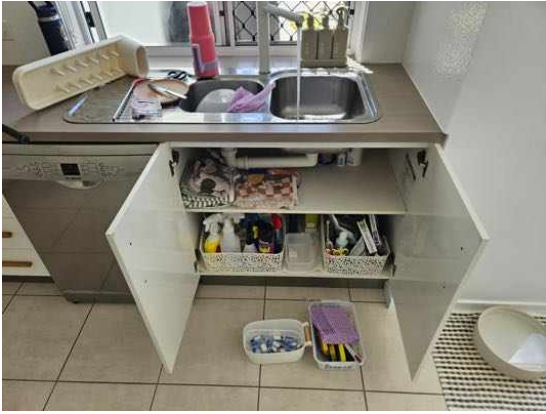
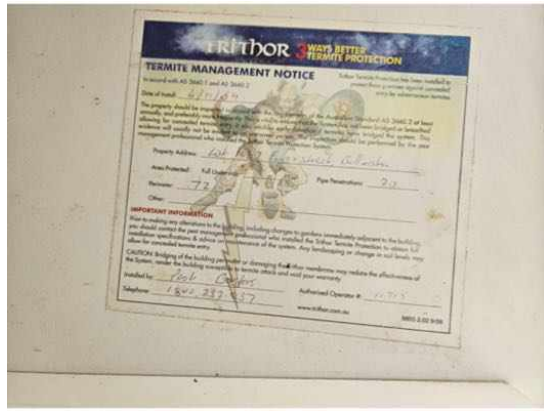
Noted Item

Where a Termite Management System has been identified you should refer to the type of barrier, date of installation, warranty conditions and any documentation provided by a builder or past owner. Consult the company who installed the barrier to confirm whether the system is still under warranty.

Most chemical termite management systems expire and require replenishment and all physical systems are primarily designed to prevent concealed entry. It is strongly advised to read and become familiar with the barrier systems requirements and maintenance. The implementation of a licensed timber pest controllers inspection programme is strongly advised.

The building employs a physical barrier system to the perimeter and slab penetrations. In order for a barrier system to be effective, the property must have regular inspections at intervals of not greater than 12 months. Depending on the risk profile attributed to the property, these inspections may be recommended at lesser time periods.
