Building and Timber Pest Inspection Report

Inspection Date: Mon, 02 Mar 2026

Property Address: 44 Folkard St, North Ryde NSW 2113,
Australia

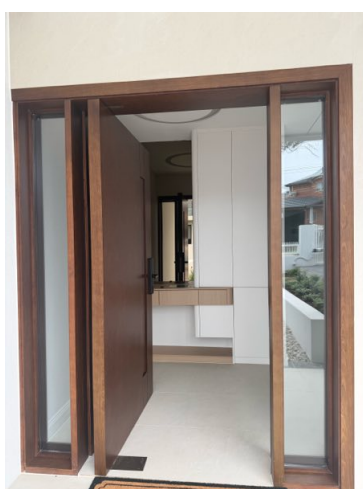
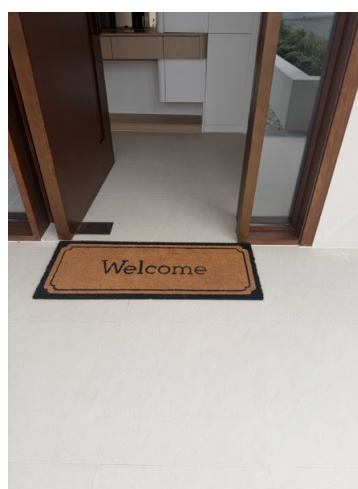
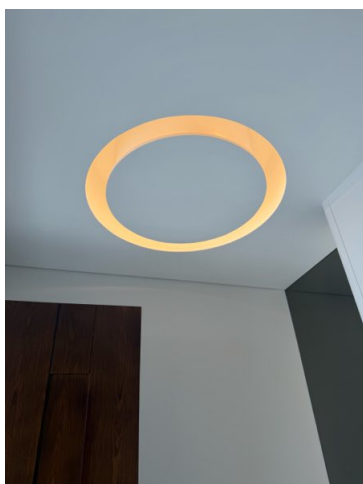
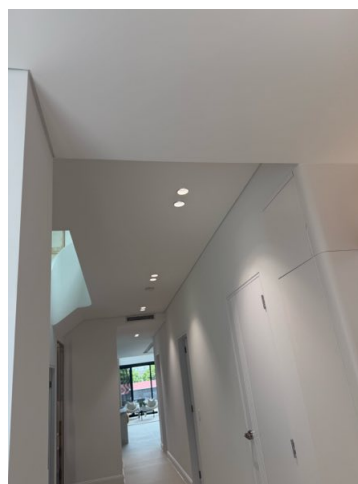
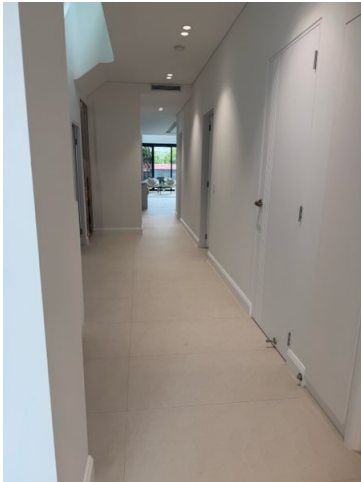
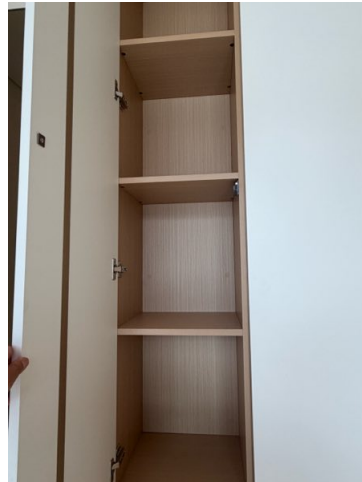
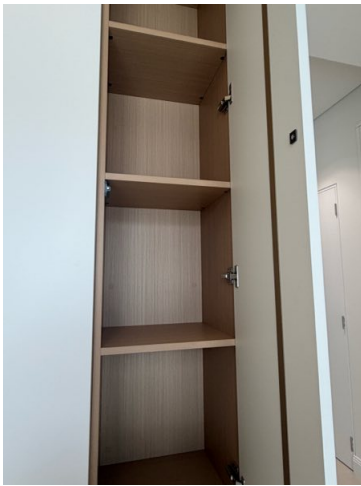
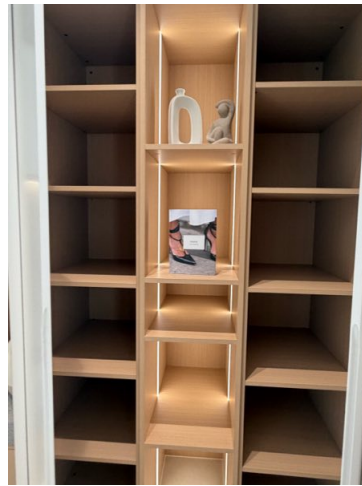
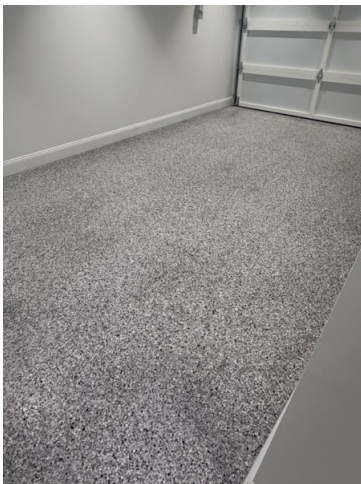
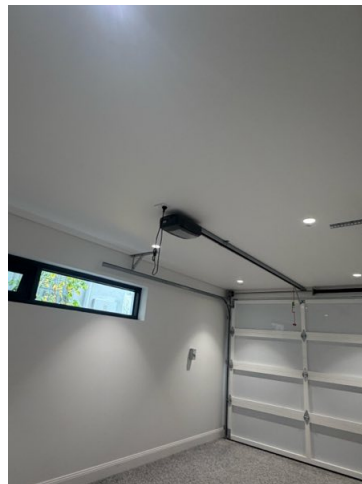
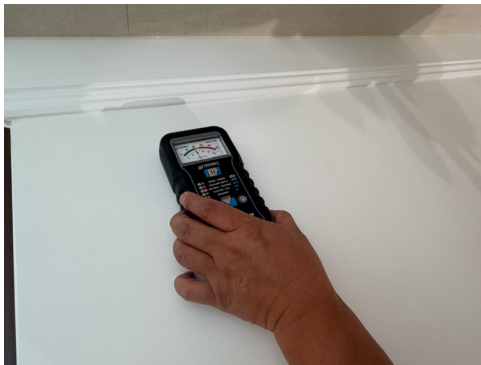
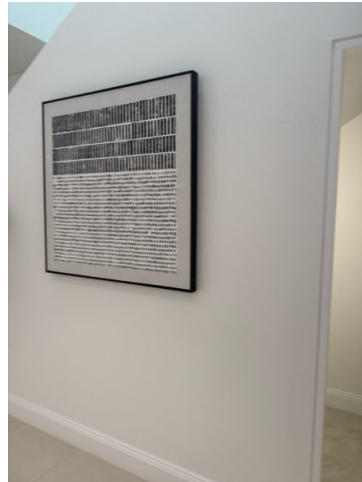
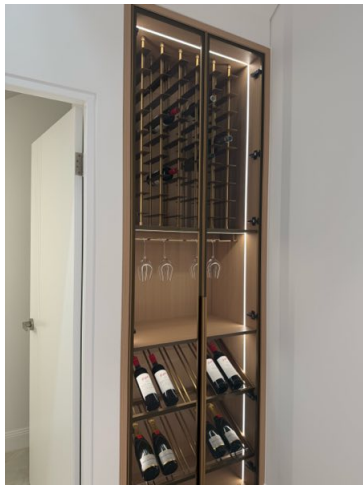
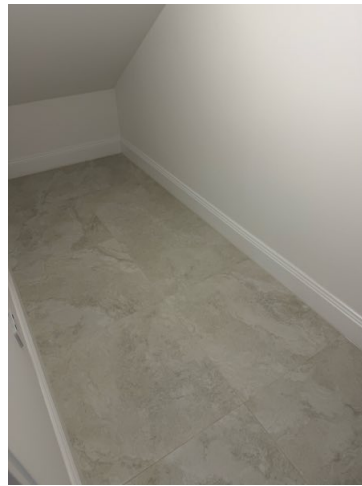
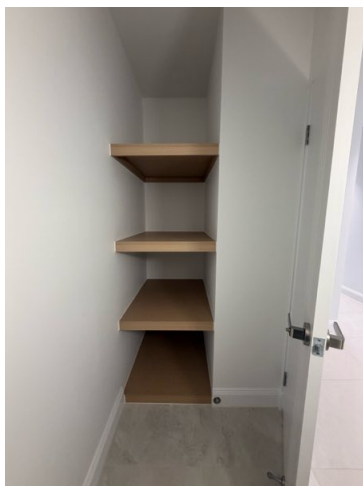
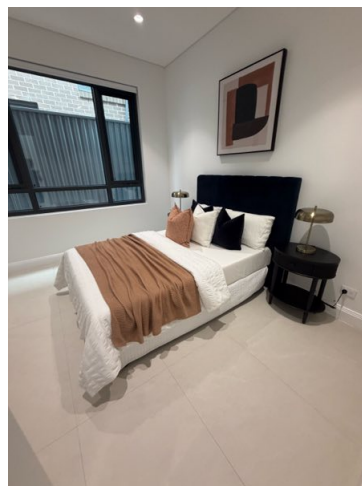
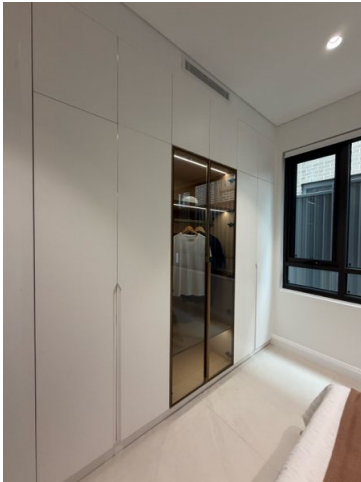
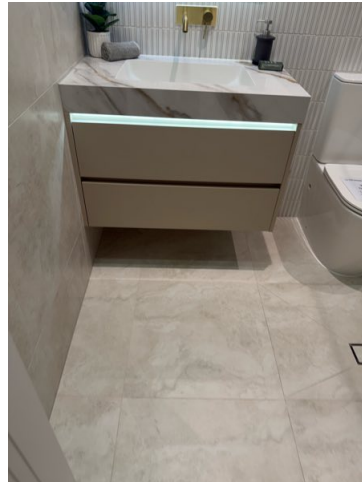
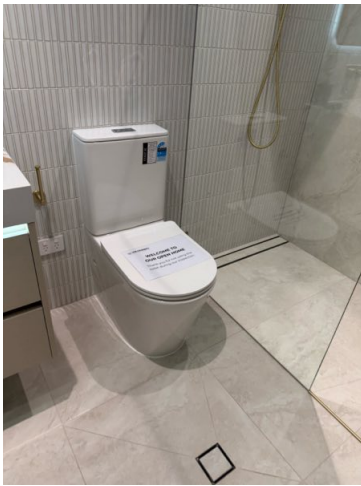
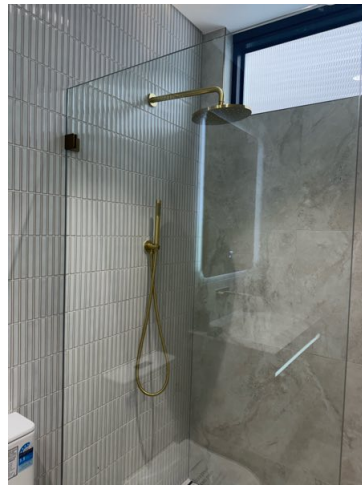
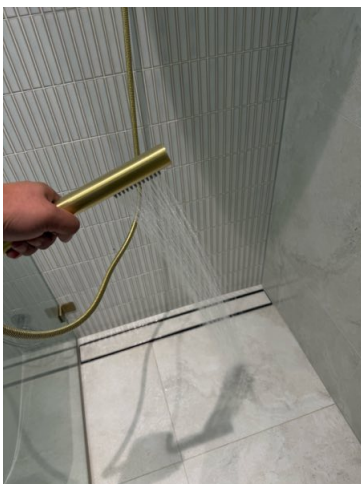
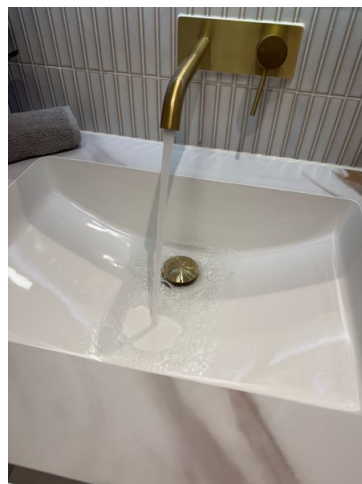
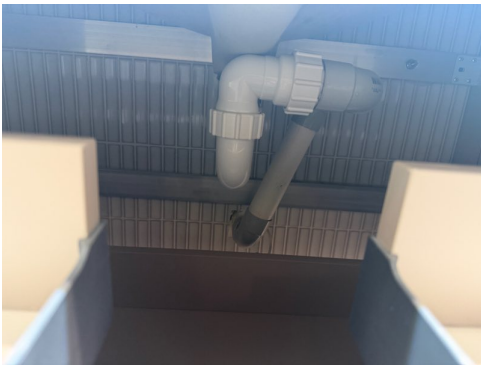
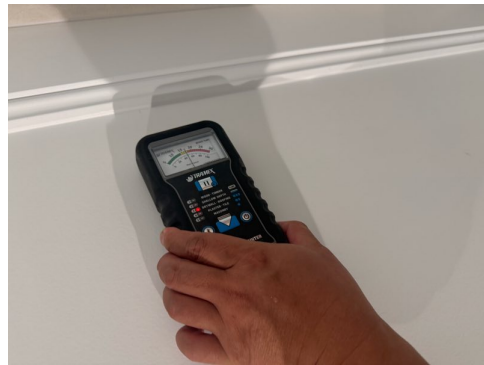
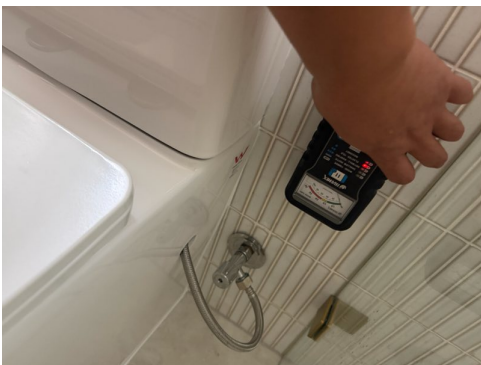
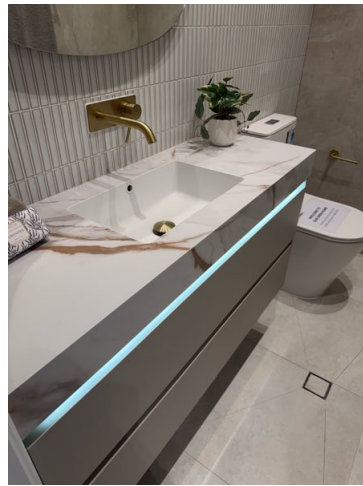
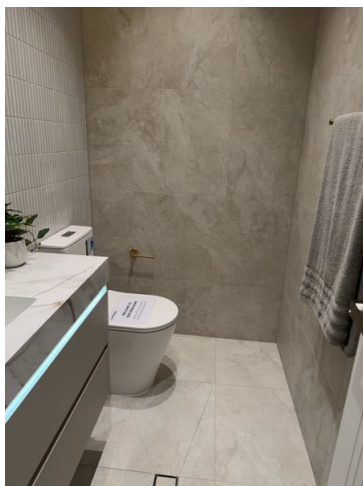
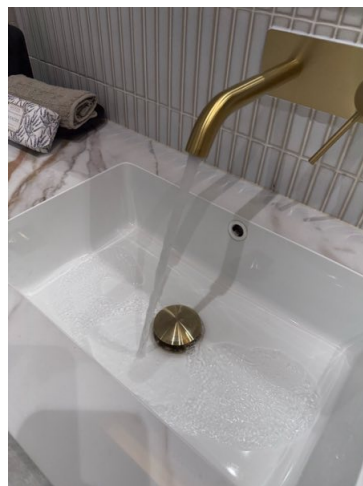
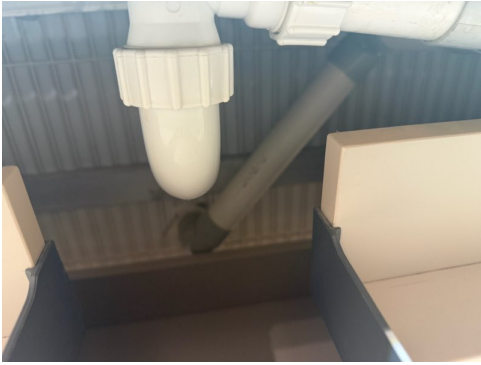
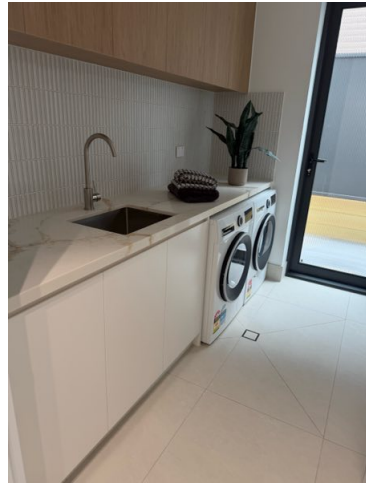
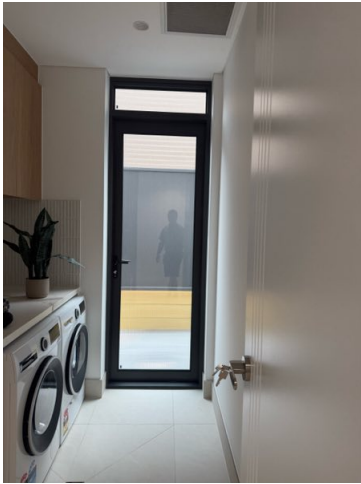
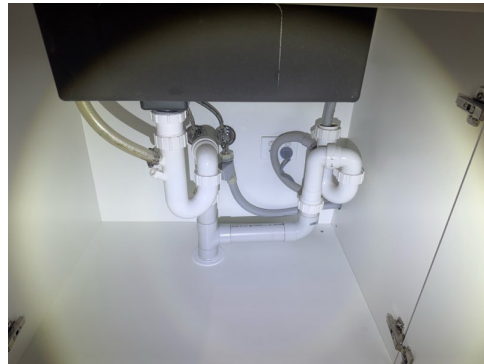
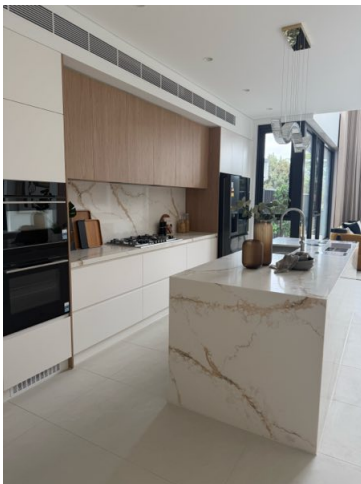
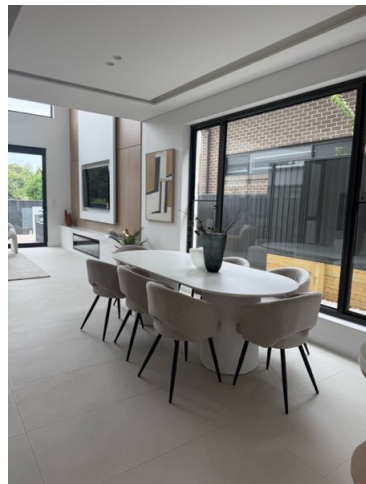
Finding: Additional Photos - Interior Area

Information: Additional photos are provided for your general reference and may include obstructions, limitations, testing of water, moisture readings or minor maintenance items.

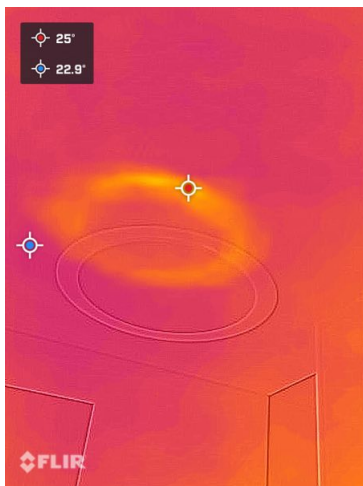
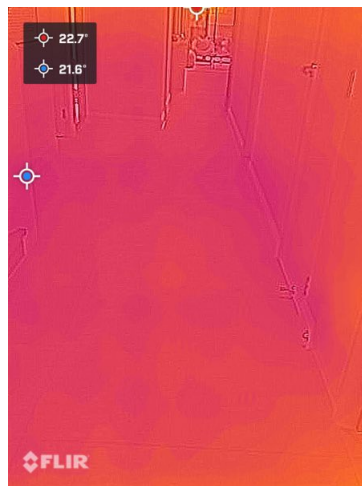
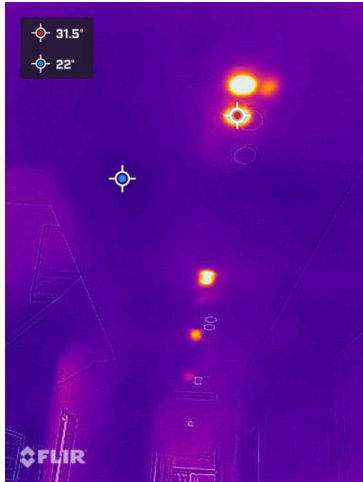
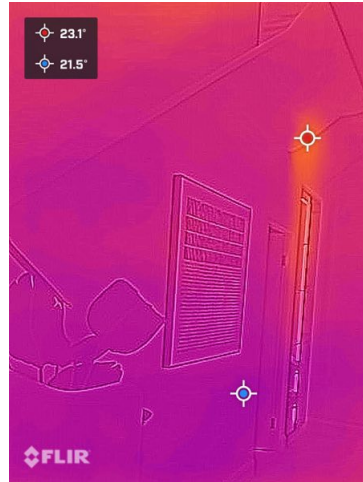
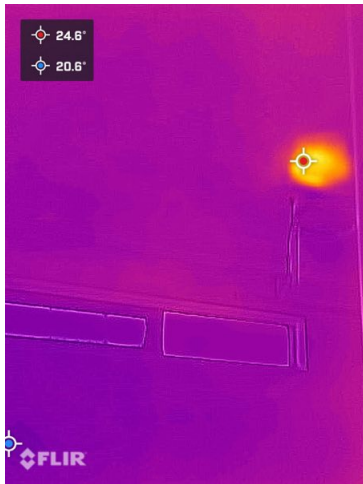
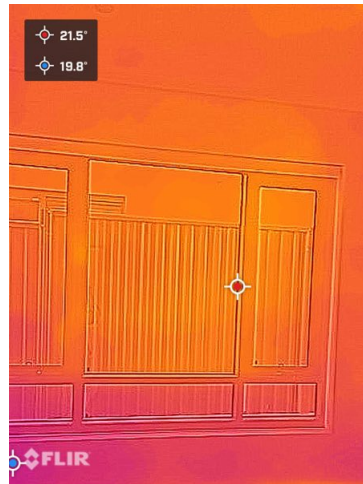
Finding: Additional Thermal Image Photos - Interior Area

Information: These Thermal Image photographs are an indication of the interior area at the time of inspection.

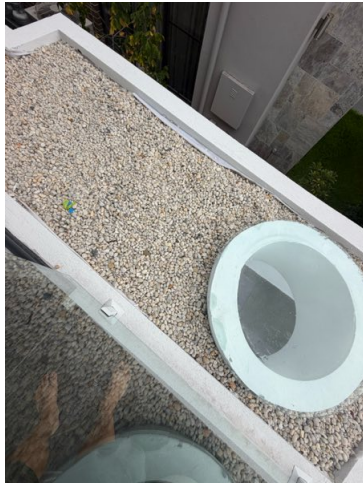
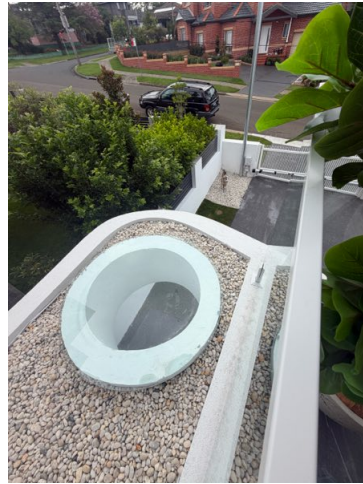
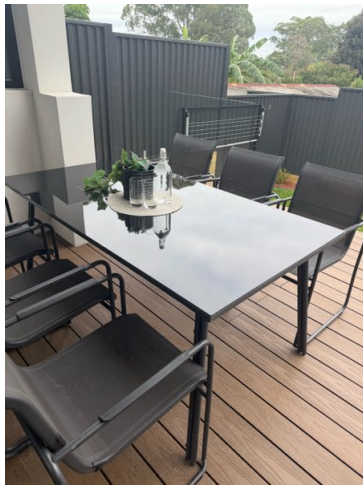
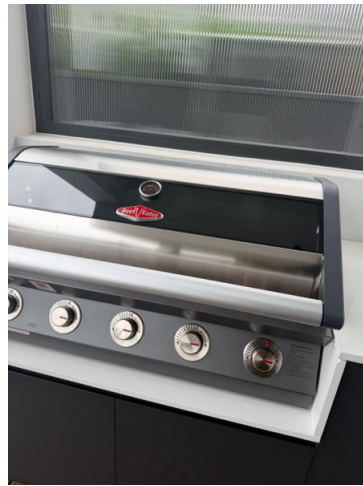
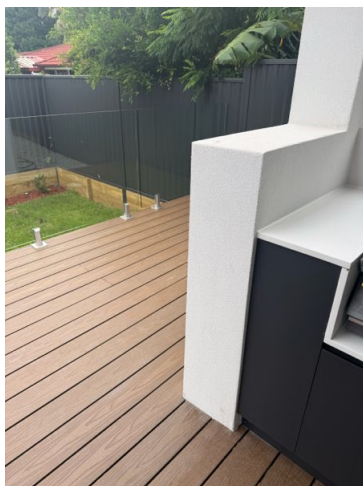
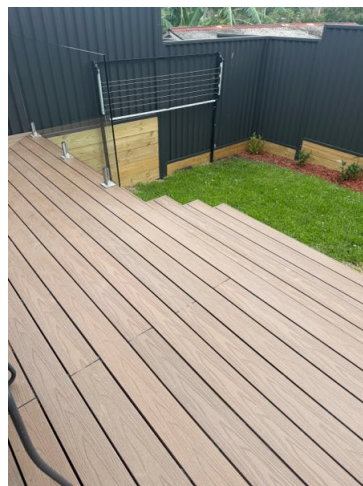
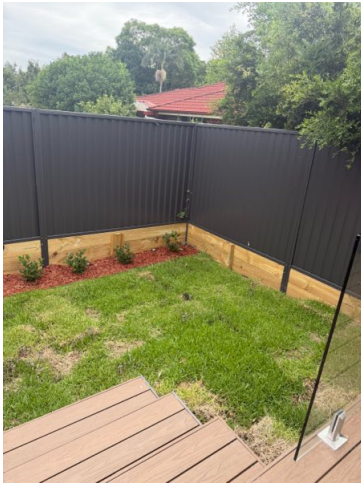
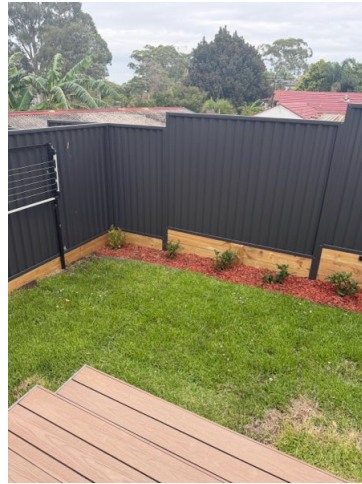
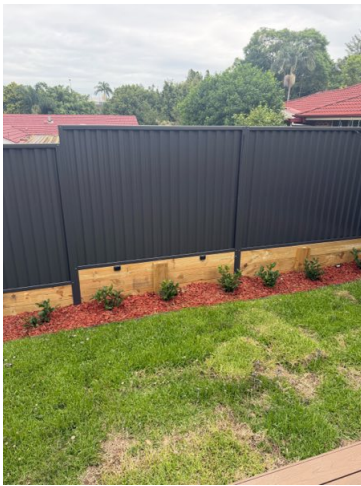
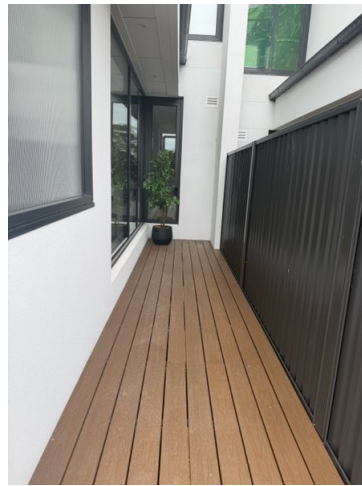
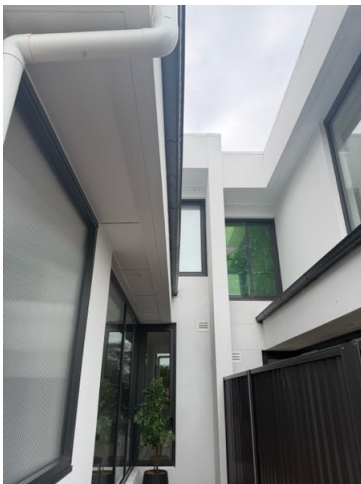
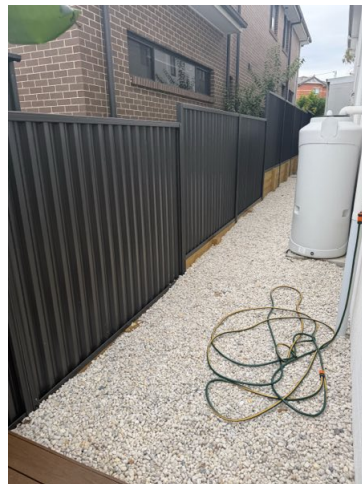
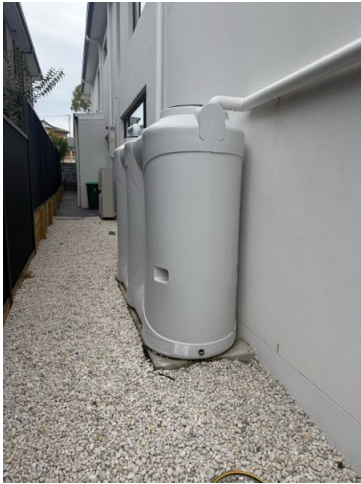
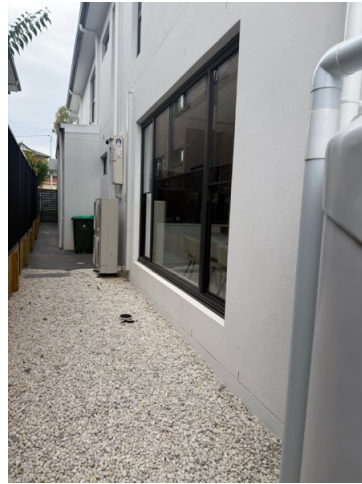
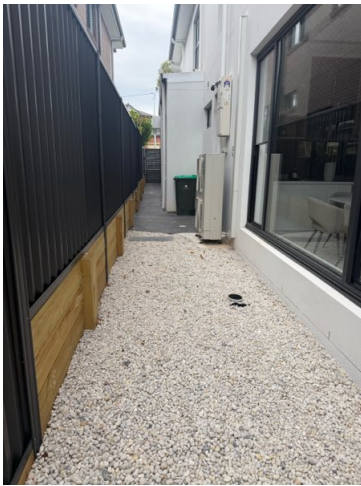
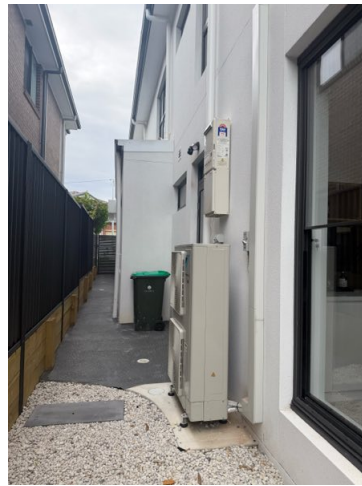
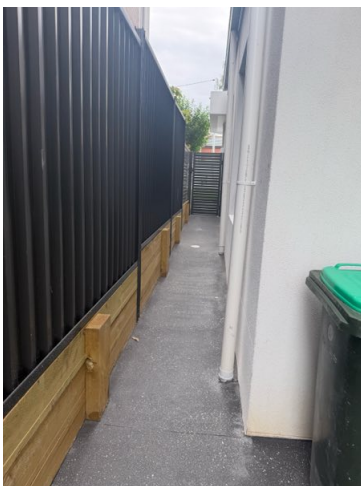
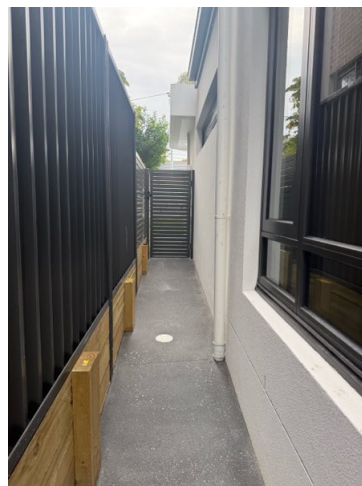
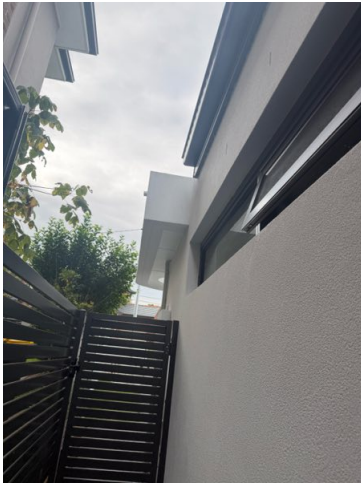
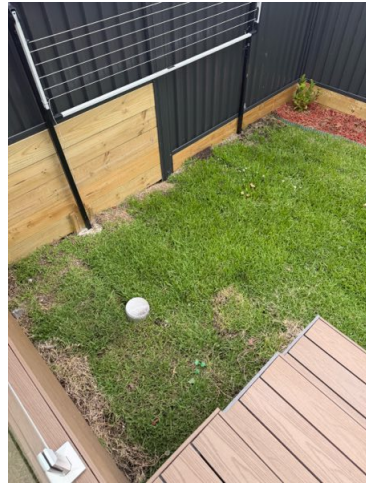
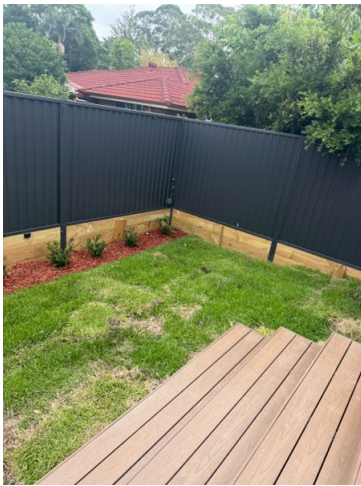
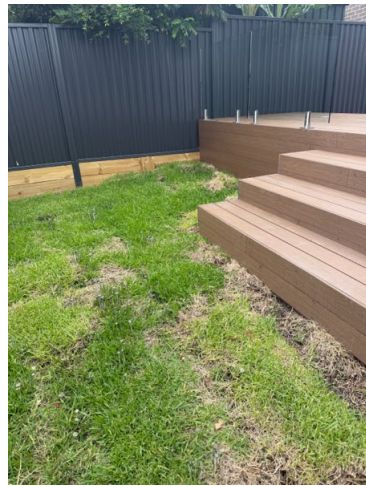
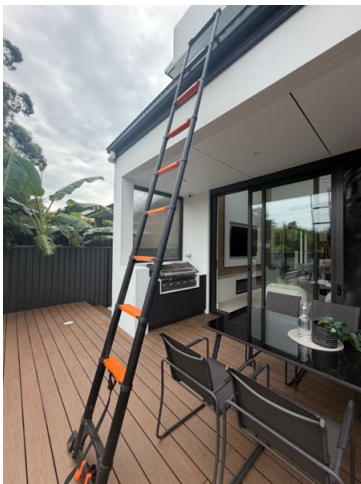
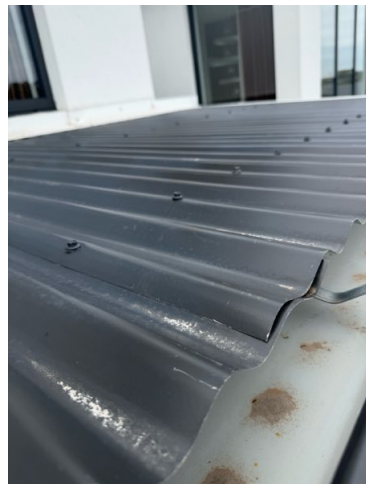
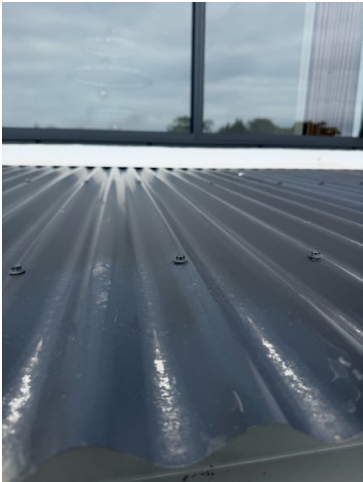
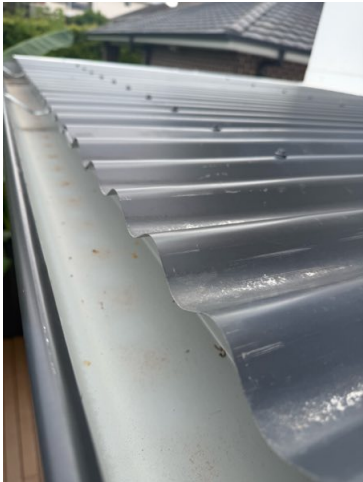
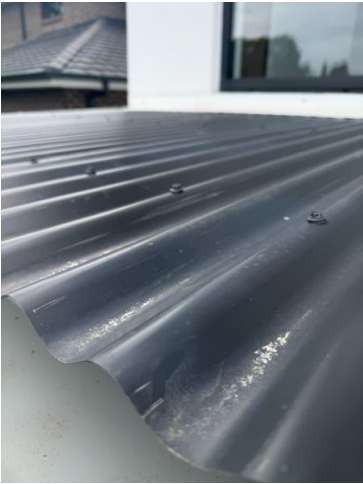
Noted Item

Building:	Main Building
Location:	All External Areas
Finding:	Additional Photos - Exterior Area
Information:	Additional photos are provided for your general reference and may include obstructions, limitations or minor maintenance items.
