Building and Timber Pest Inspection Report

Inspection Date: Mon, 9 Feb 2026

Property Address: 13 Hartford Ave, Glen Alpine NSW 2560,
Australia

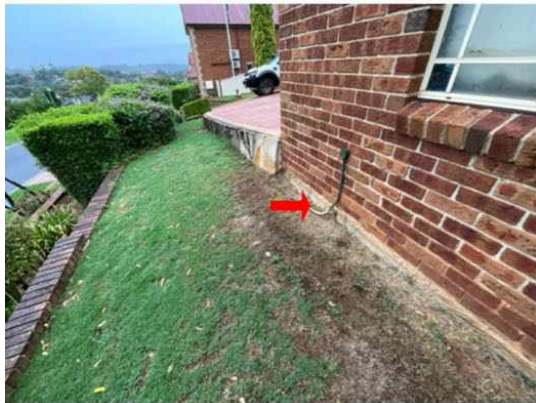
Building: Main Building
Location: Front left corner
Finding: Electrical conduit - Exposed
Information: An electrical conduit was found to be exposed at ground level and not adequately protected or buried.

The conduit is vulnerable to physical damage, weather and impact from traffic and gardening equipment or vehicles.

A licensed electrician must be appointed for added safety rectifications.

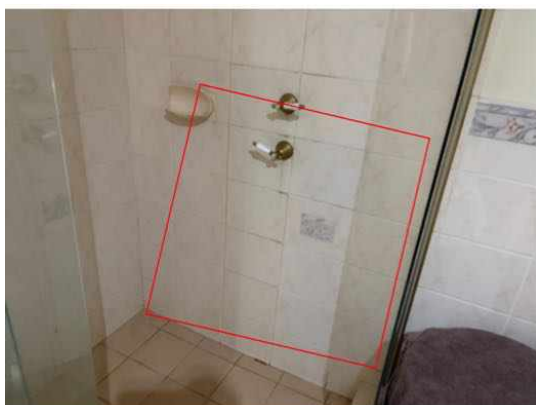
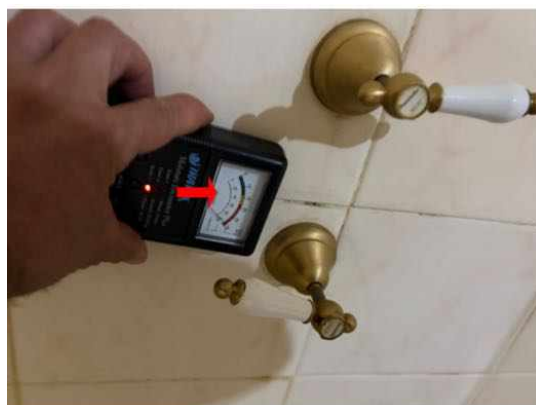
Building:	Main Building
Location:	Bathroom
Finding:	Water leak - Suspected
Information:	A water leak is suspected in this area as excessive moisture was detected at the time of inspection. Another potential cause maybe moisture ingress behind the tiles from around the wall fittings and penetrations.

Internal water leaks can be detrimental to surrounding building elements; their potential causes include damage to plumbing fittings and fixtures, through to water damage and deterioration of associated building elements.

Attracting termites, corrosion, mould, decay and water damage are potential outcomes where a minor water leak is left unattended. More serious defects may also result, such as electrical hazards, or water damage to structural building elements.

In extreme cases, structural damage may develop due to a prolonged water leak. It is highly advised that internal water leaks be addressed by a licensed plumber as a matter of relative urgency.

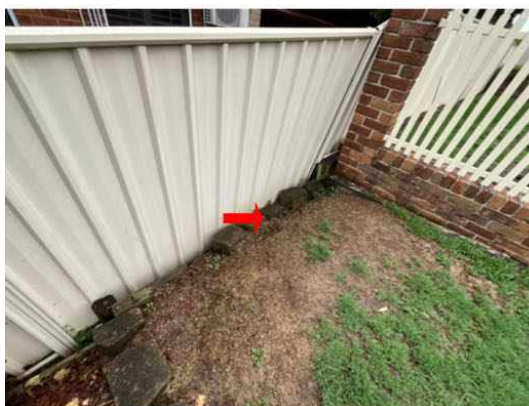
Finding 2.02

Building:	Main Building
Location:	Retaining Walls
Finding:	Retaining wall — Defective
Information:	The retaining wall in this area was found to be defective at the time of inspection. Generally, defective retaining walls are caused by poor original design or material use. However, deteriorated retaining walls may also be a result of substandard construction, poor site drainage or unmanaged stormwater flows.

AS4349.1-2007 requires all retaining walls in excess of 700mm to be inspected by a licensed and practicing structural engineer.

The structural engineer may draft a scope of works for a licensed trade to carry out rectifications.

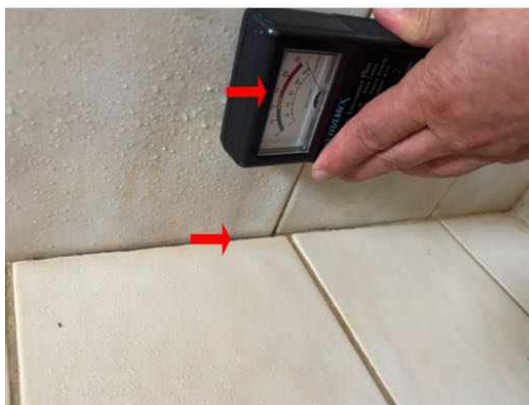
Finding 3.01

Building:	Main Building
Location:	Ensuite
Finding:	Shower damp - Sealant and grout
Information:	Damp is evident to the lower 400mm of wall to the shower alcove. This defect is quite common, and is suspected to have been caused by moisture permeating or leaching through the grouting and sealant in this area, which shows evidence of deterioration. Leaking pipes within the wall is also a possible cause however this seems unlikely in this instance as there is no moisture build up around the taps or transferring to the other side of the wall. There appears to be no sealant around the tap spindles which may be a small contributing factor.

Unmanaged damp in the shower recess is likely to facilitate the formation and development of mould and fungi growth, decaying associated building materials and compromising their structural integrity of associated elements. It is important to address damp conditions, as the World Health Organisation notes that excess moisture leads - on almost all indoor materials - to growth of microbes such as moulds, fungi and bacteria, which subsequently emit spores and other matter into the indoor air. Exposure to these contaminants is associated with a wide range of respiratory and other health-related problems. Damp conditions also create a conducive environment for termite infestation.

Consultation with a bathroom sealant specialist is advised immediately to identify the cause of damp and to perform remedial works as required.

Always ensure that sealant and grout is in good condition to prevent any moisture issues occurring in the future.

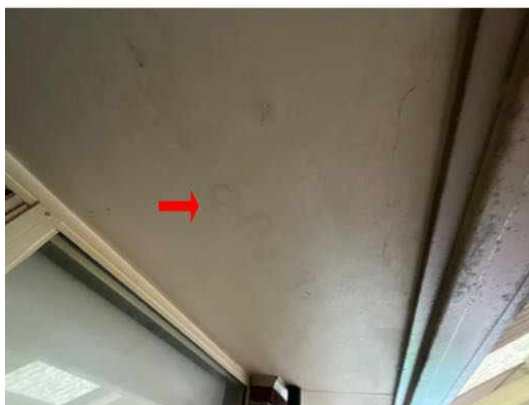
Finding 3.02

Building:	Main Building
Location:	Alfresco
Finding:	Eaves - Water staining
Information:	Water staining to eaves linings in this area was evident at the time of inspection. Water staining indicates that surfaces have been exposed to excessive moisture over time. The minerals and other elements in the water lead to staining, which may graduate to corrosion and deterioration if left unmanaged. While mostly an appearance defect, water staining can be indicative of more serious defects, which may be currently concealed by the lining. A possible cause could be overflow of stormwater from the gutters due to gutters being blocked.

The client is advised to ensure the gutters are free of any obstruction at all times. Where water staining is active, a licensed roof plumber must be consulted to identify the cause of the staining and to provide advice on any reparation works that may be

required. Replacement of any damaged structures is advised.

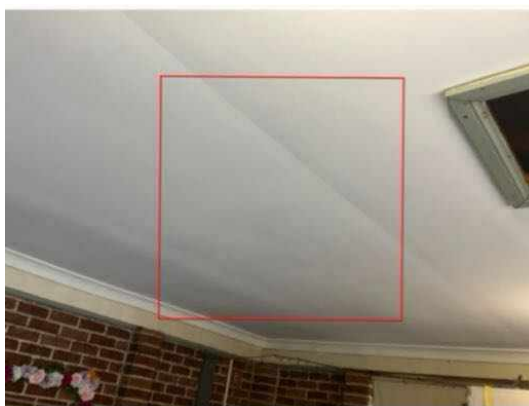
Finding 3.03

Information: Sections of the ceiling were found to be sagging at the time of inspection. Sagging to the fixed ceiling structure generally indicates that the building materials have swollen, due to contact with water, or that fixings (e.g. nails or glue) have become loose and require reattachment.

Where minor sagging is evident, comparatively minor works, such as re-gluing of ceiling sheets, may be required. Such works may be performed by relevant tradespeople, such as plasterers and painters. Where excessive moisture has caused the roofing structure to swell and sag, the source of the water leak should primarily be identified prior to any remedial works being performed.

The appropriate action should be taken by the client as soon as possible to ensure that any potential further damage is limited.

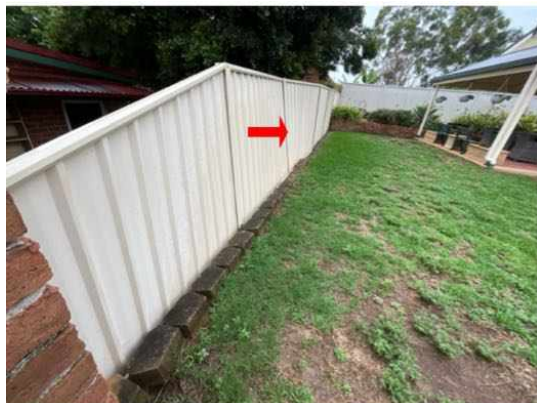
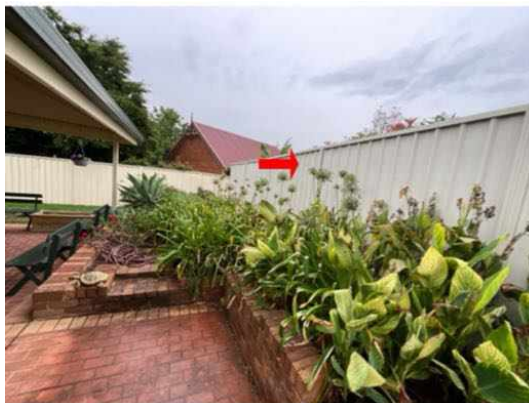
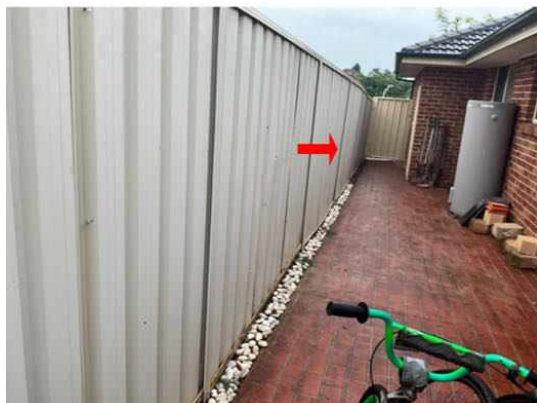
Finding 3.05

Building:	Main Building
Location:	Fencing
Finding:	Fencing - Deteriorated
Information:	It was noted at the time of inspection that sections of the fencing in this area has deteriorated. Typically fencing deteriorates due to age and or wear, rot and or rust which is generally expected for a structure of this age, due to prolonged exposure to weather conditions. Sometimes inadequate installation or maintenance can be to blame.

If left unattended, it is likely that further damage will occur. It is suspected that repair of several elements of the fencing may be required however replacement may be a consideration of the client also.

A licensed fencing contractor should be appointed to provide further advice and perform rectification works as necessary.

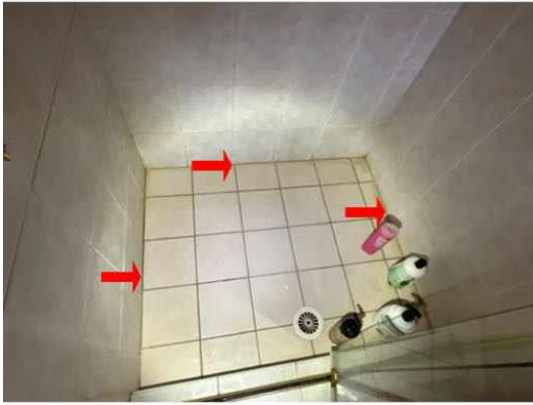
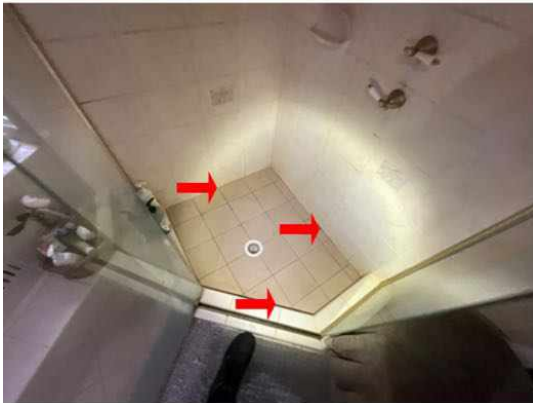
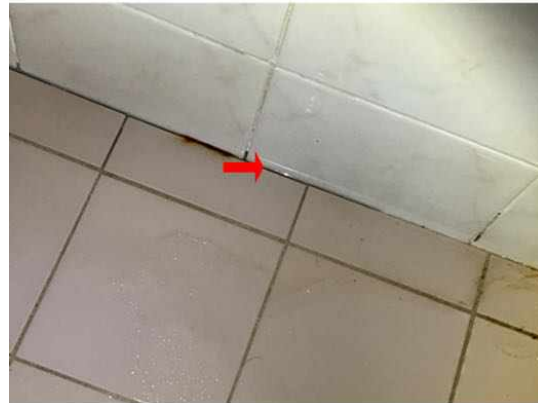
Finding 3.06

Building:	Main Building
Location:	All Wet Areas
Finding:	Sealant and grouting - Missing or damaged
Information:

It was noted on inspection that sealant or grout is degraded to this area.

Different materials and floor areas move at different rates, generally causing cracking to grout or sealant at this point. A flexible sealant is required to allow for expected expansion and contraction, while keeping the joint water tight and protective of all associated building materials.

Flexible and mould resistant materials should be applied to affected areas to prevent any subsequent water damage that is likely to occur. Regular maintenance and replacement of damage or missing or damaged sealant and grout is highly recommended to the wet areas, as this is a regular wear and tear defect. Sealant and grouting in areas that come into regular contact with water should be maintained for the long term care of your property.

A sealant specialist should be appointed to complete these works as soon as possible.

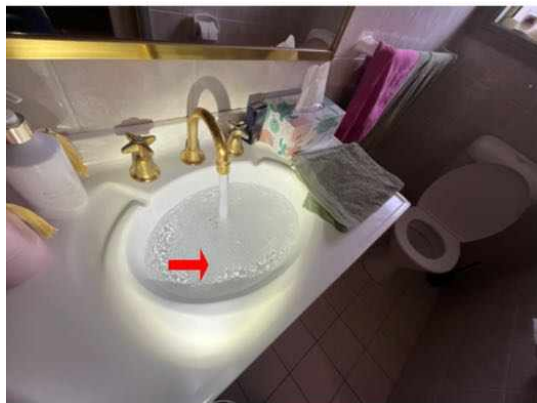
Finding 3.07

Building: Main Building
 Location: Ensuite
 Finding: Sink/basin - slow draining
 Information:

The sink/basin drain appeared to be partially blocked at the time of inspection. Blockages here are usually caused by hair and other debris. If left unmanaged, a lack of general maintenance may lead to the development of more significant defects, such as water damage to surrounding building materials.

A licensed plumber should be appointed to remove the blockage at the client discretion.

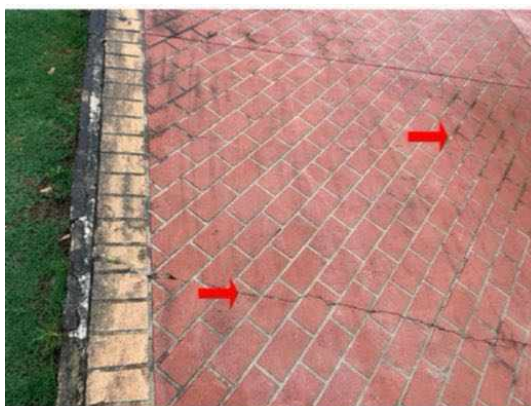
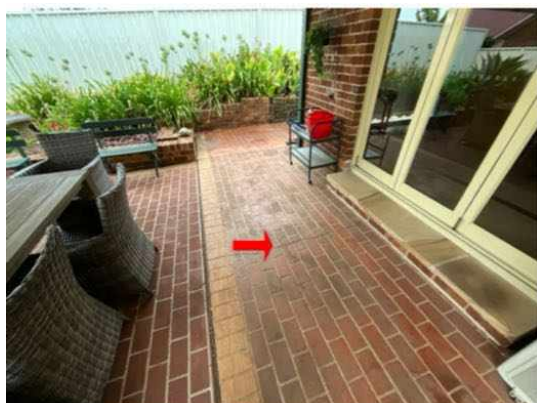
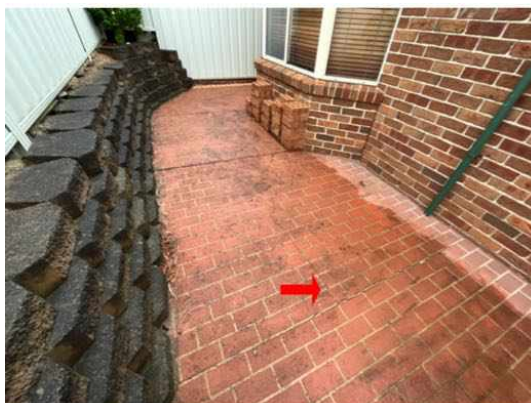
Building:	Main Building
Location:	Multiple areas
Finding:	Cracking - External Concrete Paving Damage Category 1 - Fine (less than 2mm)
Information:	Fine cracks were identified in external concrete paving. Although fine cracks are quite

noticeable, they are often only considered to be an appearance defect, and usually do not indicate any structural damage. To be considered a Category 1 or fine crack, the crack is found to be less than 2mm in width.

Generally the cause of a hairline crack in existing concrete paving such as driveways and pathways is indicative of the expansion and contraction of the concrete. Such causes are generally due to environmental factors, such as moisture levels, weather conditions, root systems of nearby trees or the soil types on which they are laid.

Fine cracks may also be due to poor original installation of the concrete. Factors such as poor compaction of the sub surface and/or inadequate reinforcing of the slab may create cracking and other secondary defects.

Monitoring of all cracking should be conducted frequently. Always contact a building inspector should cracks widen, lengthen, or become more numerous.

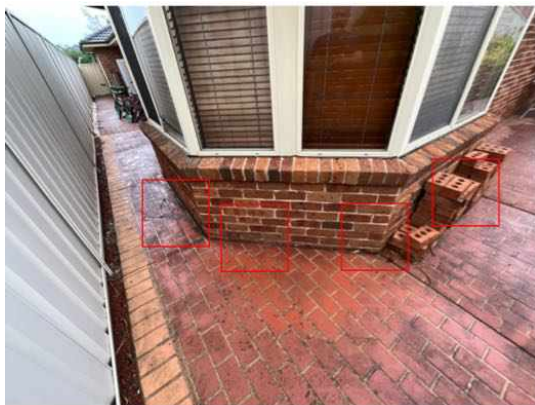
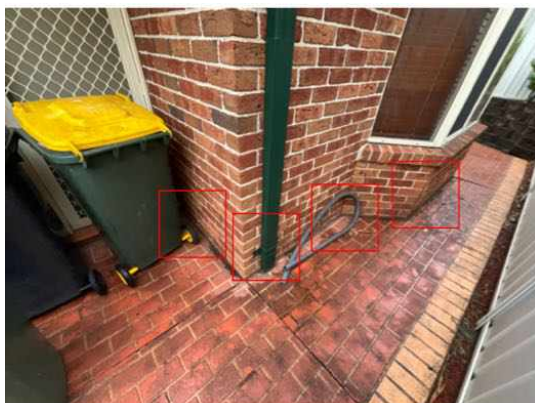
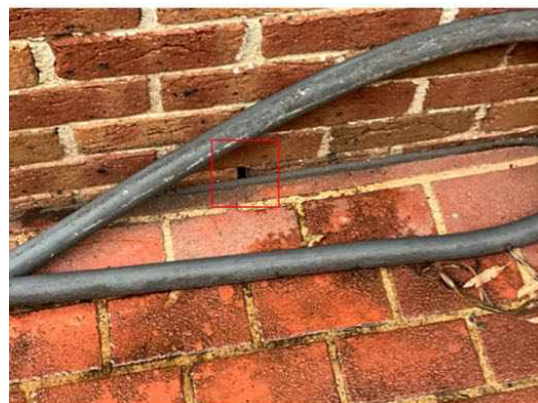
Weep holes in the exterior brickwork of the property are designed to allow condensation that may build up between the brickwork and subsequent timber framework to drain from within the wall hence preventing any deterioration of the timber building elements.

Additionally build-up of moisture is likely to occur if weep holes are covered further attracting termite activity to these areas.

It is highly recommended that weep holes are left exposed in all areas throughout the external property. Therefore if any termite activity leading into weep holes becomes easily detectable during frequent pest inspections.

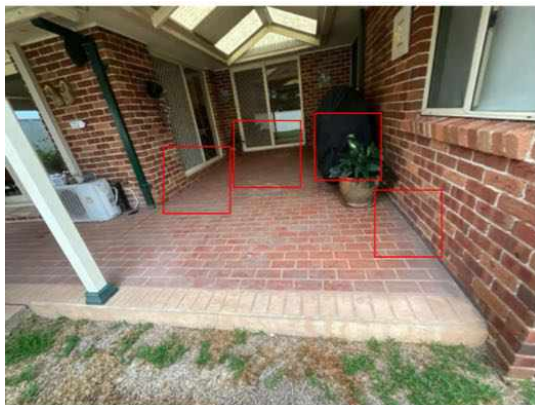
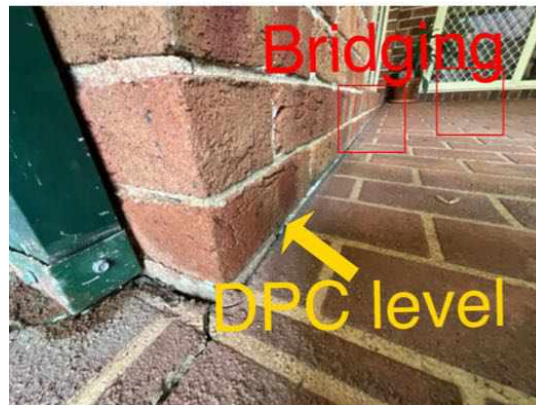
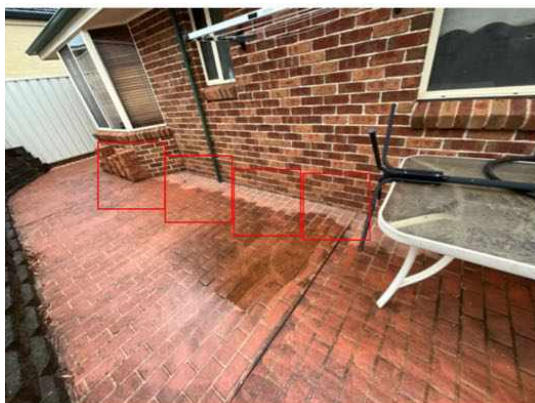
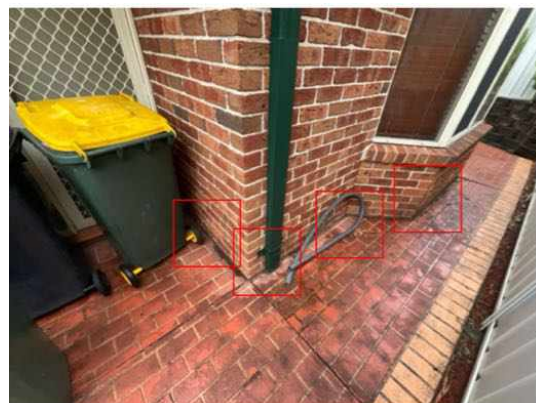
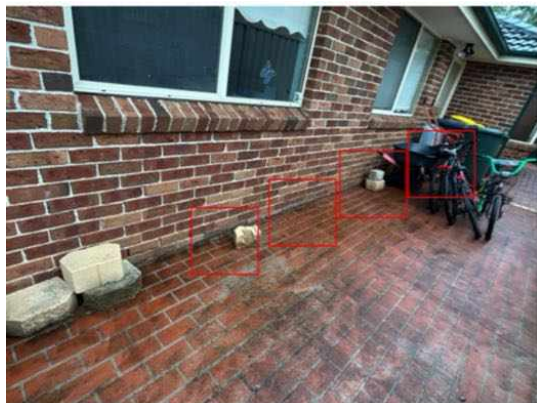
Finding 6.05

Building:	Main Building
Location:	Alfresco
Finding:	Bridging or breaching of termite barriers - damp course level
Information:	Bridging is the spanning of a termite barrier or inspection zone so that subterranean termites are provided with passage over or around that barrier.

Damp proof course (DPC) is a barrier of impervious material built into a wall or pier to prevent moisture from moving to any part of the building. Where external ground levels are built up over this barrier ingress is provided for moisture from the exterior grounds into the base brickwork or other building material and allowed to rise.

Such conditions attract termites into these damp areas which is likely to lead to infestation if left untreated.

While retrospective fitting of DPC is considered to be impractical works are required in order to prevent the extraction of moisture from the external environment into exterior brickwork or wall materials. Landscaping or re-paving of external grounds may be considered by the client. Regular annual inspections are strongly advised.

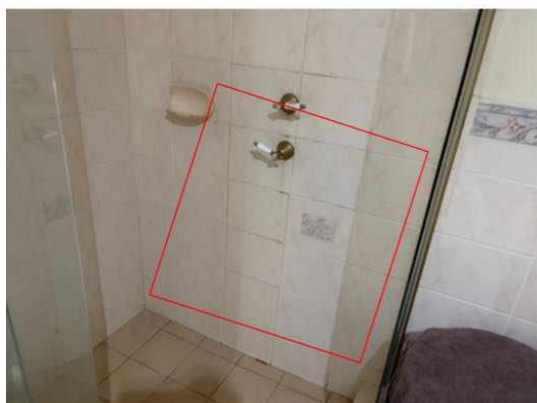
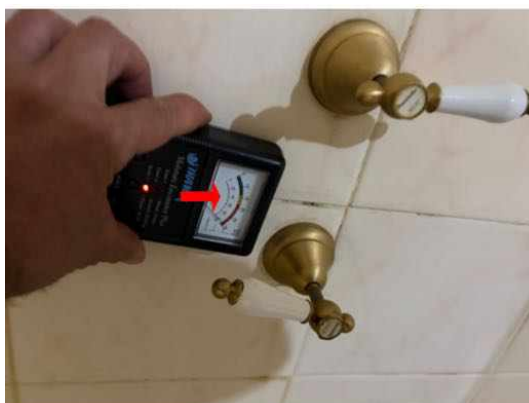
Finding 6.06

Building:	Main Building
Location:	Bathroom
Finding:	Water leak - Suspected
Information:	A water leak is suspected in this area as excessive moisture was detected at the time of inspection. Another potential cause maybe moisture ingress behind the tiles from around the wall fittings and penetrations.

Internal water leaks can be detrimental to surrounding building elements; their potential causes include damage to plumbing fittings and fixtures, through to water damage and deterioration of associated building elements.

Attracting termites, corrosion, mould, decay and water damage are potential outcomes where a minor water leak is left unattended. More serious defects may also result, such as electrical hazards, or water damage to structural building elements.

In extreme cases, structural damage may develop due to a prolonged water leak. It is highly advised that internal water leaks be addressed by a licensed plumber as a matter of relative urgency.

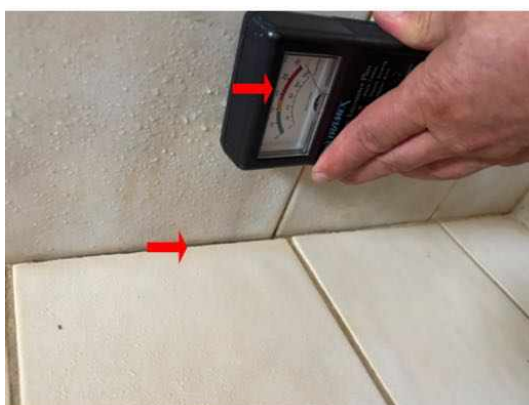
Finding 6.07

Information: Damp is evident to the lower 400mm of wall to the shower alcove. This defect is quite common, and is suspected to have been caused by moisture permeating or leaching through the grouting and sealant in this area, which shows evidence of deterioration. Leaking pipes within the wall is also a possible cause however this seems unlikely in this instance as there is no moisture build up around the taps or transferring to the other side of the wall. There appears to be no sealant around the tap spindles which may be a small contributing factor.

Unmanaged damp in the shower recess is likely to facilitate the formation and development of mould and fungi growth, decaying associated building materials and compromising their structural integrity of associated elements. It is important to address damp conditions, as the World Health Organisation notes that excess moisture leads - on almost all indoor materials - to growth of microbes such as moulds, fungi and bacteria, which subsequently emit spores and other matter into the indoor air. Exposure to these contaminants is associated with a wide range of respiratory and other health-related problems. Damp conditions also create a conducive environment for termite infestation.

Consultation with a bathroom sealant specialist is advised immediately to identify the cause of damp and to perform remedial works as required.

Always ensure that sealant and grout is in good condition to prevent any moisture issues occurring in the future.

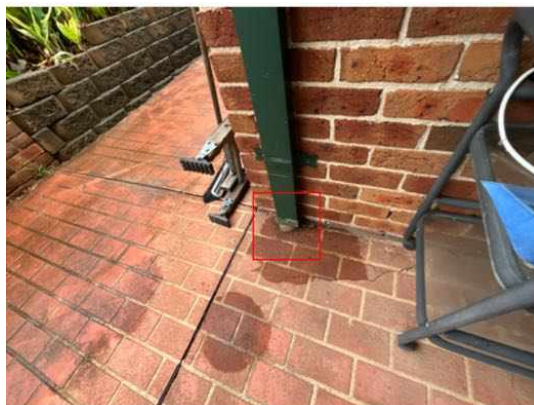
Finding 6.08

Finding: Water leak - External
 Information: Water leaks were found to be present to exterior plumbing work. Leaks are generally caused by deterioration of the plumbing elements over time, due to exposure to weather conditions, but may have also been caused by minor impact damage.

Such leaking creates damp conditions in the affected area, causing potential for water pooling and subsequent water damage if left unattended. These conditions may also attract termite attack, particularly if the area is subject to minimal levels of sun throughout daylight hours.

It is highly advised that a licensed plumber be appointed to rectify any water leaks that may be present. Areas of repair and replacement of plumbing fittings and fixtures may be required and, as such, a quotation should be sought.

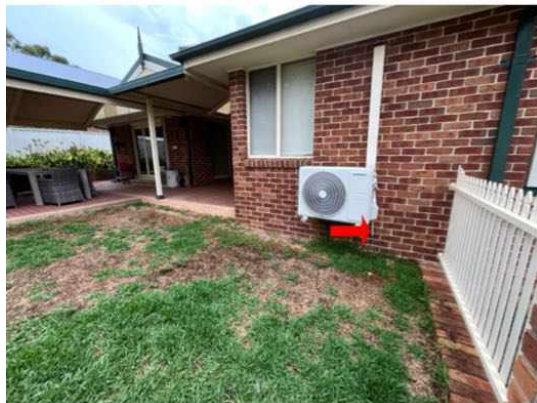
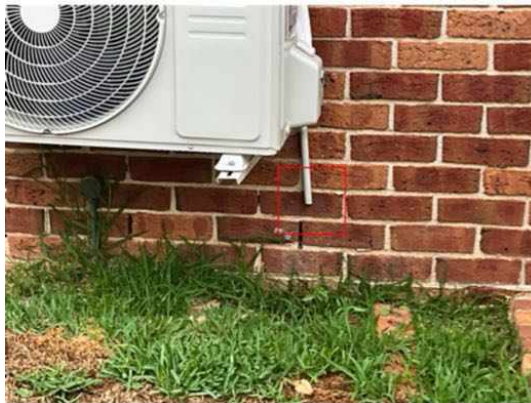
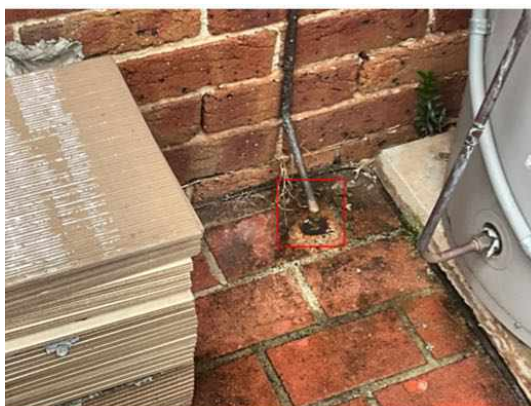
Finding 6.09

Building: Main Building
 Location: Yard - Side
 Finding: Overflow - Not plumbed for drainage
 Information: The overflow is not plumbed or connected to suitable drainage, which can result in the surrounding area becoming excessively damp.

These damp conditions can lead to secondary defects such as rot, rust or corrosion

of associated building elements, the formation of fungal decay, or even the creation of potential slip hazards. When coupled with poor site drainage, pooling of water may also attract termite activity to this area.

It is highly recommended that a licensed plumber be appointed to install adequate drainage to the overflow. These works will ensure that the area remains dry and free of any secondary defects.

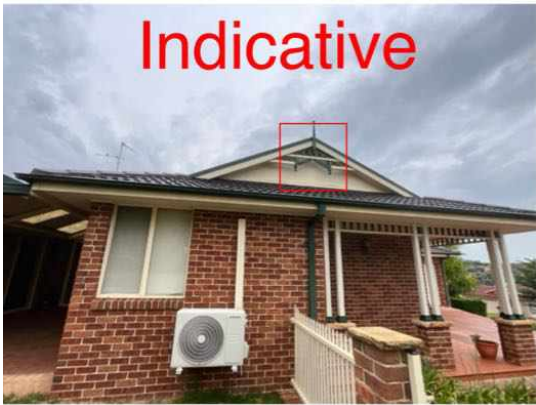
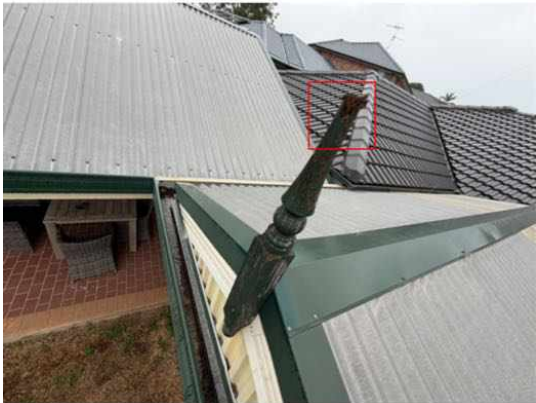
Building:	Main Building
Location:	Roof gables
Finding:	Wood rot/decay
Information:	This building element shows evidence of wood rot. Wood rot, also known as Fungal Decay, occurs when timbers and other cellulose building materials are exposed to damp conditions on an ongoing basis. This could be the result of exposure to weathering over a prolonged period of time, or the attraction of excessive moisture from other abutting building materials. Contributing factors also include poor air ventilation in the area.

Wood rot is often associated with general damp problems and is evidenced by a `musty` smell or mould and mildew occurring on surfaces. If left unmanaged, damp conditions can lead to further health problems and the decay of timbers will continue.

Early intervention and regular maintenance, particularly of exterior timbers, will prolong the useful life of these building elements. Prior to any works being performed, the cause of the moisture that has created the visible wood rot should be identified and addressed in a suitable manner. Replacement of affected timbers may then be a necessary step in protecting surrounding building elements from such deterioration.

A licensed plumber may be appointed to assess the cause of excessive moisture and to provide advice on any remedial works as required. A licensed carpenter may also be required to replace affected building materials.

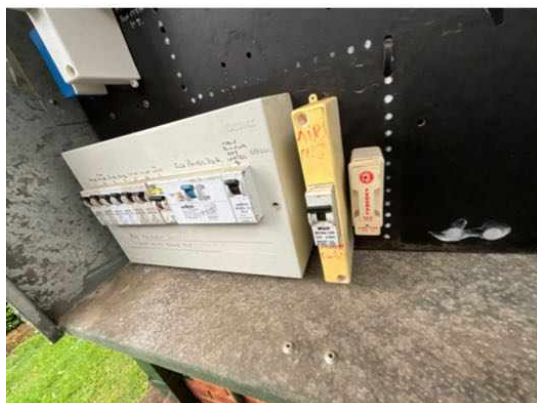
The electrical switchboard while appearing to have adequate safety switches installed has old ceramic fuses in place.

While this on its own on is not considered a defect it is noted for the clients consideration that a switchboard upgrade may be required in the short to mid term to improve the functionality of the electrical system. A licensed electrician could be appointed to provide quotation for the works at the client's discretion which may in turn expose other required works to bring the system up to a compliant state.

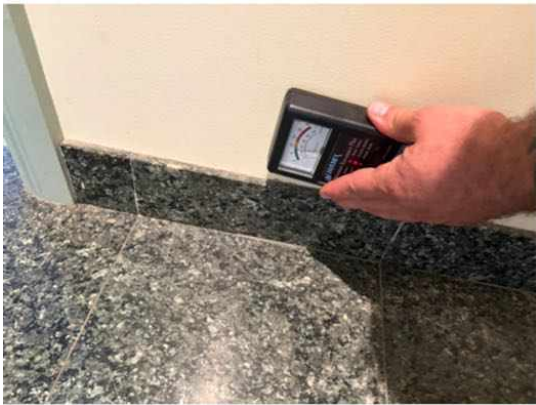
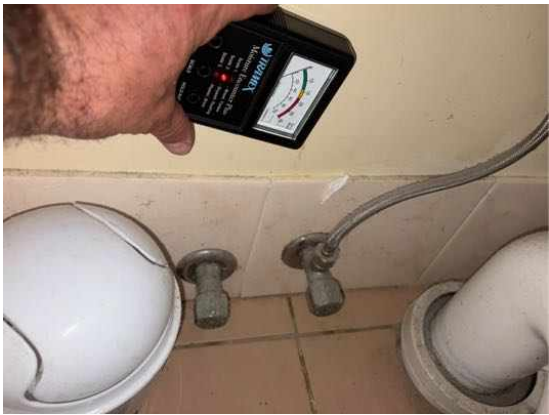
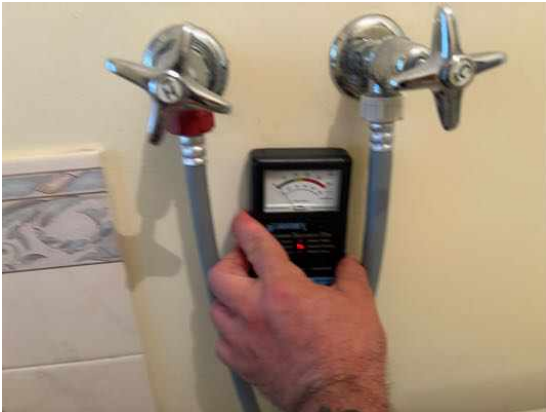
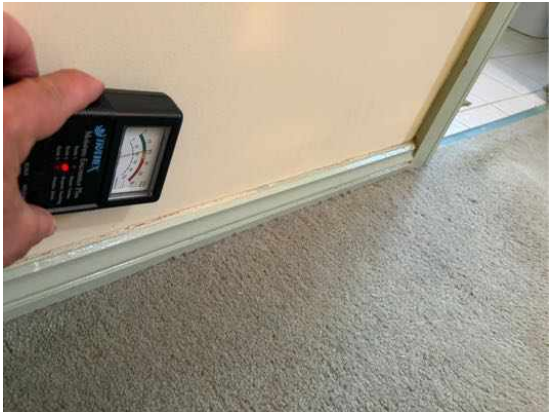
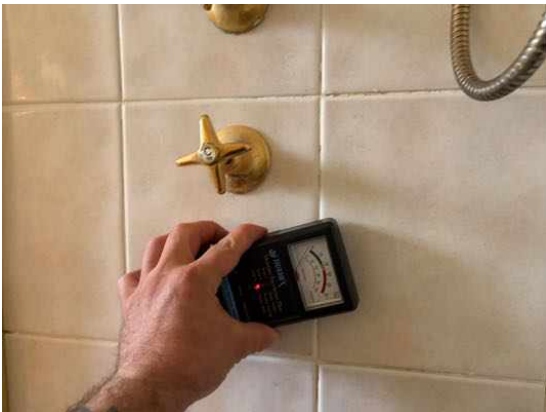
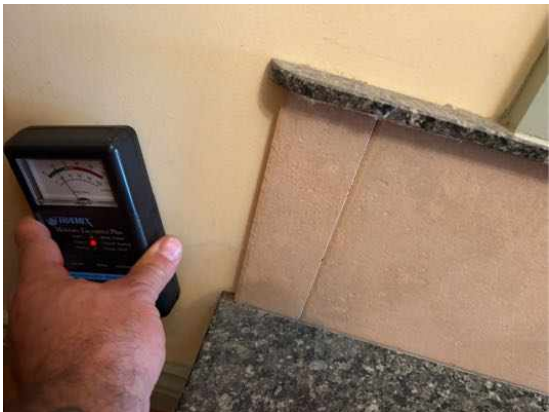
Finding: Moisture metre

Information: During the inspection the property was checked for moisture using a moisture metre.

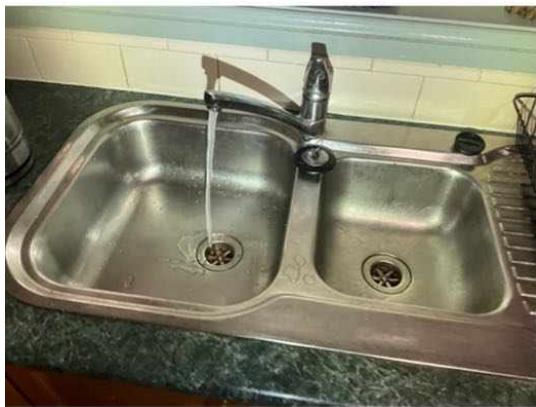
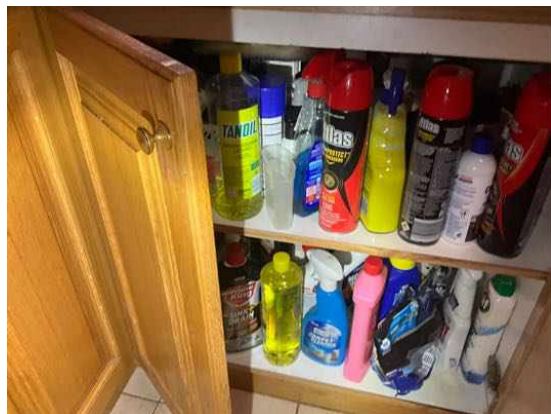
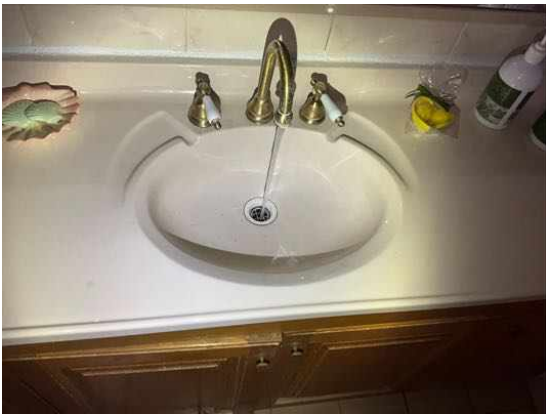
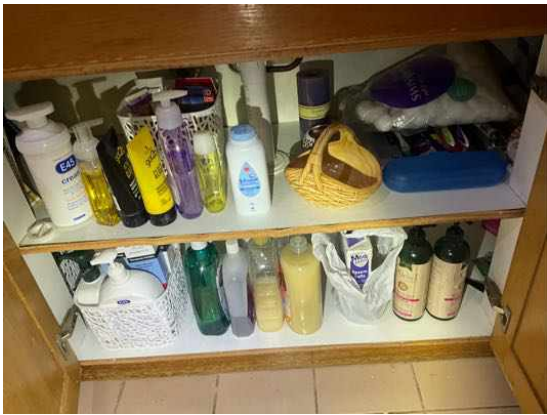
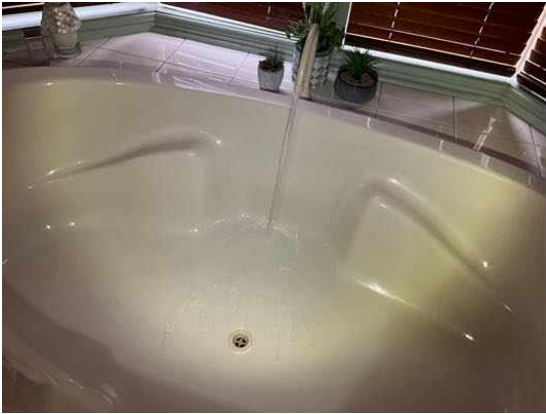
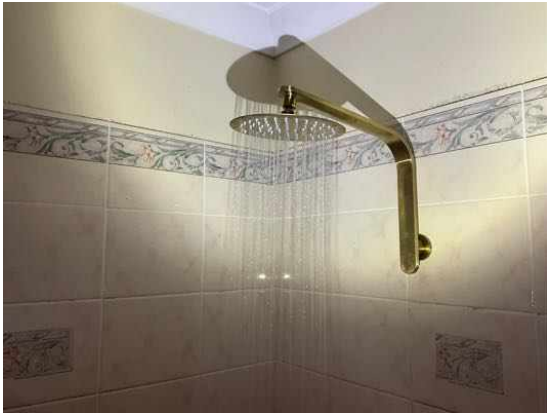
Building: Main Building
Location: All Wet Areas
Finding: Additional Photos
Information:

Additional photos are provided for your general reference.

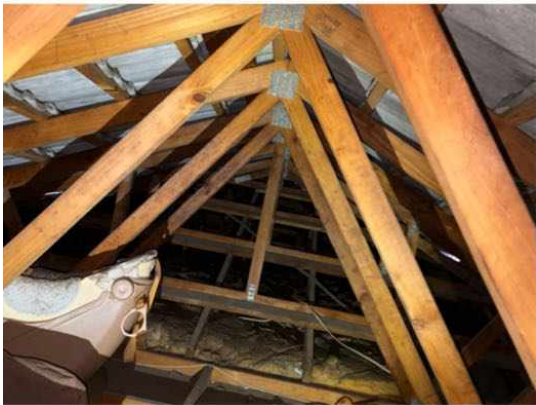
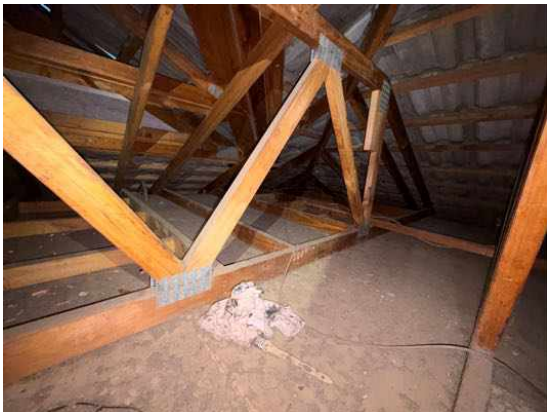
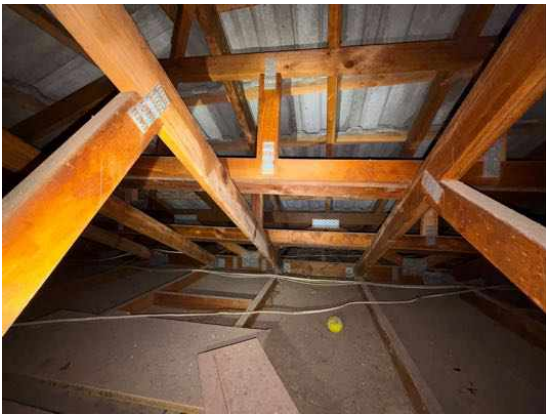
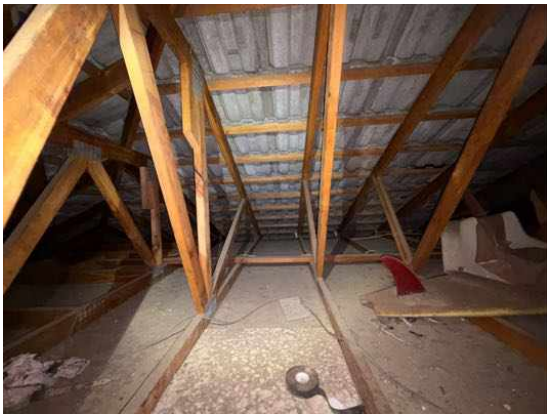
Building: Main Building
Location: Roof Void
Finding: Additional Photos
Information:

Additional photos are provided for your general reference.

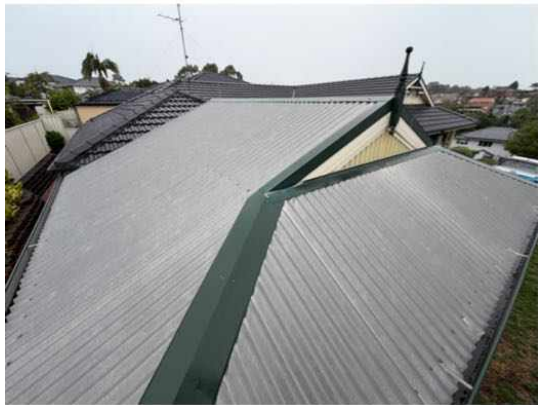
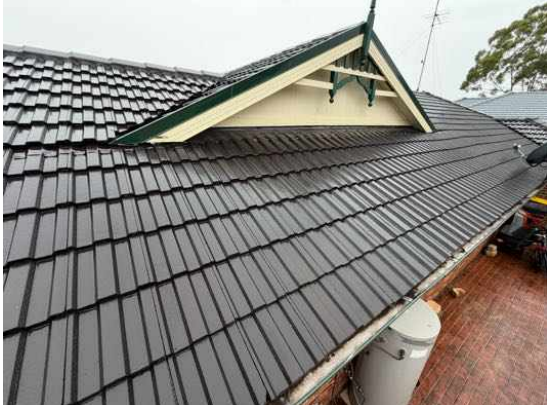
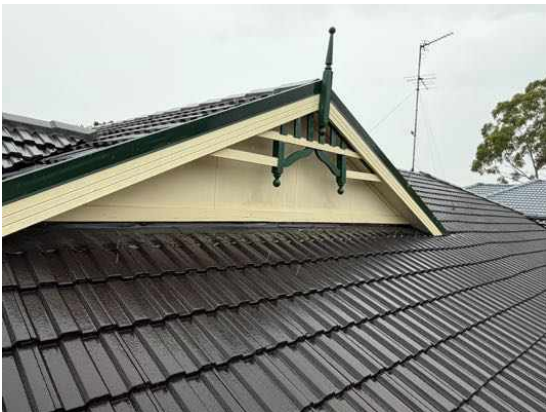
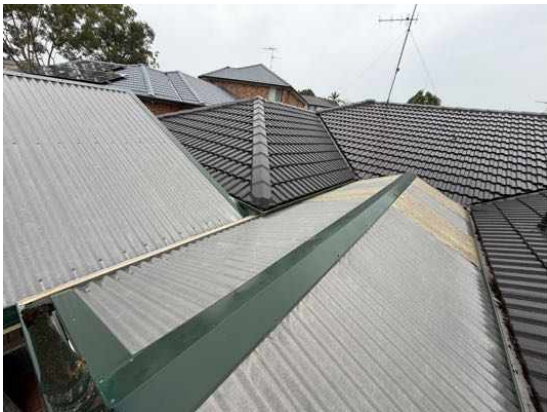
Building: Main Building
Location: Roof Exterior
Finding: Additional Photos
Information:

Additional photos are provided for your general reference.

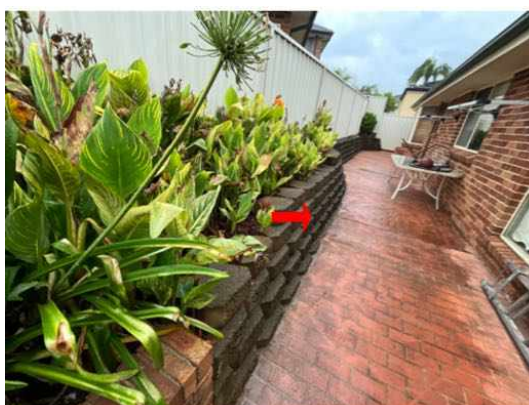
Building: Main Building
 Location: Retaining walls
 Finding: Retaining walls
 Information: At the time of inspection the retaining walls were checked and no defects were observed other than those which May have been mentioned earlier in this report.

AS4349.1-2007 requires all retaining walls in excess of 700mm to be inspected by a licensed and practicing structural engineer.

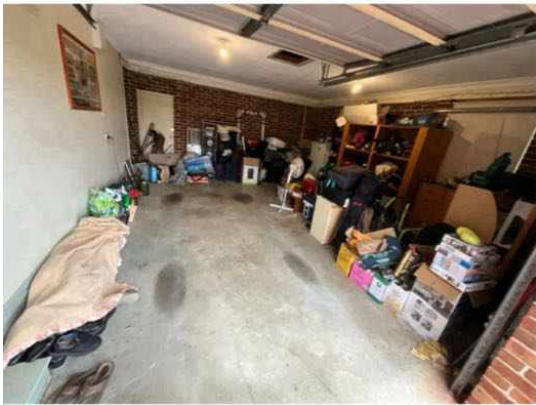
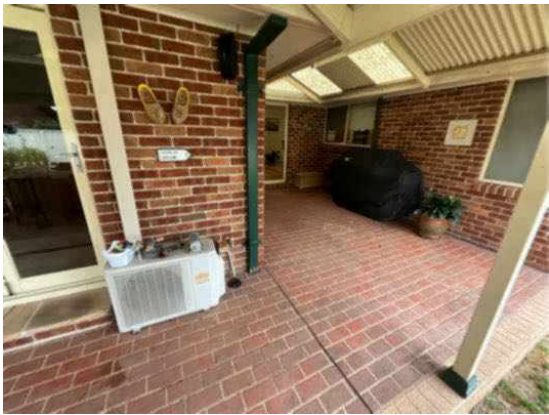
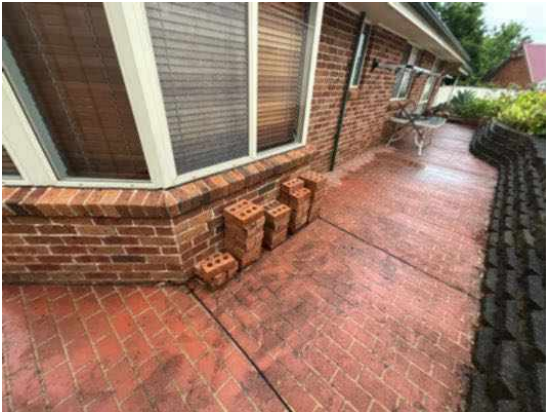
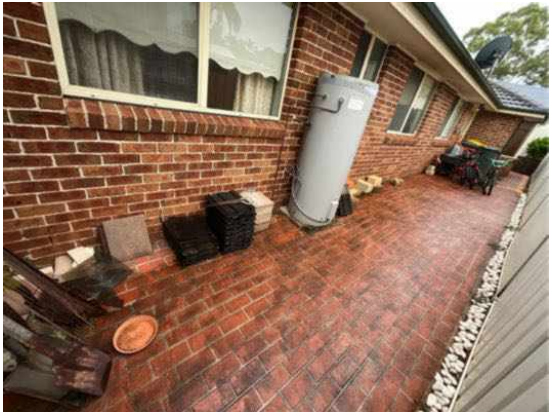
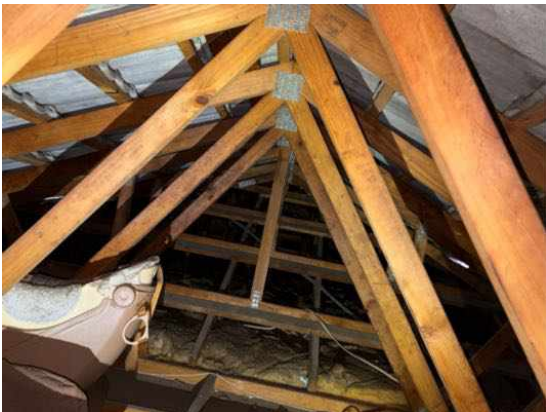
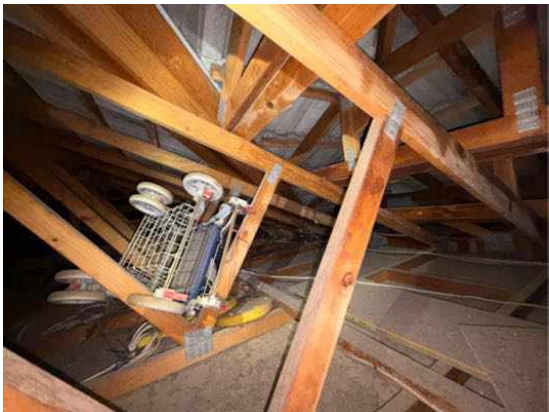
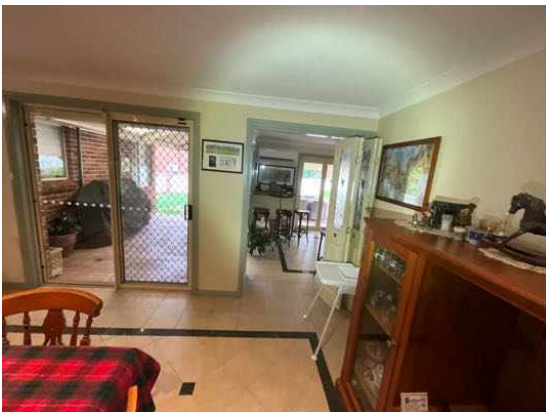
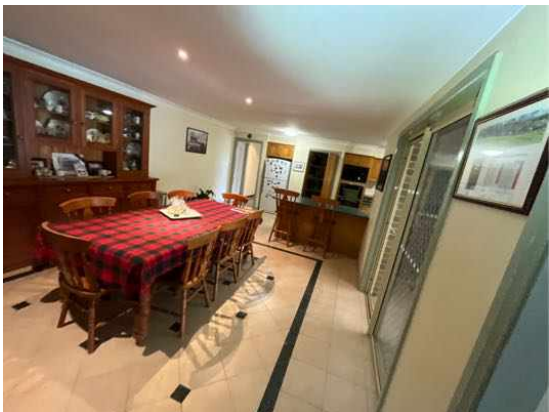
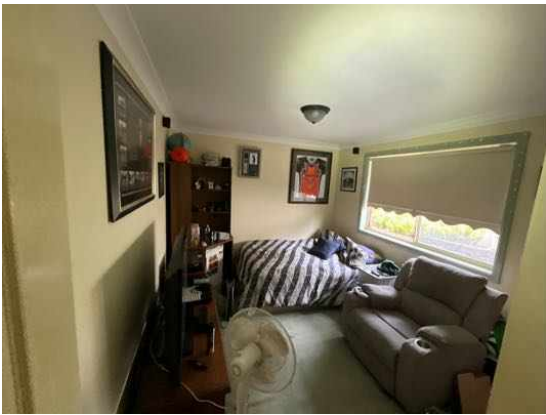
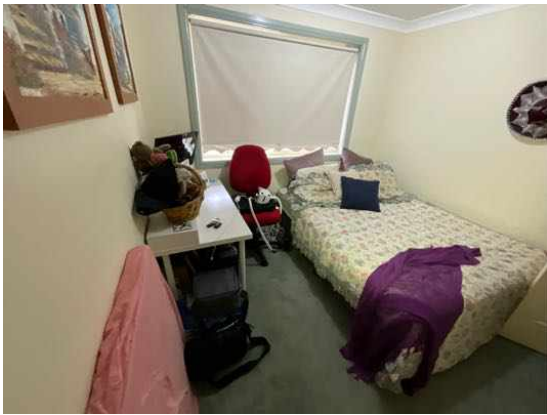
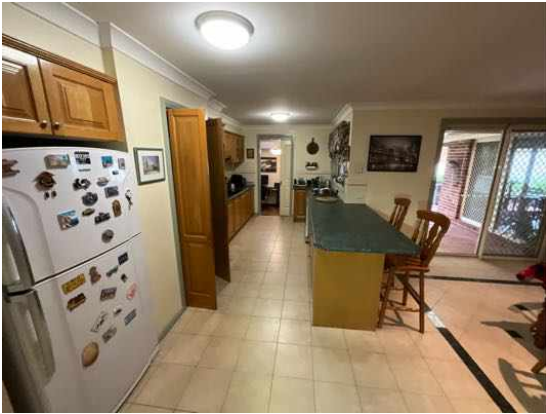
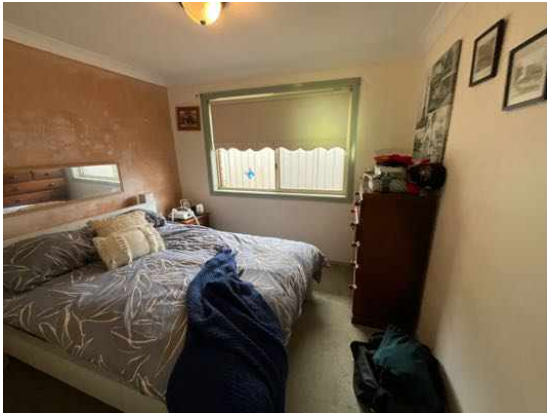
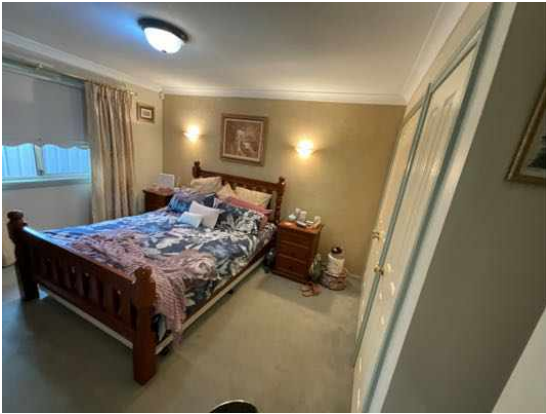
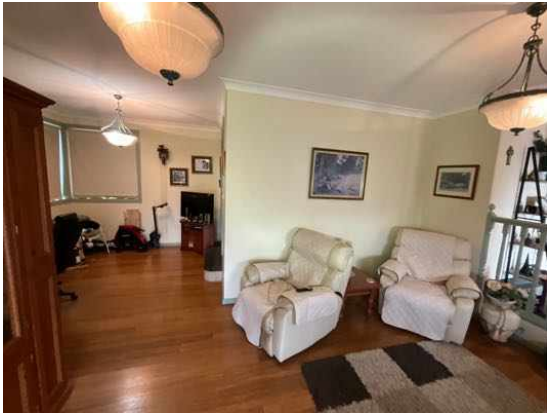
Building: Main Building
 Location: All Areas
 Finding: Additional Photos - Obstructions and Limitations
 Information:

These photographs are an indication of the obstructions and limitations which impeded full inspection of the property at the time of inspection. These obstructions can hide an array of defects and should be removed to allow full inspection to be carried out. A re-inspection is recommended once the areas are made accessible.
