# Building and Timber Pest Inspection Report

Inspection Date: Wed, 8 Apr 2026

Property Address: 76 Spitfire Dr, Raby NSW 2566, Australia

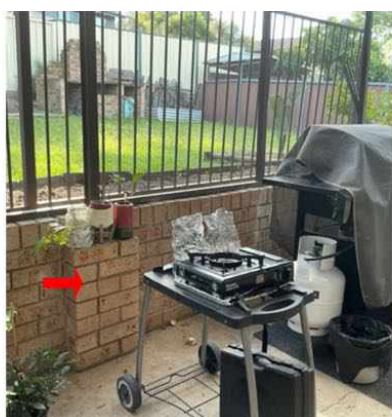
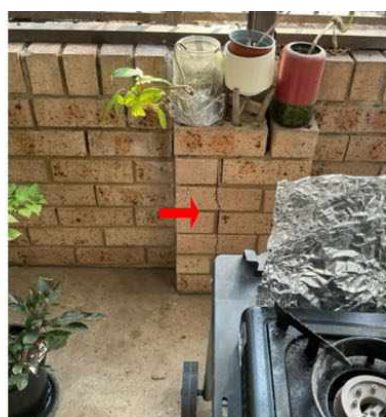
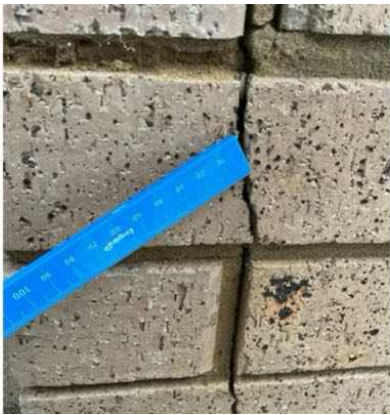
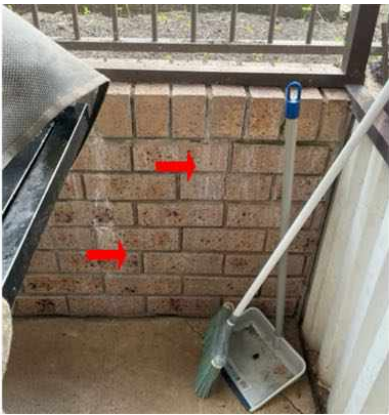
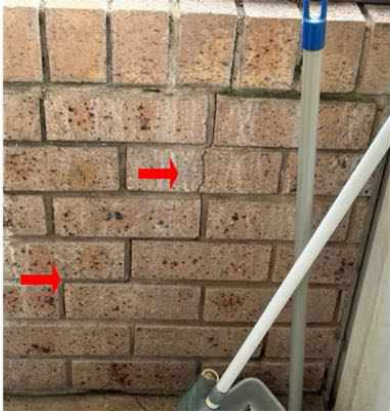
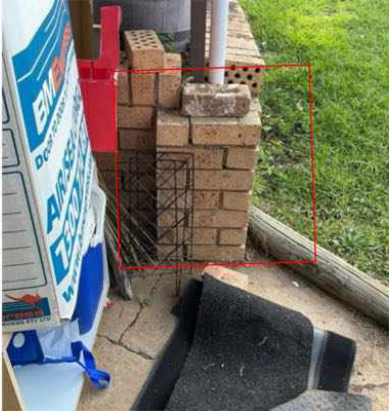
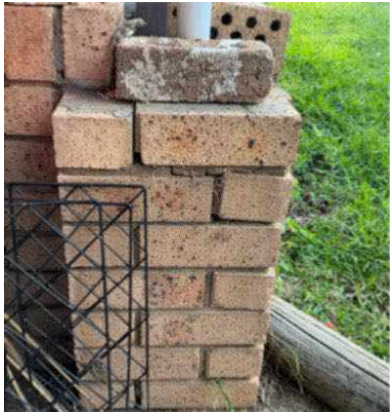
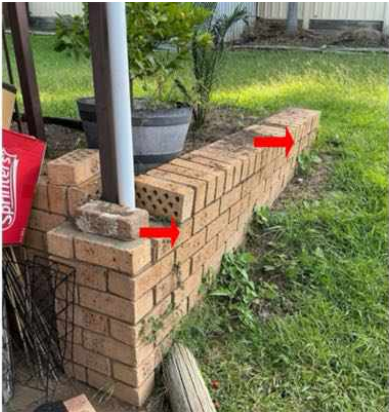
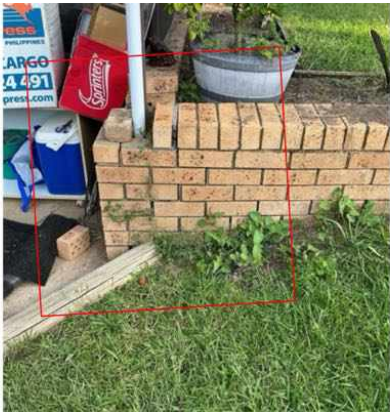
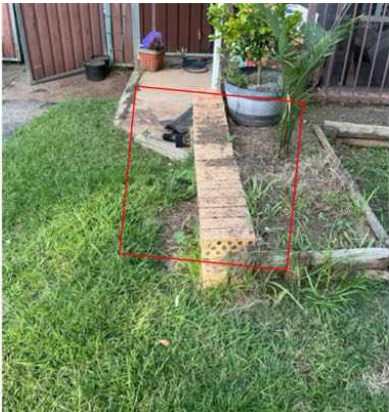
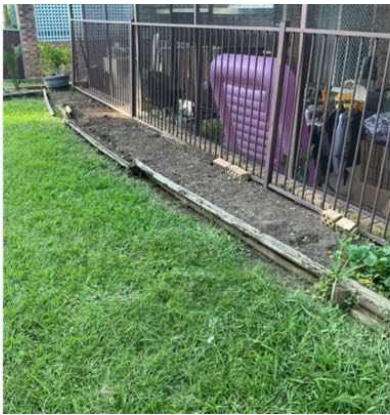
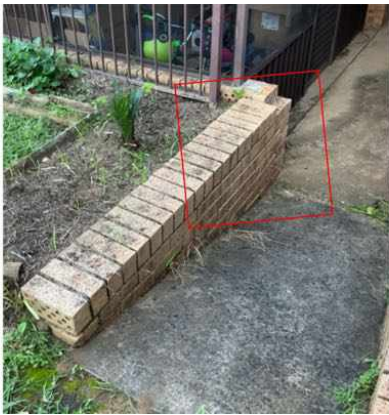
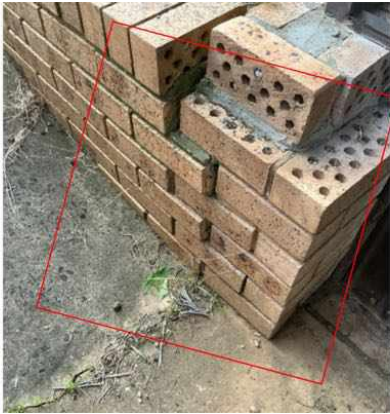
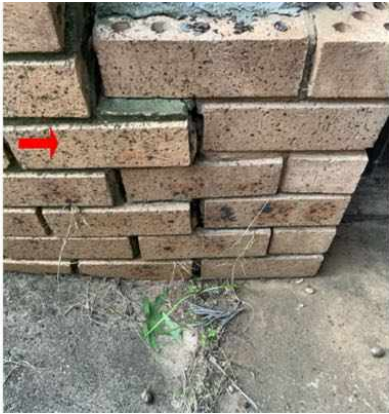
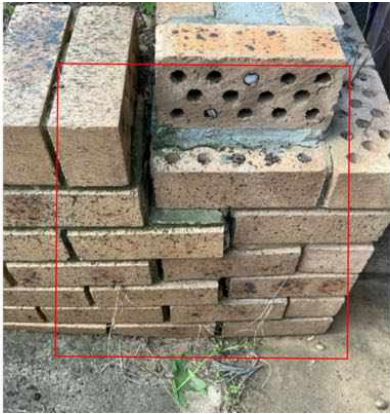
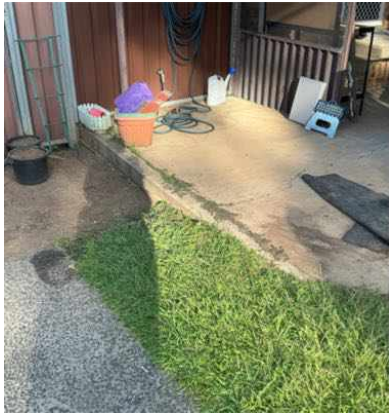
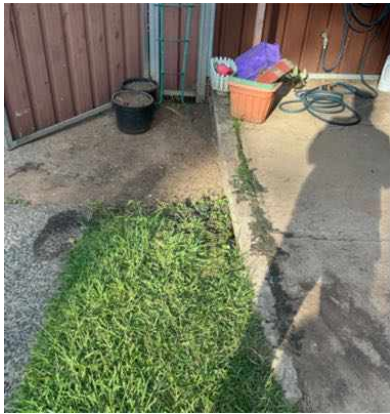
Building: Main Building  
Location: All External Areas - Rear  
Finding: Retaining wall - Defective (Cracking, step cracking) , leaning  
Information: The retaining wall in this are was found to be defective at the time of inspection. Generally, defective retaining walls are caused by poor original design or material use. However, deteriorated retaining walls may also be a result of substandard construction, poor site drainage or unmanaged stormwater flows.

If left unmanaged, the retaining wall may become a safety hazard if it continues to destabilise. Where retaining walls further rot and decay, an environment is created that is conducive to termite and pest infestation.

Significant repair and replacement should be expected. Where retaining walls are considered structural walls, a structural engineer / surveyor should be consulted regarding required remedial works. Otherwise, a landscaper or retaining wall installer may be appointed to repair or replace the wall, at the discretion of the client.

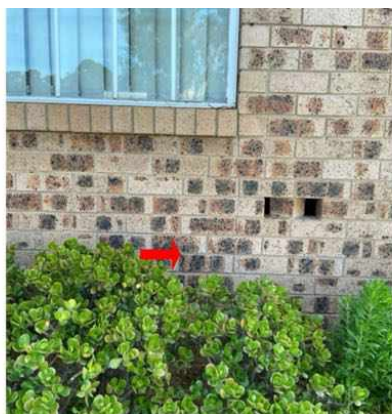
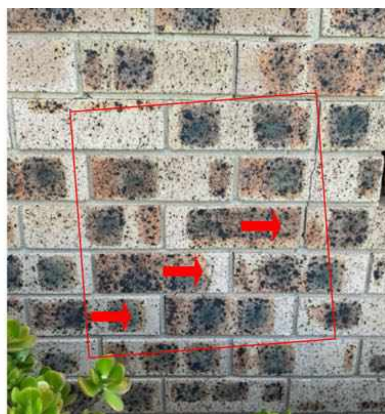
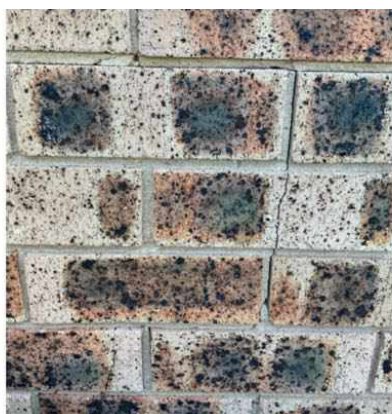
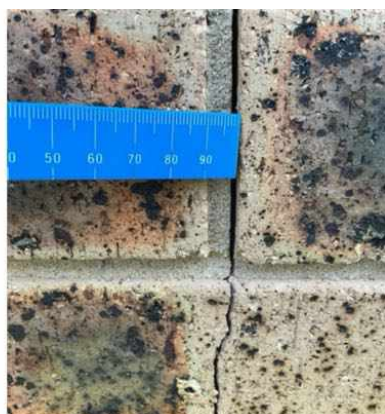
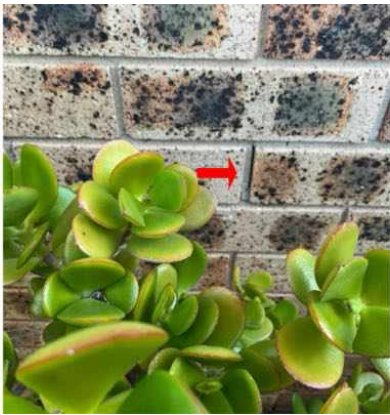
### Finding 3.01

Building:	Main Building
Location:	All External Areas - Front
Finding:	Brickwork - Step cracking
Information:	Step cracking was identified to the brickwork in this area at the time of inspection. Step cracking, which is similar to other forms of cracking, has a variety of possible causes. However, the most common is the subsidence of adjacent footings.

Step cracking is a relatively common defect, and is most likely to occur adjacent to windows, doors and other openings. Mortar failure in the gaps between affected bricks indicates the stresses and tensions affecting the wall.

Where step cracking is extensive or severe, the client is advised to consult a structural engineer. Minor step cracking can be used as a warning sign to address factors causing stress to the wall, which can include the effect of surrounding trees, water leaks, soil erosion, or even the presence of reactive soils in the surrounding area.

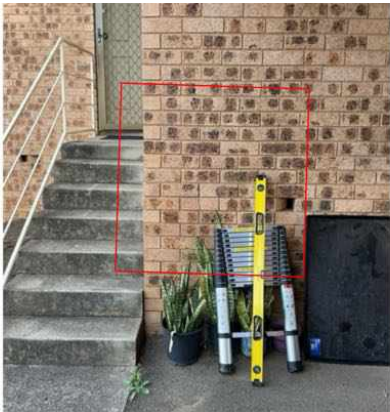
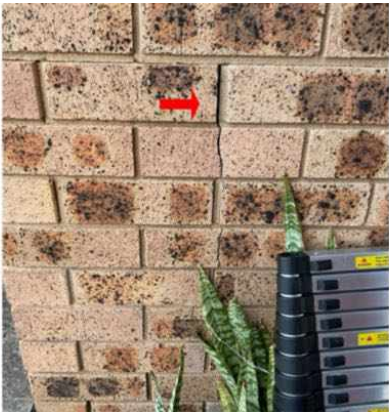
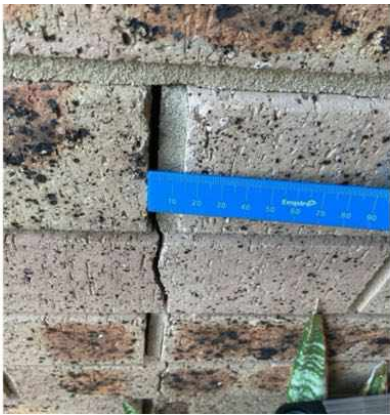
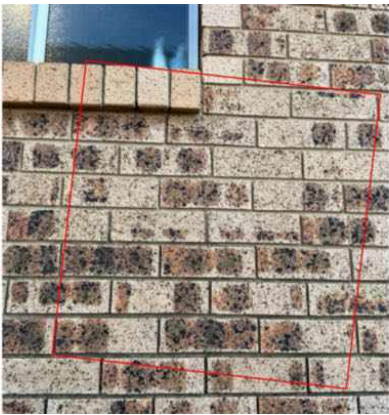
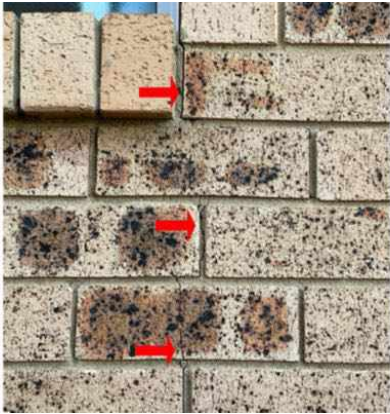
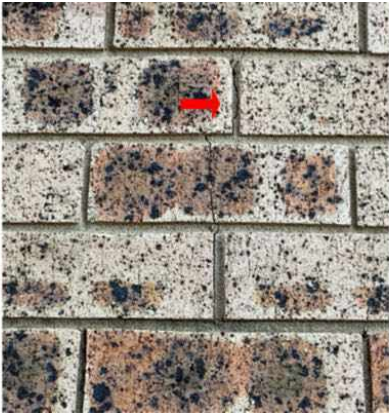
**Finding 3.02**

Building: Main Building  
Location: All External Areas - Front right, left side  
Finding: Brickwork - Cracking noticeable  
Information: Noticeable cracking was observed to external brickwork, extending through mortar joints and locally into brick units, with widths measuring approximately ~4mm. This form of cracking is commonly associated with minor foundation movement or settlement.

While no significant structural instability was evident at the time of inspection, the crack exceeds typical cosmetic tolerances and may allow moisture ingress and progressive deterioration if left unaddressed.

Further assessment by a structural engineer is recommended to determine whether movement is ongoing and to advise on appropriate rectification.

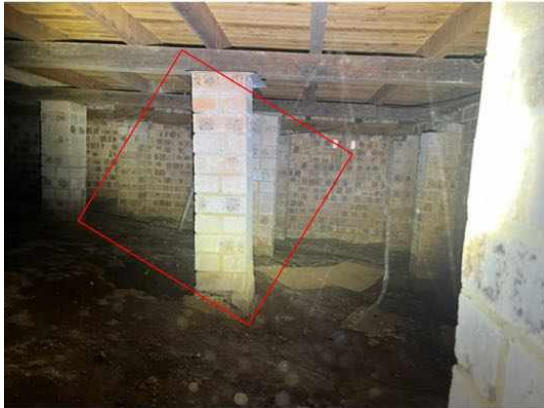
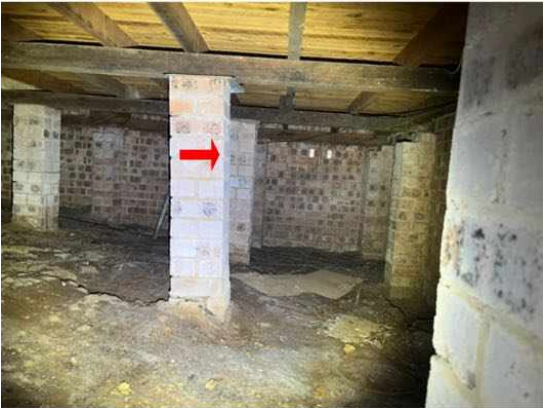
**Finding 3.03**

Building: Main Building  
Location: Subfloor  
Finding: Subfloor Pier Movement  
Information: brick pier within the subfloor area was observed to be leaning out of plumb. The movement has likely occurred due to settlement of the soil, inadequate footing support, or deterioration of the brickwork. This condition may compromise the stability of the floor system. A licensed builder or structural engineer should further assess and carry out rectification, such as rebuilding or re-supporting the pier, within the short to medium term.

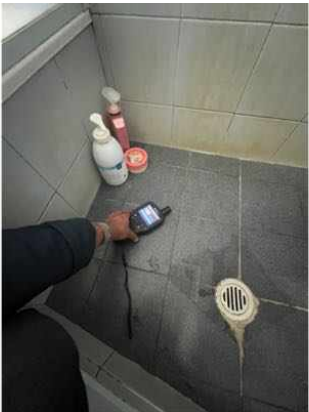
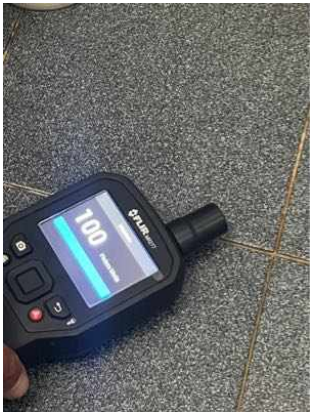
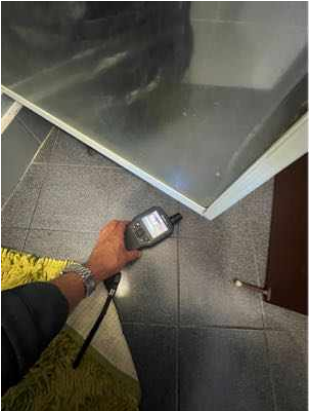
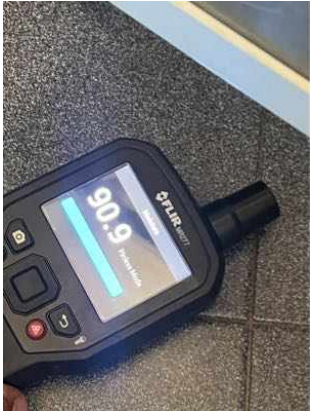
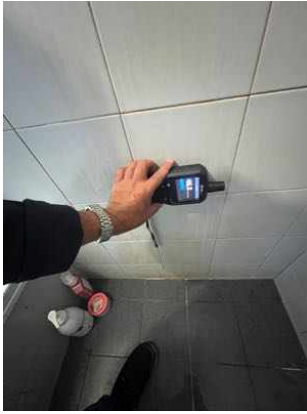
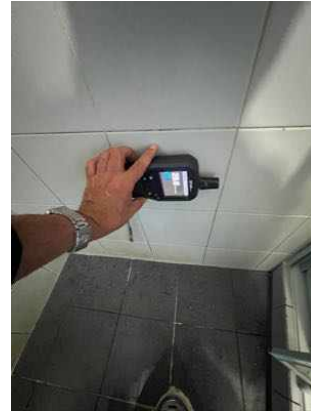
**Finding 3.04**

Building: Main Building  
Location: Bathroom  
Finding: Elevated Moisture Bathroom & Back of shower  
Information: Elevated moisture levels were detected to tiled surfaces in bathroom/shower areas. The back of shower area also showed elevated moisture but no visible deterioration was evident at the time of inspection.

This may be due to porous or missing grout, cracked tiles or recent use, however the possibility of waterproofing membrane failure or plumbing leaks cannot be excluded. Persistent moisture ingress can lead to concealed damage, including timber rot and mould growth. Further investigation by a licensed plumber and/or waterproofing contractor is recommended as soon as possible. Rectification may involve waterproofing repairs and potential refurbishment depending on findings.

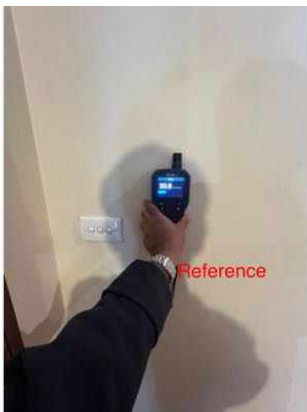
### Finding 3.05

Building:	Main Building
Location:	All Internal Areas - Front wall
Finding:	Elevated Moisture – Further Investigation Recommended
Information:	Elevated moisture readings were detected with no visible surface issues, although no significant structural damage was evident at the time of inspection, dampness can contribute to deterioration if left unaddressed. A further investigation by a licensed plumber or waterproofing specialist is recommended to confirm the source and ensure no concealed issues are developing.

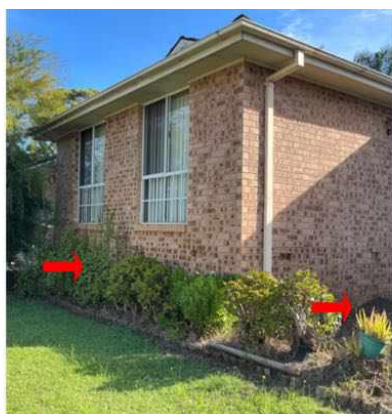
### Finding 3.06

Building:	Main Building
Location:	All External Areas
Finding:	Site drainage - Inadequate
Information:	The site drainage in this area was found to be inadequate at the time of inspection, creating potential for subsequent water damage to associated building elements.

It is important that water does not lie against the base of walls; surrounding paths and ground levels should be sloped to drain water away from walls. Downpipes should not discharge stormwater onto lower walls or plinths. Stormwater should be carried away by large, regularly cleaned drains. Ground levels may need to be lowered to expose a buried DPC.

Where site drainage is inadequate, installation of an Agricultural (Aggie) Drain may be required. A qualified plumber should be appointed to further inspect the property and perform any remedial works as necessary. Water damage and secondary defects are likely to occur if left unmanaged.

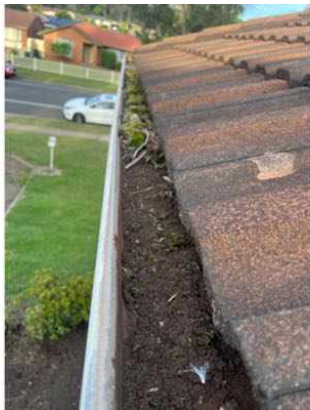
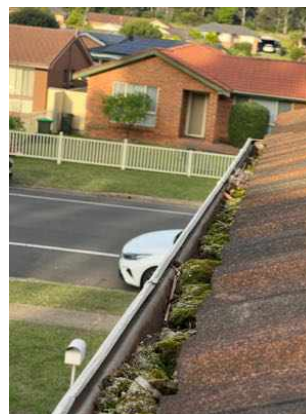
Blocked gutters are likely to lead to high levels of moisture in the affected areas. Such moisture will not only cause rust and decay of the associated building materials, but can also provide conditions that are conducive to termite and timber pest activity. Blockages in gutters should therefore be removed immediately to ensure dry

conditions are maintained.

Consult a Licensed Plumber for further specific advice on remedial works that may be required. In the interim, it is highly advised that blocked gutters be removed by the homeowner or a general handyperson as a matter of urgency.

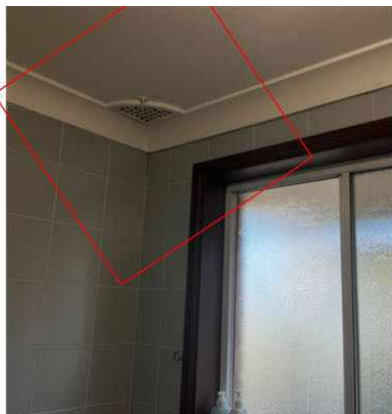
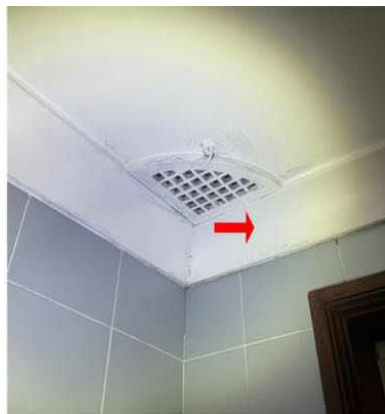
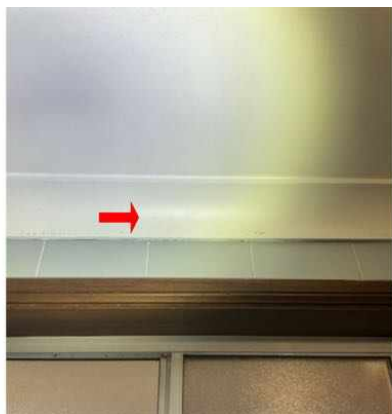
### Finding 3.08

Building:	Main Building
Location:	Bathroom
Finding:	Water Staining - Humidity or Ventilation
Information:	The ceiling surface shows faint darkened spotting or shadowing, commonly consistent with surface mould or humidity-related staining, often found in bathroom or wet area ceilings with insufficient ventilation. While there is no visible sagging or major water damage, the pattern suggests prolonged moisture exposure, possibly due to steam accumulation or minor condensation issues. According to AS 4349.1–2007 (Appendix C), this would be classified as a minor defect unless further deterioration or active leaks are found. Recommend improving mechanical or natural ventilation, cleaning the surface with mould treatment, and monitoring for recurrence.

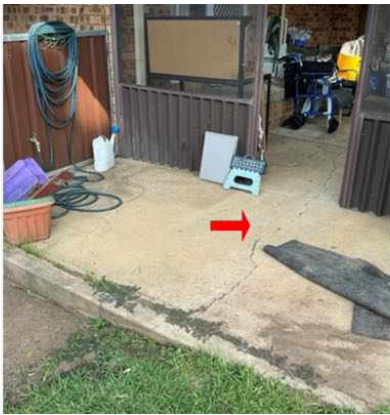
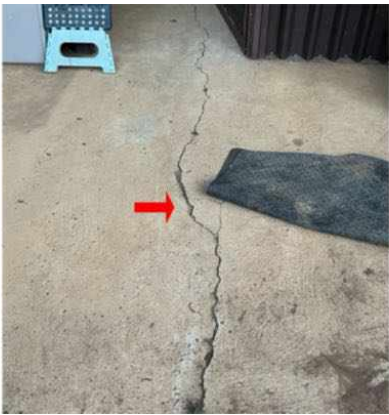
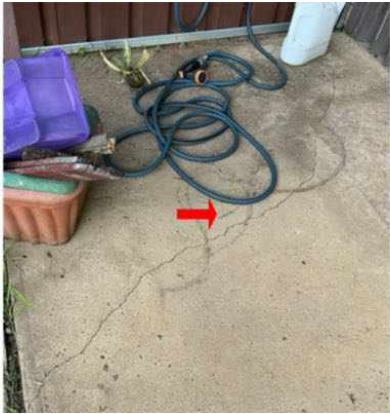
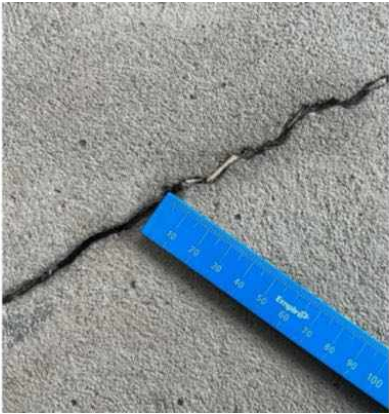
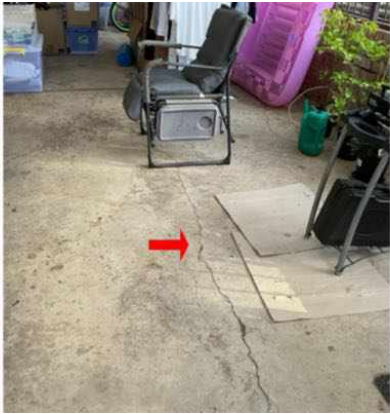
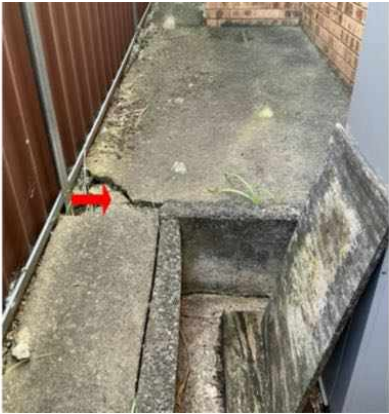
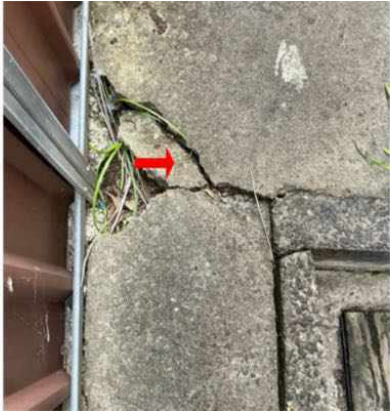
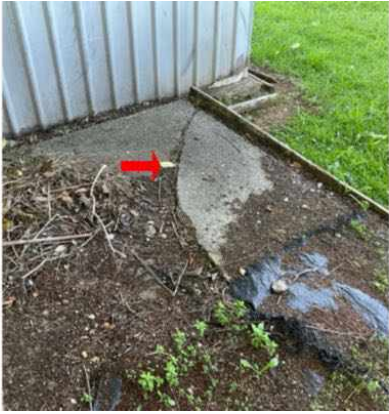
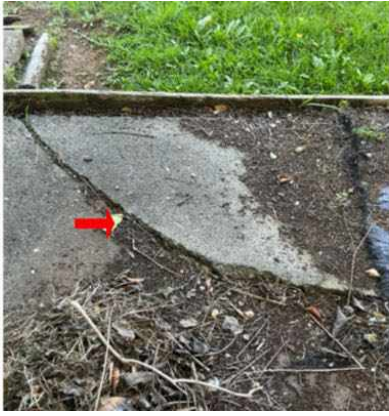
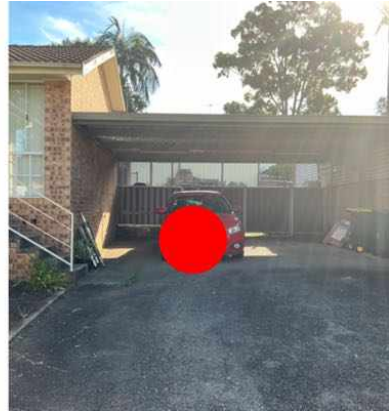
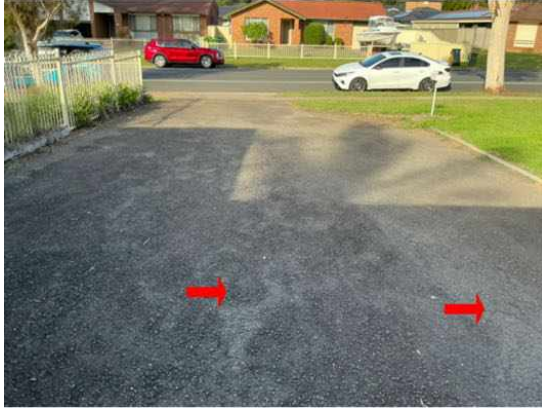
### Finding 3.13

Building:	Main Building
Location:	All External Areas
Finding:	Paving - Uneven
Information:	Sections of the external paved area are uneven, creating a potential trip hazard. It appears as though the area has been subject to rough installation, or that paving sections have lifted due to movements in the foundation of the property.

Where paving creates a trip hazard, personal injury may ensue if due caution is not taken by all persons within this area.

Re-paving of the area is required as soon as possible to remedy this situation. Further consultation with a specialist concreter is advised.

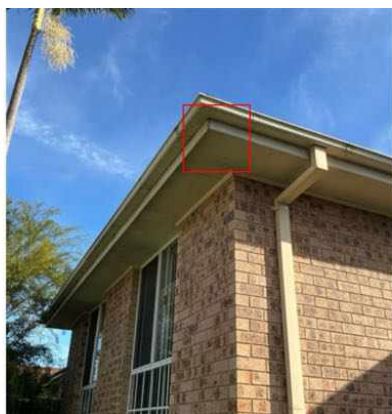
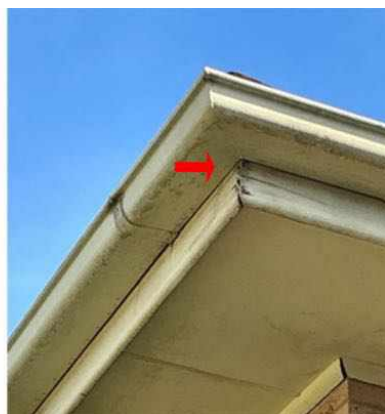
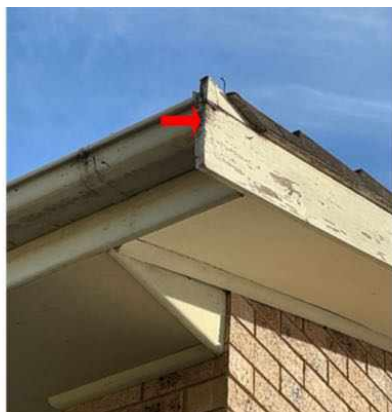
### Finding 3.15

Building:	Main Building
Location:	All External Areas
Finding:	Wood rot to some areas
Information:	This building element shows evidence of wood rot. Wood rot, also known as Fungal Decay, occurs when timbers and other cellulose building materials are exposed to damp conditions on an ongoing basis. This could be the result of exposure to weathering over a prolonged period of time, or the attraction of excessive moisture from other abutting building materials. Contributing factors also include poor air ventilation in the area.

Wood rot is often associated with general damp problems and is evidenced by a 'musty' smell or mould and mildew occurring on surfaces. If left unmanaged, damp conditions can lead to further health problems and the decay of timbers will continue.

Early intervention and regular maintenance, particularly of exterior timbers, will prolong the useful life of these building elements. Prior to any works being performed, the cause of the moisture that has created the visible wood rot should be identified and addressed in a suitable manner. Replacement of affected timbers may then be a necessary step in protecting surrounding building elements from such deterioration.

A qualified plumber may be appointed to assess the cause of excessive moisture and to provide advice on any remedial works as required. A qualified carpenter or

registered builder may also be required to replace affected building materials.

Even though Liverpool termite activity was not visible. A further invasive inspection by a licensed termite technician its also highly recommended to eliminate possibility of potential termite activity.

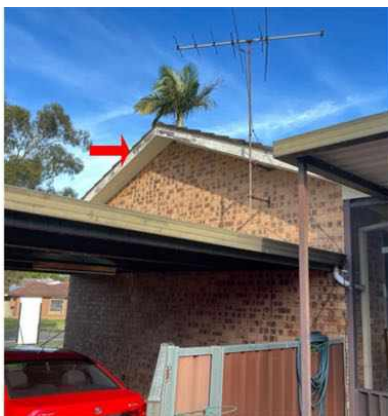
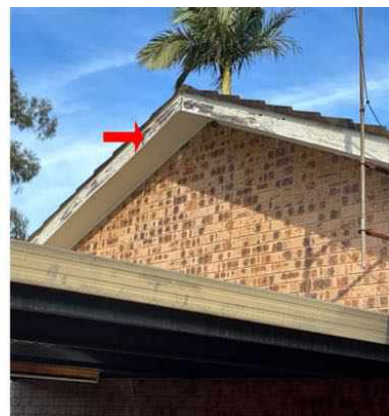
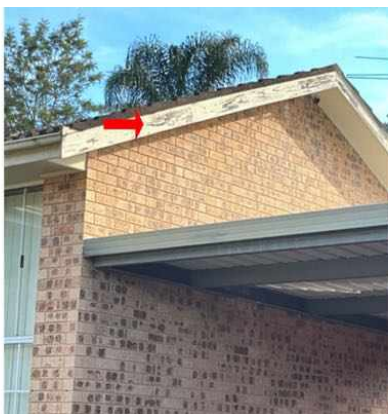
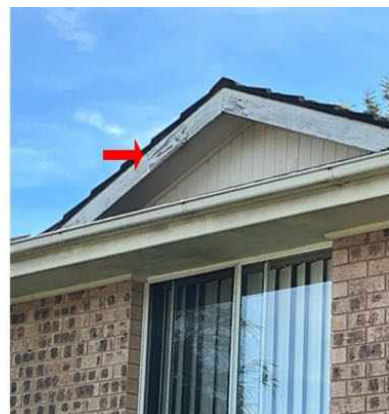
### Finding 3.23

Building:	Main Building
Location:	All External Areas
Finding:	Eave Trim Separation to some areas

Information: The external timber trim at the eaves corner displays a visible separation crack, likely due to minor building movement or timber shrinkage over time. While not structurally significant on its own, the gap may allow moisture ingress and should be sealed with a flexible exterior-grade sealant to prevent further deterioration.

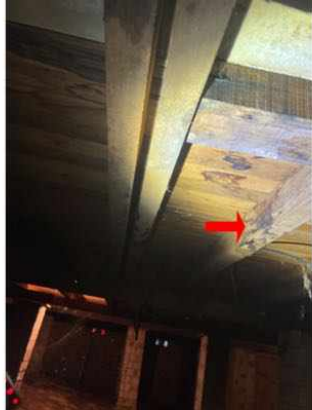
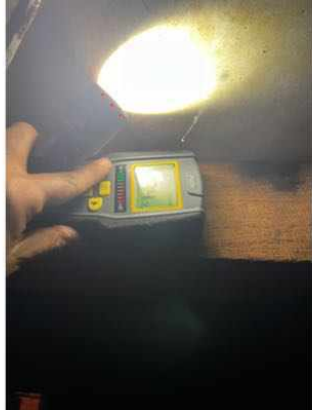
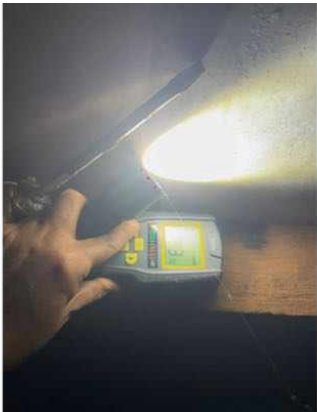
Finding 3.26

Building:	Main Building
Location:	Subfloor
Finding:	Subfloor ventilation - Inadequate
Information:	Adequate subfloor ventilation aids in preventing excessive moisture wood rot and termite activity by ensuring a dry subfloor environment.

Where ventilation is substandard it is usually caused by factors such as failure to install adequate vents during construction subsequent building works or earth and vegetation covering over vents low subfloor clearance and items or debris in the subfloor restricting airflow.

Subfloor ventilation can be improved in most cases by addressing the causes such as exposing subfloor vents installing additional new vents installing mechanical (forced airflow) ventilation and removing debris from the subfloor.

A registered builder should be appointed as soon as possible to perform these works as necessary.

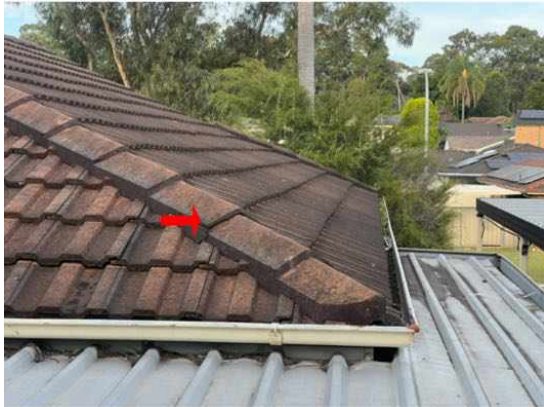
**Finding 3.28**

Building: Main Building  
Location: Roof Exterior  
Finding: Flashing defective -poor installation  
Information: The metal flashing at the wall junction appears inadequately installed, with visible gaps add or lifting and reliance on surface sealant rather than a properly chased and continuous detail. The junction does not appear fully weather-tight, increasing the risk of moisture ingress into the wall cavity or roof structure over time. Defective flashing installation can lead to concealed deterioration if not addressed. Recommend assessment and rectification by a qualified roofing contractor to ensure compliant and effective weatherproofing.

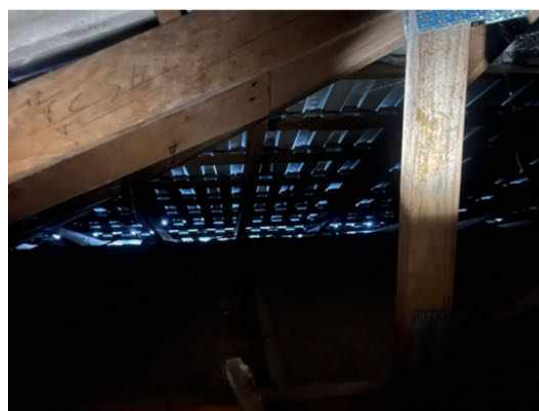
### Finding 3.30

Building:	Main Building
Location:	Roof Void
Finding:	Roof Void Observation – Timber Splitting in Roof Framing
Information:	longitudinal splits were observed in roof framing member within the roof void. No signs of distortion, bowing, deflection, moisture ingress, or fungal decay were evident at the time of inspection. Current structural integrity does not appear compromised. However, A licensed carpenter should be consulted to access further.

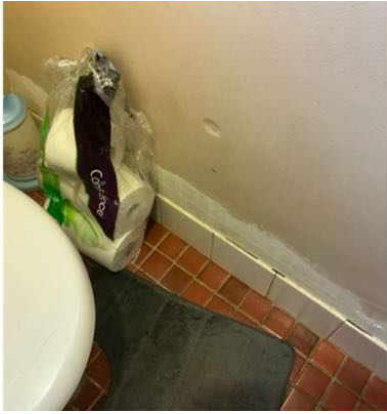
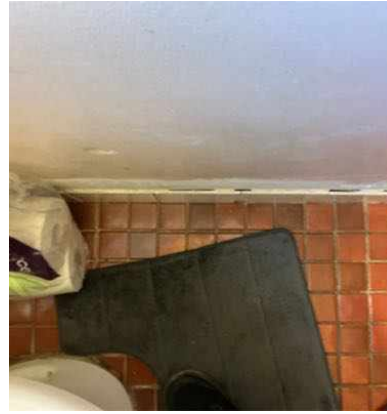
### Finding 3.32

Building:	Main Building
Location:	All Internal Areas
Finding:	Tiles - Cracked or damaged
Information:	Cracking was evident to the tiling in this area at the time of inspection. While the cracking appears to be minor, this area is frequently exposed to water, allowing potential for water penetration into adjoining sections of walls or flooring.

If left unmanaged, water penetration to these areas may lead to subsequent water damage, which is likely necessitate repair work to affected building elements.

A tiling contractor should be appointed to ensure that no further water damage occurs. The re-application of silicone and grouting throughout remaining tile work is also advised, to further protect the area against water penetration.

Where water penetration has led to water damage, appointment of a relevant tradesperson may be required to repair damaged building elements.

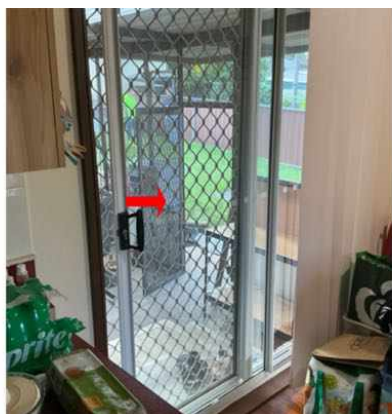
### Finding 3.34

Finding: Building element - Missing - No ventilation

Replacement of any missing building element should be conducted as soon as possible to ensure that no damage or functional issues occur to associated building materials.

The appropriate tradesperson should be appointed as soon as possible to replace the missing building element.

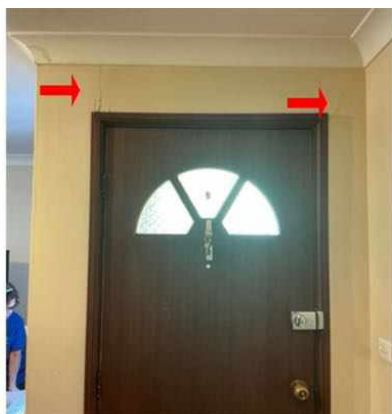
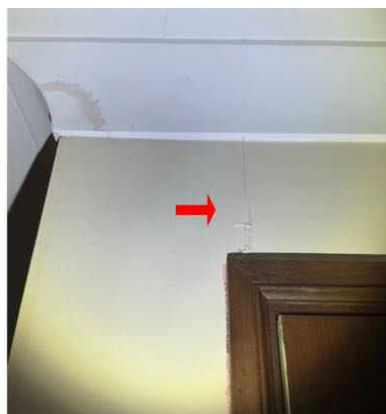
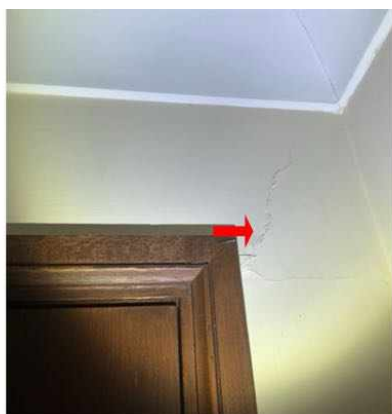
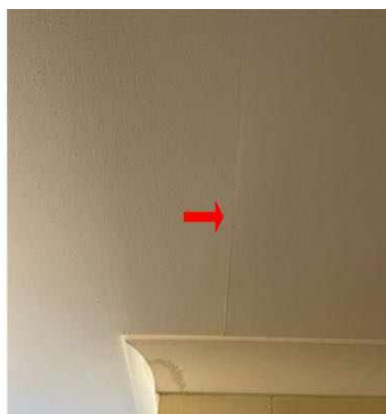
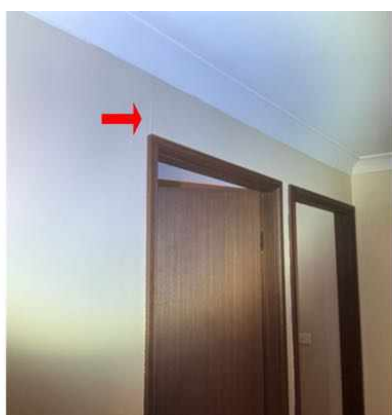
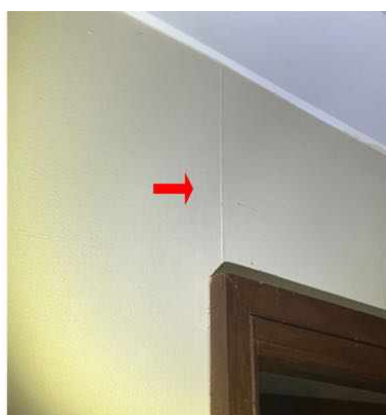
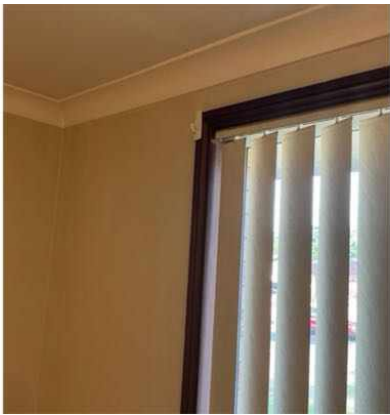
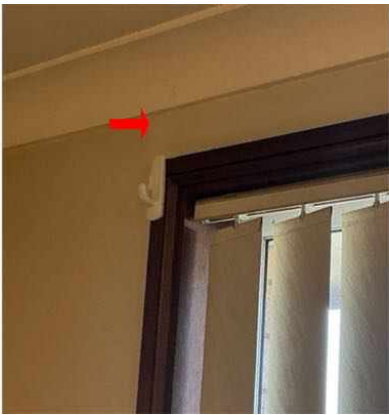
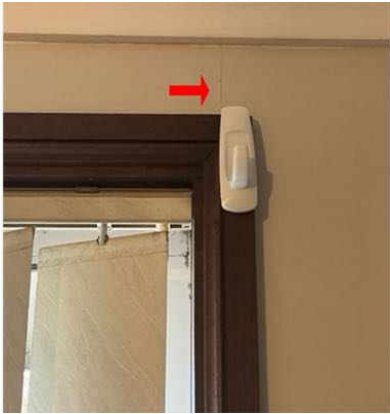
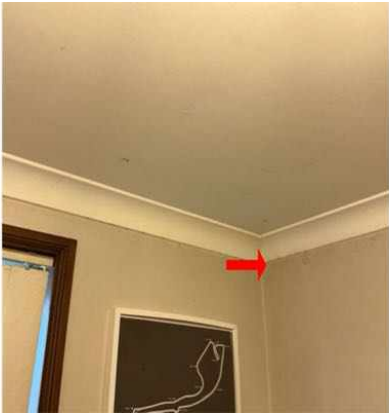
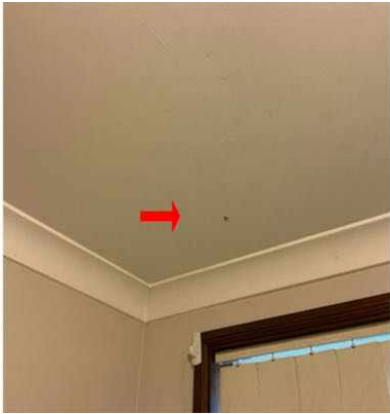
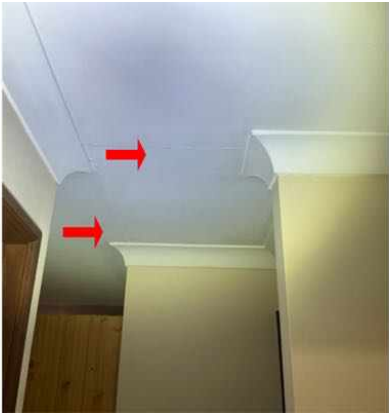
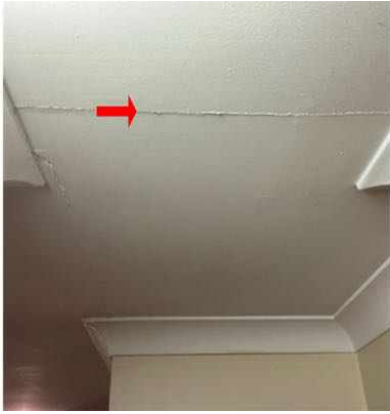
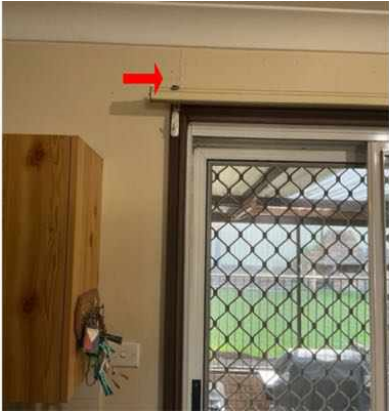
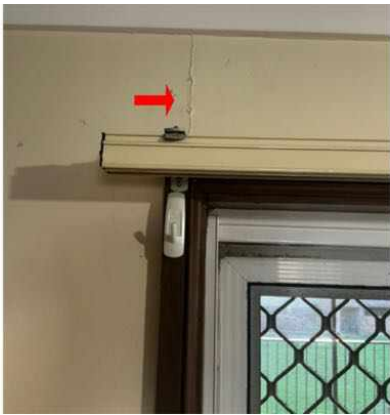
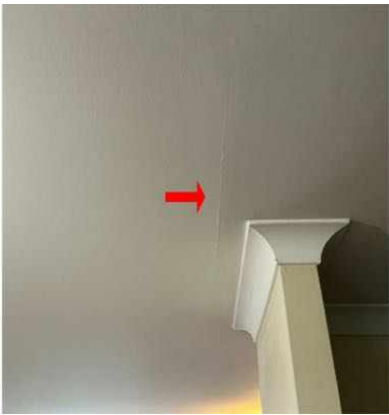
### Finding 3.39

Building:	Main Building
Location:	All Internal Areas
Finding:	Paint Finish & Hairline Cracking - To some areas
Information:	The paint finish in this area was identified as being incomplete at the time of inspection including some hairline minor cracking.

Whilst incomplete or missing paint and minor cracking and imperfections in finish is generally an appearance defect, it can also lead to the development of secondary building defects over time. Incomplete areas of paint finish expose the area to moisture, potentially accelerating the deterioration of underlying building materials.

Incomplete paint finishes should be sanded back, filled, leveled and painted, as applicable. Where inadequate or missing paint protection has led to the deterioration of the associated building element, repair and/or replacement of this building element may be required.

A painting contractor should be appointed as soon as possible to perform necessary works to aid the appearance of the affected area and to ensure the area is protected against further deterioration. Alternatively, the homeowner following manufacturer instructions may perform these works.

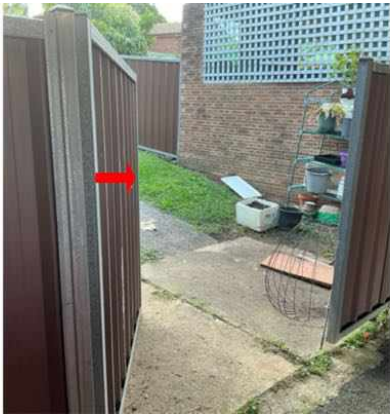
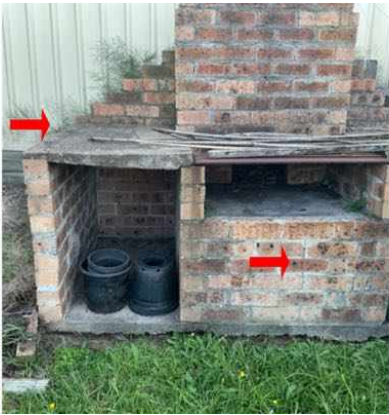
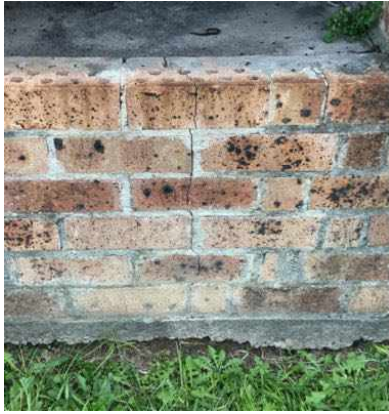
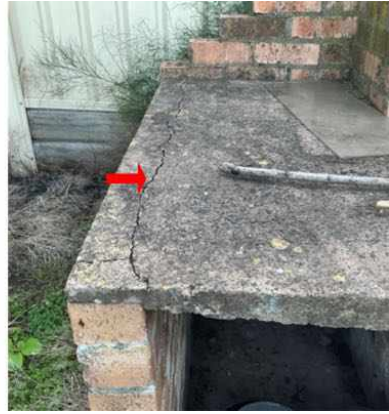
**Finding 3.40**

Building: Main Building  
Location: All External Areas  
Finding: Building element - Damaged - Gate binding , rear bbq area damaged cracking  
Information: Breakage occurs generally when the building materials have either aged and decayed, or as a result of damage (accidental or deliberate).

Repair and/or replacement of broken elements is advised to ensure that additional secondary defects do not arise as a consequence. Such works are necessary, as all building elements play a key role in the operation and function of the overall structure and its performance.

A relevant tradesperson should be appointed to repair or replace the affected building element prior to any subsequent damage being caused.

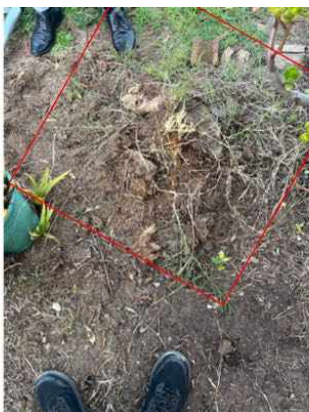
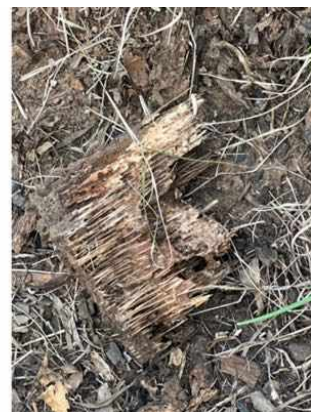
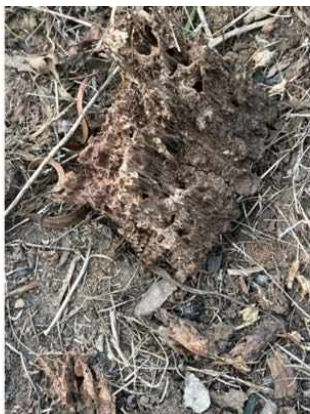
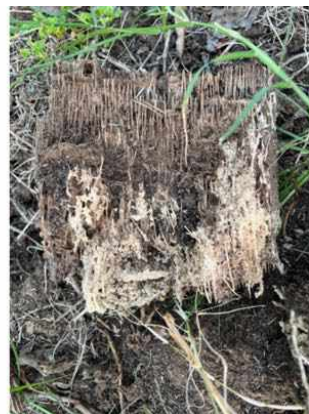
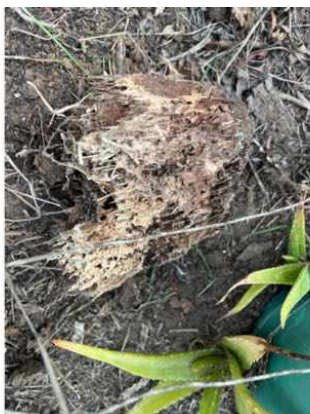
Building: Main Building  
Location: All External Areas - Tree Stump front  
Finding: Termite - damage identified  
Information: Damage was found within tree stump consistent with previous termite activity, though it appears inactive.

Recommend an invasive inspection of trees and concealed timber elements within the property by a licensed timber pest technician.

Installation of a chemical termite management system is also recommended.

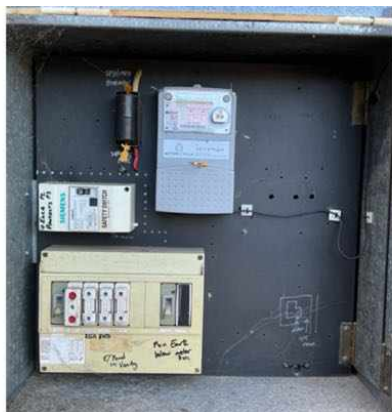
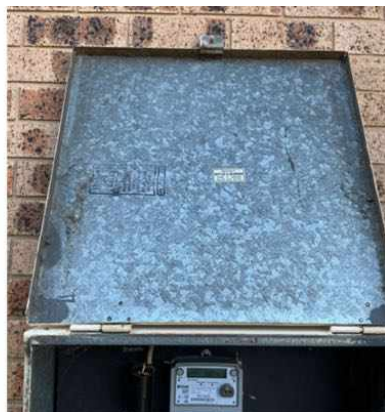
### Finding 6.01

Building:	Main Building
Location:	All External Areas
Finding:	Termite Management System - no evidence of a chemical installation
Information:	The application of a post-construction chemical termite barrier is highly recommended for all properties, particularly if live termite activity has been found on the site previously. Such barriers are highly effective in preventing termite attack on any timber building elements throughout the property.

A durable notice should be placed in the switchboard unit to indicate current termite barriers. At the time of inspection, it appeared as though no termite management system has been installed, with no evidence to suggest preventative works taking place.

The client may consider gaining further advice from a pest controller as to the costs and procedures involved with this application. It is recommended that obtaining such advice be a short-term priority.

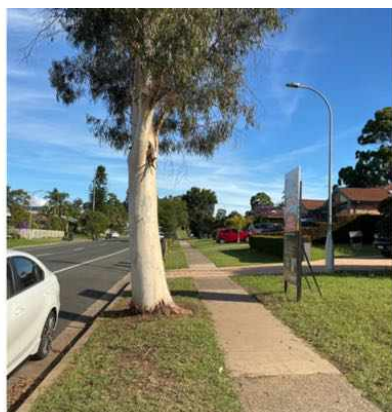
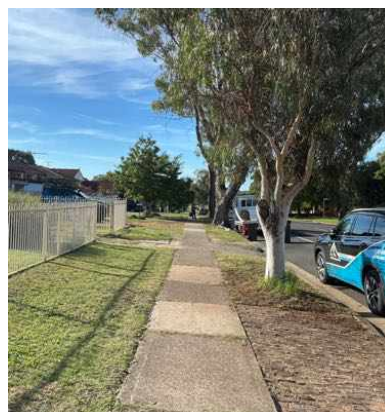
### Finding 6.02

Building:	Main Building
Location:	All External Areas
Finding:	Trees within 50m
Information:	Trees within 50m of the property can be conducive to termite activity. It is recommended an invasive inspection of all trees with 50m to the property be carried out by a qualified pest control expert.

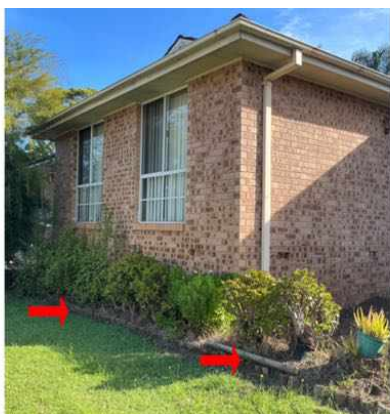
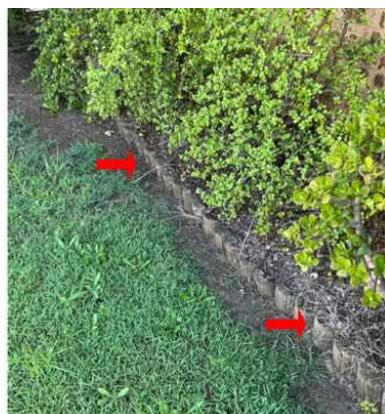
### Finding 6.03

Building:	Main Building
Location:	All External Areas
Finding:	In ground contact - Timber to some areas
Information:	Any timbers in direct ground contact provide opportunity for concealed termite entry and are likely to be subject to premature rot and decay as the soil retains moisture or damp conditions against the timbers.

Remove untreated timber that is in direct contact with external grounds. Consider replacement with more durable materials i.e. treated timber or non timber elements. Frequent pest inspections are advised to readily identify any termite activity in these areas.

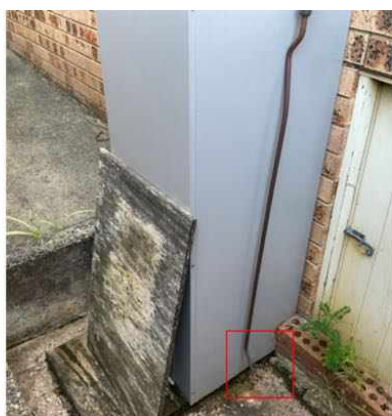
### Finding 6.04

Building:	Main Building
Location:	All External Areas
Finding:	HWS Overflow - Not Connected
Information:	The Hot Water System (HWS) overflow was found to be disconnected from storm water drainage and is creating excessive moisture in the surrounding area.

These damp conditions can lead to secondary defects such as rot, rust or corrosion of associated building elements, the formation of fungal decay, or even the creation of potential slip hazards. When coupled with poor site drainage, pooling of water may also attract termite activity to this area.

It is highly recommended that a licensed plumber be appointed to connect the HWS overflow in order to prevent such an environment from being created. These minor works should be carried out as soon as possible.

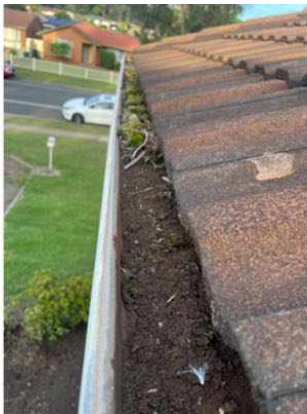
### Finding 6.05

Building:	Main Building
Location:	All External Areas
Finding:	Gutters - Blocked
Information:	Roof plumbing structures, such as guttering and downpipes, should be free of all

Blocked gutters are likely to lead to high levels of moisture in the affected areas. Such moisture will not only cause rust and decay of the associated building materials, but can also provide conditions that are conducive to termite and timber pest activity. Blockages in gutters should therefore be removed immediately to ensure dry conditions are maintained.

Consult a Licensed Plumber for further specific advice on remedial works that may be required. In the interim, it is highly advised that blocked gutters be removed by the homeowner or a general handyperson as a matter of urgency.

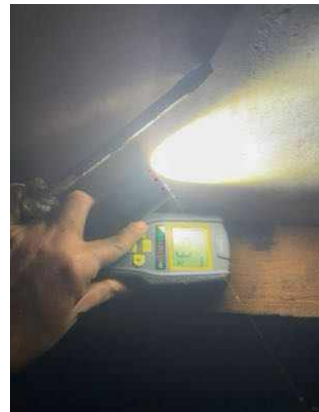
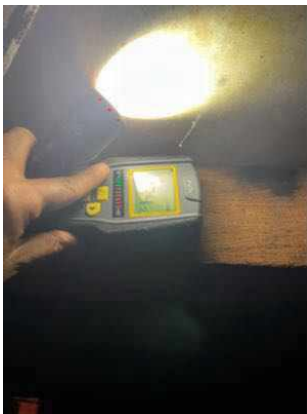
### Finding 6.06

Building:	Main Building
Location:	Subfloor, Front lower wall
Finding:	Elevated moisture - identified
Information:	Elevated moisture can attract termites and produce conditions that promote fungal growth and wood decay.

Elevated moisture is generally caused by deteriorated, inadequate or missing roof drainage, leaking plumbing pipes or fixtures, poorly plumbed HWS overflows or condenser units and poor site drainage.

Prior to any remedial works being performed a qualified plumber should be appointed to further inspect the property and to identify the cause of the excessive moisture. Works to remove affected building elements may then be necessary and should be performed by an appropriate tradesperson.

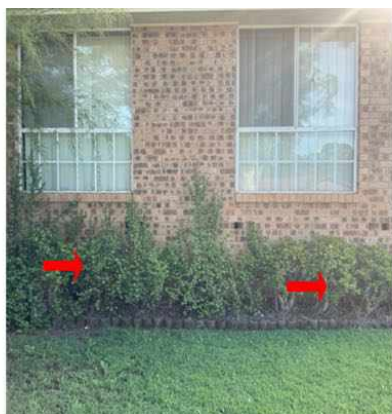
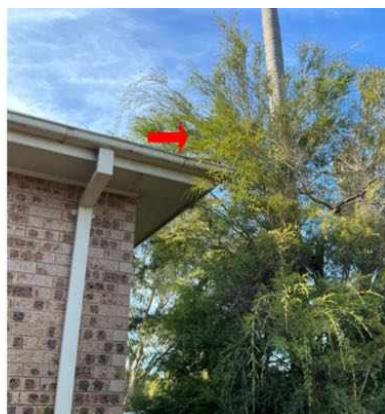
The removal and replanting of species that do not provide "cover" or cutting back of existing vegetation will assist greatly in preventing Bridging from occurring.

The removal of any such materials that may be conducive to termite activity should be carried out as soon as possible and arrange re inspection to minimize the risk of termite attack.
