# Building and Timber Pest Inspection Report

Inspection Date: Wed, 8 Apr 2026

Property Address: 76 Spitfire Dr, Raby NSW 2566, Australia

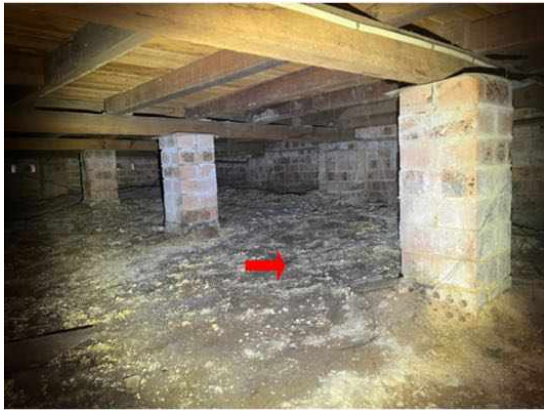
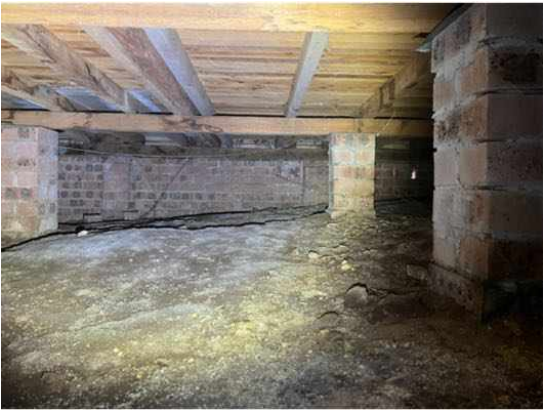
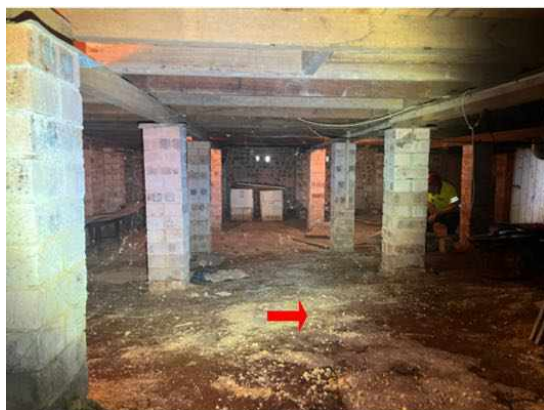
### Finding 6.08

Building:	Main Building
Location:	Subfloor
Finding:	Subfloor ventilation - Inadequate
Information:	Adequate subfloor ventilation aids in preventing excessive moisture wood rot and termite activity by ensuring a dry subfloor environment.

Where ventilation is substandard it is usually caused by factors such as failure to install adequate vents during construction subsequent building works or earth and vegetation covering over vents low subfloor clearance and items or debris in the subfloor restricting airflow.

Subfloor ventilation can be improved in most cases by addressing the causes such as exposing subfloor vents installing additional new vents installing mechanical (forced airflow) ventilation and removing debris from the subfloor.

A registered builder should be appointed as soon as possible to perform these works as necessary.

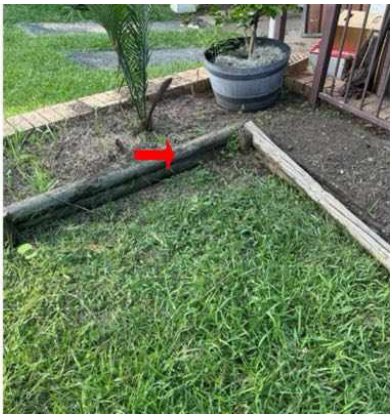
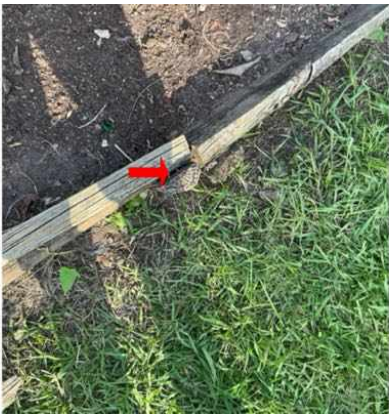
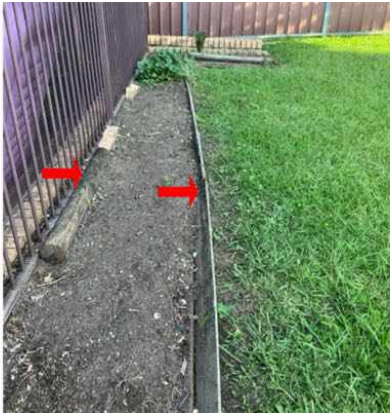
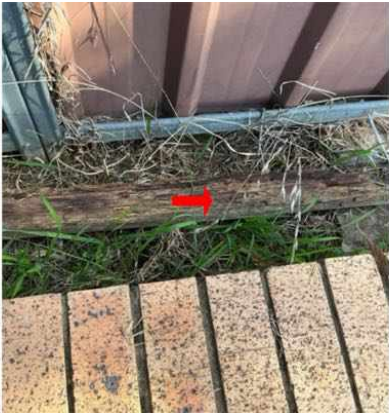
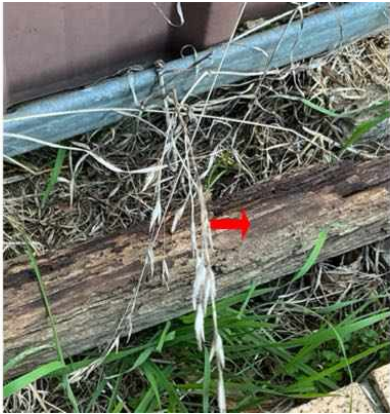
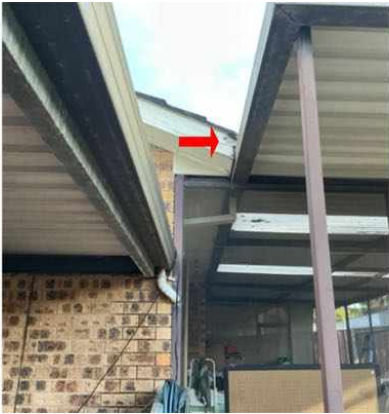
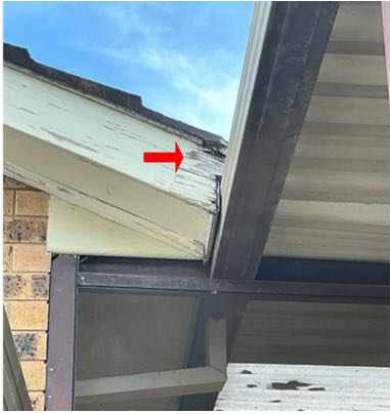
### Finding 7.01

Building:	Main Building
Location:	All External Areas
Finding:	Fungal decay - present to some areas
Information:	Fungal decay also known as wood decay or wood rot generally refers to the deterioration of timber elements when in contact with excessive levels of moisture for a prolonged period of time.

The development of fungal decay is accelerated by temperatures in the range of 5degreeC to 40degreeC as well as the presence of oxygen. Generally fungal decay develops on timber elements that are in use in an external environment which are exposed to rain penetration.

In this case although the affected timber element is in a decaying state the extent of any visible damage appears to be localised to a specific area and is yet to spread to other parts of the building element or affect adjoining structures. The fungal decay is therefore likely to be of a relatively superficial nature with minimal impact on the structural integrity or tensile strength of the timber element.

A further invasive inspection by a licensed timber pest technician is highly recommended to check for concealed activity.

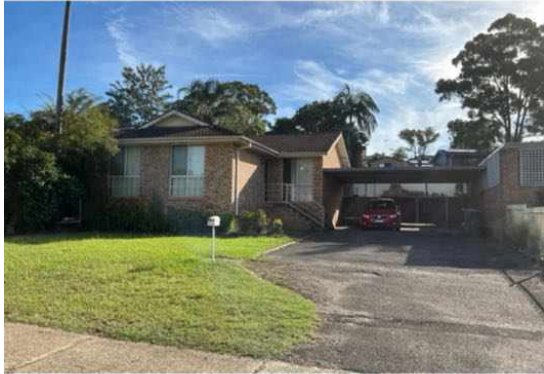
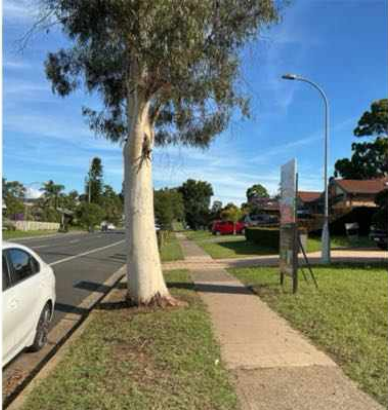
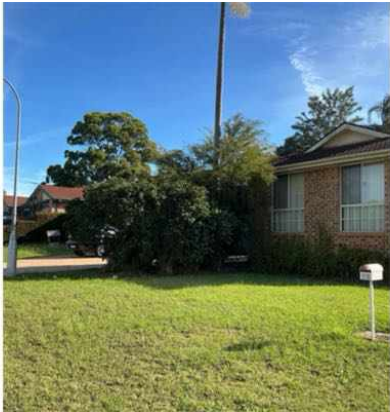
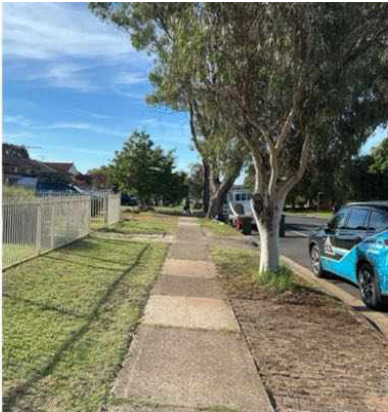
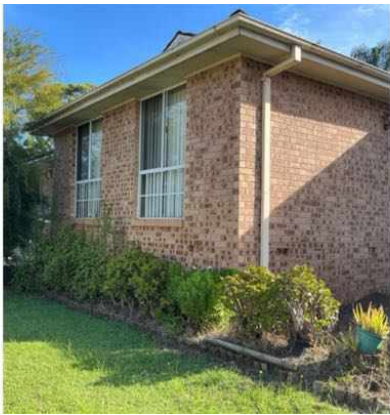
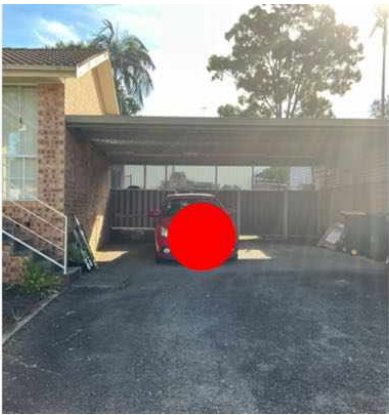
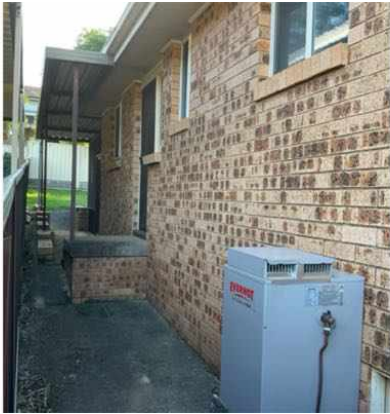
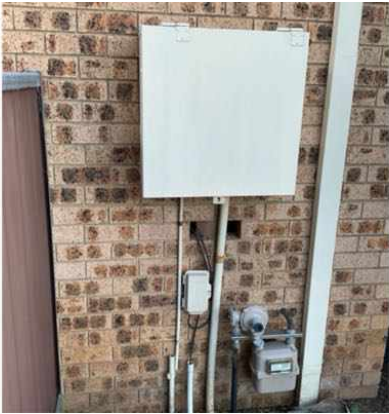
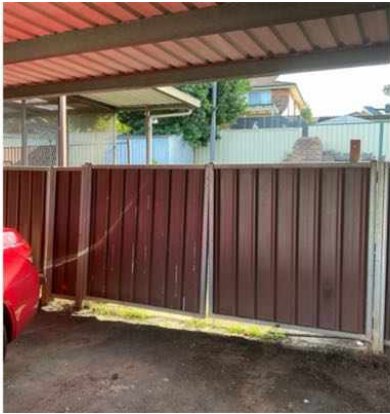
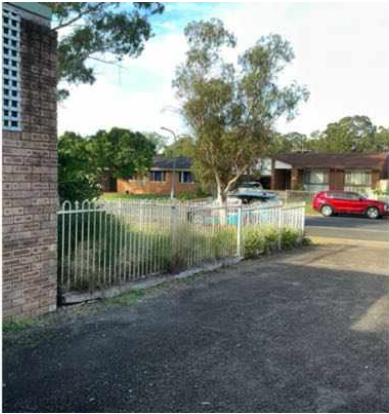
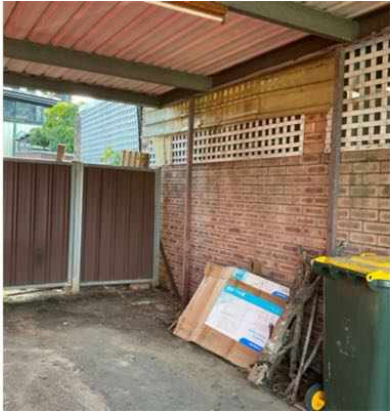
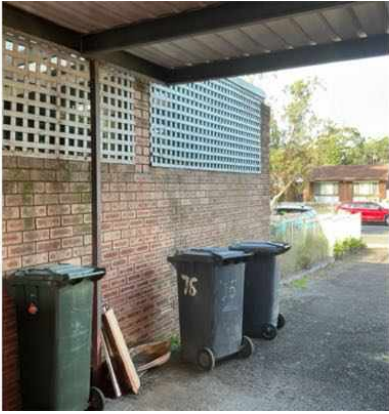
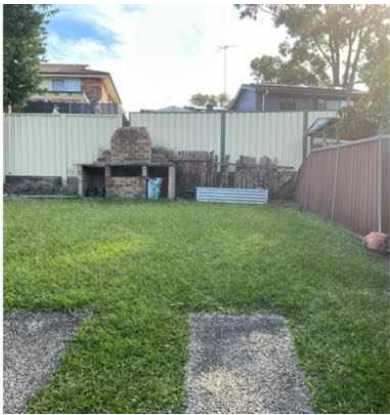
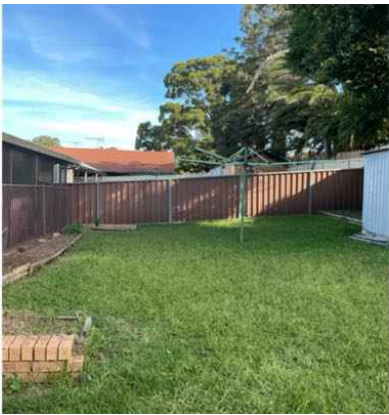
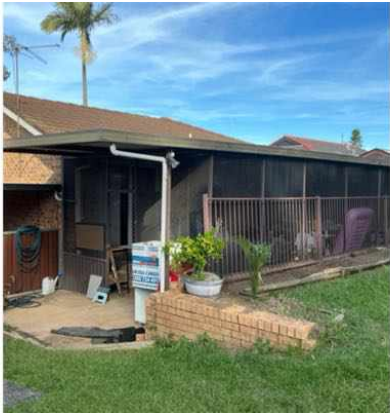
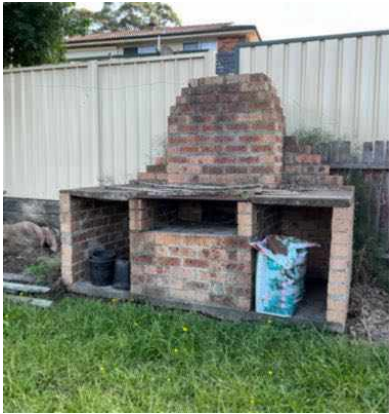
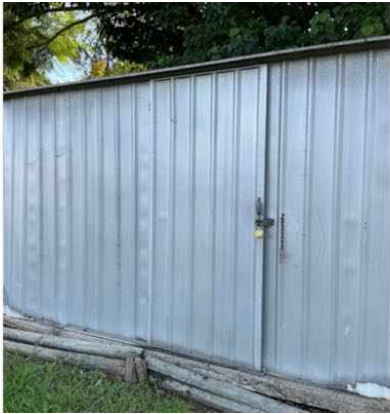
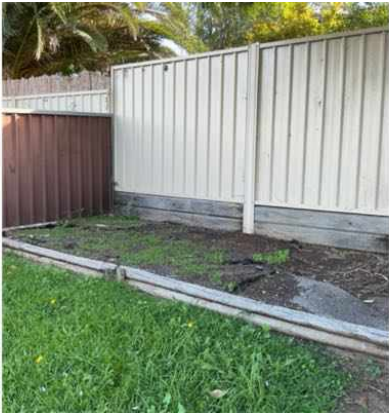
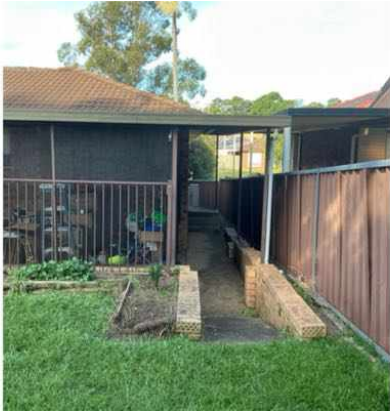
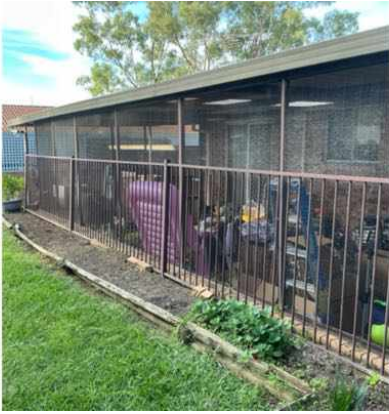
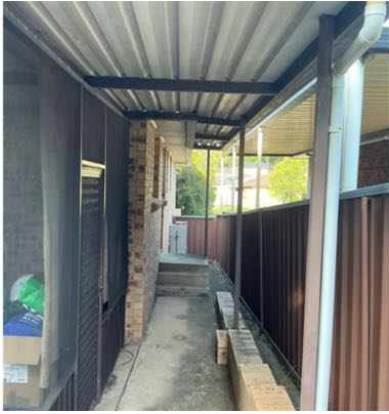
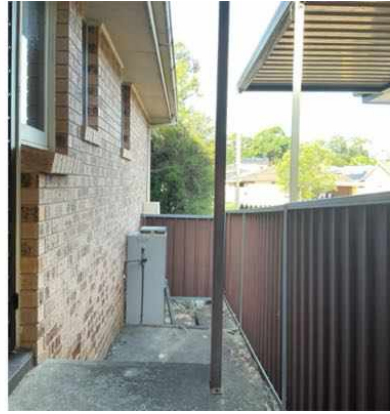
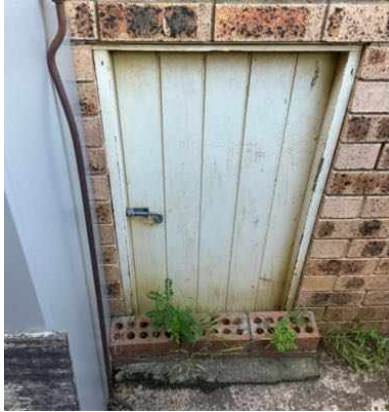
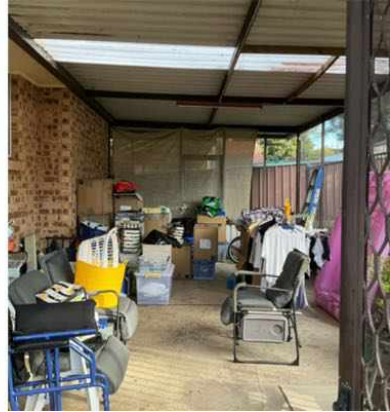
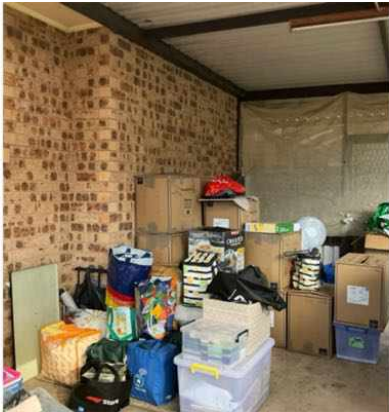
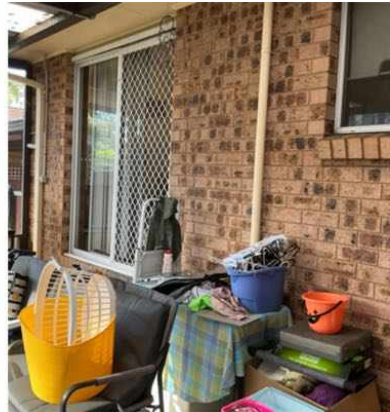
#### Noted Item

Building: Main Building  
Location: All External Areas  
Finding: Additional Photos - Obstructions and Limitations  
Information: These photographs are an indication of the obstructions and limitations which impeded full inspection of the property at the time of inspection. These obstructions can hide an array of defects and should be removed to allow full inspection to be carried out. A re-inspection is recommended once the areas are made accessible.

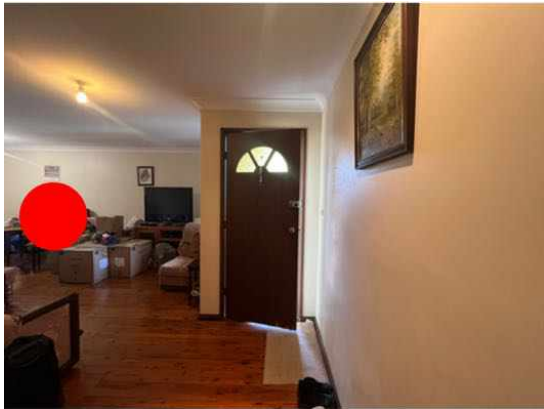
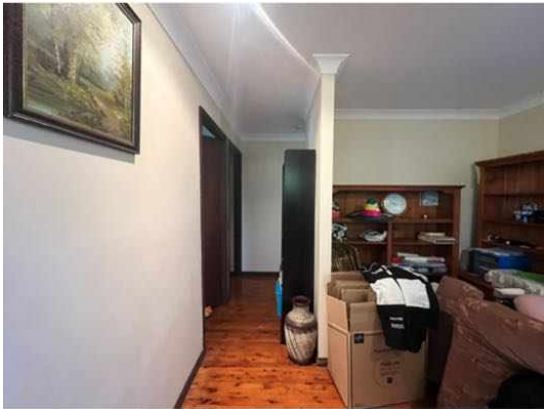
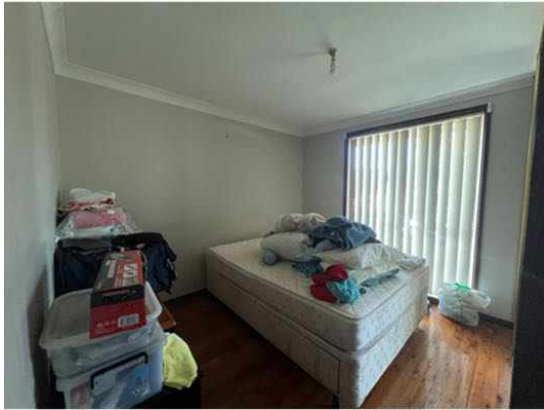
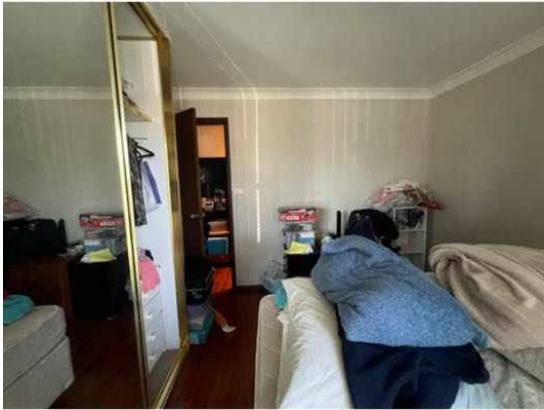
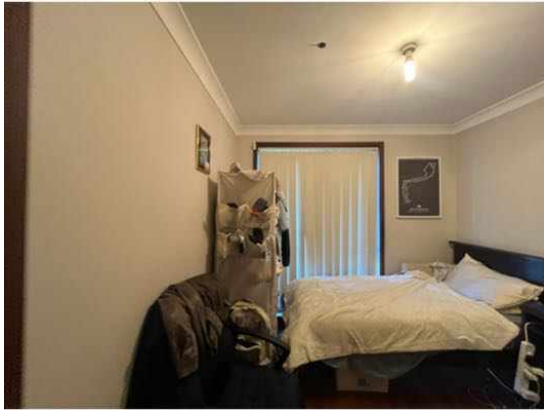
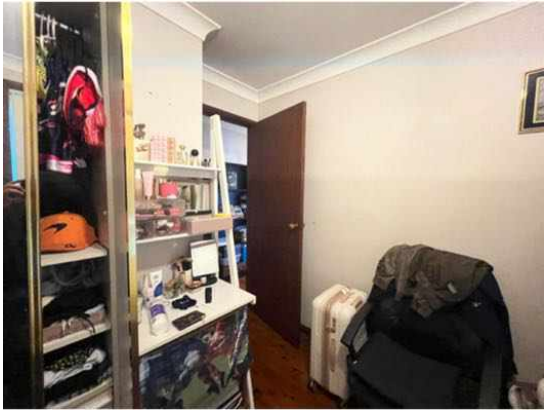
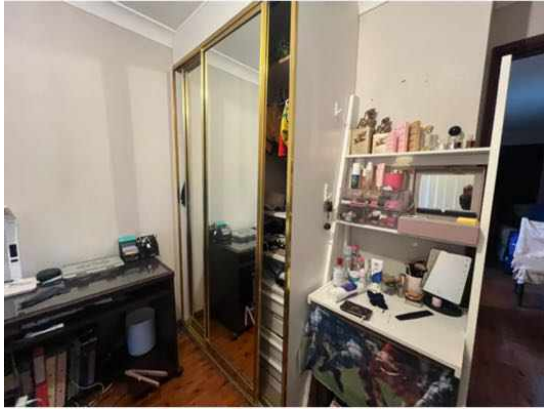
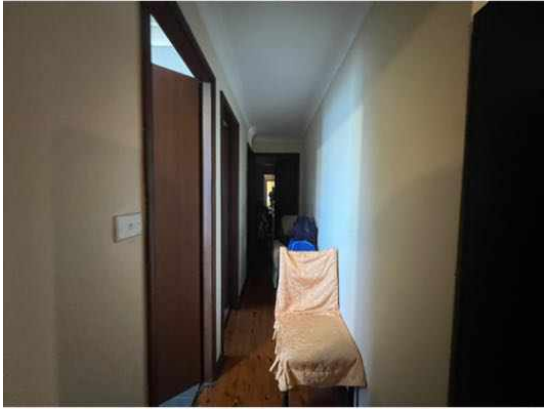
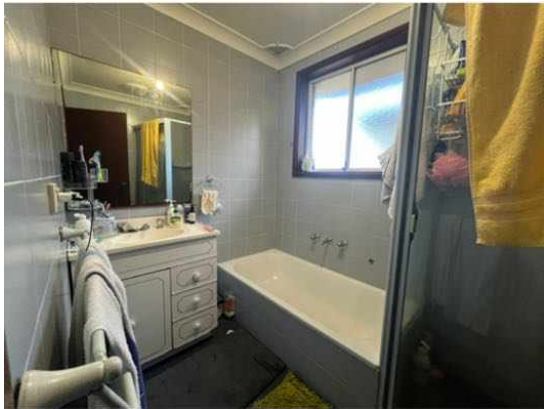
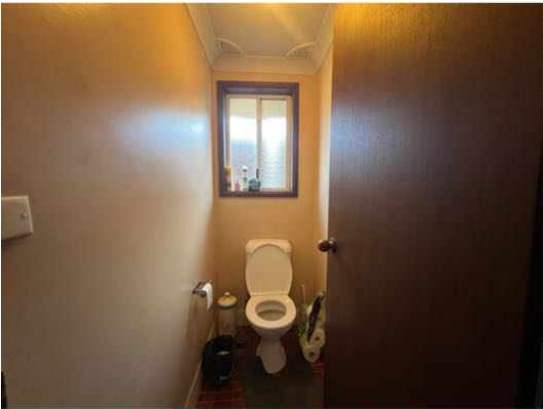
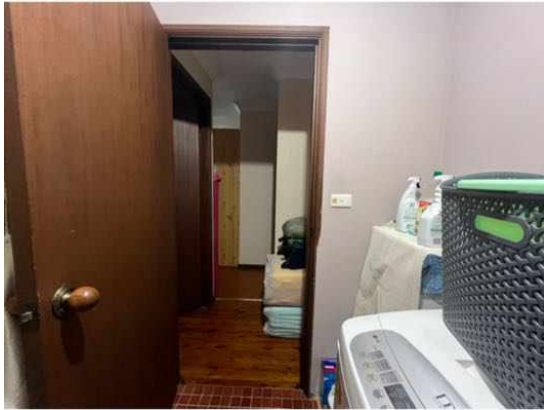
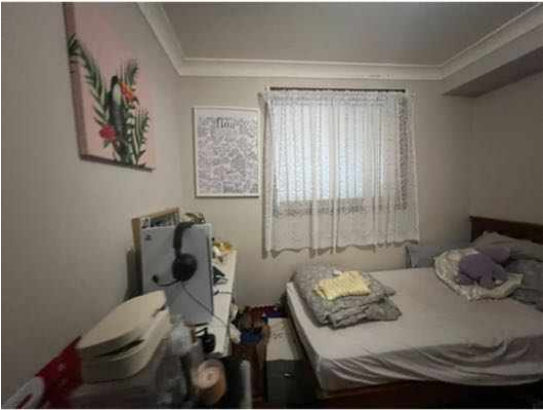
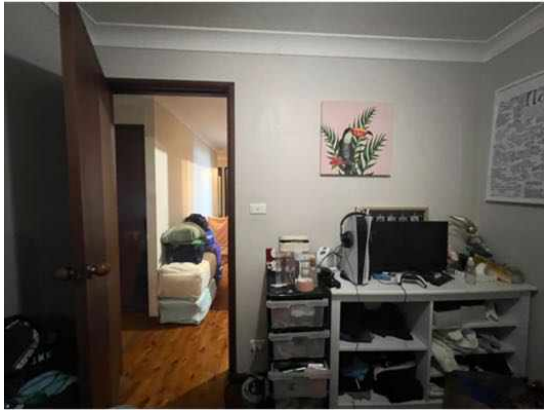
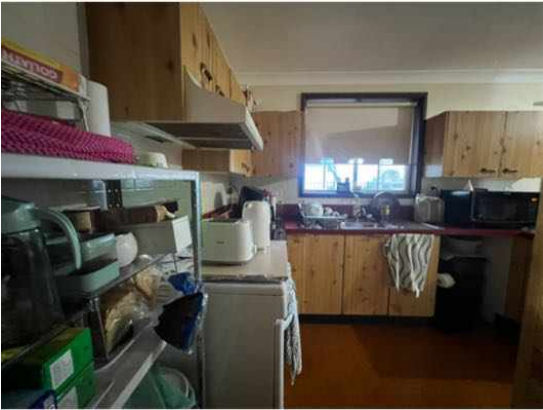
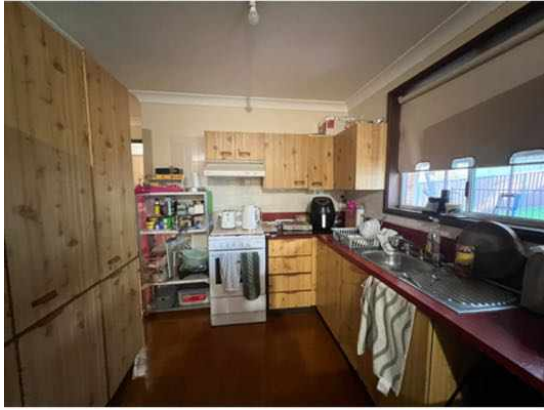
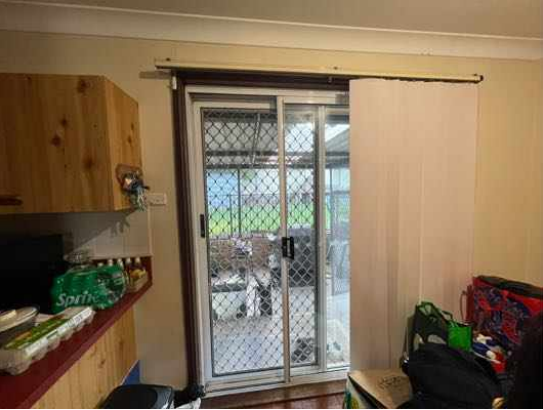
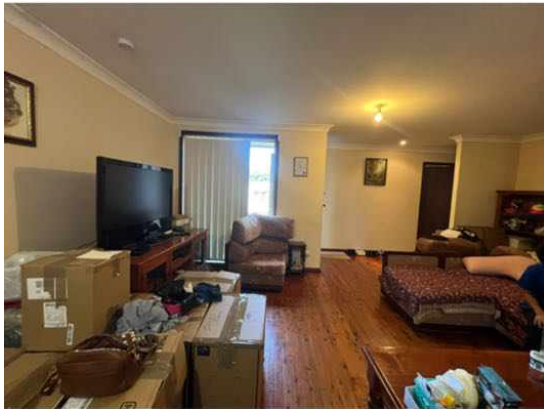
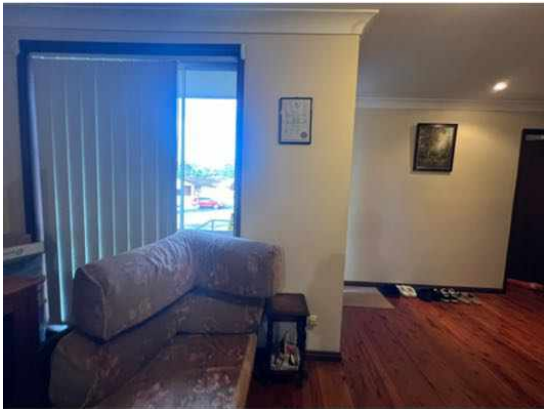
Building: Main Building  
 Location: All Internal Areas  
 Finding: Additional Photos - Obstructions and Limitations  
 Information: These photographs are an indication of the obstructions and limitations which impeded full inspection of the property at the time of inspection. These obstructions can hide an array of defects and should be removed to allow full inspection to be carried out. A re-inspection is recommended once the areas are made accessible.

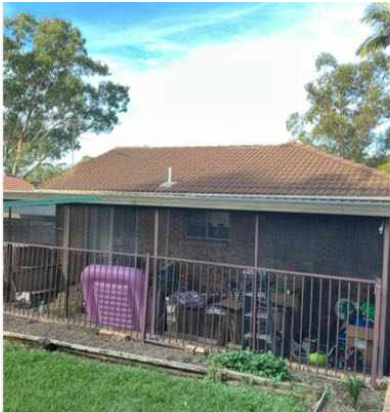
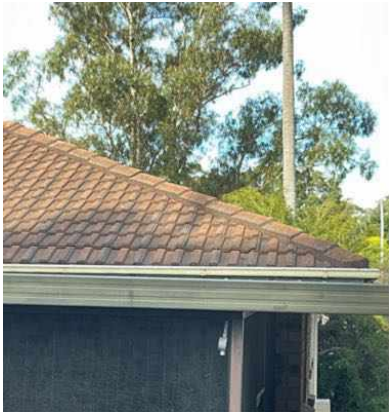
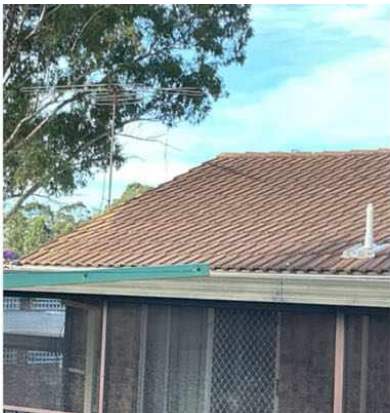
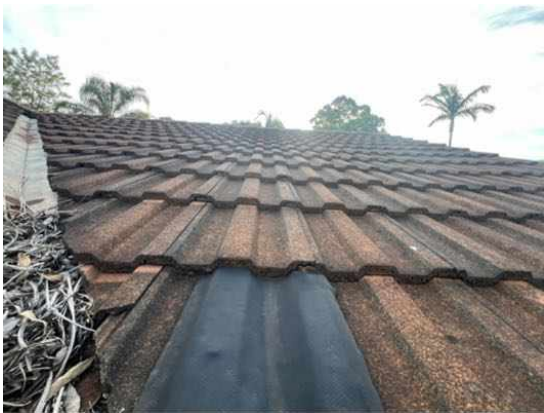
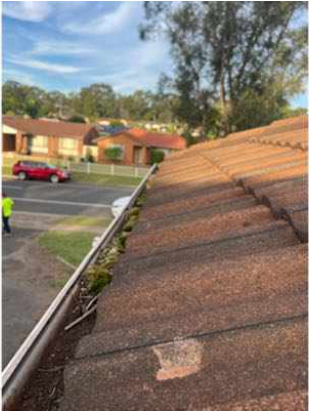
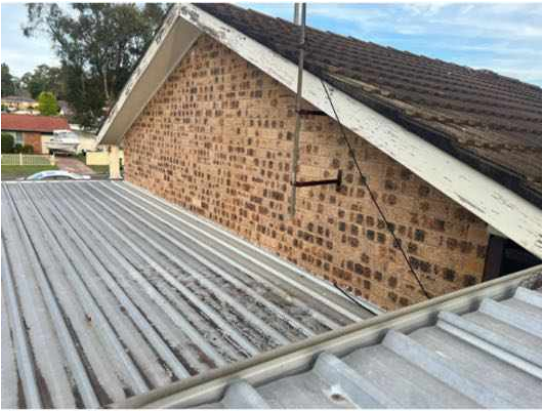
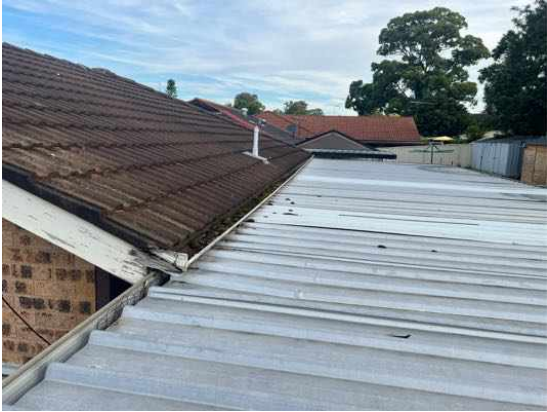
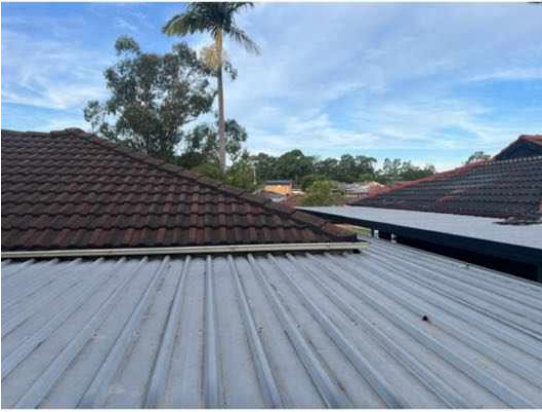
Building: Main Building  
Location: Roof Exterior  
Finding: Additional Photos - Obstructions and Limitations  
Information: These photographs are an indication of the obstructions and limitations which impeded full inspection of the property at the time of inspection. These obstructions can hide an array of defects and should be removed to allow full inspection to be carried out. A re-inspection is recommended once the areas are made accessible.

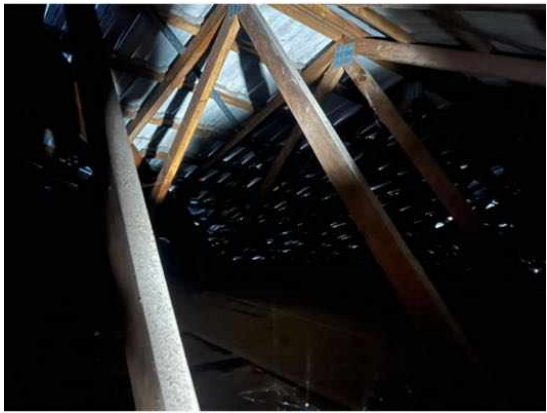
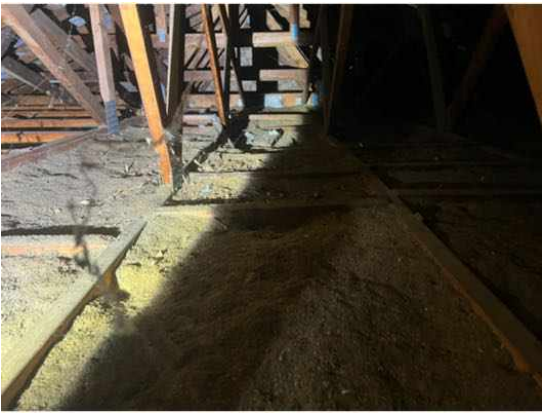
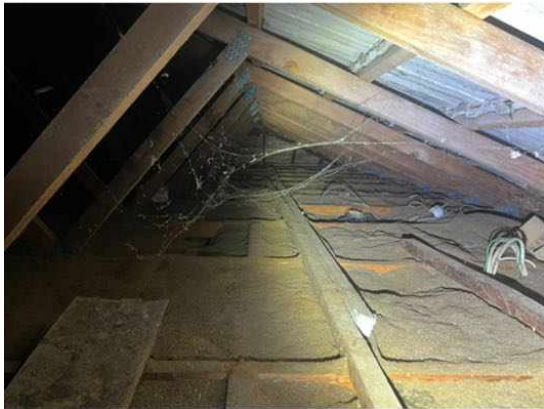
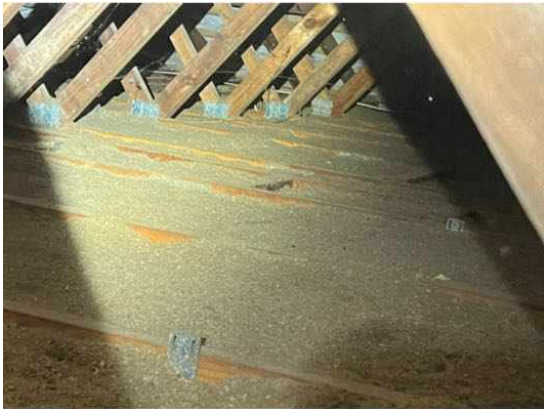
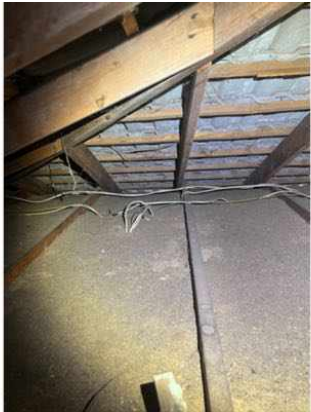
Building: Main Building  
 Location: Roof Void  
 Finding: Additional Photos - Obstructions and Limitations  
 Information: These photographs are an indication of the obstructions and limitations which impeded full inspection of the property at the time of inspection. These obstructions can hide an array of defects and should be removed to allow full inspection to be carried out. A re-inspection is recommended once the areas are made accessible.

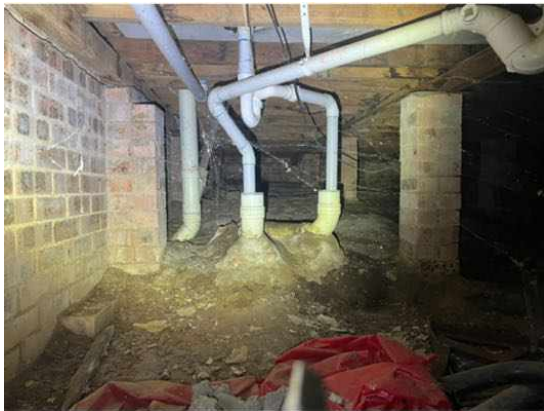
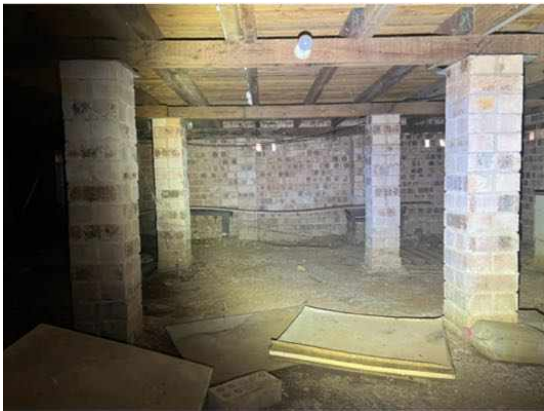
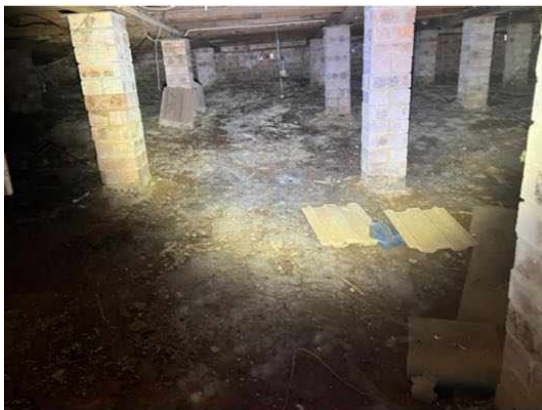
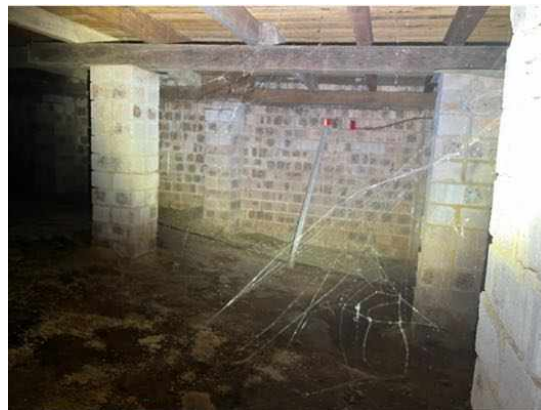
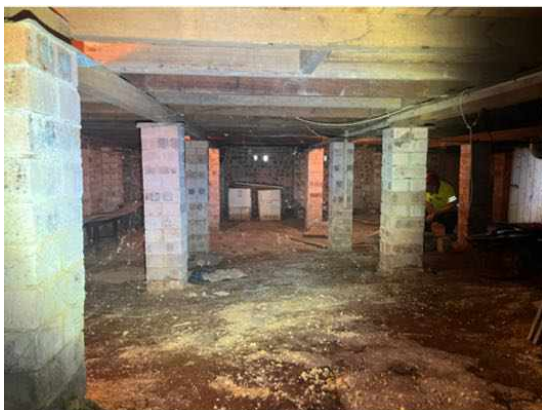
Building: Main Building  
Location: Subfloor  
Finding: Additional Photos - Obstructions and Limitations  
Information: These photographs are an indication of the obstructions and limitations which impeded full inspection of the property at the time of inspection. These obstructions can hide an array of defects and should be removed to allow full inspection to be carried out. A re-inspection is recommended once the areas are made accessible.

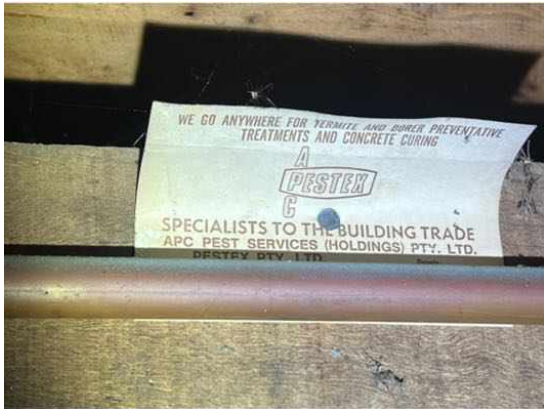
Where a Termite Management System has been identified you should refer to the type of barrier date of installation warranty conditions and any documentation provided by a builder or past owner. Consult the company who installed the barrier to confirm whether the system is still under warranty.

Most chemical termite management systems expire and require replenishment and all physical systems are primarily designed to prevent concealed entry.
