Building and Timber Pest Inspection Report

Inspection Date: Thu, 5 Feb 2026

Property Address: 19 Langley Ave, Renwick NSW 2575,
Australia

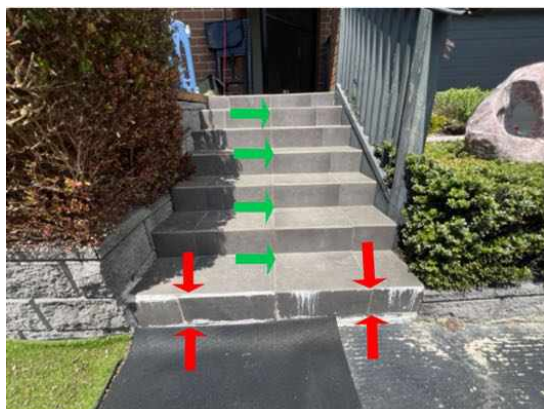
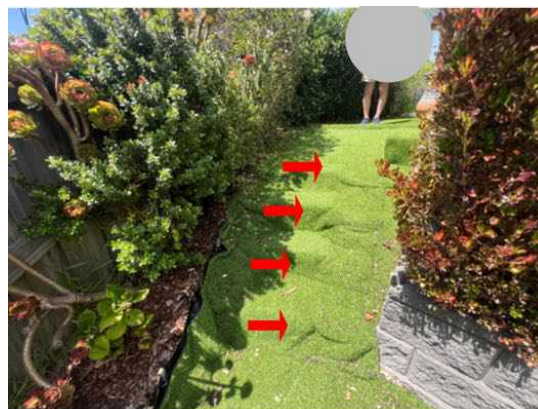
Building:	Main Building
Location:	Yard- Front, Verandah Stairs
Finding:	Steps - inconsistent heights
Information:	At the time of inspection, the steps were found to have inconsistent riser heights. Variations in step heights are considered a trip hazard and may not comply with standard building practices, which require uniformity in step construction for safe and comfortable access.

Inconsistent steps can cause missteps and present a safety risk, particularly for children, the elderly, or individuals with mobility concerns. Assessment by a licensed builder or carpenter is recommended to ensure the steps are constructed to an acceptable standard and provide safe access.

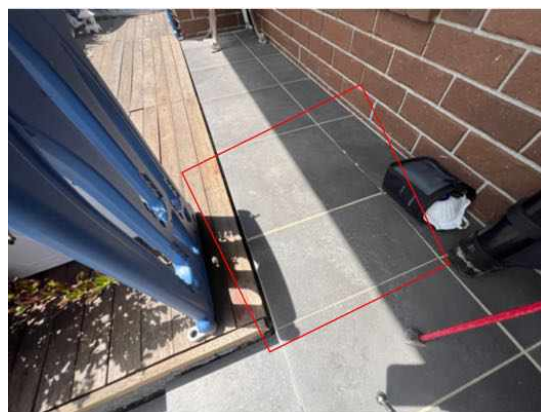
Finding 1.02

Building:	Main Building
Location:	Verandah
Finding:	Tiles - Drummy or Popped (grout degraded)
Information:	It was noted on inspection that grout is degraded to the tiled area and noticeable popped tiles.

Drummy or Popped tiles indicate that the bond between the tiles and the substrate has weakened, likely due to moisture exposure or improper installation. This can lead to tiles detaching completely over time, which may cause safety hazards. Gaps in the grout further compromise the waterproofing of the surface, allowing moisture to penetrate behind the tiles. This can cause water damage, mold growth, and deterioration of the underlying structure. The drummy effect and loose tiles also affect the visual quality and longevity of the tiled surface.

Engage a qualified tiler to carefully remove and replace the drummy or popped tiles.

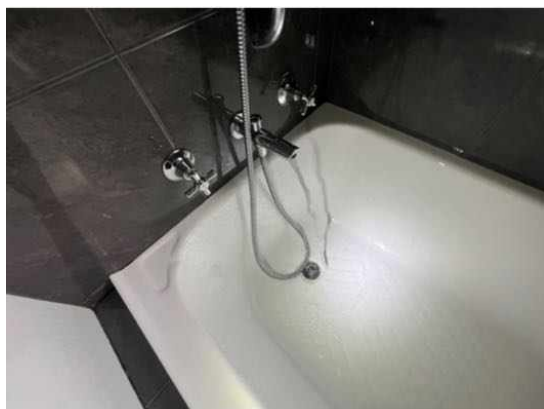
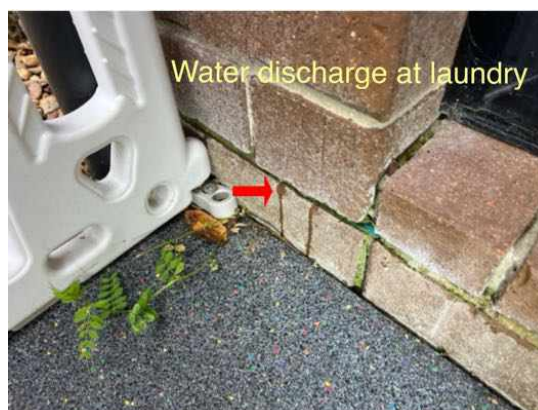
Finding: Bath - Water Leak

Information: The bath was operated during the inspection and water was subsequently observed discharging externally from weep holes and mortar joints at damp-proof course level behind the bathroom. The water was noted to track behind the bath and adjoining areas, extending toward the laundry and along the wall line toward the rear of the garage/Bedroom 2.

Once the bath tap was turned off, the external water discharge ceased. This confirms the condition is not consistent with a concealed pipe or waste failure and is instead indicative of a water leak associated with the bath tap fittings or related connection points during use.

An unmanaged water leak of this nature may result in concealed moisture exposure to surrounding building elements and may create conditions that are conducive to timber pest activity if left unattended.

It is recommended that a licensed plumber assess the bath tap fittings and associated connections to identify and rectify the source of the water leak. As no visible internal damage was identified at the time of inspection, a registered builder should undertake invasive investigation where necessary to determine whether any concealed moisture-related deterioration is present.

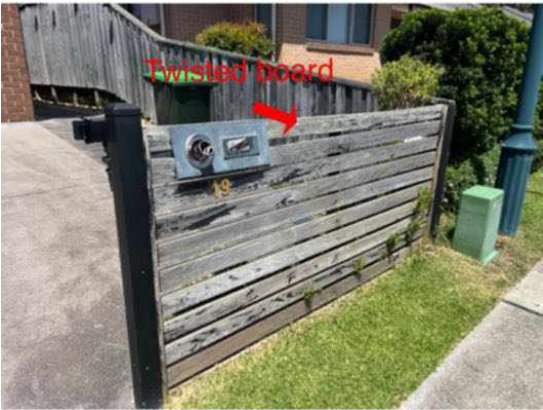
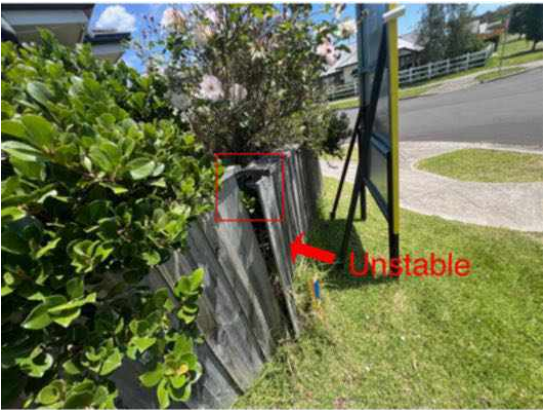
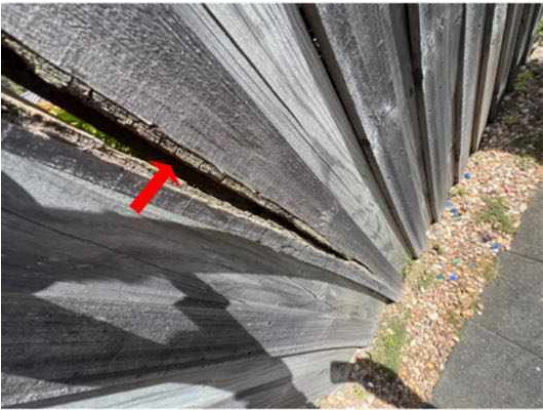
Finding 3.01

Building:	Yard
Location:	Fencing
Finding:	Fencing - Deteriorated
Information:	It was noted at the time of inspection that sections of the fencing throughout the property have deteriorated. Typically fencing deteriorates due to age and or wear, rot and or rust which is generally expected for a structure of this age, due to prolonged exposure to weather conditions. Sometimes inadequate installation or maintenance

If left unattended, it is likely that further damage will occur. It is suspected that repair of several elements of the fencing may be required however replacement may be a consideration of the client also.

A licensed fencing contractor should be appointed to provide further advice and perform rectification works as necessary.

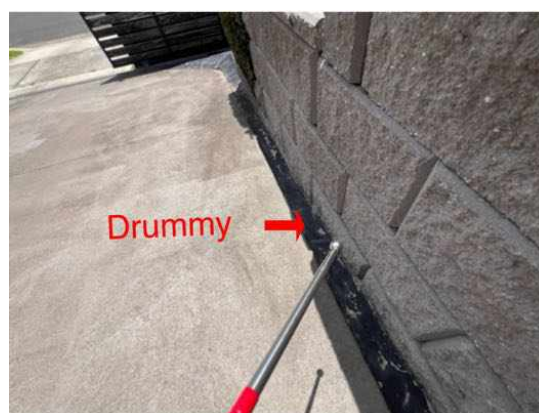
Finding 3.02

Building: Yard
Location: Yard - Front

Finding: Unconventional handyman work
 Information: This handyman work appears to have been completed to a substandard level and does not comply with regular building practices. Where handyman work is not completed satisfactorily, accelerated deterioration of the associated building elements is likely to occur and secondary defects to surrounding structures may develop.

It is highly recommended that the substandard work be rectified by professional services. Works to improve this area are likely to increase the safety and the operation of the associated building elements.

The client should exercise care when coming into the immediate vicinity of the substandard works. Rectification works are advised as soon as possible by the appropriate trades.

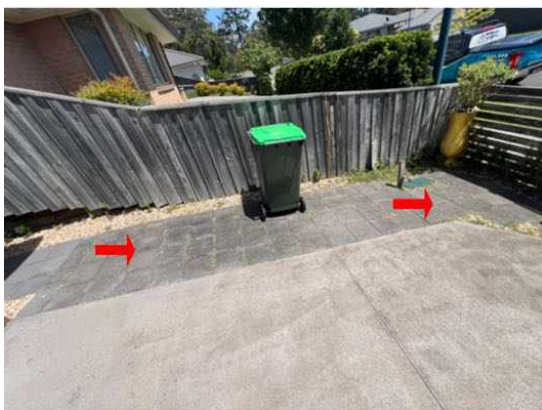
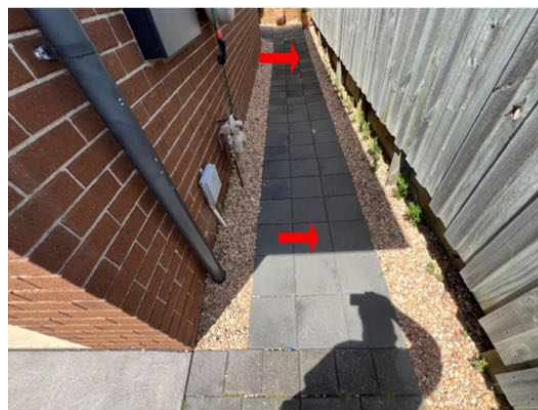
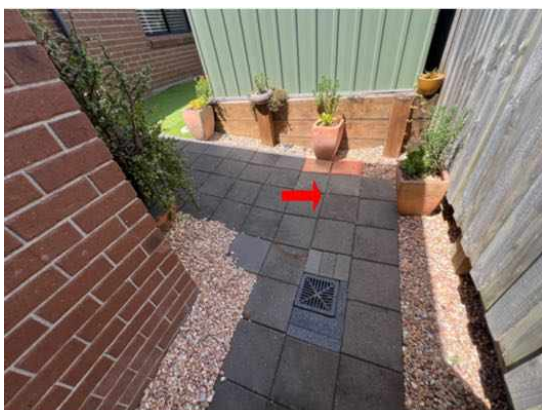
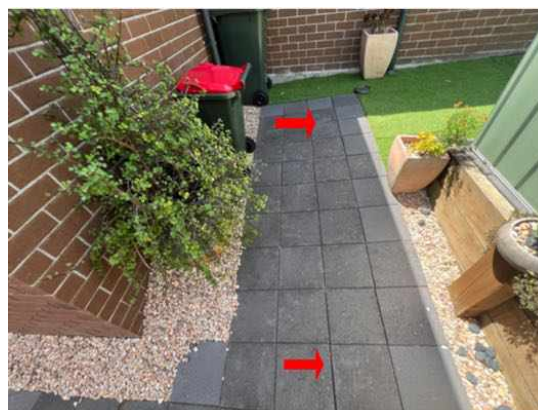
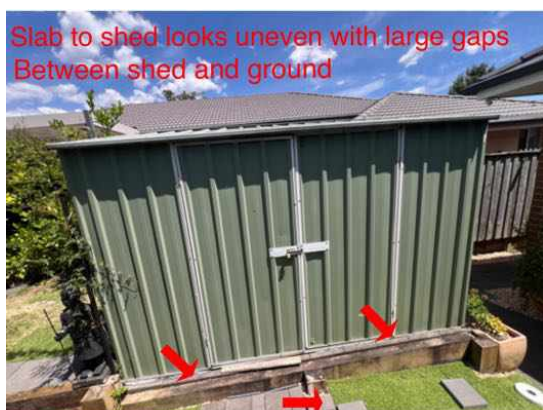
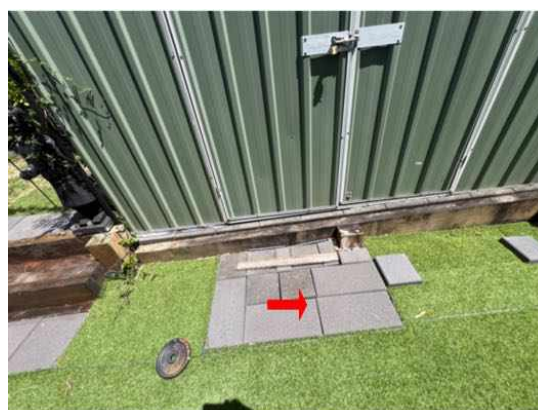
Finding 3.03

Building: Yard
 Location: Yard - Front, Side
 Finding: Paving - Uneven
 Information: Sections of the external paved area are uneven, creating a potential trip hazard. It appears as though the area has been subject to rough installation, or that paving sections have lifted due to movements in the foundation of the property.

Where paving creates a trip hazard, personal injury may ensue if due caution is not taken by all persons within this area.

Re-paving of the area is required as soon as possible to remedy this situation. Further consultation with a specialist concreter is advised.

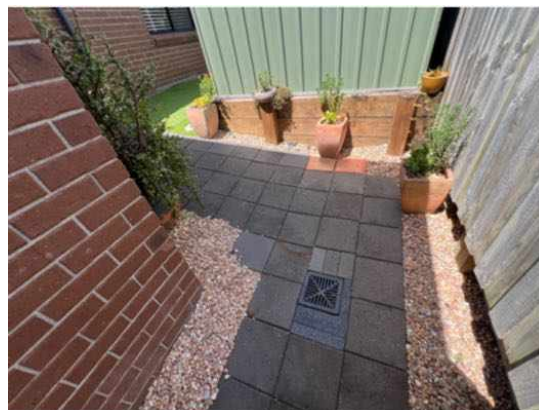
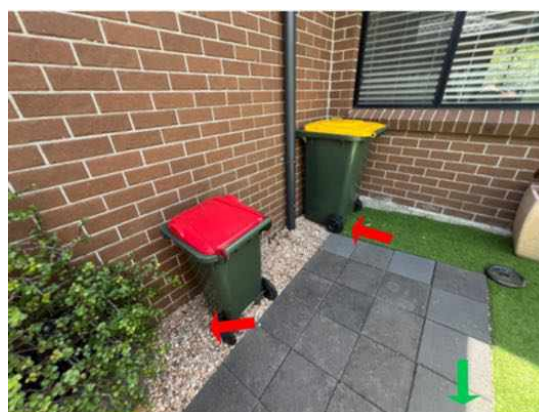
Finding 3.04

Building:	Yard
Location:	Yard - Back, Side
Finding:	Site drainage - Inadequate
Information:	The site drainage in this area was found to be inadequate at the time of inspection, creating potential for subsequent water damage to associated building elements.

It is important that water does not lie against the base of walls; surrounding paths and ground levels should be sloped to drain water away from walls. Downpipes should not disgorge stormwater onto lower walls or plinths. Stormwater should be carried away by large, regularly cleaned drains. Ground levels may need to be lowered to expose a buried DPC.

Where site drainage is inadequate, installation of an Agricultural (Aggie) Drain may be required. A qualified plumber should be appointed to further inspect the property and perform any remedial works as necessary. Water damage and secondary defects are likely to occur if left unmanaged.

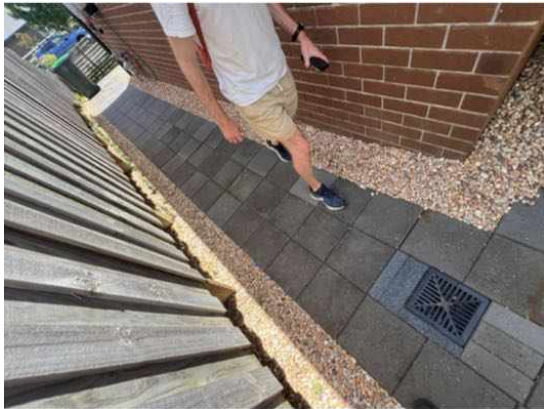
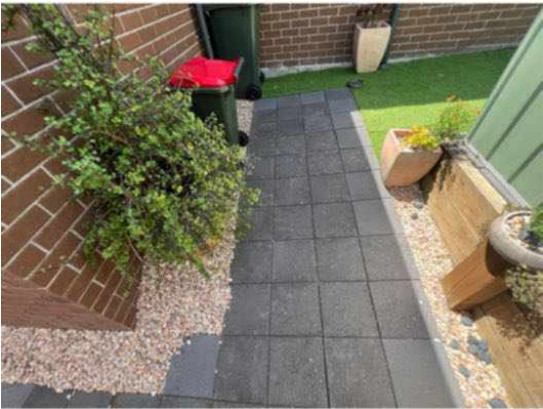
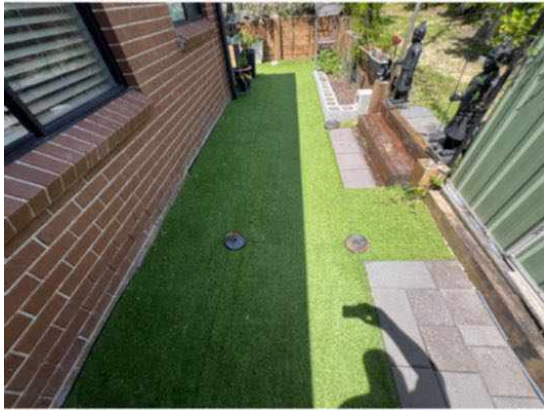
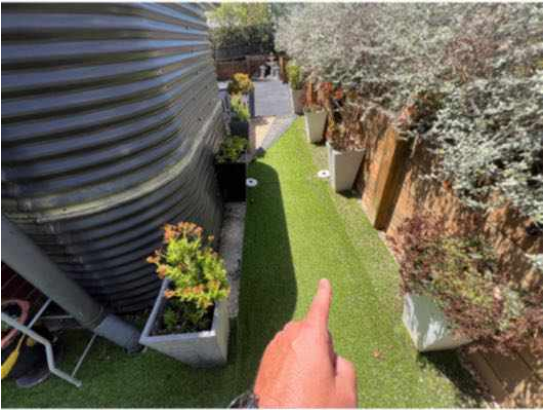
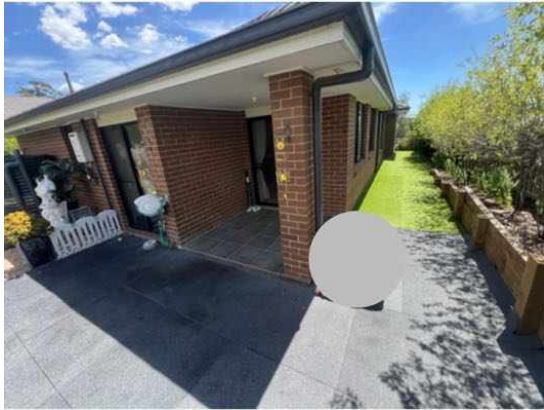
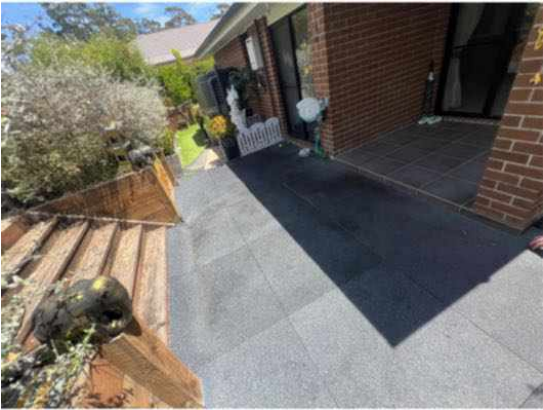
Finding 3.05

Building:	Yard
Location:	Yard - Back, Side
Finding:	Perimeter Paving - Insufficient Fall
Information:	The perimeter paving or ground levels were found to have an inadequate slope away from the adjoining building structure, creating potential for water pooling in this area.

Perimeter paving is required to fall from the building by a minimum of 25mm in the first metre and bare ground should fall away from the house by 50mm in the first meter. This standard ensures that excessive moisture does not pool around the base of building structures, which creates potential for water and structural damage, as well as making the area susceptible to termite and timber pest activity.

Where paving or ground levels do not have adequate fall, a licensed paving contractor should be appointed to install or remove and re-level pavement.

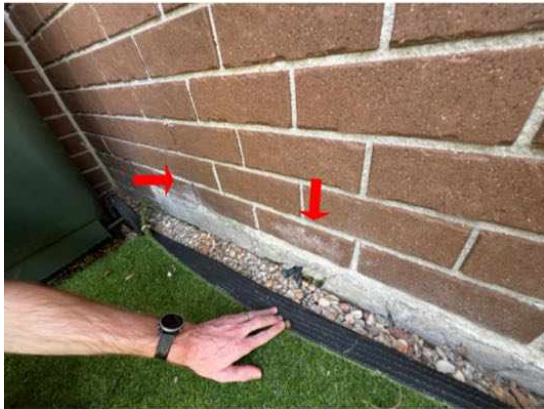
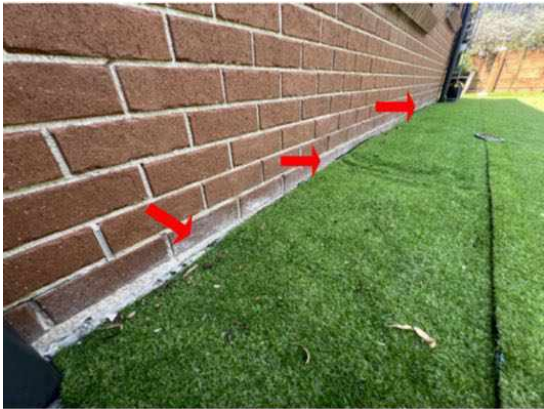
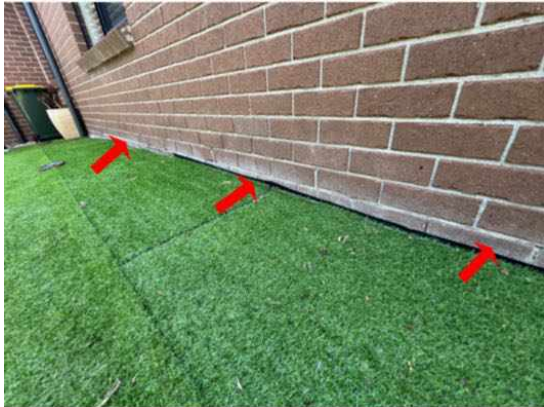
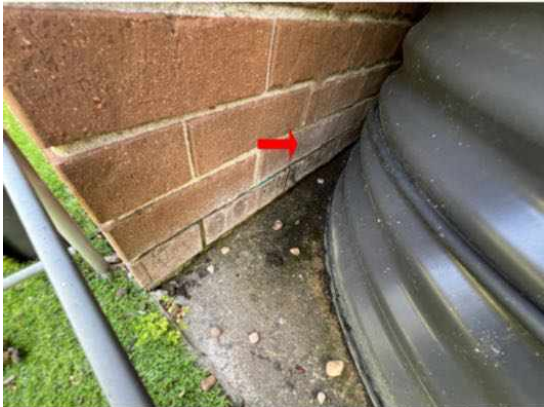
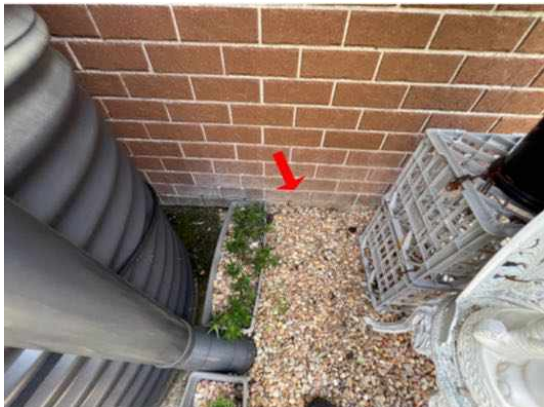
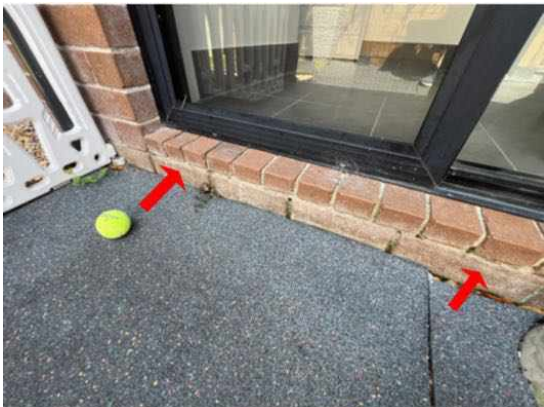
It is typically seen as white salt deposits on the surfaces of concrete pavement or mortar between bricks or tiles. While detracting from the overall appearance of the affected area, efflorescence is not likely to develop into secondary damage if left unmanaged.

Generally, soluble salt deposits can be removed by dry brushing with a stiff-bristled brush. Repeated dry brushing is an ideal treatment for eliminating this forming of efflorescence. A cleaning contractor or general handyperson may be appointed to perform these works at the discretion of the client.

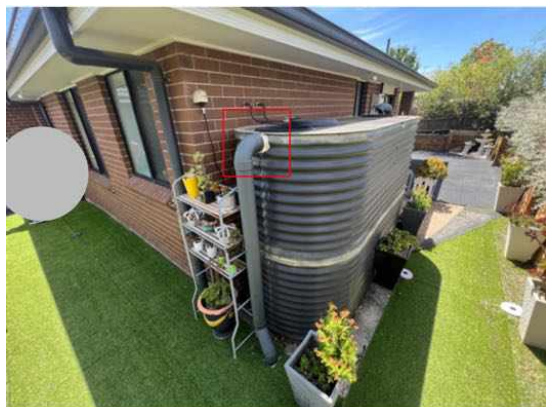
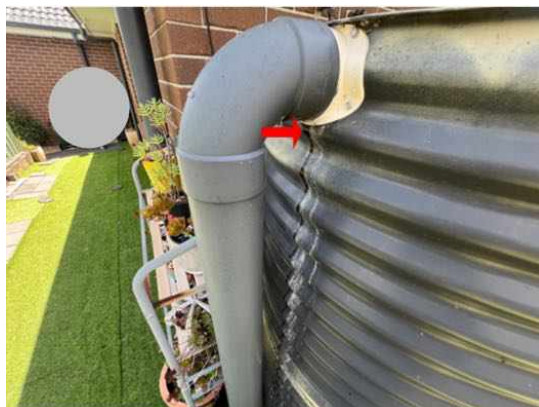
Finding 3.08

Building: Main Building
Location: Exterior walls - rear
Finding: Water Tank - Active Leak

Information: An active leak was identified at the water tank pipe during the inspection. This condition is commonly associated with physical damage, joint failure, or deterioration of fittings, allowing water to escape improperly rather than being directed through the intended system. Uncontrolled water discharge can contribute to soil erosion, damp conditions near the building perimeter, and create conducive environments for termite activity if left unmanaged.

A licensed plumber should be engaged to inspect the water tank pipe, determine the

cause of the leak, and undertake necessary repairs or replacement as a priority to prevent further deterioration and associated risks.

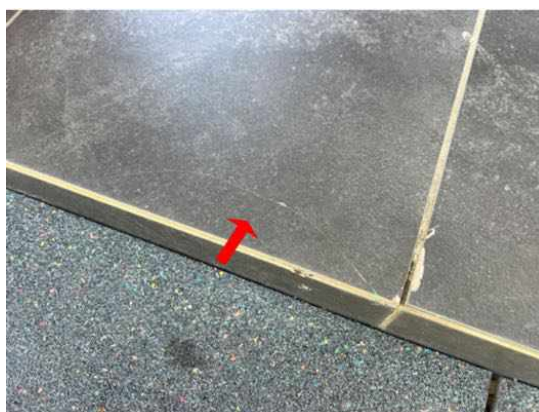
Finding 3.09

Building: Main Building

Finding: Tiles - Cracked or damaged

Information: Cracking was evident to the tiling in this area at the time of inspection. While the cracking appears to be minor, this area is frequently exposed to water, allowing potential for water penetration into adjoining sections of walls or flooring.

If left unmanaged, water penetration to these areas may lead to subsequent water damage, which is likely necessitate repair work to affected building elements.

A tiling contractor should be appointed to ensure that no further water damage occurs. The re-application of silicone and grouting throughout remaining tile work is also advised, to further protect the area against water penetration.

Where water penetration has led to water damage, appointment of a relevant tradesperson may be required to repair damaged building elements.

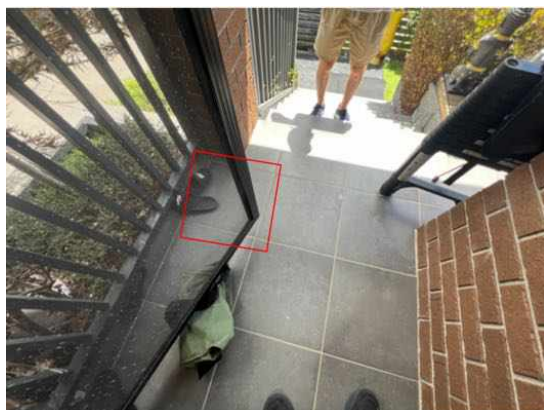
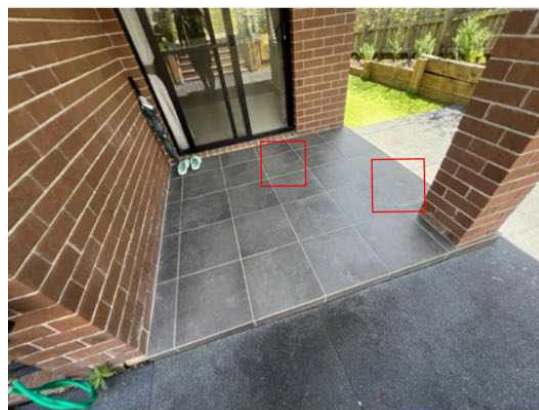
Building: Main Building
 Location: Verandah, Alfresco
 Finding: Tiles - Drummy
 Information: Drummy tiled areas were identified at the time of inspection. The term 'drummy' refers to tiles that have become detached from their fixing, despite otherwise being in relatively good condition. Such defects are generally caused by physical or moisture damage to the area. Drummy tiled areas may also be a direct result of poor workmanship during the construction process.

Tiled areas may swell and shrink with changes in air humidity if the area has sustained moisture damage. Any exposure to moisture is capable of causing tiled areas to become drummy and/or cracked over a prolonged period of time. Drummy tiled areas generally require removal and replacement of affected tiles, with adequate sealant and grouting.

Specialist trades are available for these types of services. A registered builder may be required to undertake works if damage is extensive or if secondary building defects have resulted. Otherwise, it is advised that a tiling contractor be appointed to perform works as necessary. Immediate action is recommended to ensure that no further damage is sustained in the affected area.

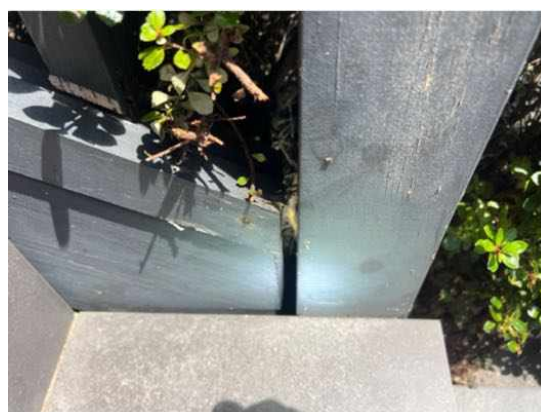
Building:	Main Building
Location:	Verandah
Finding:	Balustrade - Rusted Fixings
Information:	Corrosion was observed to fixings associated with the balustrade. Rusted fixings can reduce the effectiveness of connections over time and may contribute to loosening or instability of the balustrade if deterioration progresses.

Ongoing exposure to weather and moisture is a common contributing factor to this condition. Continued corrosion may lead to further deterioration of both fixings and adjoining timber elements.

It is recommended that a registered builder or qualified carpenter assess the balustrade fixings and determine whether repair or replacement is required to maintain adequate performance.

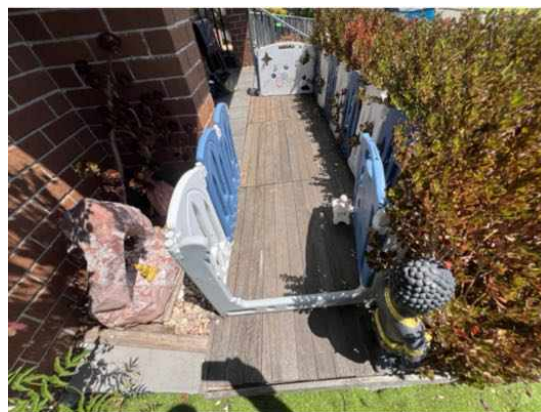
Finding 3.13

Building:	Main Building
Location:	Verandah
Finding:	Timber - exposed to weather
Information:	External timbers that are frequently exposed to harsh weather conditions require adequate protection in order to maintain their condition. Where timbers have not been painted or treated adequately, general deterioration is likely to occur at an accelerated rate.

If left unattended, replacement of these timbers is likely to be necessary in the short-term future. Adequate treatment of these timbers is required as soon as possible by a painting contractor or general handyman.

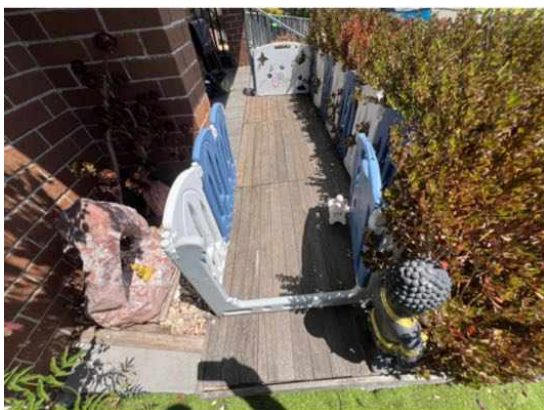
Finding 3.14

Building:	Main Building
Location:	Verandah - deck
Finding:	Decking - Unconventional handyman work
Information:	This handyman work appears to have been completed to a substandard level and does not comply with regular building practices. Where handyman work is not completed satisfactorily, accelerated deterioration of the associated building elements is likely to occur and secondary defects to surrounding structures may develop.

It is highly recommended that the substandard work be rectified by licensed carpenter or a decking specialist. Works to improve this area are likely to increase the safety and the operation of the associated building elements.

The client should exercise care when coming into the immediate vicinity of the substandard works. Rectification works are advised as soon as possible by the appropriate trades.

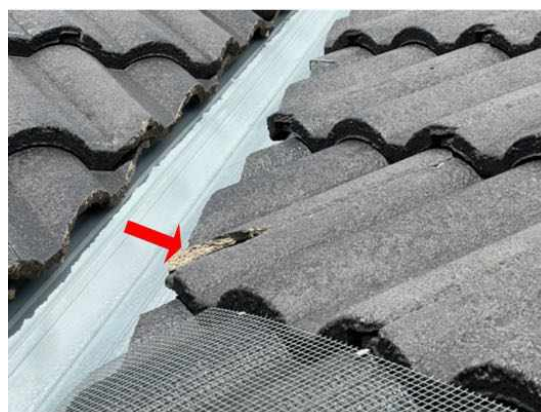
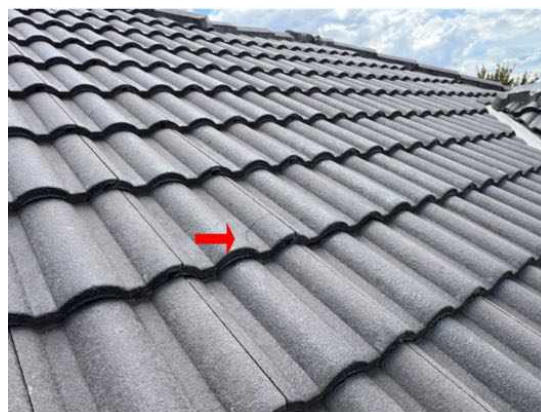
Finding 3.15

Building:	Main Building
Location:	Roof Exterior
Finding:	Roof tiles - Broken

Information: Upon inspection of the exterior roof covering, broken roofing tiles were identified. Broken and friable roof tiles are generally the result of ageing and weathering of what is essentially a porous material.

If left to further deteriorate, broken and brittle roof tiles are likely to lead to water penetration via the roof into the ceiling space, causing secondary damage to ceiling linings, insulation and roof structures. Broken roof tiles are also likely to detract from the effectiveness of the roof drainage system, creating potential for secondary damage to the exterior roof covering and roof plumbing.

Replacement of broken tiles is required and should be performed by a roofing contractor as soon as possible.

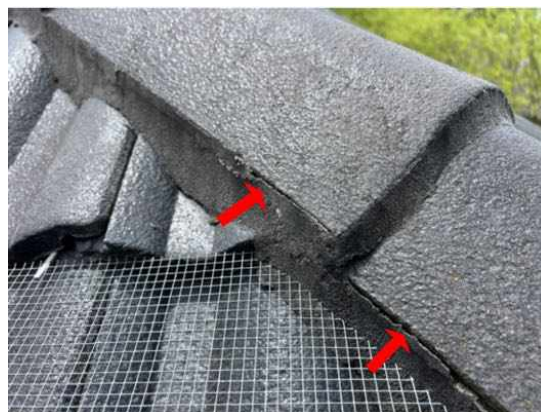
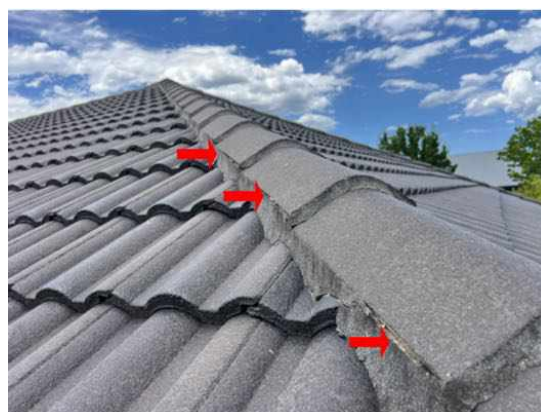
Finding 3.16

Building: Main Building
 Location: Roof Exterior
 Finding: Roof Mortar - Deterioration
 Information: Mortar, or 'bedding, is the material which fills joints and intersections between tiles and other building elements on the exterior roof covering, such as gable ends, hip capping and valleys.

Upon inspection of the exterior roof, it was noted that sections of the mortar show

varying levels of deterioration.

Mortar generally deteriorates as a result of frequent exposure to weather conditions over a prolonged period of time. Mortar that is deteriorating may allow water ingress into the roof void, putting associated building elements and roofing structures at risk of water damage. Deteriorated mortar also detracts from the functionality of roof tiles and other roofing elements, potentially decreasing weather tightness and roof drainage.

Mortar deterioration can be attended to by a licensed roofing contractor

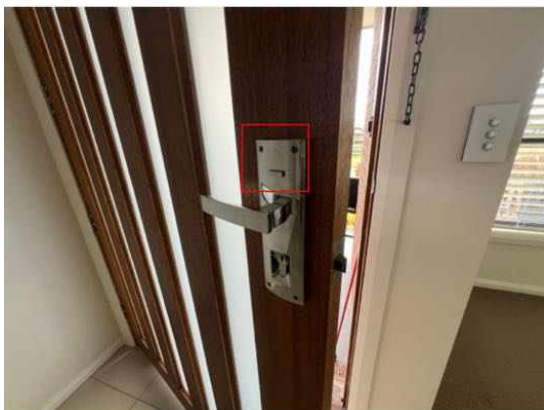
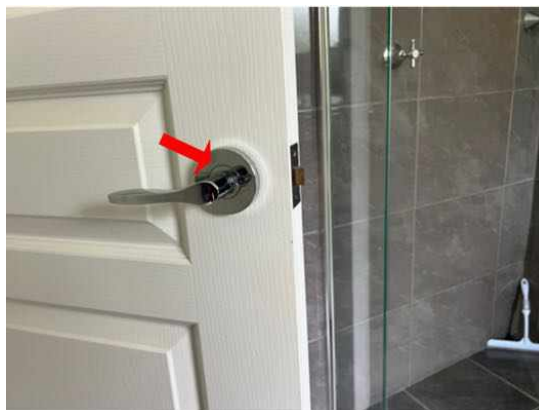
Finding 3.17

Building:	Main Building
Location:	Entry, Bathroom
Finding:	Door Handle - Loose
Information:	The door handle in this area was identified as loose at the time of inspection. A loose door handle can impede the proper operation of the door and, if left unattended, may lead to further deterioration or damage to the associated door structure.

This defect is typically caused by wear and tear, insufficient fixing, or deterioration of the handle's components.

It is recommended that a qualified carpenter or general handyperson be appointed to secure or replace the handle to restore its functionality and ensure proper operation.

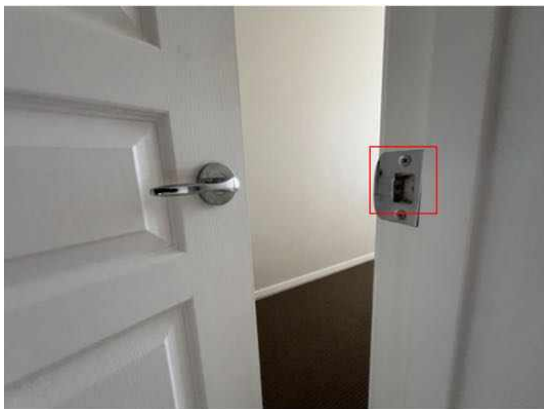
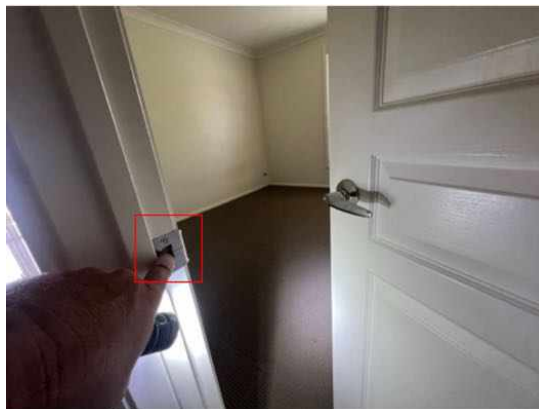
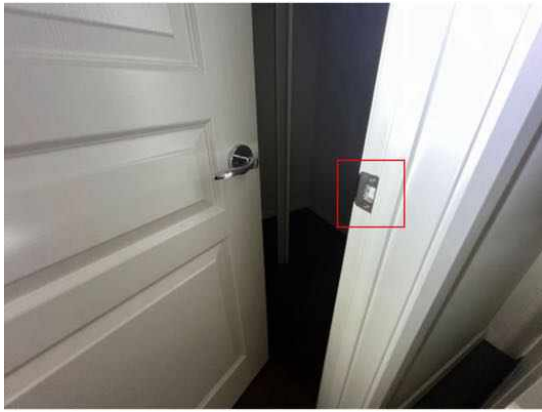
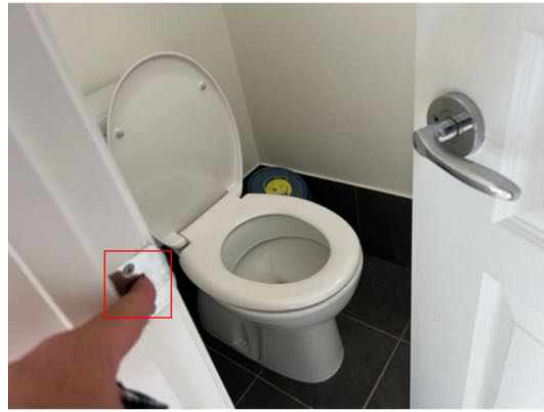
Finding 3.18

Building: Main Building
 Location: Study, Bedroom - Master, Walk In Robe, Toilet (WC)
 Finding: Doors - Striker plates misaligned. Doors rattle when closed.
 Information: The striker plates to a few doors throughout the home appear to have become misaligned and has consequently resulted in the door's operation being compromised.

This is a common defect and is expected in a property of this age, whether being due to substandard installation or general deterioration of the door hardware.

Readjustment of the striker plate is recommended at client discretion. Works such as these can be completed by a general handyman or qualified carpenter.

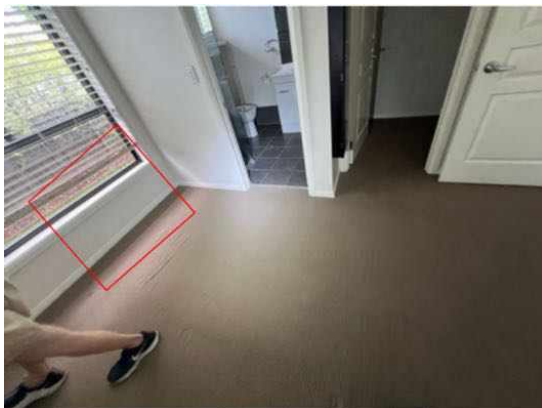
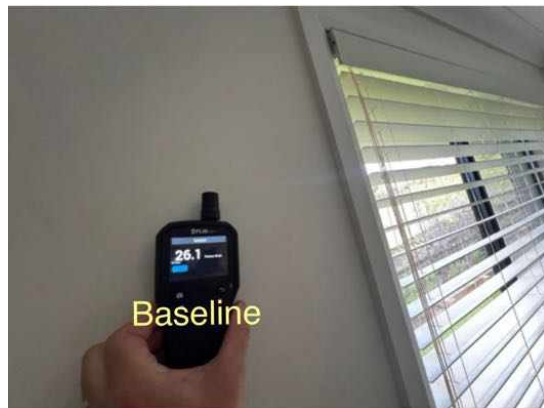
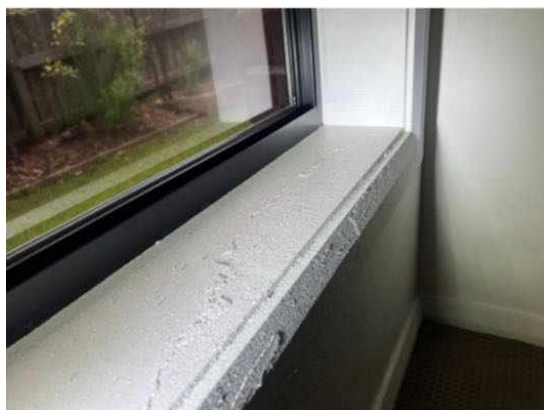
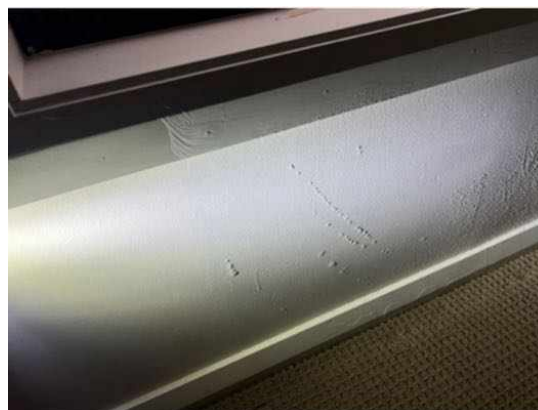
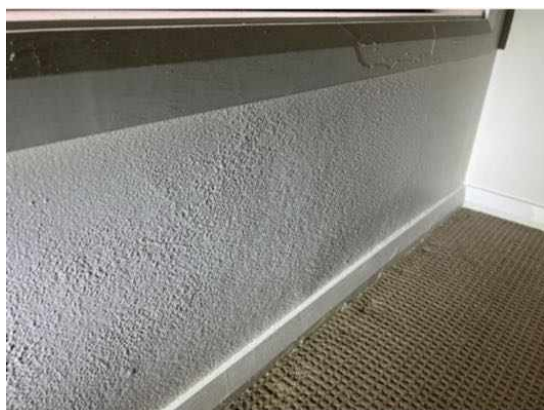
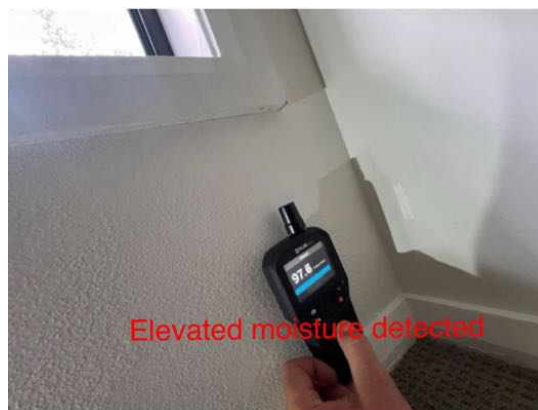
Finding 3.19

Building:	Main Building
Location:	Bedroom - Master
Finding:	Painted surface - Bubbling/flaking
Information:	Sections of paint in this area was found to have bubbled and deteriorated. Paint bubbling is generally an indication of excessive moisture in the area, that is currently hidden by the painted surface.

The presence of excessive moisture can have major implications on associated building elements if left unattended. While only seemingly minor at this stage, the damage cannot be determined due to the paint obstructing any further inspection of the damage.

It is highly advised that the affected paint be cleaned to allow a further, more invasive inspection by a licensed plumber. Failure to act on this defect may necessitate major works in the future.

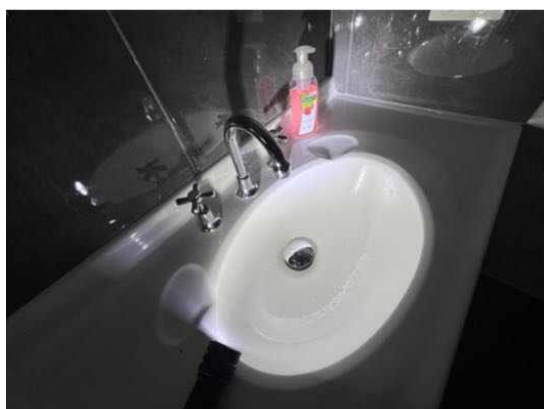
Finding 3.20

Building:	Main Building
Location:	Ensuite
Finding:	Pop up waste - Not operating (closing)
Information:	Non-operational items should be addressed to ensure that the full function of the building structure is available. Where some building elements are not operating as intended, it is possible that secondary building defects could arise due to their non-operation.

Repair and/or replacement of the faulty building element is recommended. It is highly recommended that a plumber be engaged to perform any necessary works.

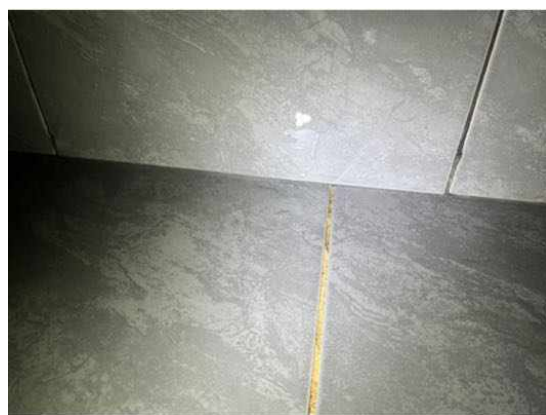
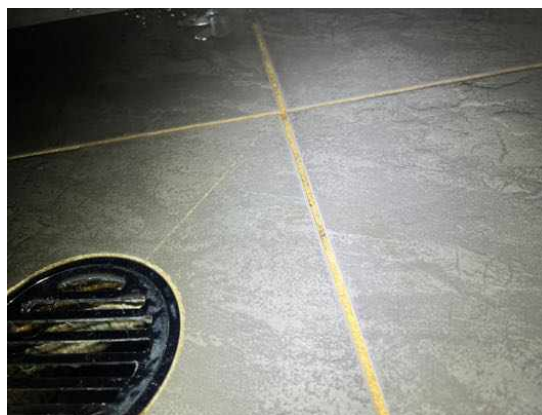
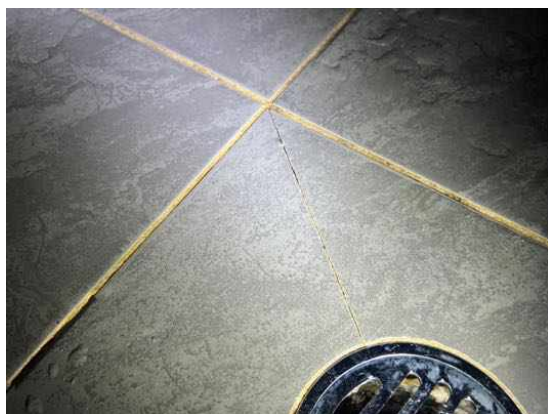
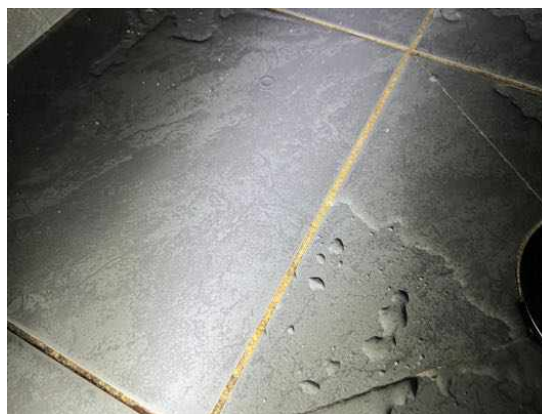
Finding 3.21

Building:	Main Building
Location:	Ensuite
Finding:	Sealant and grouting - Missing or damaged
Information:	It was noted on inspection that sealant or grout is degraded to the tiled shower alcove and or other areas of the bathroom.

Different materials and floor areas move at different rates, generally causing cracking to grout or sealant at this point. A flexible sealant is required to allow for expected expansion and contraction, while keeping the joint water tight and protective of all associated building materials.

There appears to be excessive mould to the sealant and grout which will likely require scraping out and replacement.

Flexible and mould resistant materials should be applied to affected areas to prevent any subsequent water damage that is likely to occur. Regular maintenance and replacement of damage or missing or damaged sealant and grout is highly recommended to the wet areas, as this is a regular wear and tear defect. Sealant and grouting in areas that come into regular contact with water should be maintained for the long term care of your property.

A sealant specialist or tiling contractor should be appointed to complete these works as soon as possible

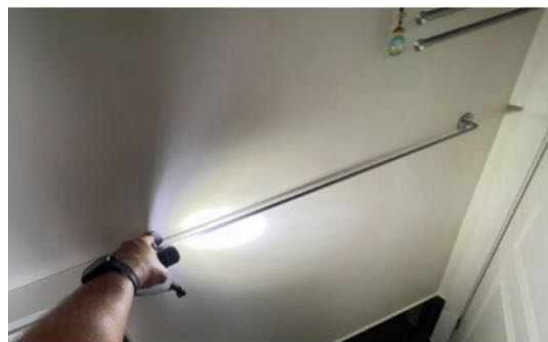
Finding 3.22

Building:	Main Building
Location:	Ensuite, Bathroom
Finding:	Fitting or fixture - Loose
Information:	The fitting in this area is loose and requires adjustment to tighten.

If left unmanaged, the fitting may further deteriorate, causing potential for the development of other minor secondary defects.

A relevant tradesperson should be appointed to perform these rectification works at discretion of the client.

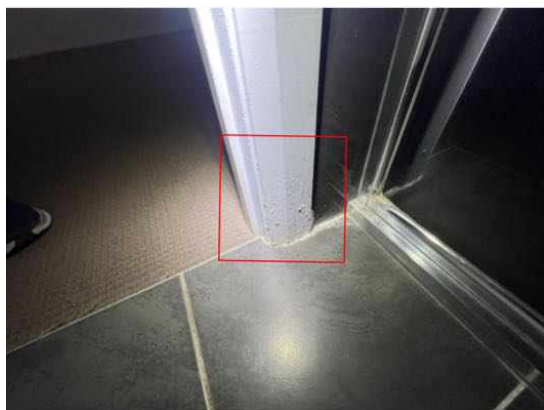
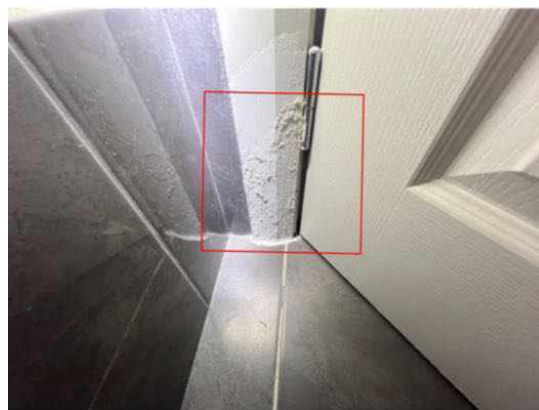
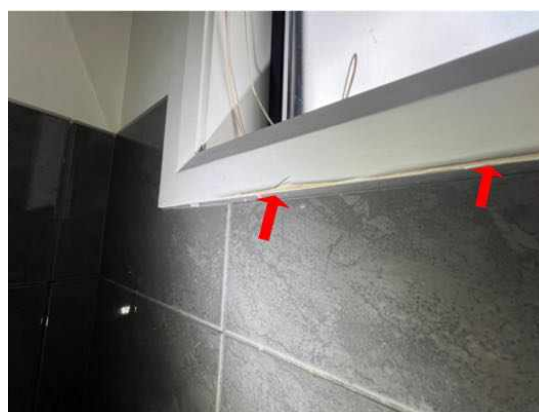
Finding 3.23

Building:	Main Building
Location:	Ensuite, Bathroom
Finding:	Paint - Flaking
Information:	Flaking paint was identified at the time of inspection. This defect is commonly caused by moisture ingress, poor surface preparation, or the natural ageing and deterioration of paint over time.

Flaking paint not only detracts from the aesthetic appeal but may also expose the underlying surface to further deterioration, including moisture absorption and potential

damage.

It is recommended that a qualified painter be engaged to prepare and repaint the affected area to ensure proper adhesion and a durable finish. Investigation into potential underlying causes, such as moisture issues, should also be considered to prevent recurrence.

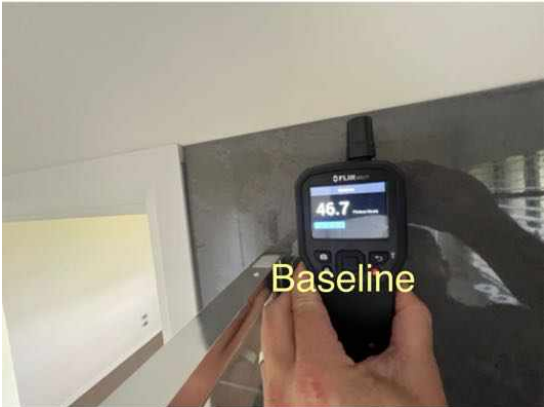
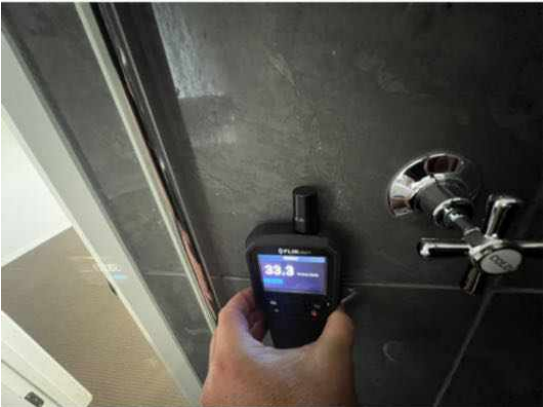
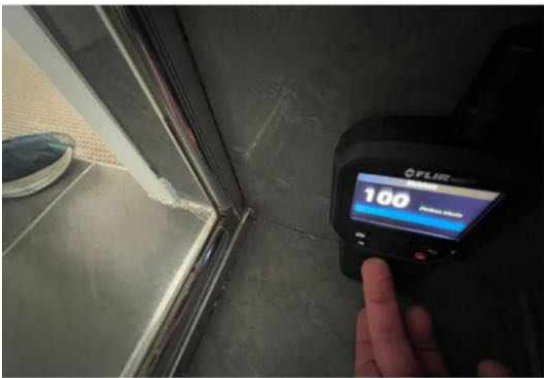
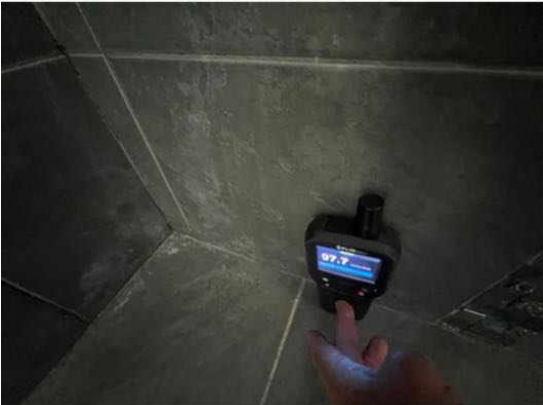
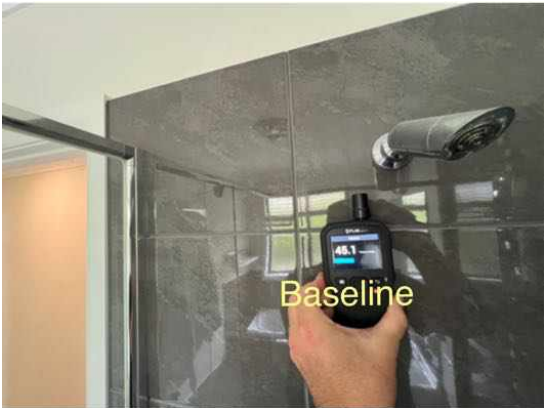
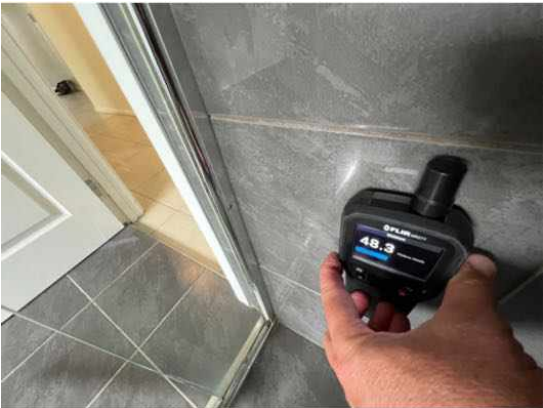
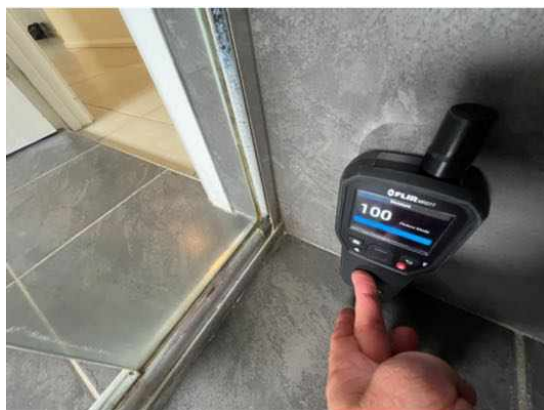
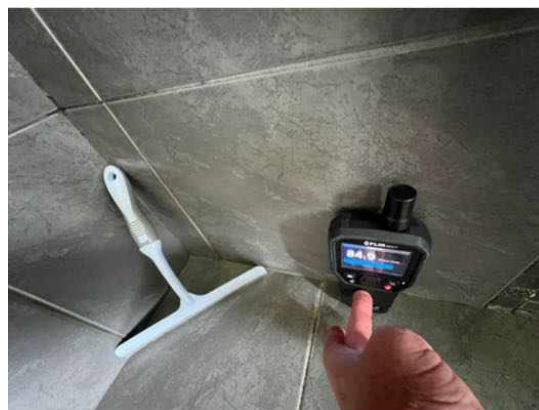
Finding 3.24

Building:	Main Building
Location:	Ensuite, Bathroom
Finding:	Moisture in Shower
Information:	Moisture is evident behind the tiles to the shower alcove. This defect is quite common, and is suspected to have been caused by moisture permeating through the grouting in this area. Leaking pipes within the adjoining wall is also a possible cause.

Damp (or structural damp) refers to the presence of unwanted moisture in the structure of a building, either as the result of intrusion from outside, or condensation from within the structure. In the shower area, internal water leaks or other sources of excessive moisture are generally the cause of damp. Always ensure that sealant and grout is in good condition to prevent any moisture issues occurring in the future.

cause of damp and to perform remedial works as required.

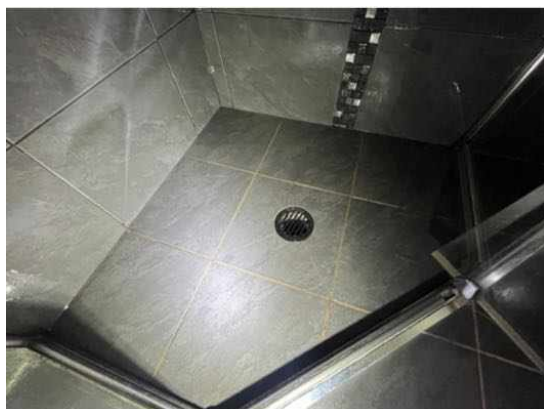
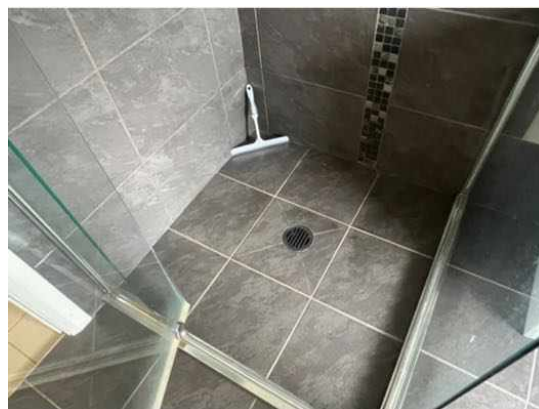
Finding 3.25

Building:	Main Building
Location:	Ensuite, Bathroom
Finding:	Tiles - Drummy (shower recess)
Information:	Drummy tiled areas were identified at the time of inspection. The term 'drummy' refers to tiles that have become detached from their fixing, despite otherwise being in relatively good condition. Such defects are generally caused by physical or moisture damage to the area. Drummy tiled areas may also be a direct result of poor workmanship during the construction process.

Tiled areas may swell and shrink with changes in air humidity if the area has sustained moisture damage. Any exposure to moisture is capable of causing tiled areas to become drummy and/or cracked over a prolonged period of time. Drummy tiled areas generally require removal and replacement of affected tiles, with adequate sealant and grouting.

Specialist trades are available for these types of services. A registered builder may be required to undertake works if damage is extensive or if secondary building defects have resulted. Otherwise, it is advised that a tiling contractor be appointed to perform works as necessary. Immediate action is recommended to ensure that no further damage is sustained in the affected area.

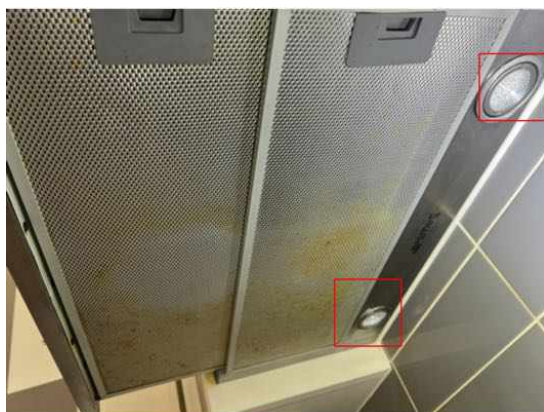
Building:	Main Building
Location:	Kitchen
Finding:	Rangehood - Light not working
Information:	While the range hood appears to be working at a satisfactory level, the light to the appliance was not working at the time of inspection.

A licensed electrician should be appointed to replace the light on the range hood to restore it to a fully operational state.

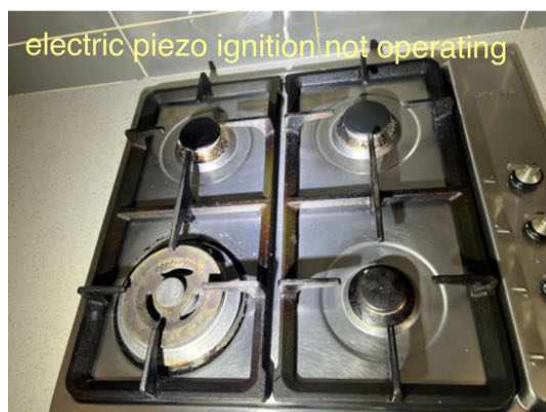
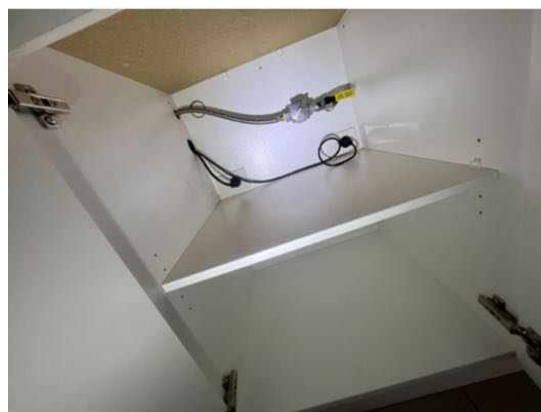
Finding 3.28

Building:	Main Building
Location:	Kitchen
Finding:	Additional Photos - gas cooktop
Information:	Additional photos are provided for your general reference
