Building and Timber Pest Inspection Report

Inspection Date: Thu, 5 Feb 2026

Property Address: 19 Langley Ave, Renwick NSW 2575,
Australia

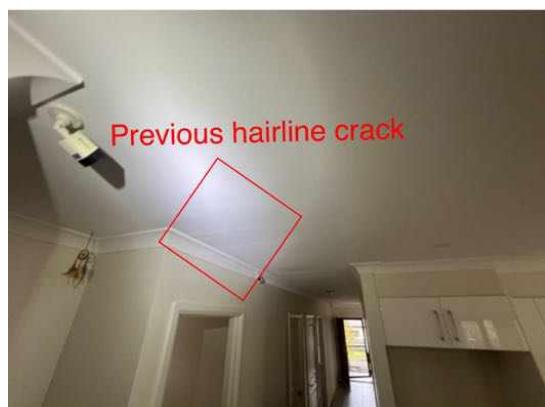
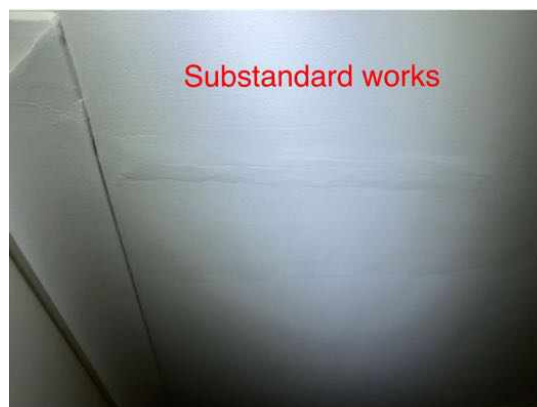
Finding 3.29

Building:	Main Building
Location:	Kitchen
Finding:	Ceiling – substandard and Hairline Cracks.
Information:	Evidence of substandard finishing were identified to the ceiling lining. The patchwork is considered substandard, with uneven finishes and incomplete blending, suggesting that previous repair attempts were cosmetic in nature and did not involve re-fixing the underlying ceiling sheets.

Additionally, hairline linear cracking was observed at several butt joints between ceiling sheets. This type of cracking is commonly caused by minor structural movement, material shrinkage, or flexing along joint lines over time.

While these issues are largely cosmetic at this stage, they indicate a history of movement and poor-quality repair work. If left unmanaged, further deterioration or

more noticeable ceiling deformation may occur.

It is recommended that a qualified plasterer or painter be engaged to assess and undertake remedial works to ensure the ceiling is properly prepared and refinished to an acceptable standard.

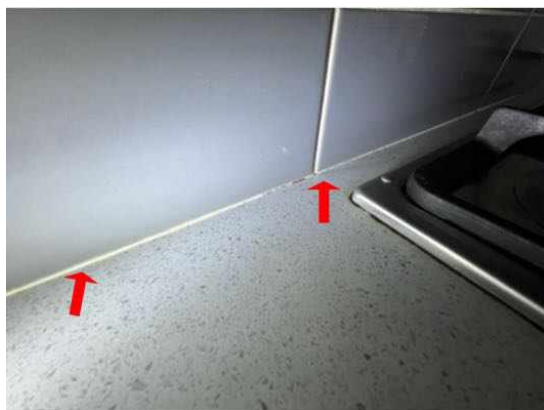
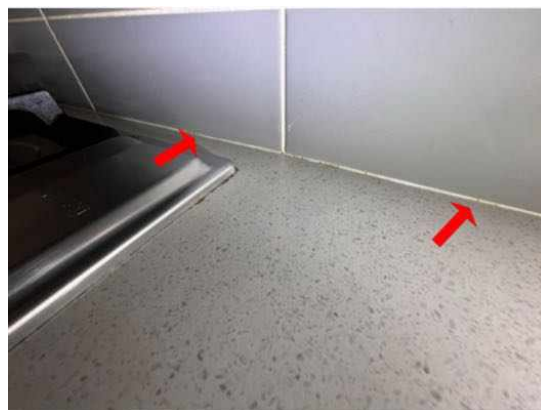
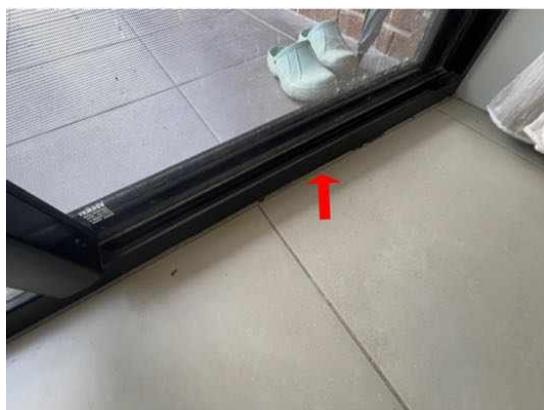
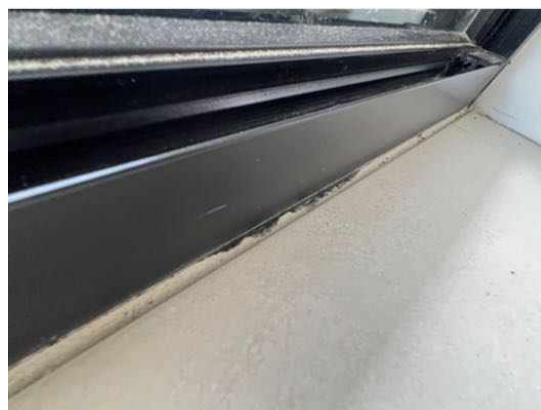
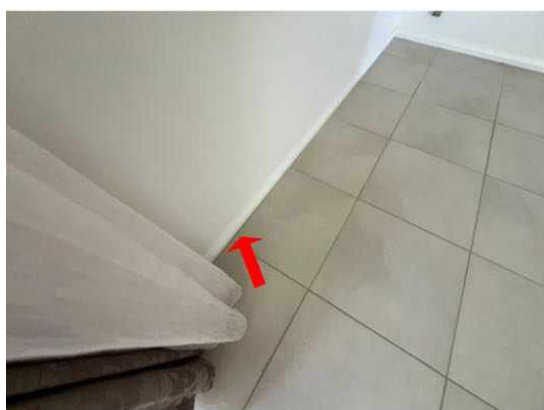
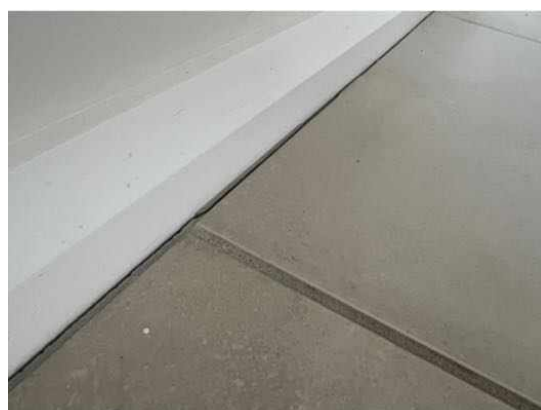
Finding 3.30

Building:	Main Building
Location:	Kitchen, Living Room, Dining Room
Finding:	Sealant - degraded
Information:	It was noted on inspection that sealant or grout is degraded to this area.

Different materials move at different rates, generally causing cracking to grout or sealant at this point. A flexible sealant is required to allow for expected expansion and contraction, while keeping the joint water tight and protective of all associated building materials.

Flexible and mould resistant materials should be applied to affected areas to prevent any subsequent water damage that is likely to occur. Regular maintenance and replacement of damage or missing or damaged sealant and grout is highly recommended to the wet areas, as this is a regular wear and tear defect. Sealant and grouting in areas that come into regular contact with water should be maintained for the long term care of your property.

A sealant specialist or tiling contractor should be appointed to complete these works as soon as possible

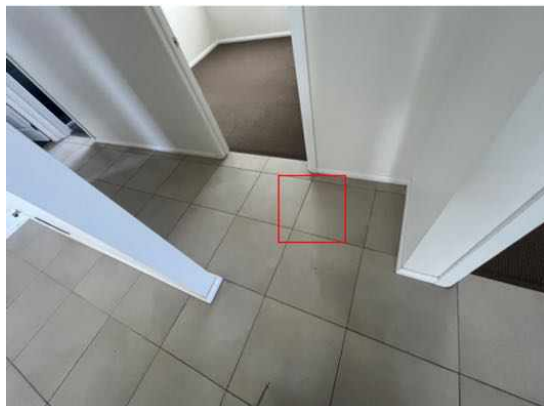
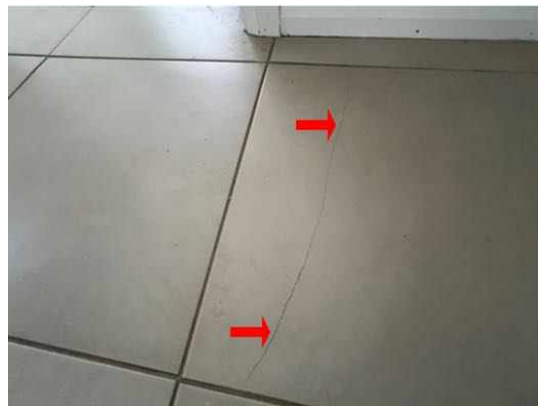
Finding 3.31

Finding: Tiles - Damaged

Information: Damage was evident to the tiling in this area at the time of inspection. While the damage appears to be minor, this area is frequently exposed to water, allowing potential for water penetration into adjoining sections of walls or flooring.

If left unmanaged, water penetration to these areas may lead to subsequent water damage, which is likely necessitate repair work to affected building elements.

A tiling contractor should be appointed to ensure that no further water damage

occurs. The re-application of silicone and grouting throughout remaining tile work is also advised, to further protect the area against water penetration.

Where water penetration has led to water damage, appointment of a relevant tradesperson may be required to repair damaged building elements.

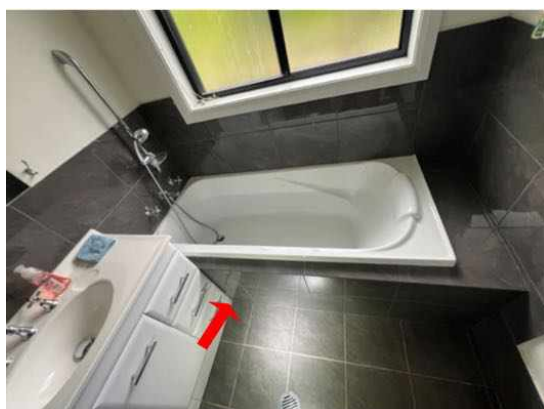
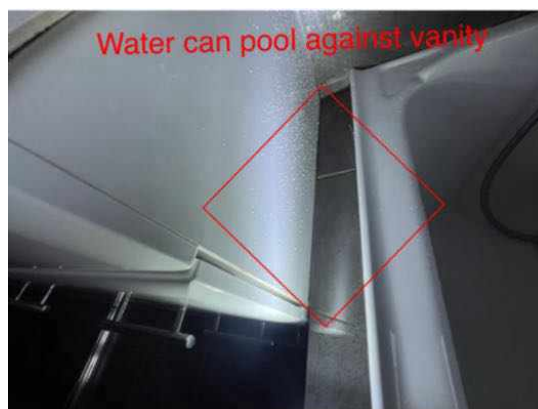
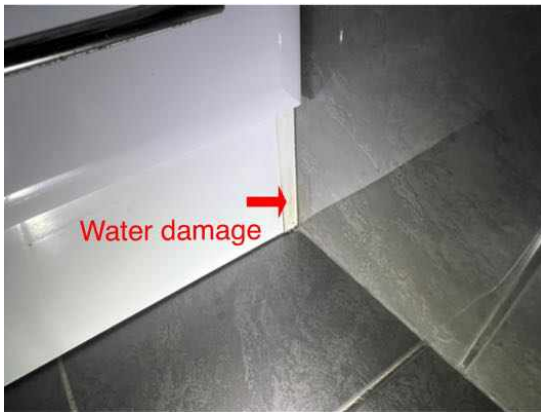
Finding 3.32

Building:	Main Building
Location:	Bathroom
Finding:	Water damage - joinery
Information:	Water damage was observed to joinery within the sink cabinet. This type of defect is typically caused by prolonged moisture exposure from minor plumbing leaks, condensation, or poor sealing around fixtures and fittings.

If left unmanaged, water ingress can lead to swelling, delamination, or deterioration of the joinery, potentially compromising its functionality and hygiene. Moist conditions in enclosed cabinetry may also create an environment conducive to mould or timber pest activity.

It is recommended that a licensed plumber be engaged to inspect the sink plumbing for leaks or seepage. A cabinetmaker or qualified joiner may also be required to replace the affected element where practical.

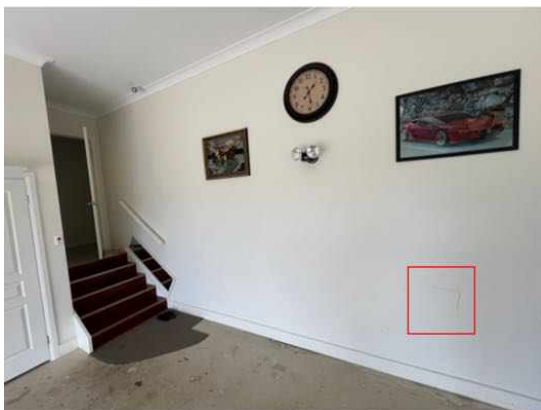
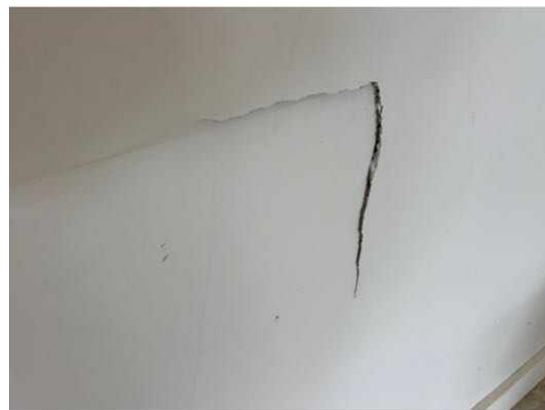
Finding 3.33

Building:	Main Building
Location:	Garage
Finding:	Plasterboard - Damaged
Information:	Breakage occurs generally when the building materials have either aged and decayed, or as a result of damage (accidental or deliberate).

Repair and/or replacement of broken elements is advised to ensure that additional secondary defects do not arise as a consequence. Such works are necessary, as all building elements play a key role in the operation and function of the overall structure and its performance.

A plasterer or general handy person should be appointed to repair or replace the affected building element prior to any subsequent damage being caused followed by a painter.

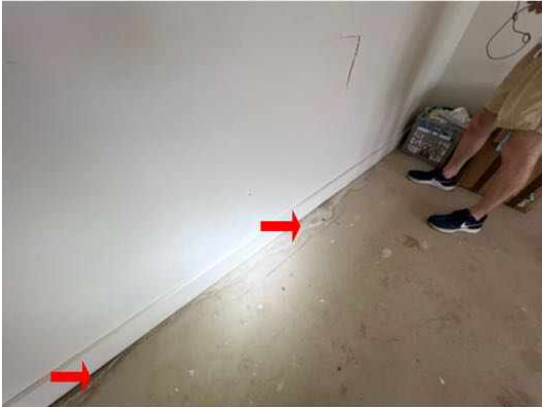
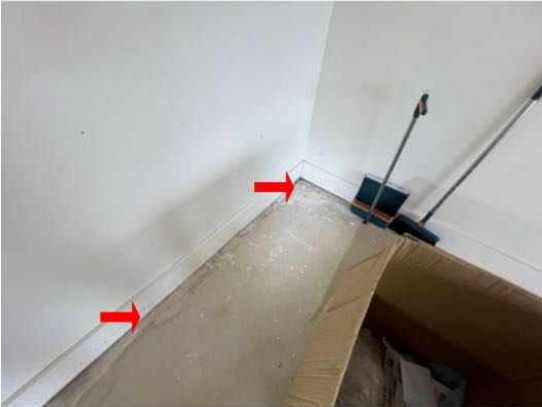
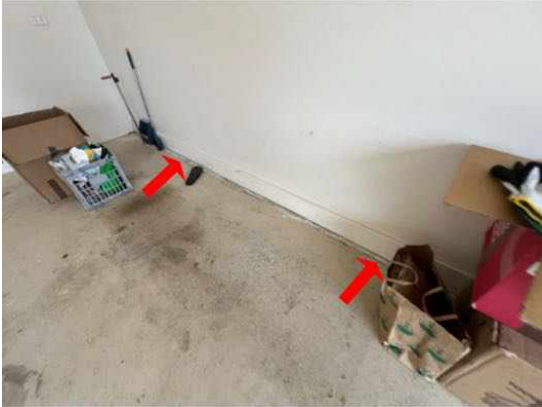
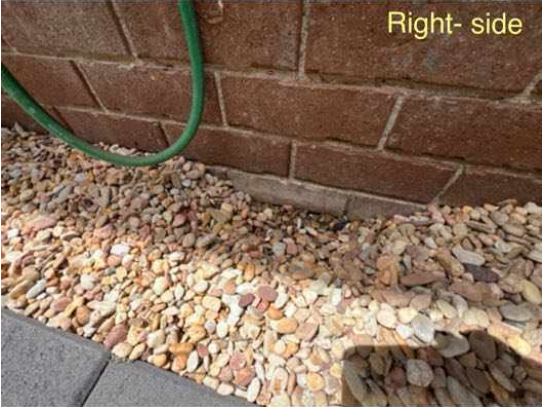
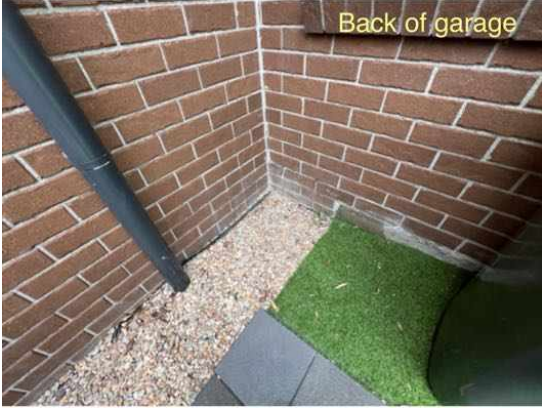
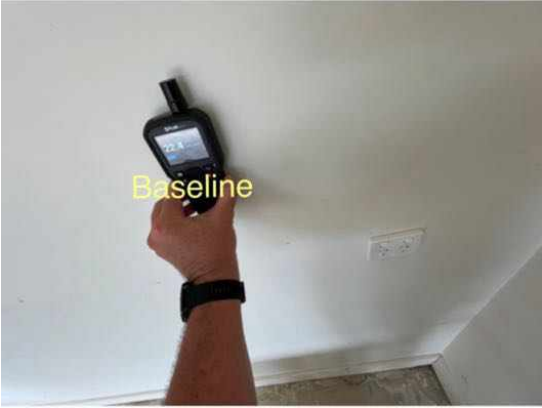
Finding 3.34

Building:	Main Building
Location:	Garage
Finding:	Garage - Moisture Staining at Floor Level
Information:	Moisture staining was observed at floor level along the rear and side areas of the

garage, with slight marking noted to the bottom edge of the skirting. Moisture meter readings were only minimally elevated, and no staining or damage was observed to the wall linings.

The condition appears limited to surface moisture at the floor interface and is likely influenced by external ground levels being higher than the internal garage slab. While the impact is minor at present, continued moisture exposure may lead to deterioration of finishes and create conditions conducive to timber pest activity if left unmanaged.

It is recommended that external ground levels and surface drainage adjacent to the garage be reviewed by a registered Builder to reduce the potential for ongoing moisture exposure.

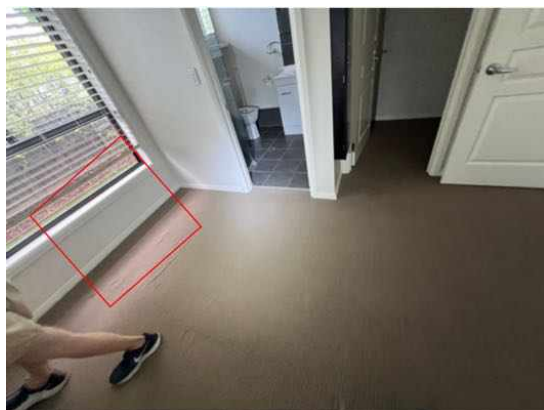
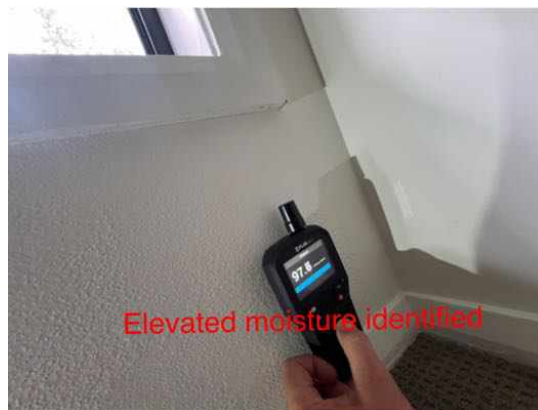
Building:	Main Building
Location:	Bedroom - Master
Finding:	Excessive moisture - identified
Information:	Excessive moisture can attract termites and produce conditions that promote fungal growth and wood decay.

Excessive moisture is generally caused by deteriorated, inadequate or missing roof drainage, leaking plumbing pipes or fixtures, poorly plumbed HWS overflows or condenser units and poor site drainage.

Prior to any remedial works being performed a qualified plumber should be appointed to further inspect the property and to identify the cause of the excessive moisture. Works to remove affected building elements may then be necessary and should be performed by an appropriate tradesperson.

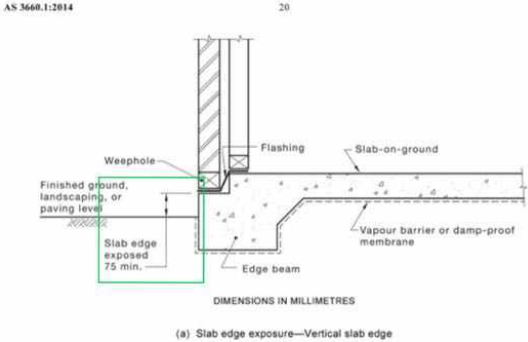
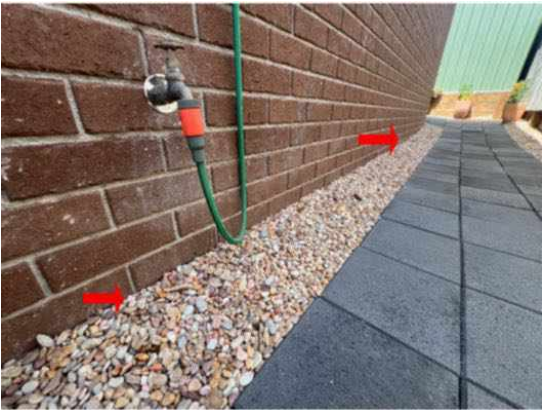
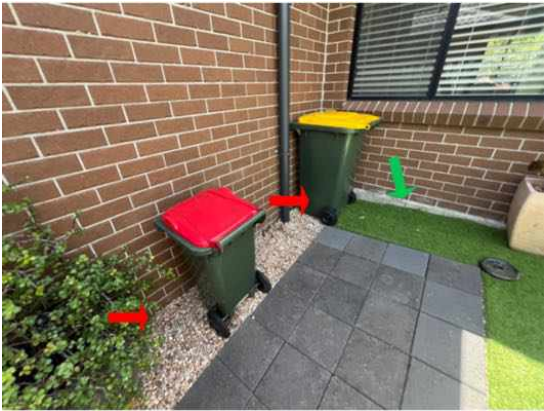
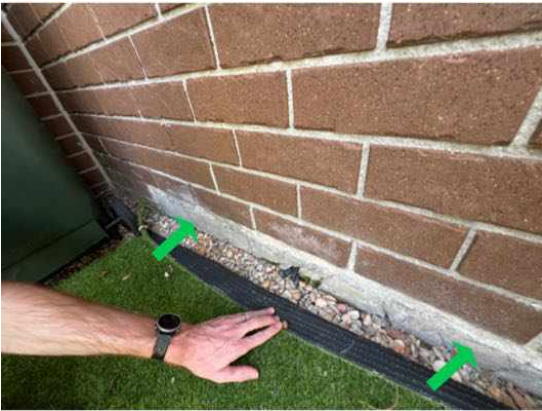
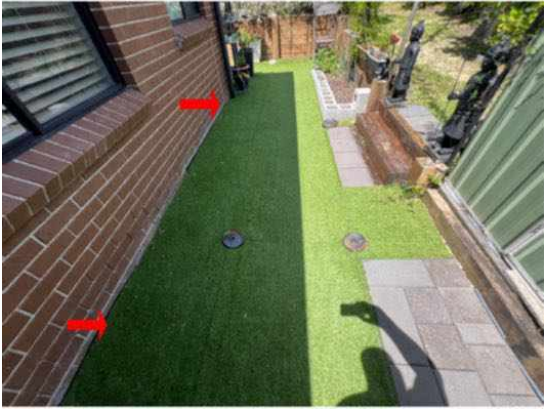
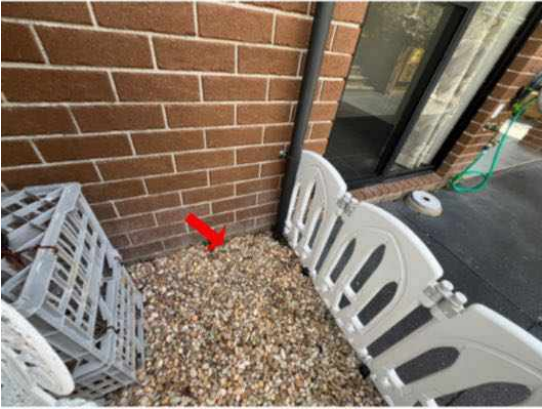
If the slab edge is not properly exposed there is a high risk of termite attack. Sometimes, in order to determine the type of slab, a suitably qualified person such as an architect or builder may be required to consult the construction plans.

Where the slab edge cannot be properly inspected, it is highly recommended that termite or timber pest inspections be carried out every 6-12 months to aid protection of the property against infestation.

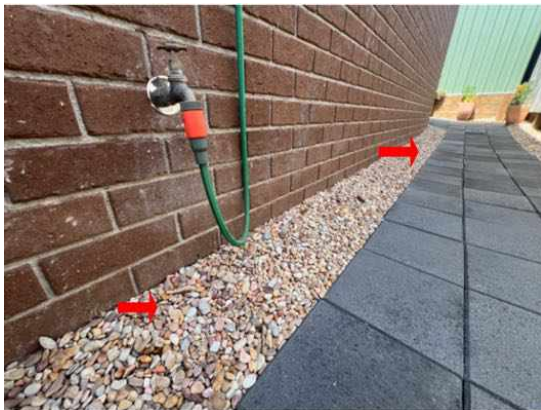
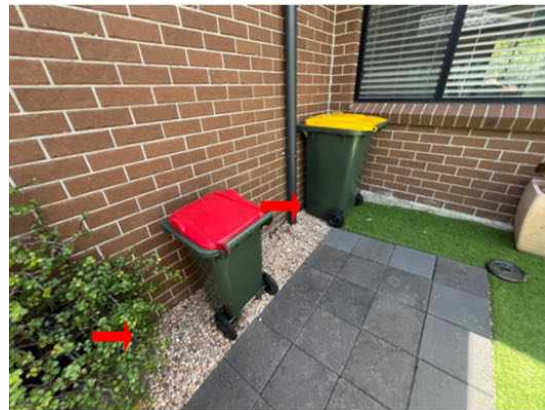
Finding 6.04

Building:	Main Building
Location:	External - Garage
Finding:	Bridging of termite barrier
Information:	Bridging of termite barriers occurs when termites bridge (usually by building a mud tunnel) a termite barrier or inspection zone or where termites have a passage allowing them to bridge the barrier.

Generally this takes the form of finished ground levels external paving or concrete being retrospectively installed above the damp course level the adjacent internal floor level or weep and ventilation holes.

Where bridging has occurred full inspection is prevented and termites may enter a property in a concealed or undetectable manner.

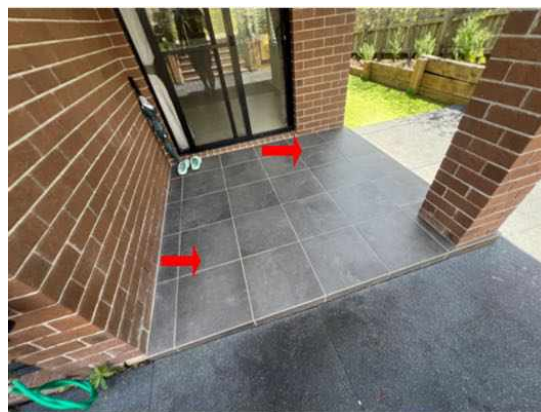
Finding 6.05

Building:	Main Building
Location:	Verandah, Alfresco
Finding:	Bridging of physical termite barriers - Concrete Patio
Information:	The tiled concrete pad to the patio and alfresco including other areas directly abuts dwelling causing bridging. Bridging is the span of a physical termite barrier or

Where a concrete patio is retrospectively installed against an external wall, this provides a concealed entry point for termites.

The client should consider obtaining further advice from a timber pest technician regarding treatments required in this area. It is recommended that obtaining such advice be a short-term priority.

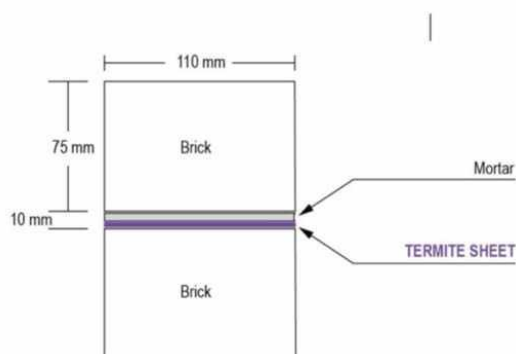
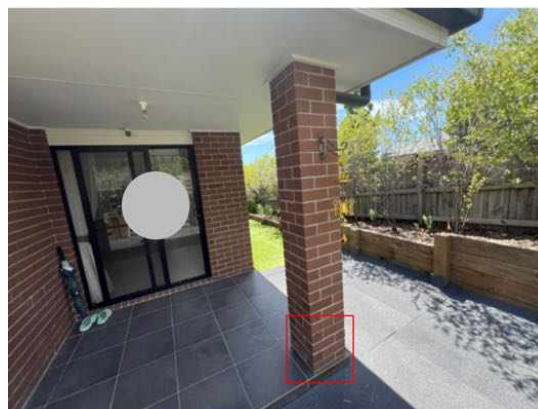
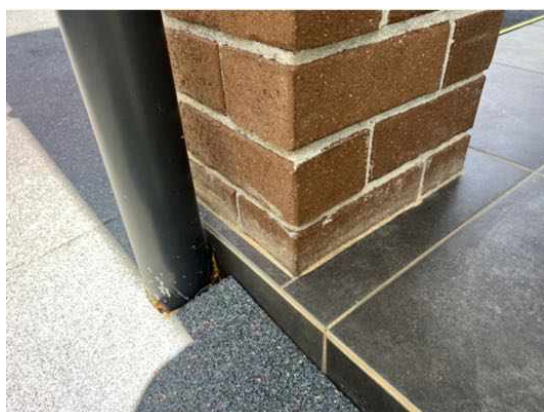
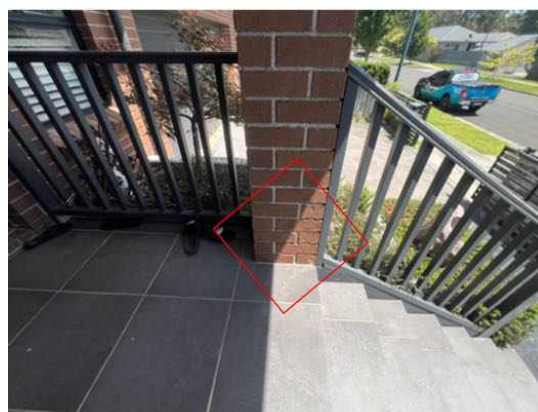
Generally this takes the form of finished ground levels external paving or concrete being retrospectively installed above the damp course level the adjacent internal floor level or weep and ventilation holes.

Where bridging has occurred full inspection is prevented and termites may enter a property in a concealed or undetectable manner.

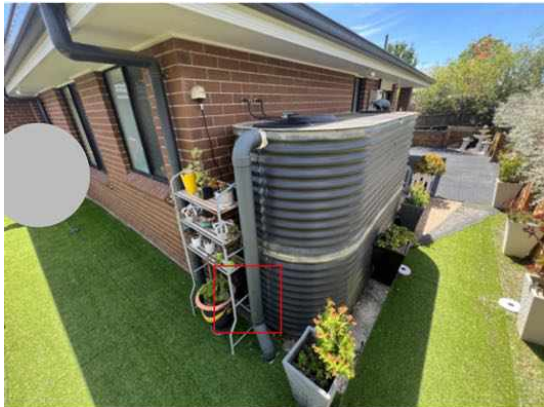
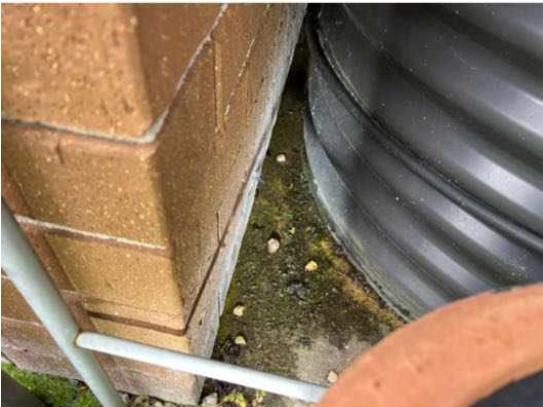
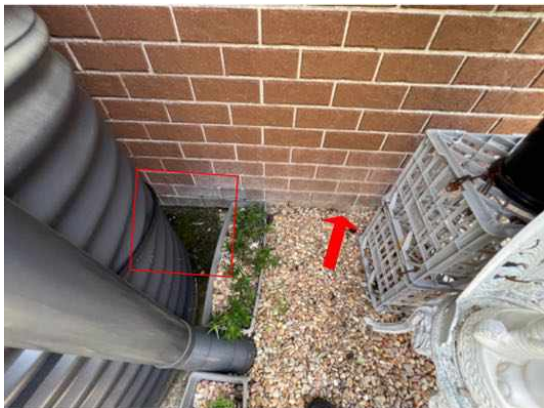
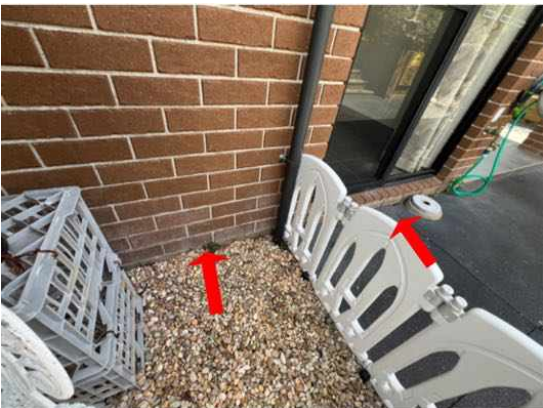
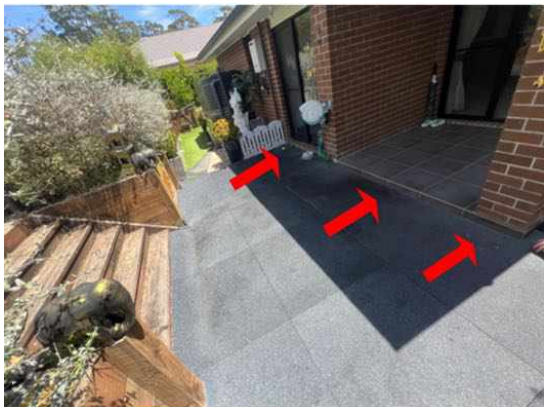
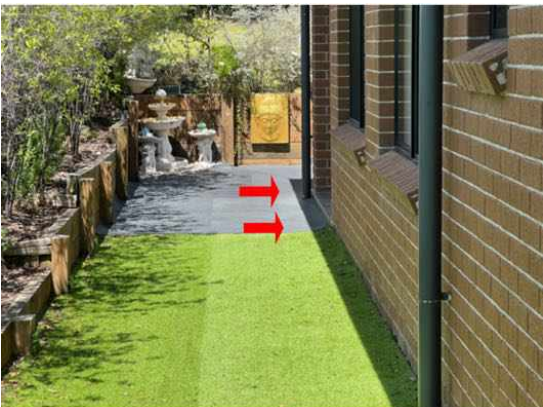
Finding 6.08

Building:	Main Building
Location:	Exterior walls - rear
Finding:	Water pooling - against property
Information:	Water appears to be pooling against the house. It is suspected that this is a result of poor site drainage but may also be due to excessive moisture from an unidentified source.

Where water is pooling against the house water damage to the external wall cladding is imminent.

Such water pooling also increases the risk of termite activity and the development of fungal decay in the area.

Consult a Licensed Plumber regarding the cost of potential site drainage rectification works.

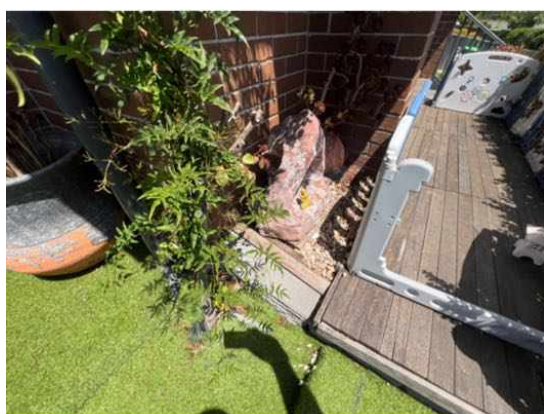
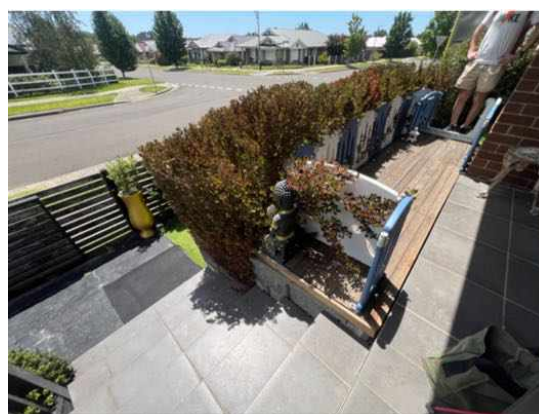
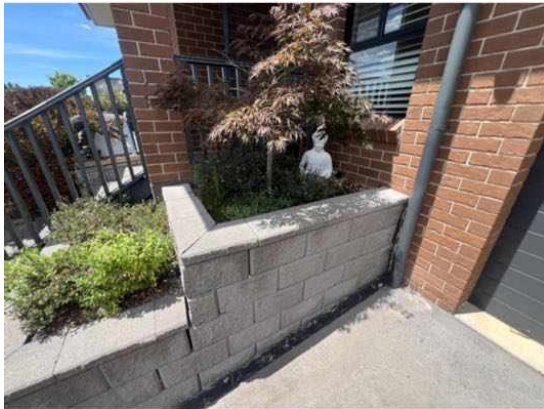
Building: Main Building
Location: All External Areas
Finding: Garden Beds - Conditions Conducive to Termites
Information: Garden beds were observed around the perimeter of the building, obstructing visual inspection of lower wall areas and providing potential concealed termite entry points.

Raised soil levels and retained moisture from watering can allow termites to access wall cavities or weep holes undetected, while timber edging materials may further encourage activity.

It is recommended that garden beds be reduced or cleared from the building perimeter, or that regular timber pest inspections be carried out in accordance with AS 4349.3 or AS 3660.2 to monitor risk.

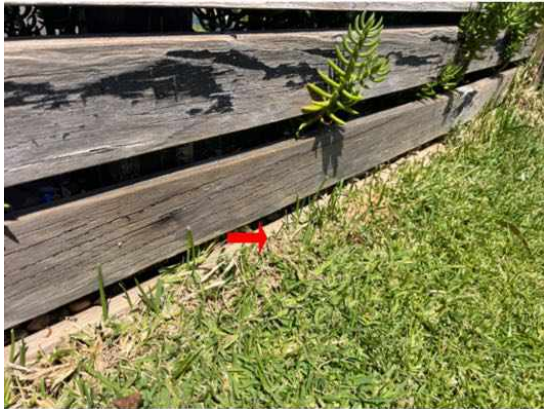
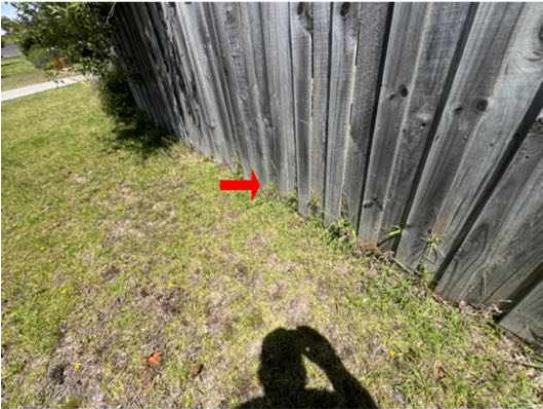
Finding 6.13

Building: Yard
Location: All External Areas
Finding: In ground contact
Information: Any timbers in direct ground contact provide opportunity for concealed termite entry and are likely to be subject to premature rot and decay as the soil retains moisture or damp conditions against the timbers.

Remove untreated timber that is in direct contact with external grounds. Consider replacement with more durable materials i.e. treated timber or non timber elements. Frequent pest inspections are advised to readily identify any termite activity in these areas.

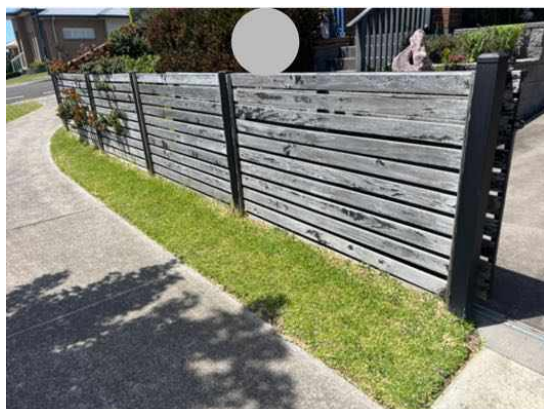
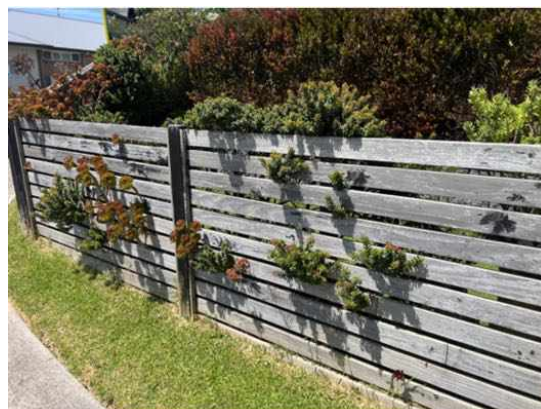
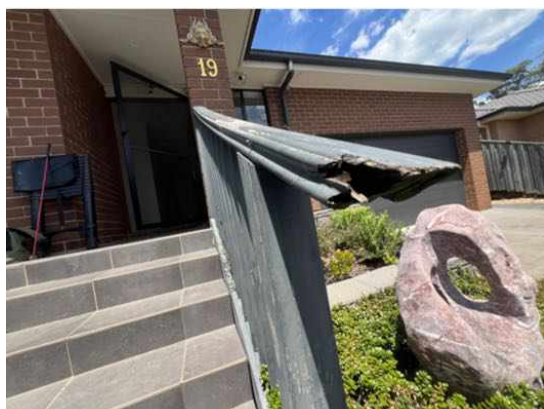
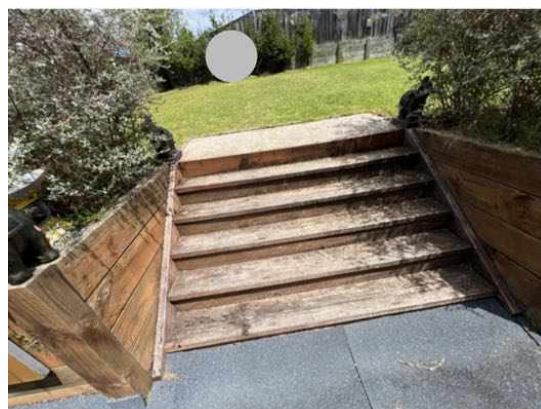
Finding 7.01

Building:	Not Applicable
Location:	All External Areas
Finding:	Fungal decay - present (localised)
Information:	Fungal decay also known as wood decay or wood rot generally refers to the deterioration of timber elements when in contact with excessive levels of moisture for a prolonged period of time.

The development of fungal decay is accelerated by temperatures in the range of 5degreeC to 40degreeC as well as the presence of oxygen. Generally fungal decay develops on timber elements that are in use in an external environment which are exposed to rain penetration.

In this case although the affected timber element is in a decaying state the extent of any visible damage appears to be localised to a specific area and is yet to spread to other parts of the building element or affect adjoining structures. The fungal decay is therefore likely to be of a relatively superficial nature with minimal impact on the structural integrity or tensile strength of the timber element.

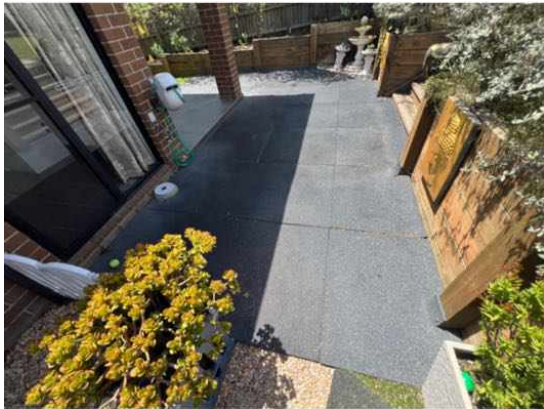
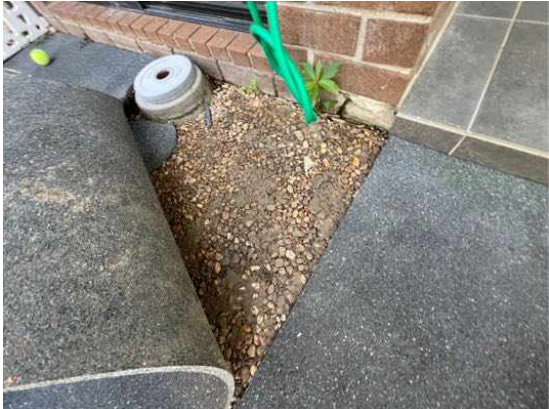
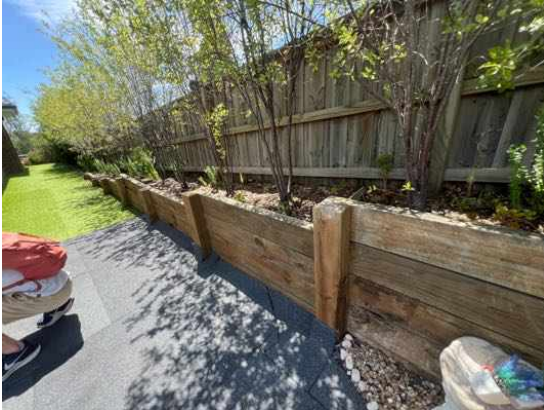
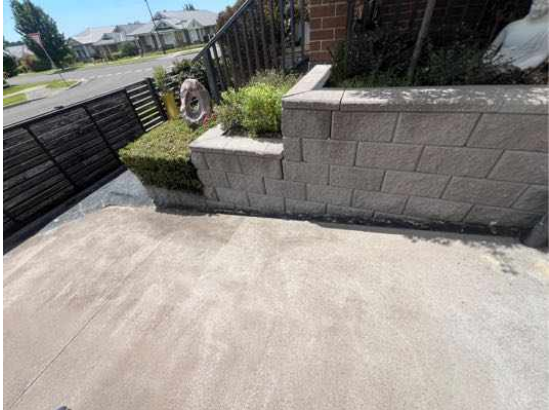
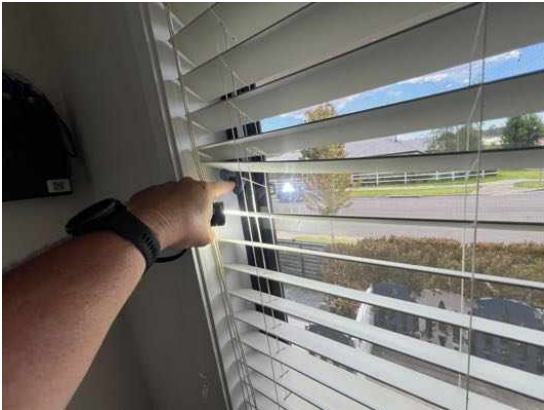
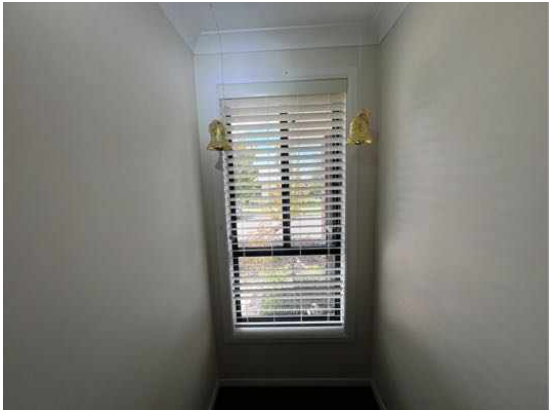
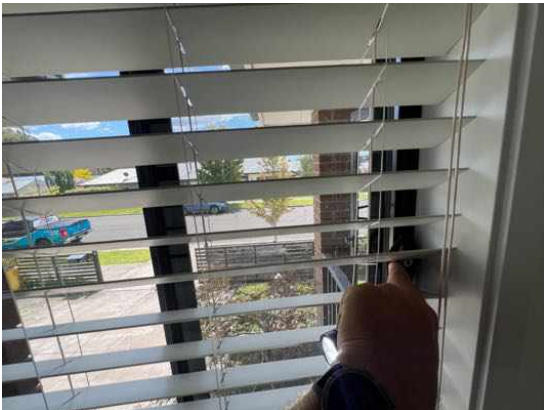
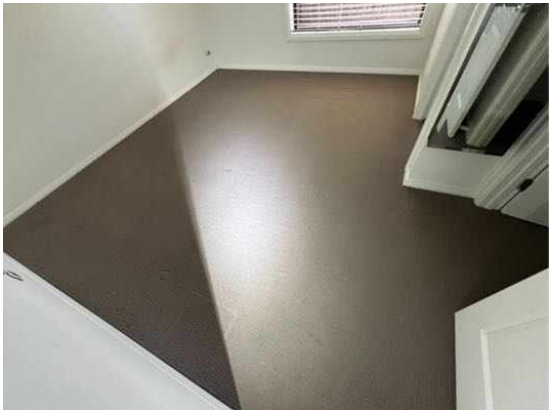
Finding: FYI - Additional Photos

Information: Additional photos are provided for your general reference and may include obstructions, testing of water & windows, moisture readings or minor maintenance items.

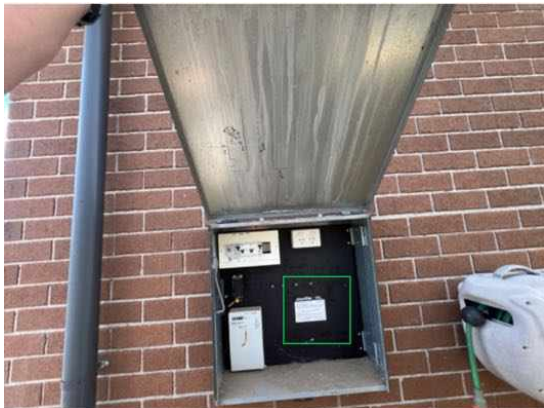
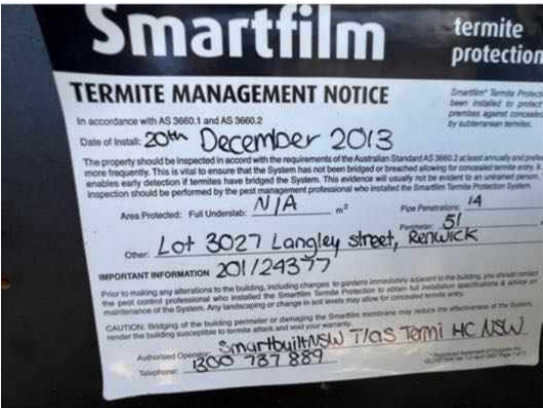
Building:	Main Building
Location:	Meter Box
Finding:	Termite Management – Durable Notice and Barrier Maintenance
Information:	A Durable Notice was observed during the inspection, indicating the presence of a physical termite management system installed in accordance with AS 3660. However, no evidence of ongoing or annual termite inspections was noted, and the notice

Physical barriers are an important component of termite protection but require ongoing monitoring to remain effective. Without regular inspections or maintenance, the property remains at increased risk of concealed termite entry and potential damage to timber building elements.

TERMITE SHEET PROTECTING A TWO BRICK REBATE

It is recommended that the purchaser make further enquiries with the vendor regarding any history of termite activity or treatments undertaken at the property, including any works to on-site trees. A licensed pest controller should also be engaged to assess the current status of the termite barrier and implement a regular inspection program in line with AS 3660 requirements.
