Building and Timber Pest Inspection Report

Inspection Date: Mon, 12 Jan 2026

Property Address: 5 Skye Ct, Kellyville NSW 2155, Australia

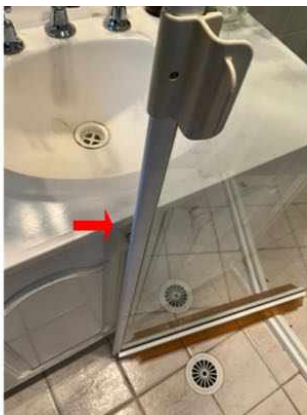
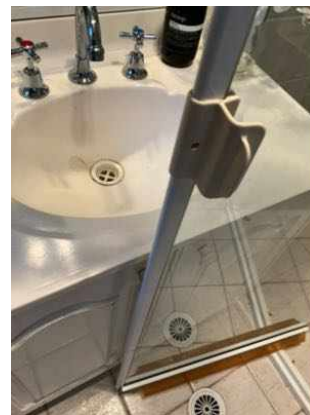
Building: Main Building
 Location: Ensuite
 Finding: shower screen door hitting vanity unit
 Information: The shower screen door makes contact with the edge of the vanity unit when opened. This indicates inadequate clearance between the shower screen and the fixed bathroom fixture. The door's operation is impeded and presents a safety concern.

- Potential for impact damage to the vanity and shower screen.
- Increased risk of glass breakage, posing a personal injury hazard.
- Ongoing stress may lead to hardware failure or misalignment of the door.

This condition does not comply with the intent of AS 4349.1-2007, Appendix C – Significant Items, under “Defects in the condition of secondary and finishing elements,” specifically where normal use may cause failure or injury.

Engage a licensed glazier or shower screen installer to adjust or replace the screen to ensure proper clearance and safe operation. A cabinetmaker may be consulted if modification to the vanity is more feasible.

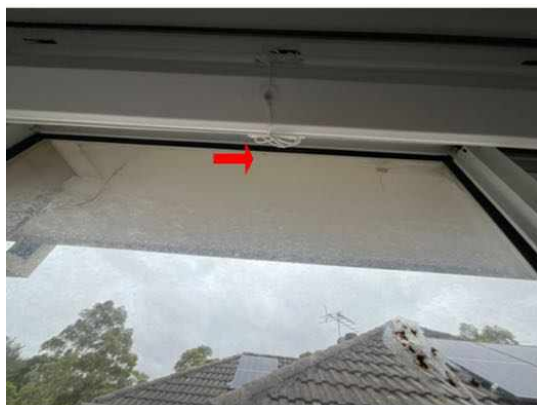
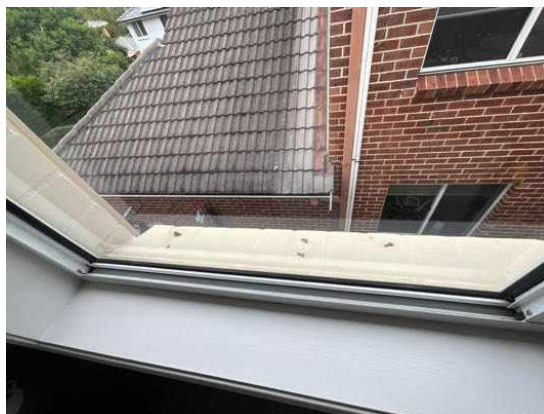
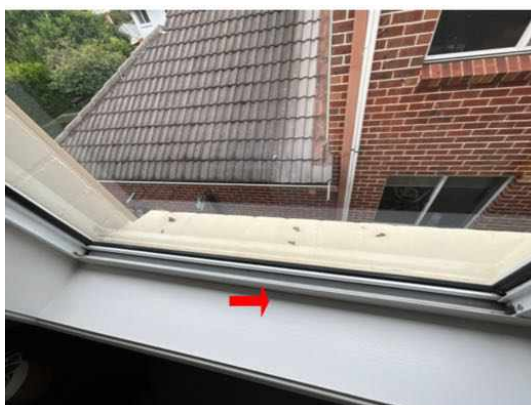
Finding 1.02

Building:	Main Building
Location:	All Areas
Finding:	Window child lock missing
Information:	The window in question lacks a child lock mechanism, which poses a potential safety risk to young occupants in the premises. As per Australian Standards windows accessible to children should be equipped with appropriate child safety locks to prevent accidental opening, reducing the risk of falls and ensuring compliance with safety regulations.

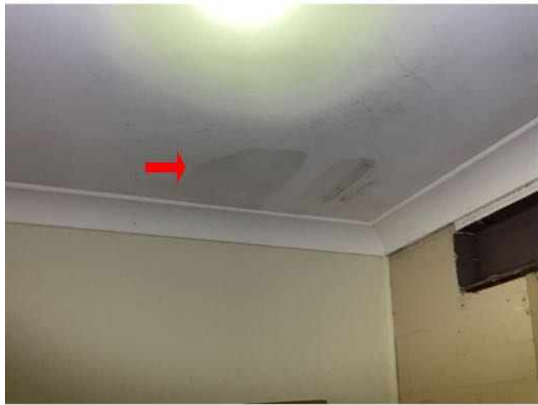
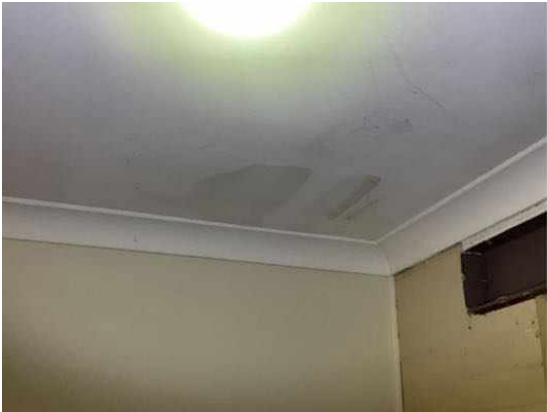
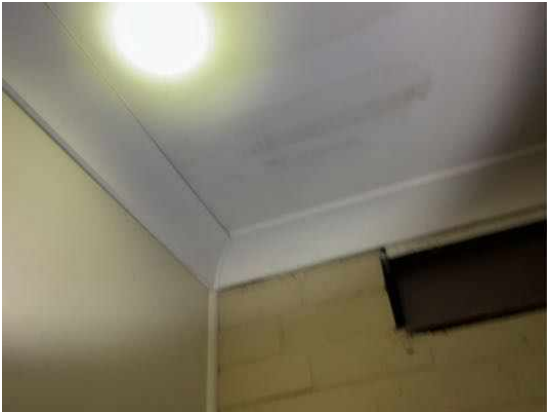
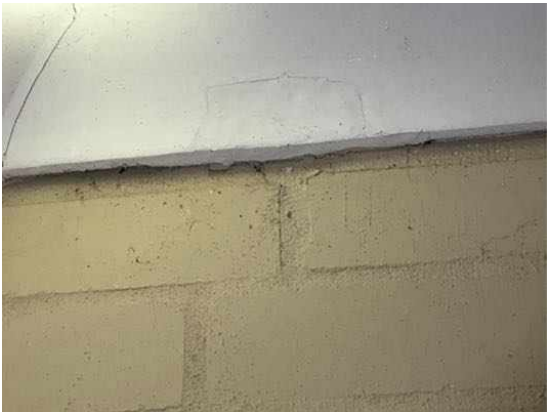
Finding 2.01

Finding: Roof Leaks

Information: The roof has developed leaks, allowing water to penetrate the building envelope. These leaks may be due to damaged or missing shingles/tiles, deteriorated flashing, clogged gutters, or other roof system failures.

A licensed roofing contractor or qualified roofer should be contacted to inspect and repair the roof leaks. They will:

- Identify the source of the leaks and assess the extent of the damage.
- Repair or replace damaged shingles, tiles, flashing, or other roofing materials.
- Ensure proper sealing around roof penetrations, such as vents, chimneys, and skylights.
- Clean and maintain gutters and downspouts to ensure proper drainage.
- Provide recommendations for any additional necessary repairs or preventive measures to avoid future leaks.

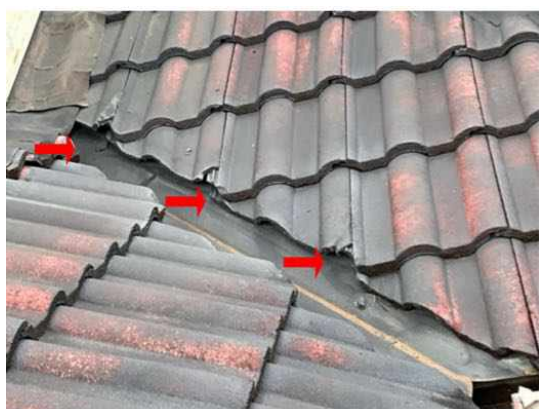
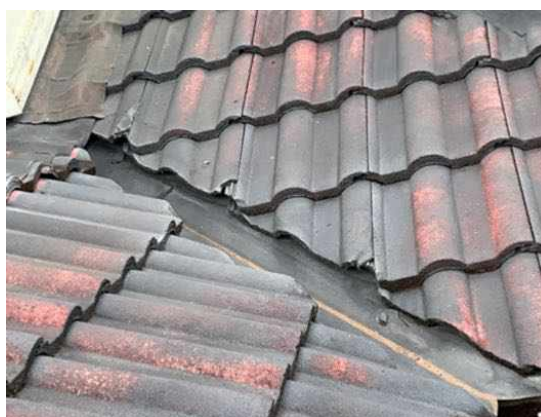
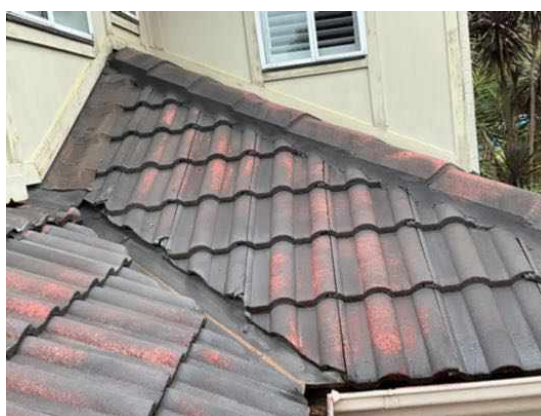
Finding 3.01

Where left unmanaged, deteriorating roof are likely to lead to a number of secondary defects, including minor water leaks and weather exposure to internal roofing structures.

Consultation with a roofing contractor is highly advised to gain advice on cost of remedial works that may be required in the short to medium term. Remedial works are likely to increase the longevity of the exterior roofing structure.

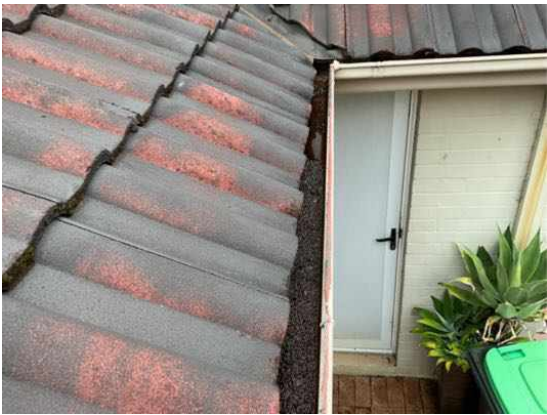
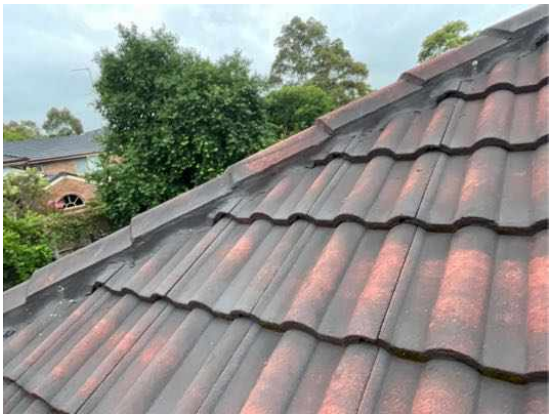
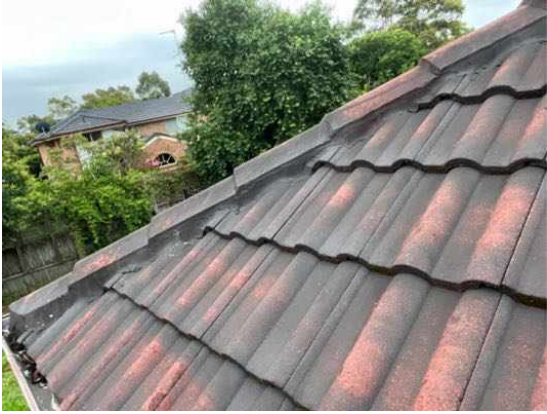
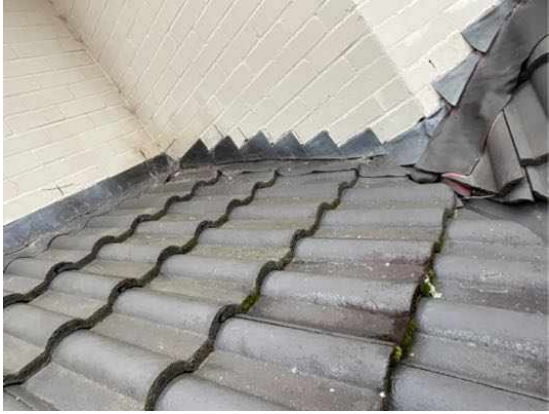
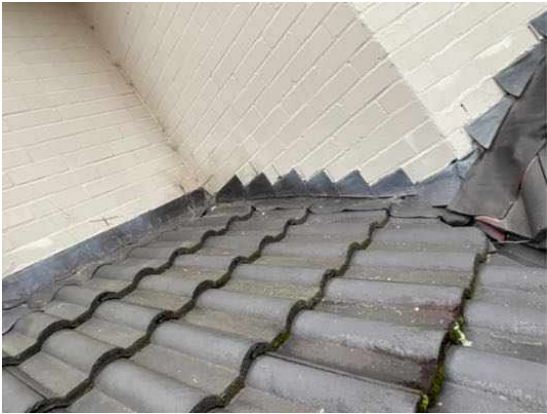
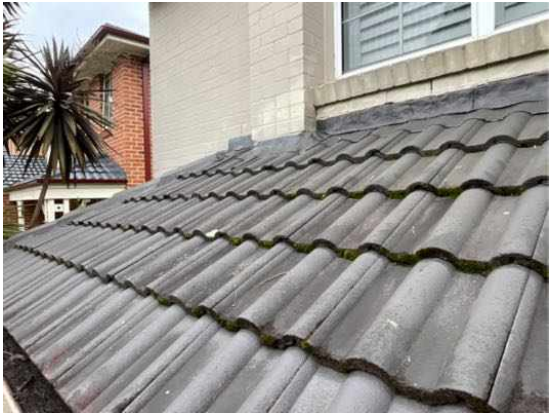
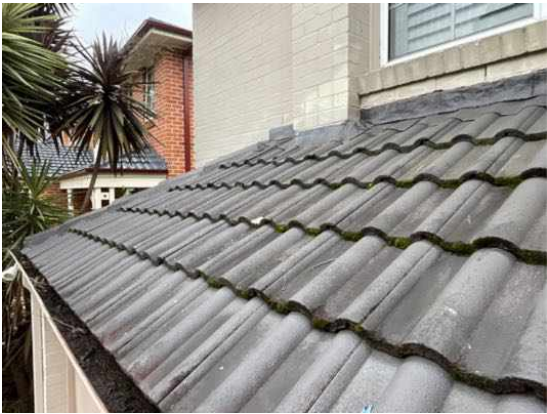
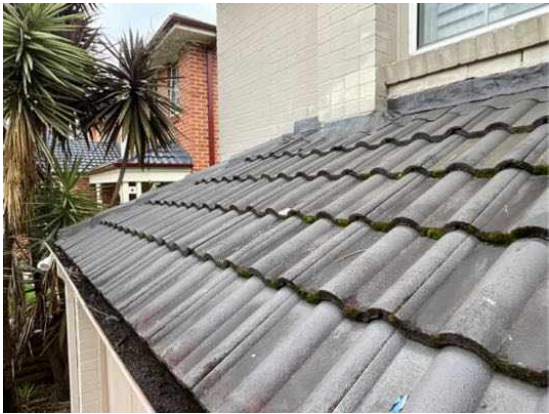
Building:	Main Building
Location:	All Areas
Finding:	Roof Weathered
Information:	Upon inspection of the exterior roofing, the majority of roof was not in a fair condition. While weathering of the roof is consistent with the age of the property, maintenance works are required.

Isolated areas of mortar have come loose in the valleys and minor cracking is also present. Re-pointing and re-sealing the may be considered as an interim solution by the client to help preserve and extend the life span of the tiles.

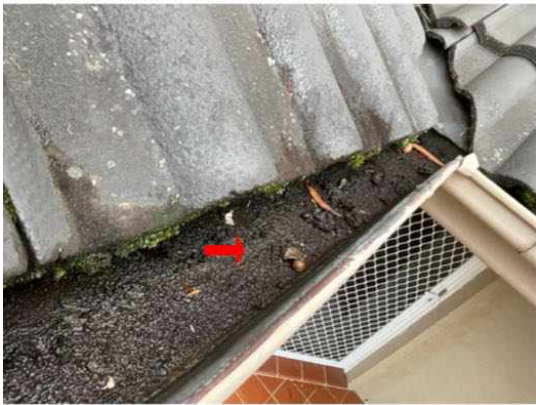
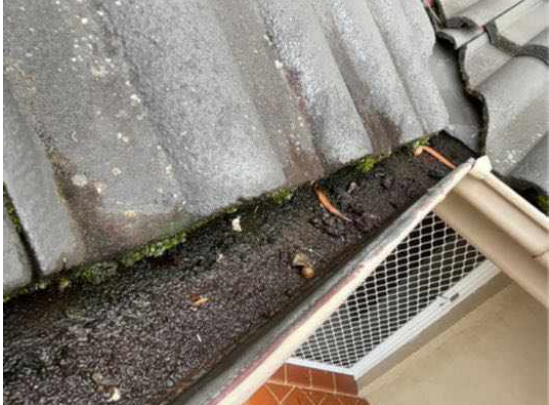
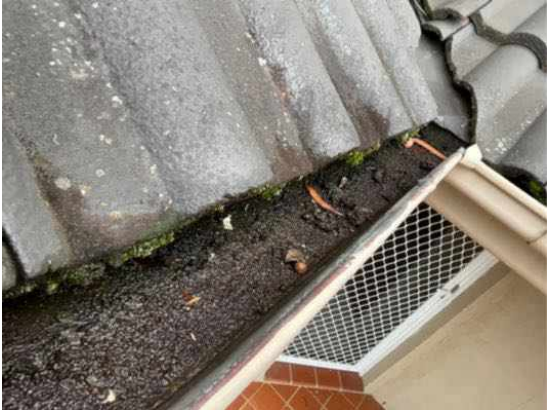
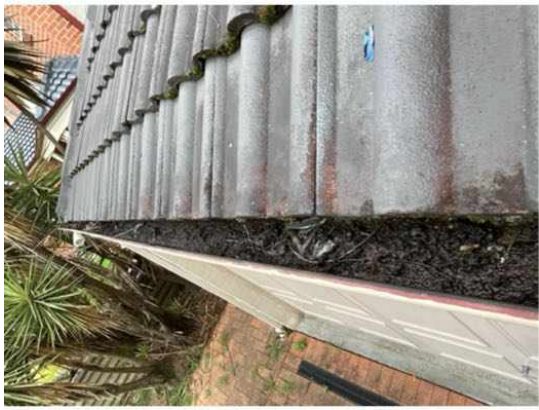
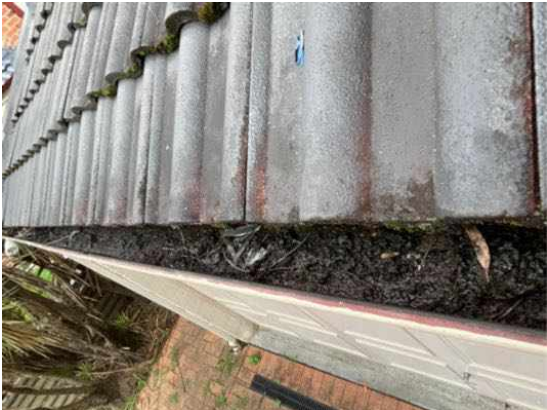
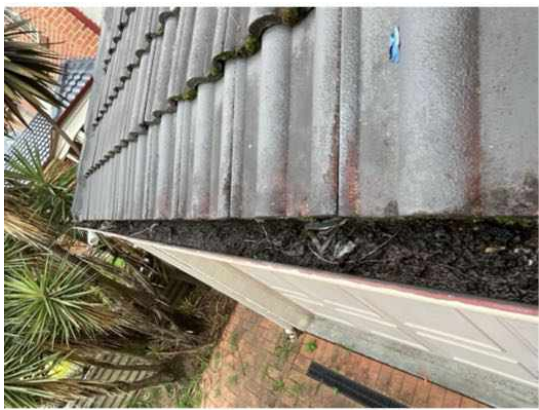
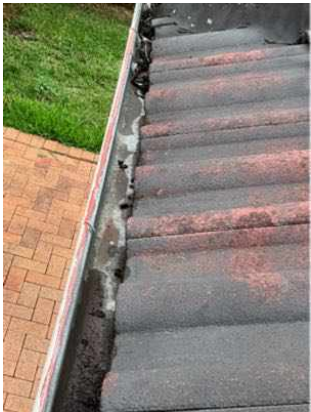
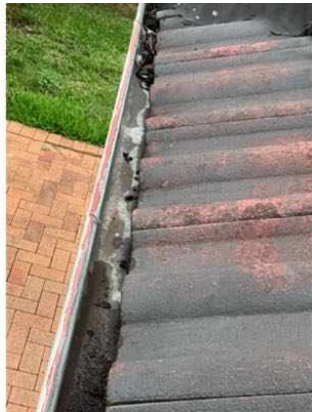
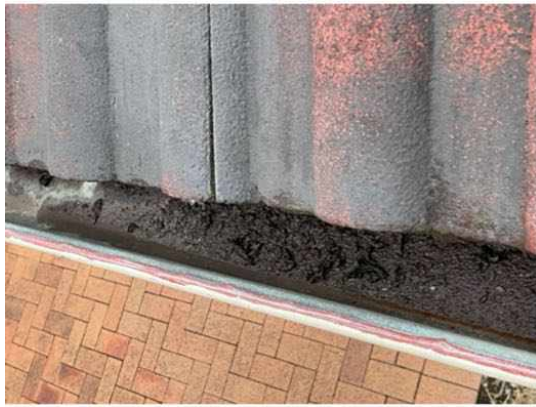
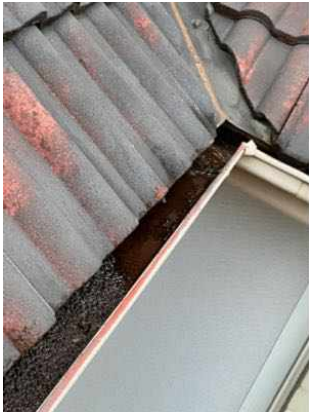
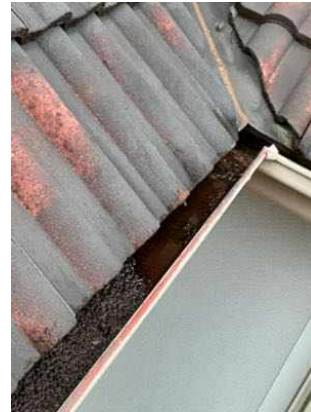
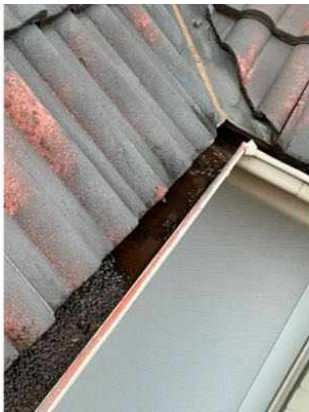
Finding 3.02

Building:	Main Building
Location:	All Areas
Finding:	Blocked gutters - organic debris
Information:	The roof gutter system was observed to be blocked with organic debris and moss growth, as evident in the provided images.

- Water ingress into the eaves or walls,
- Timber rot or deterioration of fascia and soffits,
- Accelerated moss and algae growth, promoting further blockages,
- Potential foundation issues if water pools near the base of the structure.

A licensed roofing contractor or qualified gutter cleaning service should be engaged to remove the debris and inspect the system for any further issues.

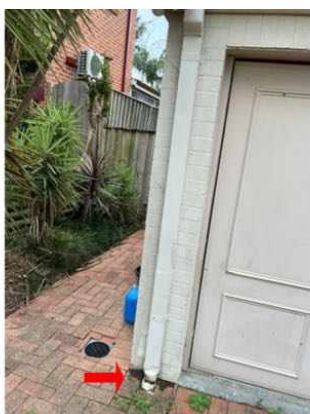
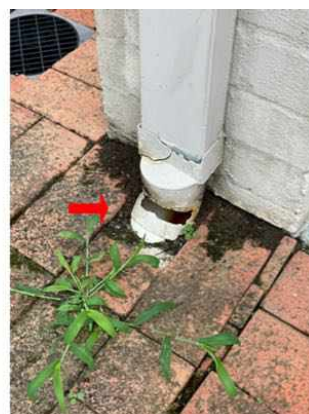
Finding 3.03

Building: Main Building
Location: Front Elevation
Finding: Downpipe cracked and damaged
Information: The downpipe is visibly cracked and damaged, compromising its ability to effectively discharge rainwater.

- Water leakage at the break point may lead to pooling near the building foundation, increasing the risk of moisture ingress and structural damage.

- Soil erosion and deterioration of landscaping around the area.
- Potential blockage due to debris entering through the cracked section.

- A licensed plumber or roof plumber should be engaged to replace or repair the damaged section of the downpipe and ensure proper reconnection to the stormwater system.

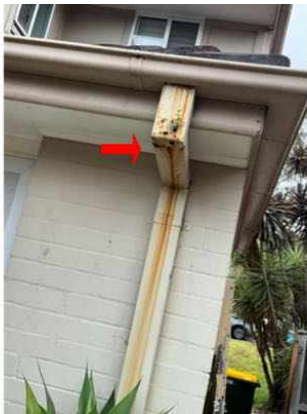
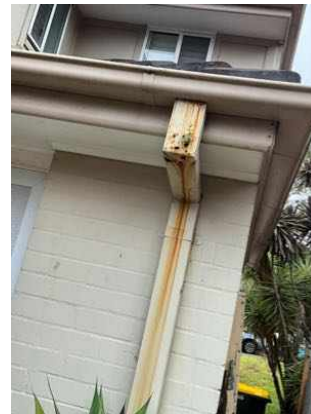
Finding 3.04

Building:	Main Building
Location:	Exterior walls - rear
Finding:	Downpipes Rusty / leaking
Information:	The downpipes on the property show significant signs of rust and leakage. The rust has weakened the structural integrity of the pipes, and the leaks are causing water to escape, potentially leading to further damage to the building's exterior and foundation.

- ****Water Damage****: Leaking downpipes can cause water to accumulate around the foundation of the building, leading to erosion, foundation damage, and potential structural instability. Additionally, water seeping into walls can cause mold growth, wood rot, and other moisture-related issues.
- ****Structural Deterioration****: The rusting of the downpipes compromises their ability to effectively channel water away from the building, increasing the risk of corrosion spreading to other parts of the drainage system and potentially causing more extensive damage.

A licensed plumber or roofing contractor should be hired to inspect and replace the rusty and leaking downpipes. The new downpipes should be made from rust-resistant

materials and properly sealed to prevent future leaks. Regular maintenance checks should also be performed to ensure the drainage system remains in good working order, preventing water damage to the property.

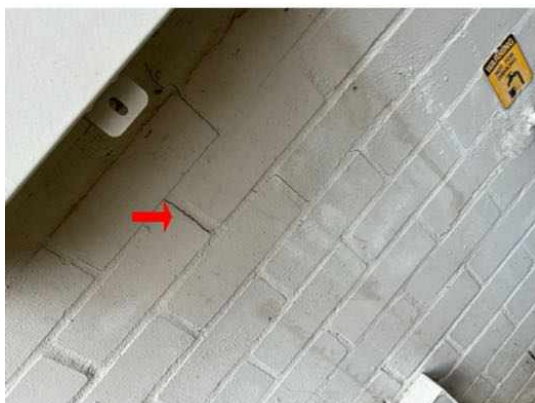
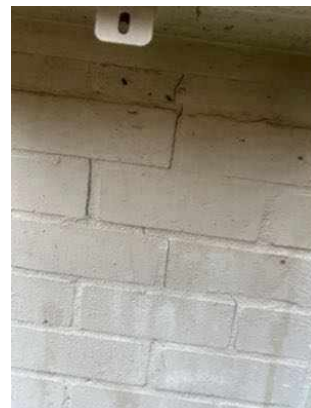
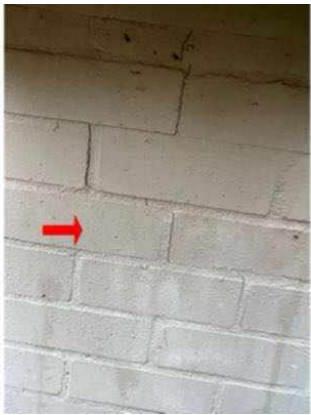
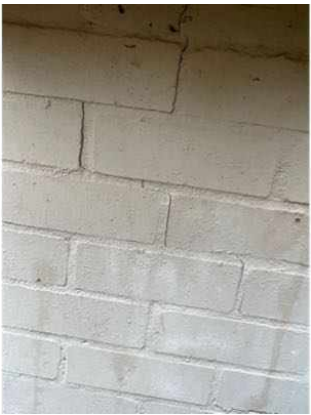
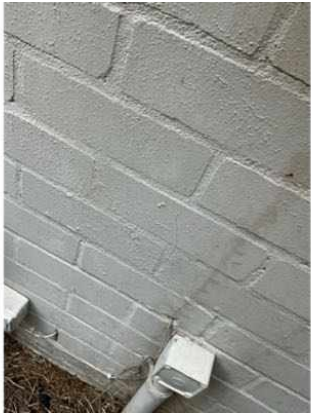
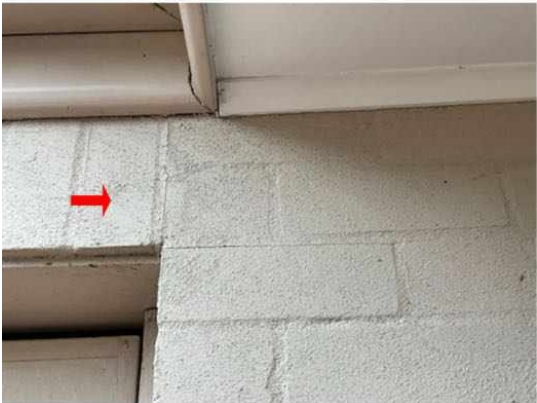
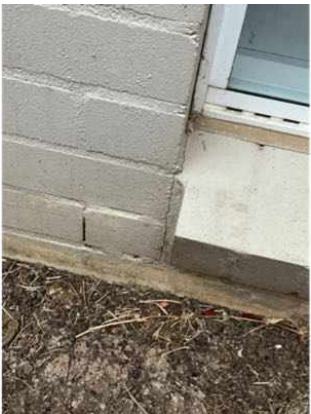
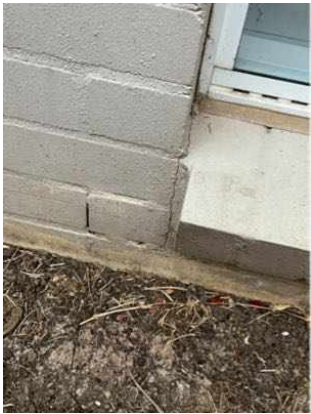
Finding 3.05

Finding: Brickwork - Cracking [Fine]

Information: Although fine cracks are quite noticeable, they are often only considered to be an appearance defect and usually do not indicate any structural damage. Generally, the cause of a fine crack is indicative of a separation between brickwork and mortar throughout the structure, but single bricks may also show cracks of this nature.

Cracking of this nature can generally be repaired with minor filling and should be conducted by a qualified bricklayer.

Always contact a building inspector should cracks widen lengthen or become more numerous.

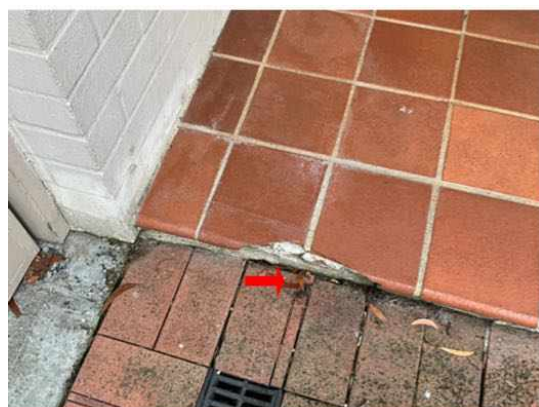
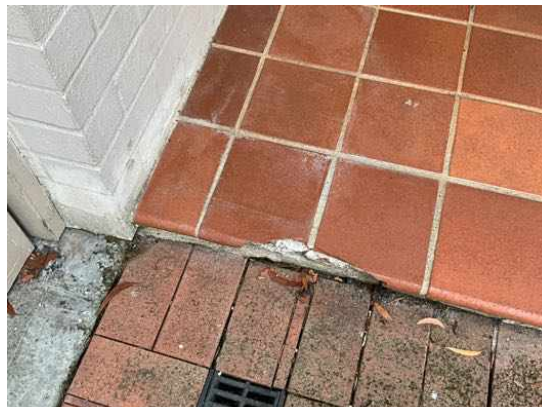
Finding 3.06

Building: Main Building
 Location: Front porch
 Finding: Tile - Floor Tile Damaged
 Information: A floor tile is visibly damaged, showing a chipped/broken section on the surface.

The damaged tile presents a trip hazard, may lead to cuts if stepped on barefoot, and can allow moisture ingress into the substrate, which may cause further deterioration or loosening of adjacent tiles. It also affects the overall appearance of the floor.

A licensed tiler should be engaged to remove the damaged tile and install a matching replacement. If spare tiles are unavailable, additional remedial work may be required to blend the repair with surrounding finishes.

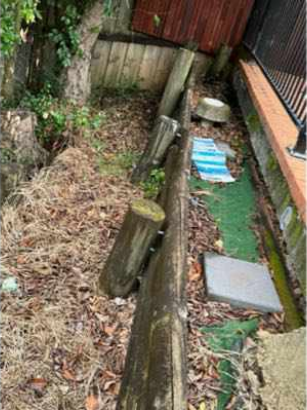
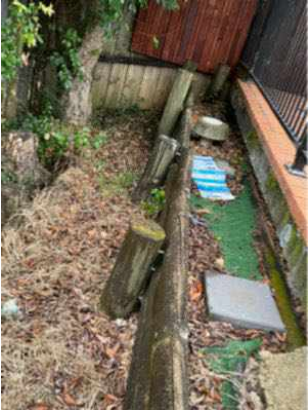
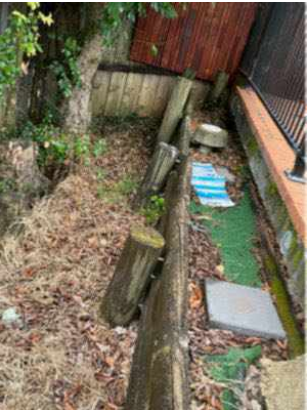
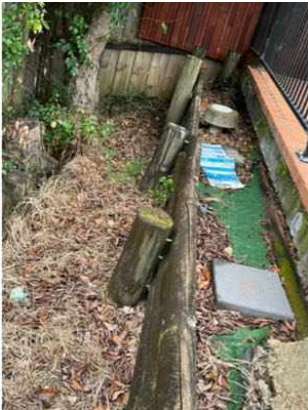
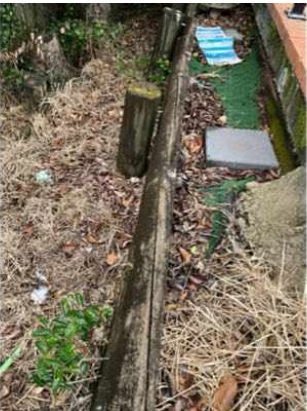
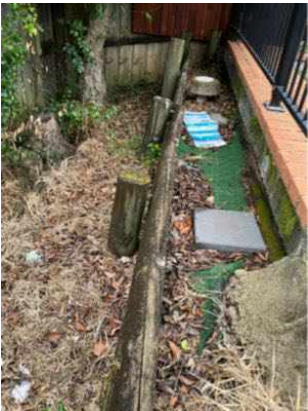
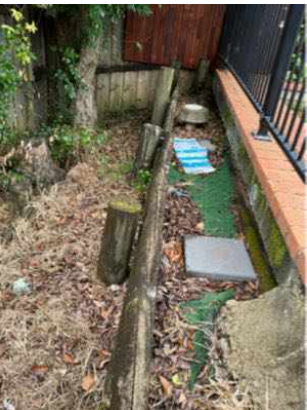
Building: Main Building
 Location: Yard - Back
 Finding: Retaining wall - Defective
 Information: The retaining wall in this area was found to be defective at the time of inspection. Generally, defective retaining walls are caused by poor original design or material use. However, deteriorated retaining walls may also be a result of substandard construction, poor site drainage or unmanaged stormwater flows.

If left unmanaged, the retaining wall may become a safety hazard if it continues to destabilise. Where retaining walls further rot and decay, an environment is created that is conducive to termite and pest infestation.

Significant repair and replacement should be expected. Where retaining walls are considered structural walls, a structural engineer / surveyor should be consulted regarding required remedial works. Otherwise, a landscaper or retaining wall installer may be appointed to repair or replace the wall, at the discretion of the client.

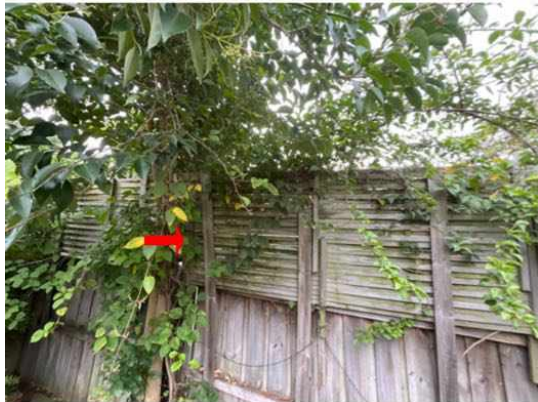
Finding 3.08

Building: Main Building
Location: Yard - Back
Finding: Leaning timber fence
Information: The fence is leaning, deviating from its vertical position, compromising its stability and aesthetic appeal.

The leaning fence poses a risk of collapse, potential property damage, and a security breach, diminishing its effectiveness as a barrier.

A skilled fencing contractor or handyman is needed to assess and rectify the leaning fence. Timely repair is crucial to restore the fence's stability and prevent further damage or safety hazards.

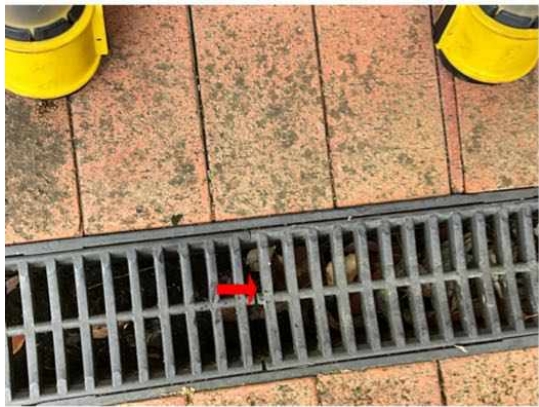
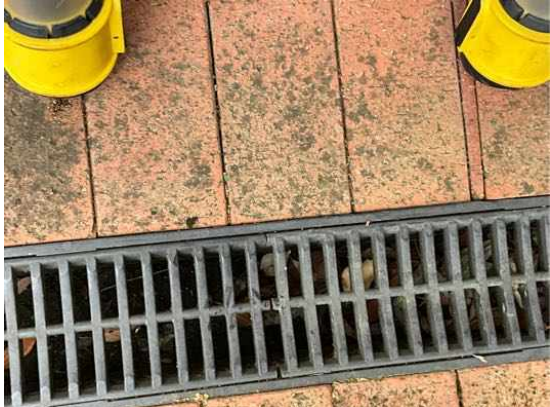
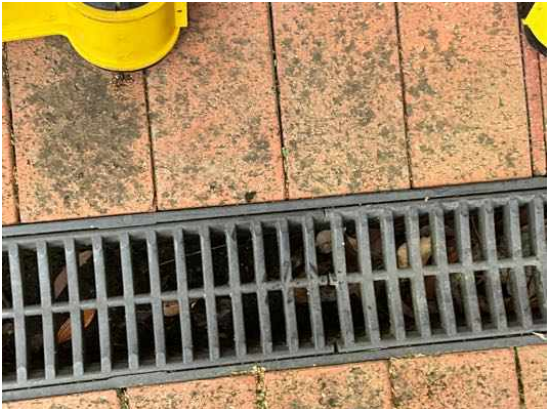
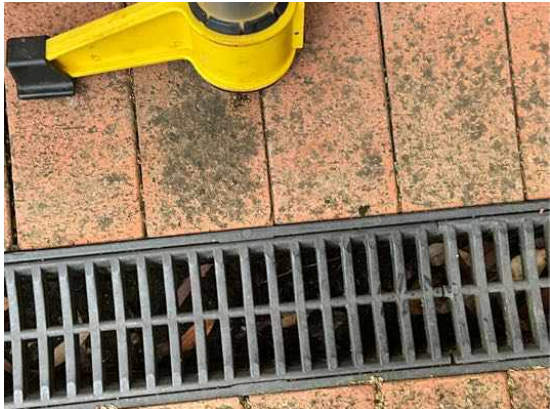
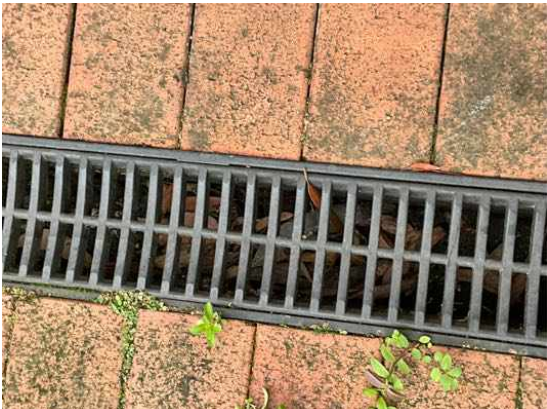
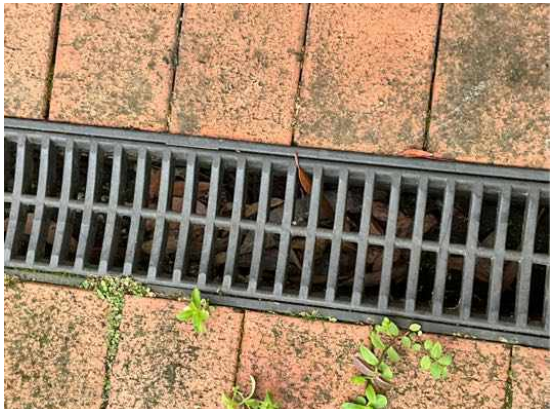
Finding 3.09

Building: Main Building
Location: All Areas
Finding: Blocked channel Drain
Information: Blocked channel Drain , observed vegetation grown in the gutter , advised channels to be cleaned.

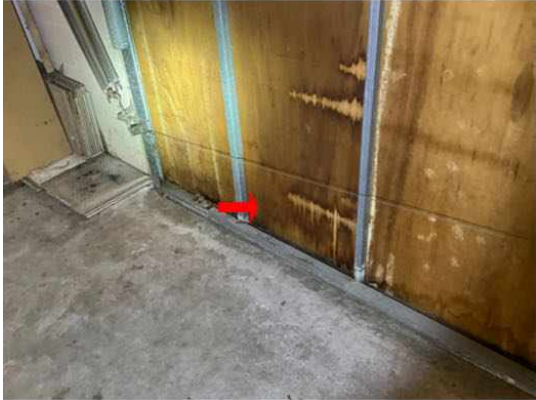
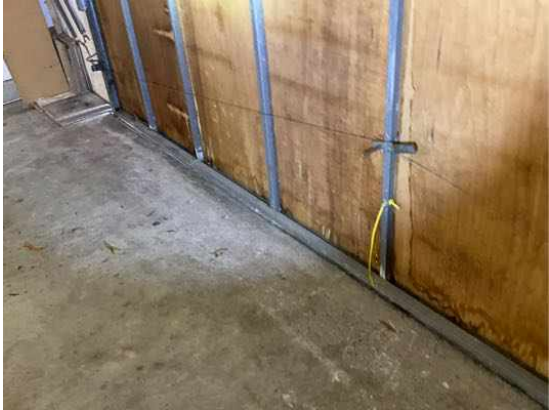
Finding 3.10

Building: Main Building
Location: Garage
Finding: Water staining
Information: Water staining was evident in this area at the time of inspection. Water staining indicates that surfaces have been exposed to excessive moisture over time. The minerals and other elements in the water lead to staining, which may graduate to corrosion and deterioration if left unmanaged.

While mostly an appearance defect, water staining can be indicative of more serious defects, which may be currently concealed by other building elements.

Where water staining is active, a licensed plumber must be consulted to identify the cause of the staining and to provide advice on any reparation works that may be required. Replacement of any broken or damaged structures is advised.

Conversely, where water staining is old and inactive, affected building materials may be repaired or replaced at client discretion. A qualified carpenter or registered builder may be appointed to perform these works.

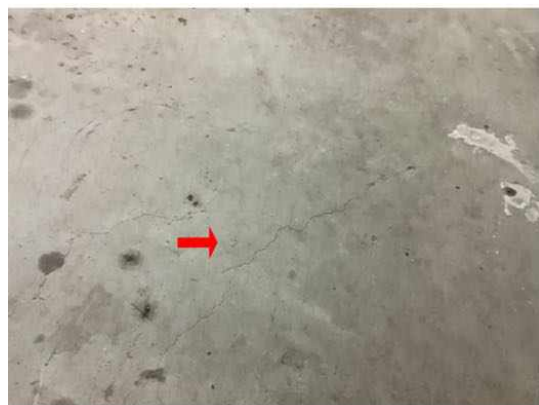
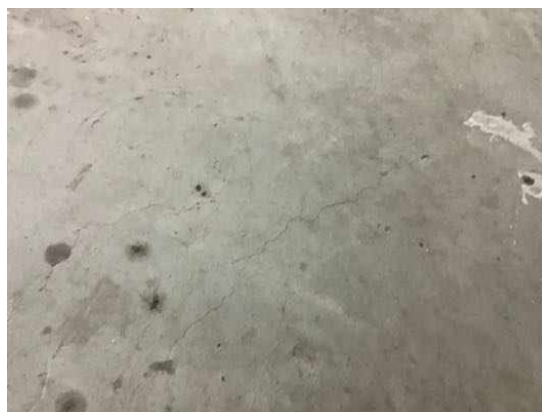
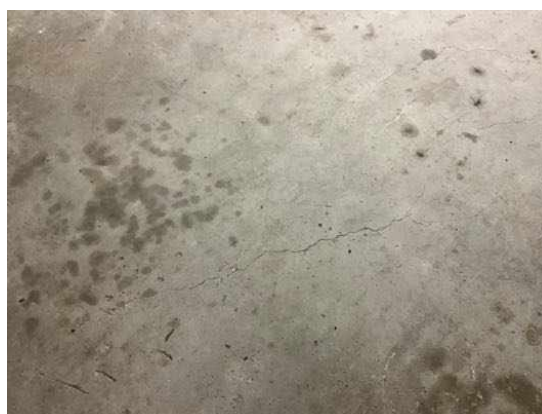
Finding 3.11

Finding: Crack in concrete slab - Category 0
 Information: A crack coded as Category 0 was identified in the slab. A Category 0 crack is described as a hairline crack, representing insignificant movement of slab from level.

The approximate width of the crack to be considered Category 0 is 0.3mm, or change in offset of less than 8mm when a 3m straight edge is placed over the defect.

No rectification is required at this time. However, all cracking should be monitored over a 12 month period to identify any further damage in the area.

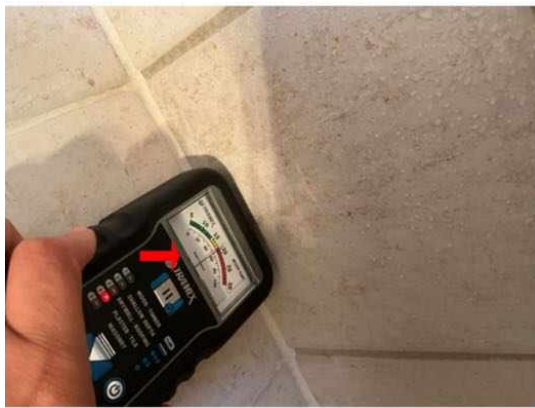
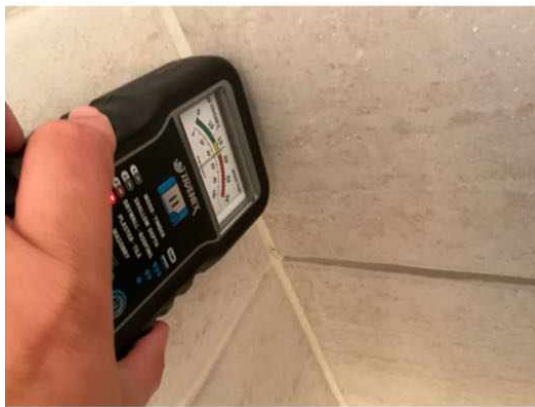
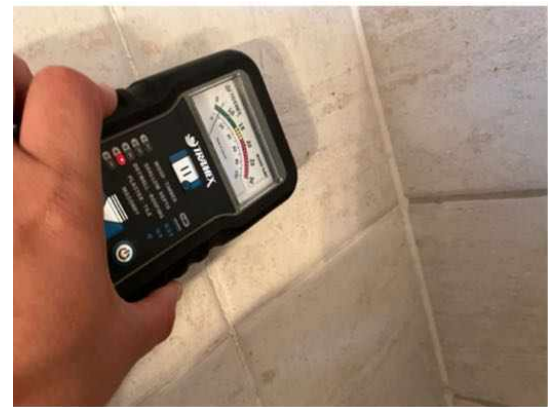
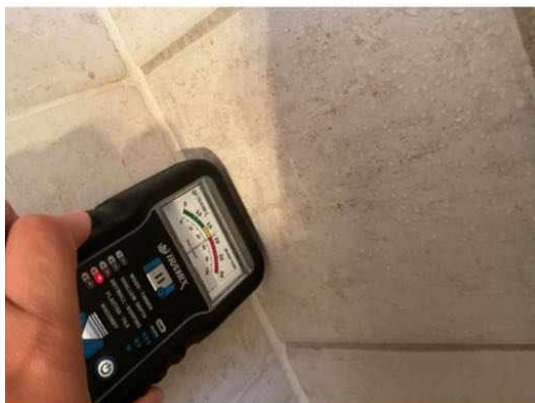
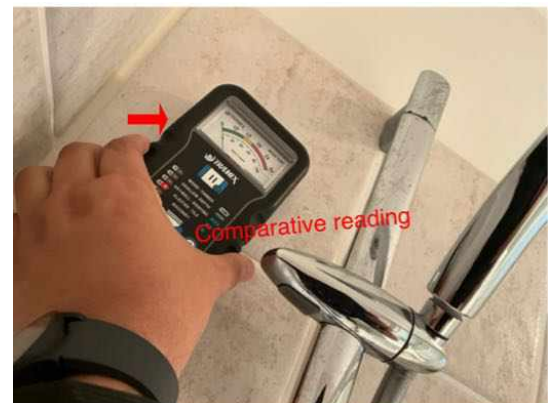
Building:	Main Building
Location:	Ensuite
Finding:	Shower - Damp
Information:	Damp is evident to the lower 300mm of wall to the shower alcove. This defect is quite common, and is suspected to have been caused by moisture permeating through the grouting in this area, which shows evidence of deterioration. Leaking pipes within the adjoining wall is also a possible cause.

Damp (or structural damp) refers to the presence of unwanted moisture in the structure of a building, either as the result of intrusion from outside, or condensation from within the structure. In the shower area, internal water leaks or other sources of excessive moisture are generally the cause of damp.

Unmanaged damp in the shower recess is likely to facilitate the formation and development of mould and fungi growth, decaying associated building materials and compromising their structural integrity. It is important to address damp conditions, as the World Health Organisation notes that excess moisture leads - on almost all indoor materials - to growth of microbes such as moulds, fungi and bacteria, which

Consultation with a qualified plumber or bathroom specialist is advised immediately to identify the cause of damp and to perform remedial works as required. Where excessive mould growth is present, further inspection by a specialist environmental health inspector should also be considered.

Always ensure that sealant and grout is in good condition to prevent any moisture issues occurring in the future.

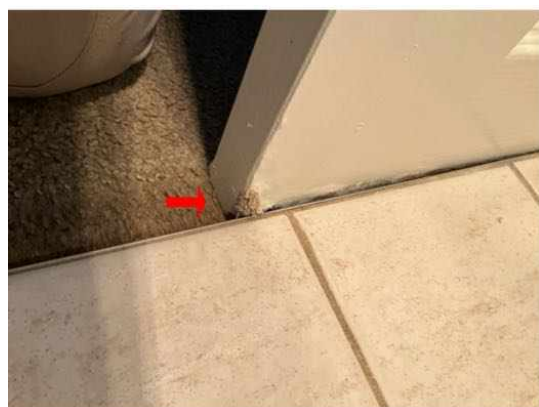
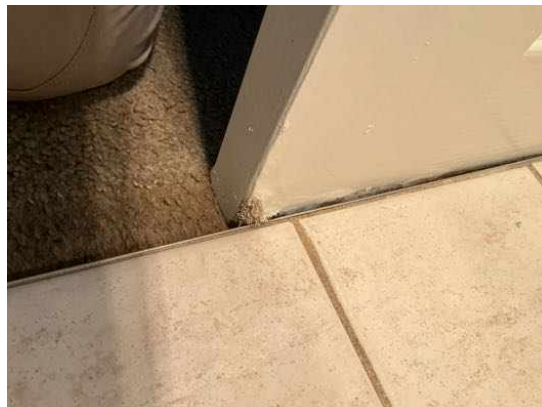
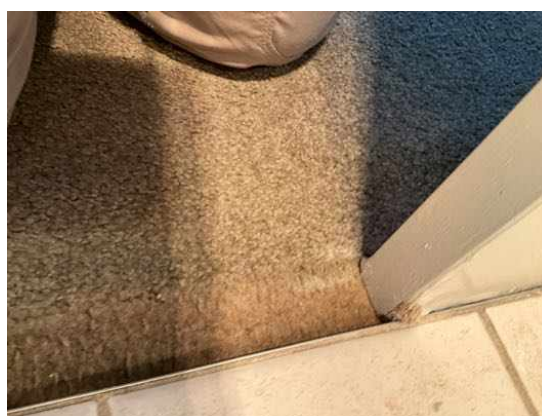
Finding 3.15

Building:	Main Building
Location:	Ensuite
Finding:	Water damage
Information:	The door in the shower area has sustained water damage, resulting in swelling and discoloration of the wood, as well as potential structural issues. This damage compromises both the aesthetic and functional aspects of the vanity."

1. **Carpenter or Woodworker:** They can assess and repair the damage to the vanity, potentially replacing any irreparable parts.
2. **Plumber:** If the water damage is due to plumbing issues, a plumber can fix leaks and ensure there are no further water-related problems.
3. **General Contractor:** If the damage is extensive and affects the surrounding area, a general contractor can coordinate the repair work, including both the vanity and any related structural or cosmetic repairs.

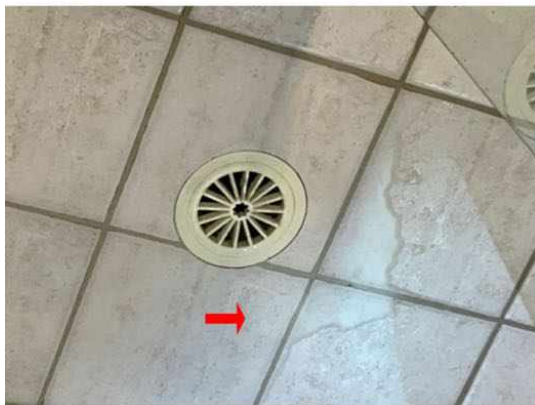
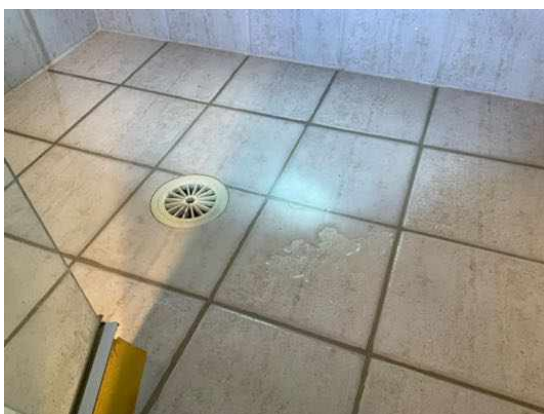
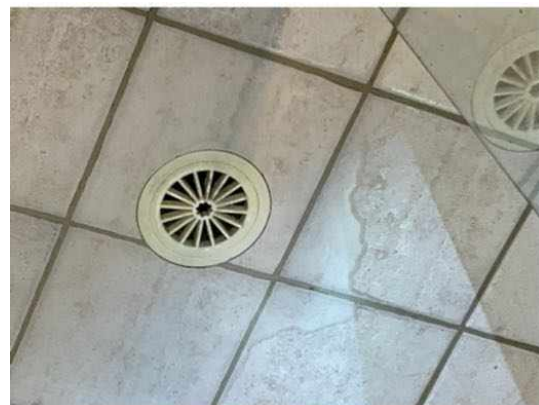
Finding 3.16

Building:	Main Building
Location:	Ensuite
Finding:	Shower base - Water pooling
Information:	Evidence of water pooling around the floor waste in the shower recess was noticed at the time of inspection. It is suspected that this excessive moisture is attributed to insufficient fall in the shower floor tiles.

This pooling is minor overall but is still considered unsatisfactory, as standard tiling practices would not permit this situation to occur. Pooling water around floor wastes can create a slip hazard in extreme cases and create conditions that are conducive to mould growth over time. Where left unmanaged, the degradation of sealant and grouting is also likely to occur, possibly necessitating further repair works.

Remedial works may involve some sections of tiling and flooring repair and replacement. A tiling contractor or bathroom specialist should be appointed to provide further advice on reparation options and to perform works as necessary.

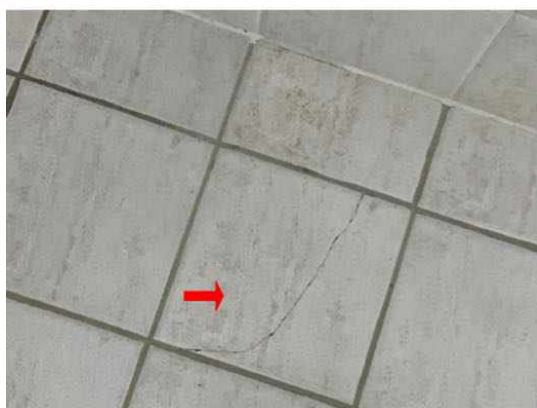
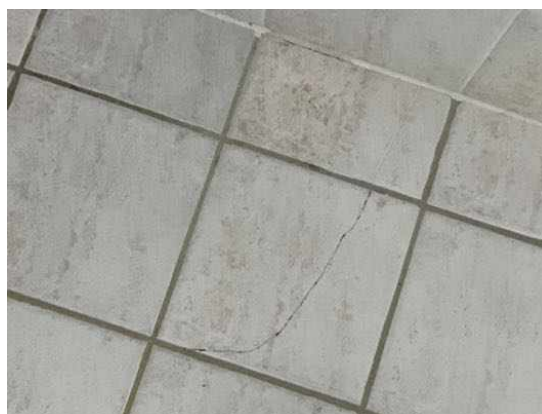
Finding 3.17

Finding:	Tiles - Cracked or damaged
Information:	Cracking was evident to the tiling in this area at the time of inspection. While the cracking appears to be minor, this area is frequently exposed to water, allowing potential for water penetration into adjoining sections of walls or flooring. If left unmanaged, water penetration to these areas may lead to subsequent water damage, which is likely necessitate repair work to affected building elements. A tiling contractor should be appointed to ensure that no further water damage occurs. The re-application of silicone and grouting throughout remaining tile work is also advised, to further protect the area against water penetration. Where water penetration has led to water damage, appointment of a relevant tradesperson may be required to repair damaged building elements.

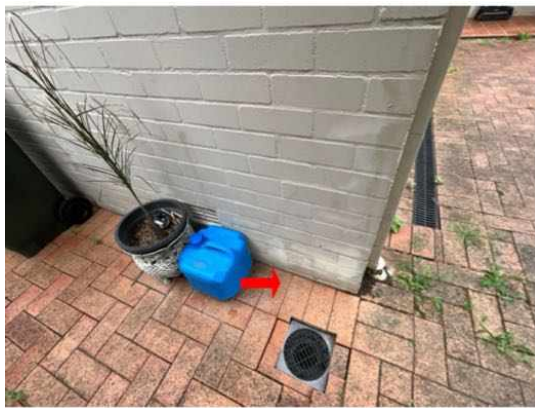
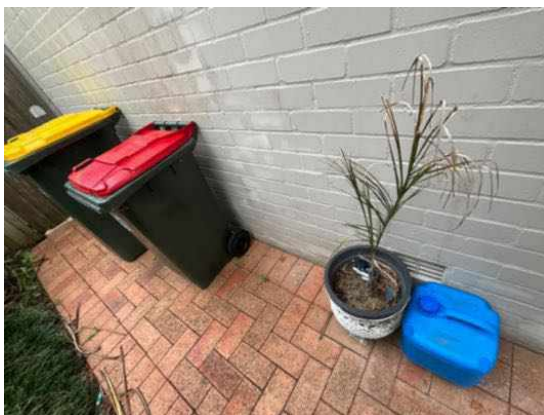
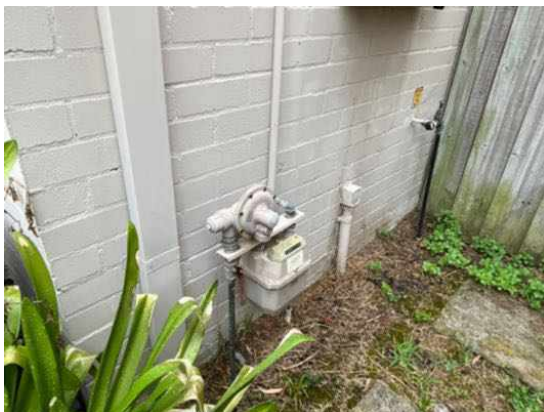
If the slab edge is not properly exposed there is a high risk of termite attack. Sometimes, in order to determine the type of slab, a suitably qualified person such as an architect or builder may be required to consult the construction plans.

Where the slab edge cannot be properly inspected, it is highly recommended that termite or timber pest inspections be carried out every 6-12 months to aid protection of the property against infestation.

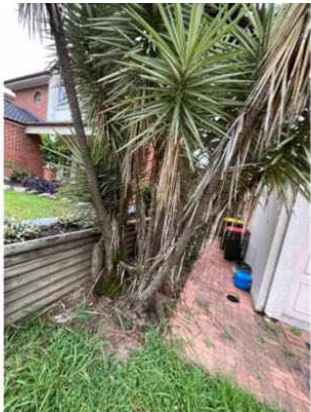
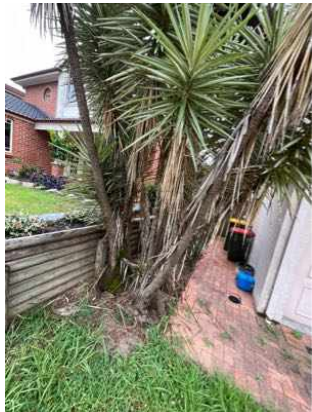
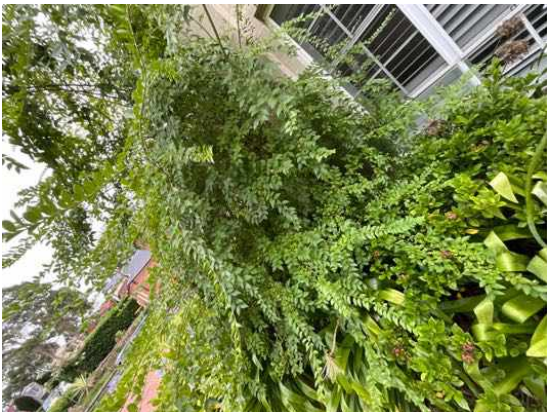
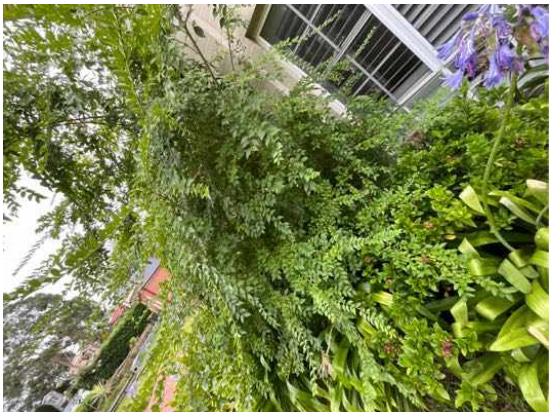
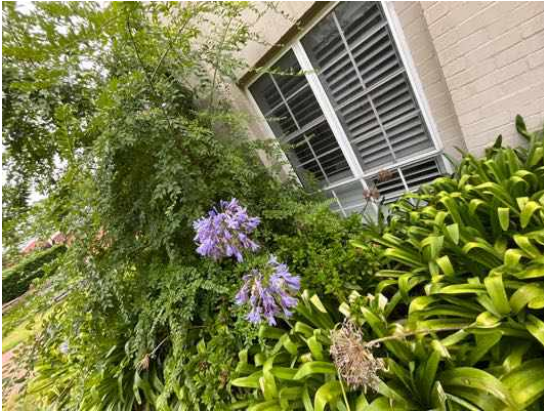
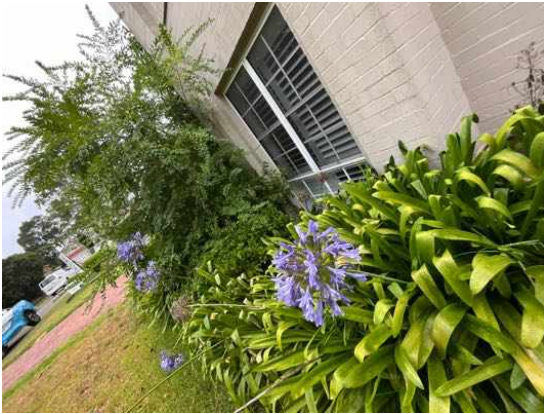
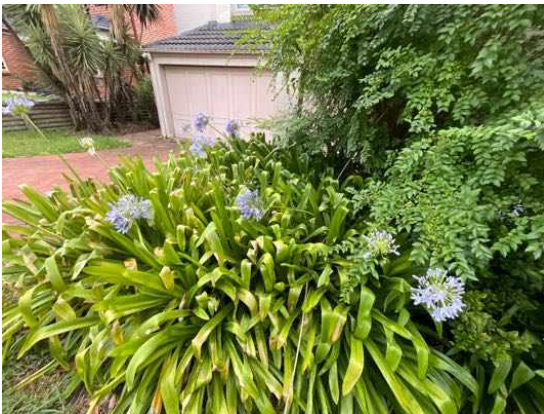
Finding 6.02

Finding: Dense vegetation around a property can increase the risk of termite infestation

Information: The presence of dense vegetation around a property can increase the risk of termite infestation, as it provides a conducive environment for them. To address this, consider maintaining a clear space between the vegetation and your home. If you suspect a termite issue, it's advisable to consult with a licensed pest control professional for inspection and treatment.

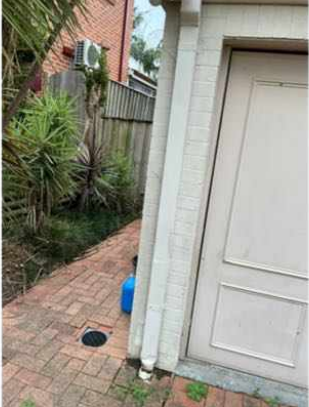
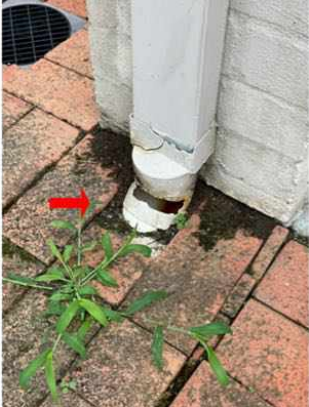
Finding 6.03

Building:	Main Building
Location:	All Areas
Finding:	Downpipes not connected- Conducive conditions for timber pest
Information:	<p>Unconnected downpipes can indeed pose a risk for attracting termites, as they provide a source of moisture near a building's foundation. Termites are attracted to moisture and wood, so it's important to address this issue to prevent potential infestations. Connecting downpipes to the stormwater system or ensuring proper drainage away from the building can help mitigate this a licensed plumber is the most qualified professional to handle plumbing-related tasks, including connecting downpipes to the stormwater system. They have the necessary expertise and tools to</p>

ensure proper installation.

Please remember that proper installation is essential to ensure effective drainage and prevent future issues, so it's often best to hire a qualified professional, especially for complex or extensive downpipe installations.
