Building and Timber Pest Inspection Report

Inspection Date: Mon, 12 Jan 2026

Property Address: 5 Skye Ct, Kellyville NSW 2155, Australia

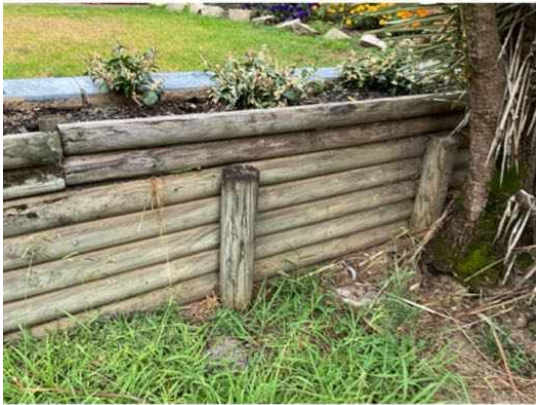
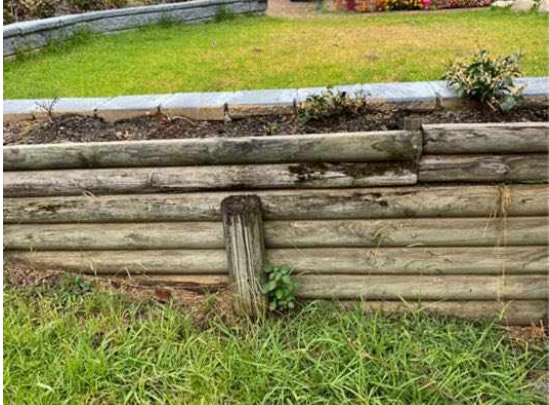
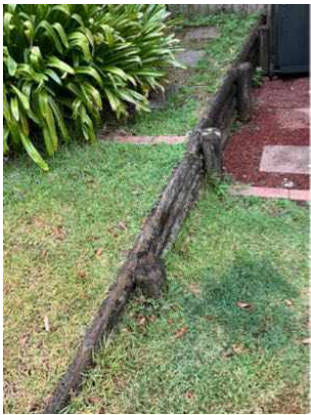
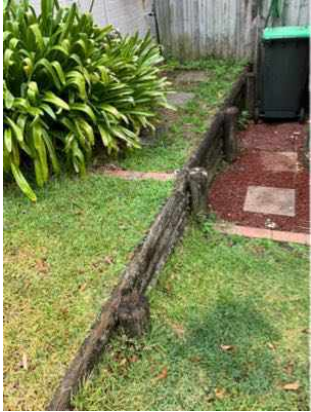
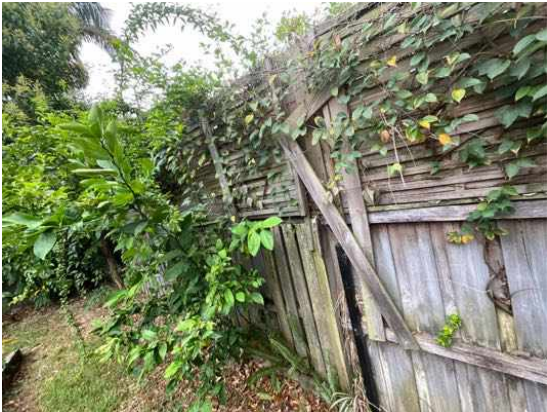
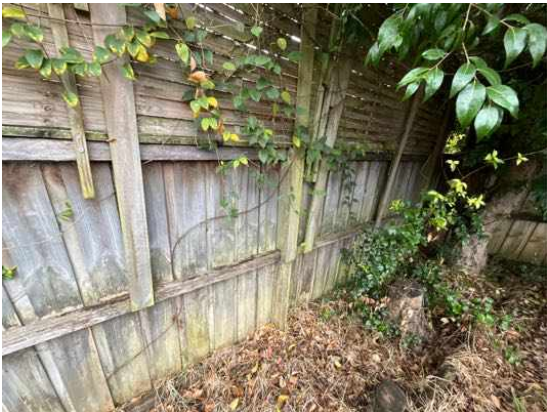
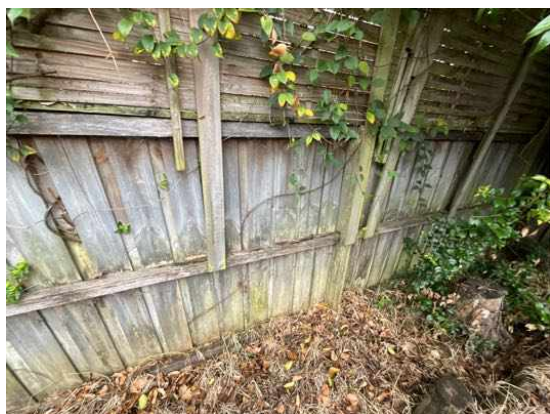
Finding 6.04

Building: Main Building
 Location: All Areas
 Finding: Timber on ground / conducive conditions to termite damage
 Information: Timber on the ground is indeed conducive to termite damage. Termites are known to thrive in moist environments, and wood in contact with soil or moisture is more susceptible to infestation.

To prevent this, it's important to keep timber elevated and away from direct ground contact. Regular inspections and proper termite control measures are also essential to protect your wooden structures from termite damage.

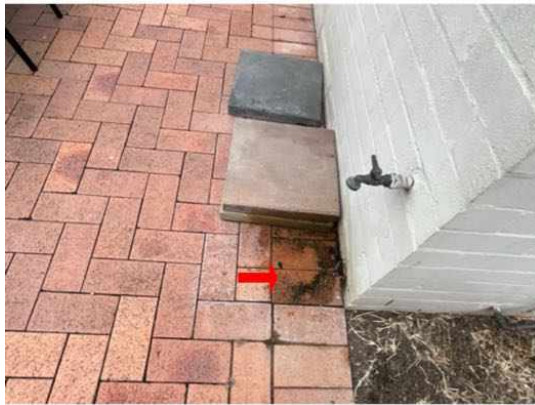
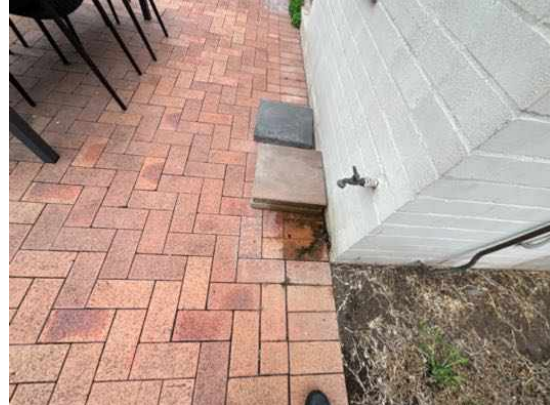
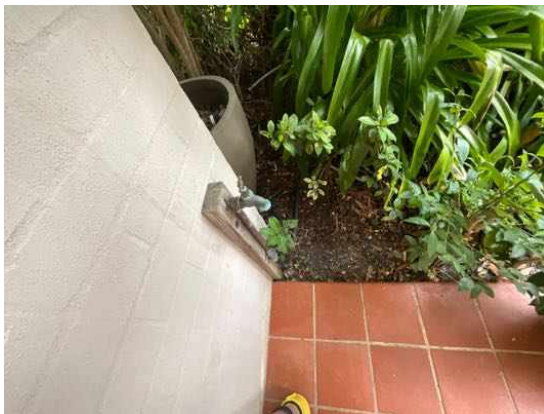
Finding 6.05

Building:	Main Building
Location:	All Areas
Finding:	No Drain under tap
Information:	There is no drain installed under the tap, leading to water accumulation and creating conducive conditions for timber pests. This defect needs immediate attention to prevent potential damage and pest infestation.

1. Water Accumulation: Without proper drainage, water can accumulate around the base of the tap, leading to persistent dampness in the surrounding area.
2. Timber Pest Infestation: The damp environment created by standing water is highly conducive to timber pests, such as termites and wood borers, which thrive in moist conditions and can cause significant damage to wooden structures.
3. Structural Damage: Prolonged exposure to moisture can lead to wood rot and deterioration of structural timber, compromising the integrity of the building.
4. Health Hazards: Persistent dampness can also promote mold and mildew growth, posing health risks to occupants.
5. Aesthetic Damage: Water stains and damage to finishes and materials around the tap area can detract from the appearance of the building and lead to costly repairs.

A licensed plumber or a qualified building contractor can address this defect by:

3. Repair and Prevention: Inspecting and repairing any existing water damage and implementing measures to prevent future water accumulation and pest infestations.

By addressing this issue promptly, you can mitigate the risks associated with water accumulation and timber pest infestation, ensuring the longevity and safety of the building.

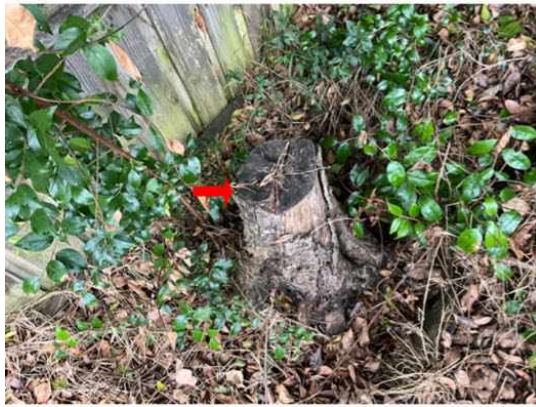
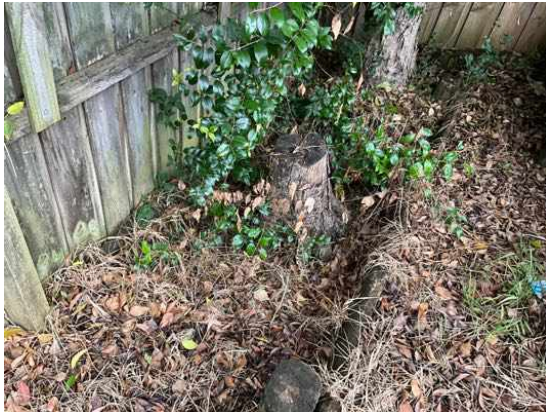
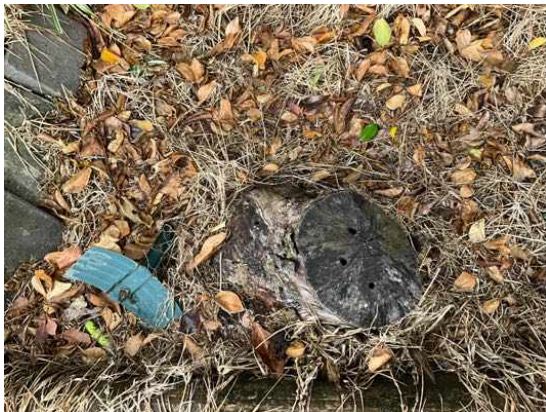
Finding 6.06

Building:	Main Building
Location:	All Areas
Finding:	Cut and Exposed tree Stumps
Information:	The tree stump, which has been cut and exposed, poses a potential risk of termite infestation due to its increased vulnerability to termite attacks.

Please contact Licenced pest controller for further advice. Pictures attached for your reference.

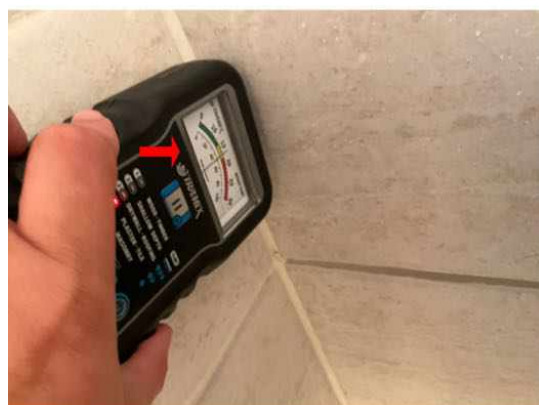
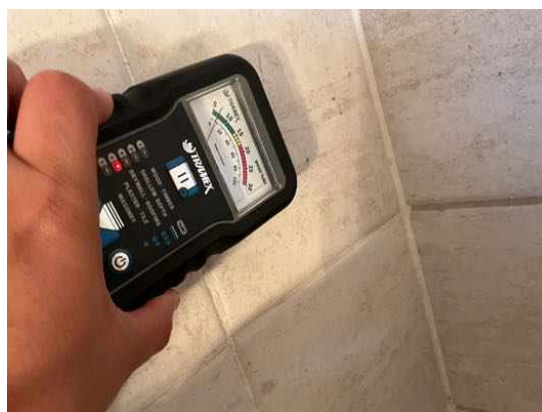
Finding 6.07

Building:	Main Building
Location:	Ensuite
Finding:	Excessive moisture - Conducive to Timber pest
Information:	Excessive moisture can attract termites and produce conditions that promote fungal growth and wood decay.

Excessive moisture is generally caused by deteriorated inadequate or missing roof drainage leaking plumbing pipes or fixtures poorly plumbed HWS overflows or condenser units and poor site drainage.

If mould growth has been found there may be environmental biological or health

issues involved. In these cases an appropriately qualified inspector should also be contacted.

Prior to any remedial works being performed a qualified plumber should be appointed to further inspect the property and to identify the cause of the excessive moisture. Works to remove affected building elements may then be necessary and should be performed by an appropriate tradesperson.

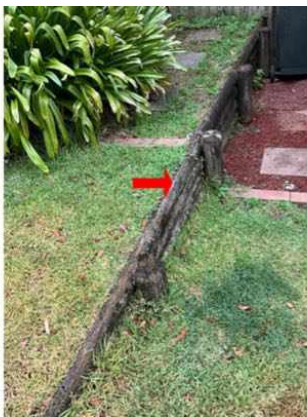
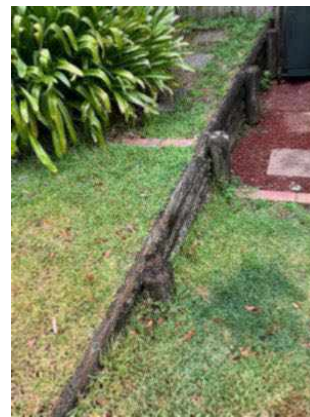
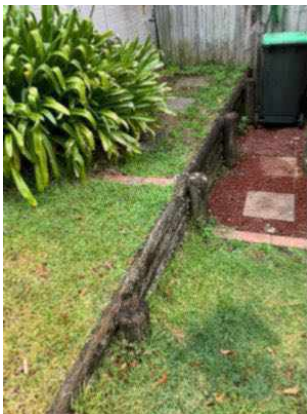
Finding 7.01

Building:	Main Building
Location:	All Areas
Finding:	Wood rot
Information:	This building element shows evidence of wood rot. Wood rot, also known as Fungal Decay, occurs when timbers and other cellulose building materials are exposed to damp conditions on an ongoing basis. This could be the result of exposure to weathering over a prolonged period of time, or the attraction of excessive moisture from other abutting building materials. Contributing factors also include poor air ventilation in the area.

Wood rot is often associated with general damp problems and is evidenced by a 'musty' smell or mould and mildew occurring on surfaces. If left unmanaged, damp conditions can lead to further health problems and the decay of timbers will continue.

Early intervention and regular maintenance, particularly of exterior timbers, will prolong the useful life of these building elements. Prior to any works being performed, the cause of the moisture that has created the visible wood rot should be identified and addressed in a suitable manner. Replacement of affected timbers may then be a necessary step in protecting surrounding building elements from such deterioration.

A qualified plumber may be appointed to assess the cause of excessive moisture and to provide advice on any remedial works as required. A qualified carpenter or registered builder may also be required to replace affected building materials.

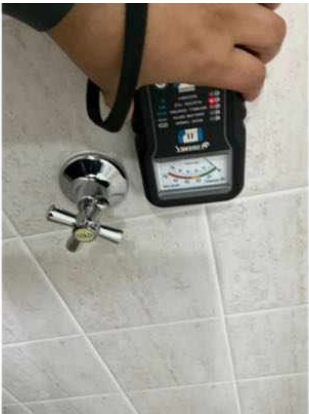
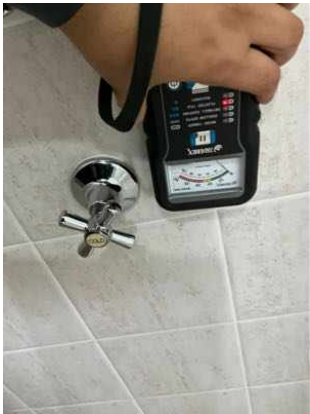
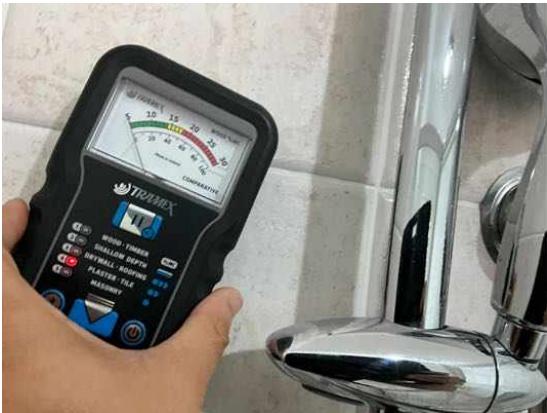
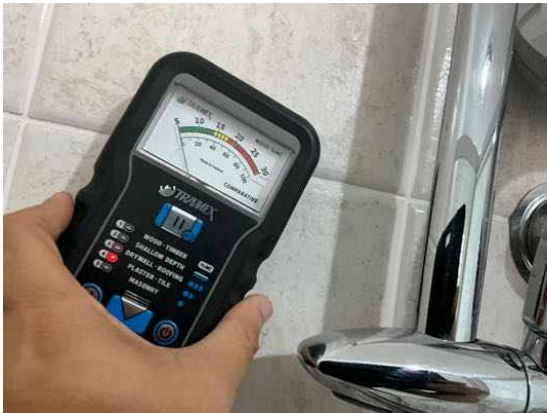
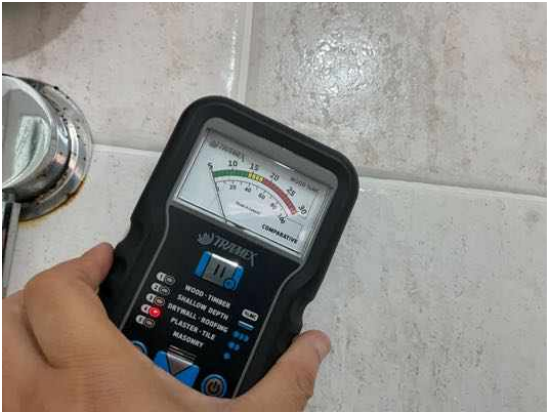
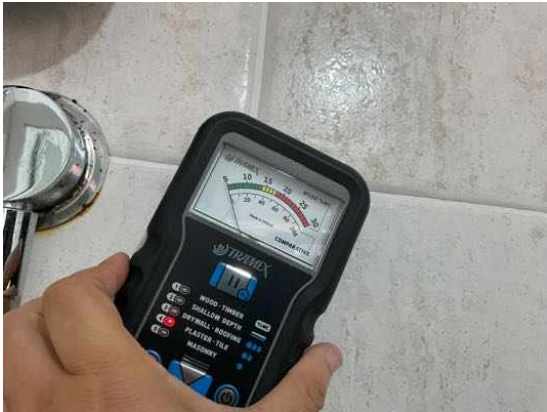
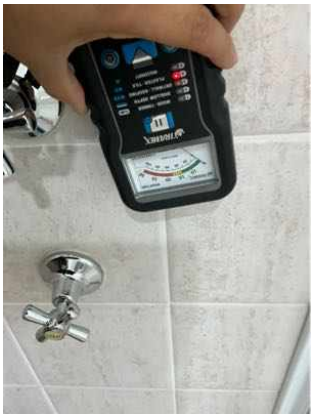
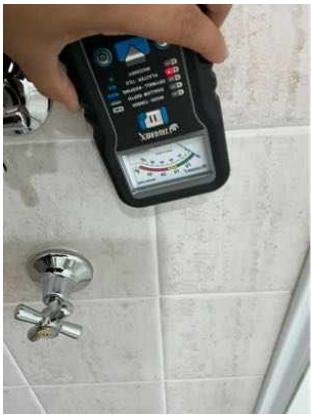
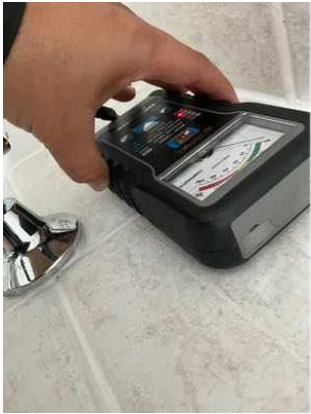
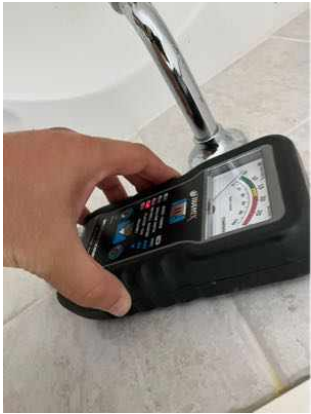
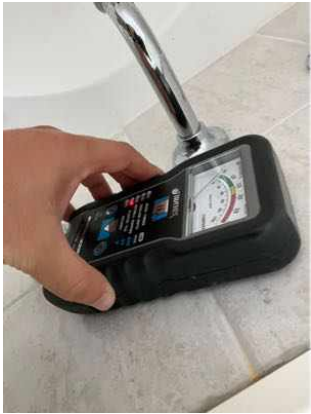
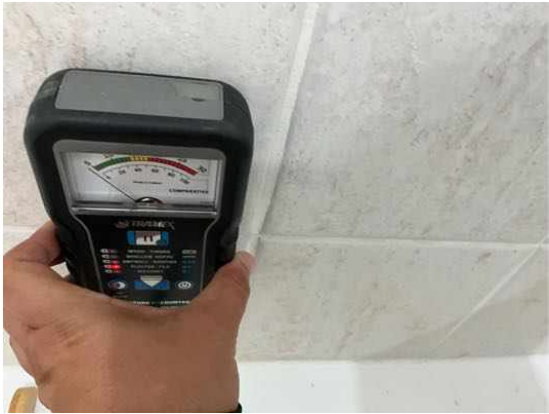
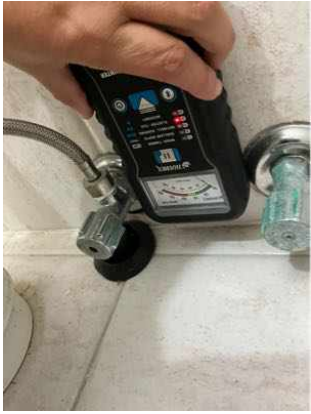
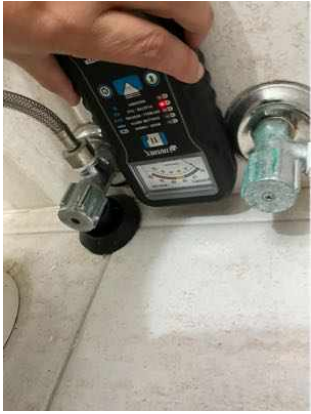
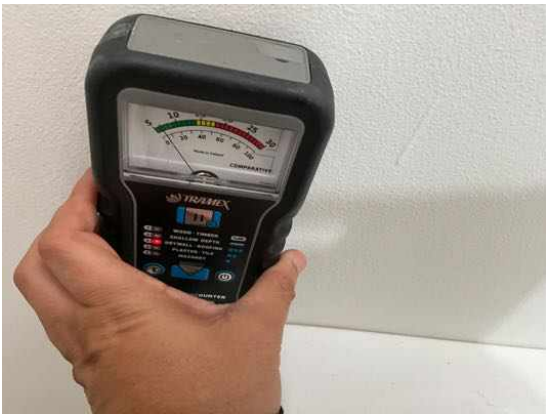
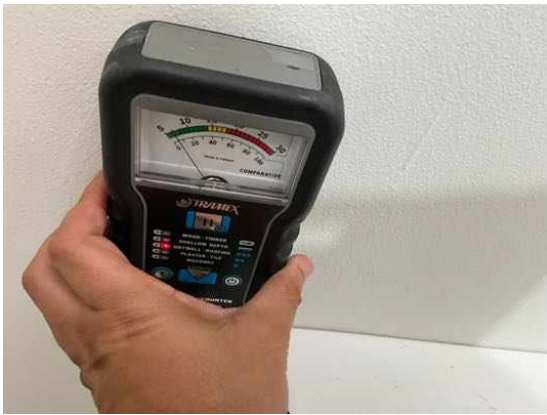
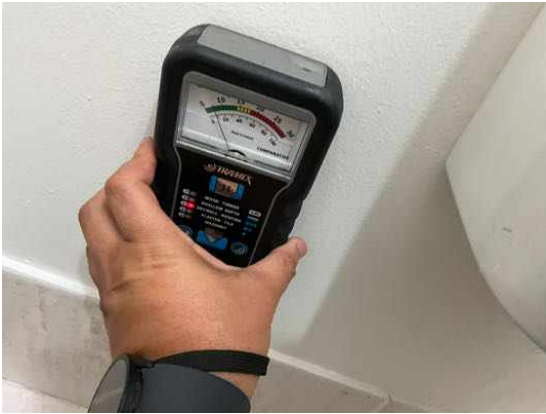
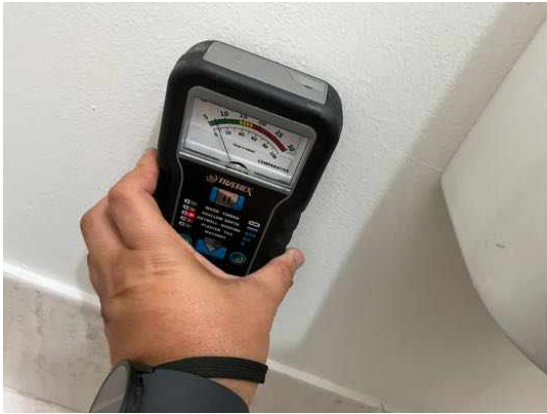
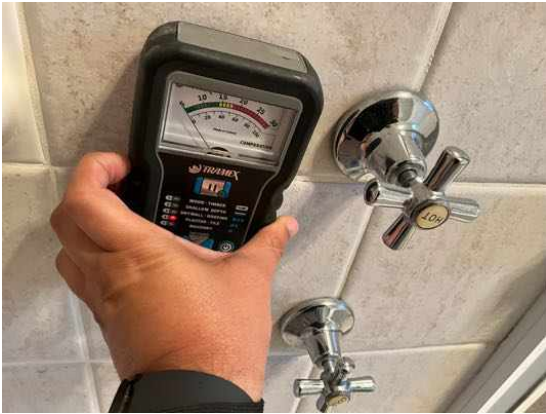
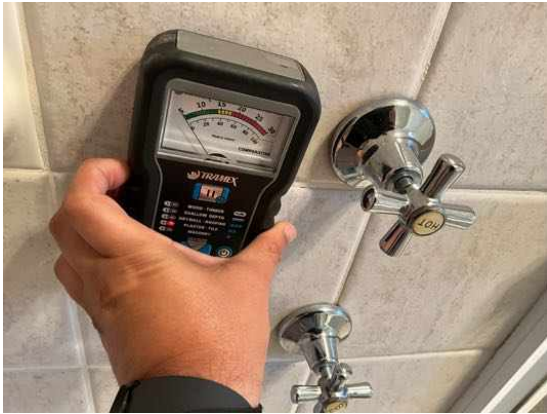
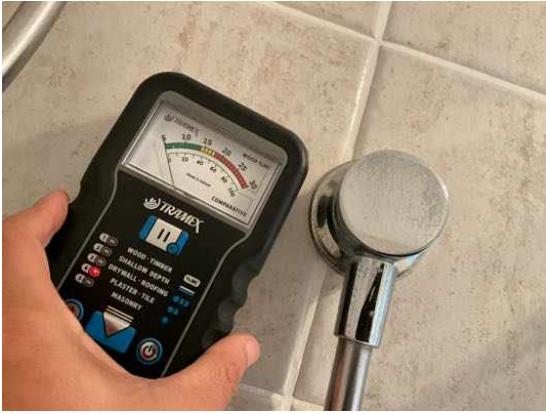
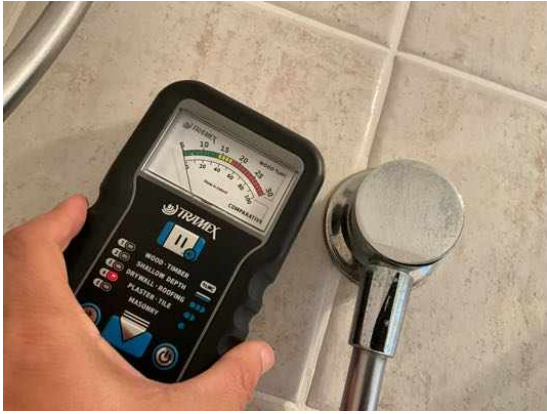
- Building: Main Building
- Location: All Areas
- Finding: Additional Photos
- Information: Additional photos are provided for your general reference

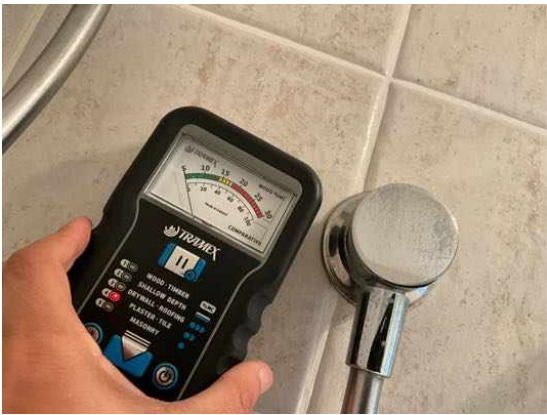
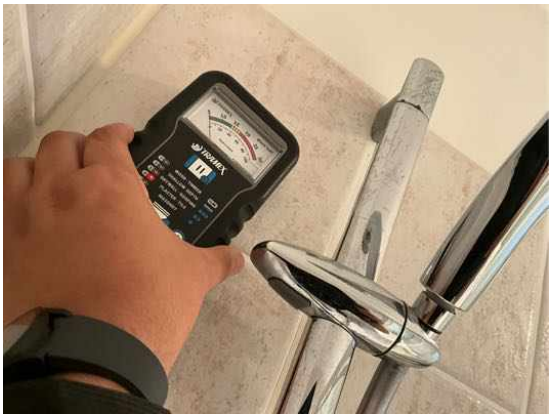
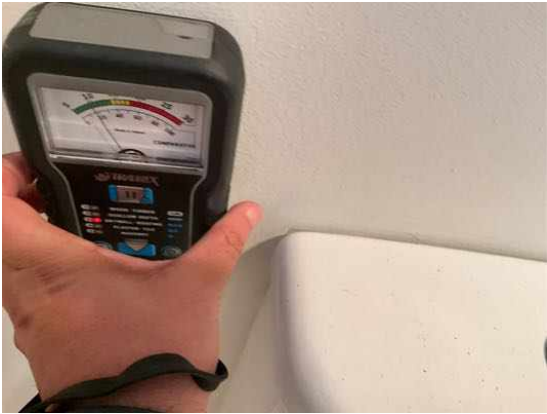
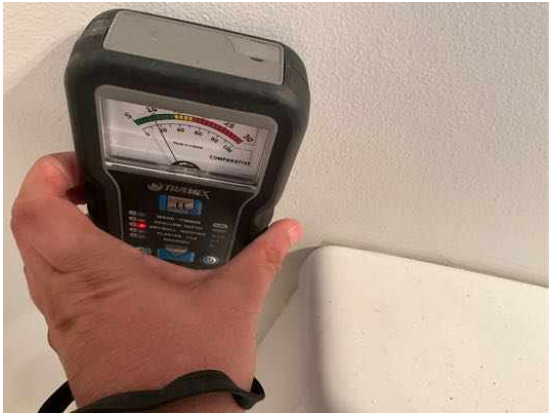
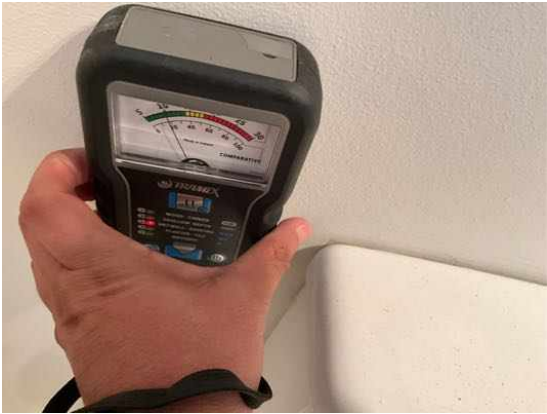
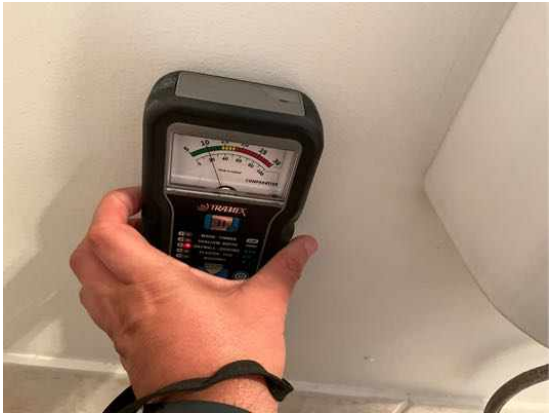
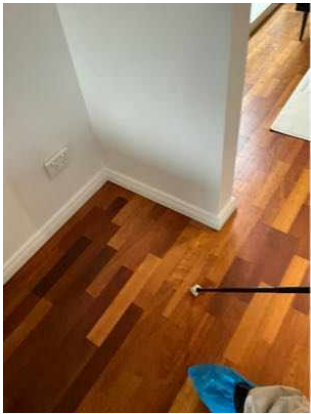
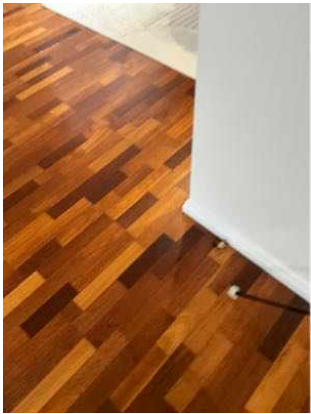
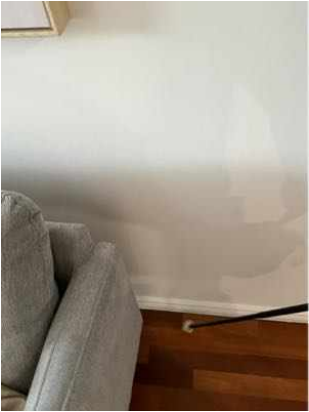
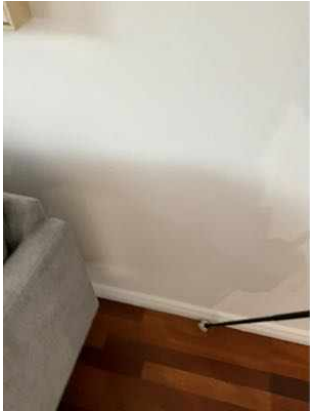
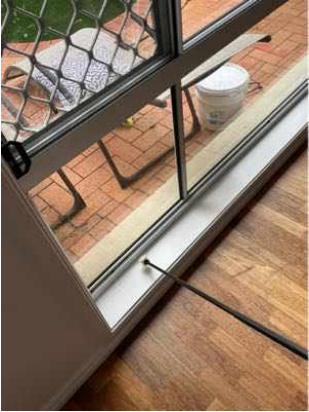
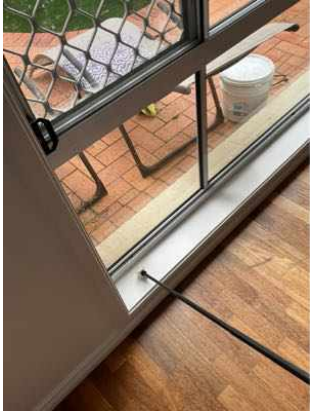
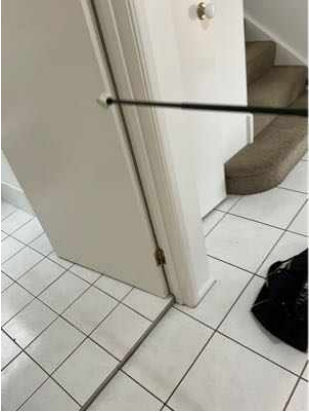
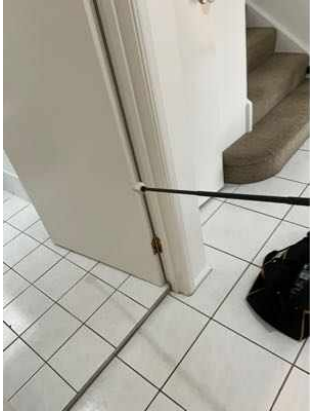
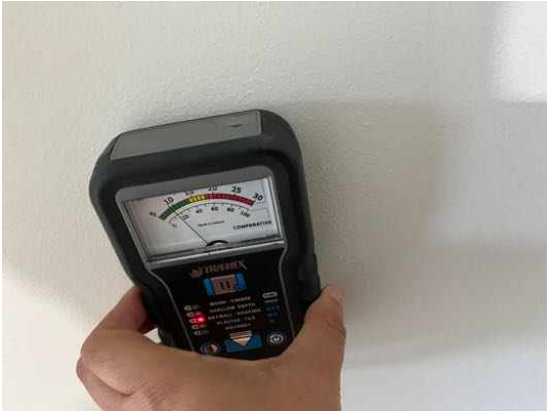
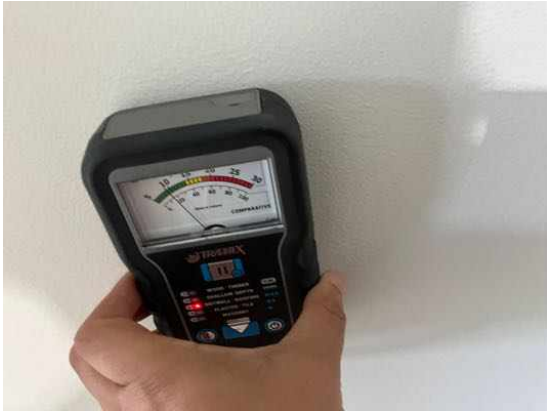
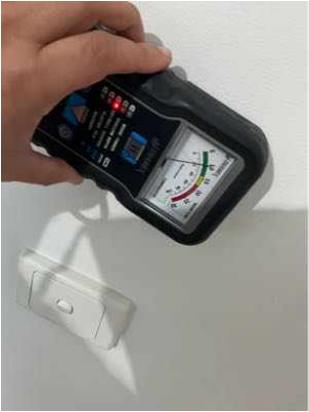
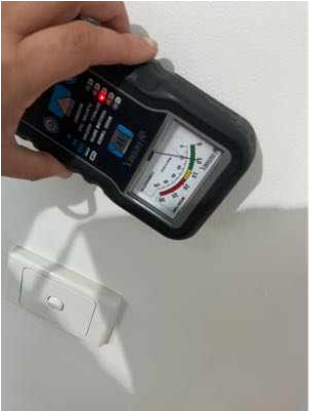
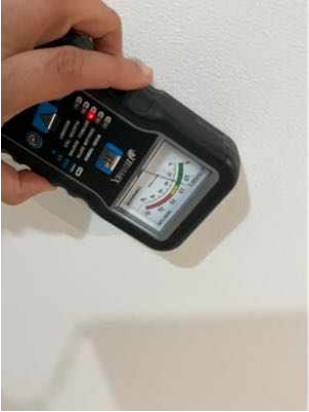
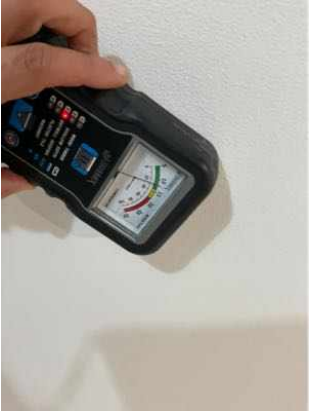
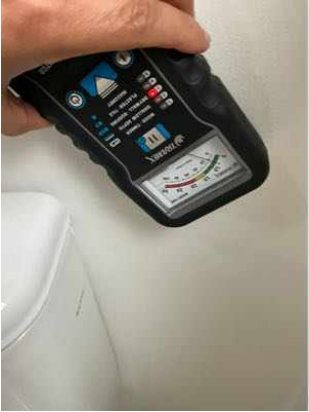
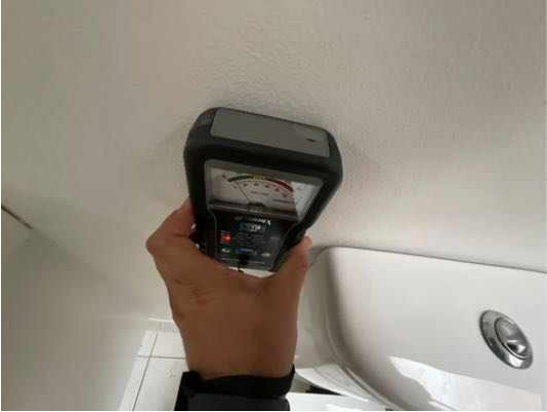
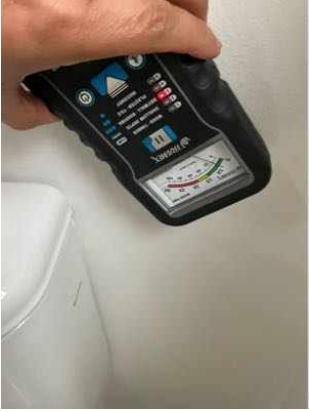
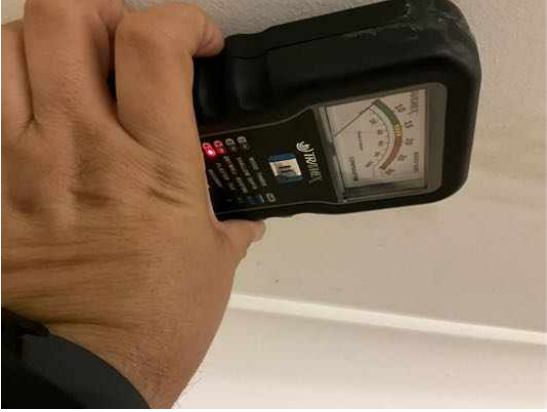
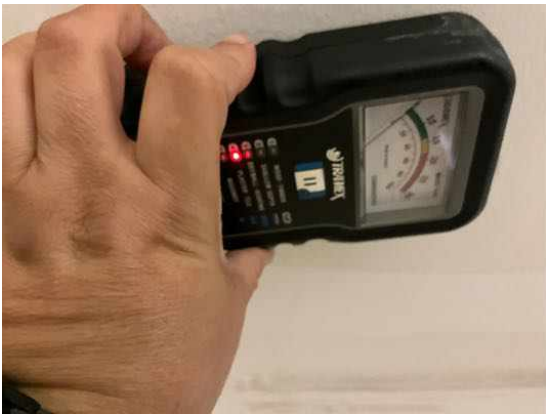
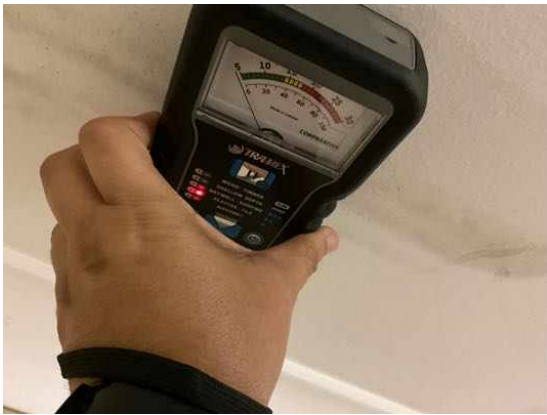
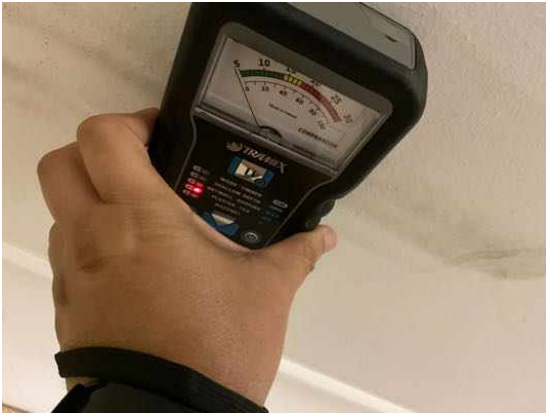
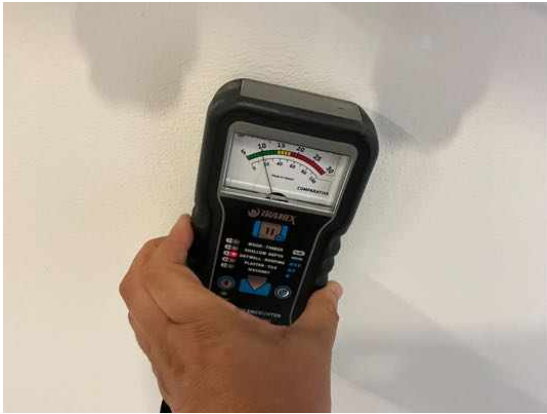
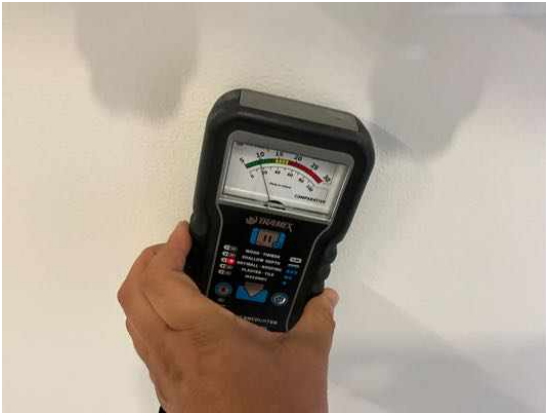
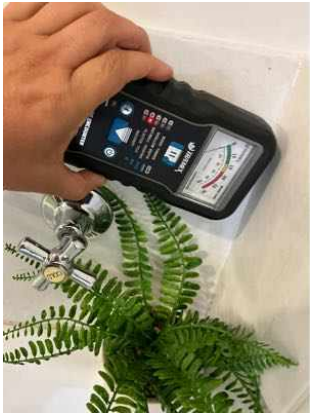
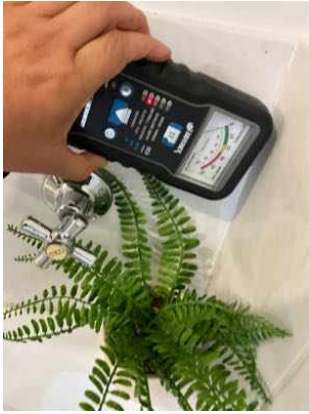
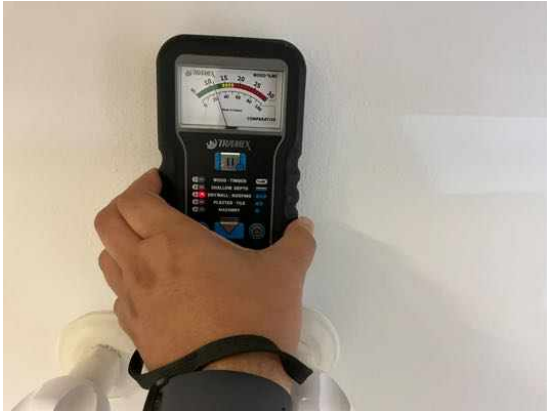
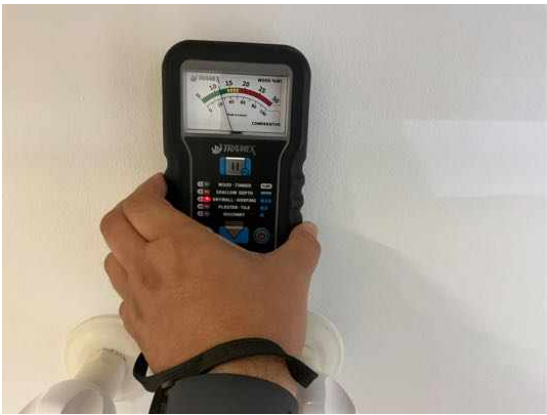
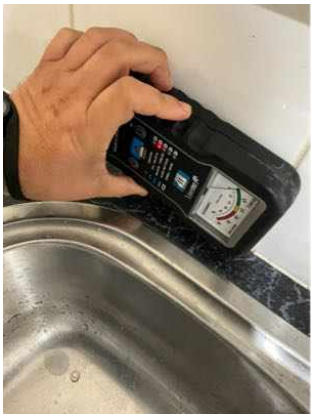
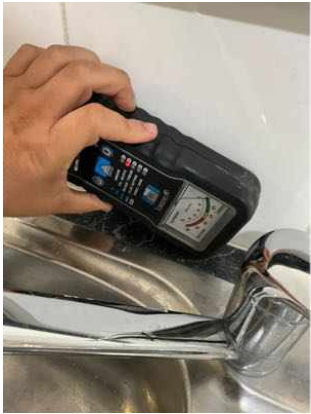
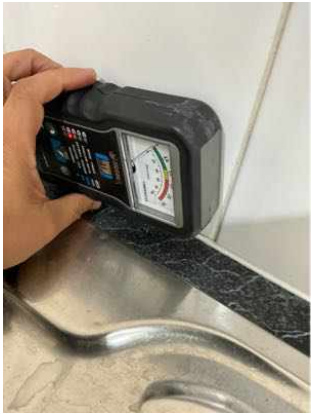
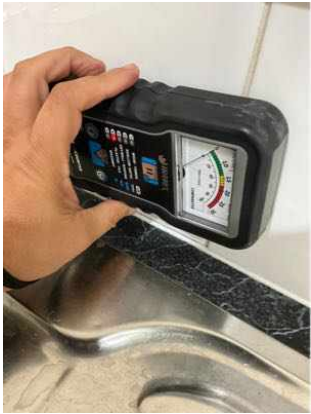
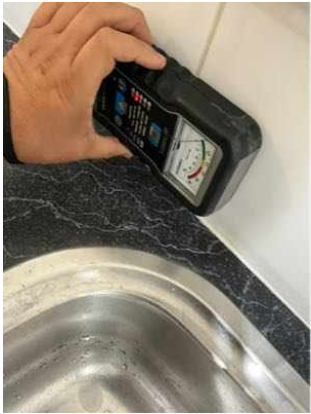
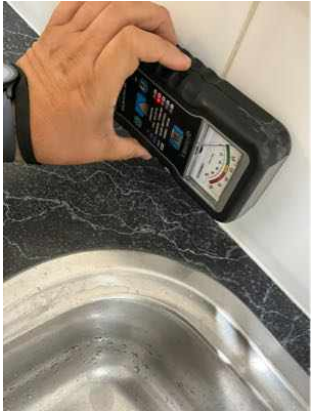
Noted Item

Building: Main Building
Location: All Areas
Finding: Additional Photos - Obstructions and Limitations
Information: These photographs are an indication of the obstructions and limitations which impeded full inspection of the property at the time of inspection. These obstructions can hide an array of defects and should be removed to allow full inspection to be carried out. A re-inspection is recommended once the areas are made accessible.
