Building and Timber Pest Inspection Report

Inspection Date: Mon, 12 Jan 2026

Property Address: 5 Skye Ct, Kellyville NSW 2155, Australia

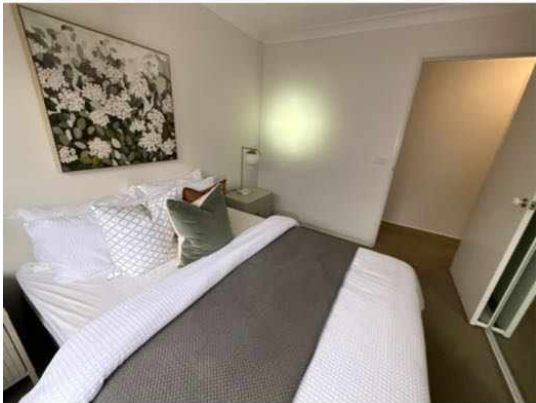
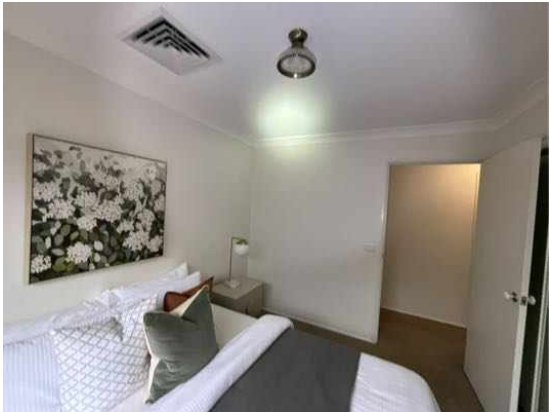
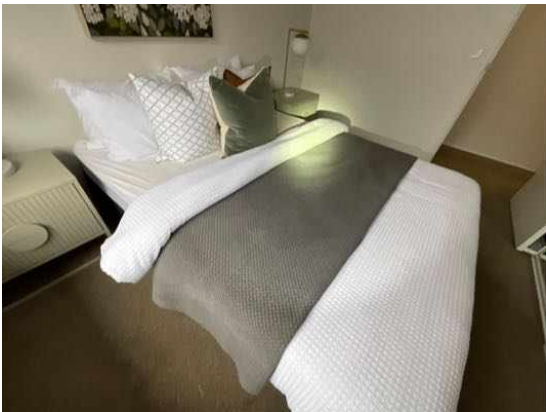
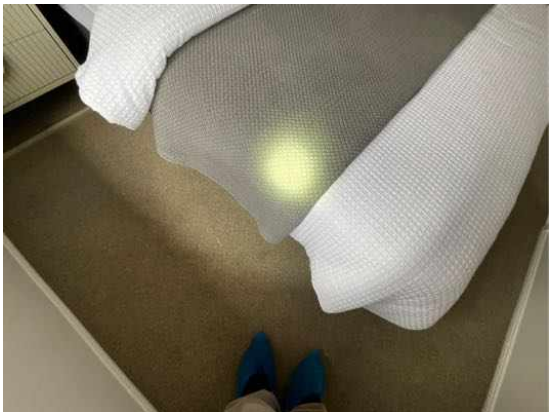
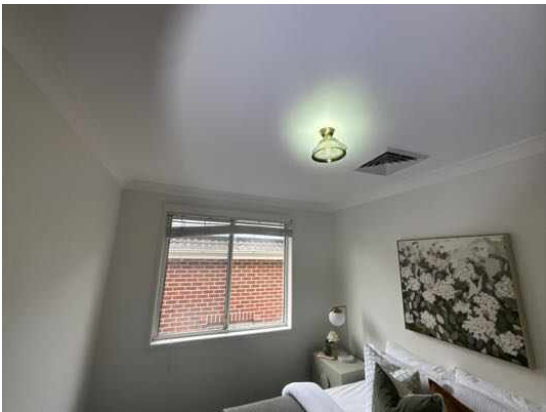
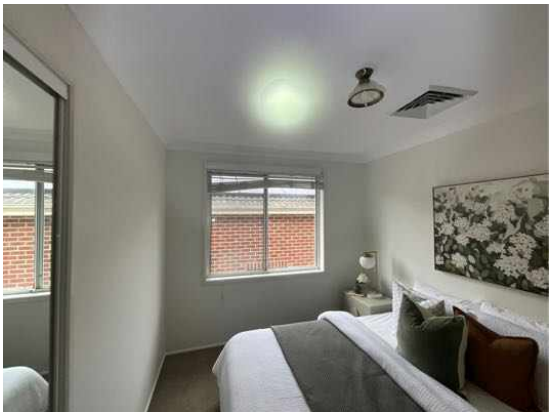
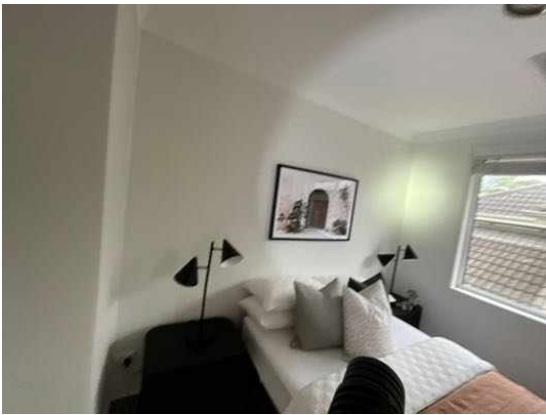
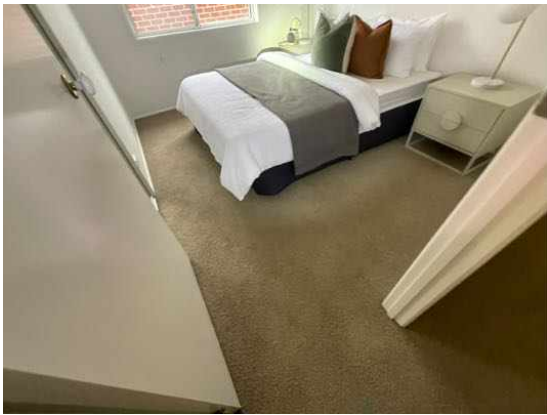
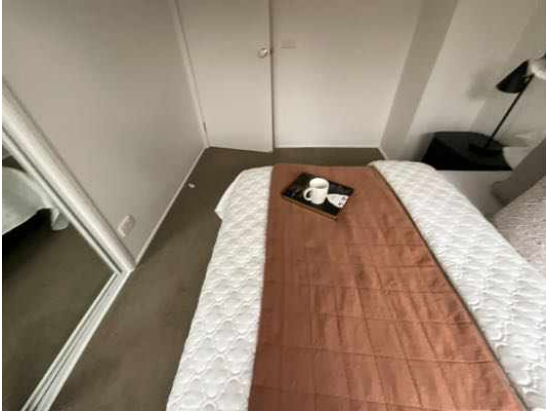
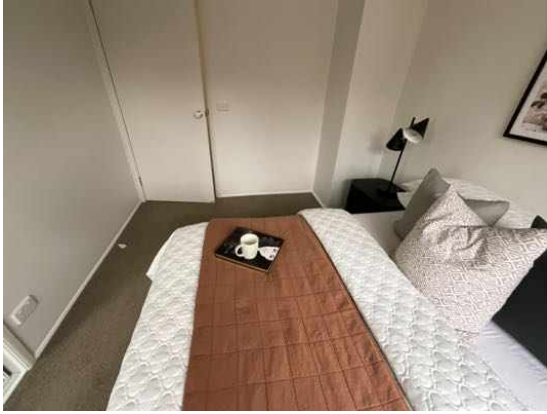
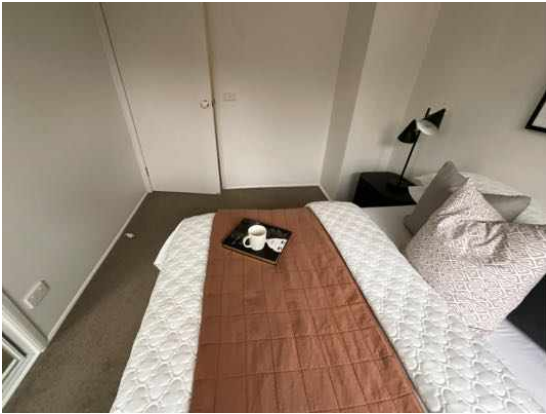
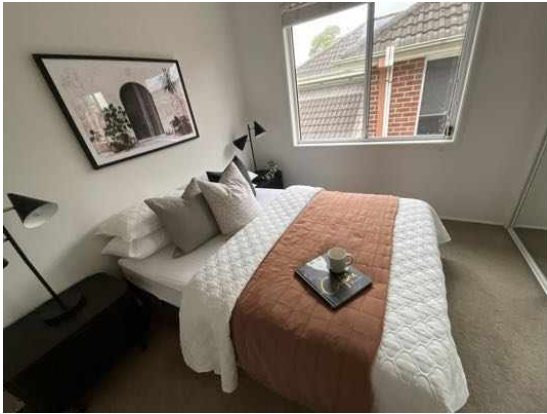
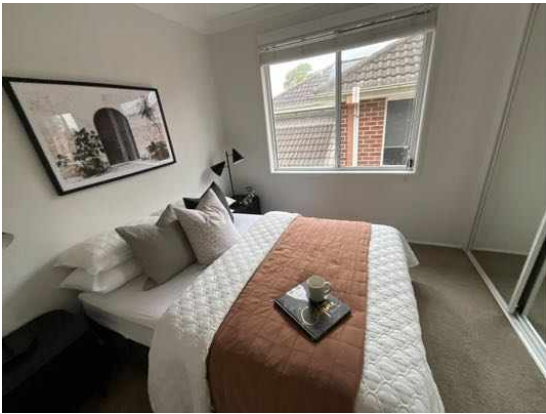
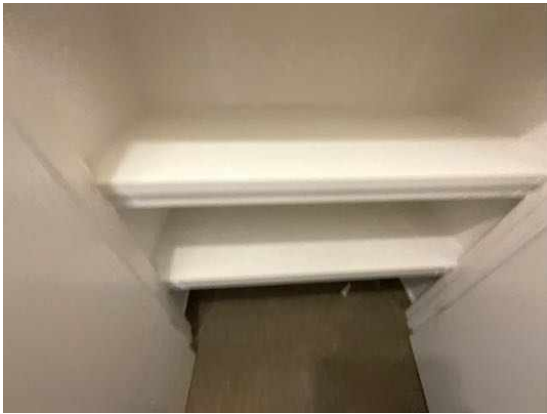
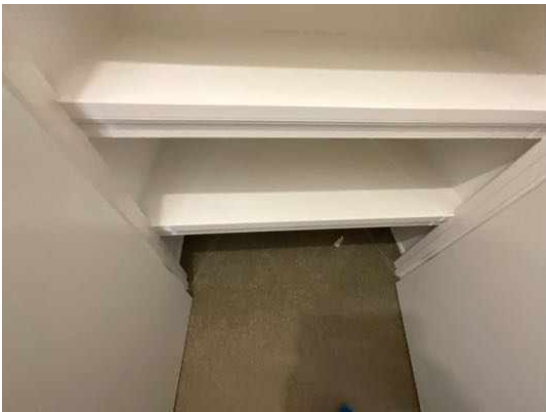
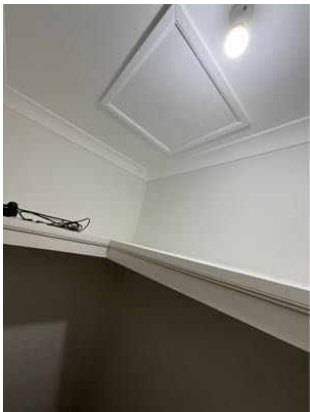
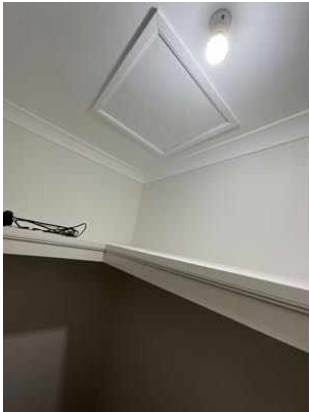
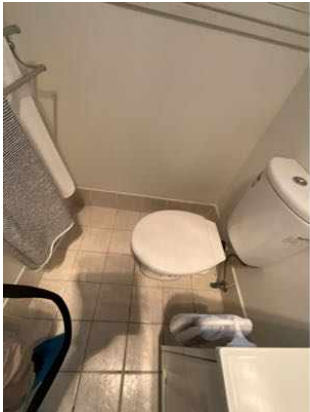
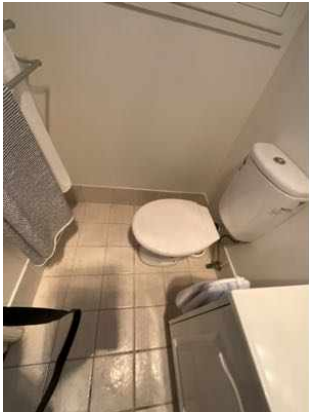
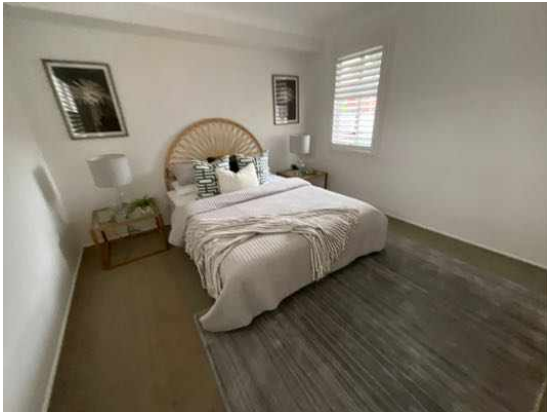
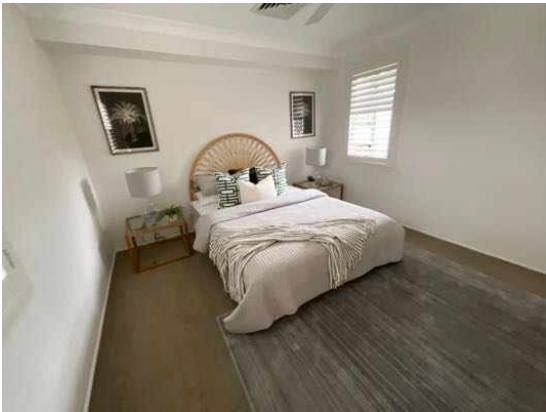
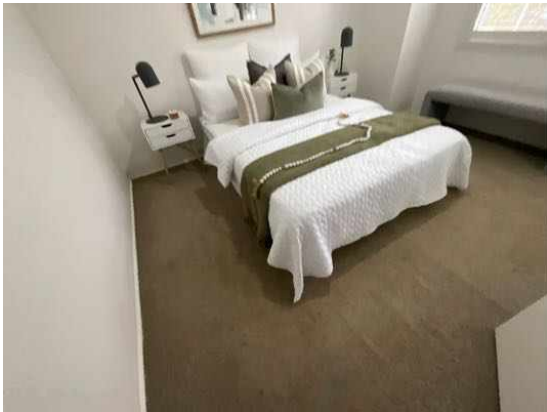
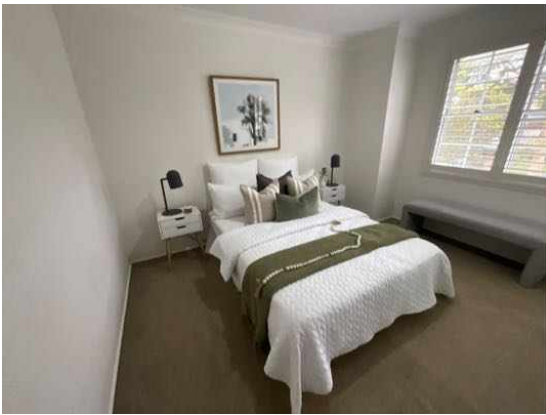
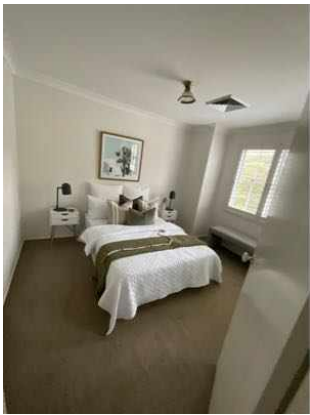
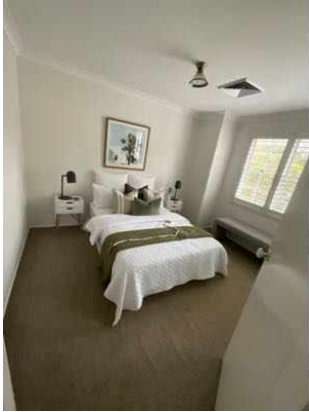
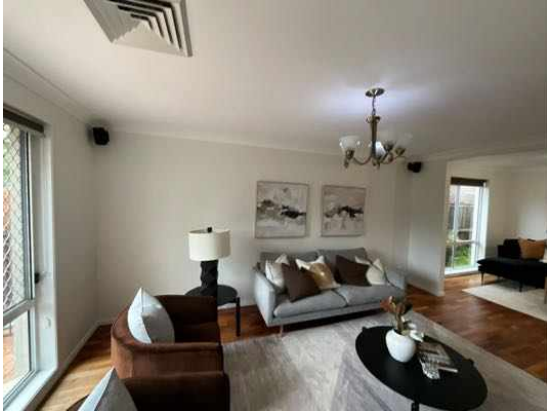
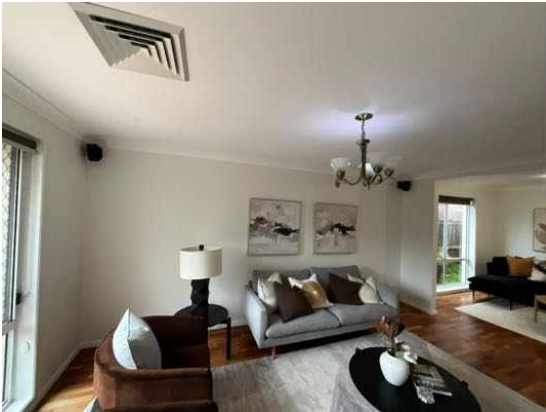
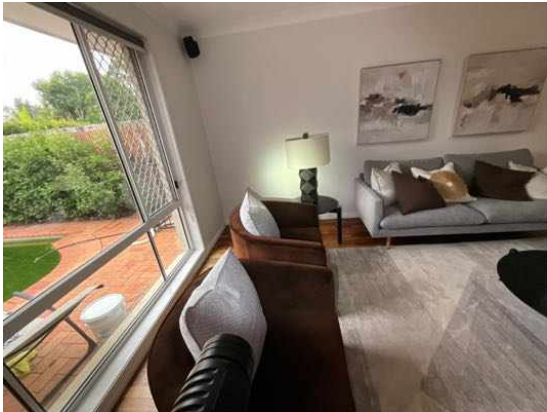
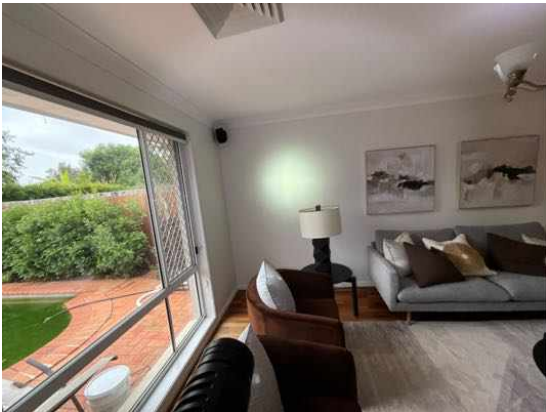
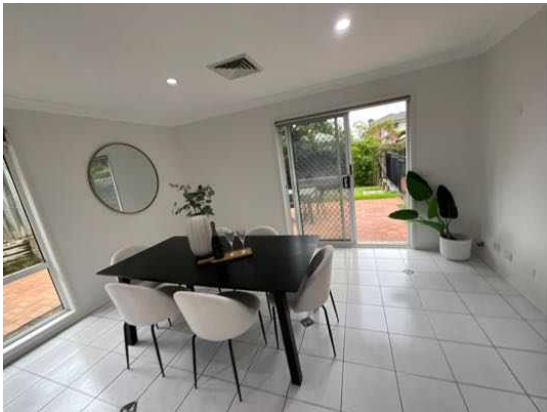
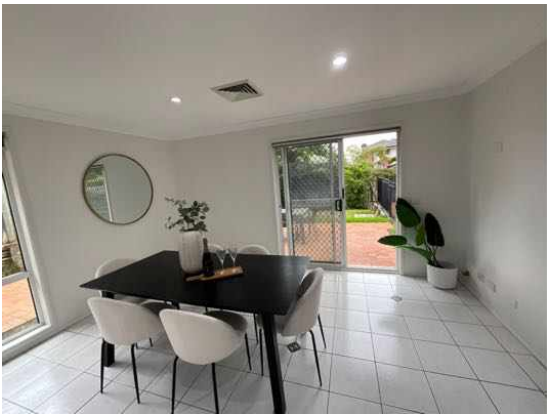
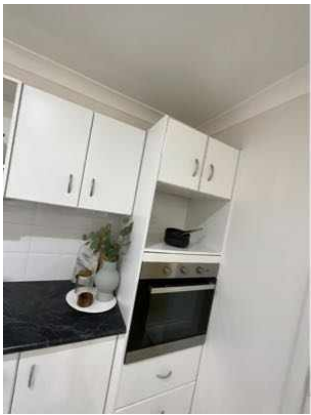
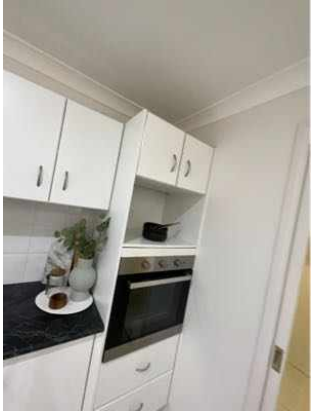
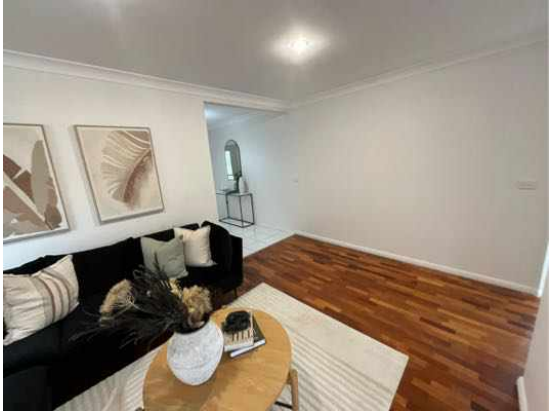
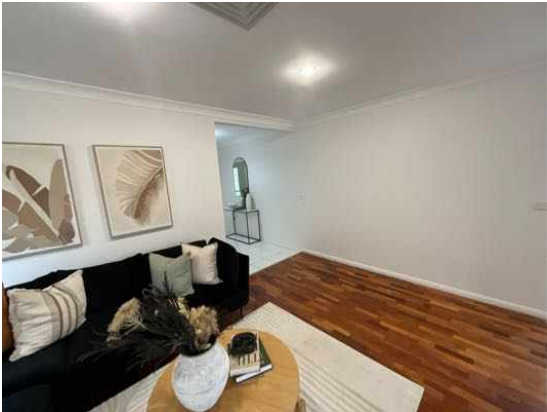
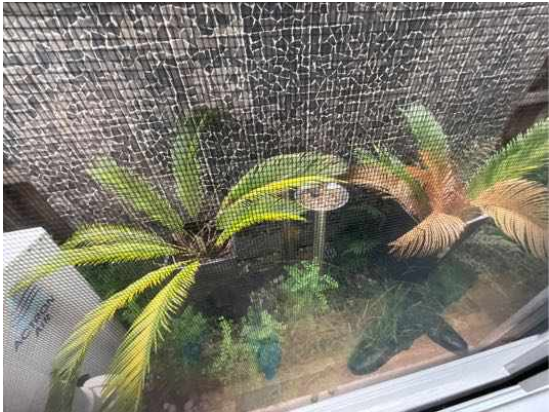
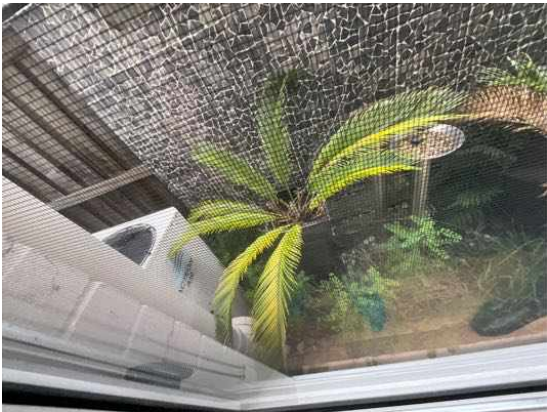
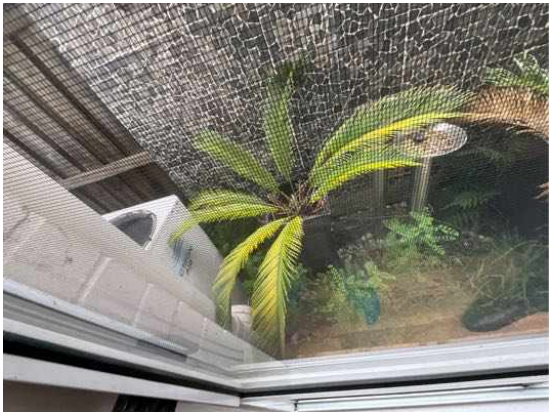
Building: Main Building
Location: All Areas
Finding: Additional Photos - Obstructions and Limitations
Information: These photographs are an indication of the obstructions and limitations which impeded full inspection of the property at the time of inspection. These obstructions can hide an array of defects and should be removed to allow full inspection to be carried out. A re-inspection is recommended once the areas are made accessible.

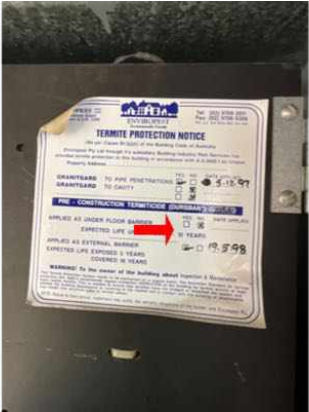
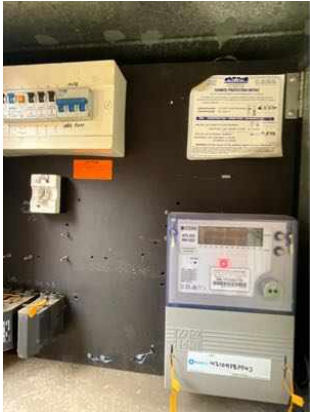
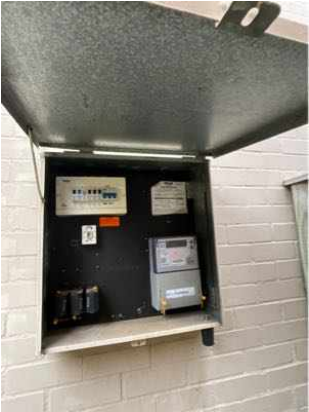
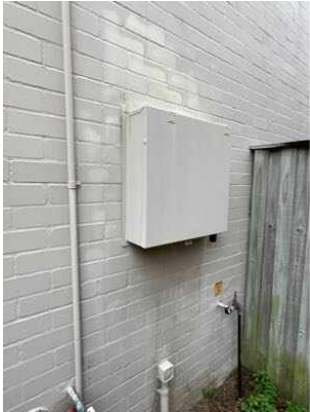
- Building: Main Building
- Location: Exterior walls - right side
- Finding: Evidence of Termite Management System - Durable notice / Legible Sticker - seek further information
- Information: The application of a pre & post-construction chemical termite barrier is highly recommended for all properties. Such barriers are highly effective in preventing termite

A durable notice placed in the switchboard unit to indicate termite barriers at the time of inspection.

Client must seek further information from the vendor or real estate agent if the conditions of termite management systems were maintained as per the label or seek advise from licensed pest controller.
