Building and Timber Pest Inspection Report

Inspection Date: Fri, 27 Feb 2026

Property Address: 32 Hedley St, Riverwood NSW 2210,
Australia

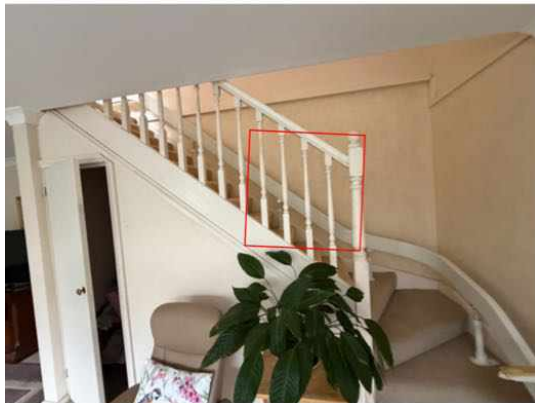
Building:	Main Building
Location:	Staircase
Finding:	Loose handrail — Fall from heights
Information:	The handrail was lacking appropriate support and fixing to the adjacent wall or floor at the time of inspection.

The handrail was further loose and moving upon minimal force applied with hand.

These handrails pose a risk and persons coming in contact may fall from heights if these handrails fail, thus causing sever injury.

A licensed builder must be appointed as soon as possible to rectify any non-compliance.

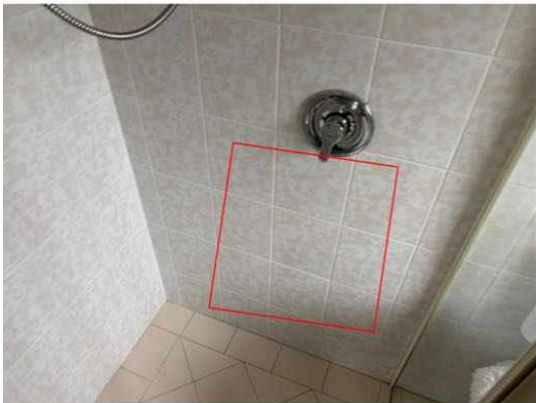
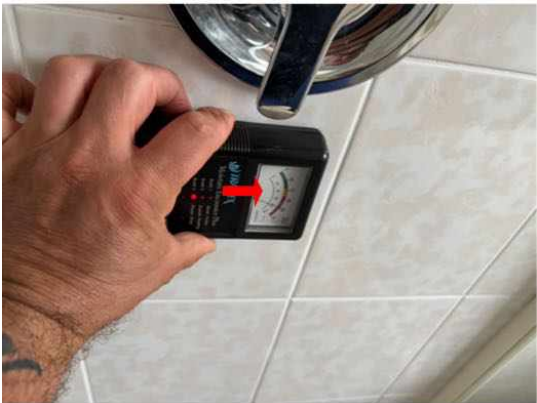
Finding 2.01

Building:	Main Building
Location:	Bathroom downstairs
Finding:	Water leak - Suspected
Information:	A water leak is suspected in this area as excessive moisture was detected at the time of inspection. Another potential cause maybe moisture ingress behind the tiles from around the wall fittings and penetrations.

Internal water leaks can be detrimental to surrounding building elements; their potential causes include damage to plumbing fittings and fixtures, through to water damage and deterioration of associated building elements.

Attracting termites, corrosion, mould, decay and water damage are potential outcomes where a minor water leak is left unattended. More serious defects may also result, such as electrical hazards, or water damage to structural building elements.

In extreme cases, structural damage may develop due to a prolonged water leak. It is highly advised that internal water leaks be addressed by a licensed plumber as a matter of relative urgency.

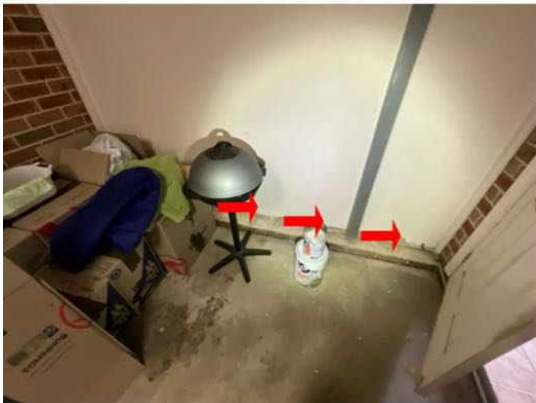
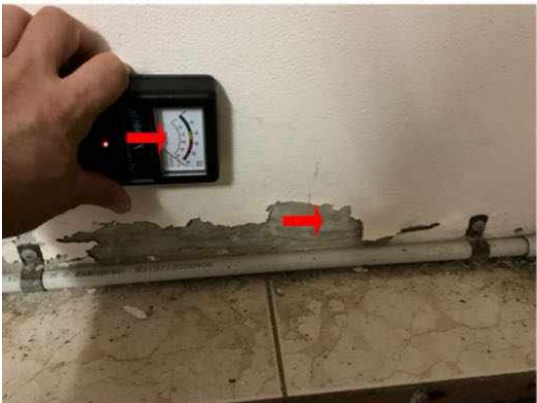
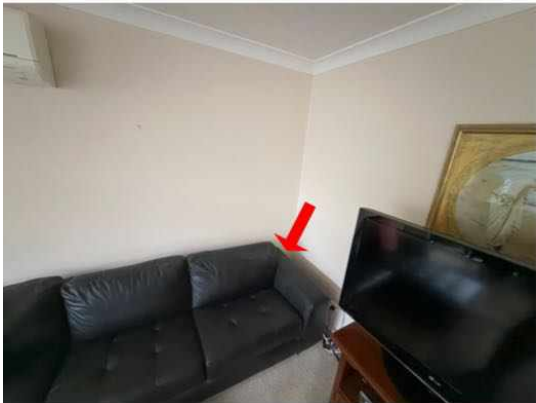
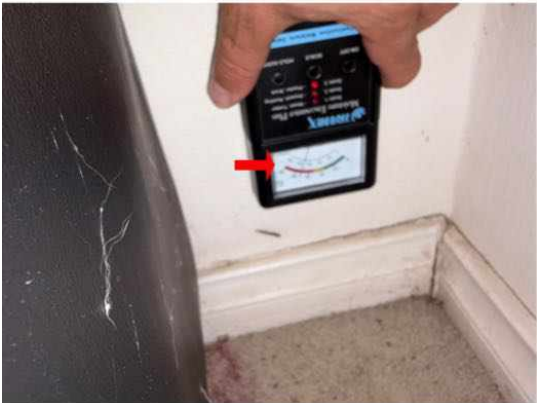
Finding 2.02

Building: Main Building
Location: Garage/lounge wall
Finding: Evidence of excessive moisture was present at the time of inspection
Information: Excessive moisture can attract termites and produce conditions that promote termite attack, fungal growth and wood decay. Excessive moisture is generally caused by deteriorated, inadequate or missing roof drainage, leaking plumbing pipes or fixtures, poorly plumbed HWS overflows or condenser units and poor site drainage. It is highly recommended that all plumbing and drainage fixtures and fittings be maintained regularly in order to prevent excessive moisture being present in the external / internal property. A licensed plumber must be appointed urgently for further assessment.

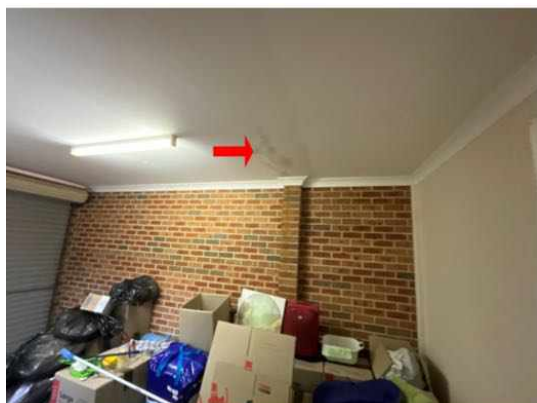
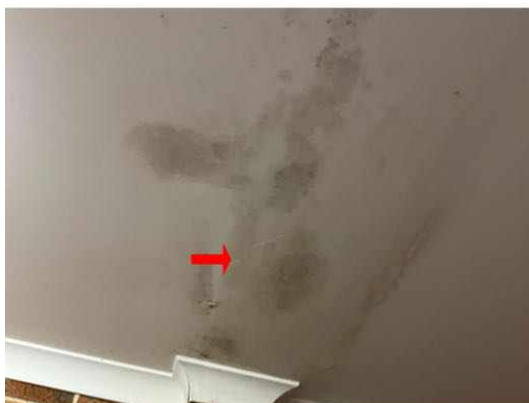
Finding 2.03

Building:	Main Building
Location:	Garage
Finding:	Ceiling - Water damaged
Information:	Water damage to the ceiling lining is generally an indication of excessive moisture being present in the roof void, usually via a leak to the roof covering.

Where water damage is evident to the ceiling, the primary requirement is to identify and rectify the source of the leak. A roofing plumber should be appointed as soon as possible to identify the leak and perform rectification works as necessary, ensuring the water damage is restricted.

Once the leak is repaired, consultation with relevant tradespeople, including plasterers and painters, is advised. Rectification works may include replacement of ceiling lining or minor repainting, depending on the extent of the damage.

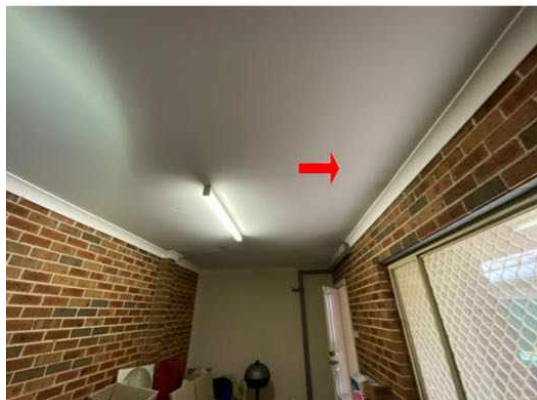
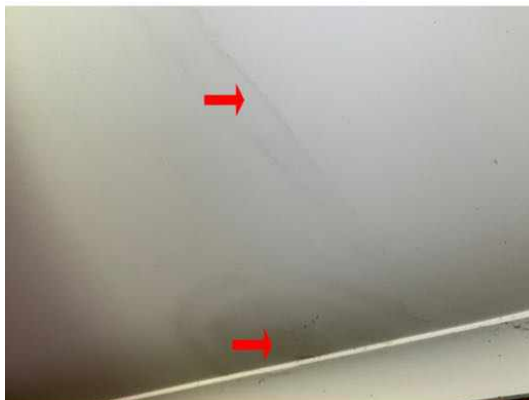
Finding 3.01

Building:	Main Building
Location:	Garage
Finding:	Ceiling - Water stained
Information:	Water staining to ceiling linings in this area was evident at the time of inspection. Water staining indicates that surfaces have been exposed to excessive moisture over time. The minerals and other elements in the water lead to staining, which may graduate to corrosion and deterioration if left unmanaged.

While mostly an appearance defect, water staining can be indicative of more serious defects, which may be currently concealed by interior ceilings.

Where water staining is active, a licensed plumber must be consulted to identify the

cause of the staining and to provide advice on any reparation works that may be required. Replacement of any damaged structures is advised.

Conversely, where water staining is old and inactive, affected building materials may be repaired or replaced at client discretion.

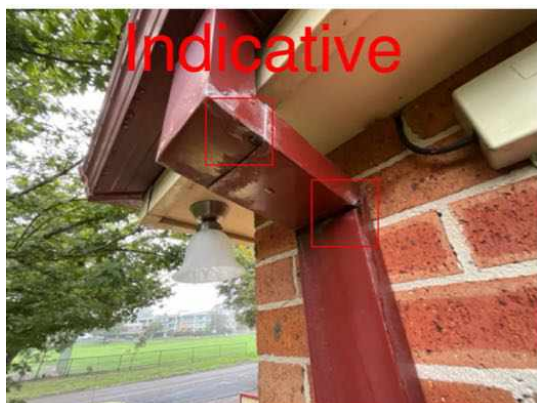
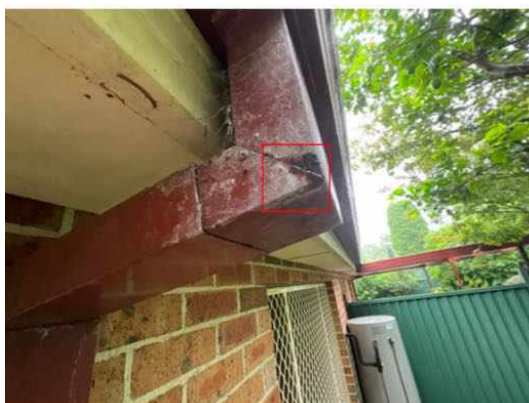
Building: Main Building
 Location: Multiple areas of roof plumbing
 Finding: Water leak - External
 Information: Water leaks were found to be present to exterior plumbing work. Leaks are generally caused by deterioration of the plumbing elements over time, due to exposure to weather conditions, but may have also been caused by minor impact damage.

Such leaking creates damp conditions in the affected area, causing potential for water pooling and subsequent water damage if left unattended. These conditions may also attract termite attack, particularly if the area is subject to minimal levels of sun throughout daylight hours.

It is highly advised that a licensed plumber be appointed to rectify any water leaks that may be present. Areas of repair and replacement of plumbing fittings and fixtures may be required and, as such, a quotation should be sought.

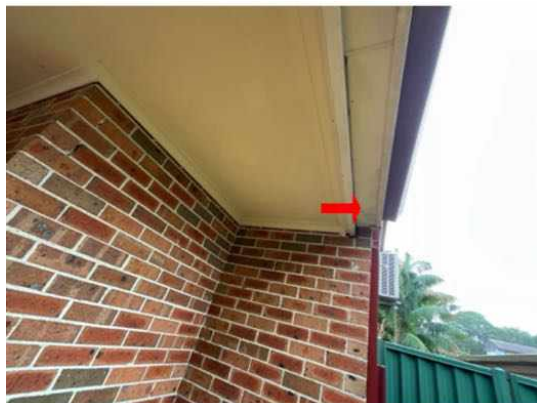
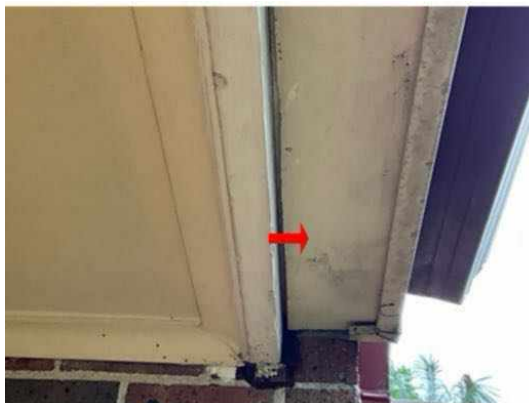
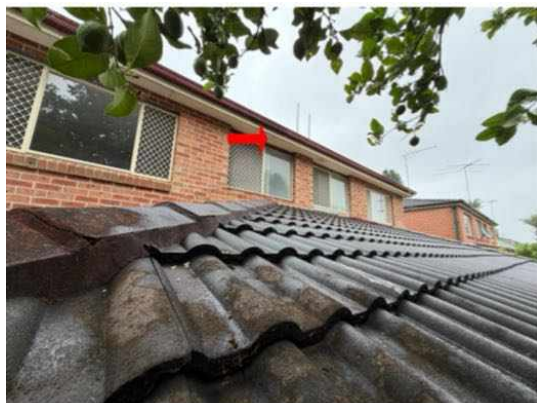
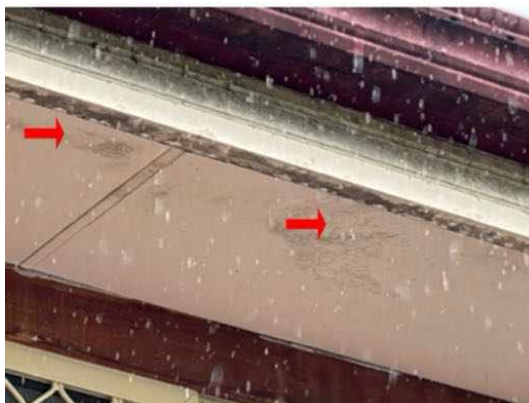
Finding: Eaves/Roof plumbing -- water damages

Information: Water damage is generally an indication of excessive moisture being present, usually via a leak. It is suspected that gutter blockages causing stormwater to backflow into the eaves causing water damages. This is additionally conducive to termite activity due to the damp conditions.

Where water damage is evident, the primary requirement is to identify and rectify the source of the leak. Gutters must be kept clear of any blockages moving forward. A roofing plumber should be appointed for further assessment if the problem persists.

Once the leak is repaired, consultation with relevant tradespeople, including carpenters, plasterers and painters, is advised.

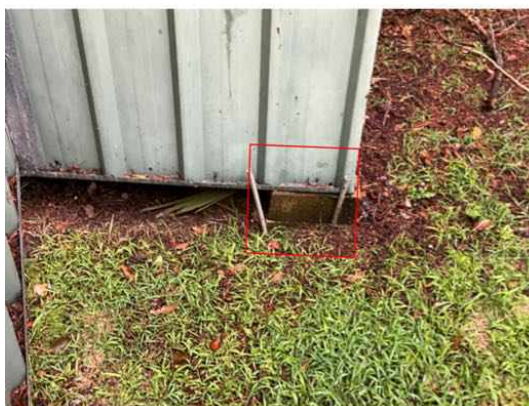
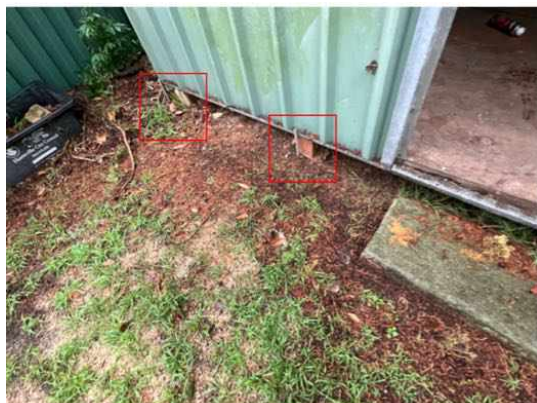
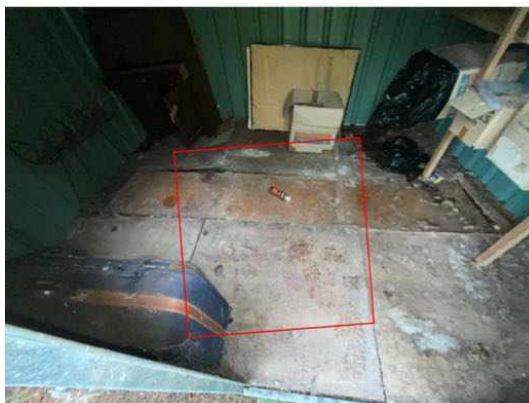
Finding 3.06

Building:	Main Building
Location:	Shed
Finding:	Unconventional handyman work
Information:	This handyman work appears to have been completed to a substandard level and does not comply with regular building practices. The footing and the flooring system is not suited for purpose.

Where handyman work is not completed satisfactorily, accelerated deterioration of the associated building elements is likely to occur and secondary defects to surrounding structures may develop.

It is highly recommended that the substandard work be rectified by professional services. Works to improve this area are likely to increase the safety and the operation of the associated building elements.

The client should exercise care when coming into the immediate vicinity of the substandard works. Rectification works are advised as soon as possible by the appropriate trades.

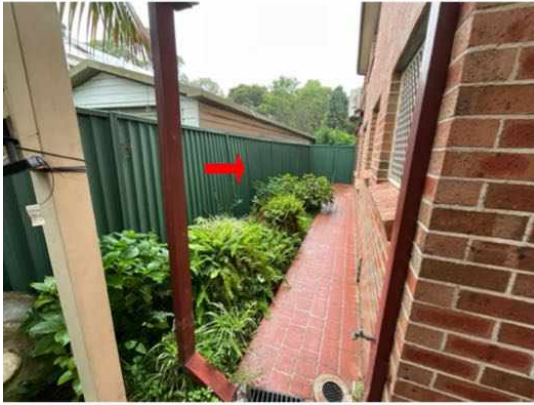
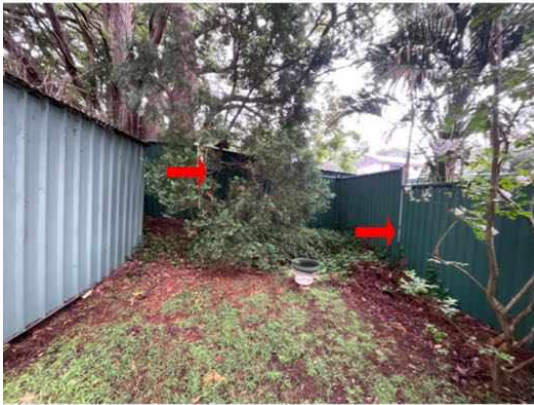
Finding 3.07

Finding: Fencing - Deteriorated

Information: It was noted at the time of inspection that sections of the fencing in this area has deteriorated. Typically fencing deteriorates due to age and or wear, rot and or rust which is generally expected for a structure of this age, due to prolonged exposure to weather conditions. Sometimes inadequate installation or maintenance can be to blame.

If left unattended, it is likely that further damage will occur. It is suspected that repair of several elements of the fencing may be required however replacement may be a consideration of the client also.

A licensed fencing contractor should be appointed to provide further advice and perform rectification works as necessary.

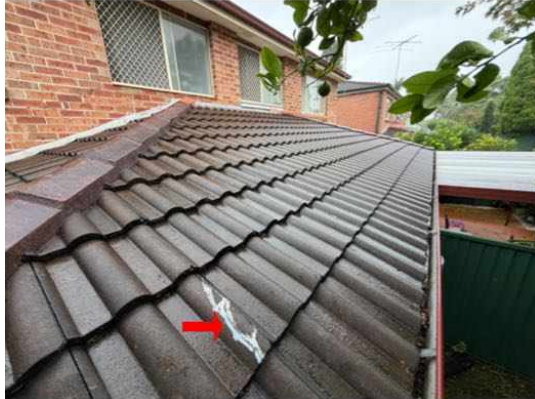
Building:	Main Building
Location:	Roof Exterior
Finding:	Cracked roof tile - Sealed (defective)
Information:	Cracked roofing tile was noted to have been sealed. This handyman work appears to

have been completed to a substandard level and does not comply with regular building practices. Further deterioration will inevitably cause cracking at the seal allowing moisture penetration.

All cracked or damaged tiles must be replaced rather than repaired.

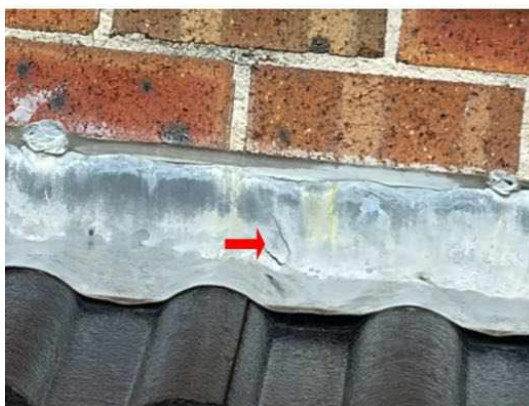
Finding 3.11

Building:	Main Building
Location:	Flashing
Finding:	Roof plumbing - Flashing cracked
Information:	Water leaks generally occur when a particular area of the property is not weather or water tight. Cracks were evident to the roof flashing in this area at the time of inspection.

Regardless of the location, if left unmanaged, even minor leaks can lead to serious damage of associated building elements, potentially resulting in the need for replacement of building materials. Damage to ceilings, wood rot, mould and other hazards, such as electrical hazards, may also arise if left unmanaged.

Further inspection and repair by a roof specialist or a licensed roof plumber is advised to adequately rectify the potential leak.

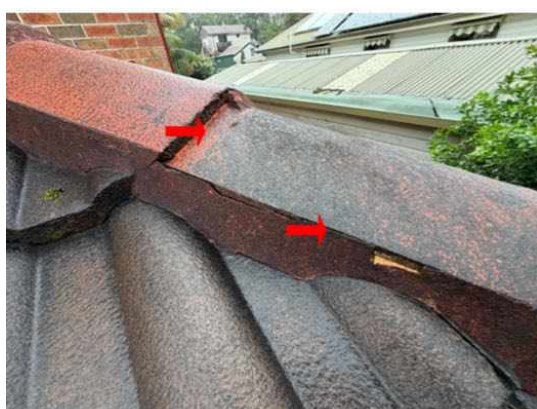
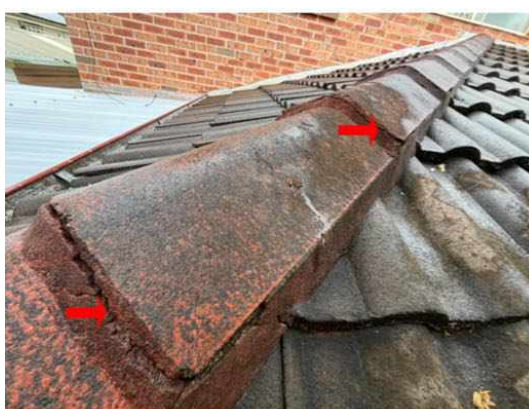
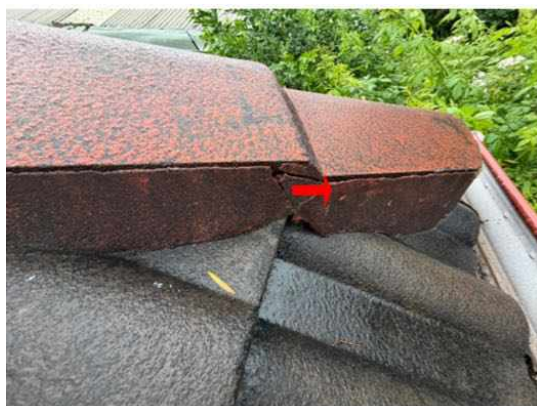
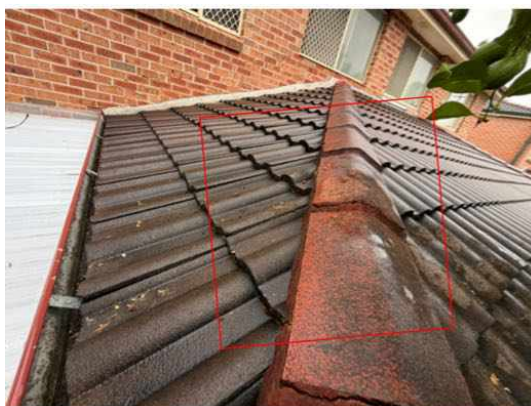
Finding 3.12

Building: Main Building
 Location: Roof Exterior
 Finding: Roof tiles - Weathered
 Information:

Upon inspection of the exterior roofing, the majority of roof tiles were considered to be in a fair condition. While weathering of the tiles is consistent with the age of the property, maintenance works are required.

Isolated areas of mortar have come loose and minor cracking is also present. Re-pointing and re-sealing the may be considered as an interim solution by the client to help preserve and extend the life span of the tiles.

Where left unmanaged, deteriorating roof tiles are likely to lead to a number of secondary defects, including minor water leaks and weather exposure to internal roofing structures.

Consultation with a licensed roofing contractor is highly advised to gain advice on cost of remedial works that may be required in the short to medium term. Remedial works are likely to increase the longevity of the exterior roofing structure.

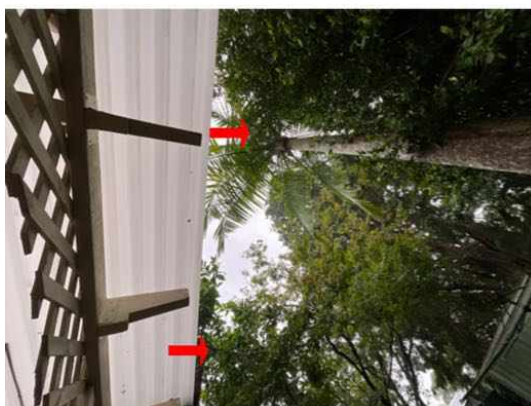
Finding 3.13

Building: Main Building
 Location: Roof Exterior
 Finding: Trees - Overhanging and filling gutters
 Information: Overhanging trees often result in excessive amounts of leaf debris accumulating in gutters.

Gutters are a critical part of the building's management of storm water and rain. It is therefore important that they be kept clear to prevent secondary damage to associated building elements, including exterior and interior walls, ceiling linings and any adjoining building elements. Where gutters are blocked, pooling of rainwater is likely to occur, fast-tracking rust and corrosion of the roof plumbing elements.

It is highly advised that all overhanging tree branches be removed as soon as possible to prevent any further damage. Repair and/or replacement of sections of damaged guttering may also be required where the extent of the damage necessitates.

Such works should be performed by the homeowner; however, appointment of a landscape contractor or an arborist may be required. Consultation with a licensed roof plumber is required where guttering has been damaged.

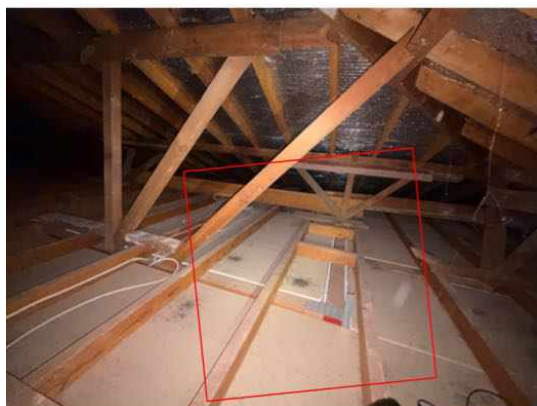
Finding 3.14

Building:	Main Building
Location:	Roof Void
Finding:	Insulation - Missing
Information:	Upon inspection of the roof void it was noted that insulation is not present.

Insufficient insulation will result in a comparatively higher cost to heat and cool a property as there is a lack of Insulation (or uneven coverage of insulation) which works as a barrier to heat transfer. This helps to keep out unwanted heat in summer and preserves warmth inside your home in winter. It can also help soundproof your home from unwanted airborne noise transfer.

Where insulation is absent, the area does not meet current Australian Standards. Installation of adequate insulation is required and should be conducted as soon as possible.

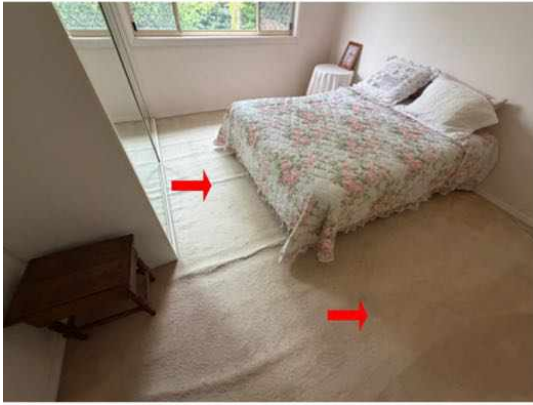
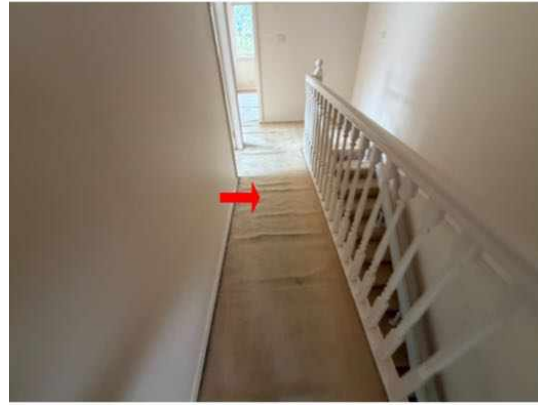
Finding 3.15

Building:	Main Building
Location:	Multiple areas upstairs
Finding:	Floors - Squeaky
Information:	The internal flooring in this area was identified as being squeaky at the time of inspection. This generally presents as a discernible change in level as they are walked across.

Although structural defects such as settlement could also be possible, however squeaky floors generally indicate that nails are coming loose from the joists that they are installed on, which is generally cosmetic rather than structural.

The client should appoint a licensed carpenter to undertake repairs.

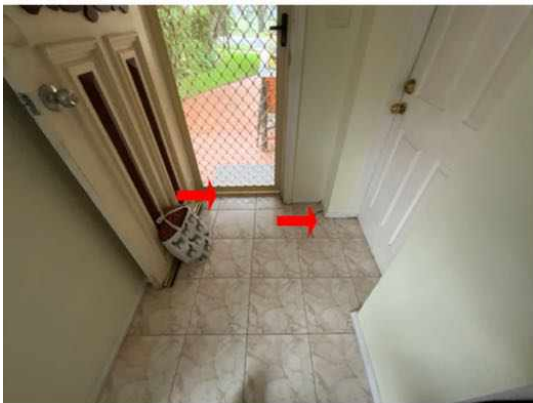
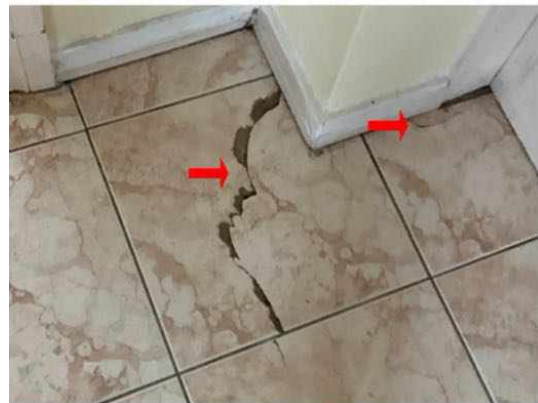
Finding 3.16

Building: Main Building
 Location: Entry
 Finding: Cracked floor tiles
 Information:

Cracking in the floor tiles was evident in this area at the time of inspection. It is suspected that this cracking has occurred as a result of minor settlement or shrinkage.

Cracked tiles throughout the household detract from the overall appearance of the affected areas however it is unlikely to create or lead to any secondary defects.

While not considered a matter of urgency, replacement of cracked floor tiles is recommended at the clients discretion. A licensed tiling contractor may be appointed to perform these works. Where cracks become more numerous, contact a licensed building inspector for further investigation.

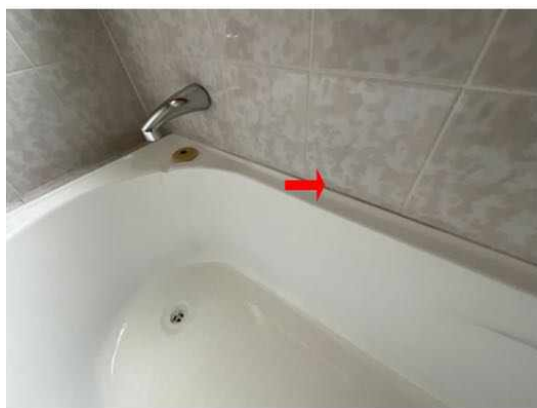
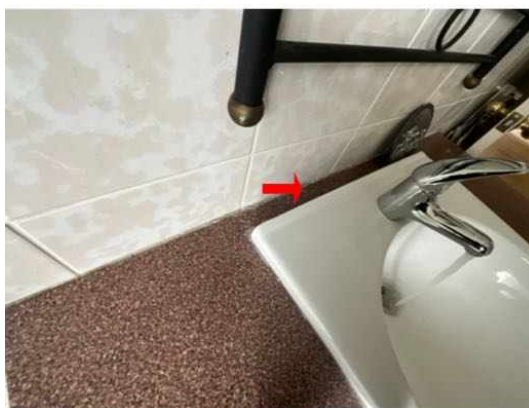
Finding 3.17

Building: Main Building
 Location: All Wet Areas
 Finding: Sealant and grouting - Missing or damaged
 Information:

It was noted on inspection that sealant or grout is degraded to this area.

Different materials and floor areas move at different rates, generally causing cracking to grout or sealant at this point. A flexible sealant is required to allow for expected expansion and contraction, while keeping the joint water tight and protective of all associated building materials.

Flexible and mould resistant materials should be applied to affected areas to prevent any subsequent water damage that is likely to occur. Regular maintenance and replacement of damage or missing or damaged sealant and grout is highly recommended to the wet areas, as this is a regular wear and tear defect. Sealant and grouting in areas that come into regular contact with water should be maintained for the long term care of your property.

A sealant specialist should be appointed to complete these works as soon as possible.

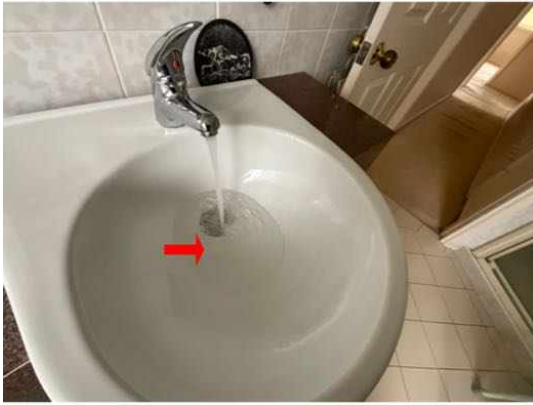
Finding 3.18

Building: Main Building
 Location: Bathroom
 Finding: Sink/basin - slow draining
 Information:

The sink/basin drain appeared to be partially blocked at the time of inspection. Blockages here are usually caused by hair and other debris. If left unmanaged, a lack of general maintenance may lead to the development of more significant defects, such as water damage to surrounding building materials.

A licensed plumber should be appointed to remove the blockage at the client discretion.

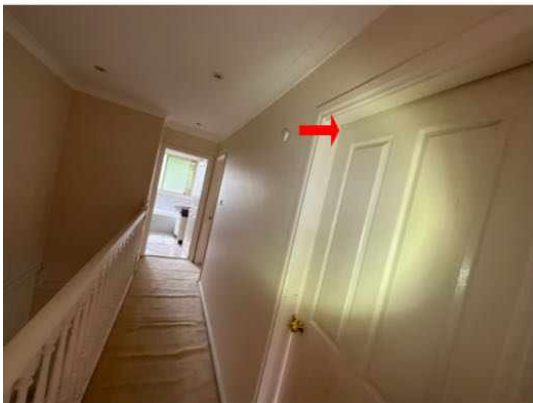
Finding 3.19

Building: Main Building
 Location: Bedroom 2
 Finding: Door - Binding/jamming
 Information:

Binding and/or jamming of this door is evident during standard operation. This defect inhibits the functionality of the affected door as well as creating potential for secondary defects to associated building elements, such as damage to the floor covering or adjacent frame.

A door that binds to flooring or to the associated door frame may have several causes, ranging from minor defects, such as poor installation of the door or deteriorated hinges.

A licensed carpenter should be appointed to perform minor rectification works at client discretion.

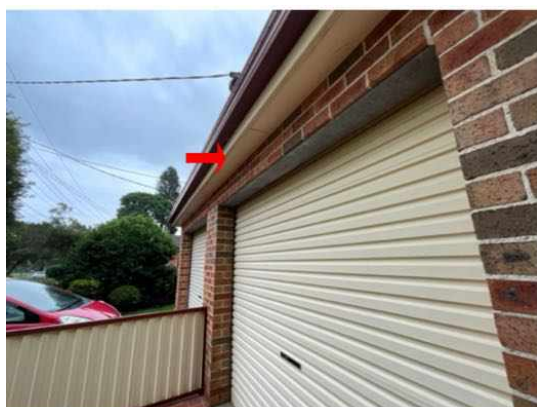
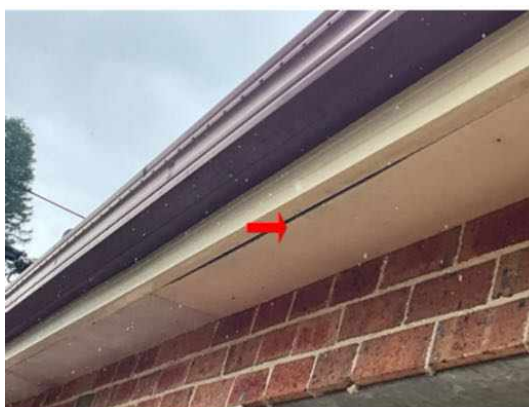
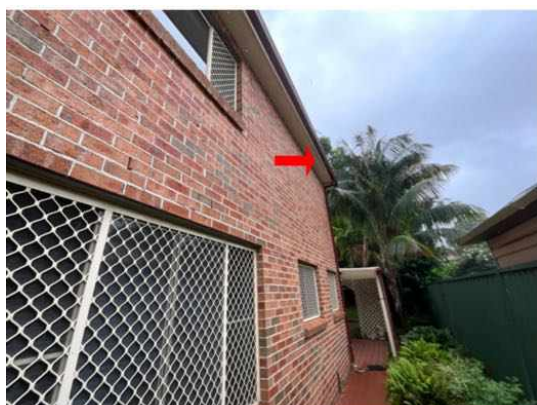
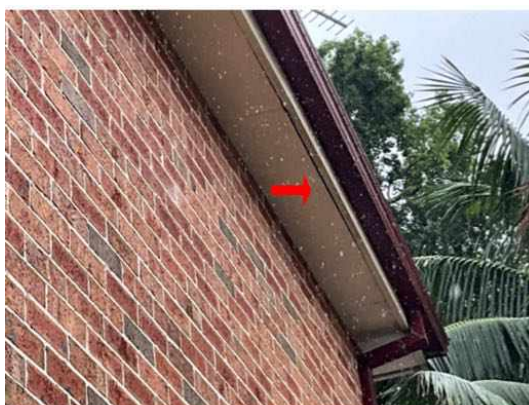
defect is generally consistent with older properties, where the eave sheeting has worn over time.

Eaves are important in preventing water ingress to associated walls by promoting adequate water run-off from roofing structures. Their secondary function is to prevent shelter to adjoining structures from excessive moisture and hence prevent water damage to these areas.

Sagging eaves are susceptible to the attraction of excessive moisture, and are therefore considered non-functional. This defect also detracts from the overall appearance and condition of the roofing structure and any associated structures.

A roofing plumbing or general handyman is recommended to perform rectification works as soon as possible. Subsequent water damage is likely to result over time if left unattended.

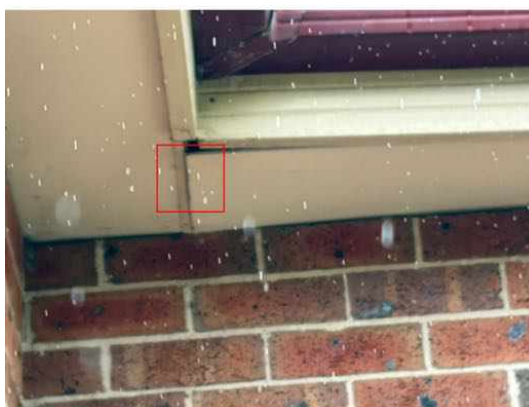
Finding 3.21

Building:	Main Building
Location:	Eaves LHS
Finding:	Beads - Damaged
Information:	Beading acts (like cornice or skirtings) to cover the intersection or joins of building materials. It was noted at the time of inspection that beading in this area has

deteriorated. This deterioration is suspected to have been caused by general ageing and frequent exposure to weather, which is expected in a building of this age and condition.

Beading is important in weatherproofing the surrounding building elements and preventing pest ingress. Furthermore, beading works to protect the joins of building materials, which are more susceptible to deterioration and decay.

Repair or replacement of the beading is advised to ensure the protection and longevity of any associated building elements. Such works may be performed by a general handyman or qualified carpenter.

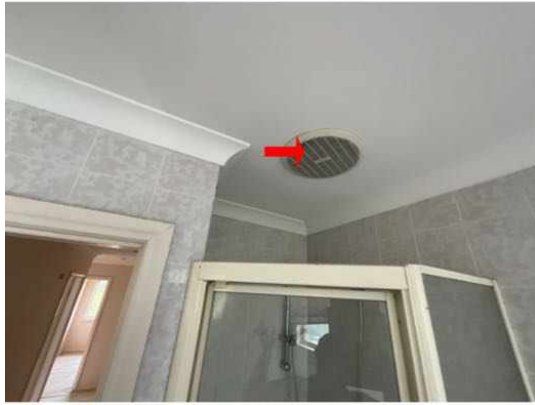
Finding 3.22

Building:	Main Building
Location:	Bathroom
Finding:	Exhaust fan - Not operating
Information:	The exhaust fan in this area appears to be damaged or blocked and is not operating as intended. If left unmanaged, a lack of general maintenance is likely to lead to the development of more significant defects, such as water damage to surrounding building materials from inadequate ventilation. If left unattended for a prolonged period of time, poor ventilation in this area may also be conducive to the development of mould.

Where no secondary damage has developed, the Homeowner may undertake minor cleaning of the area and consider replacement of the exhaust fan. Alternatively, consultation with a Licensed Electrician is required to check for any secondary or concealed damage and consider repair or replacement.

Please be advised that a cabinet maker or qualified carpenter may also be required if water damage has occurred and that an additional specialist mould inspection may be required if severe mould has resulted.

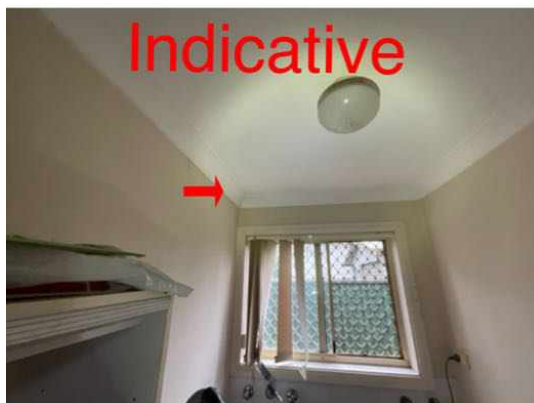
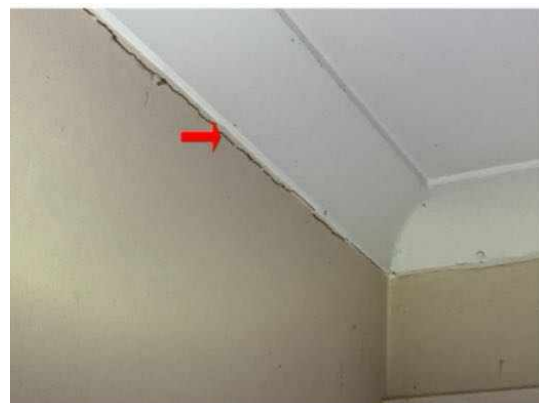
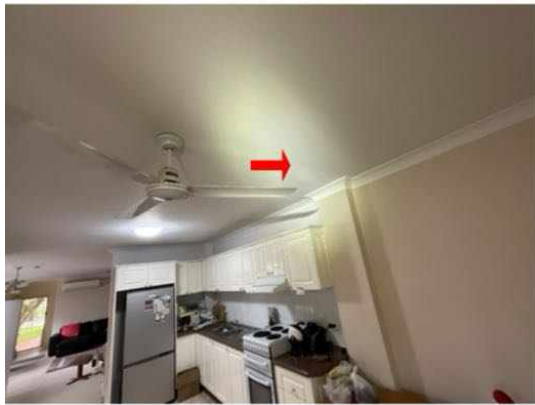
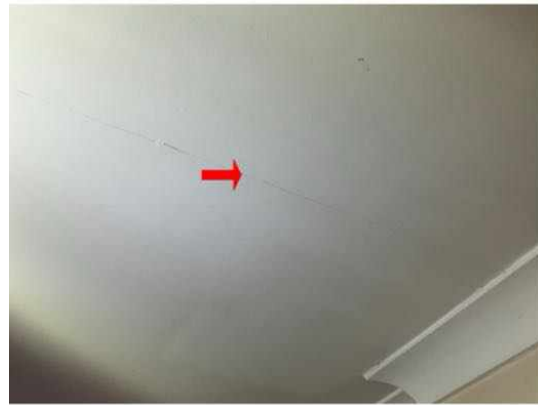
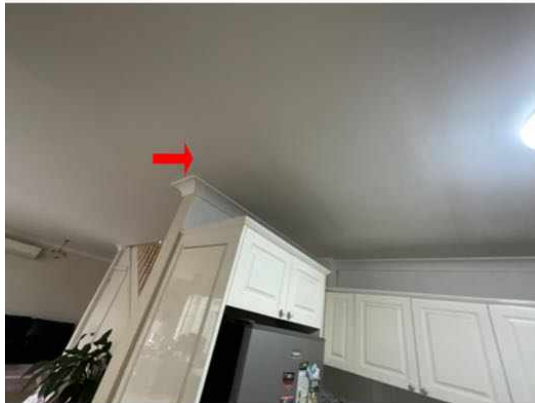
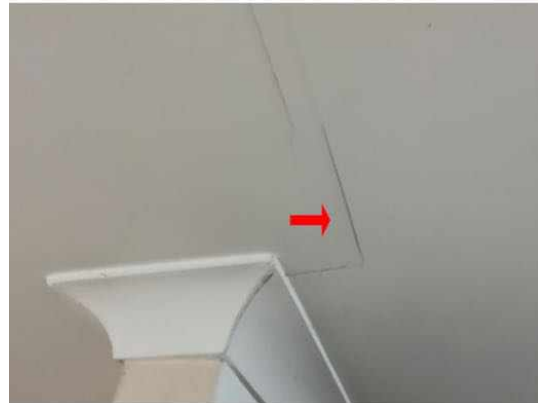
Finding 3.23

Building:	Main Building
Location:	Multiple areas
Finding:	Cracking - Damage Category 1 - Fine (up to 1mm)
Information:	Although fine cracks are quite noticeable, they are often only considered to be an appearance defect, and usually do not indicate any structural damage. Generally, the cause of a fine crack is indicative of a separation between building materials and finishes (e.g. paint, plaster, etc.) along joins.

Cracking of this nature can generally be repaired with minor sanding, filling and/or repainting. Such works should be performed by a qualified painter or a general handyman.

Monitoring of all cracking should be conducted frequently. Always contact a building inspector should cracks widen, lengthen, or become more numerous.

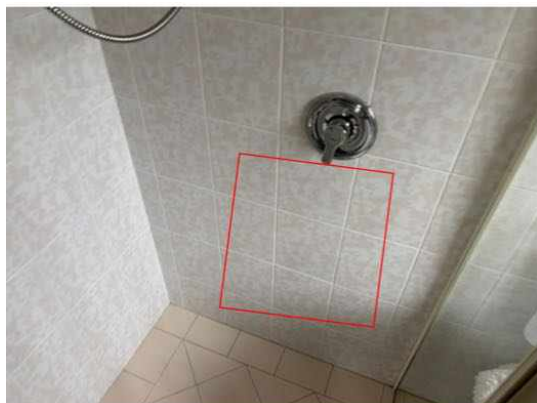
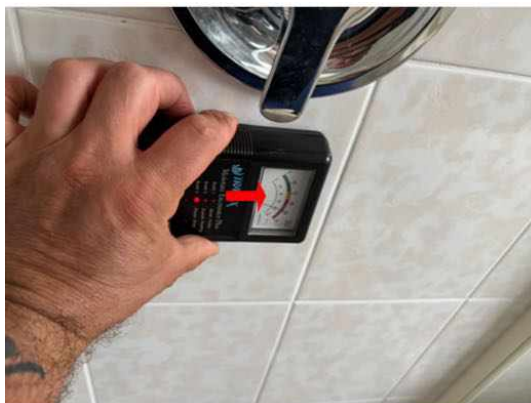
Building: Main Building
 Location: Bathroom Downstairs
 Finding: Water leak - Suspected
 Information: A water leak is suspected in this area as excessive moisture was detected at the time of inspection. Another potential cause maybe moisture ingress behind the tiles from around the wall fittings and penetrations.

Internal water leaks can be detrimental to surrounding building elements; their potential causes include damage to plumbing fittings and fixtures, through to water damage and deterioration of associated building elements.

Attracting termites, corrosion, mould, decay and water damage are potential outcomes where a minor water leak is left unattended. More serious defects may also result, such as electrical hazards, or water damage to structural building elements.

In extreme cases, structural damage may develop due to a prolonged water leak. It is highly advised that internal water leaks be addressed by a licensed plumber as a matter of relative urgency.

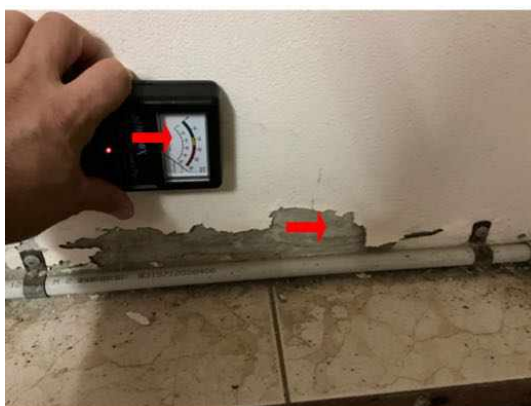
Finding 6.02

Building: Main Building
 Location: Garage
 Finding: Evidence of excessive moisture was present at the time of inspection
 Information: Excessive moisture can attract termites and produce conditions that promote termite attack, fungal growth and wood decay. Excessive moisture is generally caused by deteriorated, inadequate or missing roof drainage, leaking plumbing pipes or fixtures, poorly plumbed HWS overflows or condenser units and poor site drainage. It is highly recommended that all plumbing and drainage fixtures and fittings be maintained regularly in order to prevent excessive moisture being present in the external / internal property. A licensed plumber must be appointed urgently for further assessment.

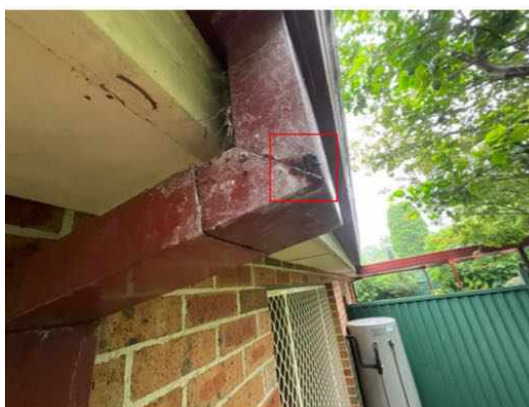
Building:	Main Building
Location:	Multiple areas of roof plumbing
Finding:	Water leak - External
Information:	Water leaks were found to be present to exterior plumbing work. Leaks are generally caused by deterioration of the plumbing elements over time, due to exposure to weather conditions, but may have also been caused by minor impact damage.

Such leaking creates damp conditions in the affected area, causing potential for water pooling and subsequent water damage if left unattended. These conditions may also attract termite attack, particularly if the area is subject to minimal levels of sun throughout daylight hours.

It is highly advised that a licensed plumber be appointed to rectify any water leaks that may be present. Areas of repair and replacement of plumbing fittings and fixtures may

be required and, as such, a quotation should be sought.

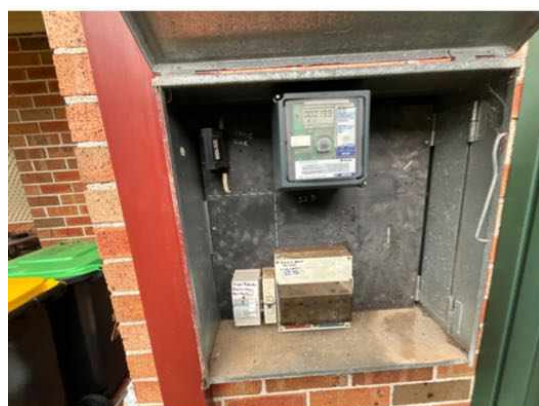
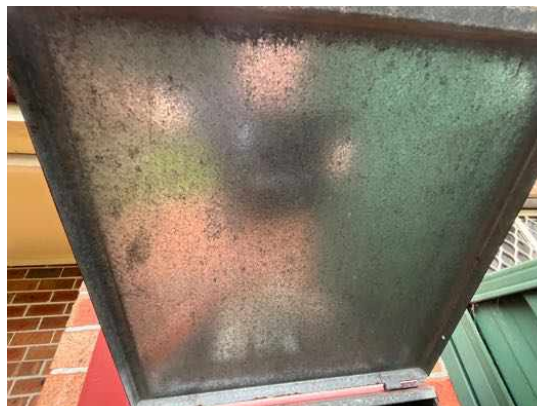
Finding 6.05

Building:	Main Building
Location:	Meterbox
Finding:	Termite Management System - no evidence of installation
Information:	The application of a post-construction chemical termite barrier is highly recommended for all properties, particularly if live termite activity has been found on the site previously. Such barriers are highly effective in preventing termite attack on any timber building elements throughout the property.

A durable notice should be placed in the switchboard unit to indicate current termite barriers. At the time of inspection, it appeared as though no termite management system has been installed, with no evidence to suggest preventative works taking place.

The client is highly recommended to retain a strata copy in relation to any active termite management systems, warranties and other details.

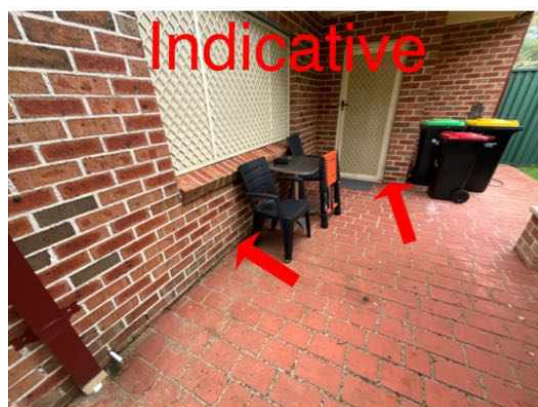
Finding 6.06

Information: Slab Edge Exposure: Where external concrete slab edges are not exposed there is a high risk of concealed termite entry. In some buildings built since July 1995 the edge of the slab forms part of the termite shield system. In these buildings an inspection zone of at least 75mm should be maintained to permit detection of termite entry. The concrete edge should not be concealed by render, tiles, cladding, flashings, adjoining structures, paving, soil, turf or landscaping etc. Where this is the case you should arrange to have the slab edge exposed for inspection. Concealed termite entry may already be taking place but could not be detected at the time of the inspection. This may have resulted in concealed timber damage. Does the slab edge inspection zone fully comply?

Not able to comment. A very high proportion of termite attacks are over the edge of both Infill and other concrete slabs types. Covering the edge of a concrete slab makes concealed termite entry easy. Infill slab type construction has an even higher risk of concealed termite ingress as the slab edge is concealed due to the construction design and cannot be exposed. The type of slab may only be determined by assessment of the construction plans by a qualified person e.g. Builder, Architect. Construction Plans may be obtainable by your local Council or Builder. Termite activity and or damage may be present in concealed timbers of the building. We strongly recommend frequent regular inspections in accordance with AS 3660.2. Where the slab edge is not fully exposed or the slab is an infill slab or the slab type cannot be determined then we strongly recommend inspections every 3 to 6 months in accordance with AS 3660.2 or AS 4349.3.

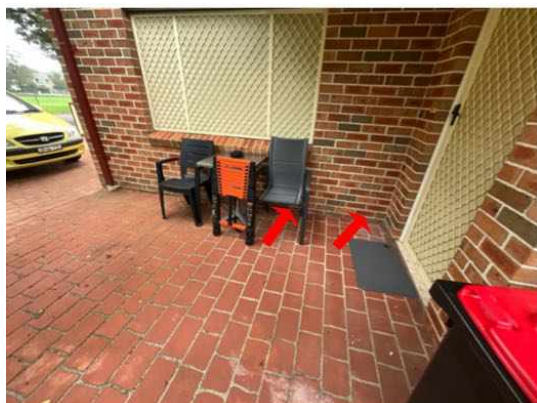
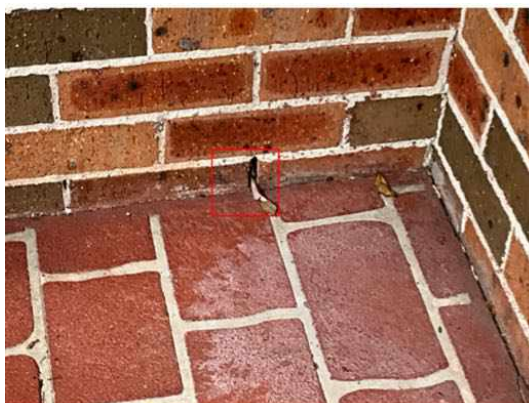
Weep holes in the exterior brickwork of the property are designed to allow condensation that may build up between the brickwork and subsequent timber framework to drain from within the wall hence preventing any deterioration of the timber building elements.

Additionally build-up of moisture is likely to occur if weep holes are covered further attracting termite activity to these areas.

It is highly recommended that weep holes are left exposed in all areas throughout the external property. Therefore if any termite activity leading into weep holes becomes easily detectable during frequent pest inspections.

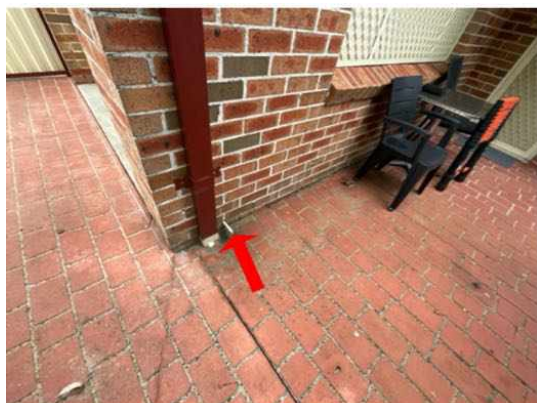
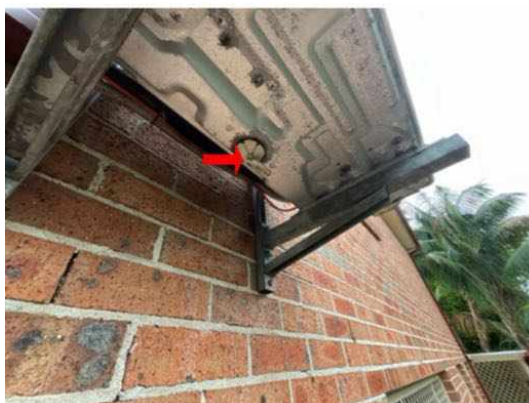
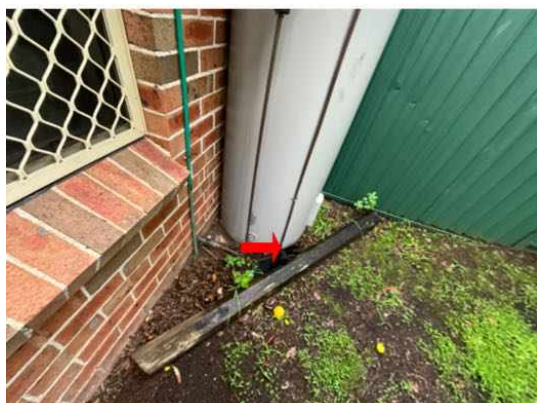
Finding 6.09

Building:	Main Building
Location:	Yard - Side
Finding:	Overflow - Not plumbed for drainage
Information:	The overflow is not plumbed or connected to suitable drainage, which can result in the surrounding area becoming excessively damp.

These damp conditions can lead to secondary defects such as rot, rust or corrosion of associated building elements, the formation of fungal decay, or even the creation of potential slip hazards. When coupled with poor site drainage, pooling of water may also attract termite activity to this area.

It is highly recommended that a licensed plumber be appointed to install adequate drainage to the overflow. These works will ensure that the area remains dry and free of any secondary defects.

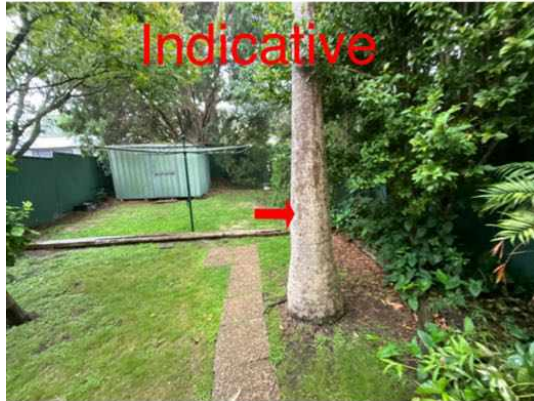
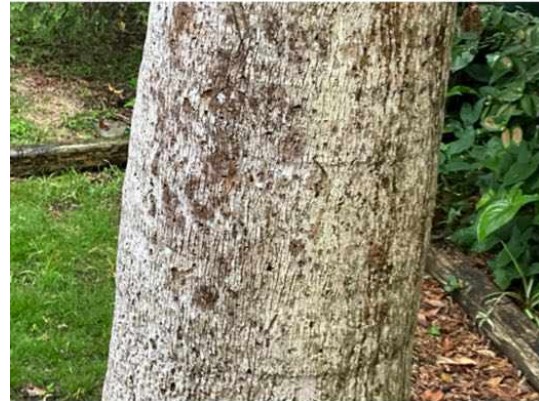
Finding 6.10

Building:	Main Building
Location:	Trees
Finding:	Evidence of wood borer activity identified
Information:	Wood borers small beetles that colonise in exposed timber elements are a common timber pest that are regularly mistaken for termites. Although wood borer activity is generally not detrimental to the affected timber they may lead to serious damage and necessitate replacement of certain building elements if left unattended.

As no live wood borer activity was identified treatment is not required at this time. Replacement of affected timbers may be considered by the client for superficial reasons.

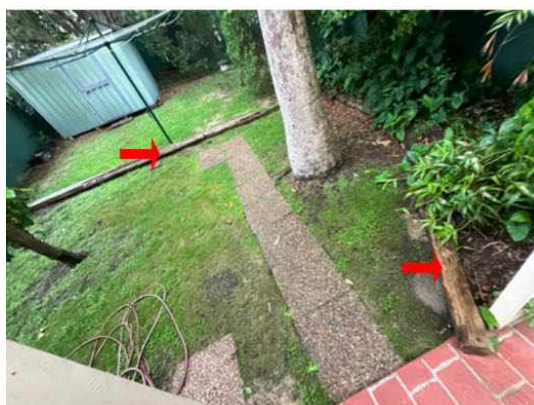
Finding 6.11

Building:	Main Building
Location:	Fencing & Landscaping
Finding:	Building materials in direct ground contact - conducive to termites
Information:	Where timber elements are in direct contact with the ground and consequently moisture or dampness they become conducive to termite activity. Whether timber is used as a building element part of a fencing structure or stored as an unused item they can provide an environment that is attractive to termite infestation.

When met with excessive moisture timber begins to decay and develop wood rot. Any timbers that are in direct contact with external grounds especially if left untreated or non-durable also provide ingress for subterranean termites into that particular element.

The removal of any such materials that may be conducive to termite activity should be removed as soon as possible to minimise the risk of termite attack.

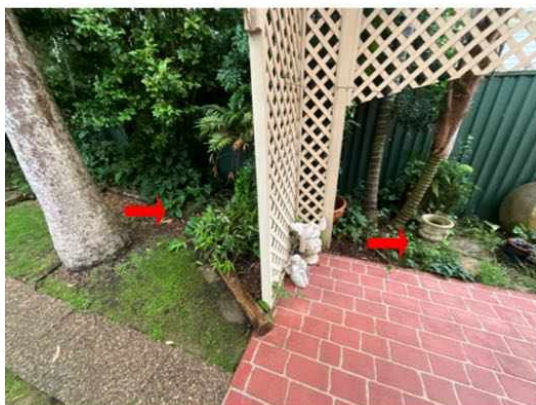
Finding 6.15

Building:	Main Building
Location:	Garden beds
Finding:	Garden Beds
Information:	Garden beds were found to be evident in the garden area. These garden beds can include untreated timber, and with a combination of moisture from watering hosing can make conditions conducive to termite activity and termite ingress.

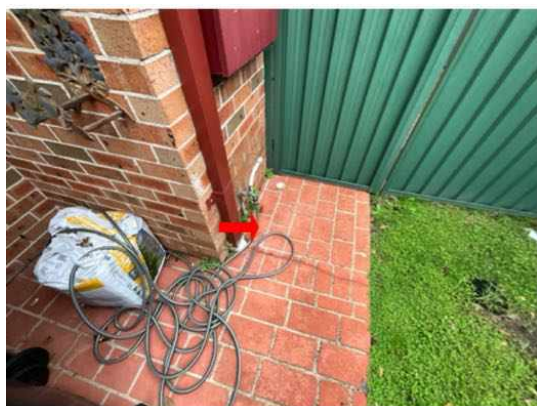
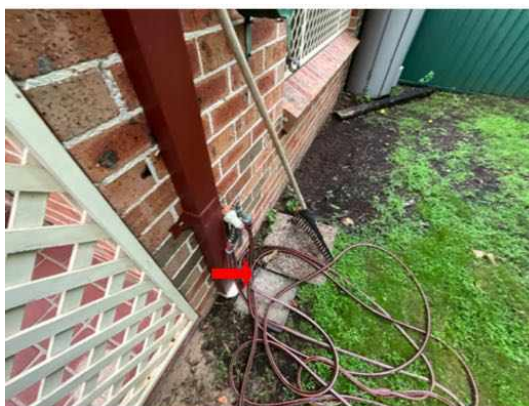
Finding 6.16

Building: Main Building
Location: External tap
Finding: Tap - No drain
Information: The external tap in this area was noted to have no drain at the time of inspection.

This keeps the surrounding surfaces damp while using the tap, which becomes conducive to termite activity.

A licensed plumber must be appointed to ensure an appropriate drain is installed.
