Building and Timber Pest Inspection Report

Inspection Date: Fri, 27 Feb 2026

Property Address: 32 Hedley St, Riverwood NSW 2210,
Australia

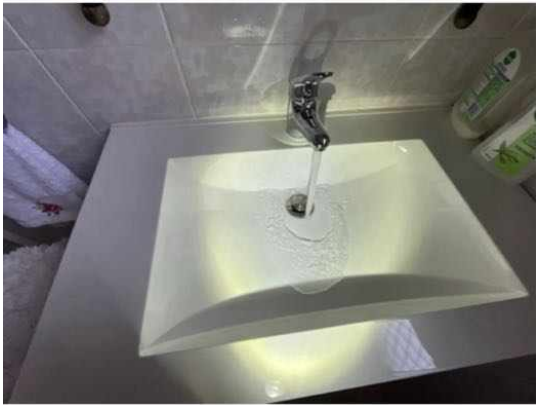
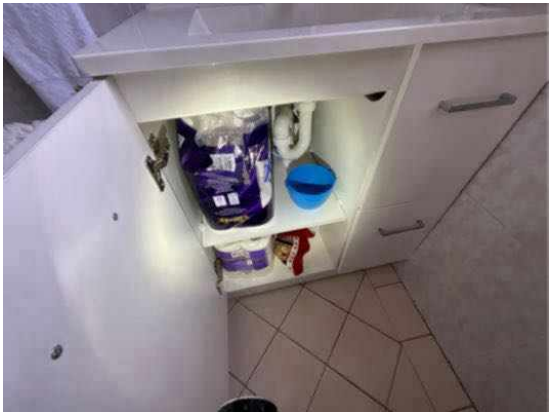
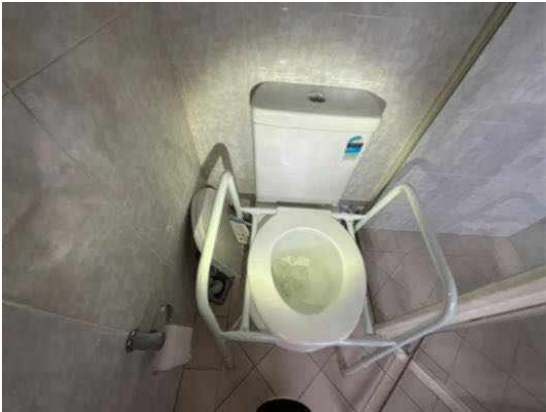
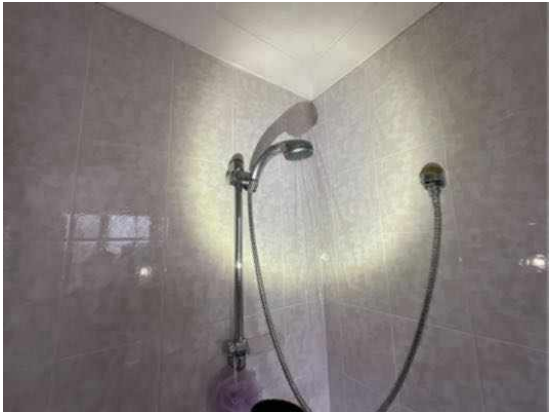
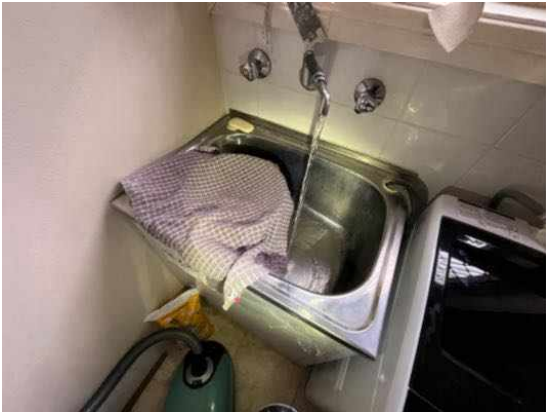
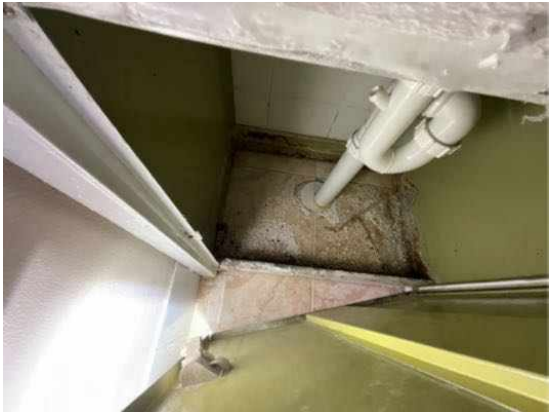
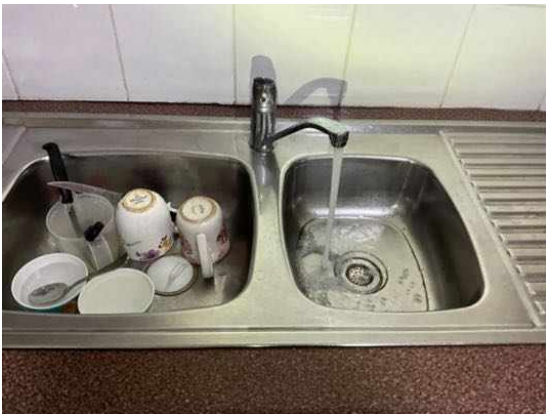
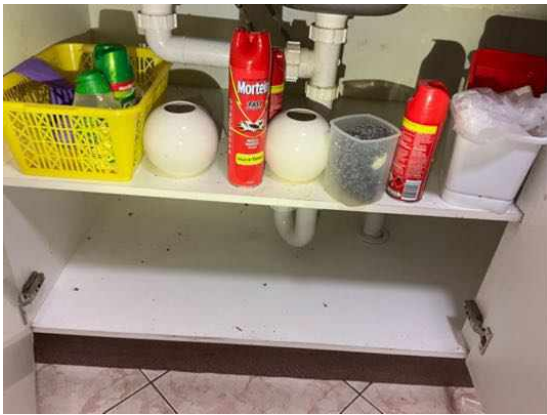
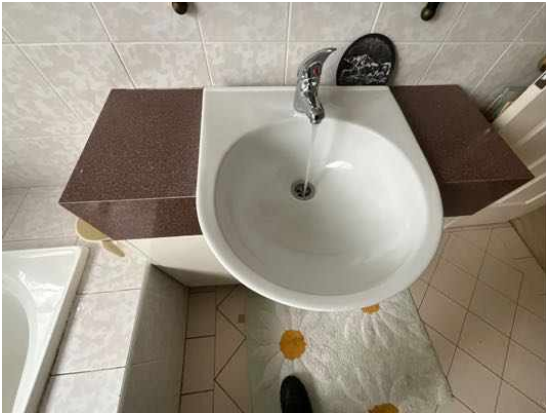
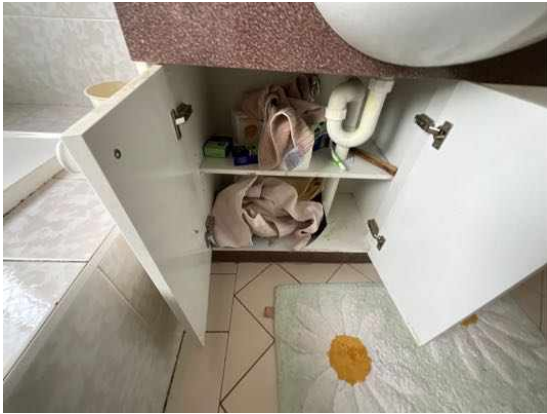
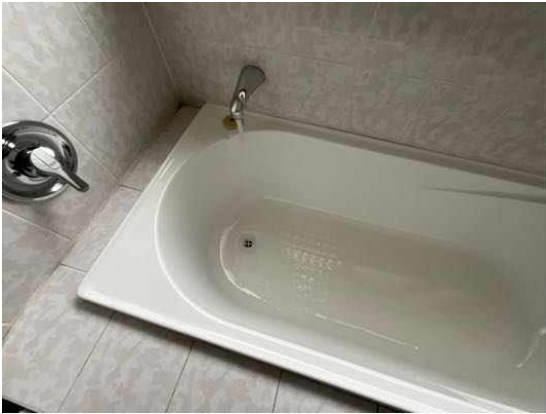
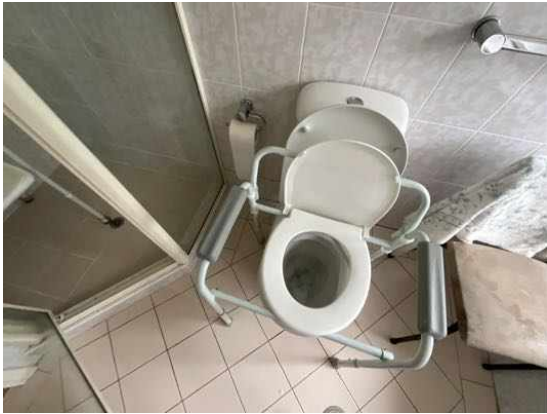
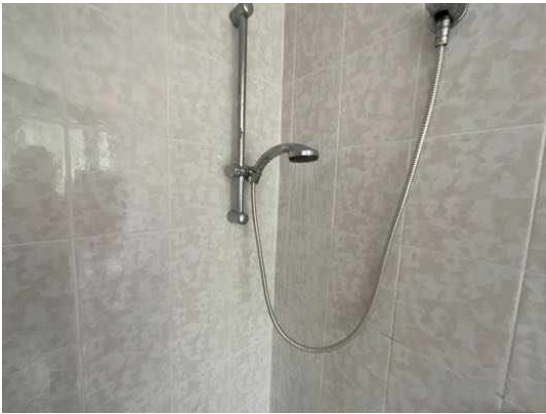
Building: Main Building
Location: All Wet Areas
Finding: Additional Photos
Information:

Additional photos are provided for your general reference.

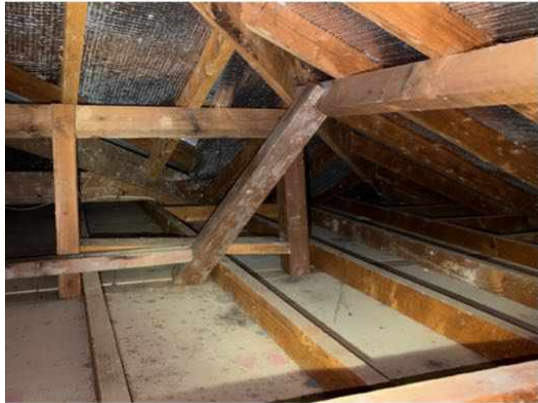
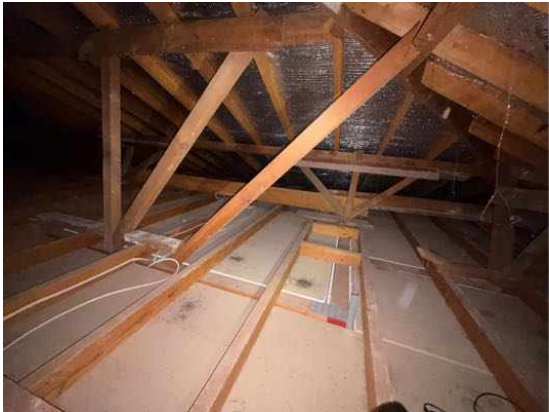
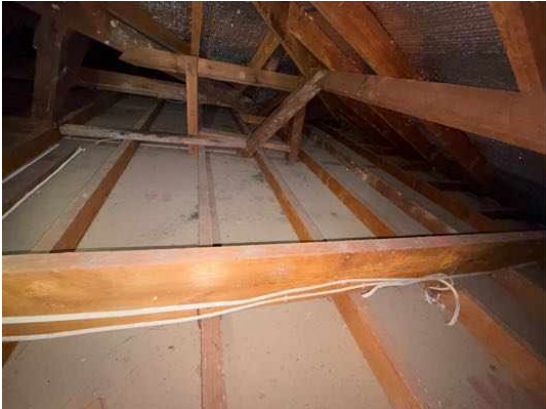
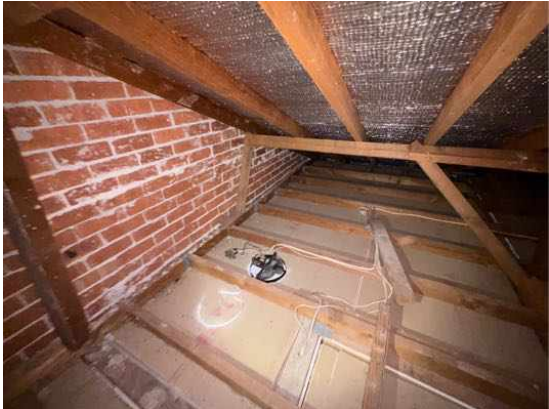
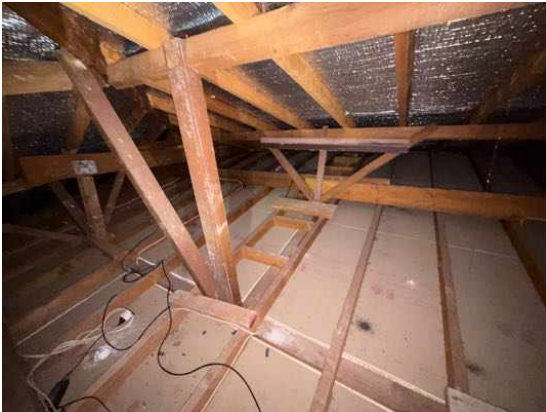
Building: Main Building
Location: Roof Void
Finding: Additional Photos
Information:

Additional photos are provided for your general reference.

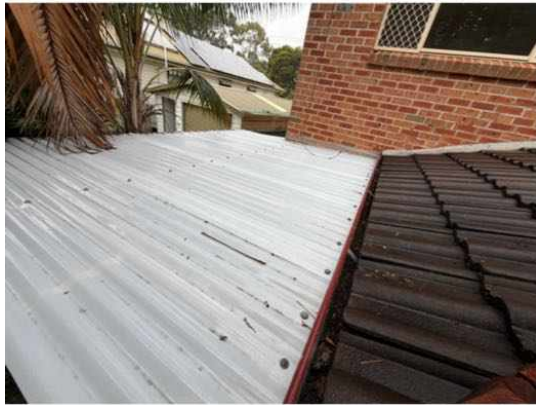
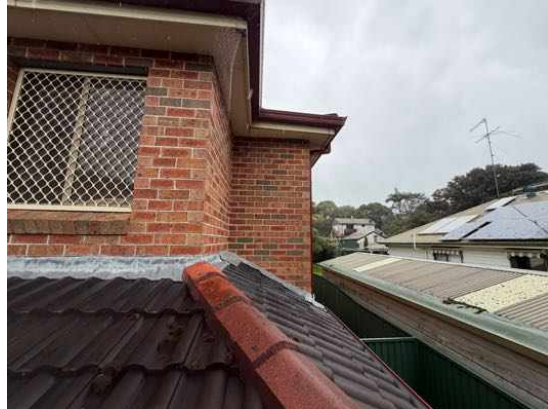
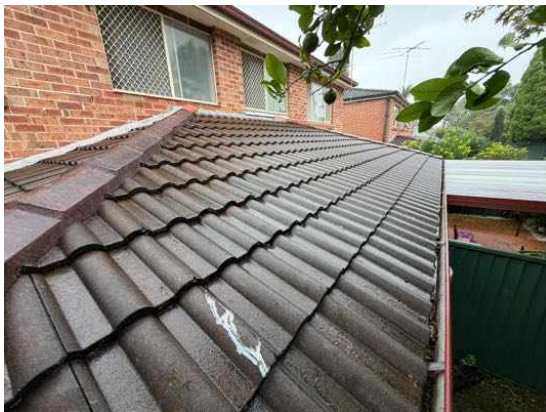
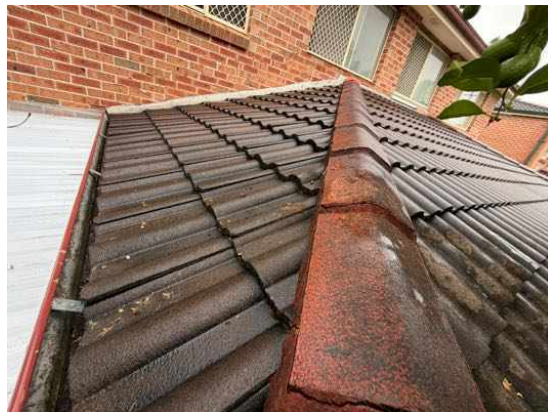
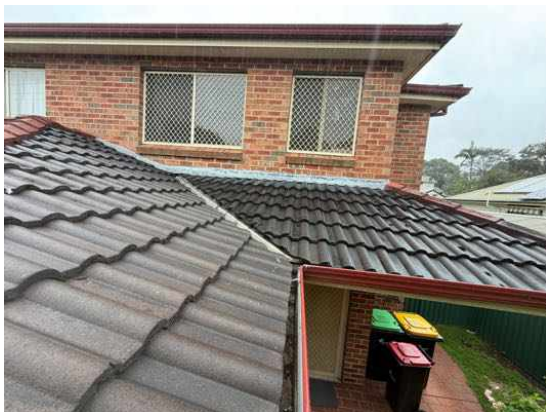
Building: Main Building
Location: Roof Exterior
Finding: Additional Photos
Information:

Additional photos are provided for your general reference.

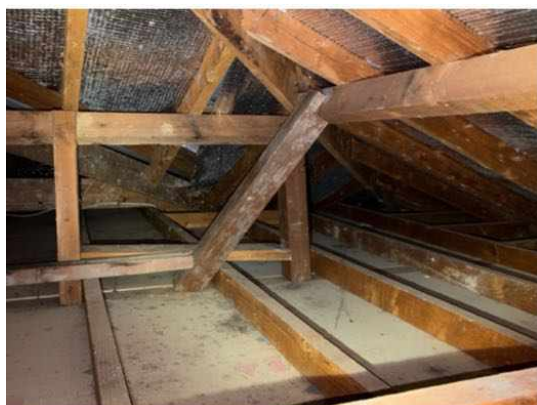
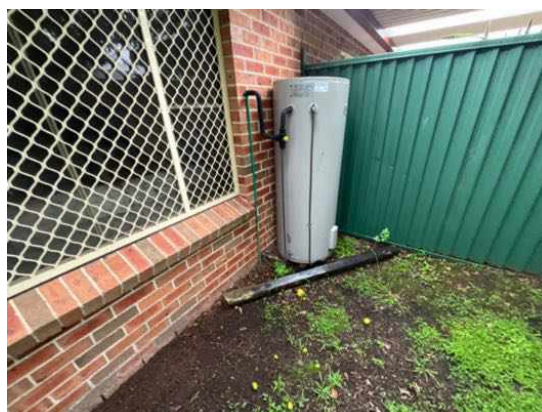
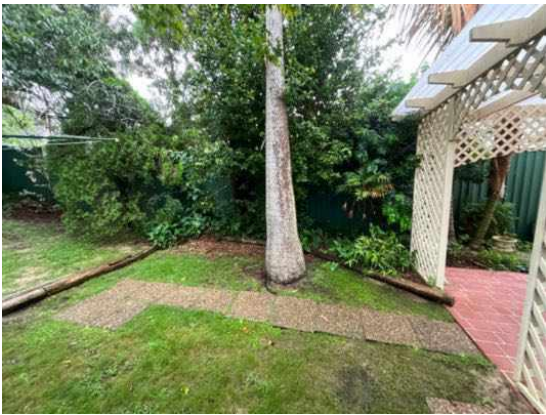
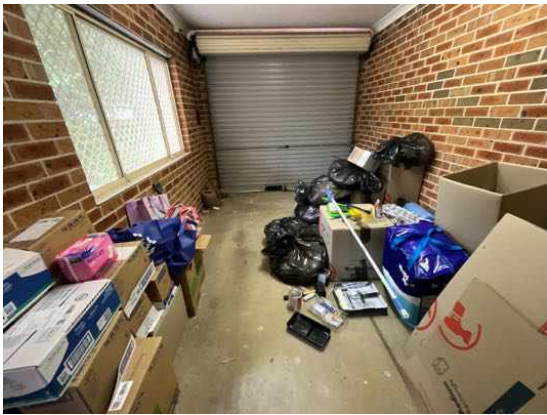
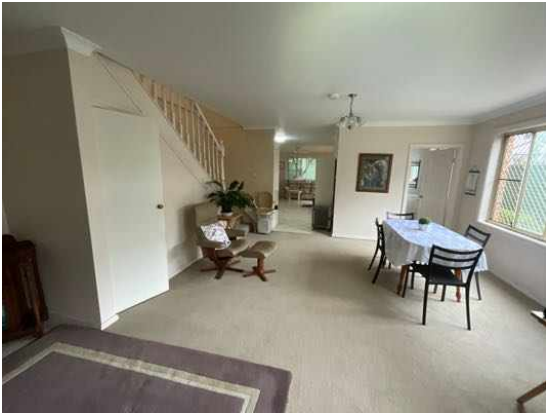
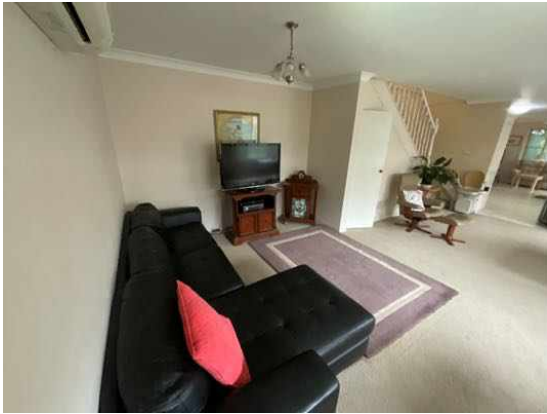
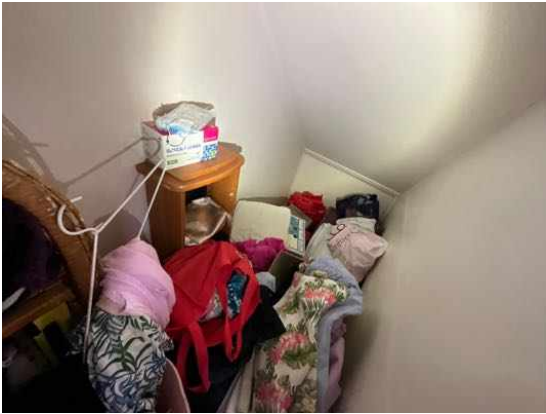
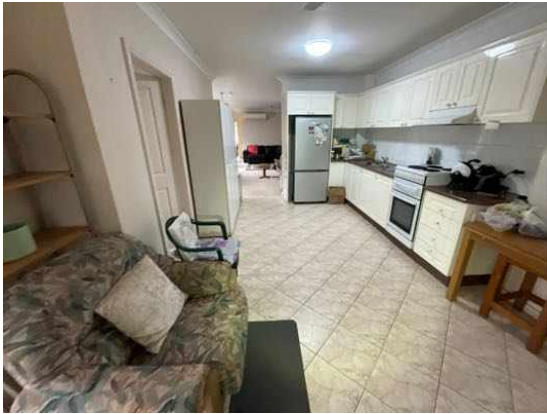
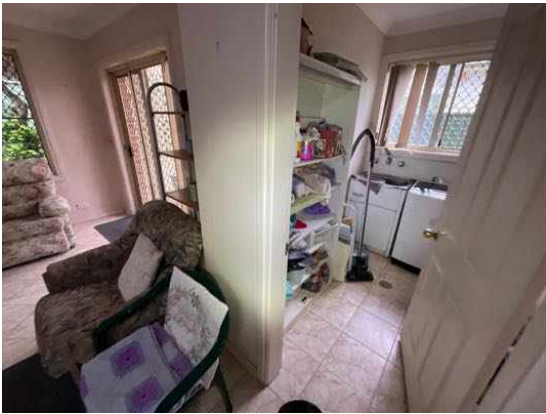
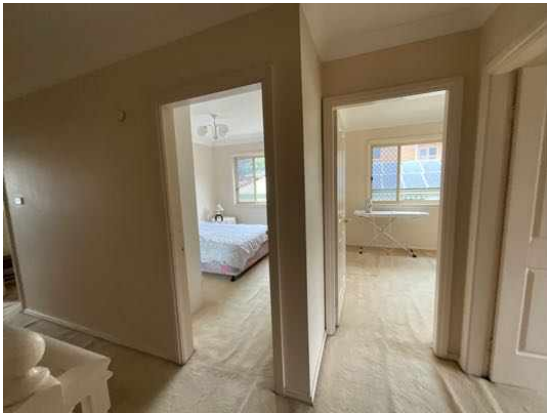
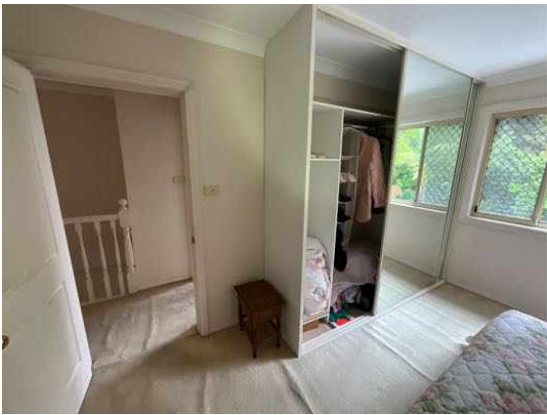
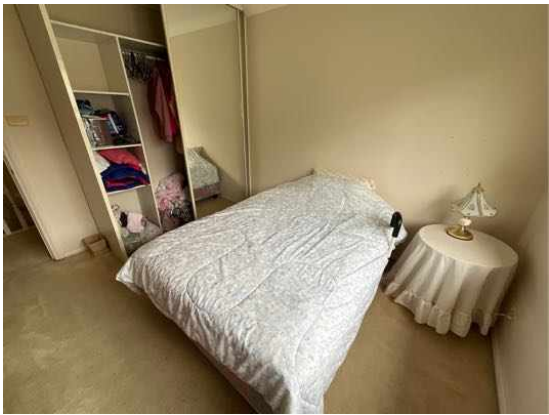
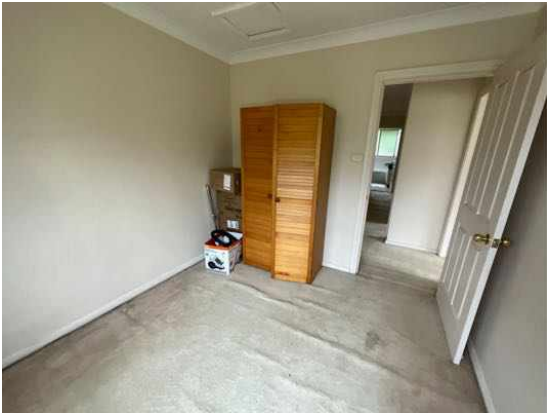
Building:	Main Building
Location:	All Areas
Finding:	Additional Photos - Obstructions and Limitations
Information:	These photographs are an indication of the obstructions and limitations which impeded full inspection of the property at the time of inspection. These obstructions can hide an array of defects and should be removed to allow full inspection to be carried out. A re-inspection is recommended once the areas are made accessible.
