Building and Timber Pest Inspection Report

Inspection Date: Thu, 19 Mar 2026

Property Address: 15/8 Myall St, Cabramatta NSW 2166,
Australia

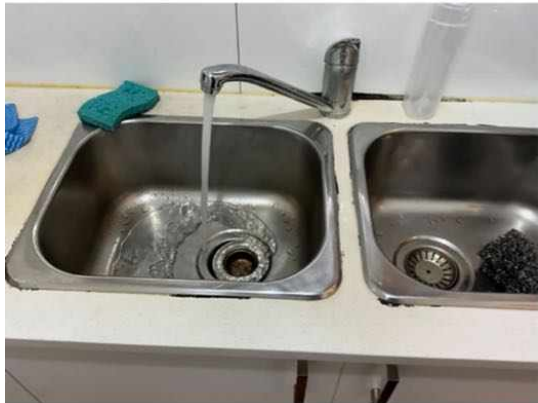
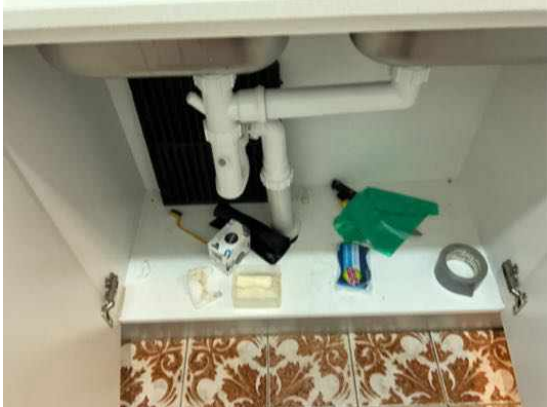
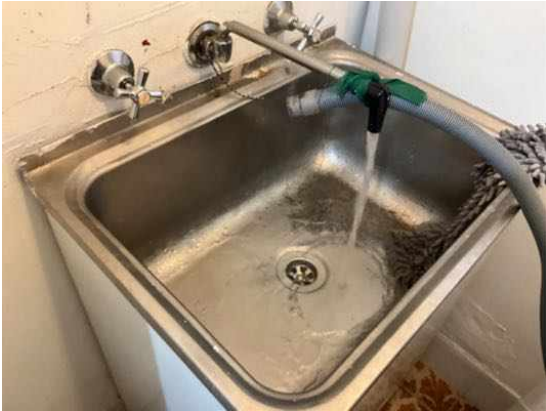
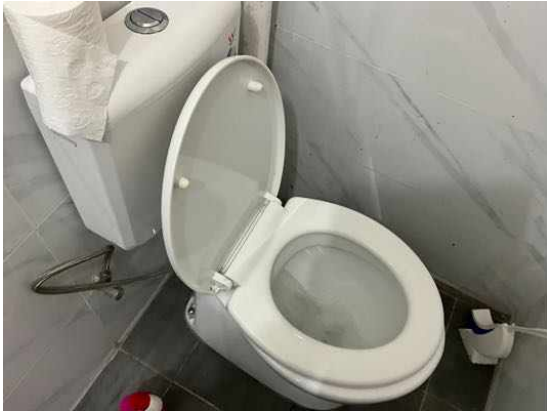
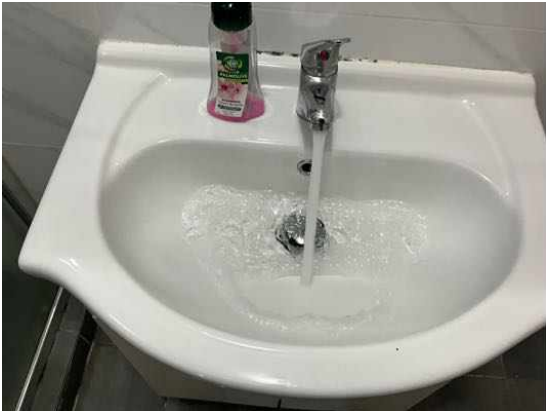
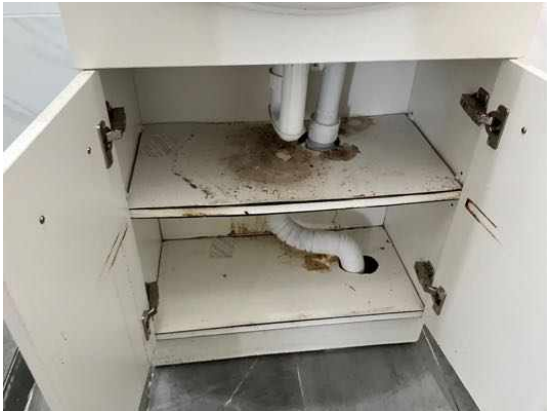
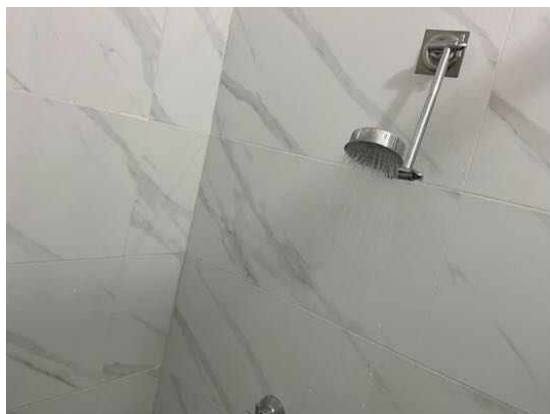
Building: Main Building
Location: All Wet Areas
Finding: Additional Photos
Information: Additional photos are provided for your general reference.

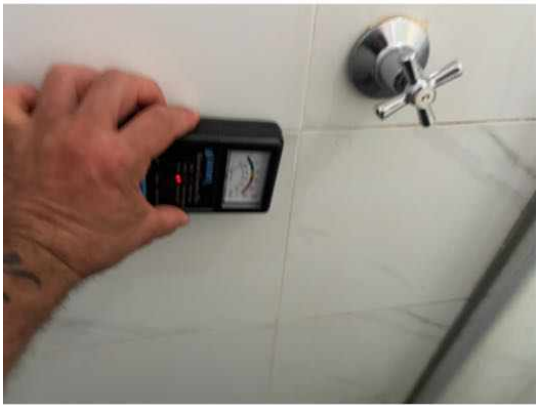
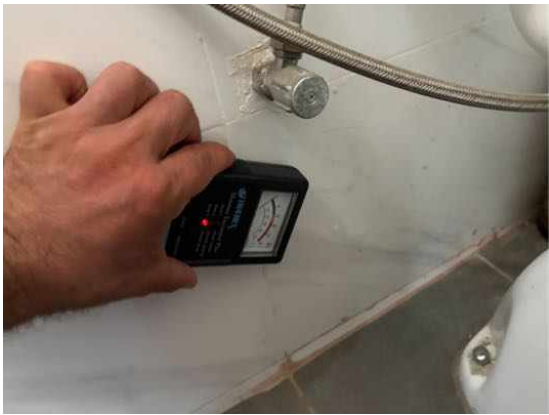
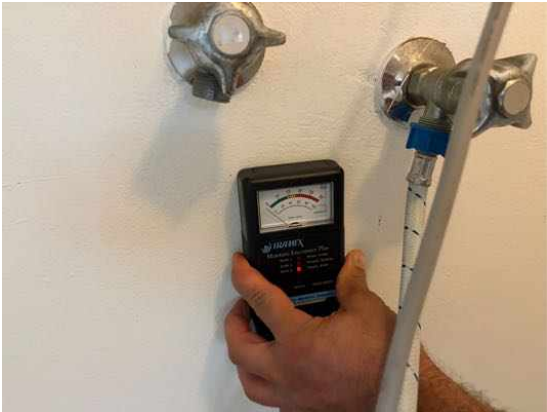
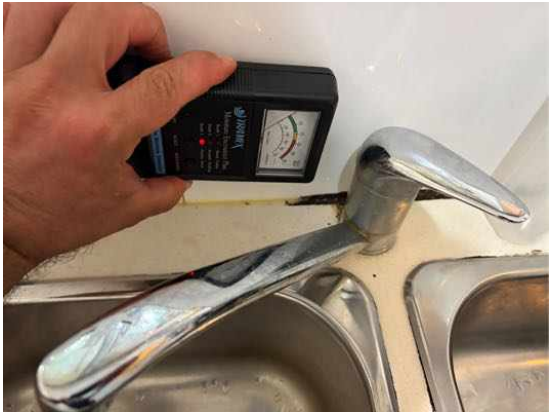
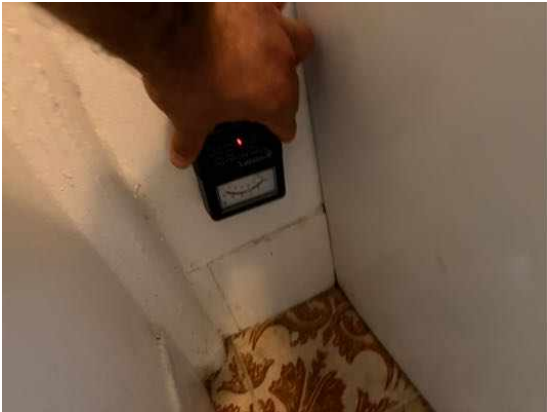
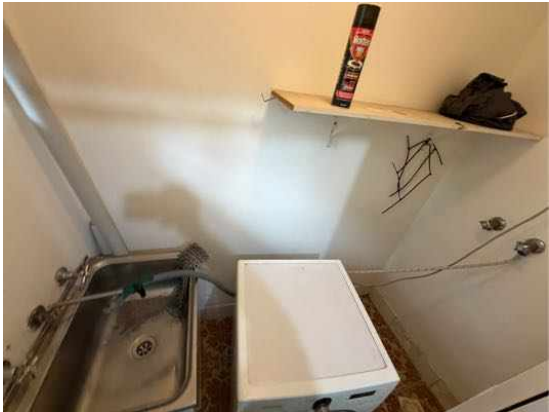
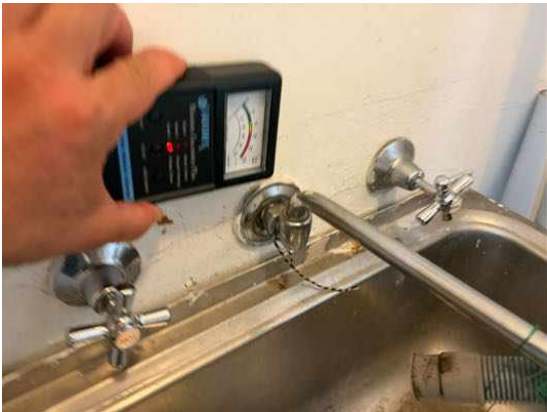
Building:	Main Building
Location:	All Areas
Finding:	Moisture meter
Information:	During the inspection the property was checked for moisture using a moisture metre. This is for information only.

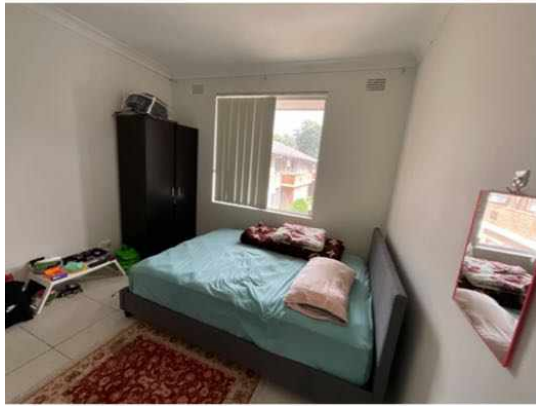
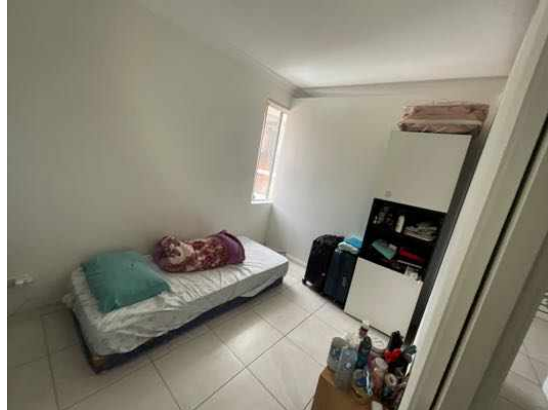
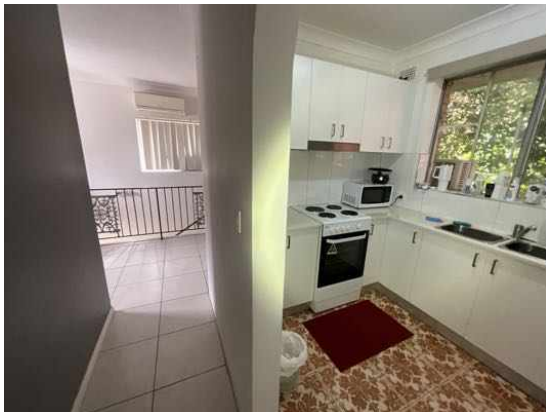
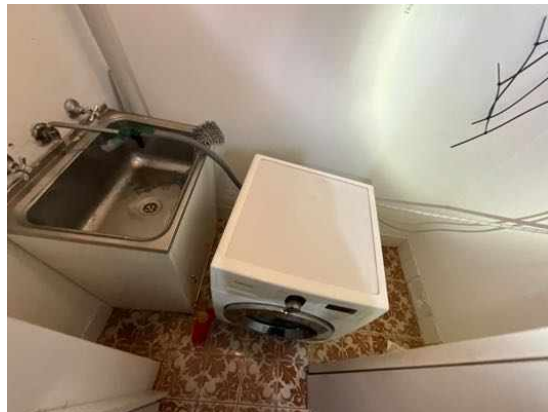
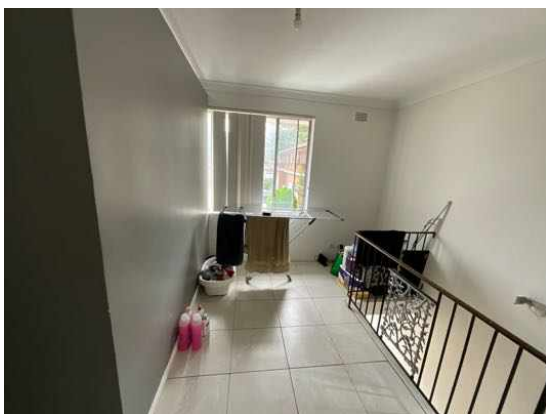
Building: Main Building
Location: All Areas
Finding: Additional Photos - Obstructions and Limitations
Information: These photographs are an indication of the obstructions and limitations which impeded full inspection of the property at the time of inspection. These obstructions can hide an array of defects and should be removed to allow full inspection to be carried out. A re-inspection is recommended once the areas are made accessible.
