Building Inspection Report

Inspection Date: Fri, 20 Mar 2026

Property Address: 5A Collins Ave, Edwardstown SA 5039,
Australia

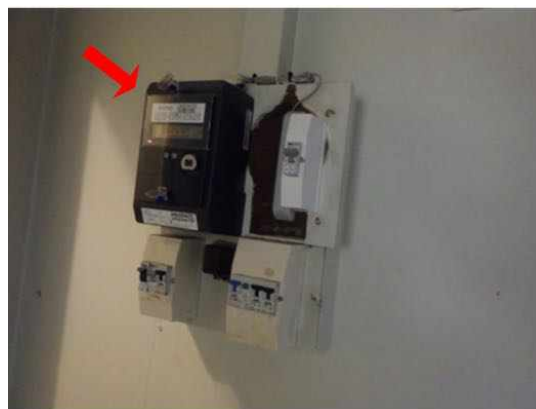
Defects 1.02

Building:	Building 1
Location:	All External Areas

Finding: Laundry Area – Electrical Meter Box - Cover was missing / Exposed / Not adequately protected

Information: At the time of inspection it was noticed that the electrical meter is installed internally within the laundry area of the property. It was also observed that the electrical meter box cover was missing / exposed / not adequately protected at the time of inspection, creating a potential safety hazard for persons coming into contact with this area.

Exposed electrical components present a significant safety risk and should be treated as an urgent defect. Although some building elements may appear minor, all building components contribute to the safe operation and overall performance of the structure.

It is strongly advised that a suitably qualified licensed electrician be appointed as soon as possible to assess the installation and provide an appropriate compliant cover / enclosure to the electrical meter box to minimise safety risks and ensure safe operation.

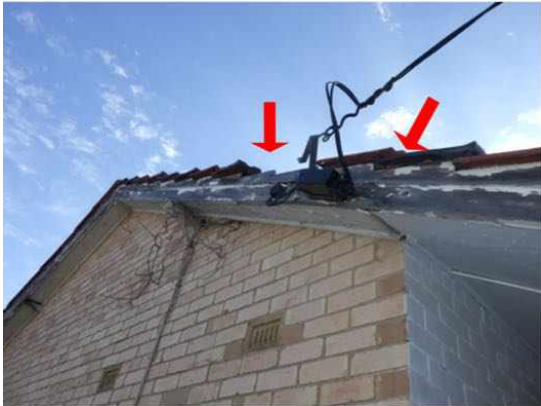
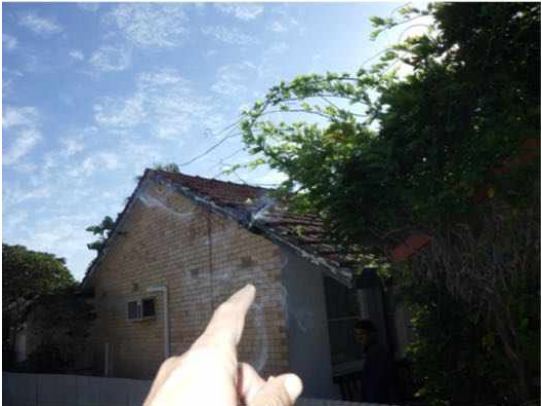
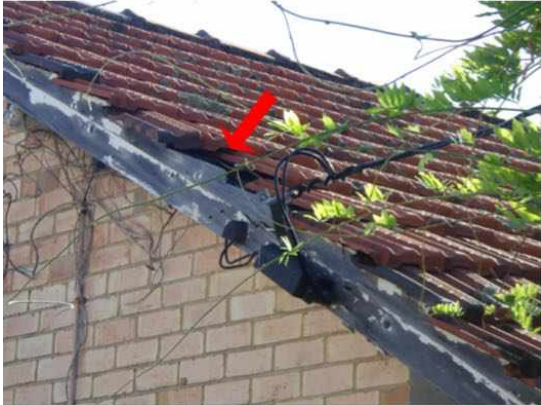
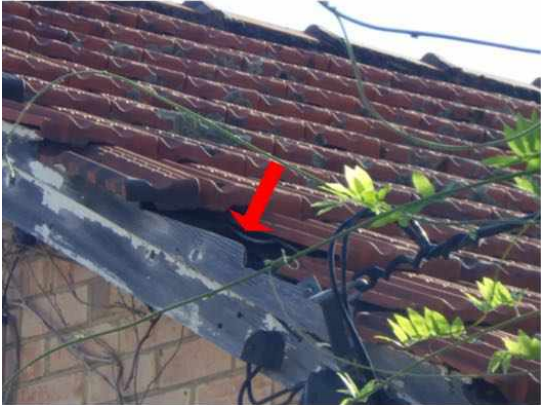
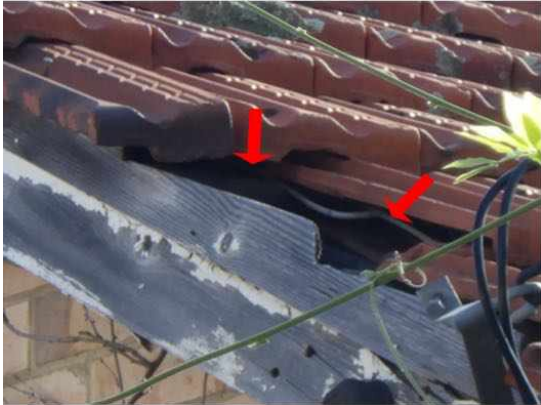
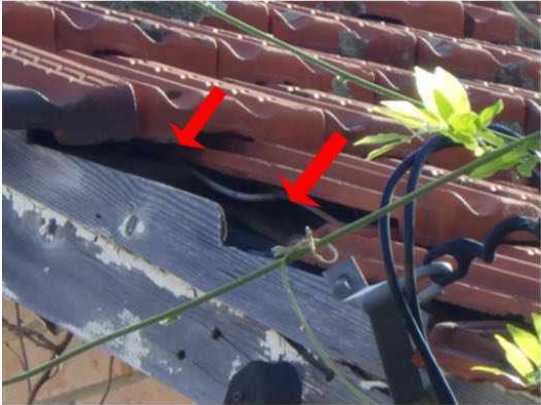
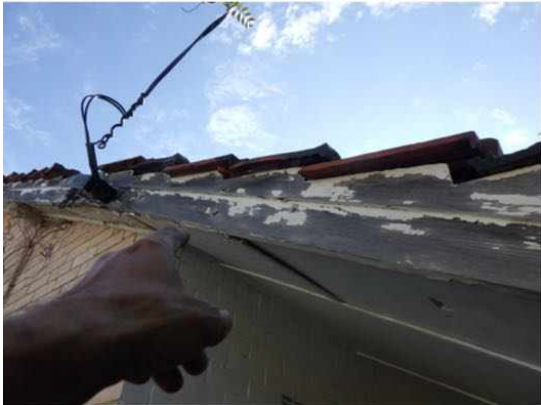
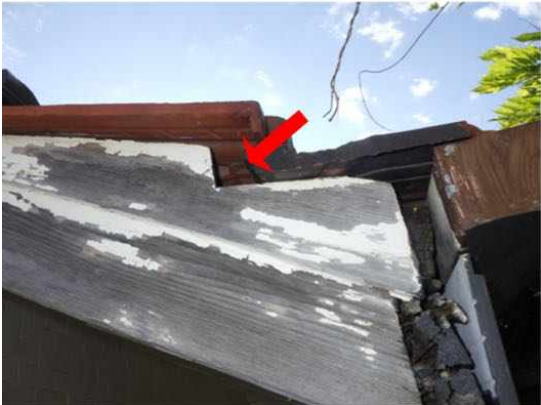
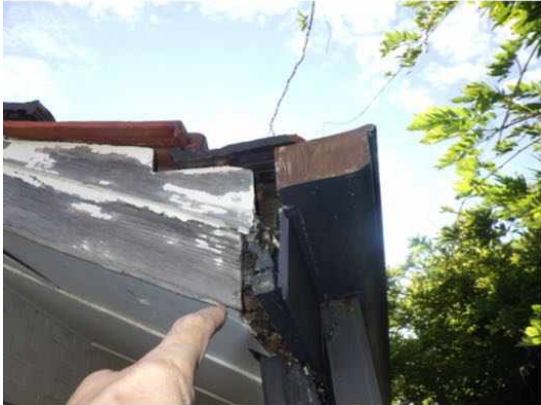
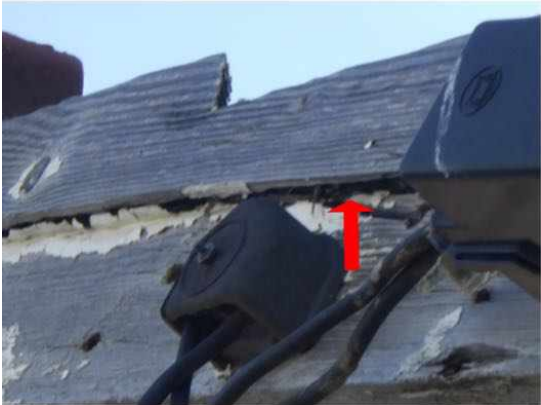
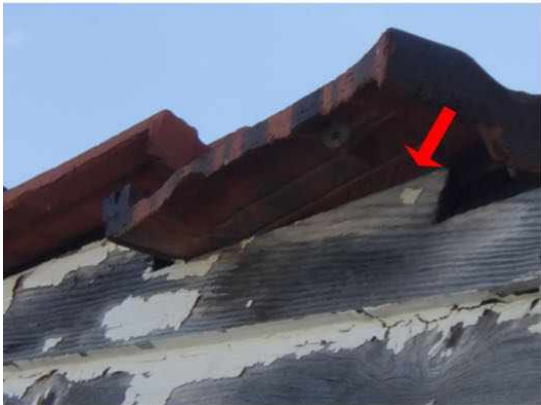
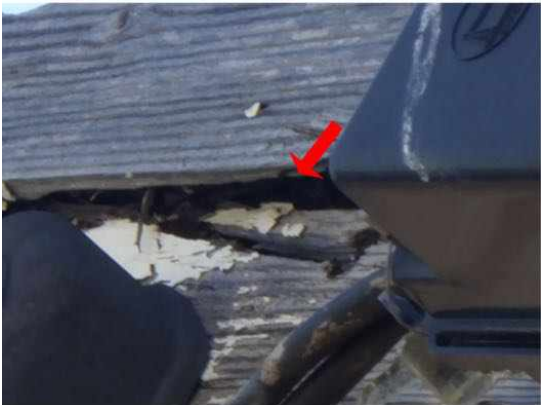
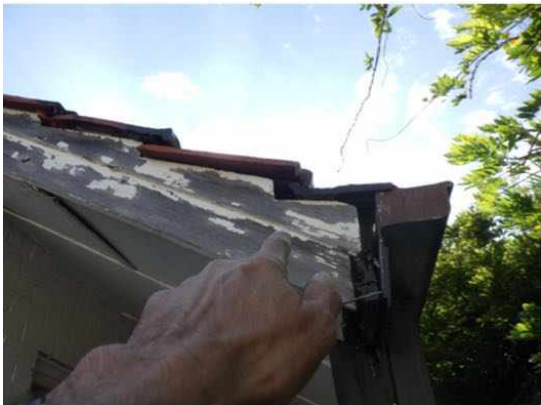
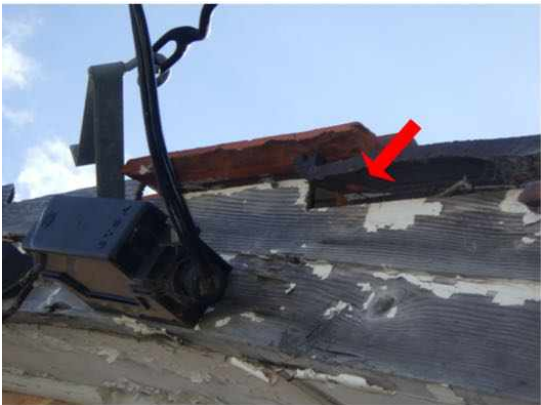
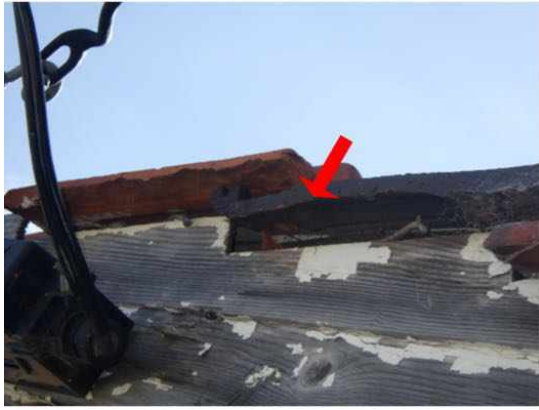
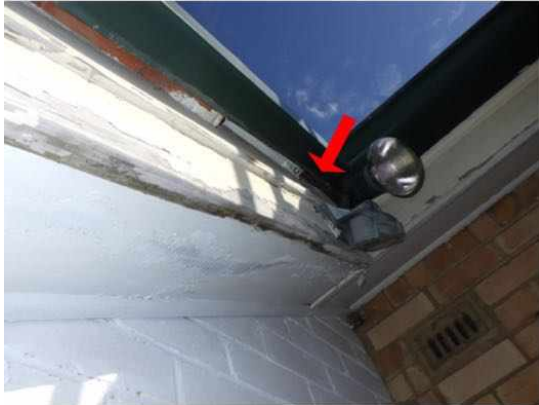
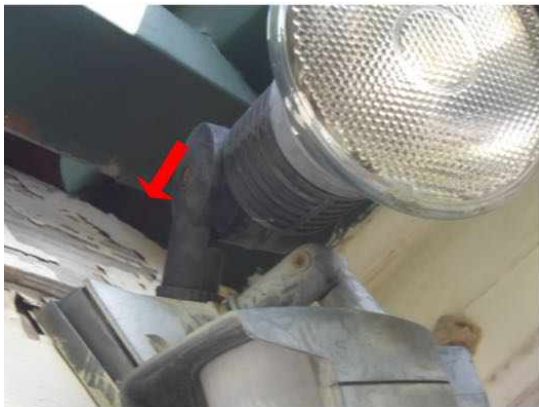
Defects 2.01

Finding: Roof plumbing - Flashing inadequate

Information: At the time of inspection it was noticed that some sections of the roof are missing or have inadequate roof flashings. Apart from that at the time of inspection it was also noticed that roof sheet was loose from its original fixing.

Flashings that are not installed adequately or are missing are likely to result in water penetration to the interior of the property, as well as creating excessively damp

conditions against the exterior surfaces and around the base perimeter of the building.

Premature ageing and secondary building defects are imminent where roof plumbing is missing or inadequately installed. Additionally, water pooling also creates an environment that is susceptible to termite and pest infestation.

A roofing plumber should be appointed as soon as possible to install relevant roof plumbing materials, ensuring that no further damage is sustained.

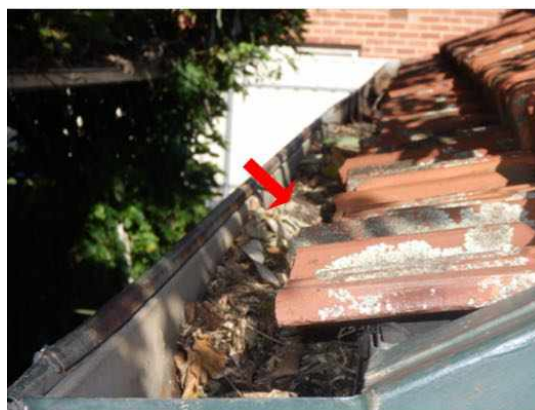
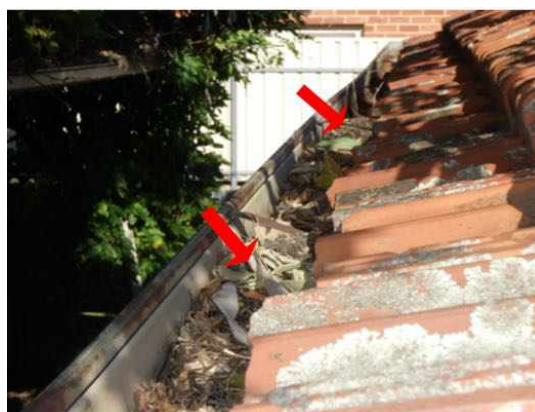
Defects 2.02

Building:	Building 1
Location:	All External Areas
Finding:	Gutters - Blocked
Information:	At the time of inspection it was noticed that gutters were blocked in few sections around the property. Gutters have to be cleaned in regular intervals.

Blocked gutters are likely to lead to high levels of moisture in the affected areas. Such moisture will not only cause rust and decay of the associated building materials, but can also provide conditions that are conducive to termite and timber pest activity. Blockages in gutters should therefore be removed immediately to ensure dry conditions are maintained.

Consult a Licensed Plumber for further specific advice on remedial works that may be required. In the interim, it is highly advised that blocked gutters be removed by the homeowner or a general handyperson as a matter of urgency.

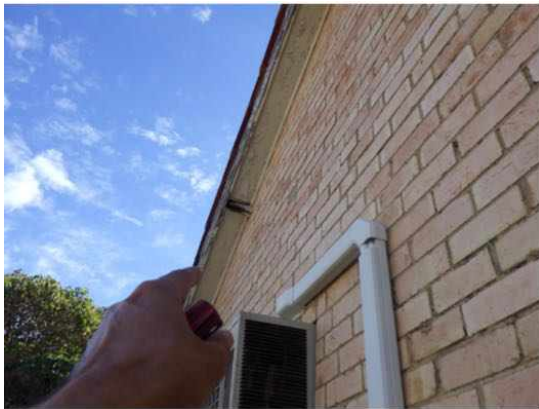
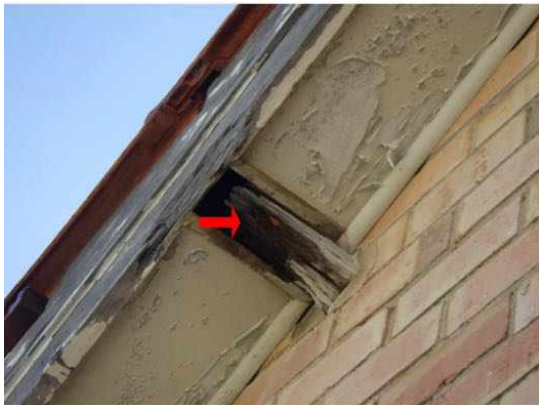
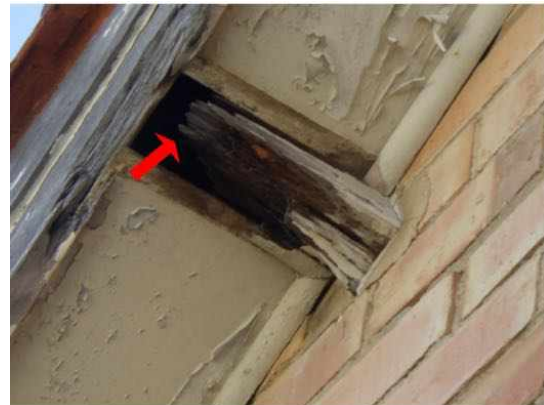
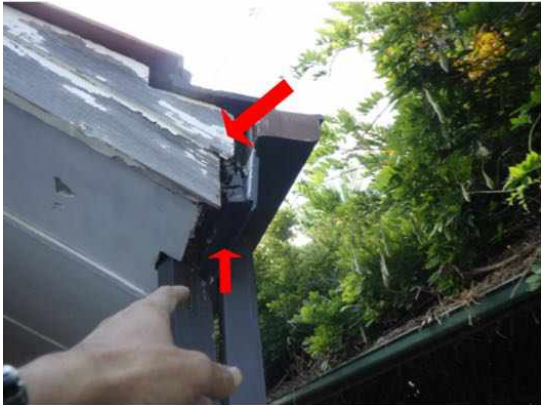
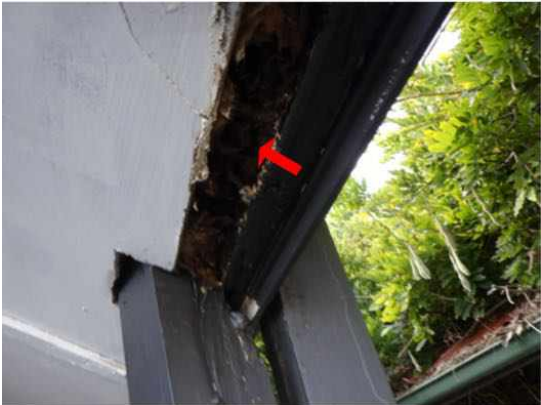
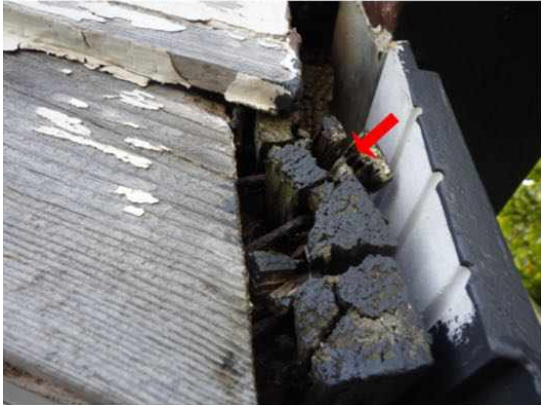
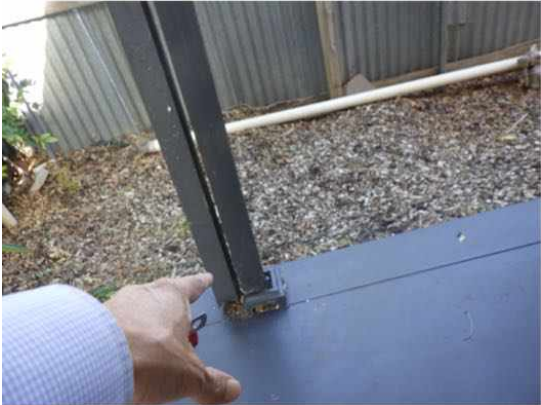
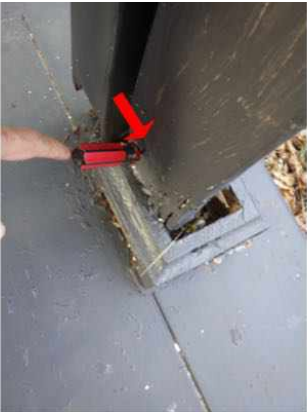
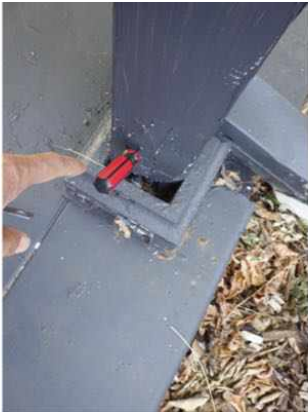
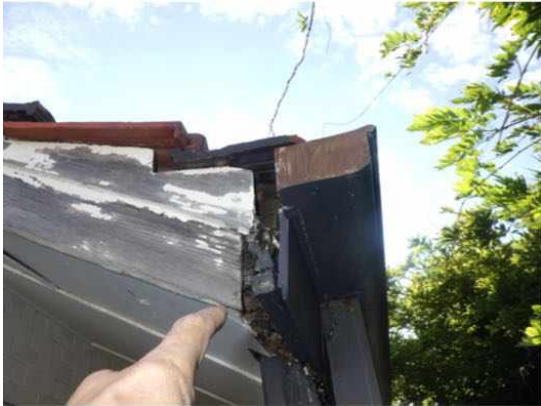
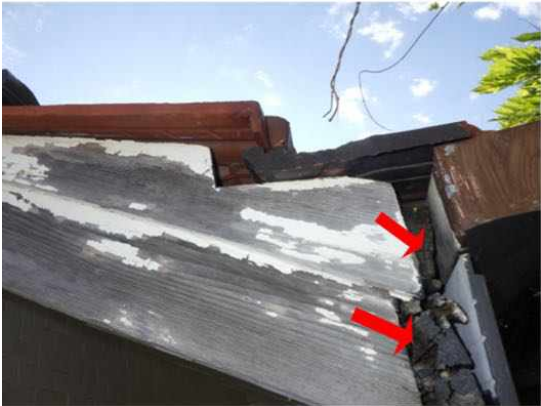
Defects 2.03

Building:	Building 1
Location:	All External Areas
Finding:	Wood rot
Information:	This building element shows evidence of wood rot. Wood rot, also known as Fungal Decay, occurs when timbers and other cellulose building materials are exposed to damp conditions on an ongoing basis. This could be the result of exposure to weathering over a prolonged period of time, or the attraction of excessive moisture from other abutting building materials. Contributing factors also include poor air

Wood rot is often associated with general damp problems and is evidenced by a 'musty' smell or mould and mildew occurring on surfaces. If left unmanaged, damp conditions can lead to further health problems and the decay of timbers will continue.

Early intervention and regular maintenance, particularly of exterior timbers, will prolong the useful life of these building elements. Prior to any works being performed, the cause of the moisture that has created the visible wood rot should be identified and addressed in a suitable manner. Replacement of affected timbers may then be a necessary step in protecting surrounding building elements from such deterioration.

A qualified plumber may be appointed to assess the cause of excessive moisture and to provide advice on any remedial works as required. A qualified carpenter or registered builder may also be required to replace affected building materials.

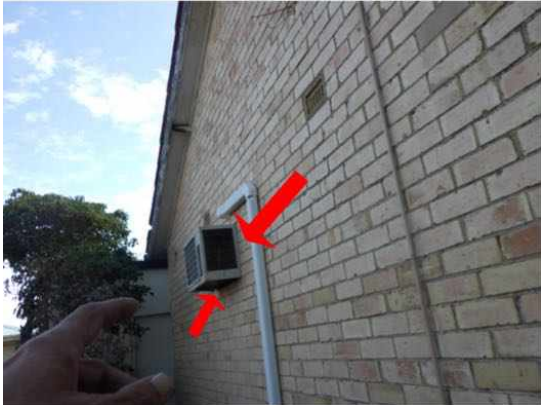
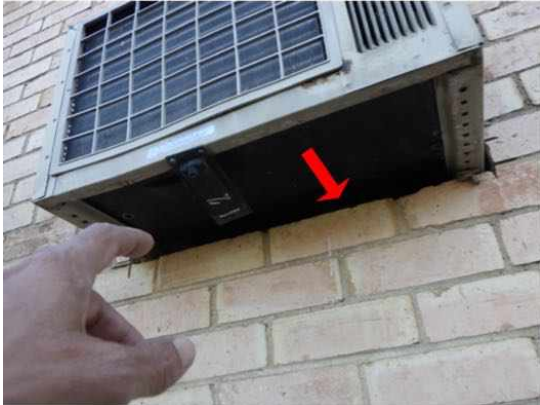
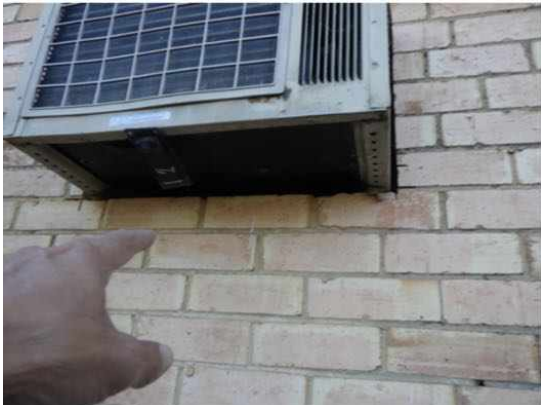
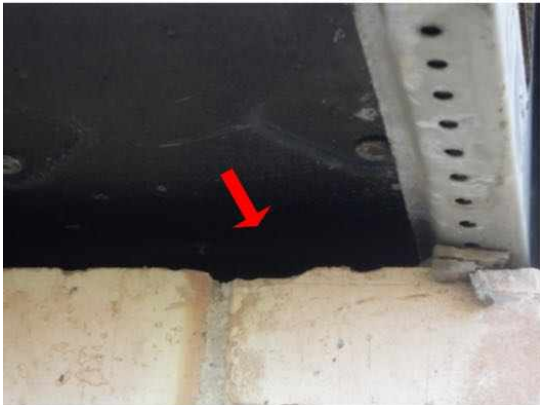
Defects 2.04

Building: Building 1
Location: All External Areas
Finding: External walls & Aircon Assembly - Significant Gaps
Information: At the time of inspection it was noticed that significant gaps between external walls and Aircon assembly.

Breakage occurs generally when the building materials have either aged and decayed, or as a result of damage (accidental or deliberate).

Repair and/or replacement of broken elements is advised to ensure that additional secondary defects do not arise as a consequence. Such works are necessary, as all building elements play a key role in the operation and function of the overall structure and its performance.

A relevant tradesperson should be appointed as soon as possible to repair or replace the affected building element prior to any subsequent damage being caused.

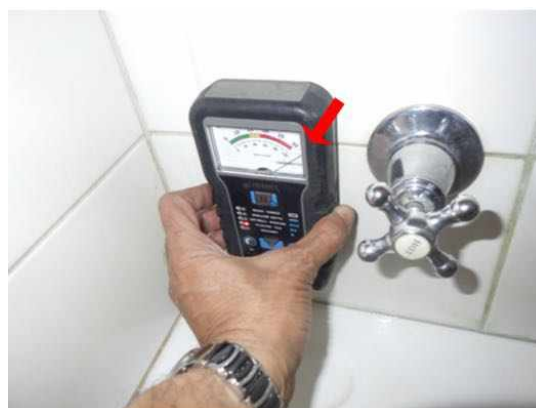
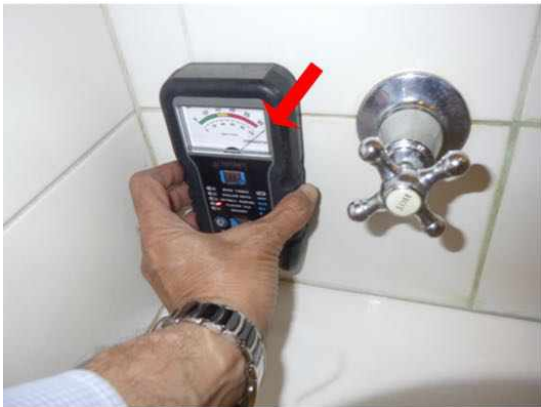
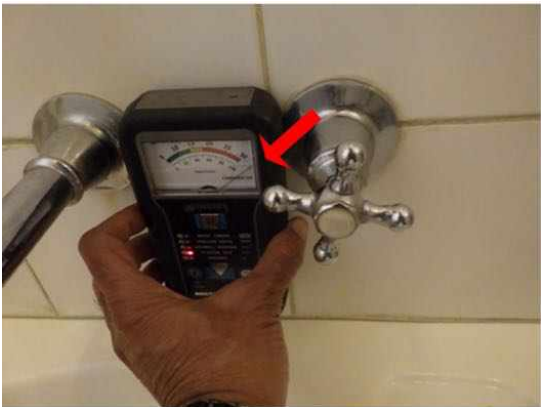
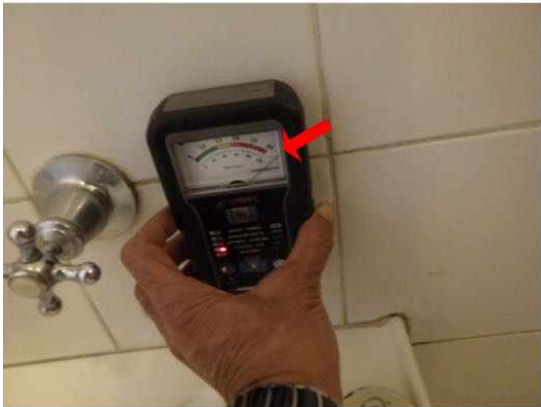
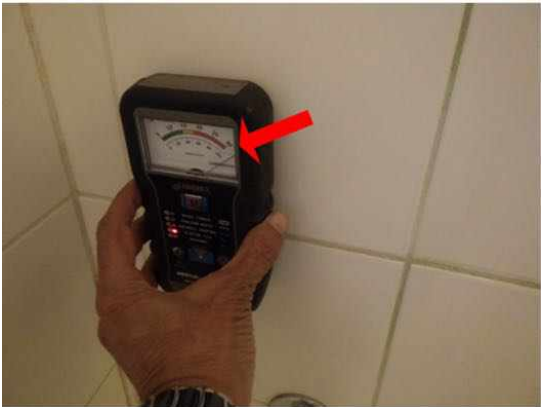
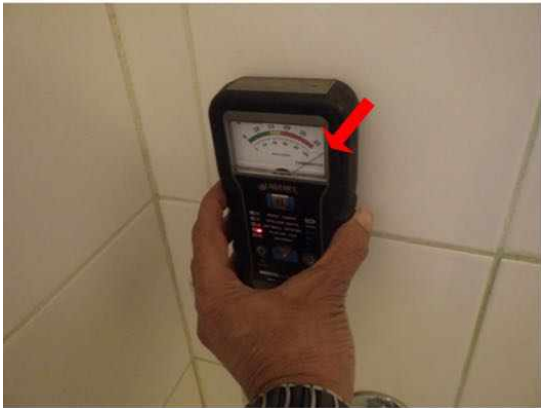
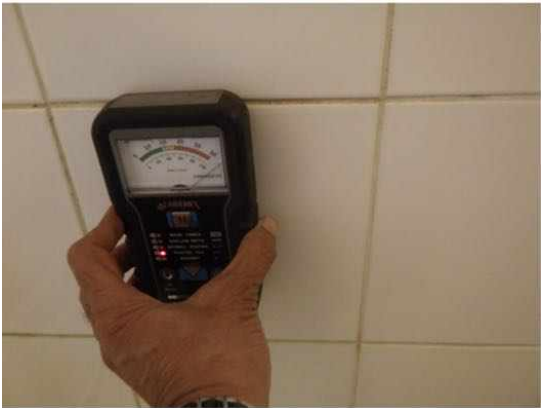
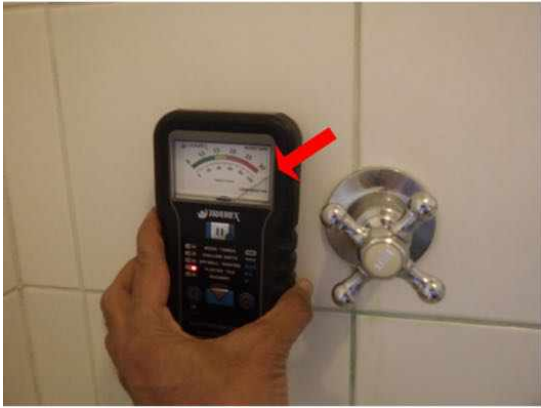
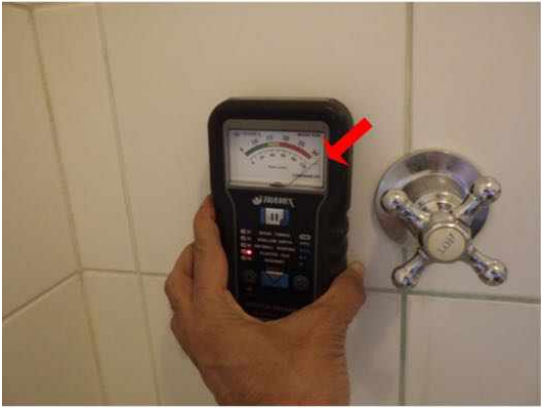
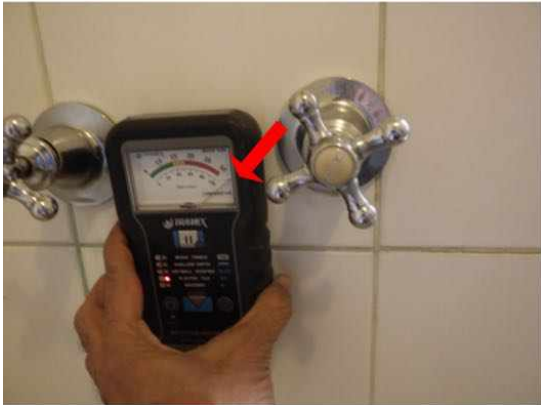
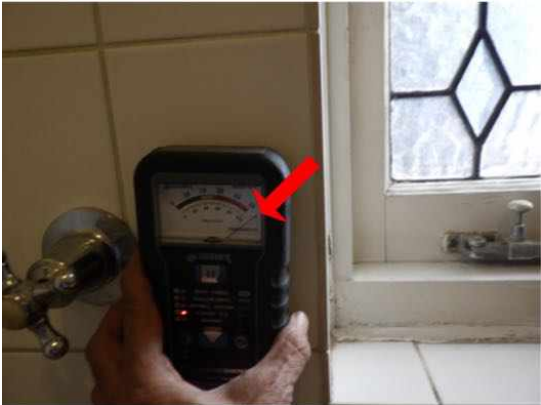
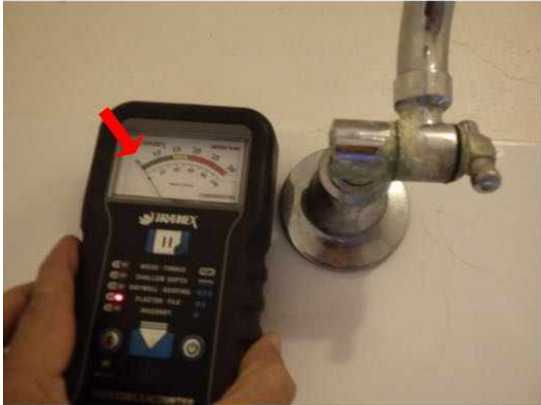
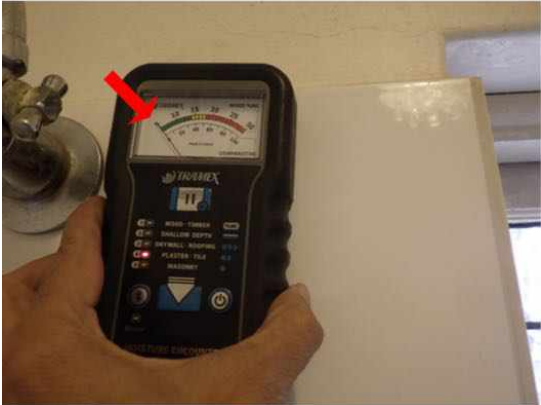
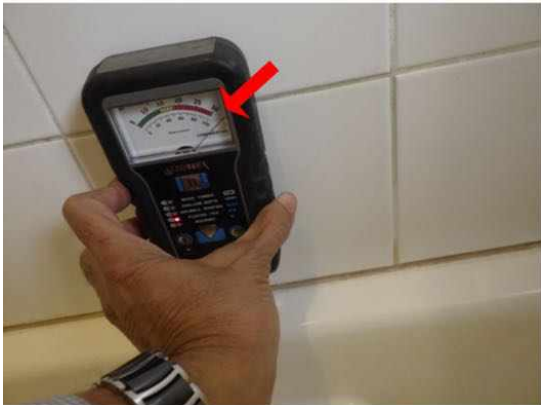
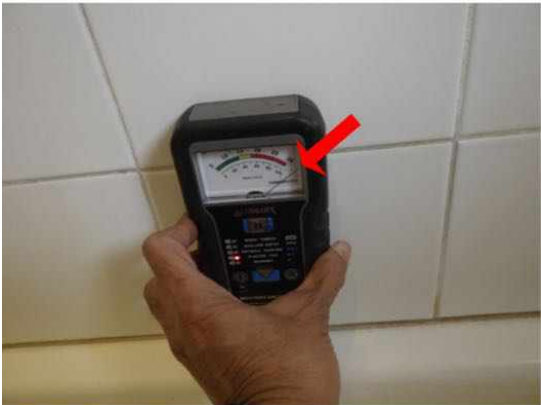
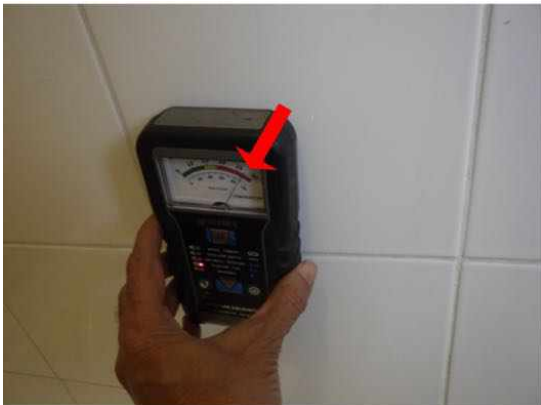
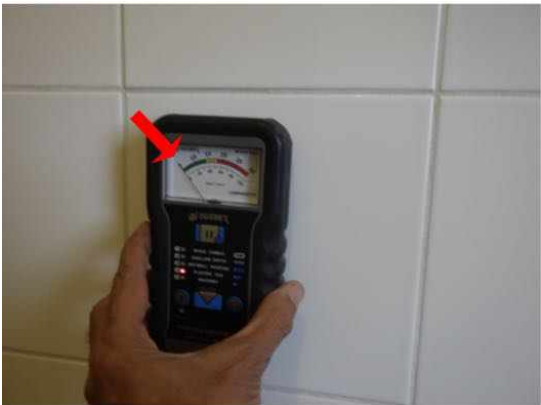
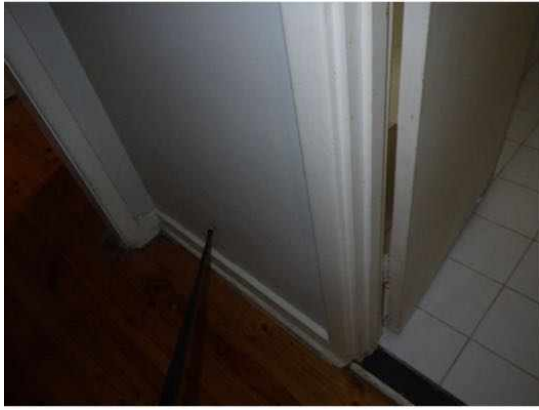
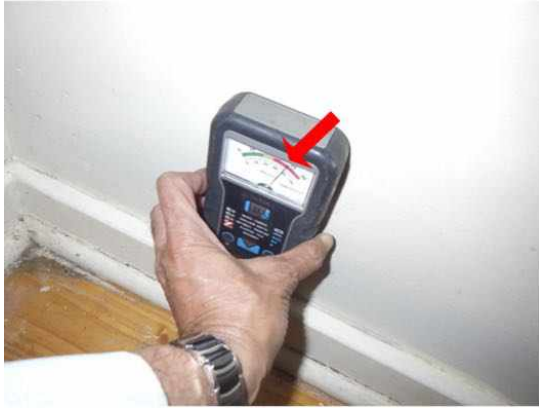
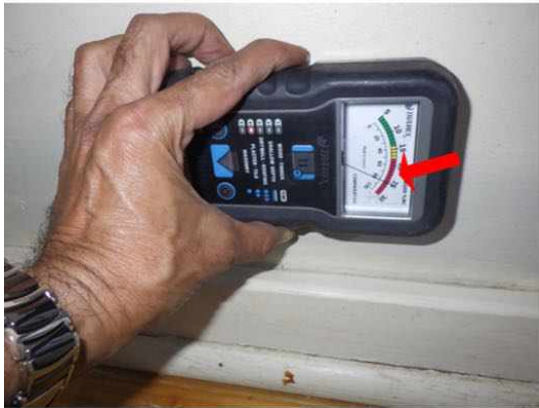
Defects 2.05

Building: Building 1
Location: Bathroom
Finding: Shower Alcove - Damp & Moisture is transferring to other side of the walls
Information: Damp is evident to the lower 500mm approximately of wall to the shower alcove. This defect is quite common, and is suspected to have been caused by moisture permeating through the grouting in this area, which shows evidence of deterioration. Leaking pipes within the adjoining wall is also a possible cause.

Apart from that at the time of inspection it was also noticed that moisture is transferring to other side of the external & internal walls.

Damp (or structural damp) refers to the presence of unwanted moisture in the structure of a building, either as the result of intrusion from outside, or condensation from within the structure. In the shower area, internal water leaks or other sources of excessive moisture are generally the cause of damp.

Unmanaged damp in the shower recess is likely to facilitate the formation and development of mould and fungi growth, decaying associated building materials and compromising their structural integrity. Exposure to these contaminants is associated with a wide range of respiratory and other health-related problems.

Consultation with a qualified plumber or bathroom specialist is advised immediately to identify the cause of damp and to perform remedial works as required. Where excessive mould growth is present, further inspection by a specialist environmental health inspector should also be considered.

Always ensure that sealant and grout is in good condition to prevent any moisture issues occurring in the future.

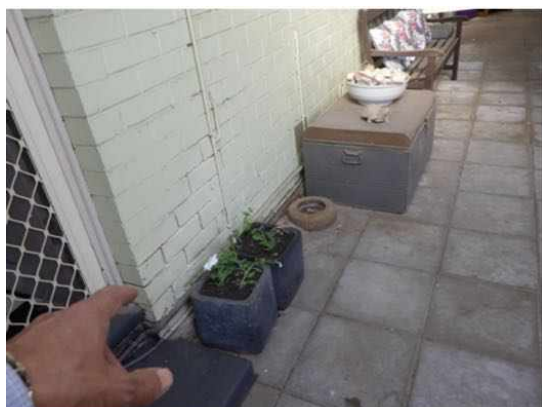
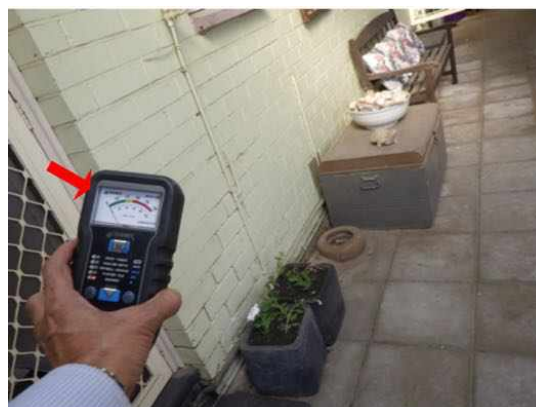
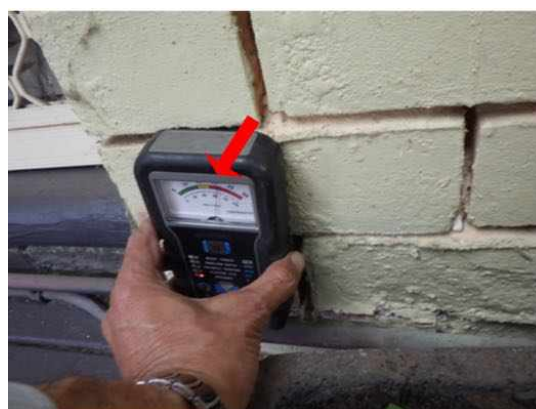
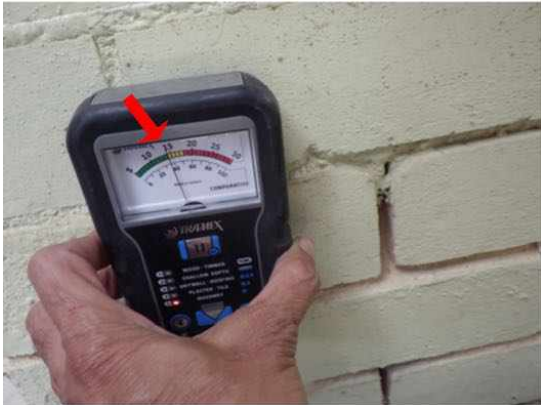
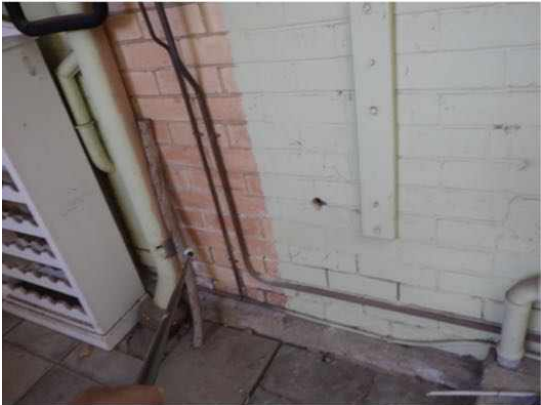
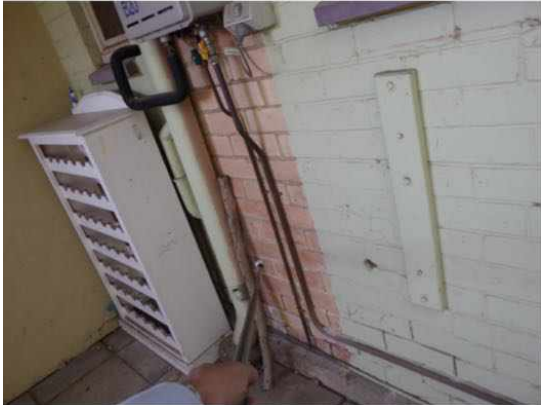
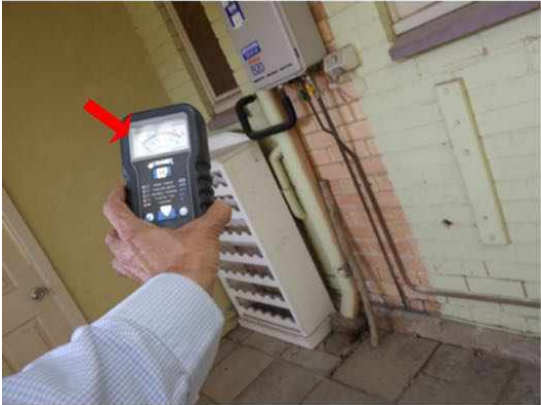
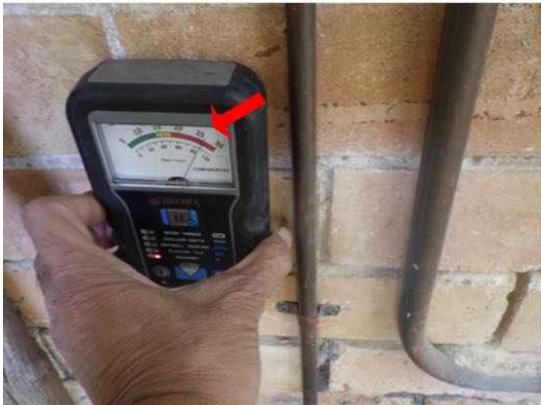
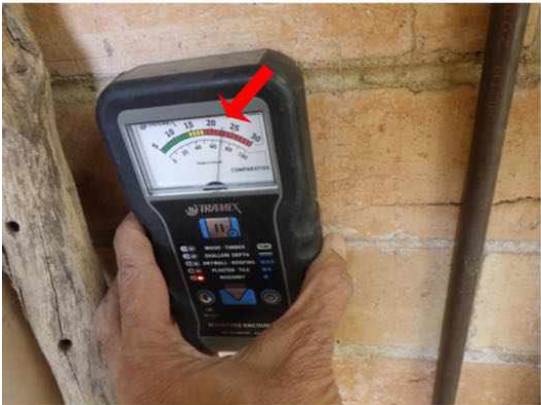
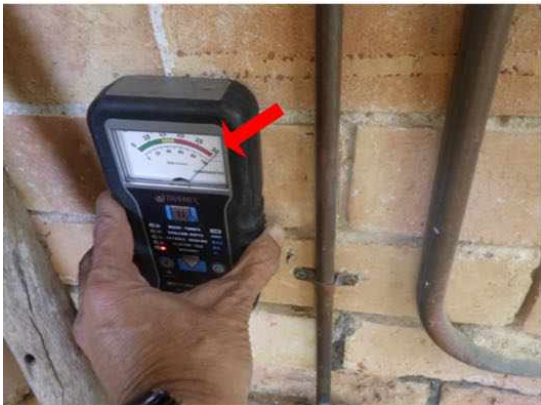
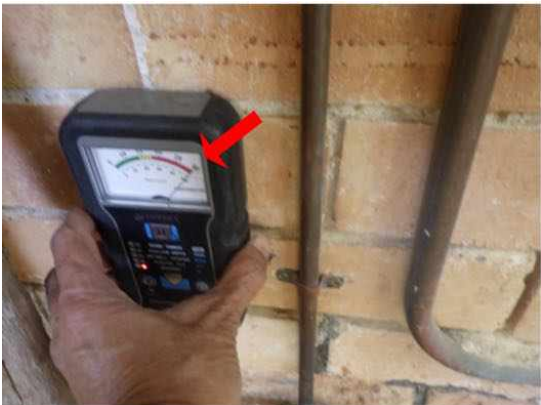
Defects 2.06

Building:	Building 1
Location:	All External Areas
Finding:	External walls - Damp at lower base
Information:	At the time of inspection it was noticed that high moisture readings were noted in the few sections of rear external wall around the property.

Damp (or structural damp) refers to the presence of unwanted moisture in the structure of a building, either as the result of intrusion from outside, or condensation from within the structure. Generally, structural damp is caused by rain penetration, rising damp, and leaks from plumbing pipes.

Unmanaged damp facilitates the formation and development of mould, fungi growth and wood rot, decaying associated building materials and compromising their structural integrity. Damage to finishes is also likely to occur, including lifting, bubbling, peeling and staining of paint, plaster and wallpaper.

The first step in addressing damp is to diagnose the cause. The identified cause should be addressed first prior to repairing the appearance and other defects which have resulted from the rising damp. If the original cause is not resolved, further cases of damp are likely to ensue, resulting in secondary defects.

Consultation with a qualified plumber is advised immediately to identify the cause of damp and perform remedial works as required. Where excessive mould growth is present, further inspection by a specialist environmental health inspector should also be considered.

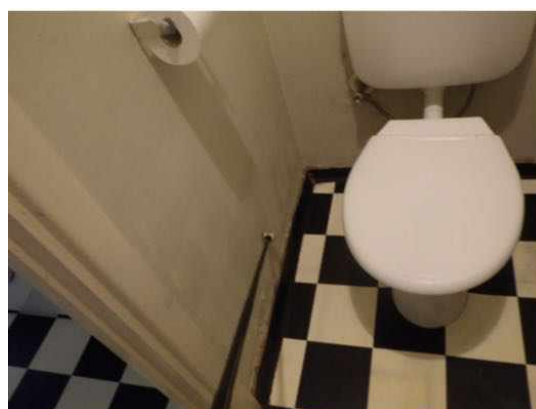
Defects 2.07

Building:	Building 1
Location:	All External Areas
Finding:	Internal walls - Damp adjacent to bathroom, laundry and toilet walls at lower base
Information:	At the time of inspection it was noticed that high moisture readings were noted in few sections of internal walls adjacent to bathroom , laundry and toilet walls at lower base.

Damp (or structural damp) refers to the presence of unwanted moisture in the structure of a building, either as the result of intrusion from outside, or condensation from within the structure. Generally, structural damp is caused by rain penetration, rising damp, and leaks from plumbing pipes.

Unmanaged damp facilitates the formation and development of mould, fungi growth and wood rot, decaying associated building materials and compromising their structural integrity. Damage to finishes is also likely to occur, including lifting, bubbling, peeling and staining of paint, plaster and wallpaper.

The first step in addressing damp is to diagnose the cause. The identified cause should be addressed first prior to repairing the appearance and other defects which have resulted from the rising damp. If the original cause is not resolved, further cases of damp are likely to ensue, resulting in secondary defects.

Consultation with a qualified plumber is advised immediately to identify the cause of damp and perform remedial works as required. Where excessive mould growth is present, further inspection by a specialist environmental health inspector should also be considered.

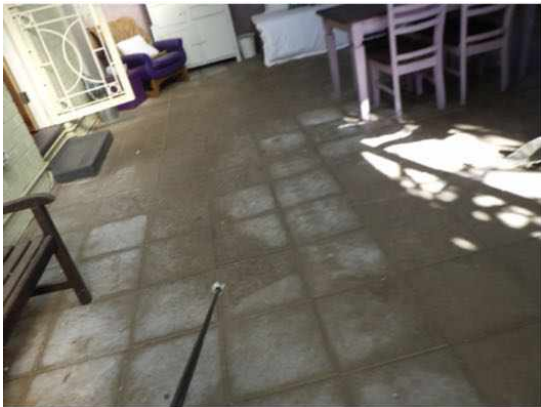
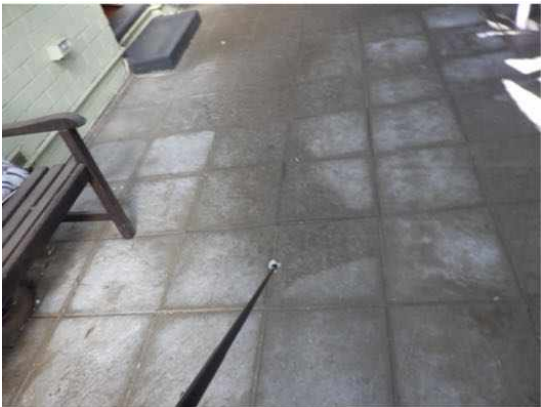
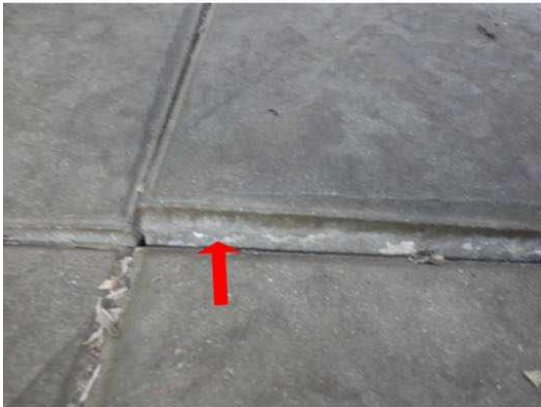
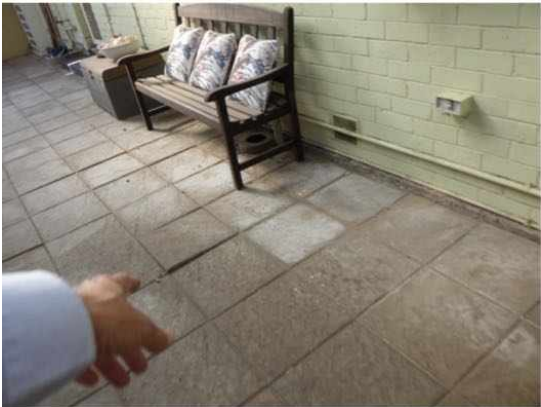
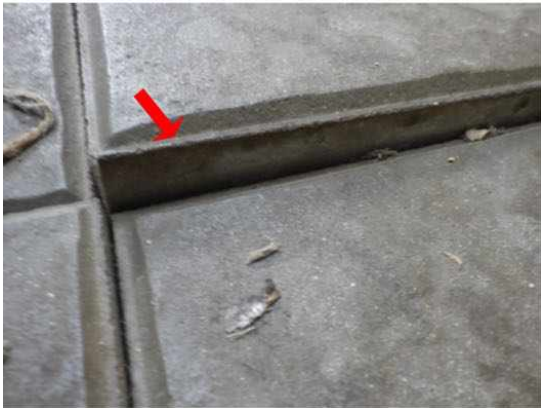
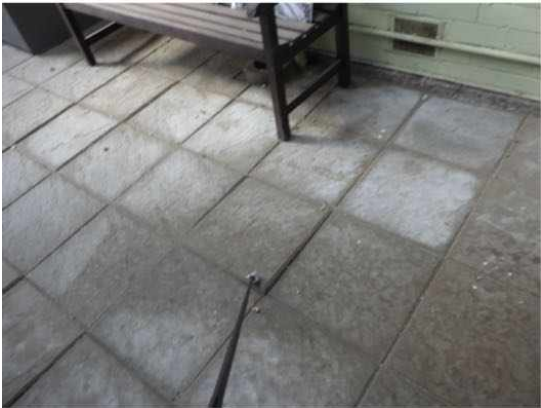
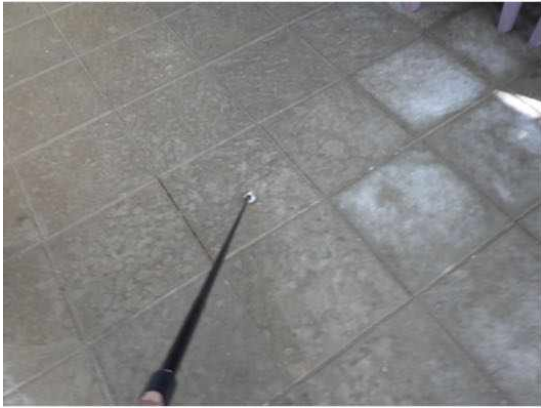
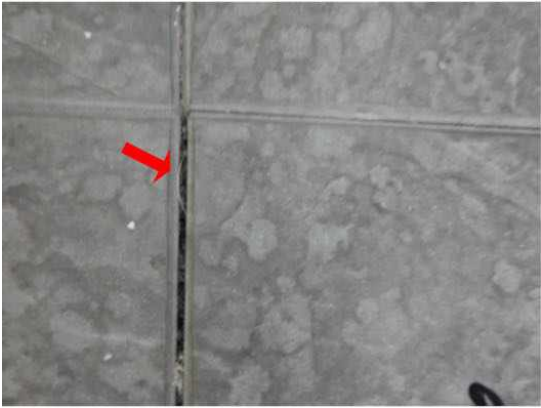
Defects 3.01

Building:	Building 1
Location:	All External Areas
Finding:	Paving - Uneven
Information:	Sections of the external paved area are uneven, creating a potential trip hazard. It appears as though the area has been subject to rough installation, or that paving sections have lifted due to movements in the foundation of the property.

Where paving creates a trip hazard, personal injury may ensue if due caution is not taken by all persons within this area.

Re-paving of the area is required as soon as possible to remedy this situation. Further consultation with a specialist concreter is advised.

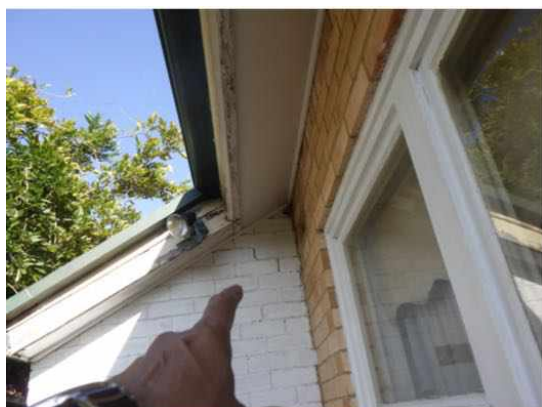
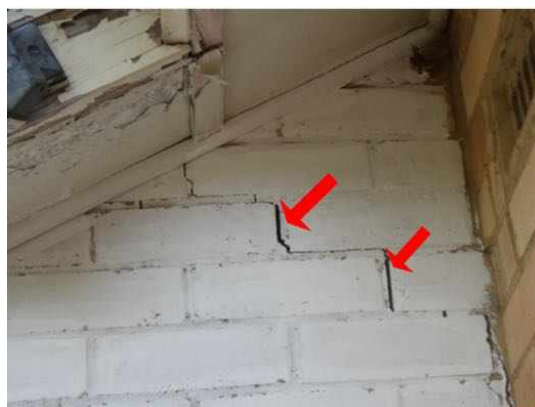
Defects 3.02

Building:	Building 1
Location:	All External Areas
Finding:	Brickwork - Step cracking
Information:	Step cracking was identified to the brickwork in this area at the time of inspection. Step cracking, which is similar to other forms of cracking, has a variety of possible causes. However, the most common is the subsidence of adjacent footings.

Step cracking is a relatively common defect, and is most likely to occur adjacent to windows, doors and other openings. Mortar failure in the gaps between affected bricks indicates the stresses and tensions affecting the wall.

Where step cracking is extensive or severe, the client is advised to consult a structural engineer. Minor step cracking can be used as a warning sign to address factors causing stress to the wall, which can include the effect of surrounding trees, water leaks, soil erosion, or even the presence of reactive soils in the surrounding area.

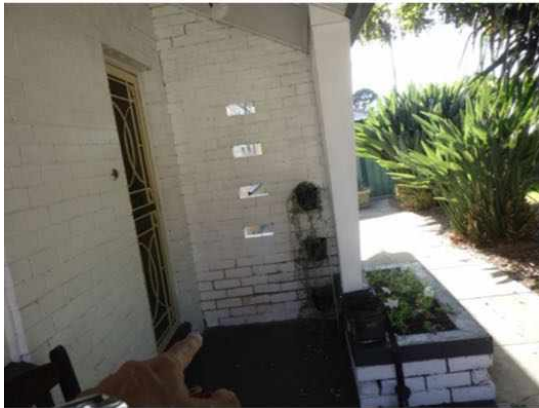
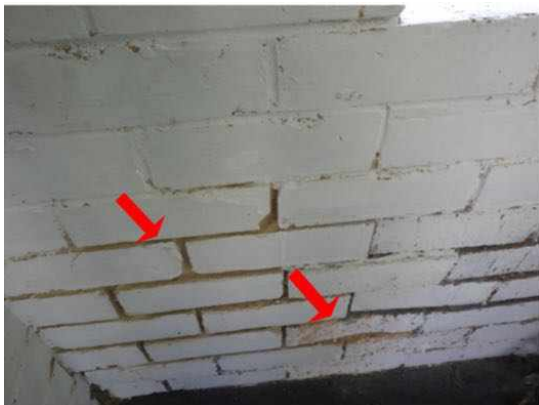
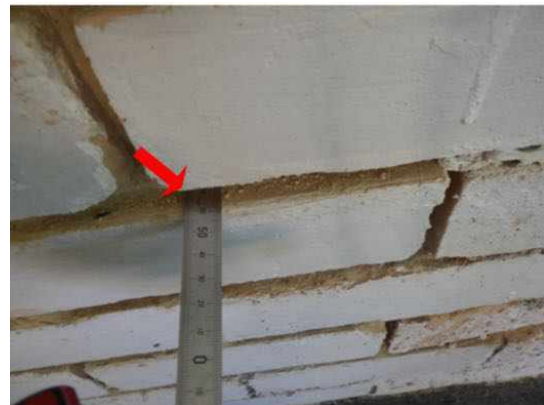
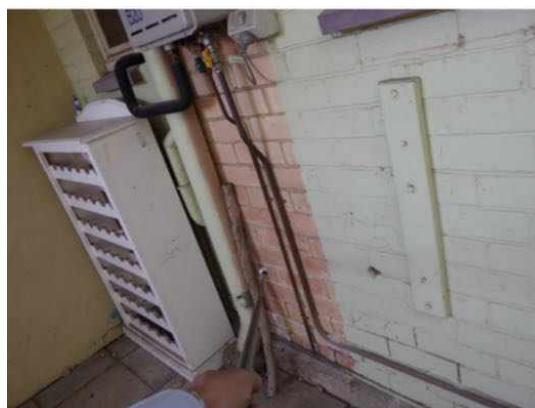
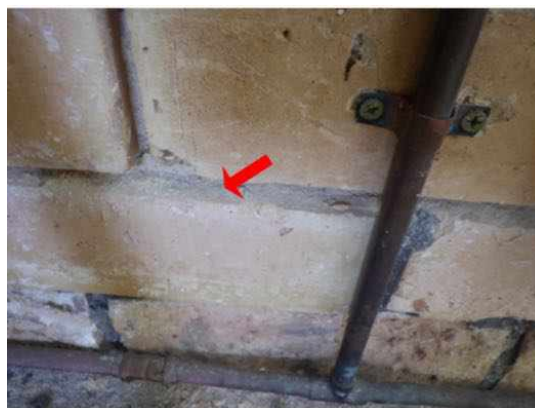
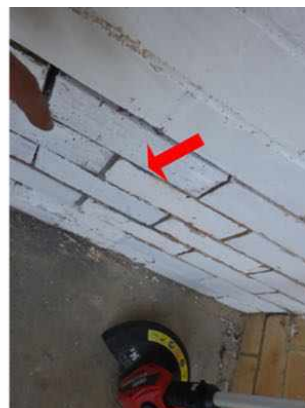
Defects 3.03

Building:	Building 1
Location:	All External Areas
Finding:	Brickwork - Deteriorated mortar

Information: At the time of inspection it was noticed evidence of mortar deterioration to few sections of bricks around the property.

Mortar, or 'bedding', is the material which fills joins and intersections between bricks in masonry walls and structures. Sections of mortar in this brickwork were identified as having deteriorated, which is generally expected for a property of this age and condition.

Mortar may deteriorate as a result of age of building materials, minor movement of bricks, or frequent exposure to weathering. Mortar should be replaced to ensure that bricks remain in their intended location and to prevent gaps, which would allow water or moisture ingress and secondary damage as a result.

Mortar deterioration can be addressed by a bricklayer where areas of deterioration are localised and easily accessible. Alternatively, appointment of a registered builder is advised, to repoint large areas of decaying mortar. Where secondary structural defects have become evident, consultation with a structural engineer may be required.

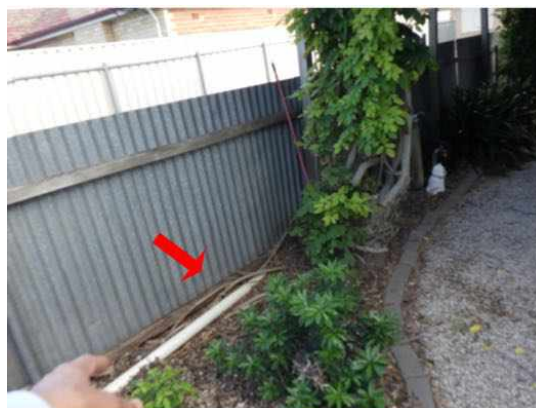
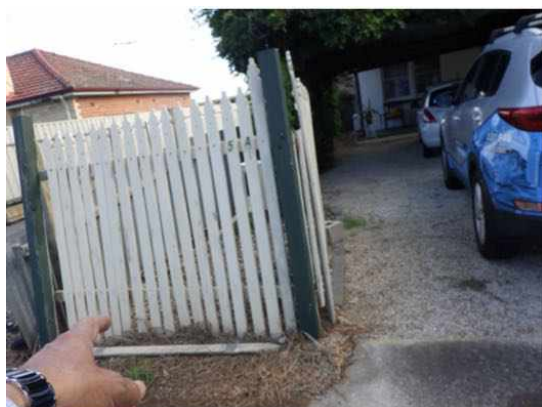
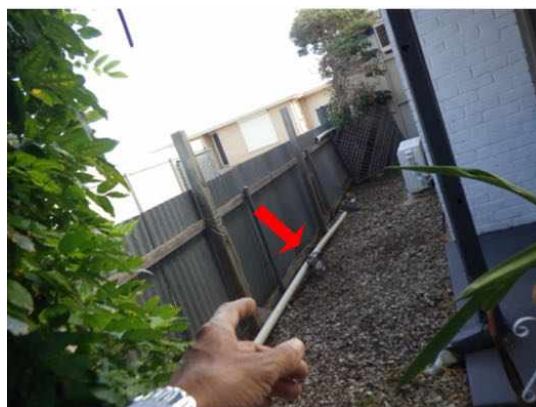
Defects 3.04

Building:	Building 1
Location:	All External Areas
Finding:	Fencing - Deteriorated
Information:	It was noted at the time of inspection that sections of the fencing throughout the property have deteriorated. Typically fencing deteriorates due to age and or wear, rot and or rust which is generally expected for a structure of this age, due to prolonged exposure to weather conditions. Sometimes inadequate installation or maintenance can be to blame.

If left unattended, it is likely that further damage will occur. It is suspected that repair of several elements of the fencing may be required however replacement may be a

consideration of the client also.

A licensed fencing contractor should be appointed to provide further advice and perform rectification works as necessary.
