Building Inspection Report

Inspection Date: Fri, 20 Mar 2026

Property Address: 5A Collins Ave, Edwardstown SA 5039,
Australia

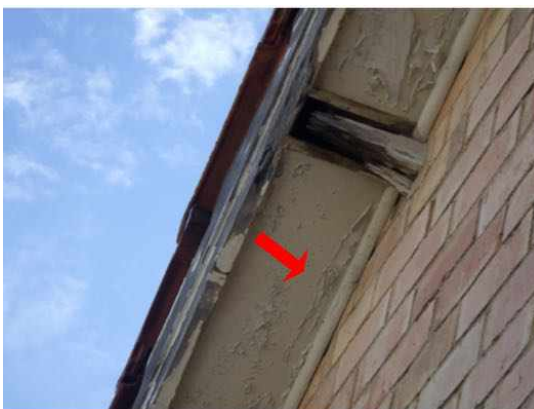
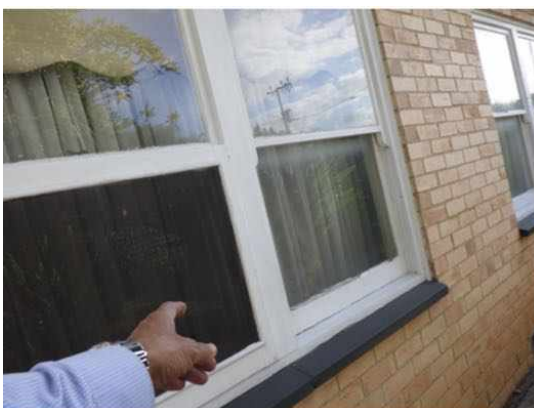
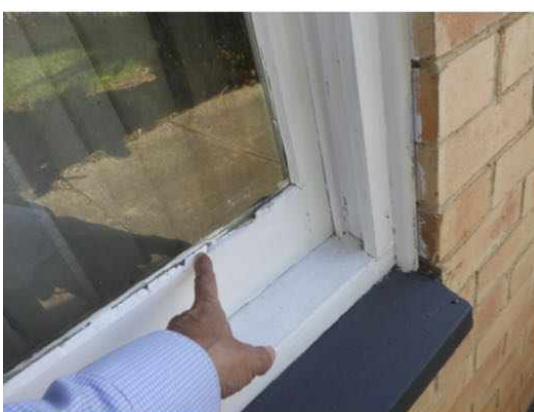
Defects 3.05

Building:	Building 1
Location:	All External Areas
Finding:	External painting deteriorated
Information:	Much of the external paintwork including but not limited to windows, fascias, guttering, veranda and other external fitments have been neglected and require attention to prepare and re-paint.

Whilst incomplete or missing paint finish is generally an appearance defect, it can also lead to the development of secondary building defects over time. Incomplete areas of paint finish expose the area to moisture, potentially accelerating the deterioration of underlying building materials.

Degraded paint finishes should be sanded back, filled, leveled and painted, as applicable. Where inadequate or missing paint protection has led to the deterioration of the associated building element, repair and/or replacement of this building element may be required.

A painting contractor should be appointed as soon as possible to perform necessary works to aid the appearance of the affected area and to ensure the area is protected against further deterioration. Alternatively, the homeowner following manufacturer instructions may perform these works.

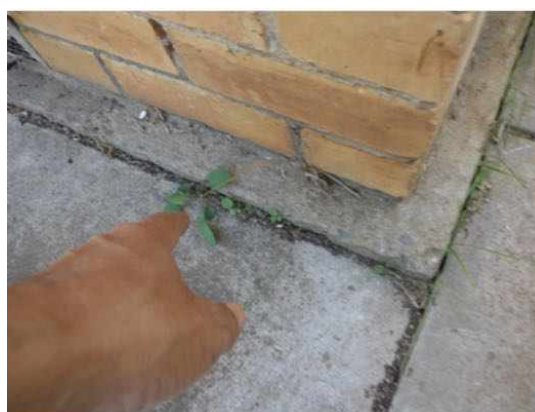
Defects 3.06

Building:	Building 1
Location:	All External Areas
Finding:	Bridging - Vegetation
Information:	Where vegetation obstructs inspection of building elements, also known as bridging as it provides a bridging point for the access of termites, full inspection can not be

achieved. Consequently moisture or dampness may be present and the areas becomes conducive to termite activity. Plants against or very close to buildings provide cover, shade and can provide an environment that is attractive to termite infestation.

The removal and replanting of species that do not provide "cover" or cutting back of existing vegetation will assist greatly in preventing Bridging from occurring.

The removal of any such materials that may be conducive to termite activity should be carried out as soon as possible and arrange re inspection to minimize the risk of termite attack.

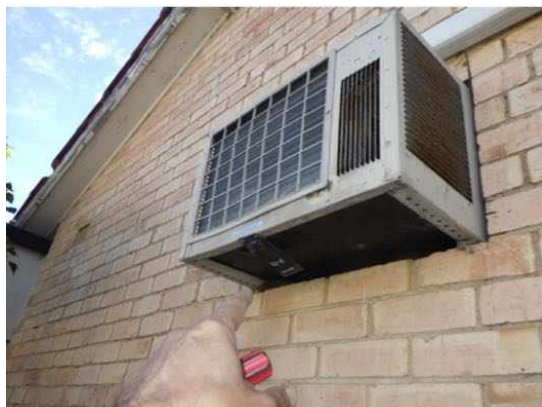
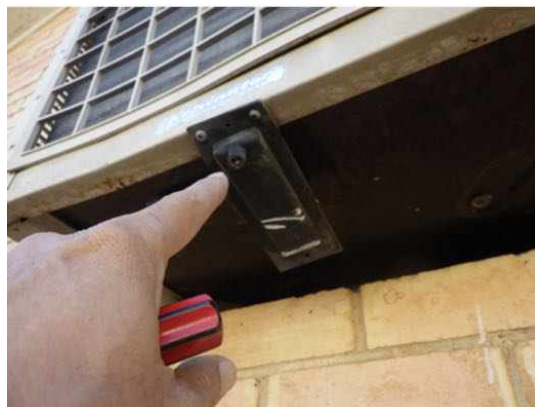
Defects 3.07

Building:	Building 1
Location:	All External Areas
Finding:	Air conditioner - Disconnected overflow
Information:	The Air Conditioner (A/C) overflow was found to be disconnected from storm water drainage and is creating excessive moisture in the surrounding area.

Such leaking creates an environment which is conducive to an array of defects, including water damage to associated building elements and the attraction of termite or timber pest infestation.

It is highly recommended that a licensed plumber be appointed to connect the A/C overflow in order to prevent such an environment from being created. These minor works should be carried out as soon as possible.

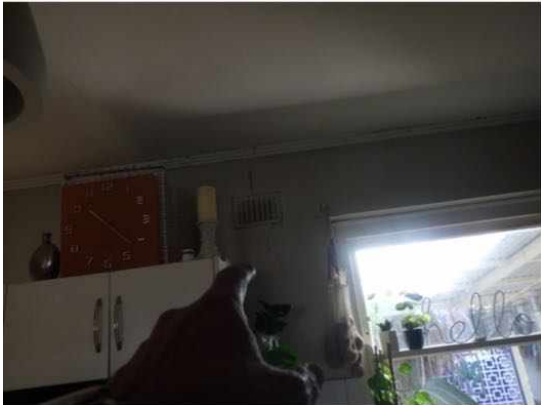
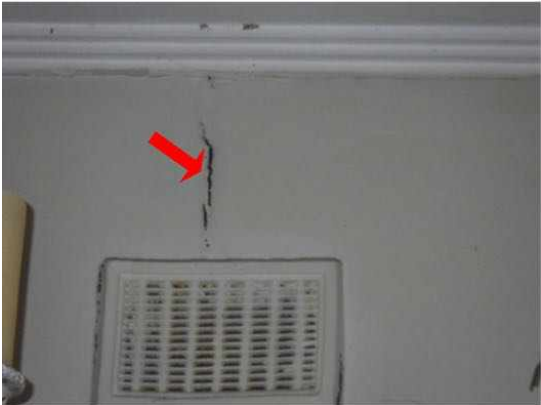
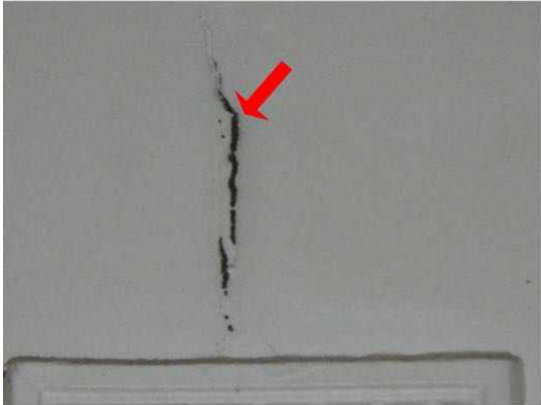
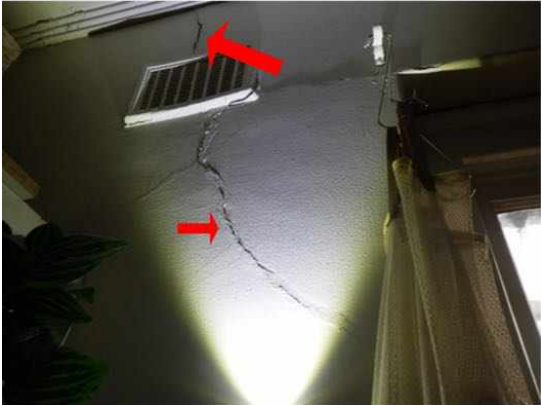
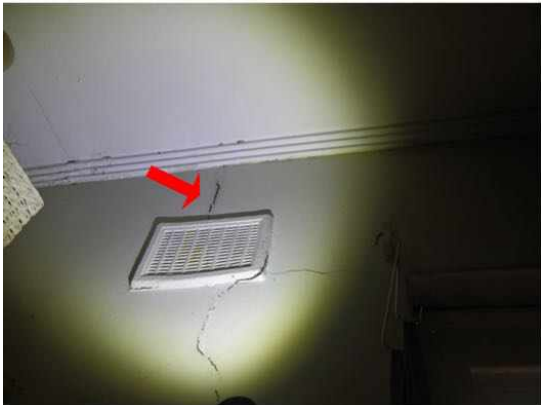
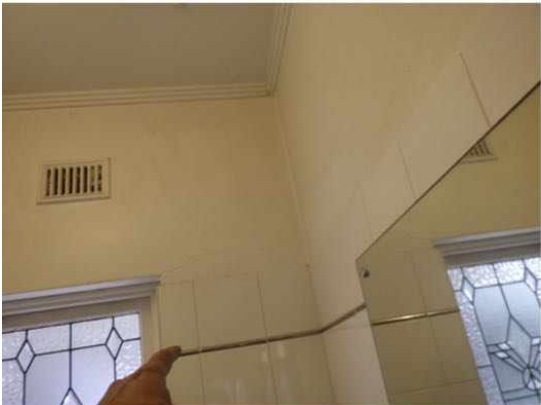
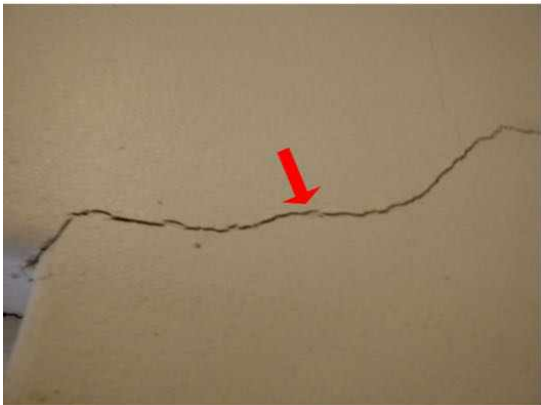
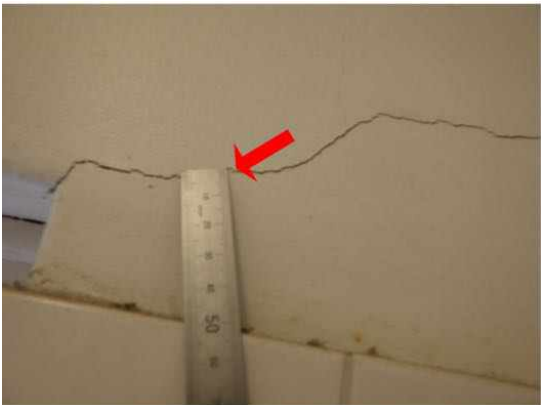
Defects 3.08

Building:	Building 1
Location:	All Internal Areas
Finding:	Cracks to internal render - Category 2
Information:	It has been observed that cracking to internal rendered surfaces has occurred. The degree of damage falls within Category 2, described as noticeable cracks which are easily filled. Cracking of this size are generally less than 5mm in width.

Category 2 damage is required to be monitored for a period of 12 months. After the monitoring period, a crack rated at Category 2 or above is considered a defect requiring rectification.

Always contact your building inspector should cracks widen, lengthen, or become more numerous.

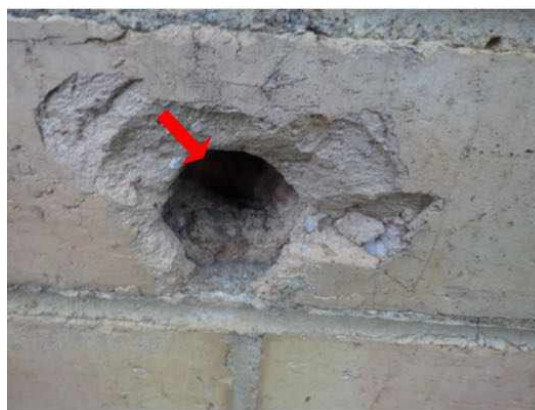
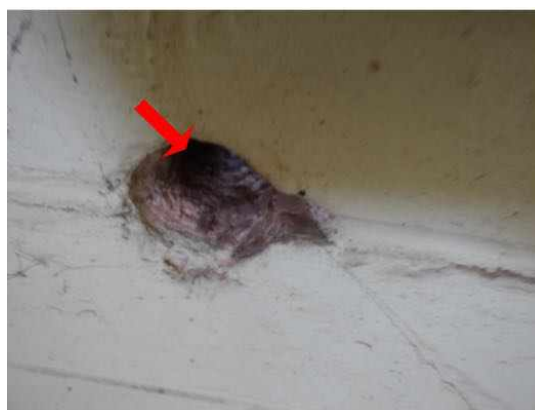
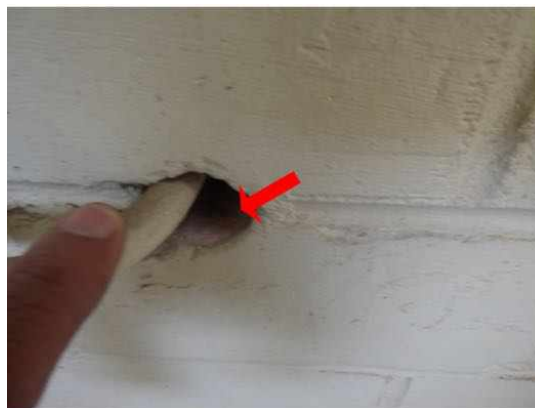
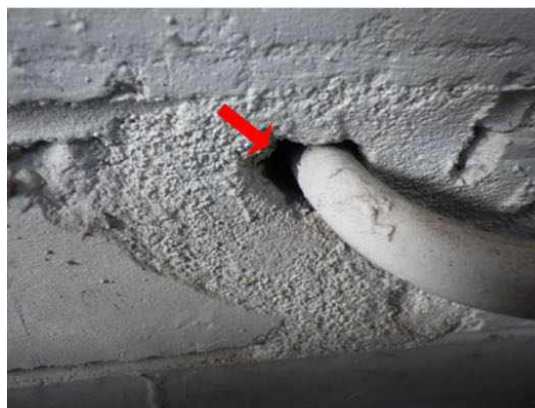
Defects 3.09

Building: Building 1
Location: All External Areas
Finding: External walls - Holes
Information: Significant holes were identified around pipe penetrations in this wall section. It is suspected that the installation of this pipework was completed to a substandard level of workmanship or is incomplete.

Gaps and holes around pipework makes the area susceptible to insect and vermin ingress, as well as allowing water penetration to the cavity wall. As such, associated building elements are likely to deteriorate at an accelerated rate, and major implications are expected if holes around the pipework are left unmanaged.

All excessive holes, gaps or cracks should be adequately filled by a suitable sealant or trimmings as soon as possible to prevent any further damage. Such works may be conducted by a general handyperson or licensed plumber.

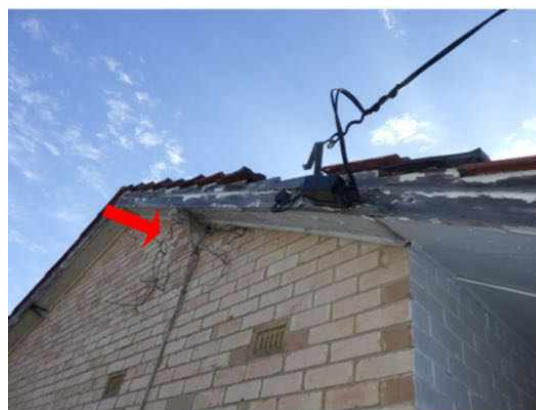
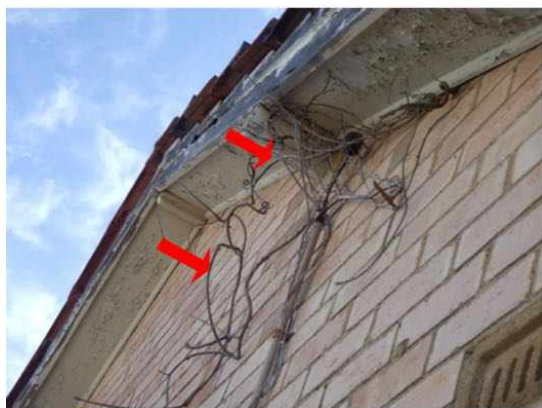
Defects 3.10

Building:	Building 1
Location:	All External Areas
Finding:	External Wall – Front Area – Creeper Vegetation
Information:	At the time of inspection it was noticed that creeper vegetation was hanging over the external wall - eaves (LHS) in the front area of the property. It was also observed that sections of the creeper vegetation were dry at the time of inspection.

Creeper vegetation in contact with external wall surfaces can retain moisture, restrict visual inspection, and may contribute to deterioration of associated building materials over time. Dry vegetation may also require maintenance to reduce unnecessary loading and improve presentation of the area.

It is advised that appropriate maintenance be carried out as required, including trimming or removal of vegetation where necessary, to allow ongoing monitoring of the wall surface and associated building elements.

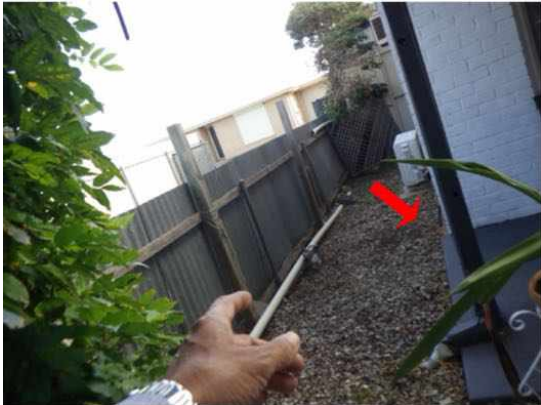
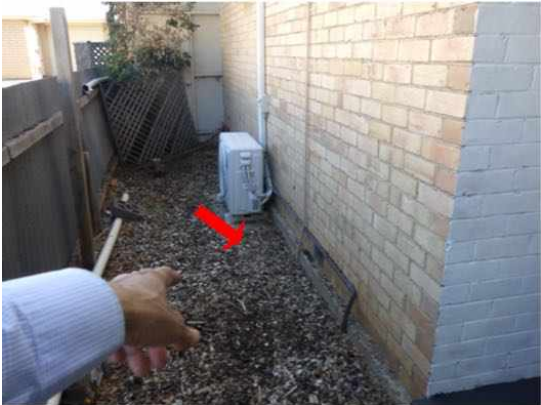
Defects 3.11

Building:	Building 1
Location:	All External Areas
Finding:	External Paving – Missing Sections / Not Installed
Information:	At the time of inspection, it was observed that several sections of external paving were missing or not installed around the perimeter of the property. This condition has resulted in exposure of the concrete slab edge, thereby compromising the intended protection to the slab and adjoining building elements.

Exposed slab edges may increase the risk of moisture penetration, deterioration of structural and non-structural elements, termite or pest ingress, and ongoing maintenance issues. This condition is considered a defect and a maintenance concern that requires attention.

It is recommended that a suitably qualified and licensed contractor be engaged to install the missing external paving sections and reinstate adequate protection to the slab edge. All works should be carried out in accordance with relevant Australian Standards, the National Construction Code (NCC), and accepted building practices.

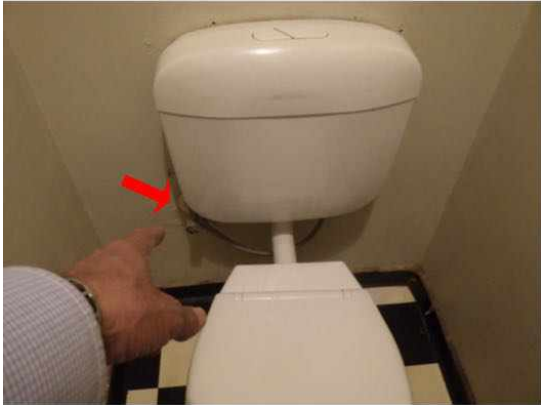
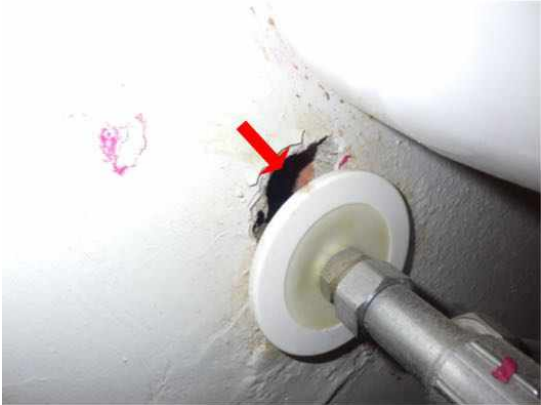
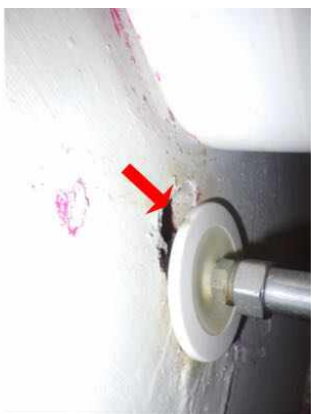
Defects 3.12

Building: Building 1
Location: Toilet (WC)
Finding: Surface - Holes
Information: At the time of inspection it was noticed hole in the internal walls of this toilet area.

Holes in surfaces are generally indicative of impact damage, whether accidental or deliberate, or a failing of the surface material.

Where holes are apparent in the surface of a building material, the surface is no longer sealed against water penetration or further impact damage, which may lead to additional damage to the surrounding surface.

Repair or replacement of the affected building element is recommended as soon as possible to ensure that any secondary defects are minimised. A qualified carpenter or general handyperson should be appointed to perform these works.

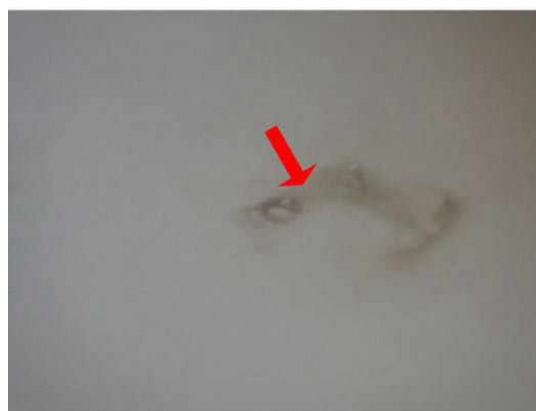
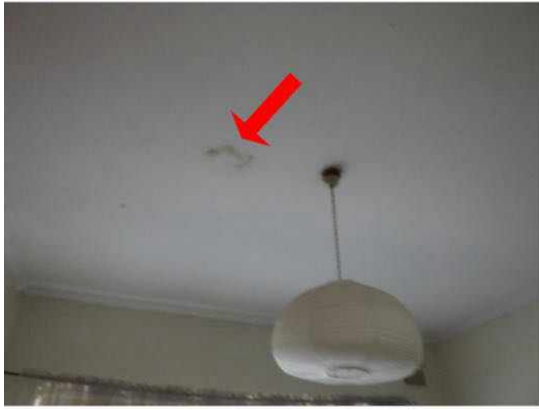
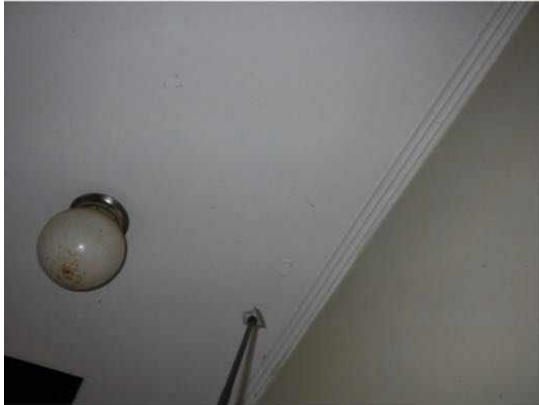
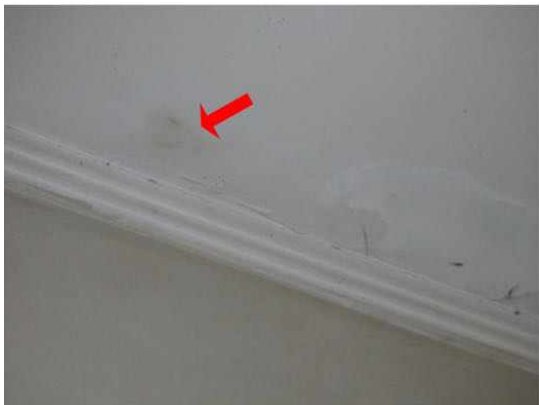
Defects 3.14

Building:	Building 1
Location:	All Internal Areas
Finding:	Ceiling - Water stained
Information:	Water staining to ceiling linings in this area was evident at the time of inspection. Water staining indicates that surfaces have been exposed to excessive moisture over time. The minerals and other elements in the water lead to staining, which may graduate to corrosion and deterioration if left unmanaged.

While mostly an appearance defect, water staining can be indicative of more serious defects, which may be currently concealed by interior ceilings.

Where water staining is active, a licensed plumber must be consulted to identify the cause of the staining and to provide advice on any reparation works that may be required. Replacement of any damaged structures is advised.

Conversely, where water staining is old and inactive, affected building materials may be repaired or replaced at client discretion.

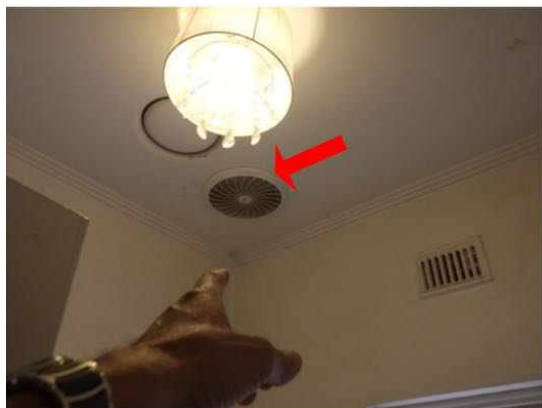
Defects 3.15

Building: Building 1
 Location: Bathroom
 Finding: Bathroom – Exhaust Fan Operation
 Information: At the time of inspection it was noticed that the exhaust fan installed within this bathroom area was making unusual noise / partially obstructing during standard operation at the time of testing.

This may indicate wear, internal obstruction, loose components, or mechanical deterioration affecting normal performance.

It is advised that an appropriate qualified tradesperson be appointed to assess the

exhaust fan and carry out repairs or replacement as required to ensure satisfactory operation.

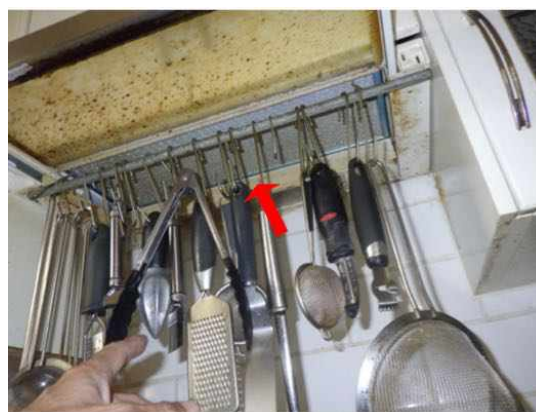
Defects 3.16

Building:	Building 1
Location:	Kitchen
Finding:	Rangehood - Light not working
Information:	While the range hood appears to be working at a satisfactory level, the light to the appliance was not working at the time of inspection.

A licensed electrician should be appointed to replace the light on the range hood to restore it to a fully operational state.

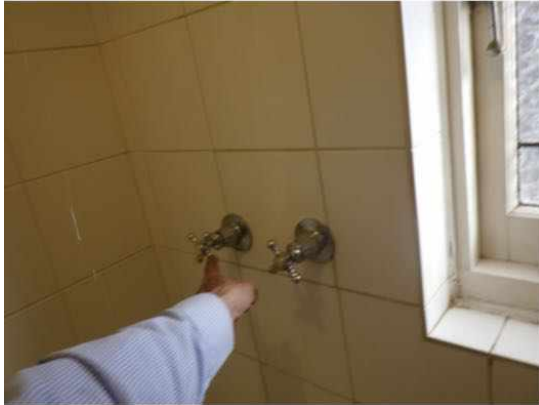
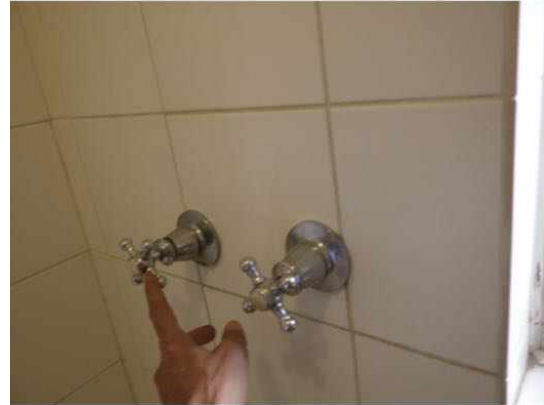
Defects 3.17

Building:	Building 1
Location:	All Areas
Finding:	Bathroom Area - Shower alcove taps - Jamming
Information:	At the time of inspection it was noticed that hot water taps in this bathroom shower alcove area was jamming during standard operation.

building structure is available. Where some building elements are not operating as intended, it is possible that secondary building defects could arise due to their non-operation.

Repair and/or replacement of the faulty building element is recommended. It is highly recommended that the relevant tradesperson be engaged to perform any necessary works.

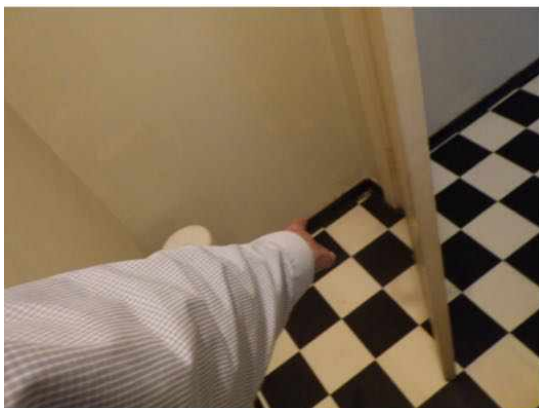
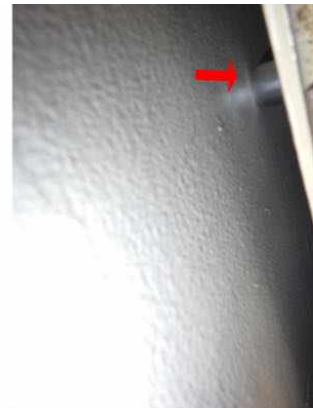
Defects 3.18

Building:	Building 1
Location:	All Internal Areas
Finding:	Door stop - Missing
Information:	The door stop is missing or is inadequate to stop the door handle from damaging the wall. Although some building elements may seem irrelevant or unnecessary, all building elements play a key role in the operation and function of the overall structure and its performance.

Re-installation or replacement of the door stop is advised as soon as possible to prevent any subsequent damage to the door or associated structures. A general handyman may be appointed to perform these works at client discretion.

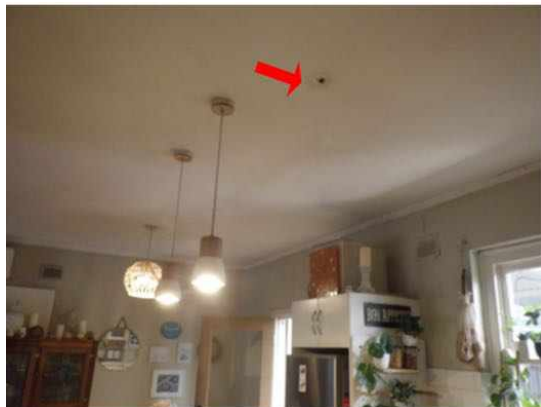
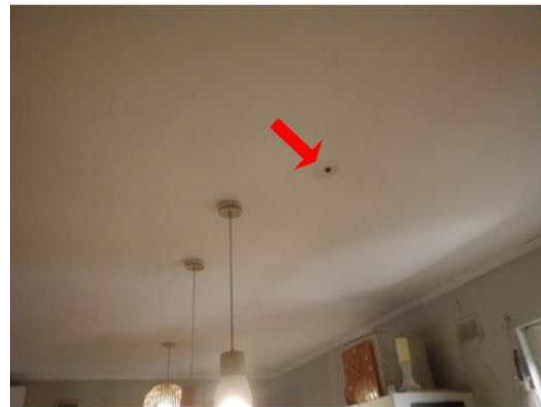
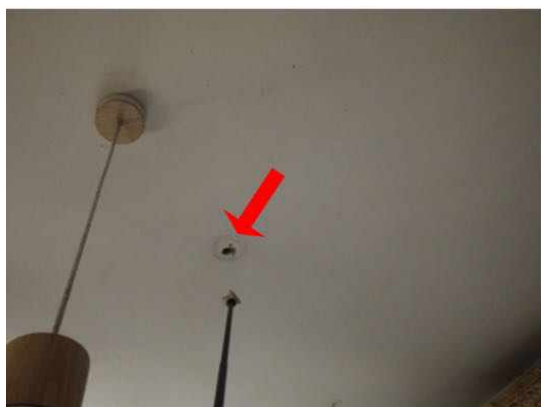
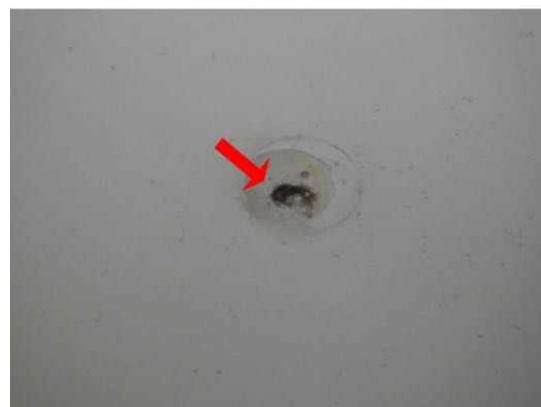
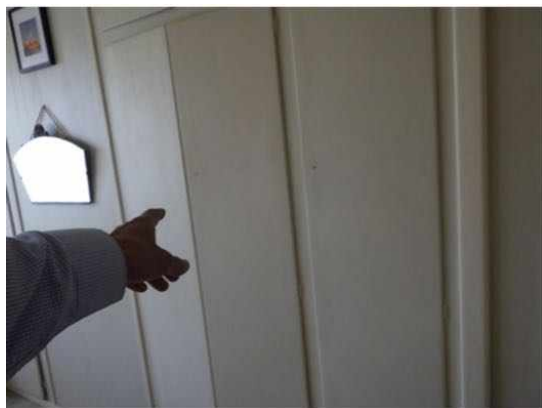
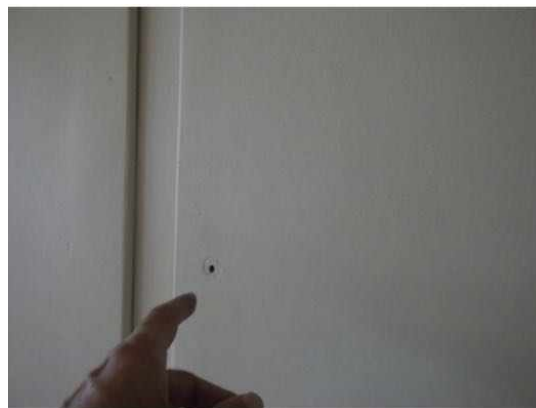
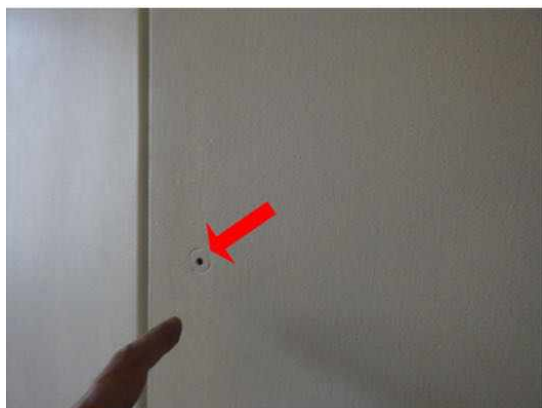
Defects 3.19

Building: Building 1
Location: All Internal Areas
Finding: Building element - Damaged
Information: At the time of inspection it was noticed few building elements were damaged around the property .. e.g - Holes in kitchen area ceilings , cabinets knobs missing.

Breakage occurs generally when the building materials have either aged and decayed, or as a result of damage (accidental or deliberate).

Repair and/or replacement of broken elements is advised to ensure that additional secondary defects do not arise as a consequence. Such works are necessary, as all building elements play a key role in the operation and function of the overall structure and its performance.

A relevant tradesperson should be appointed to repair or replace the affected building element prior to any subsequent damage being caused.

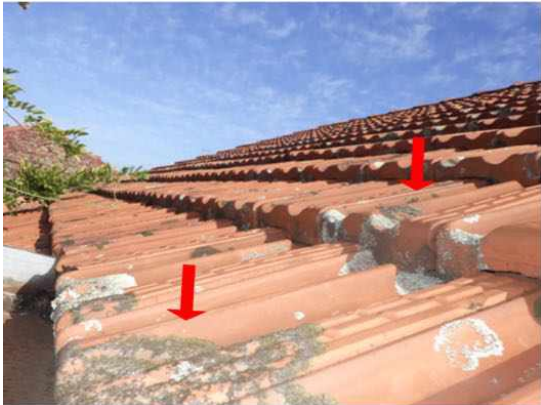
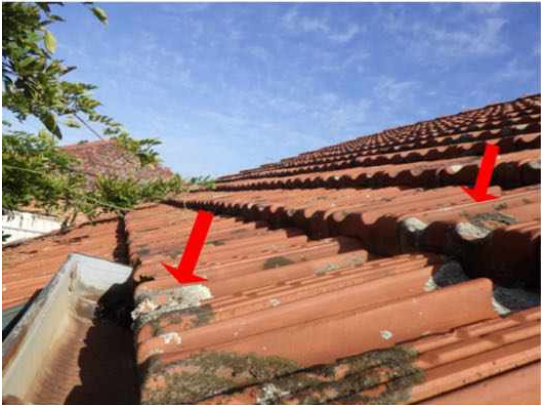
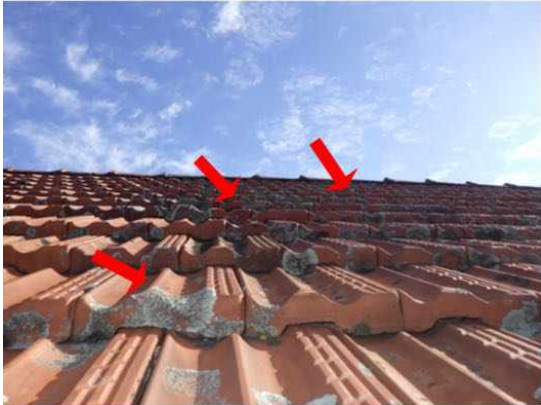
Defects 3.20

Upon inspection of the exterior roofing, the majority of roof tiles were considered to be in a fair condition. While weathering of the tiles is consistent with the age of the property, maintenance works are required.

Isolated areas of mortar have come loose in the valleys and minor cracking is also present. Re-pointing and re-sealing may be considered as an interim solution by the client to help preserve and extend the life span of the tiles.

Where left unmanaged, deteriorating roof tiles are likely to lead to a number of secondary defects, including minor water leaks and weather exposure to internal roofing structures.

Consultation with a roofing contractor is highly advised to gain advice on cost of remedial works that may be required in the short to medium term. Remedial works are likely to increase the longevity of the exterior roofing structure.

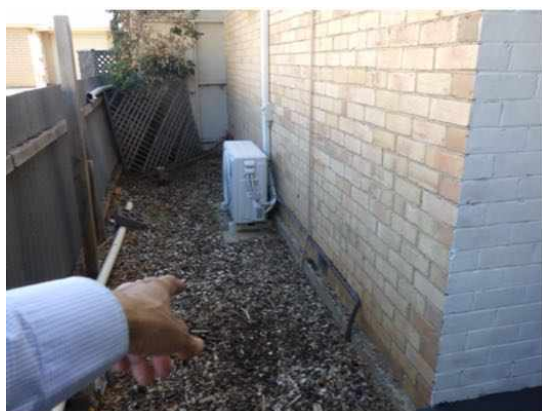
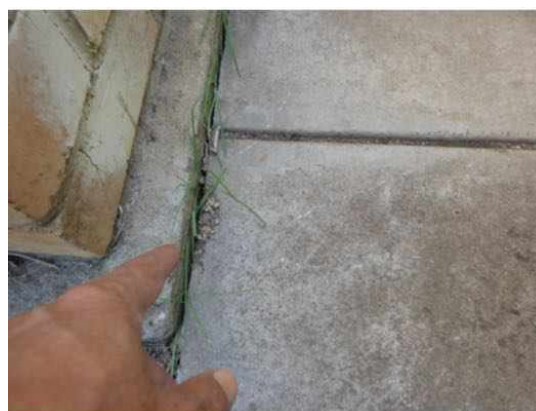
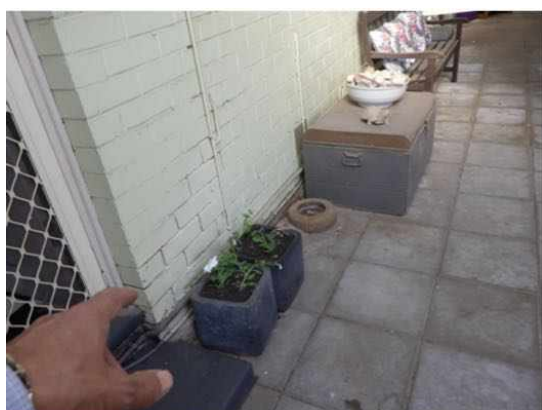
Noted Item

Building: Building 1
Location: All External Areas >
Finding: Termite Management System - No evidence of a chemical installation
Information: The application of a post-construction chemical termite barrier is highly recommended for all properties, particularly if live termite activity has been found on the site previously. Such barriers are highly effective in preventing termite attack on any timber building elements throughout the property.

A durable notice should be placed in the switchboard unit to indicate current termite barriers. At the time of inspection, it appeared as though no termite management system has been installed, with no evidence to suggest preventative works taking place.

The client may consider gaining further advice from a pest controller as to the costs and procedures involved with this application. It is recommended that obtaining such advice be a short-term priority.

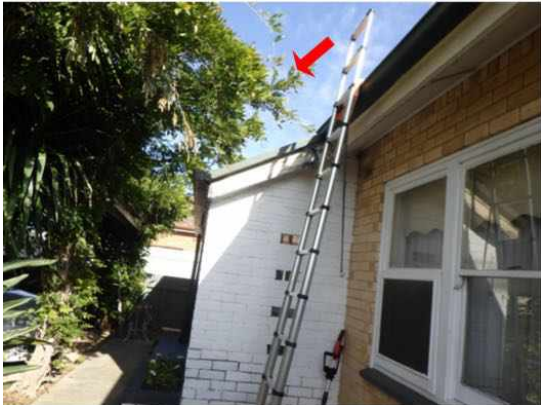
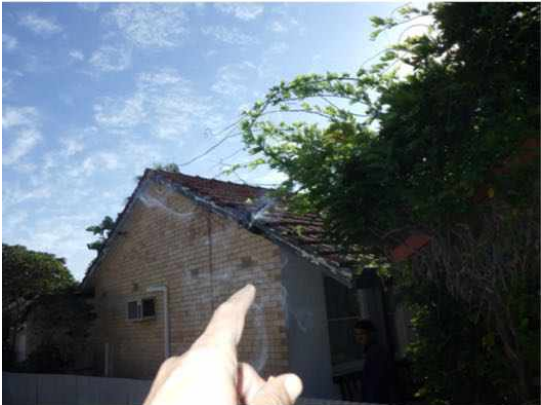
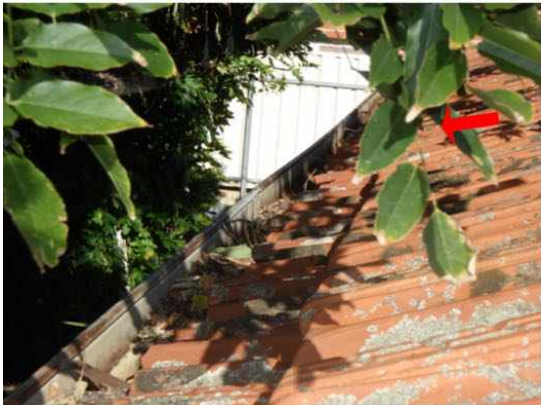
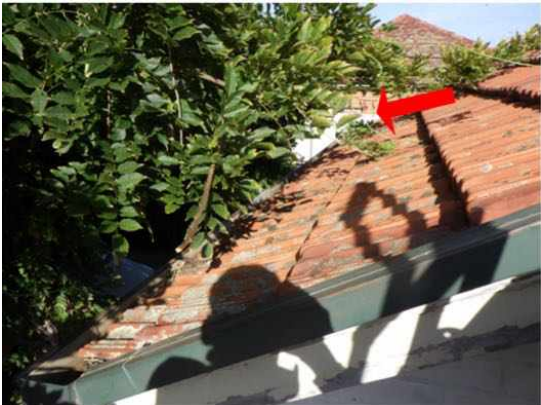
Noted Item

Building: Building 1
Location: All External Areas
Finding: Trees - Overhanging and filling gutters
Information: Overhanging trees often result in excessive amounts of leaf debris accumulating in gutters.

Gutters are a critical part of the building's management of storm water and rain. It is therefore important that they be kept clear to prevent secondary damage to associated building elements, including exterior and interior walls, ceiling linings and any adjoining building elements. Where gutters are blocked, pooling of rainwater is likely to occur, fast-tracking rust and corrosion of the roof plumbing elements.

It is highly advised that all overhanging tree branches be removed as soon as possible to prevent any further damage. Repair and/or replacement of sections of damaged guttering may also be required where the extent of the damage necessitates.

Such works should be performed by the homeowner; however, appointment of a landscape contractor or an arborist may be required. Consultation with a licensed roof plumber is required where guttering has been damaged.

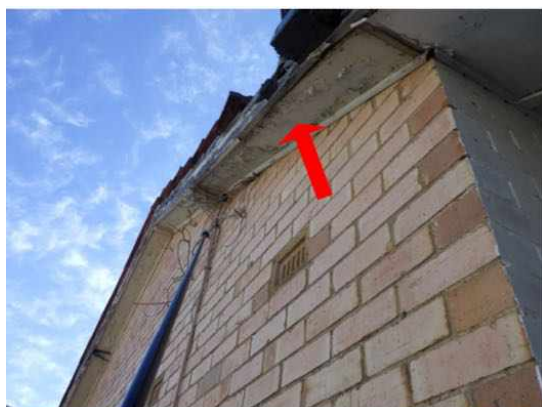
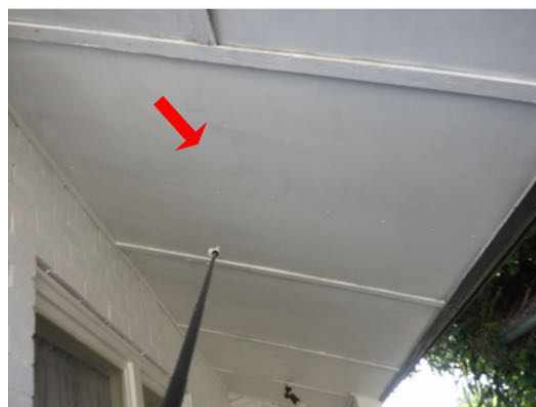
Noted Item

Building:	Building 1
Location:	All External Areas
Finding:	Asbestos - Suspected ACM Identified on Site
Information:	Reporting on Asbestos is outside the Scope of this Report. This suspected defect is highlighted as a caution only. We suspect, based on our experience in the building industry, that there is a higher risk of the identified building element containing asbestos.

As Asbestos Reporting is outside the scope of this report, we advise that you consider a separate Asbestos Inspection and Condition Audit, which can include the taking of samples for definitive confirmation of the presence of Asbestos.

In the interim, the client is advised to act with caution, especially when considering any damage to building materials general wear and tear renovations extensions demolition and general maintenance activities due to the suspected presence of Asbestos.

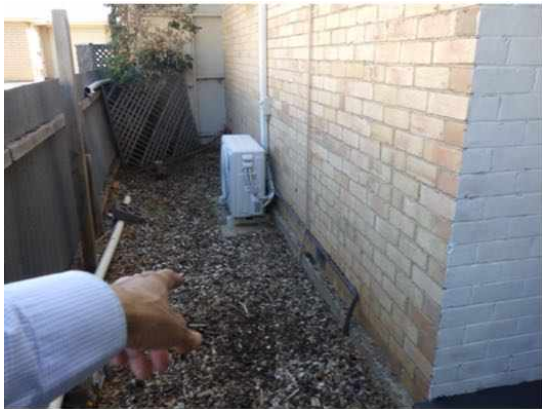
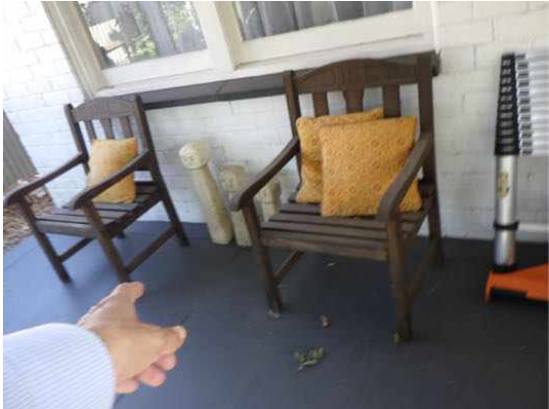
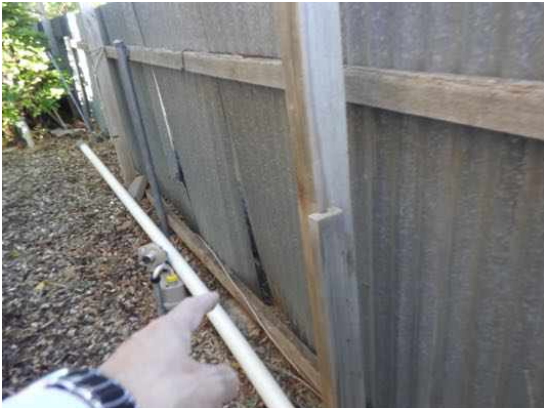
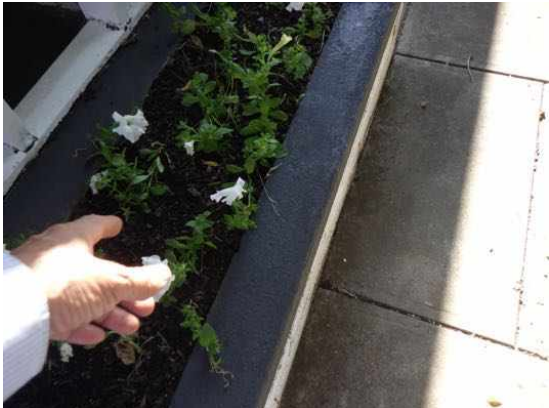
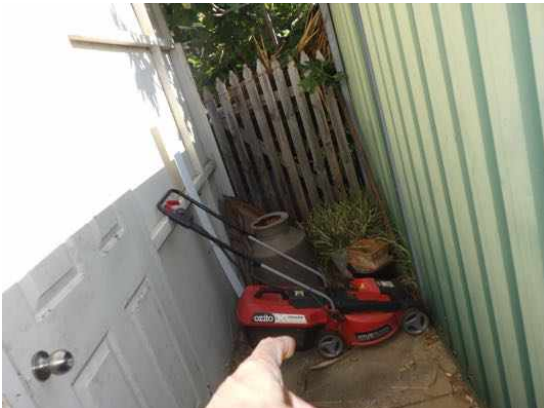
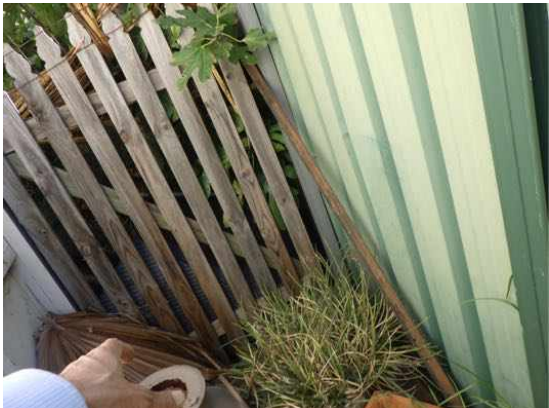
Noted Item

Building:	Building 1
Location:	All Areas
Finding:	Additional Photos - Obstructions and Limitations

Information: These photographs are an indication of the obstructions and limitations which impeded full inspection of the property at the time of inspection. These obstructions can hide an array of defects and should be removed to allow full inspection to be carried out. A re-inspection is recommended once the areas are made accessible.
