## Building Inspection Report

Inspection Date: Mon, 30 Mar 2026

Property Address: 6 Heather Grove, Cheltenham VIC 3192,  
Australia

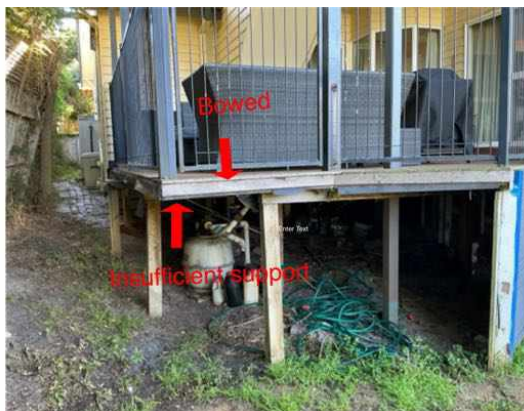
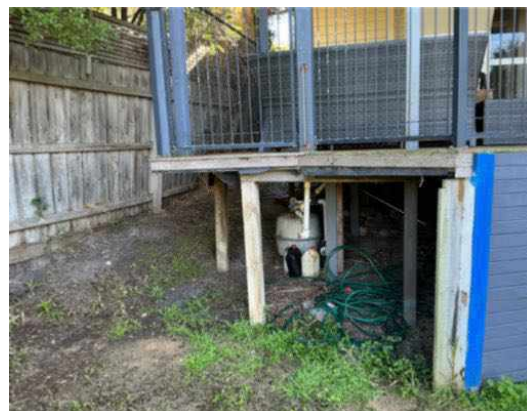
#### Defects 1.01

Building:	Main Building
Location:	Deck front and back
Finding:	External Timber Balcony or Deck - Structural Stability
Information:	The load capacity of the external balcony or deck could not be verified during the inspection, the fencing surrounding the deck is also deteriorated.

External timber structures are also constantly exposed to weather elements and can deteriorate in an accelerated manner, ongoing assessments are required.

It is highly recommended that a Structural Engineer further assess the external timber balcony or deck to inform the client of its load capacity. Regular maintenance inspections by competent practitioners is needed.

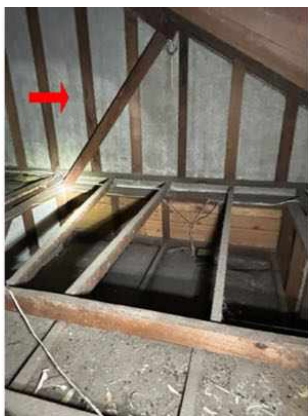
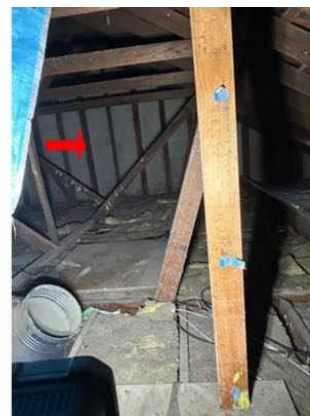
#### Defects 1.02

Building:	Main Building
Location:	Gable ends

Finding: Asbestos - Suspected ACM Identified on Site  
 Information: Reporting on Asbestos is outside the Scope of this Report. This suspected defect is highlighted as a caution only. We suspect, based on our experience in the building industry, that there is a higher risk of the identified building element containing asbestos.

As Asbestos Reporting is outside the scope of this report, we advise that you consider a separate Asbestos Inspection and Condition Audit, which can include the taking of samples for definitive confirmation of the presence of Asbestos.

In the interim, the client is advised to act with caution, especially when considering any damage to building materials general wear and tear renovations extensions demolition and general maintenance activities due to the suspected presence of Asbestos.

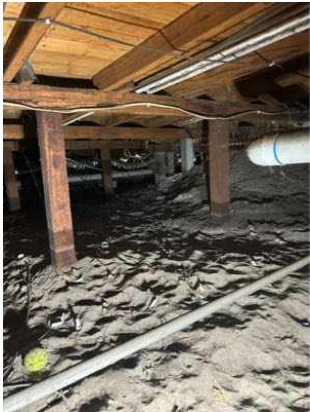
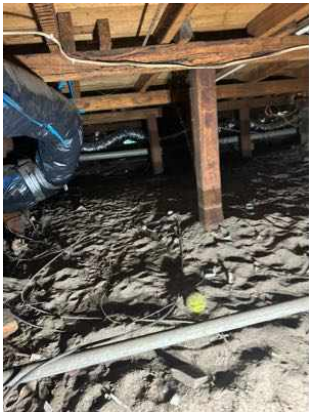
### Defects 2.01

Building:	Main Building
Location:	Subfloor
Finding:	Timber stumps - Suspected deterioration
Information:	It was noted that the property has timber stumps. Inspection of the condition of the timber stumps - below the surface of the ground - is excluded from the scope of this report. However, it is suspected that several timber stumps are deteriorating, evidenced by secondary defects such as uneven flooring, visually-observable subsidence or major cracking within the property. Even without these secondary defects, deteriorated stumps may still be present.

Where timber stumps are failing, a high degree of maintenance or even replacement of stumps may be required in the short- to medium-term future. It is probable that there is some degree of wood rot or deterioration beginning to occur in areas that are currently inaccessible for inspection. Timber stumps are no longer used in current building practices due to their susceptibility to wood rot and deterioration over a prolonged period of time.

The client should be prepared that in purchasing a property with timber stumps, that the need to restump the property in the short- to medium-term future is highly likely, which involves expensive works.

A registered builder specialising in re-stumping may be appointed to provide a more invasive inspection of the timber stumps and provide estimates on any works that may be required.

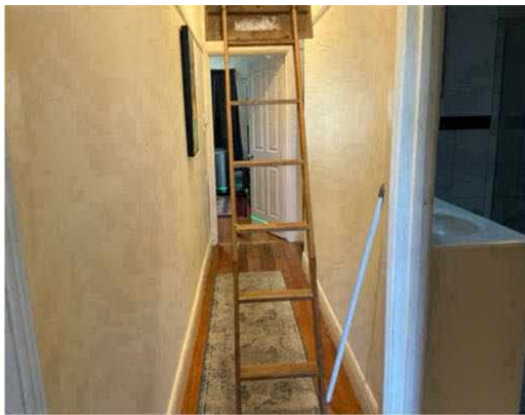
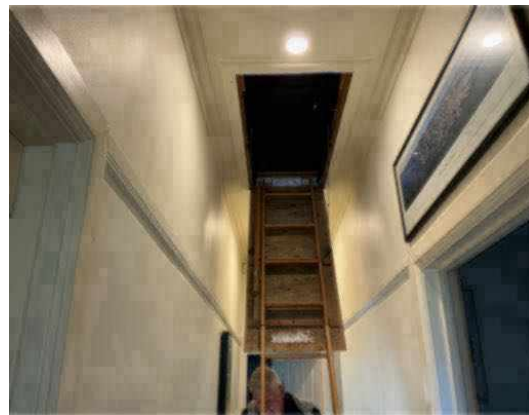
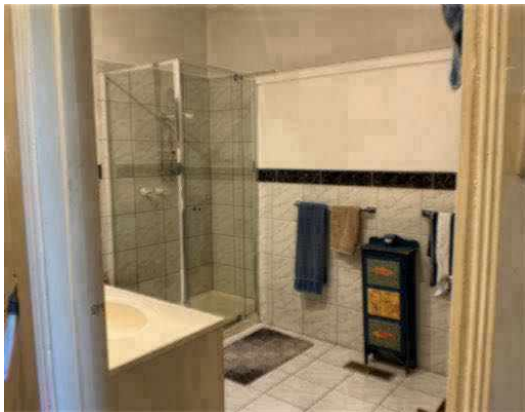
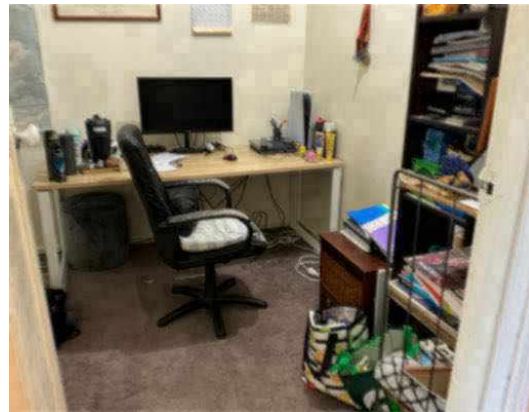
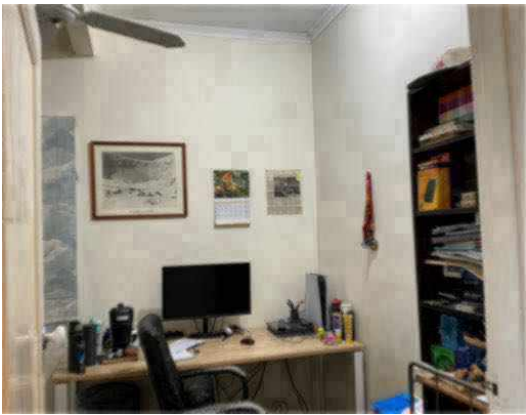
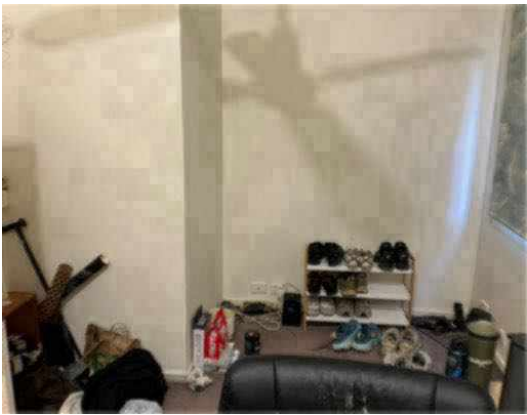
Finding: Additional Photos and Obstructions and Limitations

Information: These are additional photographs and photographs of the obstructions and limitations inside and outside (furniture, landscaping etc) which may impede full inspection of the property at the time of inspection. These obstructions can hide an array of defects and may be removed to allow full inspection to be carried out. A re-inspection may be made if clients require once the areas are made accessible.

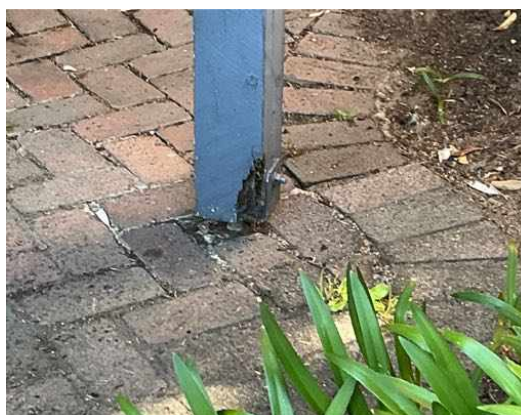
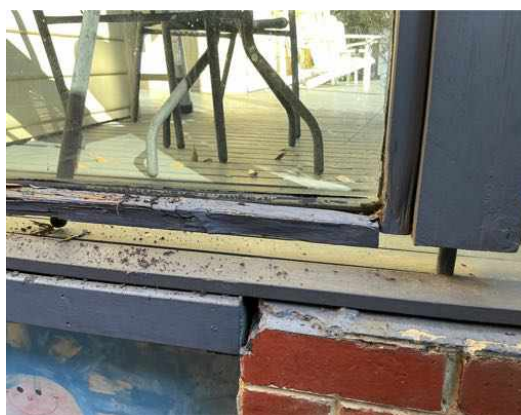
A qualified plumber may be appointed to assess the cause of excessive moisture and to provide advice on any remedial works as required. A qualified carpenter or

registered builder may also be required to replace affected building materials.

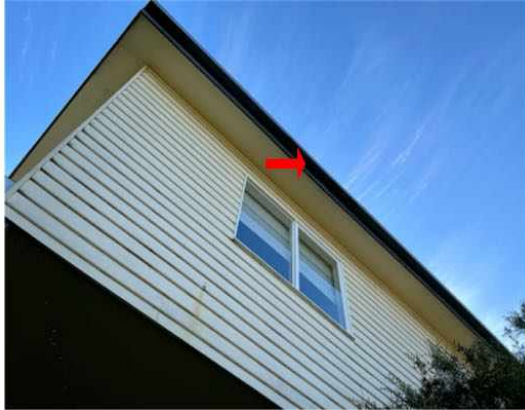
### Defects 3.03

Building:	Main Building
Location:	All Areas
Finding:	Roof plumbing - Rusted or deteriorated
Information:	The roof plumbing has areas of rust and corrosion. It is suspected that this has been caused by blockages, resulting in pooling or standing water, that have prematurely rusted elements of the roof plumbing.

Rusted roof plumbing will generally develop holes and leaks that can affect other building elements with poor drainage of storm water. Poorly drained roof areas will also lead to damp conditions surrounding the base perimeter of the building which, if left unmanaged, can lead to a range of secondary building defects.

Repair and/or replacement of rusted roof plumbing is highly required in order to reinstate the roof drainage system to a fully operational level. To further maintain these areas, gutters should be cleaned frequently, allowing the avoidance of any partial blockages.

A licensed plumber or specialist roof restoration company should be appointed to undertake these works. It is advised that such works be completed as soon as possible to prevent any further damage and deterioration.

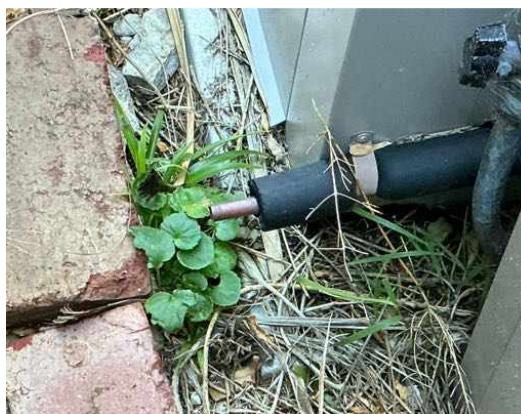
### Defects 3.04

Building:	Main Building
Location:	Exterior walls - right side
Finding:	HWS Overflow - Not Connected
Information:	The Hot Water System (HWS) overflow was found to be disconnected from storm water drainage and is creating excessive moisture in the surrounding area.

These damp conditions can lead to secondary defects such as rot, rust or corrosion of associated building elements, the formation of fungal decay, or even the creation of potential slip hazards. When coupled with poor site drainage, pooling of water may also attract termite activity to this area.

It is highly recommended that a licensed plumber be appointed to connect the HWS overflow in order to prevent such an environment from being created. These minor works should be carried out as soon as possible.

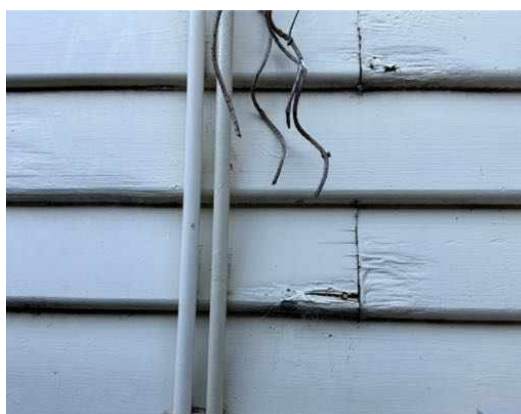
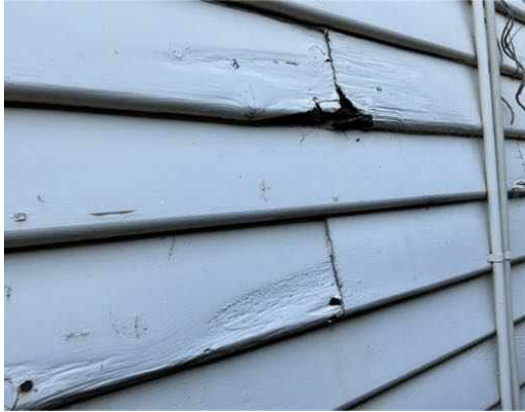
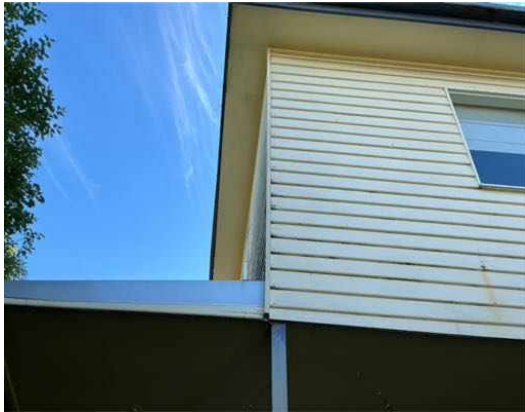
### Defects 3.05

Building:	Main Building
Location:	All Areas
Finding:	Weatherboards - Rotting
Information:	The external weatherboards show signs of fungal decay (wood rot) in several sections. This wood rot is suspected to have developed over a prolonged period of time due to frequent weather exposure, which is expected in a property of this age and condition

Weatherboards are sealed and protected by paint and other sealants. When these sealants deteriorate over time, they allow water penetration to the weatherboards, causing wood rot. If left unmanaged, the wood rot is likely to develop further, possibly necessitating major repair or replacement works in the long-term future.

To maintain the condition of the external wall cladding, any severely affected weatherboards should be substituted as soon as possible with pre-treated replacements. Where weatherboards have rotted due to excessive moisture other than rain penetration, the cause of the moisture should be identified immediately by a licensed plumber. A qualified carpenter should be appointed to repair and replace rotting weatherboards.

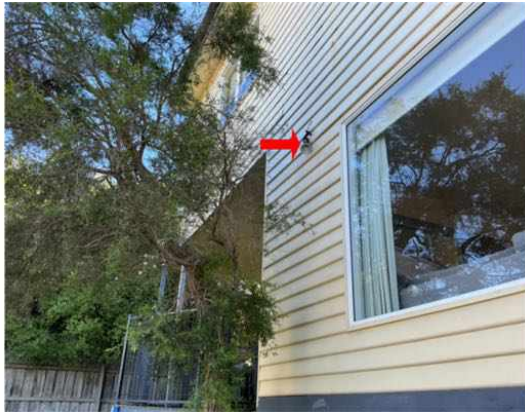
### Defects 3.06

Building:	Main Building
Location:	Rear Elevation
Finding:	Light fitting - Damaged
Information:	The light fitting in this area was found to be damaged at the time of inspection. Damage occurs generally when the building materials have aged and decayed, but may also be indicative of impact damage to the building element (accidental or deliberate).

Left unmanaged, the fitting is unlikely to cause further damage to surrounding building elements. However, the broken light fitting may expose electrical works, and may create a minor safety hazard if there is potential contact with persons in the area.

Repair and/or replacement of the damaged fitting is advised. A Licensed electrician should be appointed to repair/replace the light fitting at the client's discretion.

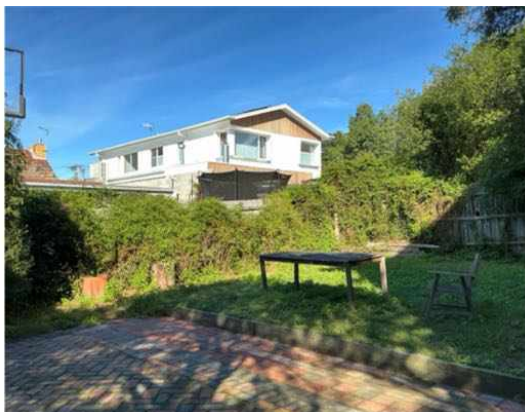
### Defects 3.07

Finding: Fencing - Deteriorated

Information: It was noted at the time of inspection that sections of the fencing throughout the property have deteriorated. Typically fencing deteriorates due to age and or wear, rot and or rust which is generally expected for a structure of this age, due to prolonged exposure to weather conditions. Sometimes inadequate installation or maintenance can be to blame.

If left unattended, it is likely that further damage will occur. It is suspected that repair of several elements of the fencing may be required however replacement may be a consideration of the client also.

A licensed fencing contractor should be appointed to provide further advice and perform rectification works as necessary.

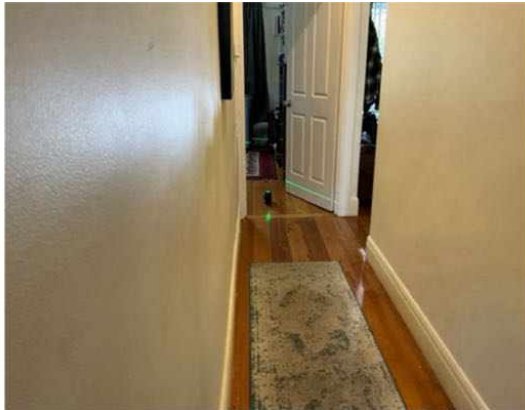
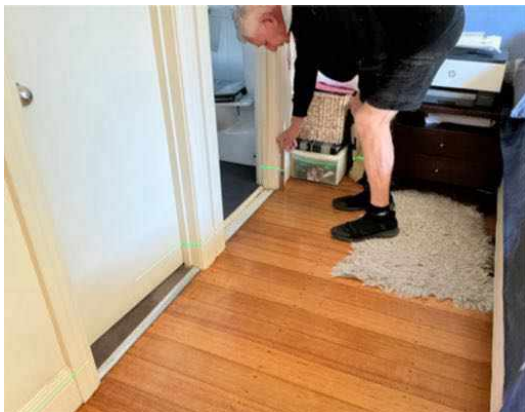
### Defects 3.08

Building: Main Building  
Location: All Areas  
Finding: Flooring - Uneven  
Information: The internal flooring in this area is out of level and uneven. Uneven flooring is likely to indicate minor defects such as expected movement of the foundations of the property, but may also indicate subsidence of the associated subfloor stumps.

It is advised that the flooring be closely monitored to identify any further movement. Where flooring remains relatively unchanged for an extended period of time (i.e. several months), it is likely that this defect has been caused by expected movement of the foundations of the property.

However, where flooring is uneven further, potentially invasive inspection of the subfloor structures and stumps in this area is required. In this case, works to repair are likely to be required, and would be carried out by a registered builder specialising in re-stumping.

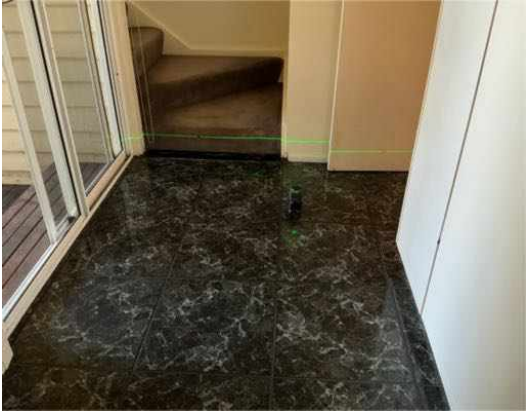
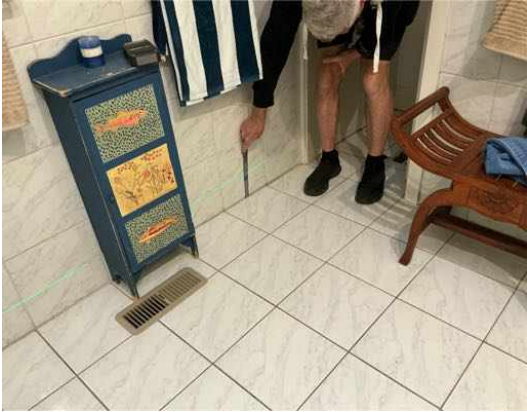
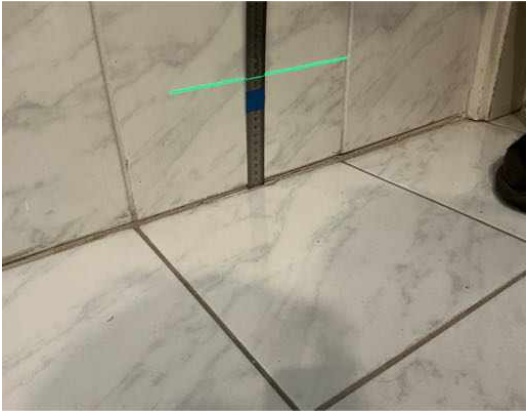
Defects 3.09

Building: Main Building  
Location: All Areas  
Finding: Floors - bouncy  
Information: The internal flooring in this area was identified as being bouncy at the time of inspection. A bouncy floor surface generally presents as a discernible change in level as they are walked across, in noisy or creaking flooring, or in consequent movement of surrounding furniture and fixtures.

Bouncy floors generally indicate that the floorboards or the subfloor structures are coming loose from the joists that they are installed on. Bouncy flooring may also be the result of gaps between flooring and stumps or joist structures, which require packing.

The client is advised to seek quotations for required repairs from a Registered Builder specialising in re-stumping. The potential resolution may range from packing gaps in subfloor structures through to replacement of subfloors stumps and refixing of flooring.

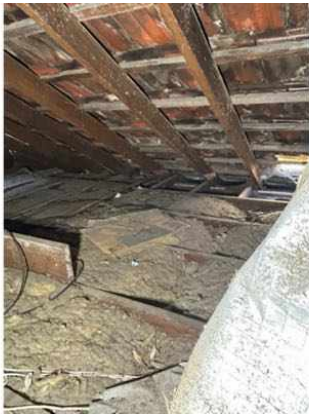
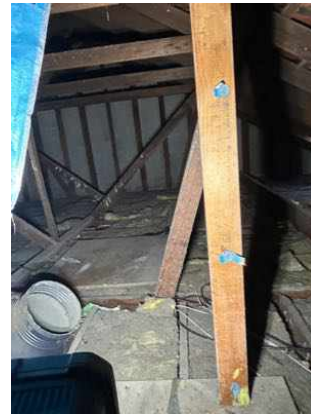
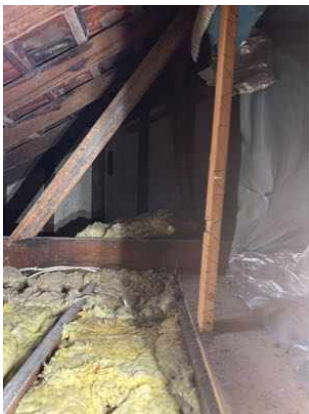
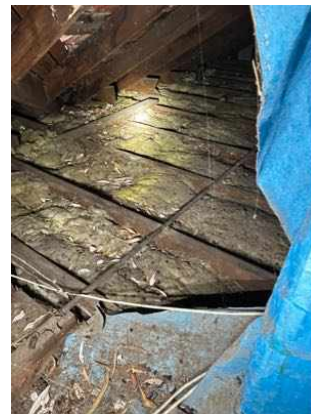
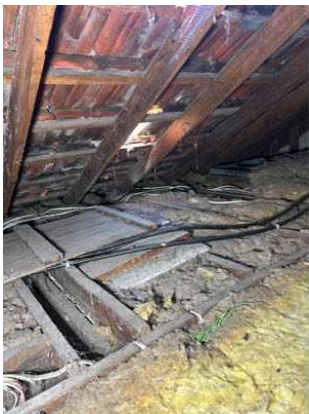
### Defects 3.18

Building:	Main Building
Location:	All Areas
Finding:	Insulation - Inadequate
Information:	Upon inspection of the roof void it was noted that there is a lack of adequate insulation.

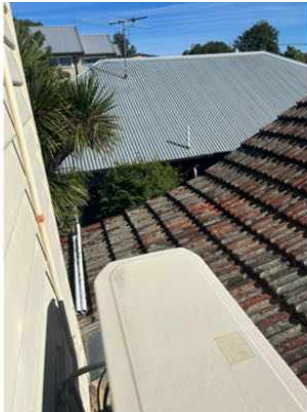
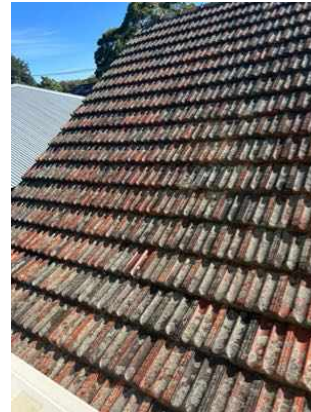
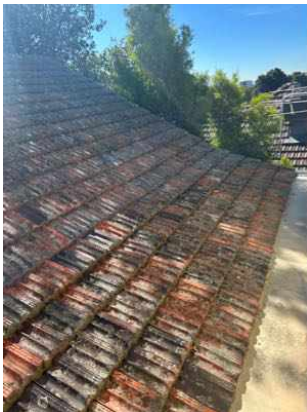
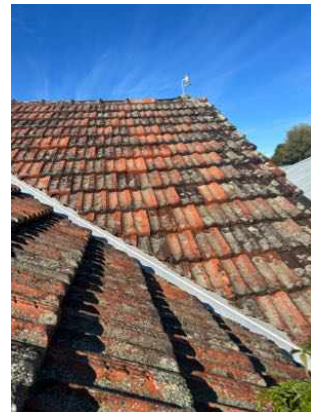
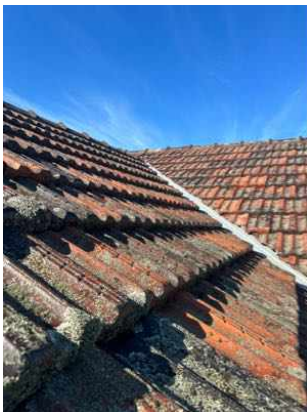
### Defects 3.19

Building:	Main Building
Location:	All Areas
Finding:	Roof tiles - Weathered
Information:	Upon inspection of the exterior roofing, the majority of roof tiles were considered to be in a fair condition. While weathering of the tiles is consistent with the age of the property, maintenance works are required.

Isolated areas of mortar have come loose in the valleys and minor cracking is also

Where left unmanaged, deteriorating roof tiles are likely to lead to a number of secondary defects, including minor water leaks and weather exposure to internal roofing structures.

Consultation with a roofing contractor is highly advised to gain advice on cost of remedial works that may be required in the short to medium term. Remedial works are likely to increase the longevity of the exterior roofing structure.
