# Building and Timber Pest Inspection Report

Inspection Date: Tue, 10 Mar 2026

Property Address: 25 Quinn St, West Tamworth NSW 2340,  
Australia

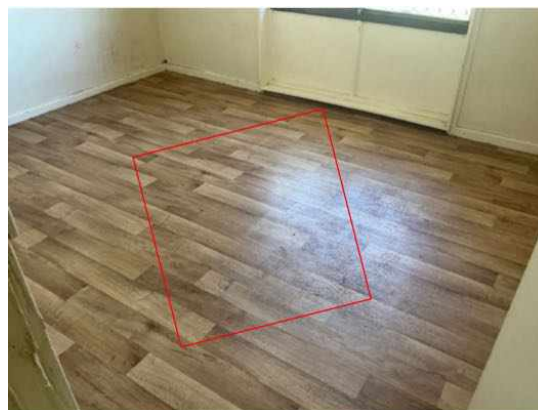
Building: Main Building  
Location: All Internal Areas  
Finding: Flooring - Severe Unevenness  
Information: The internal flooring within this area was observed to be significantly out of level and uneven. The degree of unevenness is considered excessive and is well beyond what would typically be expected from normal settlement or minor movement in a building of this age.

The severity of the floor deflection strongly suggests that there may be movement or failure within the supporting subfloor structure. This may include settlement of footings, movement or deterioration of subfloor stumps/piers, or deflection of supporting floor beams and joists.

Flooring exhibiting this level of unevenness is indicative of an underlying structural issue rather than minor cosmetic settlement. The condition is considered substantial and warrants further investigation.

A thorough inspection of the subfloor structure should be carried out by a suitably qualified structural engineer or experienced building contractor. Investigation should include assessment of the supporting piers, stumps, beams and footings to determine the cause of the movement. Rectification works may be required and could involve structural repairs of the affected area by a suitably qualified builder.

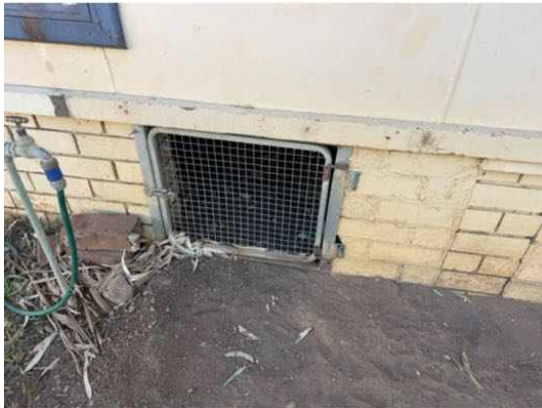
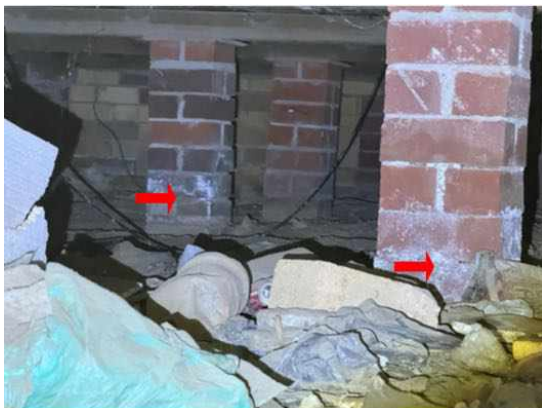
Building:	Main Building
Location:	Subfloor
Finding:	Subfloor Moisture/Efflorescence - Present
Information:	Evidence of moisture staining and salt deposits (efflorescence) was observed to several brick piers and masonry elements within the subfloor area. Efflorescence occurs when moisture moves through masonry materials and deposits mineral salts on the surface as it evaporates.

The presence of efflorescence indicates that moisture is migrating through the masonry, which may be associated with ground moisture, inadequate subfloor drainage, or limited ventilation within the subfloor space.

During periods of heavy rainfall, surface water may migrate along the ground and potentially flow beneath the dwelling, contributing to the moisture conditions observed within the subfloor area.

Prolonged moisture conditions within subfloor areas may contribute to deterioration of masonry materials, corrosion of metal components, and may increase the risk of timber decay or termite activity if moisture levels remain elevated.

The client should monitor the subfloor area for ongoing moisture presence and ensure adequate subfloor ventilation and site drainage are maintained. If excessive moisture persists, further assessment by a suitably qualified contractor may be required to determine the source and implement appropriate moisture management measures.

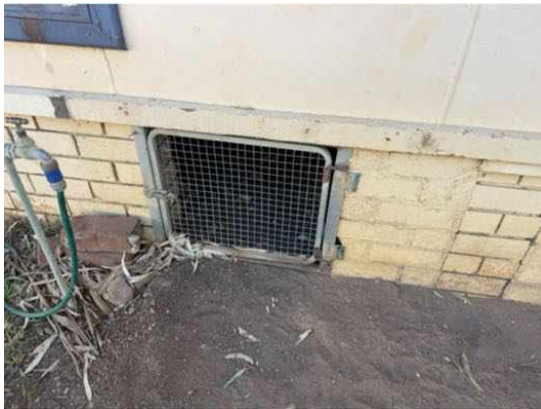
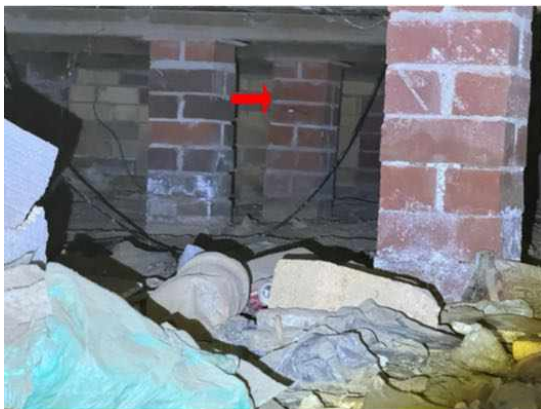
### Finding 2.05

Finding: Subfloor Brick Piers - Unstable or Deteriorated

Information: The brick piers supporting the subfloor structure are exhibiting signs of instability, suggesting that their structural integrity has been compromised. This may be the result of ground movement, deterioration of mortar joints, or other underlying structural issues. Such conditions can accelerate the degradation of the piers and pose a risk to the overall stability of the structure.

The brick piers are suspected to be failing in their intended structural function, which may lead to a variety of significant and minor building defects. If left unresolved, further and potentially severe damage to both the piers and the subfloor structure may occur.

It is essential that a Registered Builder, preferably with expertise in subfloor repairs and re-piering, be engaged without delay to assess the condition of the brick piers and recommend appropriate remedial works. This defect requires immediate attention and should not be left unaddressed.

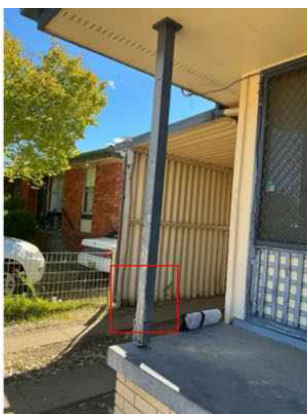
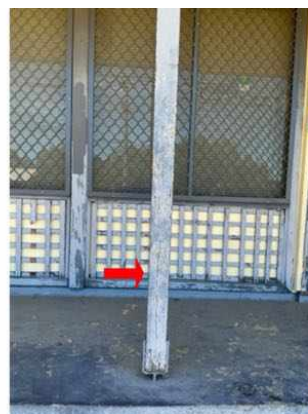
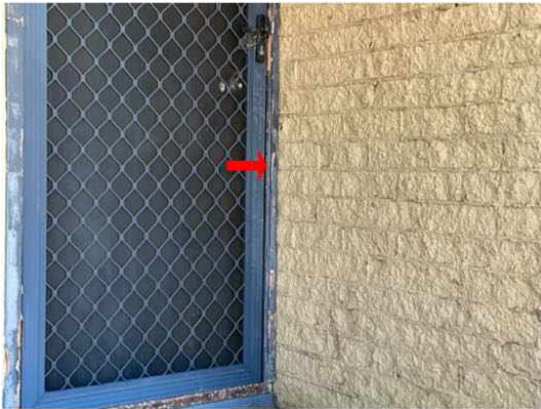
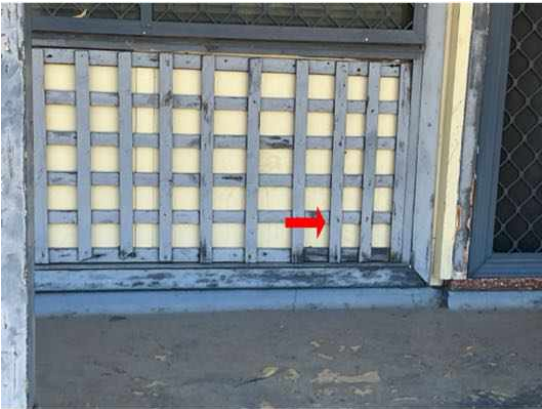
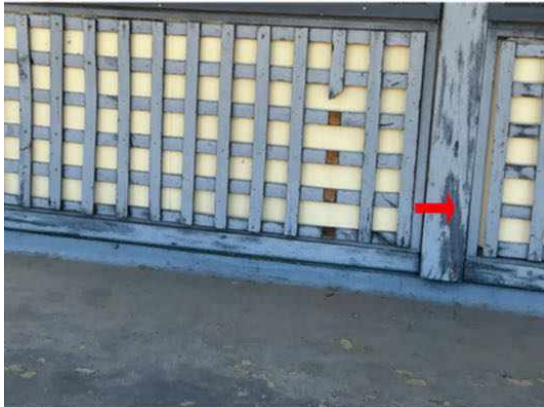
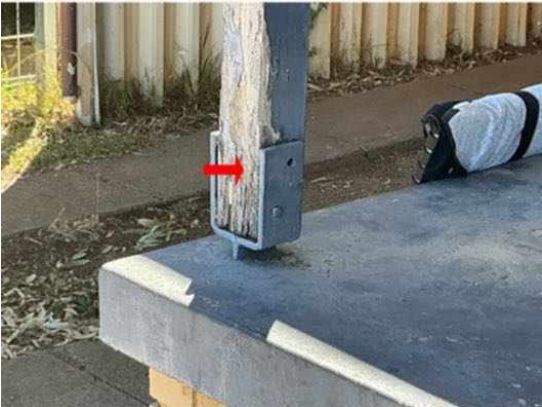
Information: External timber elements around the property were observed to be showing signs of general wear and tear, including surface deterioration, fading, and early signs of weather exposure. These conditions are commonly caused by prolonged exposure to sunlight, moisture, and temperature fluctuations, which can lead to cracking, splitting, or degradation over time if not properly maintained.

It is recommended that all external timber be inspected and maintained to ensure ongoing protection. This may include sanding, sealing, or repainting affected sections. Regular maintenance will help preserve the timber's integrity, extend its lifespan, and prevent more extensive damage in the future.

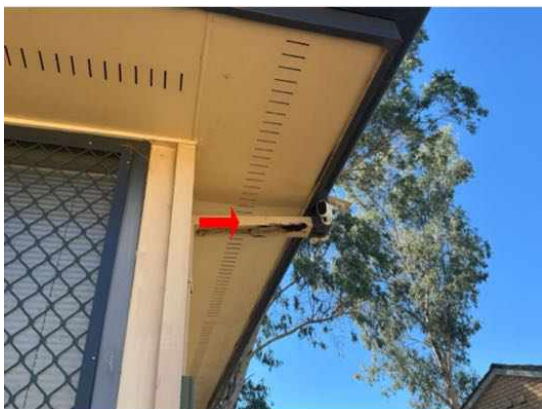
### Finding 3.02

Building:	Main Building
Location:	All External Areas
Finding:	Gutter/Fascia Damaged/Deteriorated
Information:	The damage of the gutters or fascia has occurred on the front left hand side of the facade as shown in the photos.

Breakage and deterioration occurs generally when either the metal/timber has aged and decayed with excessive moisture, or as a result of damage (accidental or deliberate).

Repair and/or replacement of the gutter is advised to ensure that additional secondary defects do not arise as a consequence. Such works are necessary, as all building elements play a key role in the operation and function of the overall structure and its performance.

A licensed roof plumber should be appointed immediately to repair or replace the damaged gutter prior to any subsequent damage being caused.

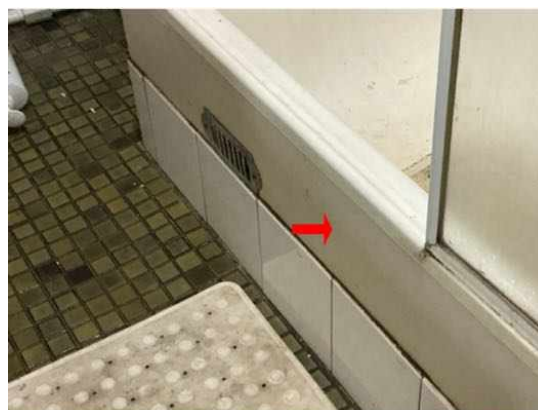
Exposed substrate materials in wet areas may be vulnerable to moisture penetration and deterioration over time. Inadequate or incomplete finishing of surfaces surrounding baths may allow water to enter wall or framing cavities, potentially leading to damage to surrounding building materials and finishes.

The client is advised to inform the builder and request that the bath hob be properly finished with suitable waterproofing and tiling in accordance with standard wet area construction practices to prevent moisture ingress and ensure a durable finish.

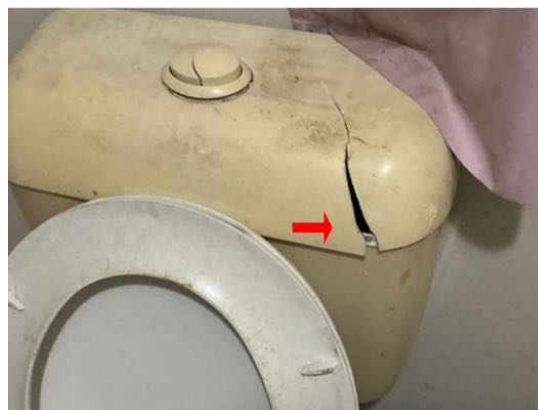
### Finding 3.06

Building:	Main Building
Location:	Bathroom
Finding:	Damaged/Deteriorated
Information:	Breakage occurs generally when the building materials have either aged and decayed, or as a result of damage (accidental or deliberate).

Repair and/or replacement of these materials is advised to ensure that additional secondary defects do not arise as a consequence. Such works are necessary, as all building elements play a key role in the operation and function of the overall structure and its performance.

A relevant tradesperson should be appointed to repair or replace the affected building element prior to any subsequent damage being caused.

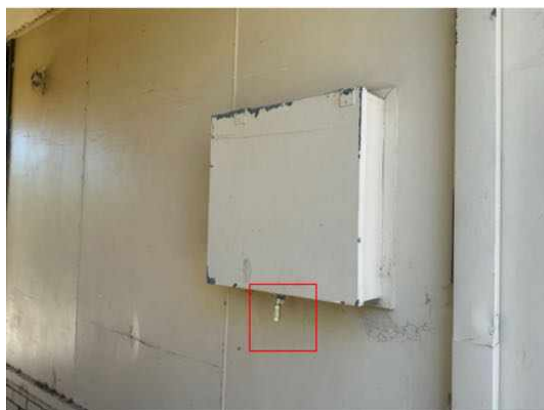
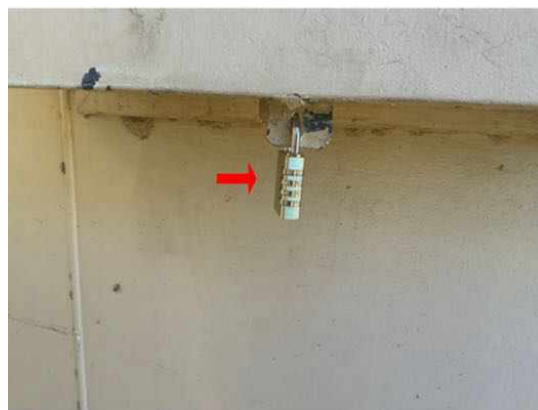
The meter box at the time of inspection was locked.

Where a Termite Management System has not been identified you should consult a licensed pest inspector immediately to undergo further investigation in what measures would be necessary to maintain a functional pest management system.

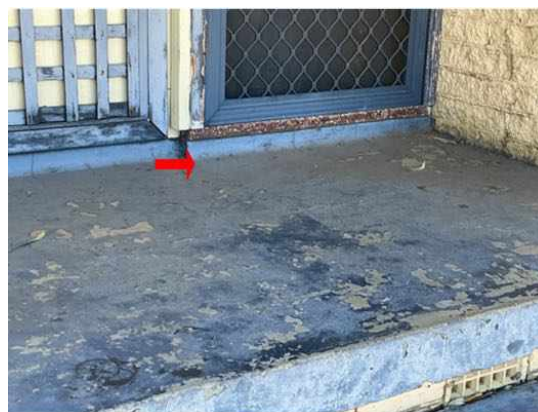
### Finding 6.02

Building: Main Building  
 Location: All External Areas >  
 Finding: Bridging Of Physical Barriers - Patios/Porches  
 Information: Breaching is the spanning of a physical termite barrier or inspection zone so that subterranean termites are provided with an entry point over or around that barrier.

The concrete porch/patios are providing a concealed entry point at the time of the inspection. Where the location of the porch is retrospectively installed against an external wall this will provide a concealed entry point for termites.

The client should consider gaining further advice from a timber pest technician as to treatments required in this area. It is recommended that obtaining such advice be a short-term priority.

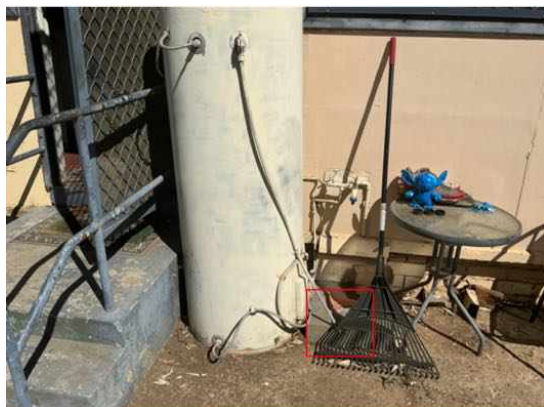
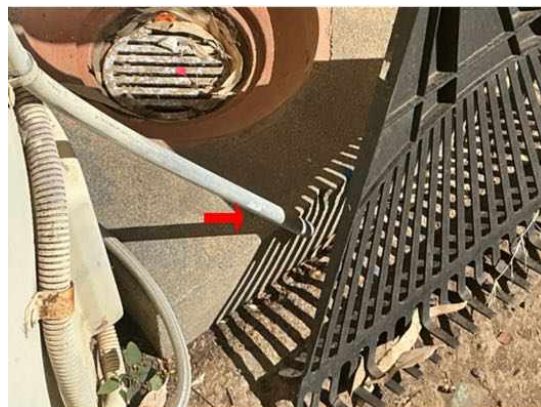
### Finding 6.03

Building: Main Building  
 Location: Exterior walls - rear  
 Finding: HWS - Disconnected overflow  
 Information: The Hot Water System overflow was found NOT to be connected to the storm water drainage and is creating excessive moisture in the surrounding area.

Poorly aligned materials can and will lead to further damage to nearby areas.

It is highly recommended that a licensed plumber be appointed to connect the A/C overflow in order to prevent such an environment from being created. These minor works should be carried out as soon as possible.

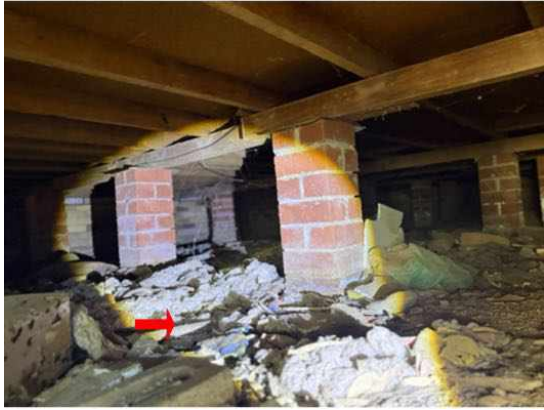
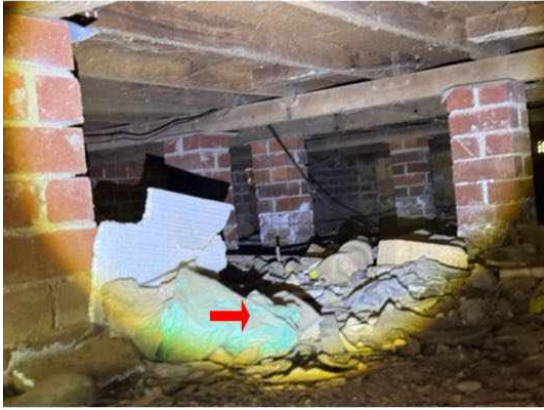
### Finding 6.04

Building:	Main Building
Location:	Subfloor
Finding:	Stored Items - Subfloor
Information:	At the time of inspection, various stored items and leftover building materials were observed within the subfloor area of the dwelling. Subfloor areas are required to remain clear and unobstructed to allow for adequate ventilation, routine inspection access, and to prevent the accumulation of moisture and pests.

The storage of materials and general items in this space can obstruct air flow, potentially contributing to poor ventilation and the buildup of damp conditions, which may lead to timber decay, mould growth, or termite activity. Additionally, stored items can conceal defects or damage within the subfloor, delaying their detection and rectification.

It is recommended that all stored items and debris be removed from the subfloor area to maintain compliance with good building practice and to preserve the structural and environmental integrity of the subfloor space.

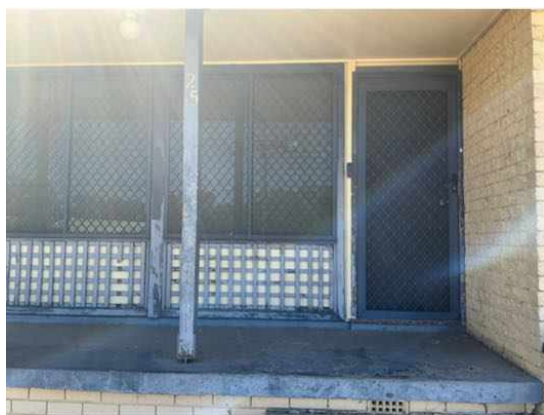
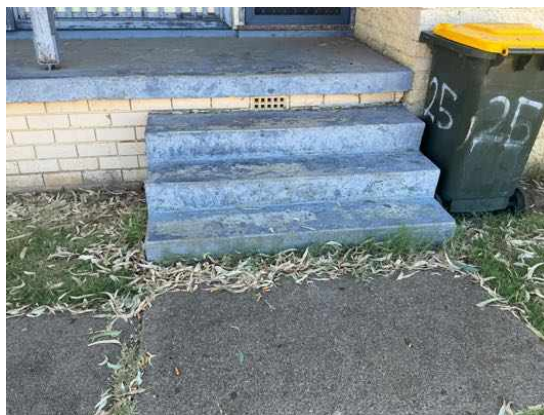
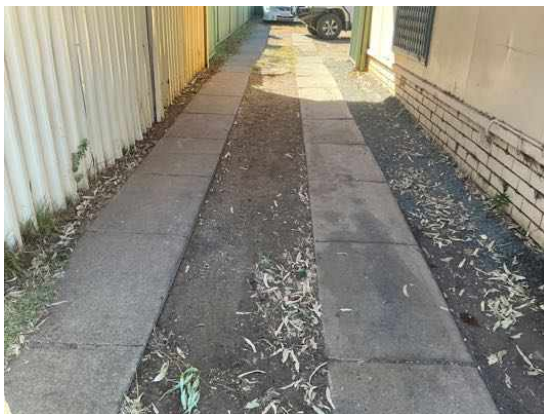
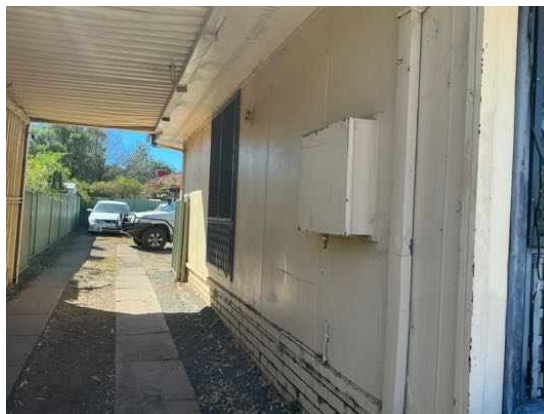
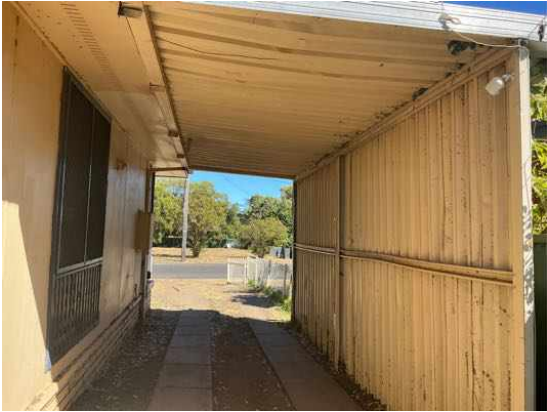
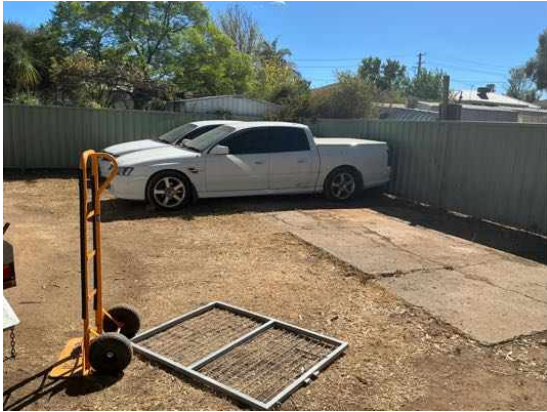
Building: Main Building  
Location: All Areas  
Finding: Additional Photos - Obstructions and Limitations  
Information: These photographs are an indication of the obstructions and limitations which impeded full inspection of the property at the time of inspection. These obstructions can hide an array of defects and should be removed to allow full inspection to be carried out. A re-inspection is recommended once the areas are made accessible.

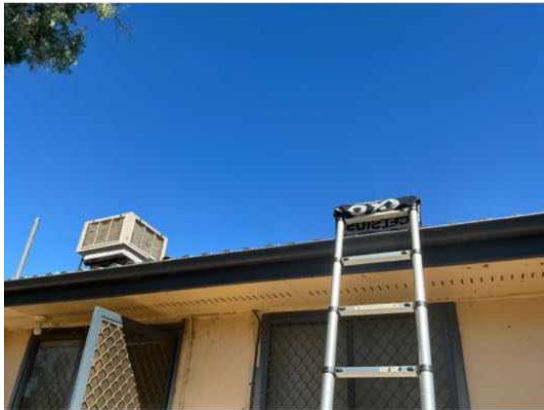
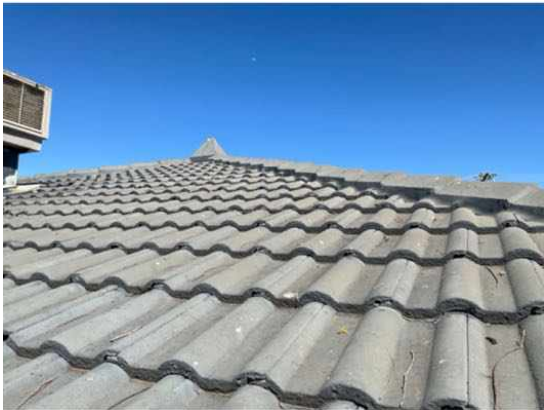
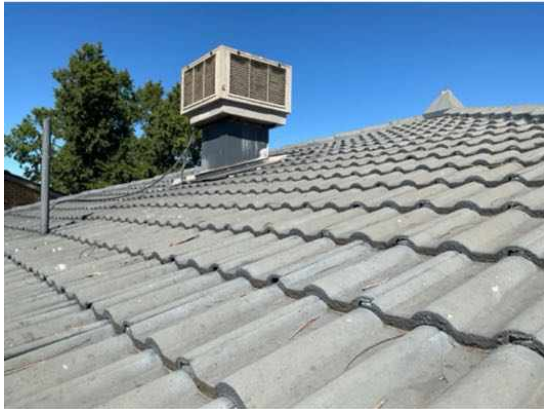
Building: Main Building  
Location: Roof Exterior  
Finding: Additional Photos Roof  
Information: Additional photos are provided of the general roof area for your general reference at the time of inspection.

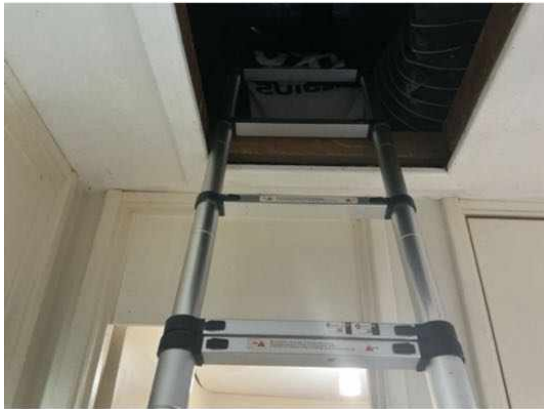
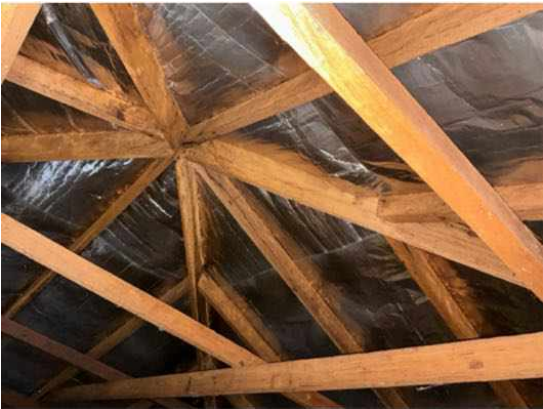
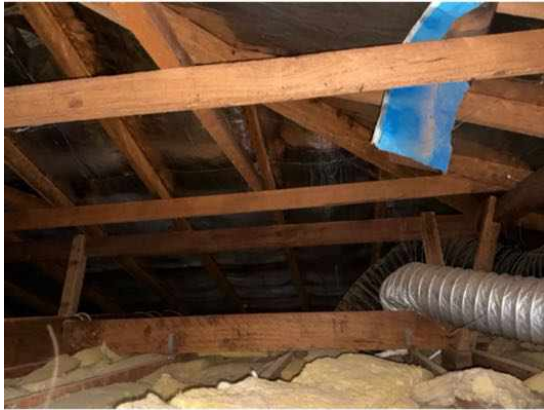
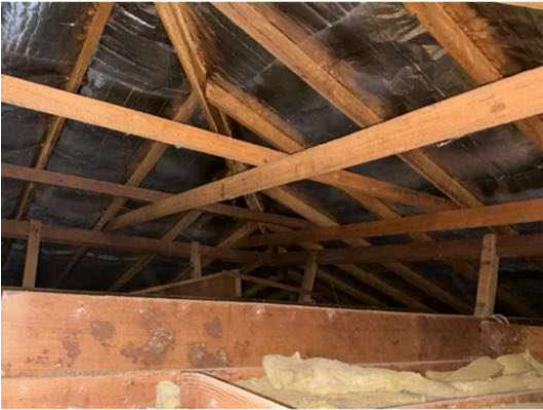
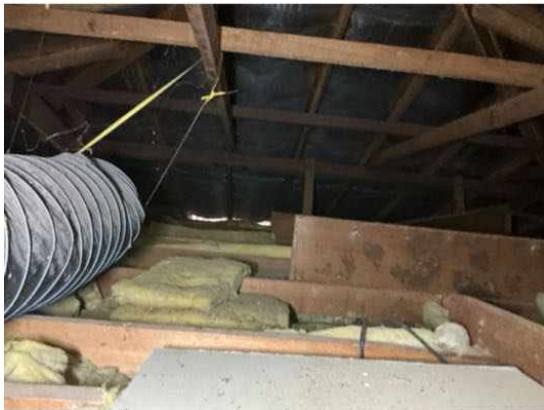
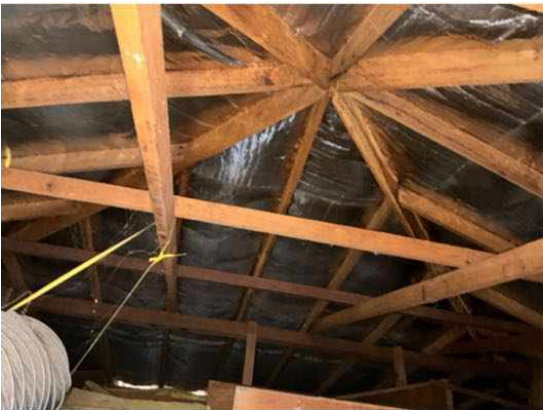
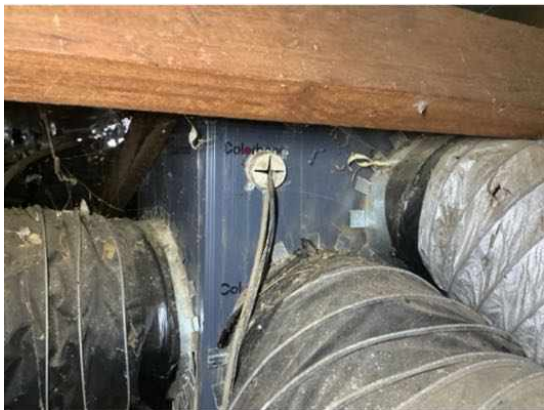
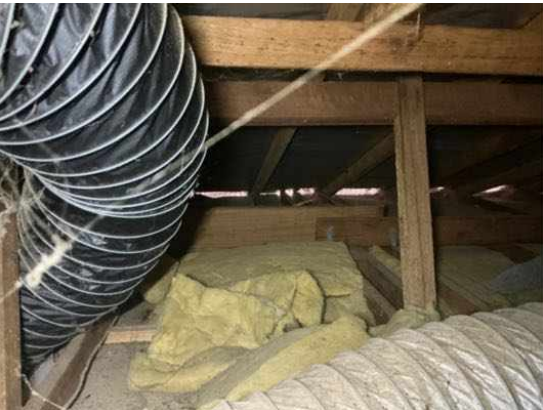
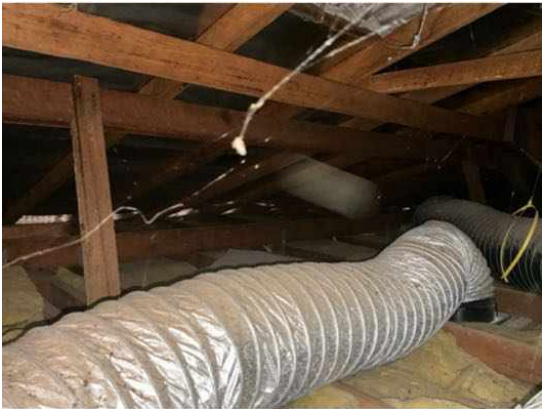
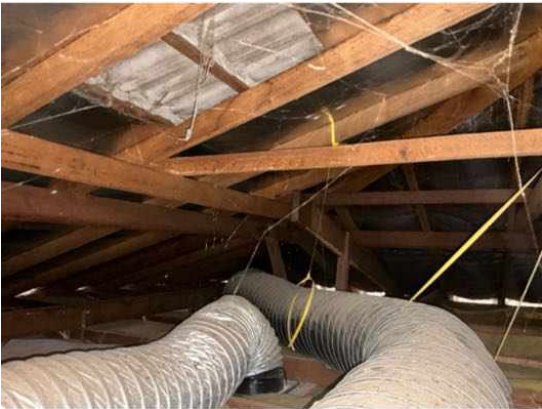
Building: Main Building  
Location: Roof Void  
Finding: Additional Photos Roof Void  
Information: Additional photos are provided of the general roof void for your general reference at the time of inspection.
