## Building Inspection Report

Inspection Date: Tue, 18 Nov 2025

Property Address: 1 Derwent Ave, Margate TAS 7054,  
Australia

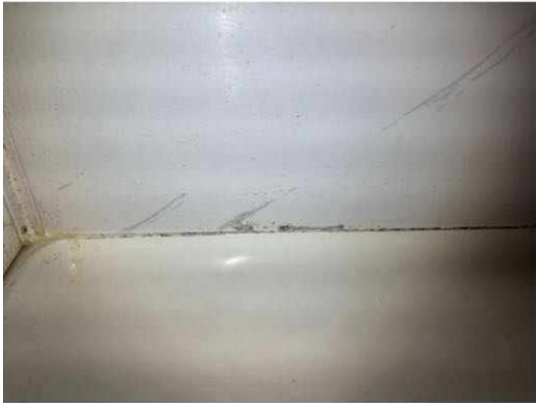
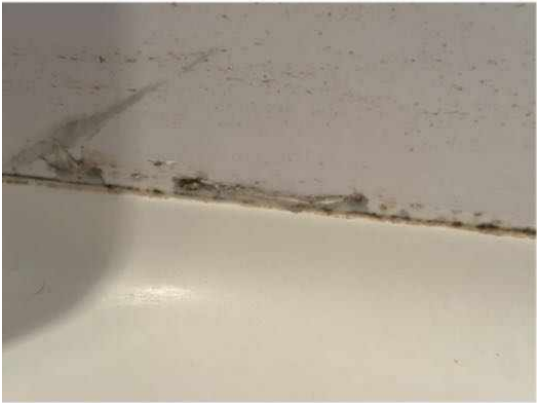
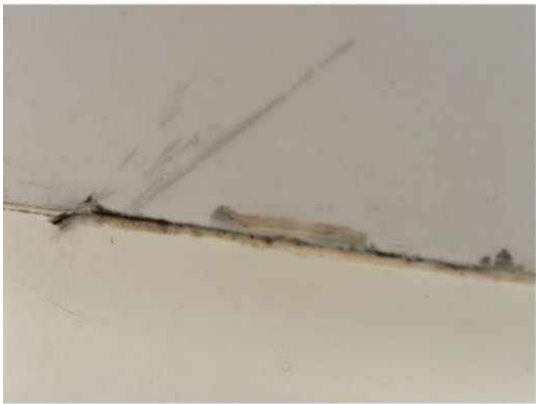
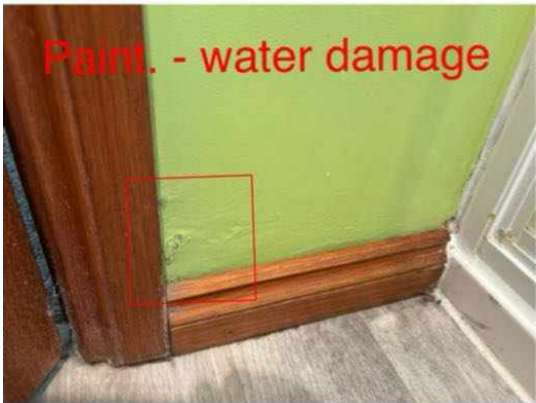
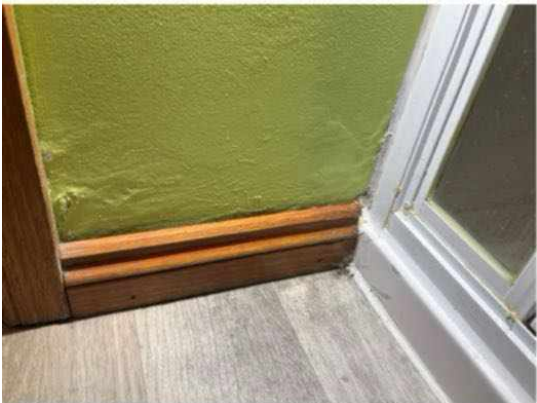
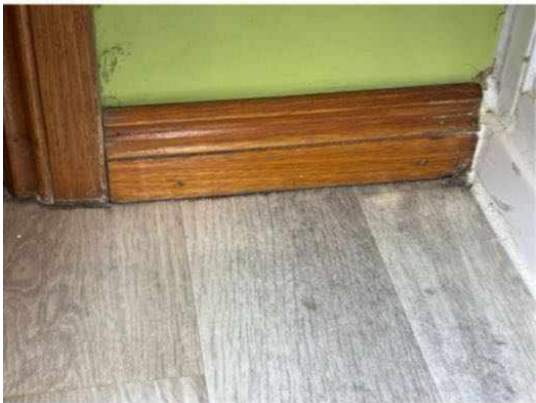
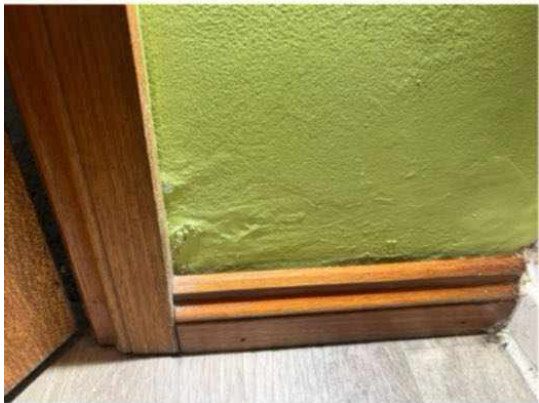
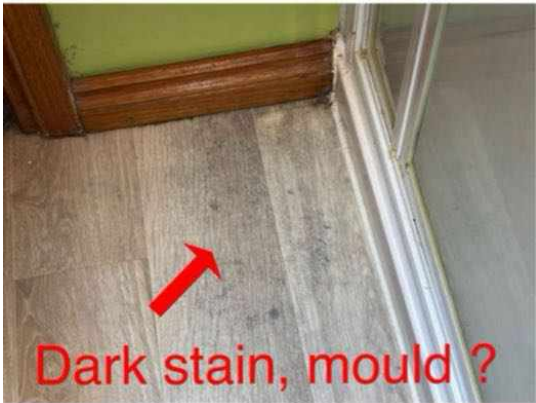
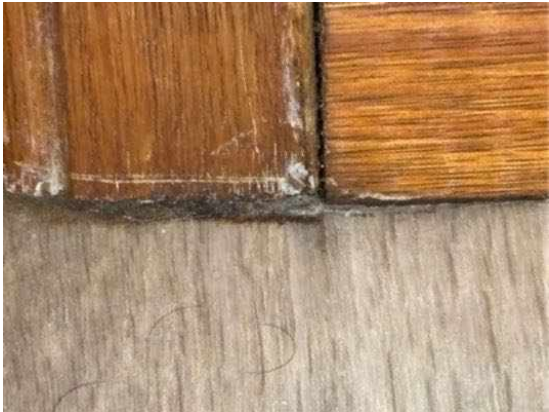
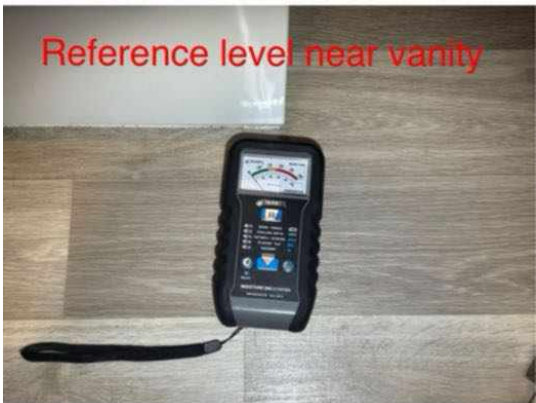
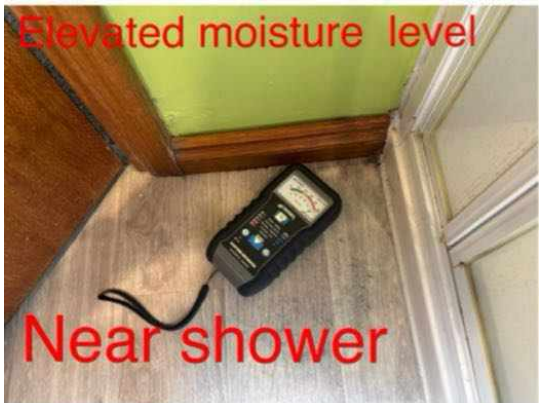
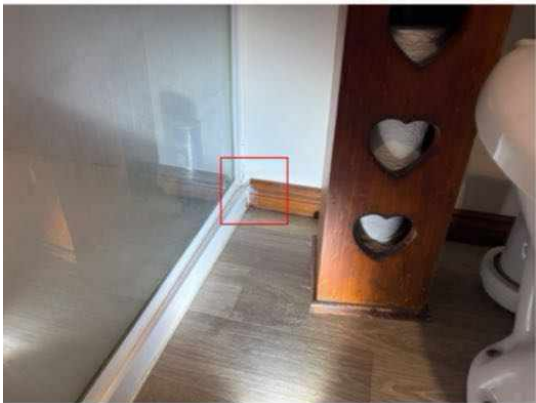
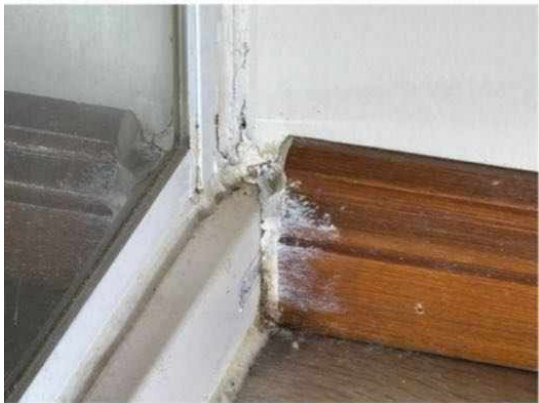
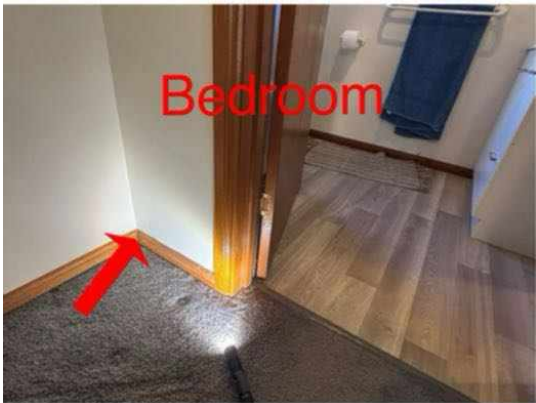
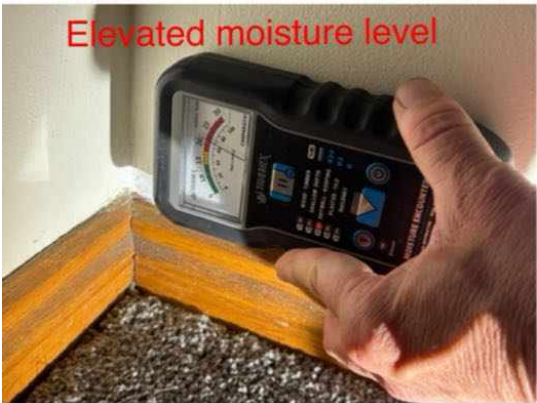
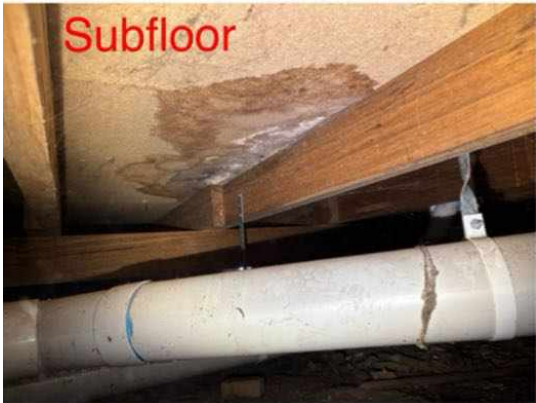
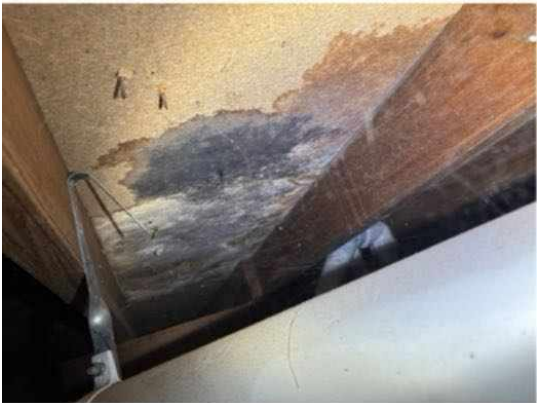
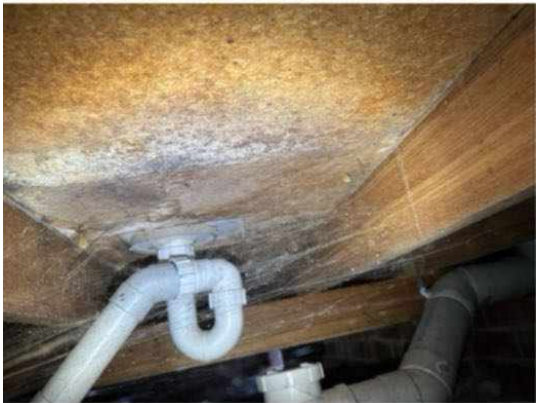
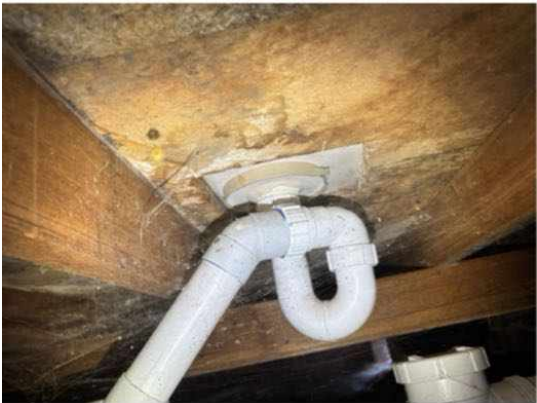
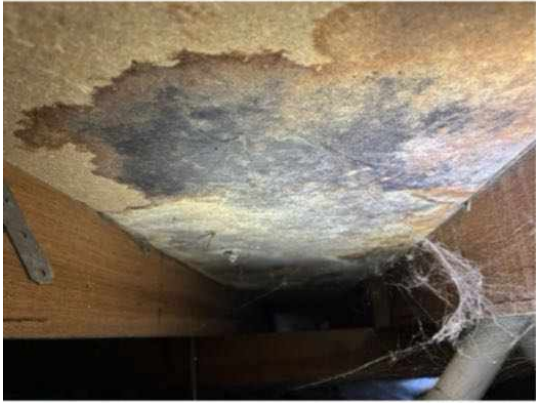
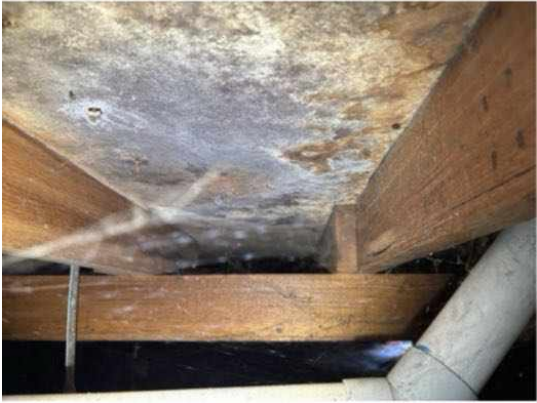
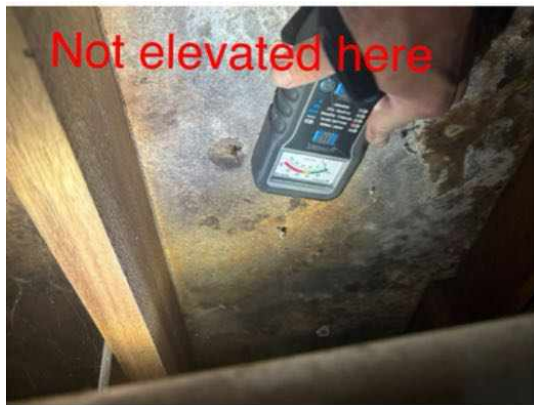
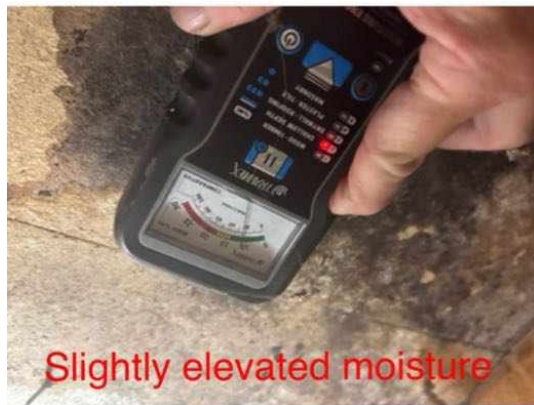
## Defects 2.02

Finding: Ensuite - water leak

Information: There is water damage and elevated moisture readings to the plasterboard beside the shower and on the bathroom and bedroom side of the wall. There have been some silicone repairs. There is elevated moisture outside of the shower to the vinyl. In the subfloor there is extensive water staining and mould to the under side of the sheet flooring. The shower silicone has deteriorated. The ensuite shower door is binding on the bottom, it may be able to be adjusted at the mounting points. The subfloor access under here was quite tight and pipes prevented moisture checks to the entire affected area. There was also some mould in the bottom of the cupboard that backed onto this bathroom, that may be related.

If not rectified, water will continue to ingress and may lead to water damage and deterioration of the surrounding building elements if the water proofing membrane is not intact or absent. However our non invasive inspections is unable to determine the adequacy of the water proofing membrane. Tiles, grout and sealants are used to

protect building materials to ensure that they are water-tight and prevent water penetration to the associated structures.

Recommend client engage a Lic Builder (who specialises in bathrooms) to investigate and rectify, as soon as possible.

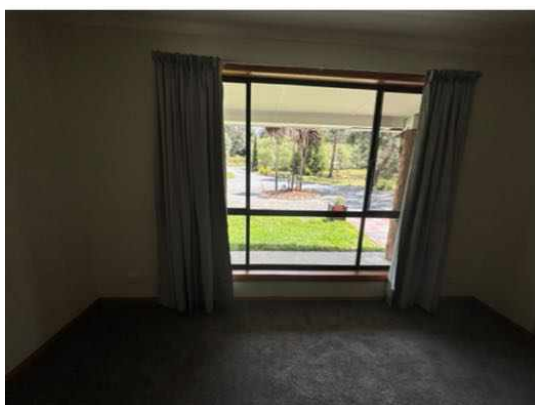
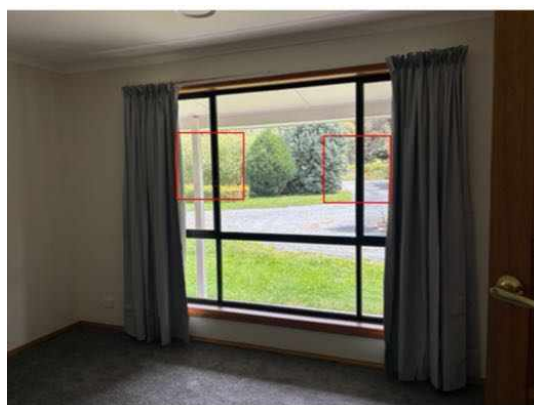
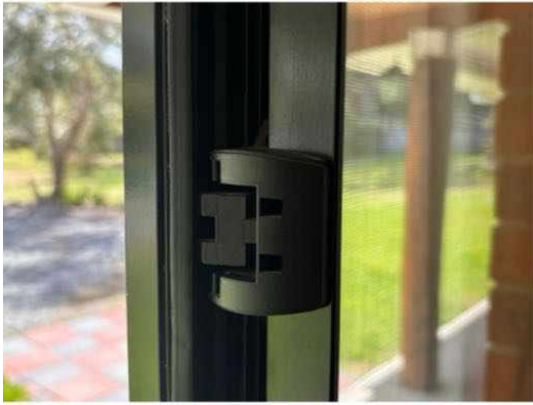
### Defects 3.01

Building:	Main Building
Location:	Front Living Room
Finding:	Window latches damaged
Information:	The window latches in the front 2nd living room are damaged and not easy to open.

Windows provide ventilation to the adjoining area and should be at a fully operational level to ensure user comfort. Restricted function of the window may also pose as a potential safety hazard if required for emergency egress from the building.

Generally, factors such as general age of the building element and a lack of maintenance are the usual causes for this type of defect.

Recommend client engage a Handy Person to rectify at clients convenience.

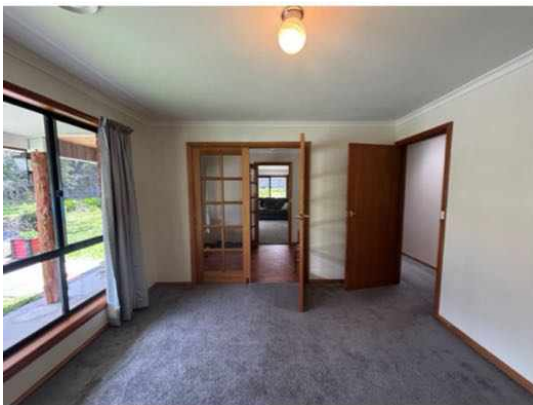
### Defects 3.02

Building: Main Building  
 Location: Entry foyer room  
 Finding: Door handle loose  
 Information: In the entry foyer room the door handle is loose. This impedes the function of the door.

Generally, factors such as general age of the building element and a lack of maintenance are the usual causes for this type of defect.

Recommend client engage Handy Person to rectify at clients convenience.

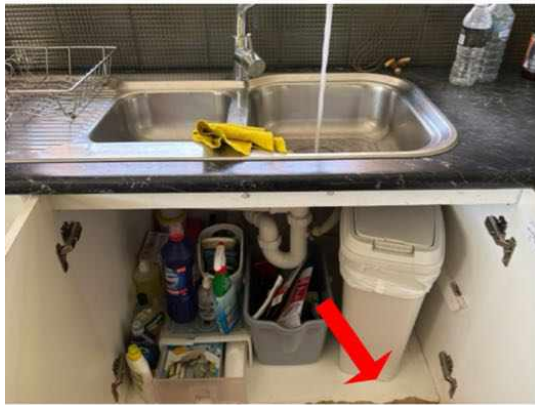
### Defects 3.03

Building: Main Building  
 Location: Kitchen  
 Finding: Laminate damaged to kitchen cabinet  
 Information: In the kitchen there is damage to the laminate of the cabinet under the kitchen sink.

Recommend client engage a Handy Person to paint at clients convenience to prevent moisture ingress.

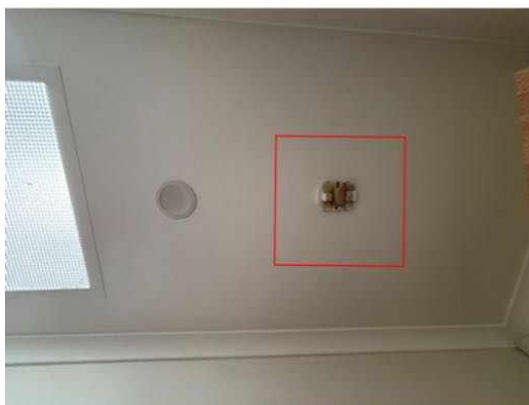
### Defects 3.05

Please note that this defect is highlighted as a caution only. We suspect, based on our

experience in the building industry, that the absence of smoke detectors, or their poor condition, should be addressed as a matter of urgency to improve occupant safety.

Always ensure sufficient working and suitable smoke detectors are installed prior to occupying any building. Additionally, it is advised that all smoke detectors be tested by the homeowner on a monthly basis.

Modern building standards would require hard wired and interconnected smoke alarms. This older property is not required to have this, but I still recommend that you install smoke alarms to meet these current standards. Recommend client engage a Lic electrician to install prior to occupation.

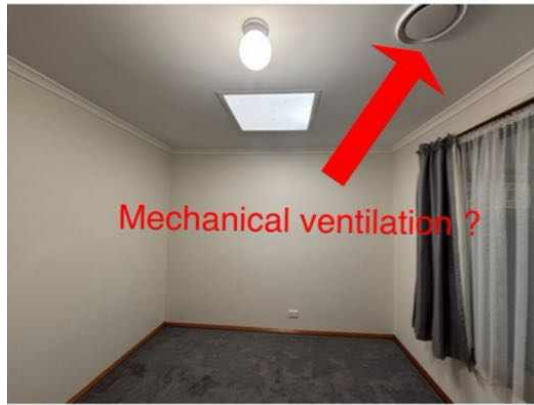
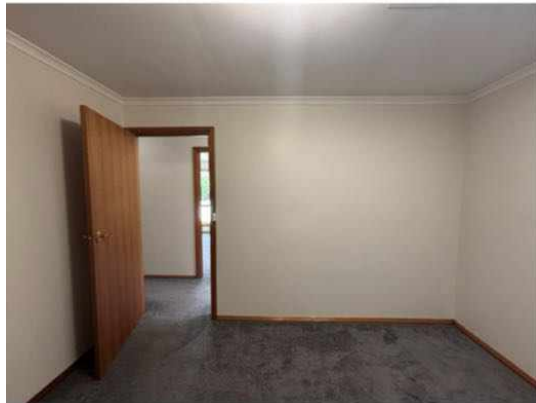
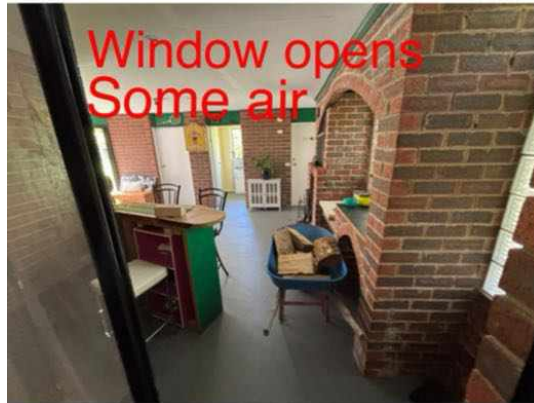
### Defects 3.06

Building:	Main Building
Location:	Internal bedroom
Finding:	FYI internal bedroom
Information:	FYI the internal bedroom has a window that opens to the entertainment area. It has also been fitted with a sky light. This may not meet current building standards, however this is not a new construction report.

If this were a new construction, the building surveyor would have had to assess the plans and approve or not approve. Maybe this was approved.

I have to assume it was approved, and am not considering a defect.

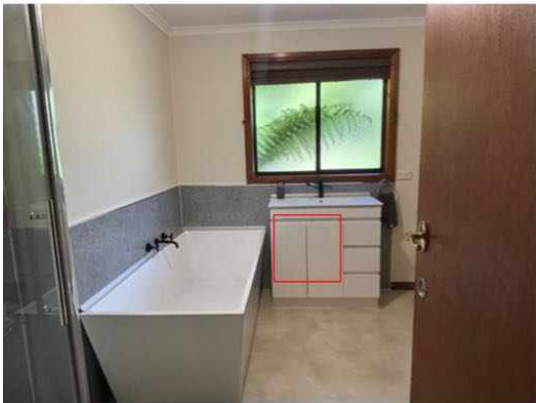
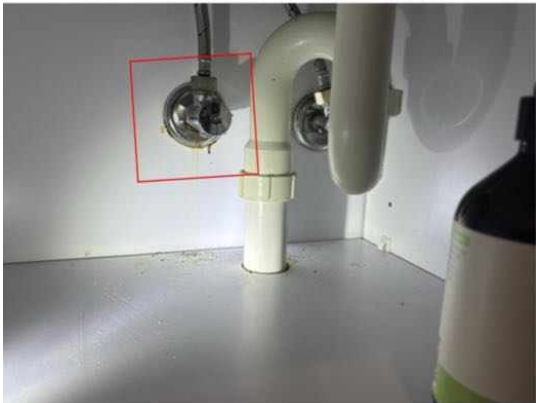
### Defects 3.07

Building:	Main Building
Location:	Bathroom
Finding:	Bathroom vanity cabinet water leak
Information:	In the bathroom vanity cabinet there is corrosion and evidence of water leak from the stop cock. It appeared to be dry at the time.

Internal water leaks can be detrimental to surrounding building elements. Rust, corrosion, decay and water damage are potential outcomes where a water leak is left unattended. In extreme cases, structural damage may develop due to a prolonged water leak.

Recommend client engage a Lic Plumber to inspect and rectify if required when attending for other items.

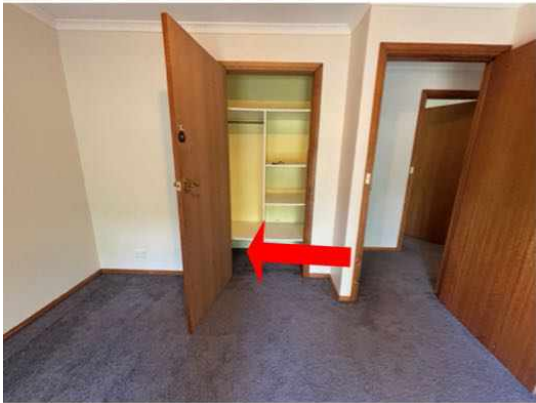
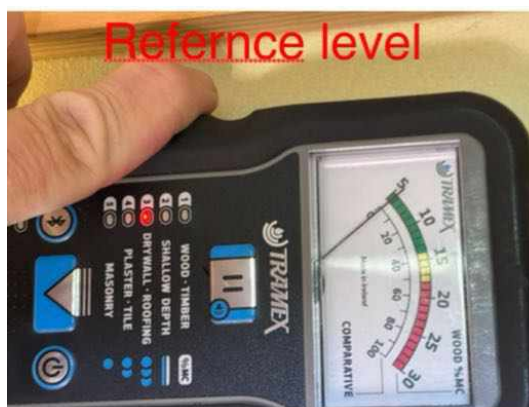
**Defects 3.08**

Building: Main Building  
 Location: Back bedroom to the deck  
 Finding: Mould  
 Information: In the back bedroom to the deck, there is mould in the lower section of the robe. This robe backs onto the ensuite. The mould will need to be treated and then painted, (after the ensuite issues has been rectified).

Mould can cause health related issues.

Recommend client engage a Handy Person to rectify as soon as practicable.

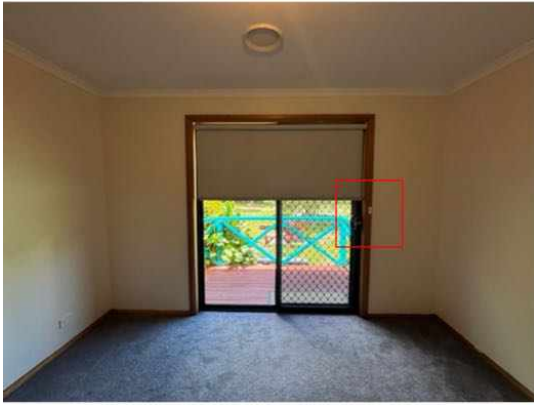
### Defects 3.09

Building:	Main Building
Location:	Back bedroom to the deck
Finding:	Sliding door latch is broken
Information:	The sliding door latch is broken to the back bedroom with the deck. This impedes the function of the door.

Although some building elements may seem irrelevant or unnecessary, all building elements play a key role in the operation and function of the overall structure and its performance.

Recommend client engage Handy Person to repair as soon as practicable.

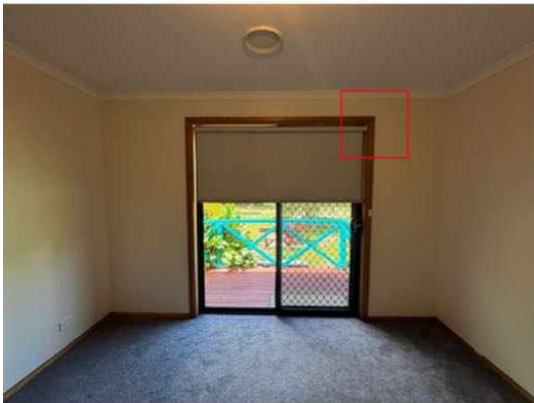
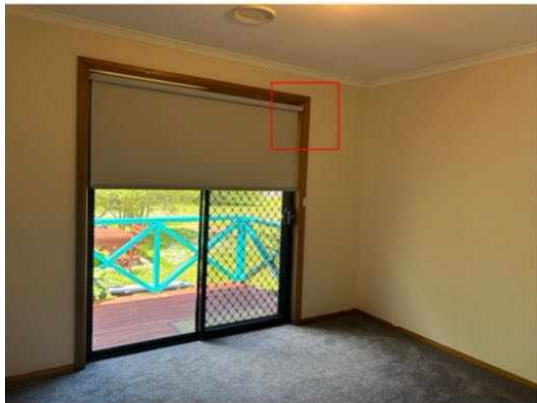
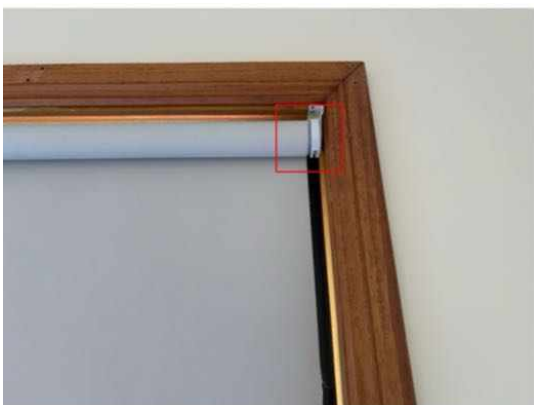
### Defects 3.10

Building: Main Building  
Location: Back bedroom to the deck  
Finding: Blind cord missing  
Information: In the back bedroom to the deck, the blind cord is missing. This impedes the function of the blind.

Recommend that client engage a Handy Person to rectify as soon as possible.

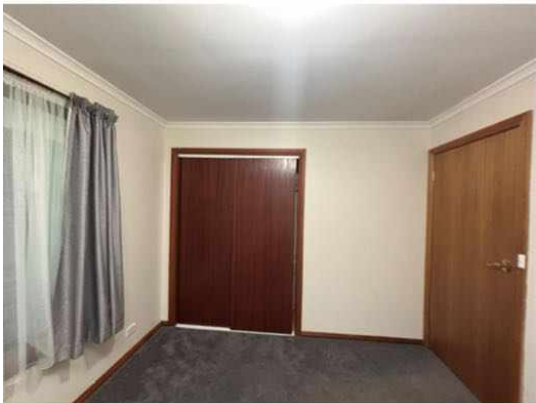
### Defects 3.11

Building: Main Building  
Location: Internal bedroom  
Finding: Internal bedroom - flooring  
Information: In the internal bedroom, the robe doesn't have carpet. However it does have vinyl over cement sheet flooring underlay, on top of chipboard. The flooring underneath this area is stained in the subfloor and there is evidence of previous water damage. There is some discoloration to the plasterboard.

This area backs onto the main bathroom where a leak has been identified. It is recommended that the flooring in the robe be removed, when carrying out other investigations for the shower that backs onto this robe.

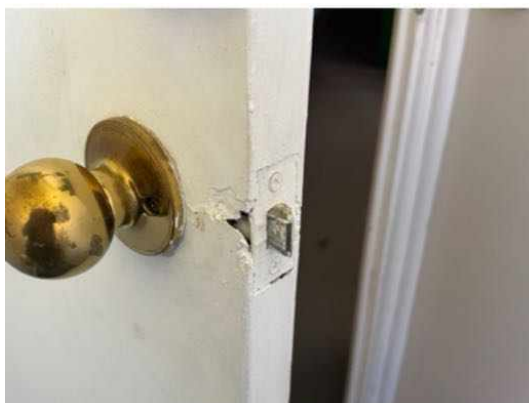
### Defects 3.12

Building:	Main Building
Location:	Entertaining Area
Finding:	Door damaged
Information:	The toilet door near the entertainment area has been damaged.

Although some building elements may seem irrelevant or unnecessary, all building elements play a key role in the operation and function of the overall structure and its performance.

Recommend client engage a Handy Person to rectify at clients convenience, to prevent any further damage.

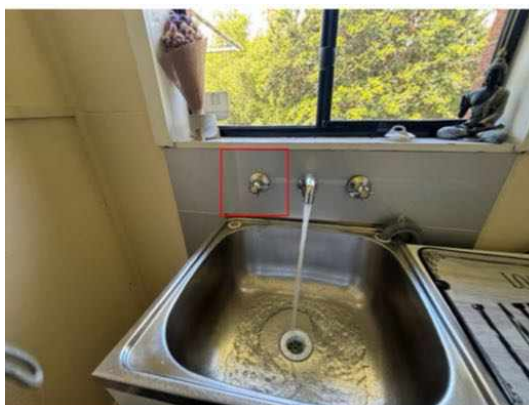
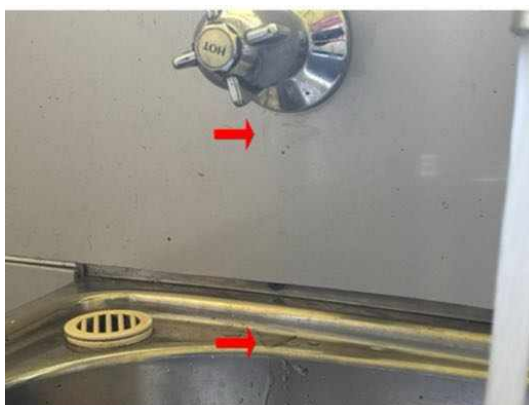
### Defects 3.13

Building:	Main Building
Location:	Laundry
Finding:	Tap dripping
Information:	The hot tap in the laundry is dripping.

Internal water leaks can be detrimental to surrounding building elements. Rust, corrosion, decay and water damage are potential outcomes where a water leak is left unattended. In extreme cases, structural damage may develop due to a prolonged water leak.

Recommend client engage a Lic Plumber to rectify as soon as possible.

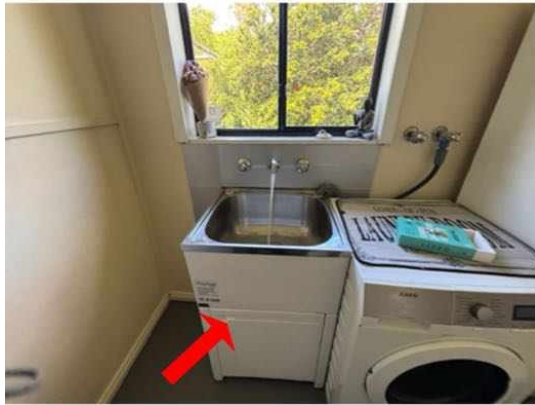
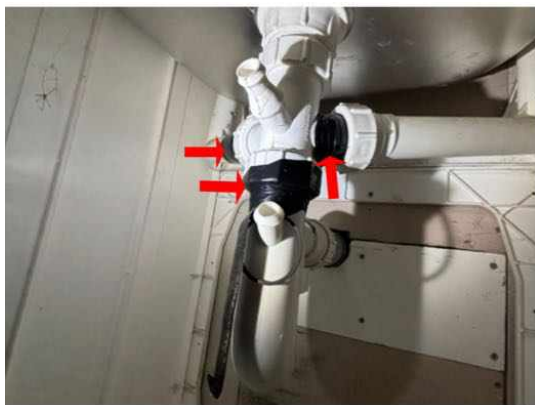
### Defects 3.14

Building:	Main Building
Location:	Laundry
Finding:	Non orthodox plumbing repairs
Information:	Under the laundry sink there are unorthodox plumbing repairs.

Internal water leaks can be detrimental to surrounding building elements. Rust, corrosion, decay and water damage are potential outcomes where a water leak is left unattended. In extreme cases, structural damage/subsidence may develop due to a

prolonged water leak.

Recommend client engage a Lic Plumber to inspect and rectify when attending for other items.

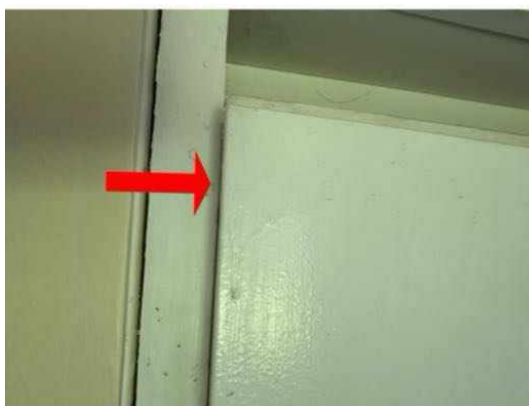
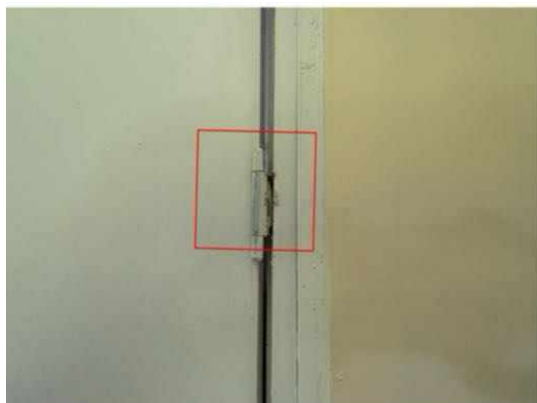
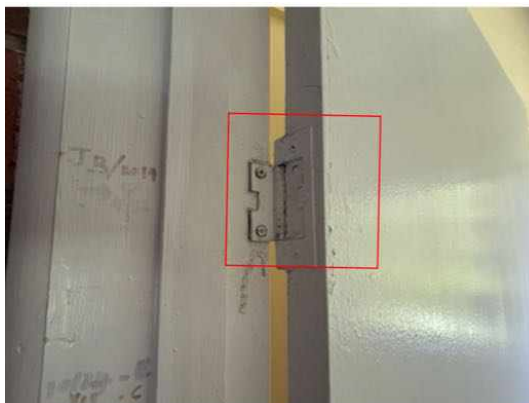
### Defects 3.15

Information: The laundry door is binding on the top of the door, also the hinge is loose or is bent. This defect inhibits the function of the door, and can cause further damage to the door and door frame if not rectified.

Recommend client engage a Handy Person to rectify at clients convenience.

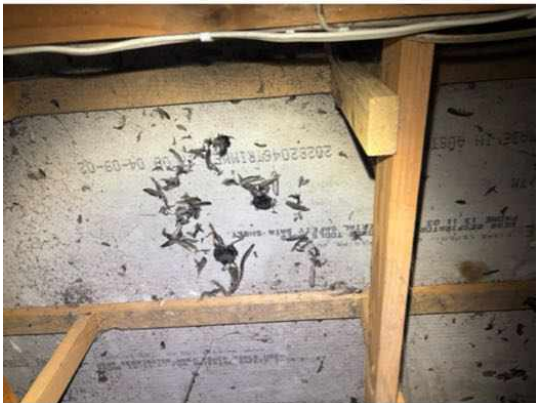
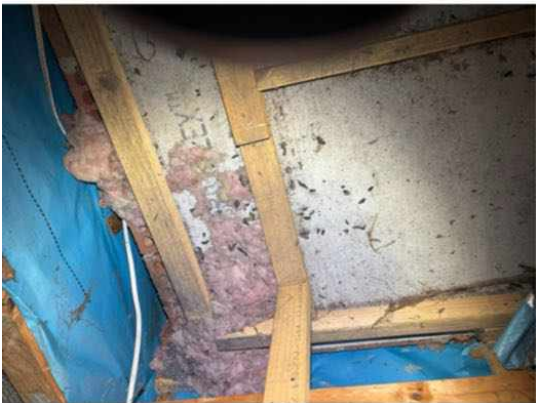
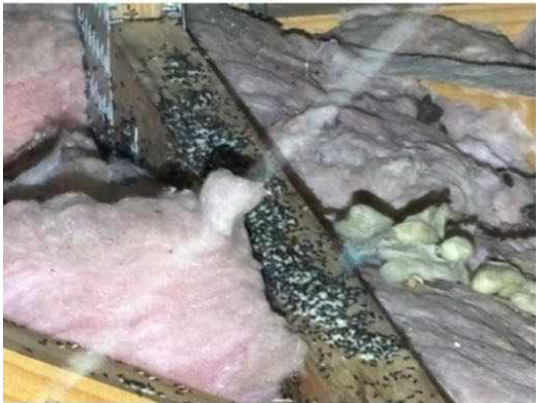
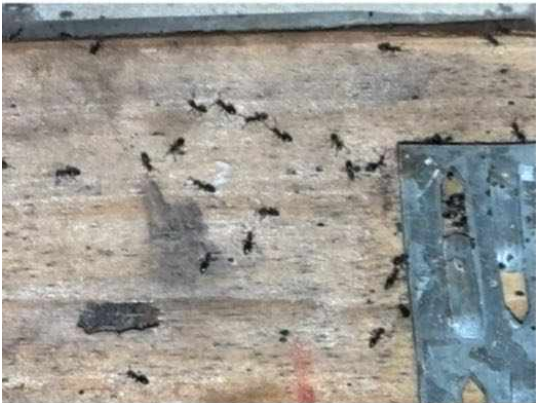
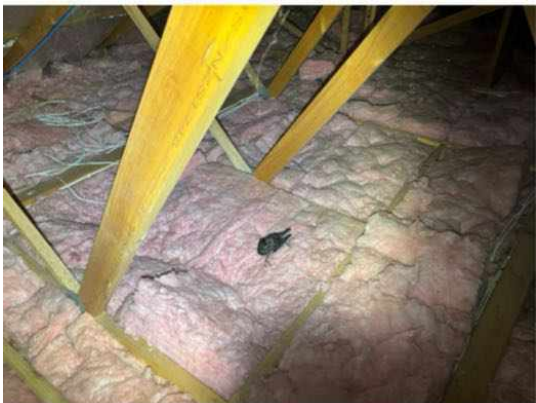
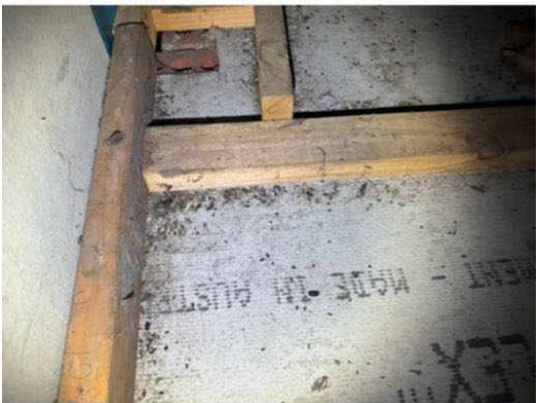
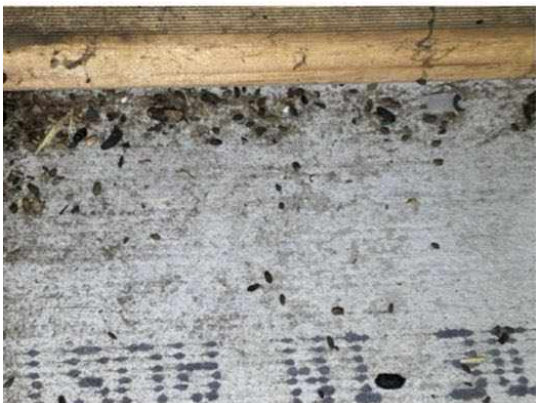
### Defects 3.16

Building:	Main Building
Location:	Roof void
Finding:	Evidence of ants, vermin & birds - roof void
Information:	In the roof void there was evidence of birds, mice, rats and lots of ant activity at the time of the inspection.

Vermin can cause issues ranging from smells and stains through to physical damage to wiring and other elements in the roof void.

Birds can cause secondary damage via their waste, and potential damage to building elements and disruption to occupants due to the noise.

Recommend client engage a Lic Pest Controller to investigate and remedy as soon as possible.

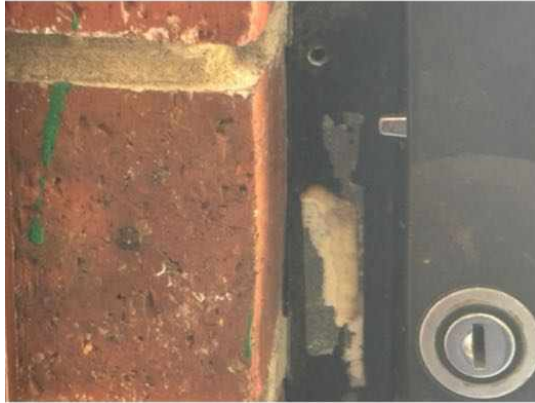
Defects 3.17

Building: Main Building  
 Location: Entertainment Area  
 Finding: Sliding door latch broken  
 Information: The sliding door latch is broken in the entertainment area. This impedes the function of the door.

Recommend client engage handy person to repair at clients convenience.

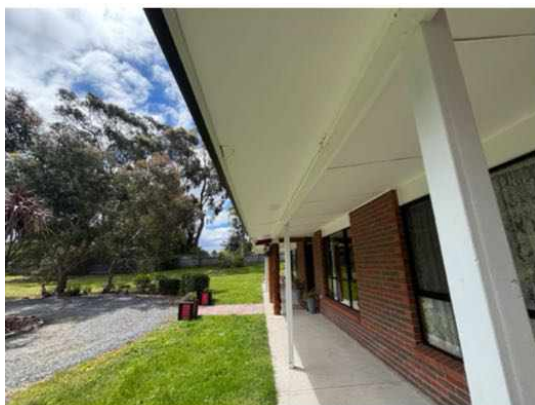
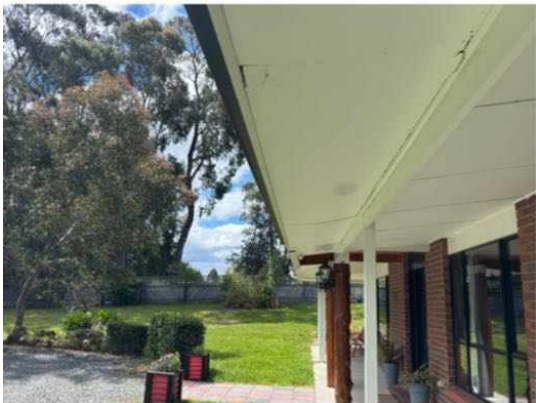
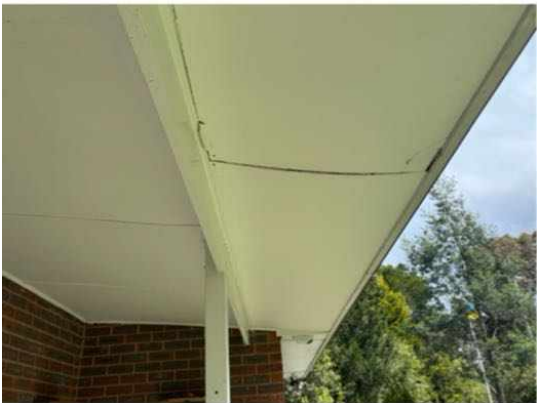
### Defects 3.18

Building: Main Building  
 Location: Front porch  
 Finding: Eaves sheeting sagging  
 Information: In multiple locations the eaves sheets are sagging. Possibly insufficient framing beneath to support the span. The eaves trim prevents vermin entry and paint to eaves protects them from window blown rain.

Recommend client engage a Handy Person the rectify as clients convenience.

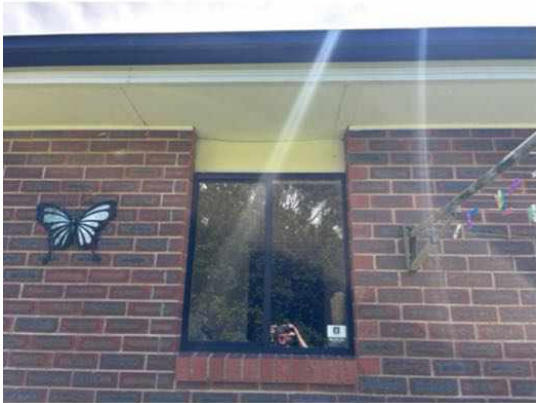
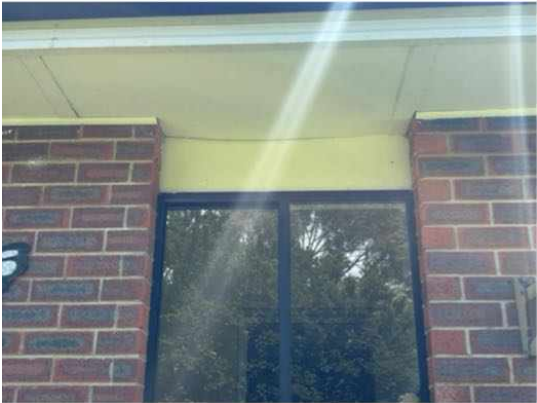
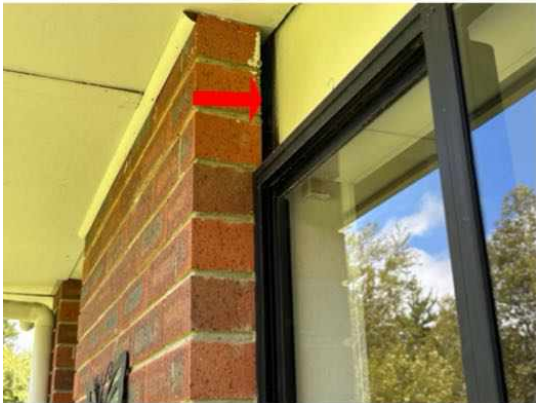
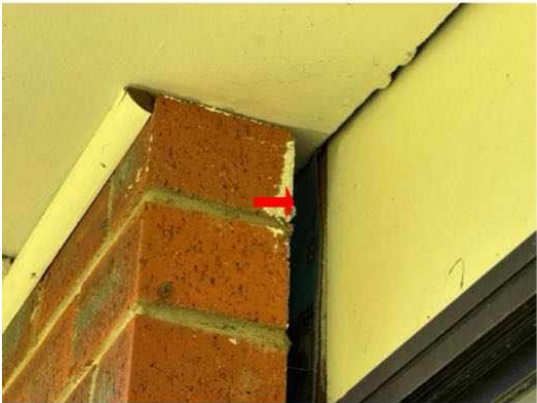
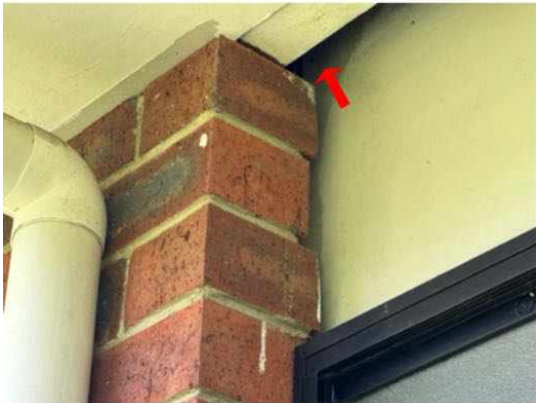
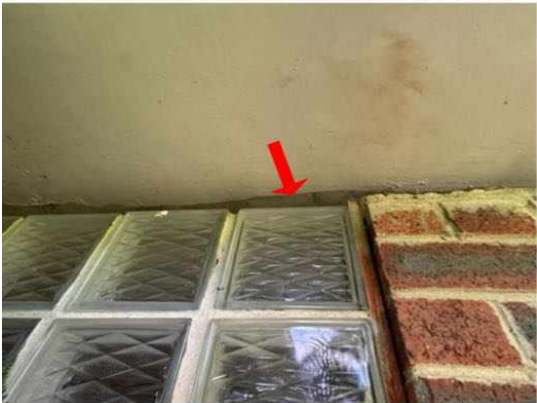
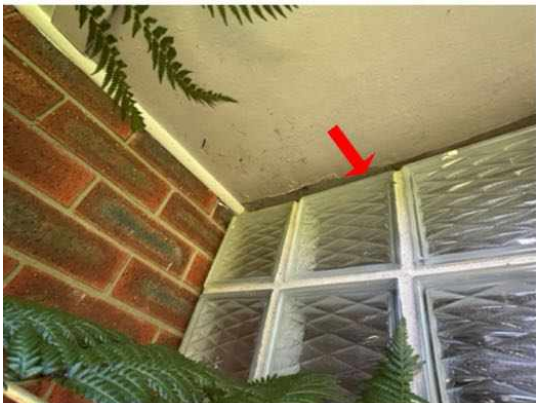
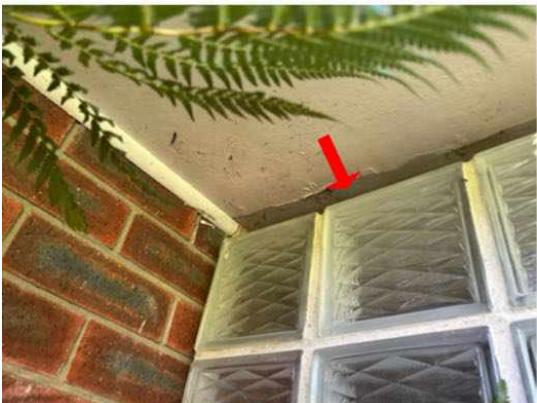
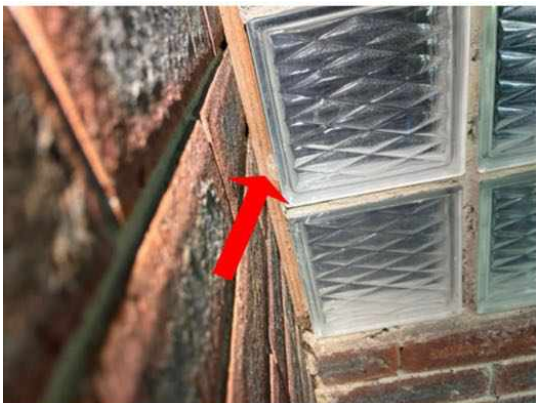
**Defects 3.19**

Building: Main Building  
Location: Rear entertainment area  
Finding: Renovation works incomplete  
Information: In the rear of the entertainment area there are some unfinished works. The toilet and laundry windows are incomplete, there are gaps to the infill panel that can allow vermin entry. Also the glass bricks have a gap in them, that could allow vermin entry.

Recommend client engage a Handy Person to rectify at clients convenience.

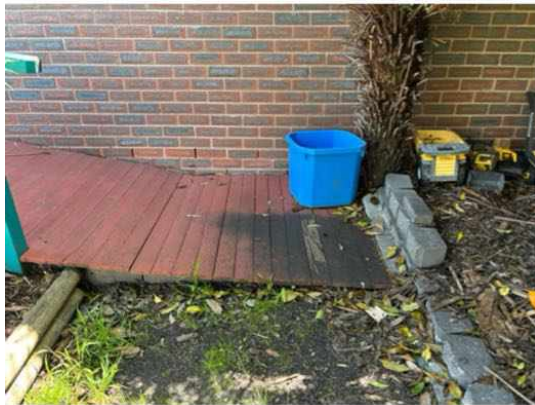
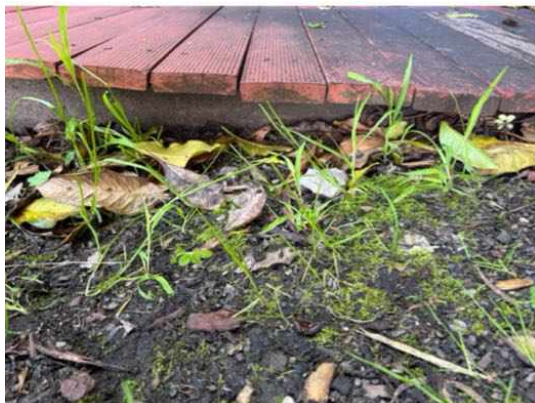
Defects 3.20

Building: Main Building  
 Location: Deck  
 Finding: Wood rot / timber decay  
 Information: The rear ramp appears to be built directly onto the ground and some timbers are rotting. Also some deck boards are bouncing.

Wood rot, also known as Fungal Decay, occurs when timbers and other cellulose building materials are exposed to damp conditions on an ongoing basis. This could be the result of exposure to weathering over a prolonged period of time, or the attraction of excessive moisture from other abutting building materials.

Recommend client engage a Carpenter to rectify as soon as possible.

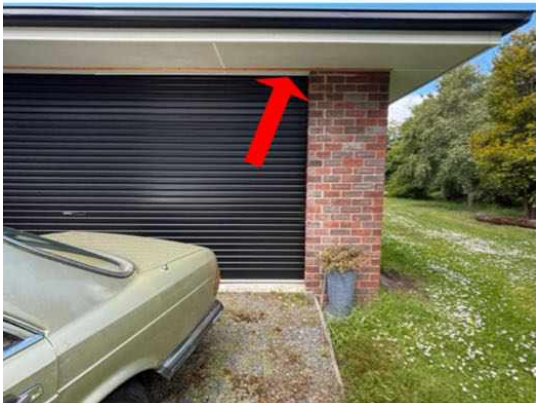
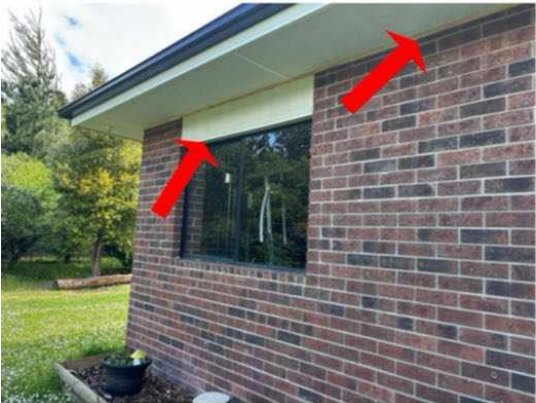
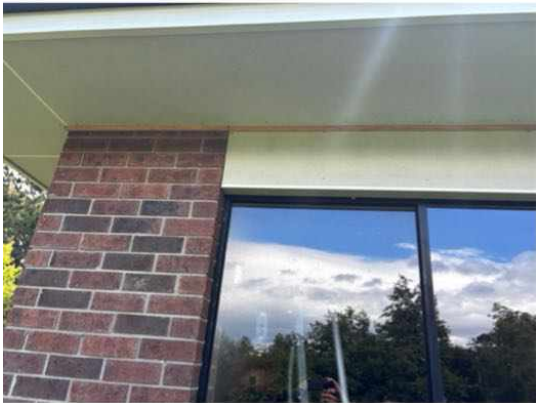
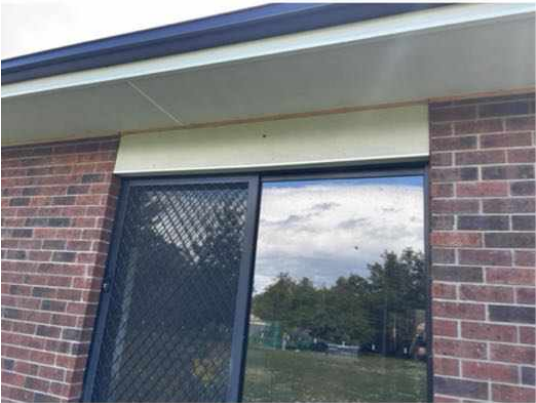
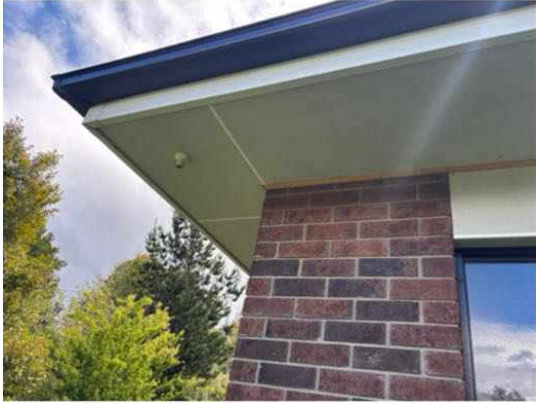
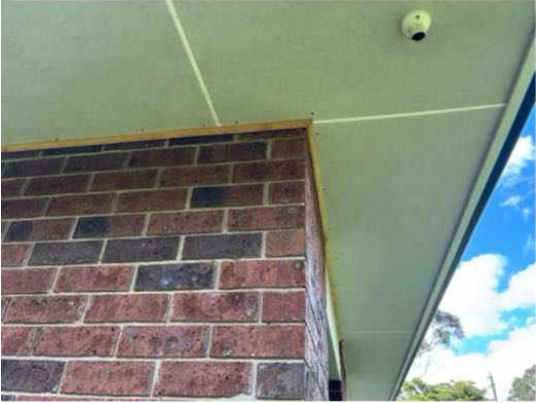
### Defects 3.21

Building: Garage  
 Location: Garage  
 Finding: Unfinished painting to exterior

Unpainted building materials that have frequent exposure to rain and other weather conditions deteriorate at an accelerate rate.

Recommend client engage a Handy Person to rectify as soon as practicable.

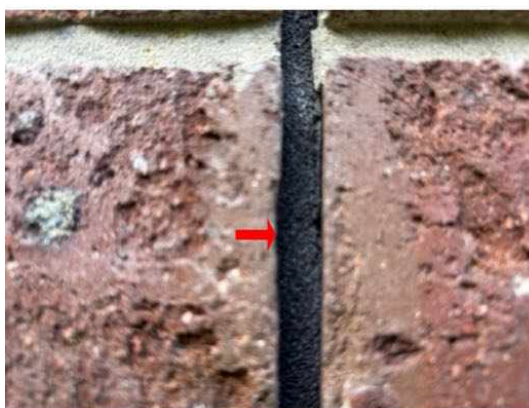
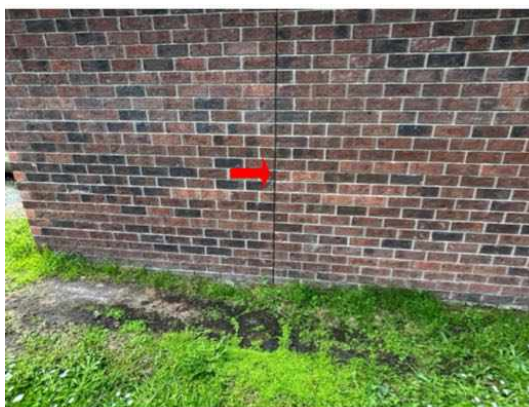
**Defects 3.22**

Building: Garage  
 Location: Garage  
 Finding: Articulation Joints/Control Joints unfinished  
 Information: In multiple locations on the garage the articulation/control joints to the brickwork, have not had the top layer of foam removed and sealant applied.

Control joints fills joints and intersections between bricks in masonry walls and structures, if not rectified gaps will allow water ingress to the surrounding building elements.

Recommend client engage a Handy Person to remedy as soon as practicable.

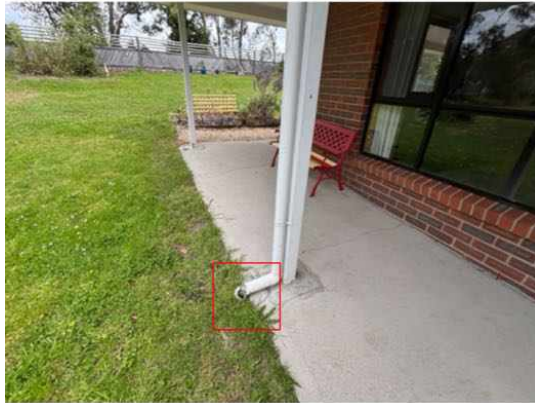
### Defects 3.23

Building: Main Building  
 Location: Front of house  
 Finding: Down pipe broken  
 Information: There is a broken down pipe to the front of the house.

Failure to rectify could lead to deterioration of the surrounding building elements as the water is discharging to the footings of the house. This could eventually cause subsidence.

Recommend client engage a Lic Plumber to rectify as soon as possible.

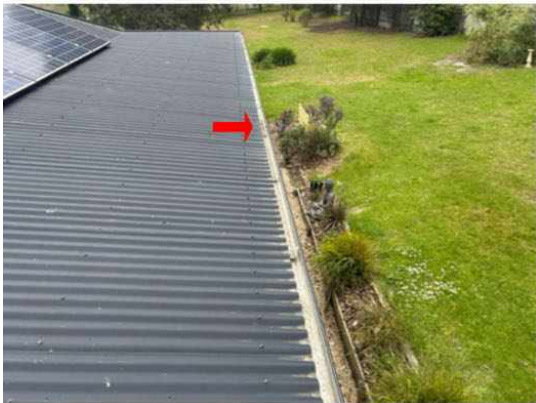
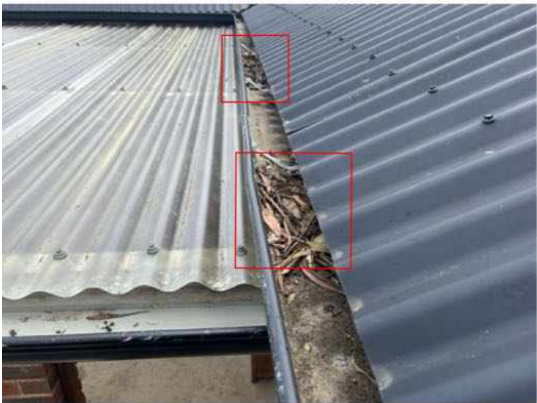
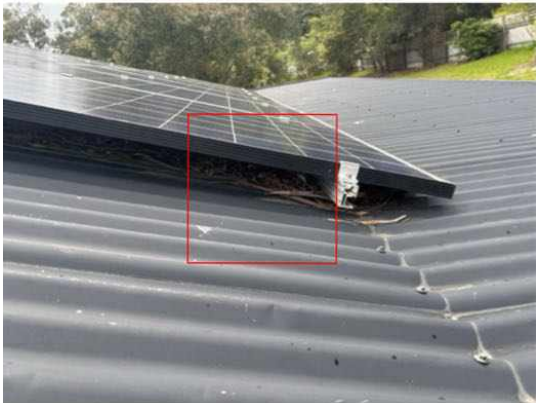
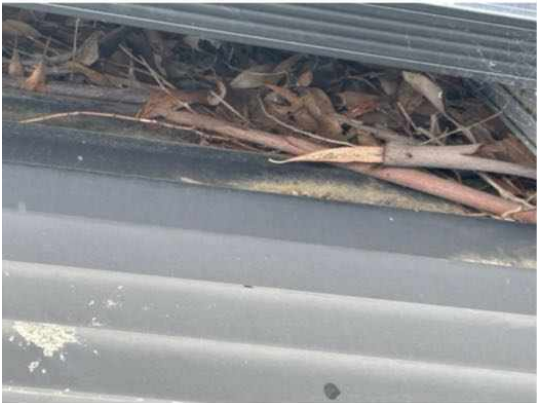
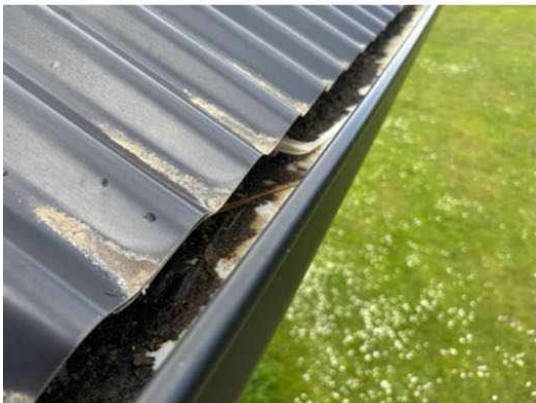
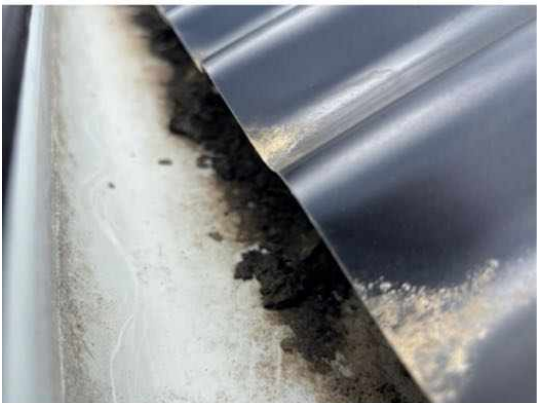
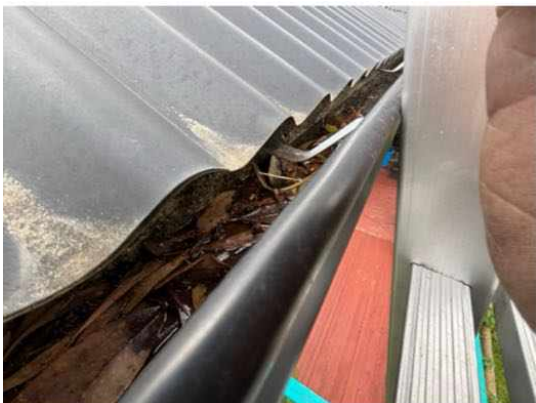
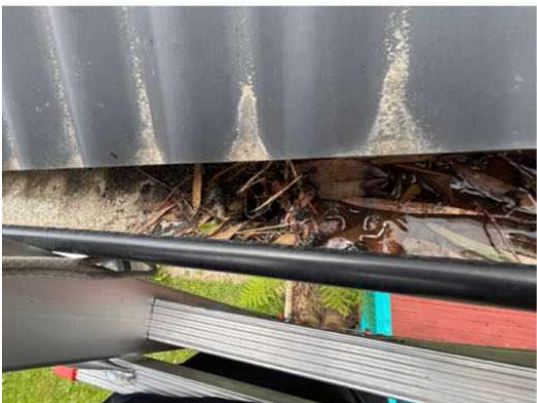
### Defects 3.24

Building:	Main Building
Location:	Roof exterior
Finding:	Gutters & underneath the solar panels need cleaning
Information:	Some gutters and underneath of the solar panels require cleaning.

Roof plumbing structures, such as guttering and downpipes, should be free of all debris to prevent blockages. Blockages of the guttering and downpipes will lead to pooling and accumulated water overflows, which is likely to subsequently flood eaves and exterior walls.

Recommend client engage a Handy Person to rectify as soon as possible.

Recommend client ensure that all gutters be maintained on a frequent basis to ensure the condition of roof plumbing.
