## Building Inspection Report

Inspection Date: Tue, 18 Nov 2025

Property Address: 1 Derwent Ave, Margate TAS 7054,  
Australia

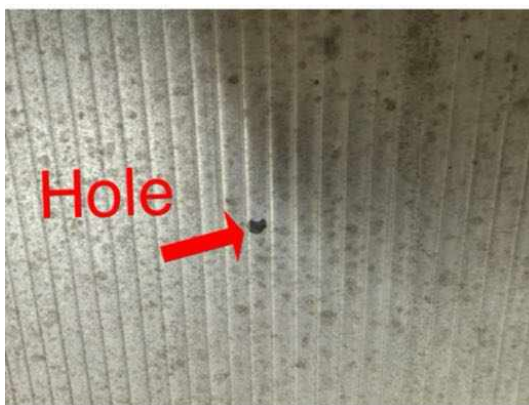
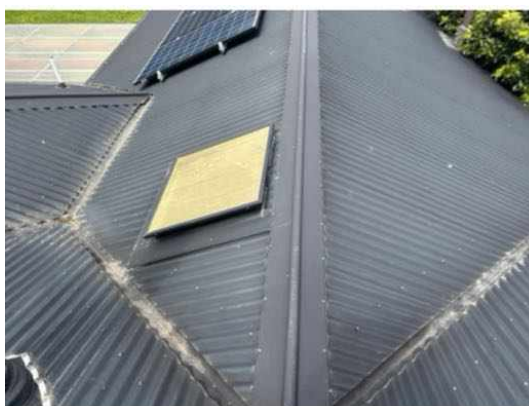
Defects 3.25

Building: Main Building  
 Location: Roof exterior  
 Finding: Skylights deteriorated  
 Information: There is a sky light fitted to the kitchen area and also the internal bedroom. The top of the skylights are made of plastic coreflute material. The top layers of coreflute have started to deteriorate, as they have been damaged by UV which causes holes. This happens to these skylights eventually.

Failure to rectify will allow water into the roof eventually.

Recommend client engage a Handy Person to rectify as soon as practicable.

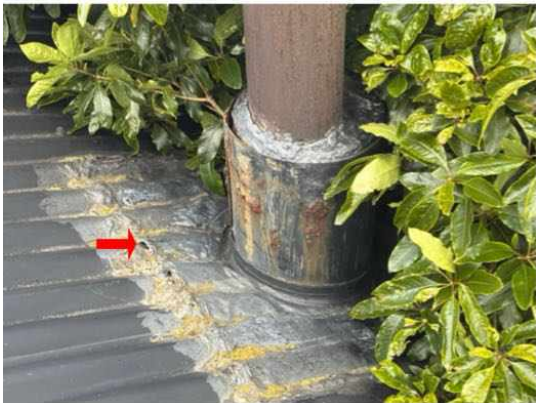
### Defects 3.27

Building:	Main Building
Location:	Roof exterior
Finding:	Wood heater flashing
Information:	The wood heater flashing on the entertainment area roof is in very poor condition and is at risk of leaks.

Water leaks can be detrimental to surrounding building elements. Rust, corrosion, decay and water damage are potential outcomes where a water leak is left unattended. In extreme cases, structural damage may develop due to a prolonged water leak.

Recommend client engage a Lic Roof Plumber or wood heater installer as soon as possible to repair.

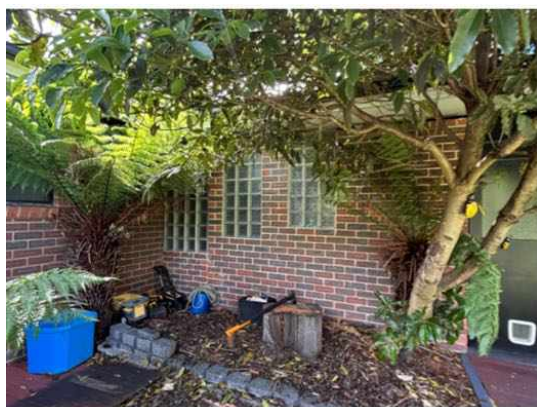
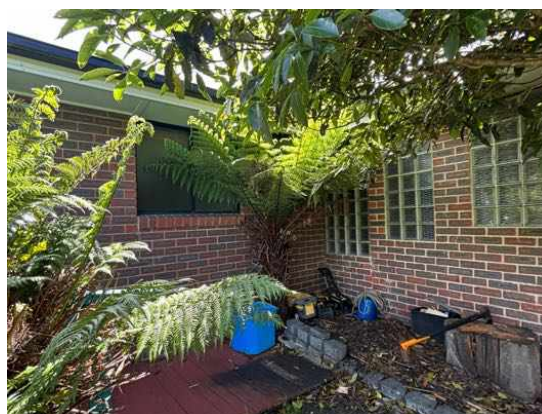
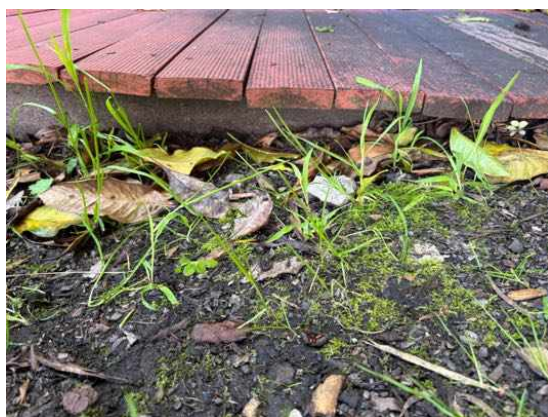
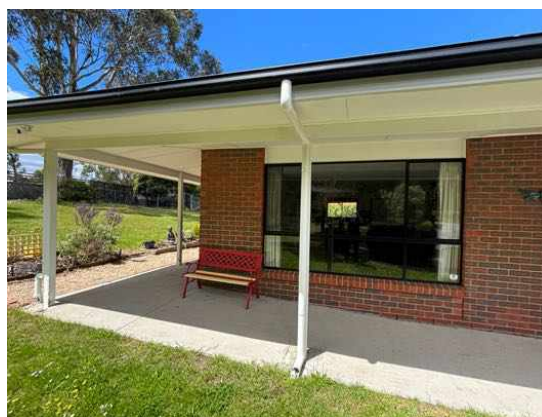
#### Noted Item

Building: Main Building  
 Location: All External Areas  
 Finding: Additional Photos - Obstructions and Limitations  
 Information: These photographs are an indication of the obstructions and limitations which impeded full inspection of the property at the time of inspection. These obstructions can hide an array of defects and should be removed to allow full inspection to be carried out. A re-inspection is recommended once the areas are made accessible.

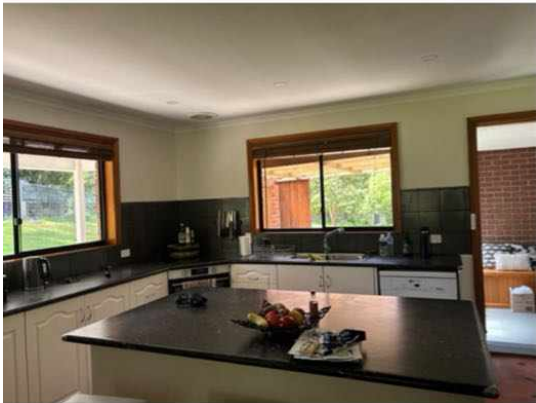
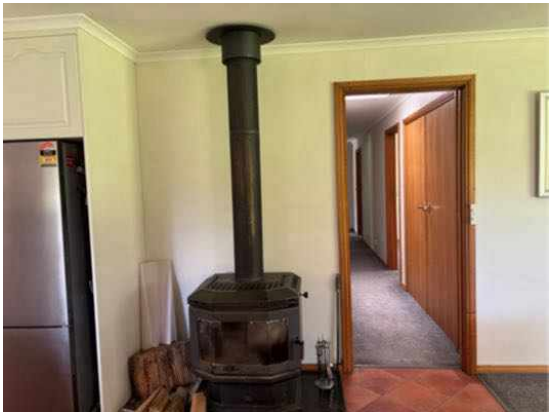
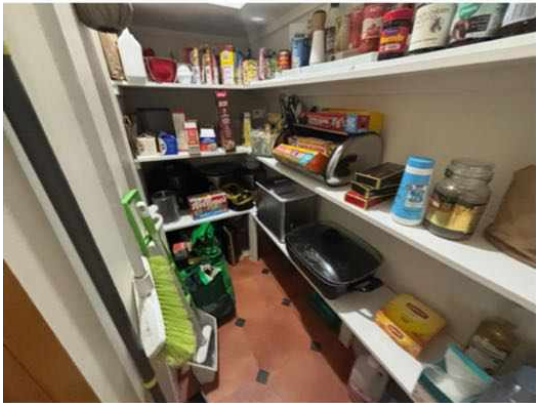
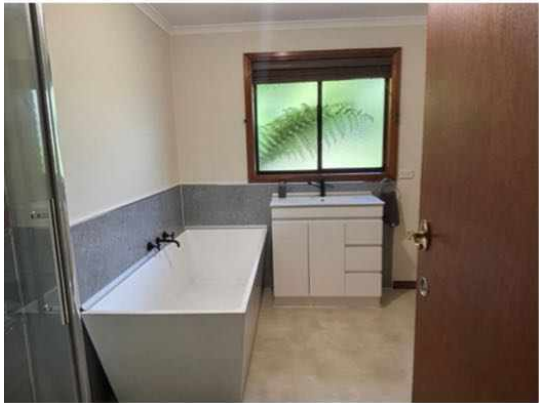
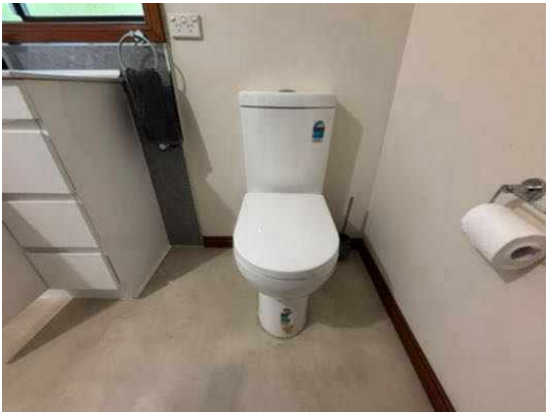
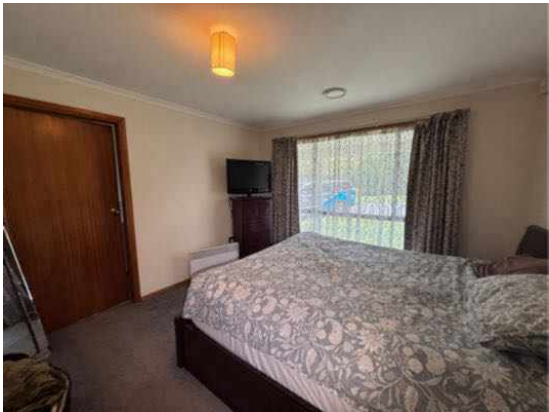
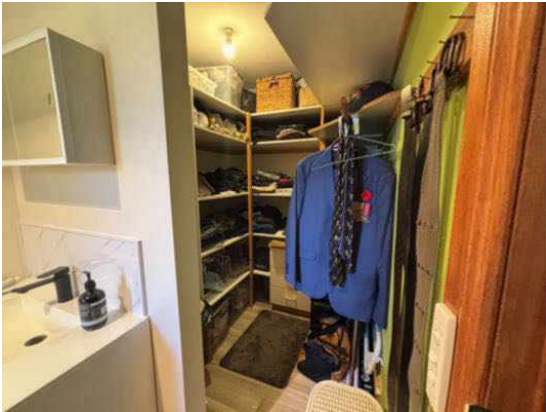
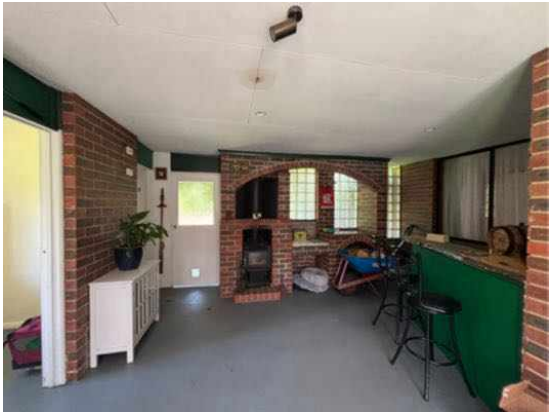
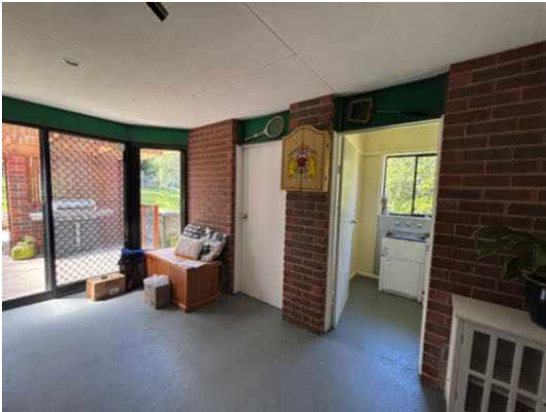
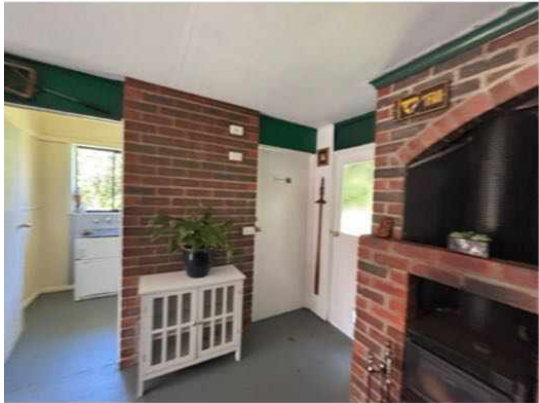
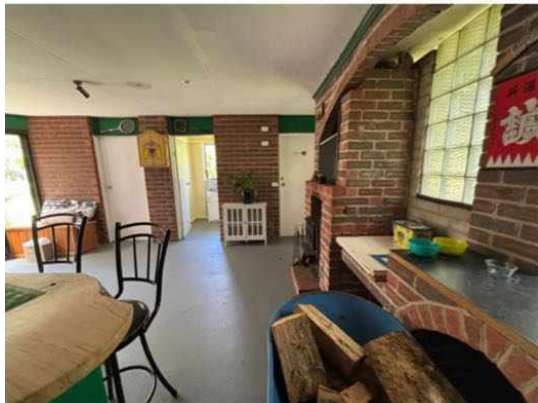
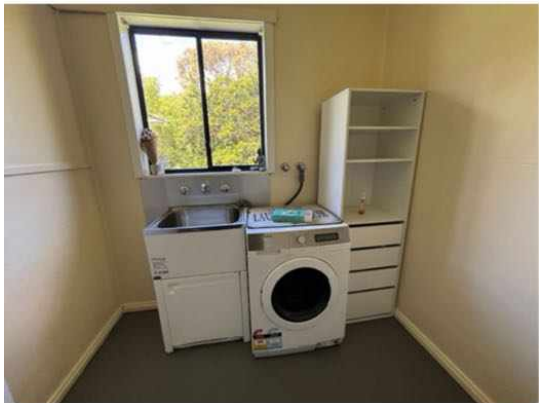
Building: Main Building  
 Location: All Internal Areas  
 Finding: Additional Photos - Obstructions and Limitations  
 Information: These photographs are an indication of the obstructions and limitations which impeded full inspection of the property at the time of inspection. These obstructions can hide an array of defects and should be removed to allow full inspection to be

carried out. A re-inspection is recommended once the areas are made accessible.

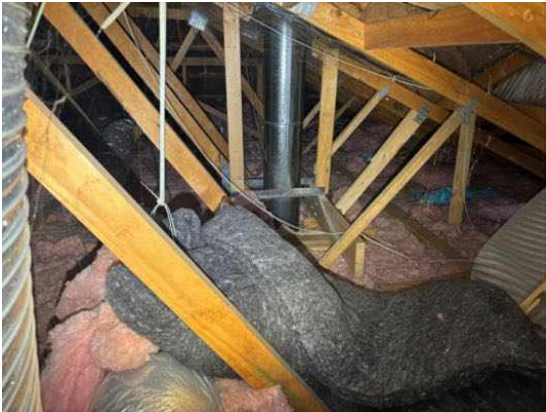
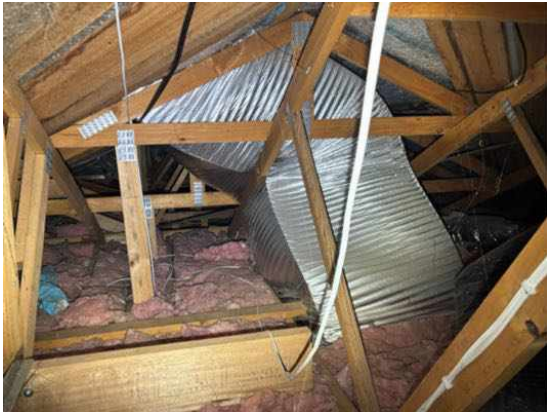
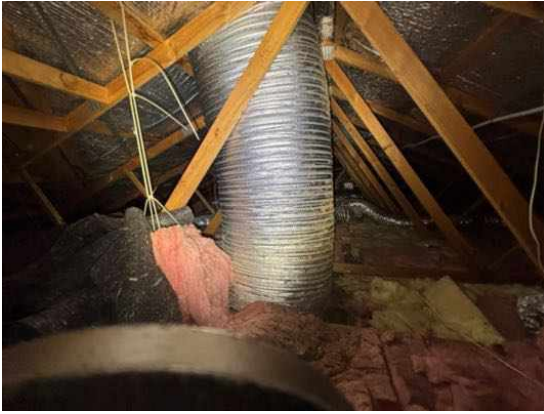
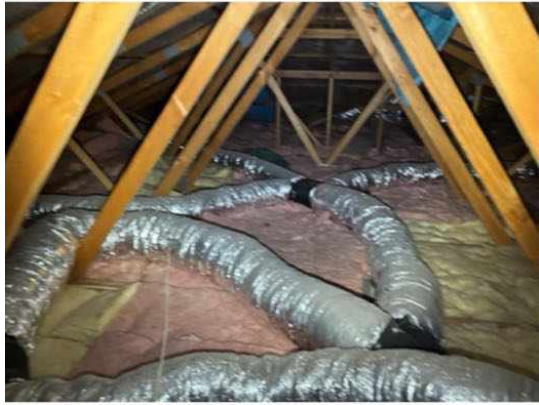
Building: Main Building  
Location: Roof Void  
Finding: Additional Photos - Obstructions and Limitations  
Information: These photographs are an indication of the obstructions and limitations which impeded full inspection of the property at the time of inspection. These obstructions can hide an array of defects and should be removed to allow full inspection to be carried out. A re-inspection is recommended once the areas are made accessible.

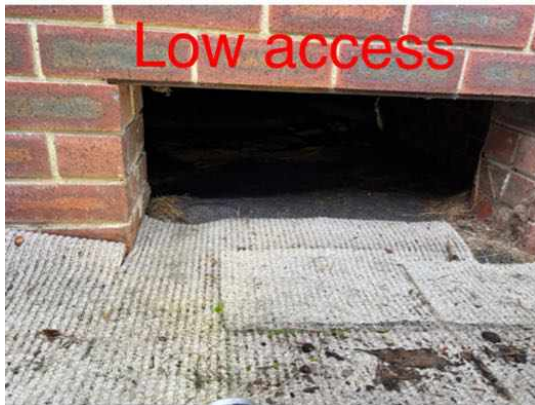
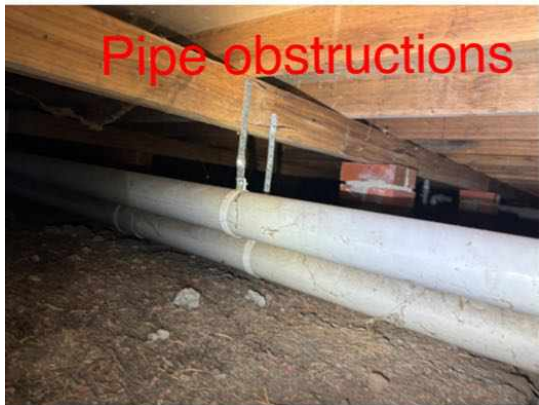
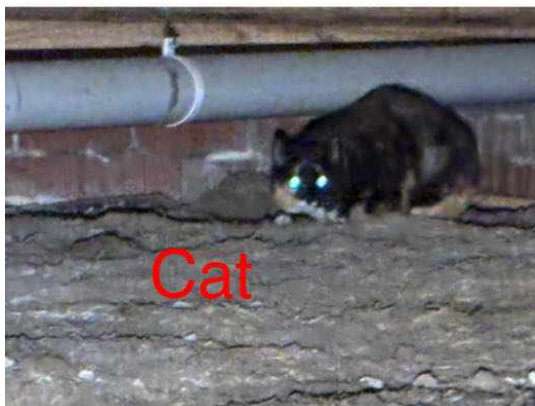
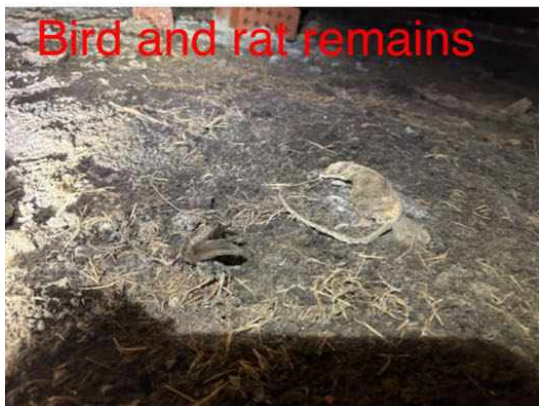
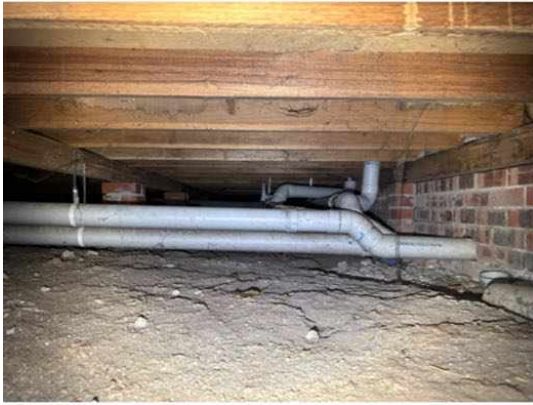
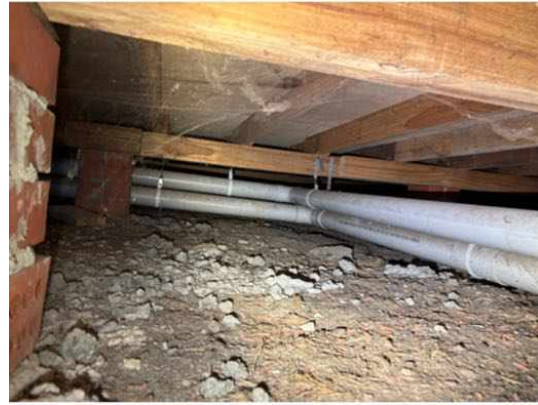
Finding: Additional Photos - Obstructions and Limitations

Information: These photographs are an indication of the obstructions and limitations which impeded full inspection of the property at the time of inspection. These obstructions can hide an array of defects and should be removed to allow full inspection to be carried out. A re-inspection is recommended once the areas are made accessible.

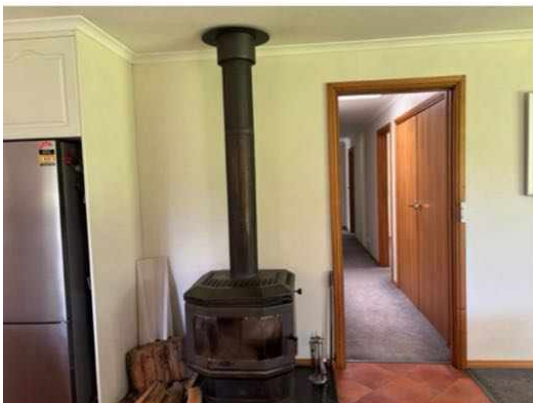
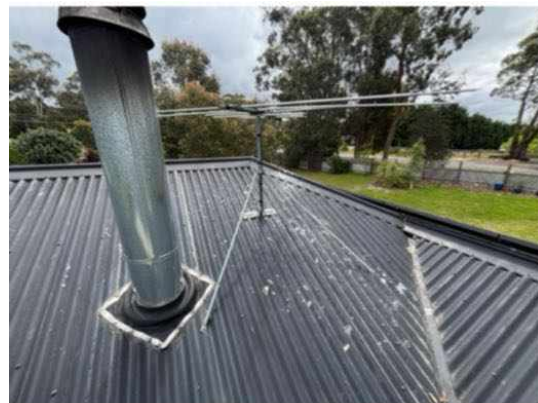
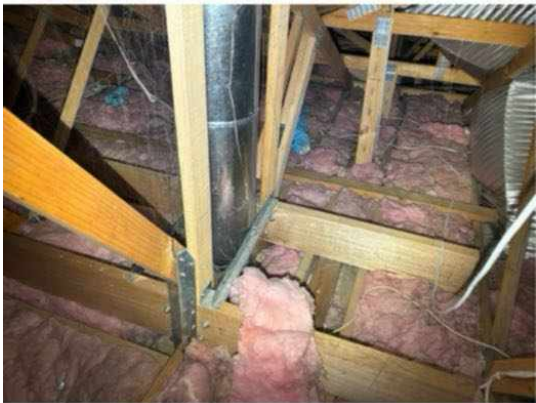
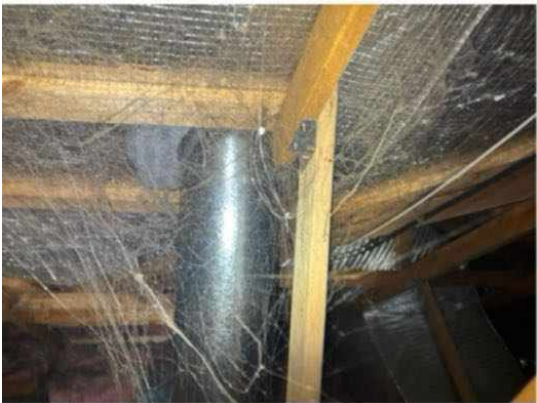
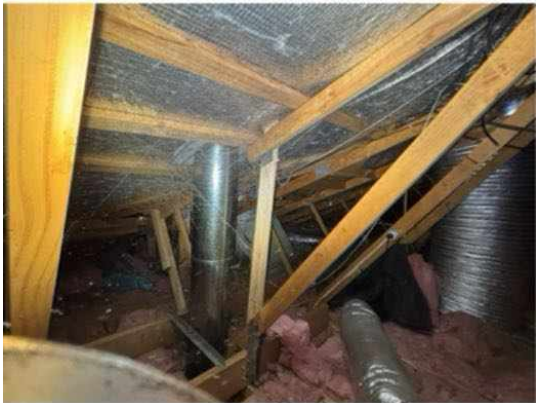
Information: FYI in the living room there is a wood heater fitted. Inspection of the wood heater is outside the scope of this report. Recommend that the client engage a Wood Heater and Flue Specialist to check the condition of the fire box and flue, to ensure safety before the wood heater is used. Faulty wood heaters and flues can cause health and fire risks.

Additionally, there were some cracks to the wood heater hearth tiles (unfortunately the photo didn't come out).

Also there were some modifications to the roof trusses where the flue exited. These look substantial.

Recommend Client monitor for signs of deflection (slump). If there is any increase recommend Client engage a Lic Builder to investigate and rectify as soon as possible.

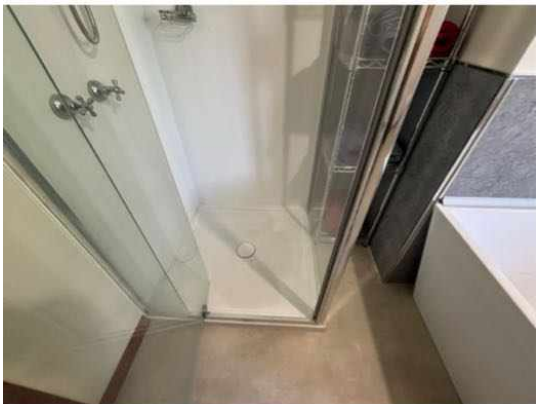
Building: Main Building  
Location: Bathroom  
Finding: FYI bathroom shower tray  
Information: FYI the shower tray in the bathroom is pitted and scratched and had a fine coating. It almost appears like crystallization of salts. Possibly the tray has become porous and this may be contributing to water damage in the subfloor. Or maybe residue from a cleaning product.

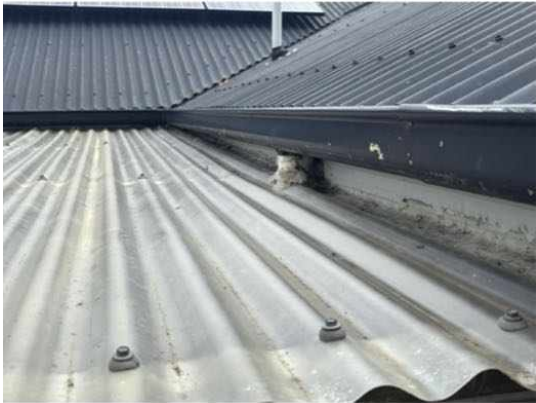
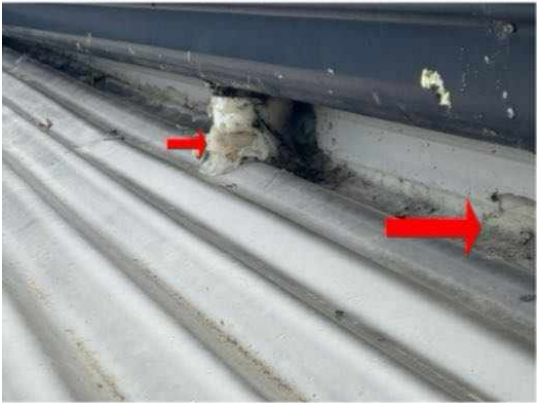
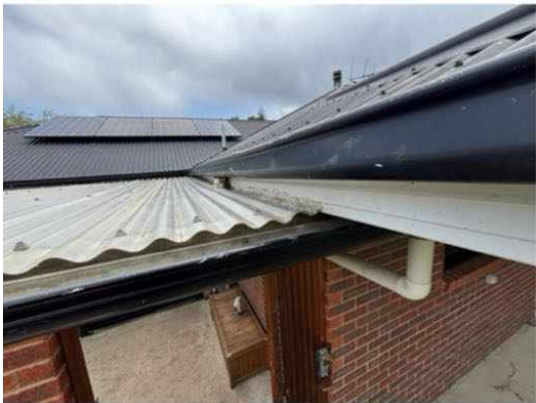
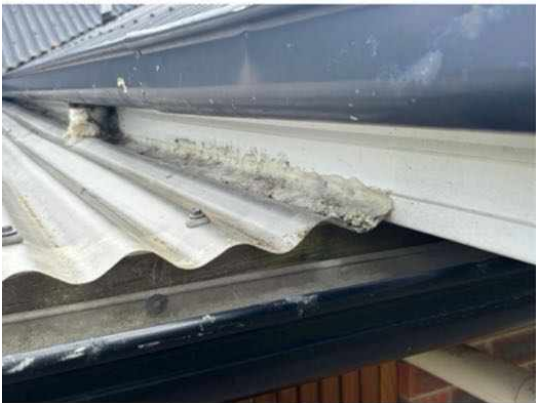
Building: Main Building  
Location: BBQ area  
Finding: BBQ area roof - unorthodox  
Information: FYI there have been some poor repairs to the bbq area roof. There is no flashing where this roof meets the fascia. This will make it more prone to leaking, but is an "outdoor area" and some water may get in.
