Building and Timber Pest Inspection Report

Inspection Date: Fri, 6 Mar 2026

Property Address: 18 Fingal Ave, Glenhaven NSW 2156,
Australia

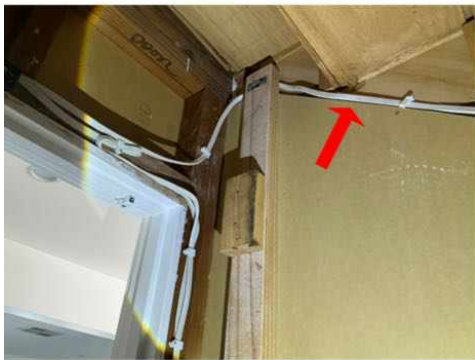
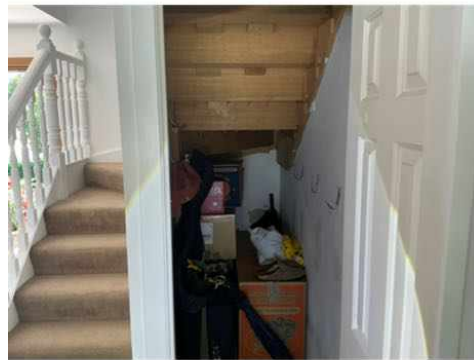
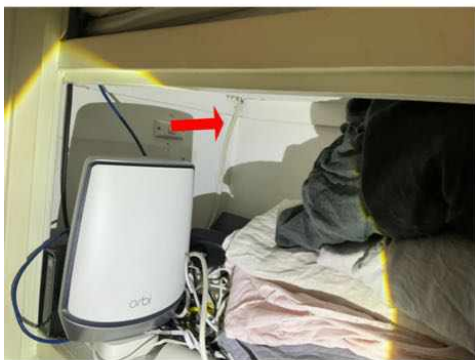
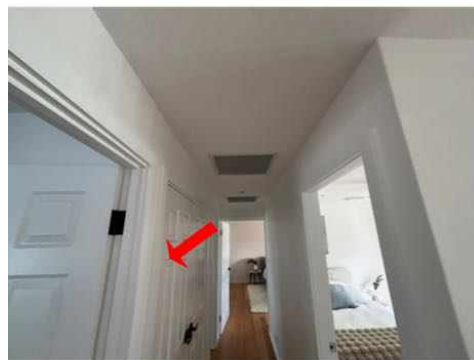
Finding 1.01

Building:	Main Building
Location:	Under Stairs Storage, Upstairs Hallway Closet
Finding:	Electrical Wires - Exposed
Information:	During the inspection, exposed electrical wires were noted. This condition poses a significant safety hazard, as it increases the risk of electrical shock, short circuits, and potential fire. It is imperative that a qualified electrician addresses this issue immediately by properly insulating the exposed wires and ensuring all electrical connections comply with safety standards. Prompt action will mitigate the risks associated with exposed wiring and maintain the safety and integrity of the property's electrical system.

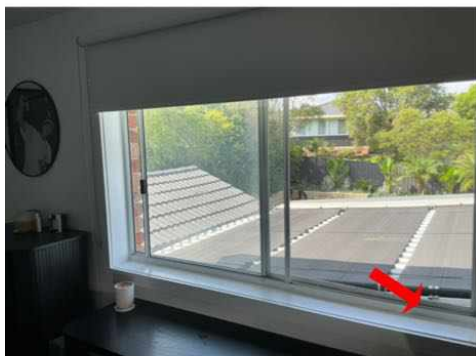
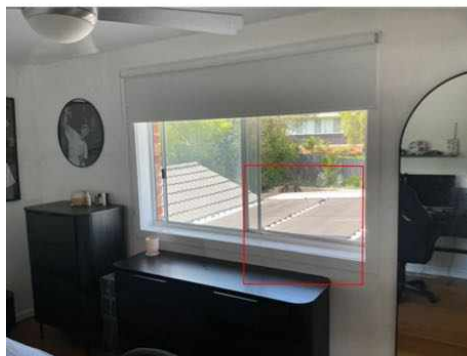
Finding 1.02

Building:	Main Building
Location:	Back Left Bedroom
Finding:	Window Restrictors - Recommended

Information: Upstairs windows did not have window restrictors installed. Although not a requirement at the time of construction, it is advisable to install window opening restrictors on all second storey windows with sill heights below 1.7 meter and potential fall of 2 meters or more.

If you live in a strata scheme, window safety devices must be installed on all applicable windows by 13 March 2018. Residents with safety devices installed can still fully open their windows but it's recommended that devices be engaged whenever children are present, to prevent falls.

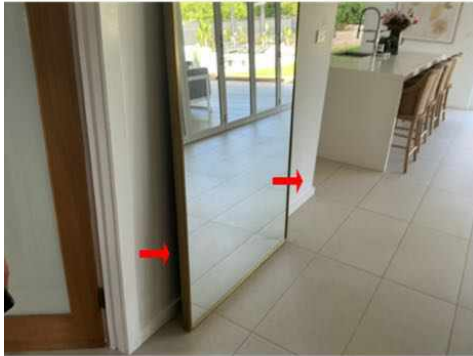
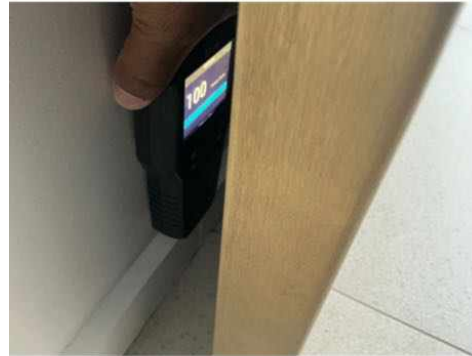
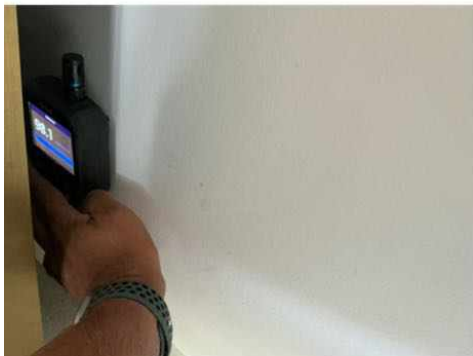
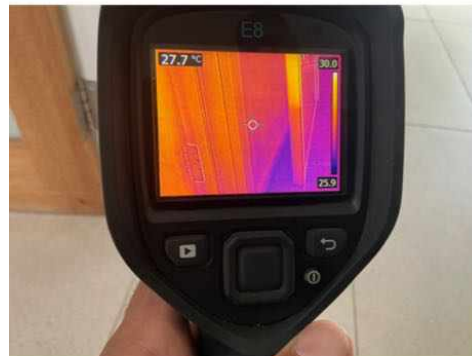
Finding 2.01

Finding: Excessive Moisture on Walls (Adjacent Bathroom)

Information: A major defect was identified during the inspection, with evidence of moisture penetration noted on the walls adjoining the bathroom and shower area. The presence of moisture raises serious concerns about the integrity of the waterproofing system, which is a critical component in preventing water ingress into adjoining structures.

The moisture penetration is likely due to a failure or inadequacy in the waterproofing membrane beneath the tiled surfaces in the bathroom and shower area. Waterproofing systems are designed to act as a barrier, and any breach can result in water escaping into adjacent walls. This could also be exacerbated by inadequate sealing around fixtures, joints, or tiles, which are common entry points for water. Additionally, the defect may be attributed to substandard installation practices or the natural wear and tear of waterproofing materials over time, both of which can compromise the membrane's effectiveness.

moisture can weaken the structural integrity of the walls, resulting in costly repairs or replacement. Damp conditions also create an ideal environment for mould growth, which poses health risks and further compromises the interior condition of the property. Moreover, unresolved waterproofing issues can adversely impact the property's value and marketability.

The client is advised to use services of a professional waterproofing specialist as soon as possible.

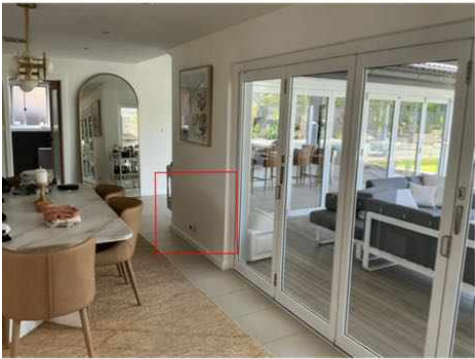
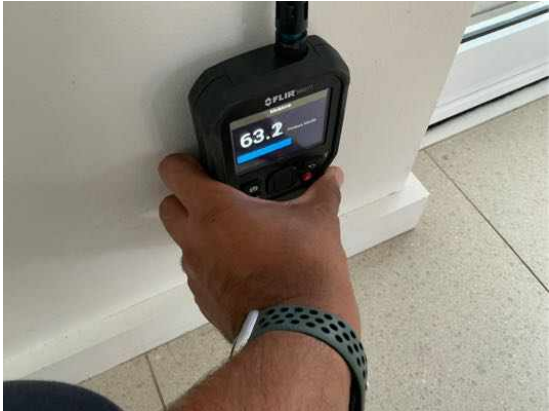
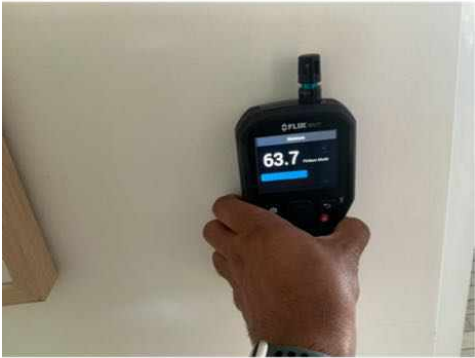
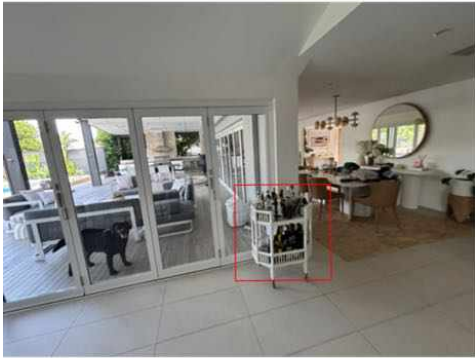
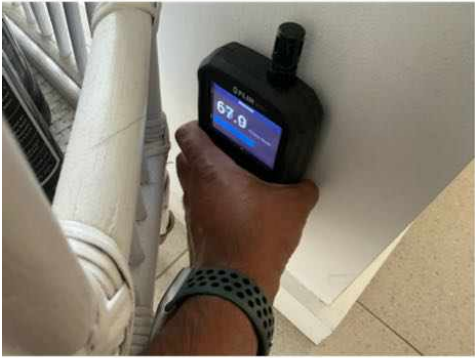
Finding 3.01

Information: At the time of inspection, rising damp was identified within the property. This condition results from the upward movement of moisture through porous building materials, such as bricks, sandstone, or mortar, via capillary action. A damp-proof course (DPC), an impermeable barrier installed at the base of walls above ground level during construction, is typically used to prevent rising damp. However, the absence, deterioration, or bridging of the DPC can compromise its effectiveness, specially in

older buildings, leading to moisture ingress. Inadequate site drainage, which allows water to accumulate around the foundation, is a common contributing factor to this issue.

No further action is required but current condition should be monitored over a 12-month period to assess its progression.

It is recommended that the client engage a qualified damp-proofing specialist for remedial actions.

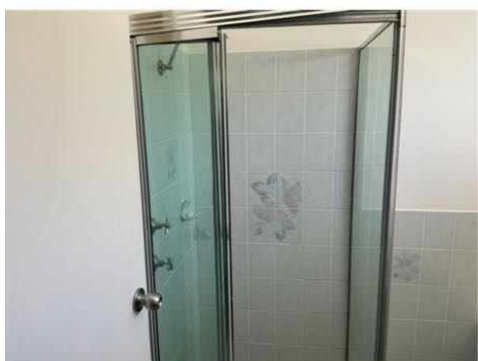
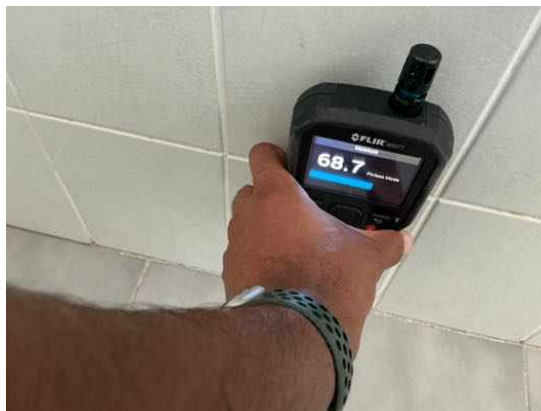
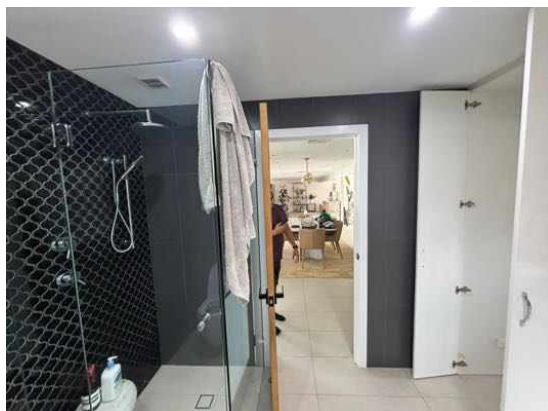
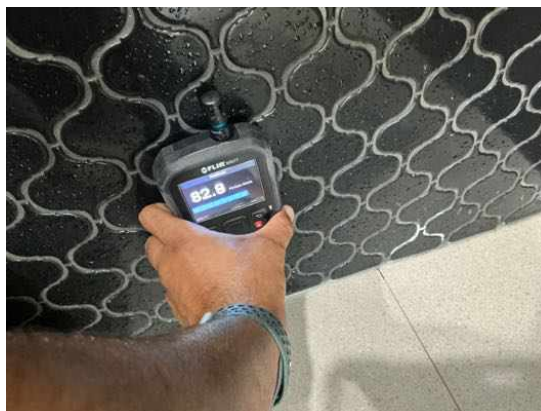
Finding 3.02

Location: Both Bathrooms
 Finding: Excessive Moisture - Shower Damp
 Information: At the time of inspection, excessive moisture was noted within the shower area, which is a common issue in wet areas due to the continual exposure to water. This condition is typically caused by moisture seeping through grout lines and settling behind tiles, resulting in localised high-moisture zones. Provided there is no evidence of water staining or elevated moisture readings on the opposite side of the wall, this is considered a minor defect.

However, persistently damp conditions may act as conducive conditions for termite activity, as termites are strongly attracted to moisture-rich environments. It is recommended that the client ensures regular use of the exhaust fan and maintains adequate ventilation after shower use to promote drying and reduce long-term moisture build-up, thereby also reducing the risk of attracting termites.

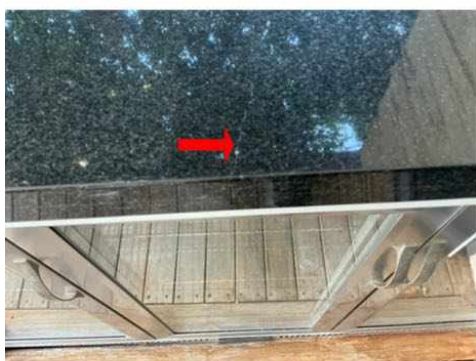
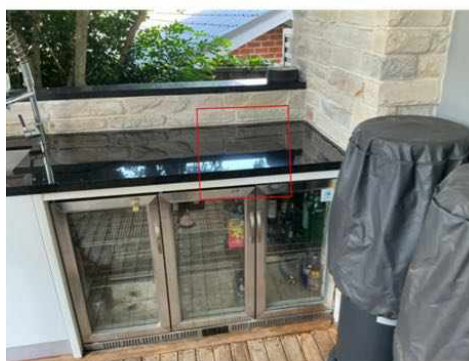
Finding 3.03

Building: Main Building
 Location: Alfresco
 Finding: Benchtop - Damaged
 Information: It was noted at the time of inspection, the benchtop exhibits visible cracks, which compromise both its aesthetic appeal and structural integrity.

The cracks extend across the surface, indicating potential underlying issues such as inadequate support, improper installation, or natural wear and tear over time. These defects not only detract from the overall appearance of the kitchen but also pose practical concerns, such as the accumulation of dirt and bacteria in the fissures, making cleaning difficult and potentially leading to hygiene issues. Additionally, the integrity of the benchtop may be further compromised with continued use, potentially resulting in further damage. Immediate attention and repairs are recommended to restore both the functionality and visual appeal of the kitchen benchtop.

The client is advised to hire bench top specialist to replace or fix the issue.

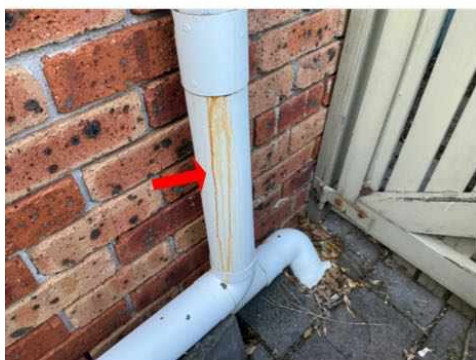
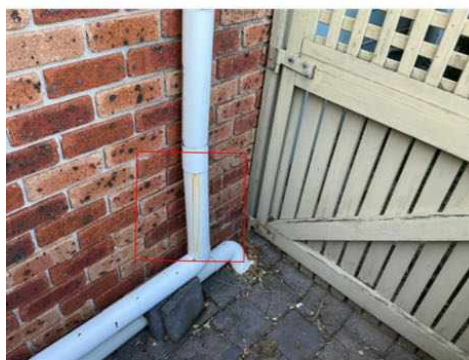
Finding 3.04

Building: Main Building
 Location: Yard - Right Side
 Finding: Previous Water Leak – Monitor
 Information: At the time of inspection, signs of a previous water leak were observed in this area. The area appeared dry at the time of inspection, and no active leakage was detected.

It is recommended that the client monitor the area over time for any signs of recurring moisture, such as dampness, staining, or deterioration. If further leakage or moisture is observed, a licensed plumber or appropriate specialist should be engaged.

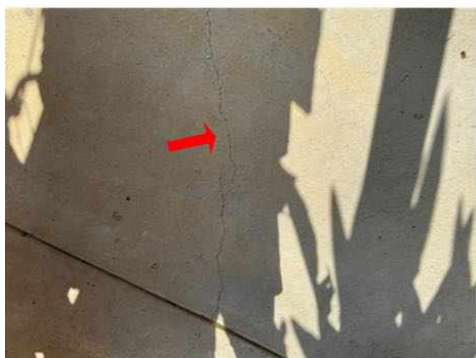
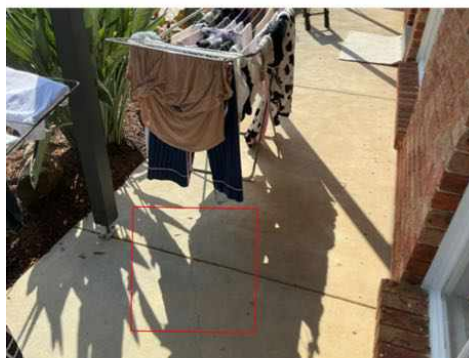
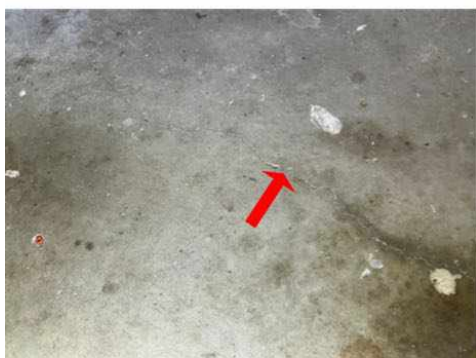
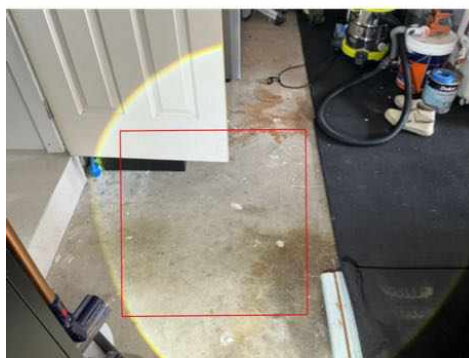
Finding 3.05

Building: Main Building
 Location: Garage, Verandah
 Finding: Crack in concrete slab - Category 2
 Information: A crack coded as Category 2 was identified in the slab. A Category 2 crack is described as a distinct crack, with the slab being noticeably curved or changed in level.

To be considered Category 2, the approximate width of the crack is less than 2.0mm, or a change in offset of less than 15mm when a 3m straight edge is placed over the defect.

Category 2 cracks to slabs should be monitored for a period of 12 months. At the end of the monitoring period, cracks rated greater than Category 2 are considered defects that require rectification.

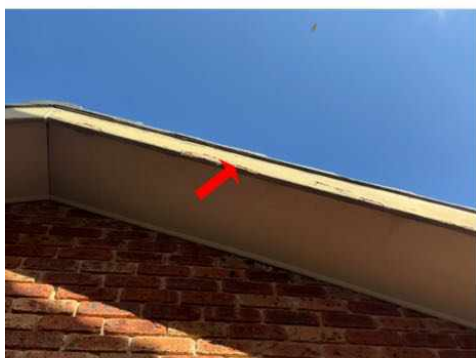
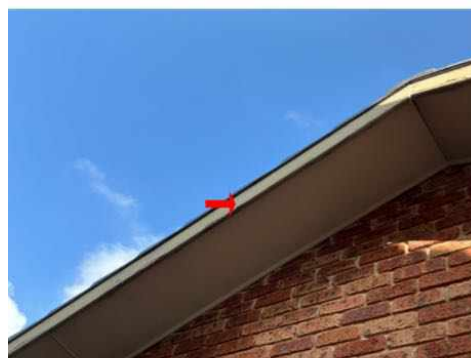
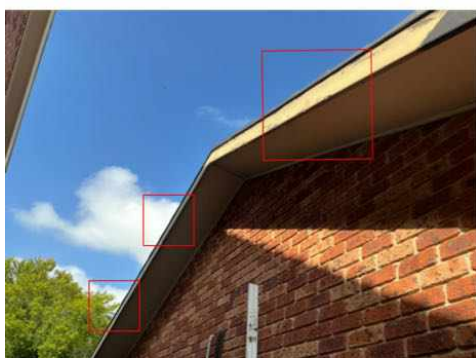
Finding 3.06

Building: Main Building
 Location: Fascia
 Finding: Peeling Paint - Exterior
 Information: At the time of inspection, peeling and deteriorated paint was noted to the fascia

boards along the roofline. Peeling paint can expose the underlying timber to weather elements, which may lead to premature deterioration or moisture penetration over time.

It is recommended that the affected areas be prepared and repainted to protect the timber and maintain the condition of the fascia. A qualified painter or maintenance contractor should be engaged to carry out the necessary surface preparation and repainting.

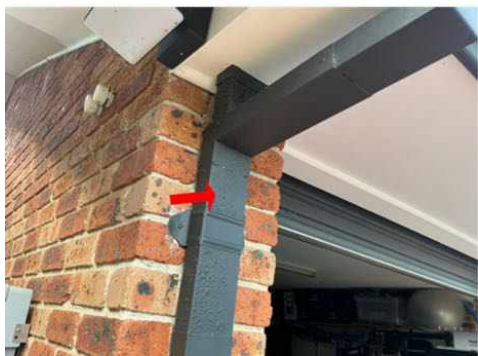
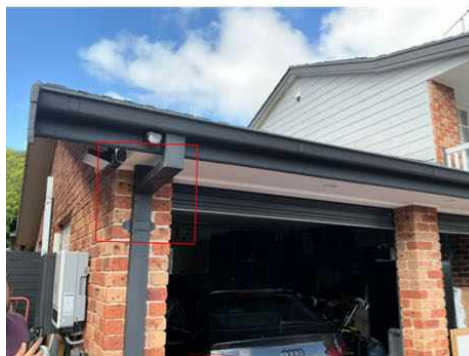
Finding 3.07

Building:	Main Building
Location:	Exterior walls - front
Finding:	Painted Over / Previously Deteriorated Downpipe
Information:	At the time of inspection, the downpipe appeared to have been previously rusted or deteriorated and subsequently painted over. Painting over corroded metal can conceal underlying deterioration rather than rectifying the issue.

Where corrosion has already occurred, the metal may have thinned or weakened. This can make the downpipe more prone to further rusting, deterioration, and potential leakage over time, particularly during periods of heavy rainfall. Painted surfaces can also trap moisture against the metal if the corrosion was not properly treated prior to painting, which may accelerate future deterioration.

It is recommended that the downpipe be monitored for signs of further corrosion or leakage. If deterioration becomes evident, the downpipe should be replaced by a licensed plumber to ensure proper stormwater drainage.

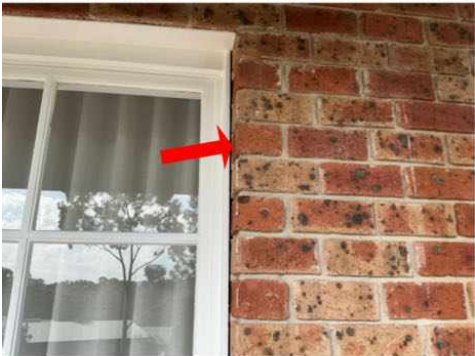
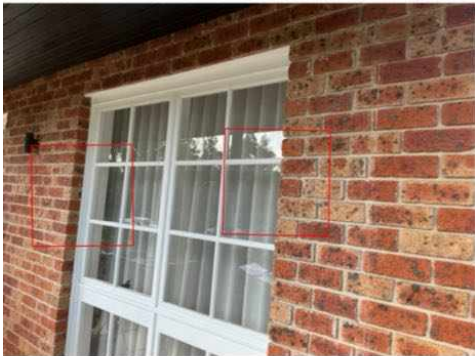
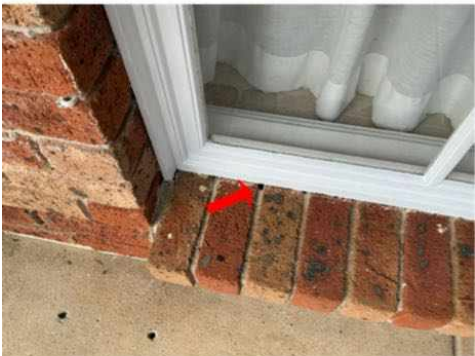
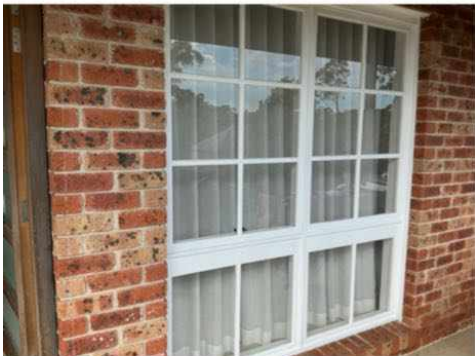
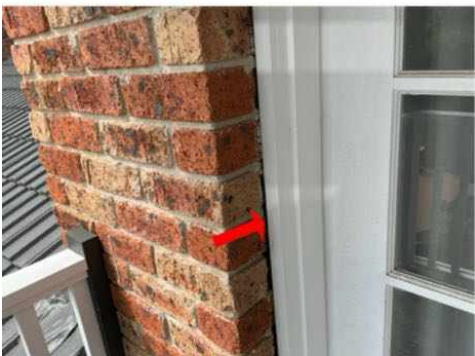
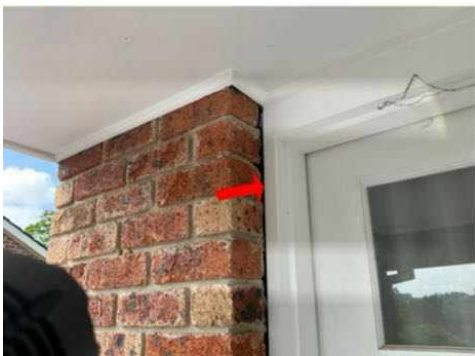
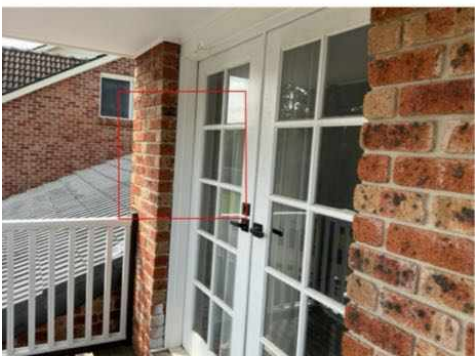
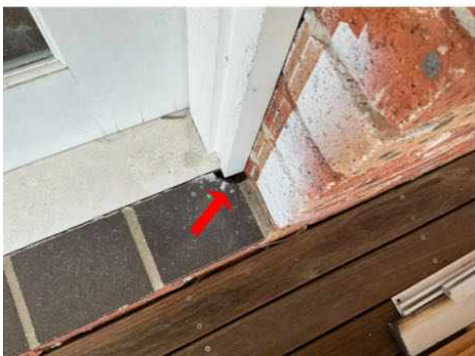
Building:	Main Building
Location:	All Areas
Finding:	Gaps - Exterior Windows
Information:	Gaps were observed along the sides of the window frame at the time of inspection, which could lead to several issues if left unaddressed.

These unsealed gaps may compromise the weatherproofing and energy efficiency of the property, allowing drafts and moisture ingress that could result in higher energy costs due to heat loss and reduced insulation. Additionally, moisture entering through these gaps can cause water damage, mould growth, or deterioration of the surrounding building materials over time.

The gaps could be attributed to several potential causes. Structural movement or settling of the building, due to foundation shifts or soil subsidence, may have caused the window frame to separate from the surrounding brickwork. Improper installation is another possibility, where the window may have been incorrectly fitted or the materials used were not adequate, leading to misalignment over time. Alternatively, the gaps may be a result of shrinkage or degradation of the original sealant, which can occur due to exposure to weather elements.

It is recommended that these gaps be professionally sealed with a high-quality weatherproof sealant to restore proper insulation, prevent moisture ingress, and maintain the overall integrity of the window installation. Additionally, a sealant or window professional should be consulted to fix the issue.

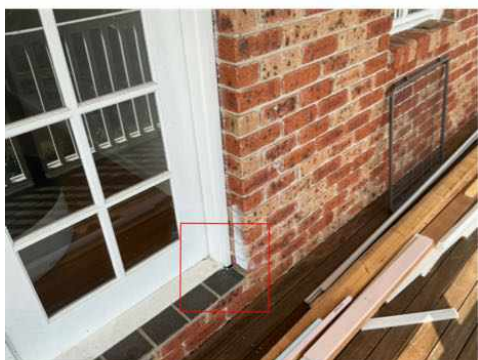
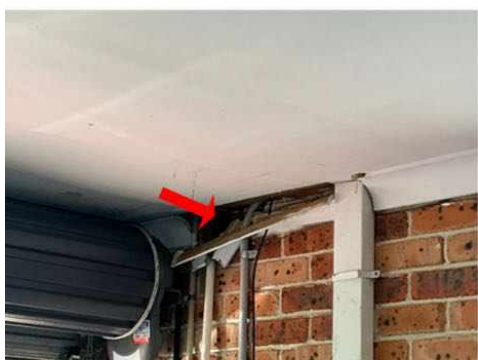
Finding 3.09

Building:	Main Building
Location:	Garage
Finding:	Damaged Cornice – Roof Space Exposed
Information:	At the time of inspection, damage to the cornice was noted in the garage area, which has resulted in a gap exposing the roof space above. This type of damage can allow dust, pests, and moisture to enter the ceiling cavity and may also indicate previous impact or deterioration of the cornice material.

It is recommended that a qualified plasterer or handyman be engaged to repair or replace the damaged section of cornice and properly seal the opening to restore the ceiling finish and prevent potential pest or debris entry into the roof space.

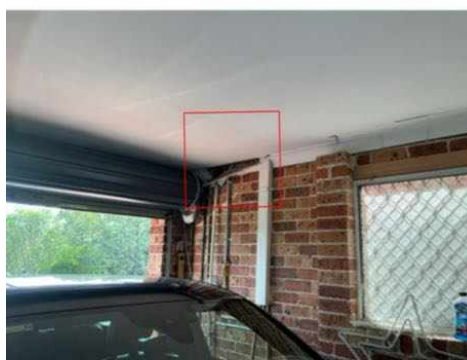
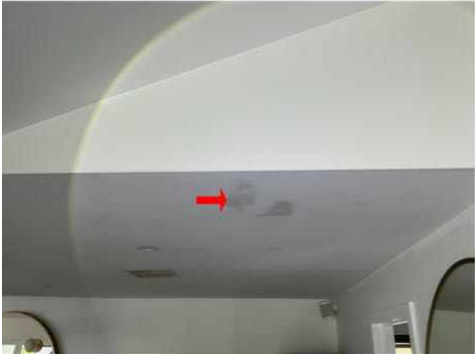
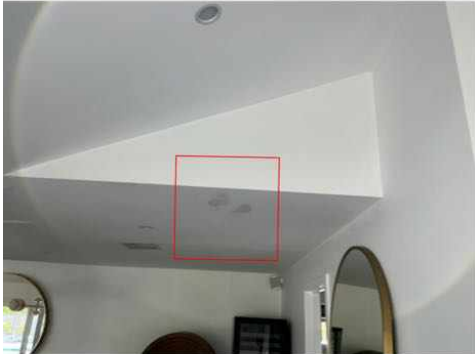
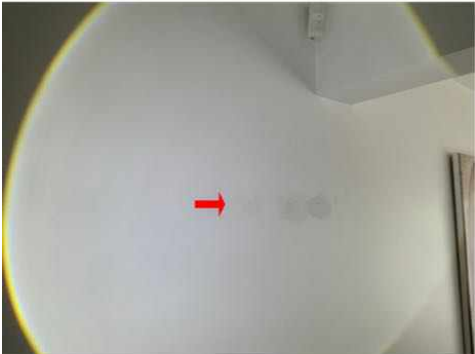
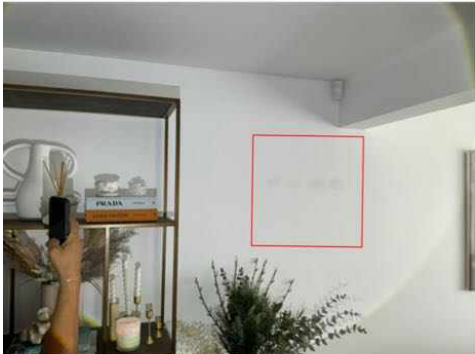
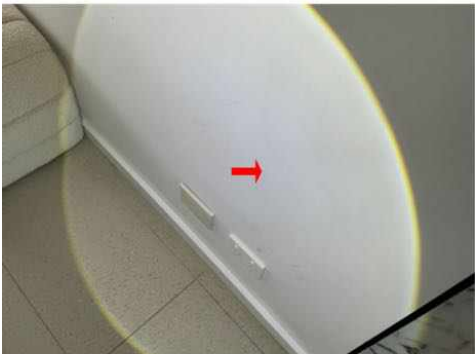
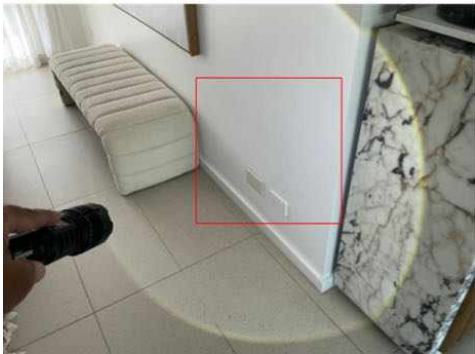
Finding 3.10

Building:	Main Building
Location:	All Areas
Finding:	Maintenance and/or Wear and tear on building elements
Information:	It was observed at the time of inspection that some building elements and areas around the property require general maintenance and/or exhibit signs of wear and tear. These typically include minor imperfections such as paint scuff marks, scratches on surfaces, small chips, nails or hooks left in walls from previous picture hanging, and

other superficial blemishes.

These are generally considered minor items that are common in established homes. While they may be noticeable on visual inspection, they do not affect the structural integrity or functionality of the property. In most cases, these issues can be easily addressed by a qualified handyman as part of routine maintenance.

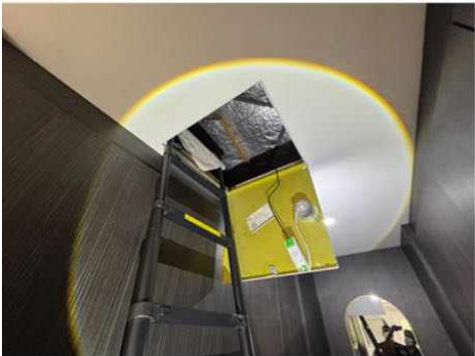
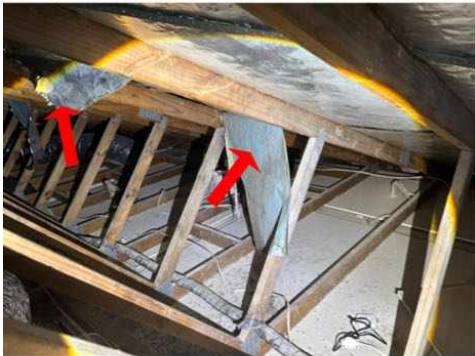
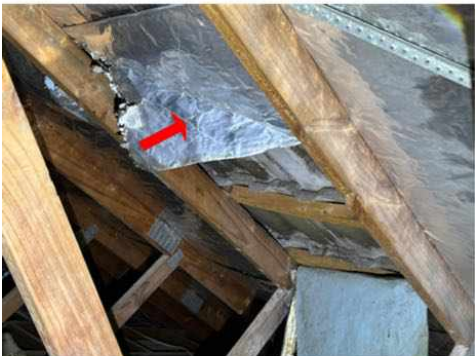
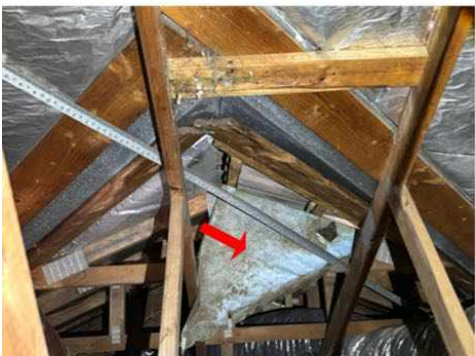
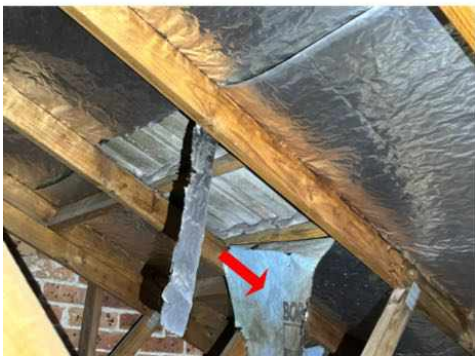
Finding 3.20

Building:	Main Building
Location:	Roof Void
Finding:	Sarking - Damaged
Information:	Sarking, a laminated aluminium foil applied to the interior of the roof covering, assists in insulating the property and acting as a vapour-barrier to the roof void and, subsequently, to the household.

Where sarking is damaged, both insulation and moisture protection of the property are inhibited. This creates a loss of energy and thus negatively impacts the energy efficiency of the property, allowing potential for moisture ingress from condensation or leaking roof tiles.

It is important to repair any holes or damaged sections of sarking to ensure that the building material is fully functional. A registered roofer should be consulted to provide further advice on this defect and to perform rectification works at client discretion.

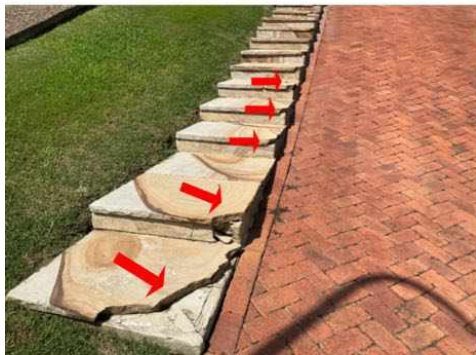
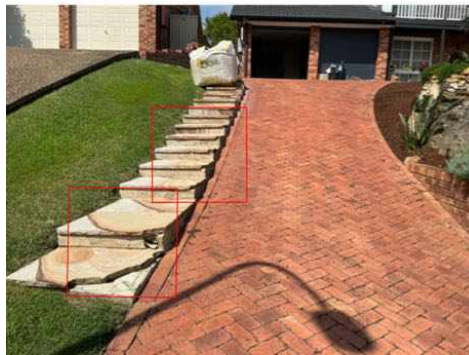
Finding 3.21

Building: Main Building
Location: Near Driveway
Finding: Damaged External Steps
Information:

At the time of inspection, damage and deterioration were noted to the external stone steps located alongside the driveway. Several of the stone treads were cracked, displaced, or broken, and sections of the supporting structure appeared deteriorated. The damaged condition of the steps may present a potential trip hazard and may worsen over time due to weather exposure and regular use.

It is recommended that a qualified landscaping contractor or stonemason be engaged to assess the condition of the steps and replace the damaged sections as required to

restore safe and stable access.

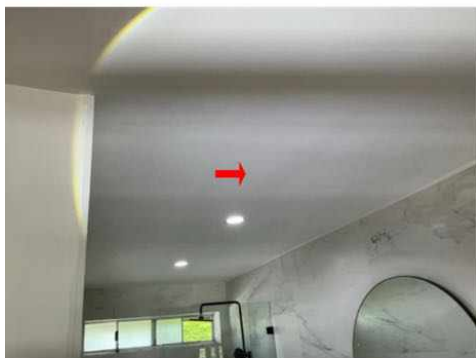
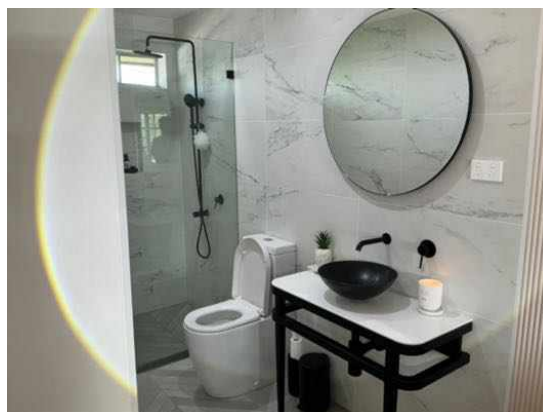
Finding 3.22

Building:	Main Building
Location:	Ensuite - Master
Finding:	Exhaust Fan Missing - Bathroom
Information:	At the time of inspection, an exhaust fan was found to be missing in the bathroom.

Adequate ventilation is essential in wet areas to prevent moisture build-up, which can lead to mould growth, dampness, and potential damage to fixtures and finishes.

It is recommended that a licensed electrician be engaged to install a compliant exhaust fan to improve air circulation and maintain healthy indoor air quality.

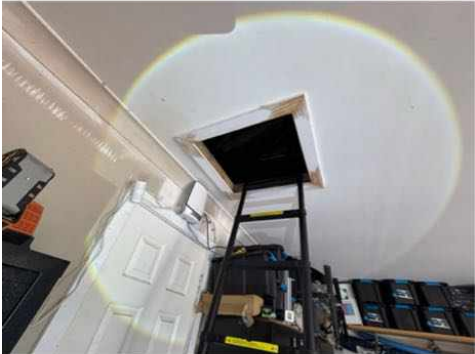
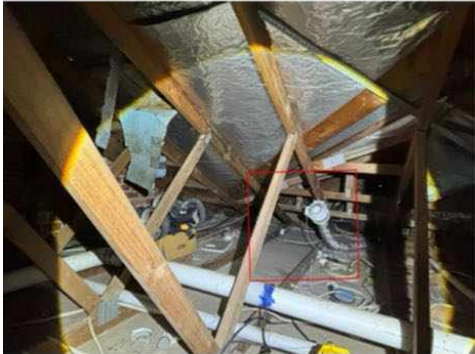
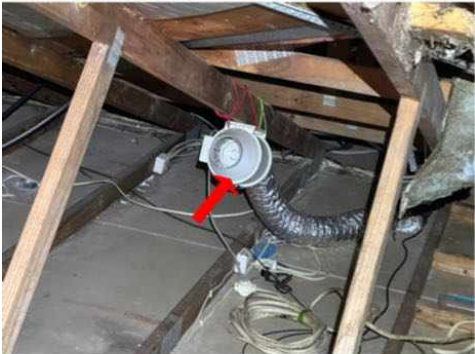
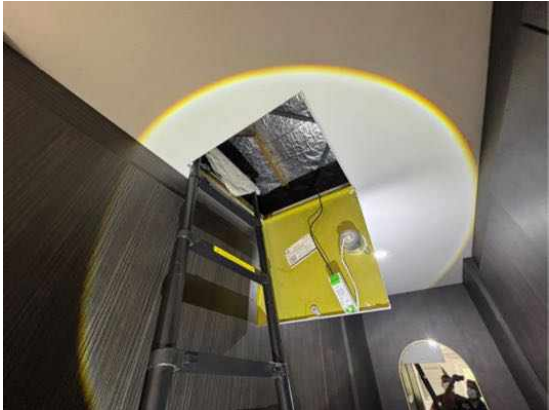
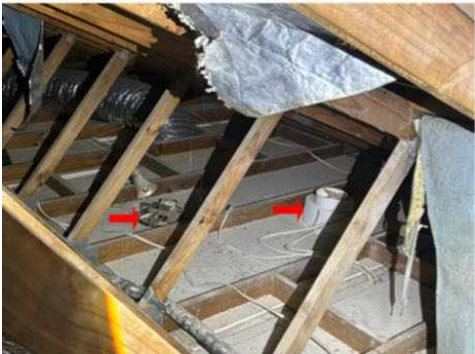
Finding 3.23

Building:	Main Building
Location:	Both Roof Voids
Finding:	Vent - Extracted into Roof Space
Information:	During the inspection, it was noted that the exhaust vent has been improperly terminated into the roof space instead of being ducted to the exterior of the property.

This configuration is a defect as it allows moist air to accumulate within the roof cavity, increasing the risk of condensation, mould growth, and deterioration of insulation or timber framing. Proper ventilation is essential to maintain a healthy indoor environment and protect the structural integrity of the building. It is recommended that the vent be appropriately re-routed to discharge externally in compliance with relevant building standards.

A licensed mechanical ventilation contractor/electrician should be appointed as soon as possible to provide further consultation on the scope of these works and to provide quotations for any necessary works.

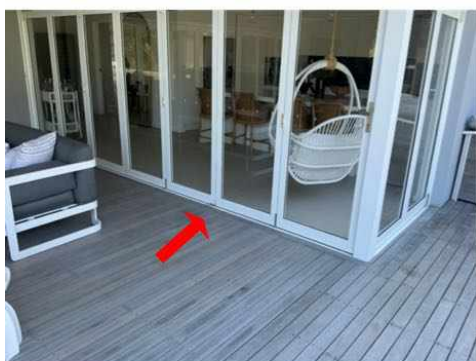
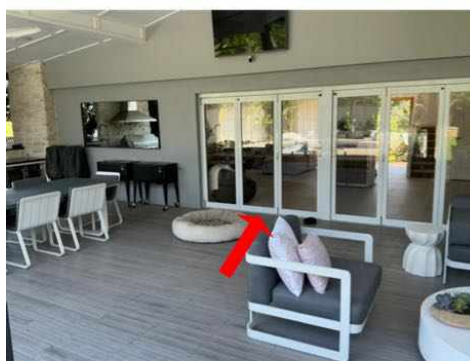
Finding 6.02

Building: Main Building
Location: Yard - Back
Finding: Bridging or Breaching of Termite Barriers - Adjacent Internal Flooring
Information: Bridging is the spanning of a termite barrier or inspection zone so that subterranean termites are provided with passage over or around that barrier.

It is important for internal flooring to be raised above adjacent external ground levels. Where external ground levels are above or same level as internal flooring, water pooling and subsequent internal flooding is likely to occur which may attract termite activity to the internal area.

It is highly advised that a landscaper or relevant tradesperson be appointed to lower external grounds that are raised above or same as adjacent internal flooring. Alternatively if external grounds and internal flooring is level installation of a raised door sill may be appropriate in preventing any water pooling in the area. If the client wishes not to make any changes, then a qualified pest controller is recommended for termite treatment around the perimeter of the house and subfloor (if any) as soon as possible.

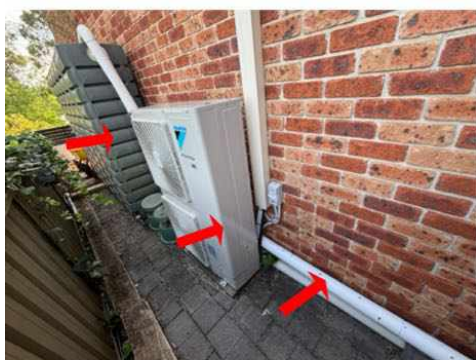
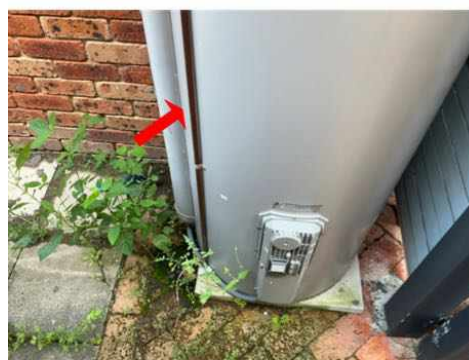
Finding 6.03

Building:	Main Building
Location:	Exterior walls - right side
Finding:	Bridging Appliances/Water Tanks - Attachment to Buildings
Information:	Bridging occurs when items against a building provide a concealed entry point for termites into the building or by passing around a termite management system.

Where any part of an attachment to a building is not isolated and is not provided with a clear gap of not less than 25mm from the building, bridging occurs. Attachments to buildings such as hot water services, downpipes, verandahs, decks, steps, fences, service conduits and the like provide the opportunity for concealed entry.

Building attachments of this nature need to be frequently inspected for termite activity by a qualified inspector.

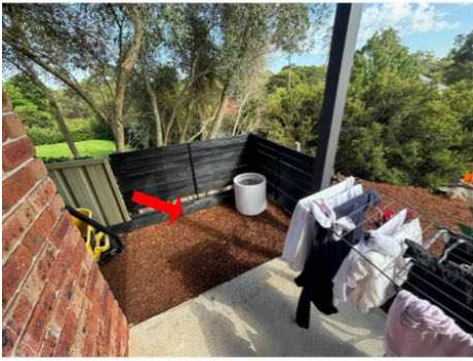
Finding 6.04

Building:	Yard
Location:	Yard - Front
Finding:	Building Materials in Direct Ground Contact - Conducive to Termites
Information:	Timber elements that are in direct contact with the ground and exposed to moisture or damp conditions are highly conducive to termite activity. This susceptibility arises

because timber, when in contact with soil and dampness, creates an environment that is particularly attractive to termites, encouraging infestation and potential structural compromise. Whether the timber is used as a part of the building's construction or incorporated into fencing, its presence near or on the ground can become a pathway for termites to access and damage the property.

When exposed to excessive moisture, timber begins to deteriorate, developing conditions such as wood decay and rot. These compromised areas of timber are even more appealing to termites, as they are easier to infest and consume. This is especially true for untreated or non-durable timber, which lacks the protective treatments that can deter or withstand termite attacks. Termites can use these weakened, moisture-laden elements as a bridge into other parts of the structure, creating an entry point for potential infestations that can spread and cause extensive damage if left unchecked.

For any timber in direct contact with the external ground, special attention is required. The combination of moisture, untreated wood, and direct ground contact not only accelerates the decay process but also provides subterranean termites with a straightforward means of ingress into the structure. This entry can lead to termites moving undetected into other vulnerable areas, resulting in potentially significant structural issues and costly repairs.

To mitigate the risk of termite activity, it is imperative that any such materials or timber elements be appropriately treated or removed as soon as possible. Timbers that are necessary for use should be made durable through appropriate treatments and maintained to ensure they do not create conditions conducive to termites. Additionally, the client is advised to schedule regular termite treatments to maintain an effective barrier against infestations and ensure ongoing protection.

The client is strongly advised to assess the property for any timber elements that may be in direct contact with the ground and ensure prompt action is taken to remove or treat them effectively. Regular inspections, proactive maintenance, and consistent termite treatment are essential steps in minimising the risk of termite attack and protecting the structural integrity of the property. Taking these preventive measures is crucial for maintaining a termite-free environment and avoiding potentially costly damage and future repairs.

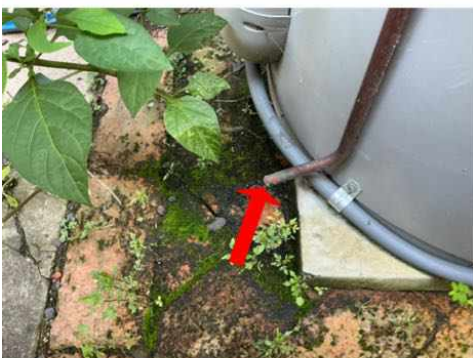
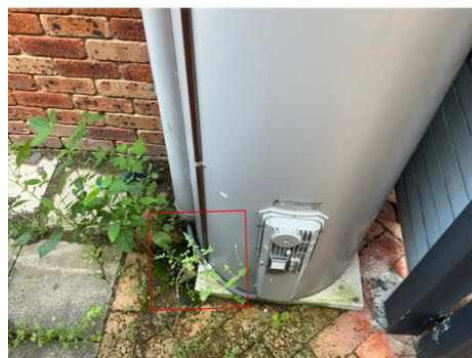
Finding 6.05

Building:	Main Building
Location:	Exterior walls - left side
Finding:	Overflow Disconnected - HWS/AC/Gas - Conducive Conditions to Termites
Information:	The overflow to this service was found to be disconnected from stormwater drainage and is creating excessive moisture in the surrounding area.

Such leaking creates an environment that is conducive to an array of defects, including water damage to associated building elements and the attraction of termite or timber pest infestation. These damp conditions can lead to secondary defects such as rot, rust, or corrosion of associated building elements, the formation of fungal decay, or even the creation of potential slip hazards. When coupled with poor site drainage, pooling of water may also attract termite activity to this area.

It is highly recommended that a licensed plumber be appointed to connect the overflow in order to prevent such an environment from being created. These minor works should be carried out as soon as possible.

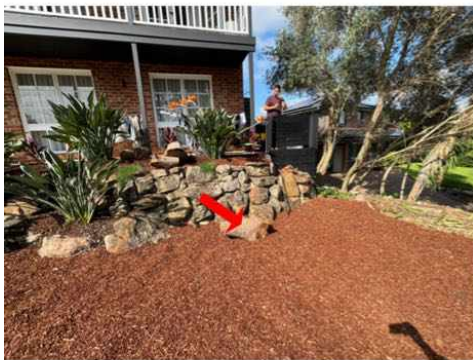
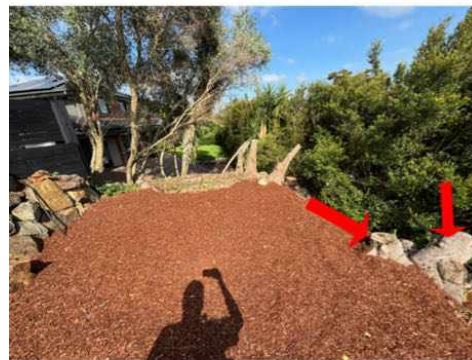
Finding 6.06

Building:	Yard
Location:	Yard - Front

Finding: Tree Stumps - Remove
 Information: Old tree stumps were found around the property.

Any tree stumps in ground contact provide opportunity for concealed termite infestation and are likely to be subject to decay as the soil retains moisture or damp conditions against the tree stump.

All tree stumps should be removed where possible or alternatively be test drilled and treated. Frequent pest inspections are advised to readily identify any termite activity in these areas.

Timber pest management plan should be implemented and 6-12 monthly Timber Pest inspections carried out in accordance with AS4349.3 or AS 3660.2.

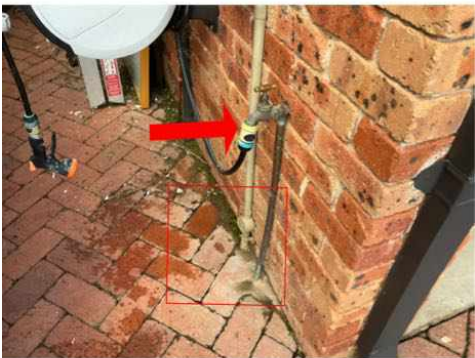
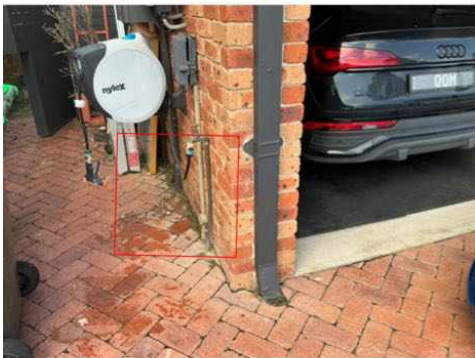
Finding 6.07

Building: Main Building
 Location: Exterior walls - left side
 Finding: No Stormwater Drain - Under Exterior Tap
 Information: The inspection identified that the exterior tap is not connected to a stormwater drainage system, allowing water to pool around the base. This can lead to moisture-related issues such as deterioration of nearby building materials, mould growth, and increased risk of termite activity—each of which may compromise the property's structural integrity and create health or safety concerns.

To prevent these risks, it is strongly recommended that a licensed plumber be engaged to assess the area and install appropriate drainage, such as a stormwater connection or splash block, to redirect water away from the property. Ongoing maintenance and monitoring of external water sources are also advised to ensure long-term protection.

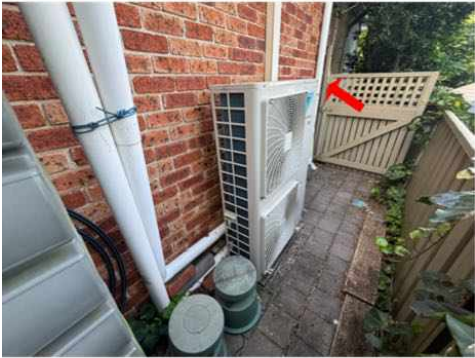
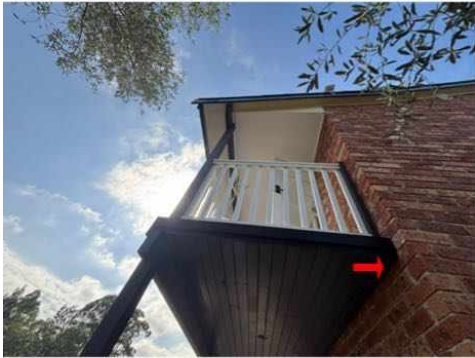
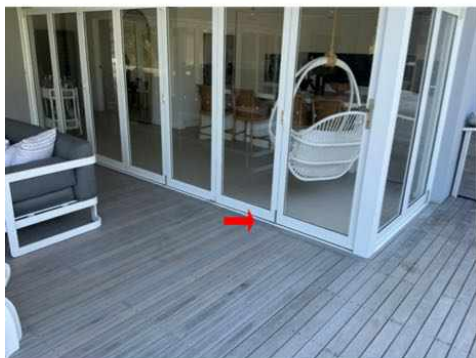
Finding 6.08

Building: Main Building
Location: All Areas
Finding: Timber Directly Attached to Building
Information: At the time of inspection, timber materials were noted to be directly attached to the external wall of the dwelling. This practice is considered a conducive condition for termite activity, as it provides both a potential food source and concealed entry point for termites into the structure.

It is recommended that the timber be removed, isolated, or appropriately treated to reduce the risk of termite infestation. A licensed pest management specialist should be consulted for further assessment and advice in line with AS 3660.2 (Termite Management).

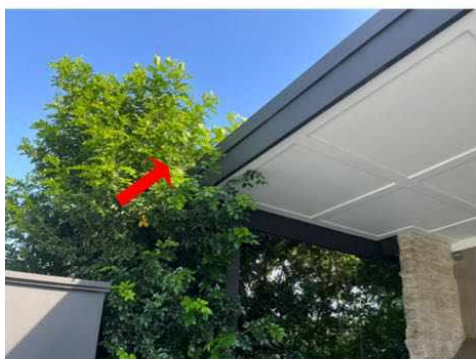
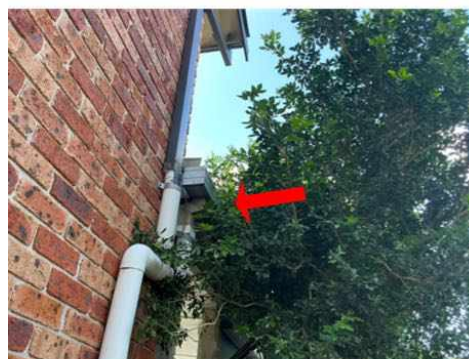
Finding 6.09

Building:	Main Building
Location:	Yard - Side
Finding:	Overhanging Trees/Branches/Roots
Information:	Overhanging trees and exposed roots were noted near the property, which pose potential risks to the structure and surrounding areas.

The overhanging branches can cause damage to the roof, gutters, or walls, particularly during storms or high winds. Additionally, the roots may pose a threat to the foundation by causing ground movement, leading to cracks or uneven settling over time. The accumulation of leaves and debris in gutters and drainage systems can also lead to blockages, contributing to water overflow and potential water damage.

It is recommended that a qualified arborist be engaged to prune back the overhanging branches and assess any potential risks posed by the tree roots to prevent further damage to the property. It is advised to get this fixed as soon as possible. Regular maintenance should be carried out to ensure the trees are managed effectively and the property remains safe.

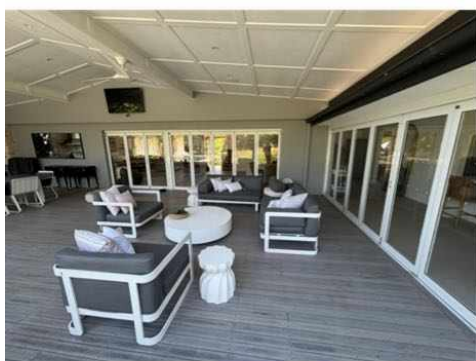
Noted Item

Building: Main Building
Location: All External Areas
Finding: Obstructions and Limitations - External Areas
Information: The attached photographs provide a visual representation of the obstructions and limitations that impeded a full inspection of the external areas of the property at the time of assessment. These obstructions, which may include vegetation, stored items, debris, or other physical barriers, can obscure potential defects and prevent a thorough evaluation of the property's condition. Obstructions of this nature can conceal a wide range of issues, such as structural damage, water ingress, pest infestations, or deteriorating building materials, which may not be visible during the initial inspection.

It is essential that these obstructions be cleared to allow for a comprehensive inspection of the external areas. Removing these barriers will enable a more accurate assessment of the property's condition and allow any hidden defects to be identified and addressed promptly. Failure to do so could result in undetected issues worsening over time, potentially leading to more costly repairs in the future.

Therefore, it is strongly recommended that the obstructions be removed and a re-inspection be scheduled once the affected areas are made fully accessible. This will ensure a complete evaluation of the property's exterior and provide the client with a clear understanding of any potential issues that may have been concealed during the initial inspection.
