Building and Timber Pest Inspection Report

Inspection Date: Fri, 6 Mar 2026

Property Address: 18 Fingal Ave, Glenhaven NSW 2156,
Australia

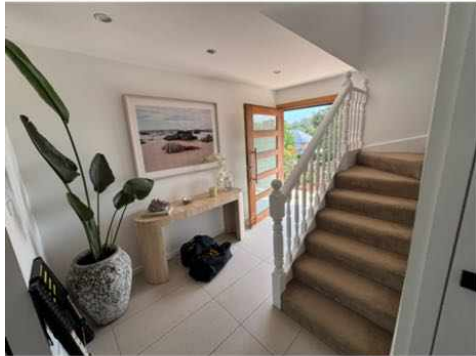
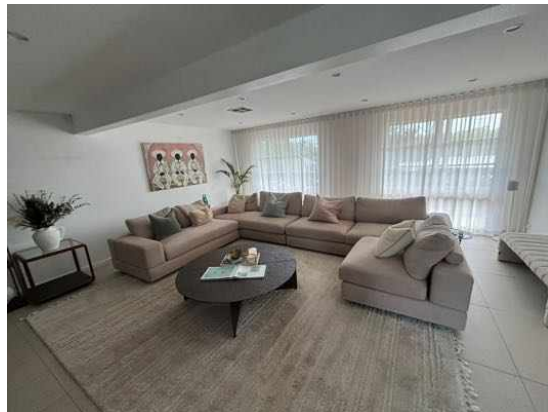
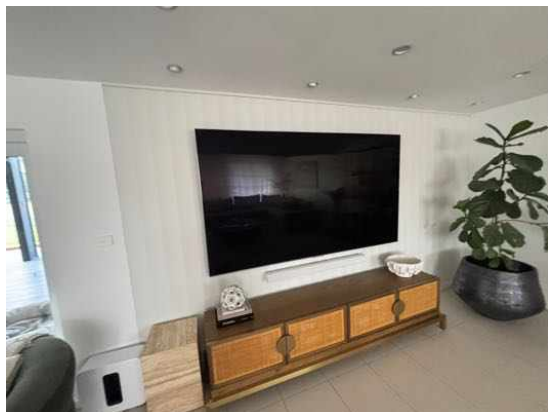
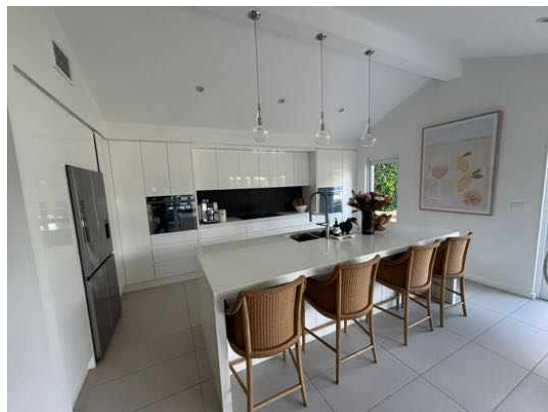
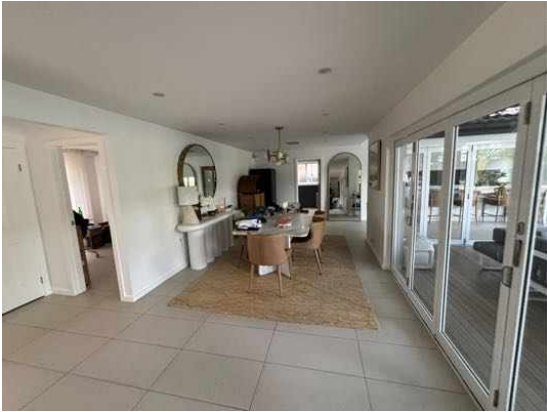
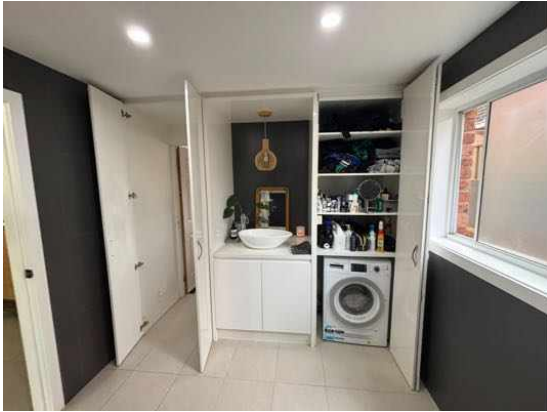
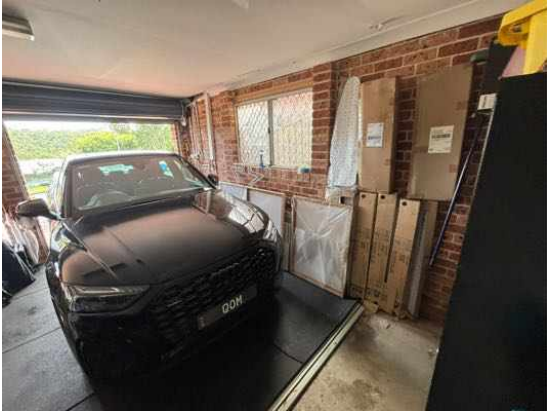
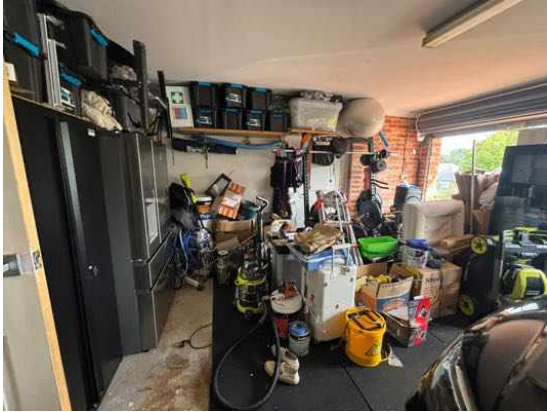
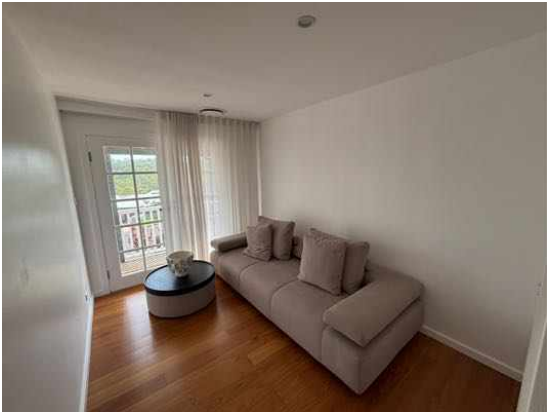
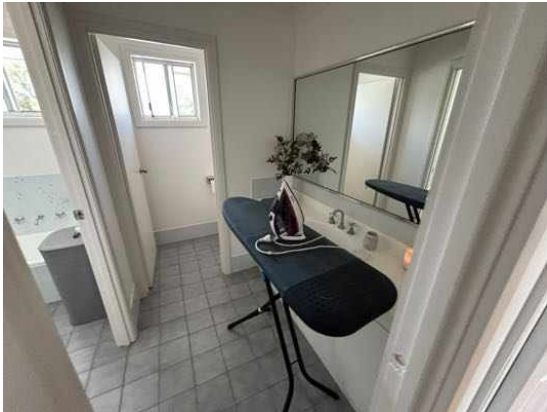
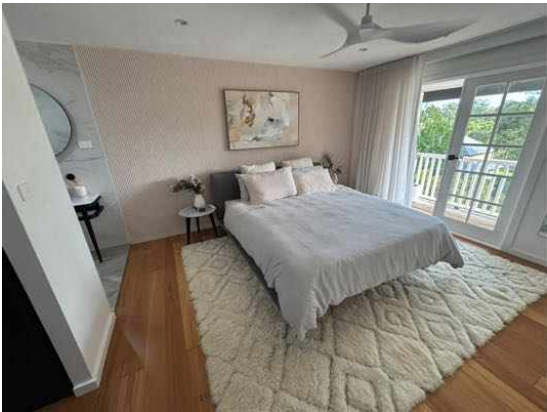
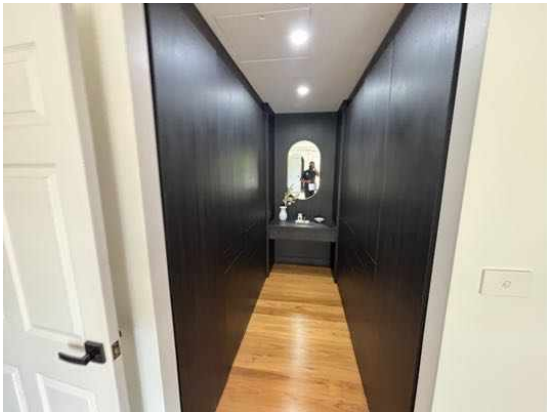
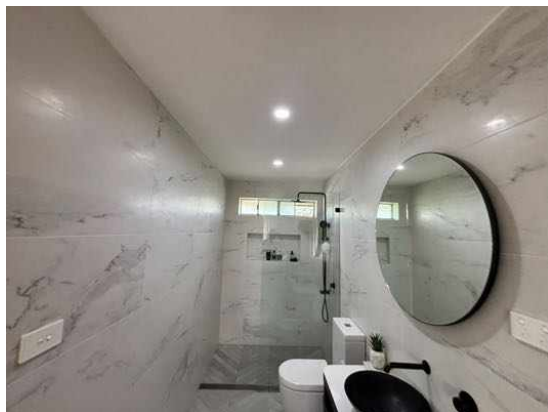
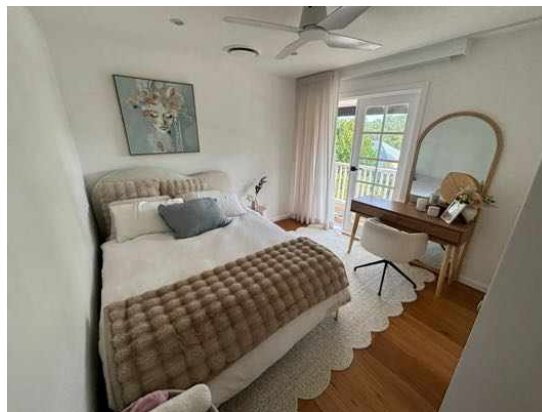
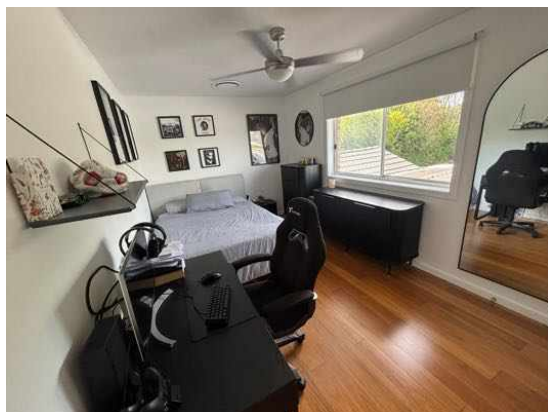
Building:	Main Building
Location:	All Internal Areas
Finding:	Obstructions and Limitations - Internal Areas
Information:	The accompanying photographs provide clear evidence of the obstructions and limitations that restricted a comprehensive inspection of the internal areas of the property at the time of assessment. These obstructions, which may include furniture, personal belongings, stored items, or structural elements such as wall coverings and built-ins, significantly hindered the ability to thoroughly evaluate these areas. It is important to note that such obstructions can potentially conceal a wide array of defects, ranging from hidden structural damage, water leaks, pest infestations, or electrical issues, to deteriorating materials that may not be visible during the initial inspection.

The presence of these impediments means that critical areas of the property were not accessible, and therefore, any underlying defects that may affect the integrity and safety of the property could remain undetected. These hidden defects, if left unaddressed, could worsen over time and may result in costly repairs or pose potential safety hazards to the occupants.

It is highly recommended that all obstructions be cleared to facilitate a complete and thorough inspection of the internal areas. Once the obstructions have been removed and full access is available, a re-inspection should be carried out to ensure that any

previously concealed issues can be properly identified and rectified. This follow-up inspection will provide a more accurate assessment of the property's internal condition and help the client make informed decisions about any necessary repairs or maintenance.

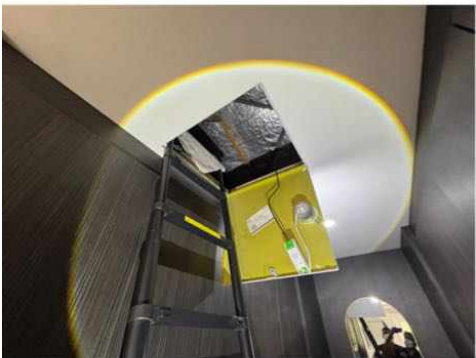
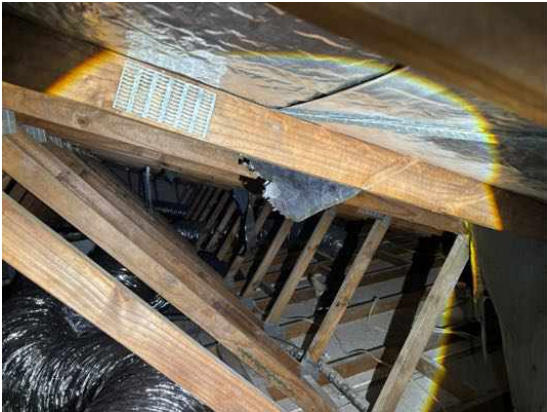
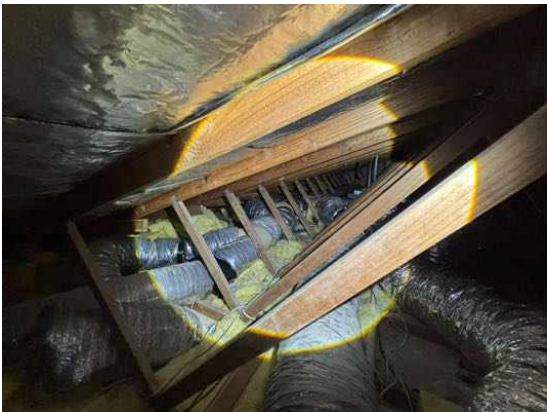
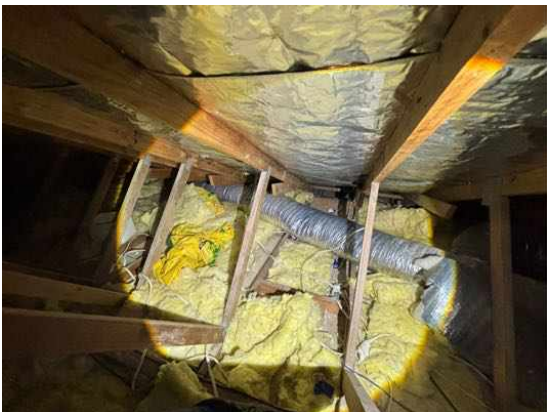
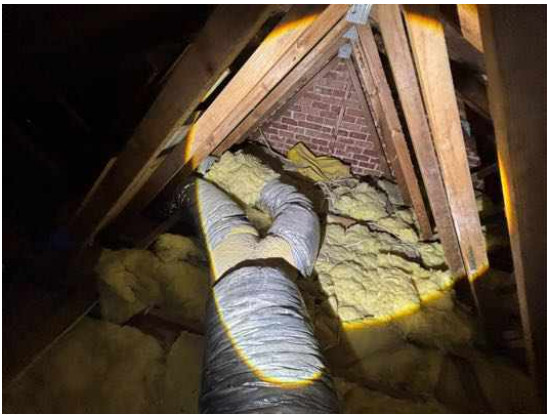
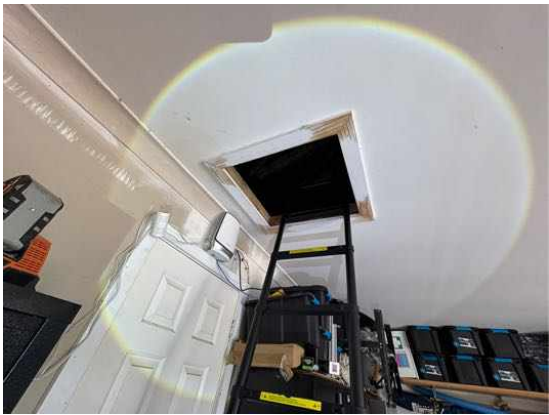
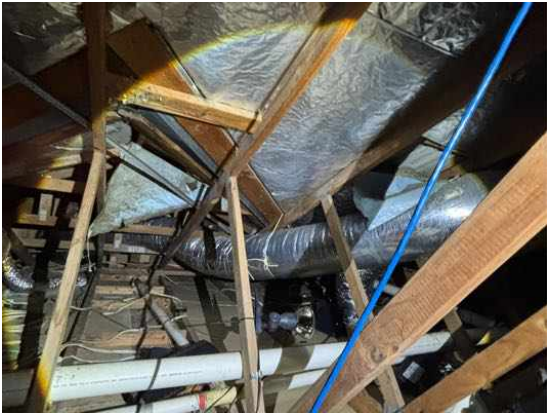
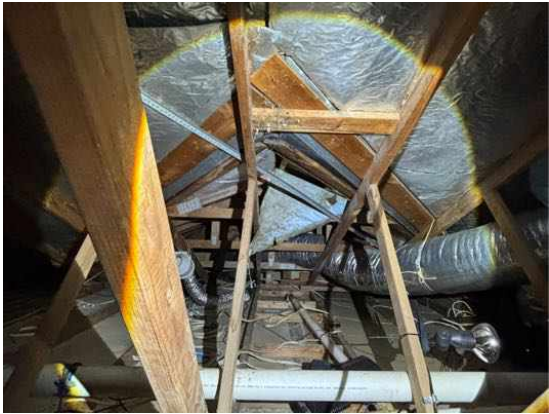
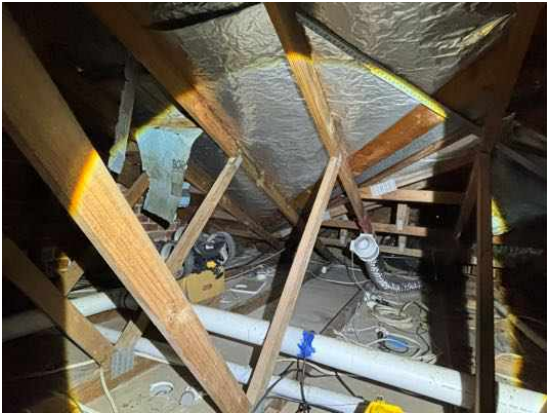
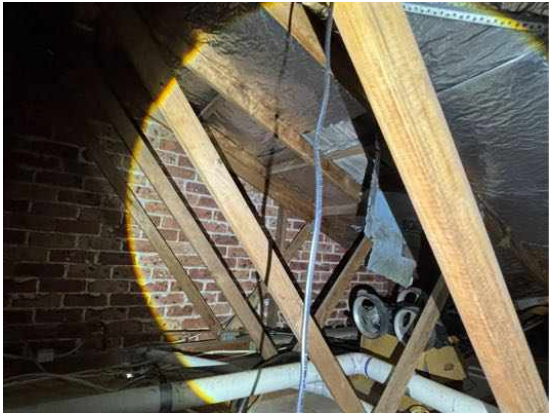
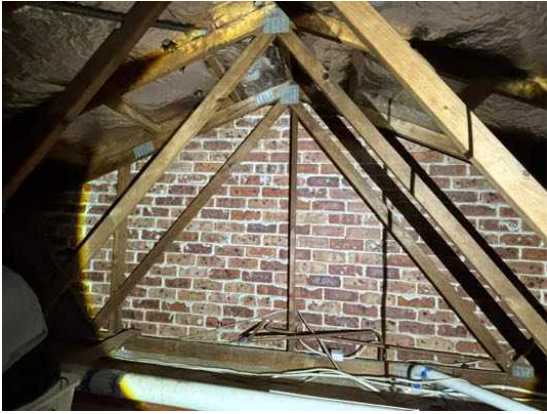
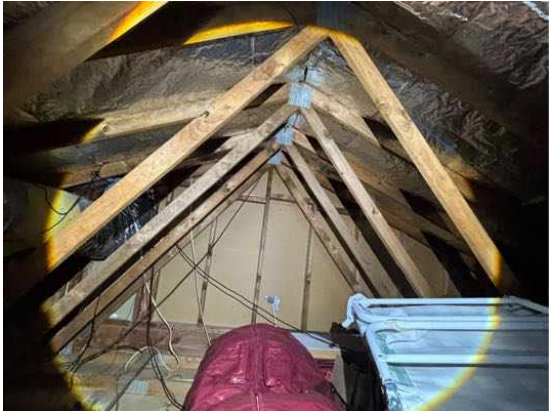
Building: Main Building
 Location: Roof Void
 Finding: Obstructions, Limitations, and General Roof Space Condition
 Information: The photographs provided document both the general condition and the obstructions and limitations that were present in the roof cavity of the main building at the time of inspection. These obstructions—such as insulation materials, stored items, structural elements, or electrical wiring—restricted safe and adequate access to key areas within the roof space. As a result, a comprehensive inspection of all components could not be completed.

Obstructions of this nature may conceal a variety of potential defects, including damaged framing, compromised insulation, evidence of moisture ingress, pest activity, or electrical hazards. While no major issues were observed in the visible areas, the presence of these limitations means that some defects may remain undetected.

It is recommended that these barriers be removed or repositioned to facilitate full and safe access to the roof space. Once clear, a follow-up inspection should be conducted to allow for a thorough assessment of all concealed areas. This will help ensure that the condition of the roof cavity is accurately evaluated and any hidden issues are appropriately identified and addressed.

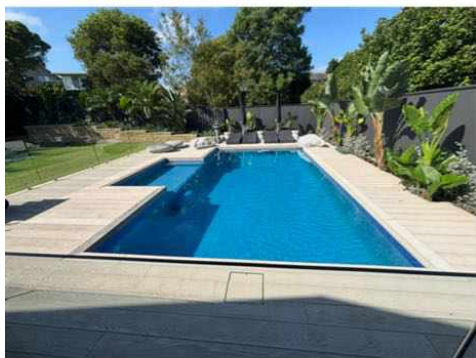
Building:	Main Building
Location:	Pool Area
Finding:	FYI - Pool Area
Information:	This inspection explicitly excludes any assessment of the pool, spa, associated pool equipment, and the surrounding areas. As a standard building inspection does not encompass these elements, it is crucial for the client to understand that no evaluation has been conducted regarding the condition, functionality, or safety compliance of the pool or its associated systems. This includes, but is not limited to, pumps, filters, heating equipment, and structural integrity of the pool or spa surrounds.

To gain a comprehensive understanding of the condition and compliance of these components, it is highly recommended that the client engages a specialist pool inspector. A pool inspection will evaluate the structural condition of the pool, ensure the functionality of all associated equipment, and assess whether the pool and its surroundings meet current safety regulations. In particular, pool safety requirements,

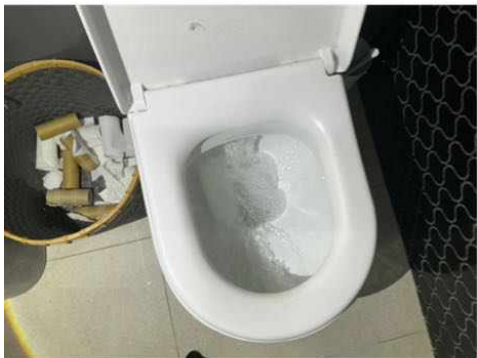
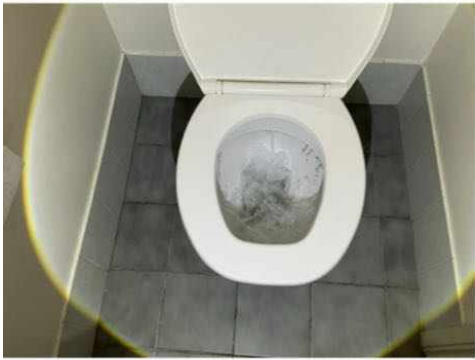
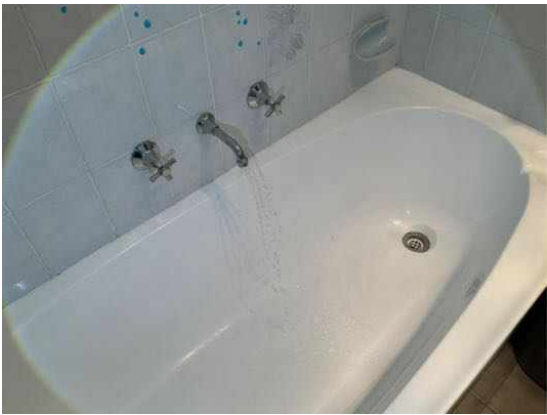
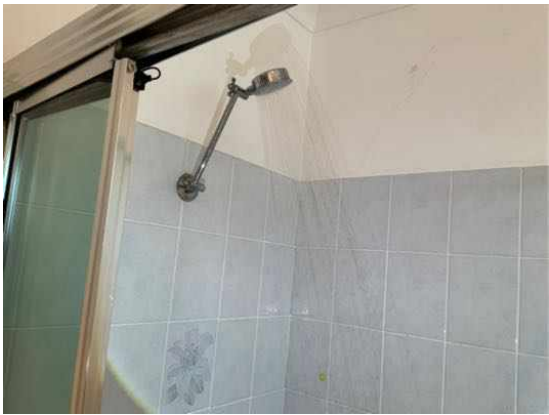
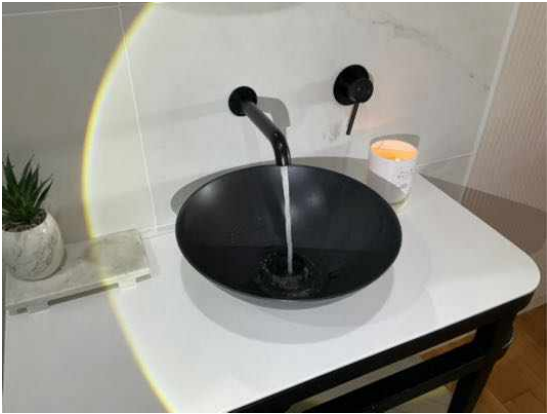
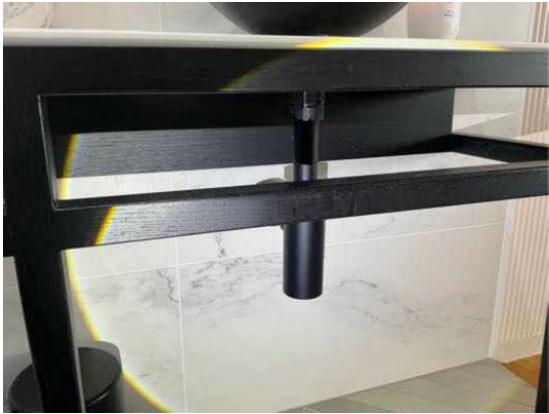
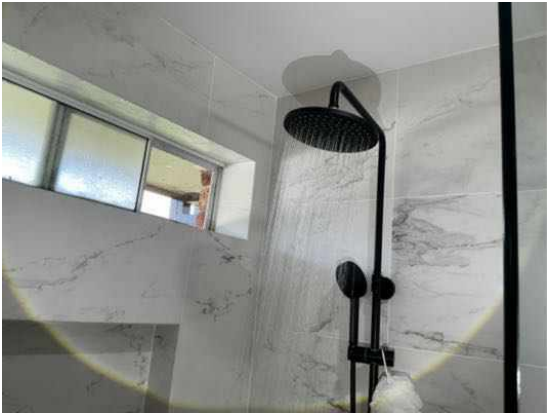
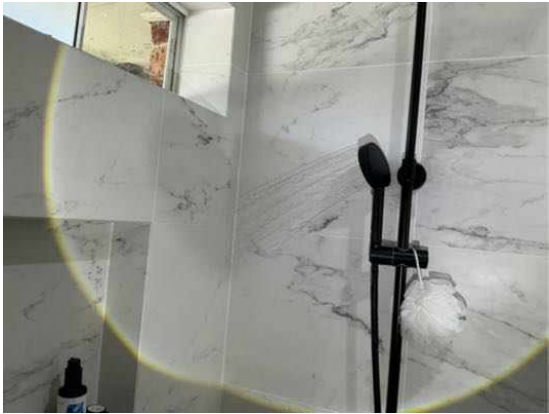
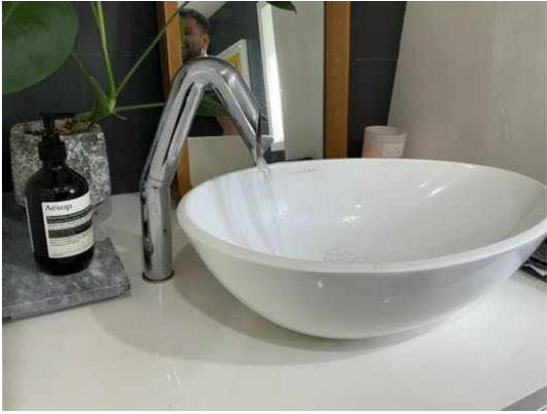
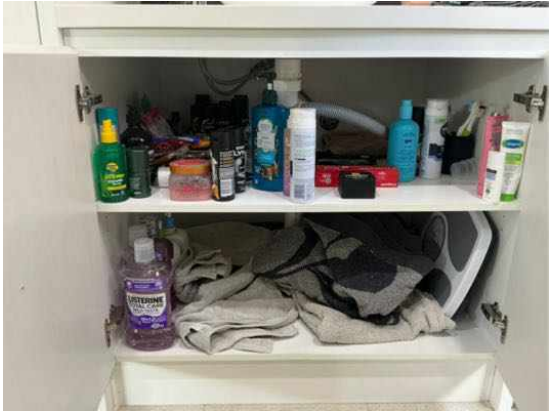
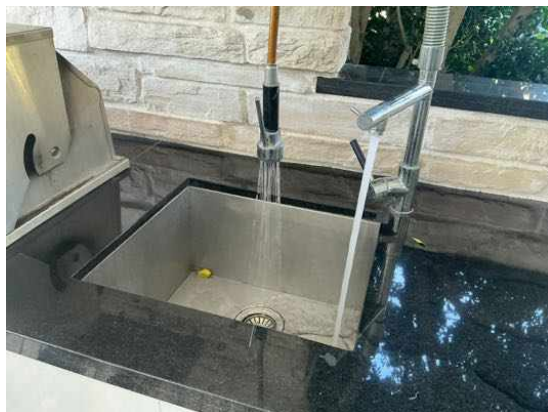
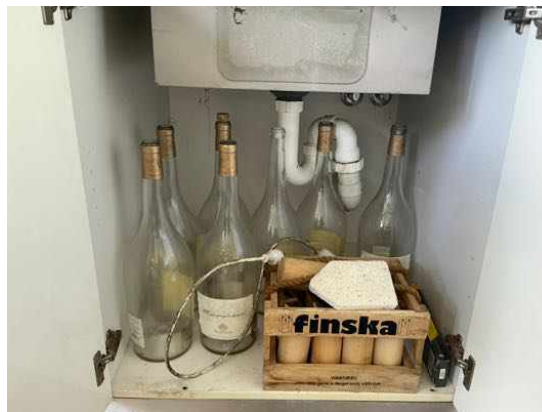
Building:	Main Building
Location:	All Areas
Finding:	FYI - Taps, Drainage & Toilets Tested and Cabinetry Obstructions
Information:	During the inspection, all accessible taps, drainage systems, and toilets were tested for water flow and drainage efficiency, and checked for any visible signs of leakage. At the time of the inspection, no issues were noted in these areas. Unless highlighted in a separate defect statement, no immediate remedial work appears necessary. Supporting images may be found in the additional photos section for reference.

It is important to note that while a visual inspection of cupboards and cabinetry beneath sinks and vanities was undertaken, stored personal items and fixtures presented obstructions that limited full visibility of the internal areas. As per standard inspection practices, inspectors are not permitted to move or disturb personal belongings during the inspection process. Therefore, only visible and accessible sections were inspected, and concealed water damage or plumbing defects may not have been detected.

Given this, a re-inspection is recommended after all obstructions have been cleared to allow for a comprehensive assessment of these areas. Regular maintenance and monitoring of plumbing and drainage systems is also advised to ensure ongoing functionality and early detection of potential issues.

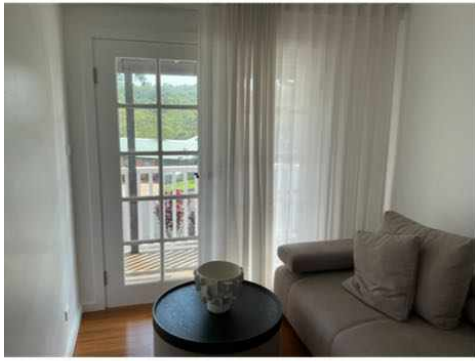
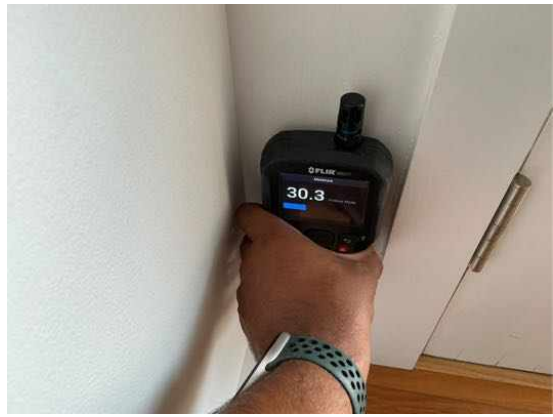
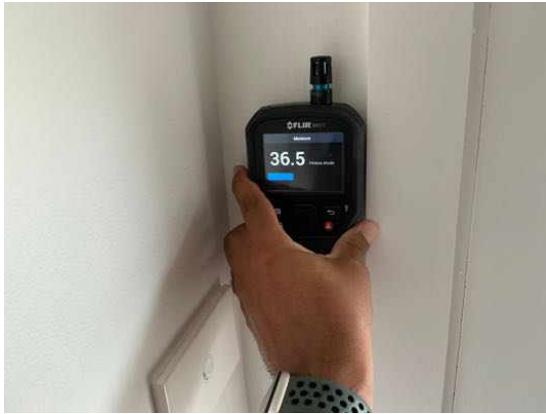
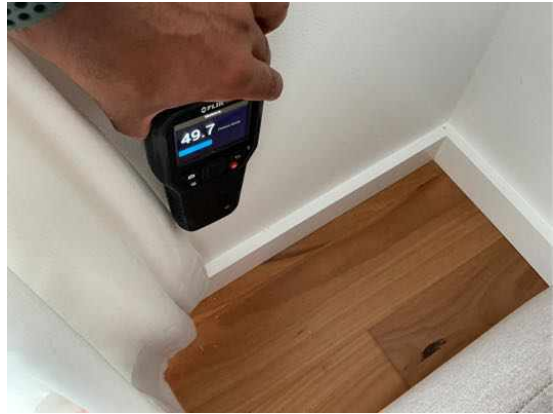
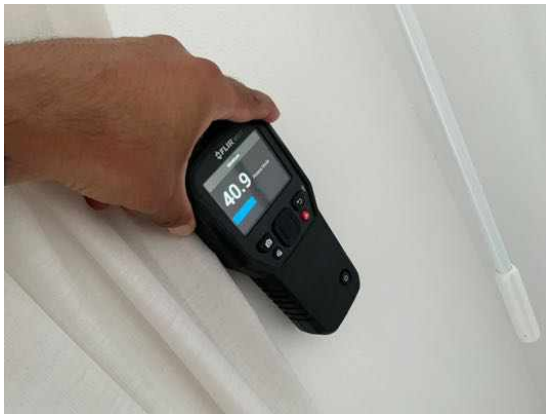
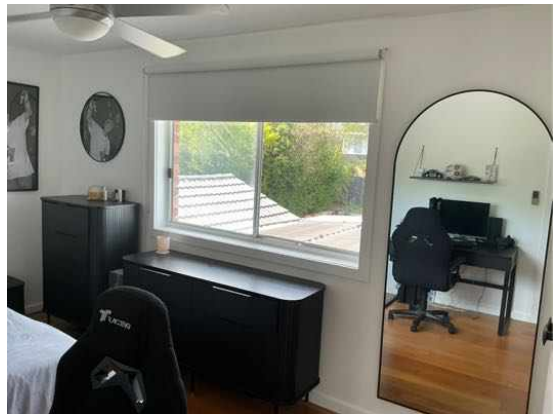
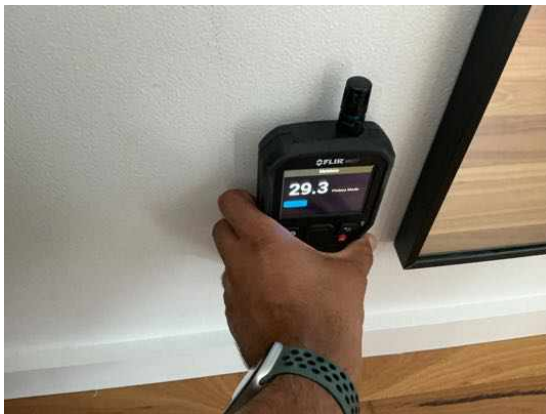
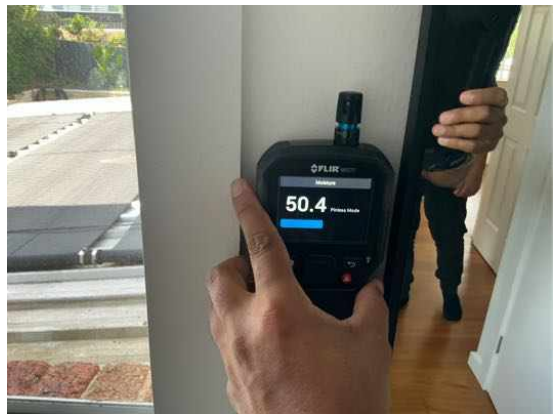
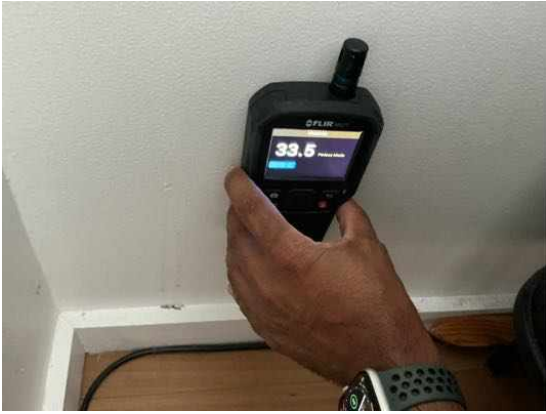
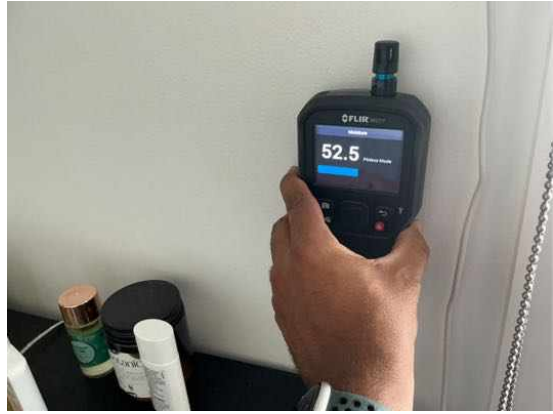
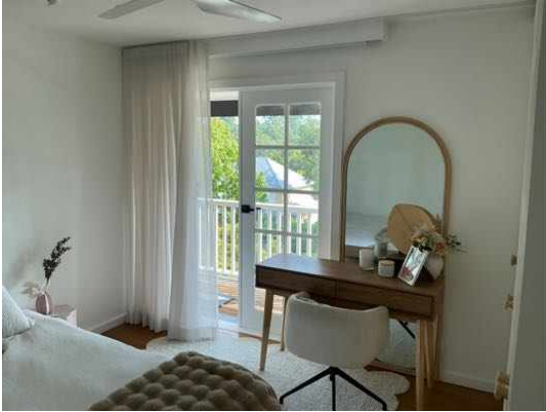
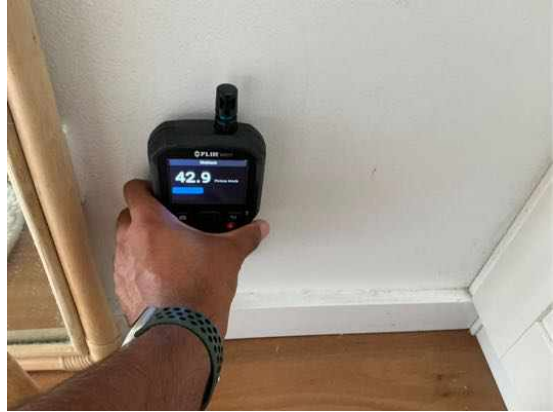
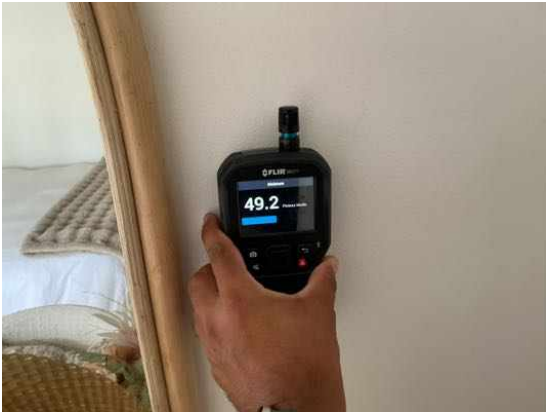
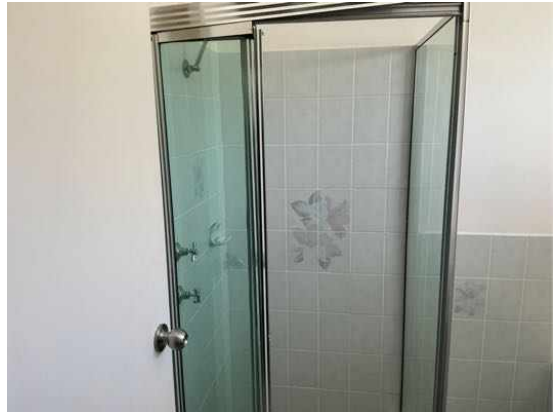
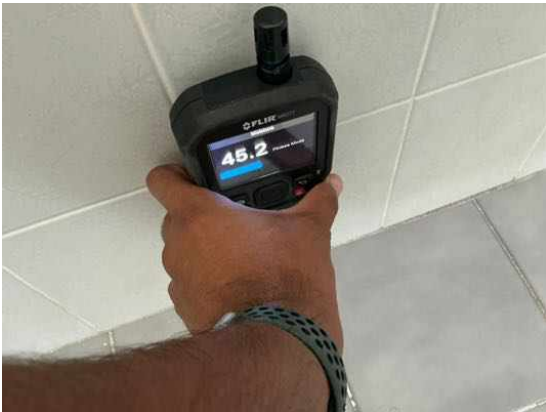
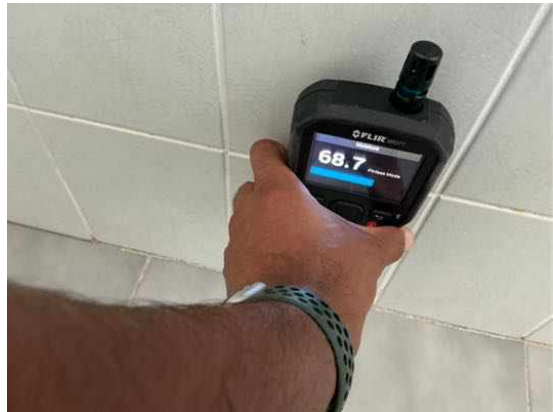
Building: Main Building
 Location: All Areas
 Finding: Additional Photos - Moisture Meter Readings
 Information: Additional moisture meter reading photos have been provided for the property to offer further clarity on areas tested during the inspection. These photos are intended to give a visual reference for the specific locations where moisture levels were measured. These readings were taken at the time of the inspection to assess any potential moisture-related issues within the property. Any defects related to moisture that were identified during the inspection have been separately mentioned in the defect statements within the report.

It is important for the client to understand that moisture levels can fluctuate over time due to various factors, including changes in weather, humidity, and environmental conditions. While the readings reflect the property's moisture levels during the inspection, they may not represent future conditions, and increased moisture could lead to issues such as dampness, mould growth, or deterioration of building materials if left unmonitored.

For further clarification or additional information regarding the moisture readings, the client is encouraged to contact the building inspector directly. Regular monitoring of moisture-prone areas is recommended to ensure any emerging concerns are addressed promptly, particularly during wetter seasons or in high-humidity conditions.
