Building and Timber Pest Inspection Report

Inspection Date: Fri, 6 Mar 2026

Property Address: 18 Fingal Ave, Glenhaven NSW 2156,
Australia

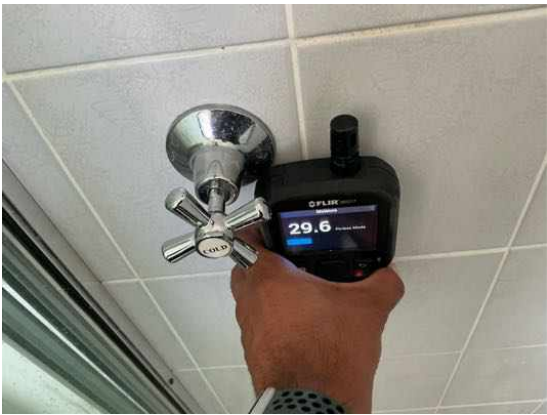
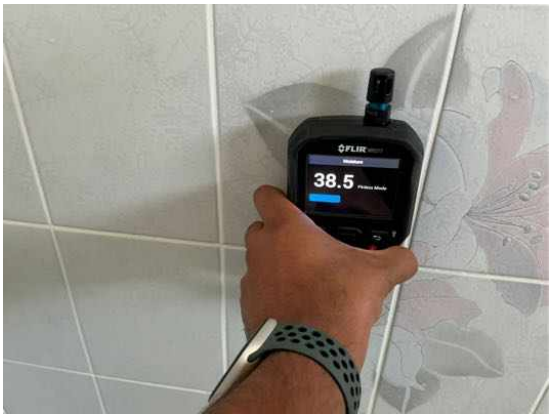
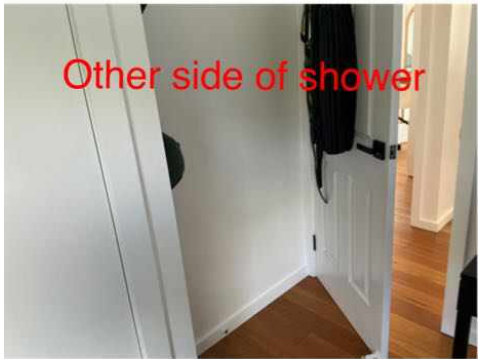
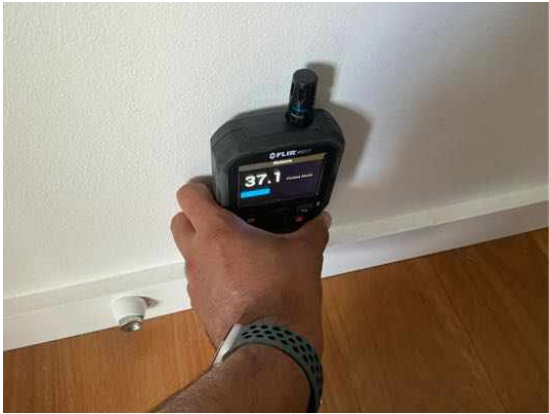
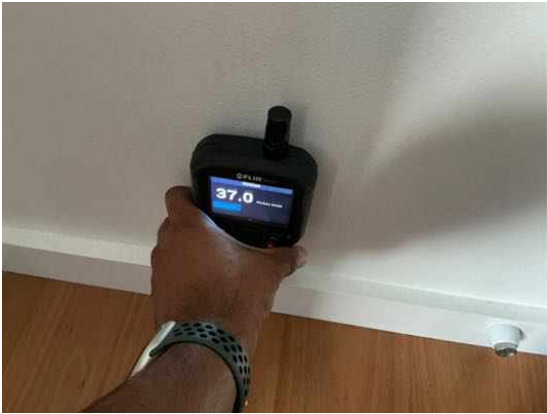
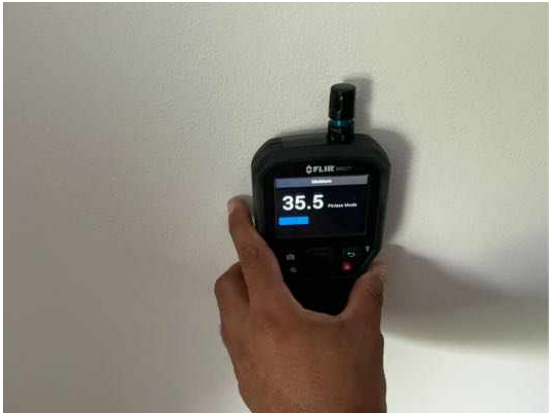
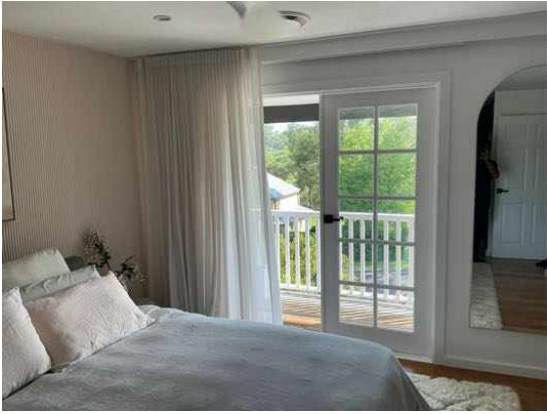
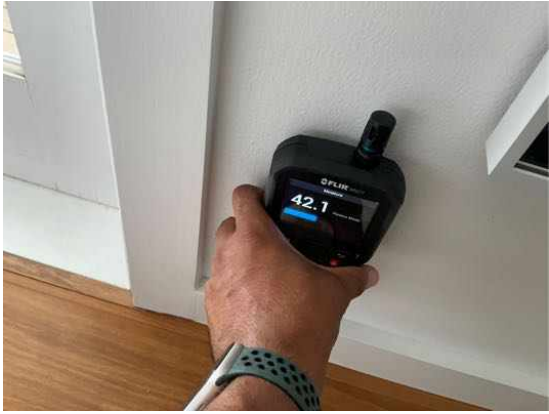
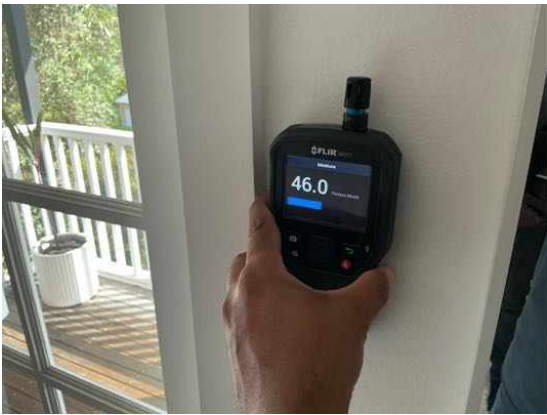
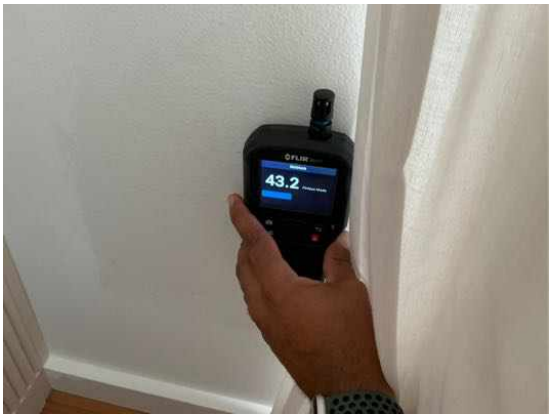
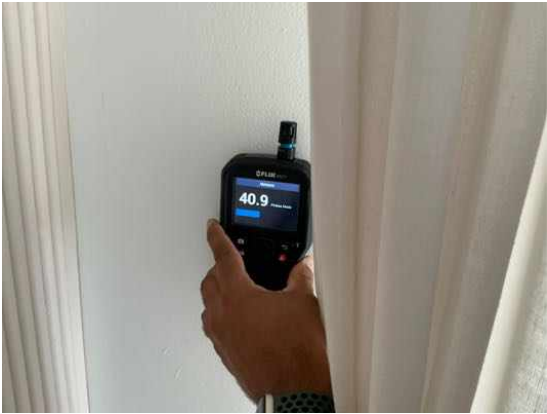
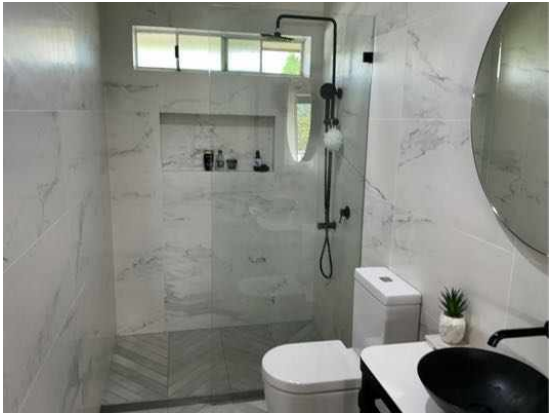
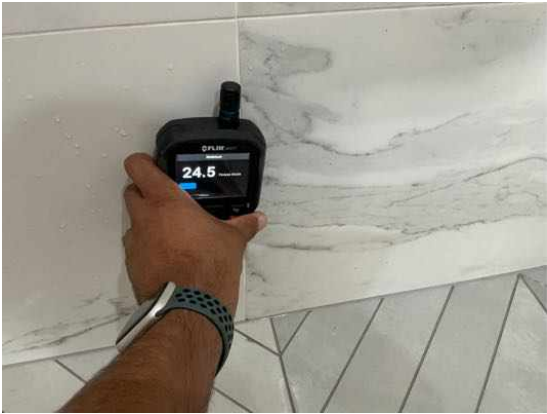
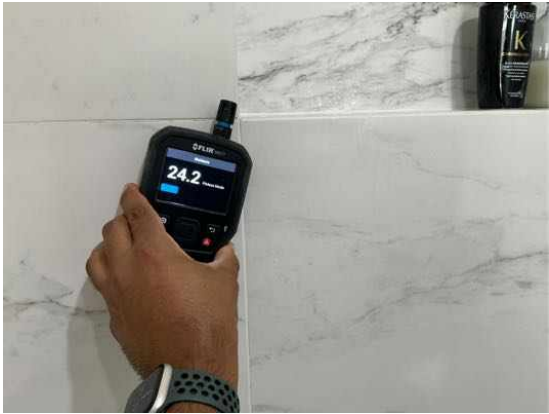
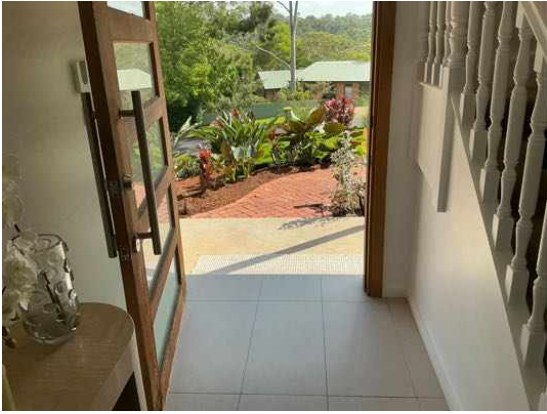
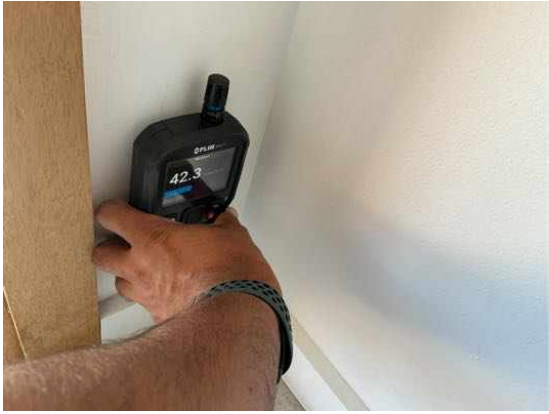
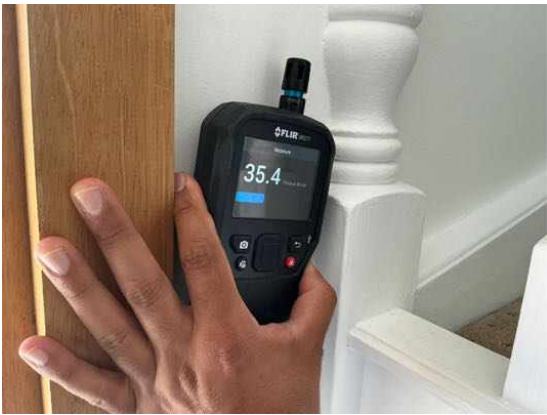
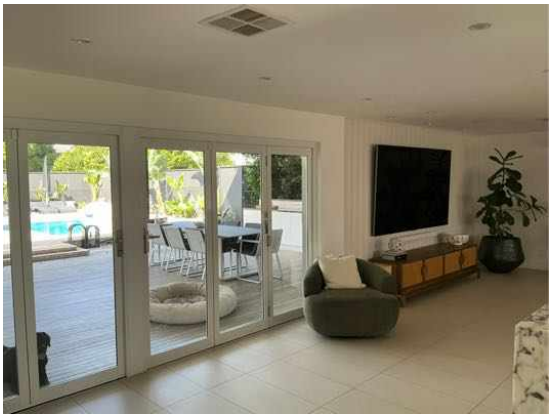
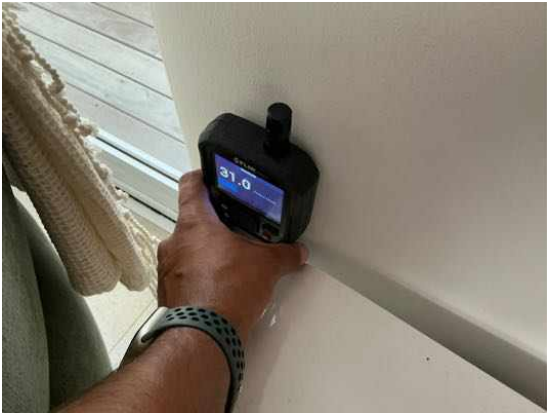
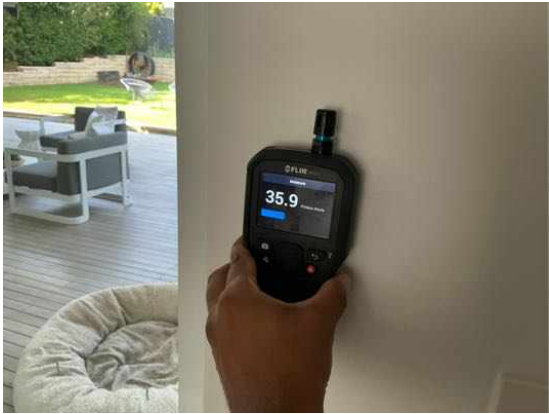
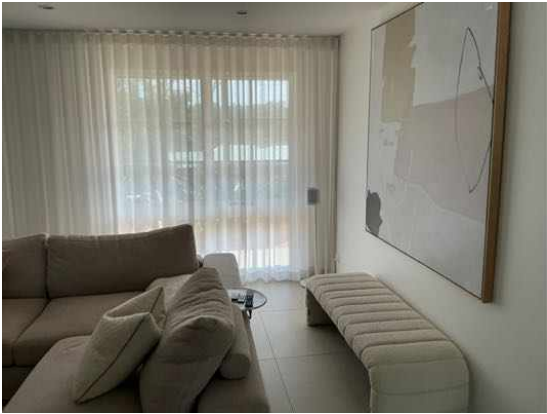
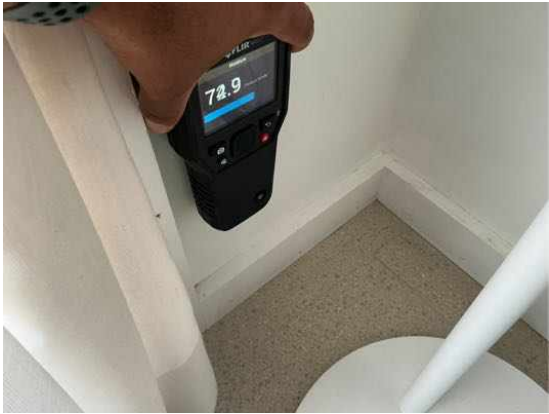
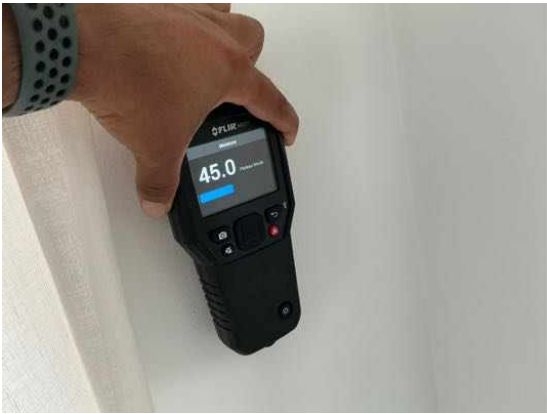
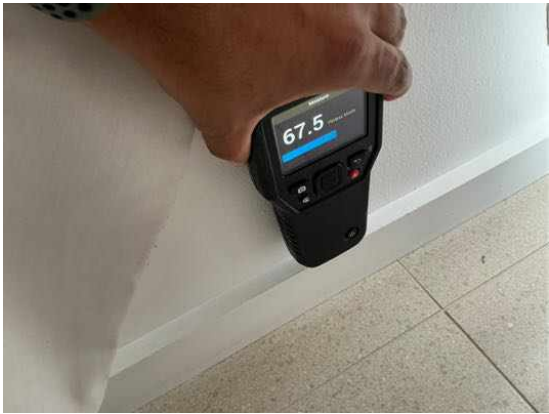
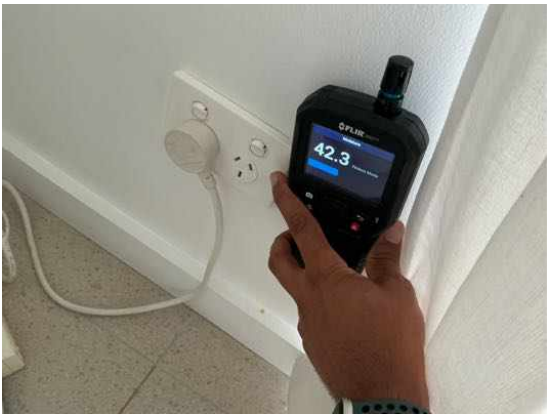
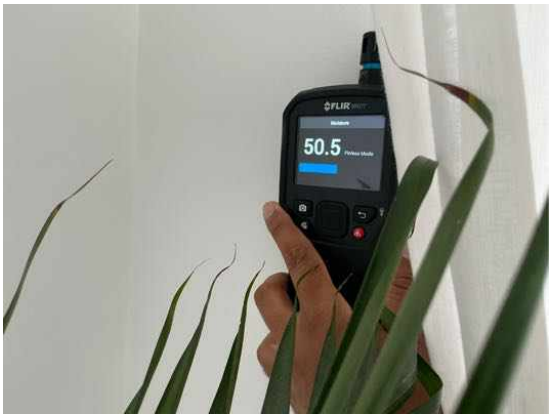
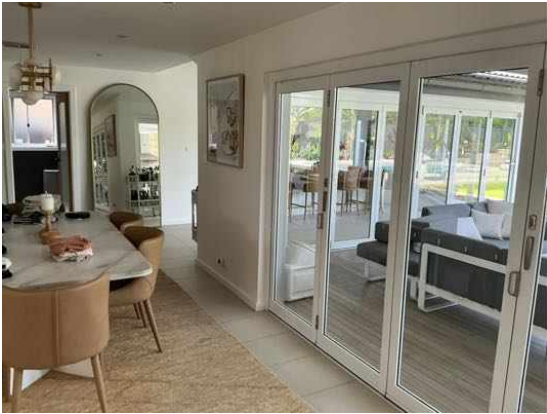
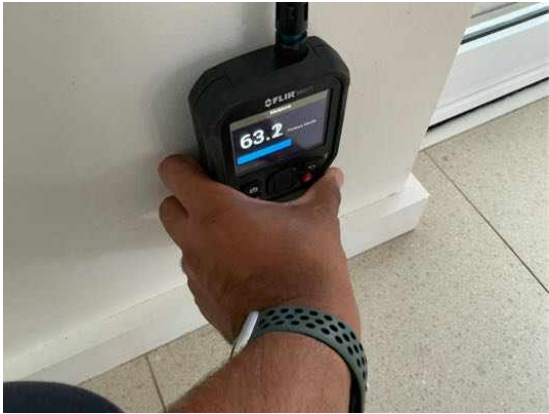
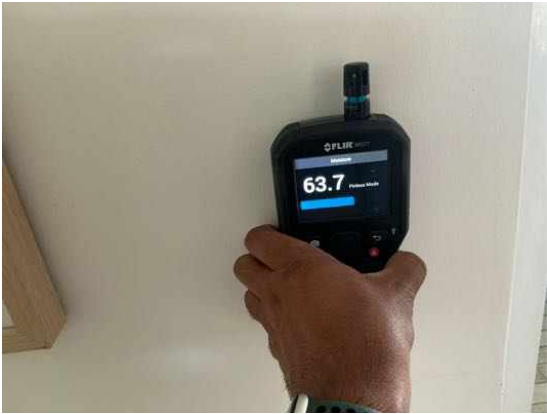
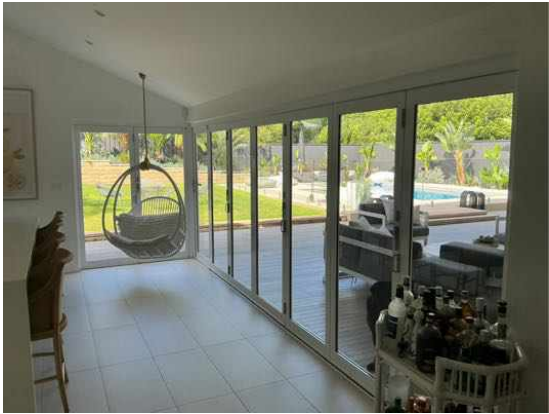
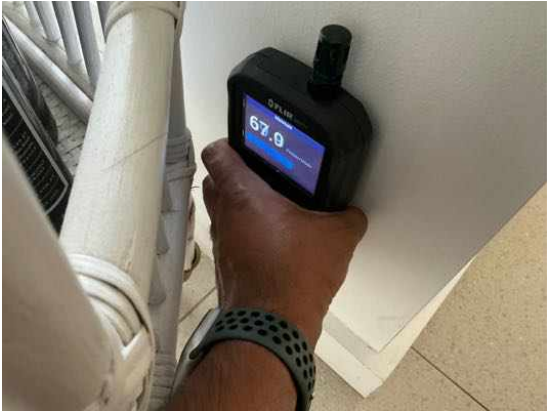
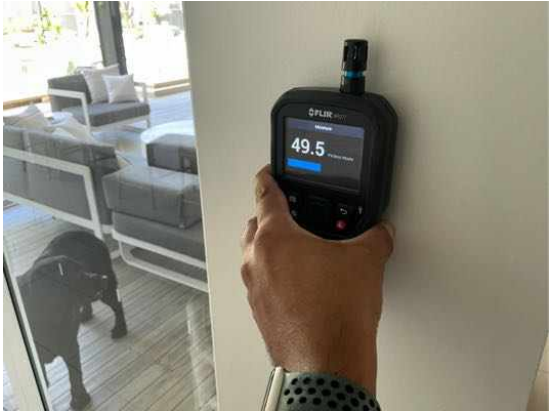
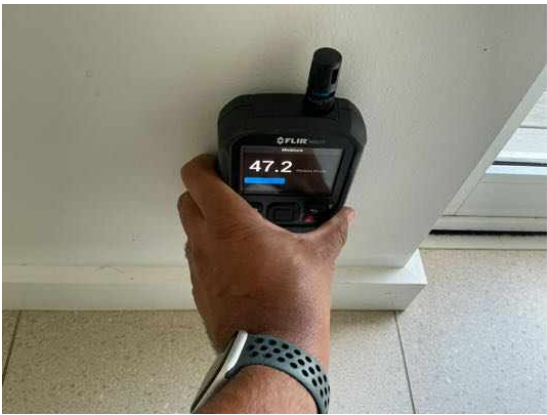
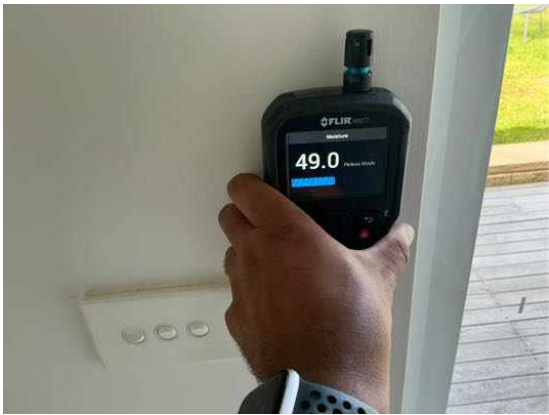
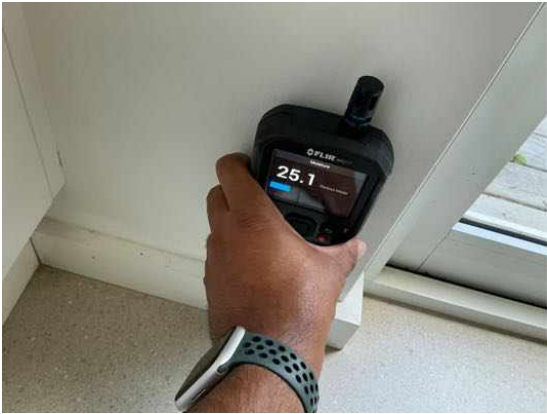
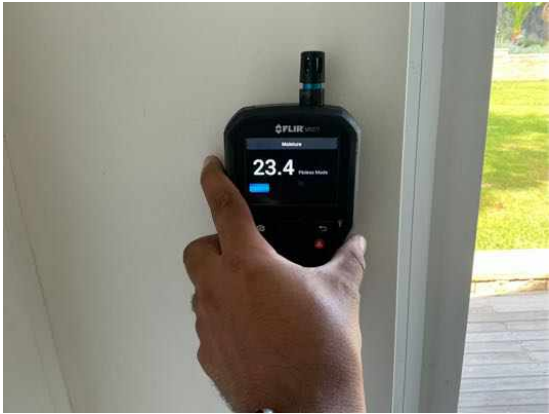
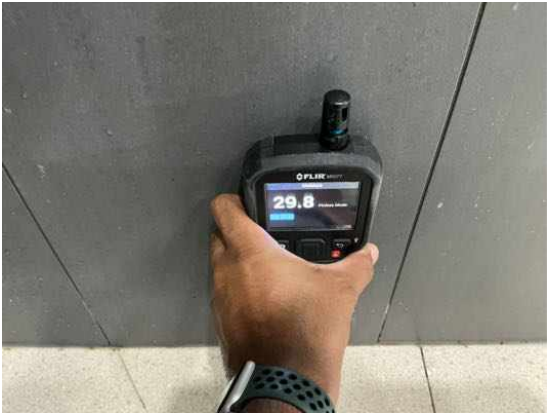
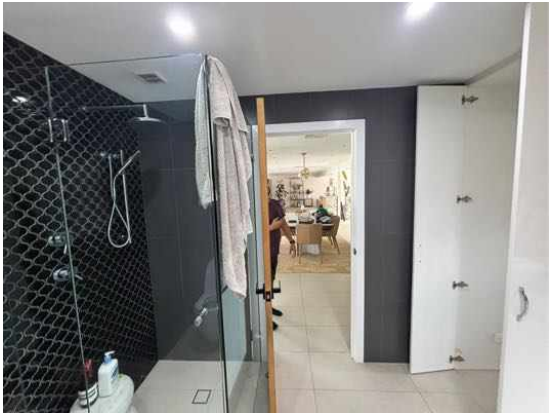
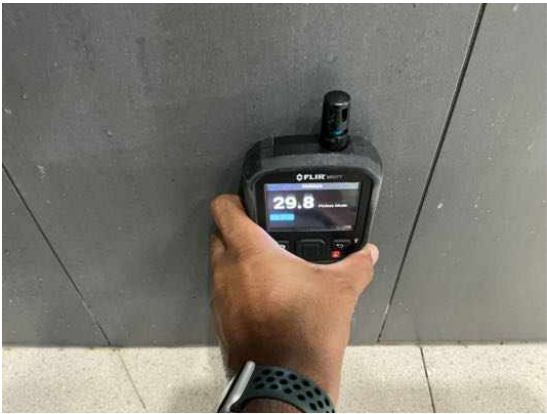
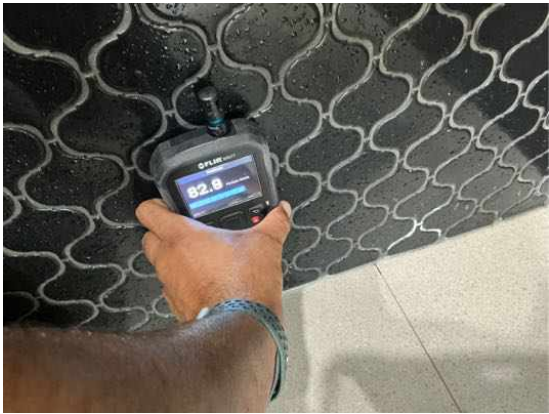
Building: Main Building
 Location: All Areas
 Finding: Additional Photos - Moisture Meter Readings
 Information: Additional moisture meter reading photos have been provided for the property to offer further clarity on areas tested during the inspection. These photos are intended to give a visual reference for the specific locations where moisture levels were measured. These readings were taken at the time of the inspection to assess any potential moisture-related issues within the property. Any defects related to moisture that were identified during the inspection have been separately mentioned in the defect statements within the report.

It is important for the client to understand that moisture levels can fluctuate over time due to various factors, including changes in weather, humidity, and environmental conditions. While the readings reflect the property's moisture levels during the inspection, they may not represent future conditions, and increased moisture could lead to issues such as dampness, mould growth, or deterioration of building materials if left unmonitored.

For further clarification or additional information regarding the moisture readings, the client is encouraged to contact the building inspector directly. Regular monitoring of moisture-prone areas is recommended to ensure any emerging concerns are addressed promptly, particularly during wetter seasons or in high-humidity conditions.

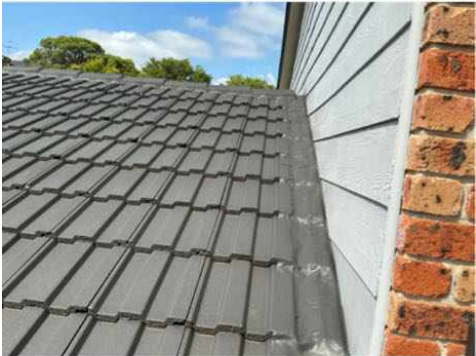
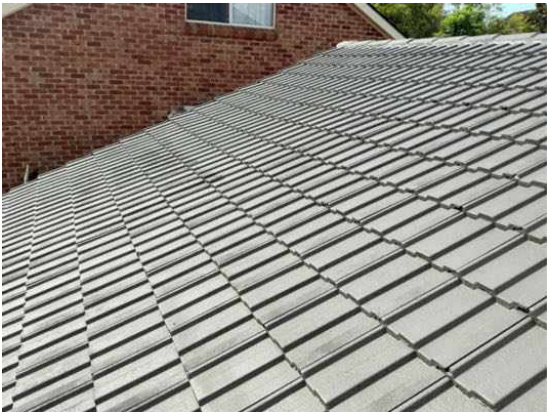
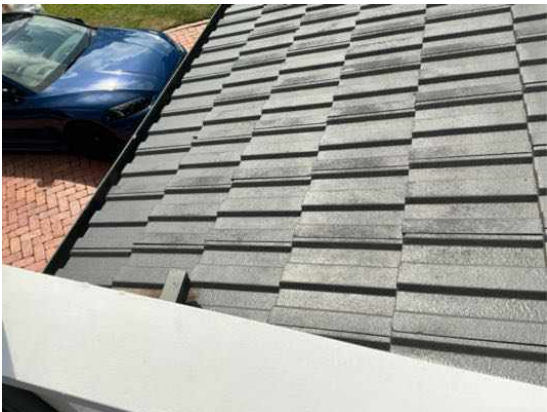
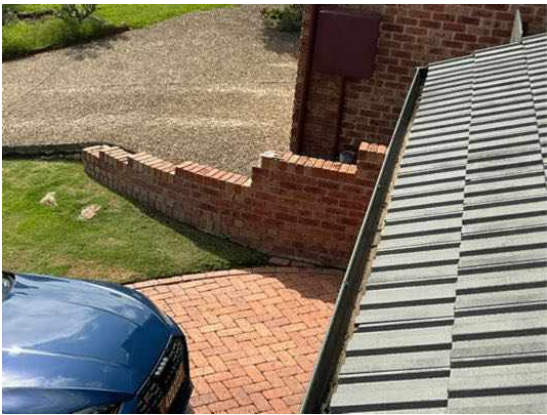
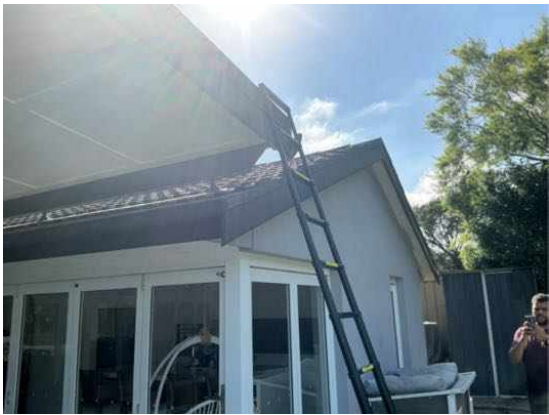
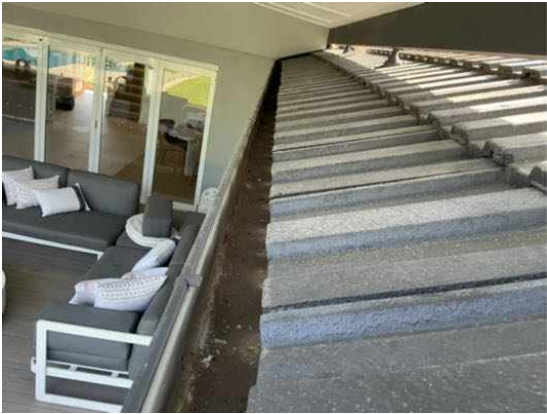
Building: Main Building
Location: Roof Exterior
Finding: Additional Roof Photos

Information: As part of the information provided, please note that the attached roof photos represent the condition of the roof at the time of inspection. These photos are for visual reference only and do not constitute a detailed roofing assessment. Any defects or issues identified with the roof are mentioned separately in the defect statements. It is strongly recommended that the client engage a qualified roofer to conduct a thorough inspection of the roof, ensuring that any potential issues, such as leaks, structural integrity, or wear and tear, are properly identified and addressed.

Additionally, the condition of the roof may change over time due to weather, natural wear, or other unforeseen factors. Regular maintenance and inspections by a licensed professional are advised to ensure the roof remains in good condition and to avoid costly repairs in the future. The information provided in these photos should be considered a snapshot of the roof's condition during the time of inspection and not a guarantee of its future performance.

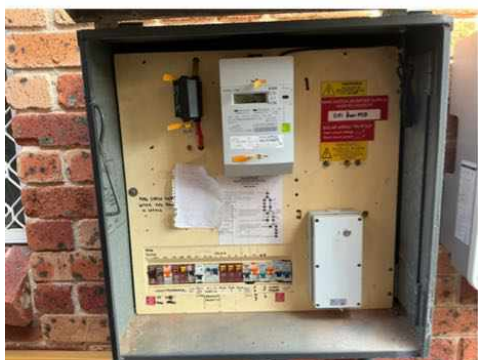
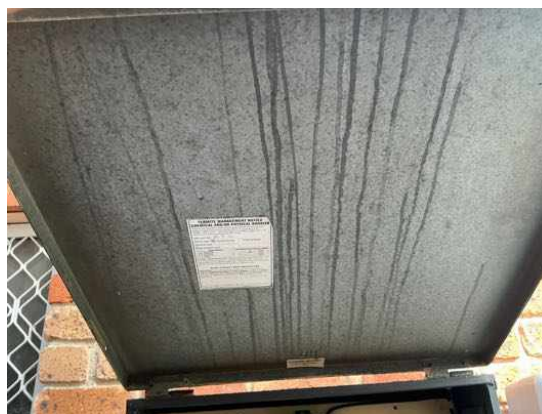
Building:	Main Building
Location:	Meter Box
Finding:	Termite Management Recommendation – No Evidence of Chemical Installation
Information:	At the time of inspection, there was no visible evidence of a chemical termite management system installed around the property. Chemical barriers are a key component of termite protection and are particularly important in preventing concealed termite entry into timber elements of the structure.

In accordance with standard requirements, a durable notice should be located within the electrical switchboard to detail any termite protection systems applied, including chemical treatments. No such notice was observed during the inspection.

It is recommended that the client engage a licensed pest controller to assess the suitability of installing a chemical barrier, and to provide advice on associated costs and procedures. This should be considered a short-term priority, particularly if the property has any history of termite activity or is located in a high-risk area.

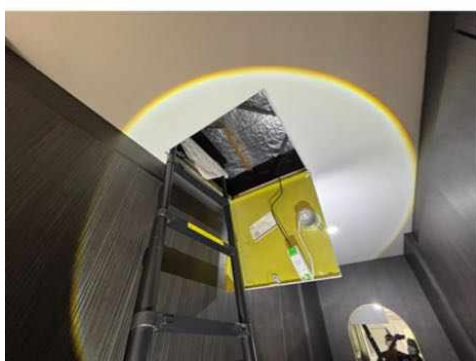
Building:	Main Building
Location:	Upstairs Roof Void
Finding:	Insulation - Not Installed
Information:	It was noted during inspection, that insulation has not been installed. This significantly undermines the thermal efficiency of the property, leading to increased energy consumption for heating and cooling. Properly installed insulation is crucial for maintaining a consistent indoor temperature, reducing energy costs, and enhancing overall comfort. Immediate corrective action is required to install the insulation as per the manufacturer's guidelines, ensuring it provides the intended thermal performance and complies with building standards.

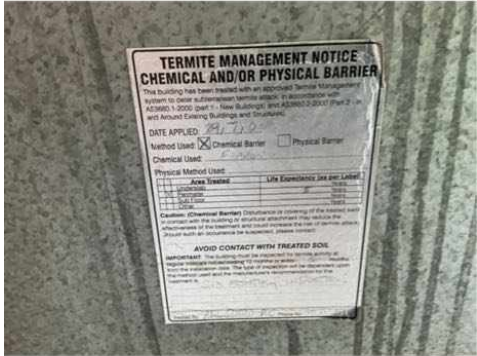
The following items were noted as - Evidence of a previous termite management program

Where a Termite Management System has been identified you should refer to the type of barrier date of installation warranty conditions and any documentation provided by a builder or past owner. Consult the company who installed the barrier to confirm whether the system is still under warranty.

Most chemical termite management systems expire and require replenishment and all physical systems are primarily designed to prevent concealed entry.
