Building Inspection Report

Inspection Date: Tue, 7 Apr 2026

Property Address: 5/528 Pascoe Vale Rd, Pascoe Vale VIC
3044, Australia

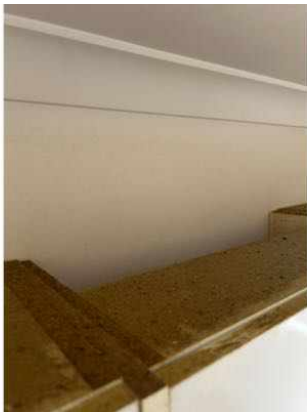
Defects 1.01

Building:	Main Building
Location:	Kitchen
Finding:	Rangehood - Vented into kitchen
Information:	The range hood flue was found to lead directly back into the kitchen, rather than venting to the exterior of the building.

The positioning of this flue is likely to lead to a build-up of grease and grime in the surrounding area, which can pose as a fire hazard and health hazard.

Without re-direction to the exterior of the building, the Rangehood is not considered fully operational and is deemed a minor safety hazard. It is therefore preferable that the flue be re-directed to vent into the external environment. A licensed plumber should be appointed as soon as possible to provide further consultation on the scope of these works and to provide quotations for any necessary works.

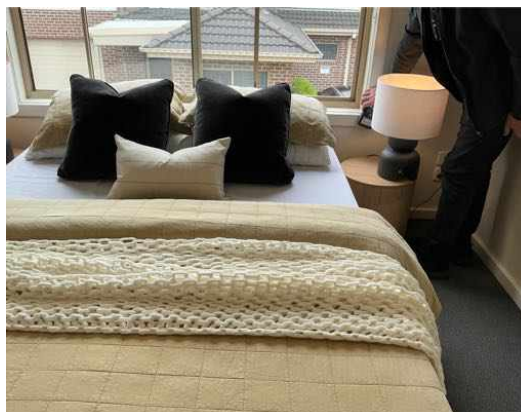
Defects 3.14

Building:	Main Building
Location:	Windows and sliding doors
Finding:	Doors and windows- stiff to slide
Information:	The doors and windows to these areas were difficult to operate at the time of inspection. This is likely due to damaged wheels which help the door to operate in a smooth fashion.

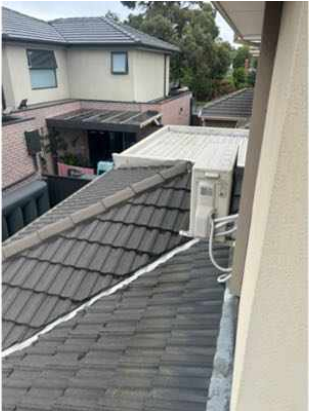
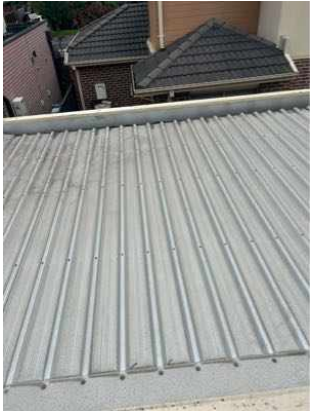
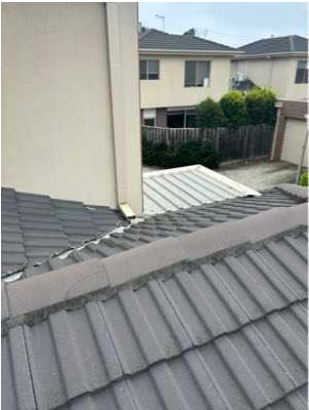
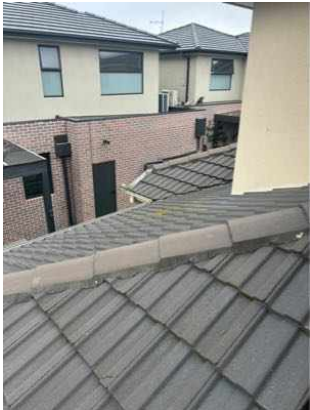
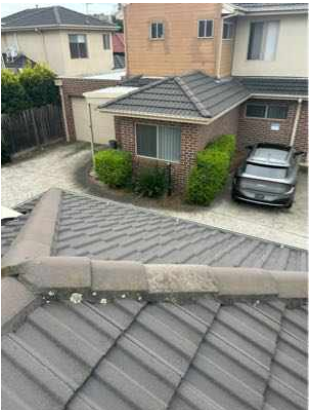
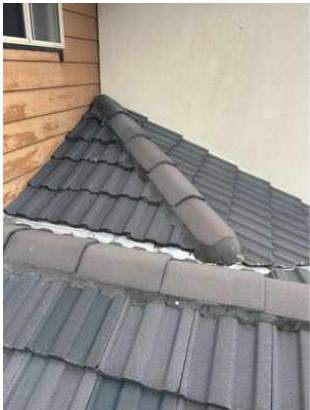
Where left unmanaged, deteriorating roof tiles are likely to lead to a number of secondary defects, including minor water leaks and weather exposure to internal roofing structures.

Consultation with a roofing contractor is highly advised to gain advice on cost of remedial works that may be required in the short to medium term. Remedial works are likely to increase the longevity of the exterior roofing structure.

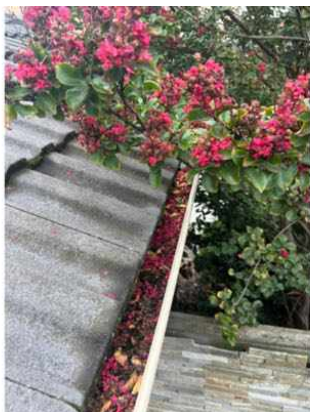
Defects 3.16

Building:	Main Building
Location:	Roof Exterior
Finding:	Trees - Overhanging and filling gutters
Information:	Overhanging trees often result in excessive amounts of leaf debris accumulating in gutters.

It is highly advised that all overhanging tree branches be removed as soon as possible to prevent any further damage. Repair and/or replacement of sections of damaged guttering may also be required where the extent of the damage necessitates.

Such works should be performed by the homeowner; however, appointment of a landscape contractor or an arborist may be required. Consultation with a licensed roof plumber is required where guttering has been damaged.

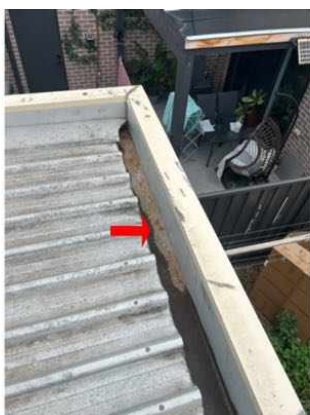
Defects 3.17

Building:	Garage
Location:	Roof Exterior
Finding:	Roof plumbing - Rusted or corroded
Information:	The roof plumbing has areas of rust and corrosion. It is suspected that this has been caused by blockages, resulting in pooling or standing water, that have prematurely rusted elements of the roof plumbing.

Repair and/or replacement of rusted roof plumbing is highly required in order to reinstate the roof drainage system to a fully operational level. To further maintain these areas, gutters should be cleaned frequently, allowing the avoidance of any partial blockages.

A licensed plumber or specialist roof restoration company should be appointed to undertake these works. It is advised that such works be completed as soon as possible to prevent any further damage and deterioration.

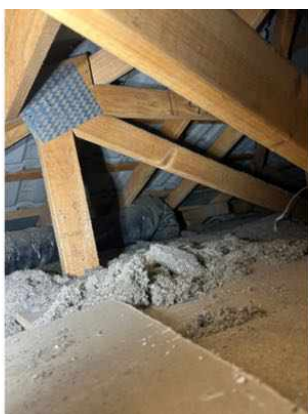
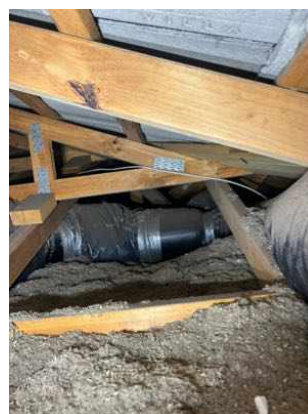
Defects 3.18

Building:	Main Building
Location:	All Areas
Finding:	Insulation - Reduced in volume
Information:	Insul-fluff is common in many older homes and is a loose form of insulation that is 'blown' into roof voids. While this type of insulation was considered effective at the time of installation, modern materials have surpassed it as the preferred insulator.

This type of insulation is susceptible to settling and reducing in volume, detracting from its effectiveness and resulting in an overall loss of energy within the household. Additionally, the reduction in volume has led to an uneven distribution of insulation within the ceiling void, further detracting from its effectiveness.

It is highly advised that this insulation be removed and replaced with a more appropriate material. This will ensure that the property is adequately insulated and will promote an increase in energy efficiency within the property. An insulation contractor should be appointed to provide further advice on replacement options and to perform works as necessary.

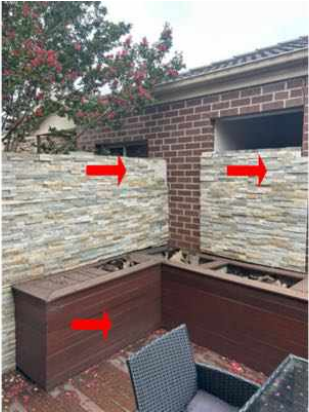
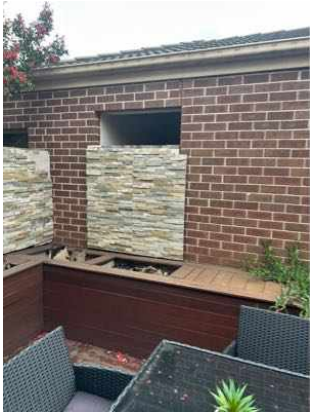
Defects 3.19

Building:	Main Building
Location:	Yard - Side
Finding:	Unconventional handyman work
Information:	This handyman work appears to have been completed to a substandard level and does not comply with regular building practices. Where handyman work is not completed satisfactorily, accelerated deterioration of the associated building elements is likely to occur and secondary defects to surrounding structures may develop.

The client should exercise care when coming into the immediate vicinity of the substandard works. Rectification works are advised as soon as possible by the

appropriate trades.

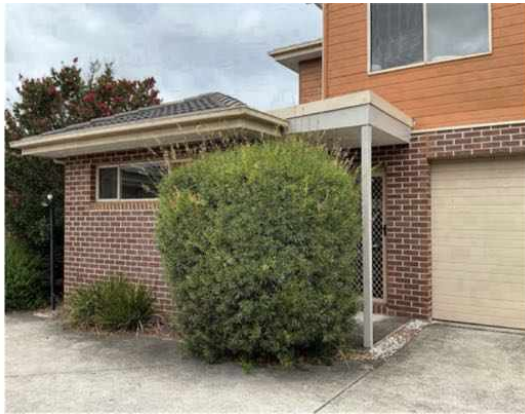
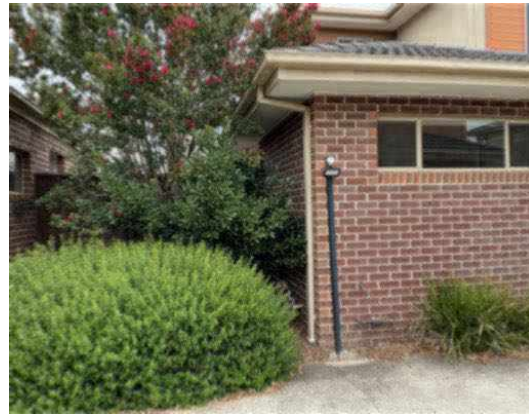
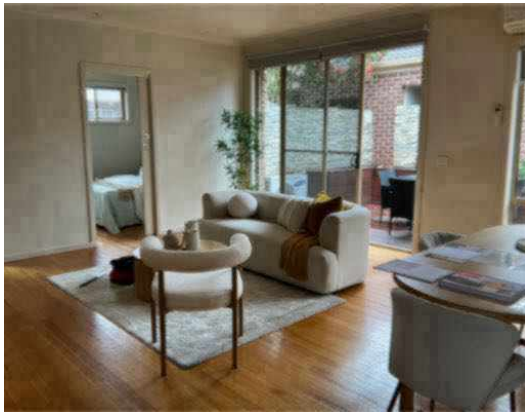
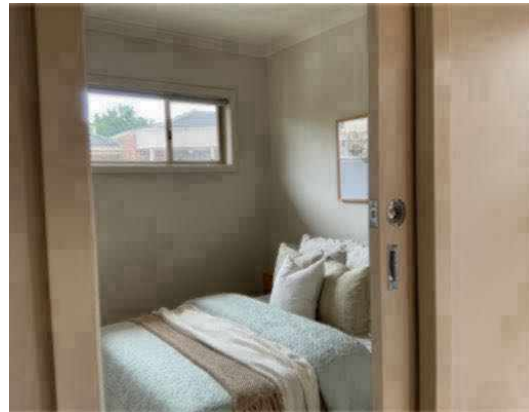
Noted Item

Building: Main Building
Location: All Areas
Finding: Additional Photos and Obstructions and Limitations
Information: These are additional photographs and photographs of the obstructions and limitations inside and outside (furniture, landscaping etc) which may impede full inspection of the property at the time of inspection. These obstructions can hide an array of defects and may be removed to allow full inspection to be carried out. A re-inspection may be made if clients require once the areas are made accessible.

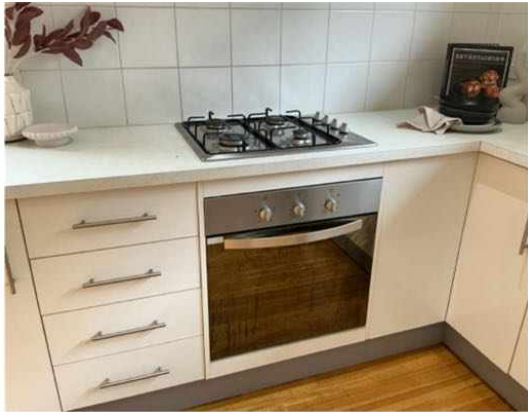
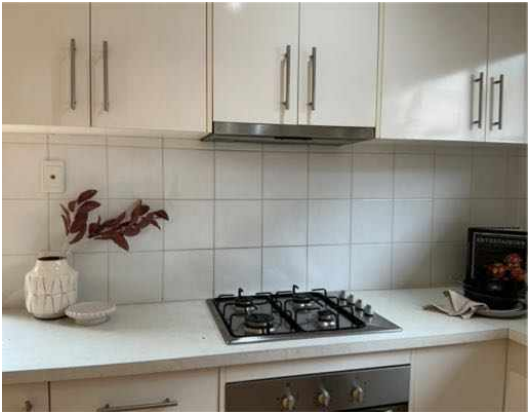
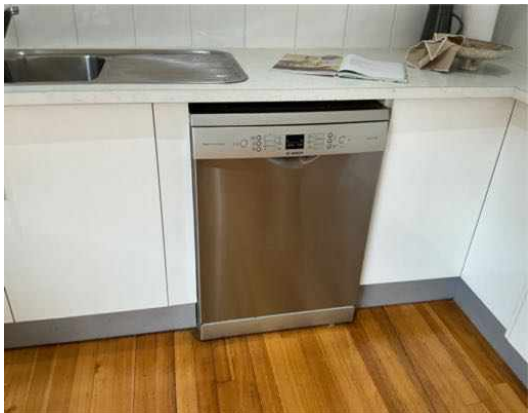
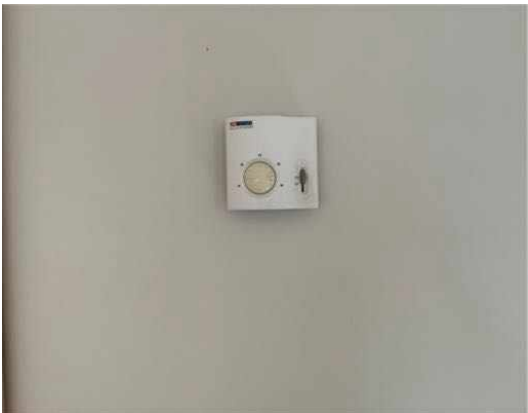
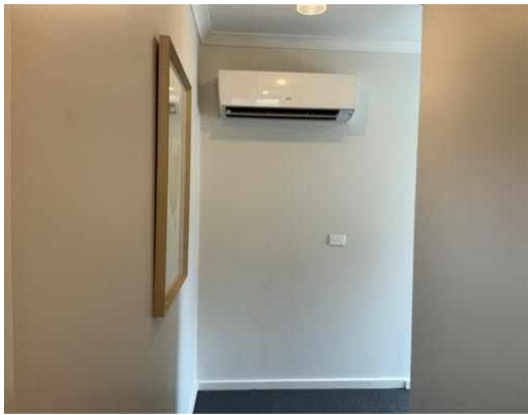
Building: Main Building
Location: All Appliances
Finding: Warranty - Expired
Information: Where appliances are beyond their warranty period, the owner should be prepared to meet the cost of replacement or repair of the item at any time. The operation of the appliance can not be guaranteed and further inspection by an appropriately qualified tradesperson may be required.
