Building Inspection Report

Inspection Date: Tue, 24 Feb 2026

Property Address: 23 Munro Ave, Cheltenham VIC 3192,
Australia

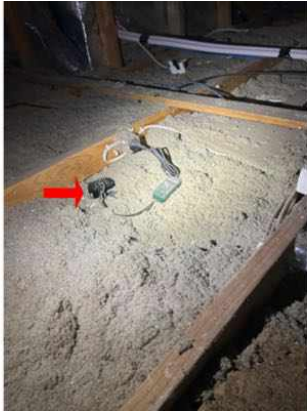
Defects 1.05

Building: Main Building
Location: All Areas
Finding: Insulation - Covering downlights
Information: Sections of insulation in the roof void have been poorly installed or moved from their original position and are covering down light fittings. While the down lights have been fitted with appropriate protective covers, the presence of this insulation creates a potential fire hazard.

Unless the lighting manufacturer has approved that insulation can be installed over their lighting fixtures.

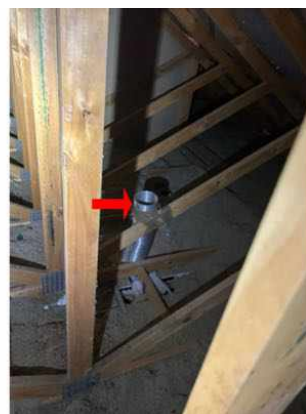
Defects 3.08

surrounding area within the ceiling void, which can pose as a fire hazard in the roof void. The presence of insulation surrounding the flue adds to this fire safety risk.

Without re-direction to the exterior of the building, the Rangehood is not considered fully operational and is deemed a minor safety hazard. It is therefore preferable that the flue be re-directed to vent into the external environment. A licensed plumber should be appointed as soon as possible to provide further consultation on the scope of these works and to provide quotations for any necessary works.

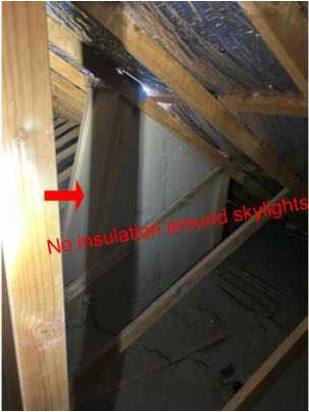
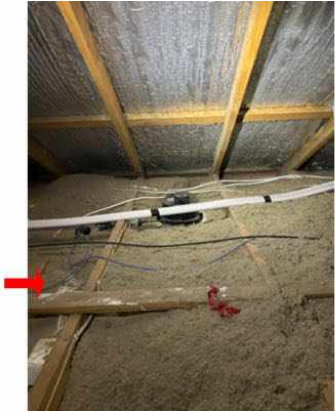
Defects 3.09

Building:	Main Building
Location:	All Areas
Finding:	Insulation - Inadequate
Information:	Upon inspection of the roof void it was noted that there is a lack of adequate insulation.

The level of insulation in the property does not meet current Australian Standards. Installation of adequate insulation is required and should be conducted as soon as possible.

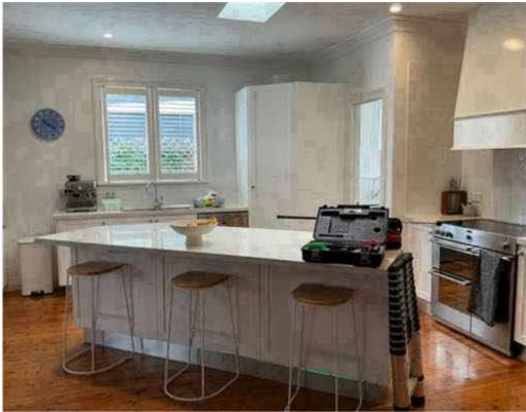
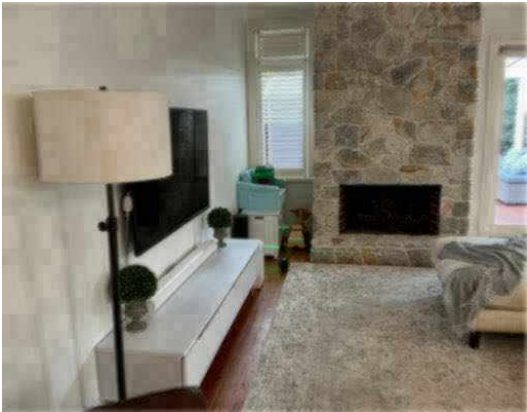
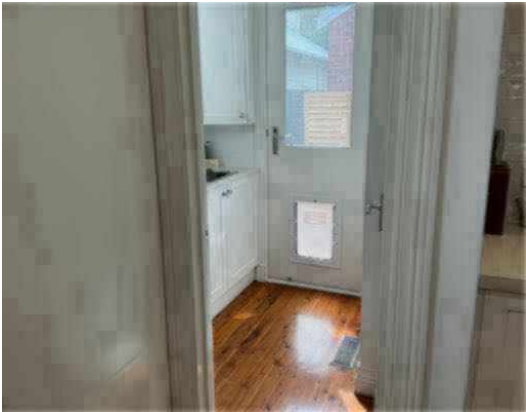
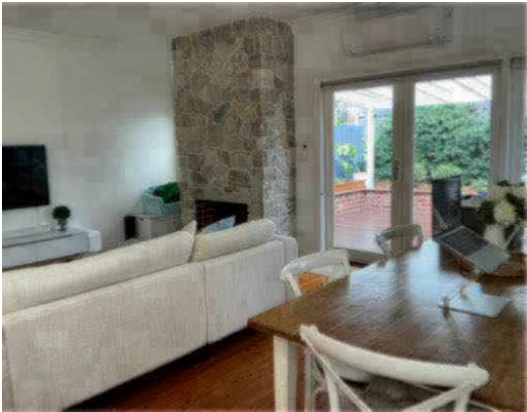
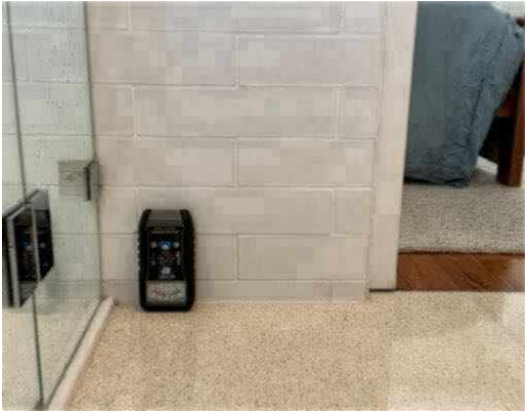
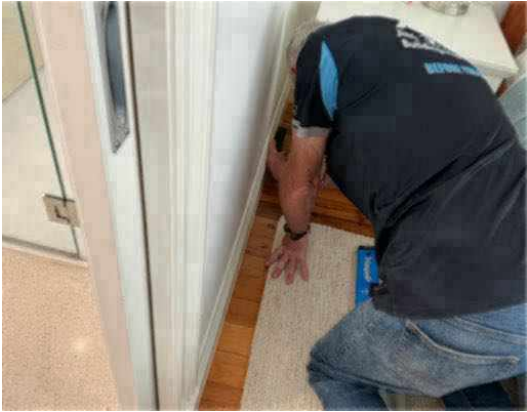
Building: Main Building
Location: All Areas
Finding: Additional Photos - Obstructions and Limitations
Information: These photographs are an indication of the obstructions and limitations which impeded full inspection of the property at the time of inspection. These obstructions can hide an array of defects and should be removed to allow full inspection to be carried out. A re-inspection is recommended once the areas are made accessible.

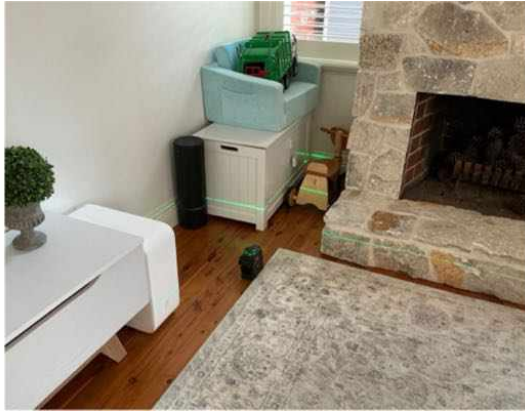
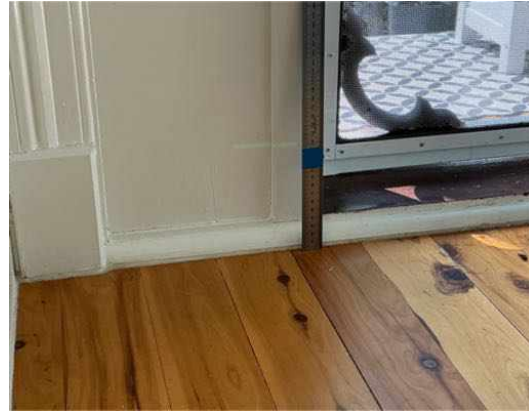
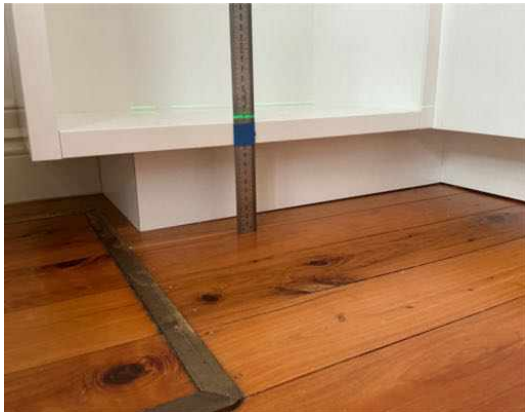
Finding: Additional Photos
Information: Floor levels were taken and found to be within tolerance at the time of inspection
Additional photos are provided for your general reference

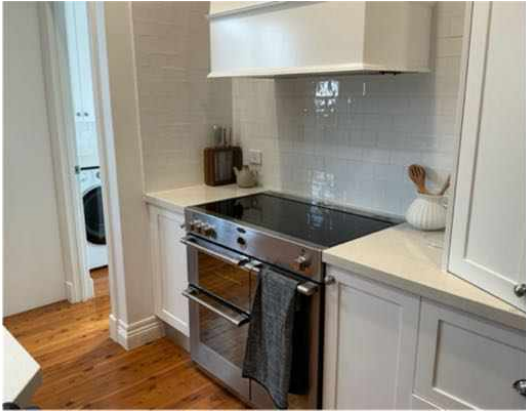
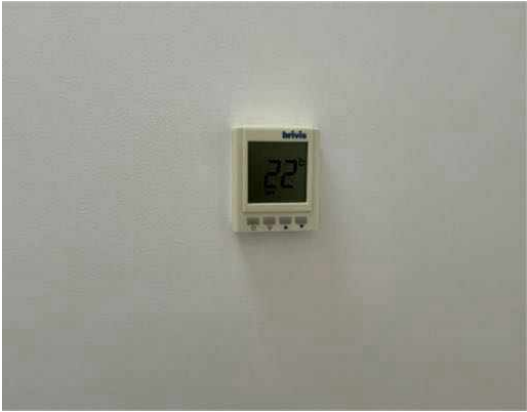
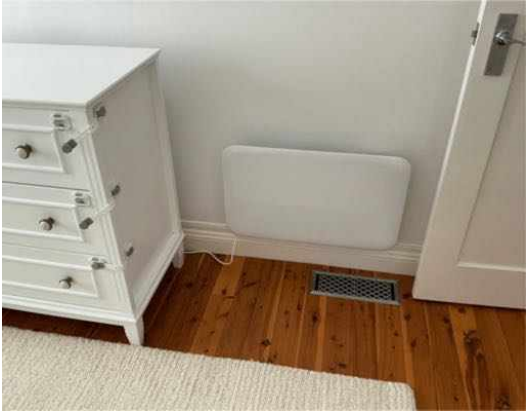
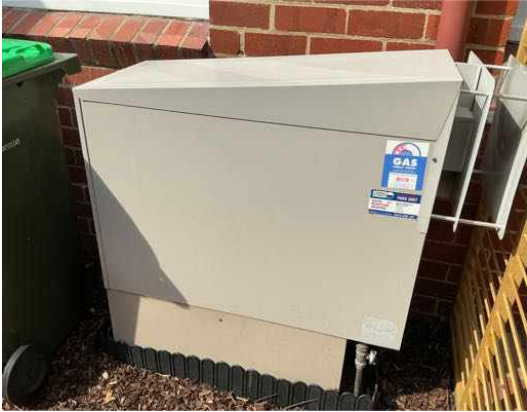
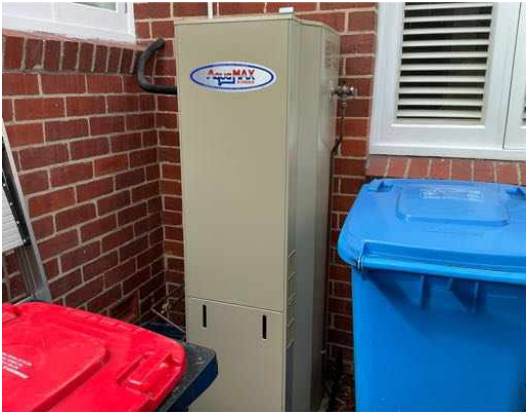
Building: Main Building
Location: Appliances
Finding: Warranty - Expired
Information: Where appliances are beyond their warranty period, the owner should be prepared to meet the cost of replacement or repair of the item at any time. The operation of the appliance can not be guaranteed and further inspection by an appropriately qualified tradesperson may be required.

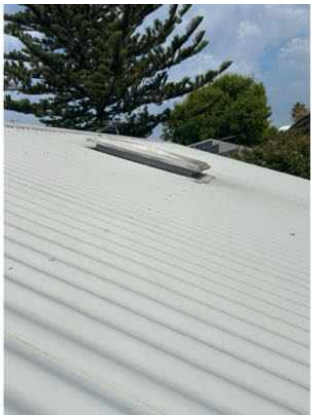
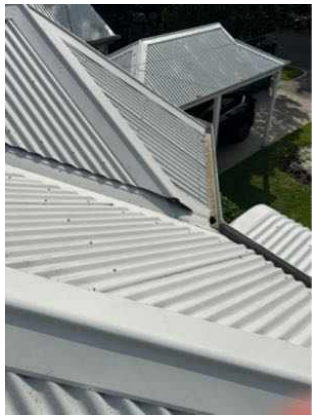
Building: Main Building
Location: All Areas
Finding: Additional Photos - Obstructions and Limitations
Information: These photographs are an indication of the obstructions and limitations which impeded full inspection of the property at the time of inspection. These obstructions can hide an array of defects and should be removed to allow full inspection to be carried out. A re-inspection is recommended once the areas are made accessible.

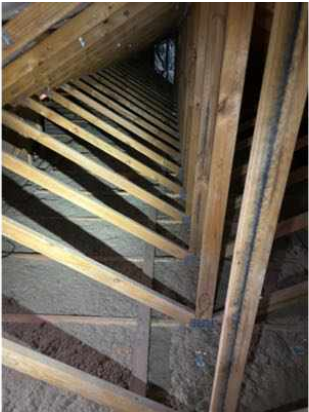
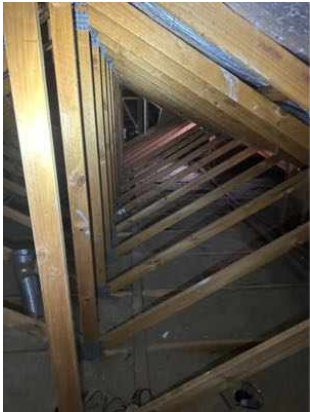
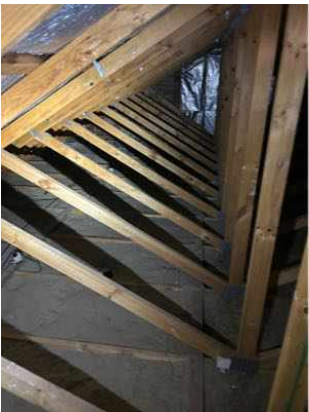
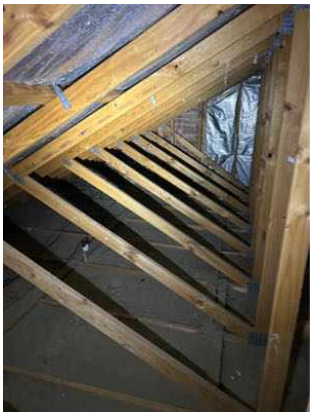
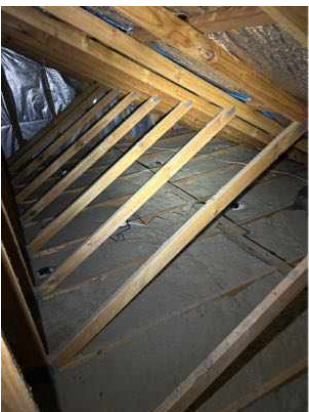
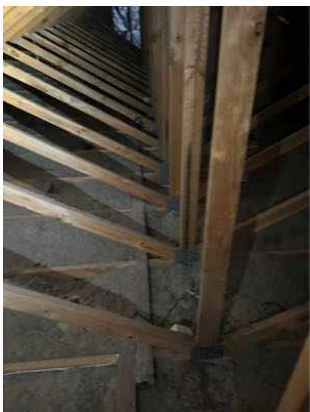
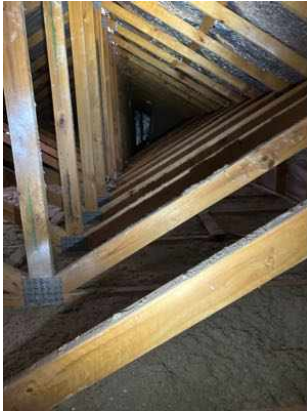
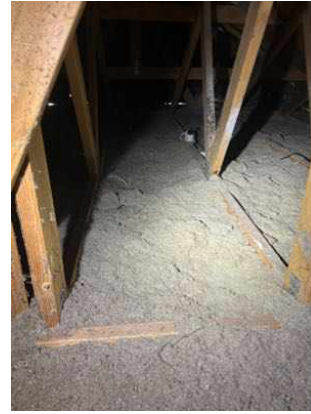
Building: Main Building
Location: All Areas
Finding: Additional Photos - Obstructions and Limitations
Information: These photographs are an indication of the obstructions and limitations which impeded full inspection of the property at the time of inspection. These obstructions can hide an array of defects and should be removed to allow full inspection to be carried out. A re-inspection is recommended once the areas are made accessible.

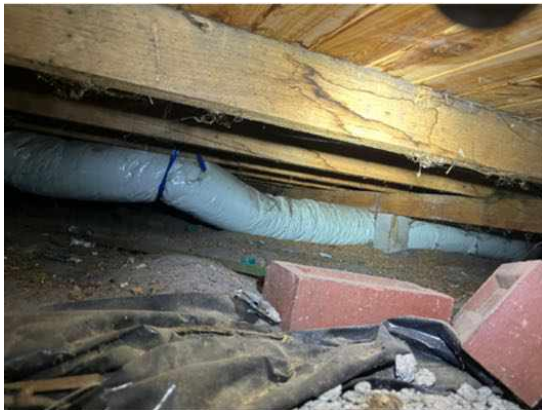
Finding: Additional Photos - Obstructions and Limitations

Information: These photographs are an indication of the obstructions and limitations which impeded full inspection of the property at the time of inspection. These obstructions can hide an array of defects and should be removed to allow full inspection to be carried out. A re-inspection is recommended once the areas are made accessible.
