Building Inspection Report

Inspection Date: Tue, 10 Feb 2026

Property Address: U6 341 Princes Hwy, Albion Park Rail NSW
2527, Australia

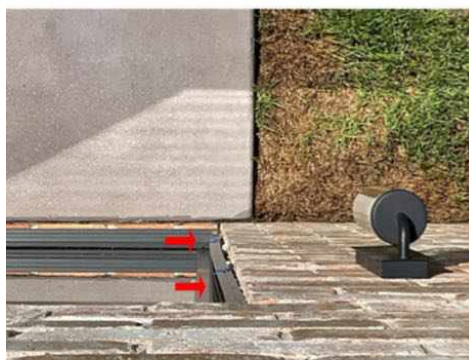
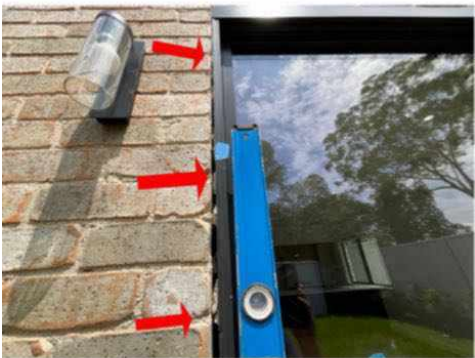
Defects 3.01

Building: Building 1
Location: Lounge Room door
Finding: Sliding door and track damaged
Information: These pictured large rear door is bent 20mm over 2 metres and the internal track is also bent.

This door appears to require replacement prior to purchase with effective sealing to all external perimeter areas due to the damage found.

This should be brought to the attention of the builder.

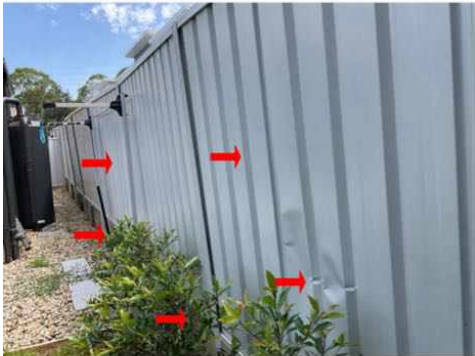
Defects 3.02

Building: Building 1
 Location: Pictured fences and small retaining wall
 Finding: Fences and retaining wall damaged and leaning
 Information: Evidence of damage to the pictured fences and lower rear retaining wall was identified at the time of the inspection. The likely cause of the leaning retaining wall and fence is not enough concrete used in the post footings. If left unmanaged this fence and wall will deteriorate further.

It is suggest a fencing contractor be engaged for rectification. This should be brought to the attention of the builder for rectification.

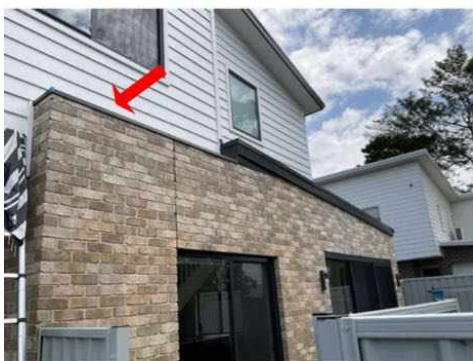
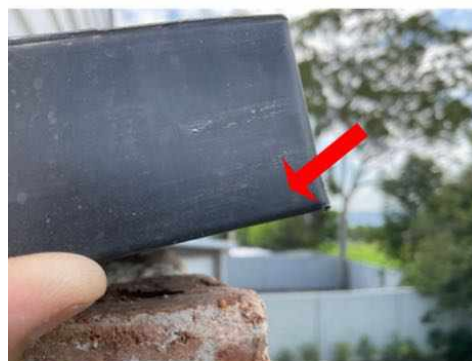
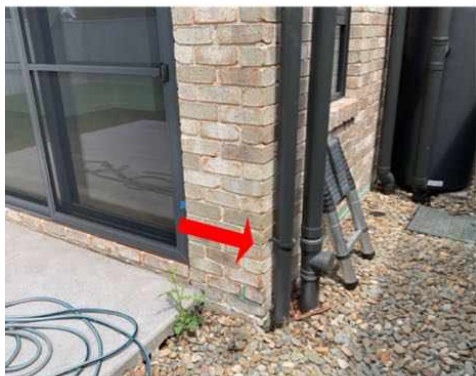
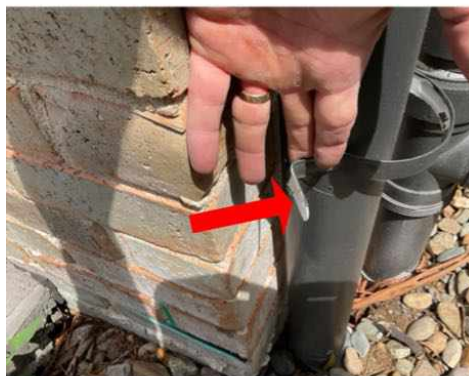
Defects 3.03

The rear flashing has no fixings to most of its length and the rear downpipe bracket is loose.

The flashing and downpipe need additional fixings to ensure their longevity. This flashing may be dislodged in large winds resulting in flooding internal areas.

This needs to be brought to the attention of the builder.

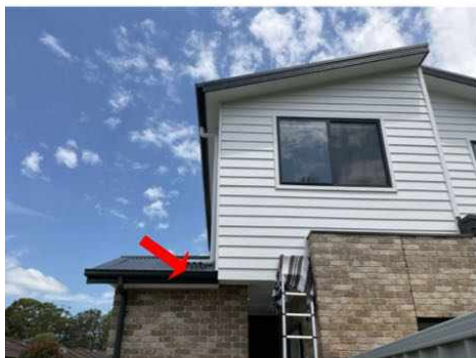
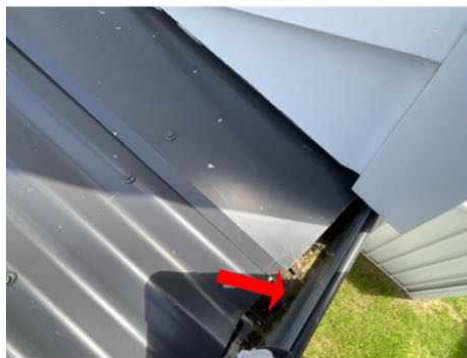
Defects 3.04

Building: Building 1
 Location: Front gutter
 Finding: Roof plumbing - Insufficient fall
 Information: There is an insufficient fall in the roof gutter, which means that the angle is inadequate to facilitate movement of rainwater. This is resulting in pooling of water in the area, creating the potential for water damage to associated building elements.

Without adequate roof drainage, premature rust and decay of the roof plumbing structures is imminent. The development of such deterioration is likely to lead to the formation of secondary defects to adjoining wall sections and roofing elements.

Adjustment by a roofing plumber is required.

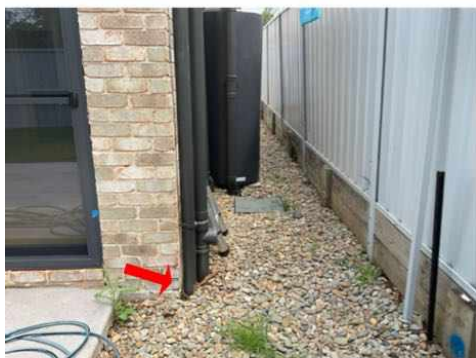
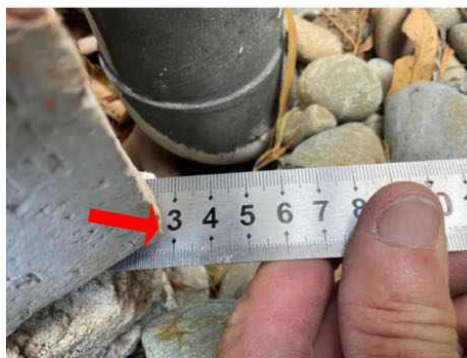
Defects 3.05

Building: Building 1
 Location: Rear wall corner area
 Finding: Masonry overhanging concrete slabs
 Information: The rear wall corner overhangs the slab by 30mm.

‘ A masonry course is defective if it is laid on a concrete slab or strip footing so as to project over the edge of the slab or footing by more than 15mm ‘

This needs to be brought to the attention of the builder for rectification.

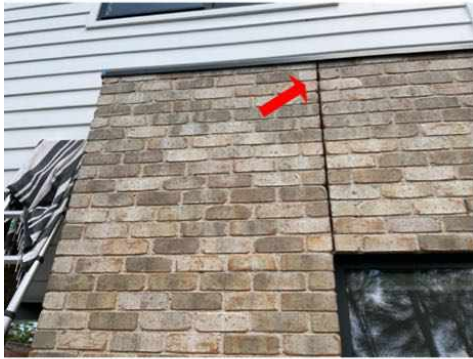
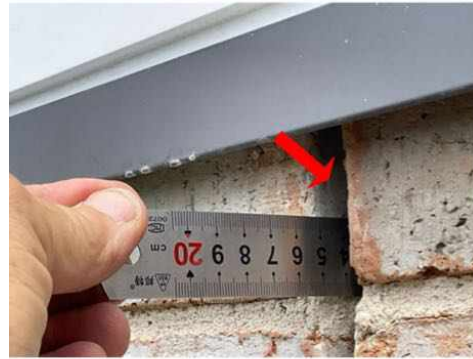
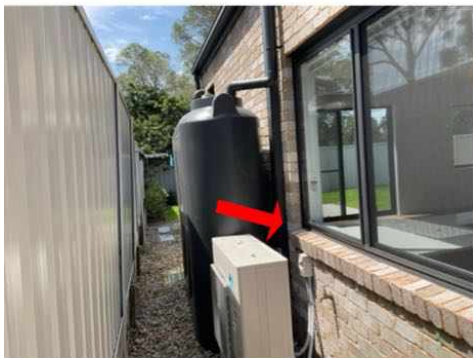
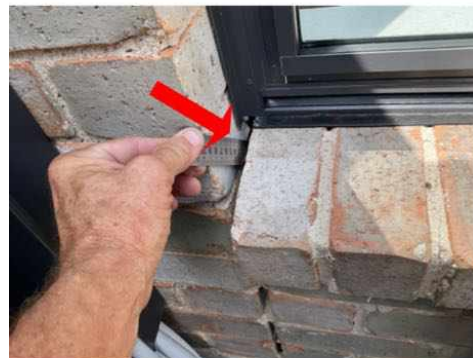
Defects 3.06

Building: Building 1
 Location: Rear wall areas
 Finding: Expansion strip - Missing (AS1720)
 Information: Parts of the expansion strips have not been installed in the control joints in these areas. Although some building elements may seem, irrelevant or unnecessary, all elements play a key role in the operation and function of the overall structure and its performance.

Where expansion strips are missing, an entry point for vermin, termites and other pests is created. Excessive moisture is also likely to accumulate in this area, making the control joint susceptible to water damage.

Expansion strips should be installed prior to purchase. Failure to install these building elements is non-compliant with AS1720 Timber Structures.

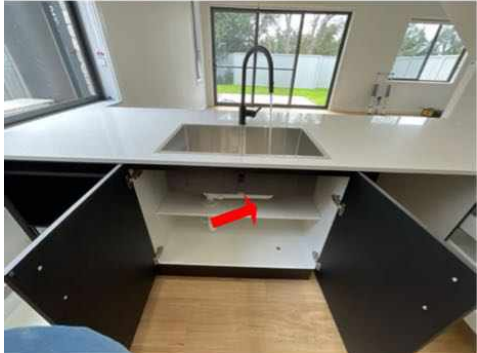
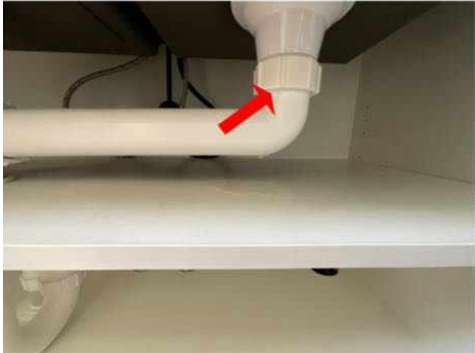
Defects 3.09

Building: Building 1
Location: Kitchen sink
Finding: Water leaks - Active
Information: Water leaks were found in the kitchen sink. Regardless of the location, even minor leaks that are left unmanaged can lead to serious damage of associated building elements and result in the need for replacement of building materials.

This should be brought to the attention of the builder.

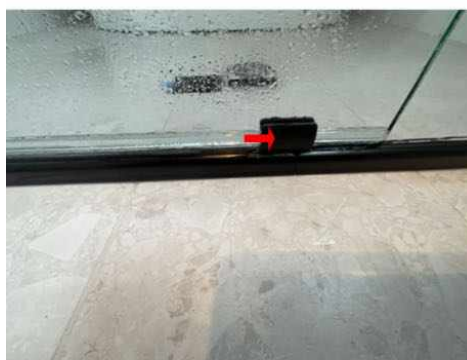
Defects 3.10

Building: Building 1
 Location: Upstairs bathroom
 Finding: Shower screen - Leaking
 Information: Leaking was evident to the ensuite shower screen through the hinge at the time of inspection. Leaking from the shower , where left unattended, is likely to lead to water damage to adjoining flooring and walls. Such damage can lead to water damage and necessitate extensive remedial works being required. Active water leaks may also create an environment that is susceptible to the formation and development of mould.

Appointment of a sealant expert is required by the builder.

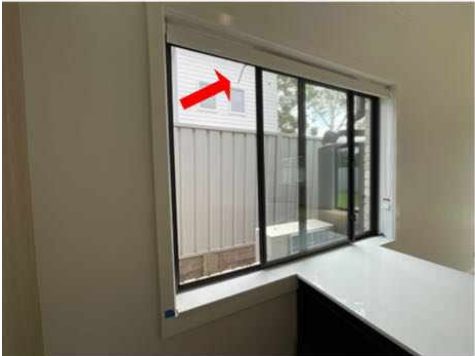
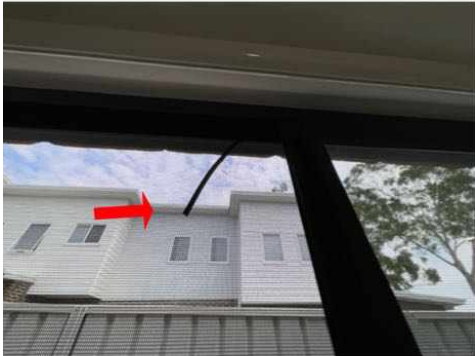
Defects 3.11

Building: Building 1
 Location: Kitchen window
 Finding: Window weather seals
 Information: Upon inspection of the kitchen window, it was noted that weather seals have become detached or moved from the window frames.

Without adequate sealing, rainwater is likely to seep into these areas and create moisture problems and other secondary defects.

These seals need to be repaired as soon as possible. This needs to be brought to the

attention of the builder.

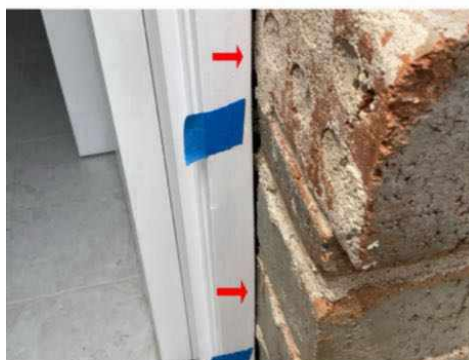
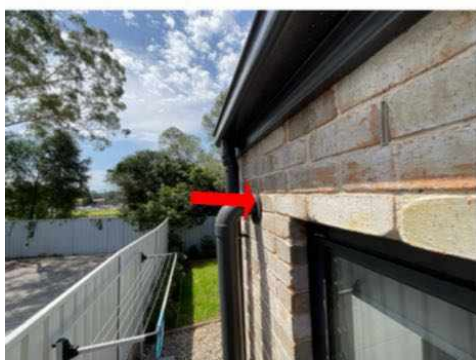
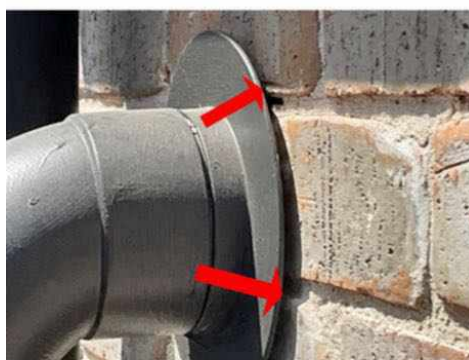
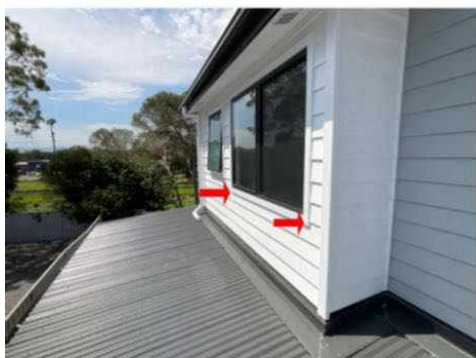
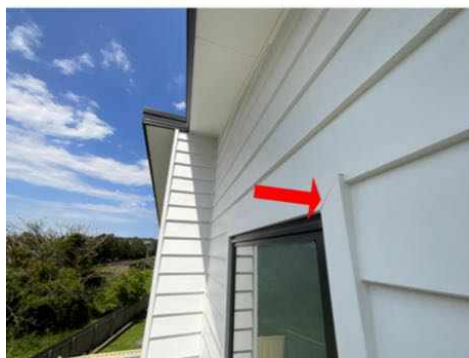
Defects 3.13

Building:	Building 1
Location:	Garage, laundry, window areas, tank pipes
Finding:	Sealant in External areas - The NSW Standards and Tolerances 2017 - 12.7
Information:	It was noted on inspection that sealant is missing or damaged to the entry, garage, front balcony, and other areas on the external walls. The right side of the main entry door and the area between the front driveway and porch are of substandard construction and require rectification works to fill gaps. The left side wall has gaps in architraves and cladding.

Flexible or waterproof sealants to junctions are defective if they are not installed

when required by the BCA and AS 3958.1.

All holes, gaps or cracks should be adequately filled by a suitable sealant or trimmings as soon as possible to prevent any water damage that may occur.

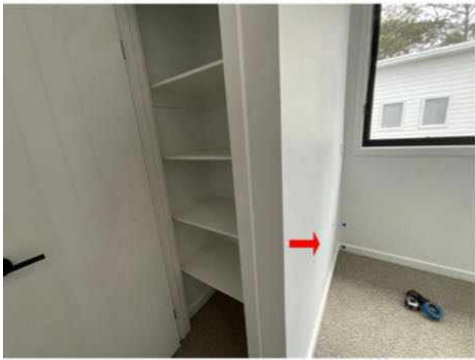
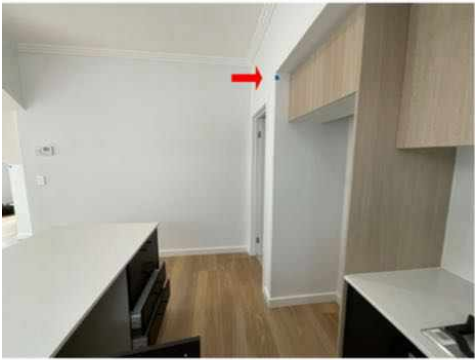
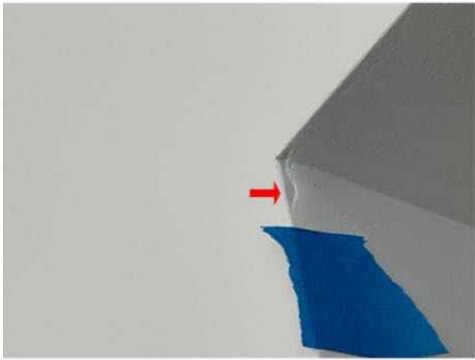
Defects 3.14

Building: Building 1
 Location: Marked up internal areas
 Finding: Paintwork defective - NSW Guide to standards and tolerances part 13.2
 Information: Several areas of substandard paint finishes were identified on the building at the time of the inspection.

Paintwork is defective if the application has blemishes such as paint runs, paint sags, wrinkling, dust, bare or starved painted areas, colour variations, surface cracks, irregular and coarse brush marks, sanding marks, blistering, non-uniformity of gloss level and other irregularities in the surface that are visible from a normal viewing position. Paintwork is defective if the application results in excessive over-painting of

fittings, trims, skirtings, architraves, glazing and other finished edges.

These areas need to be brought to the attention of the builder.

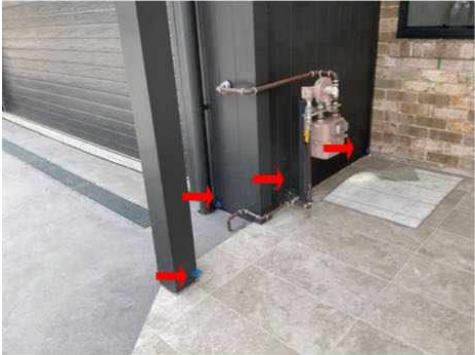
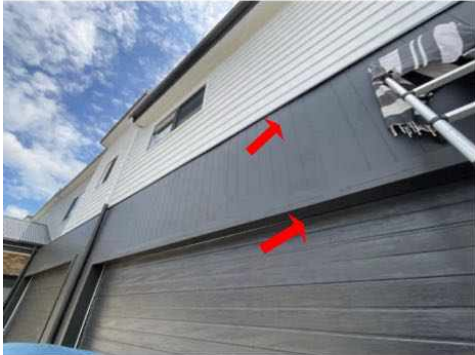
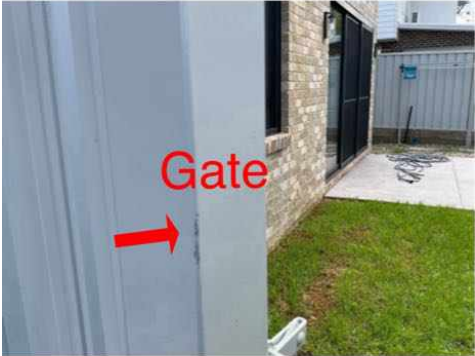
Defects 3.15

Building:	Building 1
Location:	Pictured external areas
Finding:	Paintwork defective - NSW Guide to standards and tolerances part 13.2
Information:	Several areas of substandard external paint finishes were identified on the building at the time of the inspection.

These areas need to be brought to the attention of the builder.

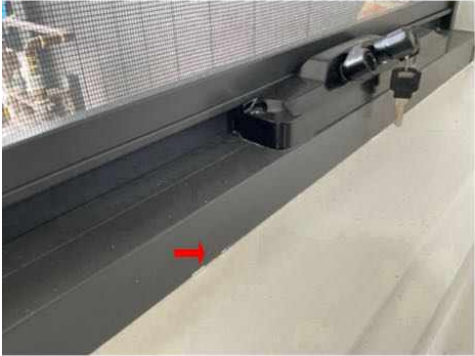
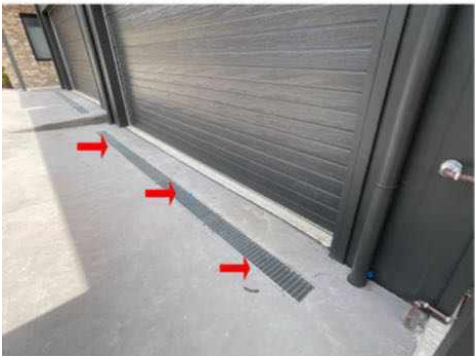
Defects 3.16

Building: Building 1
Location: Many external and internal areas marked by tape at the time of the inspection
Finding: Cleaning of building elements - NSW Standards and Tolerance 2017 - 3.11
Information: It was observed that many building elements including most windows, door hinges, floor wastes and other areas are not cleaned and ready for use.

The NSW Standards and Tolerances 2017 - 3.11 state - Cleaning, mortar smears and stains

“Stains, mortar smears and damage caused by cleaning are defective if they are visible from a normal viewing position.”

These areas need to be cleaned and ready for use.

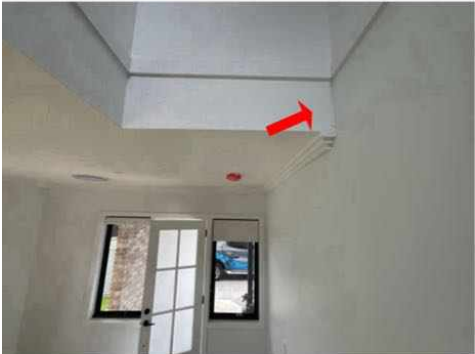
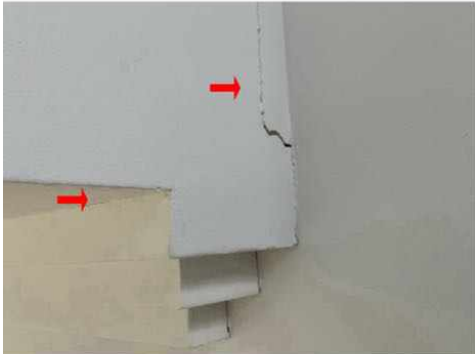
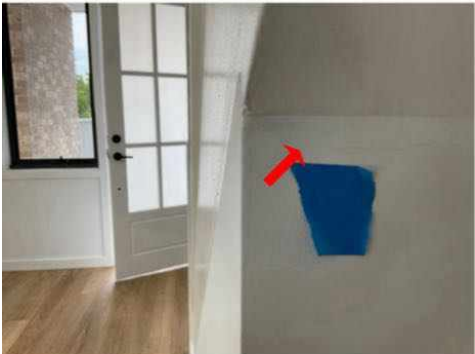
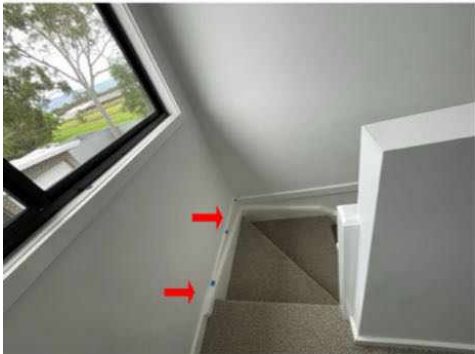
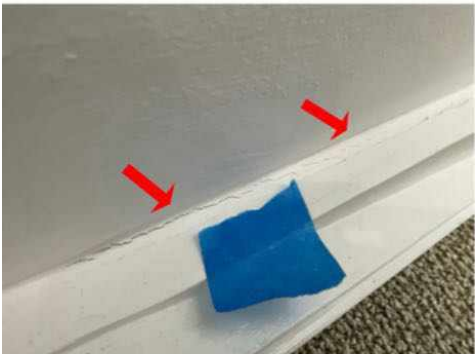
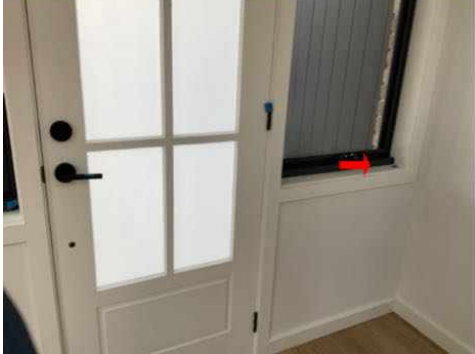
Defects 3.17

Building:	Building 1
Location:	Pictured areas
Finding:	Gaps or cracks in mouldings
Information:	Gaps were found in the mouldings in these areas.

Unless documented otherwise, gaps between mouldings or between mouldings and other fixtures, at mitre or butt joints, or at junctions with a wall or other surfaces, are defective if they exist at handover, or exceed 1 mm in width within the first 12 months of completion and are visible from a normal viewing position.

This should be brought to the attention of the builder.

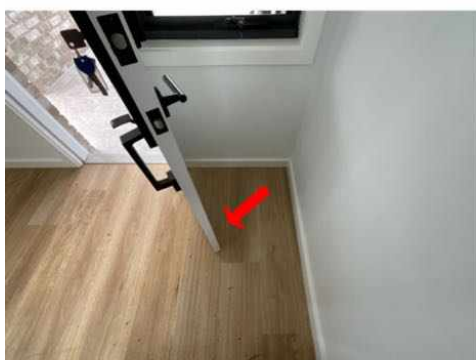
Defects 3.19

Building: Building 1
Location: Internal Areas
Finding: Door stops - Missing
Information: These areas are missing door stops. These areas required to stop the doors from damaging the wall/ toilet. Although some building elements may seem irrelevant or unnecessary, all building elements play a key role in the operation and function of the overall structure and its performance.

Installation of the door stops is advised as soon as possible to prevent any subsequent damage.

This should be brought to the attention of the builder.

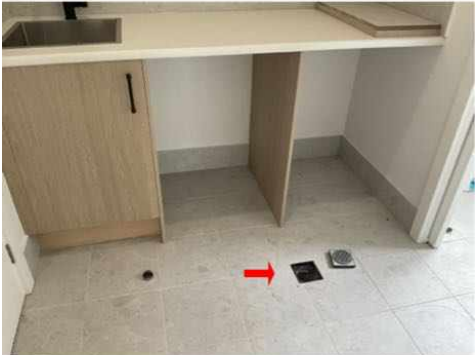
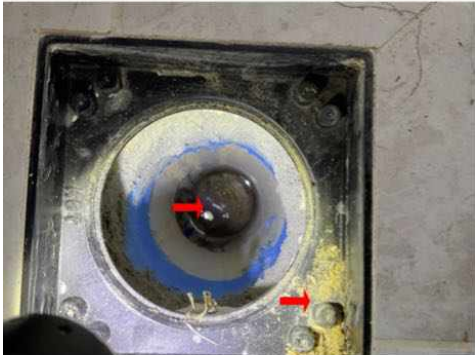
Defects 3.21

Building: Building 1
Location: Bathroom, laundry, front gutters
Finding: Building waste in drains and gutters
Information: Builders waste was found inside floor wastes and gutters at the time of the inspection. Builders waste left in these areas has the potential to interrupt the normal function of these drains and may lead to blockages and flooding of surrounding areas. These areas need to be brought to the attention of the builder.

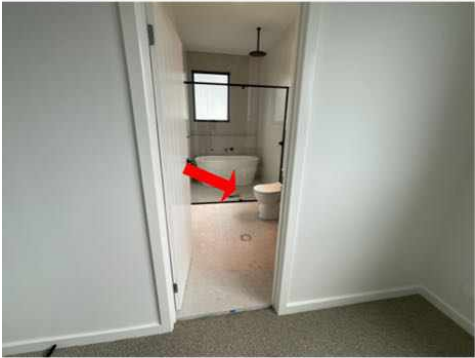
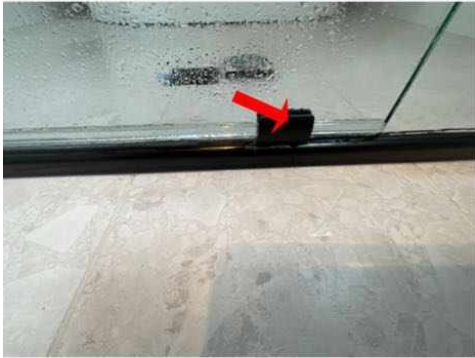
Defects 3.22

Building: Main Building
Location: Internal Areas
Finding: Shower screen - Leaking
Information:

Leaking was evident to the shower screening at the time of inspection. It is suspected that the leaking has occurred as a result missing sealant. Leaking from the shower , where left unattended, is likely to lead to water damage to adjoining flooring and walls. Such damage can lead to water damage and necessitate extensive remedial works being required. Active water leaks may also create an environment that is susceptible to the formation and development of mould.

Appointment of a sealant expert is required to repair or replace this missing sealant. These areas need to be brought to the attention of the builder.

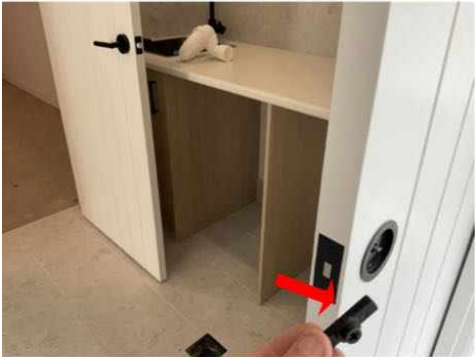
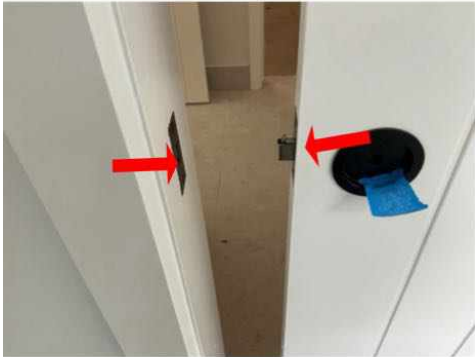
Defects 3.23

Building: Building 1
Location: Toilet (WC) - 2 and porch gas cover
Finding: Door handle loose & may not latch & gas cover loose
Information: The door handle and gas covers in these areas was found to be loose at the time of the inspection. Repair then testing of this door latch is advised to improve the operational state of the associated door. Fixing the gas covers to the wall is also required.

These areas need to be brought to the attention of the builder.

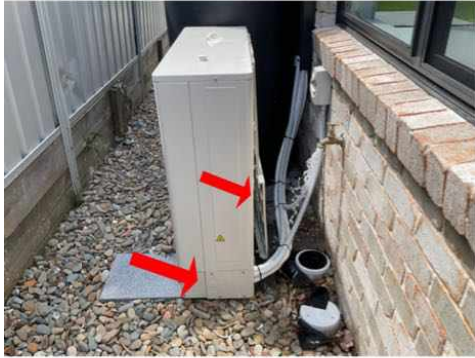
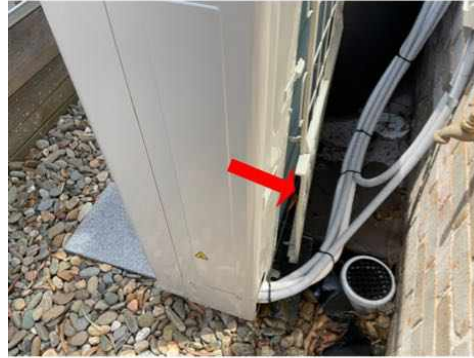
Defects 3.25

Building:	Building 1
Location:	Rear wall area
Finding:	Air conditioner - Loose

Information: The air conditioner and AC rear cover are loose, moving and require additional fixings to ensure their longevity.

If left unmanaged, the unit may further deteriorate and the cover may break off, causing potential for the development of other minor secondary defects.

These areas need to be brought to the attention of the builder.

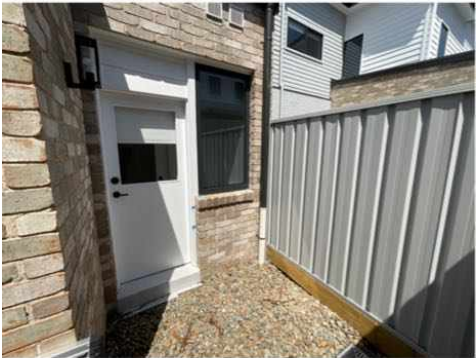
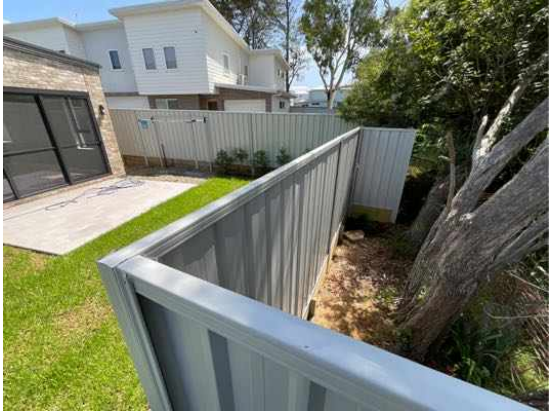
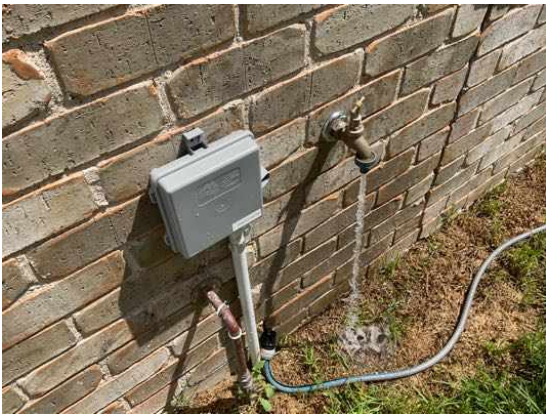
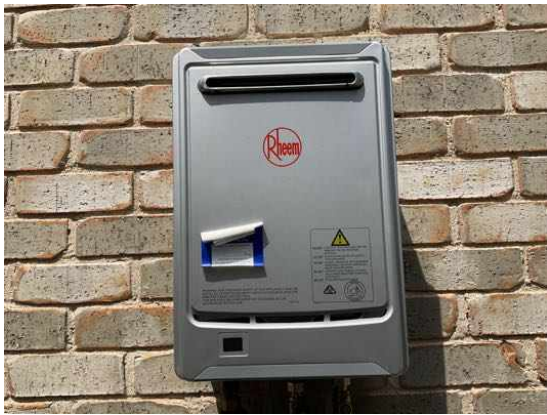
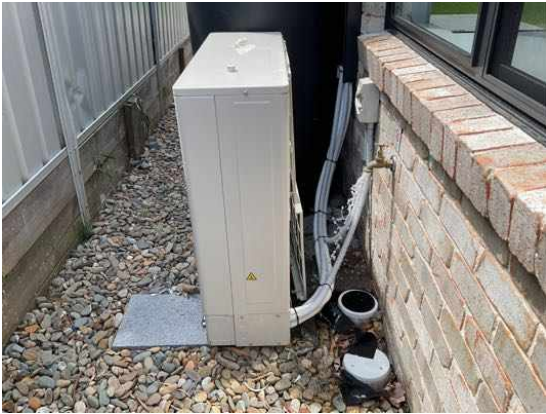
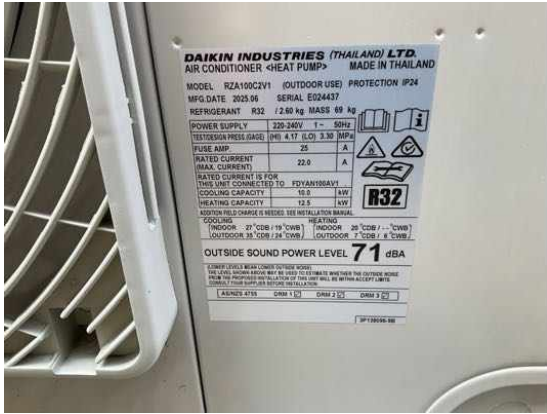
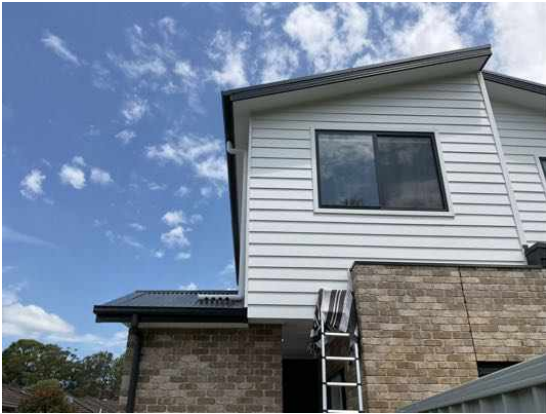
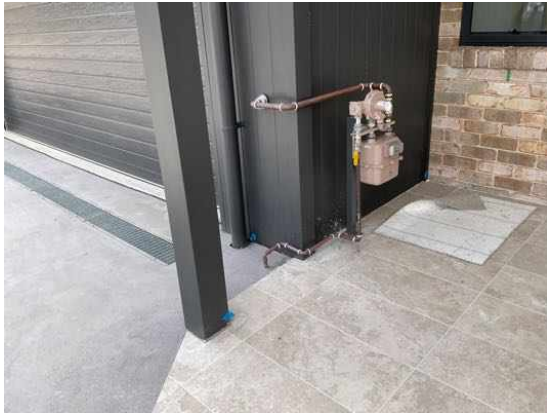
Building: Building 1
Location: External Areas
Finding: Additional Photos
Information: Additional photos are provided for your general reference

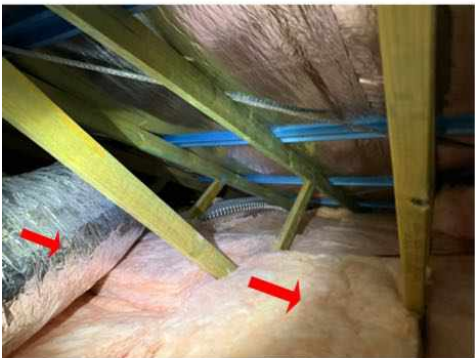
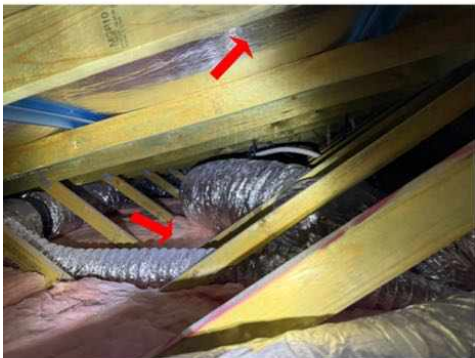
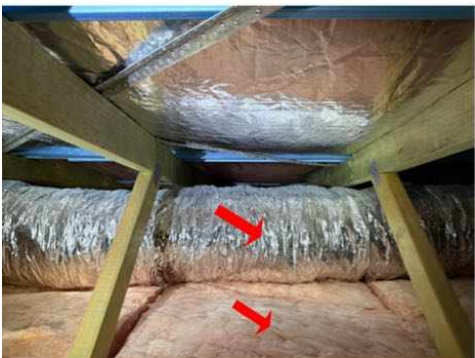
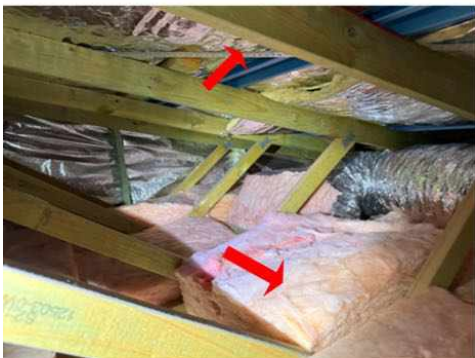
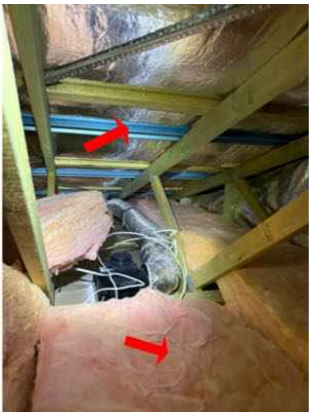
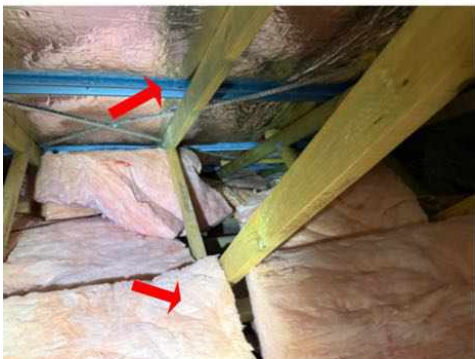
Building: Building 1
 Location: Roof Void
 Finding: Additional Photos - Obstructions and Limitations of the ROOF CAVITY
 Information: These photographs are an indication of the obstructions and limitations which impeded full inspection of roof cavity areas at the time of inspection. These obstructions can hide an array of defects and should be removed to allow full inspection to be carried out if applicable. A re-inspection is recommended once the areas are made accessible.
